Road Inventory and Condition Assessment of Paved Routes Cape Hatteras National Seashore

**Federal Lands Highway
Road Inventory Program**

**Federal Highway Administration
Eastern Federal Lands Highway Division
Road Inventory Program (RIP)**

Report Date: March 2022

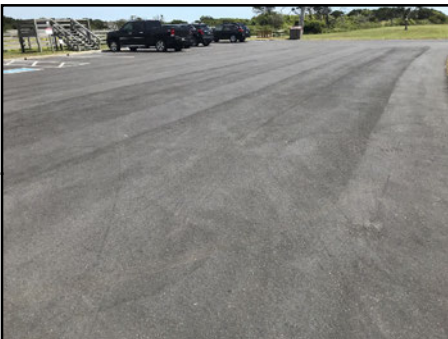
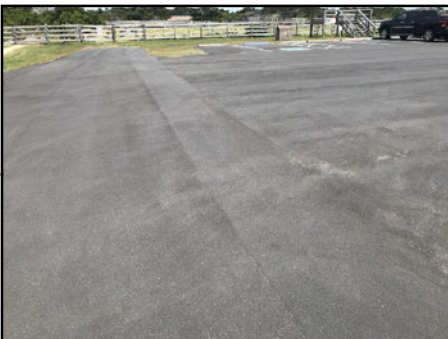
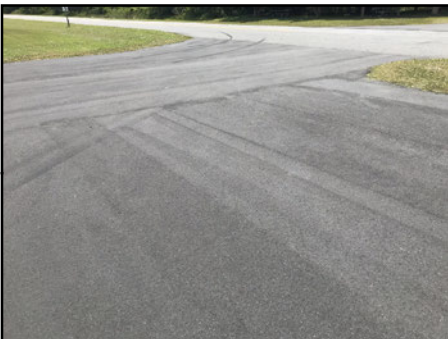
ROUTE 0929AZ: OI RD PONY PEN ACCESS A PARKING

Inspection Date	FMSS Number	User Access	Surface Type
5/7/2021	29745	PUBLIC	ASPHALT
Area (Sq. Ft.)	Lane Miles (11' Widths)	Curb Reveal (Inches)	Curb Recommendation
10,777	0.186	NOT APPLICABLE	NOT APPLICABLE
Curb Type		Curb & Gutter Type	
NO CURB		NO CURB AND GUTTER	
Pavement Recommendation		Condition Rating / PCR	
PREVENTIVE MAINTENANCE		GOOD / 90

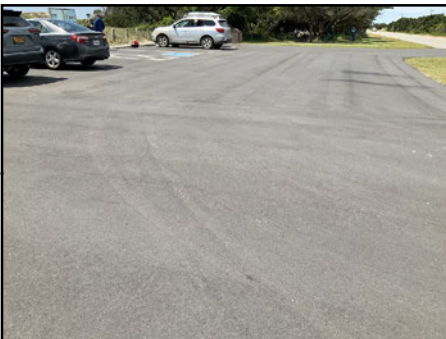
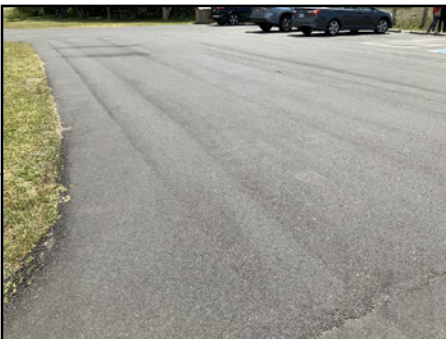
Inspection Date	FMSS Number	User Access	Surface Type
5/7/2021	29745	PUBLIC	ASPHALT
Area (Sq. Ft.)	Lane Miles (11' Widths)	Curb Reveal (Inches)	Curb Recommendation
6,163	0.106	NOT APPLICABLE	NOT APPLICABLE
Curb Type		Curb & Gutter Type	
NO CURB		NO CURB AND GUTTER	
Pavement Recommendation		Condition Rating / PCR	
PREVENTIVE MAINTENANCE		GOOD / 90

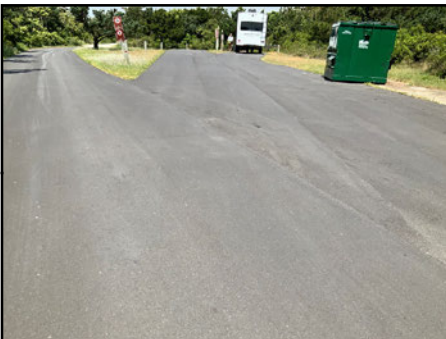
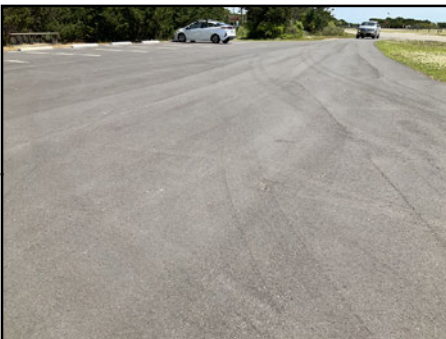
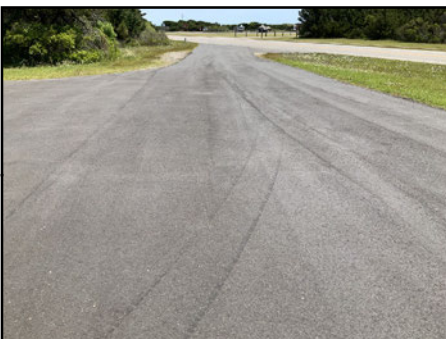
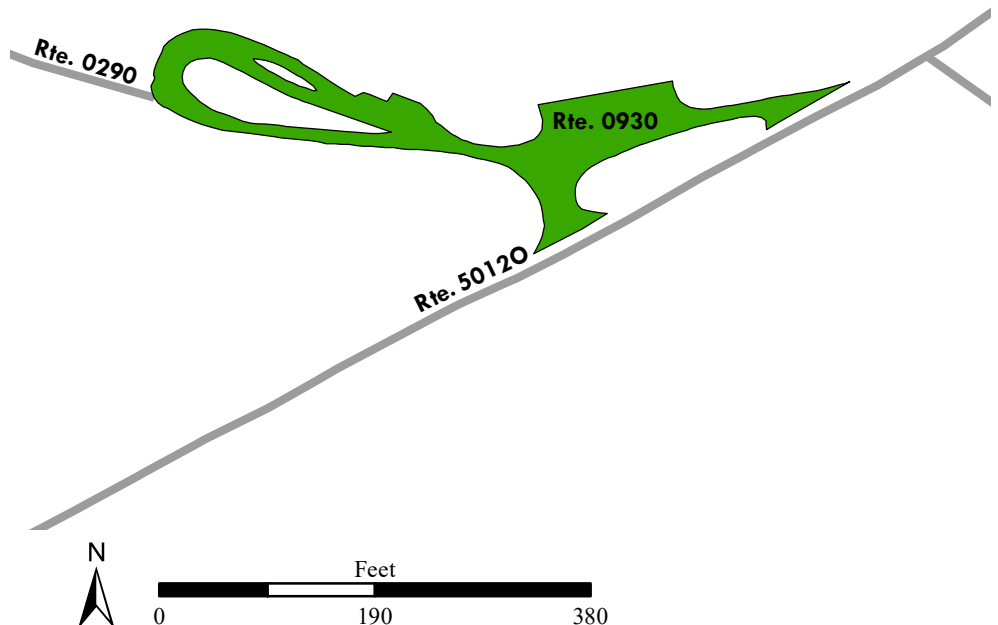
ROUTE 0930: OI RD DUMP STATION / HAMMOCK HILL

Inspection Date	FMSS Number	User Access	Surface Type
5/7/2021	29714	PUBLIC	ASPHALT
Area (Sq. Ft.)	Lane Miles (11' Widths)	Curb Reveal (Inches)	Curb Recommendation
19,178	0.33	NOT APPLICABLE	NOT APPLICABLE
Curb Type		Curb & Gutter Type	
NO CURB		NO CURB AND GUTTER	
Pavement Recommendation		Condition Rating / PCR	
PREVENTIVE MAINTENANCE		GOOD / 90

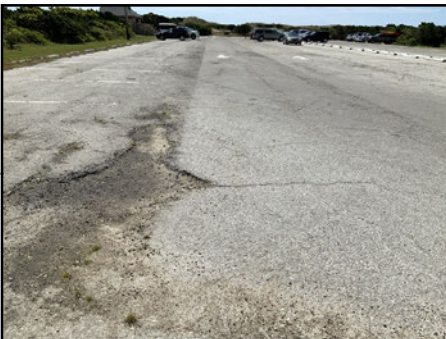
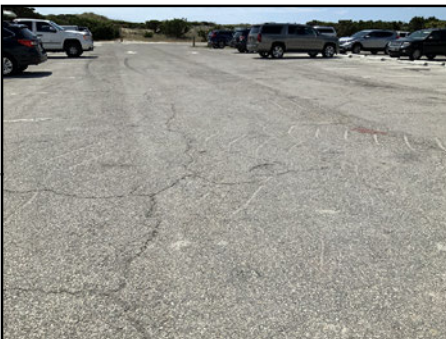
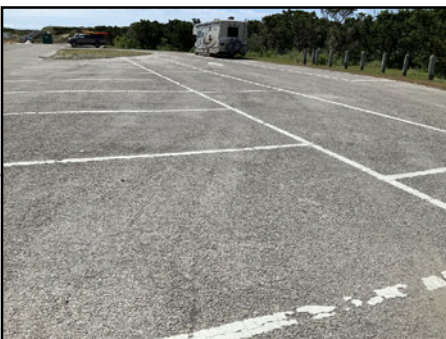
ROUTE 0931: OI RD OCRACOKE DAY USE PARKING

Inspection Date	FMSS Number	User Access	Surface Type
5/7/2021	29694	PUBLIC	ASPHALT
Area (Sq. Ft.)	Lane Miles (11' Widths)	Curb Reveal (Inches)	Curb Recommendation
47,740	0.822	NOT APPLICABLE	NOT APPLICABLE
Curb Type		Curb & Gutter Type	
NO CURB		NO CURB AND GUTTER	
Pavement Recommendation		Condition Rating / PCR	
RECONSTRUCTION		POOR / 30

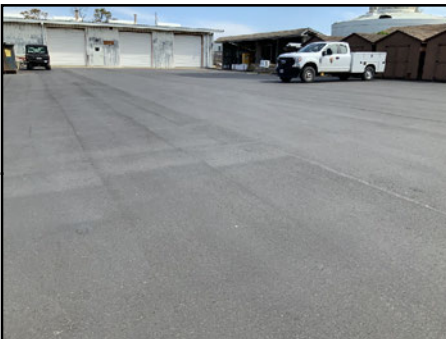
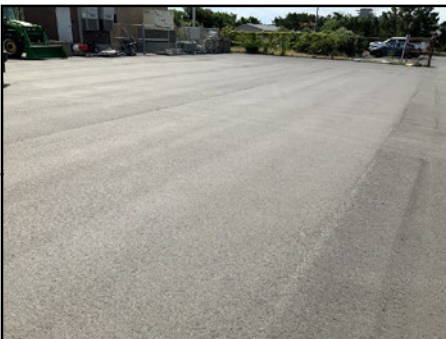
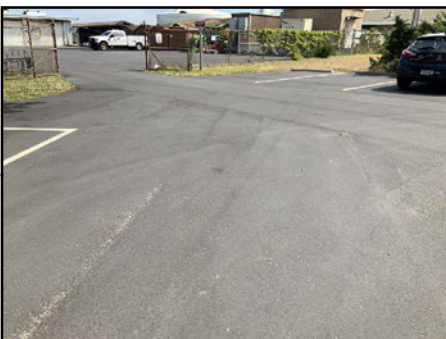
ROUTE 0932: OI RD OCRACOKE MAINTENANCE PARKING

Inspection Date	FMSS Number	User Access	Surface Type
5/7/2021	29659	NONPUBLIC	ASPHALT
Area (Sq. Ft.)	Lane Miles (11' Widths)	Curb Reveal (Inches)	Curb Recommendation
26,490	0.456	NOT APPLICABLE	NOT APPLICABLE
Curb Type		Curb & Gutter Type	
NO CURB		NO CURB AND GUTTER	
Pavement Recommendation		Condition Rating / PCR	
PREVENTIVE MAINTENANCE		GOOD / 90

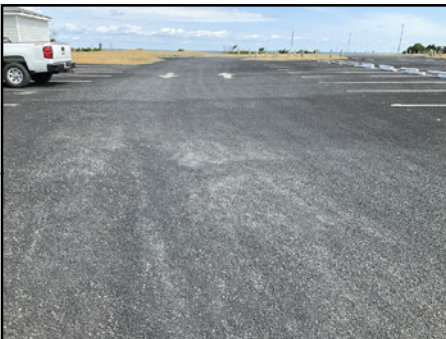
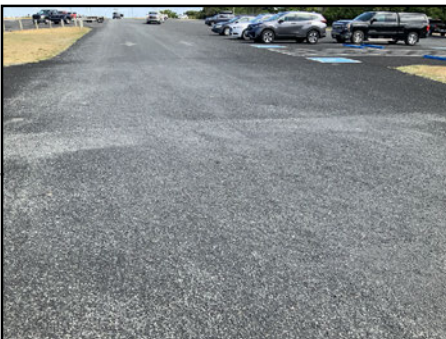
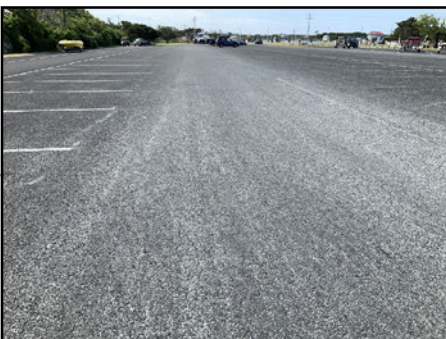
ROUTE 0933: OI RD OCRACOKE BOAT RAMP ACCESS AND PARKING

Inspection Date	FMSS Number	User Access	Surface Type
5/7/2021	29271	PUBLIC	ASPHALT
Area (Sq. Ft.)	Lane Miles (11' Widths)	Curb Reveal (Inches)	Curb Recommendation
120,487	2.075	8	DO NOTHING
Curb Type		Curb & Gutter Type	
WOOD		NOT APPLICABLE	
Pavement Recommendation		Condition Rating / PCR	
LIGHT 3R TREATMENTS		FAIR / 73

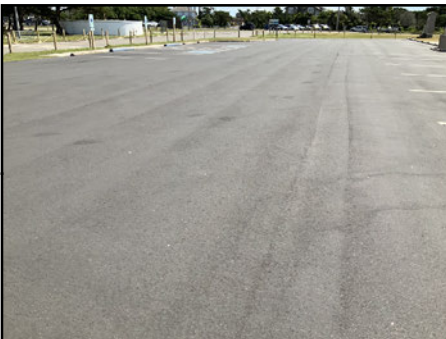
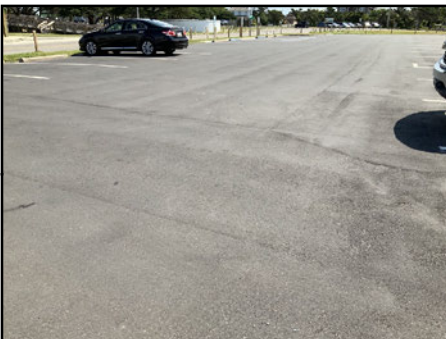
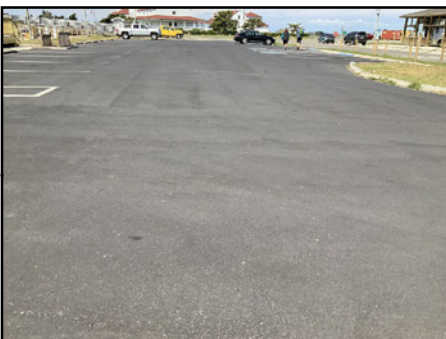
ROUTE 0934: OI RD OCRACOKE VISITOR CENTER ACCESS AND PARKING

Inspection Date	FMSS Number	User Access	Surface Type
5/7/2021	29208	PUBLIC	ASPHALT
Area (Sq. Ft.)	Lane Miles (11' Widths)	Curb Reveal (Inches)	Curb Recommendation
11,421	0.197	NOT APPLICABLE	NOT APPLICABLE
Curb Type		Curb & Gutter Type	
NO CURB		NO CURB AND GUTTER	
Pavement Recommendation		Condition Rating / PCR	
PREVENTIVE MAINTENANCE		GOOD / 90

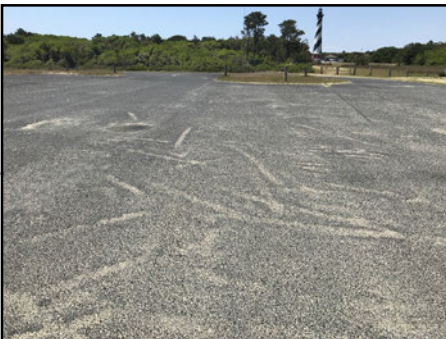
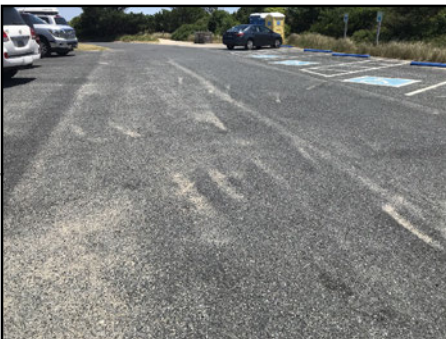
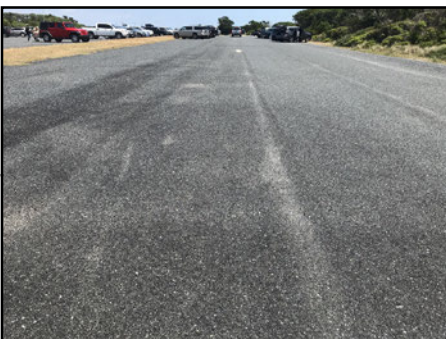
ROUTE 0935: HI RD OLD LIGHTHOUSE FOUNDATION PROTECTED BEACH PARKING

Inspection Date	FMSS Number	User Access	Surface Type
5/8/2021	28678	PUBLIC	ASPHALT
Area (Sq. Ft.)	Lane Miles (11' Widths)	Curb Reveal (Inches)	Curb Recommendation
69,631	1.199	6	DO NOTHING
Curb Type		Curb & Gutter Type	
CONCRETE		NOT APPLICABLE	
Pavement Recommendation		Condition Rating / PCR	
LIGHT 3R TREATMENTS		FAIR / 73

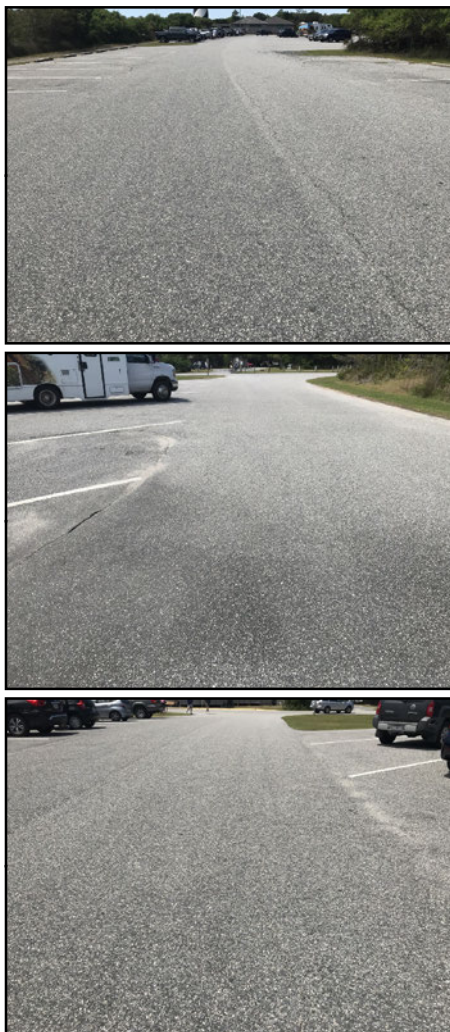
ROUTE 0936: HI RD CAPE HATTERAS LIGHTHOUSE PARKING

Inspection Date	FMSS Number	User Access	Surface Type
5/8/2021	28674	PUBLIC	ASPHALT
Area (Sq. Ft.)	Lane Miles (11' Widths)	Curb Reveal (Inches)	Curb Recommendation
71,970	1.239	NOT APPLICABLE	DO NOTHING
Curb Type		Curb & Gutter Type	
NO CURB		CONCRETE	
Pavement Recommendation		Condition Rating / PCR	
LIGHT 3R TREATMENTS		FAIR / 73

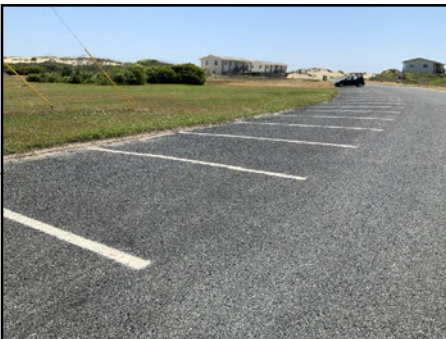
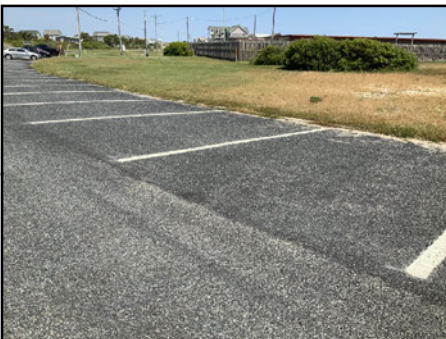
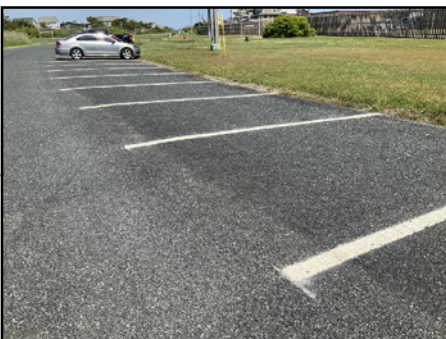
ROUTE 0937: BI RD MAINTENANCE OVERFLOW PARKING

Inspection Date	FMSS Number	User Access	Surface Type
5/9/2021	28959	NONPUBLIC	ASPHALT
Area (Sq. Ft.)	Lane Miles (11' Widths)	Curb Reveal (Inches)	Curb Recommendation
4,297	0.074	1	MODERATE REPAIR
Curb Type		Curb & Gutter Type	
CONCRETE		NOT APPLICABLE	
Pavement Recommendation		Condition Rating / PCR	
LIGHT 3R TREATMENTS		FAIR / 73

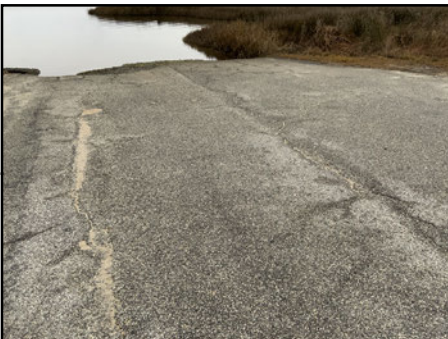
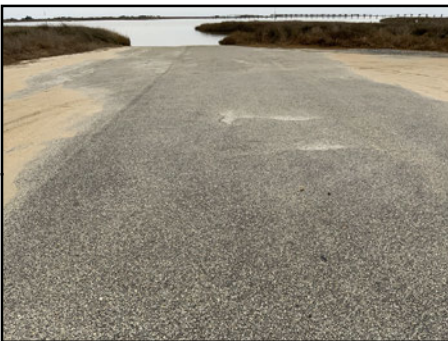
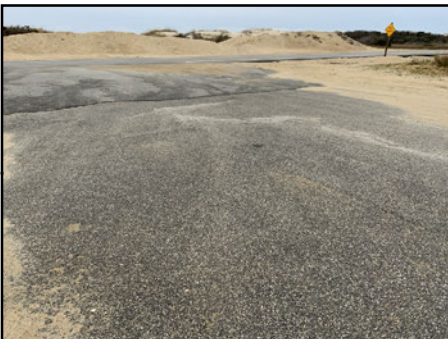
ROUTE 0938: BI RD NEW INLET BOAT RAMP PARKING

Inspection Date	FMSS Number	User Access	Surface Type
5/9/2021	28970	PUBLIC	ASPHALT
Area (Sq. Ft.)	Lane Miles (11' Widths)	Curb Reveal (Inches)	Curb Recommendation
12,900	0.222	NOT APPLICABLE	NOT APPLICABLE
Curb Type		Curb & Gutter Type	
NO CURB		NO CURB AND GUTTER	
Pavement Recommendation		Condition Rating / PCR	
LIGHT 3R TREATMENTS		FAIR / 73

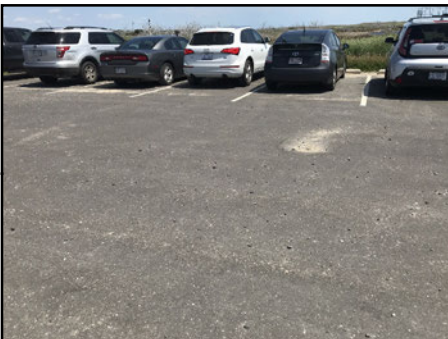
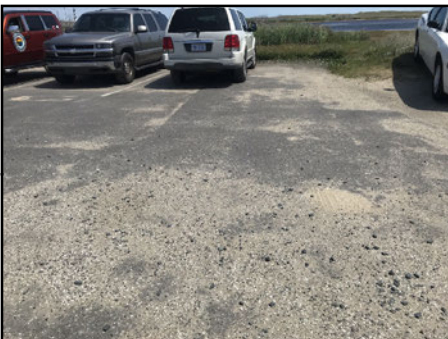
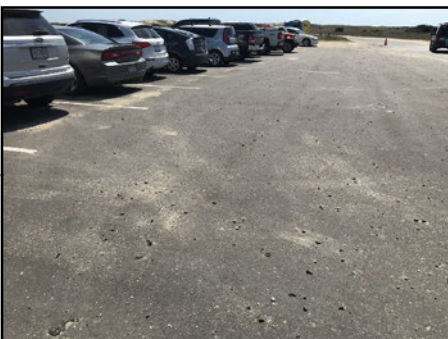
Inspection Date	FMSS Number	User Access	Surface Type
5/8/2021	28789	PUBLIC	ASPHALT
Area (Sq. Ft.)	Lane Miles (11' Widths)	Curb Reveal (Inches)	Curb Recommendation
5,814	0.1	NOT APPLICABLE	NOT APPLICABLE
Curb Type		Curb & Gutter Type	
NO CURB		NO CURB AND GUTTER	
Pavement Recommendation		Condition Rating / PCR	
PREVENTIVE MAINTENANCE		GOOD / 90

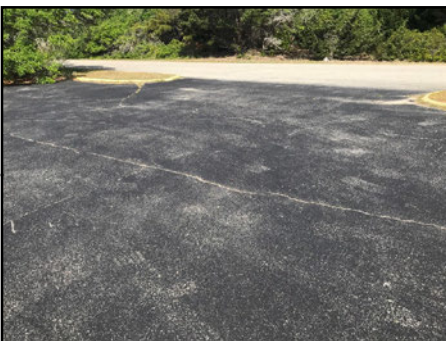
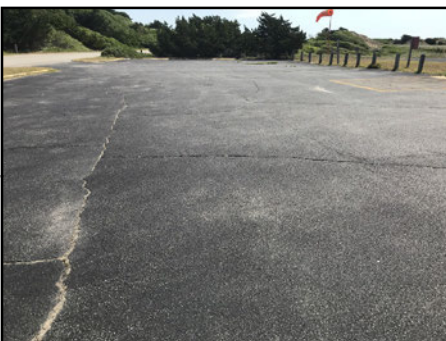
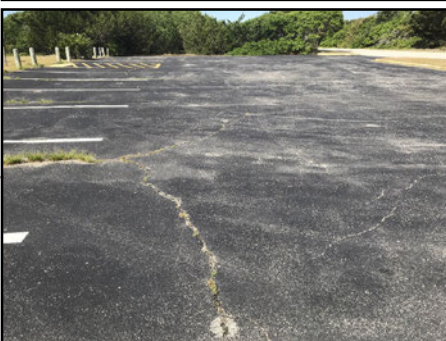
ROUTE 0940: HI RD FRISCO AIRSTRIP REFUELING PARKING

Inspection Date	FMSS Number	User Access	Surface Type
5/8/2021	28875	PUBLIC	ASPHALT
Area (Sq. Ft.)	Lane Miles (11' Widths)	Curb Reveal (Inches)	Curb Recommendation
8,559	0.147	3	MODERATE REPAIR
Curb Type		Curb & Gutter Type	
CONCRETE		NO CURB AND GUTTER	
Pavement Recommendation		Condition Rating / PCR	
HEAVY 3R TREATMENTS		POOR / 53

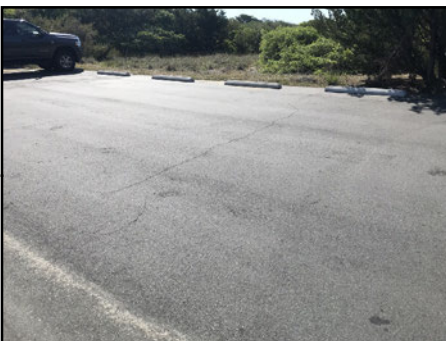
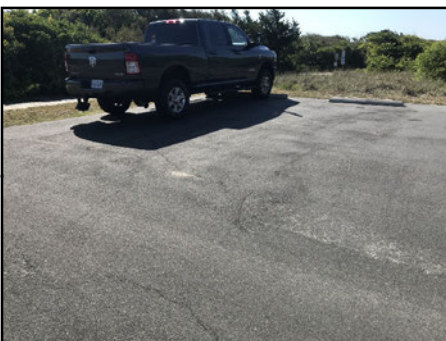
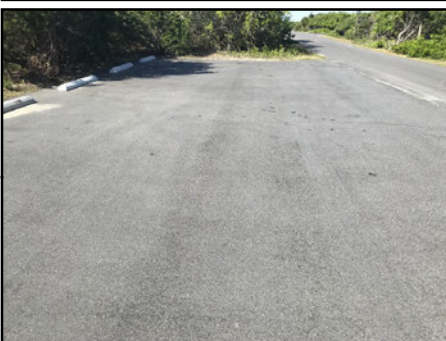
ROUTE 0941: HI RD FRISCO CAMPGROUND A PARKING

Inspection Date	FMSS Number	User Access	Surface Type
5/8/2021	28877	PUBLIC	ASPHALT
Area (Sq. Ft.)	Lane Miles (11' Widths)	Curb Reveal (Inches)	Curb Recommendation
1,901	0.033	NOT APPLICABLE	NOT APPLICABLE
Curb Type		Curb & Gutter Type	
NO CURB		NO CURB AND GUTTER	
Pavement Recommendation		Condition Rating / PCR	
PREVENTIVE MAINTENANCE		GOOD / 90

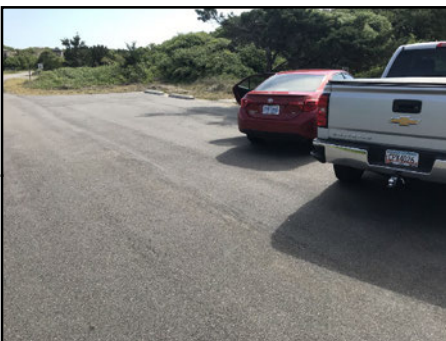
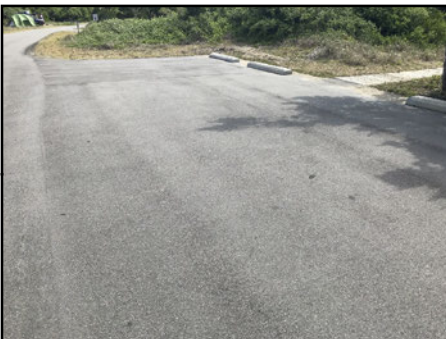
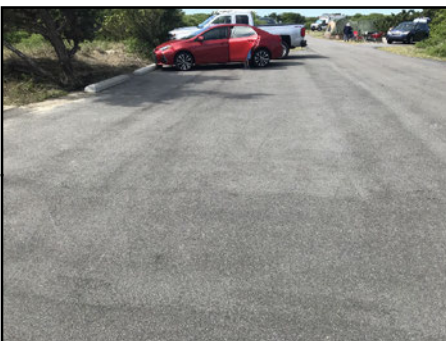
ROUTE 0942: HI RD FRISCO CAMPGROUND B PARKING

Inspection Date	FMSS Number	User Access	Surface Type
5/8/2021	28974	PUBLIC	ASPHALT
Area (Sq. Ft.)	Lane Miles (11' Widths)	Curb Reveal (Inches)	Curb Recommendation
1,723	0.03	NOT APPLICABLE	NOT APPLICABLE
Curb Type		Curb & Gutter Type	
NO CURB		NO CURB AND GUTTER	
Pavement Recommendation		Condition Rating / PCR	
PREVENTIVE MAINTENANCE		GOOD / 90

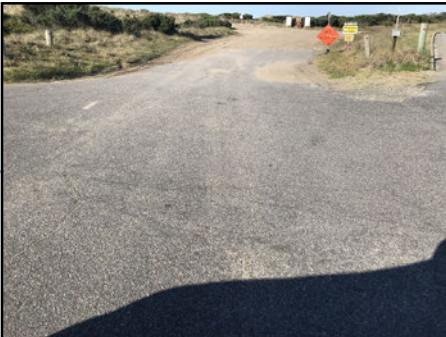
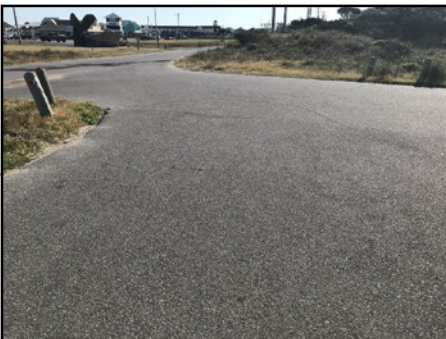
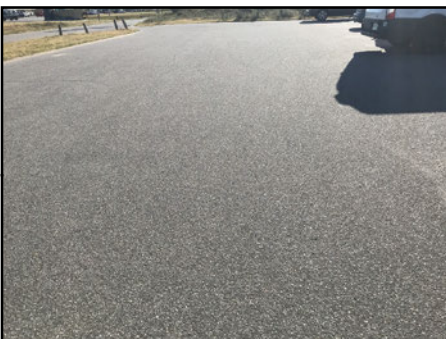
ROUTE 0943: HI RD RAMP 55 PARKING

Inspection Date	FMSS Number	User Access	Surface Type
5/8/2021	28878	PUBLIC	ASPHALT
Area (Sq. Ft.)	Lane Miles (11' Widths)	Curb Reveal (Inches)	Curb Recommendation
16,946	0.292	NOT APPLICABLE	NOT APPLICABLE
Curb Type		Curb & Gutter Type	
NO CURB		NO CURB AND GUTTER	
Pavement Recommendation		Condition Rating / PCR	
PREVENTIVE MAINTENANCE		GOOD / 90

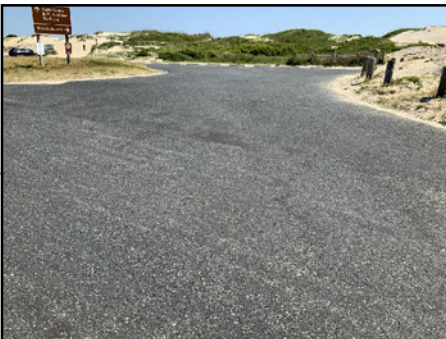
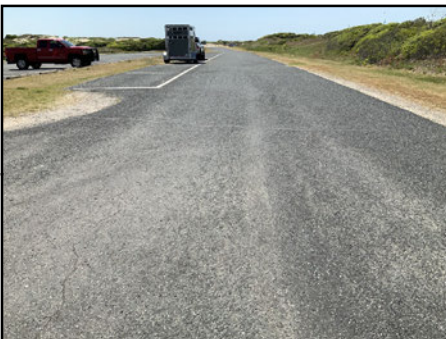
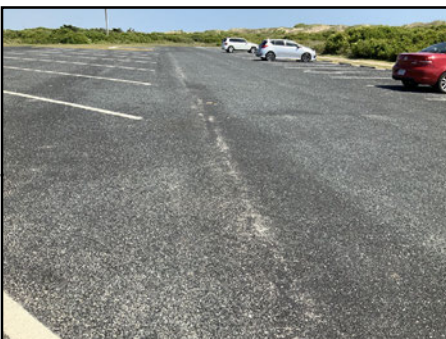
ROUTE 0944: BI RD COQUINA BEACH PARKING

Inspection Date	FMSS Number	User Access	Surface Type
5/9/2021	111013	PUBLIC	ASPHALT
Area (Sq. Ft.)	Lane Miles (11' Widths)	Curb Reveal (Inches)	Curb Recommendation
109,243	1.881	NOT APPLICABLE	NOT APPLICABLE
Curb Type		Curb & Gutter Type	
NO CURB		NO CURB AND GUTTER	
Pavement Recommendation		Condition Rating / PCR	
PREVENTIVE MAINTENANCE		GOOD / 90

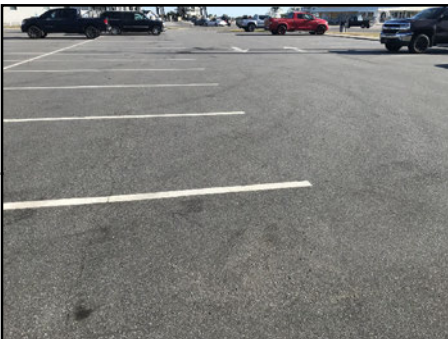
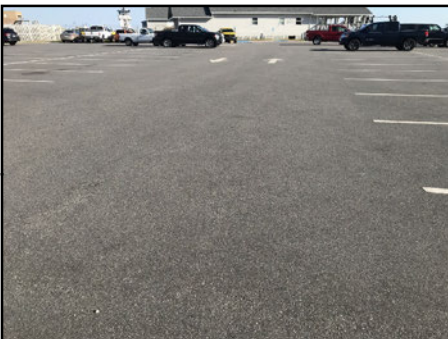
ROUTE 0945AZ: HI RD HATTERAS TO OCRACOKE ISLAND FERRY AND DOCK A PARKING

Inspection Date	FMSS Number	User Access	Surface Type
5/8/2021	110983	PUBLIC	ASPHALT
Area (Sq. Ft.)	Lane Miles (11' Widths)	Curb Reveal (Inches)	Curb Recommendation
41,713	0.718	3	DO NOTHING
Curb Type		Curb & Gutter Type	
CONCRETE		CONCRETE	
Pavement Recommendation		Condition Rating / PCR	
PREVENTIVE MAINTENANCE		GOOD / 90

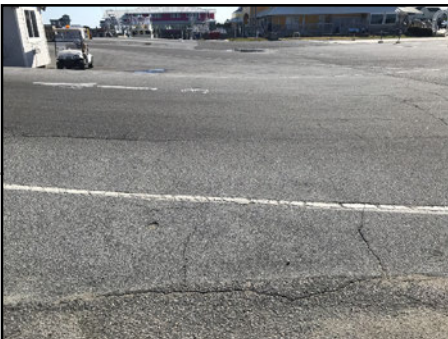
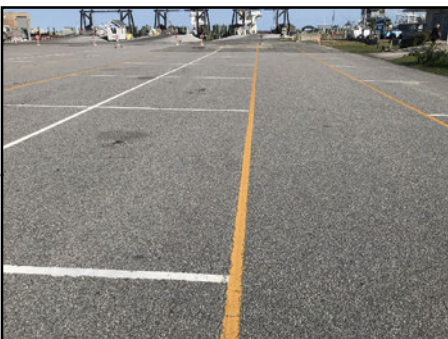
ROUTE 0945BZ: HI RD HATTERAS TO OCRACOKE ISLAND FERRY AND DOCK B PARKING

Inspection Date	FMSS Number	User Access	Surface Type
5/8/2021	110983	PUBLIC	ASPHALT
Area (Sq. Ft.)	Lane Miles (11' Widths)	Curb Reveal (Inches)	Curb Recommendation
81,414	1.402	NOT APPLICABLE	NOT APPLICABLE
Curb Type		Curb & Gutter Type	
NO CURB		NO CURB AND GUTTER	
Pavement Recommendation		Condition Rating / PCR	
LIGHT 3R TREATMENTS		FAIR / 73

NOTE: MULTIPLE SURFACE TYPES:
 ASPHALT IS 79,947 SQ FT
 CONCRETE IS 1,467 SQ FT

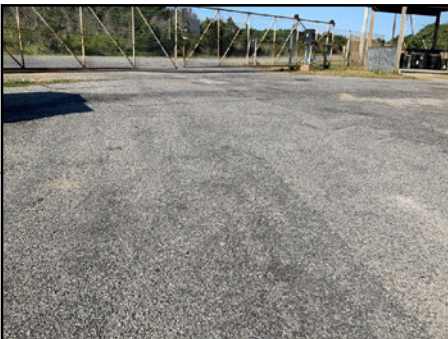
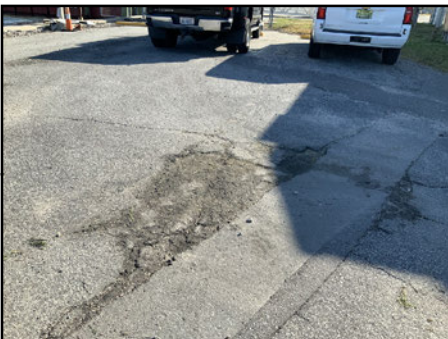
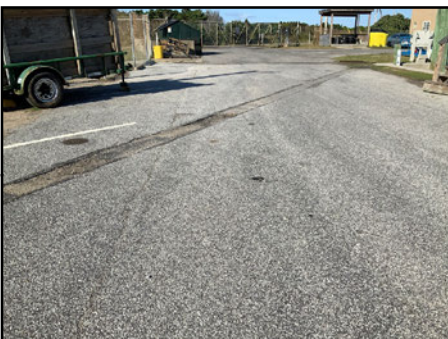
ROUTE 0945CZ: HI RD HATTERAS TO OCRACOKE ISLAND FERRY AND DOCK C PARKING

Inspection Date	FMSS Number	User Access	Surface Type
5/8/2021	110983	PUBLIC	ASPHALT
Area (Sq. Ft.)	Lane Miles (11' Widths)	Curb Reveal (Inches)	Curb Recommendation
18,244	0.314	NOT APPLICABLE	NOT APPLICABLE
Curb Type		Curb & Gutter Type	
NO CURB		NO CURB AND GUTTER	
Pavement Recommendation		Condition Rating / PCR	
LIGHT 3R TREATMENTS		FAIR / 73

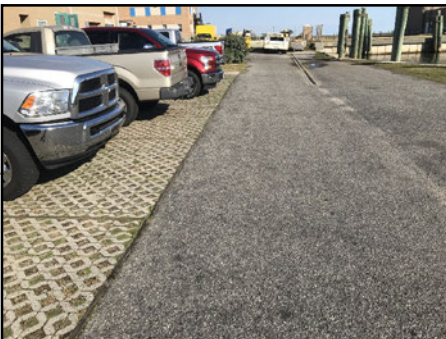
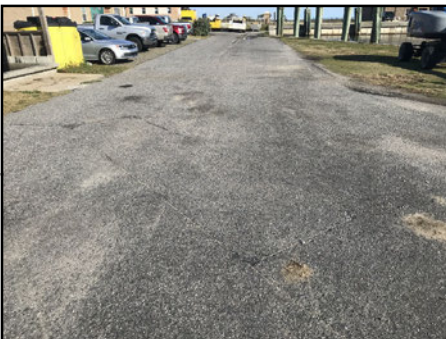
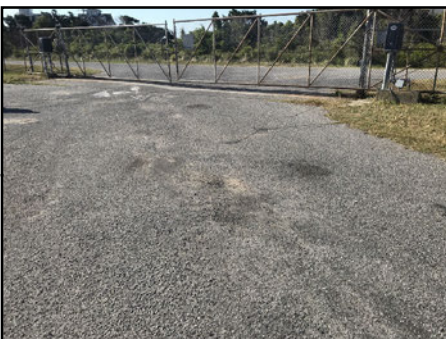
ROUTE 0945DZ: HI RD HATTERAS TO OCRACOKE ISLAND FERRY AND DOCK D PARKING

Inspection Date	FMSS Number	User Access	Surface Type
5/8/2021	110983	PUBLIC	ASPHALT
Area (Sq. Ft.)	Lane Miles (11' Widths)	Curb Reveal (Inches)	Curb Recommendation
9,720	0.167	NOT APPLICABLE	NOT APPLICABLE
Curb Type		Curb & Gutter Type	
NO CURB		NO CURB AND GUTTER	
Pavement Recommendation		Condition Rating / PCR	
LIGHT 3R TREATMENTS		FAIR / 73

NOTE: MULTIPLE SURFACE TYPES:
 ASPHALT IS 8,505 SQ FT
 BRICK IS 1,215 SQ FT

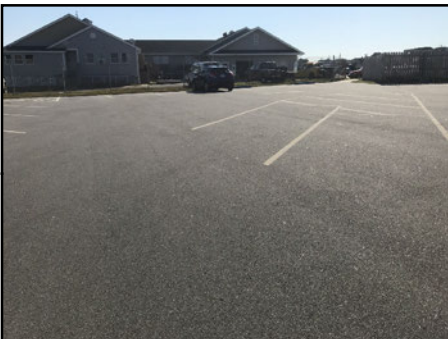
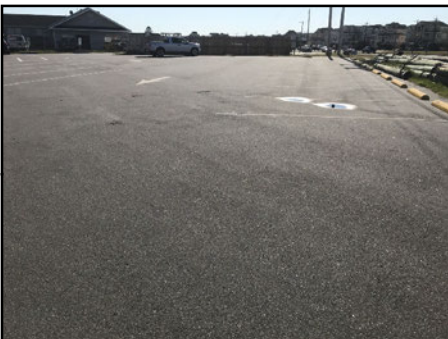
ROUTE 0946: OI RD OCRACOKE ISLAND AIRPORT TERMINAL PARKING

Inspection Date	FMSS Number	User Access	Surface Type
5/7/2021	110991	PUBLIC	ASPHALT
Area (Sq. Ft.)	Lane Miles (11' Widths)	Curb Reveal (Inches)	Curb Recommendation
6,634	0.114	NOT APPLICABLE	NOT APPLICABLE
Curb Type		Curb & Gutter Type	
NO CURB		NO CURB AND GUTTER	
Pavement Recommendation		Condition Rating / PCR	
PREVENTIVE MAINTENANCE		GOOD / 90

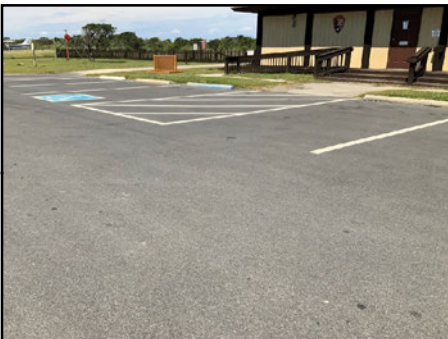
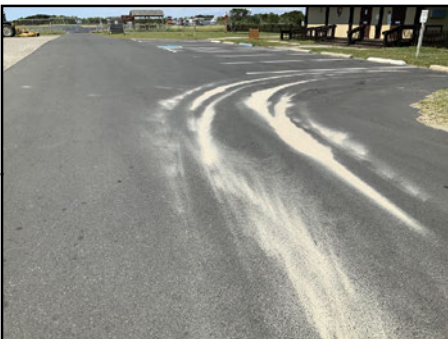
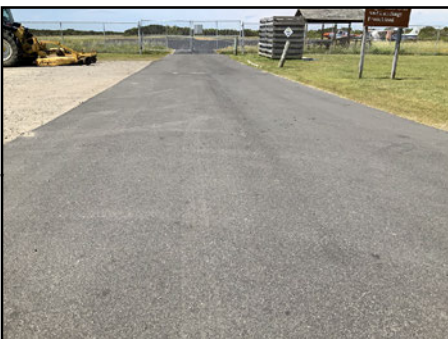
ROUTE 0947: OI RD OCRACOKE CAMPGROUND OVERFLOW PARKING

Inspection Date	FMSS Number	User Access	Surface Type
5/7/2021	110992	PUBLIC	ASPHALT
Area (Sq. Ft.)	Lane Miles (11' Widths)	Curb Reveal (Inches)	Curb Recommendation
18,608	0.32	NOT APPLICABLE	NOT APPLICABLE
Curb Type		Curb & Gutter Type	
NO CURB		NO CURB AND GUTTER	
Pavement Recommendation		Condition Rating / PCR	
PREVENTIVE MAINTENANCE		GOOD / 90

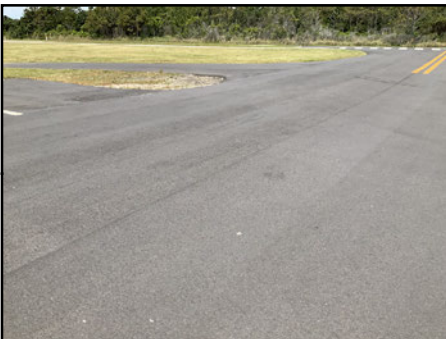
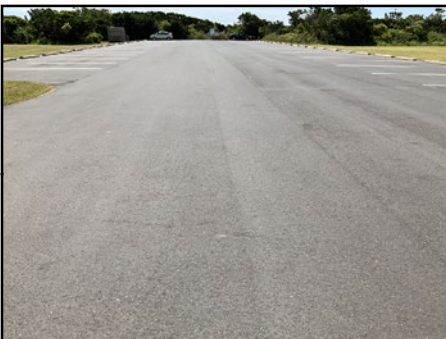
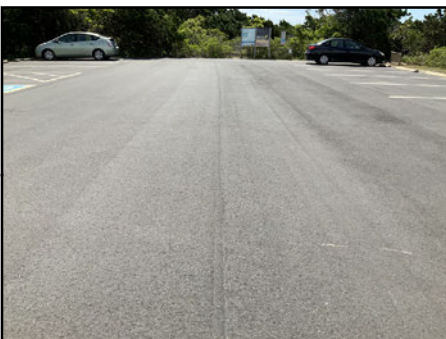
ROUTE 0948: HI RD RAMP 49 PARKING

Inspection Date	FMSS Number	User Access	Surface Type
5/8/2021	35795	PUBLIC	ASPHALT
Area (Sq. Ft.)	Lane Miles (11' Widths)	Curb Reveal (Inches)	Curb Recommendation
2,819	0.049	3	REPLACE
Curb Type		Curb & Gutter Type	
CONCRETE		NO CURB AND GUTTER	
Pavement Recommendation		Condition Rating / PCR	
HEAVY 3R TREATMENTS		POOR / 53

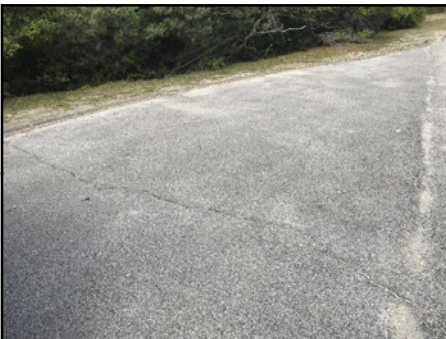
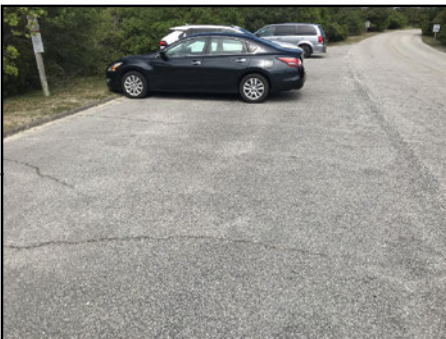
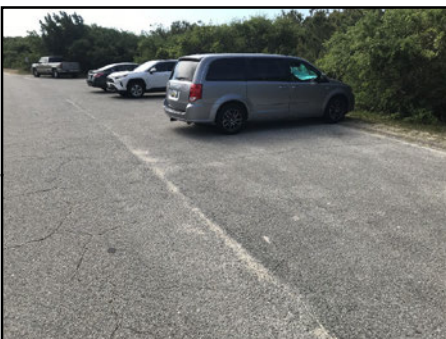
ROUTE 0949: HI RD FRISCO AIRPORT TERMINAL PARKING

Inspection Date	FMSS Number	User Access	Surface Type
5/8/2021	110993	PUBLIC	ASPHALT
Area (Sq. Ft.)	Lane Miles (11' Widths)	Curb Reveal (Inches)	Curb Recommendation
9,054	0.156	2	MODERATE REPAIR
Curb Type		Curb & Gutter Type	
CONCRETE		NO CURB AND GUTTER	
Pavement Recommendation		Condition Rating / PCR	
HEAVY 3R TREATMENTS		POOR / 53

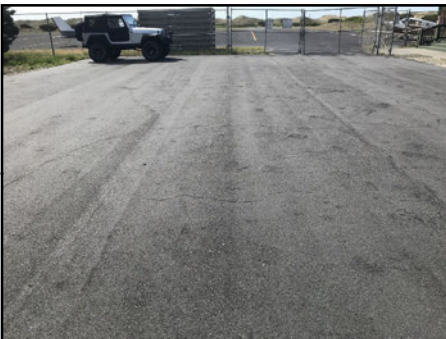
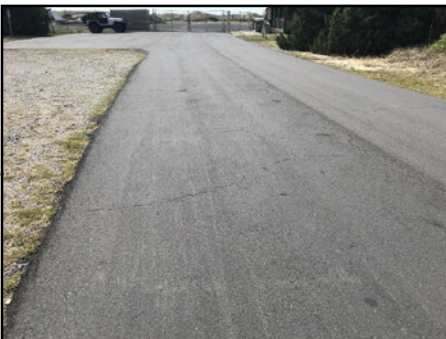
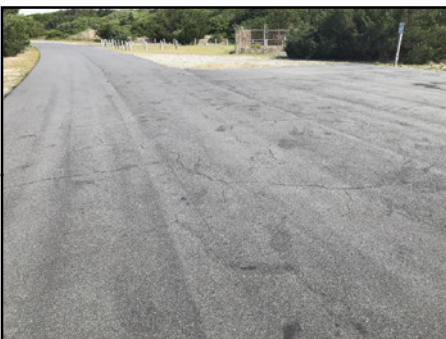
ROUTE 0950: OI RD OCRACOKE TO CEDAR ISLAND FERRY PARKING

Inspection Date	FMSS Number	User Access	Surface Type
5/7/2021	110994	PUBLIC	ASPHALT
Area (Sq. Ft.)	Lane Miles (11' Widths)	Curb Reveal (Inches)	Curb Recommendation
65,828	1.133	3	DO NOTHING
Curb Type		Curb & Gutter Type	
CONCRETE		NO CURB AND GUTTER	
Pavement Recommendation		Condition Rating / PCR	
HEAVY 3R TREATMENTS		POOR / 53

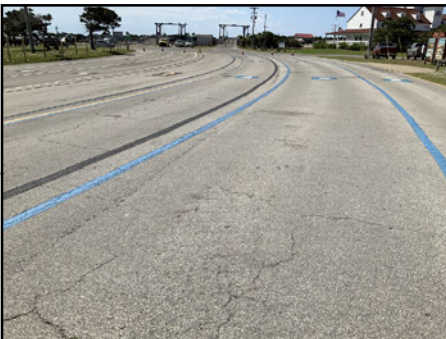
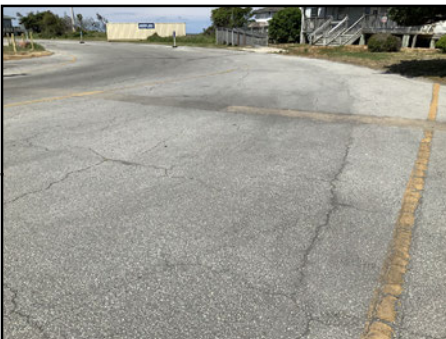
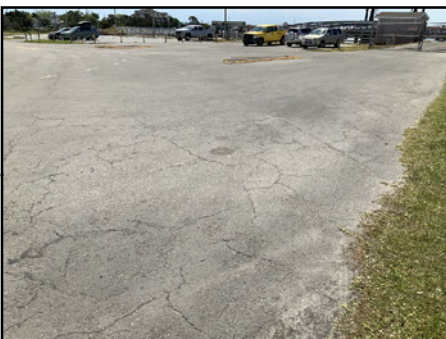
ROUTE 0951: OI RD OCRACOKE TO HATTERAS ISLAND FERRY PARKING

Inspection Date	FMSS Number	User Access	Surface Type
5/7/2021	111003	PUBLIC	ASPHALT
Area (Sq. Ft.)	Lane Miles (11' Widths)	Curb Reveal (Inches)	Curb Recommendation
69,875	1.203	NOT APPLICABLE	NOT APPLICABLE
Curb Type		Curb & Gutter Type	
NO CURB		NO CURB AND GUTTER	
Pavement Recommendation		Condition Rating / PCR	
PREVENTIVE MAINTENANCE		GOOD / 90

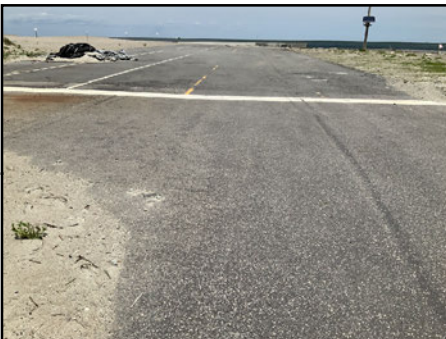
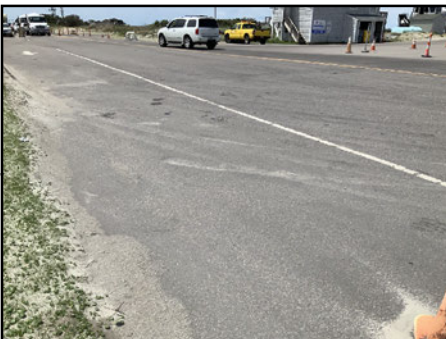
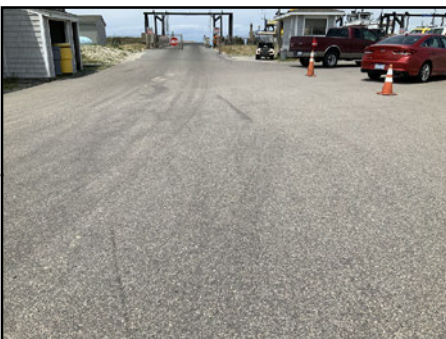
ROUTE 0952ZZ: HI RD FRISCO CAMPGROUND COMFORT STATION PARKING

Inspection Date	FMSS Number	User Access	Surface Type
5/8/2021	111007	PUBLIC	ASPHALT
Area (Sq. Ft.)	Lane Miles (11' Widths)	Condition Rating / PCR	
3,407	0.058	SUMMARY /	94

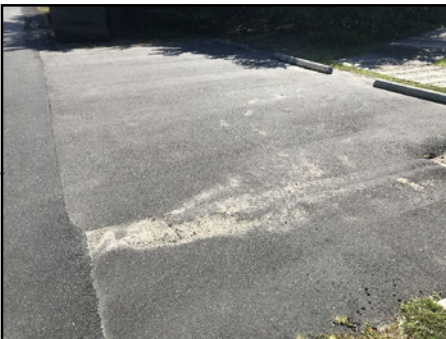
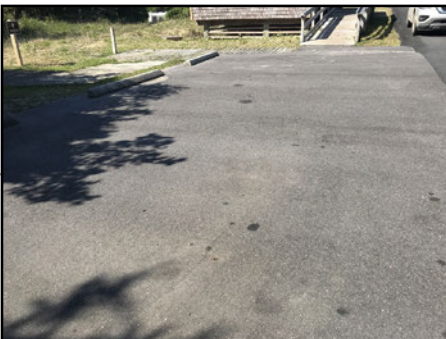
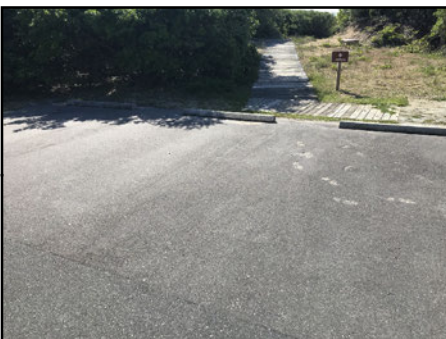
ROUTE 0952BZ: HI RD FRISCO CAMPGROUND COMFORT STATION B PARKING

Inspection Date	FMSS Number	User Access	Surface Type
5/8/2021	111007	PUBLIC	ASPHALT
Area (Sq. Ft.)	Lane Miles (11' Widths)	Curb Reveal (Inches)	Curb Recommendation
888	0.015	NOT APPLICABLE	NOT APPLICABLE
Curb Type		Curb & Gutter Type	
NO CURB		NO CURB AND GUTTER	
Pavement Recommendation		Condition Rating / PCR	
DO NOTHING		EXCELLENT / 97

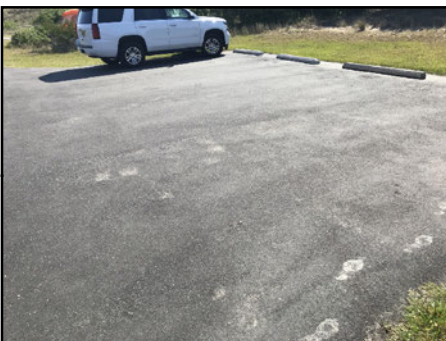
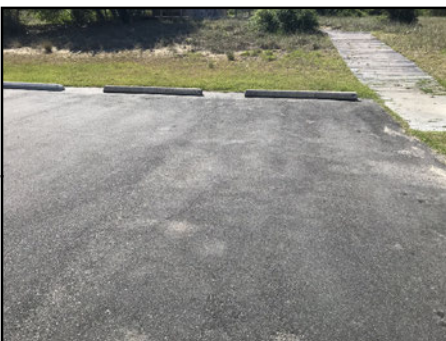
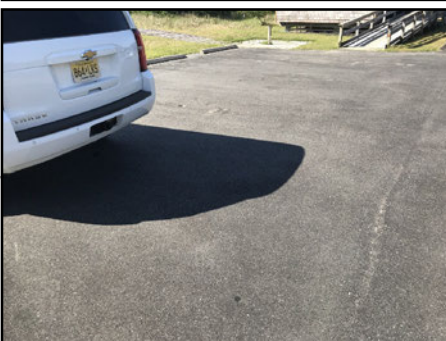
ROUTE 0952CZ: HI RD FRISCO CAMPGROUND COMFORT STATION C PARKING

Inspection Date	FMSS Number	User Access	Surface Type
5/8/2021	111007	PUBLIC	ASPHALT
Area (Sq. Ft.)	Lane Miles (11' Widths)	Curb Reveal (Inches)	Curb Recommendation
720	0.012	NOT APPLICABLE	NOT APPLICABLE
Curb Type		Curb & Gutter Type	
NO CURB		NO CURB AND GUTTER	
Pavement Recommendation		Condition Rating / PCR	
PREVENTIVE MAINTENANCE		GOOD / 90

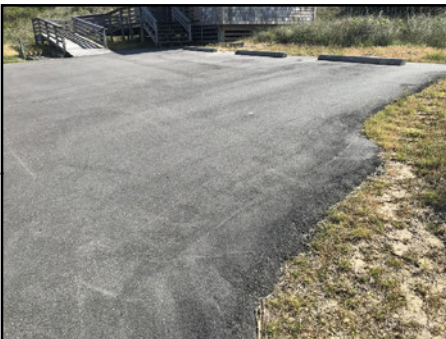
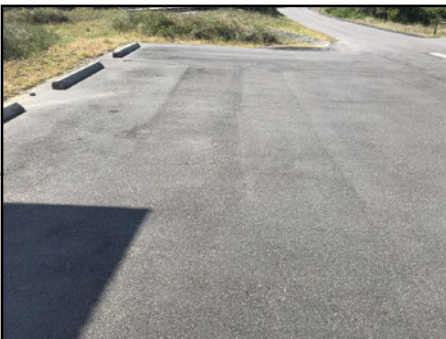
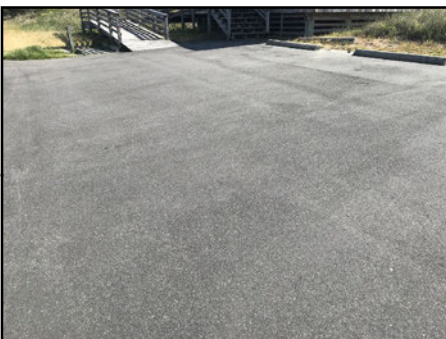
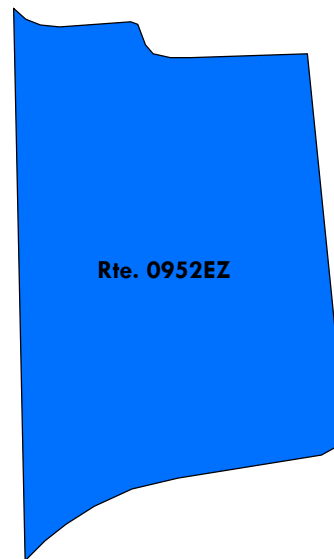
ROUTE 0952EZ: HI RD FRISCO CAMPGROUND COMFORT STATION E PARKING

Inspection Date	FMSS Number	User Access	Surface Type
5/8/2021	111007	PUBLIC	ASPHALT
Area (Sq. Ft.)	Lane Miles (11' Widths)	Curb Reveal (Inches)	Curb Recommendation
952	0.016	NOT APPLICABLE	NOT APPLICABLE
Curb Type		Curb & Gutter Type	
NO CURB		NO CURB AND GUTTER	
Pavement Recommendation		Condition Rating / PCR	
DO NOTHING		EXCELLENT / 97

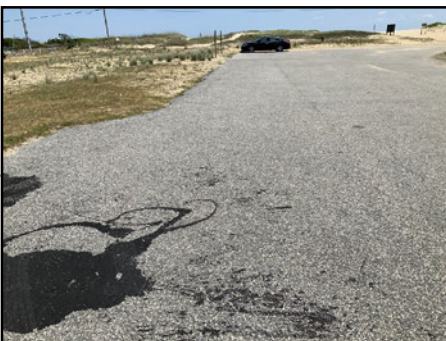
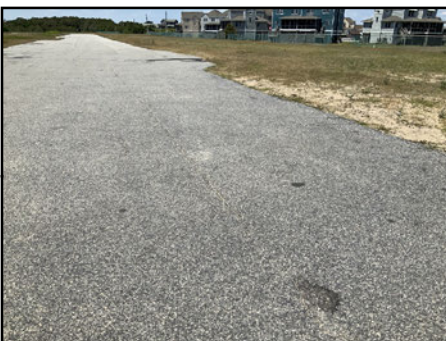
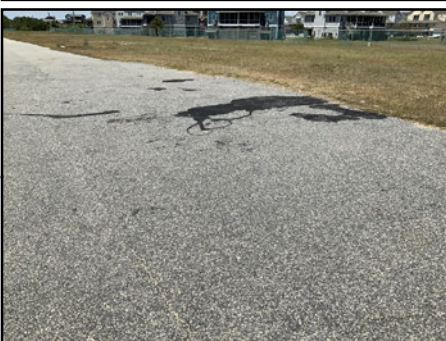
ROUTE 0954AZ: HI RD SCHOONER LOOP ROAD A PARKING

Inspection Date	FMSS Number	User Access	Surface Type
5/8/2021	111008	NONPUBLIC	ASPHALT
Area (Sq. Ft.)	Lane Miles (11' Widths)	Curb Reveal (Inches)	Curb Recommendation
3,732	0.064	NOT APPLICABLE	NOT APPLICABLE
Curb Type		Curb & Gutter Type	
NO CURB		NO CURB AND GUTTER	
Pavement Recommendation		Condition Rating / PCR	
LIGHT 3R TREATMENTS		FAIR / 73

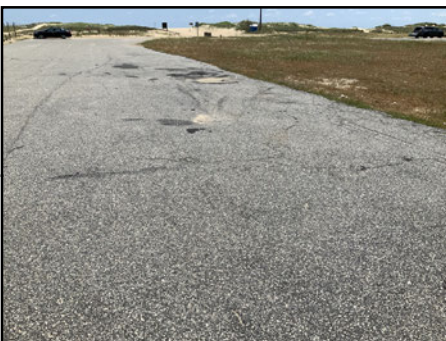
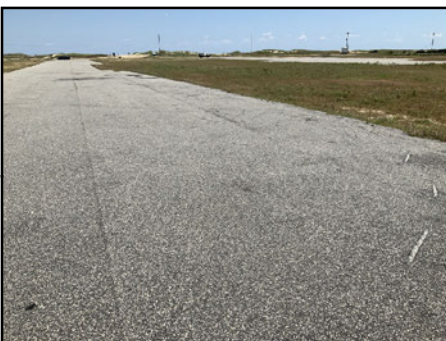
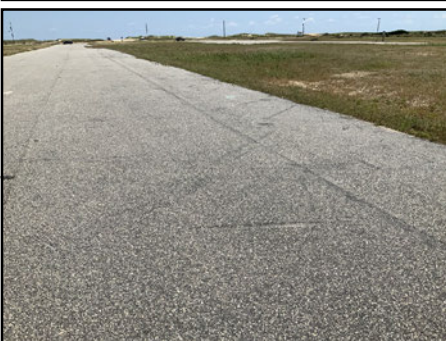
ROUTE 0954BZ: HI RD SCHOONER LOOP ROAD B PARKING

Inspection Date	FMSS Number	User Access	Surface Type
5/8/2021	111008	NONPUBLIC	ASPHALT
Area (Sq. Ft.)	Lane Miles (11' Widths)	Curb Reveal (Inches)	Curb Recommendation
12,351	0.213	0	DO NOTHING
Curb Type		Curb & Gutter Type	
WOOD		NO CURB AND GUTTER	
Pavement Recommendation		Condition Rating / PCR	
LIGHT 3R TREATMENTS		FAIR / 73

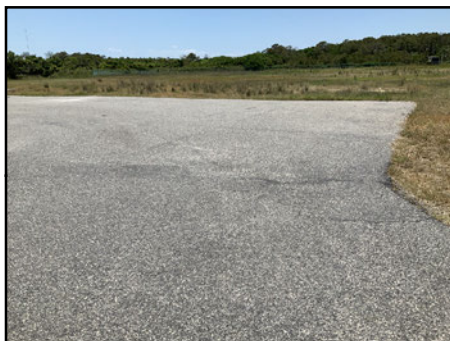
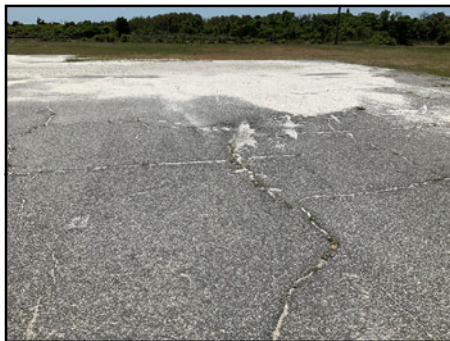
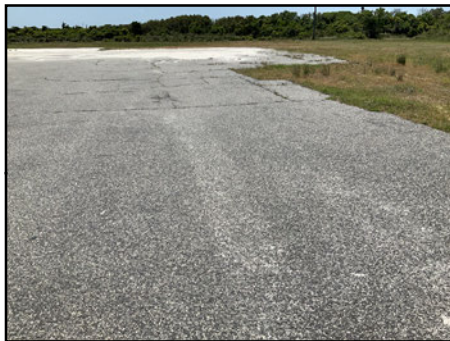
ROUTE 0954CZ: HI RD SCHOONER LOOP ROAD C PARKING

Inspection Date	FMSS Number	User Access	Surface Type
5/8/2021	111008	NONPUBLIC	ASPHALT
Area (Sq. Ft.)	Lane Miles (11' Widths)	Curb Reveal (Inches)	Curb Recommendation
4,559	0.078	NOT APPLICABLE	NOT APPLICABLE
Curb Type		Curb & Gutter Type	
NO CURB		NO CURB AND GUTTER	
Pavement Recommendation		Condition Rating / PCR	
HEAVY 3R TREATMENTS		POOR / 53

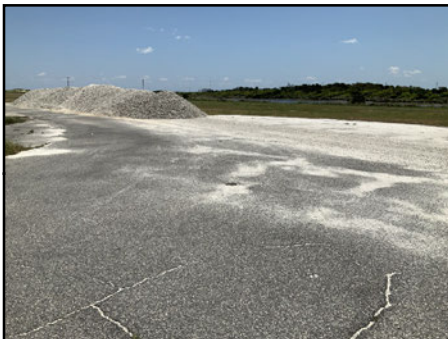
ROUTE 0954DZ: HI RD SCHOONER LOOP ROAD D PARKING

Inspection Date	FMSS Number	User Access	Surface Type
5/8/2021	111008	NONPUBLIC	ASPHALT
Area (Sq. Ft.)	Lane Miles (11' Widths)	Curb Reveal (Inches)	Curb Recommendation
5,461	0.094	NOT APPLICABLE	NOT APPLICABLE
Curb Type		Curb & Gutter Type	
NO CURB		NO CURB AND GUTTER	
Pavement Recommendation		Condition Rating / PCR	
NOT APPLICABLE		NOT RATED / N/A

NOTE: ROUTE NOT RATED DUE TO SURFACE BEING COVERED WITH SAND.

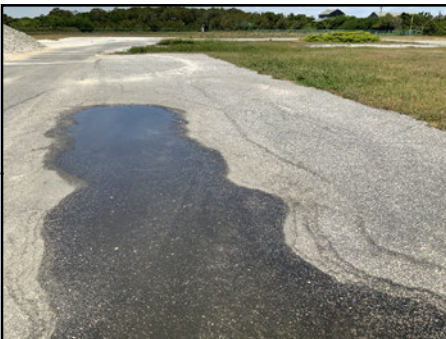
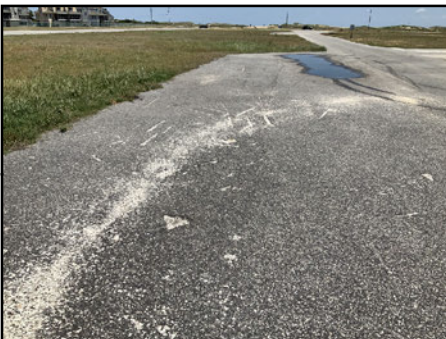
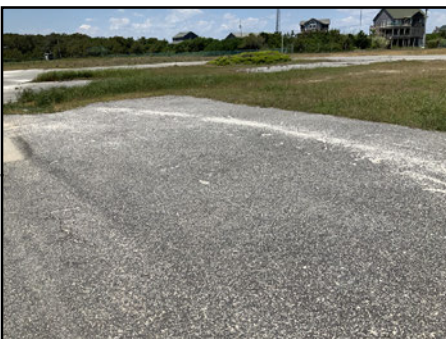
ROUTE 0954EZ: HI RD SCHOONER LOOP ROAD E PARKING

Inspection Date	FMSS Number	User Access	Surface Type
5/8/2021	111008	NONPUBLIC	ASPHALT
Area (Sq. Ft.)	Lane Miles (11' Widths)	Curb Reveal (Inches)	Curb Recommendation
1,949	0.034	NOT APPLICABLE	NOT APPLICABLE
Curb Type		Curb & Gutter Type	
NO CURB		NO CURB AND GUTTER	
Pavement Recommendation		Condition Rating / PCR	
LIGHT 3R TREATMENTS		FAIR / 73

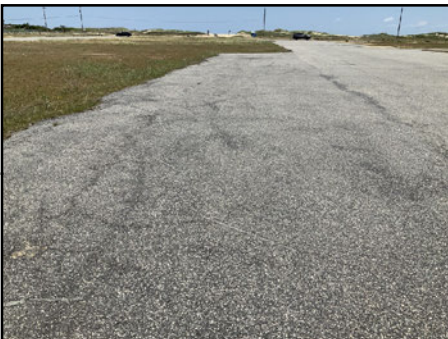
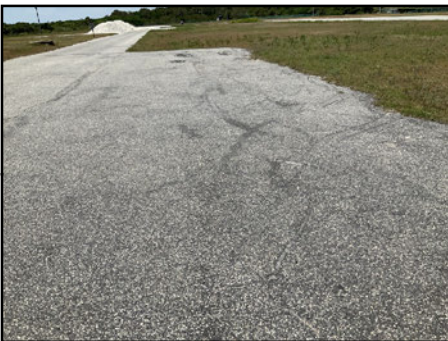
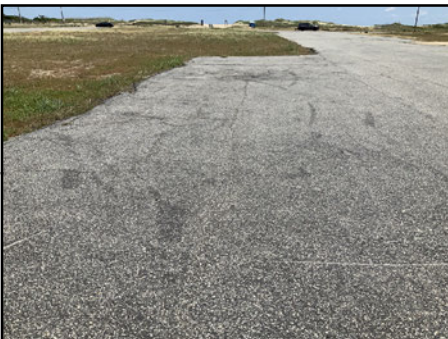
ROUTE 0954FZ: HI RD SCHOONER LOOP ROAD F PARKING

Inspection Date	FMSS Number	User Access	Surface Type
5/8/2021	111008	NONPUBLIC	ASPHALT
Area (Sq. Ft.)	Lane Miles (11' Widths)	Curb Reveal (Inches)	Curb Recommendation
2,795	0.048	NOT APPLICABLE	NOT APPLICABLE
Curb Type		Curb & Gutter Type	
NO CURB		NO CURB AND GUTTER	
Pavement Recommendation		Condition Rating / PCR	
LIGHT 3R TREATMENTS		FAIR / 73

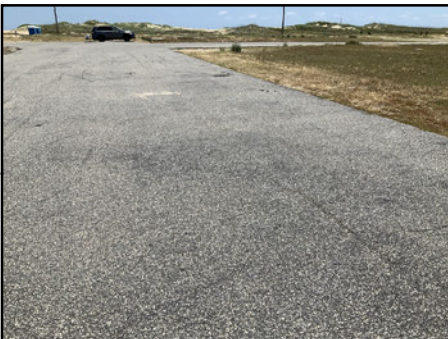
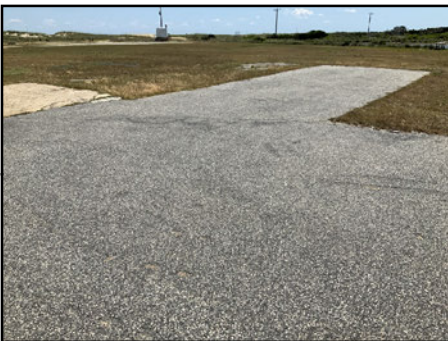
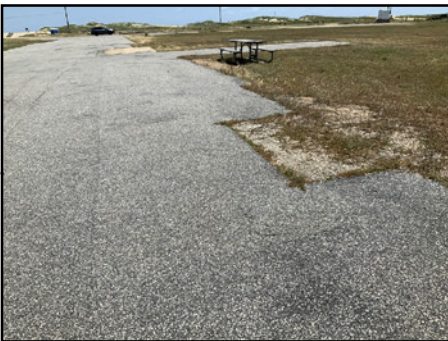
ROUTE 0954GZ: HI RD SCHOONER LOOP ROAD G PARKING

Inspection Date	FMSS Number	User Access	Surface Type
5/8/2021	111008	NONPUBLIC	ASPHALT
Area (Sq. Ft.)	Lane Miles (11' Widths)	Curb Reveal (Inches)	Curb Recommendation
6,028	0.104	NOT APPLICABLE	NOT APPLICABLE
Curb Type		Curb & Gutter Type	
NO CURB		NO CURB AND GUTTER	
Pavement Recommendation		Condition Rating / PCR	
LIGHT 3R TREATMENTS		FAIR / 73

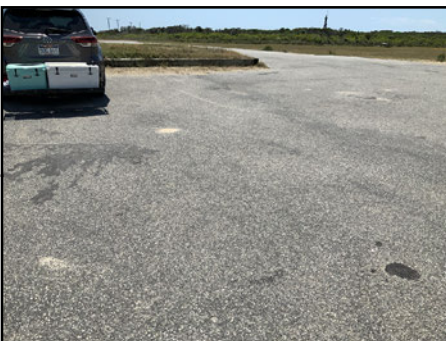
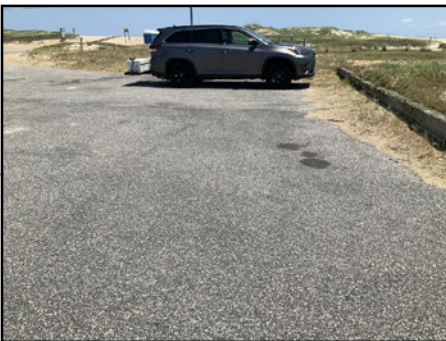
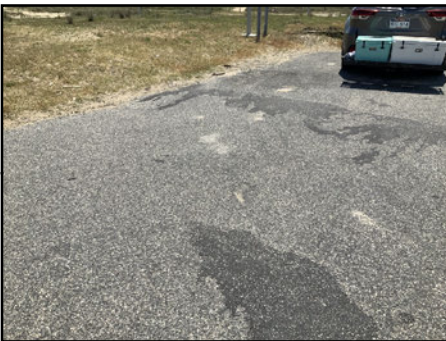
ROUTE 0954HZ: HI RD SCHOONER LOOP ROAD H PARKING

Inspection Date	FMSS Number	User Access	Surface Type
5/8/2021	111008	NONPUBLIC	ASPHALT
Area (Sq. Ft.)	Lane Miles (11' Widths)	Curb Reveal (Inches)	Curb Recommendation
873	0.015	NOT APPLICABLE	NOT APPLICABLE
Curb Type		Curb & Gutter Type	
NO CURB		NO CURB AND GUTTER	
Pavement Recommendation		Condition Rating / PCR	
LIGHT 3R TREATMENTS		FAIR / 73

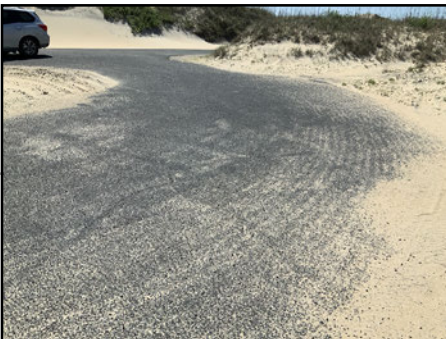
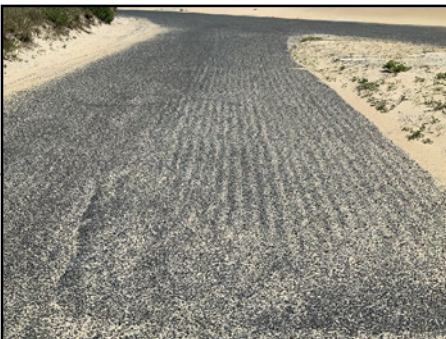
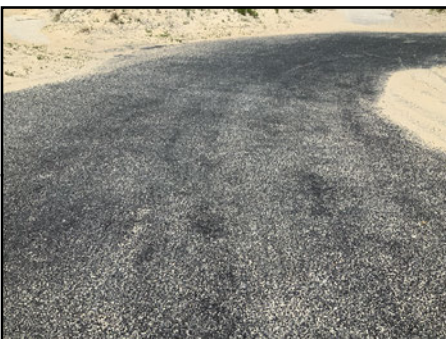
Inspection Date	FMSS Number	User Access	Surface Type
5/9/2021	111010	NONPUBLIC	ASPHALT
Area (Sq. Ft.)	Lane Miles (11' Widths)	Curb Reveal (Inches)	Curb Recommendation
3,322	0.057	NOT APPLICABLE	NOT APPLICABLE
Curb Type		Curb & Gutter Type	
NO CURB		NO CURB AND GUTTER	
Pavement Recommendation		Condition Rating / PCR	
LIGHT 3R TREATMENTS		FAIR / 73
