Road Inventory and Condition Assessment of Paved Routes Cape Hatteras National Seashore

**Federal Lands Highway
Road Inventory Program**

**Federal Highway Administration
Eastern Federal Lands Highway Division
Road Inventory Program (RIP)**

Report Date: March 2022

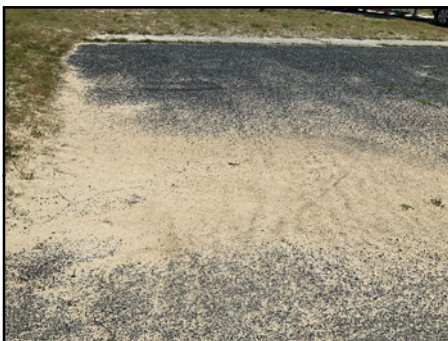
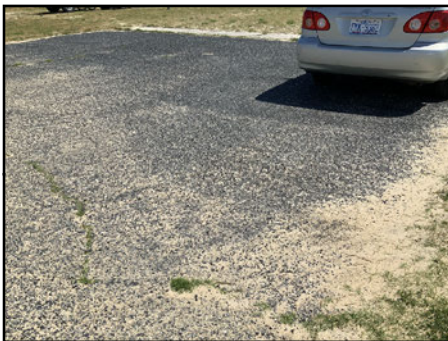
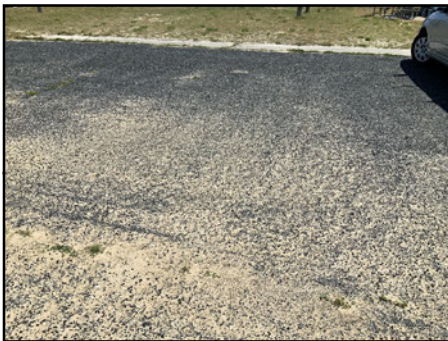
ROUTE 0956BZ: BI RD PARK SERVICE ROAD B PARKING

Inspection Date	FMSS Number	User Access	Surface Type
5/9/2021	111010	NONPUBLIC	ASPHALT
Area (Sq. Ft.)	Lane Miles (11' Widths)	Curb Reveal (Inches)	Curb Recommendation
974	0.017	NOT APPLICABLE	NOT APPLICABLE
Curb Type		Curb & Gutter Type	
NO CURB		NO CURB AND GUTTER	
Pavement Recommendation		Condition Rating / PCR	
LIGHT 3R TREATMENTS		FAIR / 73

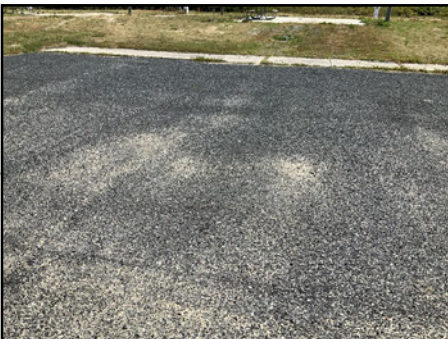
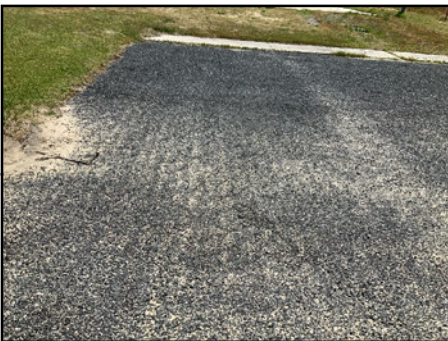
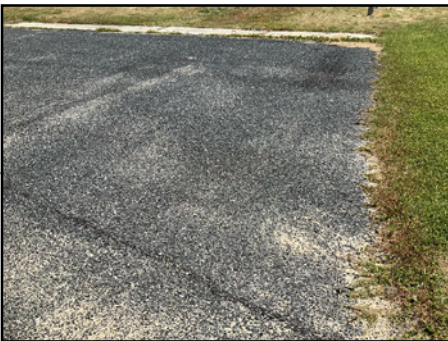
ROUTE 0956CZ: BI RD PARK SERVICE ROAD C PARKING

Inspection Date	FMSS Number	User Access	Surface Type
5/9/2021	111010	NONPUBLIC	ASPHALT
Area (Sq. Ft.)	Lane Miles (11' Widths)	Curb Reveal (Inches)	Curb Recommendation
1,108	0.019	0	MODERATE REPAIR
Curb Type		Curb & Gutter Type	
CONCRETE		NO CURB AND GUTTER	
Pavement Recommendation		Condition Rating / PCR	
LIGHT 3R TREATMENTS		FAIR / 73

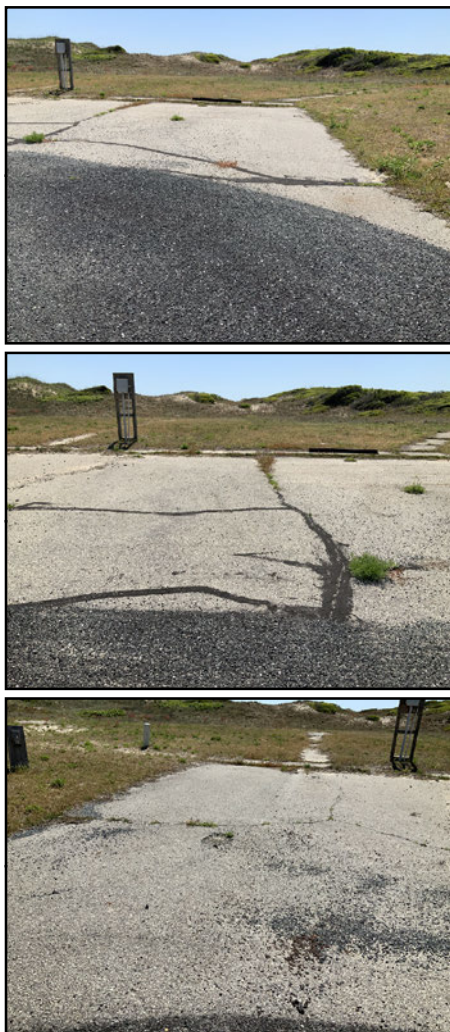
ROUTE 0956DZ: BI RD PARK SERVICE ROAD D PARKING

Inspection Date	FMSS Number	User Access	Surface Type
5/9/2021	111010	NONPUBLIC	ASPHALT
Area (Sq. Ft.)	Lane Miles (11' Widths)	Curb Reveal (Inches)	Curb Recommendation
1,053	0.018	NOT APPLICABLE	NOT APPLICABLE
Curb Type		Curb & Gutter Type	
NO CURB		NO CURB AND GUTTER	
Pavement Recommendation		Condition Rating / PCR	
PREVENTIVE MAINTENANCE		GOOD / 90

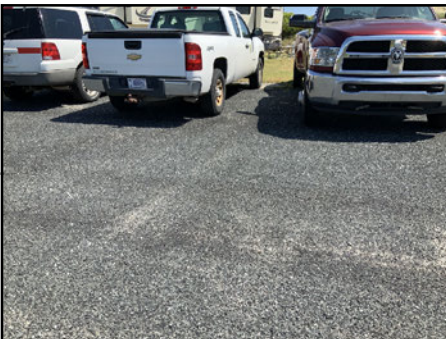
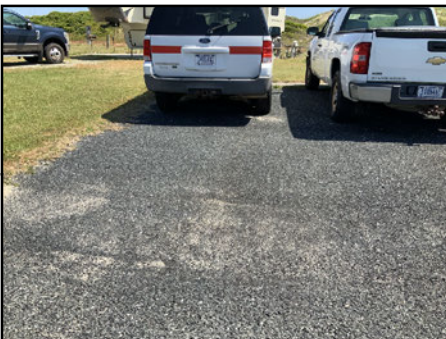
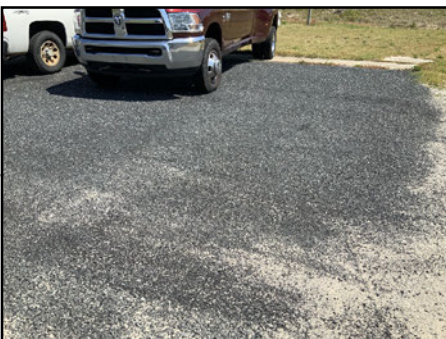
ROUTE 0956EZ: BI RD PARK SERVICE ROAD E PARKING

Inspection Date	FMSS Number	User Access	Surface Type
5/9/2021	111010	NONPUBLIC	ASPHALT
Area (Sq. Ft.)	Lane Miles (11' Widths)	Curb Reveal (Inches)	Curb Recommendation
964	0.017	NOT APPLICABLE	NOT APPLICABLE
Curb Type		Curb & Gutter Type	
NO CURB		NO CURB AND GUTTER	
Pavement Recommendation		Condition Rating / PCR	
LIGHT 3R TREATMENTS		FAIR / 73

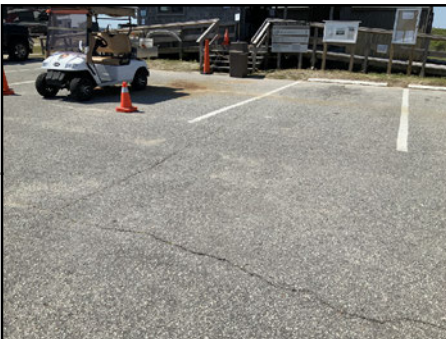
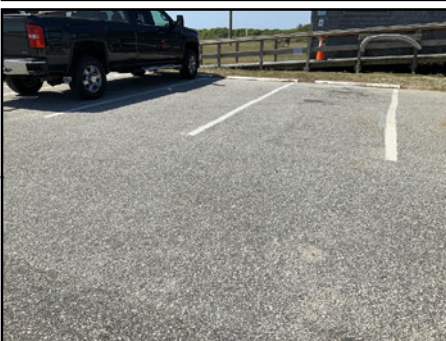
ROUTE 0957: BI RD OREGON INLET CAMPGROUND ENTRANCE STATION PARKING

Inspection Date	FMSS Number	User Access	Surface Type
5/9/2021	111011	PUBLIC	ASPHALT
Area (Sq. Ft.)	Lane Miles (11' Widths)	Curb Reveal (Inches)	Curb Recommendation
5,216	0.09	NOT APPLICABLE	NOT APPLICABLE
Curb Type		Curb & Gutter Type	
NO CURB		NO CURB AND GUTTER	
Pavement Recommendation		Condition Rating / PCR	
LIGHT 3R TREATMENTS		FAIR / 73

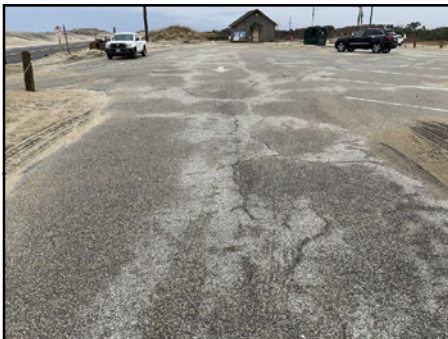
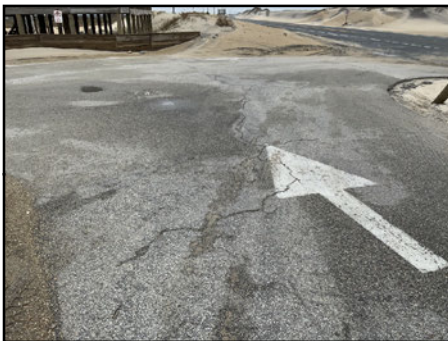
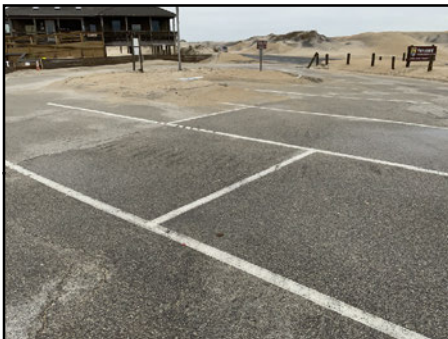
ROUTE 0960: BI RD PEA ISLAND COMFORT STATION PARKING

Inspection Date	FMSS Number	User Access	Surface Type
5/9/2021	111012	PUBLIC	ASPHALT
Area (Sq. Ft.)	Lane Miles (11' Widths)	Curb Reveal (Inches)	Curb Recommendation
19,384	0.334	NOT APPLICABLE	NOT APPLICABLE
Curb Type		Curb & Gutter Type	
NO CURB		NO CURB AND GUTTER	
Pavement Recommendation		Condition Rating / PCR	
HEAVY 3R TREATMENTS		POOR / 53

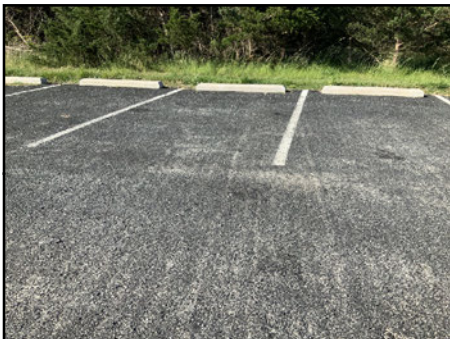
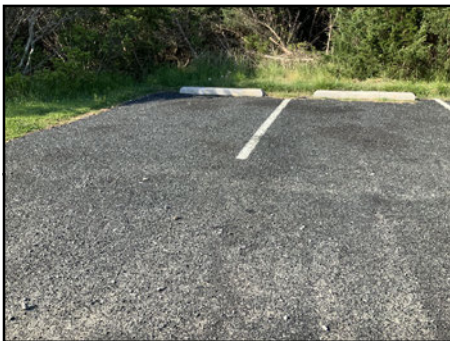
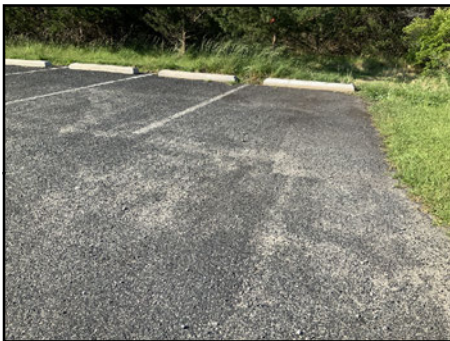
ROUTE 0961AZ: BI RD SALVO DAY USE A PARKING

Inspection Date	FMSS Number	User Access	Surface Type
5/9/2021	104929	PUBLIC	ASPHALT
Area (Sq. Ft.)	Lane Miles (11' Widths)	Curb Reveal (Inches)	Curb Recommendation
2,037	0.035	NOT APPLICABLE	NOT APPLICABLE
Curb Type		Curb & Gutter Type	
NO CURB		NO CURB AND GUTTER	
Pavement Recommendation		Condition Rating / PCR	
LIGHT 3R TREATMENTS		FAIR / 73

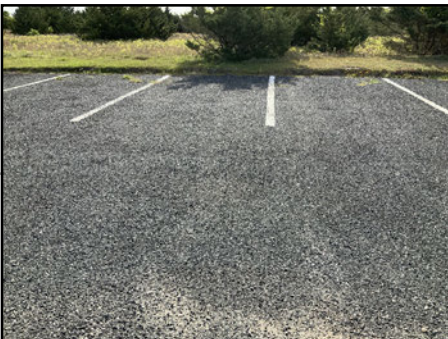
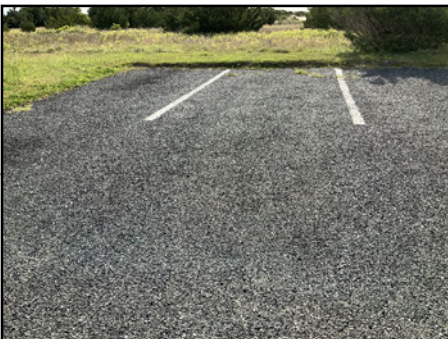
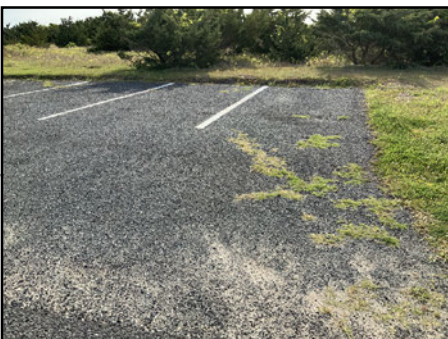
ROUTE 0961BZ: BI RD SALVO DAY USE B PARKING

Inspection Date	FMSS Number	User Access	Surface Type
5/9/2021	104929	PUBLIC	ASPHALT
Area (Sq. Ft.)	Lane Miles (11' Widths)	Curb Reveal (Inches)	Curb Recommendation
1,481	0.025	NOT APPLICABLE	NOT APPLICABLE
Curb Type		Curb & Gutter Type	
NO CURB		NO CURB AND GUTTER	
Pavement Recommendation		Condition Rating / PCR	
LIGHT 3R TREATMENTS		FAIR / 73

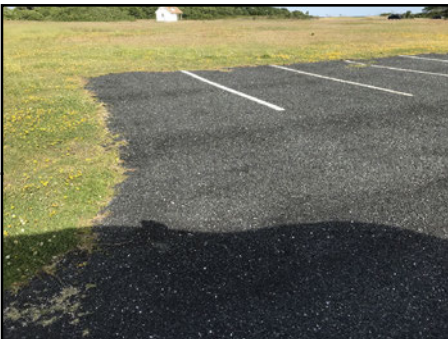
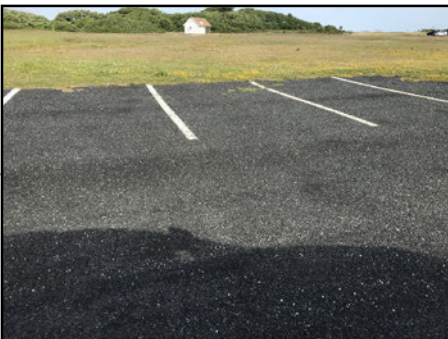
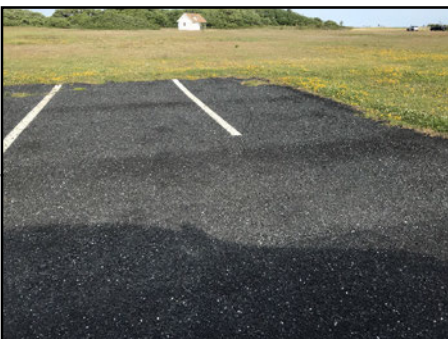
ROUTE 0961CZ: BI RD SALVO DAY USE C PARKING

Inspection Date	FMSS Number	User Access	Surface Type
5/9/2021	104929	PUBLIC	ASPHALT
Area (Sq. Ft.)	Lane Miles (11' Widths)	Curb Reveal (Inches)	Curb Recommendation
1,288	0.022	NOT APPLICABLE	NOT APPLICABLE
Curb Type		Curb & Gutter Type	
NO CURB		NO CURB AND GUTTER	
Pavement Recommendation		Condition Rating / PCR	
LIGHT 3R TREATMENTS		FAIR / 73

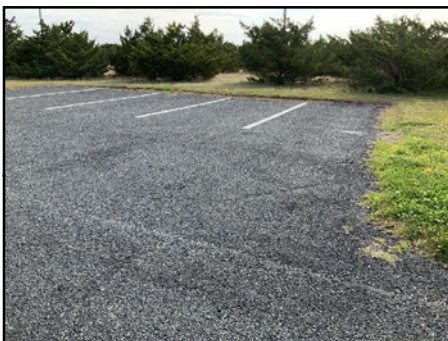
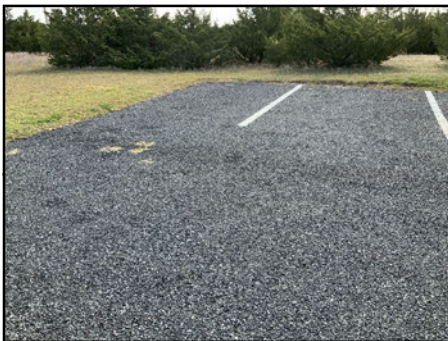
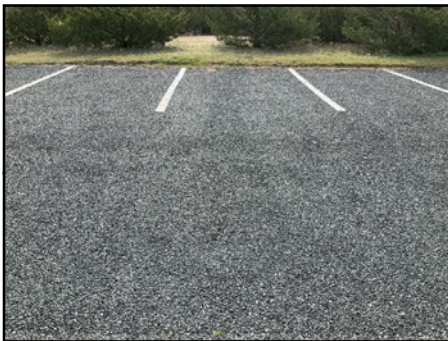
ROUTE 0961FZ: BI RD SALVO DAY USE F PARKING

Inspection Date	FMSS Number	User Access	Surface Type
5/9/2021	104929	PUBLIC	ASPHALT
Area (Sq. Ft.)	Lane Miles (11' Widths)	Curb Reveal (Inches)	Curb Recommendation
1,458	0.025	NOT APPLICABLE	NOT APPLICABLE
Curb Type		Curb & Gutter Type	
NO CURB		NO CURB AND GUTTER	
Pavement Recommendation		Condition Rating / PCR	
LIGHT 3R TREATMENTS		FAIR / 73

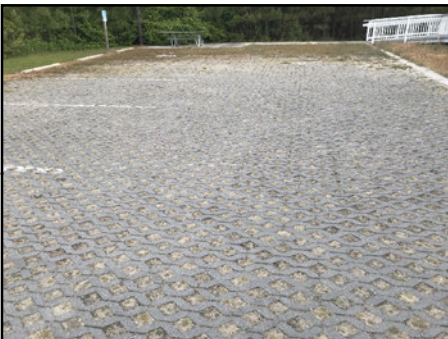
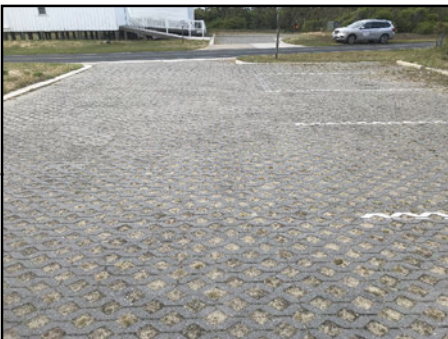
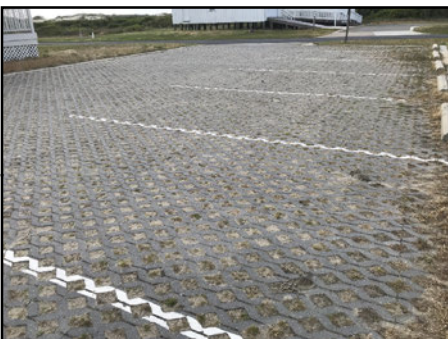
ROUTE 0966: BI RD COAST GUARD STATION PARKING

Inspection Date	FMSS Number	User Access	Surface Type
5/9/2021	228855	PUBLIC	BRICK PAVERS
Area (Sq. Ft.)	Lane Miles (11' Widths)	Curb Reveal (Inches)	Curb Recommendation
4,339	0.075	0	DO NOTHING
Curb Type		Curb & Gutter Type	
CONCRETE		NO CURB AND GUTTER	
Pavement Recommendation		Condition Rating / PCR	
DO NOTHING		EXCELLENT / 97

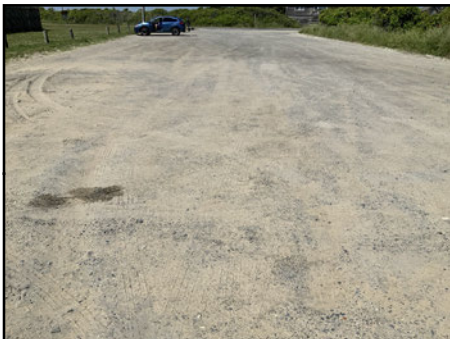
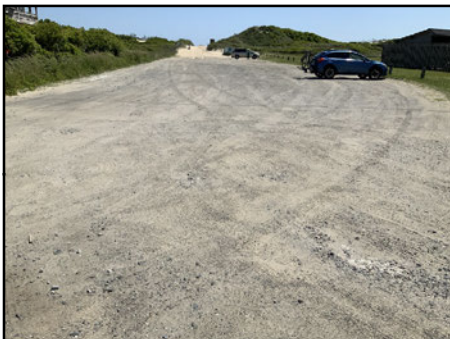
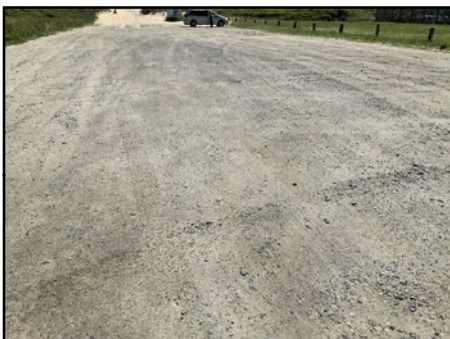
ROUTE 0967: BI RD BEACH RAMP 1 PARKING

Inspection Date	FMSS Number	User Access	Surface Type
5/7/2021	28976	PUBLIC	ASPHALT
Area (Sq. Ft.)	Lane Miles (11' Widths)	Curb Reveal (Inches)	Curb Recommendation
14,095	0.243	NOT APPLICABLE	NOT APPLICABLE
Curb Type		Curb & Gutter Type	
NOT APPLICABLE		NOT APPLICABLE	
Pavement Recommendation		Condition Rating / PCR	
NOT APPLICABLE		NOT RATED / N/A

NOTE: ROUTE NOT RATED DUE TO SURFACE BEING COVERED WITH SAND.

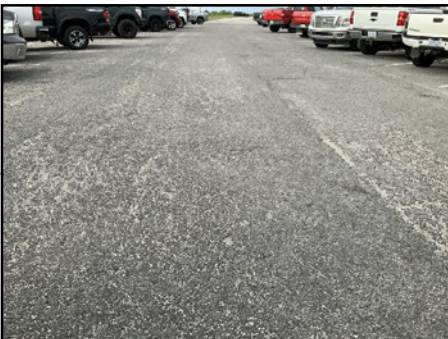
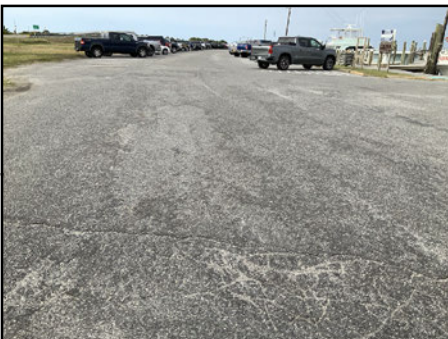
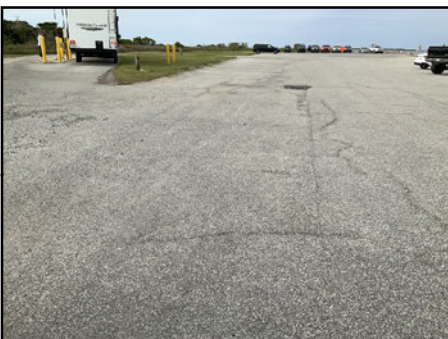
ROUTE 0970: BI RD OREGON INLET SMALL BOAT ACCESS

Inspection Date	FMSS Number	User Access	Surface Type
5/9/2021	28953	PUBLIC	ASPHALT
Area (Sq. Ft.)	Lane Miles (11' Widths)	Curb Reveal (Inches)	Curb Recommendation
145,725	2.509	3	MODERATE REPAIR
Curb Type		Curb & Gutter Type	
CONCRETE		NO CURB AND GUTTER	
Pavement Recommendation		Condition Rating / PCR	
PREVENTIVE MAINTENANCE		GOOD / 90

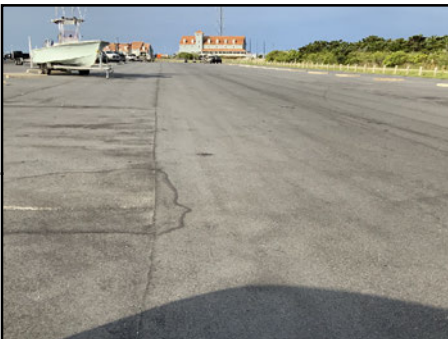
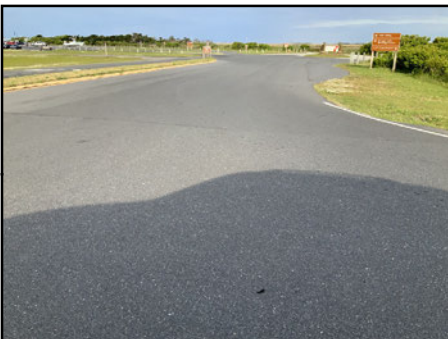
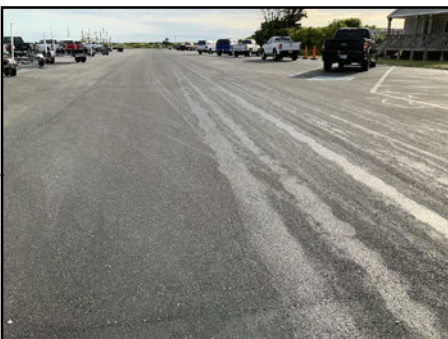
ROUTE 0971: BI RD DUCK BLIND PARKING

Inspection Date	FMSS Number	User Access	Surface Type
5/9/2021	N/A	PUBLIC	CONCRETE
Area (Sq. Ft.)	Lane Miles (11' Widths)	Curb Reveal (Inches)	Curb Recommendation
4,436	0.076	NOT APPLICABLE	NOT APPLICABLE
Curb Type		Curb & Gutter Type	
NO CURB		NO CURB AND GUTTER	
Pavement Recommendation		Condition Rating / PCR	
DO NOTHING		EXCELLENT / 97

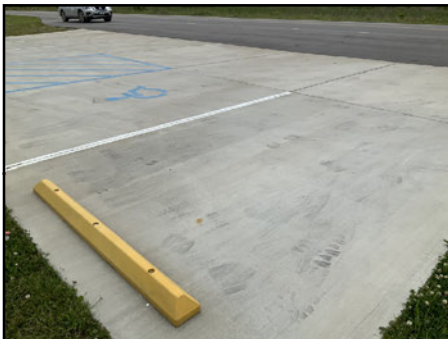
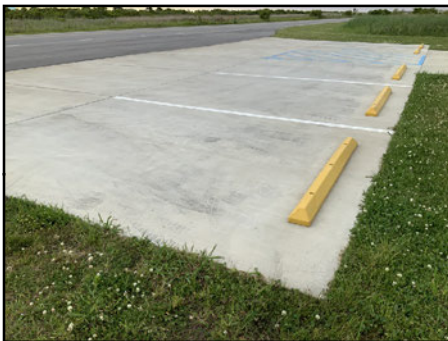
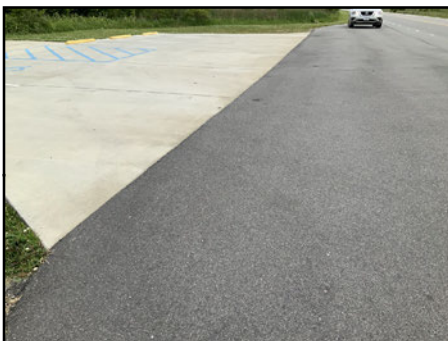
ROUTE 0975: HI RD RAMP 32 PARKING

NOTE: MULTIPLE SURFACE TYPES:
 CONCRETE IS 2,747 SQ FT
 ASPHALT IS 1,689 SQ FT

Inspection Date	FMSS Number	User Access	Surface Type
5/9/2021	244477	PUBLIC	BRICK PAVERS
Area (Sq. Ft.)	Lane Miles (11' Widths)	Curb Reveal (Inches)	Curb Recommendation
8,958	0.154	0	DO NOTHING
Curb Type		Curb & Gutter Type	
CONCRETE		NO CURB AND GUTTER	
Pavement Recommendation		Condition Rating / PCR	
DO NOTHING		EXCELLENT / 97
