COLO Cycle 6

Final Report

Road Inventory and Condition Assessment of Paved Routes Colonial National Historical Park

**Federal Highway Administration
Eastern Federal Lands Highway Division
Road Inventory Program (RIP)**

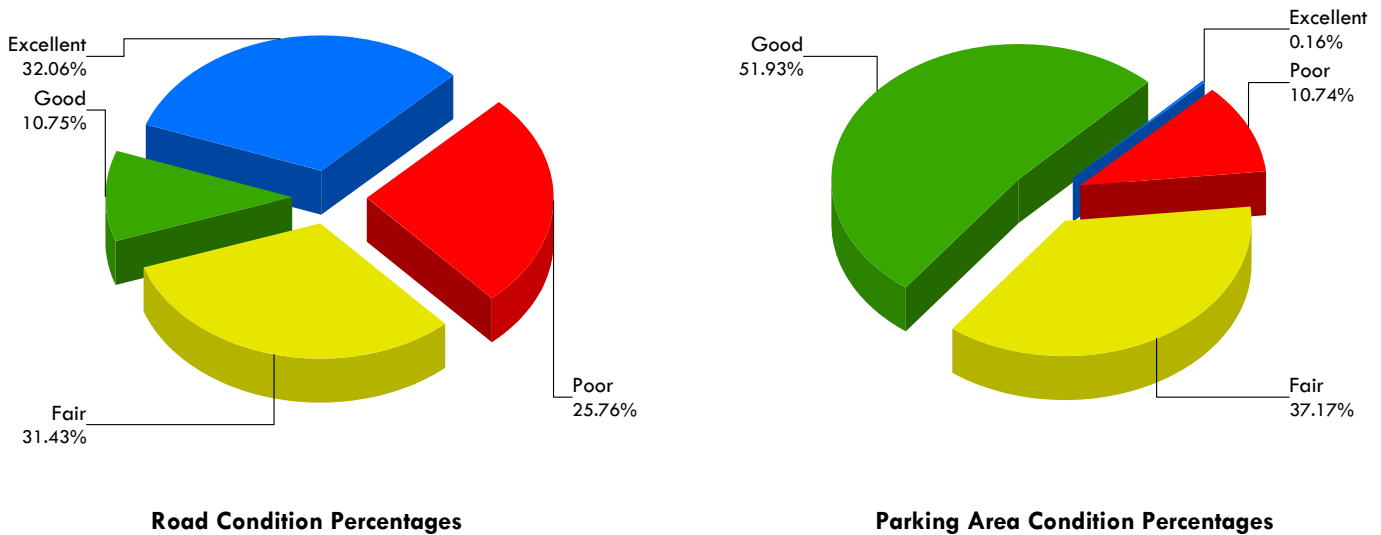
Figure 1: Pavement Condition Rating Breakdown for Paved Roads and Parking Areas

Parkwide Condition Percentages

The Road Inventory Program aims to provide assistance in translating the excellent / good / fair / poor rating categories into pavement needs categories. The PCR can be used to indicate the place in the Pavement Life Cycle and the type of treatments that should be considered now and into the future.

- Excellent / New: PCR of 95-100
 - Pavements in this range will require only spot repairs
- Good: PCR of 85-94
 - Pavements in this range will likely be candidates for Preventive Maintenance. Examples include Chip and Slurry Seals, Micro Surfacing and Thin Overlays.
- Fair: PCR of 61-84
 - Pavements in this range will likely be candidates of Light Rehabilitation (L3R). Examples include singlelift overlays up to 2.5 inches in total thickness, milling and overlays.
- Poor: PCR of 0-60
 - Pavements in this range will likely be candidates of Heavy Rehabilitation or Reconstruction (H3R or 4R). Examples include Pulverization, Multiple Lift Overlays, and Reconstruction.

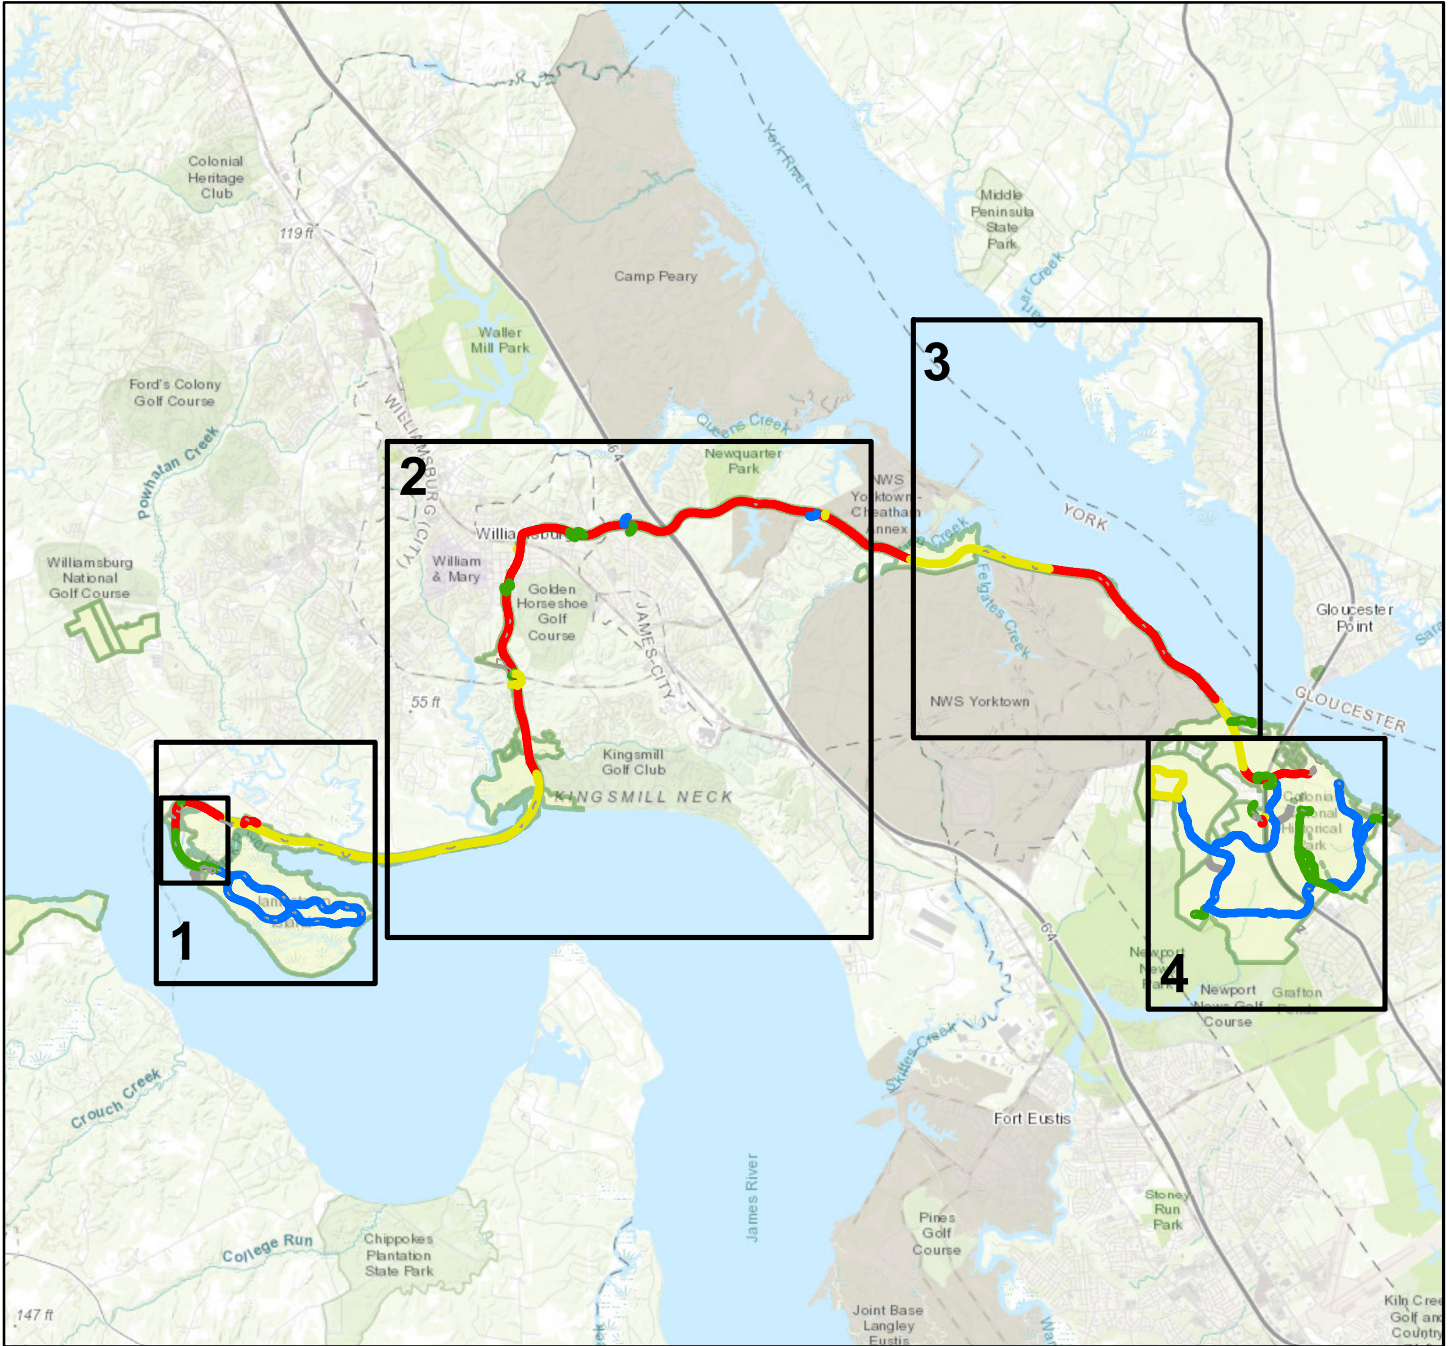
Key Map

ROUTE CONDITION MAP

PCR - MILE BY MILE

Colors on map represent condition scores at 1-mile intervals. See Appendix for definitions and formulas
Only Data Collection Vehicle and Manually Rated Roads are displayed

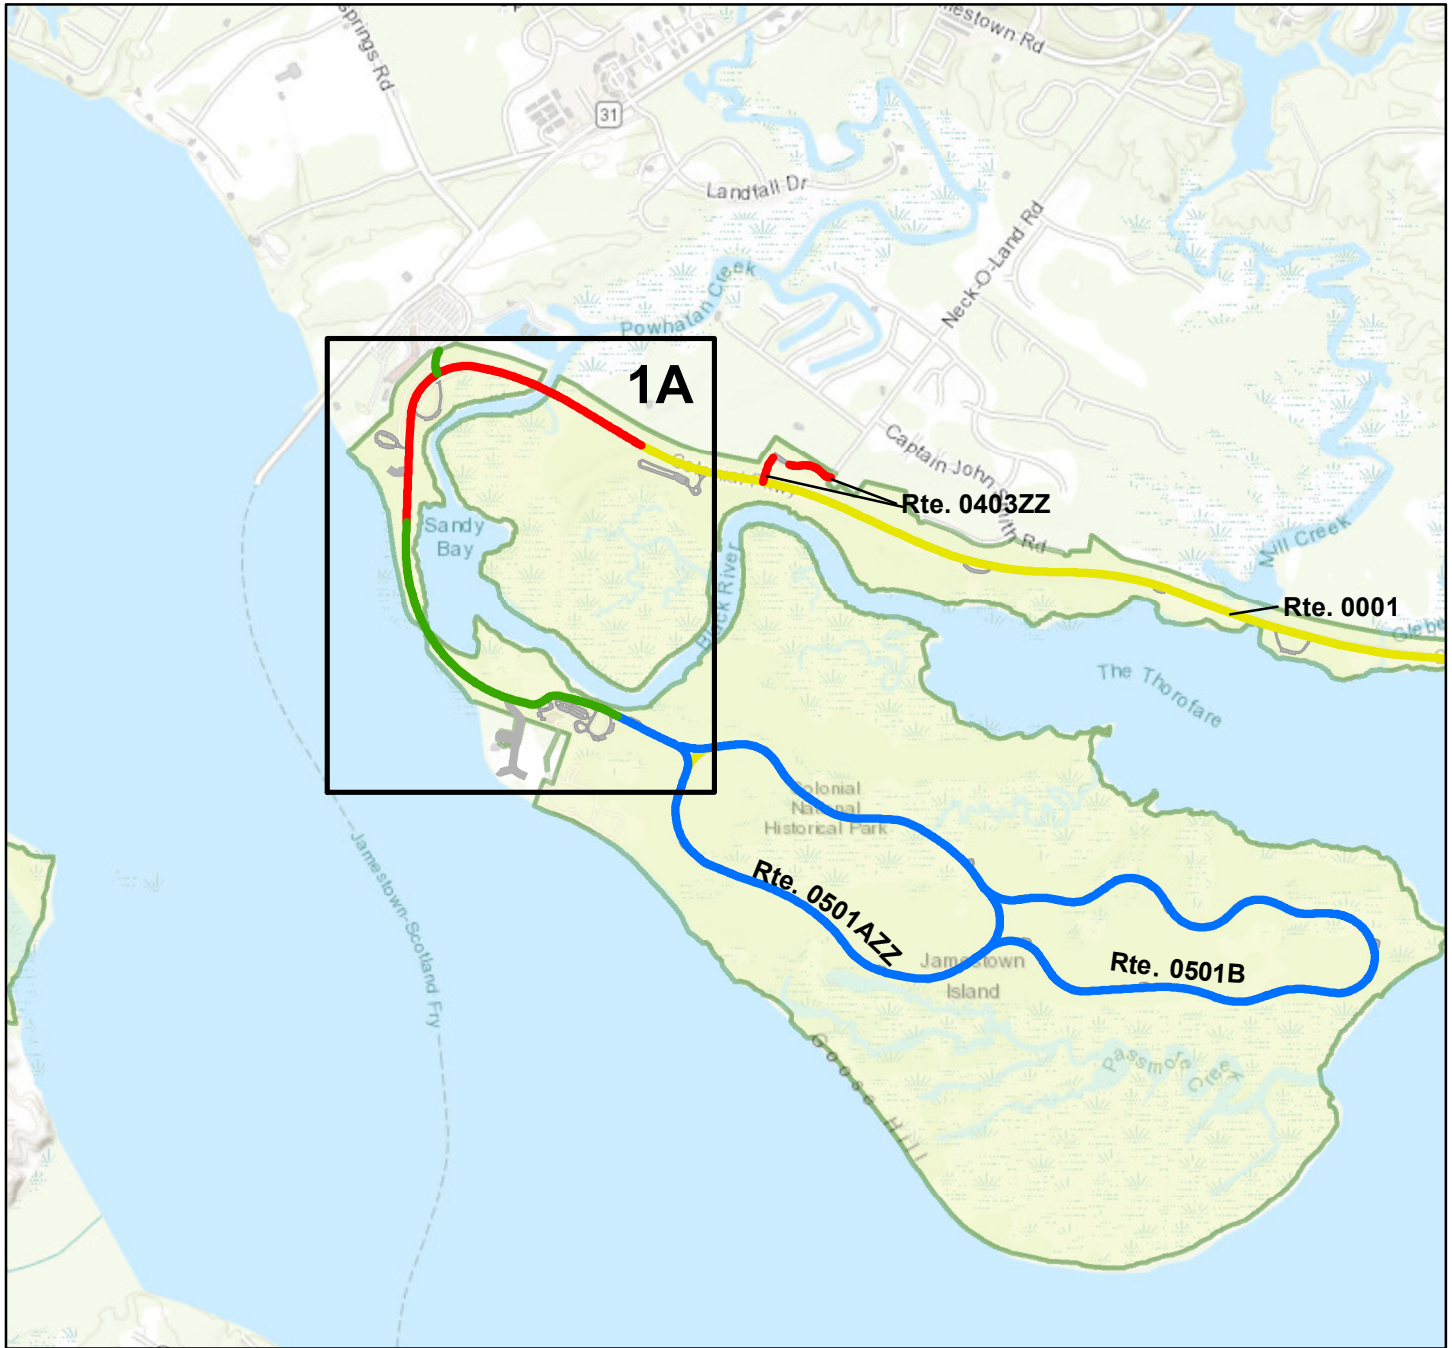
Area Map 1

ROUTE CONDITION MAP

PCR - MILE BY MILE

Colors on map represent condition scores at 1-mile intervals. See Appendix for definitions and formulas
Only Data Collection Vehicle and Manually Rated Roads are displayed

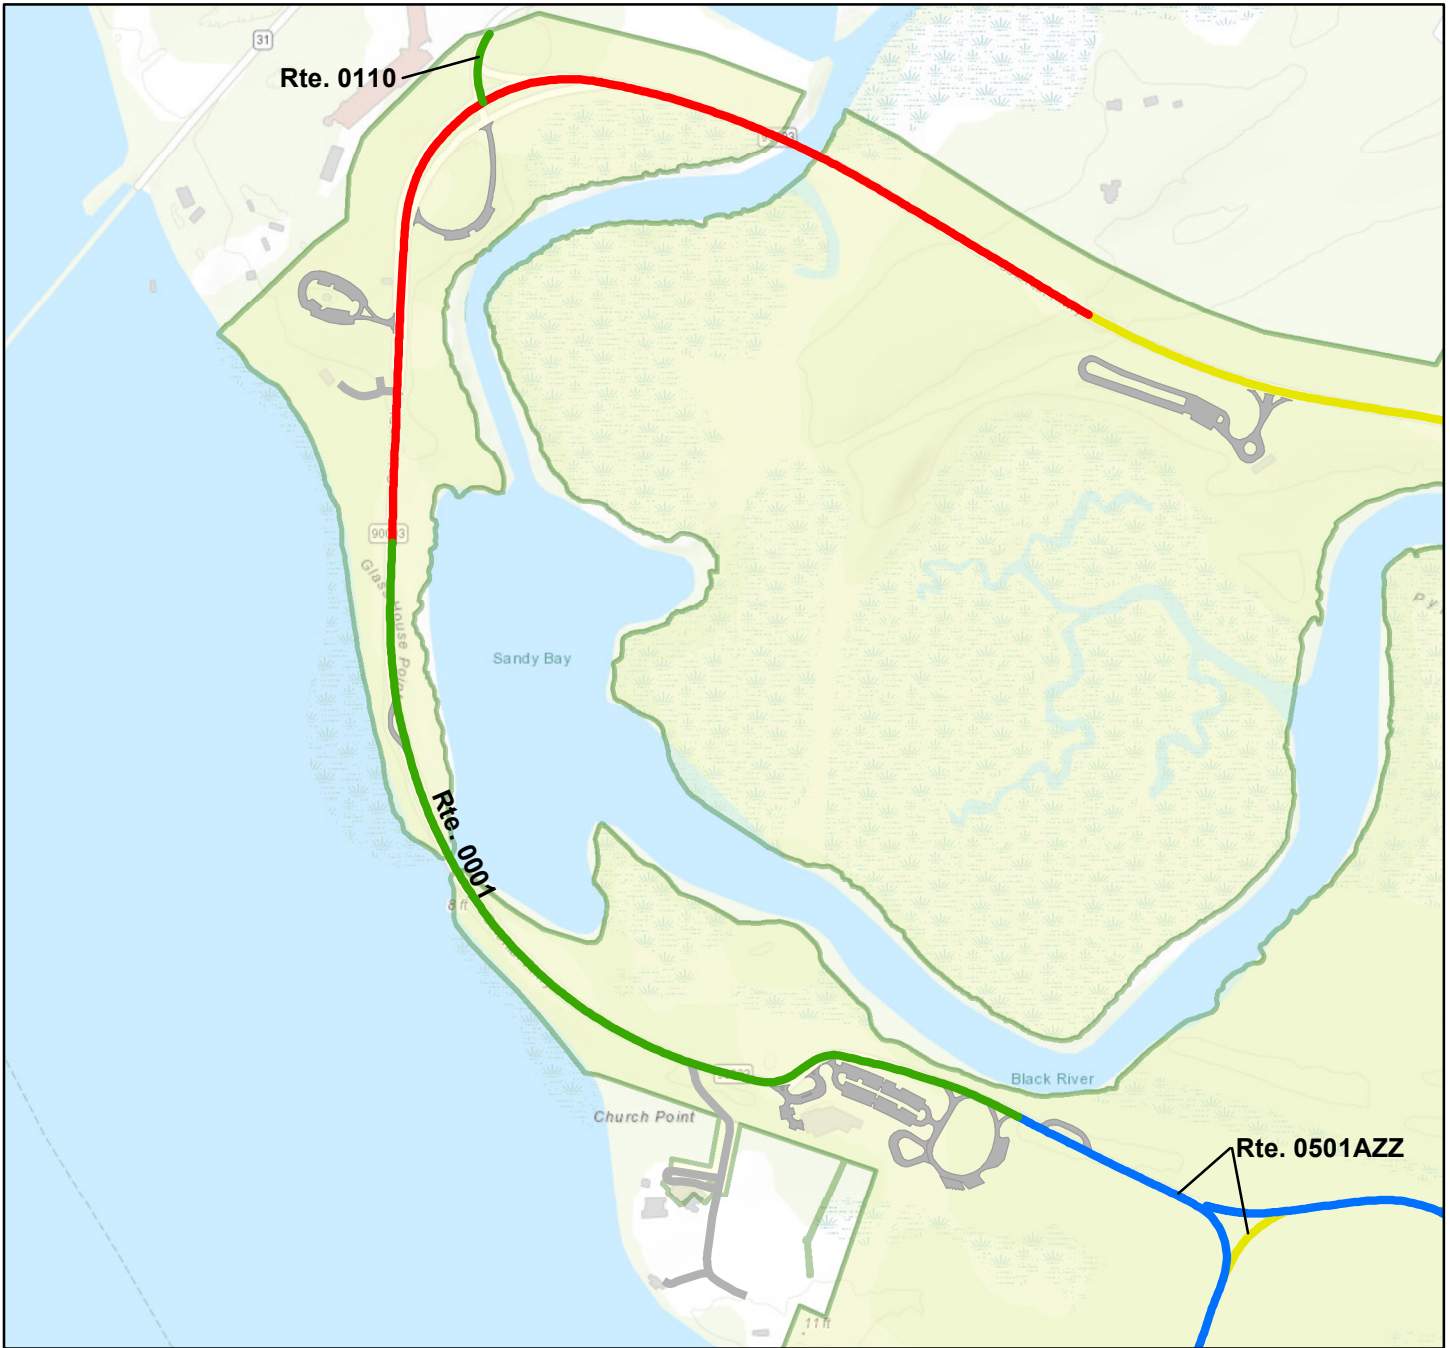
Area Map 1A

ROUTE CONDITION MAP

PCR - MILE BY MILE

Colors on map represent condition scores at 1-mile intervals. See Appendix for definitions and formulas
Only Data Collection Vehicle and Manually Rated Roads are displayed

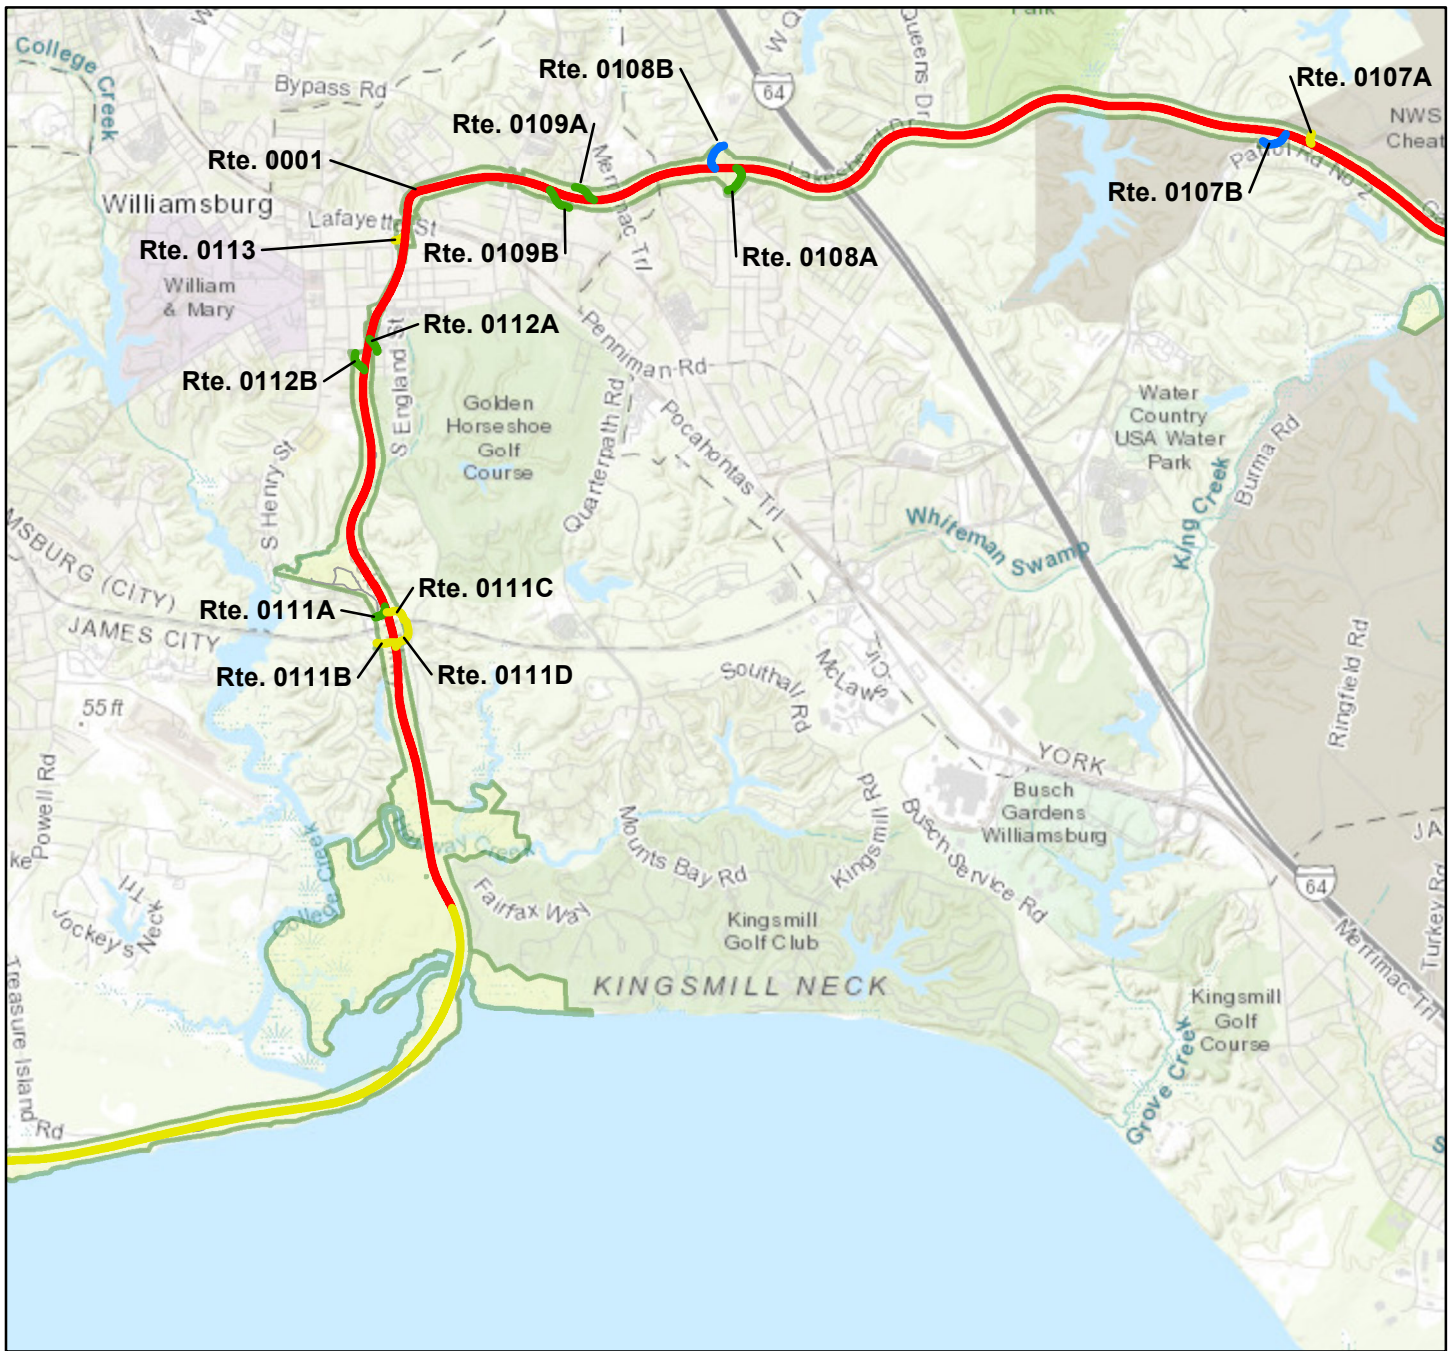
Area Map 2

ROUTE CONDITION MAP

PCR - MILE BY MILE

Colors on map represent condition scores at 1-mile intervals. See Appendix for definitions and formulas
 Only Data Collection Vehicle and Manually Rated Roads are displayed

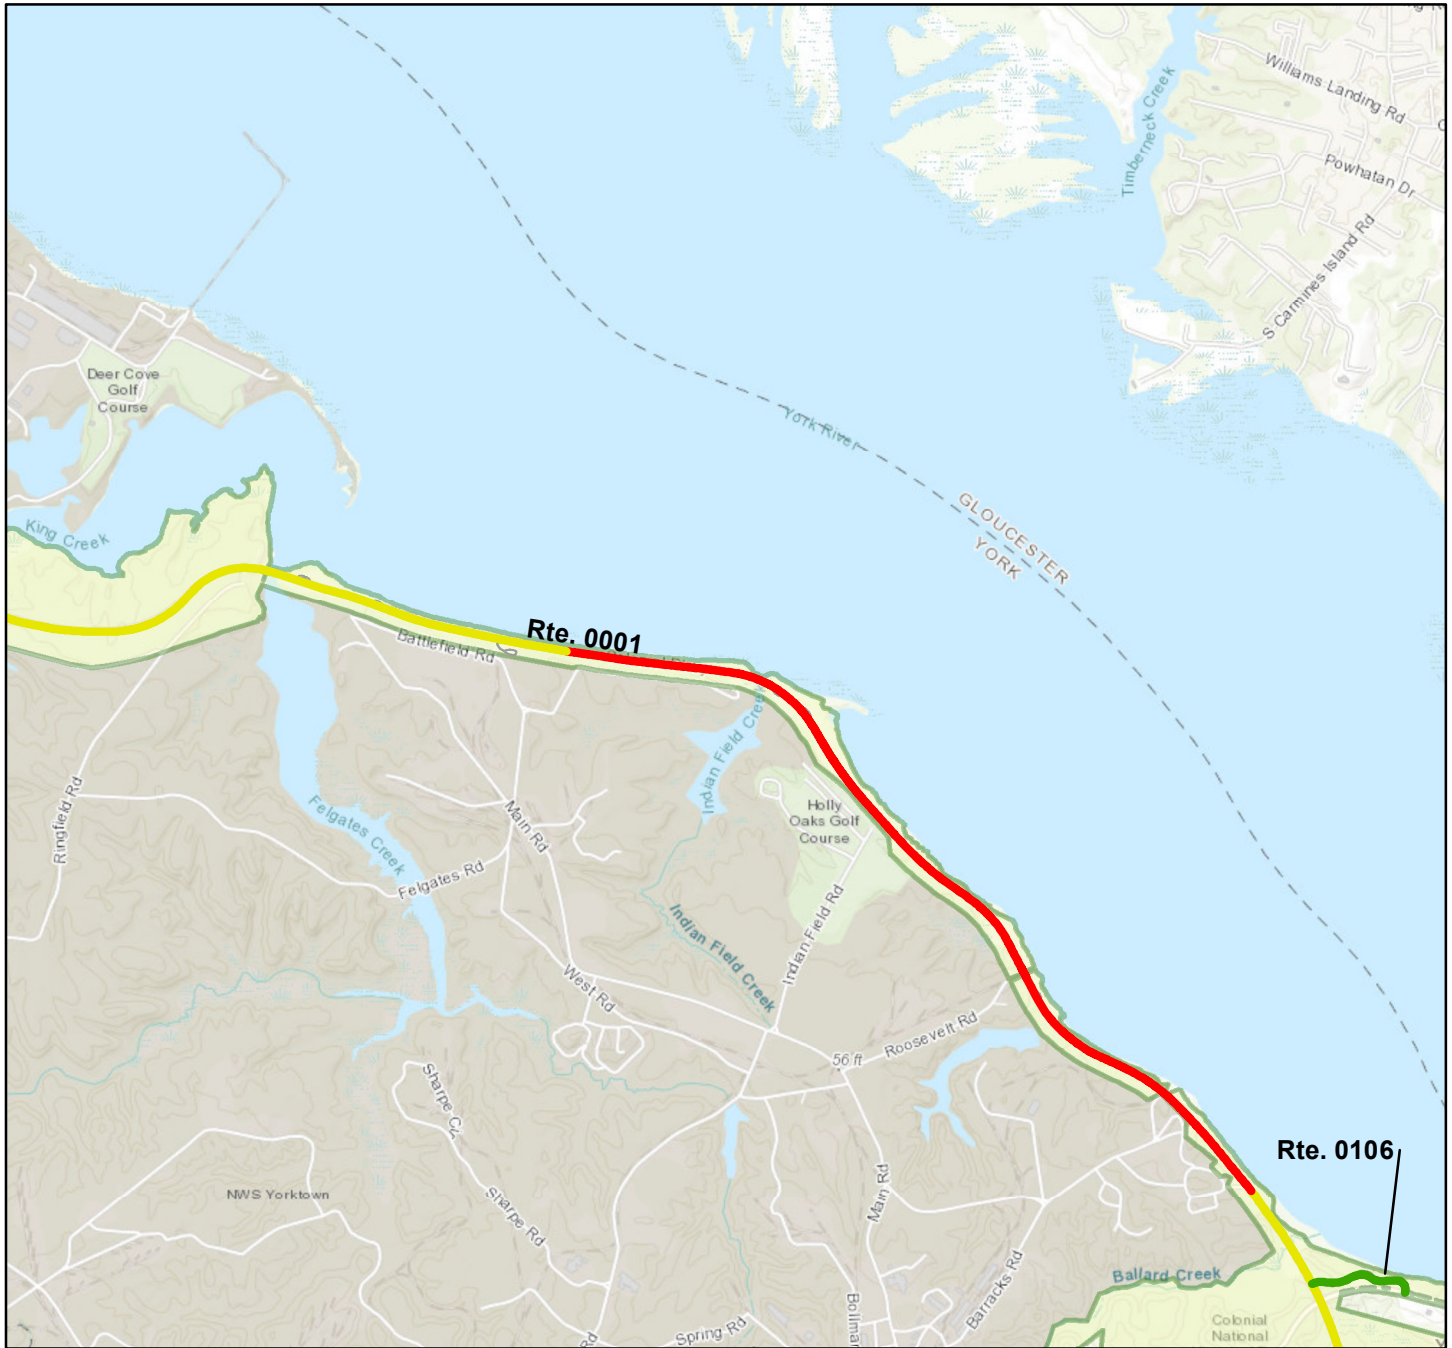
Area Map 3

ROUTE CONDITION MAP

PCR - MILE BY MILE

Colors on map represent condition scores at 1-mile intervals. See Appendix for definitions and formulas
 Only Data Collection Vehicle and Manually Rated Roads are displayed

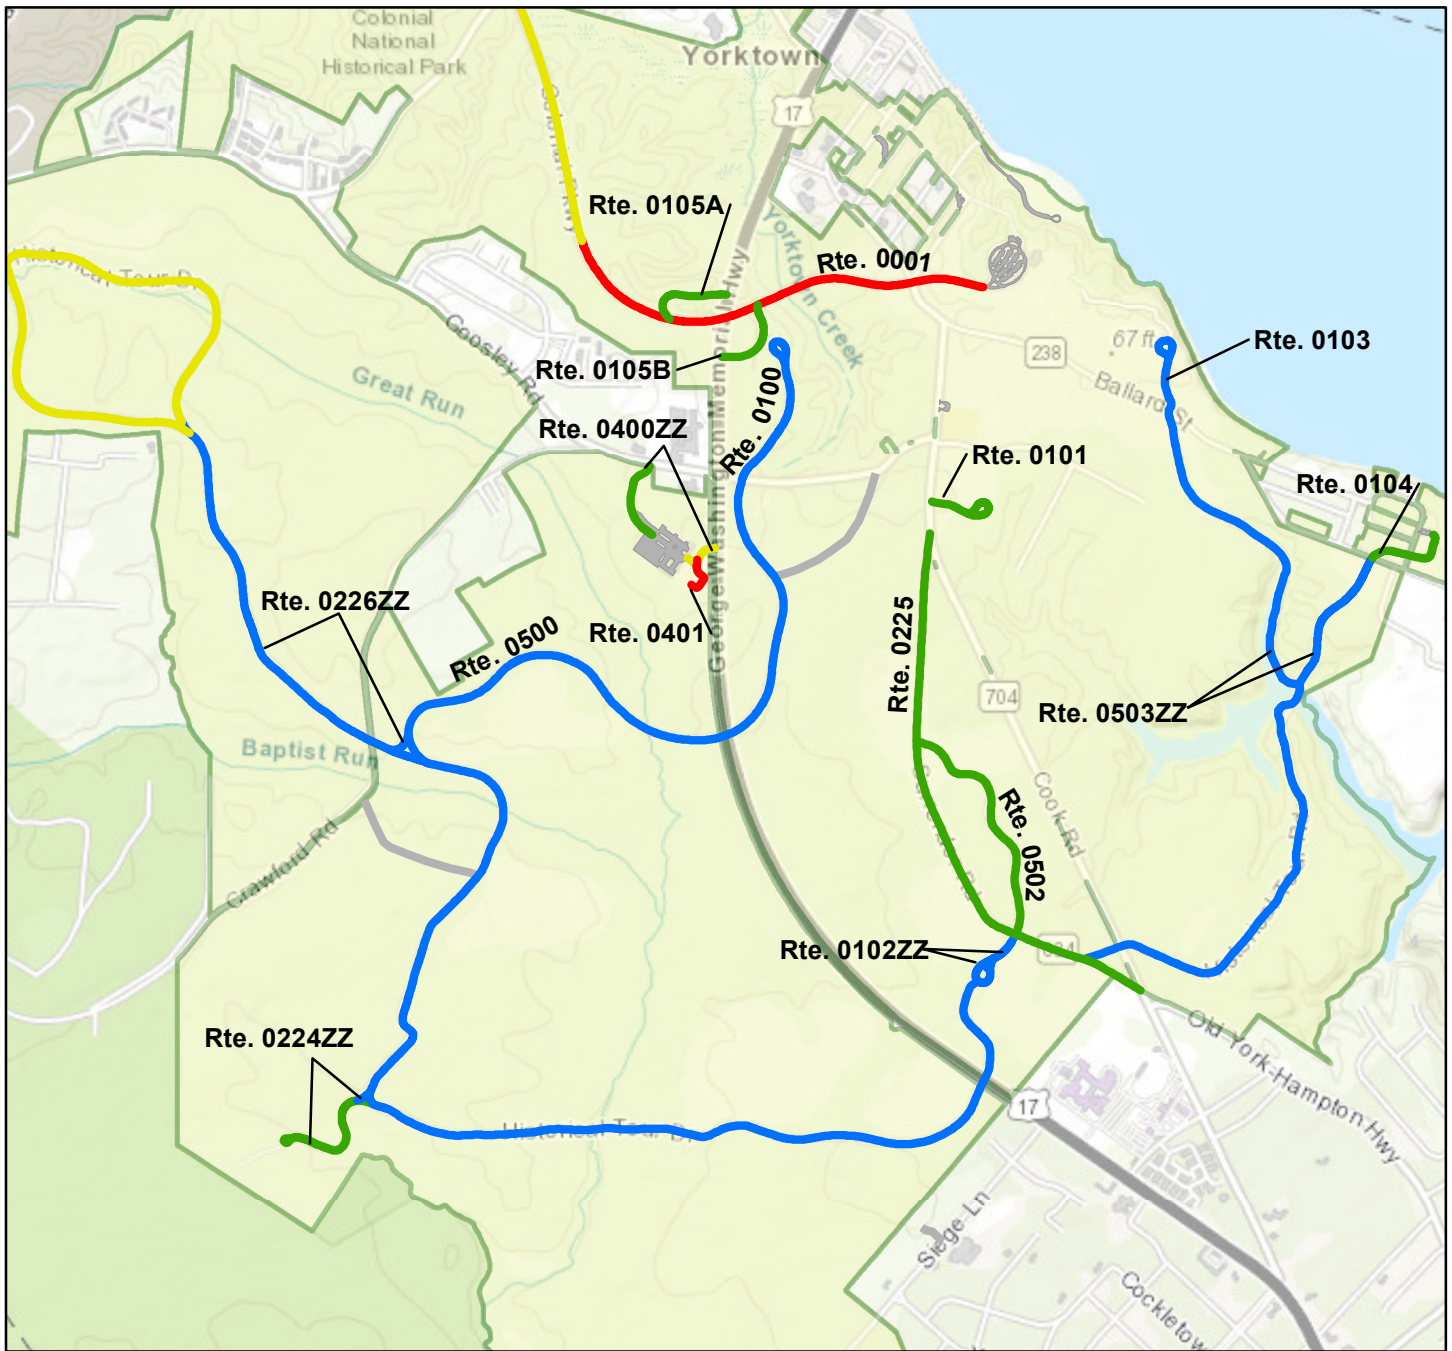
Area Map 4

ROUTE CONDITION MAP

PCR - MILE BY MILE

Colors on map represent condition scores at 1-mile intervals. See Appendix for definitions and formulas
Only Data Collection Vehicle and Manually Rated Roads are displayed

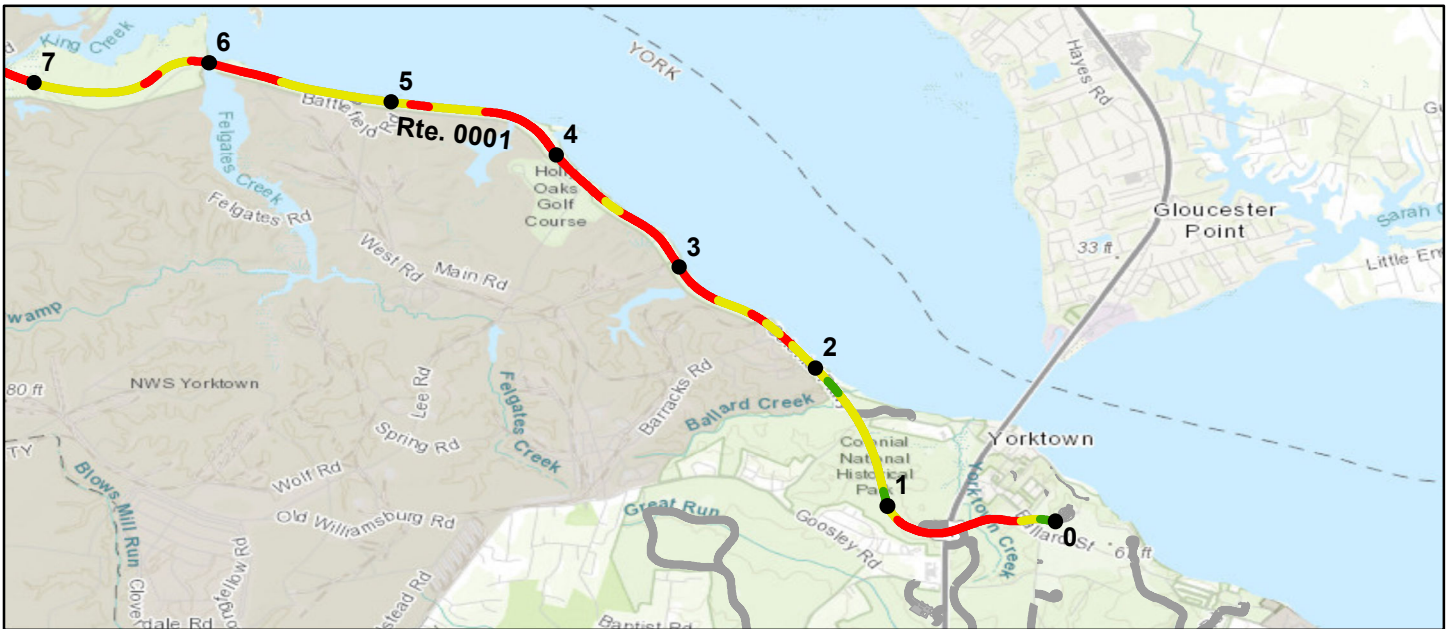
ROUTE 0001: COLONIAL PARKWAY

Data Collection Vehicle (DCV) Rating

Route Condition Legend – Pavement Condition Rating (PCR)						
Poor (0 - 60)	Fair (61- 84)	Good (85 - 94)	Excellent (95 - 100)	Not Rated		
Colors on map represent condition scores at 0.10-mile intervals. See Appendix for definitions and formulas.						
Inspection Date: 4/18/2021	Beginning Section MP	0	1	2	3	4
Paved Length (Miles): 22.87	Section Length (MI)	1	1	1	1	1
Surface Type: CONCRETE	Route Summary					
Roadway Condition Information						
Pavement Condition Rating (PCR)	58	29	77	54	39	56
Surface Condition Rating (SCR)	N/A	N/A	N/A	N/A	N/A	N/A
Roughness Condition Index (RCI)	58	29	77	54	39	56
Distress Index Values						
Structural Crack Index	N/A	N/A	N/A	N/A	N/A	N/A
Alligator Crack Index	N/A	N/A	N/A	N/A	N/A	N/A
Longitudinal Crack Index	N/A	N/A	N/A	N/A	N/A	N/A
Transverse Cracking Index	N/A	N/A	N/A	N/A	N/A	N/A
Patching Index	N/A	N/A	N/A	N/A	N/A	N/A
Rutting Index	N/A	N/A	N/A	N/A	N/A	N/A
International Roughness Index (IRI)	209	264	160	217	246	212

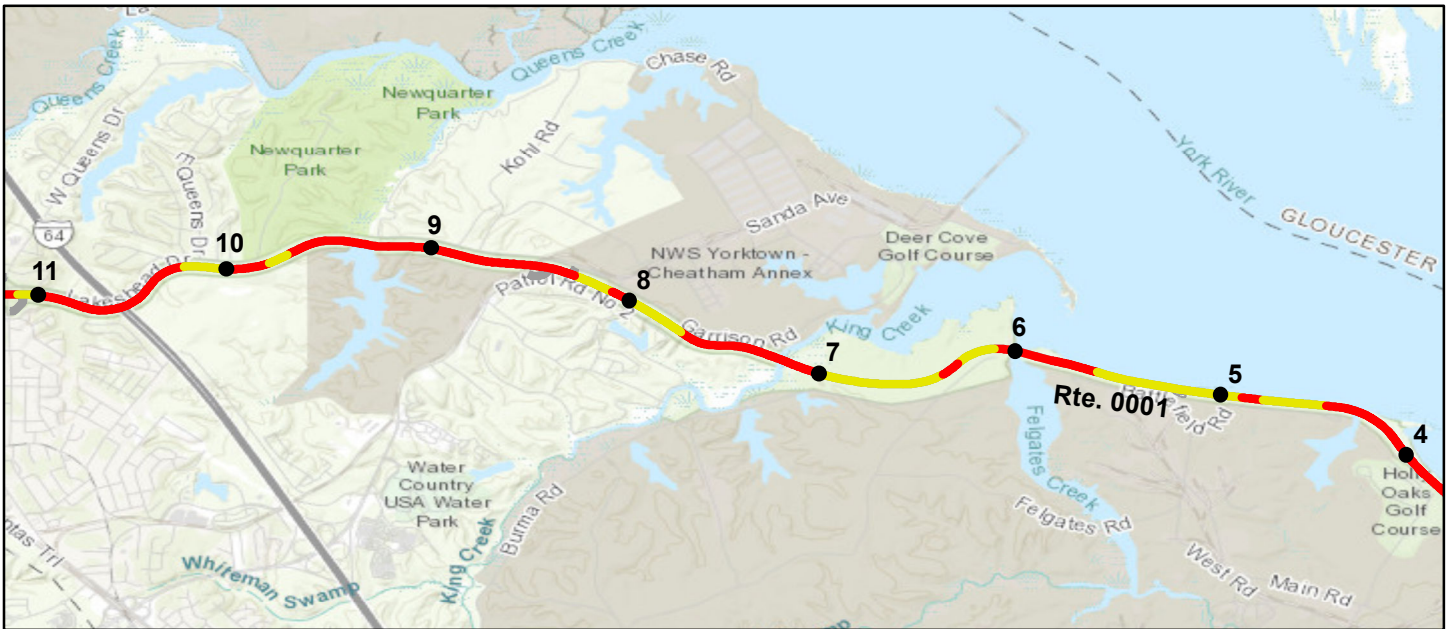
ROUTE 0001: COLONIAL PARKWAY

Data Collection Vehicle (DCV) Rating

Route Condition Legend – Pavement Condition Rating (PCR)						
Poor (0 - 60)	Fair (61- 84)	Good (85 - 94)	Excellent (95 - 100)	Not Rated		
Colors on map represent condition scores at 0.10-mile intervals. See Appendix for definitions and formulas.						
Inspection Date: 4/18/2021	Beginning Section MP	5	6	7	8	9
Paved Length (Miles): 22.87	Section Length (MI)	1	1	1	1	1
Surface Type: CONCRETE	Route Summary					
Roadway Condition Information						
Pavement Condition Rating (PCR)	58	62	68	57	50	39
Surface Condition Rating (SCR)	N/A	N/A	N/A	N/A	N/A	N/A
Roughness Condition Index (RCI)	58	62	68	57	50	39
Distress Index Values						
Structural Crack Index	N/A	N/A	N/A	N/A	N/A	N/A
Alligator Crack Index	N/A	N/A	N/A	N/A	N/A	N/A
Longitudinal Crack Index	N/A	N/A	N/A	N/A	N/A	N/A
Transverse Cracking Index	N/A	N/A	N/A	N/A	N/A	N/A
Patching Index	N/A	N/A	N/A	N/A	N/A	N/A
Rutting Index	N/A	N/A	N/A	N/A	N/A	N/A
International Roughness Index (IRI)	209	199	185	210	224	246

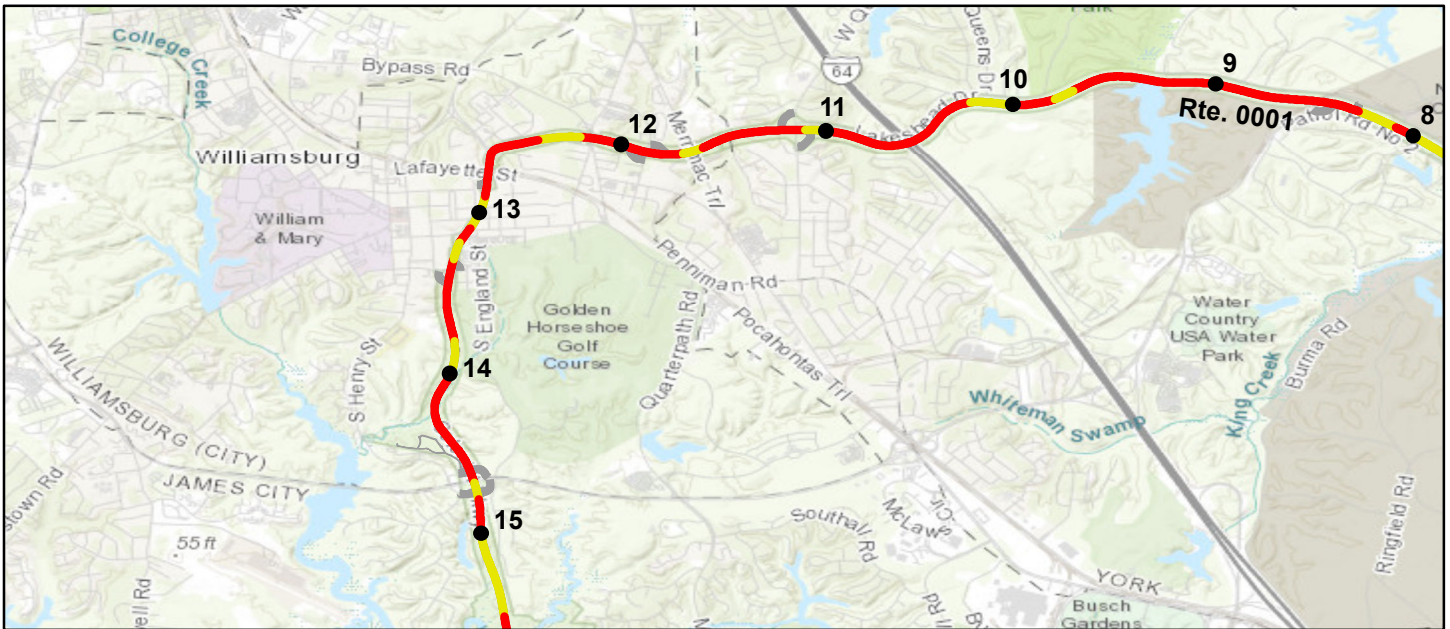
ROUTE 0001: COLONIAL PARKWAY

Data Collection Vehicle (DCV) Rating

Colors on map represent condition scores at 0.10-mile intervals. See Appendix for definitions and formulas.

Inspection Date: 4/18/2021	Beginning Section MP	10	11	12	13	14
Paved Length (Miles): 22.87	Section Length (MI)	1	1	1	1	1
Surface Type: CONCRETE	Route Summary					
Roadway Condition Information						
Pavement Condition Rating (PCR)	58	45	38	49	60	44
Surface Condition Rating (SCR)	N/A	N/A	N/A	N/A	N/A	N/A
Roughness Condition Index (RCI)	58	45	38	49	60	44
Distress Index Values						
Structural Crack Index	N/A	N/A	N/A	N/A	N/A	N/A
Alligator Crack Index	N/A	N/A	N/A	N/A	N/A	N/A
Longitudinal Crack Index	N/A	N/A	N/A	N/A	N/A	N/A
Transverse Cracking Index	N/A	N/A	N/A	N/A	N/A	N/A
Patching Index	N/A	N/A	N/A	N/A	N/A	N/A
Rutting Index	N/A	N/A	N/A	N/A	N/A	N/A
International Roughness Index (IRI)	209	234	248	227	204	236
Lane & Width Information						
Number of Lanes	2	2	2	2	2	2
Paved Width (ft)	28.5	29.4	29.5	27.8	26.4	29.3
Lane Width (ft)	14.3	14.7	14.8	13.9	13.1	14.7

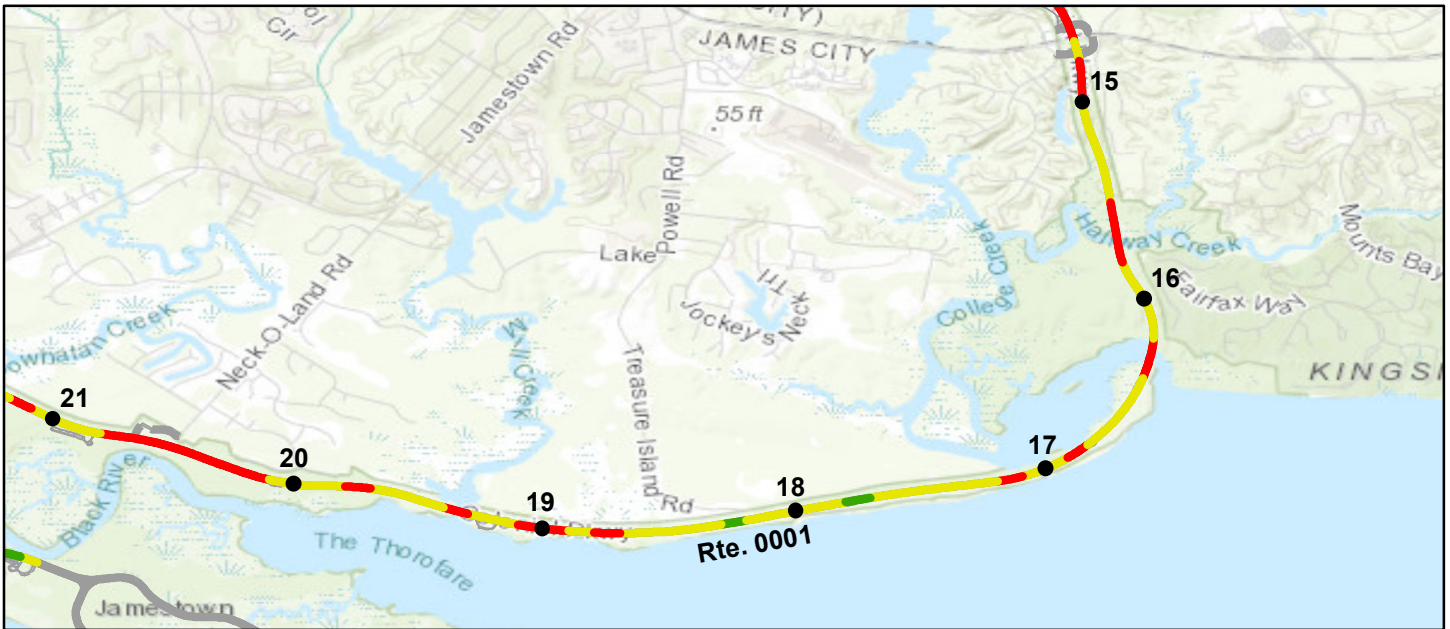
ROUTE 0001: COLONIAL PARKWAY

Data Collection Vehicle (DCV) Rating

Route Condition Legend – Pavement Condition Rating (PCR)						
Poor (0 - 60)	Fair (61- 84)	Good (85 - 94)	Excellent (95 - 100)	Not Rated		
Colors on map represent condition scores at 0.10-mile intervals. See Appendix for definitions and formulas.						
Inspection Date: 4/18/2021	Beginning Section MP	15	16	17	18	19
Paved Length (Miles): 22.87	Section Length (MI)	1	1	1	1	1
Surface Type: CONCRETE	Route Summary					
Roadway Condition Information						
Pavement Condition Rating (PCR)	58	60	68	76	70	66
Surface Condition Rating (SCR)	N/A	N/A	N/A	N/A	N/A	N/A
Roughness Condition Index (RCI)	58	60	68	76	70	66
Distress Index Values						
Structural Crack Index	N/A	N/A	N/A	N/A	N/A	N/A
Alligator Crack Index	N/A	N/A	N/A	N/A	N/A	N/A
Longitudinal Crack Index	N/A	N/A	N/A	N/A	N/A	N/A
Transverse Cracking Index	N/A	N/A	N/A	N/A	N/A	N/A
Patching Index	N/A	N/A	N/A	N/A	N/A	N/A
Rutting Index	N/A	N/A	N/A	N/A	N/A	N/A
International Roughness Index (IRI)	209	205	184	162	178	190

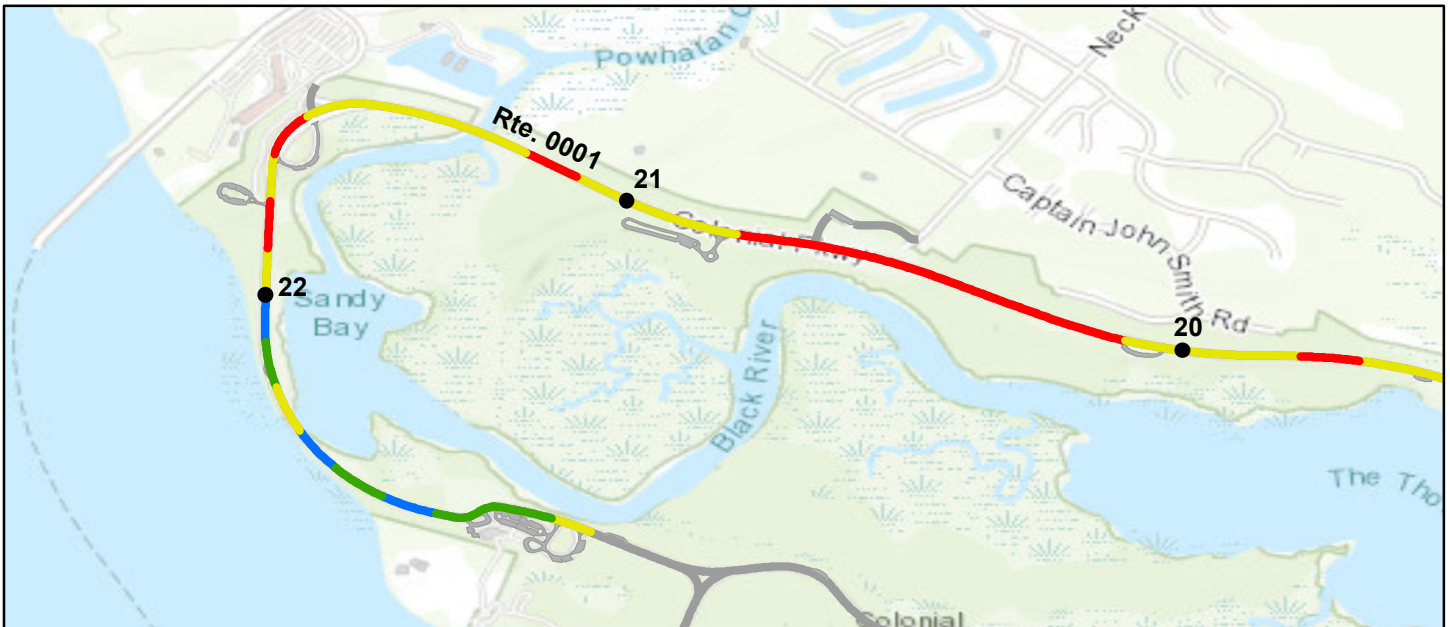
ROUTE 0001: COLONIAL PARKWAY

Data Collection Vehicle (DCV) Rating

Route Condition Legend – Pavement Condition Rating (PCR)										
Poor (0 - 60)		Fair (61- 84)		Good (85 - 94)		Excellent (95 - 100)		Not Rated		
Colors on map represent condition scores at 0.10-mile intervals. See Appendix for definitions and formulas.										
Inspection Date:	4/18/2021	Beginning Section MP	20	21	22					
Paved Length (Miles):	22.87	Section Length (MI)	1	1	0.87					
Surface Type:	CONCRETE	Route Summary								
Roadway Condition Information										
Pavement Condition Rating (PCR)	58	67	50	91						
Surface Condition Rating (SCR)	N/A	N/A	N/A	95						
Roughness Condition Index (RCI)	58	67	50	86						
Distress Index Values										
Structural Crack Index	N/A	N/A	N/A	95						
Alligator Crack Index	N/A	N/A	N/A	100						
Longitudinal Crack Index	N/A	N/A	N/A	95						
Transverse Cracking Index	N/A	N/A	N/A	95						
Patching Index	N/A	N/A	N/A	98						
Rutting Index	N/A	N/A	N/A	98						
International Roughness Index (IRI)	209	187	224	151

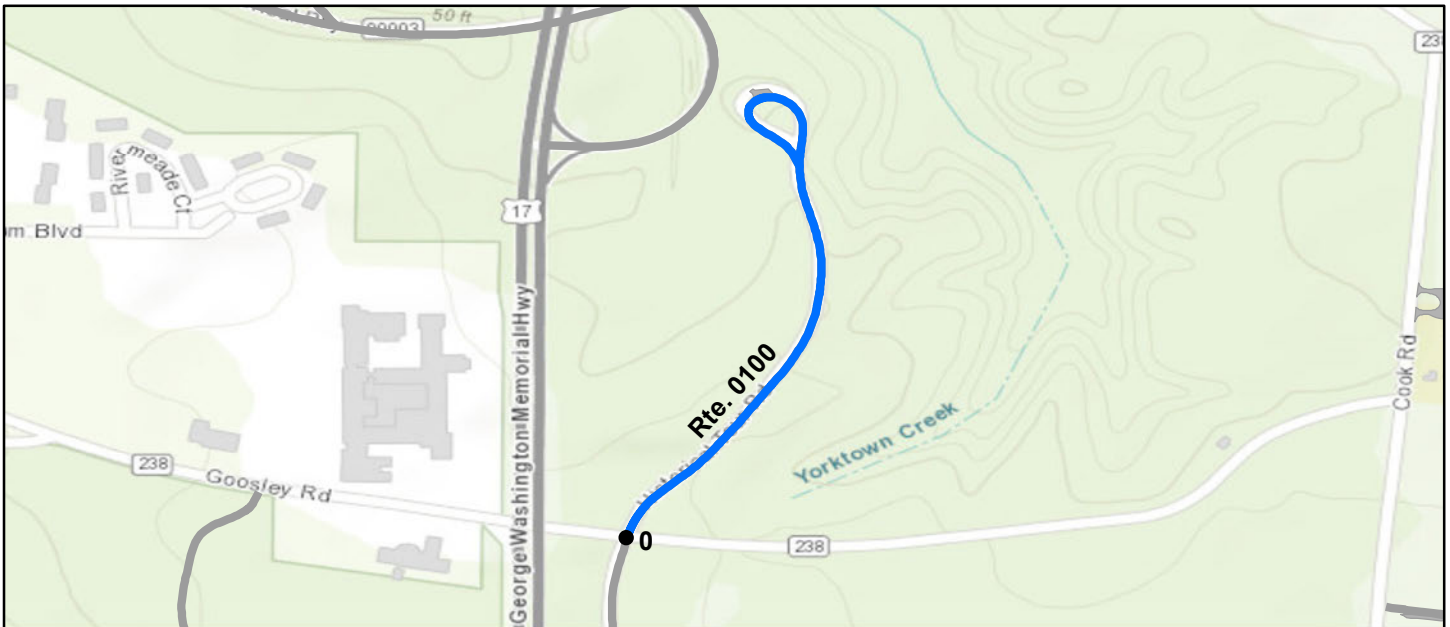
ROUTE 0100: UNTOUCHED REDOUBT ROAD

Data Collection Vehicle (DCV) Rating

Colors on map represent condition scores at 0.10-mile intervals. See Appendix for definitions and formulas.

Inspection Date: 4/18/2021	Beginning Section MP	0				
Paved Length (Miles): 0.41	Section Length (MI)	0.41				
Surface Type: ASPHALT	Route Summary					
Roadway Condition Information						
Pavement Condition Rating (PCR)	99	99				
Surface Condition Rating (SCR)	99	99				
Roughness Condition Index (RCI)	N/A	N/A				
Distress Index Values						
Structural Crack Index	99	99				
Alligator Crack Index	100	100				
Longitudinal Crack Index	99	99				
Transverse Cracking Index	100	100				
Patching Index	100	100				
Rutting Index	99	99				
International Roughness Index (IRI)	N/A	N/A				
Lane & Width Information						
Number of Lanes	2	2				
Paved Width (ft)	19.1	19.1				
Lane Width (ft)	9.5	9.5

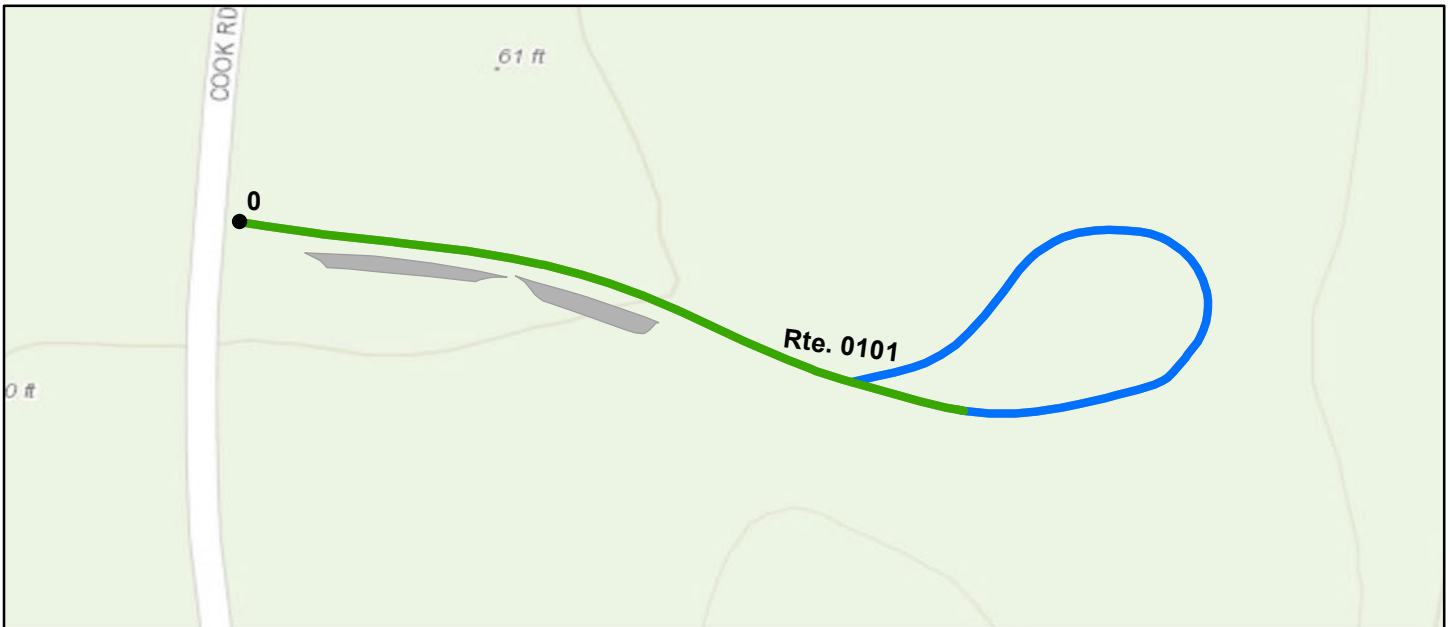
ROUTE 0101: GRAND FRENCH BATTERY ROAD

Data Collection Vehicle (DCV) Rating

Colors on map represent condition scores at 0.10-mile intervals. See Appendix for definitions and formulas.

Inspection Date:	4/18/2021	Beginning Section MP	0				
Paved Length (Miles):	0.2	Section Length (MI)	0.2				
Surface Type:	ASPHALT	Route Summary					
Roadway Condition Information							
Pavement Condition Rating (PCR)	93	93					
Surface Condition Rating (SCR)	93	93					
Roughness Condition Index (RCI)	N/A	N/A					
Distress Index Values							
Structural Crack Index	100	100					
Alligator Crack Index	100	100					
Longitudinal Crack Index	100	100					
Transverse Cracking Index	100	100					
Patching Index	97	97					
Rutting Index	93	93					
International Roughness Index (IRI)	N/A	N/A					
Lane & Width Information							
Number of Lanes	2	2					
Paved Width (ft)	18.7	18.7					
Lane Width (ft)	9.3	9.3

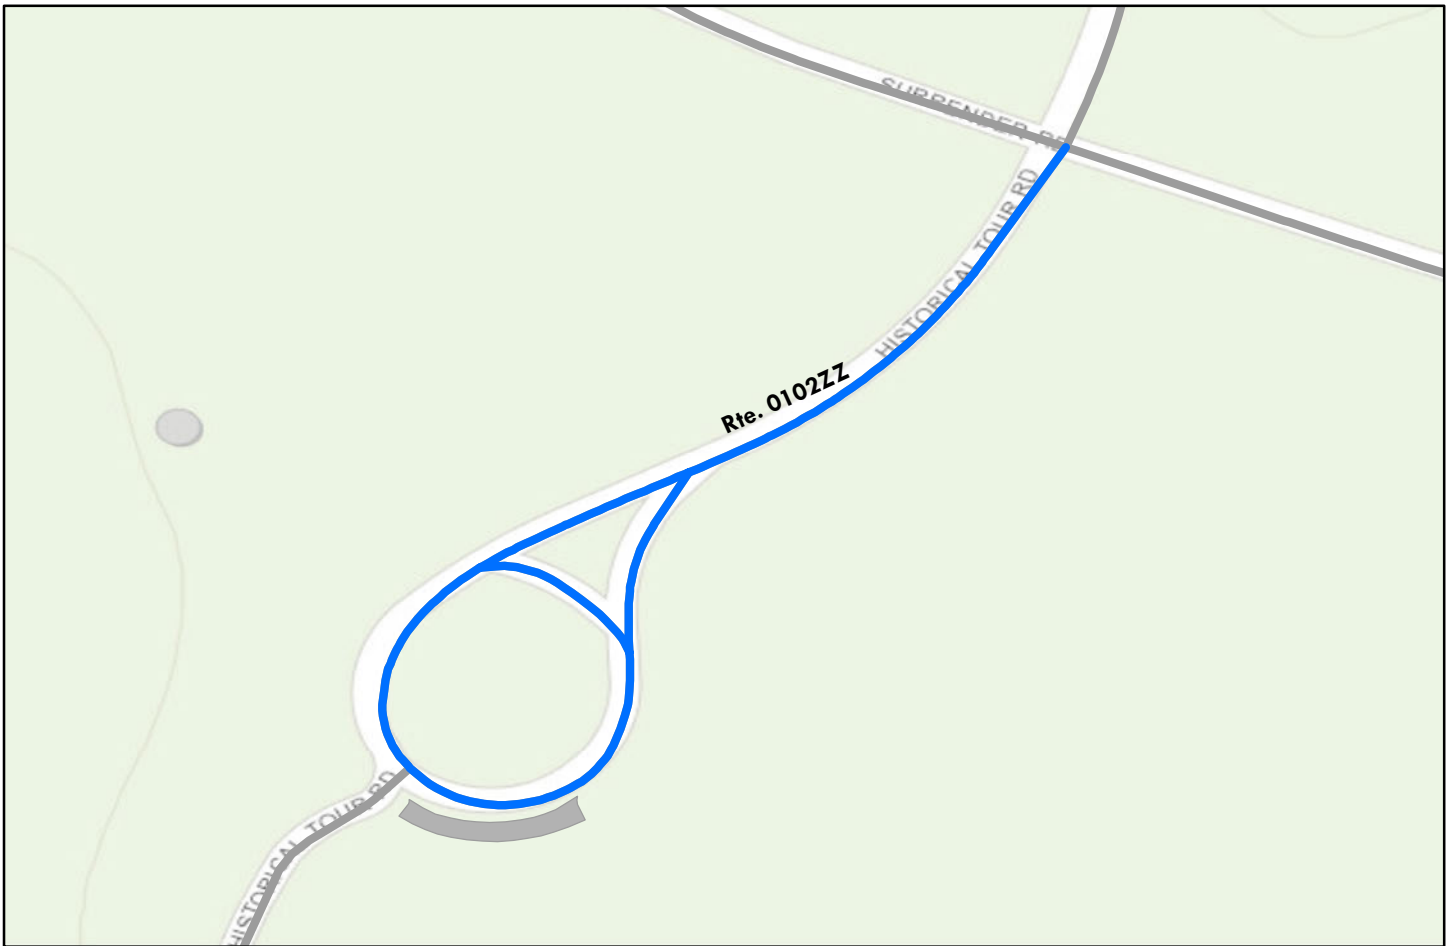
ROUTE 0102ZZ: SURRENDER FIELD ACCESS ROADS

Summary Route

Note: The weighted average summary PCR value is calculated from only the sections of road where the PCR was collected. The overall PCR for the summary route may not reflect individual subcomponent ratings.

Route Condition Legend – Pavement Condition Rating (PCR)						
Poor (0 - 60)	Fair (61- 84)	Good (85 - 94)	Excellent (95 - 100)	Not Rated		
See Appendix for definitions and formulas						
Inspection Date: 4/18/2021						
Paved Length (Miles): 0.24						
Surface Type: ASPHALT	Route Summary					
Roadway Condition Information						
Pavement Condition Rating (PCR)	95					
Lane & Width Information						
Number of Lanes	2					
Paved Width (ft)	18.4					
Lane Width (ft)	10
