COLO Cycle 6

Final Report

Road Inventory and Condition Assessment of Paved Routes Colonial National Historical Park

**Federal Highway Administration
Eastern Federal Lands Highway Division
Road Inventory Program (RIP)**

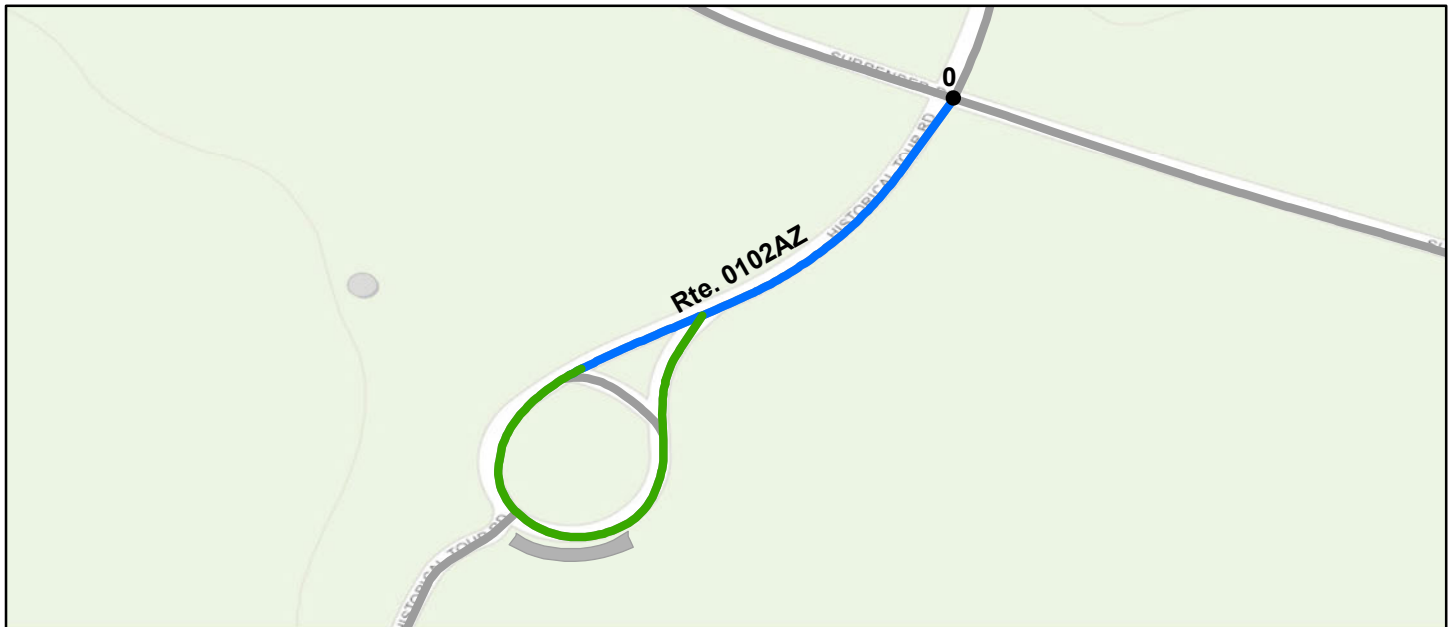
ROUTE 0102AZ: SURRENDER FIELD ACCESS ROAD

Subcomponent of Route COLO-0102ZZ
Data Collection Vehicle (DCV) Rating

Route Condition Legend – Pavement Condition Rating (PCR)						
Poor (0 - 60)	Fair (61- 84)	Good (85 - 94)	Excellent (95 - 100)	Not Rated		
Colors on map represent condition scores at 0.10-mile intervals. See Appendix for definitions and formulas.						
Inspection Date:	4/18/2021	Beginning Section MP	0			
Paved Length (Miles):	0.21	Section Length (MI)	0.21			
Surface Type:	ASPHALT	Route Summary				
Roadway Condition Information						
Pavement Condition Rating (PCR)	95	95				
Surface Condition Rating (SCR)	95	95				
Roughness Condition Index (RCI)	N/A	N/A				
Distress Index Values						
Structural Crack Index	100	100				
Alligator Crack Index	100	100				
Longitudinal Crack Index	100	100				
Transverse Cracking Index	99	99				
Patching Index	100	100				
Rutting Index	95	95				
International Roughness Index (IRI)	N/A	N/A				
Lane & Width Information						
Number of Lanes	2	2				
Paved Width (ft)	18.8	18.8				
Lane Width (ft)	9.4	9.4

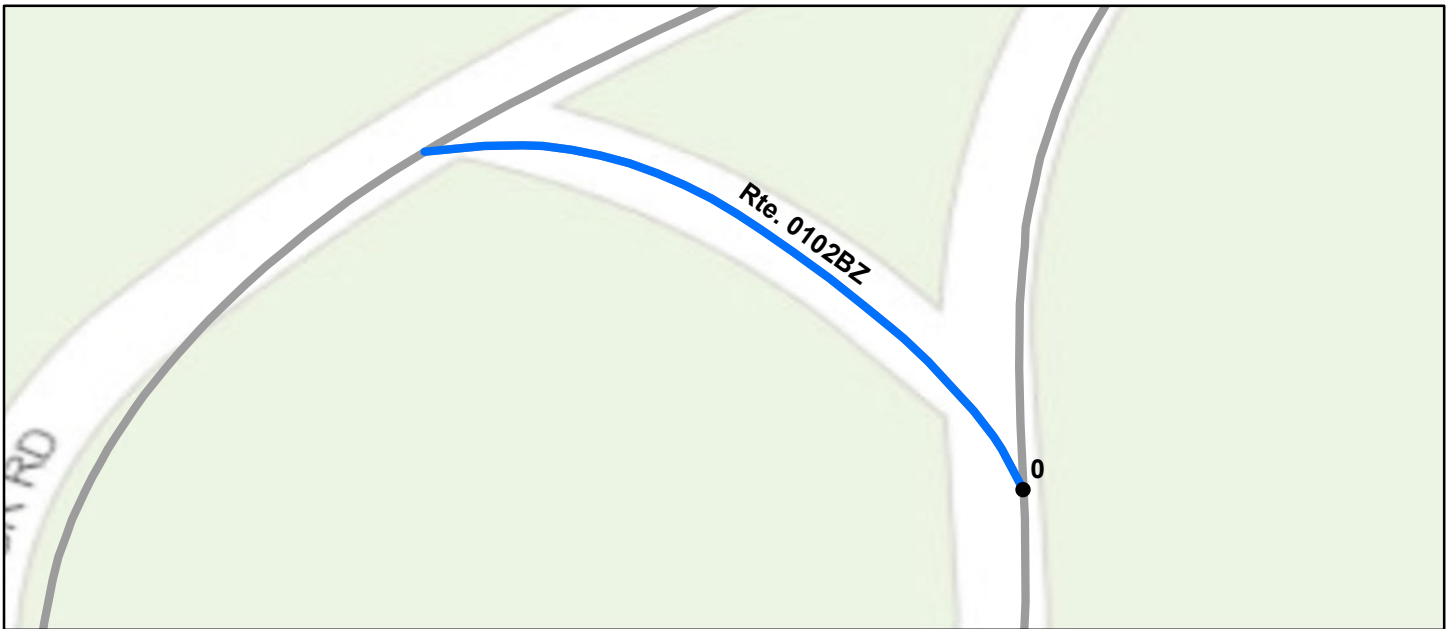
ROUTE 0102BZ: SURRENDER FIELD ACCESS SPUR ROAD

Route Condition Legend – Pavement Condition Rating (PCR)						
Poor (0 - 60)	Fair (61- 84)	Good (85 - 94)	Excellent (95 - 100)	Not Rated		
Colors on map represent condition scores at 0.10-mile intervals. See Appendix for definitions and formulas.						
Inspection Date: 4/18/2021	Beginning Section MP	0				
Paved Length (Miles): 0.03	Section Length (MI)	0.03				
Surface Type: ASPHALT	Route Summary					
Roadway Condition Information						
Pavement Condition Rating (PCR)	99	99				
Surface Condition Rating (SCR)	99	99				
Roughness Condition Index (RCI)	N/A	N/A				
Distress Index Values						
Structural Crack Index	100	100				
Alligator Crack Index	100	100				
Longitudinal Crack Index	100	100				
Transverse Cracking Index	100	100				
Patching Index	100	100				
Rutting Index	99	99				
International Roughness Index (IRI)	N/A	N/A				
Lane & Width Information						
Number of Lanes	1	1				
Paved Width (ft)	14.8	14.8

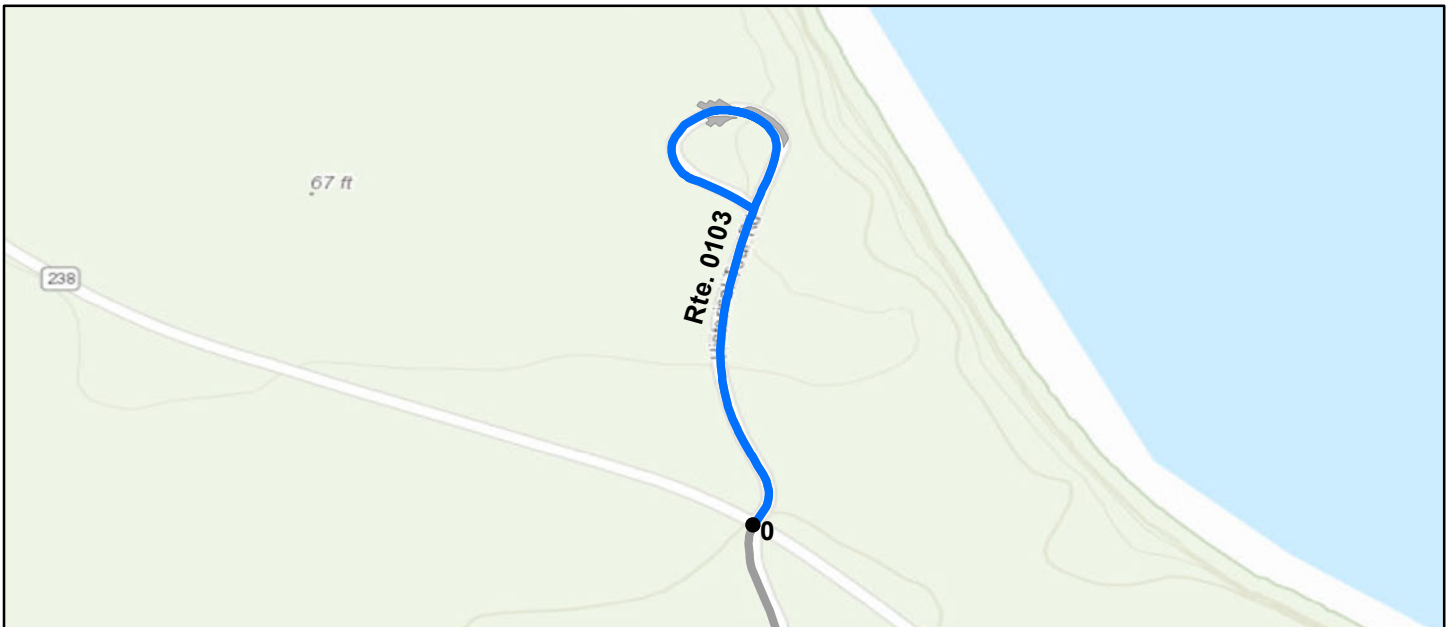
ROUTE 0103: REDOUBT 9 AND 10 ACCESS ROAD

Inspection Date: 4/18/2021	Beginning Section MP	0				
Paved Length (Miles): 0.22	Section Length (MI)	0.22				
Surface Type: ASPHALT	Route Summary					
Roadway Condition Information						
Pavement Condition Rating (PCR)	97	97				
Surface Condition Rating (SCR)	97	97				
Roughness Condition Index (RCI)	N/A	N/A				
Distress Index Values						
Structural Crack Index	100	100				
Alligator Crack Index	100	100				
Longitudinal Crack Index	100	100				
Transverse Cracking Index	100	100				
Patching Index	100	100				
Rutting Index	97	97				
International Roughness Index (IRI)	N/A	N/A				
Lane & Width Information						
Number of Lanes	2	2				
Paved Width (ft)	17.8	17.8				
Lane Width (ft)	12.5	12.5

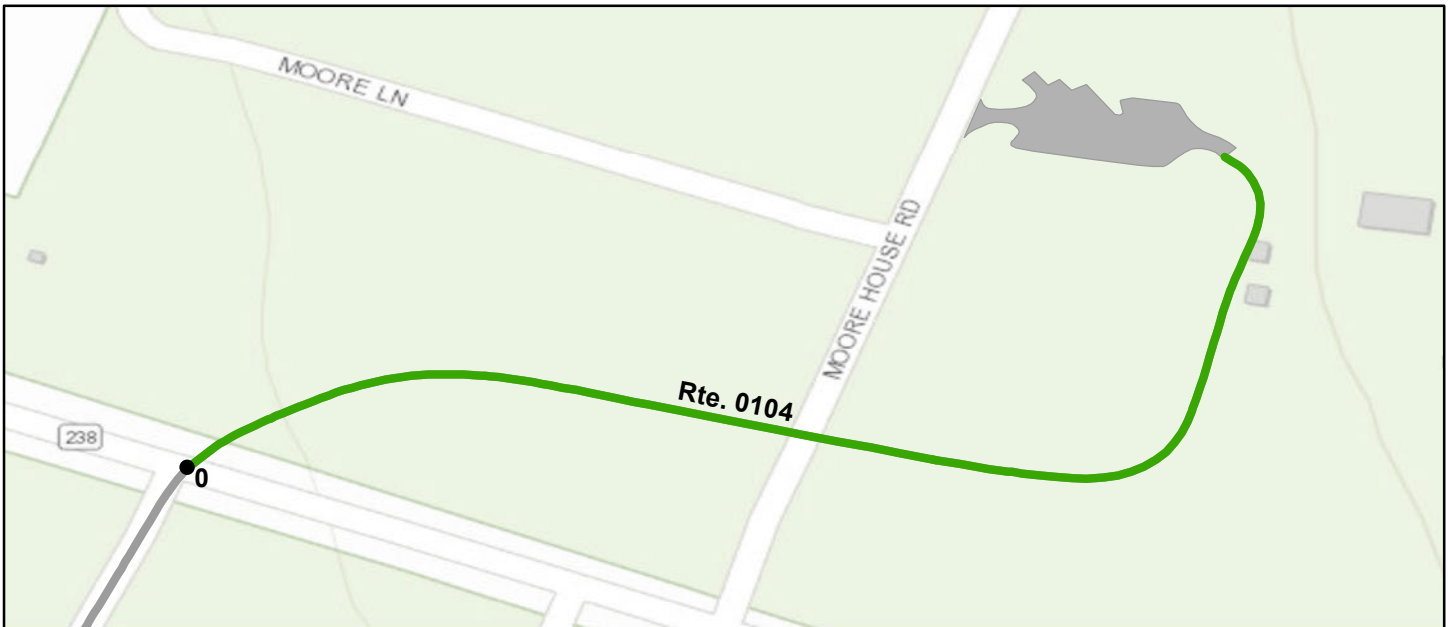
ROUTE 0104: MOORE HOUSE ACCESS ROAD

Route Condition Legend – Pavement Condition Rating (PCR)						
Poor (0 - 60)	Fair (61- 84)	Good (85 - 94)	Excellent (95 - 100)	Not Rated		
Colors on map represent condition scores at 0.10-mile intervals. See Appendix for definitions and formulas.						
Inspection Date: 4/18/2021	Beginning Section MP	0				
Paved Length (Miles): 0.18	Section Length (MI)	0.18				
Surface Type: ASPHALT	Route Summary					
Roadway Condition Information						
Pavement Condition Rating (PCR)	90	90				
Surface Condition Rating (SCR)	90	90				
Roughness Condition Index (RCI)	N/A	N/A				
Distress Index Values						
Structural Crack Index	99	99				
Alligator Crack Index	100	100				
Longitudinal Crack Index	99	99				
Transverse Cracking Index	98	98				
Patching Index	100	100				
Rutting Index	90	90				
International Roughness Index (IRI)	N/A	N/A				
Lane & Width Information						
Number of Lanes	2	2				
Paved Width (ft)	20.7	20.7				
Lane Width (ft)	10.3	10.3

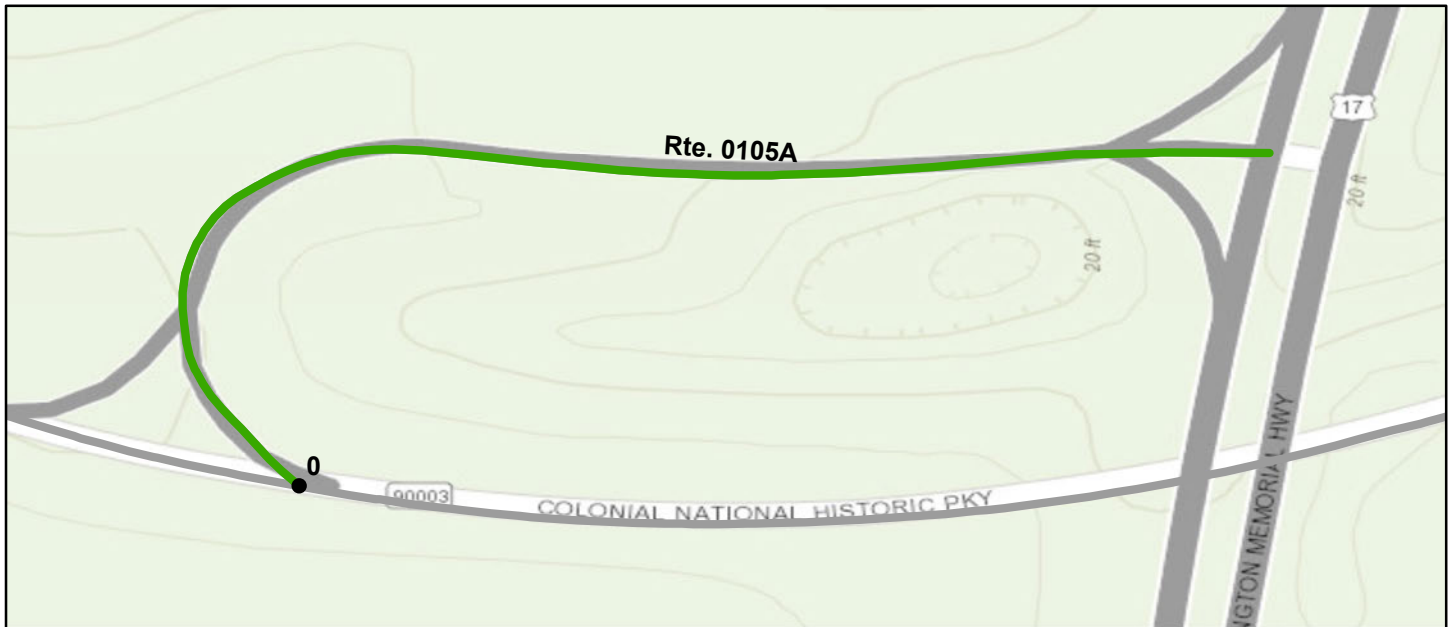
ROUTE 0105A: U.S. HIGHWAY 17 ACCESS ROAD A

Route Condition Legend – Pavement Condition Rating (PCR)						
Poor (0 - 60)	Fair (61- 84)	Good (85 - 94)	Excellent (95 - 100)	Not Rated		
Colors on map represent condition scores at 0.10-mile intervals. See Appendix for definitions and formulas.						
Inspection Date:	4/18/2021	Beginning Section MP	0			
Paved Length (Miles):	0.18	Section Length (MI)	0.18			
Surface Type:	CONCRETE	Route Summary				
Roadway Condition Information						
Pavement Condition Rating (PCR)	90	90				
Surface Condition Rating (SCR)	N/A	N/A				
Roughness Condition Index (RCI)	N/A	N/A				
Distress Index Values						
Structural Crack Index	N/A	N/A				
Alligator Crack Index	N/A	N/A				
Longitudinal Crack Index	N/A	N/A				
Transverse Cracking Index	N/A	N/A				
Patching Index	N/A	N/A				
Rutting Index	N/A	N/A				
International Roughness Index (IRI)	N/A	N/A				
Lane & Width Information						
Number of Lanes	2	2				
Paved Width (ft)	26.2	26.2

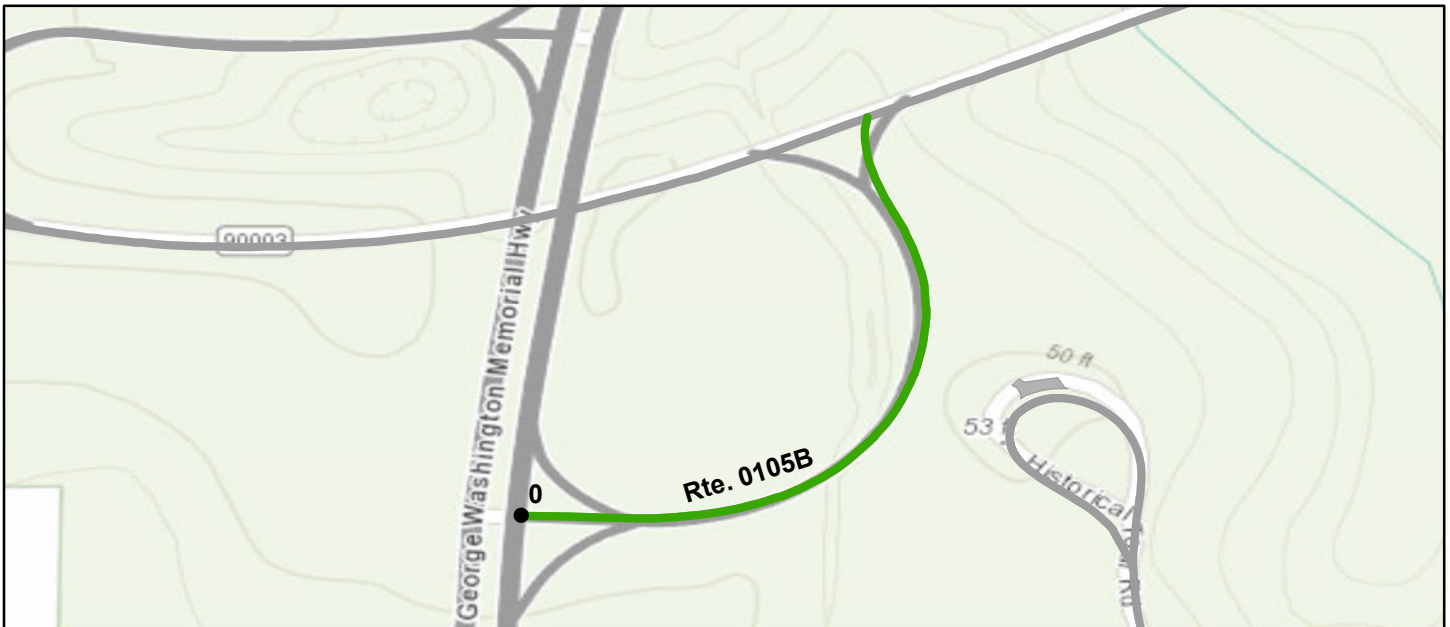
ROUTE 0105B: U.S. HIGHWAY 17 ACCESS ROAD B

Route Condition Legend – Pavement Condition Rating (PCR)						
Poor (0 - 60)	Fair (61- 84)	Good (85 - 94)	Excellent (95 - 100)	Not Rated		
Colors on map represent condition scores at 0.10-mile intervals. See Appendix for definitions and formulas.						
Inspection Date: 4/18/2021	Beginning Section MP	0				
Paved Length (Miles): 0.18	Section Length (MI)	0.18				
Surface Type: CONCRETE	Route Summary					
Roadway Condition Information						
Pavement Condition Rating (PCR)	90	90				
Surface Condition Rating (SCR)	N/A	N/A				
Roughness Condition Index (RCI)	N/A	N/A				
Distress Index Values						
Structural Crack Index	N/A	N/A				
Alligator Crack Index	N/A	N/A				
Longitudinal Crack Index	N/A	N/A				
Transverse Cracking Index	N/A	N/A				
Patching Index	N/A	N/A				
Rutting Index	N/A	N/A				
International Roughness Index (IRI)	N/A	N/A				
Lane & Width Information						
Number of Lanes	2	2				
Paved Width (ft)	26.3	26.3

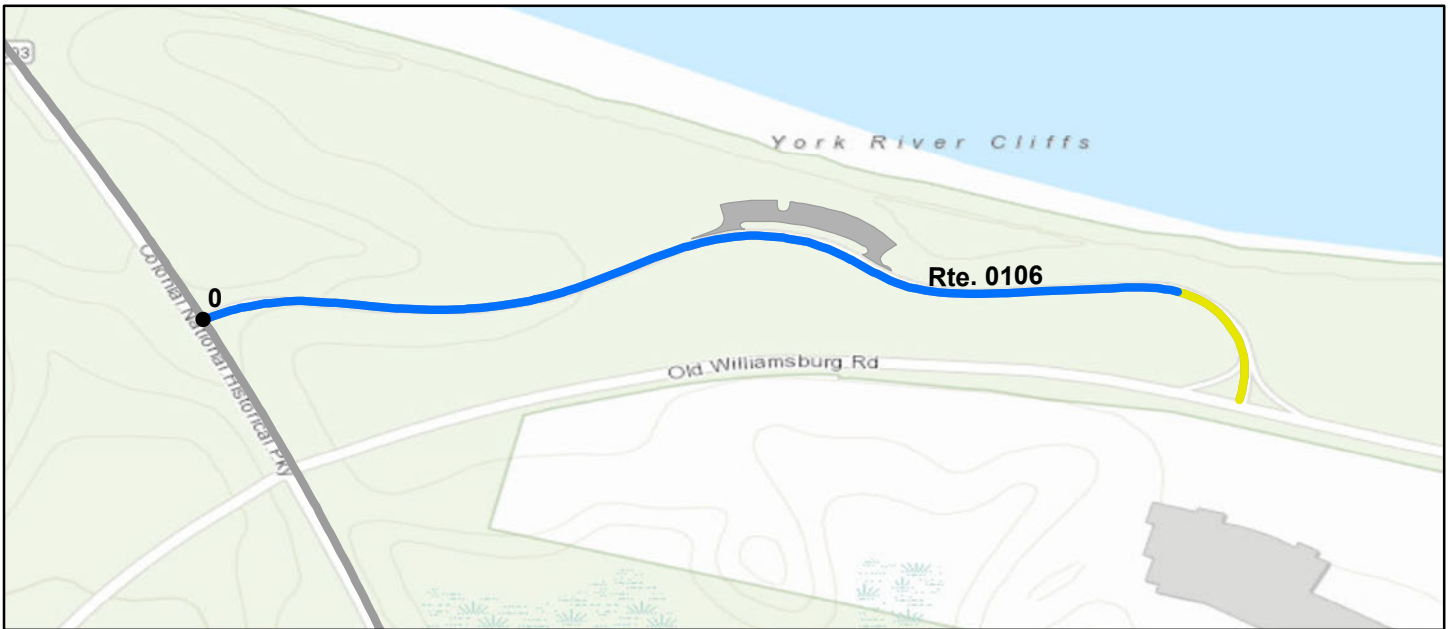
ROUTE 0106: FUSILIER'S ROAD

Inspection Date: 4/18/2021	Beginning Section MP	0				
Paved Length (Miles): 0.35	Section Length (MI)	0.35				
Surface Type: ASPHALT	Route Summary					
Roadway Condition Information						
Pavement Condition Rating (PCR)	94	94				
Surface Condition Rating (SCR)	94	94				
Roughness Condition Index (RCI)	N/A	N/A				
Distress Index Values						
Structural Crack Index	100	100				
Alligator Crack Index	100	100				
Longitudinal Crack Index	100	100				
Transverse Cracking Index	99	99				
Patching Index	100	100				
Rutting Index	94	94				
International Roughness Index (IRI)	N/A	N/A				
Lane & Width Information						
Number of Lanes	2	2				
Paved Width (ft)	22.7	22.7				
Lane Width (ft)	11	11

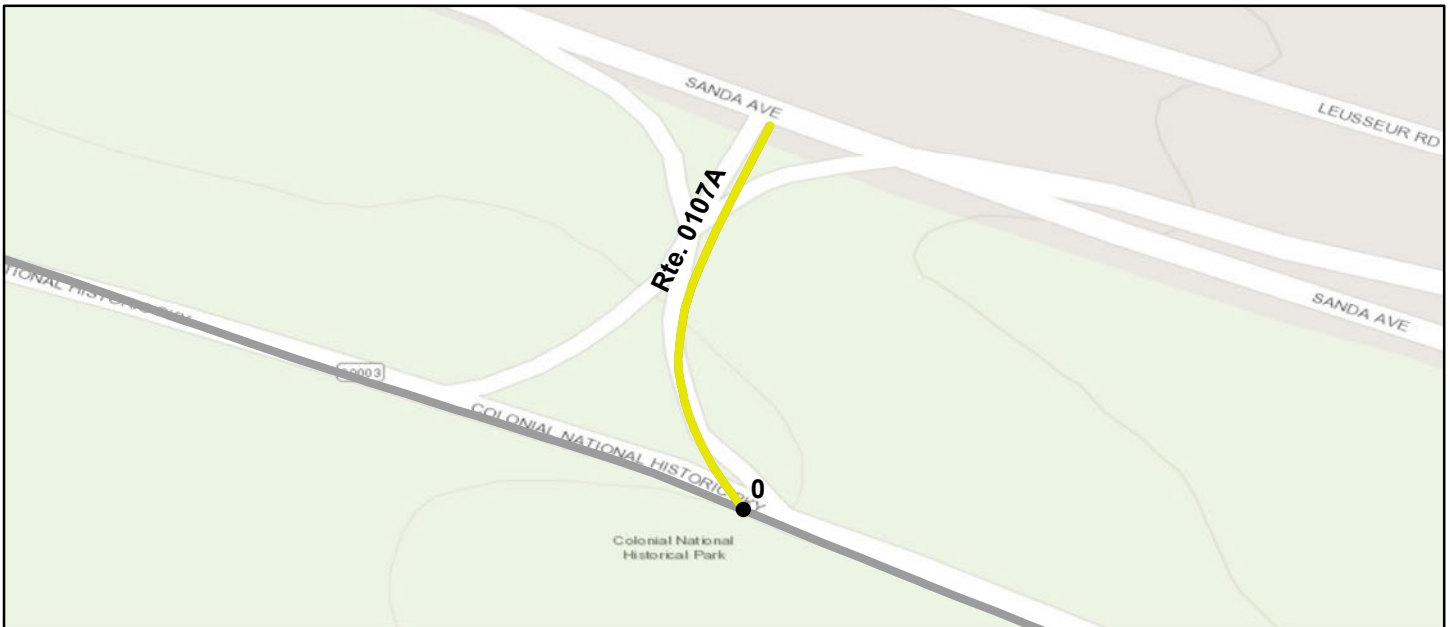
ROUTE 0107A: CHEATHAM ANNEX ACCESS ROAD A

Route Condition Legend – Pavement Condition Rating (PCR)						
Poor (0 - 60)	Fair (61- 84)	Good (85 - 94)	Excellent (95 - 100)	Not Rated		
Colors on map represent condition scores at 0.10-mile intervals. See Appendix for definitions and formulas.						
Inspection Date: 4/18/2021	Beginning Section MP	0				
Paved Length (Miles): 0.04	Section Length (MI)	0.04				
Surface Type: ASPHALT	Route Summary					
Roadway Condition Information						
Pavement Condition Rating (PCR)	73	73				
Surface Condition Rating (SCR)	73	73				
Roughness Condition Index (RCI)	N/A	N/A				
Distress Index Values						
Structural Crack Index	73	73				
Alligator Crack Index	100	100				
Longitudinal Crack Index	73	73				
Transverse Cracking Index	91	91				
Patching Index	100	100				
Rutting Index	91	91				
International Roughness Index (IRI)	N/A	N/A				
Lane & Width Information						
Number of Lanes	2	2				
Paved Width (ft)	36.3	36.3				
Lane Width (ft)	18.8	18.8

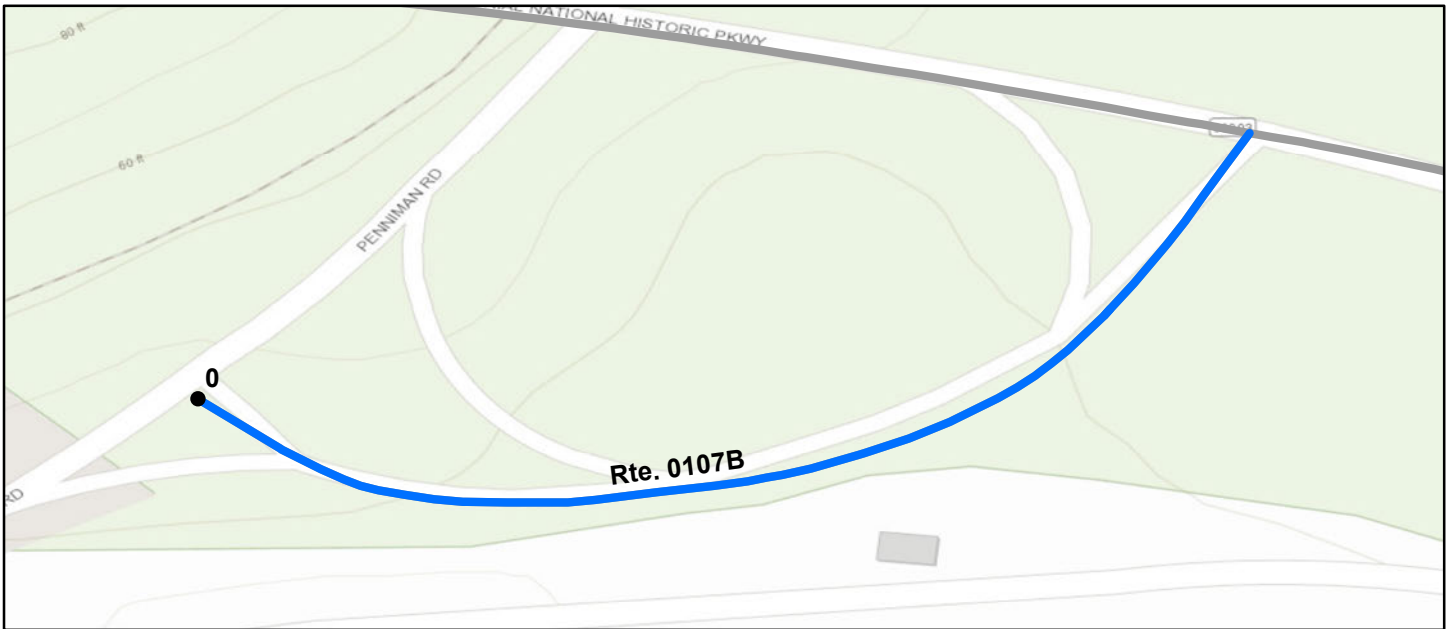
ROUTE 0107B: CHEATHAM ANNEX ACCESS ROAD B

Route Condition Legend – Pavement Condition Rating (PCR)						
Poor (0 - 60)	Fair (61- 84)	Good (85 - 94)	Excellent (95 - 100)	Not Rated		
Colors on map represent condition scores at 0.10-mile intervals. See Appendix for definitions and formulas.						
Inspection Date: 4/18/2021	Beginning Section MP	0				
Paved Length (Miles): 0.12	Section Length (MI)	0.12				
Surface Type: ASPHALT	Route Summary					
Roadway Condition Information						
Pavement Condition Rating (PCR)	96	96				
Surface Condition Rating (SCR)	96	96				
Roughness Condition Index (RCI)	N/A	N/A				
Distress Index Values						
Structural Crack Index	96	96				
Alligator Crack Index	100	100				
Longitudinal Crack Index	96	96				
Transverse Cracking Index	99	99				
Patching Index	99	99				
Rutting Index	99	99				
International Roughness Index (IRI)	N/A	N/A				
Lane & Width Information						
Number of Lanes	2	2				
Paved Width (ft)	25.9	25.9				
Lane Width (ft)	12.9	12.9

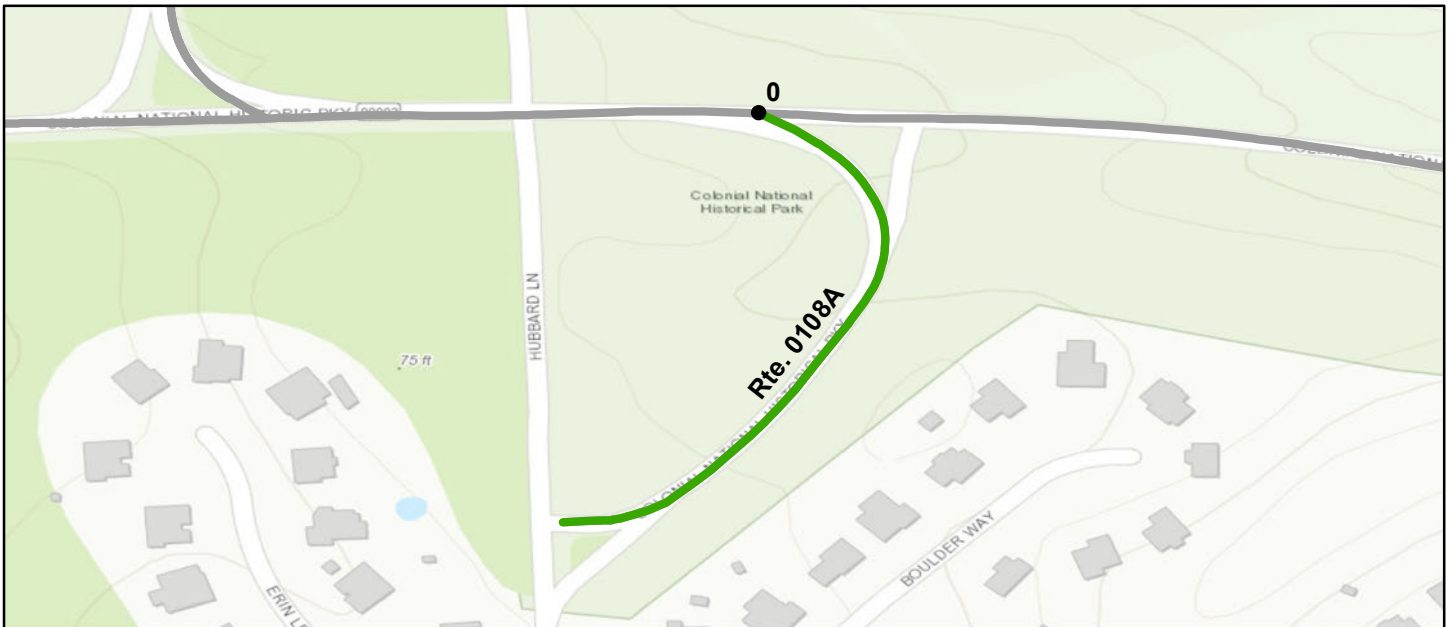
ROUTE 0108A: QUEENS LAKE ACCESS A

Inspection Date: 4/18/2021	Beginning Section MP	0				
Paved Length (Miles): 0.14	Section Length (MI)	0.14				
Surface Type: ASPHALT	Route Summary					
Roadway Condition Information						
Pavement Condition Rating (PCR)	87	87				
Surface Condition Rating (SCR)	87	87				
Roughness Condition Index (RCI)	N/A	N/A				
Distress Index Values						
Structural Crack Index	87	87				
Alligator Crack Index	100	100				
Longitudinal Crack Index	87	87				
Transverse Cracking Index	94	94				
Patching Index	100	100				
Rutting Index	98	98				
International Roughness Index (IRI)	N/A	N/A				
Lane & Width Information						
Number of Lanes	2	2				
Paved Width (ft)	25	25				
Lane Width (ft)	11.8	11.8

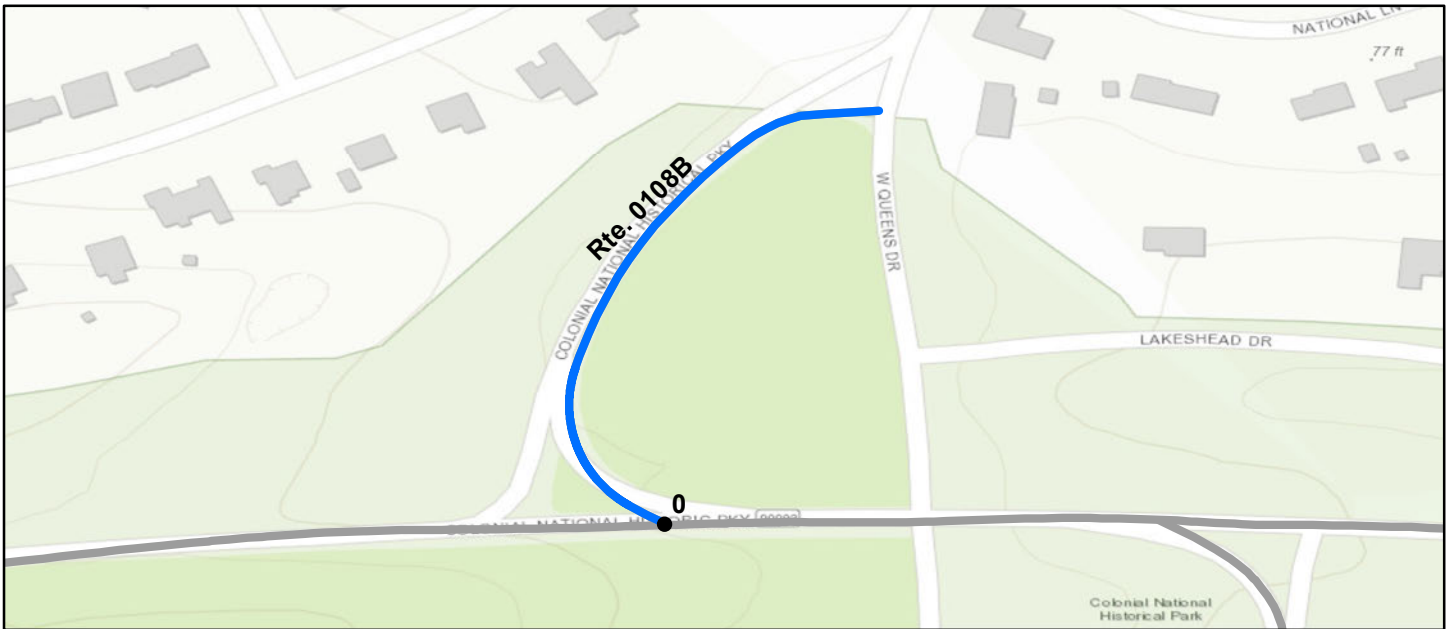
ROUTE 0108B: QUEENS LAKE ACCESS B

Inspection Date: 4/18/2021	Beginning Section MP	0				
Paved Length (Miles): 0.13	Section Length (MI)	0.13				
Surface Type: ASPHALT	Route Summary					
Roadway Condition Information						
Pavement Condition Rating (PCR)	97	97				
Surface Condition Rating (SCR)	97	97				
Roughness Condition Index (RCI)	N/A	N/A				
Distress Index Values						
Structural Crack Index	98	98				
Alligator Crack Index	100	100				
Longitudinal Crack Index	98	98				
Transverse Cracking Index	97	97				
Patching Index	100	100				
Rutting Index	98	98				
International Roughness Index (IRI)	N/A	N/A				
Lane & Width Information						
Number of Lanes	2	2				
Paved Width (ft)	24.6	24.6				
Lane Width (ft)	12.7	12.7

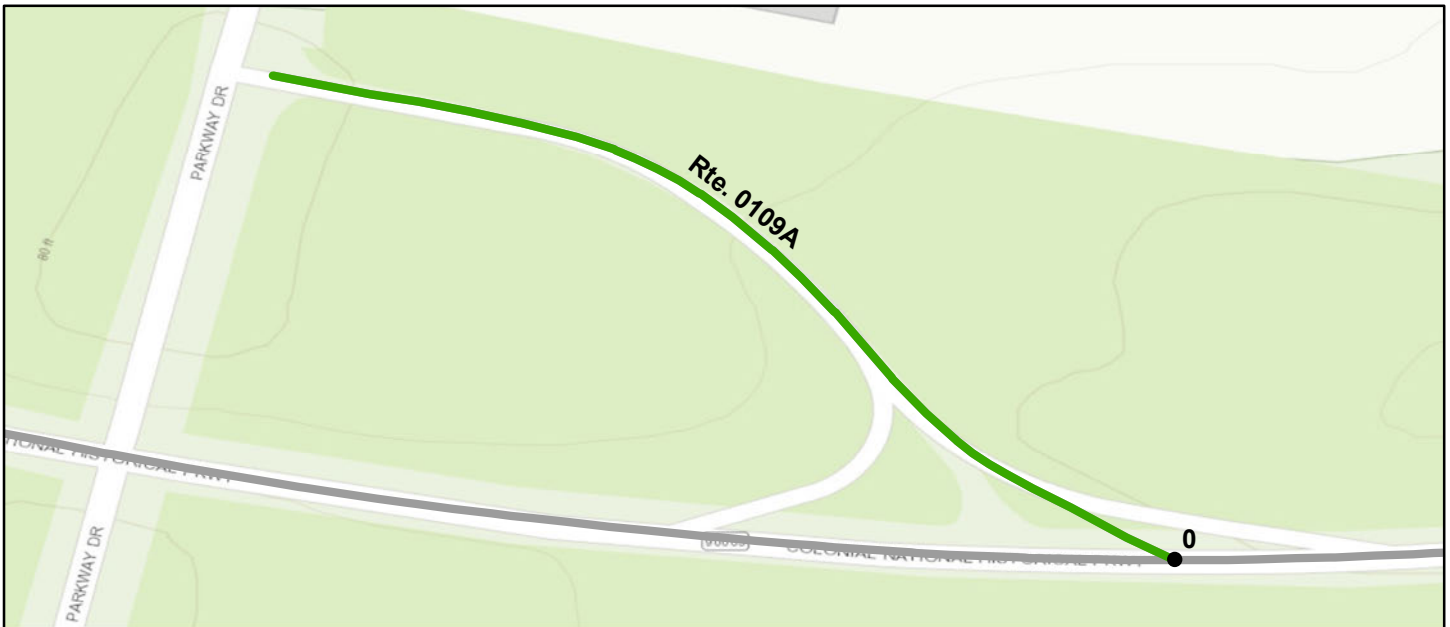
ROUTE 0109A: PARKWAY DRIVE ACCESS ROAD A

Inspection Date:	4/18/2021	Beginning Section MP	0				
Paved Length (Miles):	0.1	Section Length (MI)	0.1				
Surface Type:	ASPHALT	Route Summary					
Roadway Condition Information							
Pavement Condition Rating (PCR)	94	94					
Surface Condition Rating (SCR)	94	94					
Roughness Condition Index (RCI)	N/A	N/A					
Distress Index Values							
Structural Crack Index	97	97					
Alligator Crack Index	100	100					
Longitudinal Crack Index	97	97					
Transverse Cracking Index	94	94					
Patching Index	97	97					
Rutting Index	94	94					
International Roughness Index (IRI)	N/A	N/A					
Lane & Width Information							
Number of Lanes	2	2					
Paved Width (ft)	25.2	25.2					
Lane Width (ft)	13.5	13.5

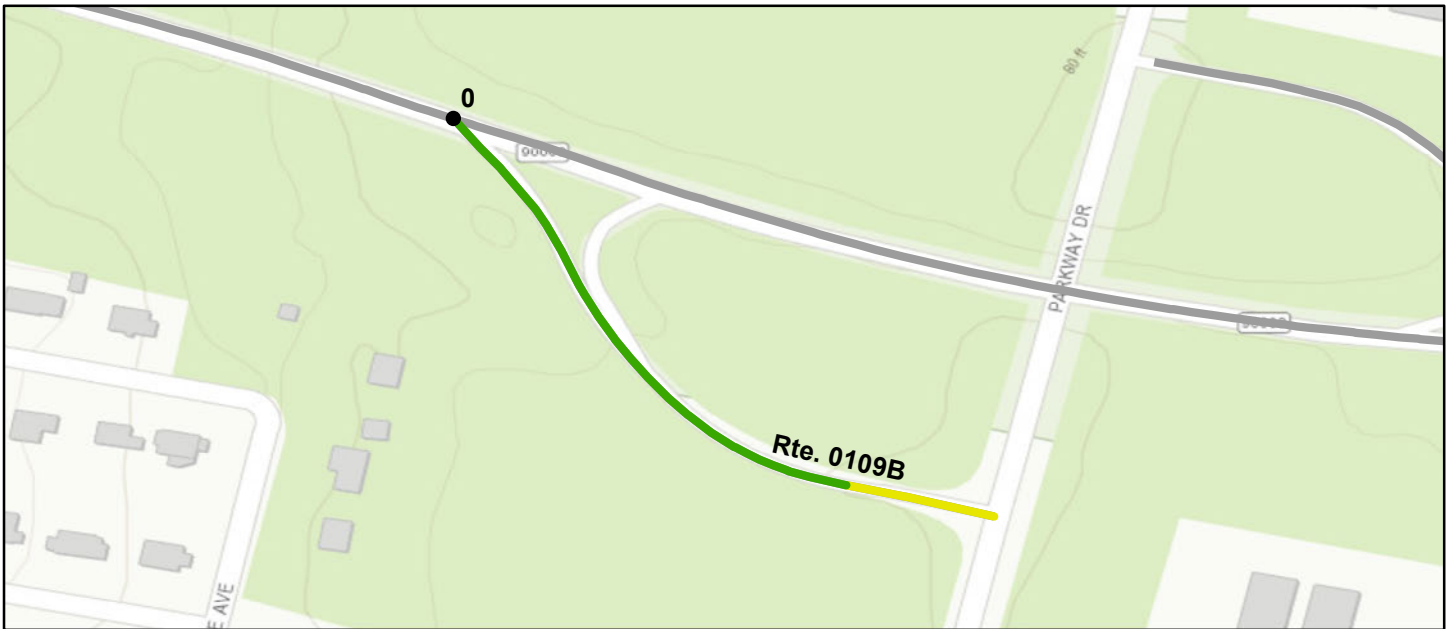
ROUTE 0109B: PARKWAY DRIVE ACCESS ROAD B

Route Condition Legend – Pavement Condition Rating (PCR)						
Poor (0 - 60)	Fair (61- 84)	Good (85 - 94)	Excellent (95 - 100)	Not Rated		
Colors on map represent condition scores at 0.10-mile intervals. See Appendix for definitions and formulas.						
Inspection Date: 4/18/2021	Beginning Section MP	0				
Paved Length (Miles): 0.12	Section Length (MI)	0.12				
Surface Type: ASPHALT	Route Summary					
Roadway Condition Information						
Pavement Condition Rating (PCR)	87	87				
Surface Condition Rating (SCR)	87	87				
Roughness Condition Index (RCI)	N/A	N/A				
Distress Index Values						
Structural Crack Index	94	94				
Alligator Crack Index	100	100				
Longitudinal Crack Index	94	94				
Transverse Cracking Index	87	87				
Patching Index	100	100				
Rutting Index	96	96				
International Roughness Index (IRI)	N/A	N/A				
Lane & Width Information						
Number of Lanes	2	2				
Paved Width (ft)	25.4	25.4				
Lane Width (ft)	13.2	13.2

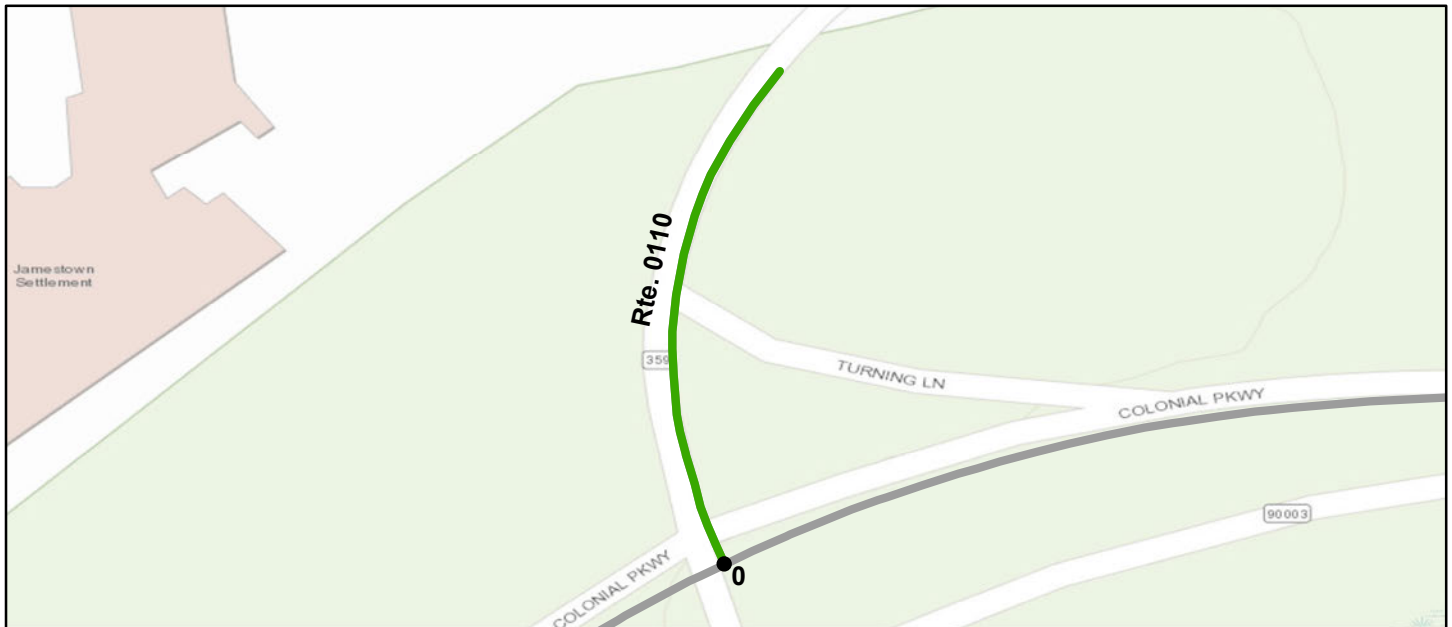
ROUTE 0110: STATE HIGHWAY 359

Route Condition Legend – Pavement Condition Rating (PCR)						
Poor (0 - 60)	Fair (61- 84)	Good (85 - 94)	Excellent (95 - 100)	Not Rated		
Colors on map represent condition scores at 0.10-mile intervals. See Appendix for definitions and formulas.						
Inspection Date: 4/18/2021	Beginning Section MP	0				
Paved Length (Miles): 0.06	Section Length (MI)	0.06				
Surface Type: CONCRETE	Route Summary					
Roadway Condition Information						
Pavement Condition Rating (PCR)	90	90				
Surface Condition Rating (SCR)	N/A	N/A				
Roughness Condition Index (RCI)	N/A	N/A				
Distress Index Values						
Structural Crack Index	N/A	N/A				
Alligator Crack Index	N/A	N/A				
Longitudinal Crack Index	N/A	N/A				
Transverse Cracking Index	N/A	N/A				
Patching Index	N/A	N/A				
Rutting Index	N/A	N/A				
International Roughness Index (IRI)	N/A	N/A				
Lane & Width Information						
Number of Lanes	2	2				
Paved Width (ft)	28.5	28.5

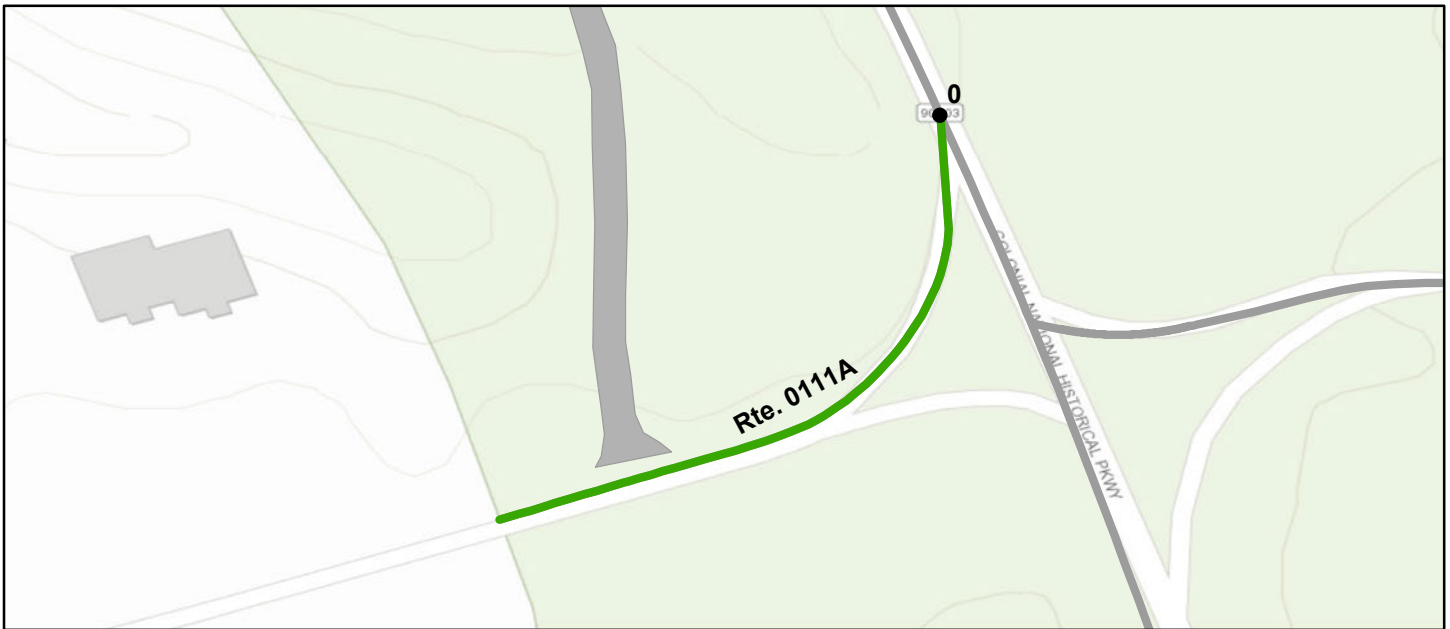
ROUTE 0111A: STATE HIGHWAY 199 KINGS POINT A

Route Condition Legend – Pavement Condition Rating (PCR)						
Poor (0 - 60)	Fair (61- 84)	Good (85 - 94)	Excellent (95 - 100)	Not Rated		
Colors on map represent condition scores at 0.10-mile intervals. See Appendix for definitions and formulas.						
Inspection Date: 4/18/2021	Beginning Section MP	0				
Paved Length (Miles): 0.06	Section Length (MI)	0.06				
Surface Type: ASPHALT	Route Summary					
Roadway Condition Information						
Pavement Condition Rating (PCR)	94	94				
Surface Condition Rating (SCR)	94	94				
Roughness Condition Index (RCI)	N/A	N/A				
Distress Index Values						
Structural Crack Index	94	94				
Alligator Crack Index	100	100				
Longitudinal Crack Index	94	94				
Transverse Cracking Index	99	99				
Patching Index	100	100				
Rutting Index	99	99				
International Roughness Index (IRI)	N/A	N/A				
Lane & Width Information						
Number of Lanes	2	2				
Paved Width (ft)	21.2	21.2				
Lane Width (ft)	11.1	11.1

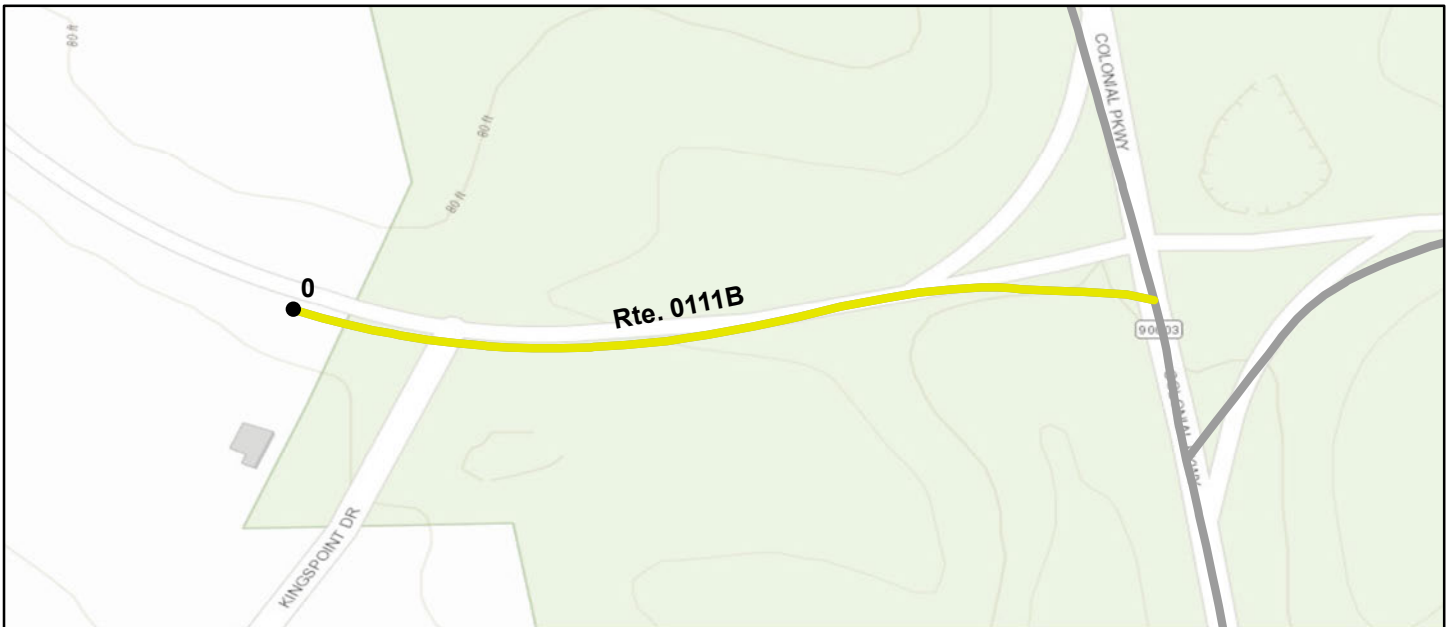
ROUTE 0111B: STATE HIGHWAY 199 KINGS POINT B

Route Condition Legend – Pavement Condition Rating (PCR)						
Poor (0 - 60)	Fair (61- 84)	Good (85 - 94)	Excellent (95 - 100)	Not Rated		
Colors on map represent condition scores at 0.10-mile intervals. See Appendix for definitions and formulas.						
Inspection Date:	4/18/2021	Beginning Section MP	0			
Paved Length (Miles):	0.08	Section Length (MI)	0.08			
Surface Type:	ASPHALT	Route Summary				
Roadway Condition Information						
Pavement Condition Rating (PCR)	70	70				
Surface Condition Rating (SCR)	70	70				
Roughness Condition Index (RCI)	N/A	N/A				
Distress Index Values						
Structural Crack Index	78	78				
Alligator Crack Index	100	100				
Longitudinal Crack Index	78	78				
Transverse Cracking Index	70	70				
Patching Index	100	100				
Rutting Index	98	98				
International Roughness Index (IRI)	N/A	N/A				
Lane & Width Information						
Number of Lanes	2	2				
Paved Width (ft)	23.2	23.2				
Lane Width (ft)	12.3	12.3

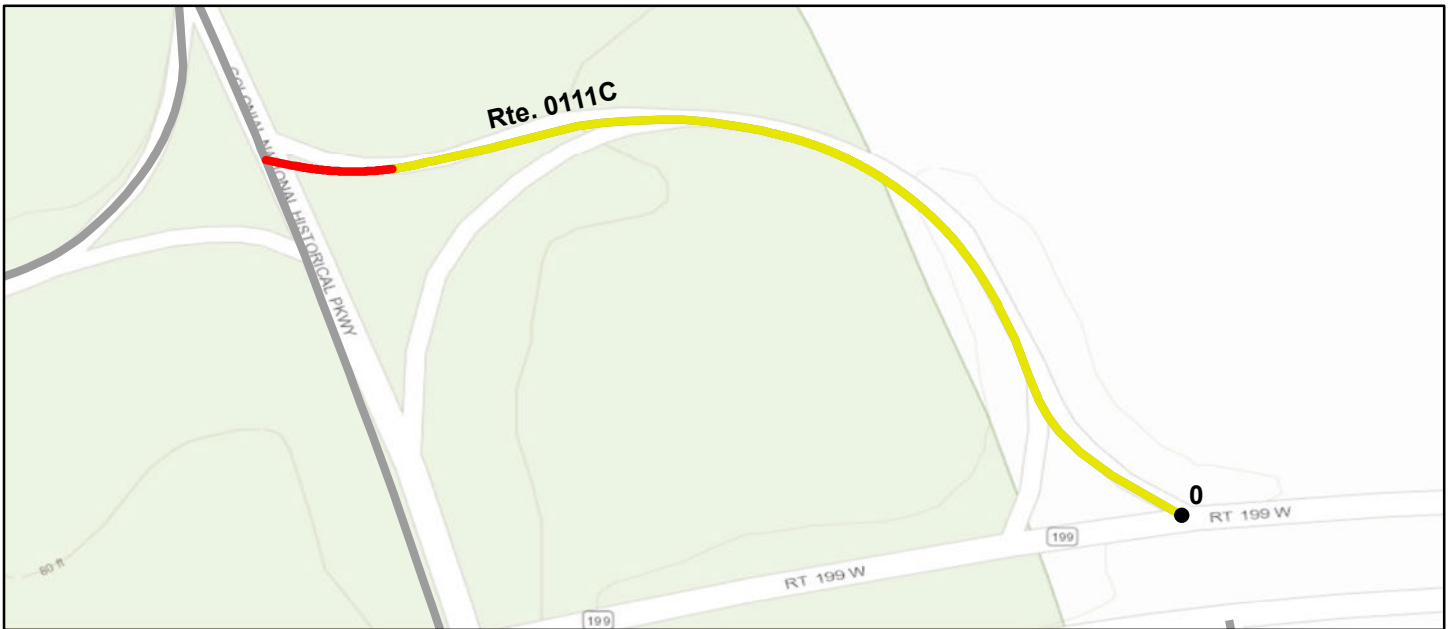
ROUTE 0111C: STATE HIGHWAY 199 KINGS POINT C

Route Condition Legend – Pavement Condition Rating (PCR)						
Poor (0 - 60)	Fair (61- 84)	Good (85 - 94)	Excellent (95 - 100)	Not Rated		
Colors on map represent condition scores at 0.10-mile intervals. See Appendix for definitions and formulas.						
Inspection Date:	4/18/2021	Beginning Section MP	0			
Paved Length (Miles):	0.11	Section Length (MI)	0.11			
Surface Type:	ASPHALT	Route Summary				
Roadway Condition Information						
Pavement Condition Rating (PCR)	73	73				
Surface Condition Rating (SCR)	73	73				
Roughness Condition Index (RCI)	N/A	N/A				
Distress Index Values						
Structural Crack Index	73	73				
Alligator Crack Index	100	100				
Longitudinal Crack Index	73	73				
Transverse Cracking Index	76	76				
Patching Index	100	100				
Rutting Index	98	98				
International Roughness Index (IRI)	N/A	N/A				
Lane & Width Information						
Number of Lanes	2	2				
Paved Width (ft)	28	28				
Lane Width (ft)	14.2	14.2

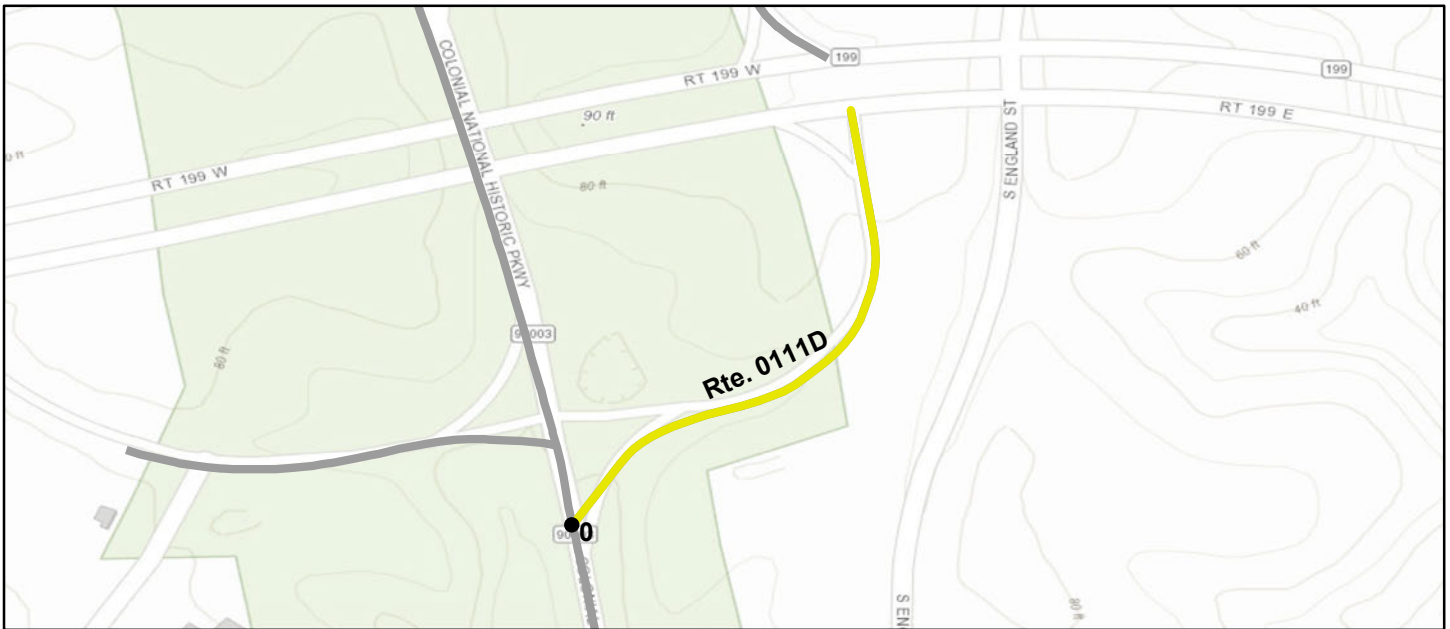
ROUTE 0111D: STATE HIGHWAY 199 KINGS POINT D

Route Condition Legend – Pavement Condition Rating (PCR)						
Poor (0 - 60)	Fair (61- 84)	Good (85 - 94)	Excellent (95 - 100)	Not Rated		
Colors on map represent condition scores at 0.10-mile intervals. See Appendix for definitions and formulas.						
Inspection Date:	4/18/2021	Beginning Section MP	0			
Paved Length (Miles):	0.12	Section Length (MI)	0.12			
Surface Type:	ASPHALT	Route Summary				
Roadway Condition Information						
Pavement Condition Rating (PCR)	79	79				
Surface Condition Rating (SCR)	79	79				
Roughness Condition Index (RCI)	N/A	N/A				
Distress Index Values						
Structural Crack Index	92	92				
Alligator Crack Index	100	100				
Longitudinal Crack Index	92	92				
Transverse Cracking Index	79	79				
Patching Index	99	99				
Rutting Index	99	99				
International Roughness Index (IRI)	N/A	N/A				
Lane & Width Information						
Number of Lanes	2	2				
Paved Width (ft)	27.1	27.1				
Lane Width (ft)	12.7	12.7

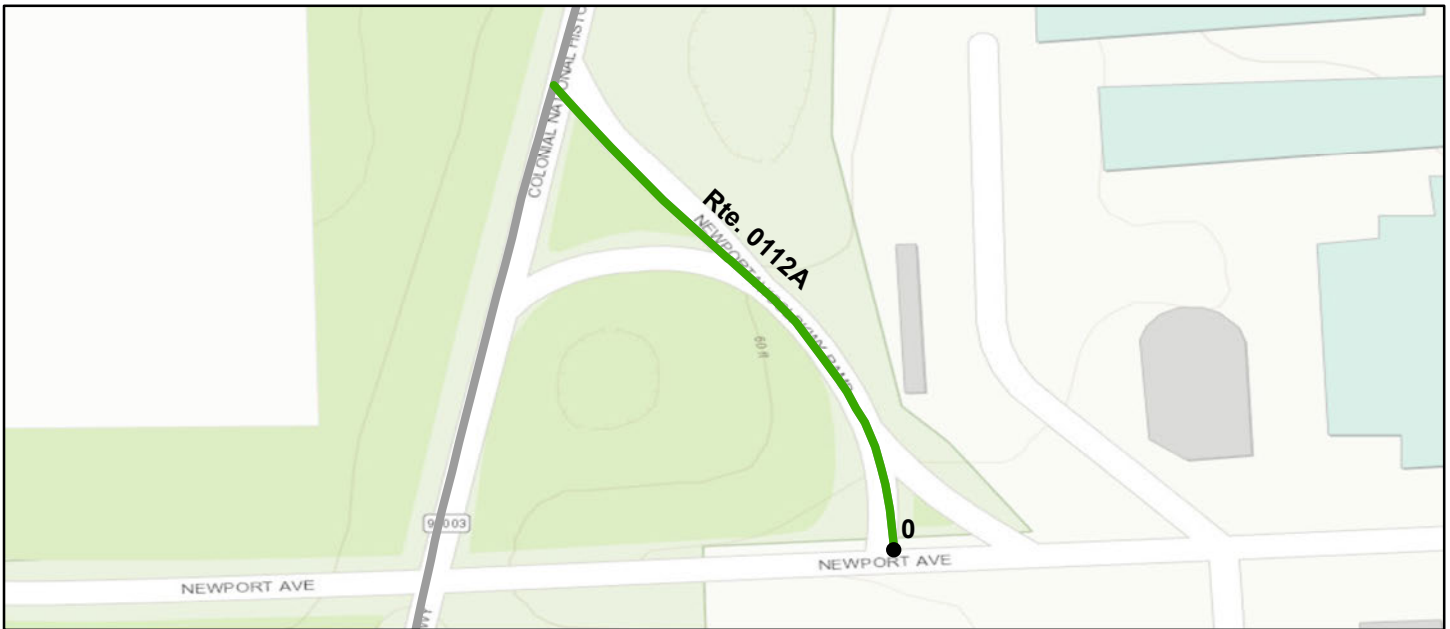
ROUTE 0112A: NEWPORT AVENUE ACCESS ROAD A

Route Condition Legend – Pavement Condition Rating (PCR)						
Poor (0 - 60)	Fair (61- 84)	Good (85 - 94)	Excellent (95 - 100)	Not Rated		
Colors on map represent condition scores at 0.10-mile intervals. See Appendix for definitions and formulas.						
Inspection Date:	4/18/2021	Beginning Section MP	0			
Paved Length (Miles):	0.06	Section Length (MI)	0.06			
Surface Type:	CONCRETE	Route Summary				
Roadway Condition Information						
Pavement Condition Rating (PCR)	90	90				
Surface Condition Rating (SCR)	N/A	N/A				
Roughness Condition Index (RCI)	N/A	N/A				
Distress Index Values						
Structural Crack Index	N/A	N/A				
Alligator Crack Index	N/A	N/A				
Longitudinal Crack Index	N/A	N/A				
Transverse Cracking Index	N/A	N/A				
Patching Index	N/A	N/A				
Rutting Index	N/A	N/A				
International Roughness Index (IRI)	N/A	N/A				
Lane & Width Information						
Number of Lanes	2	2				
Paved Width (ft)	30.5	30.5
