COLO Cycle 6

Final Report

Road Inventory and Condition Assessment of Paved Routes Colonial National Historical Park

**Federal Highway Administration
Eastern Federal Lands Highway Division
Road Inventory Program (RIP)**

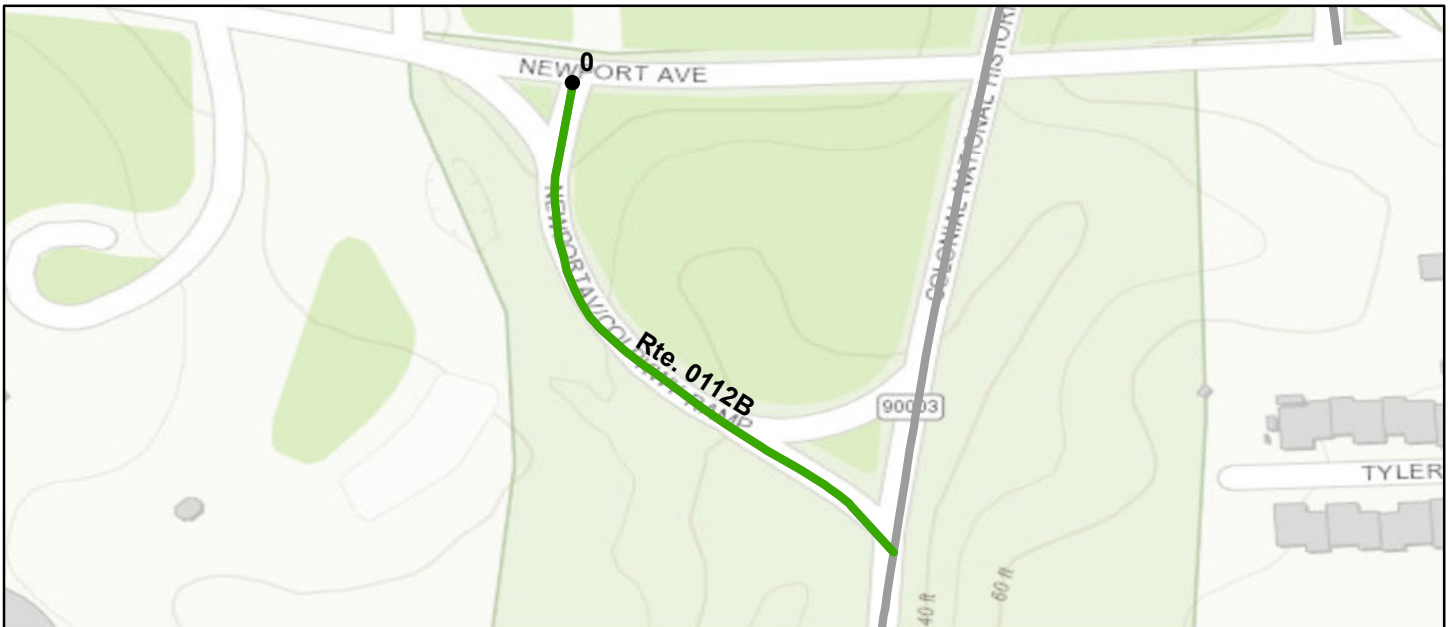
ROUTE 0112B: NEWPORT AVENUE ACCESS ROAD B

Route Condition Legend – Pavement Condition Rating (PCR)						
Poor (0 - 60)	Fair (61- 84)	Good (85 - 94)	Excellent (95 - 100)	Not Rated		
Colors on map represent condition scores at 0.10-mile intervals. See Appendix for definitions and formulas.						
Inspection Date: 4/18/2021	Beginning Section MP	0				
Paved Length (Miles): 0.09	Section Length (MI)	0.09				
Surface Type: CONCRETE	Route Summary					
Roadway Condition Information						
Pavement Condition Rating (PCR)	90	90				
Surface Condition Rating (SCR)	N/A	N/A				
Roughness Condition Index (RCI)	N/A	N/A				
Distress Index Values						
Structural Crack Index	N/A	N/A				
Alligator Crack Index	N/A	N/A				
Longitudinal Crack Index	N/A	N/A				
Transverse Cracking Index	N/A	N/A				
Patching Index	N/A	N/A				
Rutting Index	N/A	N/A				
International Roughness Index (IRI)	N/A	N/A				
Lane & Width Information						
Number of Lanes	2	2				
Paved Width (ft)	31.4	31.4

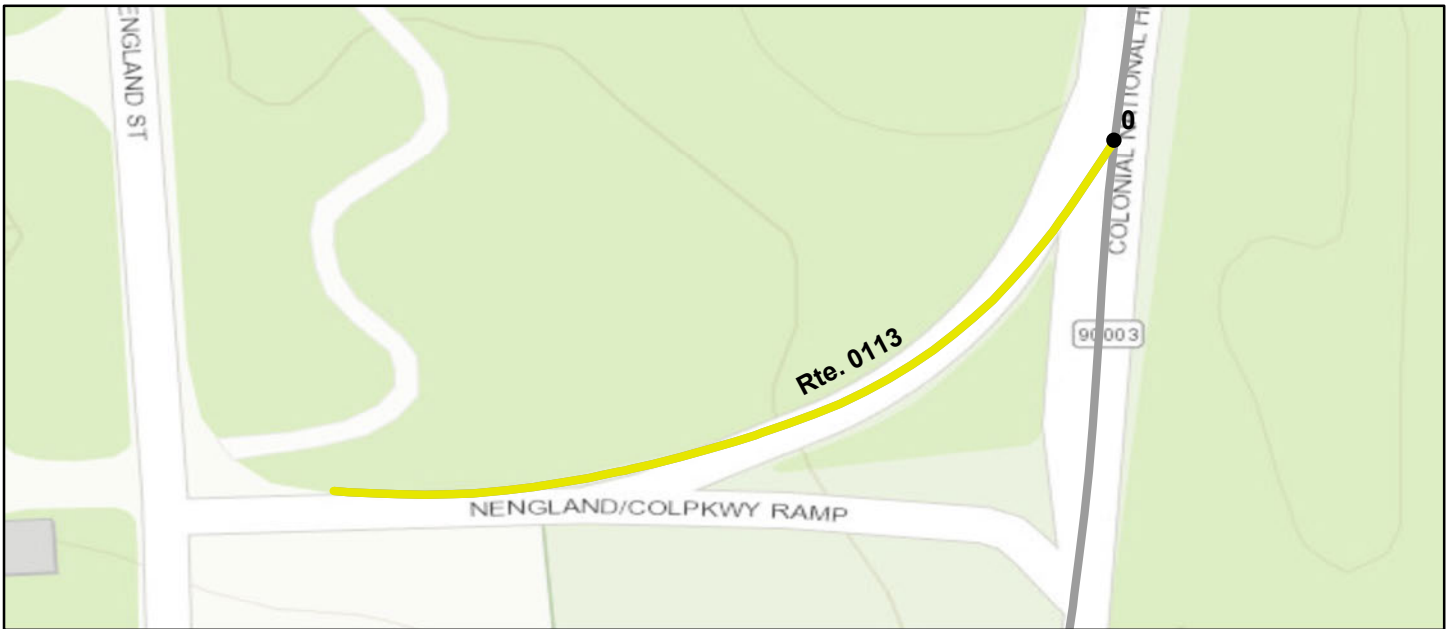
ROUTE 0113: NORTH ENGLAND STREET ACCESS ROAD

Route Condition Legend – Pavement Condition Rating (PCR)						
Poor (0 - 60)	Fair (61- 84)	Good (85 - 94)	Excellent (95 - 100)	Not Rated		
Colors on map represent condition scores at 0.10-mile intervals. See Appendix for definitions and formulas.						
Inspection Date:	4/18/2021	Beginning Section MP	0			
Paved Length (Miles):	0.06	Section Length (MI)	0.06			
Surface Type:	CONCRETE	Route Summary				
Roadway Condition Information						
Pavement Condition Rating (PCR)	73	73				
Surface Condition Rating (SCR)	N/A	N/A				
Roughness Condition Index (RCI)	N/A	N/A				
Distress Index Values						
Structural Crack Index	N/A	N/A				
Alligator Crack Index	N/A	N/A				
Longitudinal Crack Index	N/A	N/A				
Transverse Cracking Index	N/A	N/A				
Patching Index	N/A	N/A				
Rutting Index	N/A	N/A				
International Roughness Index (IRI)	N/A	N/A				
Lane & Width Information						
Number of Lanes	1	1				
Paved Width (ft)	17.5	17.5

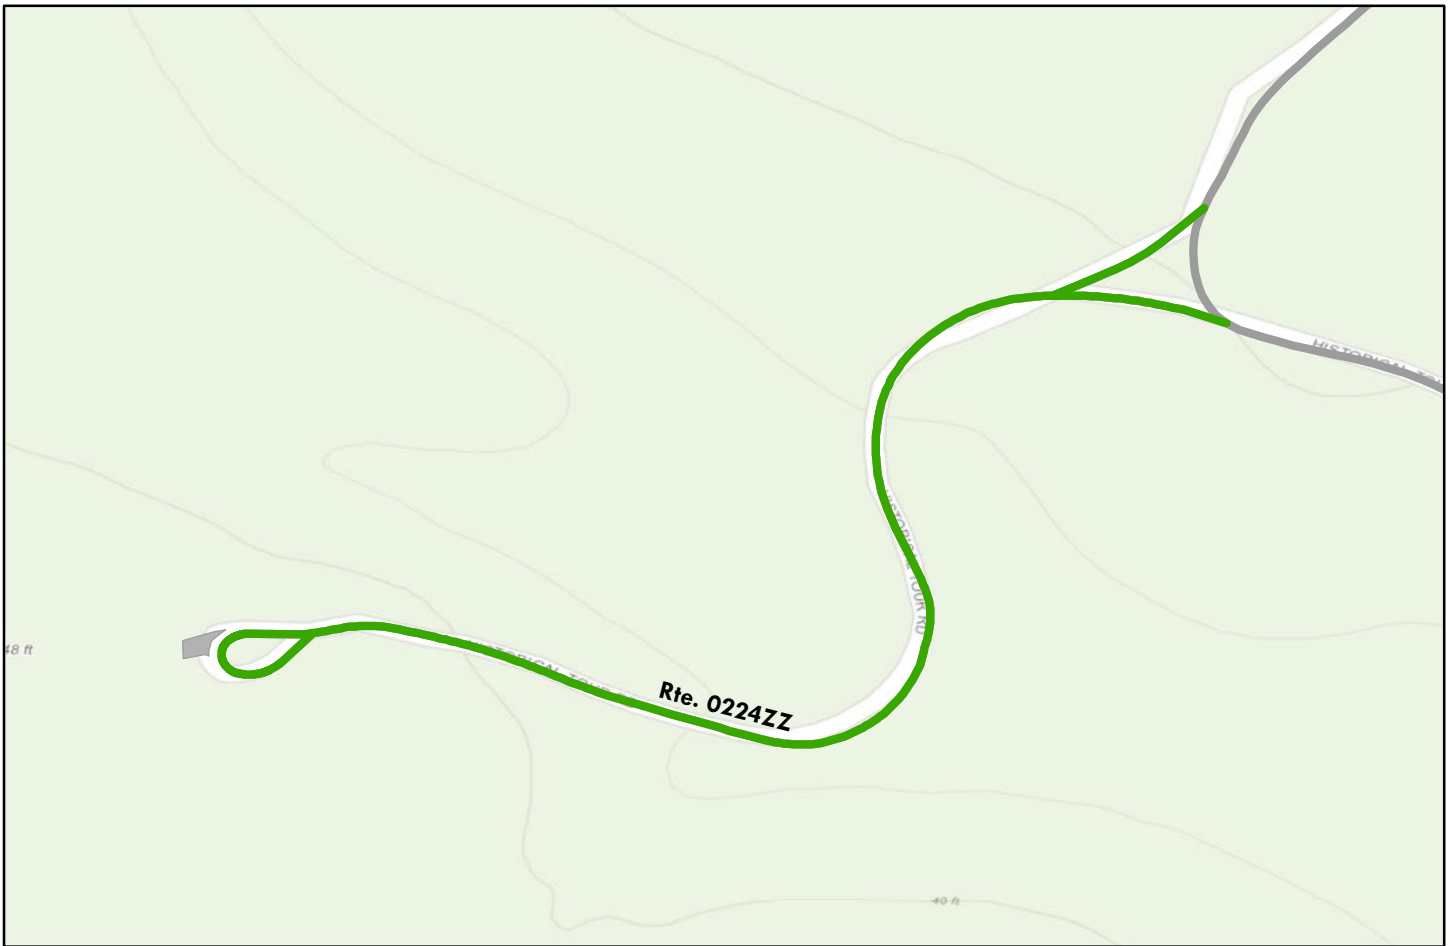
ROUTE 0224ZZ: WASHINGTON'S HEADQUARTERS ROADS

Note: The weighted average summary PCR value is calculated from only the sections of road where the PCR was collected. The overall PCR for the summary route may not reflect individual subcomponent ratings.

Route Condition Legend – Pavement Condition Rating (PCR)						
Poor (0 - 60)	Fair (61- 84)	Good (85 - 94)	Excellent (95 - 100)	Not Rated		
See Appendix for definitions and formulas						
Inspection Date: 4/18/2021						
Paved Length (Miles): 0.35						
Surface Type: ASPHALT	Route Summary					
Roadway Condition Information						
Pavement Condition Rating (PCR)	93					
Lane & Width Information						
Number of Lanes	1					
Paved Width (ft)	16.5					
Lane Width (ft)	10.8

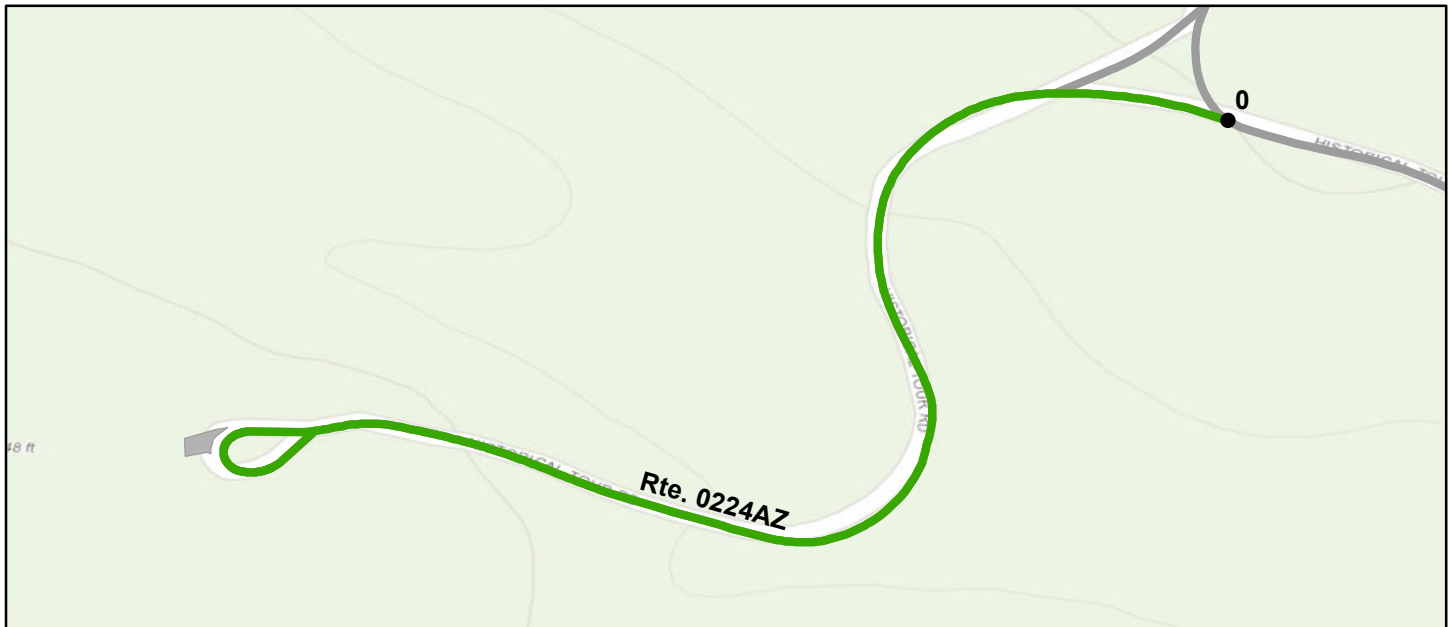
ROUTE 0224AZ: WASHINGTON'S HEADQUARTERS ROAD

Subcomponent of Route COLO-0224ZZ
Data Collection Vehicle (DCV) Rating

Route Condition Legend – Pavement Condition Rating (PCR)						
Poor (0 - 60)	Fair (61- 84)	Good (85 - 94)	Excellent (95 - 100)	Not Rated		
Colors on map represent condition scores at 0.10-mile intervals. See Appendix for definitions and formulas.						
Inspection Date: 4/18/2021	Beginning Section MP	0				
Paved Length (Miles): 0.32	Section Length (MI)	0.32				
Surface Type: ASPHALT	Route Summary					
Roadway Condition Information						
Pavement Condition Rating (PCR)	93	93				
Surface Condition Rating (SCR)	93	93				
Roughness Condition Index (RCI)	N/A	N/A				
Distress Index Values						
Structural Crack Index	100	100				
Alligator Crack Index	100	100				
Longitudinal Crack Index	100	100				
Transverse Cracking Index	100	100				
Patching Index	100	100				
Rutting Index	93	93				
International Roughness Index (IRI)	N/A	N/A				
Lane & Width Information						
Number of Lanes	2	2				
Paved Width (ft)	17	17				
Lane Width (ft)	10.8	10.8

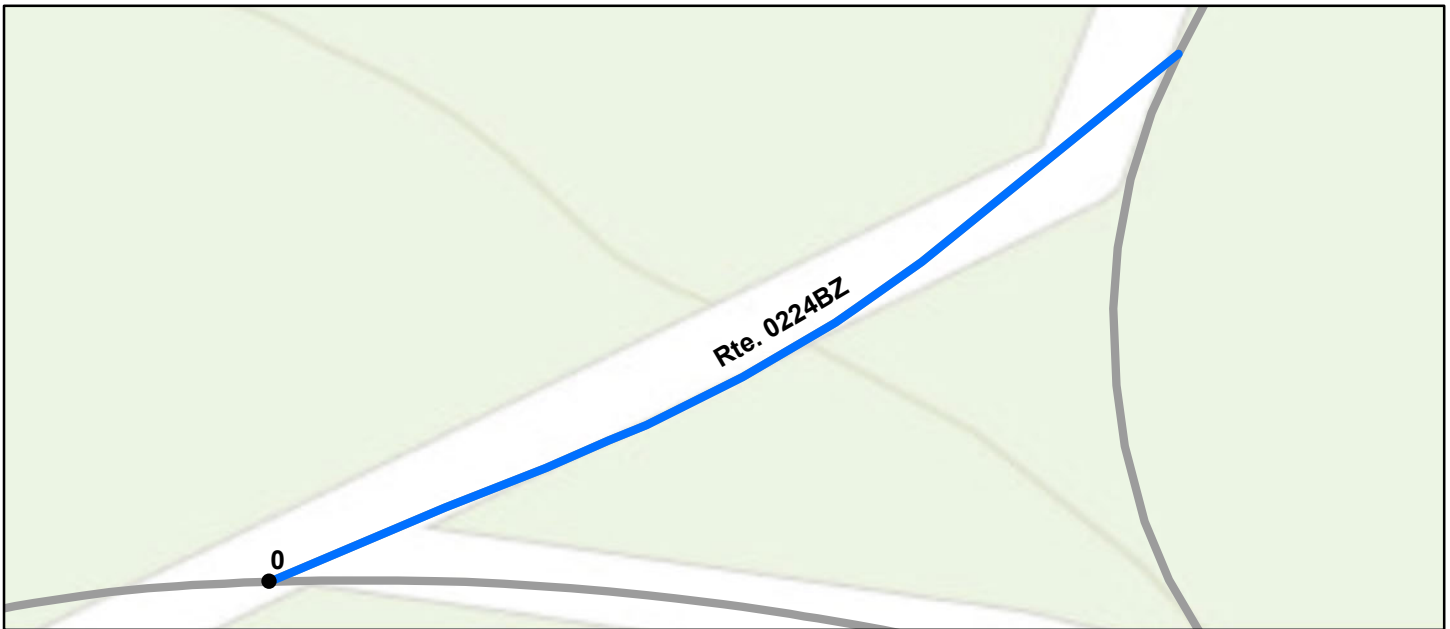
ROUTE 0224BZ: WASHINGTON'S HEADQUARTERS SPUR ROAD

Subcomponent of Route COLO-0224ZZ
Data Collection Vehicle (DCV) Rating

Route Condition Legend – Pavement Condition Rating (PCR)						
Poor (0 - 60)	Fair (61- 84)	Good (85 - 94)	Excellent (95 - 100)	Not Rated		
Colors on map represent condition scores at 0.10-mile intervals. See Appendix for definitions and formulas.						
Inspection Date: 4/18/2021	Beginning Section MP	0				
Paved Length (Miles): 0.03	Section Length (MI)	0.03				
Surface Type: ASPHALT	Route Summary					
Roadway Condition Information						
Pavement Condition Rating (PCR)	97	97				
Surface Condition Rating (SCR)	97	97				
Roughness Condition Index (RCI)	N/A	N/A				
Distress Index Values						
Structural Crack Index	100	100				
Alligator Crack Index	100	100				
Longitudinal Crack Index	100	100				
Transverse Cracking Index	100	100				
Patching Index	100	100				
Rutting Index	97	97				
International Roughness Index (IRI)	N/A	N/A				
Lane & Width Information						
Number of Lanes	1	1				
Paved Width (ft)	10.2	10.2

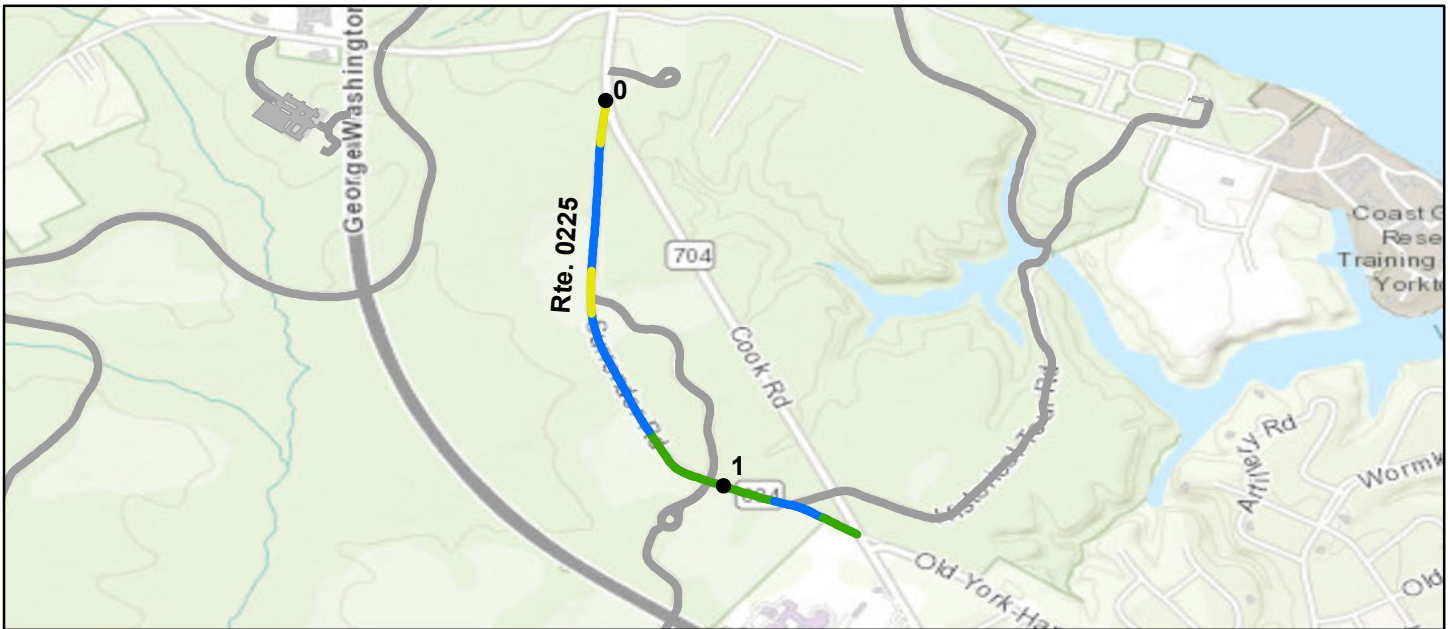
ROUTE 0225: SURRENDER ROAD

Data Collection Vehicle (DCV) Rating

Route Condition Legend – Pavement Condition Rating (PCR)									
Poor (0 - 60)		Fair (61- 84)		Good (85 - 94)		Excellent (95 - 100)		Not Rated	
Colors on map represent condition scores at 0.10-mile intervals. See Appendix for definitions and formulas.									
Inspection Date:	4/18/2021	Beginning Section MP	0	1					
Paved Length (Miles):	1.27	Section Length (MI)	1	0.27					
Surface Type:	ASPHALT	Route Summary							
Roadway Condition Information									
Pavement Condition Rating (PCR)		94	93	93					
Surface Condition Rating (SCR)		98	98	92					
Roughness Condition Index (RCI)		87	85	95					
Distress Index Values									
Structural Crack Index		100	100	100					
Alligator Crack Index		100	100	100					
Longitudinal Crack Index		100	100	100					
Transverse Cracking Index		100	100	100					
Patching Index		98	100	92					
Rutting Index		98	98	98					
International Roughness Index (IRI)		148	154	126					
Lane & Width Information

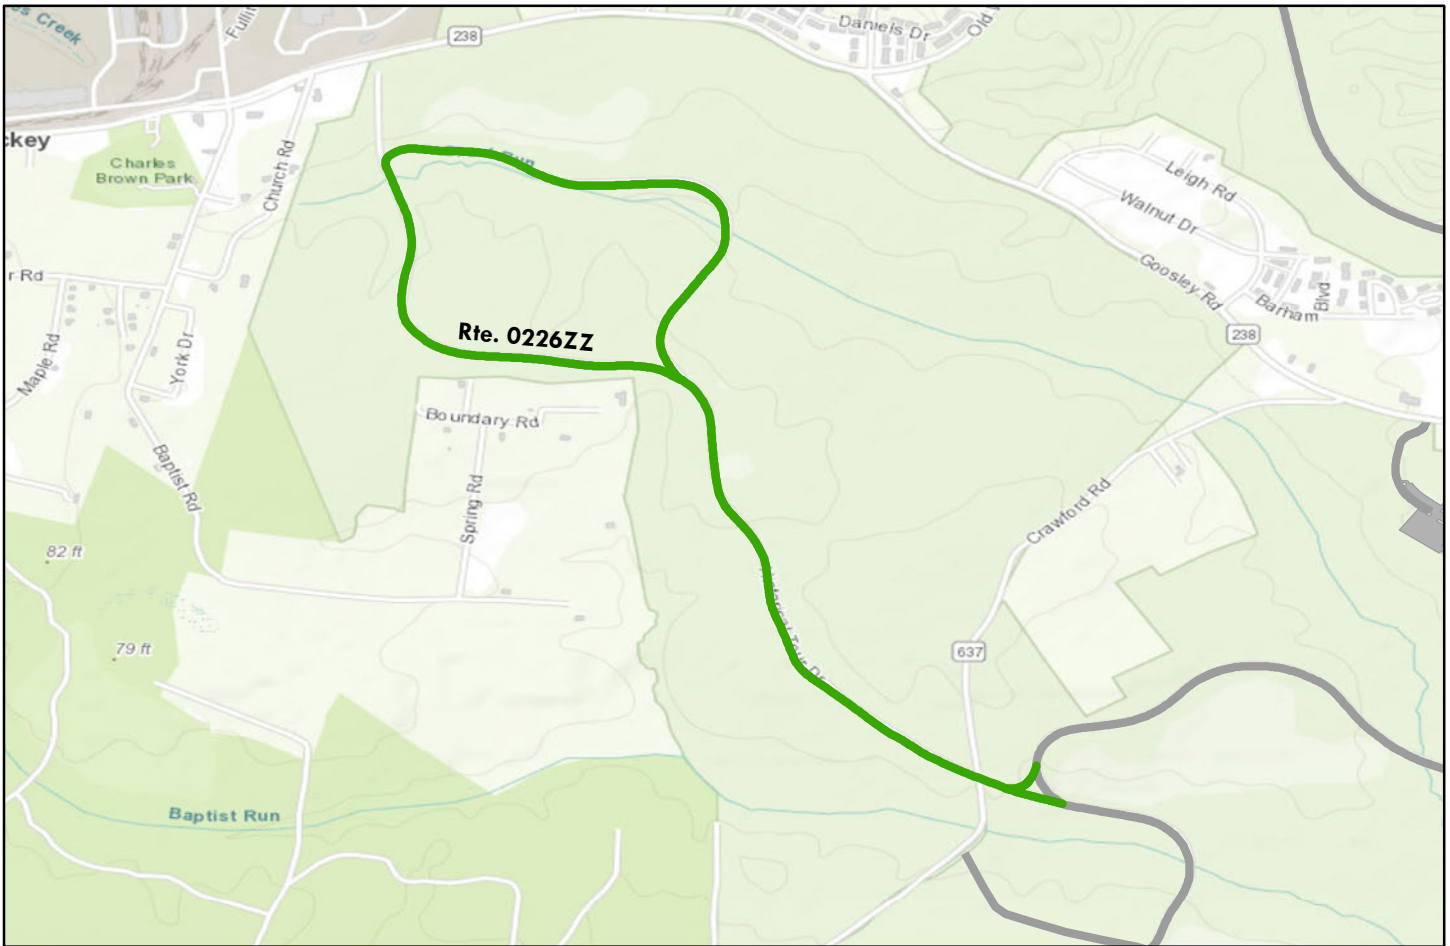
ROUTE 0226ZZ: FRENCH LOOP ROADS

Summary Route

Note: The weighted average summary PCR value is calculated from only the sections of road where the PCR was collected. The overall PCR for the summary route may not reflect individual subcomponent ratings.

Route Condition Legend – Pavement Condition Rating (PCR)						
Poor (0 - 60)	Fair (61- 84)	Good (85 - 94)	Excellent (95 - 100)	Not Rated		
See Appendix for definitions and formulas						
Inspection Date:	4/18/2021					
Paved Length (Miles):	2.54					
Surface Type:	ASPHALT	Route Summary				
Roadway Condition Information						
Pavement Condition Rating (PCR)	89					
Lane & Width Information						
Number of Lanes	1					
Paved Width (ft)	14.4					
Lane Width (ft)	11

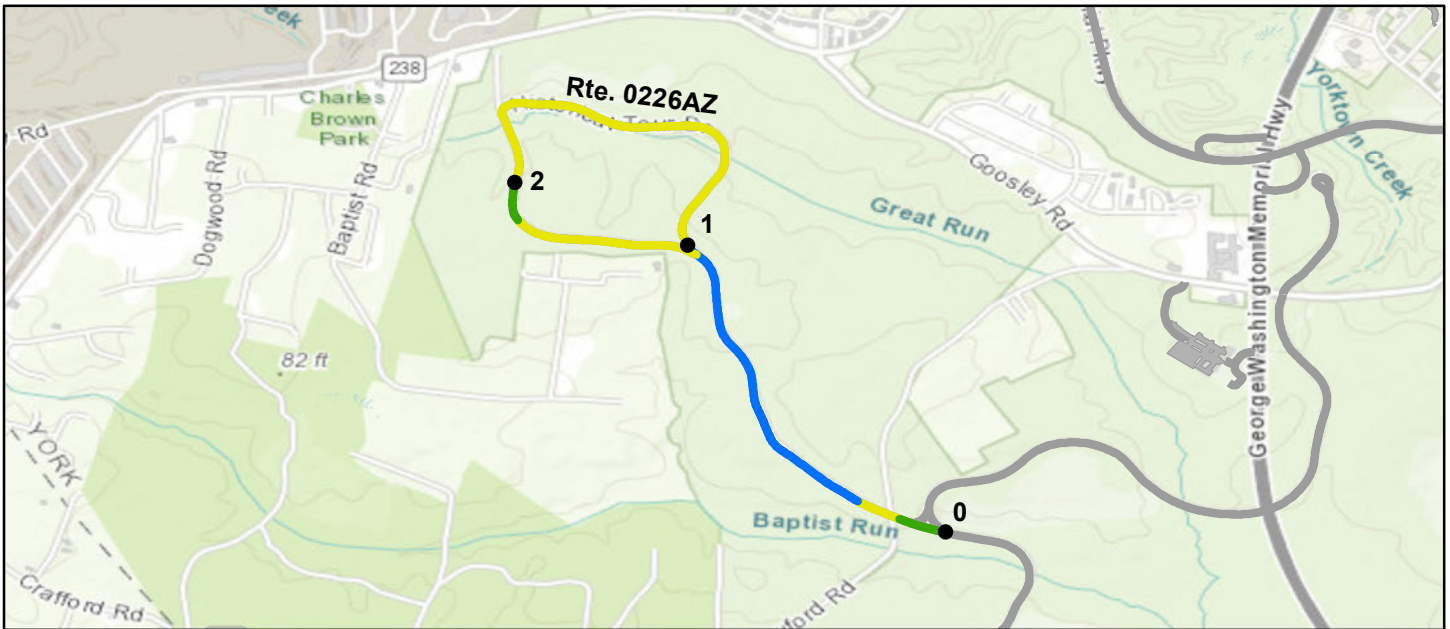
Subcomponent of Route COLO-0226ZZ

Data Collection Vehicle (DCV) Rating

Colors on map represent condition scores at 0.10-mile intervals. See Appendix for definitions and formulas.

Inspection Date:	4/18/2021	Beginning Section MP	0	1	2		
Paved Length (Miles):	2.49	Section Length (MI)	1	1	0.49		
Surface Type:	ASPHALT	Route Summary					
Roadway Condition Information							
Pavement Condition Rating (PCR)	89	97	84	84			
Surface Condition Rating (SCR)	83	99	73	73			
Roughness Condition Index (RCI)	98	94	100	100			
Distress Index Values							
Structural Crack Index	99	99	99	95			
Alligator Crack Index	100	100	100	100			
Longitudinal Crack Index	99	99	99	95			
Transverse Cracking Index	100	100	99	100			
Patching Index	83	99	73	73			
Rutting Index	99	99	99	99			
International Roughness Index (IRI)	120	128	115	114			
Lane & Width Information							
Number of Lanes	1	2	1	1			
Paved Width (ft)	14.4	18.4	11.9	11.4			
Lane Width (ft)	11	9.8	11.9	11.4

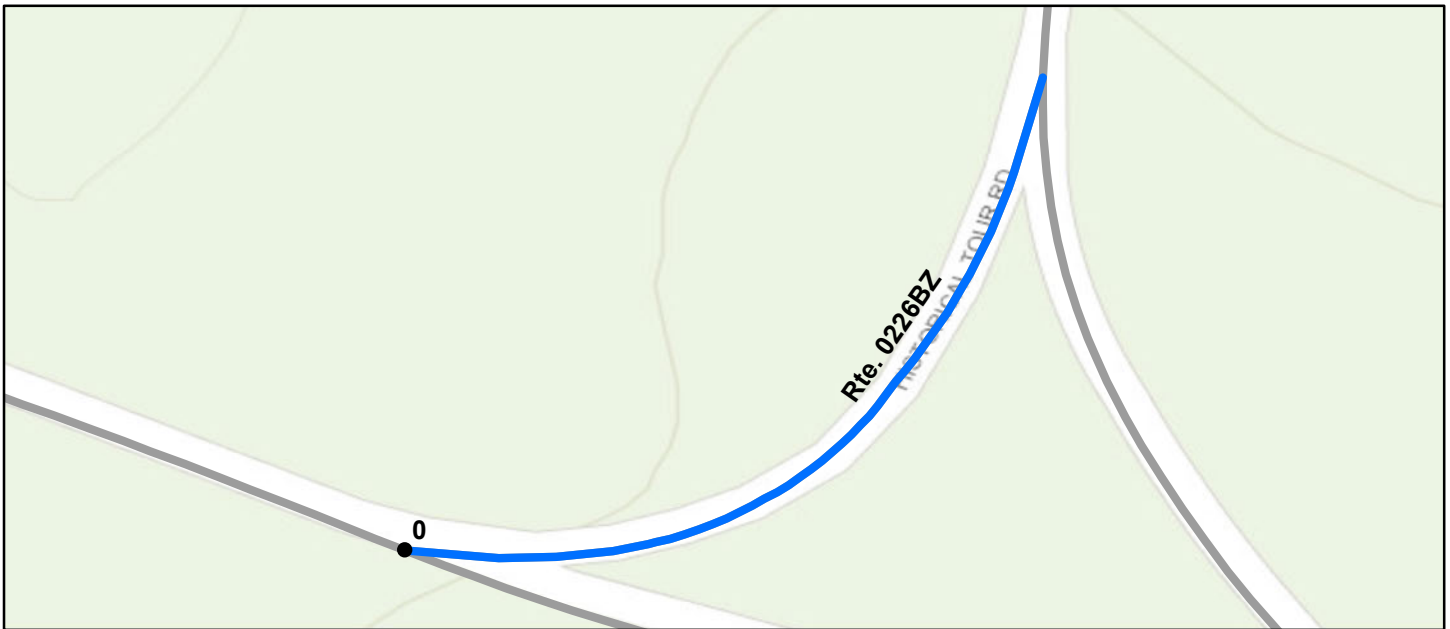
Subcomponent of Route COLO-0226ZZ

Data Collection Vehicle (DCV) Rating

Colors on map represent condition scores at 0.10-mile intervals. See Appendix for definitions and formulas.

Inspection Date:	4/18/2021	Beginning Section MP	0				
Paved Length (Miles):	0.05	Section Length (MI)	0.05				
Surface Type:	ASPHALT	Route Summary					
Roadway Condition Information							
Pavement Condition Rating (PCR)	96	96					
Surface Condition Rating (SCR)	96	96					
Roughness Condition Index (RCI)	N/A	N/A					
Distress Index Values							
Structural Crack Index	100	100					
Alligator Crack Index	100	100					
Longitudinal Crack Index	100	100					
Transverse Cracking Index	100	100					
Patching Index	100	100					
Rutting Index	96	96					
International Roughness Index (IRI)	N/A	N/A					
Lane & Width Information							
Number of Lanes	1	1					
Paved Width (ft)	12.8	12.8					
Lane Width (ft)	12.8	12.8

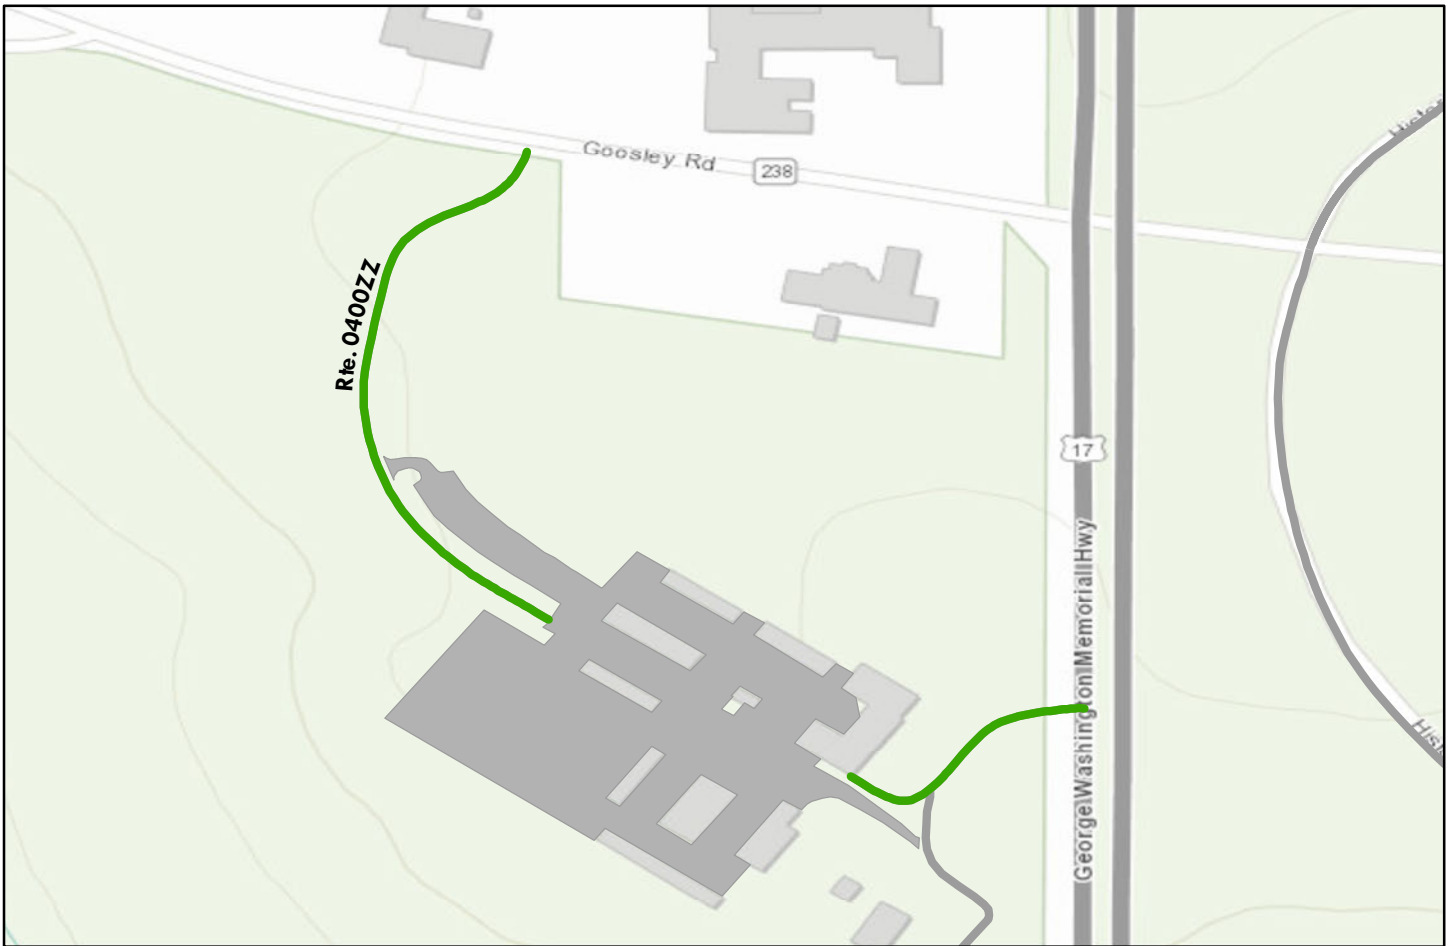
ROUTE 0400ZZ: YORKTOWN MAINTENANCE UTILITY ROADS

Summary Route

Note: The weighted average summary PCR value is calculated from only the sections of road where the PCR was collected. The overall PCR for the summary route may not reflect individual subcomponent ratings.

Route Condition Legend – Pavement Condition Rating (PCR)						
Poor (0 - 60)	Fair (61- 84)	Good (85 - 94)	Excellent (95 - 100)	Not Rated		
See Appendix for definitions and formulas						
Inspection Date:	4/18/2021					
Paved Length (Miles):	0.26					
Surface Type:	ASPHALT	Route Summary				
Roadway Condition Information						
Pavement Condition Rating (PCR)	89					
Lane & Width Information						
Number of Lanes	1					
Paved Width (ft)	20.1					
Lane Width (ft)	10.3

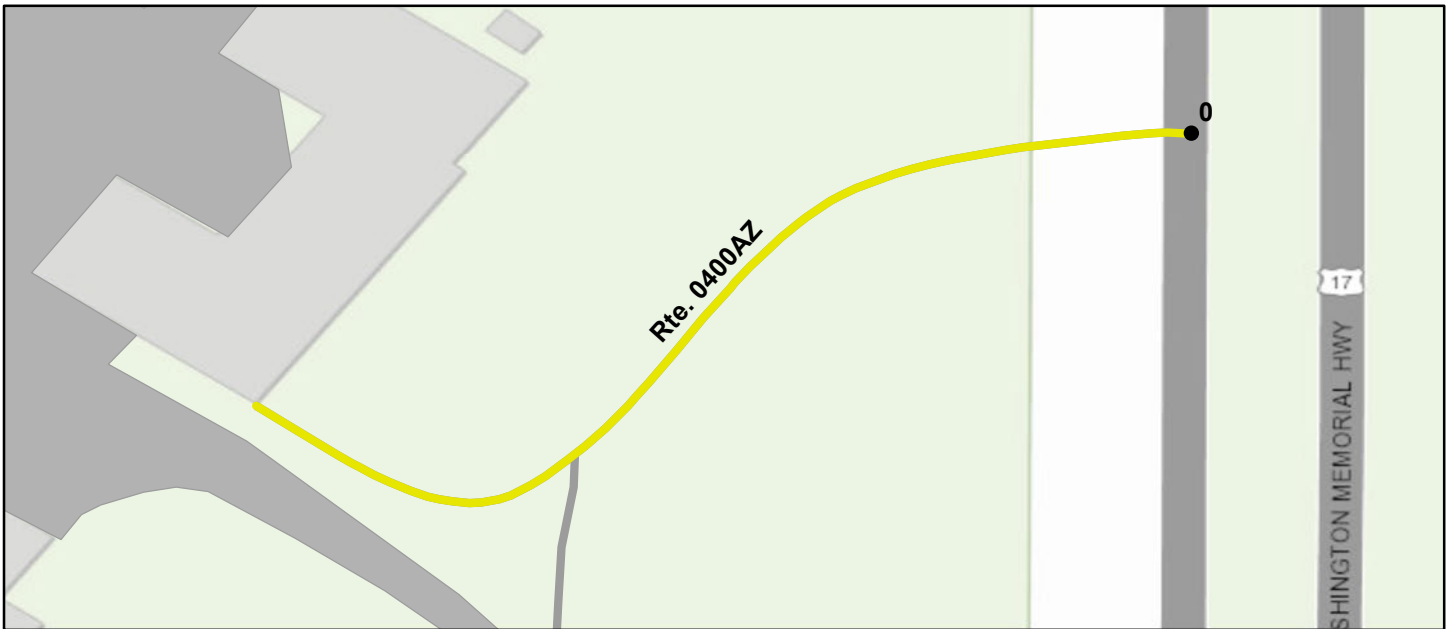
ROUTE 0400AZ: YORKTOWN MAINTENANCE UTILITY ROAD A

Subcomponent of Route COLO-0400ZZ
 Data Collection Vehicle (DCV) Rating

Route Condition Legend – Pavement Condition Rating (PCR)						
Poor (0 - 60)	Fair (61- 84)	Good (85 - 94)	Excellent (95 - 100)	Not Rated		
Colors on map represent condition scores at 0.10-mile intervals. See Appendix for definitions and formulas.						
Inspection Date: 4/18/2021	Beginning Section MP	0				
Paved Length (Miles): 0.07	Section Length (MI)	0.07				
Surface Type: ASPHALT	Route Summary					
Roadway Condition Information						
Pavement Condition Rating (PCR)	77	77				
Surface Condition Rating (SCR)	77	77				
Roughness Condition Index (RCI)	N/A	N/A				
Distress Index Values						
Structural Crack Index	93	93				
Alligator Crack Index	100	100				
Longitudinal Crack Index	93	93				
Transverse Cracking Index	77	77				
Patching Index	100	100				
Rutting Index	94	94				
International Roughness Index (IRI)	N/A	N/A				
Lane & Width Information						
Number of Lanes	2	2				
Paved Width (ft)	17.2	17.2				
Lane Width (ft)	9.2	9.2

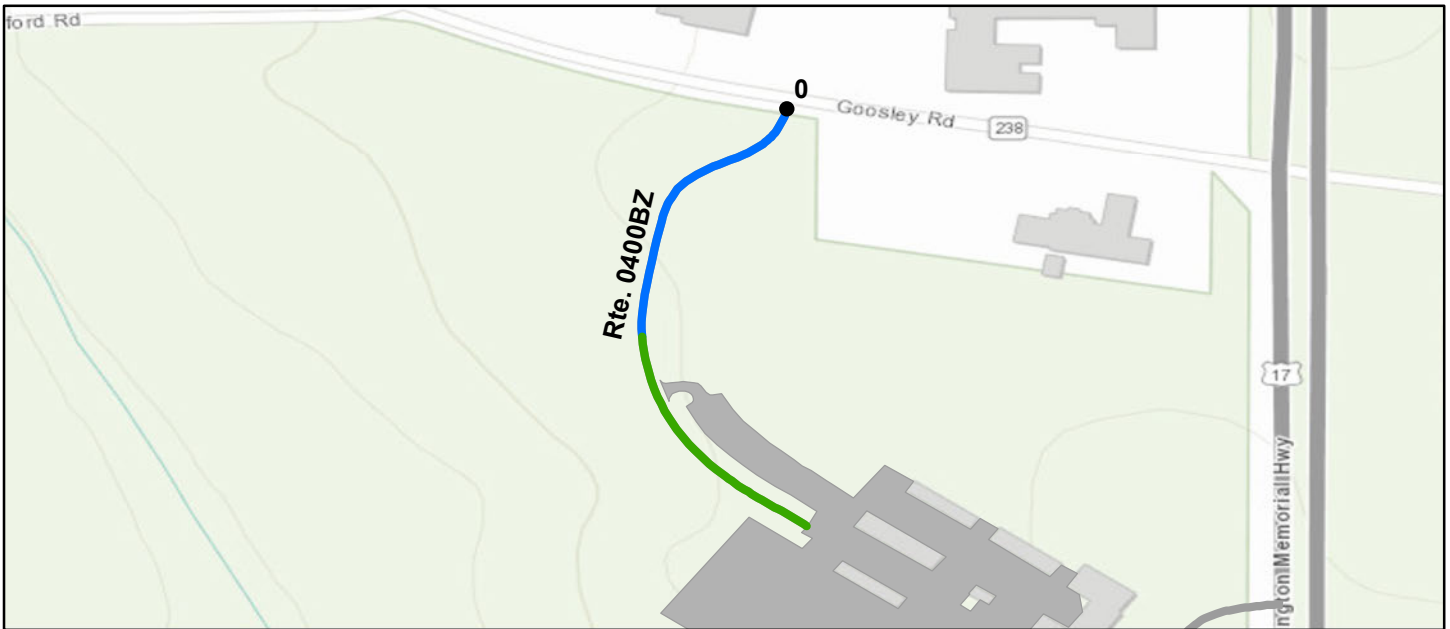
ROUTE 0400BZ: YORKTOWN MAINTENANCE UTILITY ROAD B

Subcomponent of Route COLO-0400ZZ
Data Collection Vehicle (DCV) Rating

Route Condition Legend – Pavement Condition Rating (PCR)						
Poor (0 - 60)	Fair (61- 84)	Good (85 - 94)	Excellent (95 - 100)	Not Rated		
Colors on map represent condition scores at 0.10-mile intervals. See Appendix for definitions and formulas.						
Inspection Date:	4/18/2021	Beginning Section MP	0			
Paved Length (Miles):	0.19	Section Length (MI)	0.19			
Surface Type:	ASPHALT	Route Summary				
Roadway Condition Information						
Pavement Condition Rating (PCR)	92	92				
Surface Condition Rating (SCR)	92	92				
Roughness Condition Index (RCI)	N/A	N/A				
Distress Index Values						
Structural Crack Index	95	95				
Alligator Crack Index	99	99				
Longitudinal Crack Index	96	96				
Transverse Cracking Index	92	92				
Patching Index	100	100				
Rutting Index	96	96				
International Roughness Index (IRI)	N/A	N/A				
Lane & Width Information						
Number of Lanes	2	2				
Paved Width (ft)	21.2	21.2				
Lane Width (ft)	10.7	10.7

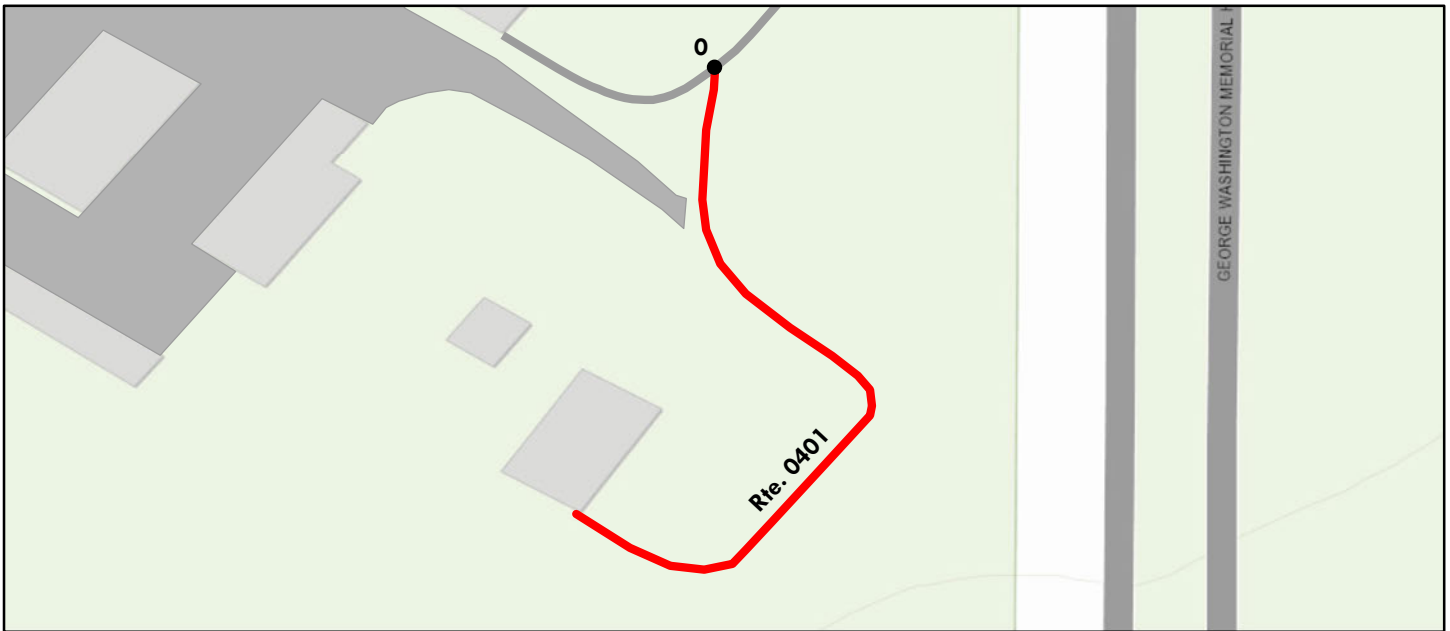
ROUTE 0401: YORKTOWN MAINTENANCE AREA RESIDENCE ROAD

Manual Rating

Route Condition Legend – Pavement Condition Rating (PCR)						
Poor (0 - 60)	Fair (61- 84)	Good (85 - 94)	Excellent (95 - 100)	Not Rated		
See Appendix for definitions and formulas						
Inspection Date: 2/19/2021	Beginning Section MP	0.00				
Paved Length (Miles): 0.09	Section Length (MI)	0.09				
Surface Type: ASPHALT	Route Summary					
Roadway Condition Information						
Pavement Condition Rating (PCR)	30	30				
Surface Condition Rating (SCR)	30	30				
Roughness Condition Index (RCI)	N/A	N/A				
Distress Index Values						
Structural Crack Index	N/A	N/A				
Alligator Crack Index	97	97				
Longitudinal Crack Index	90	90				
Transverse Cracking Index	73	73				
Patching Index	30	30				
Rutting Index	53	53				
International Roughness Index (IRI)	N/A	N/A				
Lane & Width Information						
Number of Lanes	1	1				
Paved Width (ft)	12	12				
Lane Width (ft)	12	12

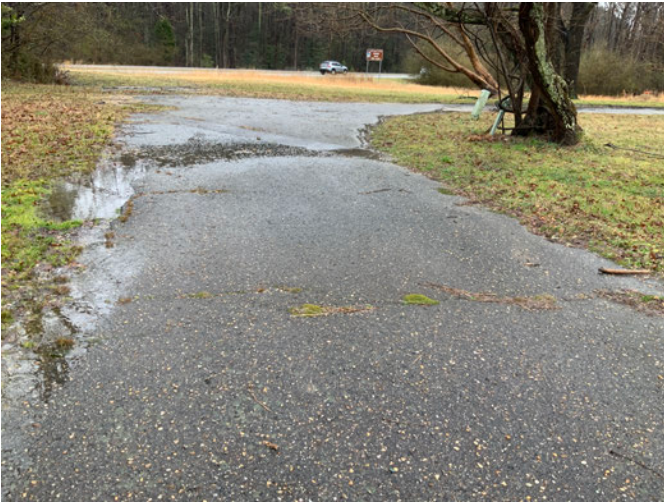
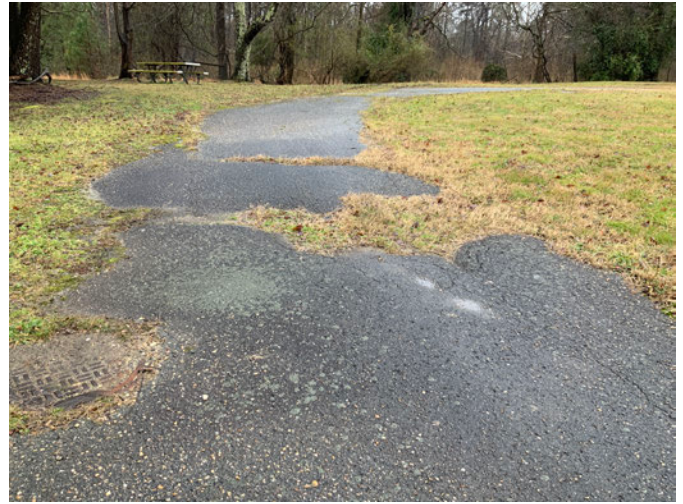
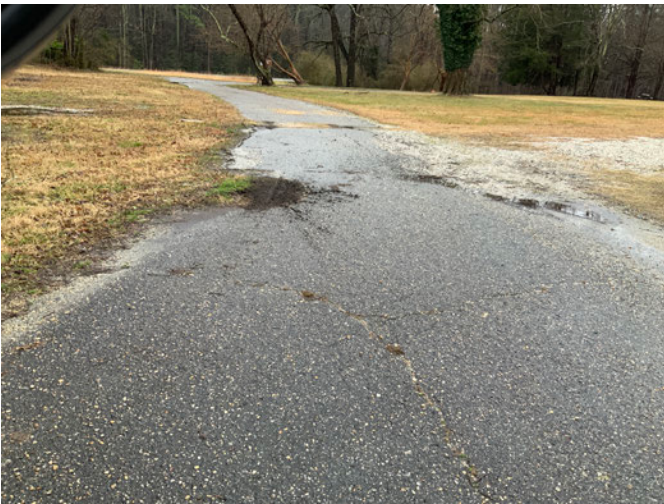
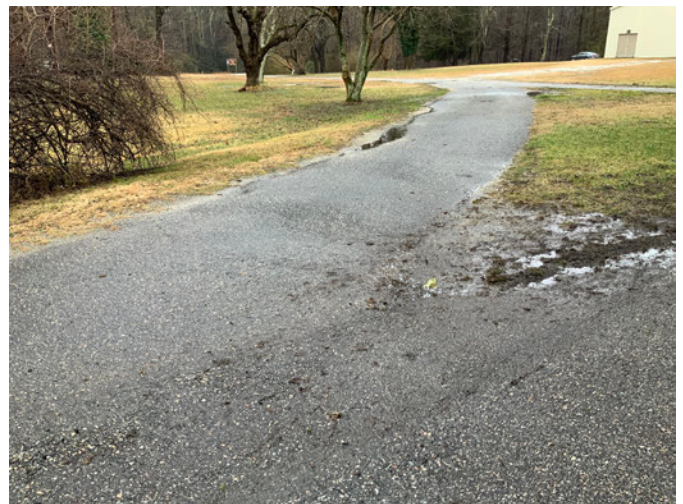
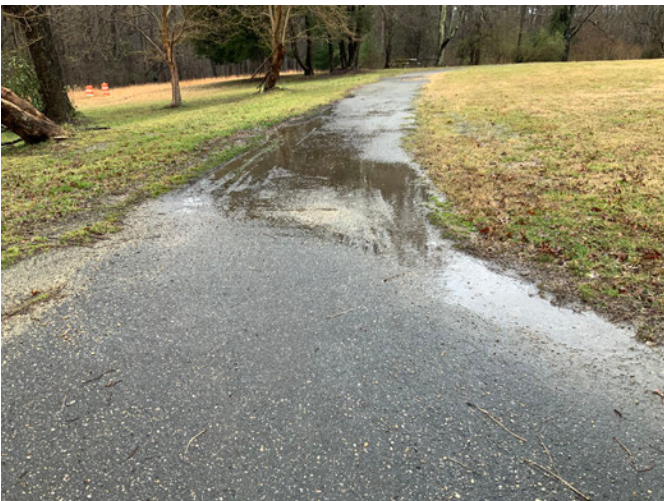
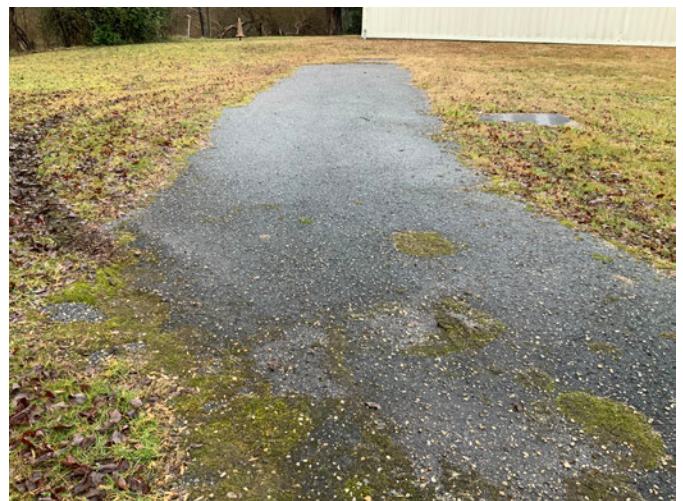
Condition Photos

Condition photos are shown only for manually rated roads. Use the PathView program to see images of DCV rated roads.

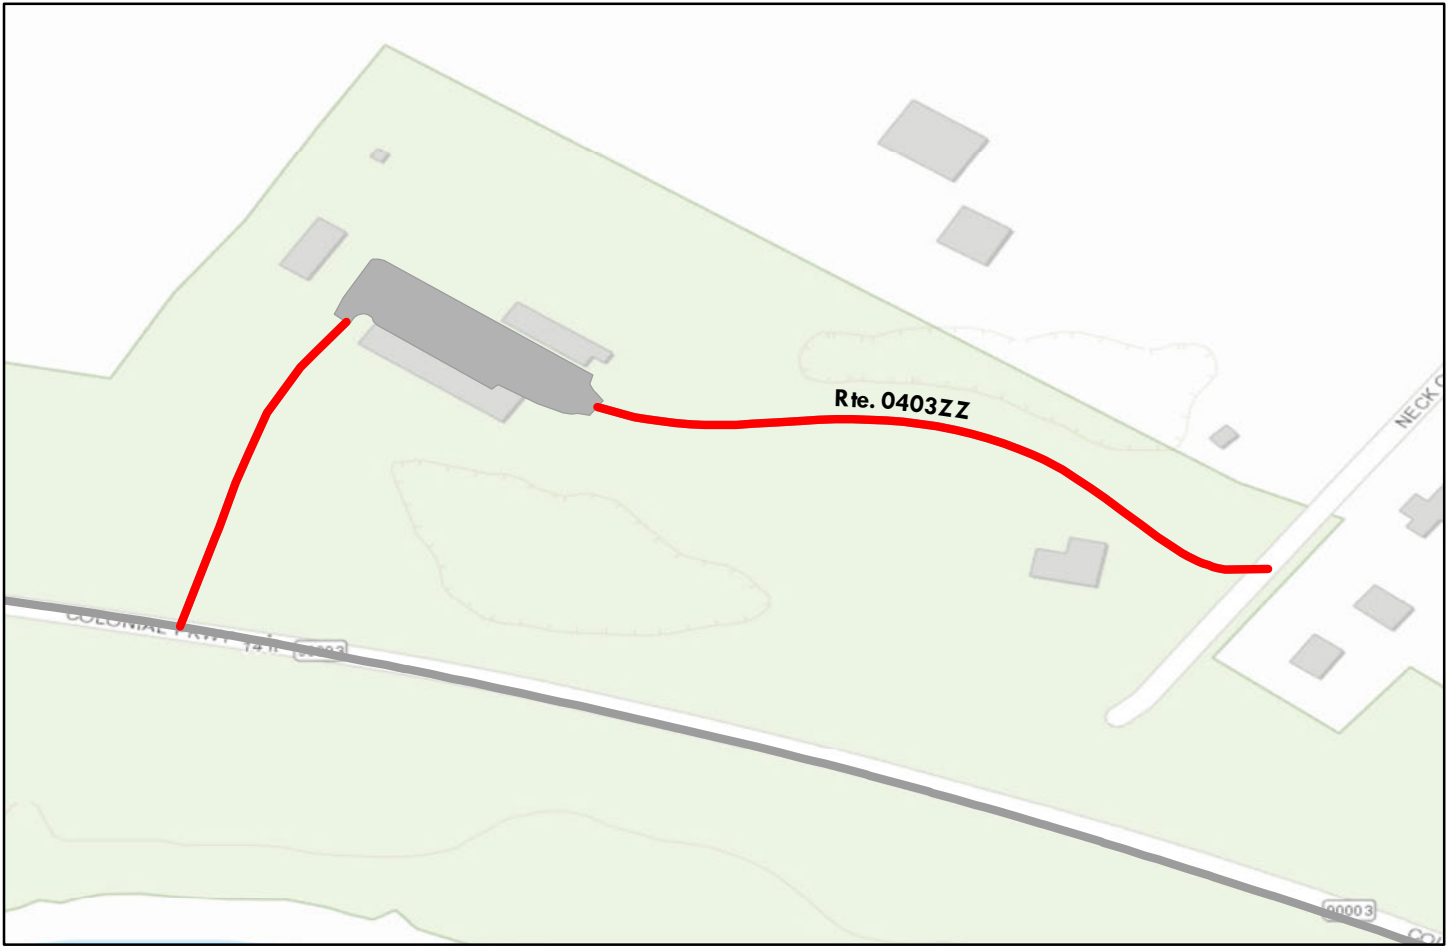
ROUTE 0403ZZ: JAMESTOWN MAINTENANCE ROADS

Summary Route

Note: The weighted average summary PCR value is calculated from only the sections of road where the PCR was collected. The overall PCR for the summary route may not reflect individual subcomponent ratings.

Route Condition Legend – Pavement Condition Rating (PCR)						
Poor (0 - 60)	Fair (61- 84)	Good (85 - 94)	Excellent (95 - 100)	Not Rated		
See Appendix for definitions and formulas						
Inspection Date:	4/18/2021					
Paved Length (Miles):	0.18					
Surface Type:	ASPHALT	Route Summary				
Roadway Condition Information						
Pavement Condition Rating (PCR)	0					
Lane & Width Information						
Number of Lanes	1					
Paved Width (ft)	16.3					
Lane Width (ft)	8

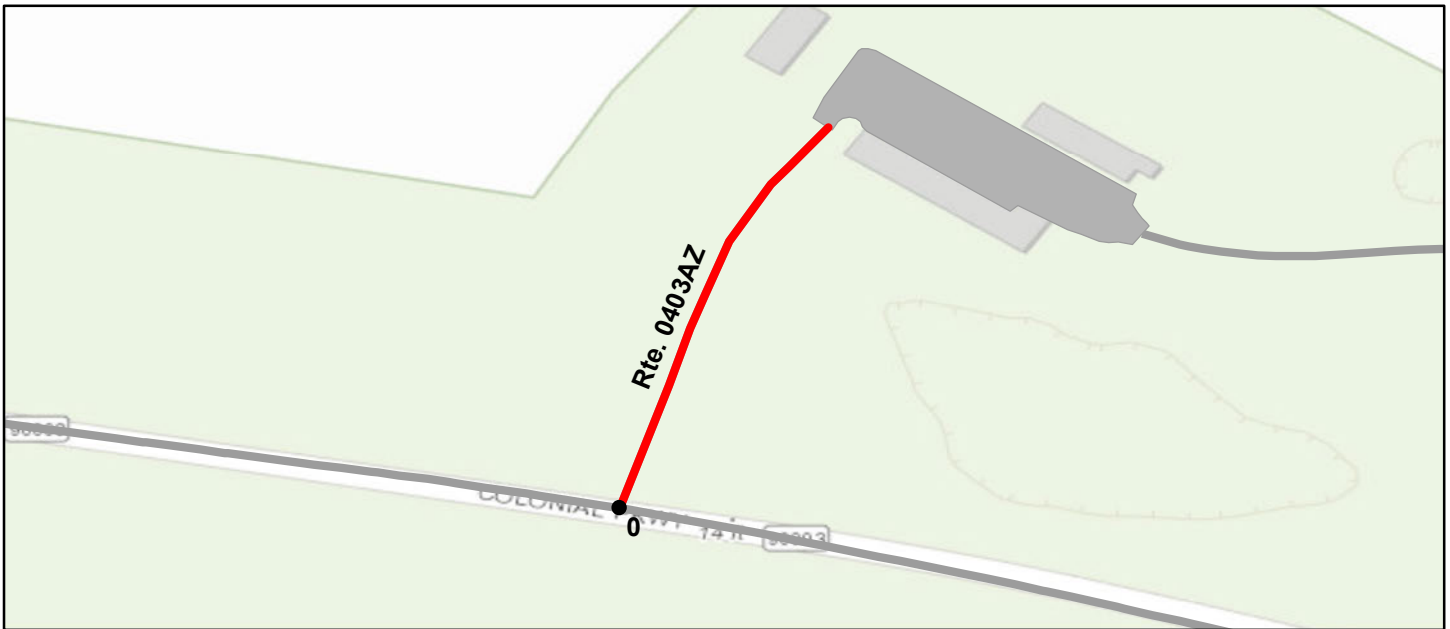
ROUTE 0403AZ: JAMESTOWN MAINTENANCE ROAD A

Subcomponent of Route COLO-0403ZZ
Data Collection Vehicle (DCV) Rating

Route Condition Legend – Pavement Condition Rating (PCR)						
Poor (0 - 60)	Fair (61- 84)	Good (85 - 94)	Excellent (95 - 100)	Not Rated		
Colors on map represent condition scores at 0.10-mile intervals. See Appendix for definitions and formulas.						
Inspection Date:	4/18/2021	Beginning Section MP	0			
Paved Length (Miles):	0.07	Section Length (MI)	0.07			
Surface Type:	ASPHALT	Route Summary				
Roadway Condition Information						
Pavement Condition Rating (PCR)	0	0				
Surface Condition Rating (SCR)	0	0				
Roughness Condition Index (RCI)	N/A	N/A				
Distress Index Values						
Structural Crack Index	16	16				
Alligator Crack Index	97	97				
Longitudinal Crack Index	19	19				
Transverse Cracking Index	0	0				
Patching Index	100	100				
Rutting Index	92	92				
International Roughness Index (IRI)	N/A	N/A				
Lane & Width Information						
Number of Lanes	2	2				
Paved Width (ft)	16.7	16.7				
Lane Width (ft)	8	8

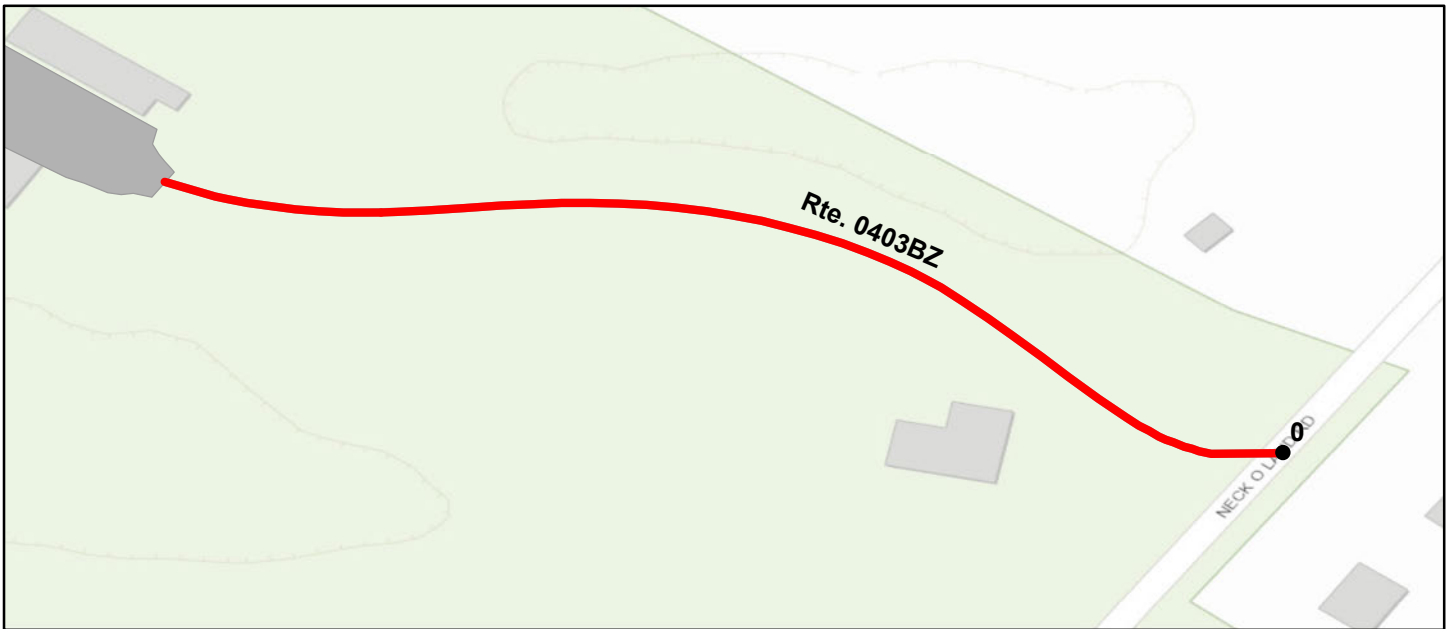
ROUTE 0403BZ: JAMESTOWN MAINTENANCE ROAD B

Subcomponent of Route COLO-0403ZZ
Data Collection Vehicle (DCV) Rating

Route Condition Legend – Pavement Condition Rating (PCR)						
Poor (0 - 60)	Fair (61- 84)	Good (85 - 94)	Excellent (95 - 100)	Not Rated		
Colors on map represent condition scores at 0.10-mile intervals. See Appendix for definitions and formulas.						
Inspection Date: 4/18/2021	Beginning Section MP	0				
Paved Length (Miles): 0.12	Section Length (MI)	0.12				
Surface Type: ASPHALT	Route Summary					
Roadway Condition Information						
Pavement Condition Rating (PCR)	0	0				
Surface Condition Rating (SCR)	0	0				
Roughness Condition Index (RCI)	N/A	N/A				
Distress Index Values						
Structural Crack Index	0	0				
Alligator Crack Index	91	91				
Longitudinal Crack Index	0	0				
Transverse Cracking Index	20	20				
Patching Index	98	98				
Rutting Index	89	89				
International Roughness Index (IRI)	N/A	N/A				
Lane & Width Information						
Number of Lanes	2	2				
Paved Width (ft)	16.1	16.1				
Lane Width (ft)	8	8
