COLO Cycle 6

Final Report

Road Inventory and Condition Assessment of Paved Routes Colonial National Historical Park

**Federal Highway Administration
Eastern Federal Lands Highway Division
Road Inventory Program (RIP)**

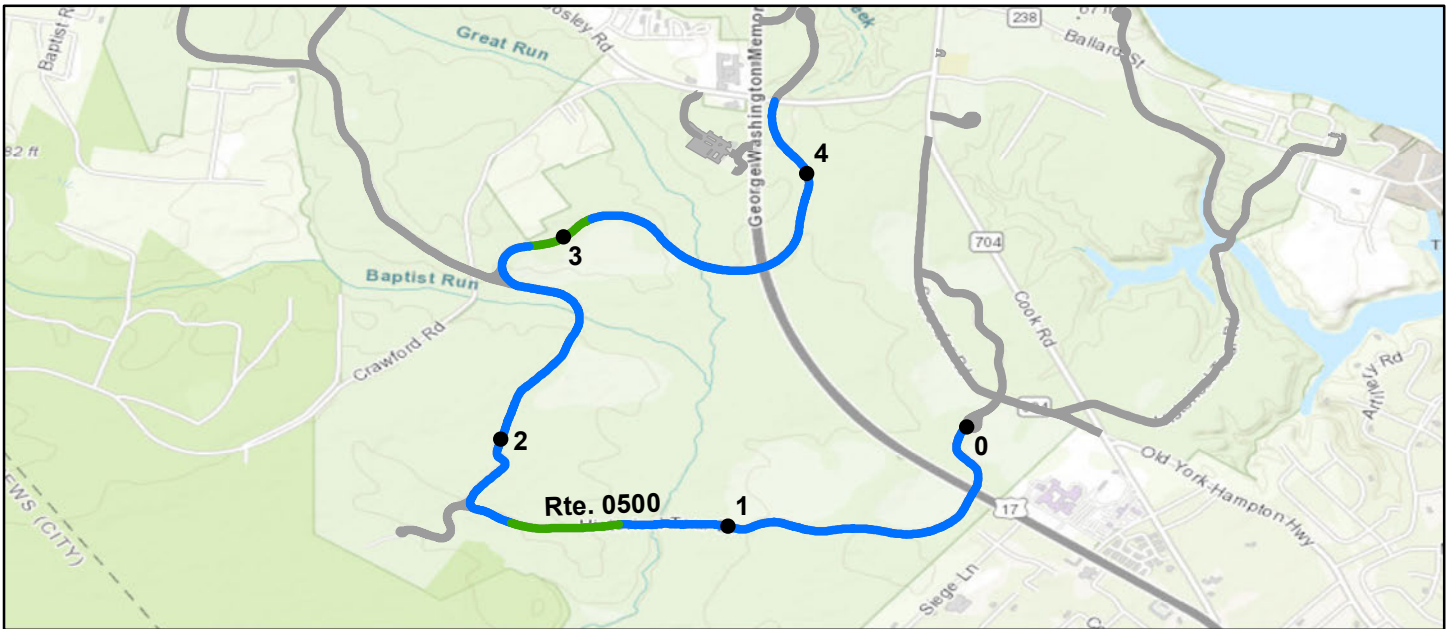
ROUTE 0500: WEST TOUR ROAD

Data Collection Vehicle (DCV) Rating

Colors on map represent condition scores at 0.10-mile intervals. See Appendix for definitions and formulas.

Inspection Date:	Beginning Section MP					
	0	1	2	3	4	
Paved Length (Miles): 4.28	Section Length (MI)					
Surface Type: ASPHALT	Route Summary					
Roadway Condition Information						
Pavement Condition Rating (PCR)	98	99	96	99	99	98
Surface Condition Rating (SCR)	98	99	96	99	99	98
Roughness Condition Index (RCI)	N/A	N/A	N/A	N/A	N/A	N/A
Distress Index Values						
Structural Crack Index	100	100	100	99	99	100
Alligator Crack Index	100	100	100	100	100	100
Longitudinal Crack Index	100	100	100	99	99	100
Transverse Cracking Index	100	100	100	100	100	98
Patching Index	100	100	100	100	100	100
Rutting Index	98	99	96	99	100	99
International Roughness Index (IRI)	N/A	N/A	N/A	N/A	N/A	N/A
Lane & Width Information						
Number of Lanes	1	1	1	1	1	1
Paved Width (ft)	12	12	11.9	11.7	12.3	12.1
Lane Width (ft)	12	12	11.9	11.7	12.3	12.1

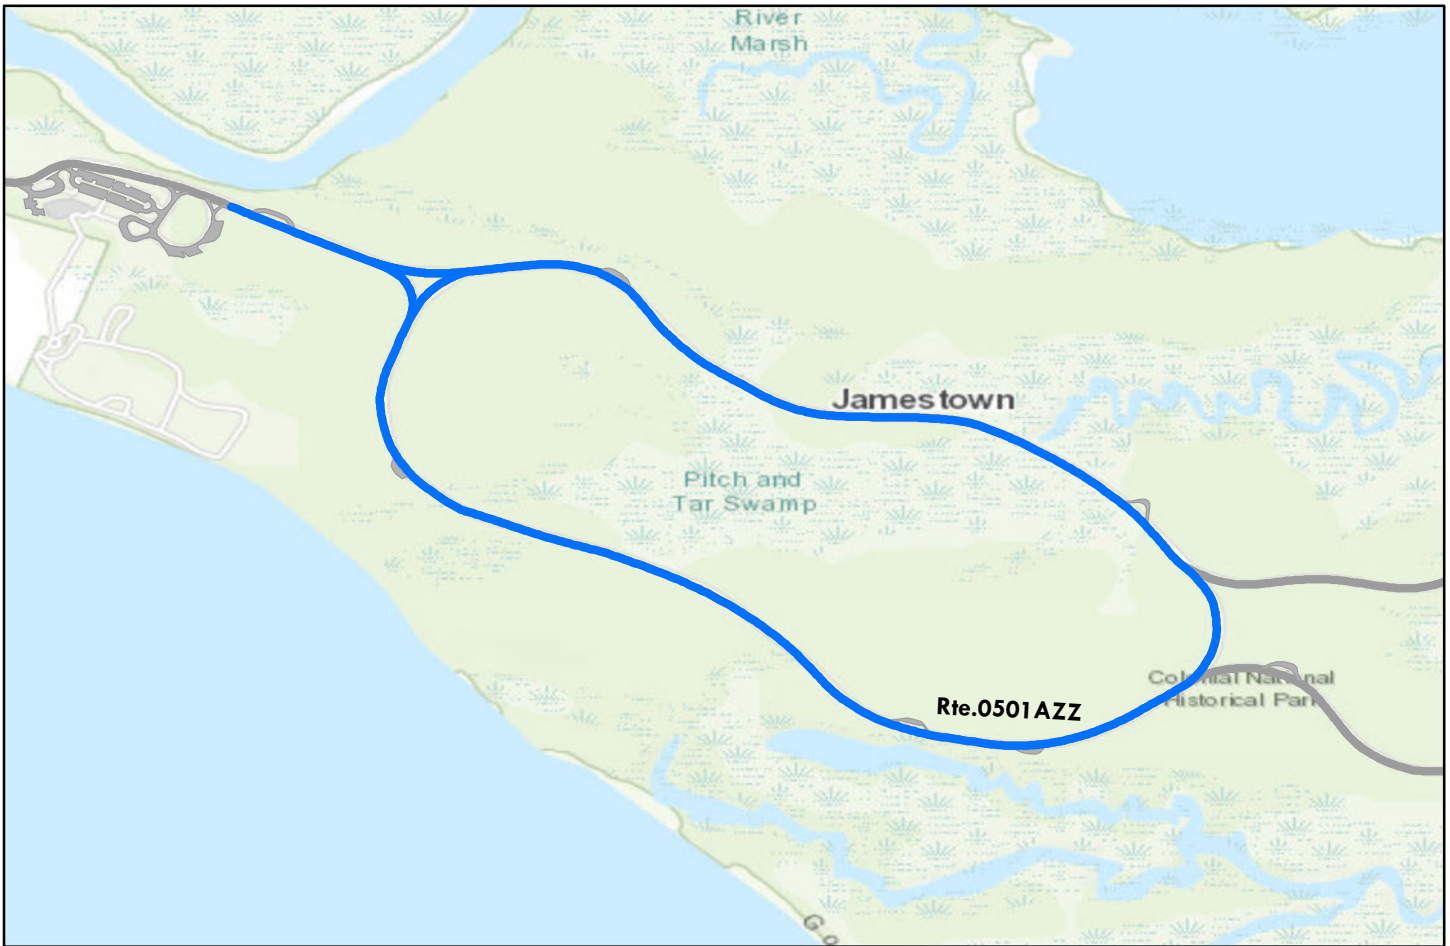
ROUTE 0501AZZ: ISLAND DRIVE WEST LOOP ROADS

Summary Route

Note: The weighted average summary PCR value is calculated from only the sections of road where the PCR was collected. The overall PCR for the summary route may not reflect individual subcomponent ratings.

Route Condition Legend – Pavement Condition Rating (PCR)						
Poor (0 - 60)	Fair (61- 84)	Good (85 - 94)	Excellent (95 - 100)	Not Rated		
See Appendix for definitions and formulas						
Inspection Date: 4/19/2021						
Paved Length (Miles): 2.4						
Surface Type: ASPHALT	Route Summary					
Roadway Condition Information						
Pavement Condition Rating (PCR)	99					
Lane & Width Information						
Number of Lanes	1					
Paved Width (ft)	13.6					
Lane Width (ft)	12.5

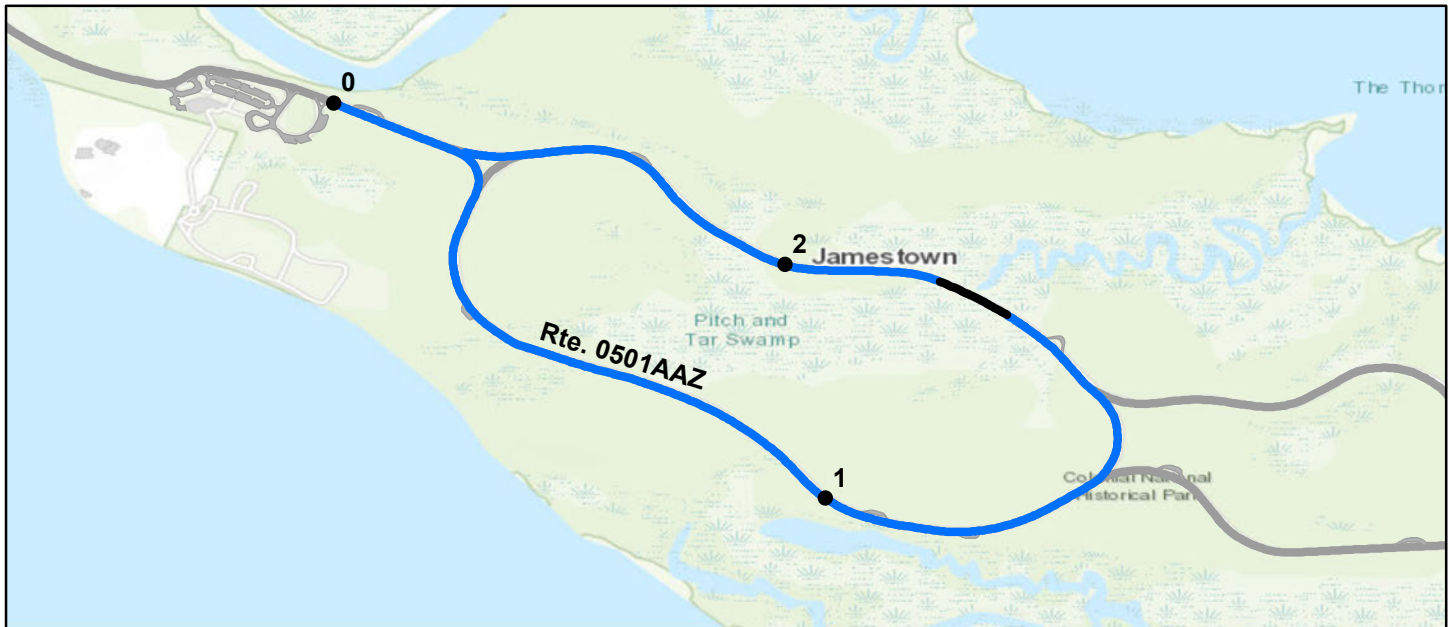
Subcomponent of Route COLO-0501AZZ

Data Collection Vehicle (DCV) Rating

Colors on map represent condition scores at 0.10-mile intervals. See Appendix for definitions and formulas.

Inspection Date:	4/19/2021	Beginning Section MP	0	1	2		
Paved Length (Miles):	2.34	Section Length (MI)	1	1	0.48		
Surface Type:	ASPHALT	Route Summary					
Roadway Condition Information							
Pavement Condition Rating (PCR)	100	100	100	100			
Surface Condition Rating (SCR)	100	100	100	100			
Roughness Condition Index (RCI)	N/A	N/A	N/A	N/A			
Distress Index Values							
Structural Crack Index	100	100	100	100			
Alligator Crack Index	100	100	100	100			
Longitudinal Crack Index	100	100	100	100			
Transverse Cracking Index	100	100	100	100			
Patching Index	100	100	100	100			
Rutting Index	100	100	100	100			
International Roughness Index (IRI)	N/A	N/A	N/A	N/A			
Lane & Width Information							
Number of Lanes	1	1	1	1			
Paved Width (ft)	13.5	14.7	12.7	12.9			
Lane Width (ft)	12.4	11.8	12.7	12.9

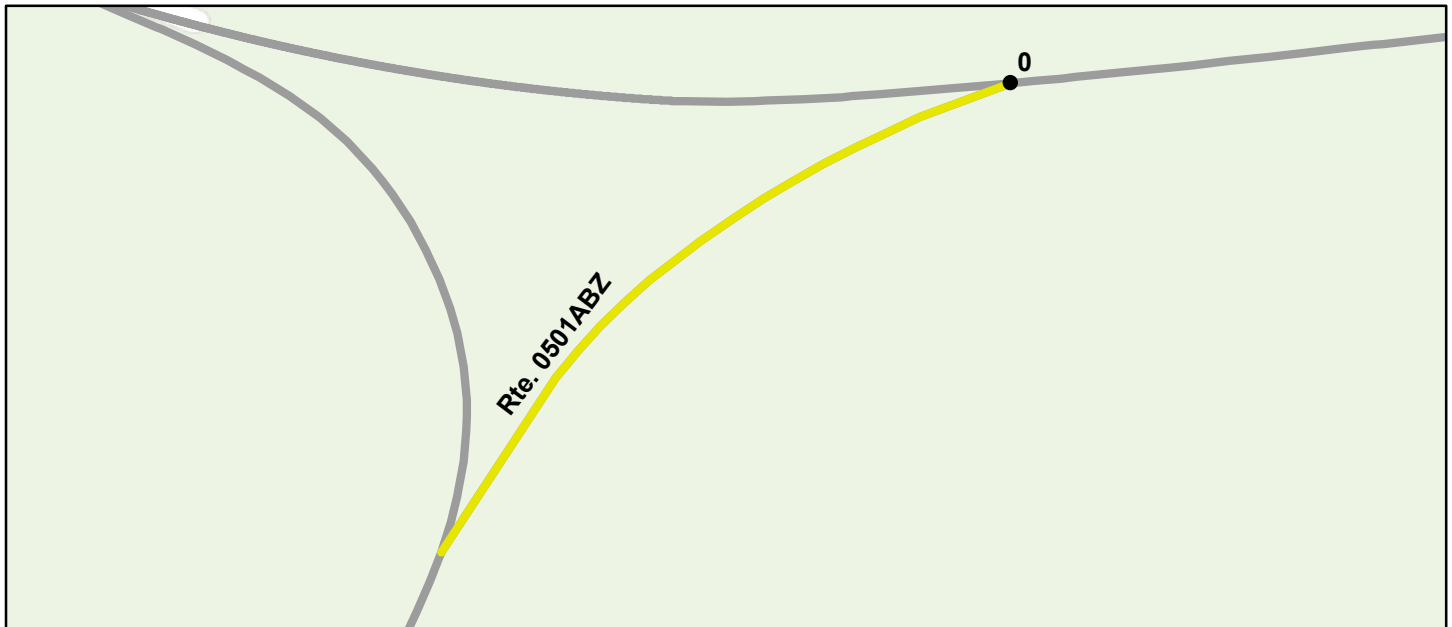
ROUTE 0501ABZ: ISLAND DRIVE WEST LOOP SPUR

Subcomponent of Route COLO-0501AZZ
Data Collection Vehicle (DCV) Rating

Route Condition Legend – Pavement Condition Rating (PCR)						
Poor (0 - 60)	Fair (61- 84)	Good (85 - 94)	Excellent (95 - 100)	Not Rated		
Colors on map represent condition scores at 0.10-mile intervals. See Appendix for definitions and formulas.						
Inspection Date: 4/19/2021	Beginning Section MP	0				
Paved Length (Miles): 0.06	Section Length (MI)	0.06				
Surface Type: ASPHALT	Route Summary					
Roadway Condition Information						
Pavement Condition Rating (PCR)	73	73				
Surface Condition Rating (SCR)	N/A	N/A				
Roughness Condition Index (RCI)	N/A	N/A				
Distress Index Values						
Structural Crack Index	N/A	N/A				
Alligator Crack Index	N/A	N/A				
Longitudinal Crack Index	N/A	N/A				
Transverse Cracking Index	N/A	N/A				
Patching Index	N/A	N/A				
Rutting Index	N/A	N/A				
International Roughness Index (IRI)	N/A	N/A				
Lane & Width Information						
Number of Lanes	1	1				
Paved Width (ft)	15.7	15.7

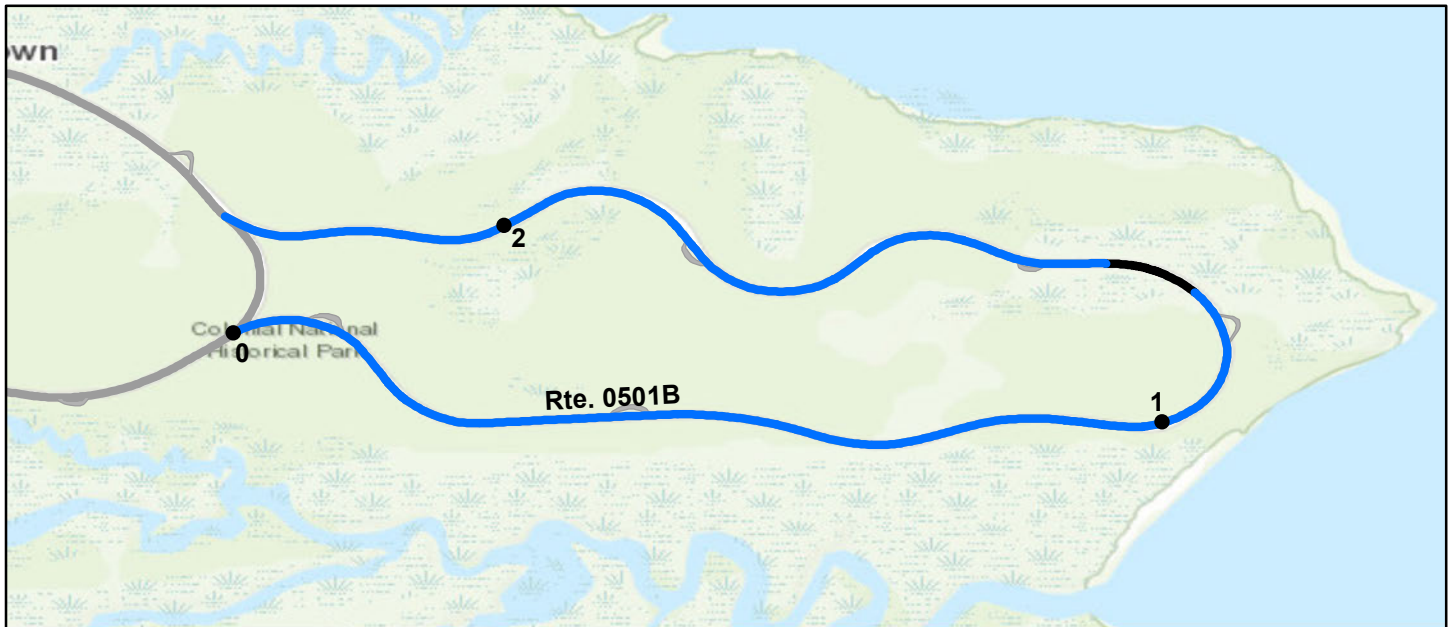
ROUTE 0501B: ISLAND DRIVE EAST LOOP

Data Collection Vehicle (DCV) Rating

Route Condition Legend – Pavement Condition Rating (PCR)						
Poor (0 - 60)	Fair (61- 84)	Good (85 - 94)	Excellent (95 - 100)	Not Rated		
Colors on map represent condition scores at 0.10-mile intervals. See Appendix for definitions and formulas.						
Inspection Date: 4/19/2021	Beginning Section MP	0	1	2		
Paved Length (Miles): 2.16	Section Length (MI)	1	1	0.28		
Surface Type: ASPHALT	Route Summary					
Roadway Condition Information						
Pavement Condition Rating (PCR)	99	99	99	100		
Surface Condition Rating (SCR)	99	99	99	100		
Roughness Condition Index (RCI)	N/A	N/A	N/A	N/A		
Distress Index Values						
Structural Crack Index	100	100	100	100		
Alligator Crack Index	100	100	100	100		
Longitudinal Crack Index	100	100	100	100		
Transverse Cracking Index	100	100	100	100		
Patching Index	100	100	100	100		
Rutting Index	99	99	99	100		
International Roughness Index (IRI)	N/A	N/A	N/A	N/A		
Lane & Width Information

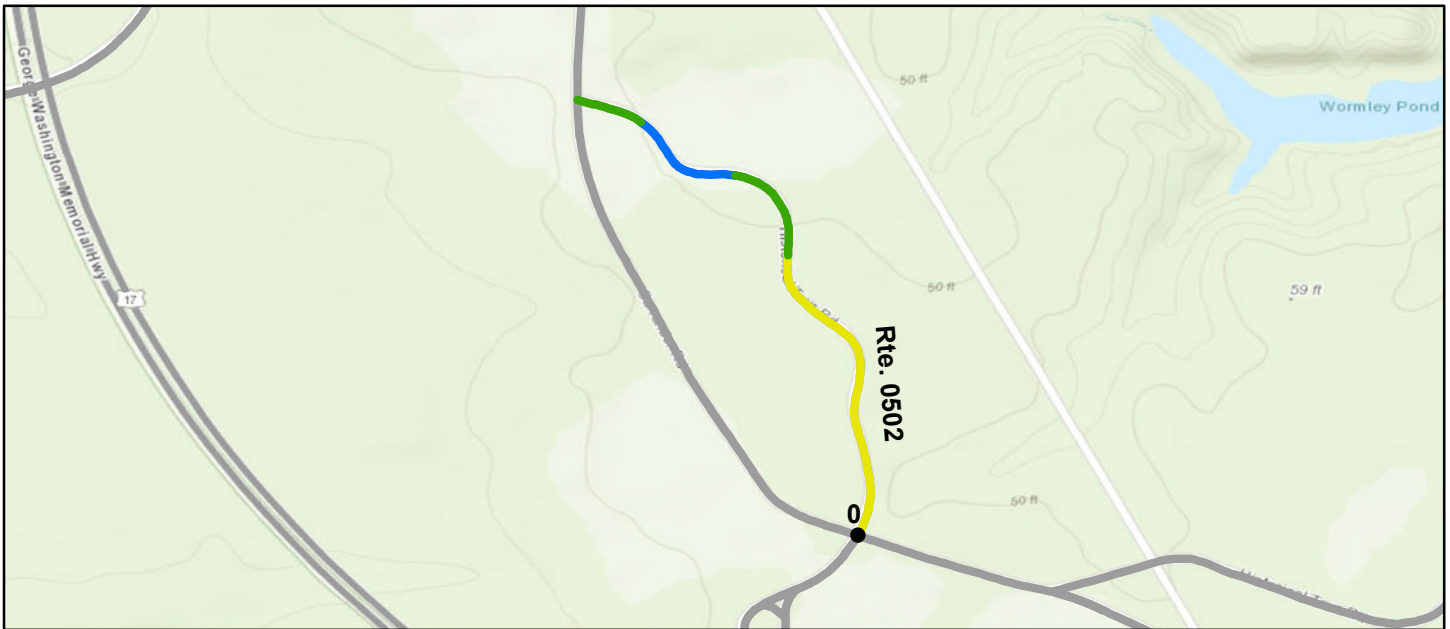
ROUTE 0502: AFTERMATH ROAD

Data Collection Vehicle (DCV) Rating

Route Condition Legend – Pavement Condition Rating (PCR)						
Poor (0 - 60)	Fair (61- 84)	Good (85 - 94)	Excellent (95 - 100)	Not Rated		
Colors on map represent condition scores at 0.10-mile intervals. See Appendix for definitions and formulas.						
Inspection Date: 4/18/2021	Beginning Section MP	0				
Paved Length (Miles): 0.55	Section Length (MI)	0.55				
Surface Type: ASPHALT	Route Summary					
Roadway Condition Information						
Pavement Condition Rating (PCR)	86	86				
Surface Condition Rating (SCR)	86	86				
Roughness Condition Index (RCI)	N/A	N/A				
Distress Index Values						
Structural Crack Index	100	100				
Alligator Crack Index	100	100				
Longitudinal Crack Index	100	100				
Transverse Cracking Index	100	100				
Patching Index	86	86				
Rutting Index	99	99				
International Roughness Index (IRI)	N/A	N/A				
Lane & Width Information						
Number of Lanes	1	1				
Paved Width (ft)	12.1	12.1

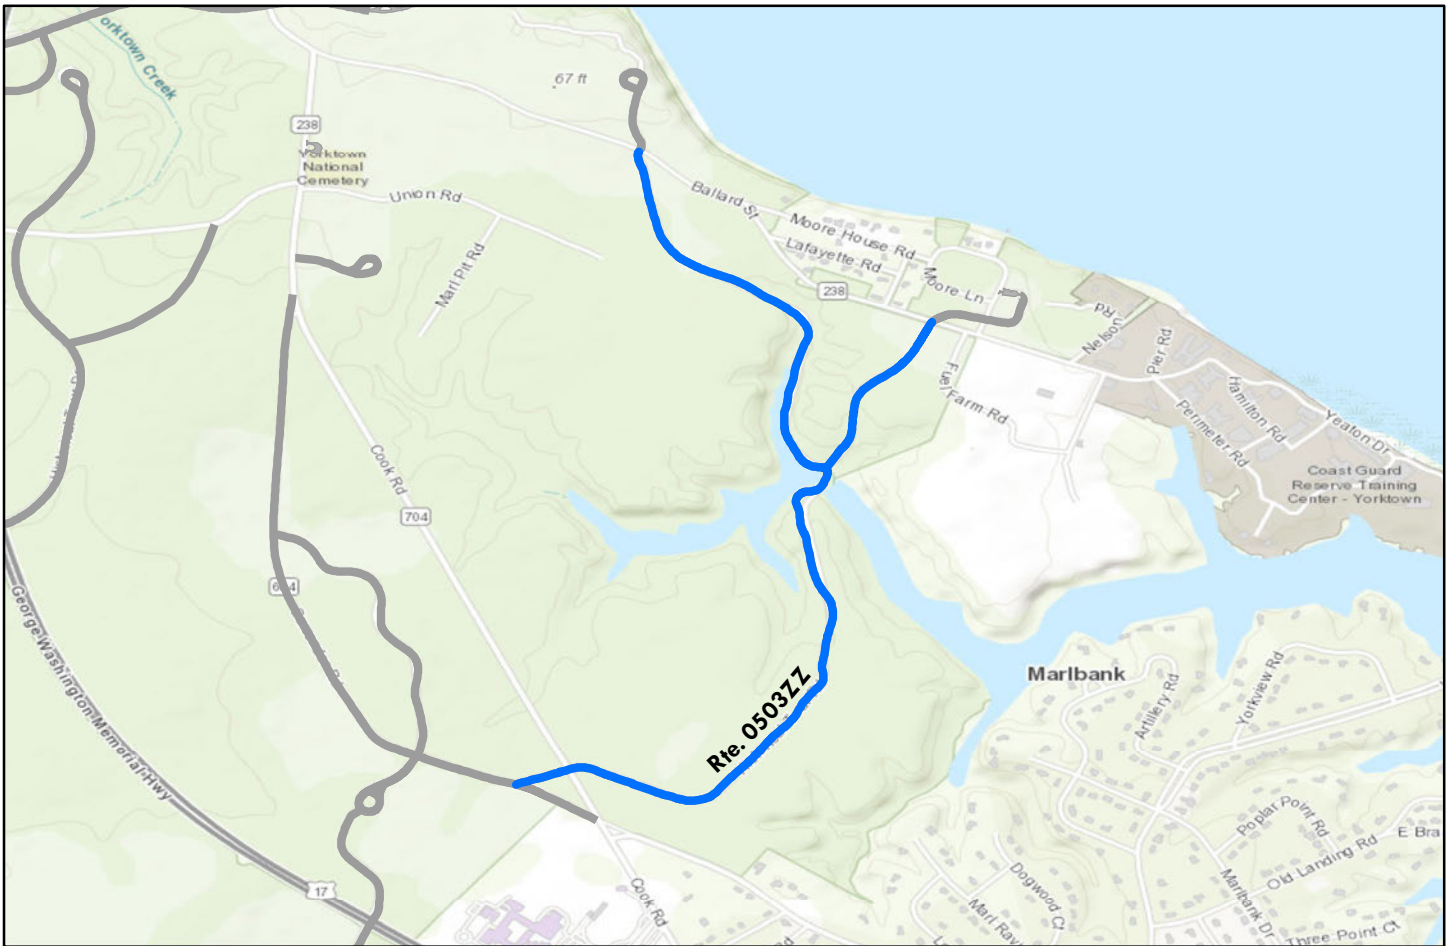
ROUTE 0503ZZ: EAST TOUR ROADS

Summary Route

Note: The weighted average summary PCR value is calculated from only the sections of road where the PCR was collected. The overall PCR for the summary route may not reflect individual subcomponent ratings.

Route Condition Legend – Pavement Condition Rating (PCR)						
Poor (0 - 60)	Fair (61- 84)	Good (85 - 94)	Excellent (95 - 100)	Not Rated		
See Appendix for definitions and formulas						
Inspection Date:	4/18/2021					
Paved Length (Miles):	2.16					
Surface Type:	ASPHALT	Route Summary				
Roadway Condition Information						
Pavement Condition Rating (PCR)	98					
Lane & Width Information						
Number of Lanes	1					
Paved Width (ft)	13					
Lane Width (ft)	11.5

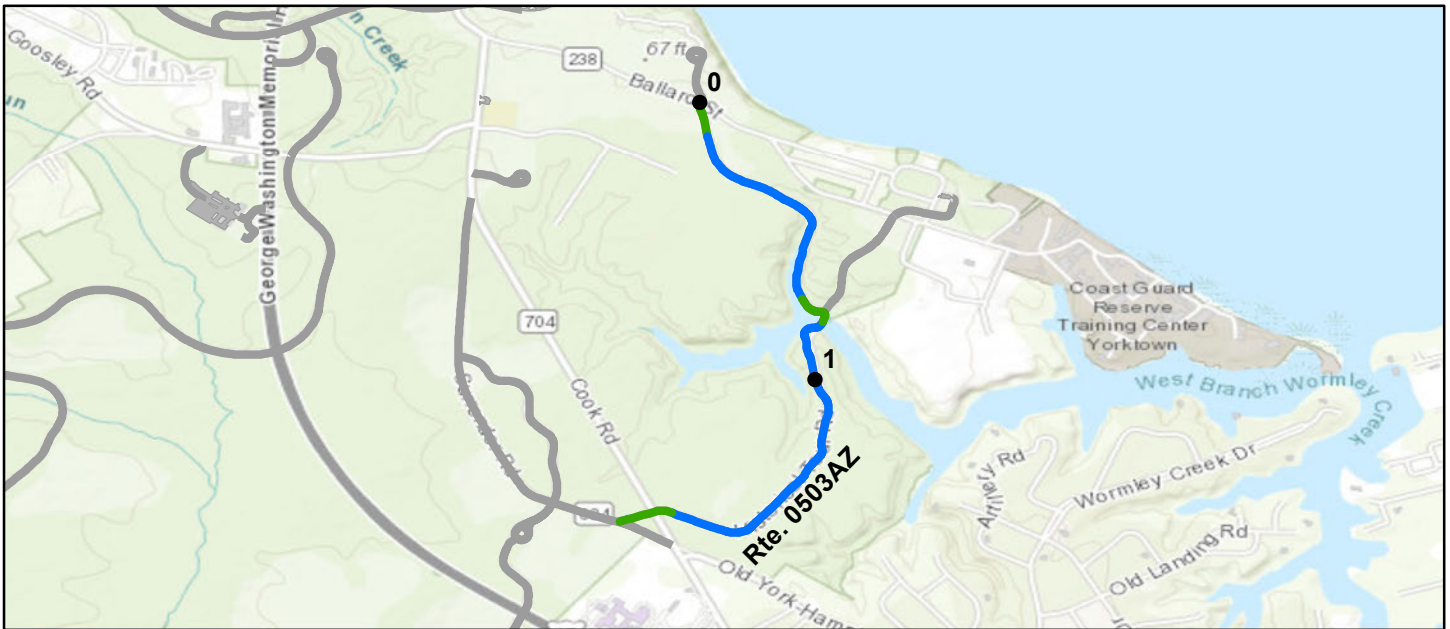
Subcomponent of Route COLO-0503ZZ

Data Collection Vehicle (DCV) Rating

Colors on map represent condition scores at 0.10-mile intervals. See Appendix for definitions and formulas.

Inspection Date:	4/18/2021	Beginning Section MP	0	1			
Paved Length (Miles):	1.83	Section Length (MI)	1	0.83			
Surface Type:	ASPHALT	Route Summary					
Roadway Condition Information							
Pavement Condition Rating (PCR)	98	97	99				
Surface Condition Rating (SCR)	98	97	99				
Roughness Condition Index (RCI)	N/A	N/A	N/A				
Distress Index Values							
Structural Crack Index	100	99	100				
Alligator Crack Index	100	100	100				
Longitudinal Crack Index	100	99	100				
Transverse Cracking Index	98	98	99				
Patching Index	100	100	100				
Rutting Index	98	97	99				
International Roughness Index (IRI)	N/A	N/A	N/A				
Lane & Width Information							
Number of Lanes	1	1	1				
Paved Width (ft)	11.9	12	11.7				
Lane Width (ft)	11.9	12	11.7

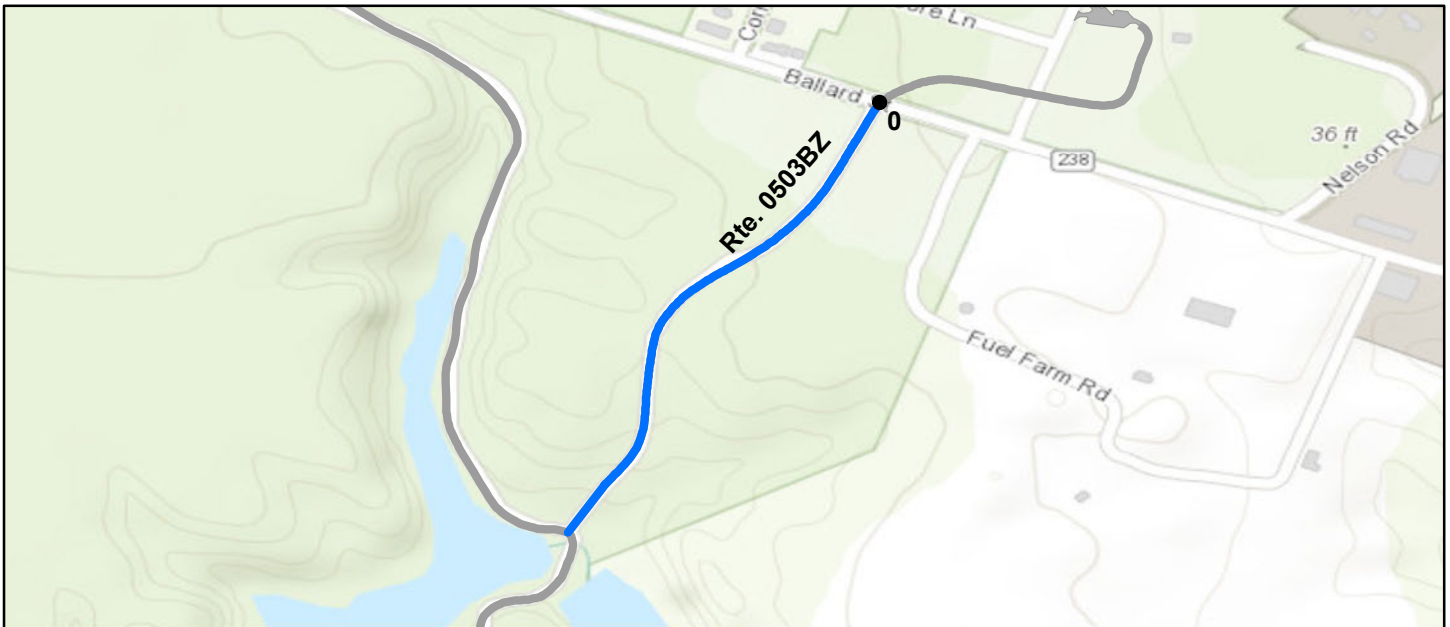
Subcomponent of Route COLO-0503ZZ

Data Collection Vehicle (DCV) Rating

Inspection Date: 4/18/2021	Beginning Section MP	0				
Paved Length (Miles): 0.33	Section Length (MI)	0.33				
Surface Type: ASPHALT	Route Summary					
Roadway Condition Information						
Pavement Condition Rating (PCR)	98	98				
Surface Condition Rating (SCR)	98	98				
Roughness Condition Index (RCI)	N/A	N/A				
Distress Index Values						
Structural Crack Index	99	99				
Alligator Crack Index	100	100				
Longitudinal Crack Index	99	99				
Transverse Cracking Index	100	100				
Patching Index	100	100				
Rutting Index	98	98				
International Roughness Index (IRI)	N/A	N/A				
Lane & Width Information						
Number of Lanes	2	2				
Paved Width (ft)	19.3	19.3				
Lane Width (ft)	9.6	9.6

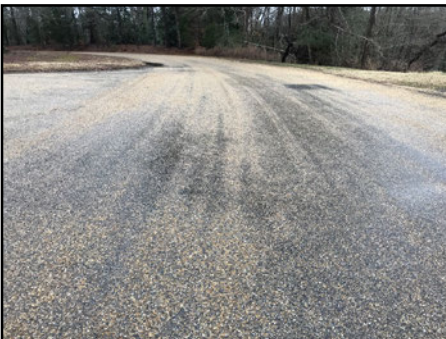
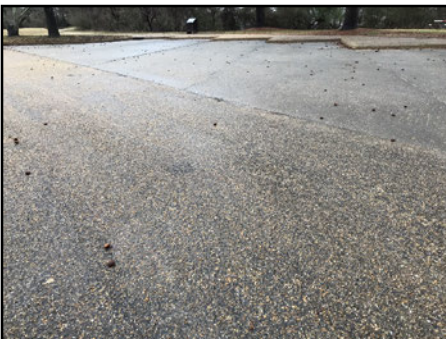
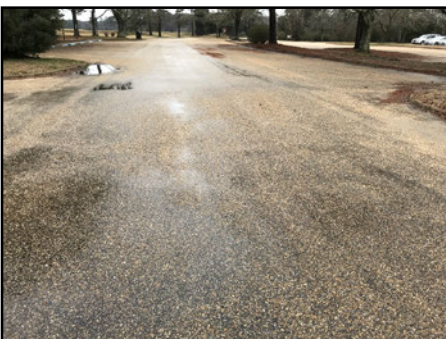
ROUTE 0902ZZ: REDOUBT 9 & 10 ACCESS ROAD PARKING AREAS

Inspection Date	FMSS Number	User Access	Surface Type
2/19/2021	54914	PUBLIC	ASPHALT
Area (Sq. Ft.)	Lane Miles (11' Widths)	Condition Rating / PCR	
2,177	0.038	SUMMARY /	73

The condition shown on this page reflects the overall route condition and may not reflect individual subcomponent ratings.

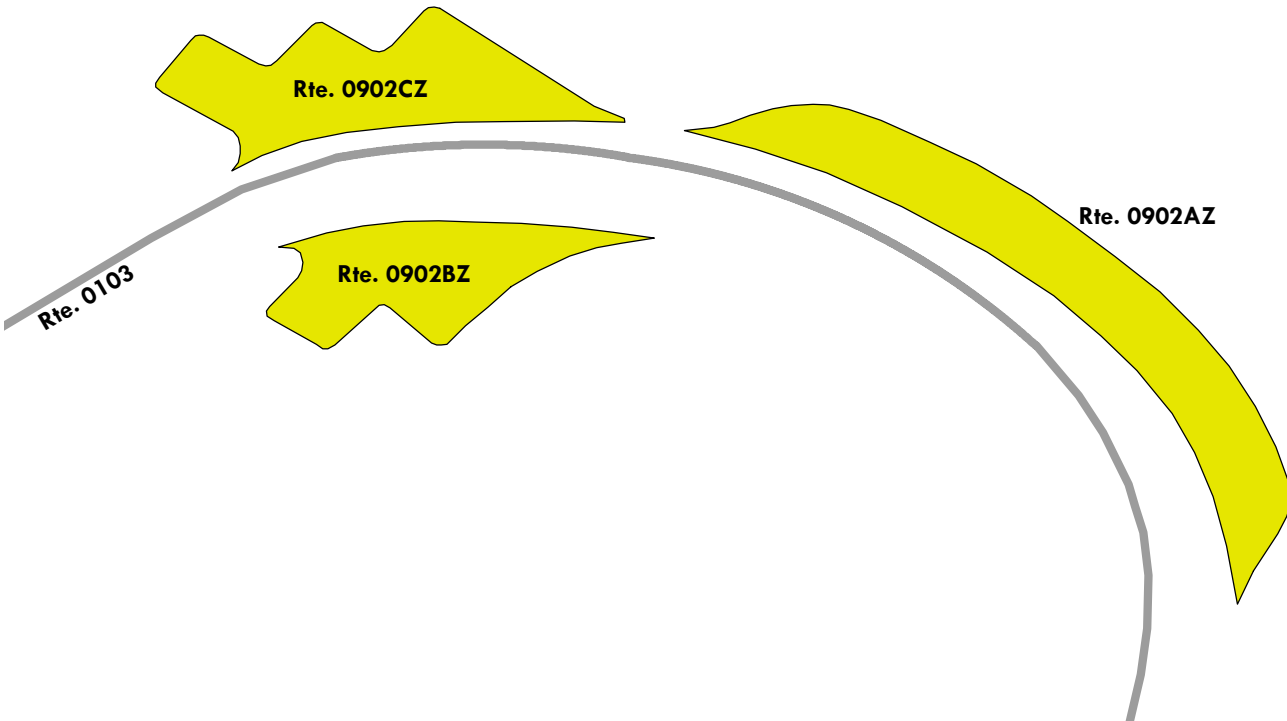
ROUTE 0902AZ: REDOUBT 9 & 10 ACCESS ROAD PARKING A

Inspection Date	FMSS Number	User Access	Surface Type
2/19/2021	54914	PUBLIC	ASPHALT
Area (Sq. Ft.)	Lane Miles (11' Widths)	Curb Reveal (Inches)	Curb Recommendation
986	0.017	2	LIGHT REPAIR
Curb Type		Curb & Gutter Type	
CONCRETE		NO CURB AND GUTTER	
Pavement Recommendation		Condition Rating / PCR	
LIGHT 3R TREATMENTS		FAIR / 73

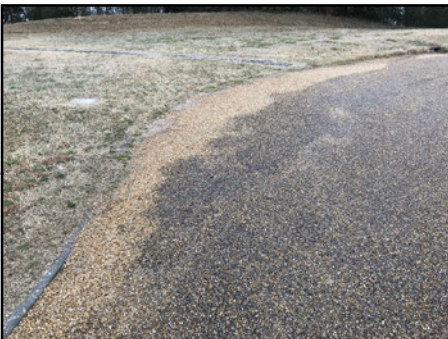
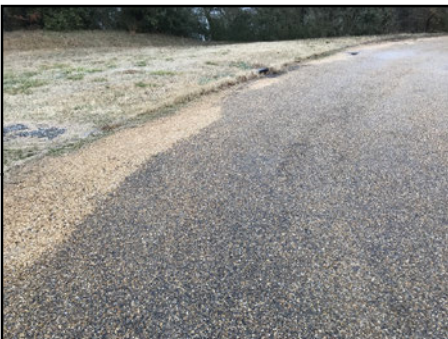
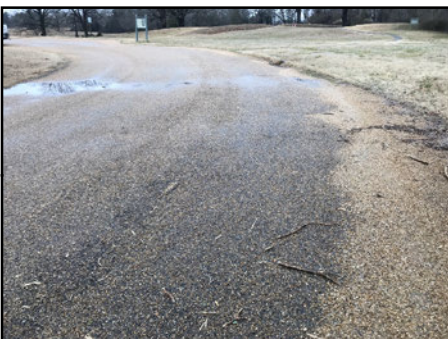
ROUTE 0902BZ: REDOUBT 9 & 10 ACCESS ROAD PARKING B

Inspection Date	FMSS Number	User Access	Surface Type
2/19/2021	54914	PUBLIC	ASPHALT
Area (Sq. Ft.)	Lane Miles (11' Widths)	Curb Reveal (Inches)	Curb Recommendation
508	0.009	2	LIGHT REPAIR
Curb Type		Curb & Gutter Type	
CONCRETE		NO CURB AND GUTTER	
Pavement Recommendation		Condition Rating / PCR	
NOT APPLICABLE		NOT RATED

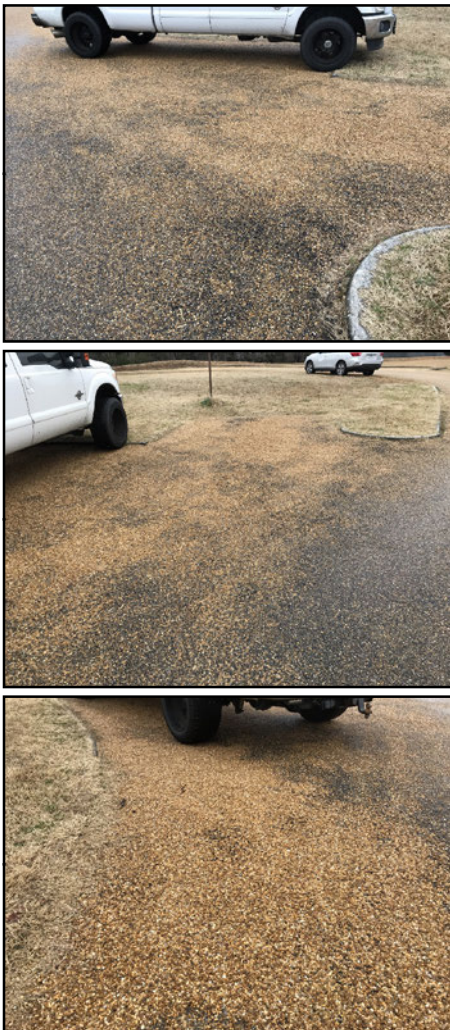
Note: Route not rated - pavement covered.

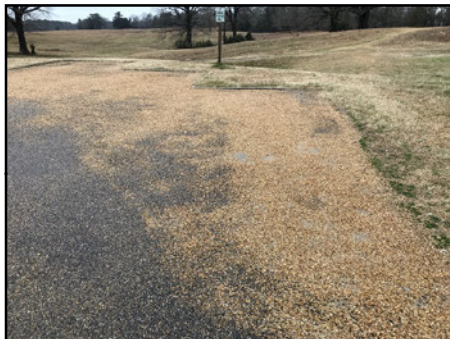
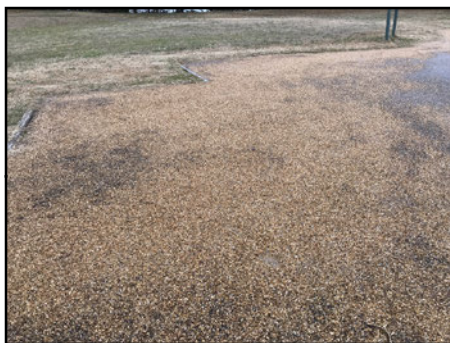
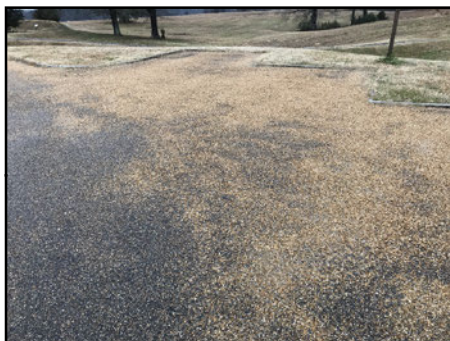
Note: Route not rated - pavement covered.

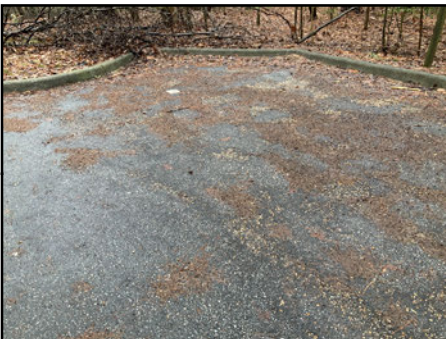
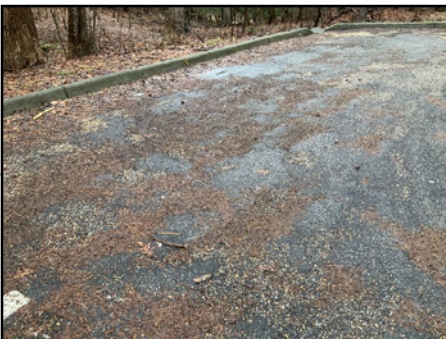
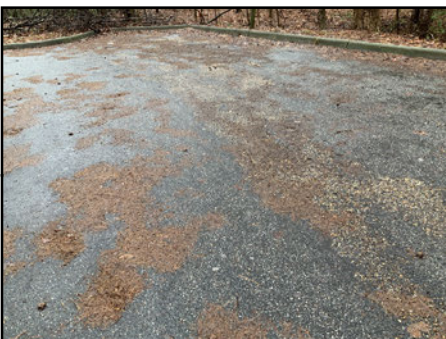
ROUTE 0904: GLASSHOUSE PARKING

Inspection Date	FMSS Number	User Access	Surface Type
2/20/2021	54917	PUBLIC	ASPHALT
Area (Sq. Ft.)	Lane Miles (11' Widths)	Curb Reveal (Inches)	Curb Recommendation
40,359	0.695	4	REPLACE
Curb Type		Curb & Gutter Type	
CONCRETE		NO CURB AND GUTTER	
Pavement Recommendation		Condition Rating / PCR	
PREVENTIVE MAINTENANCE		GOOD / 90

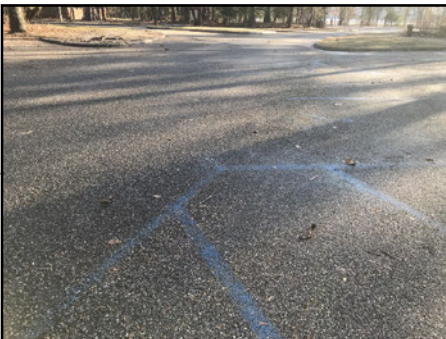
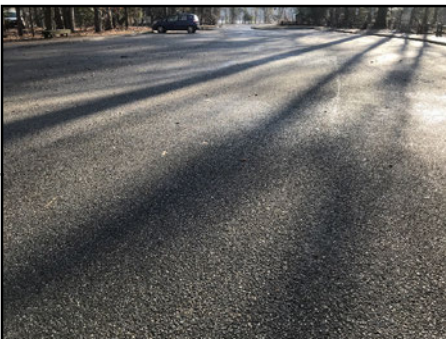
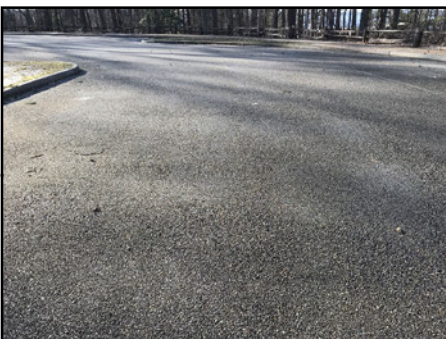
ROUTE 0905: FUSILIER'S PARKING

Inspection Date	FMSS Number	User Access	Surface Type
2/19/2021	54918	PUBLIC	ASPHALT
Area (Sq. Ft.)	Lane Miles (11' Widths)	Curb Reveal (Inches)	Curb Recommendation
12,114	0.209	3	MODERATE REPAIR
Curb Type		Curb & Gutter Type	
CONCRETE		NO CURB AND GUTTER	
Pavement Recommendation		Condition Rating / PCR	
LIGHT 3R TREATMENTS		FAIR / 73

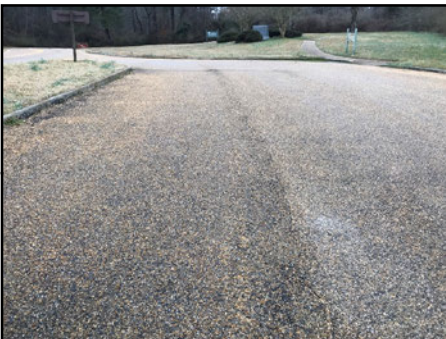
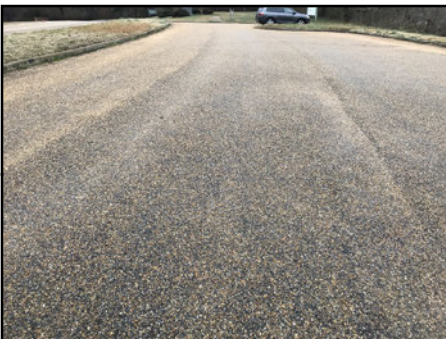
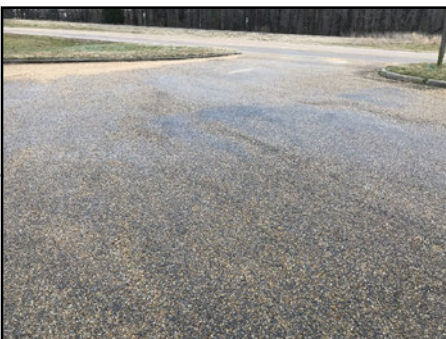
ROUTE 0906: NAVAL WEAPONS STATION PARKING

Inspection Date	FMSS Number	User Access	Surface Type
2/19/2021	54919	PUBLIC	CONCRETE
Area (Sq. Ft.)	Lane Miles (11' Widths)	Curb Reveal (Inches)	Curb Recommendation
8,340	0.144	6	LIGHT REPAIR
Curb Type		Curb & Gutter Type	
CONCRETE		NO CURB AND GUTTER	
Pavement Recommendation		Condition Rating / PCR	
PREVENTIVE MAINTENANCE		GOOD / 90

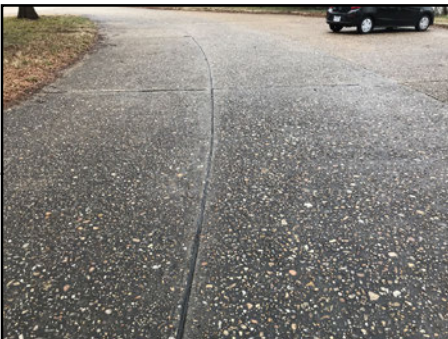
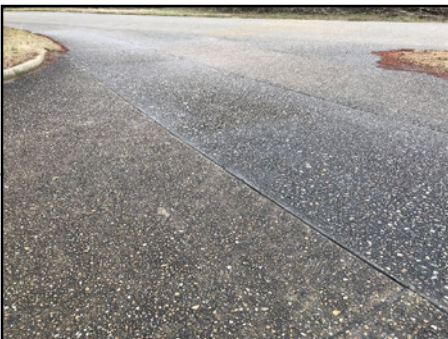
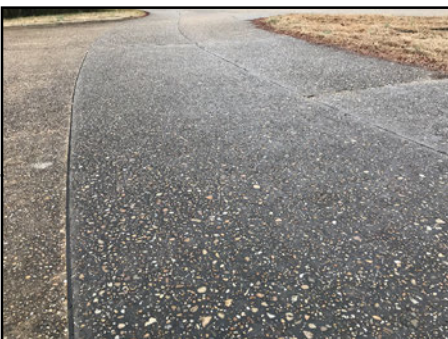
ROUTE 0907: YORKTOWN RIVER OVERLOOK

Inspection Date	FMSS Number	User Access	Surface Type
2/19/2021	54920	PUBLIC	CONCRETE
Area (Sq. Ft.)	Lane Miles (11' Widths)	Curb Reveal (Inches)	Curb Recommendation
4,648	0.08	6	REPLACE
Curb Type		Curb & Gutter Type	
CONCRETE		NOT APPLICABLE	
Pavement Recommendation		Condition Rating / PCR	
PREVENTIVE MAINTENANCE		GOOD / 90

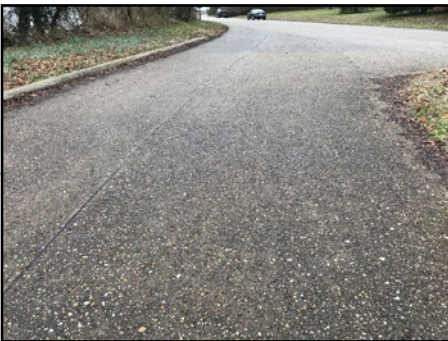
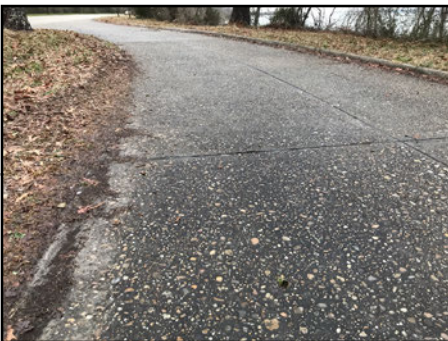
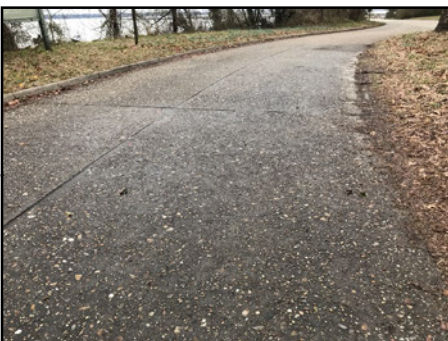
ROUTE 0908: POWHATAN VILLAGE

Inspection Date	FMSS Number	User Access	Surface Type
2/19/2021	54921	PUBLIC	CONCRETE
Area (Sq. Ft.)	Lane Miles (11' Widths)	Curb Reveal (Inches)	Curb Recommendation
9,045	0.156	6	LIGHT REPAIR
Curb Type		Curb & Gutter Type	
CONCRETE		NO CURB AND GUTTER	
Pavement Recommendation		Condition Rating / PCR	
PREVENTIVE MAINTENANCE		GOOD / 90

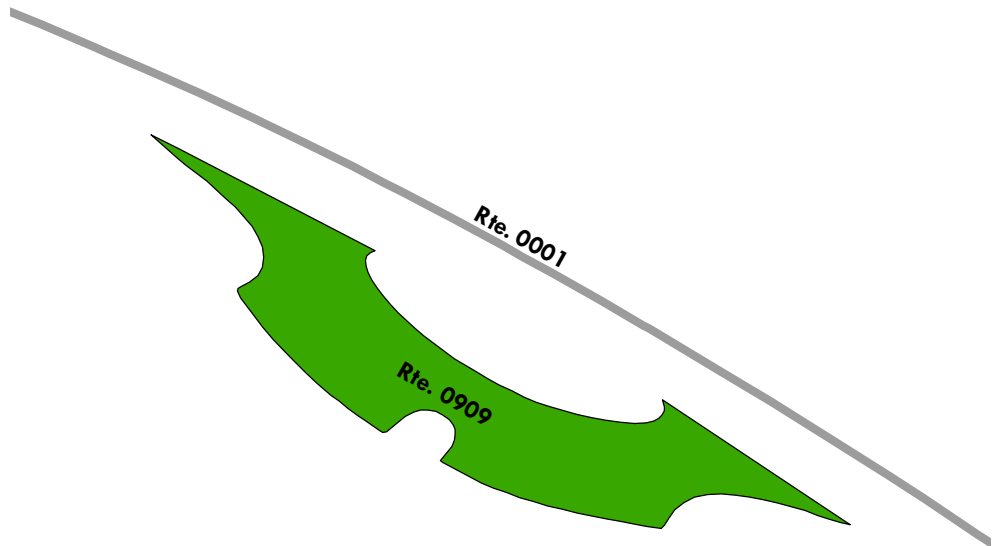
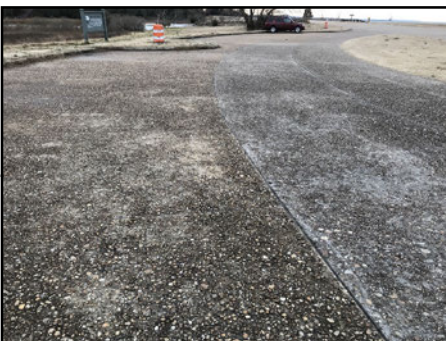
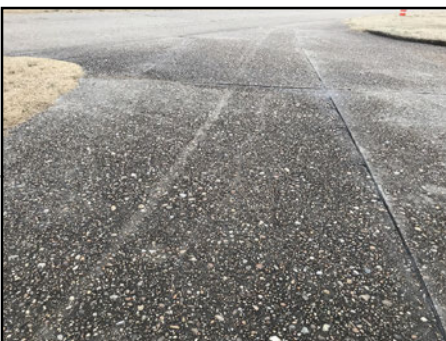
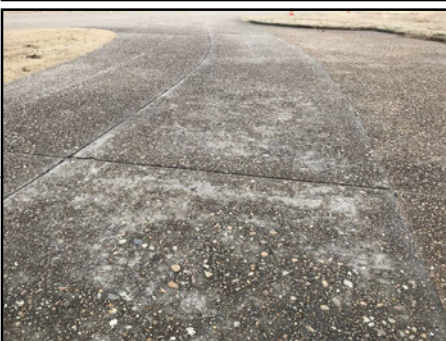
ROUTE 0909: INDIAN FIELD CREEK PARKING

Inspection Date	FMSS Number	User Access	Surface Type
2/19/2021	54927	PUBLIC	CONCRETE
Area (Sq. Ft.)	Lane Miles (11' Widths)	Curb Reveal (Inches)	Curb Recommendation
8,159	0.14	6	LIGHT REPAIR
Curb Type		Curb & Gutter Type	
CONCRETE		NO CURB AND GUTTER	
Pavement Recommendation		Condition Rating / PCR	
PREVENTIVE MAINTENANCE		GOOD / 90

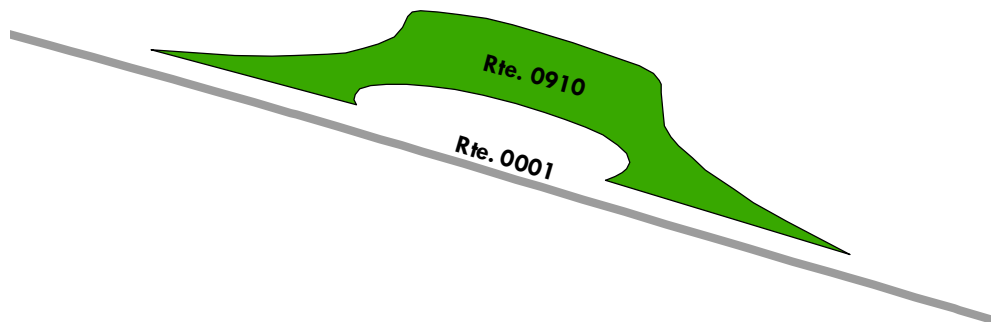
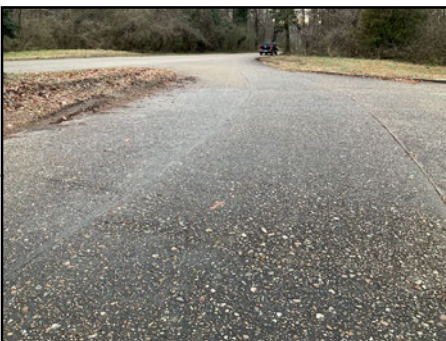
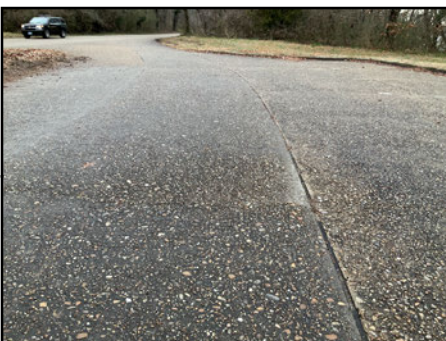
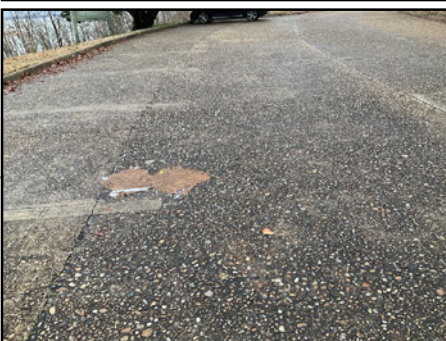
ROUTE 0910: CHEATHAM ANNEX PARKING

Inspection Date	FMSS Number	User Access	Surface Type
2/19/2021	54931	PUBLIC	CONCRETE
Area (Sq. Ft.)	Lane Miles (11' Widths)	Curb Reveal (Inches)	Curb Recommendation
8,472	0.146	6	REPLACE
Curb Type		Curb & Gutter Type	
CONCRETE		NO CURB AND GUTTER	
Pavement Recommendation		Condition Rating / PCR	
PREVENTIVE MAINTENANCE		GOOD / 90

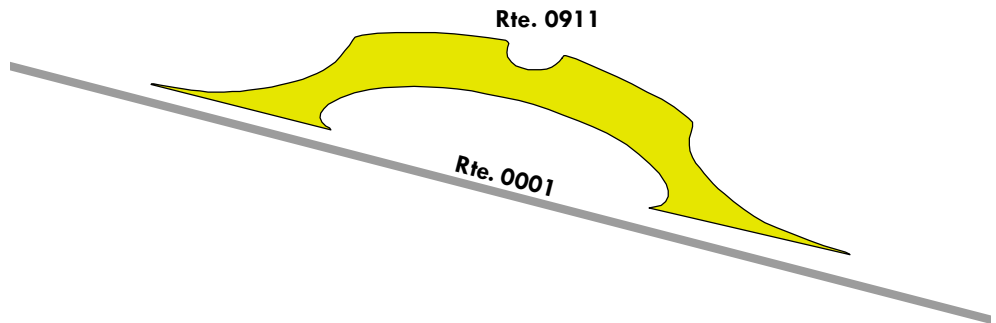
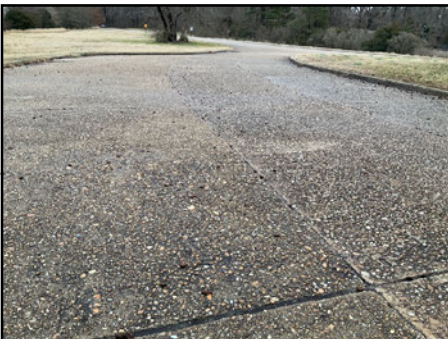
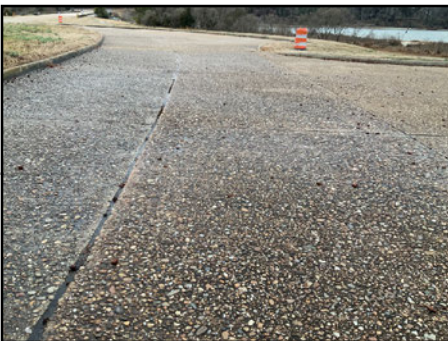
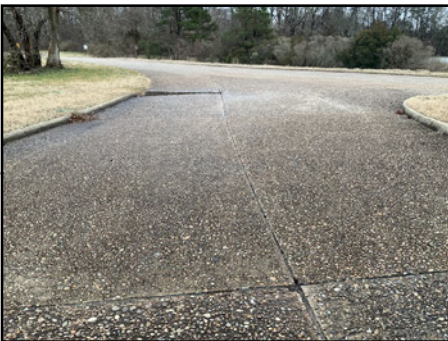
ROUTE 0911: RINGFIELD PLANTATION PARKING

Inspection Date	FMSS Number	User Access	Surface Type
2/19/2021	54932	PUBLIC	CONCRETE
Area (Sq. Ft.)	Lane Miles (11' Widths)	Curb Reveal (Inches)	Curb Recommendation
12,212	0.21	7	MODERATE REPAIR
Curb Type		Curb & Gutter Type	
CONCRETE		NO CURB AND GUTTER	
Pavement Recommendation		Condition Rating / PCR	
LIGHT 3R TREATMENTS		FAIR / 73

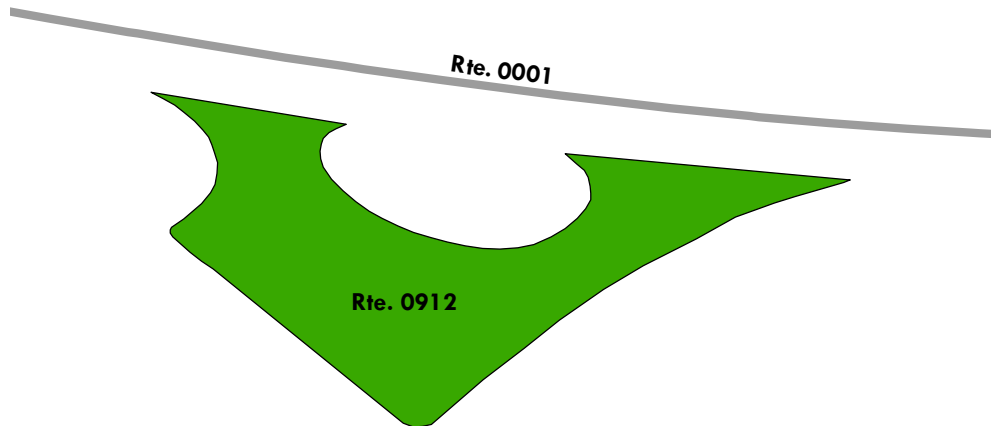
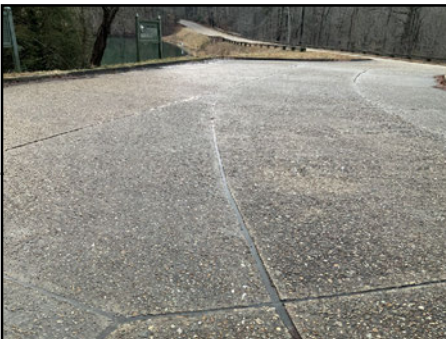
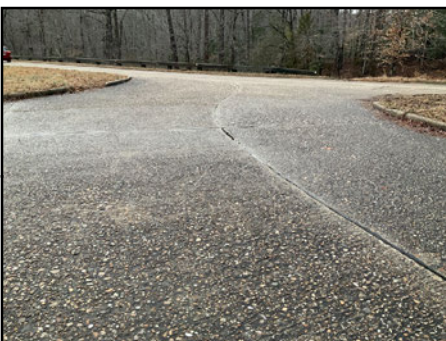
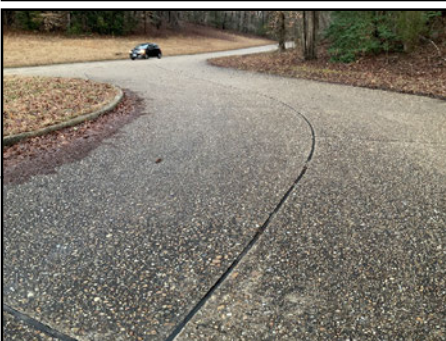
ROUTE 0912: JONES MILL PARKING

Inspection Date	FMSS Number	User Access	Surface Type
2/19/2021	56258	PUBLIC	CONCRETE
Area (Sq. Ft.)	Lane Miles (11' Widths)	Curb Reveal (Inches)	Curb Recommendation
6,557	0.113	6	DO NOTHING
Curb Type		Curb & Gutter Type	
CONCRETE		NO CURB AND GUTTER	
Pavement Recommendation		Condition Rating / PCR	
PREVENTIVE MAINTENANCE		GOOD / 90

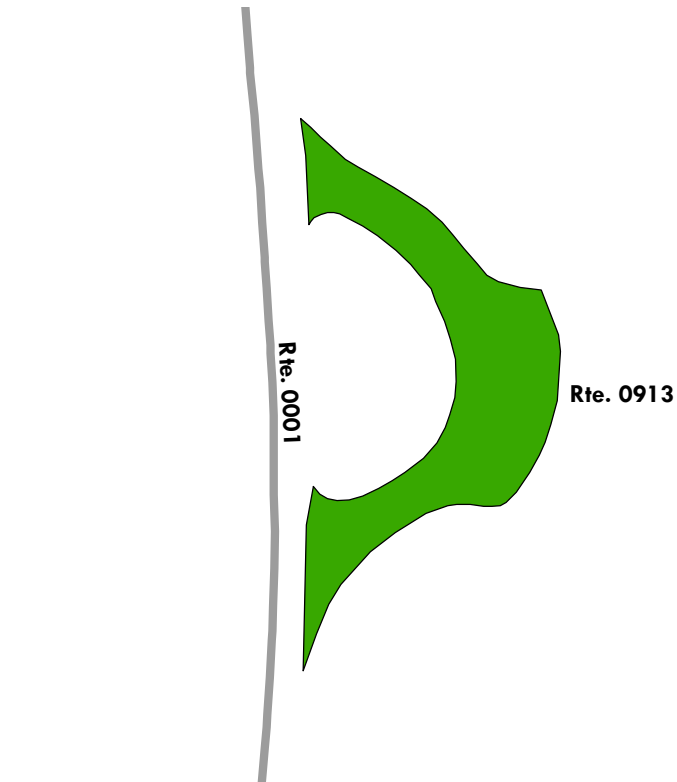
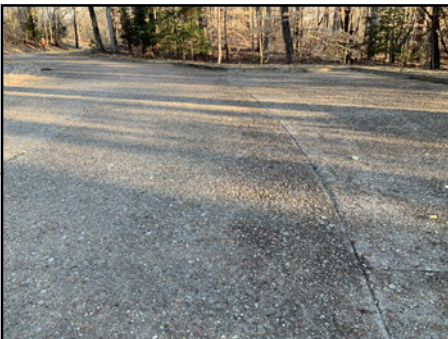
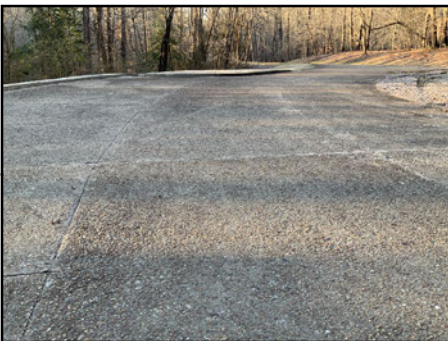
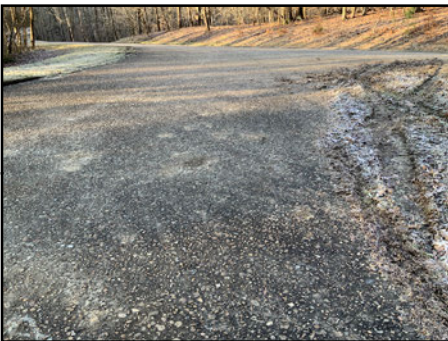
ROUTE 0913: PALISADES GREAT OAKS PARKING

Inspection Date	FMSS Number	User Access	Surface Type
2/20/2021	56259	PUBLIC	CONCRETE
Area (Sq. Ft.)	Lane Miles (11' Widths)	Curb Reveal (Inches)	Curb Recommendation
9,942	0.171	6	DO NOTHING
Curb Type		Curb & Gutter Type	
CONCRETE		NO CURB AND GUTTER	
Pavement Recommendation		Condition Rating / PCR	
PREVENTIVE MAINTENANCE		GOOD / 90
