COLO Cycle 6

Final Report

Road Inventory and Condition Assessment of Paved Routes Colonial National Historical Park

**Federal Highway Administration
Eastern Federal Lands Highway Division
Road Inventory Program (RIP)**

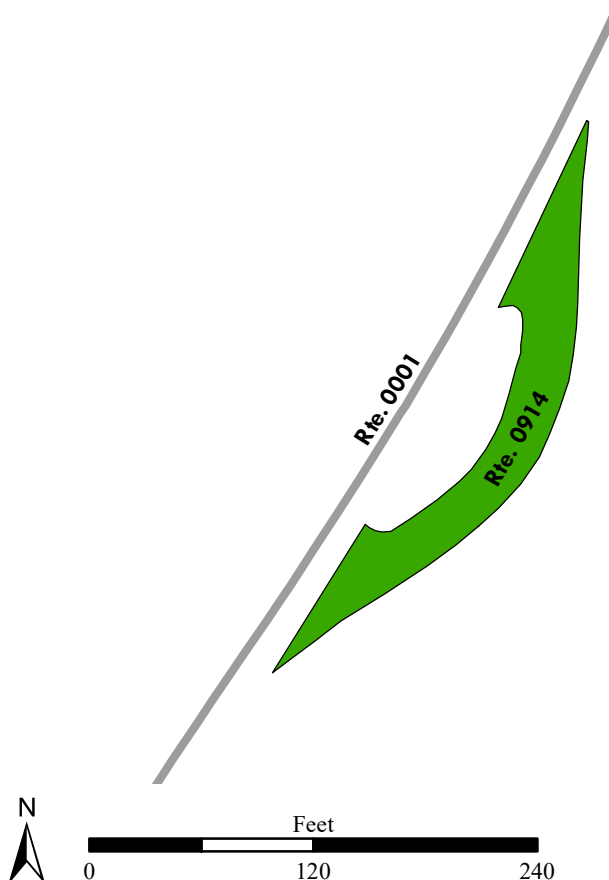
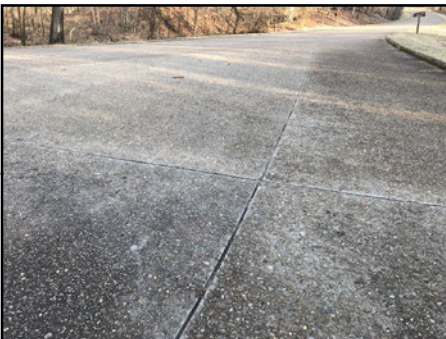
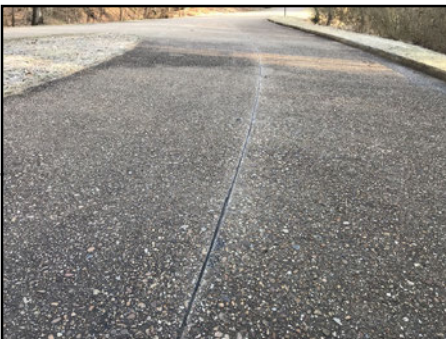
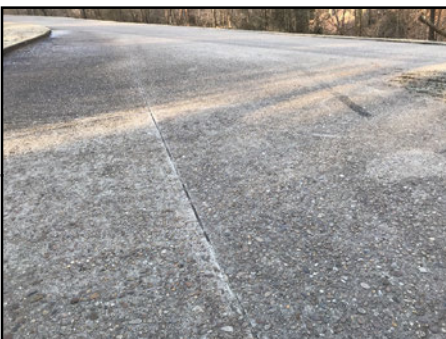
ROUTE 0914: PAPER MILL CREEK PARKING

Inspection Date	FMSS Number	User Access	Surface Type
2/20/2021	56260	PUBLIC	CONCRETE
Area (Sq. Ft.)	Lane Miles (11' Widths)	Curb Reveal (Inches)	Curb Recommendation
6,513	0.112	6	DO NOTHING
Curb Type		Curb & Gutter Type	
CONCRETE		NO CURB AND GUTTER	
Pavement Recommendation		Condition Rating / PCR	
PREVENTIVE MAINTENANCE		GOOD / 90

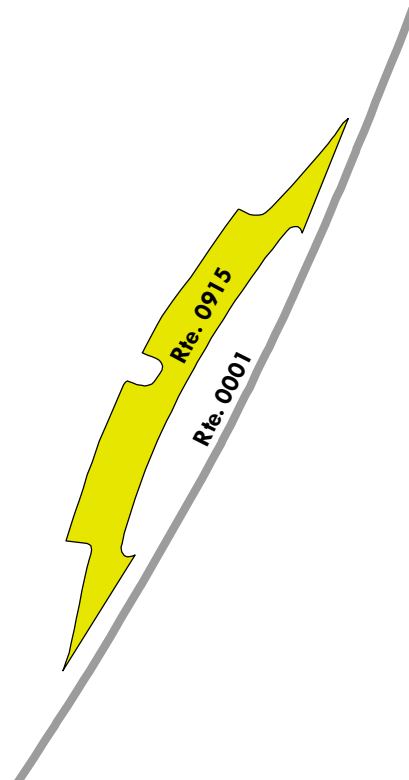
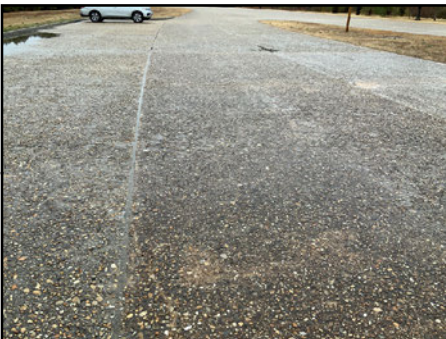
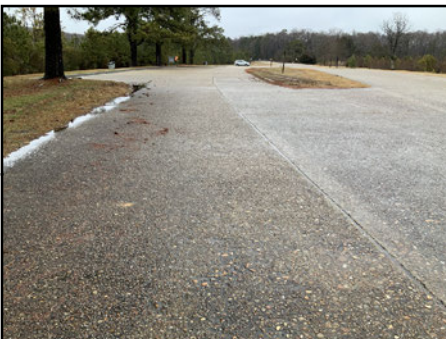
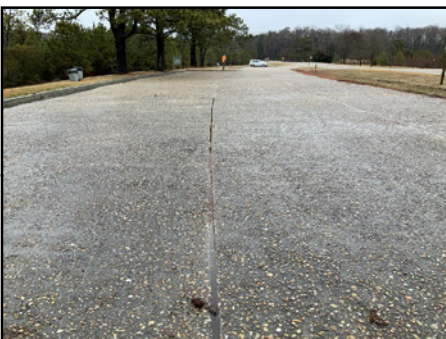
ROUTE 0915: COLLEGE CREEK PARKING

Inspection Date	FMSS Number	User Access	Surface Type
2/19/2021	56261	PUBLIC	CONCRETE
Area (Sq. Ft.)	Lane Miles (11' Widths)	Curb Reveal (Inches)	Curb Recommendation
19,640	0.338	7	DO NOTHING
Curb Type		Curb & Gutter Type	
CONCRETE		NO CURB AND GUTTER	
Pavement Recommendation		Condition Rating / PCR	
LIGHT 3R TREATMENTS		FAIR / 73

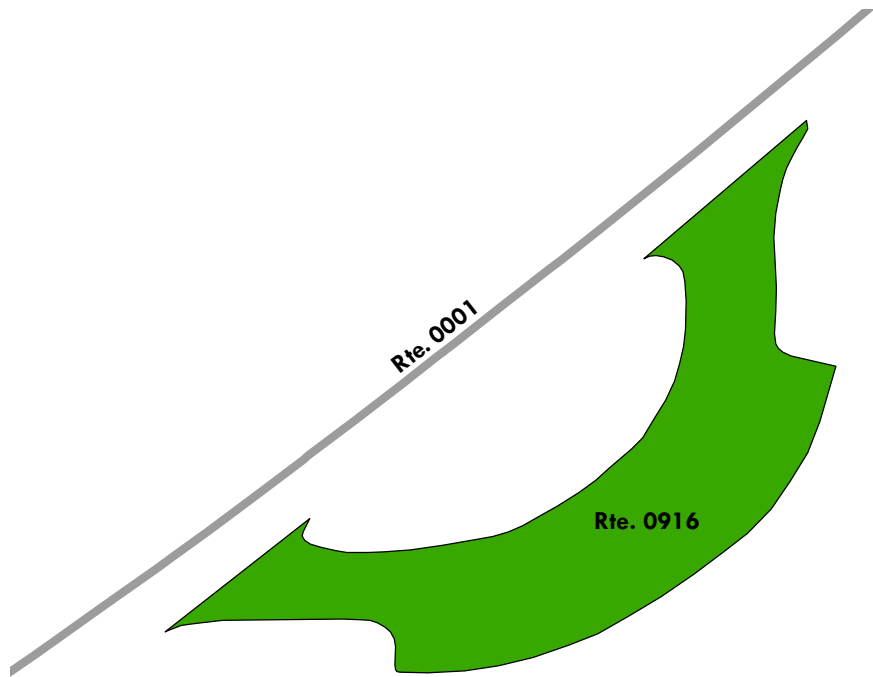
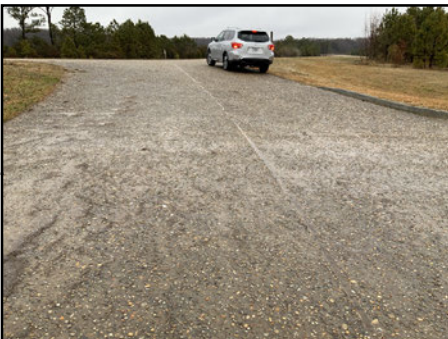
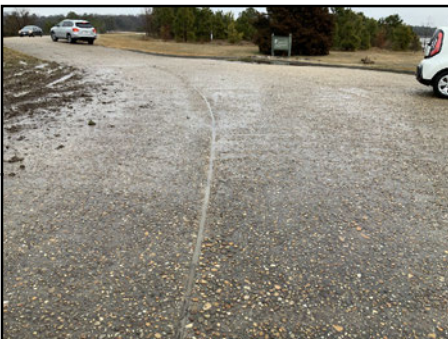
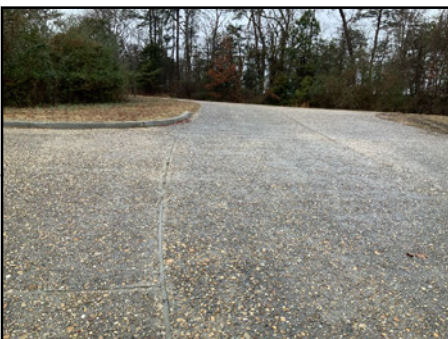
ROUTE 0916: JAMES RIVER (ORIENTATION MAP) PARKING

Inspection Date	FMSS Number	User Access	Surface Type
2/19/2021	56262	PUBLIC	CONCRETE
Area (Sq. Ft.)	Lane Miles (11' Widths)	Curb Reveal (Inches)	Curb Recommendation
9,891	0.17	7	DO NOTHING
Curb Type		Curb & Gutter Type	
CONCRETE		NO CURB AND GUTTER	
Pavement Recommendation		Condition Rating / PCR	
PREVENTIVE MAINTENANCE		GOOD / 90

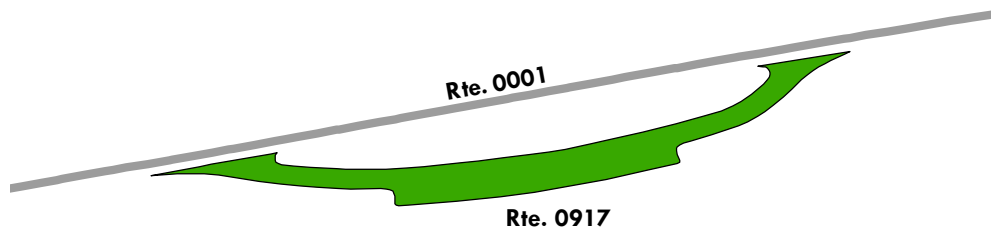
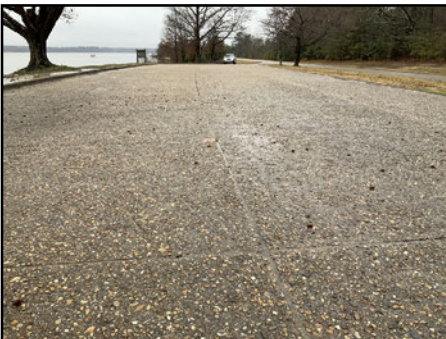
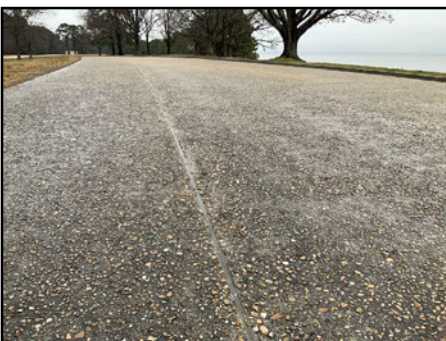
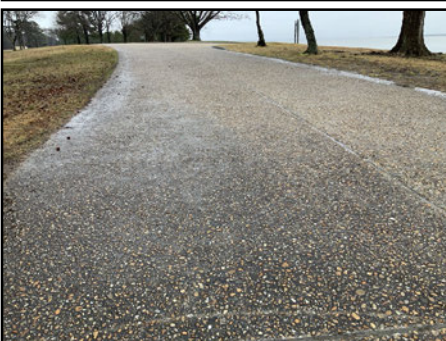
ROUTE 0917: ARCHER'S HOPE PARKING

Inspection Date	FMSS Number	User Access	Surface Type
2/19/2021	56263	PUBLIC	CONCRETE
Area (Sq. Ft.)	Lane Miles (11' Widths)	Curb Reveal (Inches)	Curb Recommendation
19,300	0.332	7	DO NOTHING
Curb Type		Curb & Gutter Type	
CONCRETE		NO CURB AND GUTTER	
Pavement Recommendation		Condition Rating / PCR	
PREVENTIVE MAINTENANCE		GOOD / 90

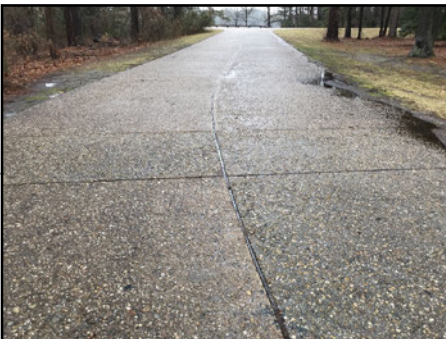
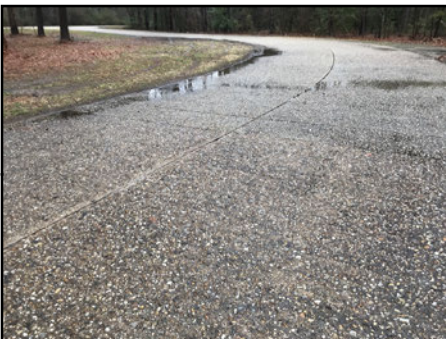
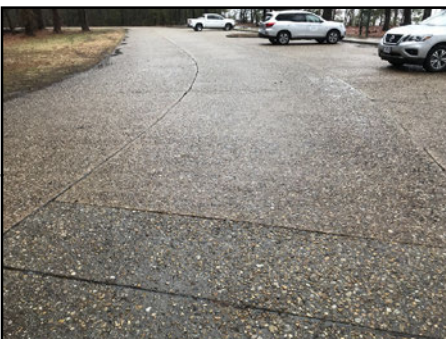
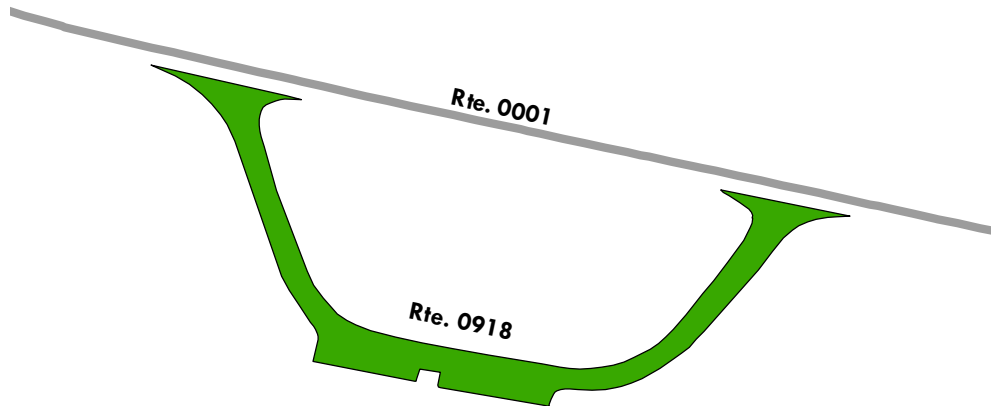
Inspection Date	FMSS Number	User Access	Surface Type
2/19/2021	56264	PUBLIC	CONCRETE
Area (Sq. Ft.)	Lane Miles (11' Widths)	Curb Reveal (Inches)	Curb Recommendation
25,887	0.446	6	DO NOTHING
Curb Type		Curb & Gutter Type	
CONCRETE		NO CURB AND GUTTER	
Pavement Recommendation		Condition Rating / PCR	
PREVENTIVE MAINTENANCE		GOOD / 90

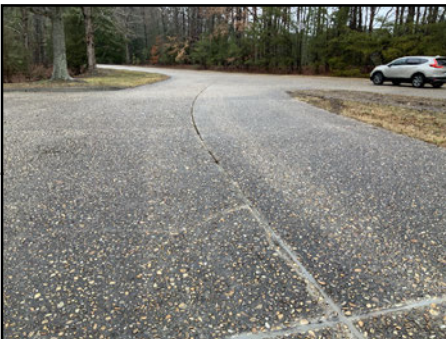
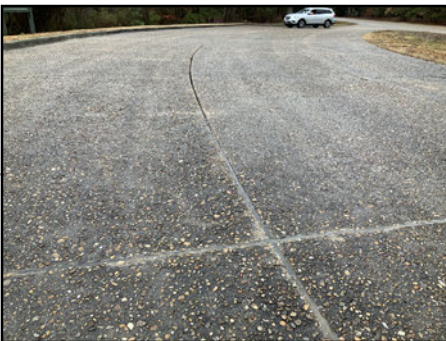
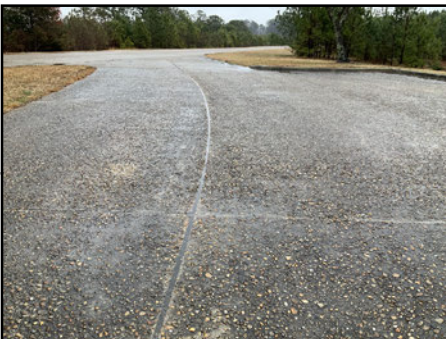
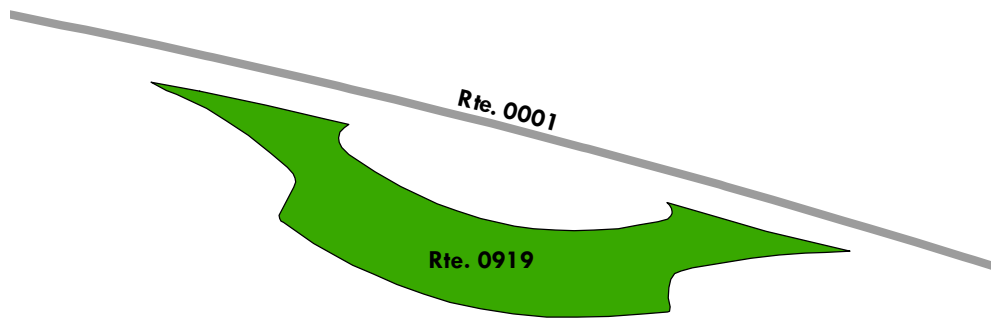
ROUTE 0919: REAL ESTATE PARKING

Inspection Date	FMSS Number	User Access	Surface Type
2/19/2021	56265	PUBLIC	CONCRETE
Area (Sq. Ft.)	Lane Miles (11' Widths)	Curb Reveal (Inches)	Curb Recommendation
9,320	0.16	7	DO NOTHING
Curb Type		Curb & Gutter Type	
CONCRETE		NO CURB AND GUTTER	
Pavement Recommendation		Condition Rating / PCR	
PREVENTIVE MAINTENANCE		GOOD / 90

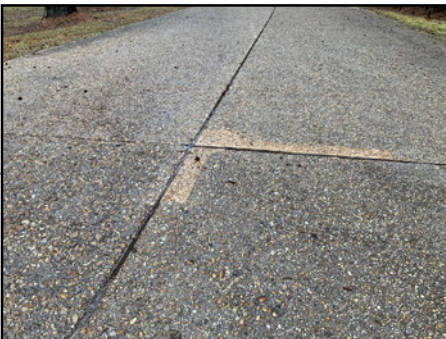
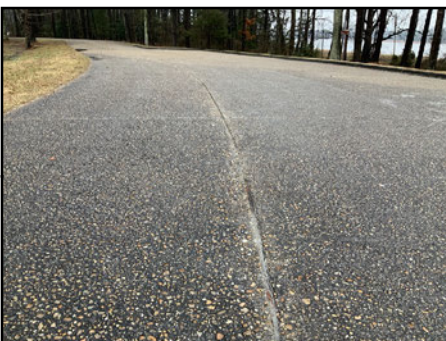
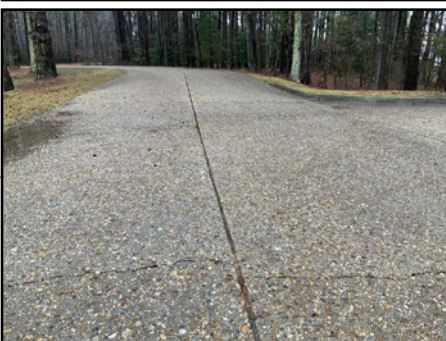
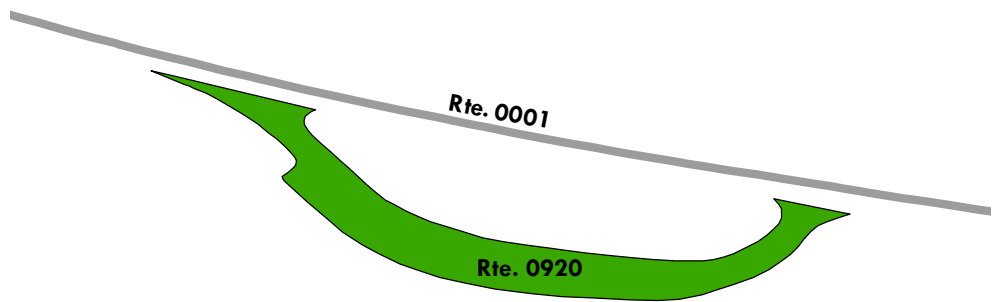
ROUTE 0920: NECK O LAND PARKING

Inspection Date	FMSS Number	User Access	Surface Type
2/19/2021	56266	PUBLIC	CONCRETE
Area (Sq. Ft.)	Lane Miles (11' Widths)	Curb Reveal (Inches)	Curb Recommendation
18,557	0.32	7	DO NOTHING
Curb Type		Curb & Gutter Type	
CONCRETE		NO CURB AND GUTTER	
Pavement Recommendation		Condition Rating / PCR	
PREVENTIVE MAINTENANCE		GOOD / 90

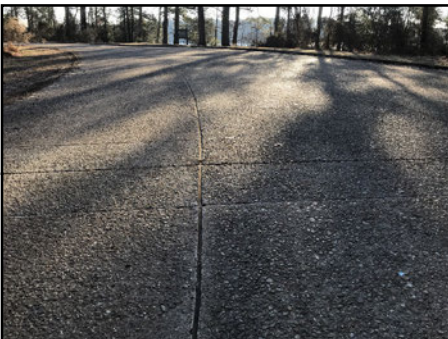
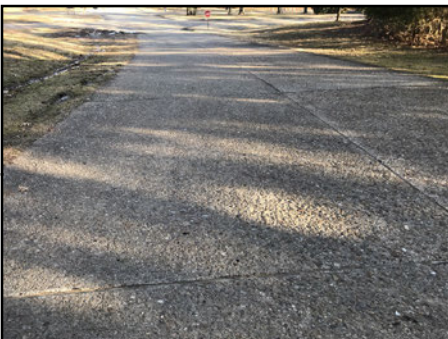
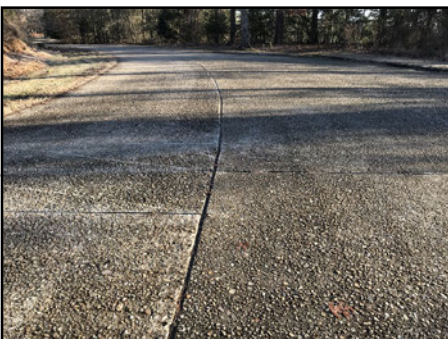
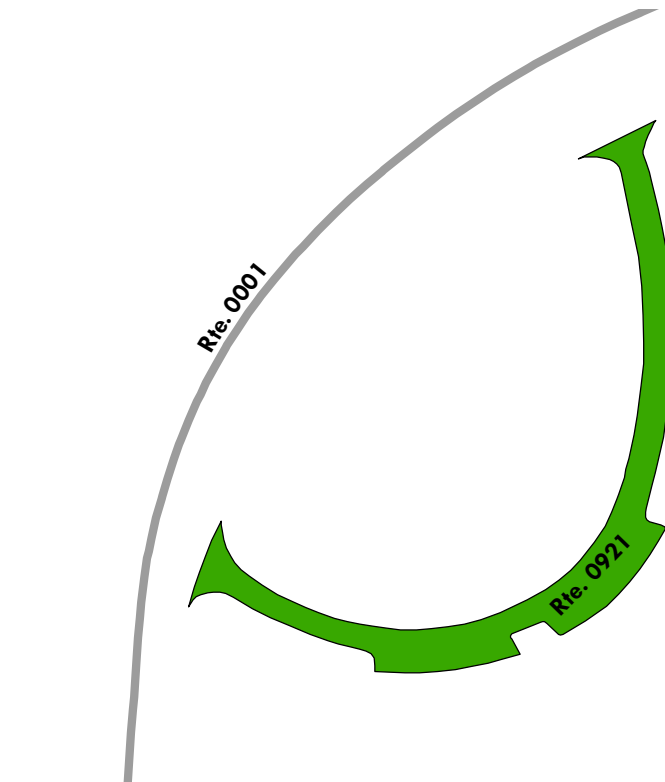
ROUTE 0921: POWHATAN CREEK PARKING

Inspection Date	FMSS Number	User Access	Surface Type
2/20/2021	56267	PUBLIC	CONCRETE
Area (Sq. Ft.)	Lane Miles (11' Widths)	Curb Reveal (Inches)	Curb Recommendation
24,688	0.425	6	DO NOTHING
Curb Type		Curb & Gutter Type	
CONCRETE		NO CURB AND GUTTER	
Pavement Recommendation		Condition Rating / PCR	
PREVENTIVE MAINTENANCE		GOOD / 90

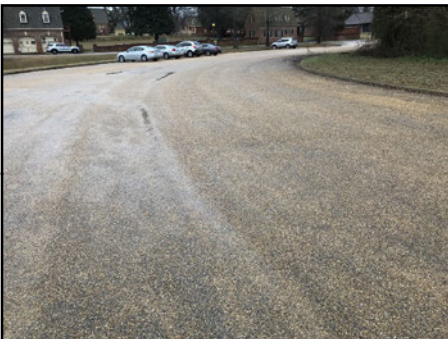
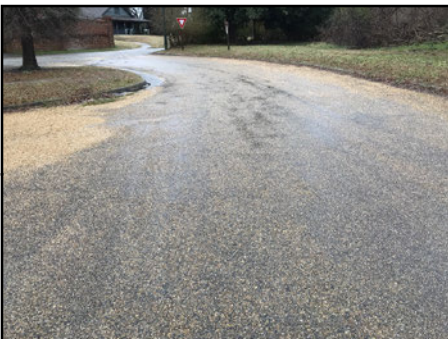
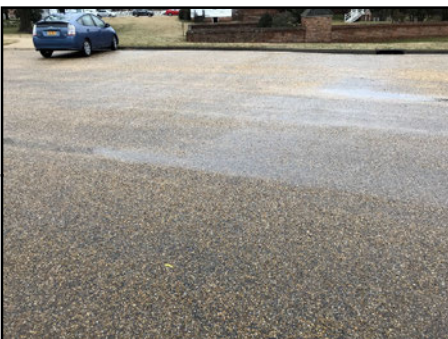
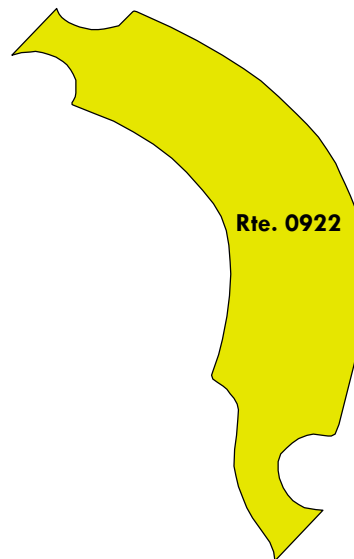
ROUTE 0922: YORKTOWN VISITOR PARKING (CHURCH STREET)

Inspection Date	FMSS Number	User Access	Surface Type
2/19/2021	56269	PUBLIC	ASPHALT
Area (Sq. Ft.)	Lane Miles (11' Widths)	Curb Reveal (Inches)	Curb Recommendation
18,811	0.324	NOT APPLICABLE	NOT APPLICABLE
Curb Type		Curb & Gutter Type	
NO CURB		NO CURB AND GUTTER	
Pavement Recommendation		Condition Rating / PCR	
LIGHT 3R TREATMENTS		FAIR / 73

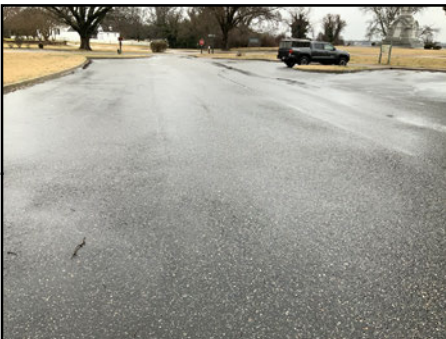
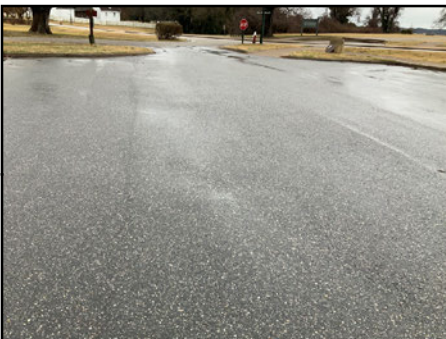
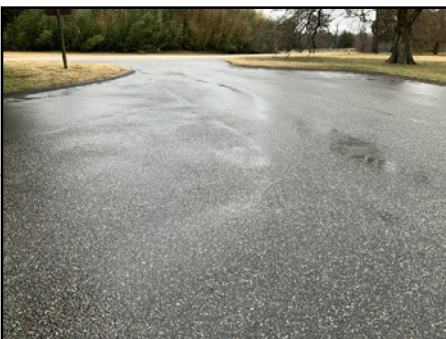
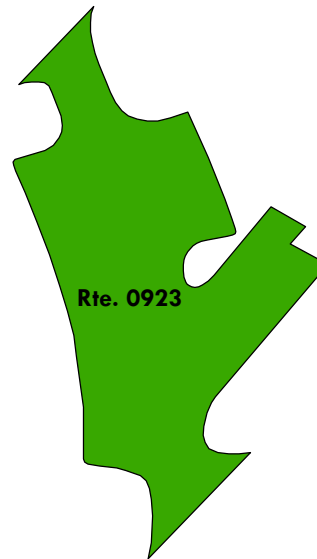
ROUTE 0923: YORKTOWN MONUMENT VICTORY AND ALLIANCE PARKING

Inspection Date	FMSS Number	User Access	Surface Type
2/19/2021	56272	PUBLIC	ASPHALT
Area (Sq. Ft.)	Lane Miles (11' Widths)	Curb Reveal (Inches)	Curb Recommendation
9,646	0.166	6	MODERATE REPAIR
Curb Type		Curb & Gutter Type	
CONCRETE		NO CURB AND GUTTER	
Pavement Recommendation		Condition Rating / PCR	
PREVENTIVE MAINTENANCE		GOOD / 90

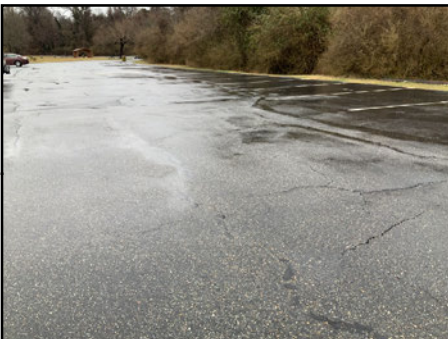
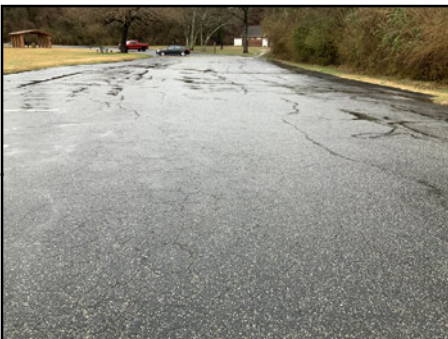
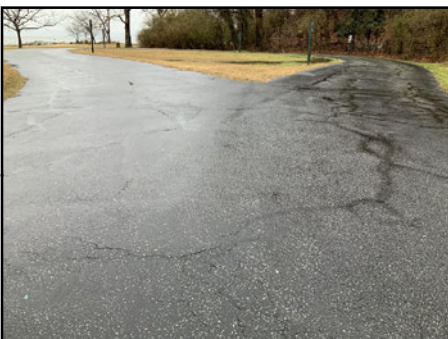
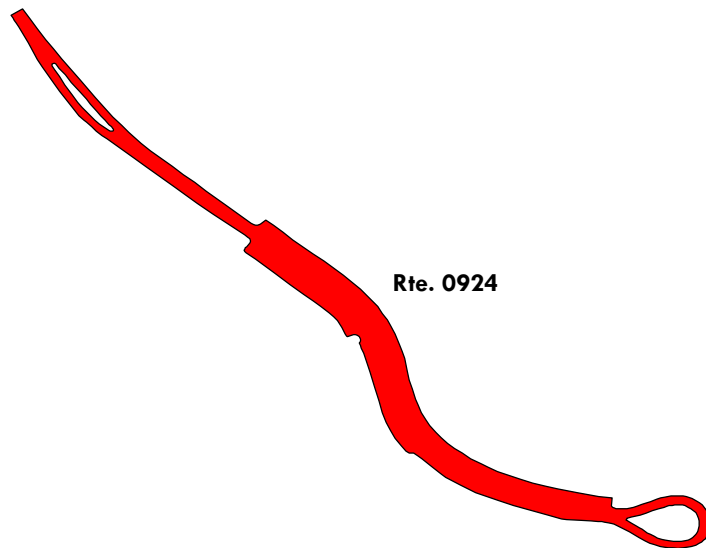
ROUTE 0924: YORKTOWN BEACH PICNIC AREA PARKING

Inspection Date	FMSS Number	User Access	Surface Type
2/19/2021	56273	PUBLIC	ASPHALT
Area (Sq. Ft.)	Lane Miles (11' Widths)	Curb Reveal (Inches)	Curb Recommendation
52,353	0.901	NOT APPLICABLE	NOT APPLICABLE
Curb Type		Curb & Gutter Type	
NO CURB		NO CURB AND GUTTER	
Pavement Recommendation		Condition Rating / PCR	
RECONSTRUCTION		POOR / 30

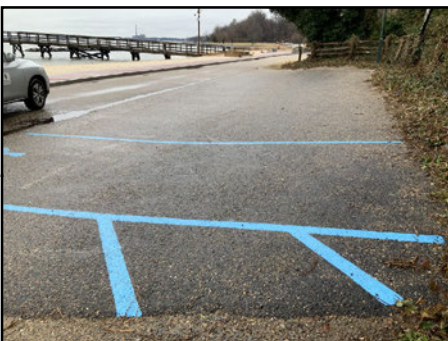
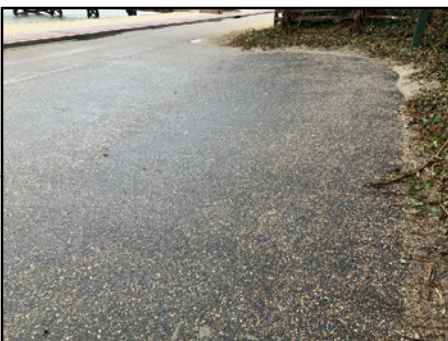
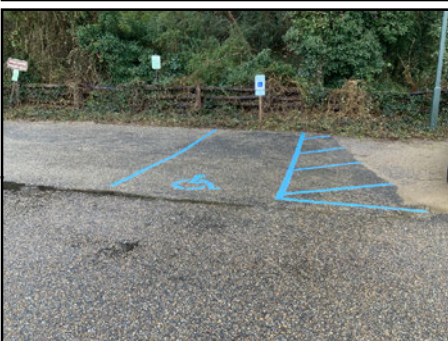
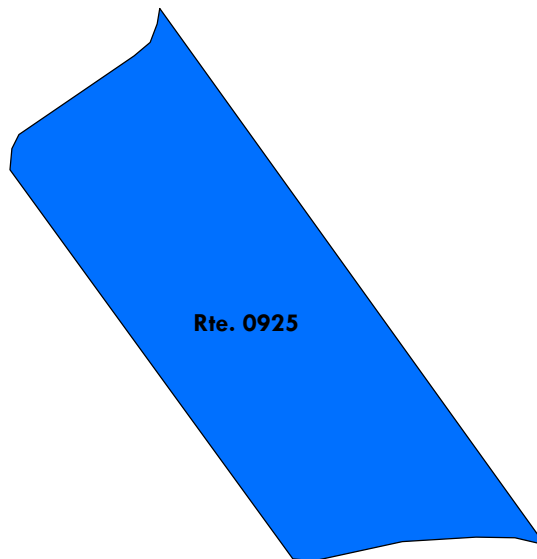
ROUTE 0925: CORNWALLIS' CAVE PARKING

Inspection Date	FMSS Number	User Access	Surface Type
2/19/2021	56274	PUBLIC	ASPHALT
Area (Sq. Ft.)	Lane Miles (11' Widths)	Curb Reveal (Inches)	Curb Recommendation
1,655	0.028	NOT APPLICABLE	NOT APPLICABLE
Curb Type		Curb & Gutter Type	
NO CURB		NO CURB AND GUTTER	
Pavement Recommendation		Condition Rating / PCR	
DO NOTHING		EXCELLENT / 97

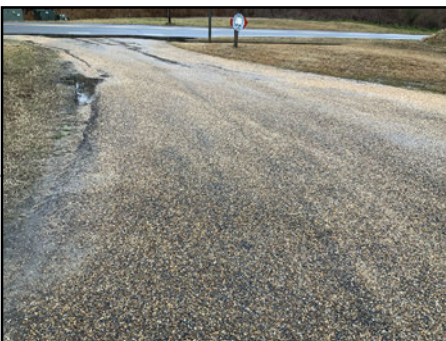
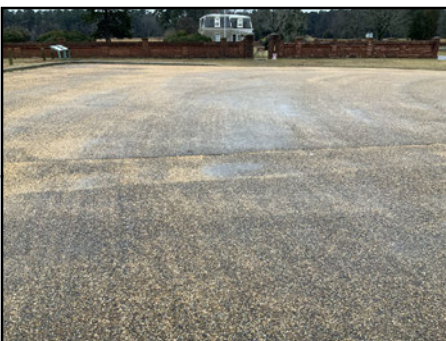
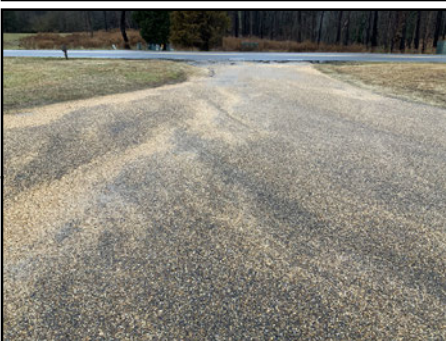
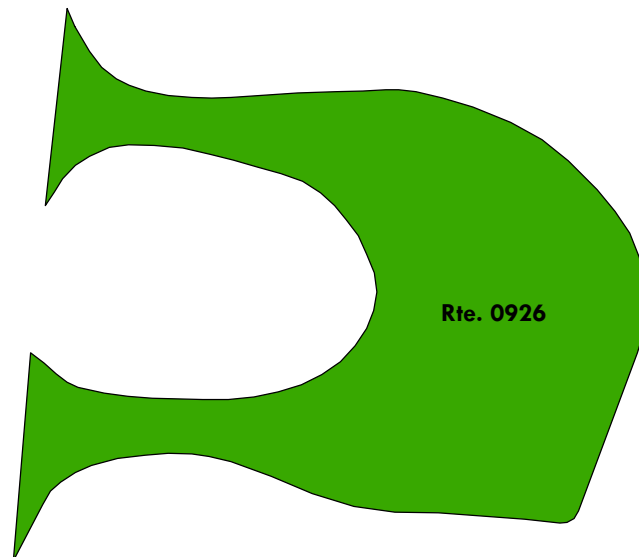
ROUTE 0926: YORKTOWN NATIONAL CEMETERY / SECOND SIEGE PARKING

Inspection Date	FMSS Number	User Access	Surface Type
2/19/2021	56275	PUBLIC	ASPHALT
Area (Sq. Ft.)	Lane Miles (11' Widths)	Curb Reveal (Inches)	Curb Recommendation
8,517	0.147	6	LIGHT REPAIR
Curb Type		Curb & Gutter Type	
CONCRETE		NO CURB AND GUTTER	
Pavement Recommendation		Condition Rating / PCR	
PREVENTIVE MAINTENANCE		GOOD / 90

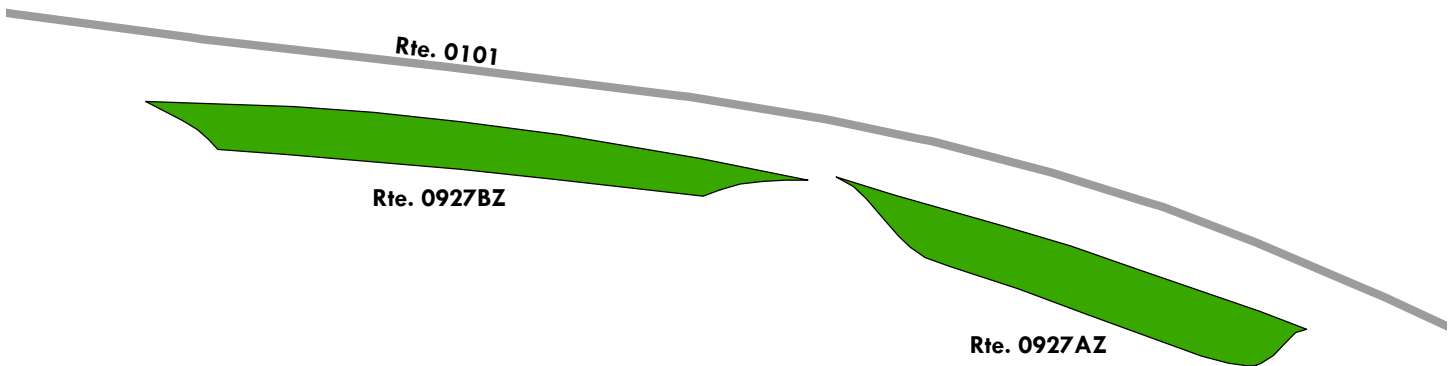
Rte. 0927ZZ (2 Subcomponents)

Inspection Date	FMSS Number	User Access	Surface Type
2/19/2021	56276	PUBLIC	ASPHALT
Area (Sq. Ft.)	Lane Miles (11' Widths)	Condition Rating / PCR	
2,739	0.047	SUMMARY /	90

The condition shown on this page reflects the overall route condition and may not reflect individual subcomponent ratings.

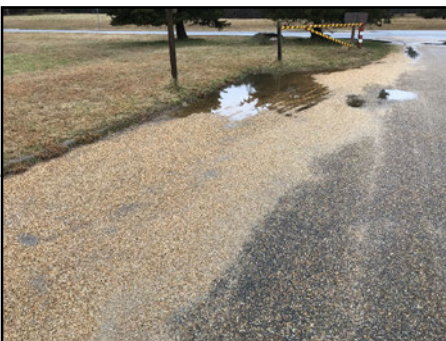
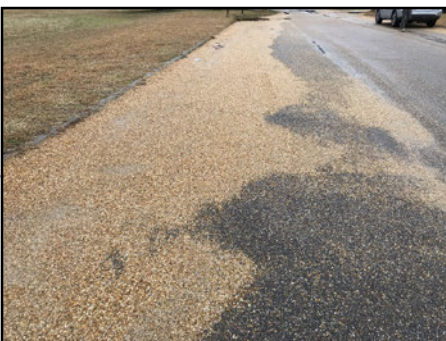
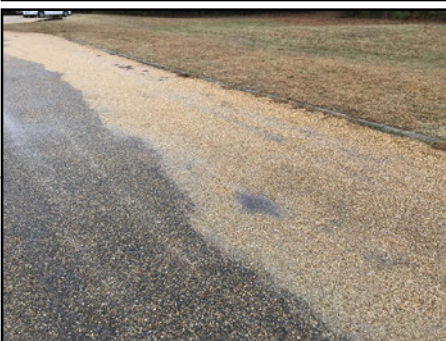
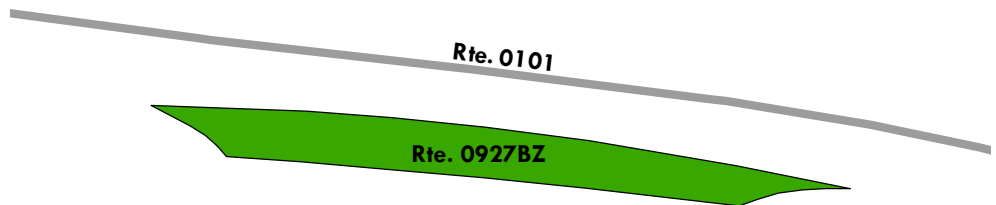
ROUTE 0927BZ: GRAND FRENCH BATTERY PARKING B

Inspection Date	FMSS Number	User Access	Surface Type
2/19/2021	56276	PUBLIC	ASPHALT
Area (Sq. Ft.)	Lane Miles (11' Widths)	Curb Reveal (Inches)	Curb Recommendation
1,409	0.024	2	DO NOTHING
Curb Type		Curb & Gutter Type	
CONCRETE		NO CURB AND GUTTER	
Pavement Recommendation		Condition Rating / PCR	
PREVENTIVE MAINTENANCE		GOOD / 90

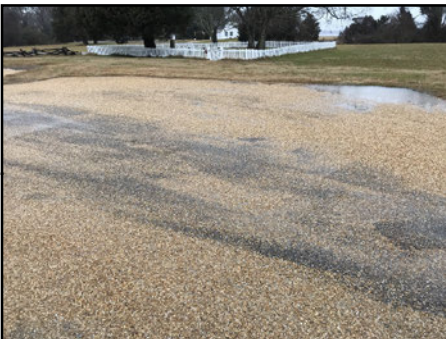
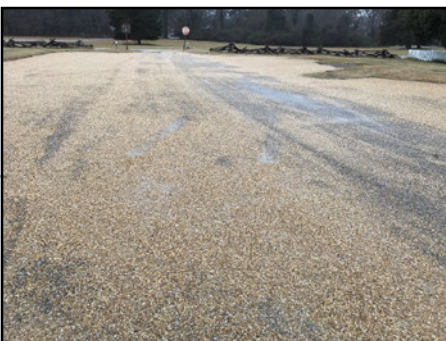
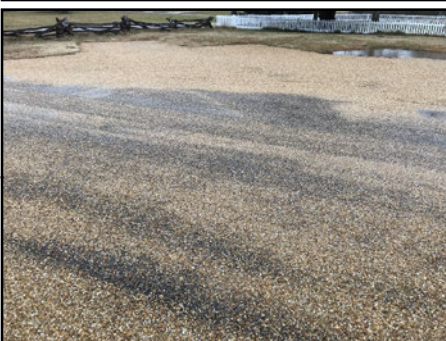
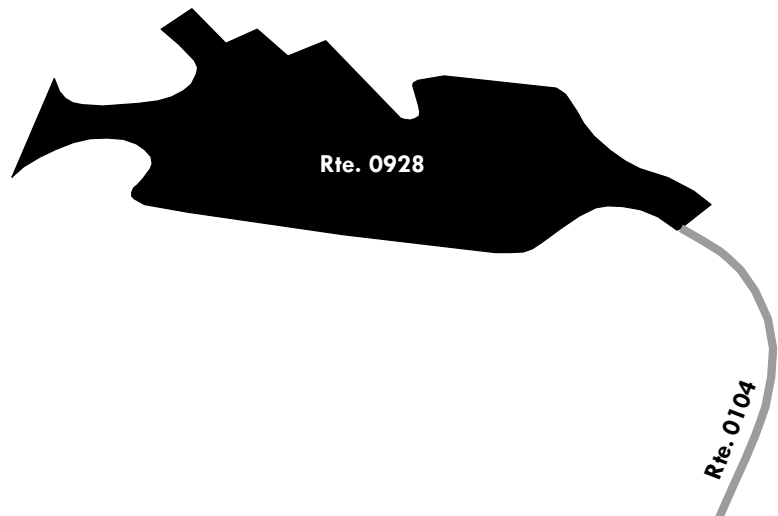
ROUTE 0928: MOORE HOUSE PARKING

Inspection Date	FMSS Number	User Access	Surface Type
2/18/2021	56277	PUBLIC	ASPHALT
Area (Sq. Ft.)	Lane Miles (11' Widths)	Curb Reveal (Inches)	Curb Recommendation
7,403	0.127	NOT APPLICABLE	NOT APPLICABLE
Curb Type		Curb & Gutter Type	
NO CURB		NO CURB AND GUTTER	
Pavement Recommendation		Condition Rating / PCR	
NOT APPLICABLE		NOT RATED

Note: Route not rated - pavement covered.

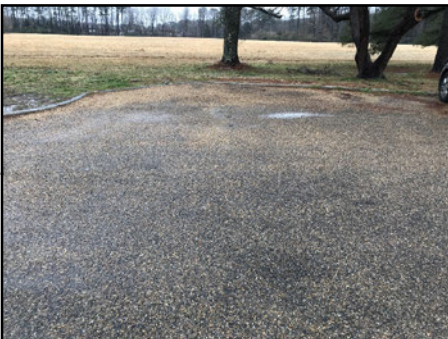
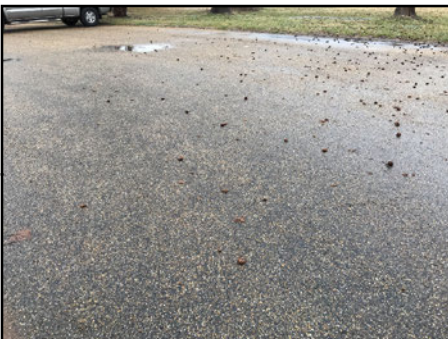
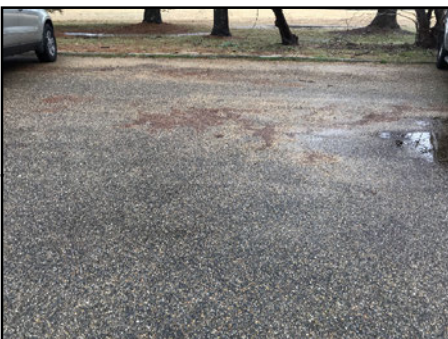
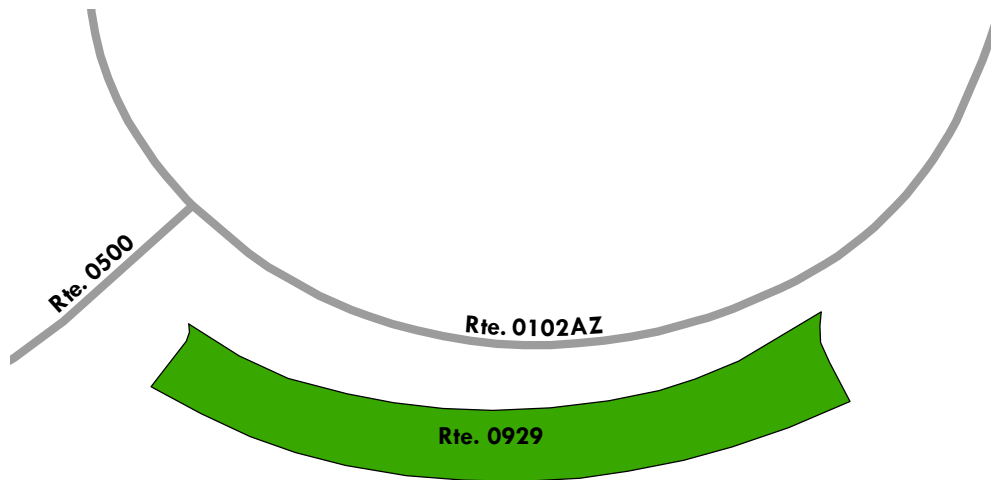
ROUTE 0929: SURRENDER FIELD ACCESS PARKING

Inspection Date	FMSS Number	User Access	Surface Type
2/19/2021	56279	PUBLIC	ASPHALT
Area (Sq. Ft.)	Lane Miles (11' Widths)	Curb Reveal (Inches)	Curb Recommendation
2,160	0.037	3	LIGHT REPAIR
Curb Type		Curb & Gutter Type	
CONCRETE		NO CURB AND GUTTER	
Pavement Recommendation		Condition Rating / PCR	
PREVENTIVE MAINTENANCE		GOOD / 90

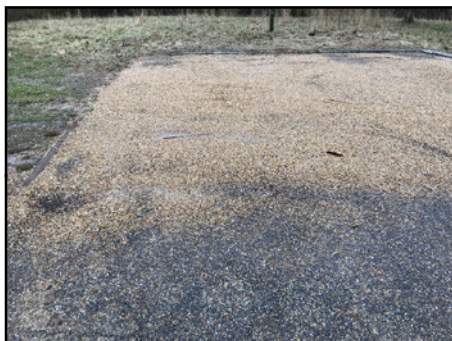
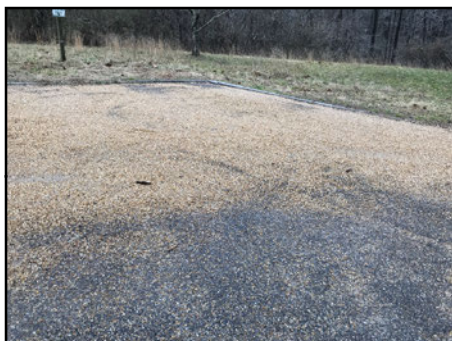
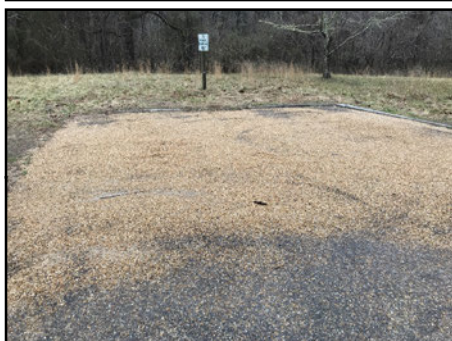
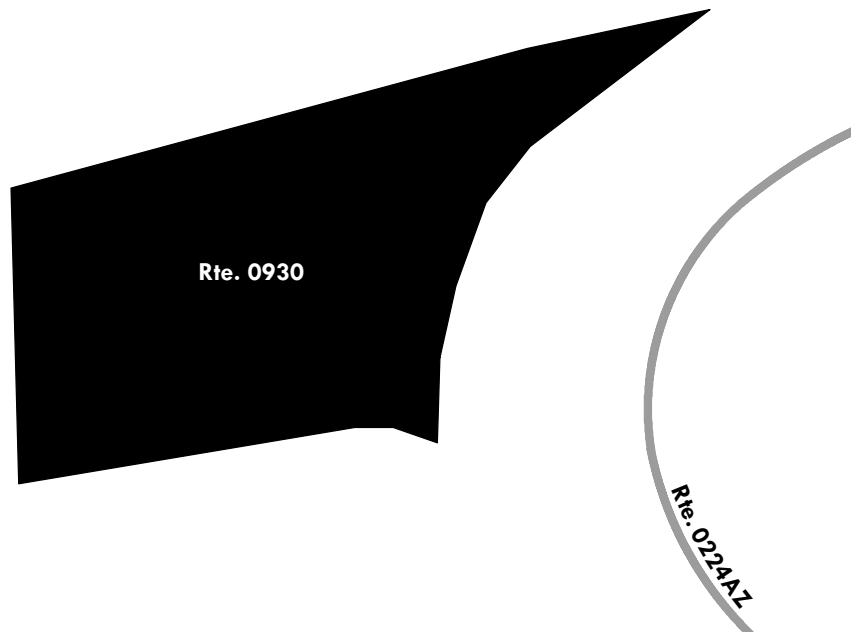
ROUTE 0930: WASHINGTON'S HEADQUARTERS PARKING

Inspection Date	FMSS Number	User Access	Surface Type
2/19/2021	56280	PUBLIC	ASPHALT
Area (Sq. Ft.)	Lane Miles (11' Widths)	Curb Reveal (Inches)	Curb Recommendation
804	0.014	2	DO NOTHING
Curb Type		Curb & Gutter Type	
CONCRETE AND WOOD		NO CURB AND GUTTER	
Pavement Recommendation		Condition Rating / PCR	
NOT APPLICABLE		NOT RATED

Note: Route not rated - pavement covered.

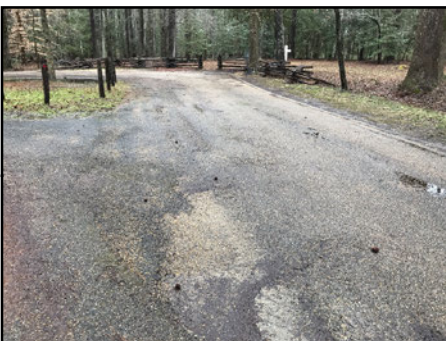
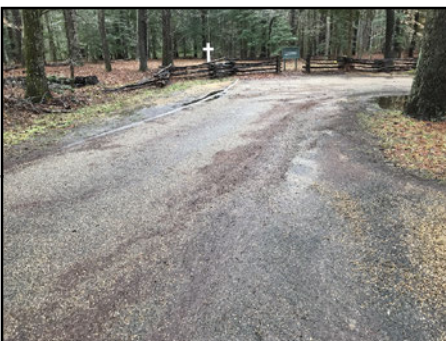
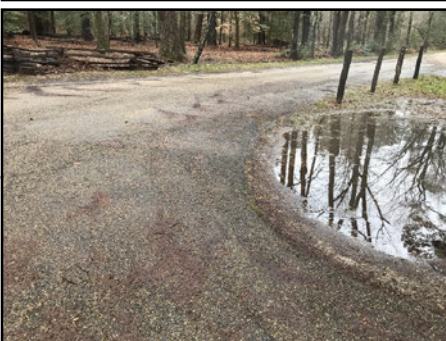
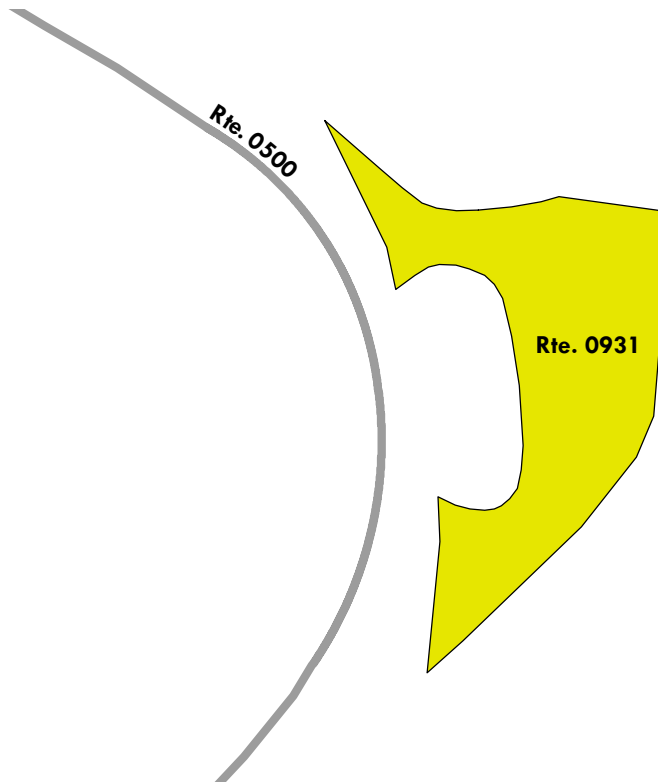
ROUTE 0931: FRENCH CEMETERY PARKING

Inspection Date	FMSS Number	User Access	Surface Type
2/19/2021	56281	PUBLIC	ASPHALT
Area (Sq. Ft.)	Lane Miles (11' Widths)	Curb Reveal (Inches)	Curb Recommendation
2,281	0.039	NOT APPLICABLE	NOT APPLICABLE
Curb Type		Curb & Gutter Type	
NO CURB		NO CURB AND GUTTER	
Pavement Recommendation		Condition Rating / PCR	
LIGHT 3R TREATMENTS		FAIR / 73

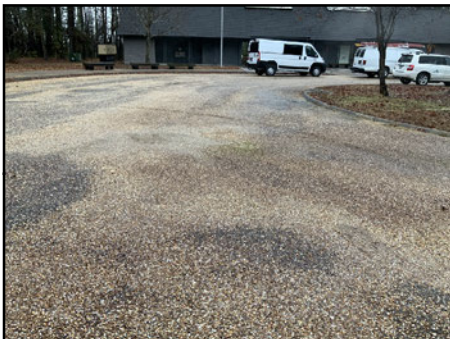
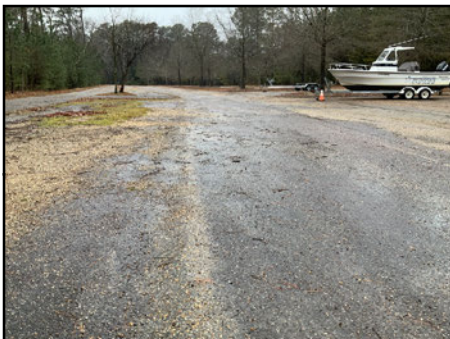
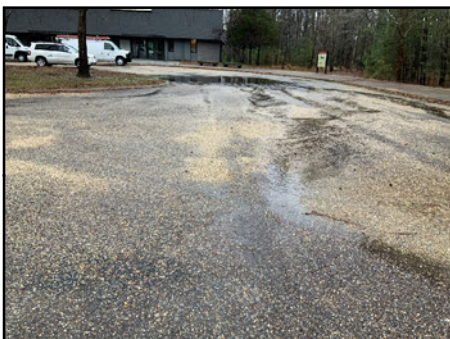
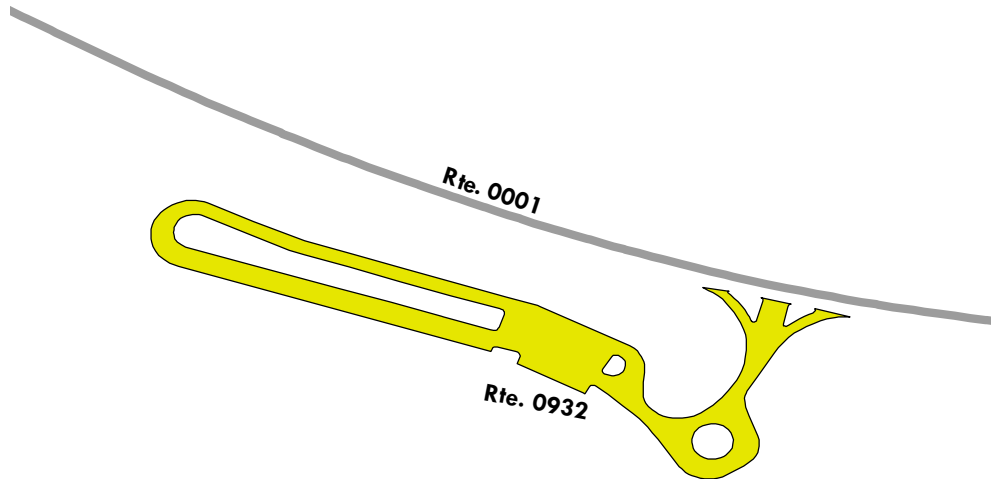
ROUTE 0932: NECK O LAND VISITOR CONTACT PARKING

Inspection Date	FMSS Number	User Access	Surface Type
2/19/2021	99128	PUBLIC	ASPHALT
Area (Sq. Ft.)	Lane Miles (11' Widths)	Curb Reveal (Inches)	Curb Recommendation
76,224	1.312	5	MODERATE REPAIR
Curb Type		Curb & Gutter Type	
CONCRETE		NO CURB AND GUTTER	
Pavement Recommendation		Condition Rating / PCR	
LIGHT 3R TREATMENTS		FAIR / 73

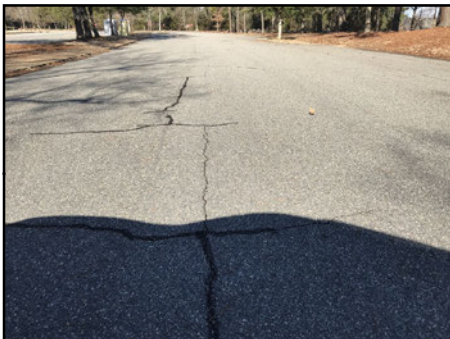
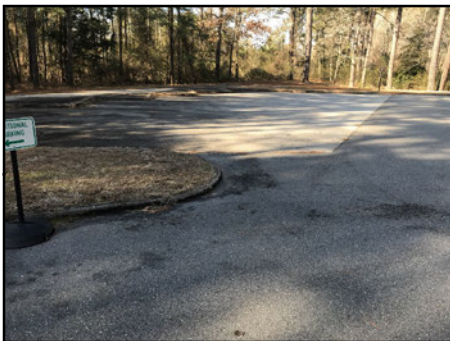
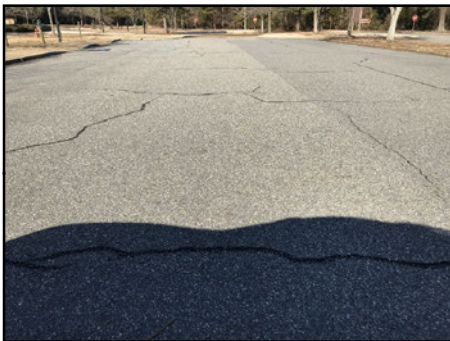
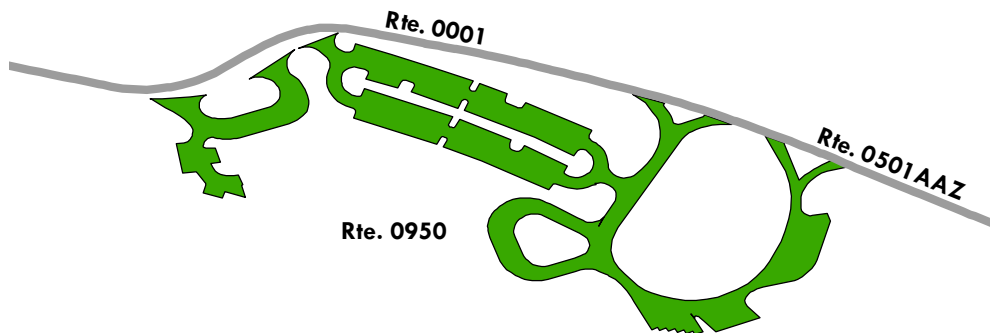
ROUTE 0950: JAMESTOWN VISITOR CENTER PARKING

Inspection Date	FMSS Number	User Access	Surface Type
2/20/2021	56282	PUBLIC	ASPHALT
Area (Sq. Ft.)	Lane Miles (11' Widths)	Curb Reveal (Inches)	Curb Recommendation
129,457	2.229	2	REPLACE
Curb Type		Curb & Gutter Type	
CONCRETE		NO CURB AND GUTTER	
Pavement Recommendation		Condition Rating / PCR	
PREVENTIVE MAINTENANCE		GOOD / 90

Note: Parking area consists of multiple surface types: 1 part Asphalt at 90,306 square feet; 1 part Concrete at 38,635; 1 part Brick at 516 square feet.

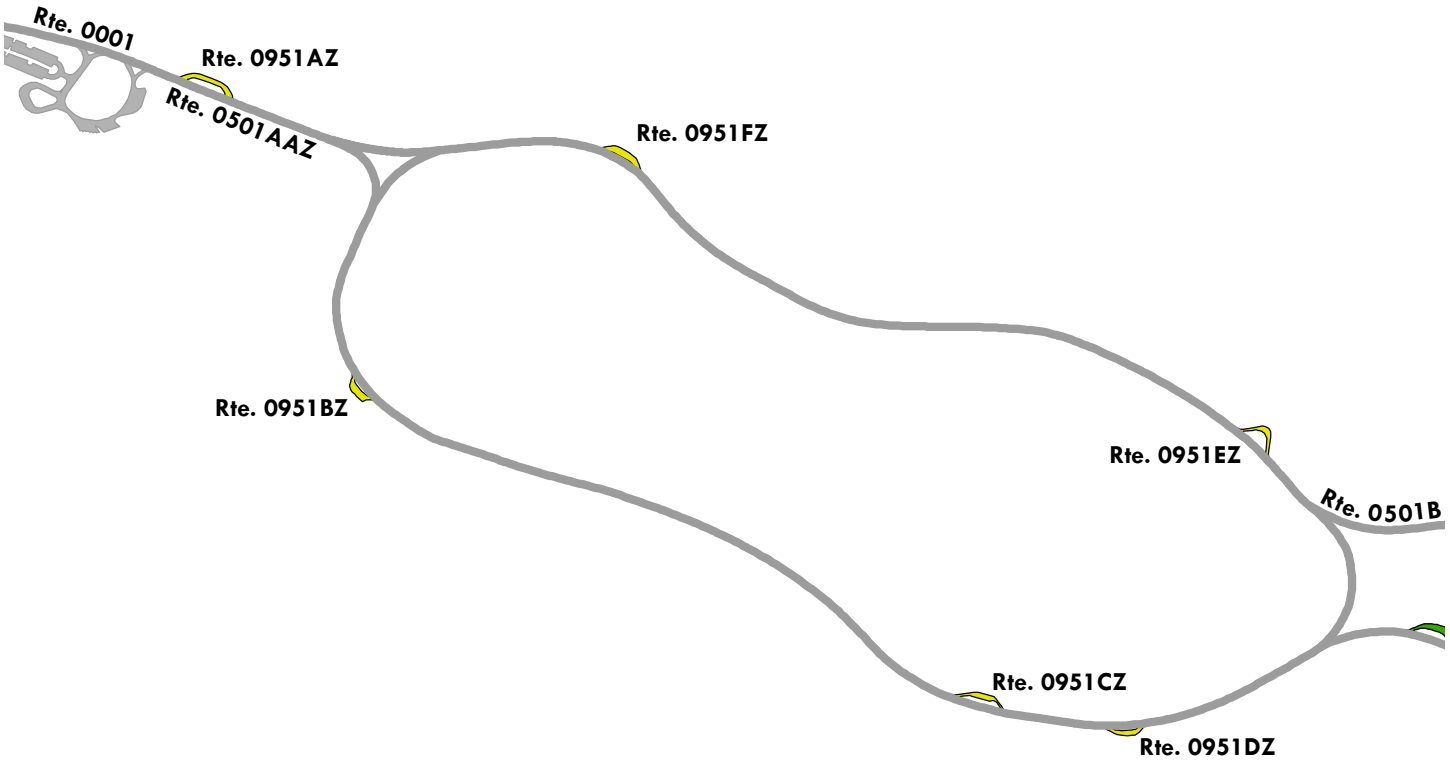
Rte. 0951ZZ (6 Subcomponents)

Inspection Date	FMSS Number	User Access	Surface Type
2/20/2021	N/A	PUBLIC	ASPHALT
Area (Sq. Ft.)	Lane Miles (11' Widths)	Condition Rating / PCR	
33,471	0.576	SUMMARY / 78

The condition shown on this page reflects the overall route condition and may not reflect individual subcomponent ratings.

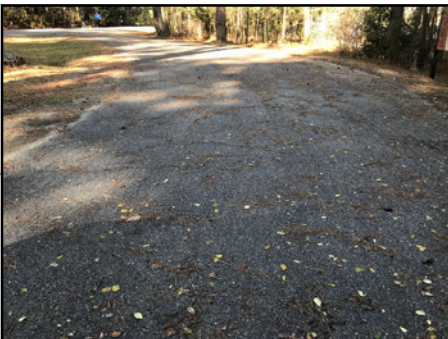
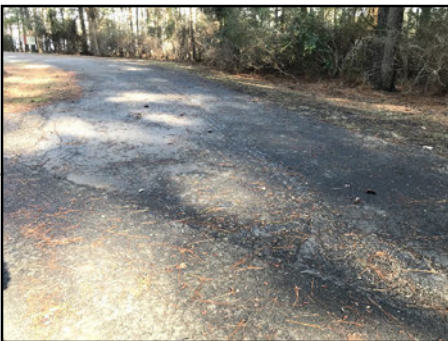
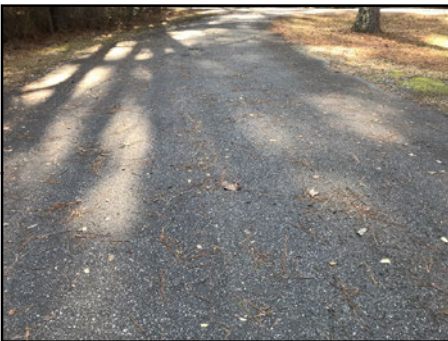
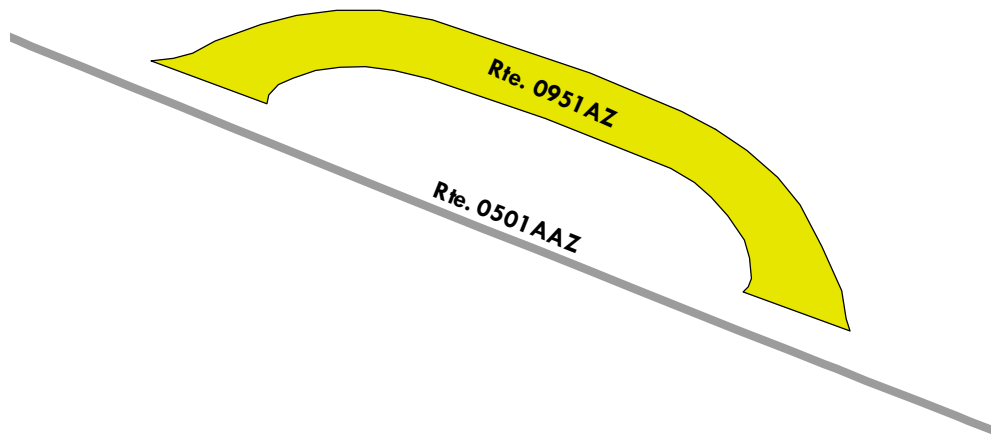
ROUTE 0951AZ: EARLY AFRICAN RESIDENTS PARKING

Inspection Date	FMSS Number	User Access	Surface Type
2/20/2021	N/A	PUBLIC	ASPHALT
Area (Sq. Ft.)	Lane Miles (11' Widths)	Curb Reveal (Inches)	Curb Recommendation
6,822	0.117	NOT APPLICABLE	NOT APPLICABLE
Curb Type		Curb & Gutter Type	
NO CURB		NO CURB AND GUTTER	
Pavement Recommendation		Condition Rating / PCR	
LIGHT 3R TREATMENTS		FAIR / 73

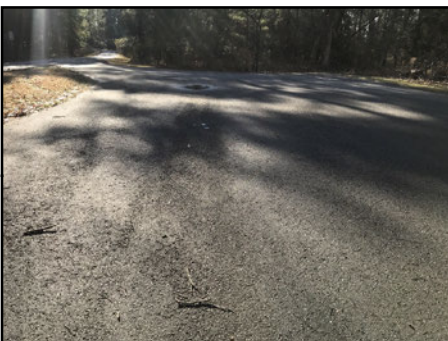
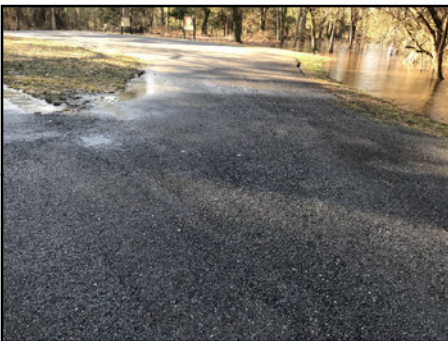
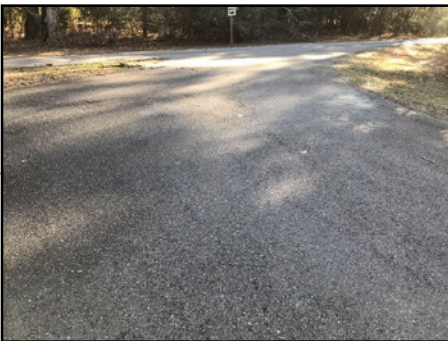
ROUTE 0951CZ: JAMESTOWN DURING THE CIVIL WAR PARKING

Inspection Date	FMSS Number	User Access	Surface Type
2/20/2021	N/A	PUBLIC	ASPHALT
Area (Sq. Ft.)	Lane Miles (11' Widths)	Curb Reveal (Inches)	Curb Recommendation
4,569	0.079	NOT APPLICABLE	NOT APPLICABLE
Curb Type		Curb & Gutter Type	
NO CURB		NO CURB AND GUTTER	
Pavement Recommendation		Condition Rating / PCR	
PREVENTIVE MAINTENANCE		GOOD / 90

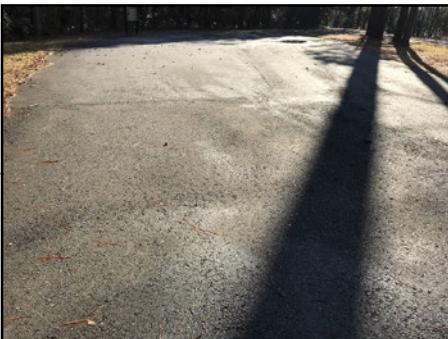
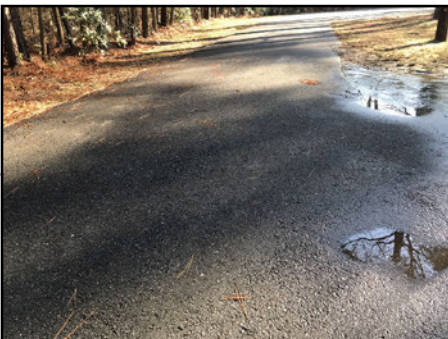
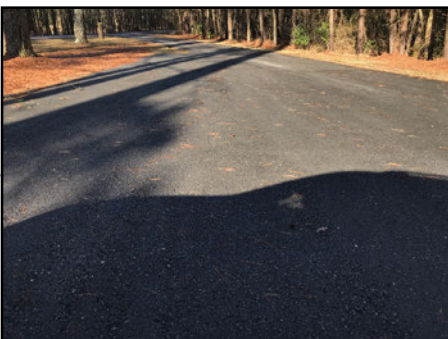
ROUTE 0951DZ: THE CHANGING LAND PARKING

Inspection Date	FMSS Number	User Access	Surface Type
2/20/2021	N/A	PUBLIC	ASPHALT
Area (Sq. Ft.)	Lane Miles (11' Widths)	Curb Reveal (Inches)	Curb Recommendation
4,477	0.077	NOT APPLICABLE	NOT APPLICABLE
Curb Type		Curb & Gutter Type	
NO CURB		NO CURB AND GUTTER	
Pavement Recommendation		Condition Rating / PCR	
PREVENTIVE MAINTENANCE		GOOD / 90
