COLO Cycle 6

Final Report

Road Inventory and Condition Assessment of Paved Routes Colonial National Historical Park

**Federal Highway Administration
Eastern Federal Lands Highway Division
Road Inventory Program (RIP)**

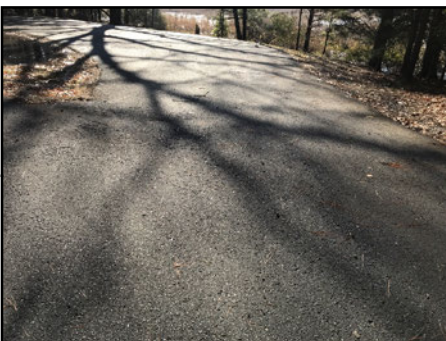
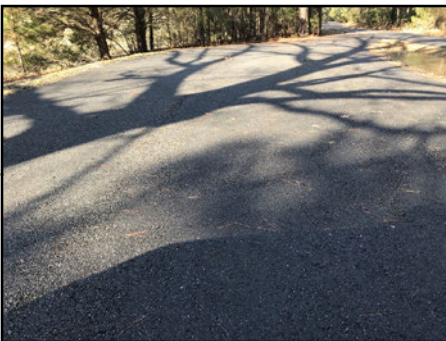
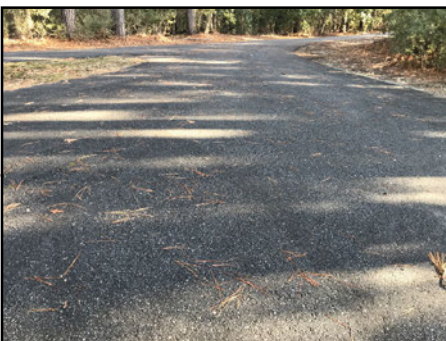
ROUTE 0951EZ: PRECIOUS PLANTS PARKING

Inspection Date	FMSS Number	User Access	Surface Type
2/20/2021	N/A	PUBLIC	ASPHALT
Area (Sq. Ft.)	Lane Miles (11' Widths)	Curb Reveal (Inches)	Curb Recommendation
4,774	0.082	NOT APPLICABLE	NOT APPLICABLE
Curb Type		Curb & Gutter Type	
NO CURB		NO CURB AND GUTTER	
Pavement Recommendation		Condition Rating / PCR	
PREVENTIVE MAINTENANCE		GOOD / 90

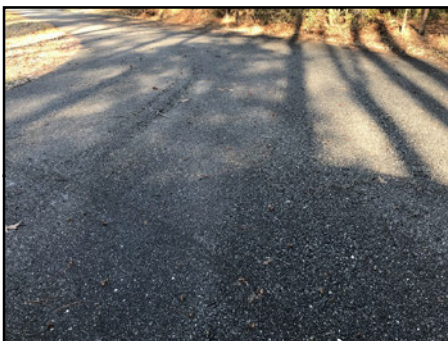
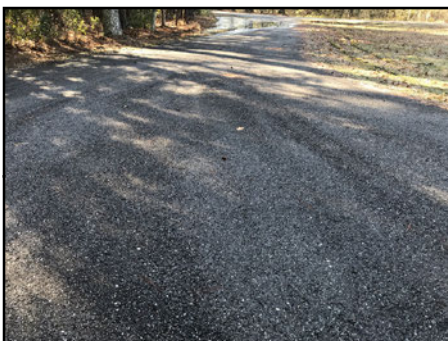
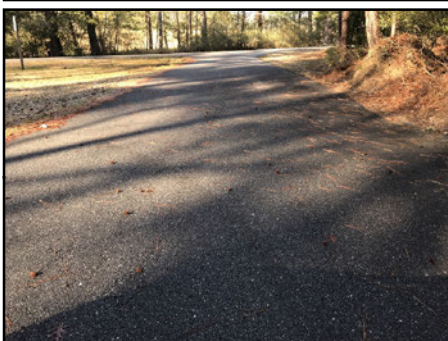
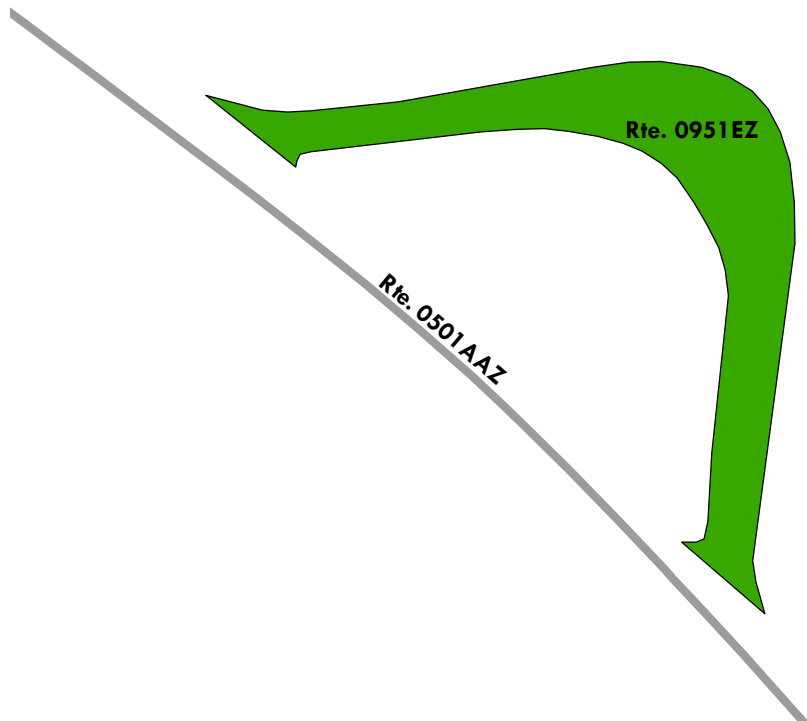
ROUTE 0951FZ: SOILE FIT TO PRODUCE PARKING

Inspection Date	FMSS Number	User Access	Surface Type
2/20/2021	N/A	PUBLIC	ASPHALT
Area (Sq. Ft.)	Lane Miles (11' Widths)	Curb Reveal (Inches)	Curb Recommendation
7,441	0.128	NOT APPLICABLE	NOT APPLICABLE
Curb Type		Curb & Gutter Type	
NO CURB		NO CURB AND GUTTER	
Pavement Recommendation		Condition Rating / PCR	
HEAVY 3R TREATMENTS		POOR / 53

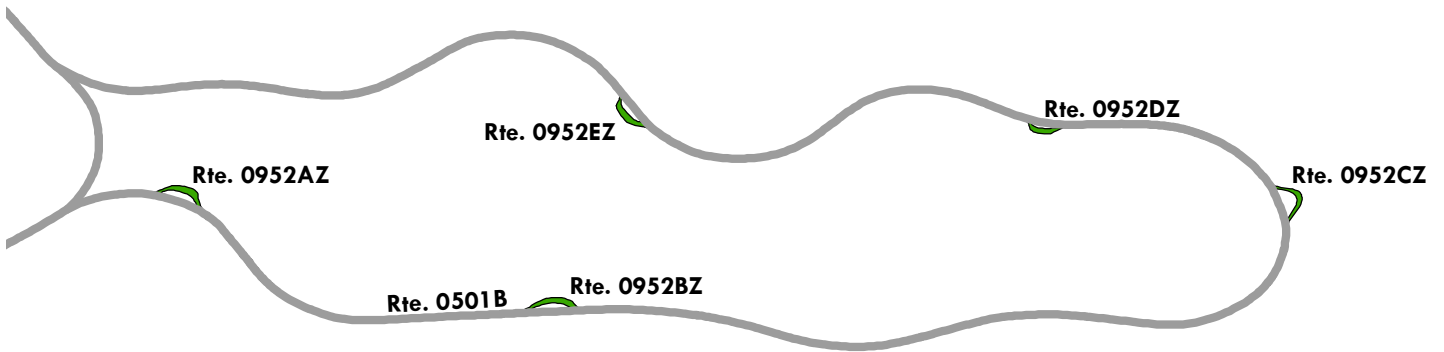
Rte. 0952ZZ (5 Subcomponents)

Inspection Date	FMSS Number	User Access	Surface Type
2/20/2021	N/A	PUBLIC	ASPHALT
Area (Sq. Ft.)	Lane Miles (11' Widths)	Condition Rating / PCR	
27,881	0.479	SUMMARY / 86

The condition shown on this page reflects the overall route condition and may not reflect individual subcomponent ratings.

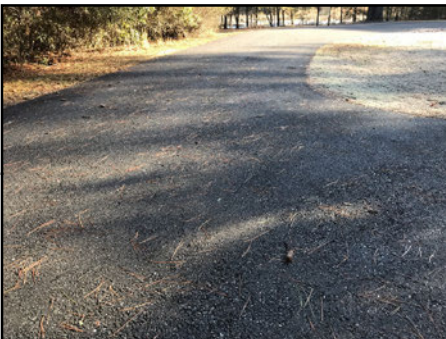
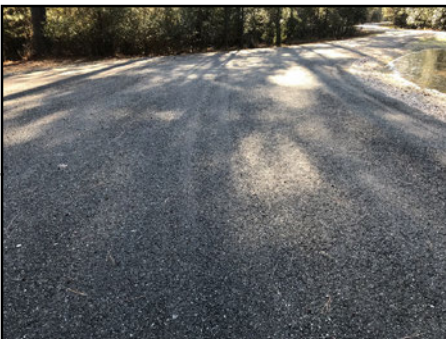
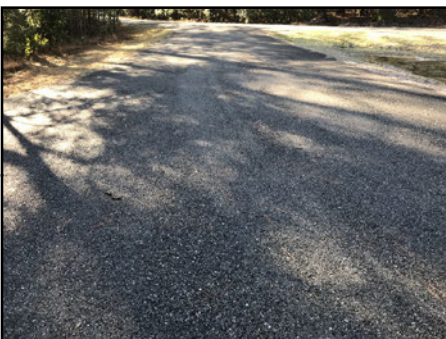
ROUTE 0952BZ: AN ANCIENT PLANTER PARKING

Inspection Date	FMSS Number	User Access	Surface Type
2/20/2021	N/A	PUBLIC	ASPHALT
Area (Sq. Ft.)	Lane Miles (11' Widths)	Curb Reveal (Inches)	Curb Recommendation
6,353	0.109	NOT APPLICABLE	NOT APPLICABLE
Curb Type		Curb & Gutter Type	
NO CURB		NO CURB AND GUTTER	
Pavement Recommendation		Condition Rating / PCR	
LIGHT 3R TREATMENTS		FAIR / 73

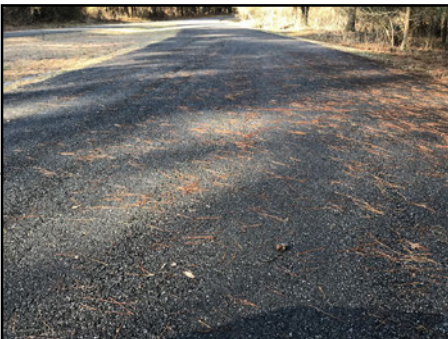
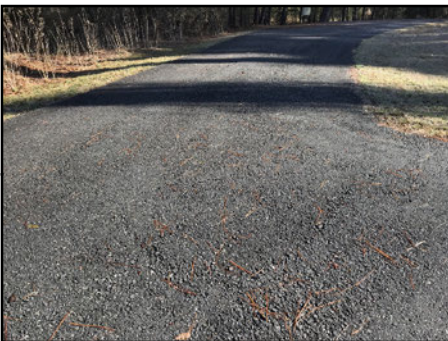
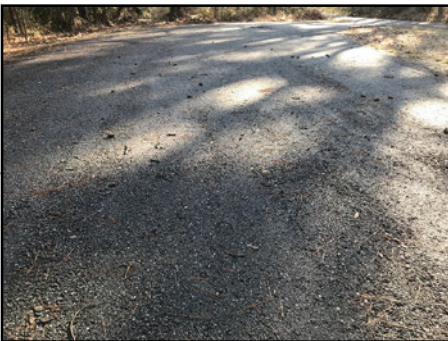
ROUTE 0952CZ: THE TRAVIS ESTATE PARKING

Inspection Date	FMSS Number	User Access	Surface Type
2/20/2021	N/A	PUBLIC	ASPHALT
Area (Sq. Ft.)	Lane Miles (11' Widths)	Curb Reveal (Inches)	Curb Recommendation
5,071	0.087	NOT APPLICABLE	NOT APPLICABLE
Curb Type		Curb & Gutter Type	
NO CURB		NO CURB AND GUTTER	
Pavement Recommendation		Condition Rating / PCR	
PREVENTIVE MAINTENANCE		GOOD / 90

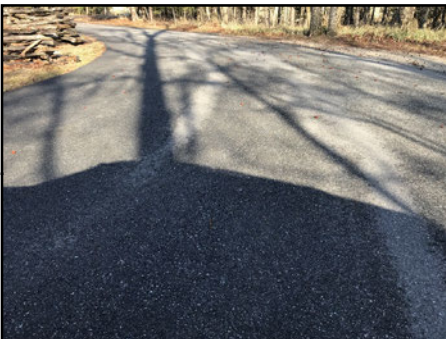
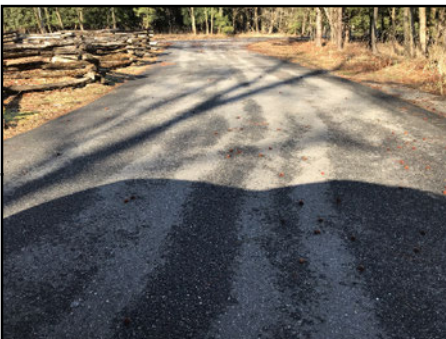
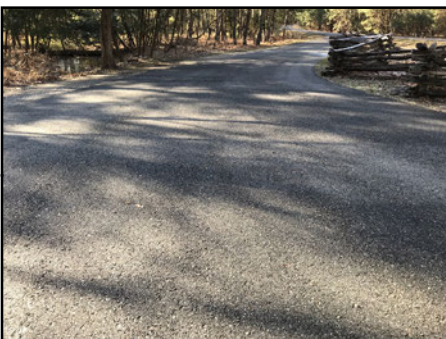
ROUTE 0952DZ: FENCES AND DITCHES PARKING

Inspection Date	FMSS Number	User Access	Surface Type
2/20/2021	N/A	PUBLIC	ASPHALT
Area (Sq. Ft.)	Lane Miles (11' Widths)	Curb Reveal (Inches)	Curb Recommendation
4,280	0.074	NOT APPLICABLE	NOT APPLICABLE
Curb Type		Curb & Gutter Type	
NO CURB		NO CURB AND GUTTER	
Pavement Recommendation		Condition Rating / PCR	
PREVENTIVE MAINTENANCE		GOOD / 90

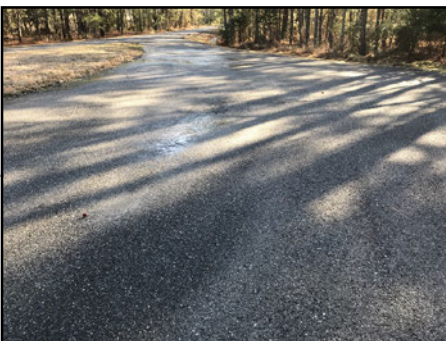
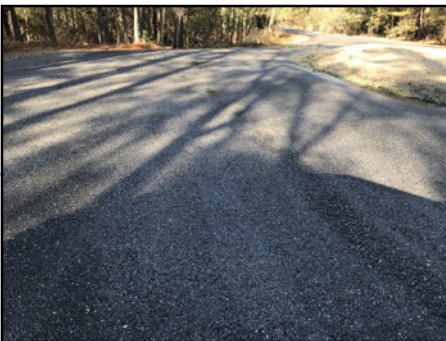
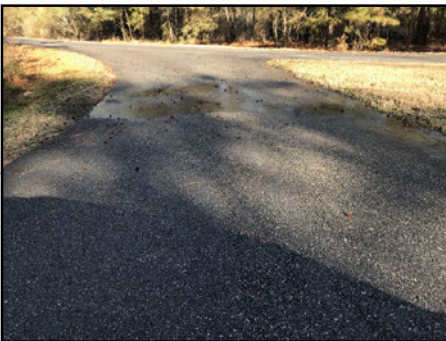
ROUTE 0952EZ: THE ISLAND HOUSE / PLANTS FROM THE PAST PARKING

Inspection Date	FMSS Number	User Access	Surface Type
2/20/2021	N/A	PUBLIC	ASPHALT
Area (Sq. Ft.)	Lane Miles (11' Widths)	Curb Reveal (Inches)	Curb Recommendation
5,529	0.095	NOT APPLICABLE	NOT APPLICABLE
Curb Type		Curb & Gutter Type	
NO CURB		NO CURB AND GUTTER	
Pavement Recommendation		Condition Rating / PCR	
PREVENTIVE MAINTENANCE		GOOD / 90

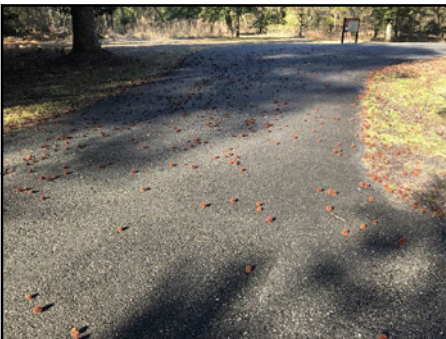
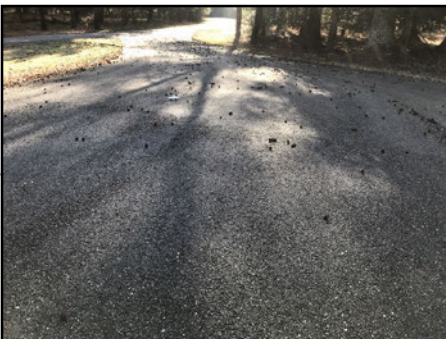
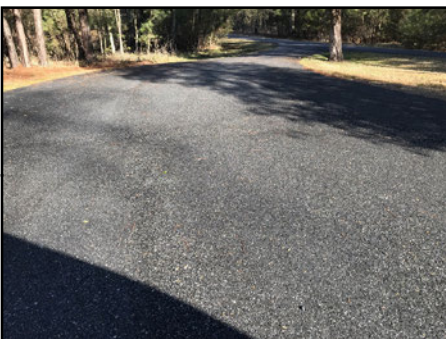
ROUTE 0953: BELLFIELD INTERPRETIVE AREA PARKING

Inspection Date	FMSS Number	User Access	Surface Type
2/19/2021	N/A	PUBLIC	CONCRETE
Area (Sq. Ft.)	Lane Miles (11' Widths)	Curb Reveal (Inches)	Curb Recommendation
12,769	0.22	4	DO NOTHING
Curb Type		Curb & Gutter Type	
CONCRETE		NO CURB AND GUTTER	
Pavement Recommendation		Condition Rating / PCR	
NOT APPLICABLE		NOT RATED

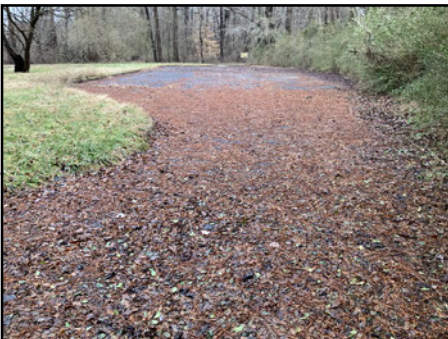
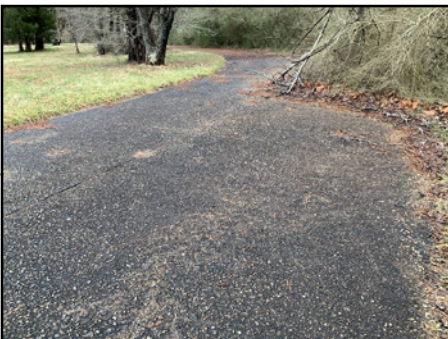
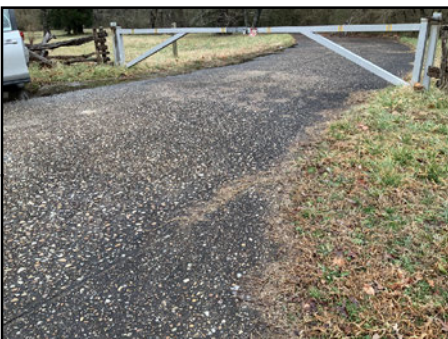
ROUTE 0954: GREAT NECK PICNIC PARKING

Inspection Date	FMSS Number	User Access	Surface Type
2/19/2021	N/A	PUBLIC	ASPHALT
Area (Sq. Ft.)	Lane Miles (11' Widths)	Curb Reveal (Inches)	Curb Recommendation
50,386	0.868	NOT APPLICABLE	NOT APPLICABLE
Curb Type		Curb & Gutter Type	
NO CURB		NO CURB AND GUTTER	
Pavement Recommendation		Condition Rating / PCR	
HEAVY 3R TREATMENTS		POOR / 53

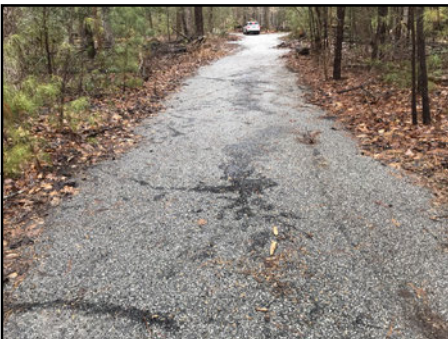
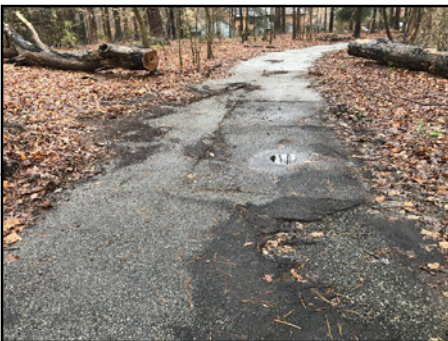
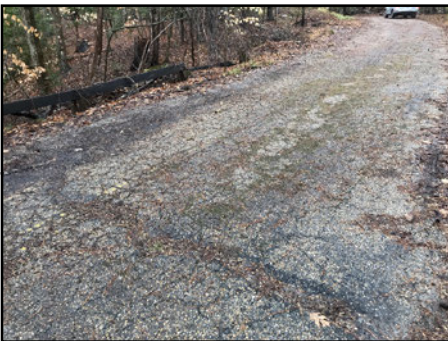
ROUTE 0955: ISTHMUS OVERLOOK PARKING

Inspection Date	FMSS Number	User Access	Surface Type
2/20/2021	N/A	PUBLIC	ASPHALT
Area (Sq. Ft.)	Lane Miles (11' Widths)	Curb Reveal (Inches)	Curb Recommendation
4,904	0.084	2	DO NOTHING
Curb Type		Curb & Gutter Type	
CONCRETE		NO CURB AND GUTTER	
Pavement Recommendation		Condition Rating / PCR	
LIGHT 3R TREATMENTS		FAIR / 73

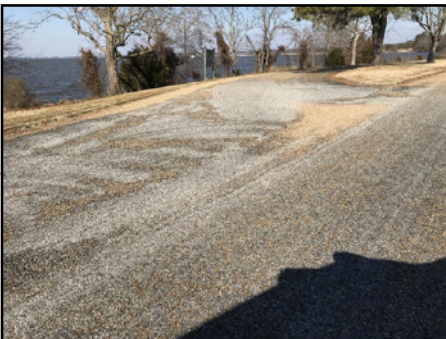
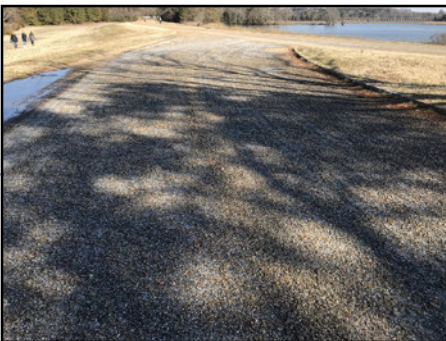
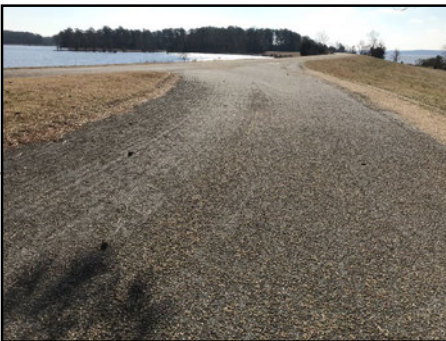
ROUTE 0990: JAMESTOWN MAINTENANCE PARKING

Inspection Date	FMSS Number	User Access	Surface Type
2/19/2021	56283	NONPUBLIC	ASPHALT
Area (Sq. Ft.)	Lane Miles (11' Widths)	Curb Reveal (Inches)	Curb Recommendation
14,195	0.244	NOT APPLICABLE	NOT APPLICABLE
Curb Type		Curb & Gutter Type	
NO CURB		NO CURB AND GUTTER	
Pavement Recommendation		Condition Rating / PCR	
LIGHT 3R TREATMENTS		FAIR / 73

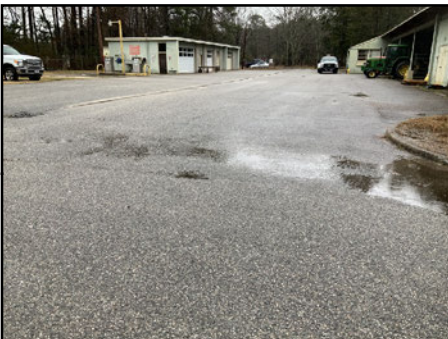
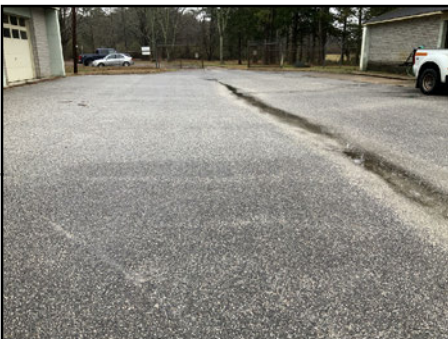
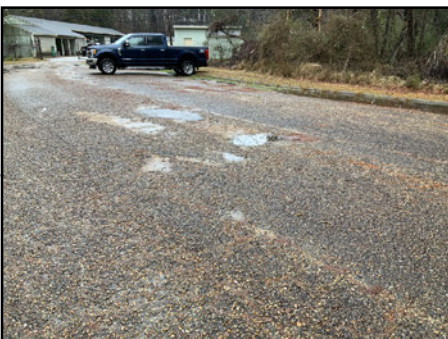
ROUTE 0999: YORKTOWN MAINTENANCE PARKING

Inspection Date	FMSS Number	User Access	Surface Type
2/19/2021	56284	NONPUBLIC	ASPHALT
Area (Sq. Ft.)	Lane Miles (11' Widths)	Curb Reveal (Inches)	Curb Recommendation
205,715	3.542	NOT APPLICABLE	NOT APPLICABLE
Curb Type		Curb & Gutter Type	
NO CURB		NO CURB AND GUTTER	
Pavement Recommendation		Condition Rating / PCR	
LIGHT 3R TREATMENTS		FAIR / 73

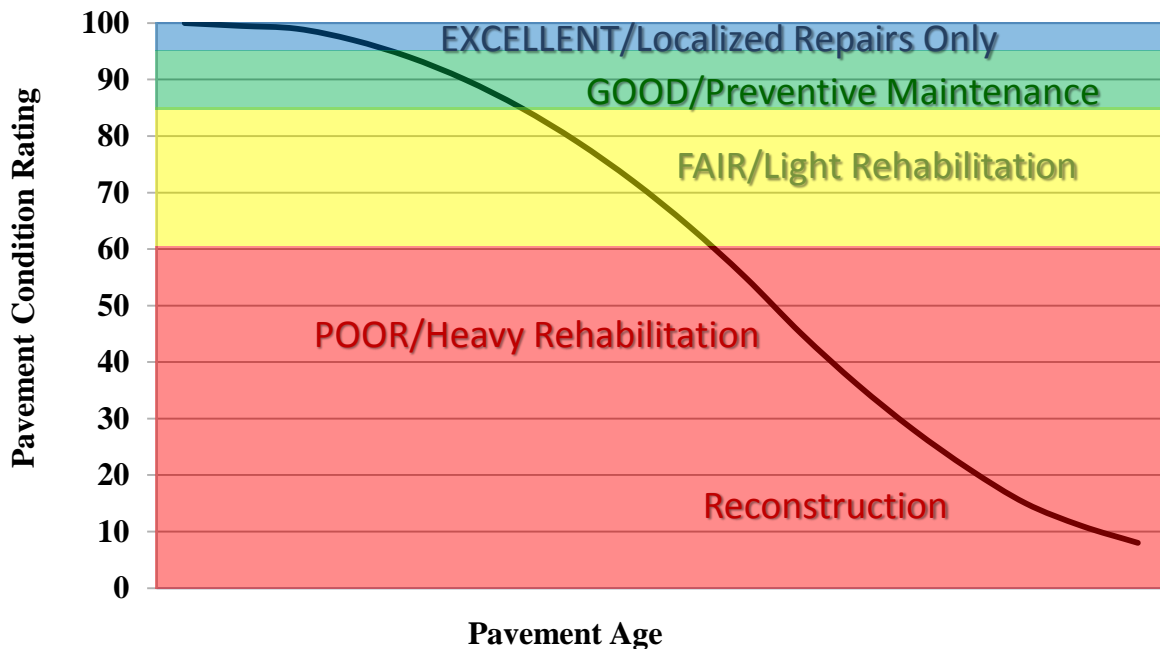
Condition Categories and Treatments

Description of Pavement Treatment Types

1. **Preventive Maintenance** is a planned strategy of cost-effective treatments to an existing roadway system and its appurtenances that preserves the system, retards future deterioration, and maintains or improves the functional condition of the system (without significantly increasing the structural capacity). Preventive maintenance is typically applied to pavements in good condition having significant remaining service life. As a major component of pavement preservation, preventive maintenance is a strategy of extending the service life by applying cost-effective treatments to the surface or near-surface of structurally sound pavements. Examples of preventive treatments include asphalt crack sealing, chip sealing, slurry or micro-surfacing, thin and ultra-thin hot-mix asphalt overlay, concrete joint sealing, diamond grinding, dowel-bar retrofit, and isolated, partial and/or full-depth concrete repairs to restore functionality of individual slabs.
