Road Inventory and Condition Assessment of Paved Routes Curecanti National Recreation Area

**Federal Lands Highway
Road Inventory Program**

**Federal Highway Administration
Eastern Federal Lands Highway Division
Road Inventory Program (RIP)**

Report Date: November 2015

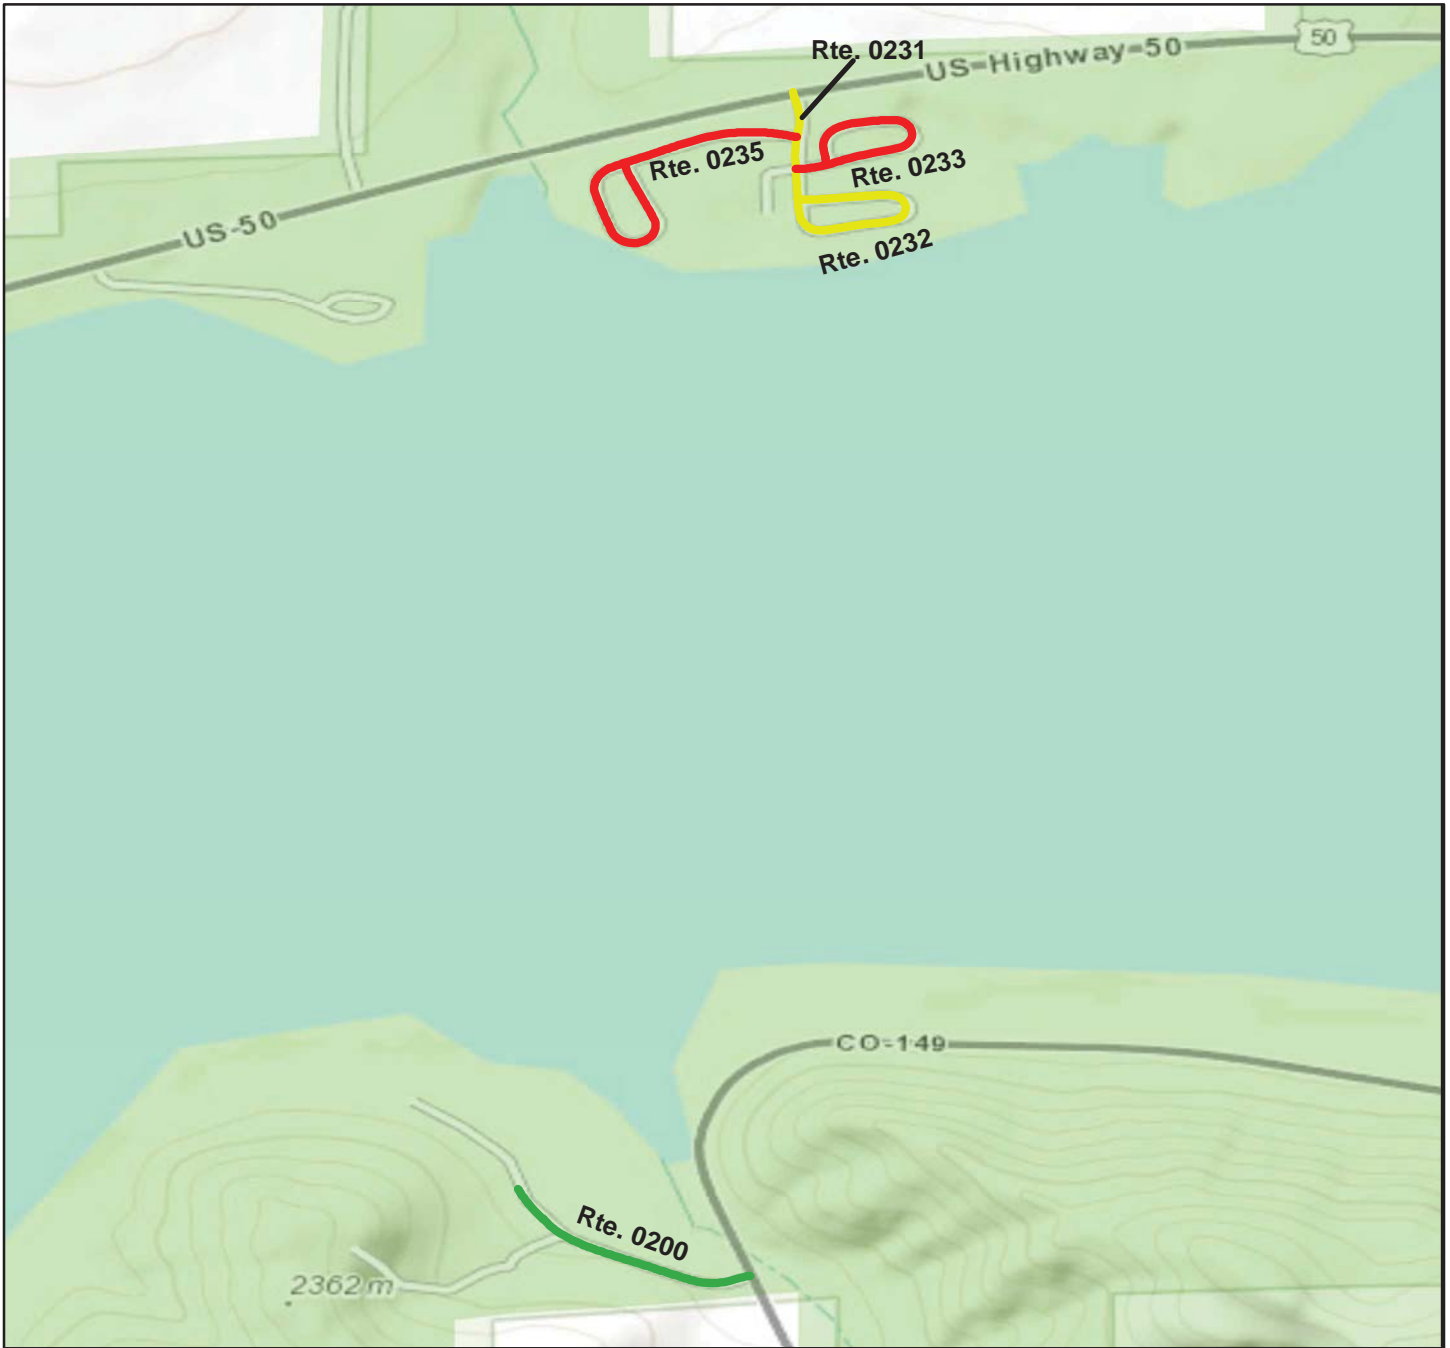
Area Map 1A

ROUTE CONDITION MAP

PCR - MILE BY MILE

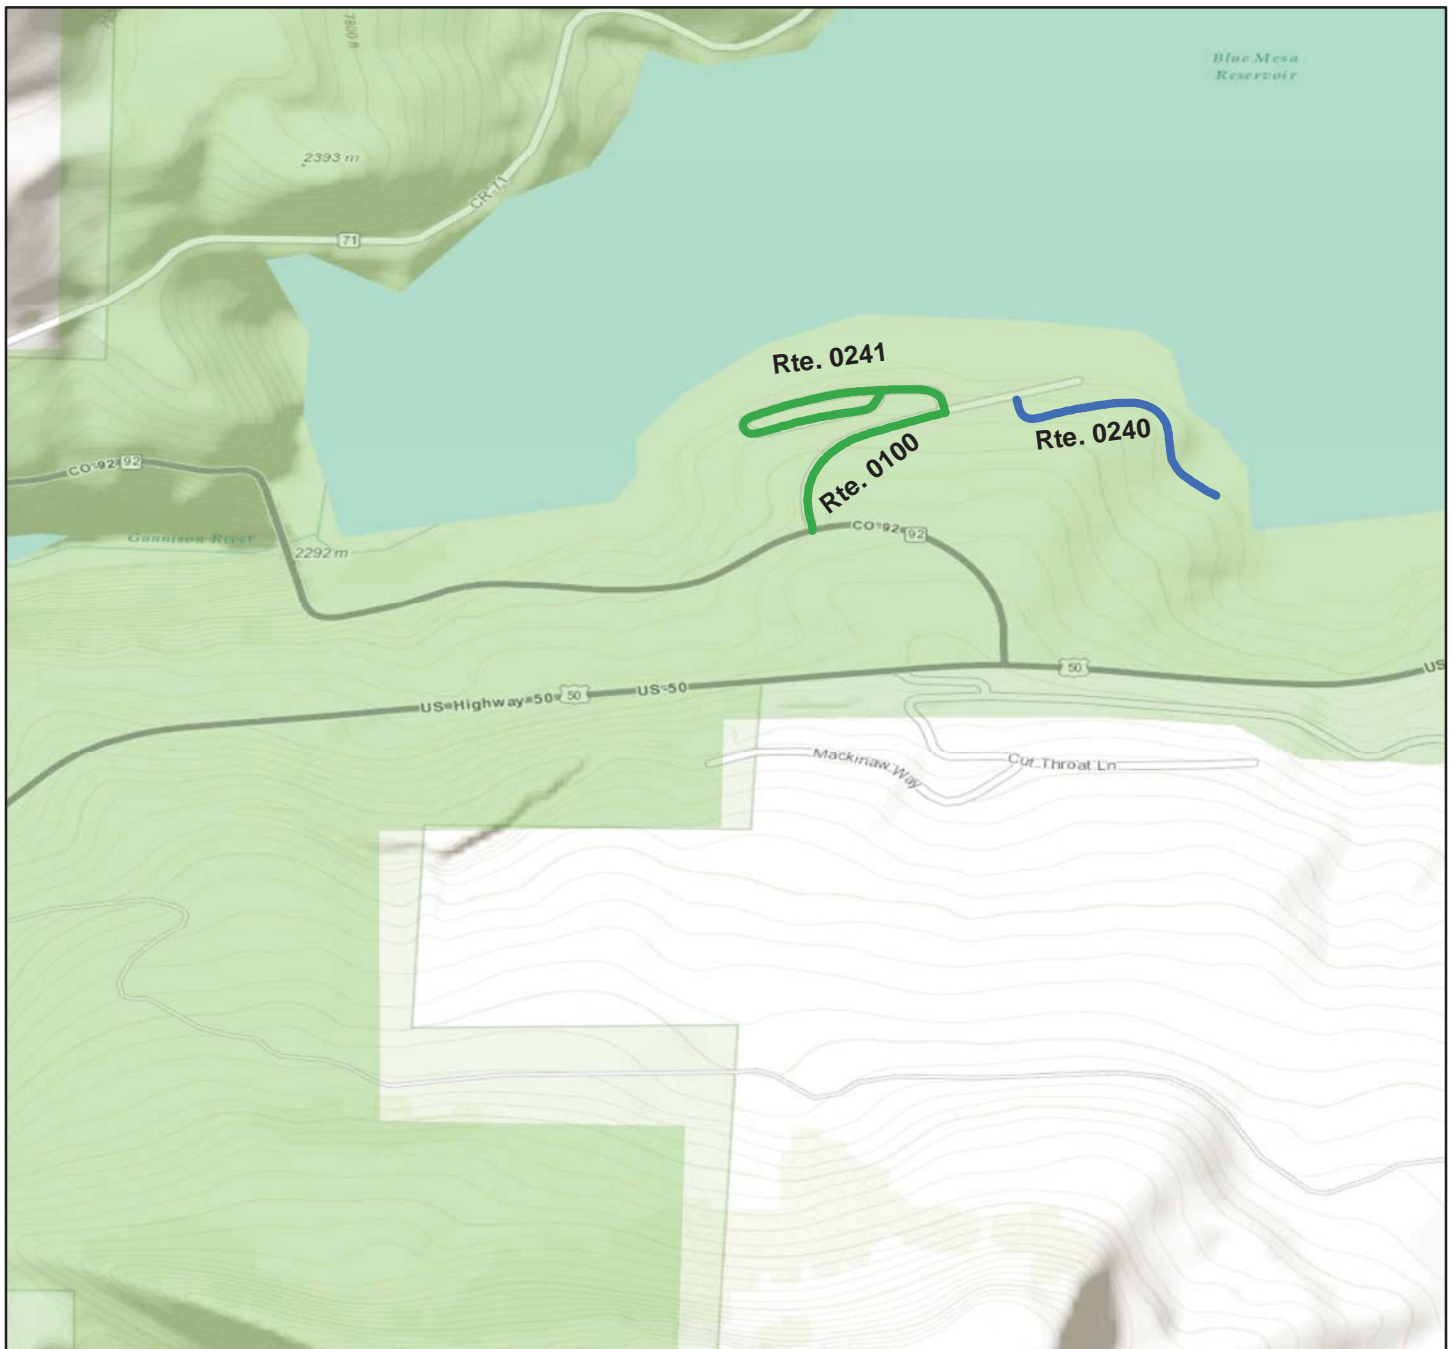
Area Map 3B

ROUTE CONDITION MAP

PCR - MILE BY MILE

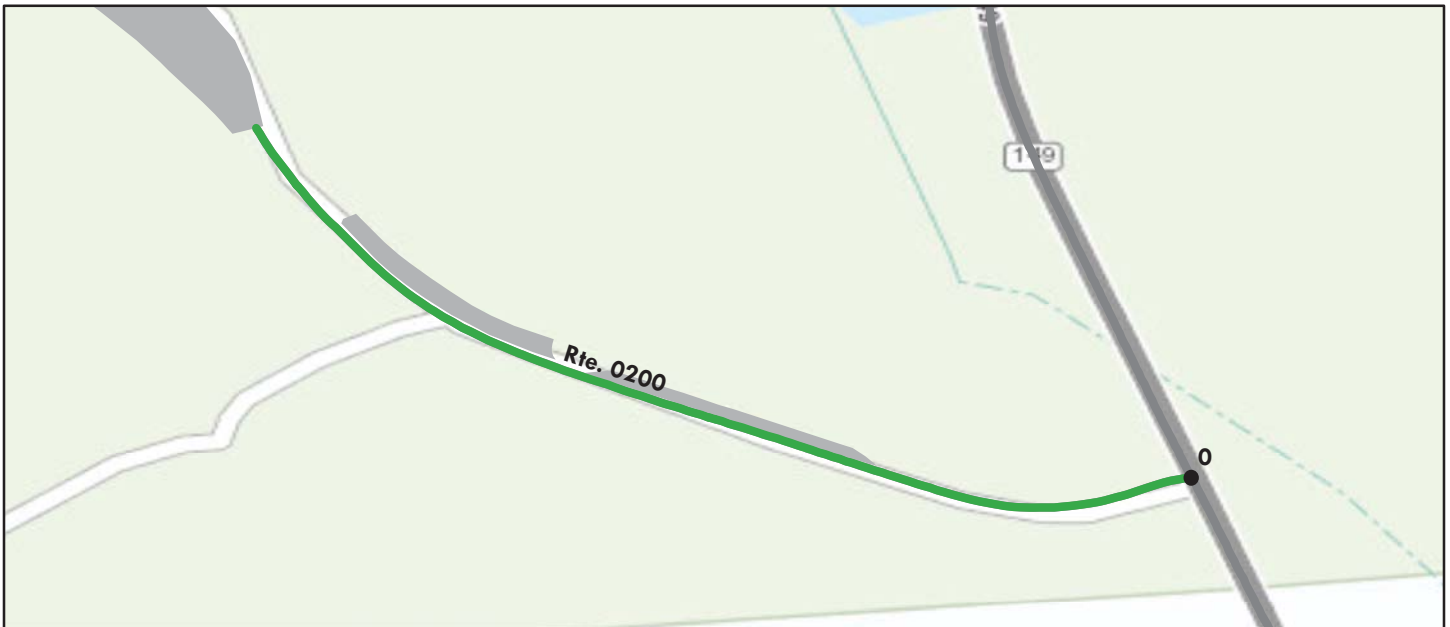
ROUTE 0200: IOLA ROAD

Data Collection Vehicle (DCV) Rating

Route Condition Legend – Pavement Condition Rating (PCR)						
Poor (0 - 60)	Fair (61- 84)	Good (85 - 94)	Excellent (95 - 100)	Not Rated		
See Appendix for definitions and formulas						
Inspection Date: 5/14/2015	Beginning Section MP	0				
Paved Length (Miles): 0.22	Section Length (MI)	0.22				
Surface Type: ASPHALT	Route Summary					
Roadway Condition Information						
Pavement Condition Rating (PCR)	89	89				
Surface Condition Rating (SCR)	89	89				
Roughness Condition Index (RCI)	N/A	N/A				
Distress Index Values						
Structural Crack Index	96	96				
Alligator Crack Index	100	100				
Longitudinal Crack Index	96	96				
Transverse Cracking Index	89	89				
Patching Index	100	100				
Rutting Index	99	99				
International Roughness Index (IRI)	N/A	N/A				
Lane & Width Information						
Number of Lanes	2	2				
Paved Width (ft)	21.2	21.2				
Lane Width (ft)	9.3	9.3

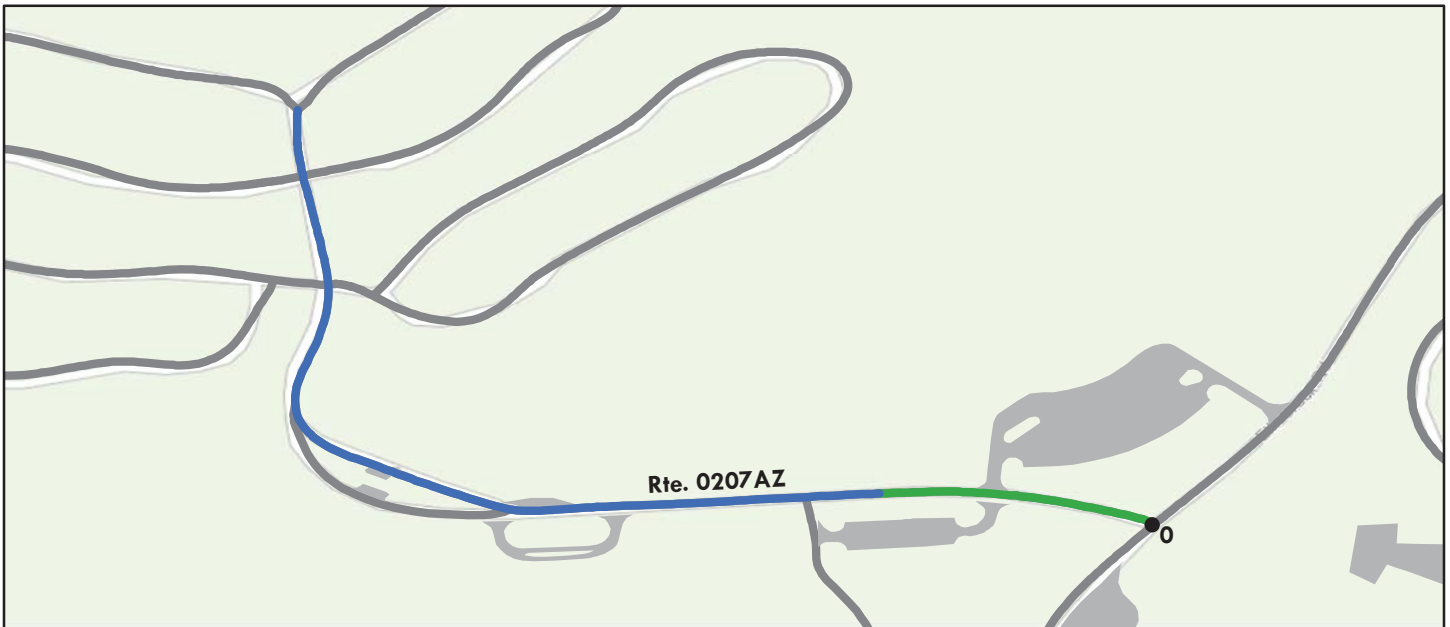
ROUTE 0207AZ: ELK CREEK CAMPGROUND ROAD A

Subcomponent of Route CURE-0207ZZ
Data Collection Vehicle (DCV) Rating

Route Condition Legend – Pavement Condition Rating (PCR)						
Poor (0 - 60)	Fair (61- 84)	Good (85 - 94)	Excellent (95 - 100)	Not Rated		
See Appendix for definitions and formulas						
Inspection Date: 5/14/2015	Beginning Section MP	0				
Paved Length (Miles): 0.46	Section Length (MI)	0.46				
Surface Type: ASPHALT	Route Summary					
Roadway Condition Information						
Pavement Condition Rating (PCR)	97	97				
Surface Condition Rating (SCR)	97	97				
Roughness Condition Index (RCI)	N/A	N/A				
Distress Index Values						
Structural Crack Index	99	99				
Alligator Crack Index	100	100				
Longitudinal Crack Index	99	99				
Transverse Cracking Index	97	97				
Patching Index	100	100				
Rutting Index	99	99				
International Roughness Index (IRI)	N/A	N/A				
Lane & Width Information						
Number of Lanes	2	2				
Paved Width (ft)	21.3	21.3				
Lane Width (ft)	9.3	9.3

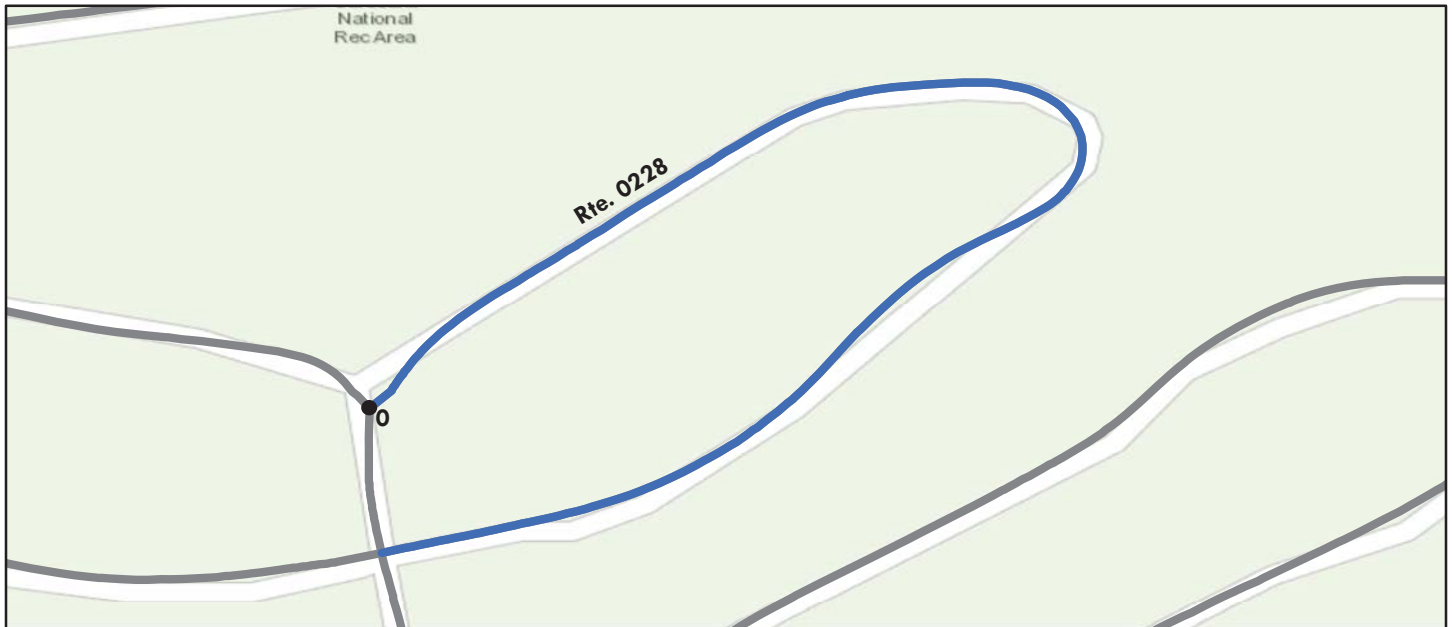
ROUTE 0228: ELK CREEK CAMPGROUND LOOP C

Data Collection Vehicle (DCV) Rating

Route Condition Legend – Pavement Condition Rating (PCR)						
Poor (0 - 60)	Fair (61- 84)	Good (85 - 94)	Excellent (95 - 100)	Not Rated		
See Appendix for definitions and formulas						
Inspection Date: 5/14/2015	Beginning Section MP	0				
Paved Length (Miles): 0.29	Section Length (MI)	0.29				
Surface Type: ASPHALT	Route Summary					
Roadway Condition Information						
Pavement Condition Rating (PCR)	98	98				
Surface Condition Rating (SCR)	98	98				
Roughness Condition Index (RCI)	N/A	N/A				
Distress Index Values						
Structural Crack Index	98	98				
Alligator Crack Index	100	100				
Longitudinal Crack Index	98	98				
Transverse Cracking Index	98	98				
Patching Index	100	100				
Rutting Index	98	98				
International Roughness Index (IRI)	N/A	N/A				
Lane & Width Information						
Number of Lanes	1	1				
Paved Width (ft)	14	14				
Lane Width (ft)	14	14

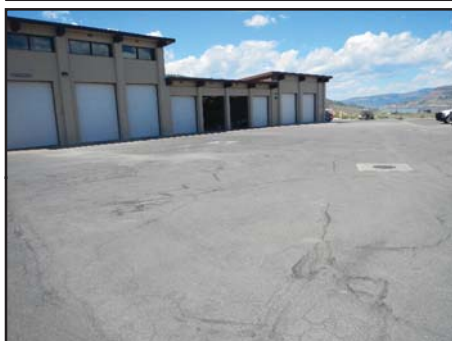
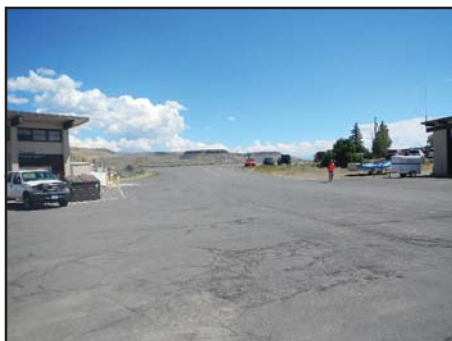
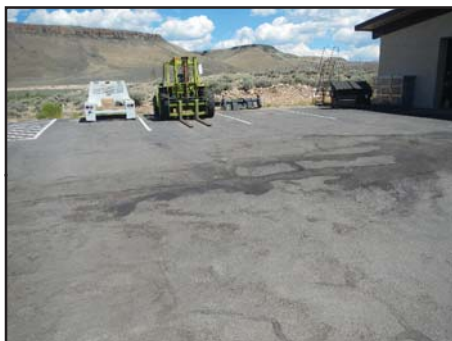
ROUTE 0901: EMPLOYEE PARKING

Inspection Date	FMSS Number	User Access	Surface Type
8/7/2014	90854	NONPUBLIC	ASPHALT
Area (Sq. Ft.)	Lane Miles (11' Widths)	Curb Reveal (Inches)	Curb Recommendation
5,750	0.099	NOT APPLICABLE	NOT APPLICABLE
Curb Type		Curb & Gutter Type	
NO CURB		NO CURB AND GUTTER	
Pavement Recommendation		Condition Rating / PCR	
LIGHT 3R TREATMENTS		FAIR / 73

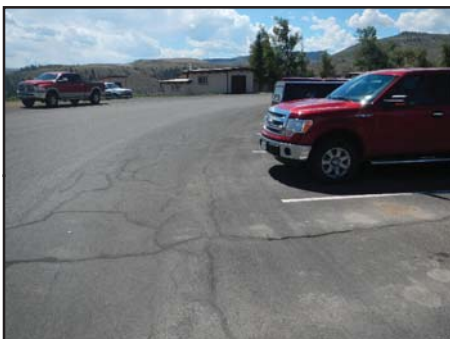
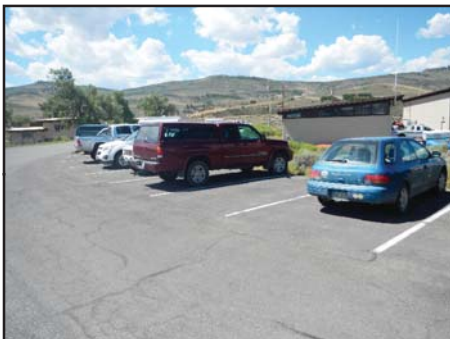
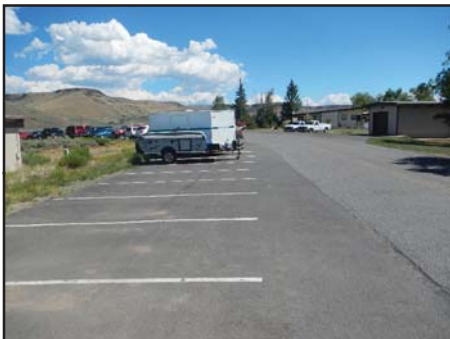
ROUTE 0902A: EC6 PARKING

Inspection Date	FMSS Number	User Access	Surface Type
8/7/2014	103038	NONPUBLIC	ASPHALT
Area (Sq. Ft.)	Lane Miles (11' Widths)	Curb Reveal (Inches)	Curb Recommendation
2,415	0.042	NOT APPLICABLE	NOT APPLICABLE
Curb Type		Curb & Gutter Type	
NO CURB		NO CURB AND GUTTER	
Pavement Recommendation		Condition Rating / PCR	
HEAVY 3R TREATMENTS		POOR / 53

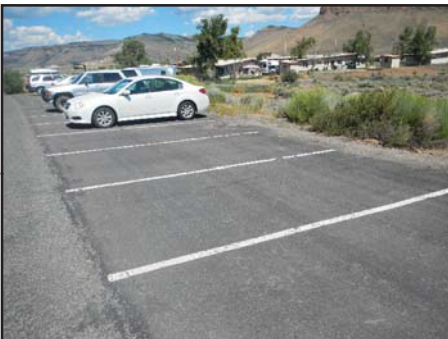
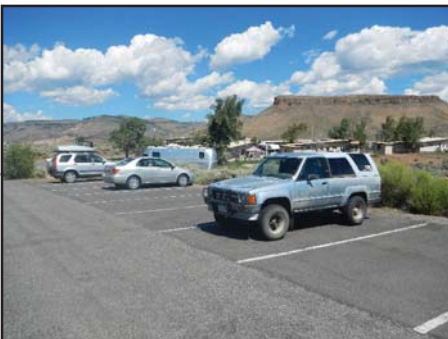
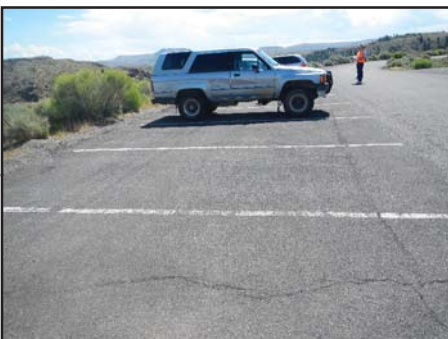
ROUTE 0902B: EC7 PARKING

Inspection Date	FMSS Number	User Access	Surface Type
8/7/2014	103036	NONPUBLIC	ASPHALT
Area (Sq. Ft.)	Lane Miles (11' Widths)	Curb Reveal (Inches)	Curb Recommendation
1,828	0.031	NOT APPLICABLE	NOT APPLICABLE
Curb Type		Curb & Gutter Type	
NO CURB		NO CURB AND GUTTER	
Pavement Recommendation		Condition Rating / PCR	
HEAVY 3R TREATMENTS		POOR / 53

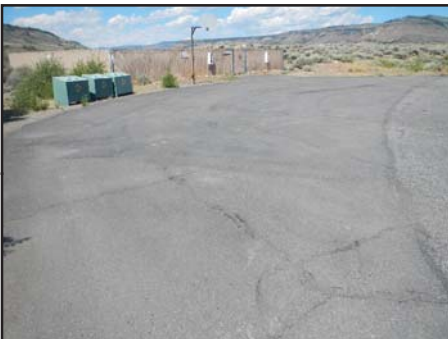
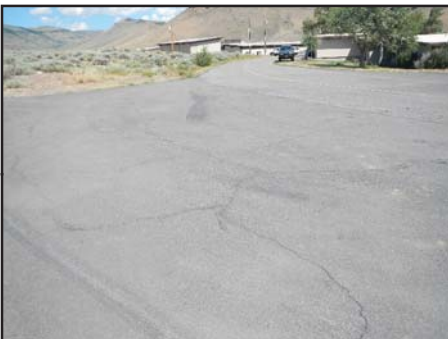
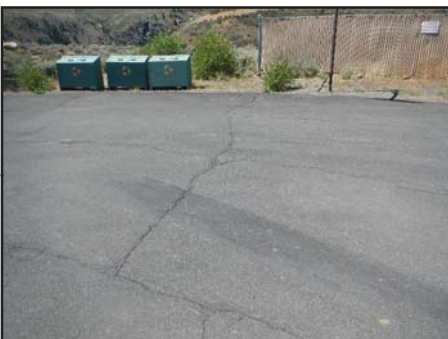
ROUTE 0902E: EC1 PARKING

Inspection Date	FMSS Number	User Access	Surface Type
8/7/2014	238302	NONPUBLIC	ASPHALT
Area (Sq. Ft.)	Lane Miles (11' Widths)	Curb Reveal (Inches)	Curb Recommendation
11,268	0.194	NOT APPLICABLE	NOT APPLICABLE
Curb Type		Curb & Gutter Type	
NO CURB		NO CURB AND GUTTER	
Pavement Recommendation		Condition Rating / PCR	
PREVENTIVE MAINTENANCE		GOOD / 90

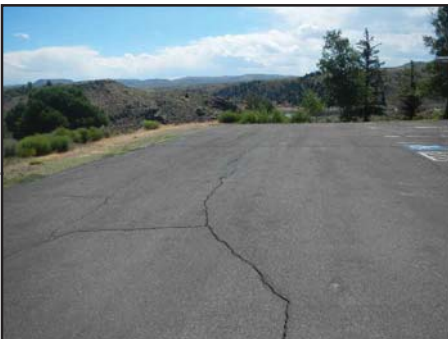
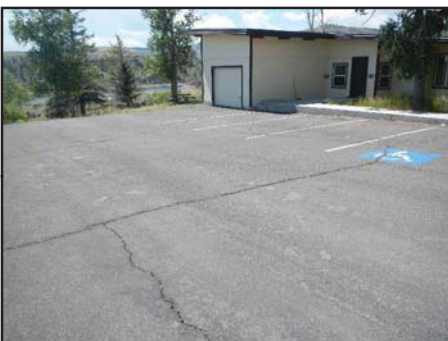
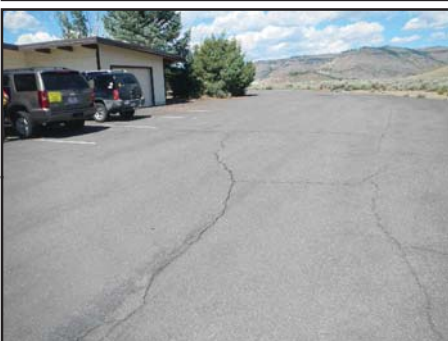
ROUTE 0903: VISITOR CENTER PARKING

Inspection Date	FMSS Number	User Access	Surface Type
8/7/2014	90856	PUBLIC	ASPHALT
Area (Sq. Ft.)	Lane Miles (11' Widths)	Curb Reveal (Inches)	Curb Recommendation
75,229	1.295	NOT APPLICABLE	LIGHT REPAIR
Curb Type		Curb & Gutter Type	
NO CURB		CONCRETE	
Pavement Recommendation		Condition Rating / PCR	
PREVENTIVE MAINTENANCE		GOOD / 90

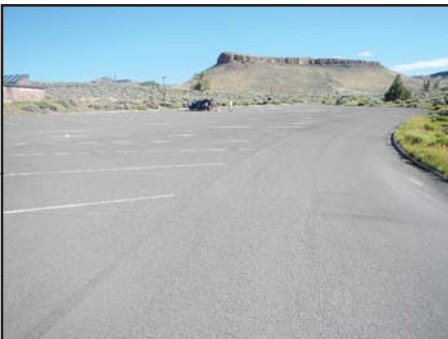
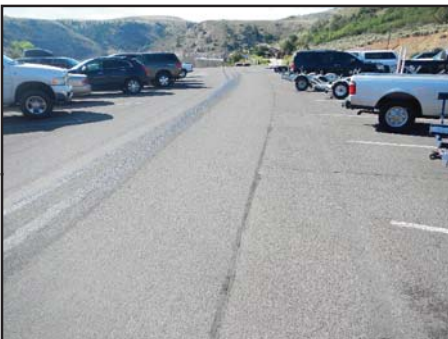
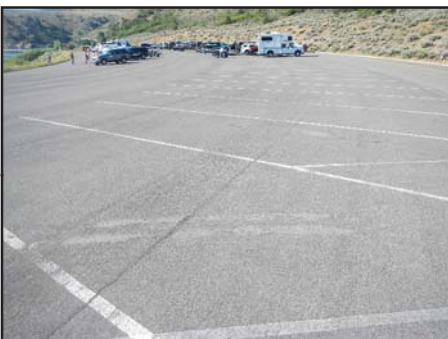
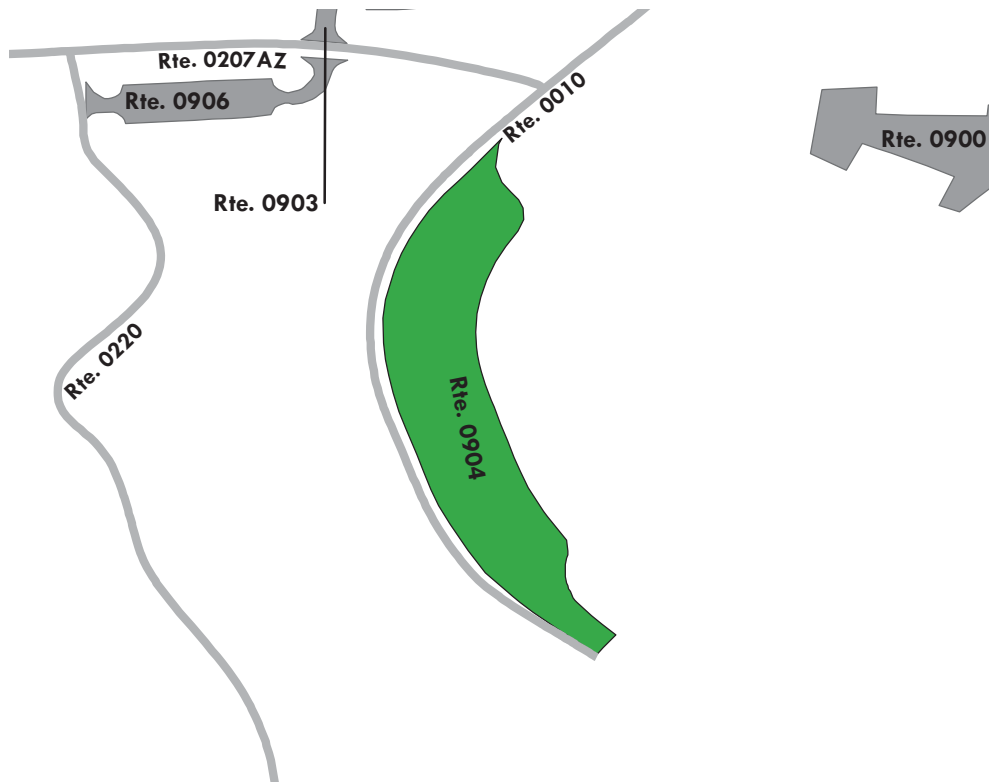
ROUTE 0906: ELK CREEK PICNIC AREA PARKING

Inspection Date	FMSS Number	User Access	Surface Type
8/7/2014	90858	PUBLIC	ASPHALT
Area (Sq. Ft.)	Lane Miles (11' Widths)	Curb Reveal (Inches)	Curb Recommendation
18,514	0.319	NOT APPLICABLE	DO NOTHING
Curb Type		Curb & Gutter Type	
NO CURB		CONCRETE	
Pavement Recommendation		Condition Rating / PCR	
PREVENTIVE MAINTENANCE		GOOD / 90

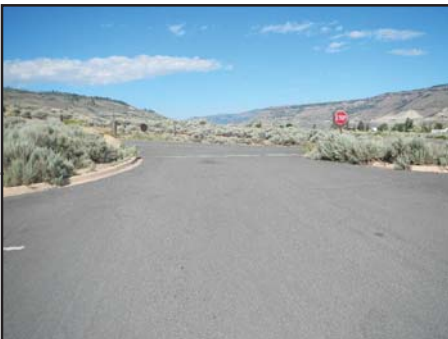
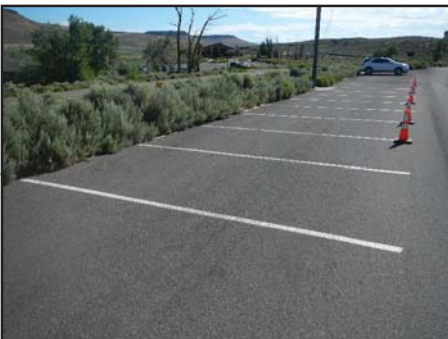
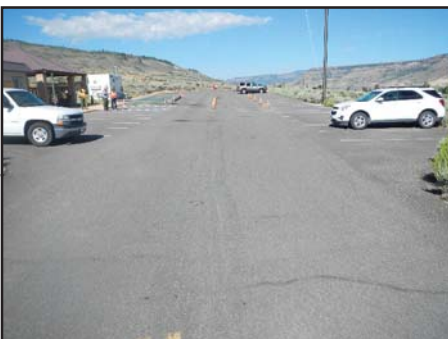
ROUTE 0907: RV SEWER DUMP STATION

Inspection Date	FMSS Number	User Access	Surface Type
8/7/2014	90859	PUBLIC	ASPHALT
Area (Sq. Ft.)	Lane Miles (11' Widths)	Curb Reveal (Inches)	Curb Recommendation
8,438	0.145	NOT APPLICABLE	DO NOTHING
Curb Type		Curb & Gutter Type	
NO CURB		CONCRETE	
Pavement Recommendation		Condition Rating / PCR	
PREVENTIVE MAINTENANCE		GOOD / 90

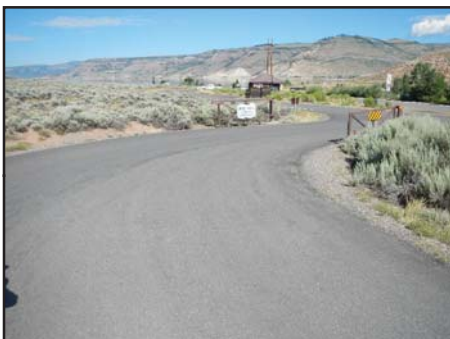
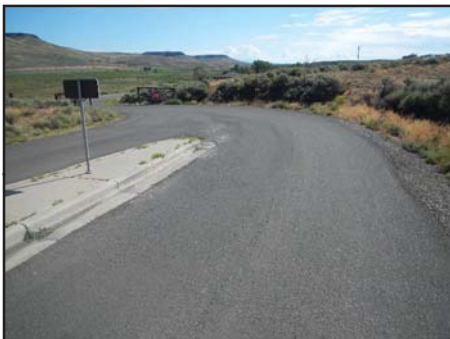
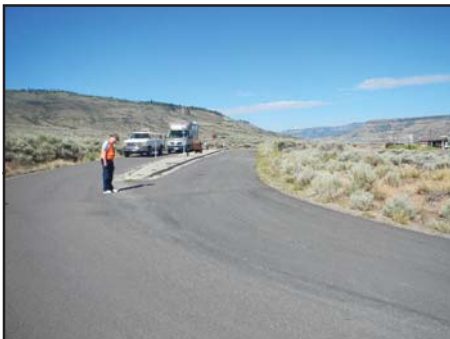
ROUTE 0908: WASH STATION

Inspection Date	FMSS Number	User Access	Surface Type
8/7/2014	90860	PUBLIC	ASPHALT
Area (Sq. Ft.)	Lane Miles (11' Widths)	Curb Reveal (Inches)	Curb Recommendation
2,067	0.036	NOT APPLICABLE	NOT APPLICABLE
Curb Type		Curb & Gutter Type	
NO CURB		NO CURB AND GUTTER	
Pavement Recommendation		Condition Rating / PCR	
PREVENTIVE MAINTENANCE		GOOD / 90

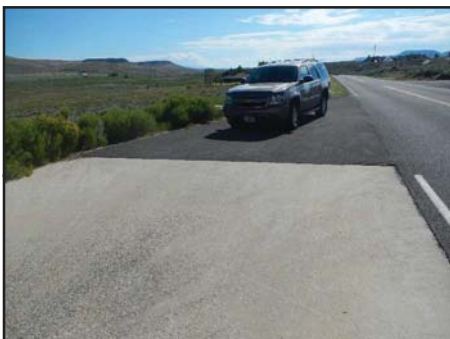
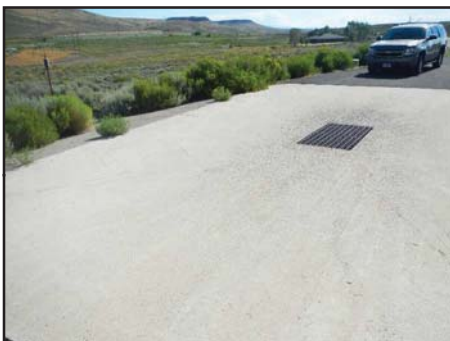
ROUTE 0909A: KIOSK PARKING A

Multiple Surface Types (Asphalt = 1138 Sf, Concrete = 929 Sf)

Inspection Date	FMSS Number	User Access	Surface Type
8/7/2014	103034	NONPUBLIC	ASPHALT
Area (Sq. Ft.)	Lane Miles (11' Widths)	Curb Reveal (Inches)	Curb Recommendation
1,230	0.021	NOT APPLICABLE	DO NOTHING
Curb Type		Curb & Gutter Type	
NO CURB		CONCRETE	
Pavement Recommendation		Condition Rating / PCR	
PREVENTIVE MAINTENANCE		GOOD / 90

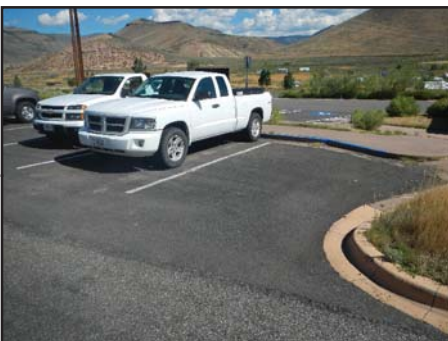
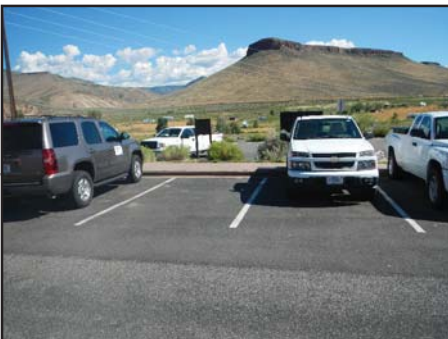
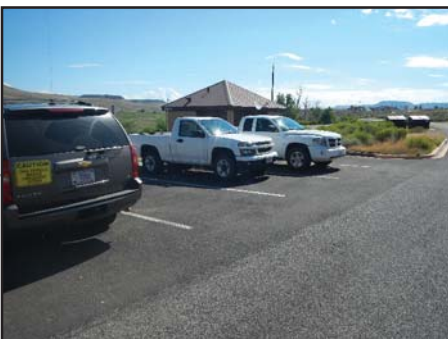
ROUTE 0909B: KIOSK PARKING B

Inspection Date	FMSS Number	User Access	Surface Type
8/7/2014	90861	NONPUBLIC	ASPHALT
Area (Sq. Ft.)	Lane Miles (11' Widths)	Curb Reveal (Inches)	Curb Recommendation
833	0.014	NOT APPLICABLE	DO NOTHING
Curb Type		Curb & Gutter Type	
NO CURB		CONCRETE	
Pavement Recommendation		Condition Rating / PCR	
PREVENTIVE MAINTENANCE		GOOD / 90

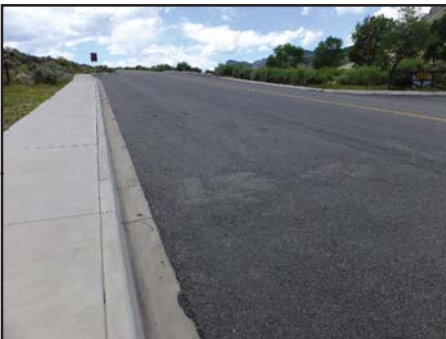
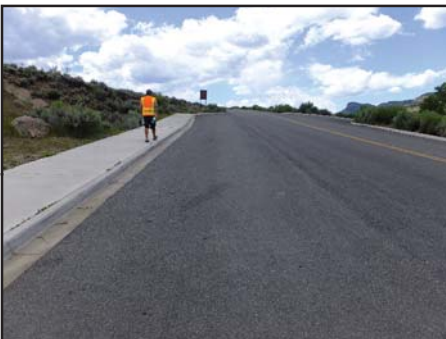
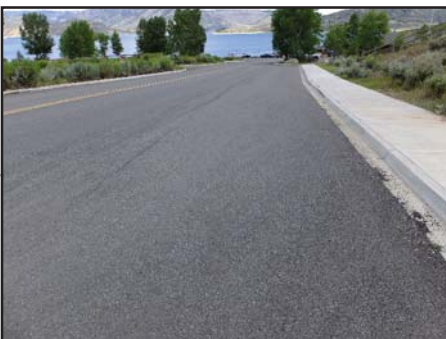
ROUTE 0910B: LAKE FORK VISITOR CENTER PARKING B

Inspection Date	FMSS Number	User Access	Surface Type
8/7/2014	103039	PUBLIC	ASPHALT
Area (Sq. Ft.)	Lane Miles (11' Widths)	Curb Reveal (Inches)	Curb Recommendation
1,963	0.034	NOT APPLICABLE	DO NOTHING
Curb Type		Curb & Gutter Type	
NO CURB		CONCRETE	
Pavement Recommendation		Condition Rating / PCR	
PREVENTIVE MAINTENANCE		GOOD / 90

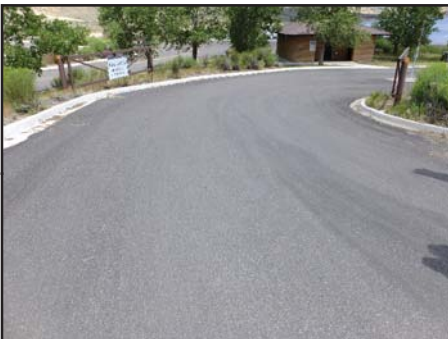
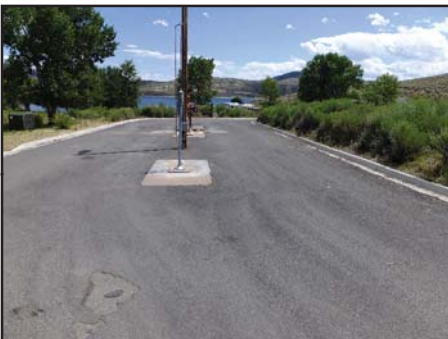
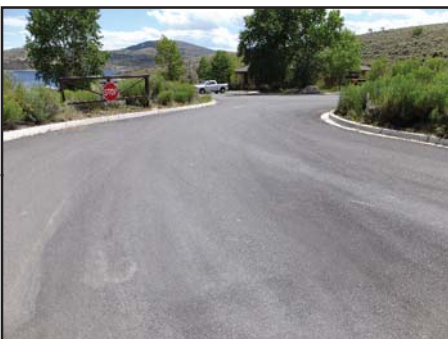
ROUTE 0912: LAKE FORK LOWER CAMPGROUND LOOP PARKING

Inspection Date	FMSS Number	User Access	Surface Type
8/7/2014	90864	PUBLIC	ASPHALT
Area (Sq. Ft.)	Lane Miles (11' Widths)	Curb Reveal (Inches)	Curb Recommendation
1,604	0.028	NOT APPLICABLE	DO NOTHING
Curb Type		Curb & Gutter Type	
NO CURB		CONCRETE	
Pavement Recommendation		Condition Rating / PCR	
PREVENTIVE MAINTENANCE		GOOD / 90

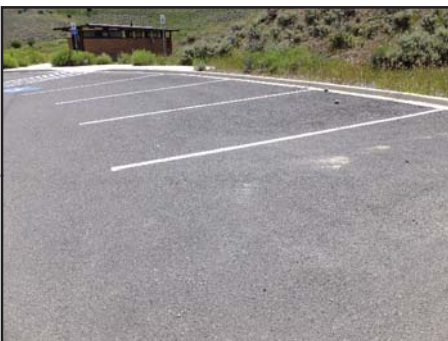
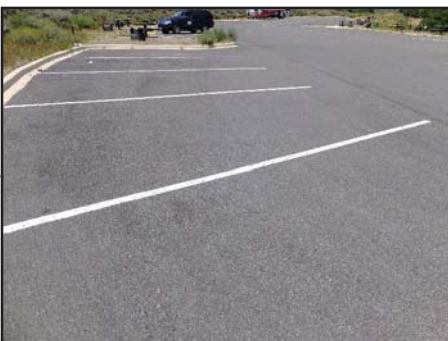
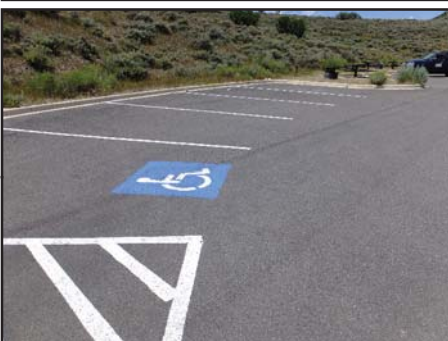
ROUTE 0914A: LAKE FORK MARINA PARKING A

Inspection Date	FMSS Number	User Access	Surface Type
8/7/2014	90866	PUBLIC	ASPHALT
Area (Sq. Ft.)	Lane Miles (11' Widths)	Curb Reveal (Inches)	Curb Recommendation
62,328	1.073	NOT APPLICABLE	DO NOTHING
Curb Type		Curb & Gutter Type	
NO CURB		CONCRETE	
Pavement Recommendation		Condition Rating / PCR	
PREVENTIVE MAINTENANCE		GOOD / 90

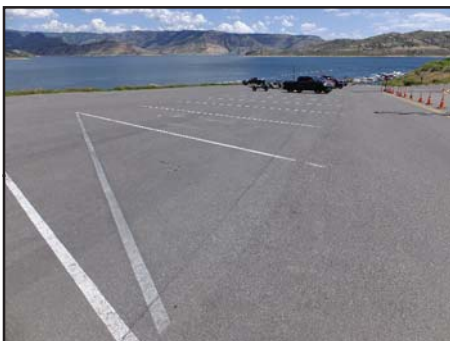
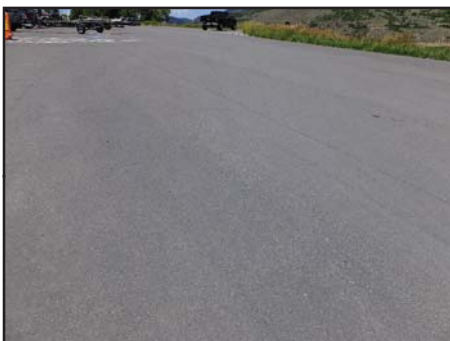
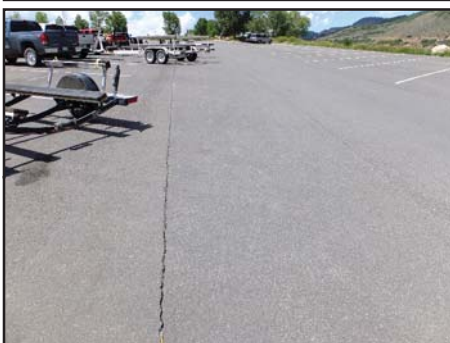
ROUTE 0914B: LAKE FORK MARINA PARKING B

Inspection Date	FMSS Number	User Access	Surface Type
8/7/2014	103021	PUBLIC	ASPHALT
Area (Sq. Ft.)	Lane Miles (11' Widths)	Curb Reveal (Inches)	Curb Recommendation
18,583	0.32	NOT APPLICABLE	DO NOTHING
Curb Type		Curb & Gutter Type	
NO CURB		CONCRETE	
Pavement Recommendation		Condition Rating / PCR	
PREVENTIVE MAINTENANCE		GOOD / 90

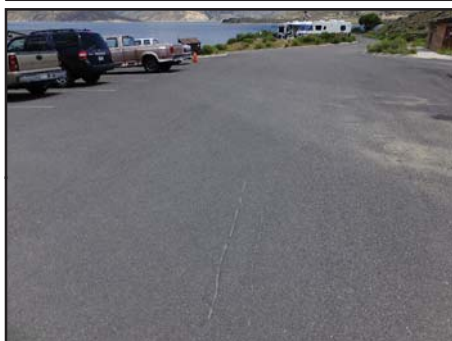
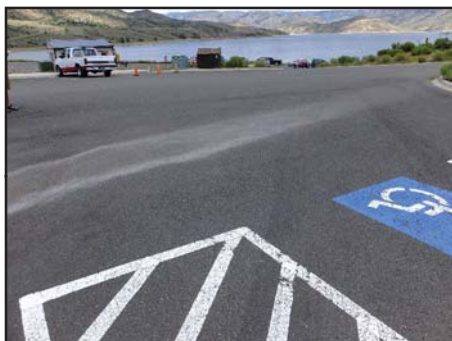
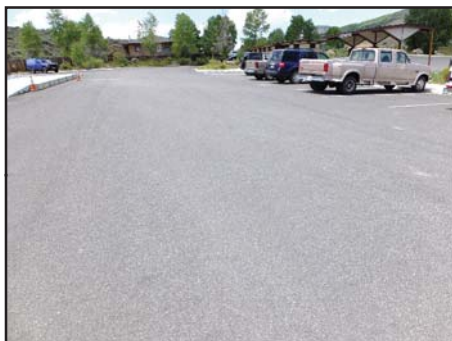
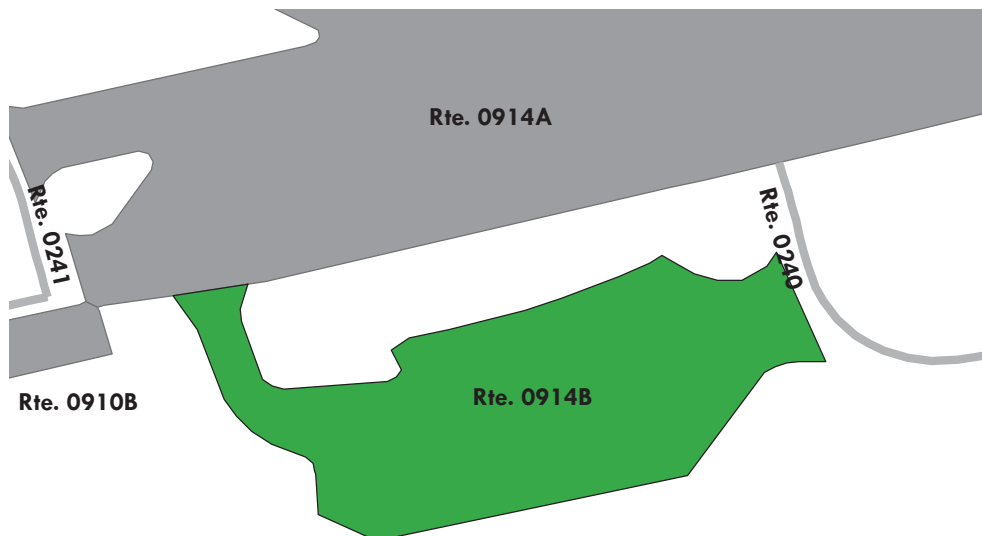
ROUTE 0915: LAKE FORK HANDICAP PARKING

Inspection Date	FMSS Number	User Access	Surface Type
8/7/2014	90867	PUBLIC	ASPHALT
Area (Sq. Ft.)	Lane Miles (11' Widths)	Curb Reveal (Inches)	Curb Recommendation
783	0.013	NOT APPLICABLE	DO NOTHING
Curb Type		Curb & Gutter Type	
NO CURB		CONCRETE	
Pavement Recommendation		Condition Rating / PCR	
PREVENTIVE MAINTENANCE		GOOD / 90

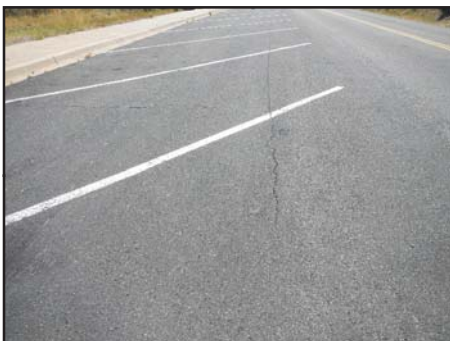
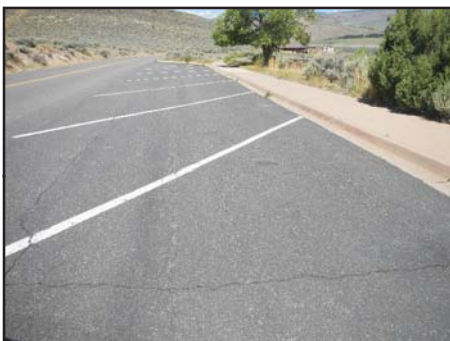
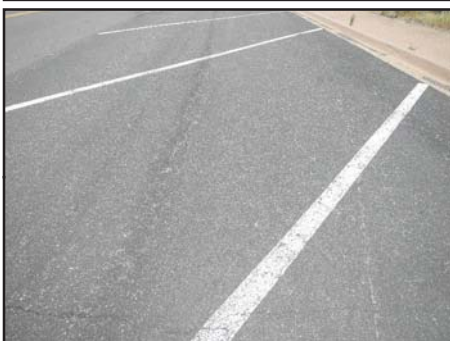
ROUTE 0916B: IOLA PARKING B

Inspection Date	FMSS Number	User Access	Surface Type
8/7/2014	75851	PUBLIC	ASPHALT
Area (Sq. Ft.)	Lane Miles (11' Widths)	Curb Reveal (Inches)	Curb Recommendation
4,178	0.072	NOT APPLICABLE	DO NOTHING
Curb Type		Curb & Gutter Type	
NO CURB		CONCRETE	
Pavement Recommendation		Condition Rating / PCR	
PREVENTIVE MAINTENANCE		GOOD / 90

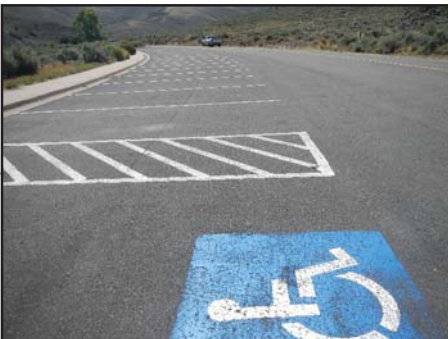
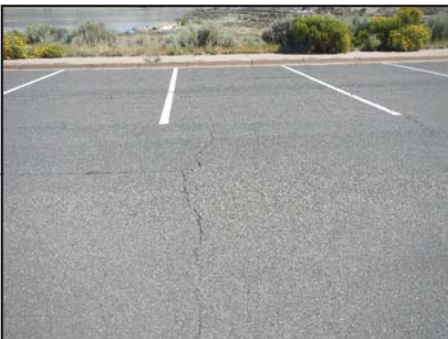
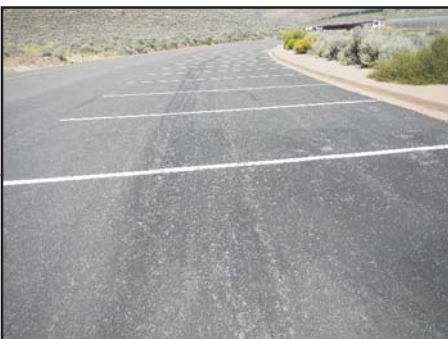
ROUTE 0917: IOLA BOAT PARKING

Inspection Date	FMSS Number	User Access	Surface Type
8/7/2014	90868	PUBLIC	ASPHALT
Area (Sq. Ft.)	Lane Miles (11' Widths)	Curb Reveal (Inches)	Curb Recommendation
60,843	1.048	NOT APPLICABLE	NOT APPLICABLE
Curb Type		Curb & Gutter Type	
NO CURB		NO CURB AND GUTTER	
Pavement Recommendation		Condition Rating / PCR	
HEAVY 3R TREATMENTS		POOR / 53

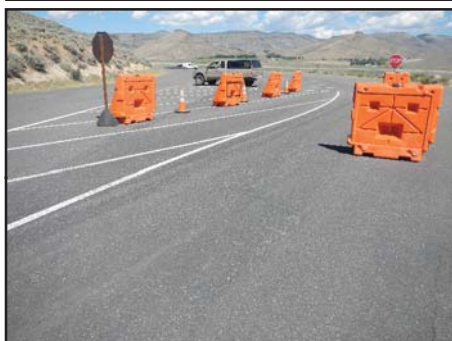
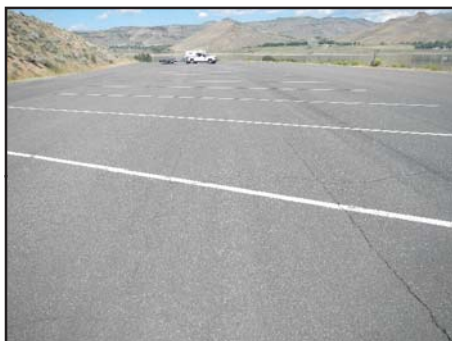
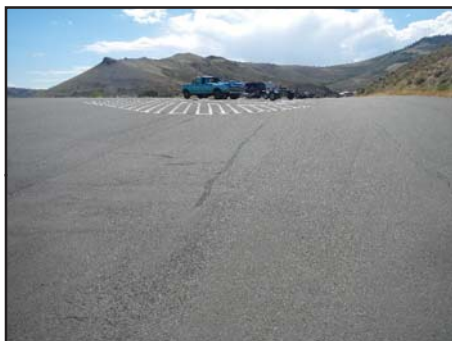
ROUTE 0918: NEVERSINK PARKING

Inspection Date	FMSS Number	User Access	Surface Type
8/7/2014	90869	PUBLIC	ASPHALT
Area (Sq. Ft.)	Lane Miles (11' Widths)	Curb Reveal (Inches)	Curb Recommendation
20,555	0.354	NOT APPLICABLE	NOT APPLICABLE
Curb Type		Curb & Gutter Type	
NO CURB		NO CURB AND GUTTER	
Pavement Recommendation		Condition Rating / PCR	
PREVENTIVE MAINTENANCE		GOOD / 90

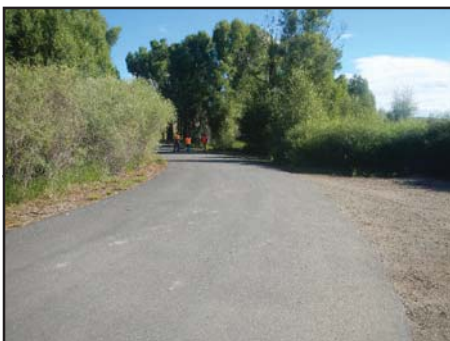
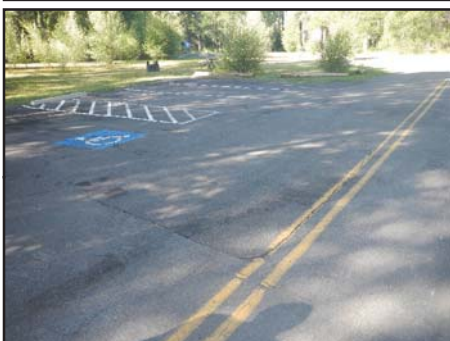
ROUTE 0919: COOPER RANCH PARKING

Inspection Date	FMSS Number	User Access	Surface Type
8/7/2014	90870	PUBLIC	ASPHALT
Area (Sq. Ft.)	Lane Miles (11' Widths)	Curb Reveal (Inches)	Curb Recommendation
36,113	0.622	NOT APPLICABLE	NOT APPLICABLE
Curb Type		Curb & Gutter Type	
NO CURB		NO CURB AND GUTTER	
Pavement Recommendation		Condition Rating / PCR	
HEAVY 3R TREATMENTS		POOR / 53

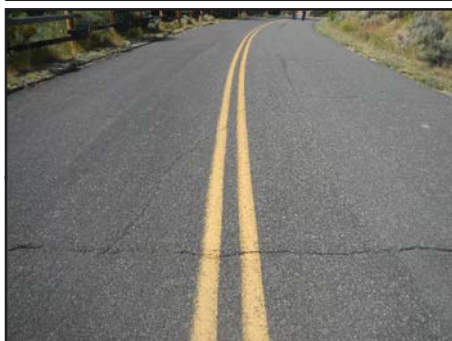
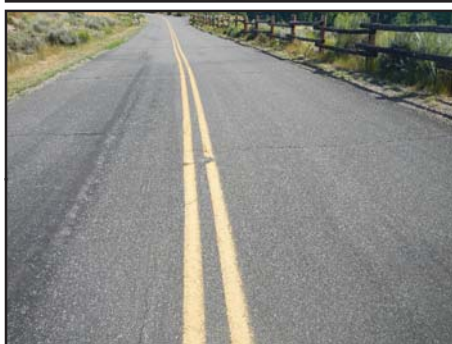
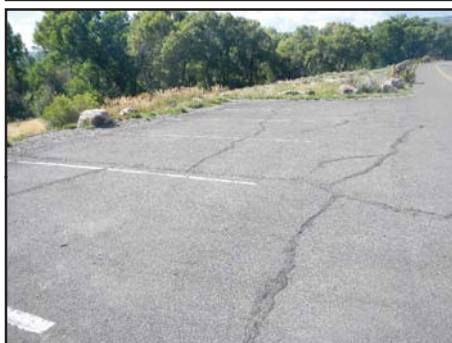
ROUTE 0920: NEW STEVENS CREEK PARKING

Inspection Date	FMSS Number	User Access	Surface Type
8/7/2014	90871	PUBLIC	ASPHALT
Area (Sq. Ft.)	Lane Miles (11' Widths)	Curb Reveal (Inches)	Curb Recommendation
27,844	0.479	NOT APPLICABLE	NOT APPLICABLE
Curb Type		Curb & Gutter Type	
NO CURB		NO CURB AND GUTTER	
Pavement Recommendation		Condition Rating / PCR	
HEAVY 3R TREATMENTS		POOR / 53

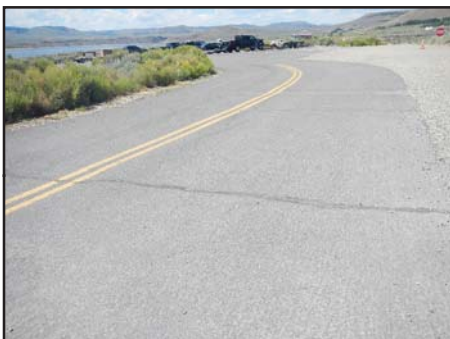
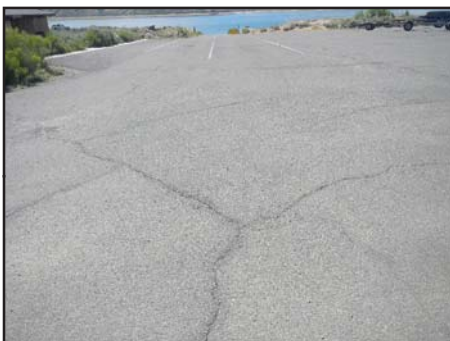
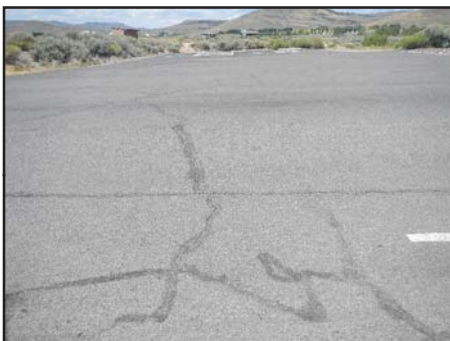
ROUTE 0921: OLD STEVENS CREEK PARKING

Inspection Date	FMSS Number	User Access	Surface Type
8/7/2014	90872	PUBLIC	ASPHALT
Area (Sq. Ft.)	Lane Miles (11' Widths)	Curb Reveal (Inches)	Curb Recommendation
44,088	0.759	NOT APPLICABLE	NOT APPLICABLE
Curb Type		Curb & Gutter Type	
NO CURB		NO CURB AND GUTTER	
Pavement Recommendation		Condition Rating / PCR	
PREVENTIVE MAINTENANCE		GOOD / 90

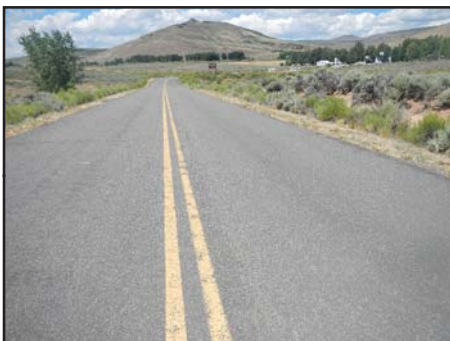
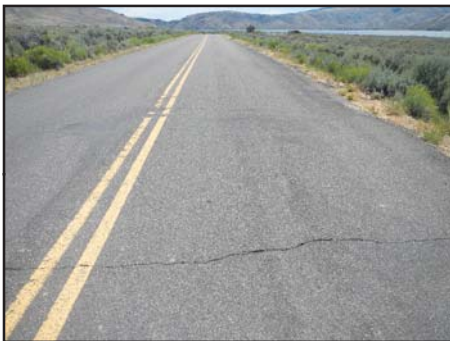
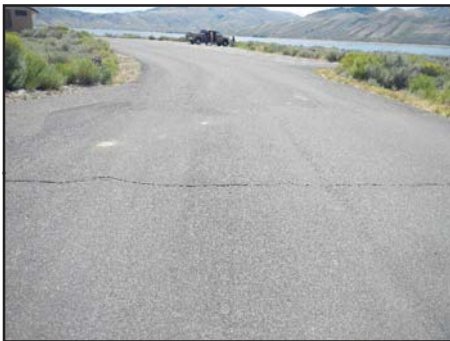
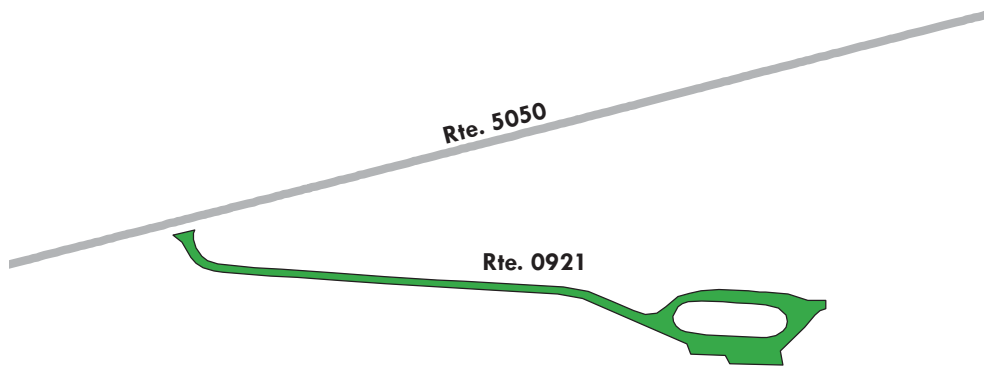
ROUTE 0922: DRY CREEK PARKING

Inspection Date	FMSS Number	User Access	Surface Type
8/7/2014	90873	PUBLIC	ASPHALT
Area (Sq. Ft.)	Lane Miles (11' Widths)	Curb Reveal (Inches)	Curb Recommendation
26,223	0.451	NOT APPLICABLE	LIGHT REPAIR
Curb Type		Curb & Gutter Type	
NO CURB		CONCRETE	
Pavement Recommendation		Condition Rating / PCR	
LIGHT 3R TREATMENTS		FAIR / 73

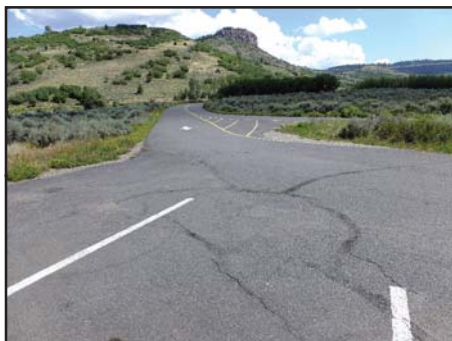
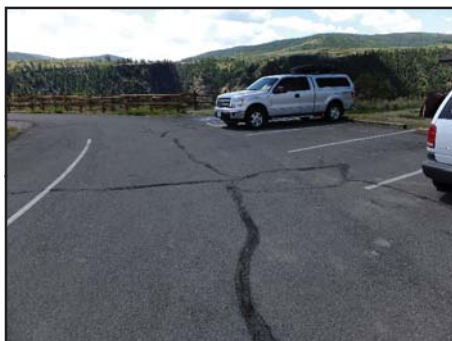
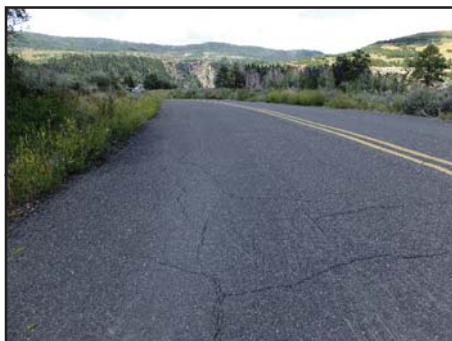
ROUTE 0925: HERMITS REST LOOKOUT

Inspection Date	FMSS Number	User Access	Surface Type
8/7/2014	90877	PUBLIC	ASPHALT
Area (Sq. Ft.)	Lane Miles (11' Widths)	Curb Reveal (Inches)	Curb Recommendation
14,174	0.244	NOT APPLICABLE	MODERATE REPAIR
Curb Type		Curb & Gutter Type	
NO CURB		CONCRETE	
Pavement Recommendation		Condition Rating / PCR	
PREVENTIVE MAINTENANCE		GOOD / 90

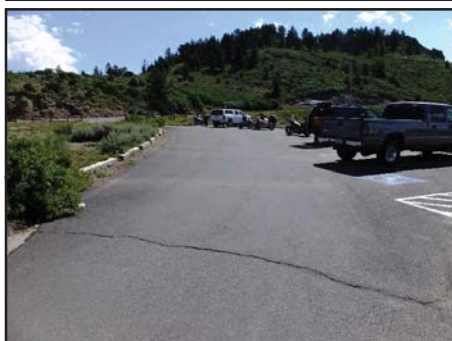
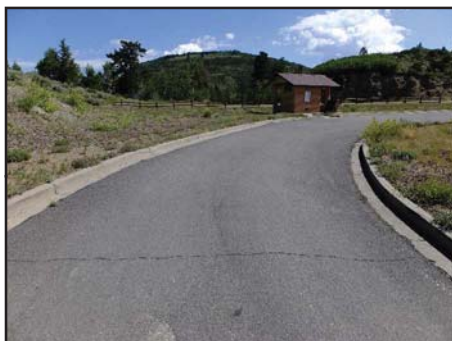
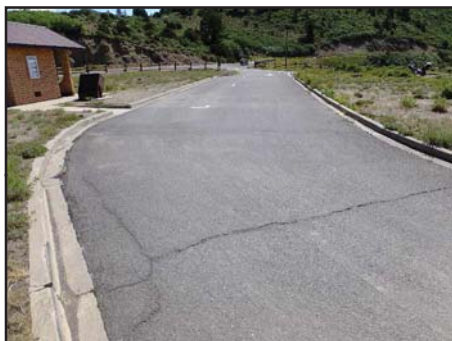
ROUTE 0926: BLUE MESA DAM PARKING

Inspection Date	FMSS Number	User Access	Surface Type
8/7/2014	75050	PUBLIC	ASPHALT
Area (Sq. Ft.)	Lane Miles (11' Widths)	Curb Reveal (Inches)	Curb Recommendation
14,099	0.243	NOT APPLICABLE	NOT APPLICABLE
Curb Type		Curb & Gutter Type	
NO CURB		NO CURB AND GUTTER	
Pavement Recommendation		Condition Rating / PCR	
HEAVY 3R TREATMENTS		POOR / 53

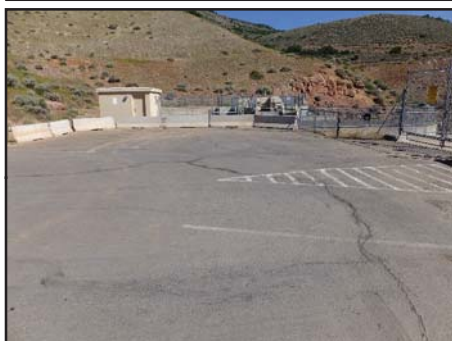
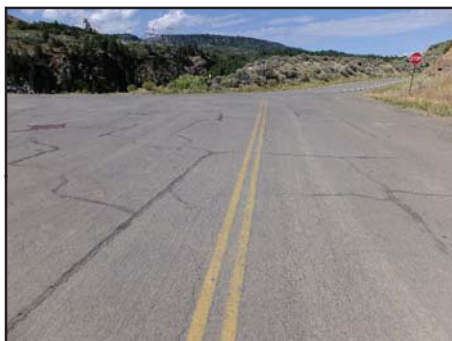
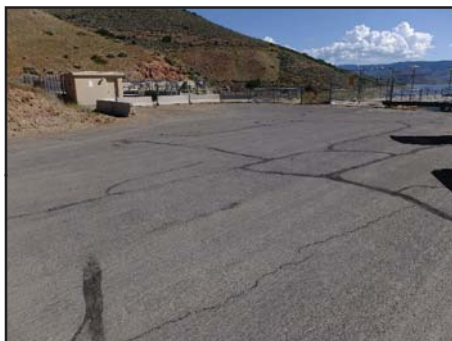
ROUTE 0927: EAST CIMARRON PARKING

Inspection Date	FMSS Number	User Access	Surface Type
8/7/2014	90878	PUBLIC	ASPHALT
Area (Sq. Ft.)	Lane Miles (11' Widths)	Curb Reveal (Inches)	Curb Recommendation
9,924	0.171	NOT APPLICABLE	NOT APPLICABLE
Curb Type		Curb & Gutter Type	
NO CURB		NO CURB AND GUTTER	
Pavement Recommendation		Condition Rating / PCR	
RECONSTRUCTION		POOR / 30
