Road Inventory and Condition Assessment of Paved Routes Curecanti National Recreation Area

**Federal Lands Highway
Road Inventory Program**

**Federal Highway Administration
Eastern Federal Lands Highway Division
Road Inventory Program (RIP)**

Report Date: November 2015

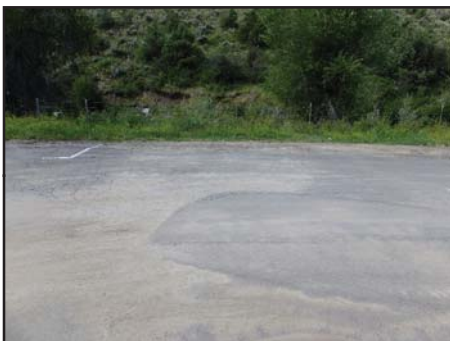
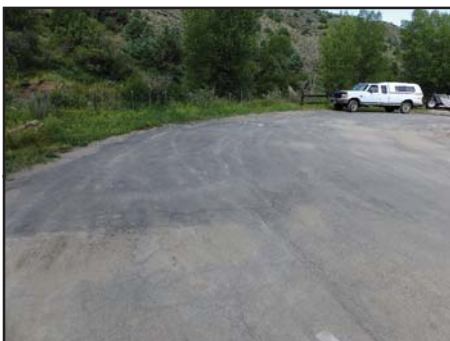
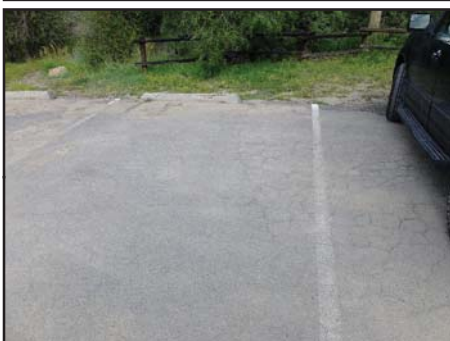
ROUTE 0929: CIMARRON DUMP STATION

Inspection Date	FMSS Number	User Access	Surface Type
8/7/2014	90880	PUBLIC	ASPHALT
Area (Sq. Ft.)	Lane Miles (11' Widths)	Curb Reveal (Inches)	Curb Recommendation
7,417	0.128	4	DO NOTHING
Curb Type		Curb & Gutter Type	
CONCRETE		NO CURB AND GUTTER	
Pavement Recommendation		Condition Rating / PCR	
LIGHT 3R TREATMENTS		FAIR / 73

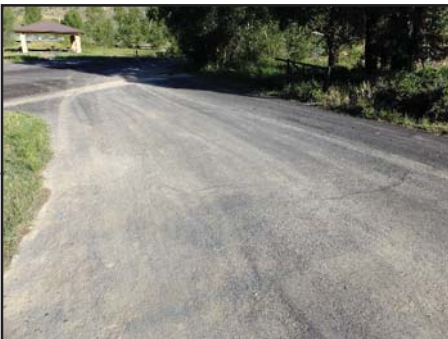
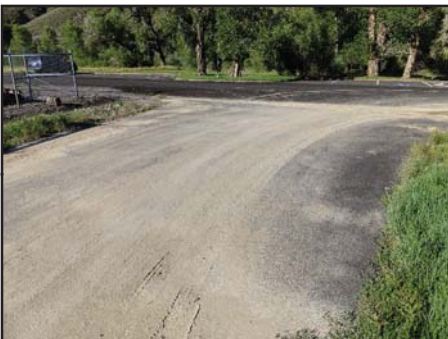
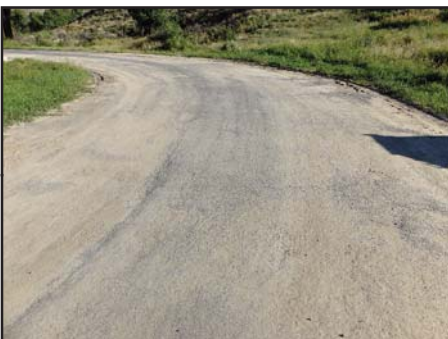
ROUTE 0930A: CIMARRON VISITOR CENTER PARKING A

Inspection Date	FMSS Number	User Access	Surface Type
8/7/2014	90881	PUBLIC	ASPHALT
Area (Sq. Ft.)	Lane Miles (11' Widths)	Curb Reveal (Inches)	Curb Recommendation
1,162	0.02	NOT APPLICABLE	REPLACE
Curb Type		Curb & Gutter Type	
NO CURB		CONCRETE	
Pavement Recommendation		Condition Rating / PCR	
LIGHT 3R TREATMENTS		FAIR / 73

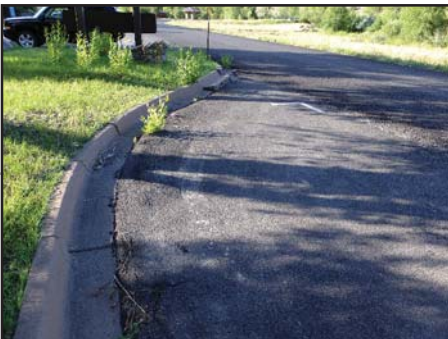
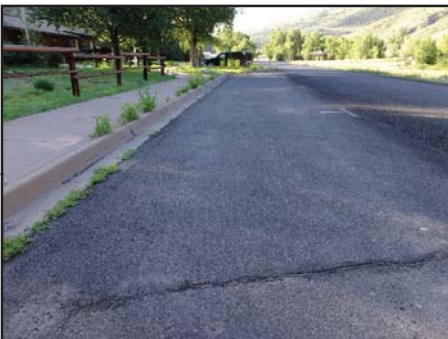
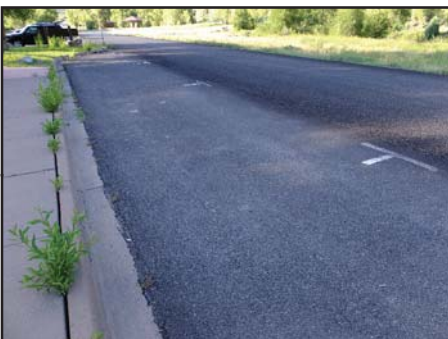
ROUTE 0930B: CIMARRON VISITOR CENTER PARKING B

Inspection Date	FMSS Number	User Access	Surface Type
8/7/2014	103016	PUBLIC	ASPHALT
Area (Sq. Ft.)	Lane Miles (11' Widths)	Curb Reveal (Inches)	Curb Recommendation
1,804	0.031	NOT APPLICABLE	DO NOTHING
Curb Type		Curb & Gutter Type	
NO CURB		CONCRETE	
Pavement Recommendation		Condition Rating / PCR	
PREVENTIVE MAINTENANCE		GOOD / 90

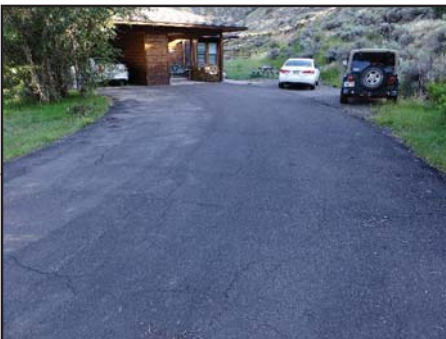
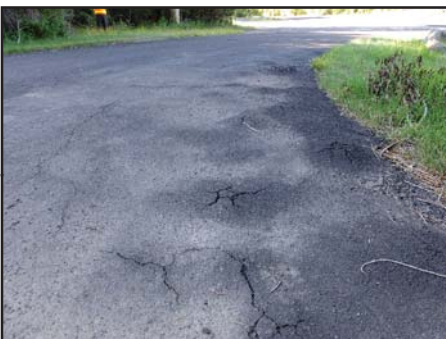
ROUTE 0932: BEAVER CREEK PARKING

Inspection Date	FMSS Number	User Access	Surface Type
8/7/2014	90883	PUBLIC	ASPHALT
Area (Sq. Ft.)	Lane Miles (11' Widths)	Curb Reveal (Inches)	Curb Recommendation
14,890	0.256	NOT APPLICABLE	LIGHT REPAIR
Curb Type		Curb & Gutter Type	
NO CURB		CONCRETE	
Pavement Recommendation		Condition Rating / PCR	
HEAVY 3R TREATMENTS		POOR / 53

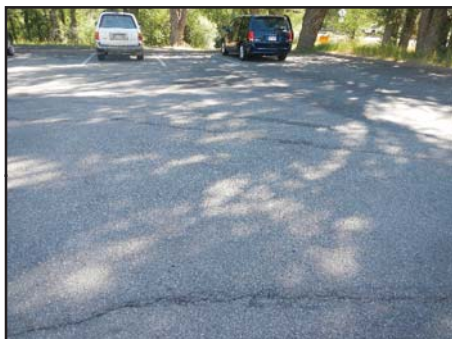
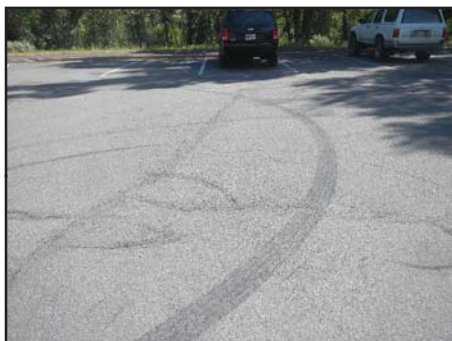
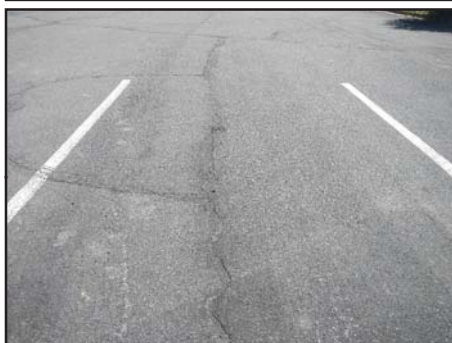
ROUTE 0933: LAKE CITY BRIDGE PARKING

Inspection Date	FMSS Number	User Access	Surface Type
8/7/2014	90884	PUBLIC	ASPHALT
Area (Sq. Ft.)	Lane Miles (11' Widths)	Curb Reveal (Inches)	Curb Recommendation
9,084	0.156	4	DO NOTHING
Curb Type		Curb & Gutter Type	
CONCRETE		NO CURB AND GUTTER	
Pavement Recommendation		Condition Rating / PCR	
HEAVY 3R TREATMENTS		POOR / 53

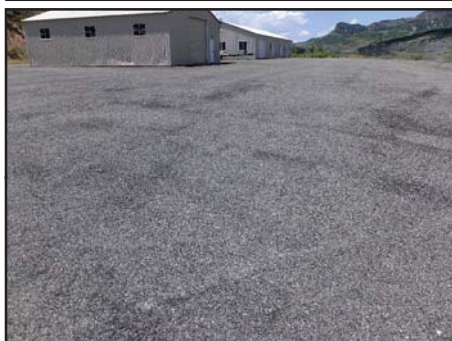
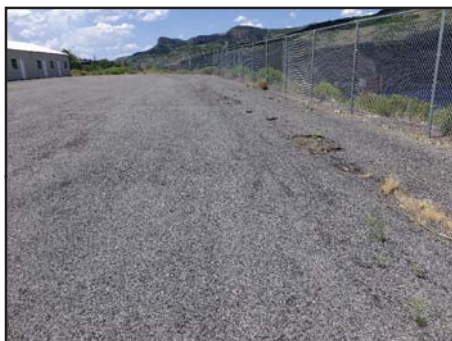
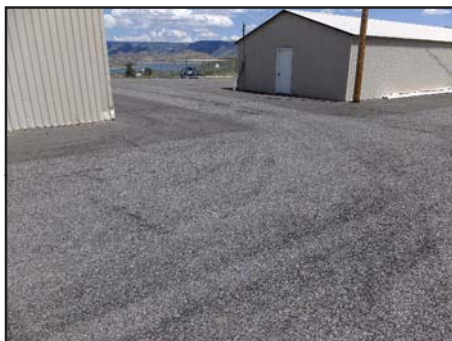
ROUTE 0937: LAKE FORK MAINTENANCE AREA

Inspection Date	FMSS Number	User Access	Surface Type
8/7/2014	75839	NONPUBLIC	ASPHALT
Area (Sq. Ft.)	Lane Miles (11' Widths)	Curb Reveal (Inches)	Curb Recommendation
41,905	0.722	NOT APPLICABLE	NOT APPLICABLE
Curb Type		Curb & Gutter Type	
NO CURB		NO CURB AND GUTTER	
Pavement Recommendation		Condition Rating / PCR	
HEAVY 3R TREATMENTS		POOR / 53

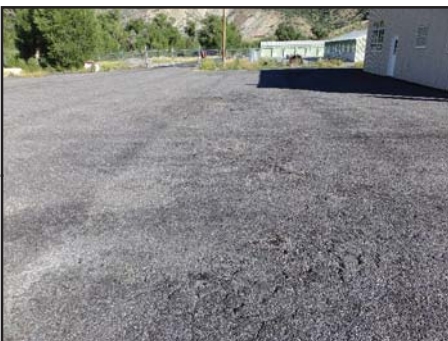
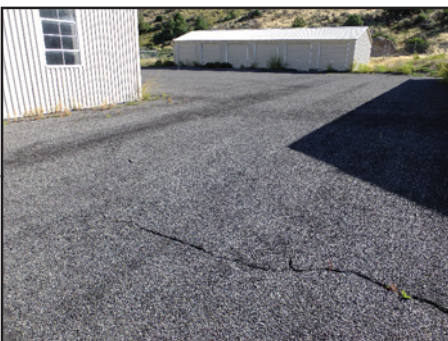
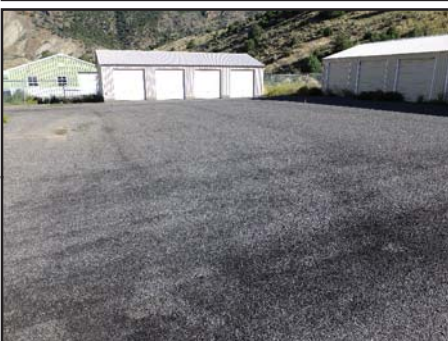
ROUTE 0938: CIMARRON MAINTENANCE AREA

Inspection Date	FMSS Number	User Access	Surface Type
8/7/2014	90891	NONPUBLIC	ASPHALT
Area (Sq. Ft.)	Lane Miles (11' Widths)	Curb Reveal (Inches)	Curb Recommendation
23,361	0.402	NOT APPLICABLE	NOT APPLICABLE
Curb Type		Curb & Gutter Type	
NO CURB		NO CURB AND GUTTER	
Pavement Recommendation		Condition Rating / PCR	
HEAVY 3R TREATMENTS		POOR / 53

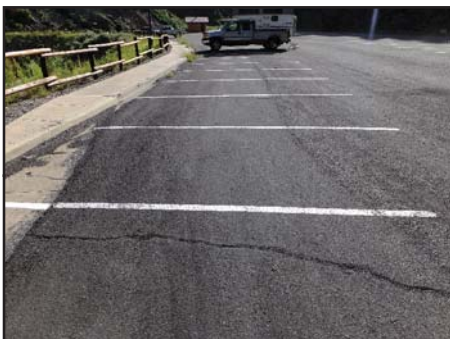
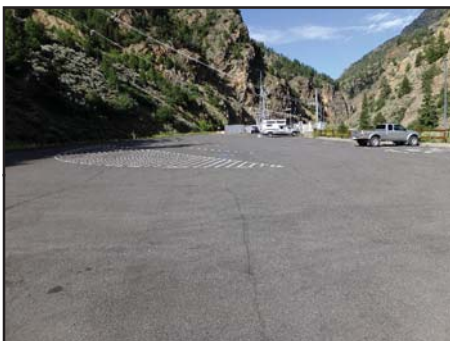
ROUTE 0939: MORROW POINT DAM PICNIC AREA

Inspection Date	FMSS Number	User Access	Surface Type
8/7/2014	90897	PUBLIC	ASPHALT
Area (Sq. Ft.)	Lane Miles (11' Widths)	Curb Reveal (Inches)	Curb Recommendation
31,277	0.539	NOT APPLICABLE	LIGHT REPAIR
Curb Type		Curb & Gutter Type	
NO CURB		CONCRETE	
Pavement Recommendation		Condition Rating / PCR	
HEAVY 3R TREATMENTS		POOR / 53

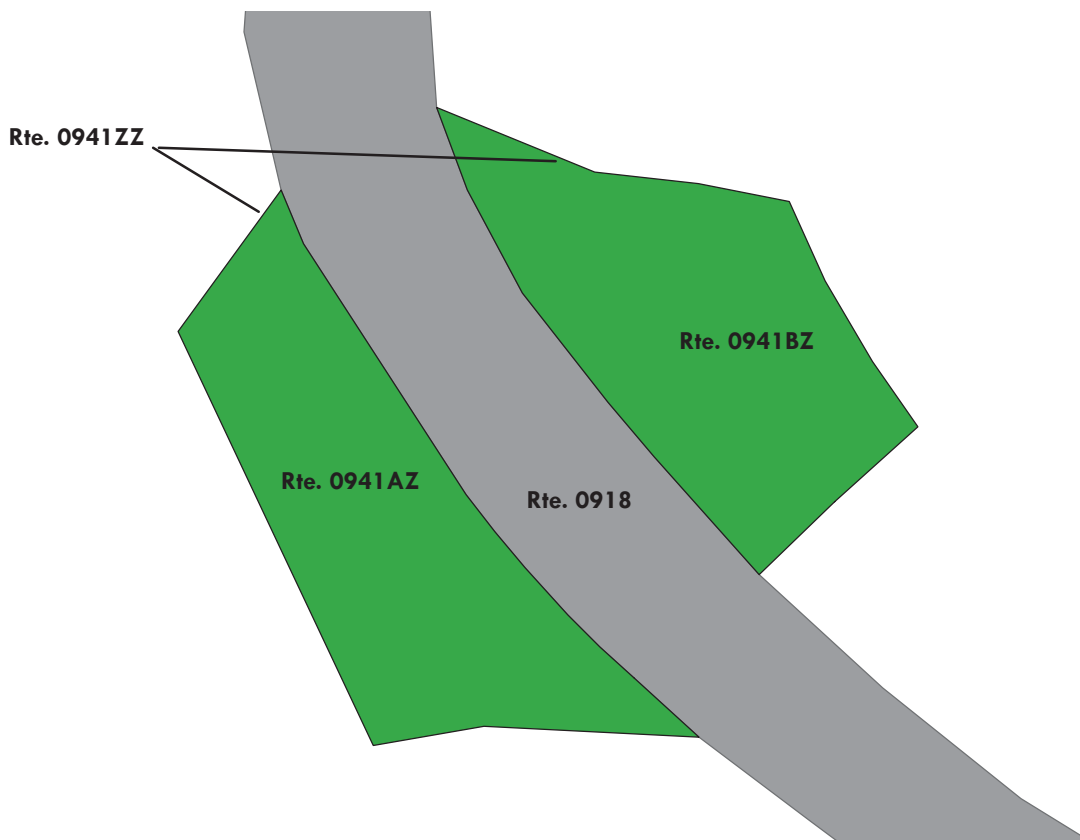
ROUTE 0941ZZ: NEVERSINK PARKING AREAS

Inspection Date	FMSS Number	User Access	Surface Type
8/7/2014	90899	PUBLIC	ASPHALT
Area (Sq. Ft.)	Lane Miles (11' Widths)	Condition Rating / PCR	
1,821	0.031	SUMMARY / 90	
Route Condition Legend – Pavement Condition Rating (PCR)			
Poor (0 - 60)	Fair (61- 84)	Good (85 - 94)	Excellent (95 - 100)
See Appendix for definitions and formulas

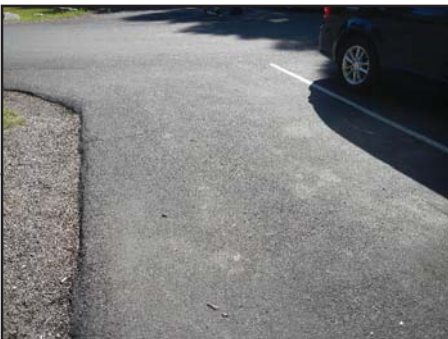
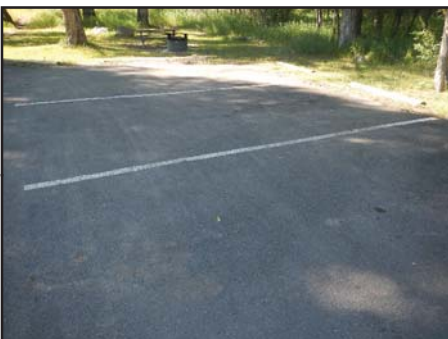
ROUTE 0941AZ: NEVERSINK PARKING AREA A

Inspection Date	FMSS Number	User Access	Surface Type
8/7/2014	90899	PUBLIC	ASPHALT
Area (Sq. Ft.)	Lane Miles (11' Widths)	Curb Reveal (Inches)	Curb Recommendation
935	0.016	NOT APPLICABLE	NOT APPLICABLE
Curb Type		Curb & Gutter Type	
NO CURB		NO CURB AND GUTTER	
Pavement Recommendation		Condition Rating / PCR	
PREVENTIVE MAINTENANCE		GOOD / 90

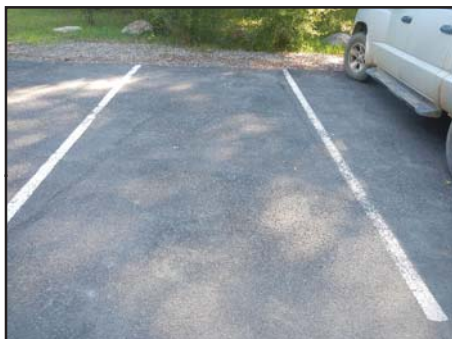
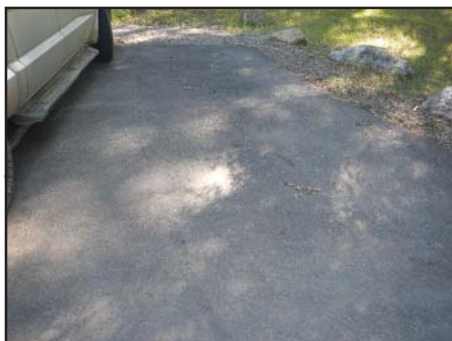
ROUTE 0941BZ: NEVERSINK PARKING AREA B

Inspection Date	FMSS Number	User Access	Surface Type
8/7/2014	90899	PUBLIC	ASPHALT
Area (Sq. Ft.)	Lane Miles (11' Widths)	Curb Reveal (Inches)	Curb Recommendation
886	0.015	NOT APPLICABLE	NOT APPLICABLE
Curb Type		Curb & Gutter Type	
NO CURB		NO CURB AND GUTTER	
Pavement Recommendation		Condition Rating / PCR	
PREVENTIVE MAINTENANCE		GOOD / 90

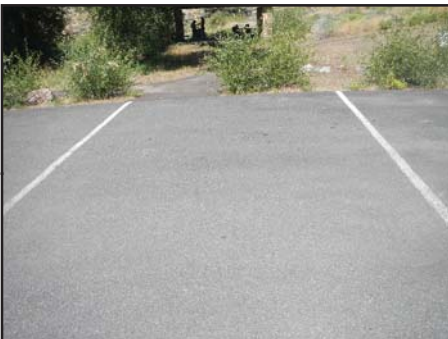
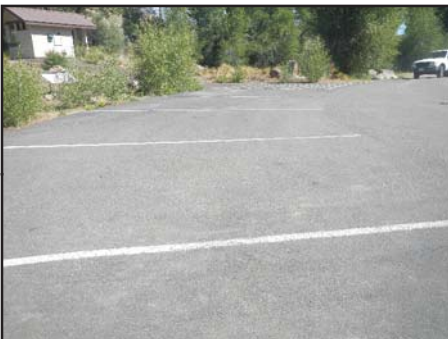
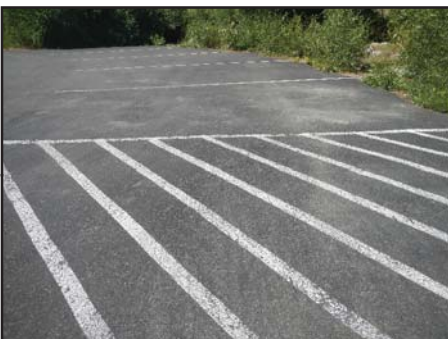
ROUTE 0943: COOPER RANCH COMFORT STATION PARKING

Inspection Date	FMSS Number	User Access	Surface Type
8/7/2014	90901	PUBLIC	ASPHALT
Area (Sq. Ft.)	Lane Miles (11' Widths)	Curb Reveal (Inches)	Curb Recommendation
1,341	0.023	NOT APPLICABLE	NOT APPLICABLE
Curb Type		Curb & Gutter Type	
NO CURB		NO CURB AND GUTTER	
Pavement Recommendation		Condition Rating / PCR	
DO NOTHING		EXCELLENT / 97

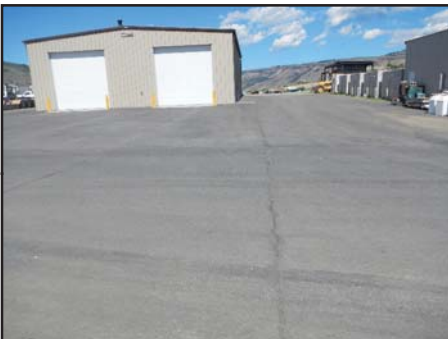
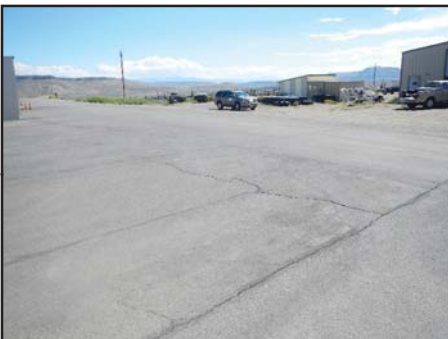
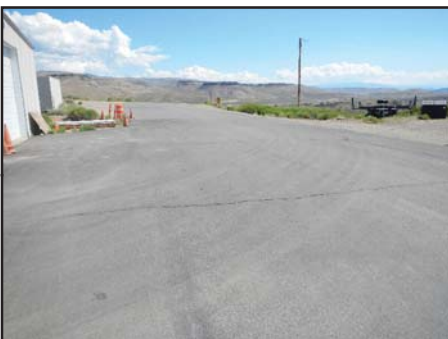
ROUTE 0960: WAREHOUSE STORAGE AREA

Inspection Date	FMSS Number	User Access	Surface Type
8/7/2014	238303	NONPUBLIC	ASPHALT
Area (Sq. Ft.)	Lane Miles (11' Widths)	Curb Reveal (Inches)	Curb Recommendation
19,143	0.33	NOT APPLICABLE	NOT APPLICABLE
Curb Type		Curb & Gutter Type	
NO CURB		NO CURB AND GUTTER	
Pavement Recommendation		Condition Rating / PCR	
PREVENTIVE MAINTENANCE		GOOD / 90

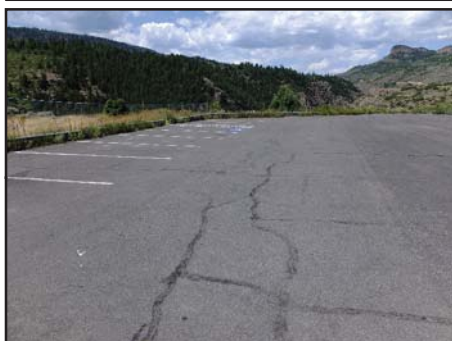
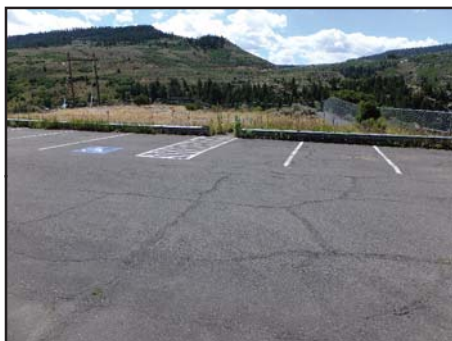
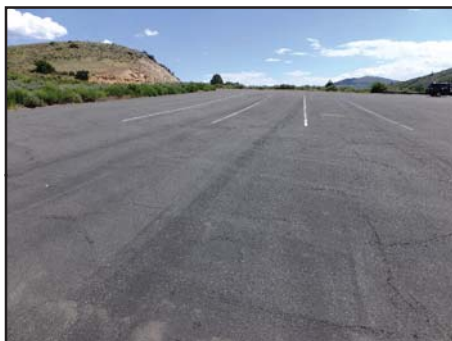
ROUTE 0963: BLUE MESA OVERLOOK PARKING

Inspection Date	FMSS Number	User Access	Surface Type
8/7/2014	238306	PUBLIC	ASPHALT
Area (Sq. Ft.)	Lane Miles (11' Widths)	Curb Reveal (Inches)	Curb Recommendation
35,720	0.615	NOT APPLICABLE	NOT APPLICABLE
Curb Type		Curb & Gutter Type	
NO CURB		NO CURB AND GUTTER	
Pavement Recommendation		Condition Rating / PCR	
HEAVY 3R TREATMENTS		POOR / 53

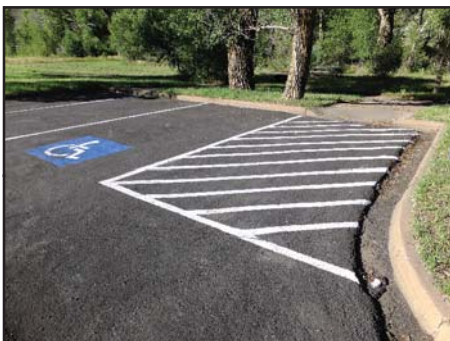
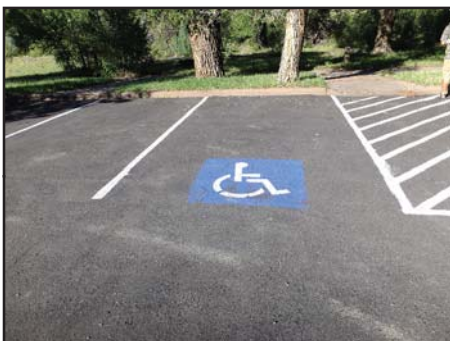
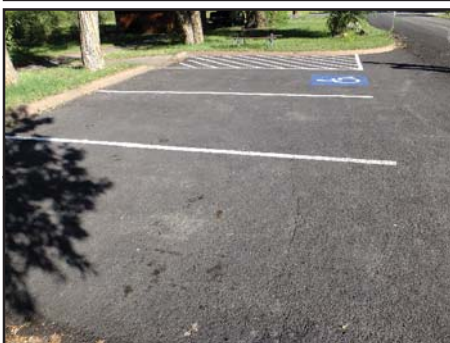
ROUTE 0964BZ: CIMARRON CS WEST PARKING

Inspection Date	FMSS Number	User Access	Surface Type
8/7/2014	N/A	PUBLIC	ASPHALT
Area (Sq. Ft.)	Lane Miles (11' Widths)	Curb Reveal (Inches)	Curb Recommendation
855	0.015	NOT APPLICABLE	DO NOTHING
Curb Type		Curb & Gutter Type	
NO CURB		CONCRETE	
Pavement Recommendation		Condition Rating / PCR	
LIGHT 3R TREATMENTS		FAIR / 73

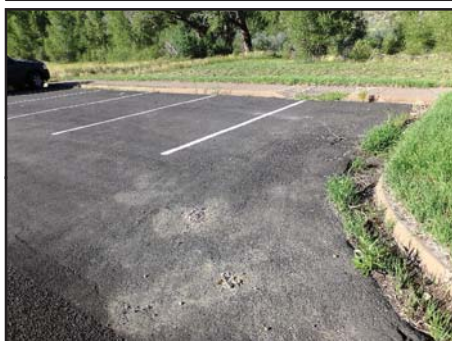
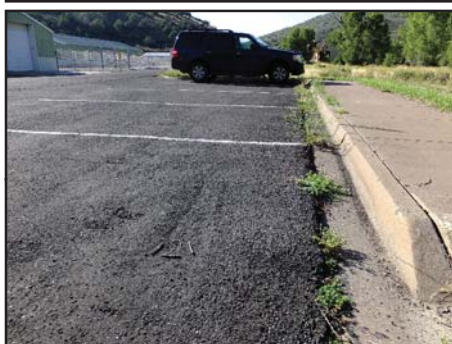
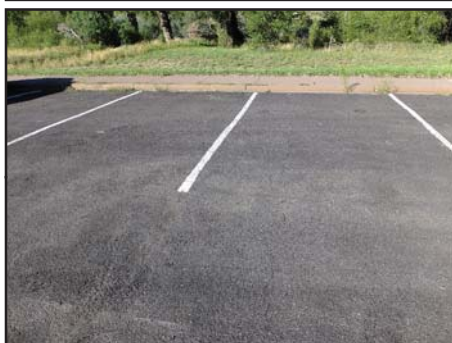
ROUTE 0964CZ: CIMARRON CS EAST PARKING

Inspection Date	FMSS Number	User Access	Surface Type
8/7/2014	N/A	PUBLIC	ASPHALT
Area (Sq. Ft.)	Lane Miles (11' Widths)	Curb Reveal (Inches)	Curb Recommendation
1,415	0.024	NOT APPLICABLE	LIGHT REPAIR
Curb Type		Curb & Gutter Type	
NO CURB		CONCRETE	
Pavement Recommendation		Condition Rating / PCR	
LIGHT 3R TREATMENTS		FAIR / 73
