DEWA Cycle 6

Final Report

Road Inventory and Condition Assessment of Paved Routes Delaware Water Gap National Recreation Area

Report Date: May 2020

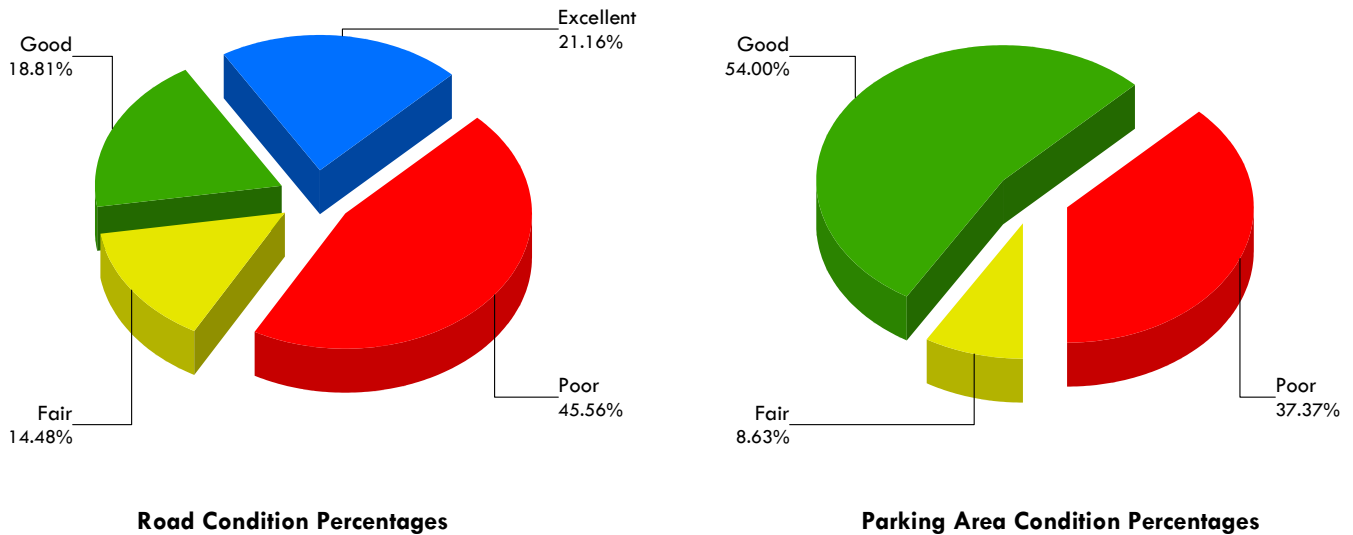
Figure 1: Pavement Condition Rating Breakdown for Paved Roads and Parking Areas

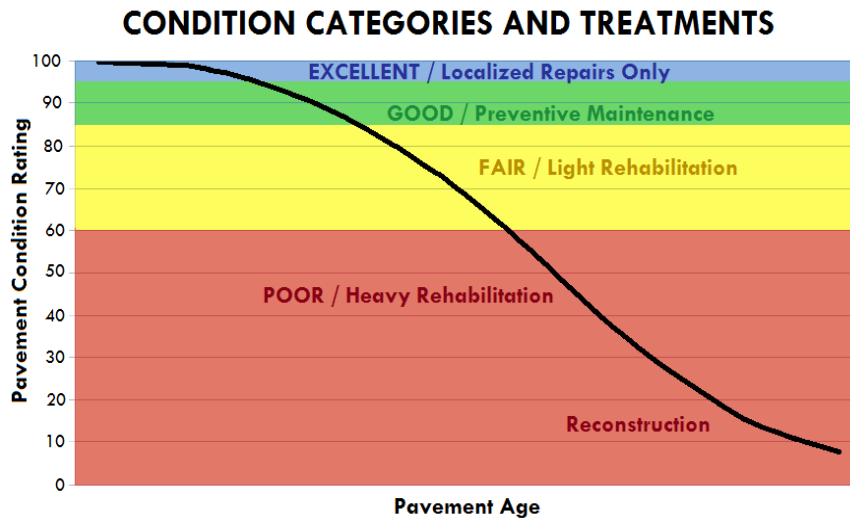
- Excellent / New: PCR of 95-100
 - Pavements in this range will require only spot repairs
- Good: PCR of 85-94
 - Pavements in this range will likely be candidates for Preventive Maintenance. Examples include Chip and Slurry Seals, Micro Surfacing and Thin Overlays.
- Fair: PCR of 61-84
 - Pavements in this range will likely be candidates of Light Rehabilitation (L3R). Examples include singlelift overlays up to 2.5 inches in total thickness, milling and overlays.
- Poor: PCR of 0-60
 - Pavements in this range will likely be candidates of Heavy Rehabilitation or Reconstruction (H3R or 4R). Examples include Pulverization, Multiple Lift Overlays, and Reconstruction.

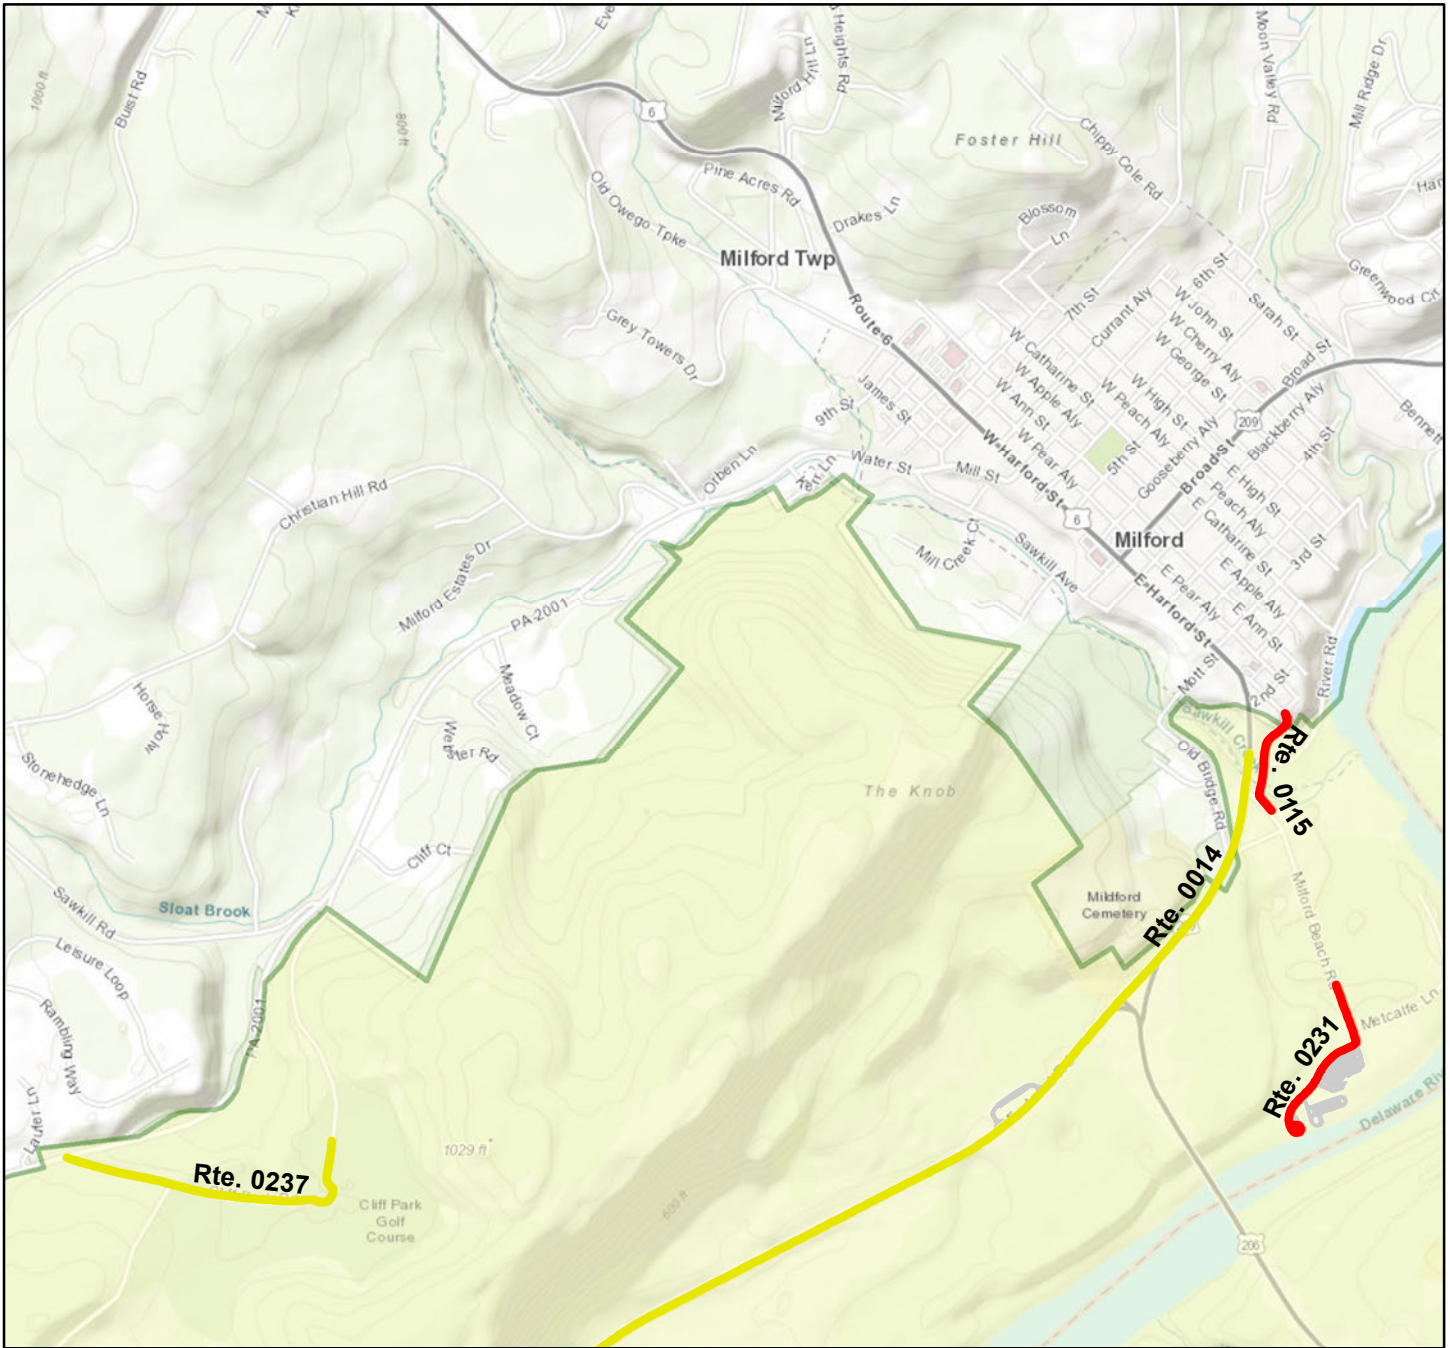
Area Map 1A

ROUTE CONDITION MAP

PCR - MILE BY MILE

Colors on map represent condition scores at 1-mile intervals. See Appendix for definitions and formulas
Only Data Collection Vehicle and Manually Rated Roads are displayed

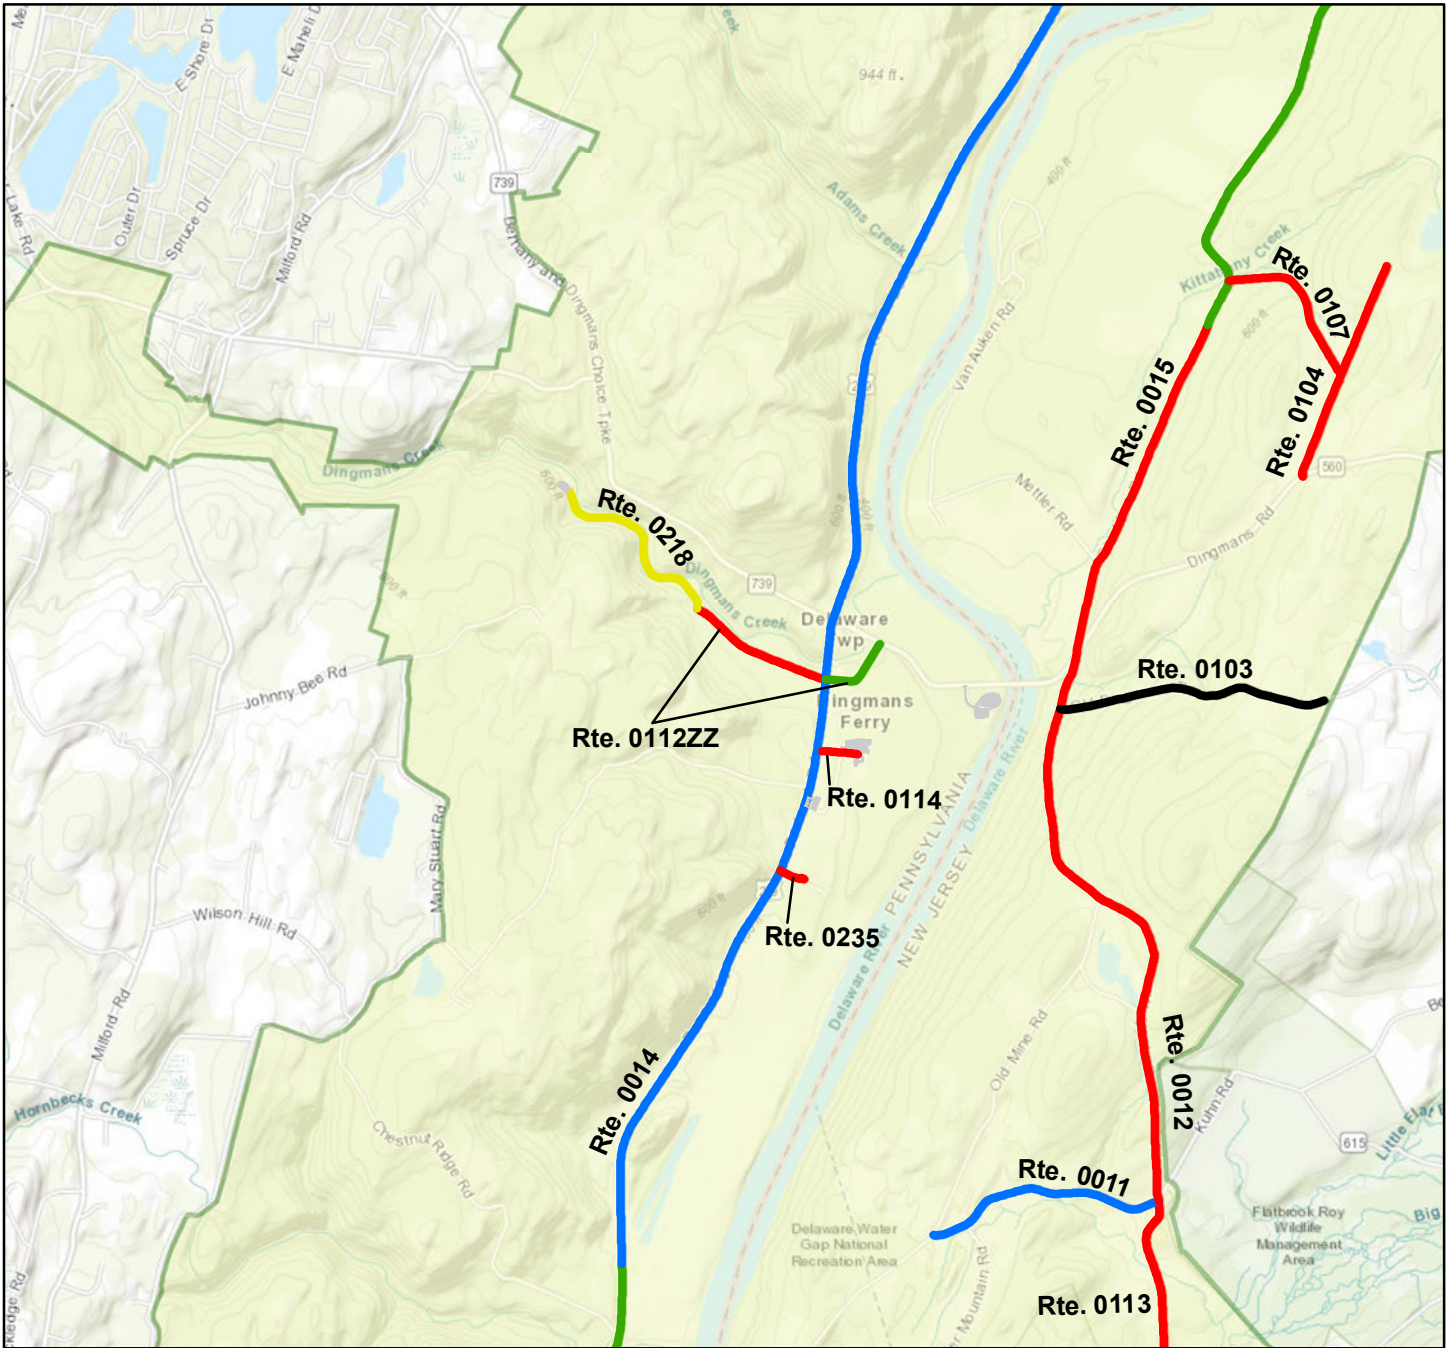
Area Map 1B

ROUTE CONDITION MAP

PCR - MILE BY MILE

Colors on map represent condition scores at 1-mile intervals. See Appendix for definitions and formulas
Only Data Collection Vehicle and Manually Rated Roads are displayed

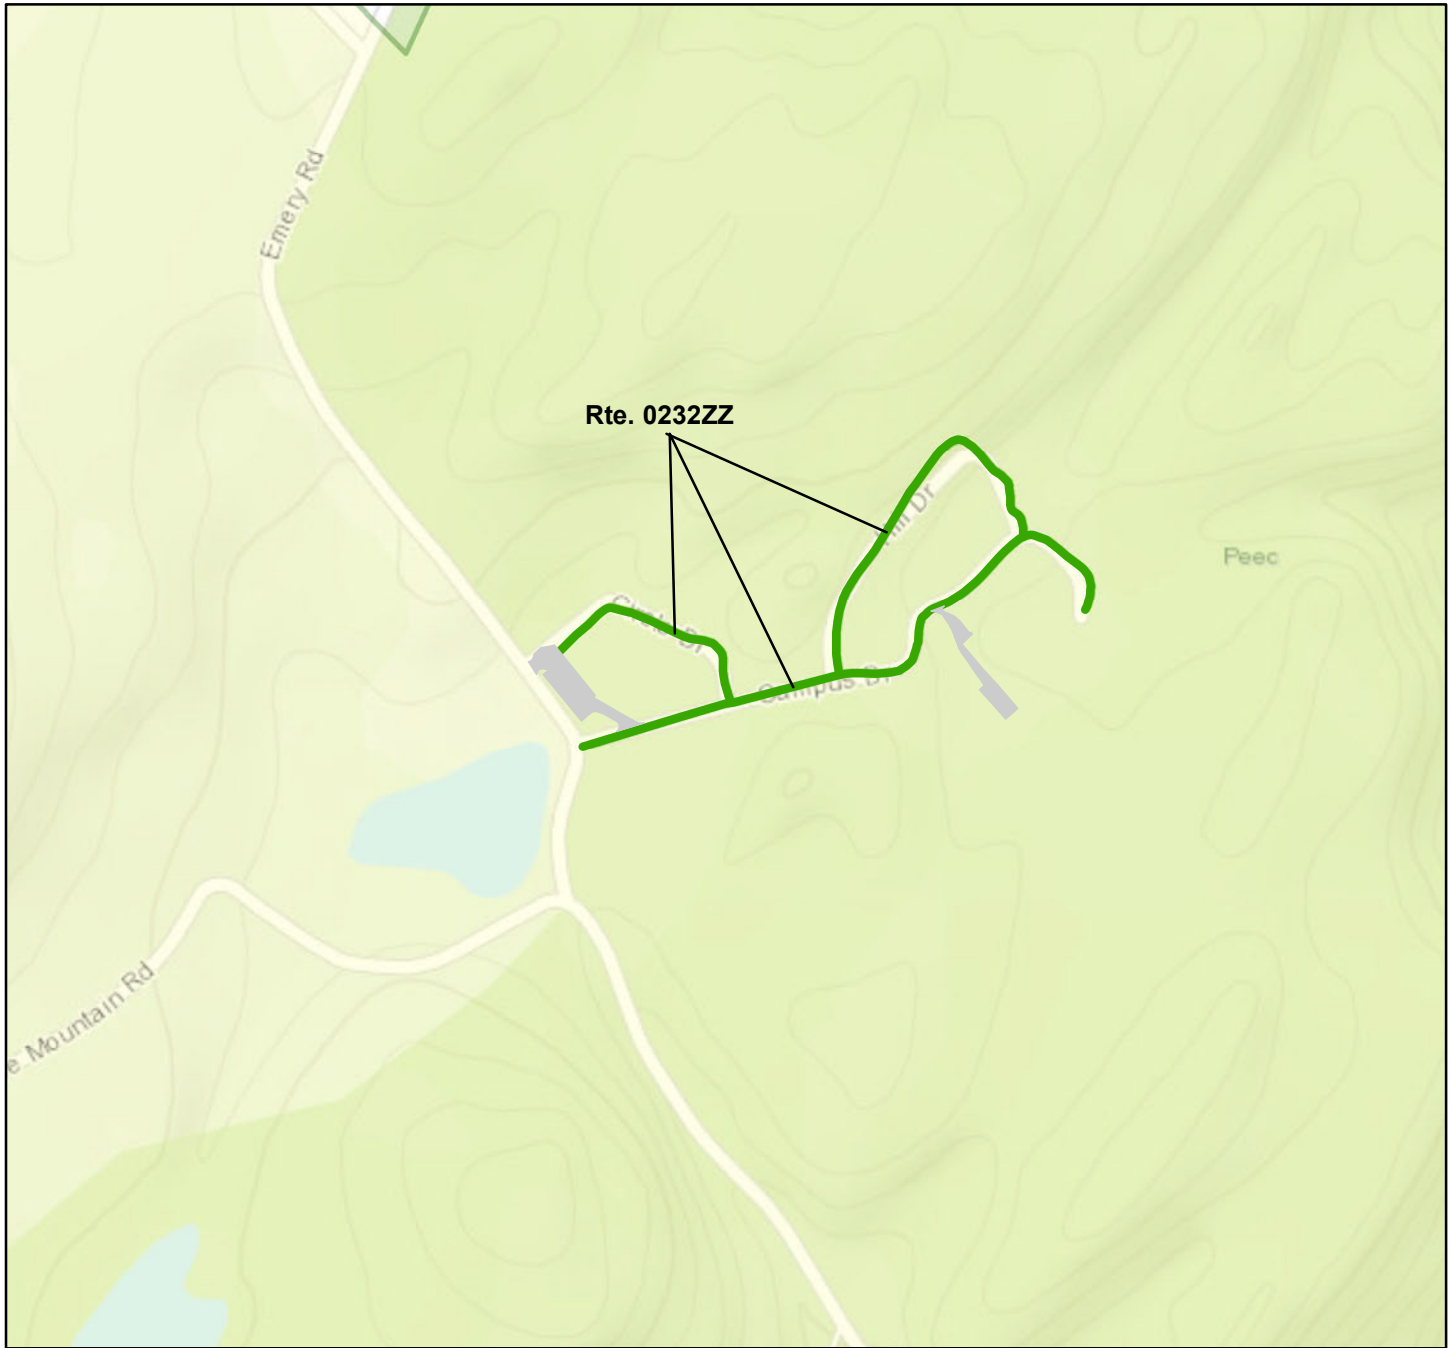
Area Map 1C

ROUTE CONDITION MAP

PCR - MILE BY MILE

Colors on map represent condition scores at 1-mile intervals. See Appendix for definitions and formulas
Only Data Collection Vehicle and Manually Rated Roads are displayed

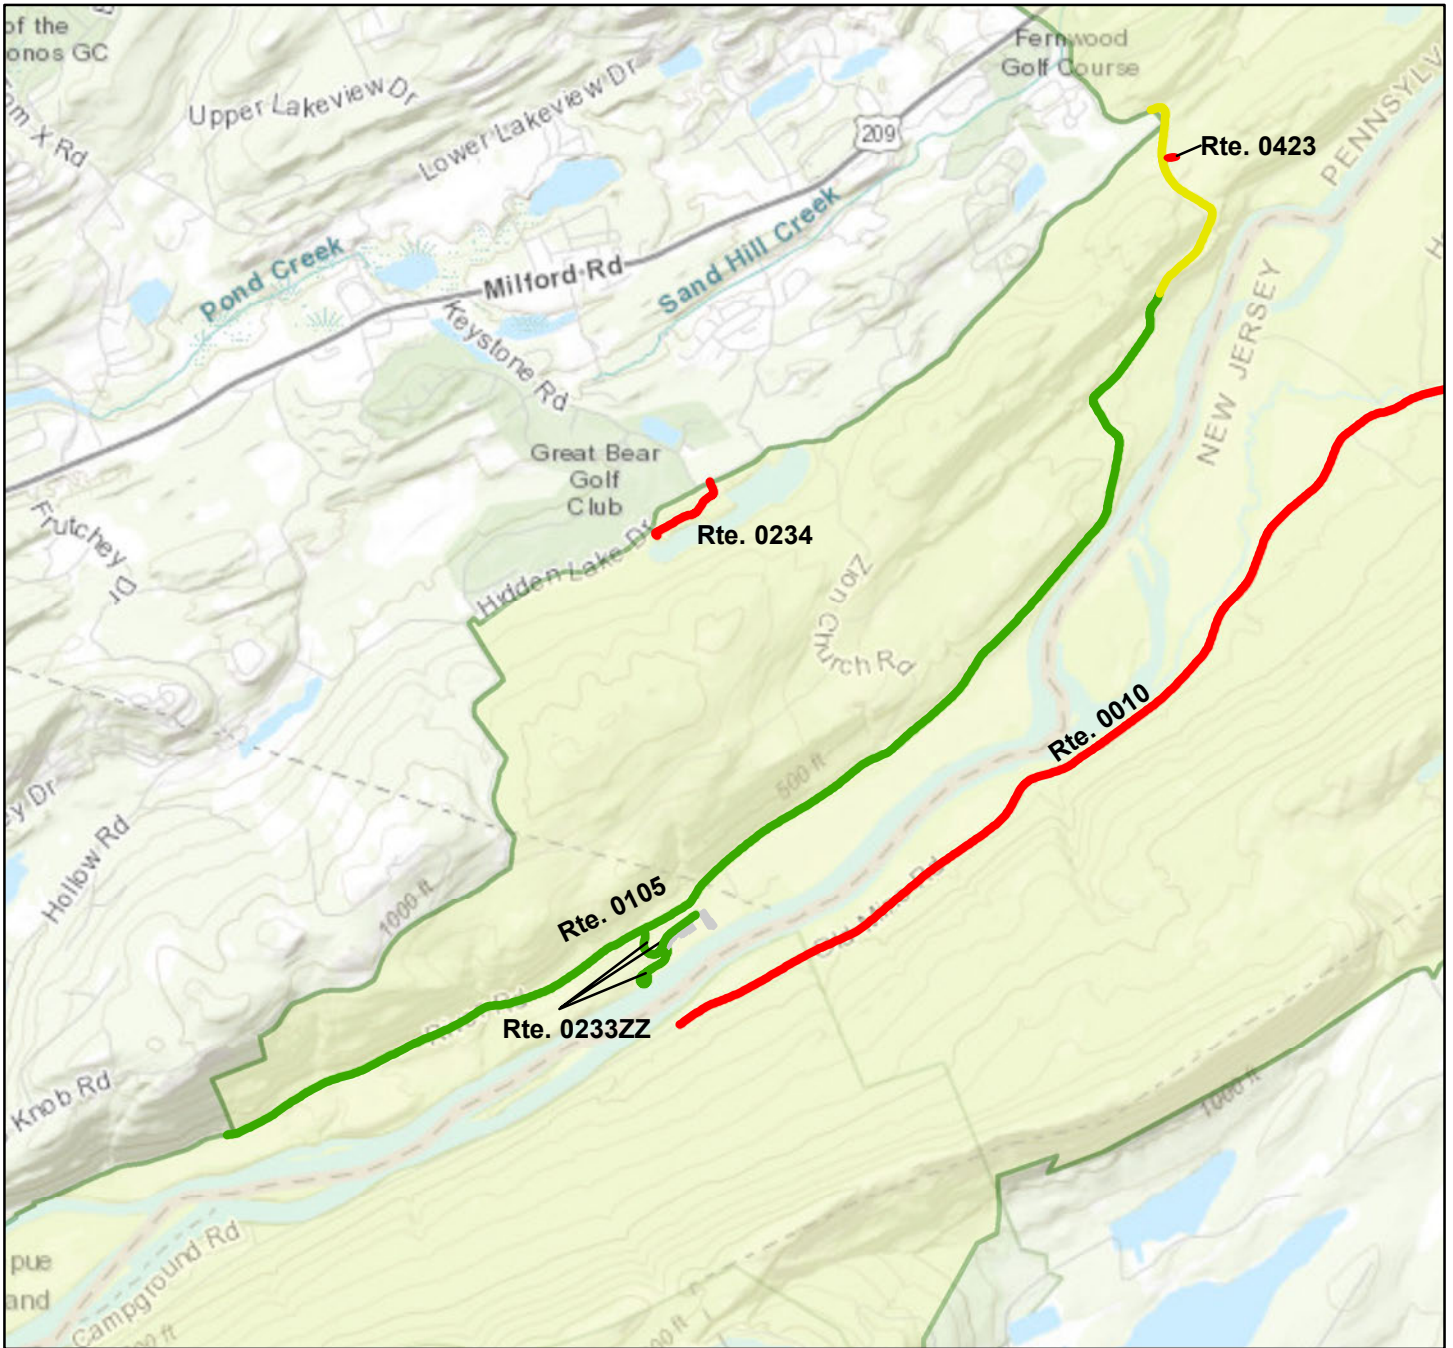
Area Map 2B

ROUTE CONDITION MAP

PCR - MILE BY MILE

Colors on map represent condition scores at 1-mile intervals. See Appendix for definitions and formulas
 Only Data Collection Vehicle and Manually Rated Roads are displayed

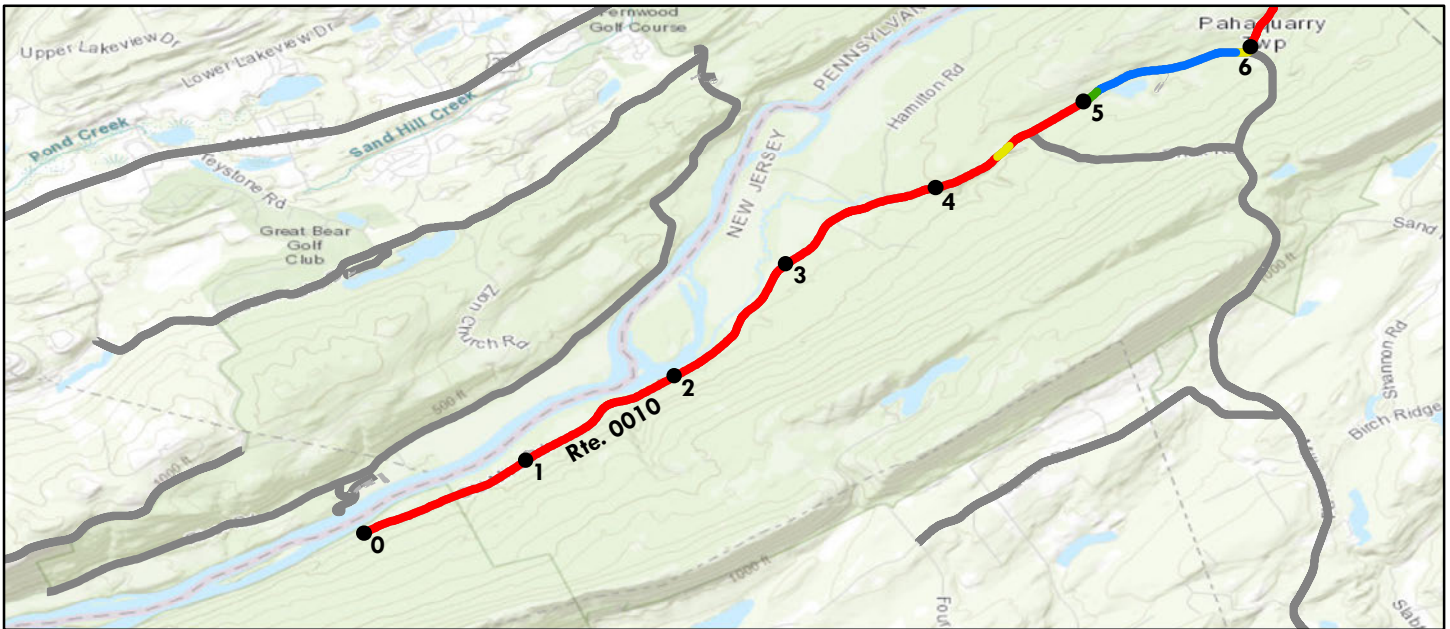
ROUTE 0010: OLD MINE ROAD (SOUTH SECTION)

Data Collection Vehicle (DCV) Rating

Route Condition Legend – Pavement Condition Rating (PCR)						
Poor (0 - 60)	Fair (61- 84)	Good (85 - 94)	Excellent (95 - 100)	Not Rated		
Colors on map represent condition scores at 0.10-mile intervals. See Appendix for definitions and formulas.						
Inspection Date: 6/12/2018	Beginning Section MP	0	1	2	3	4
Paved Length (Miles): 13.47	Section Length (MI)	1	1	1	1	1
Surface Type: ASPHALT	Route Summary					
Roadway Condition Information						
Pavement Condition Rating (PCR)	26	17	25	30	29	33
Surface Condition Rating (SCR)	0	0	0	0	0	0
Roughness Condition Index (RCI)	65	42	62	74	73	83
Distress Index Values						
Structural Crack Index	0	0	0	0	0	0
Alligator Crack Index	25	0	0	11	43	55
Longitudinal Crack Index	0	0	0	0	5	35
Transverse Cracking Index	68	93	88	82	69	92
Patching Index	97	88	98	99	100	100
Rutting Index	93	89	94	93	94	94
International Roughness Index (IRI)	219	325	230	189	192	160
Lane & Width Information

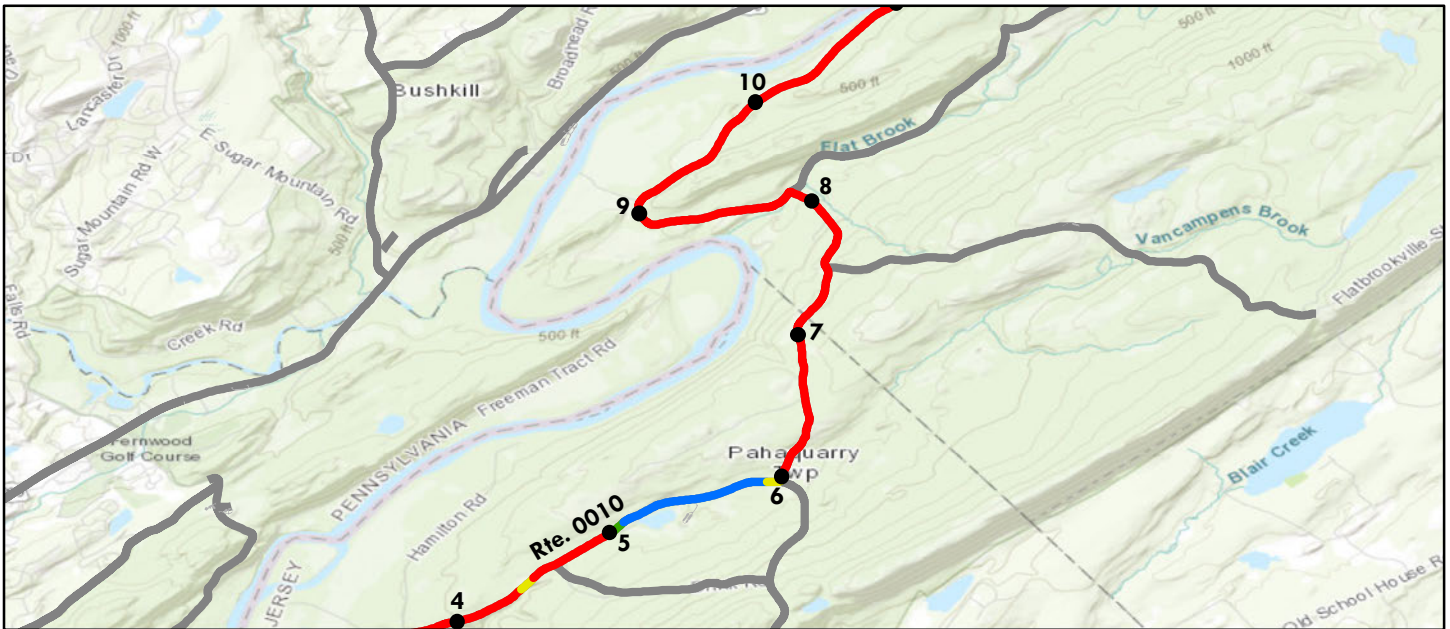
ROUTE 0010: OLD MINE ROAD (SOUTH SECTION)

Data Collection Vehicle (DCV) Rating

Colors on map represent condition scores at 0.10-mile intervals. See Appendix for definitions and formulas.

Inspection Date:	6/12/2018	Beginning Section MP	5	6	7	8	9
	Paved Length (Miles):	13.47	Section Length (MI)	1	1	1	1
Surface Type:	ASPHALT	Route Summary					
Roadway Condition Information							
Pavement Condition Rating (PCR)	26	96	28	9	30	26	
Surface Condition Rating (SCR)	0	98	0	0	0	0	
Roughness Condition Index (RCI)	65	94	71	23	75	64	
Distress Index Values							
Structural Crack Index	0	98	0	0	0	0	
Alligator Crack Index	25	99	79	25	75	23	
Longitudinal Crack Index	0	99	0	0	0	0	
Transverse Cracking Index	68	99	72	61	0	52	
Patching Index	97	100	100	81	98	99	
Rutting Index	93	100	93	79	95	96	
International Roughness Index (IRI)	219	130	197	476	185	224	
Lane & Width Information							
Number of Lanes	2	2	2	2	2	2	
Paved Width (ft)	20	20.2	22.2	20.8	19.6	19.7	
Lane Width (ft)	8.8	7.9	9	8.4	9.2	9.5

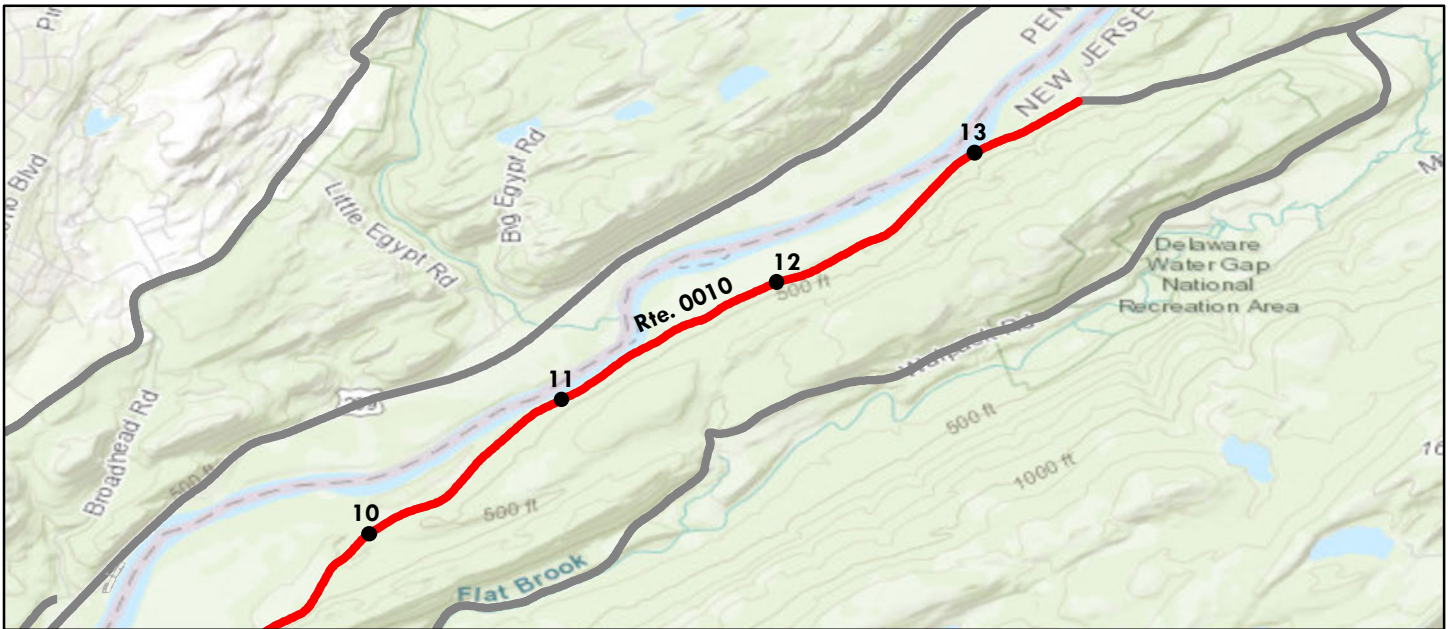
ROUTE 0010: OLD MINE ROAD (SOUTH SECTION)

Data Collection Vehicle (DCV) Rating

Route Condition Legend – Pavement Condition Rating (PCR)									
Poor (0 - 60)		Fair (61- 84)		Good (85 - 94)		Excellent (95 - 100)		Not Rated	
Colors on map represent condition scores at 0.10-mile intervals. See Appendix for definitions and formulas.									
Inspection Date:	6/12/2018	Beginning Section MP	10	11	12	13			
Paved Length (Miles):	13.47	Section Length (MI)	1	1	1	0.47			
Surface Type:	ASPHALT	Route Summary							
Roadway Condition Information									
Pavement Condition Rating (PCR)	26	27	28	27	27				
Surface Condition Rating (SCR)	0	0	0	0	0				
Roughness Condition Index (RCI)	65	68	69	67	67				
Distress Index Values									
Structural Crack Index	0	0	0	0	0				
Alligator Crack Index	25	0	14	15	0				
Longitudinal Crack Index	0	0	0	0	0				
Transverse Cracking Index	68	70	75	49	41				
Patching Index	97	100	100	99	100				
Rutting Index	93	95	96	95	94				
International Roughness Index (IRI)	219	207	207	212	211

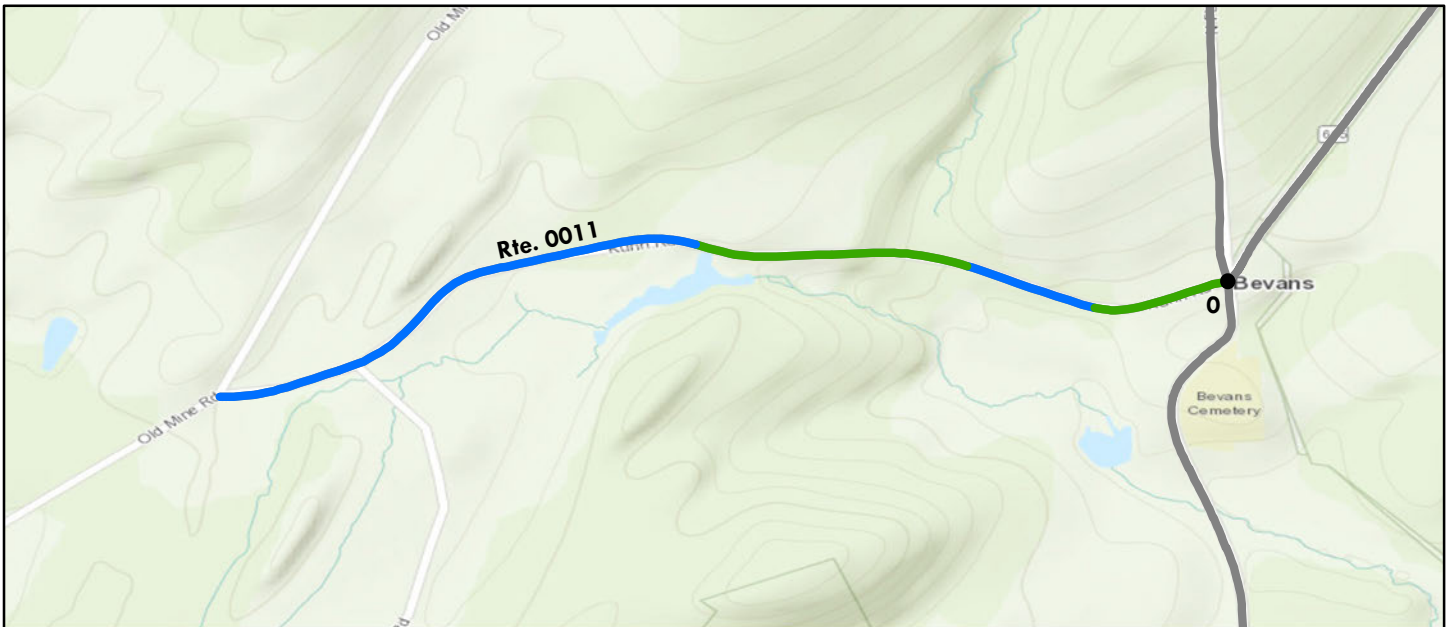
ROUTE 0011: KUHN ROAD

Data Collection Vehicle (DCV) Rating

Colors on map represent condition scores at 0.10-mile intervals. See Appendix for definitions and formulas.

Inspection Date: 6/12/2018	Beginning Section MP	0				
Paved Length (Miles): 0.79	Section Length (MI)	0.79				
Surface Type: ASPHALT	Route Summary					
Roadway Condition Information						
Pavement Condition Rating (PCR)	95	95				
Surface Condition Rating (SCR)	100	100				
Roughness Condition Index (RCI)	87	87				
Distress Index Values						
Structural Crack Index	100	100				
Alligator Crack Index	100	100				
Longitudinal Crack Index	100	100				
Transverse Cracking Index	100	100				
Patching Index	100	100				
Rutting Index	100	100				
International Roughness Index (IRI)	150	150				
Lane & Width Information						
Number of Lanes	2	2				
Paved Width (ft)	19	19				
Lane Width (ft)	8.5	8.5

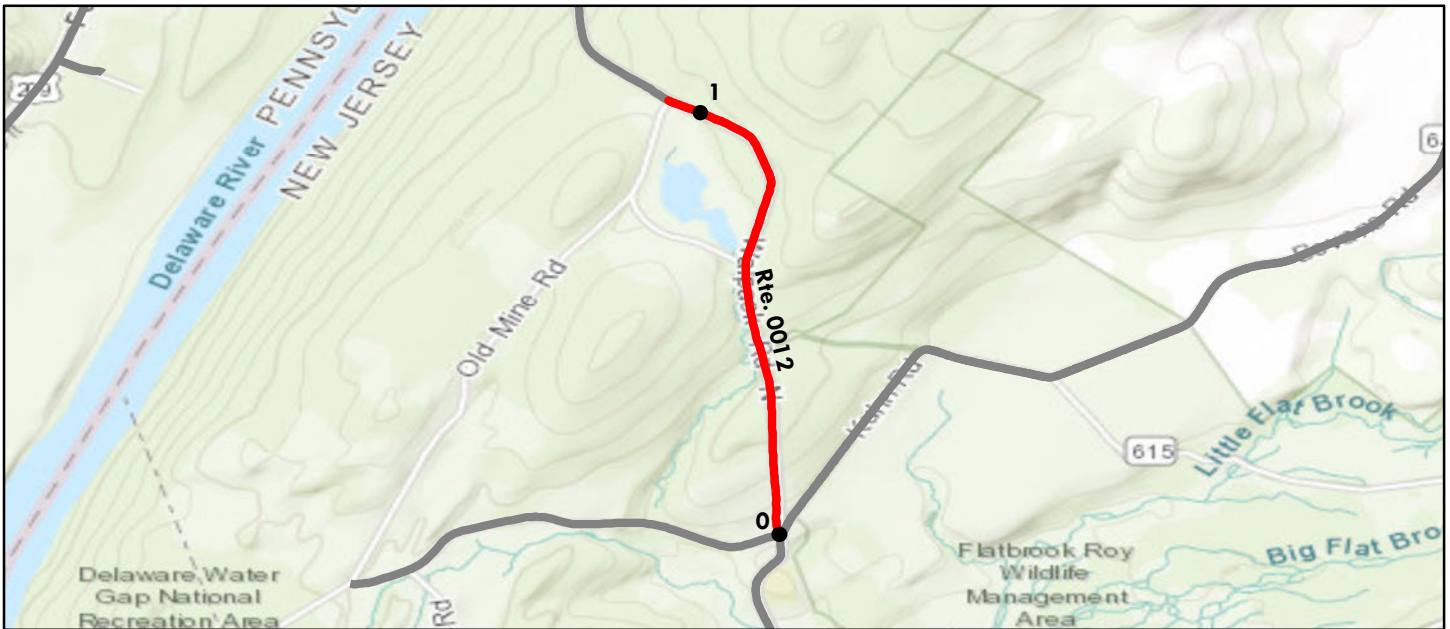
ROUTE 0012: PETERS VALLEY - WAGONWHEEL ROAD

Data Collection Vehicle (DCV) Rating

Colors on map represent condition scores at 0.10-mile intervals. See Appendix for definitions and formulas.

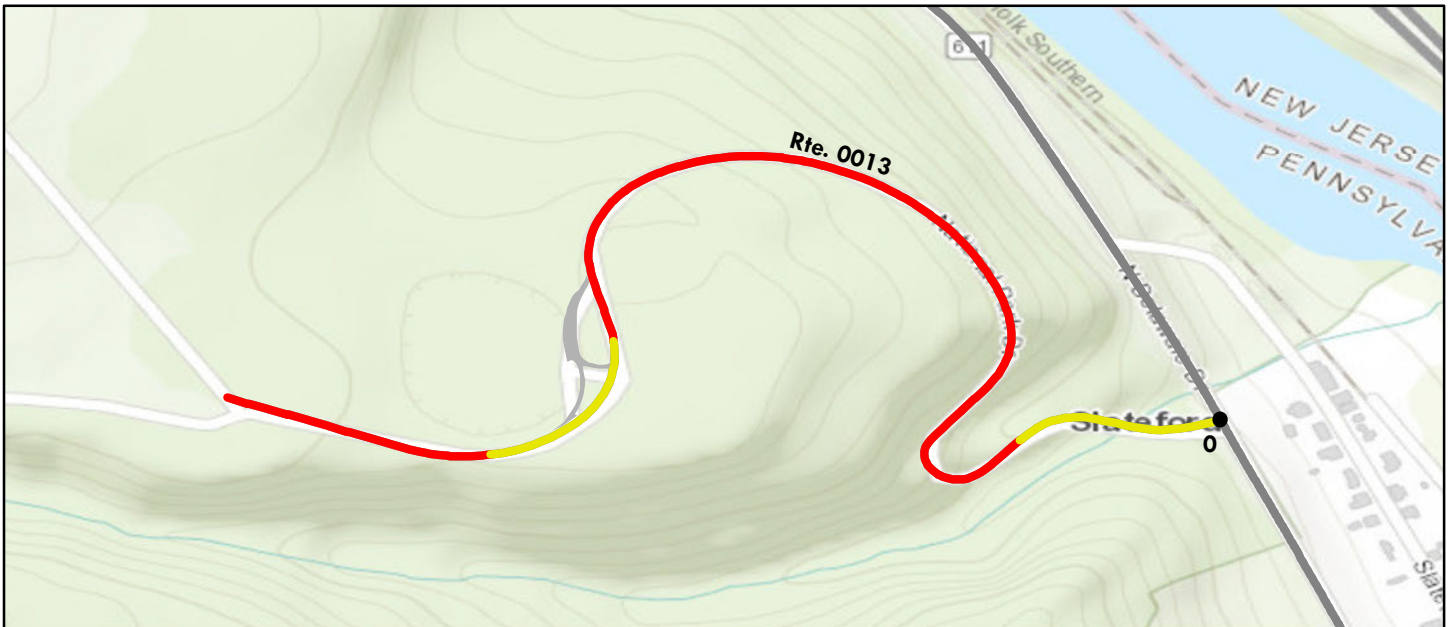
ROUTE 0013: NATIONAL PARK DRIVE

Data Collection Vehicle (DCV) Rating

Colors on map represent condition scores at 0.10-mile intervals. See Appendix for definitions and formulas.

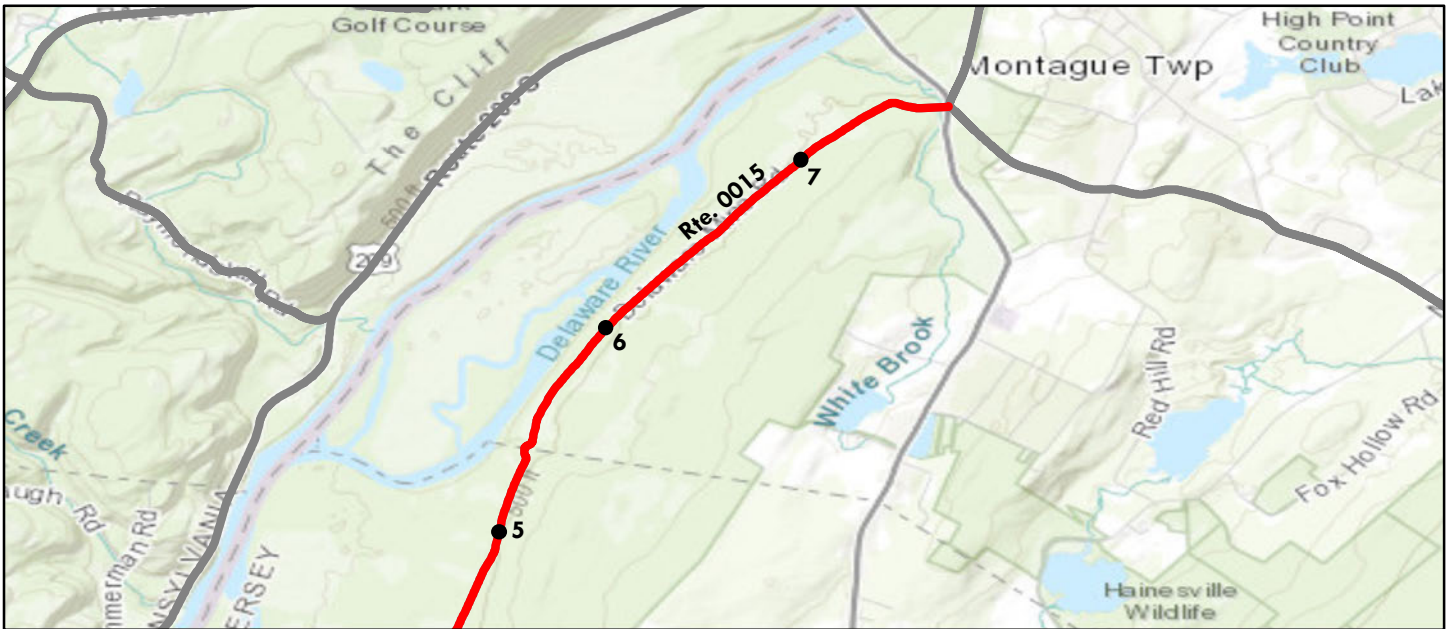
ROUTE 0015: OLD MINE ROAD (NORTH SECTION)

Data Collection Vehicle (DCV) Rating

Colors on map represent condition scores at 0.10-mile intervals. See Appendix for definitions and formulas.

Inspection Date:	6/12/2018	Beginning Section MP	5	6	7		
Paved Length (Miles):	7.58	Section Length (MI)	1	1	0.58		
Surface Type:	ASPHALT	Route Summary					
Roadway Condition Information							
Pavement Condition Rating (PCR)	24	18	16	14			
Surface Condition Rating (SCR)	0	0	0	0			
Roughness Condition Index (RCI)	61	45	40	36			
Distress Index Values							
Structural Crack Index	0	0	0	0			
Alligator Crack Index	20	19	0	0			
Longitudinal Crack Index	0	0	0	0			
Transverse Cracking Index	59	24	22	26			
Patching Index	98	96	93	95			
Rutting Index	94	94	92	92			
International Roughness Index (IRI)	234	307	341	364			
Lane & Width Information							
Number of Lanes	2	2	2	2			
Paved Width (ft)	19.6	19.4	20.7	20.3			
Lane Width (ft)	8.6	8.5	8.6	8.5

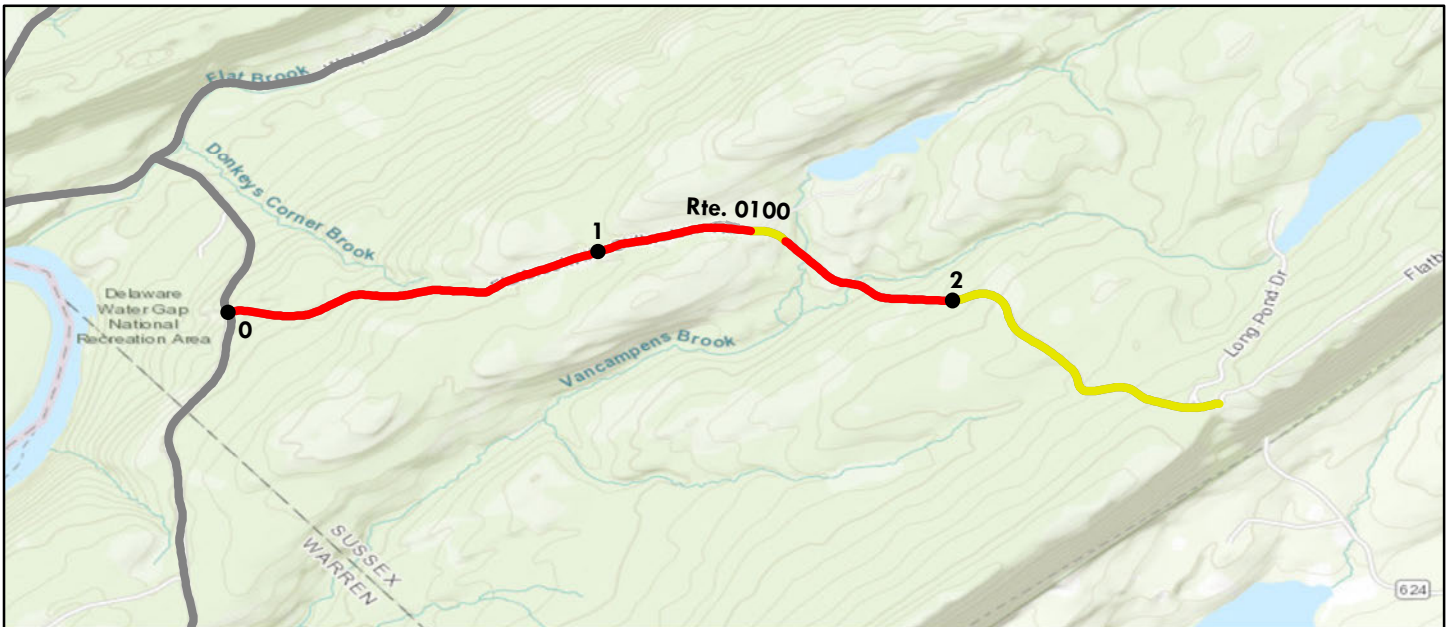
ROUTE 0100: BLUE MOUNTAIN LAKE ROAD

Data Collection Vehicle (DCV) Rating

Colors on map represent condition scores at 0.10-mile intervals. See Appendix for definitions and formulas.

Inspection Date:	6/11/2018	Beginning Section MP	0	1	2		
Paved Length (Miles):	2.88	Section Length (MI)	1	1	0.88		
Surface Type:	ASPHALT	Route Summary					
Roadway Condition Information							
Pavement Condition Rating (PCR)	22	22	18	73			
Surface Condition Rating (SCR)	0	0	0	78			
Roughness Condition Index (RCI)	54	54	45	65			
Distress Index Values							
Structural Crack Index	0	0	0	78			
Alligator Crack Index	59	70	14	98			
Longitudinal Crack Index	41	0	52	80			
Transverse Cracking Index	77	70	73	89			
Patching Index	99	98	98	100			
Rutting Index	94	95	93	97			
International Roughness Index (IRI)	267	264	311	219			
Lane & Width Information							
Number of Lanes	2	2	2	2			
Paved Width (ft)	21.1	22.2	20.7	20.4			
Lane Width (ft)	10.2	10.2	10.3	9.8

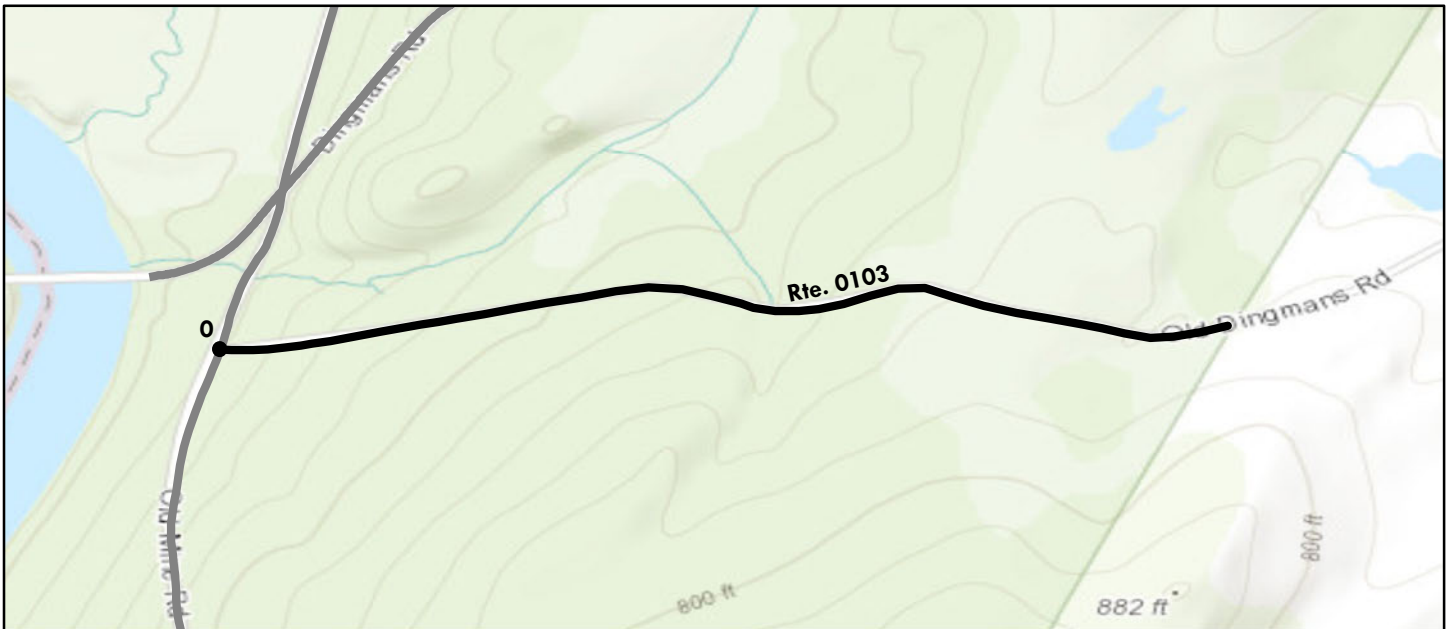
ROUTE 0103: OLD DINGMANS BRIDGE ROAD

Manual Rating

Route Condition Legend – Pavement Condition Rating (PCR)							
Poor (0 - 60)		Fair (61- 84)		Good (85 - 94)		Excellent (95 - 100)	Not Rated
See Appendix for definitions and formulas							
Inspection Date:	7/9/2018	Beginning Section MP	0.00				
Paved Length (Miles):	0.87	Section Length (MI)	0.87				
Surface Type:	ASPHALT	Route Summary					
Roadway Condition Information							
Pavement Condition Rating (PCR)		N/A	N/A				
Surface Condition Rating (SCR)		N/A	N/A				
Roughness Condition Index (RCI)		N/A	N/A				
Distress Index Values							
Structural Crack Index		N/A	N/A				
Alligator Crack Index		N/A	N/A				
Longitudinal Crack Index		N/A	N/A				
Transverse Cracking Index		N/A	N/A				
Patching Index		N/A	N/A				
Rutting Index		N/A	N/A				
International Roughness Index (IRI)		N/A	N/A				
Lane & Width Information							
Number of Lanes		2	2				
Paved Width (ft)		15	15				
Lane Width (ft)		7.5	7.5

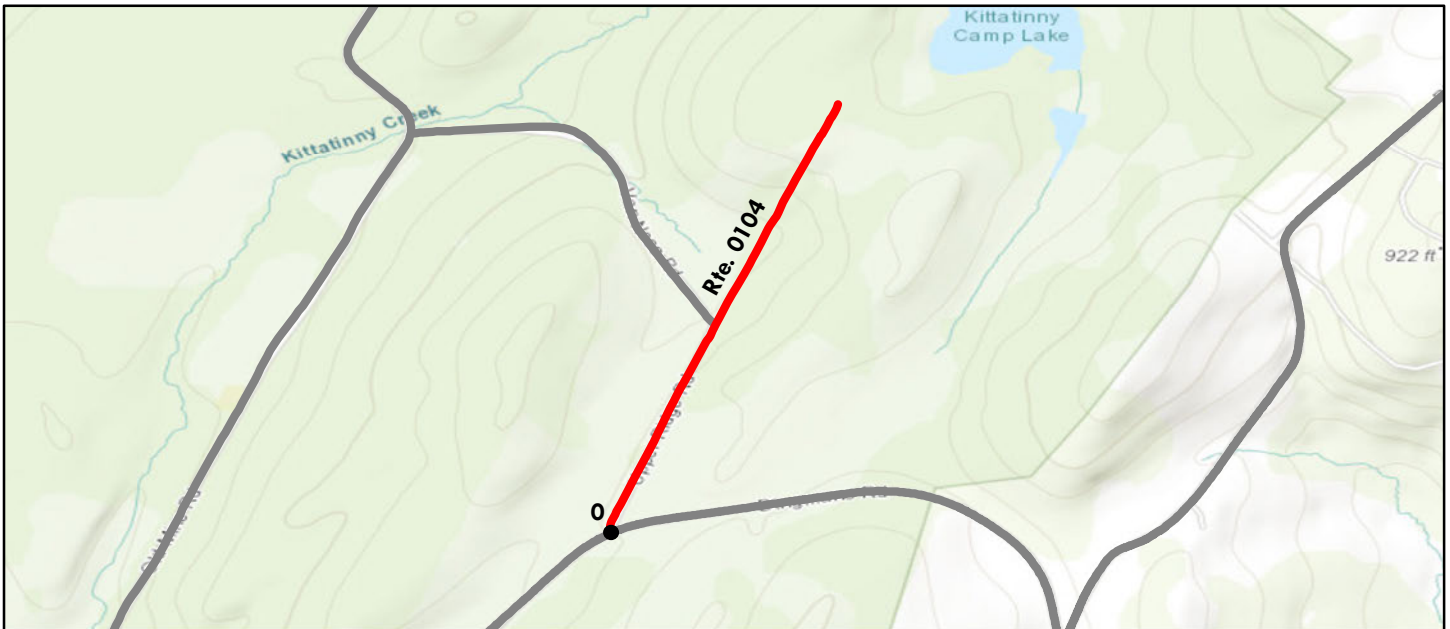
ROUTE 0104: UPPER RIDGE ROAD

Manual Rating

Inspection Date: 7/9/2018	Beginning Section MP	0.00				
Paved Length (Miles): 0.72	Section Length (MI)	0.72				
Surface Type: ASPHALT	Route Summary					
Roadway Condition Information						
Pavement Condition Rating (PCR)	30	30				
Surface Condition Rating (SCR)	30	30				
Roughness Condition Index (RCI)	N/A	N/A				
Distress Index Values						
Structural Crack Index	N/A	N/A				
Alligator Crack Index	30	30				
Longitudinal Crack Index	30	30				
Transverse Cracking Index	90	90				
Patching Index	97	97				
Rutting Index	53	53				
International Roughness Index (IRI)	N/A	N/A				
Lane & Width Information						
Number of Lanes	2	2				
Paved Width (ft)	18	18				
Lane Width (ft)	9	9

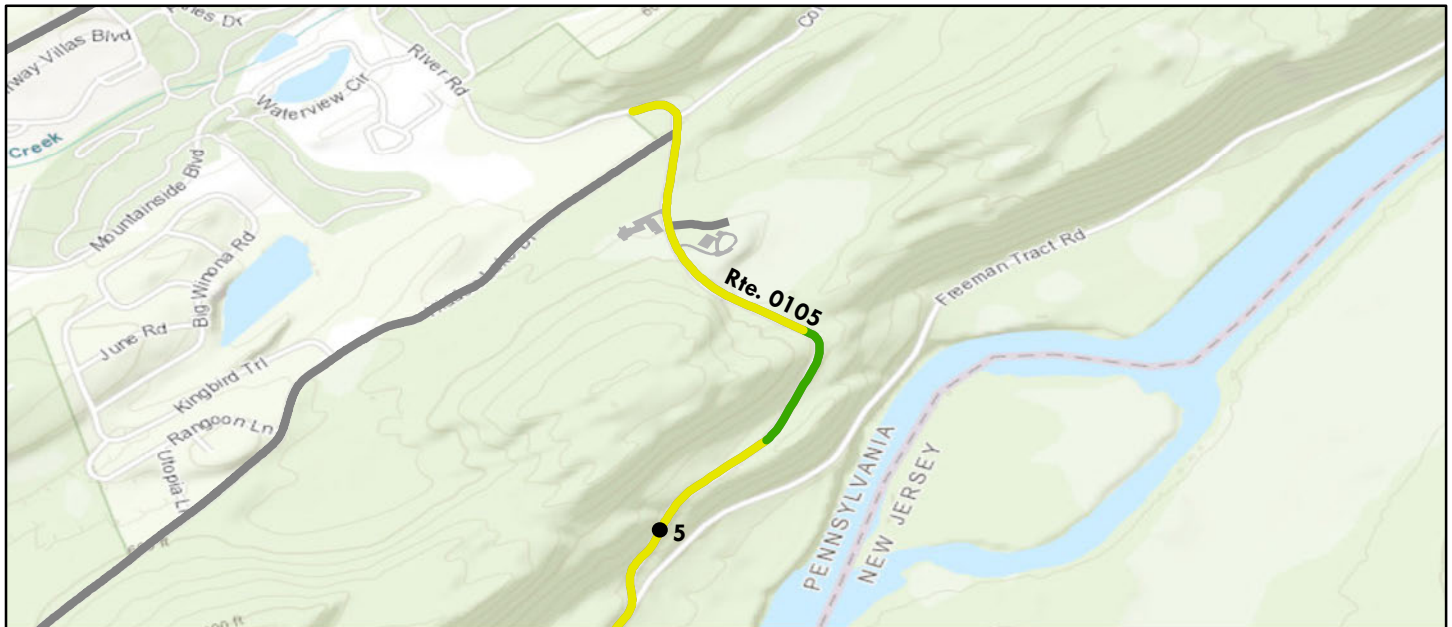
ROUTE 0105: RIVER ROAD

Data Collection Vehicle (DCV) Rating

Colors on map represent condition scores at 0.10-mile intervals. See Appendix for definitions and formulas.

Inspection Date: 6/11/2018	Beginning Section MP	5				
Paved Length (Miles): 5.89	Section Length (MI)	0.89				
Surface Type: ASPHALT	Route Summary					
Roadway Condition Information						
Pavement Condition Rating (PCR)	86	80				
Surface Condition Rating (SCR)	97	97				
Roughness Condition Index (RCI)	69	55				
Distress Index Values						
Structural Crack Index	97	97				
Alligator Crack Index	100	100				
Longitudinal Crack Index	97	97				
Transverse Cracking Index	100	99				
Patching Index	99	98				
Rutting Index	98	97				
International Roughness Index (IRI)	204	262				
Lane & Width Information						
Number of Lanes	2	2				
Paved Width (ft)	19.4	21.1				
Lane Width (ft)	8.6	9.4

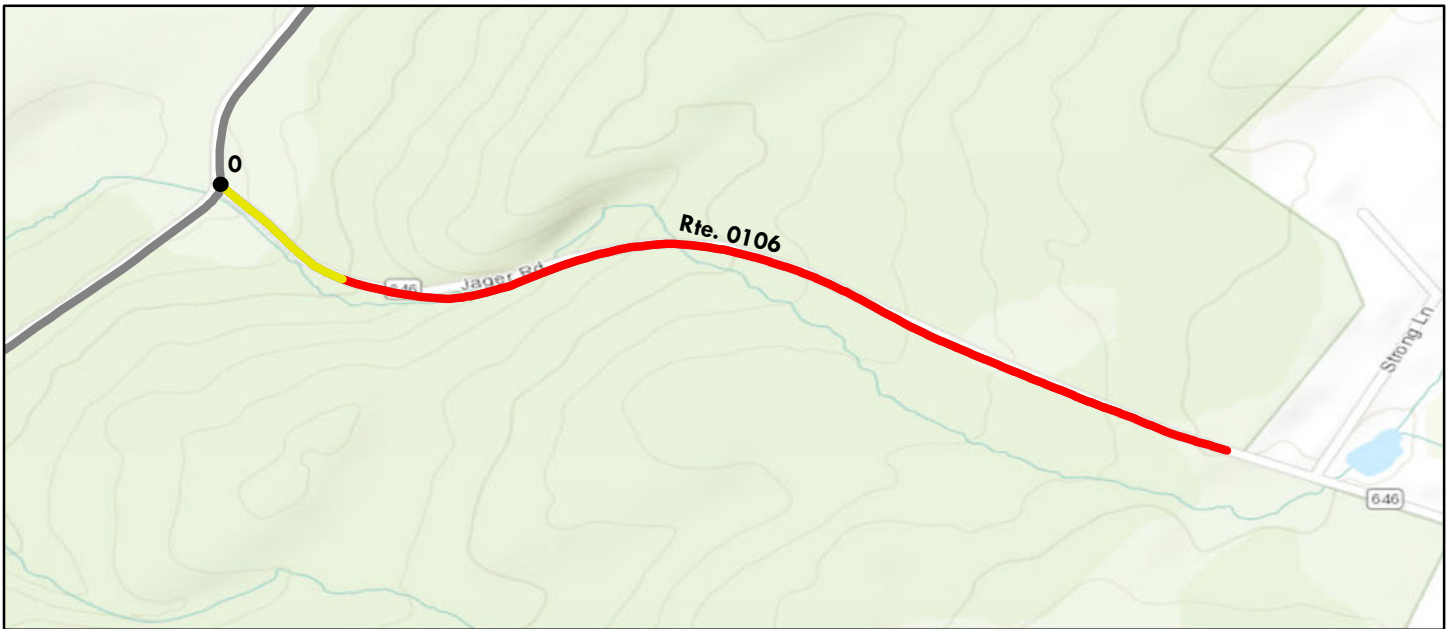
ROUTE 0106: JAGER ROAD

Data Collection Vehicle (DCV) Rating

Colors on map represent condition scores at 0.10-mile intervals. See Appendix for definitions and formulas.

Inspection Date: 6/12/2018	Beginning Section MP	0				
Paved Length (Miles): 0.68	Section Length (MI)	0.68				
Surface Type: ASPHALT	Route Summary					
Roadway Condition Information						
Pavement Condition Rating (PCR)	42	42				
Surface Condition Rating (SCR)	21	21				
Roughness Condition Index (RCI)	73	73				
Distress Index Values						
Structural Crack Index	21	21				
Alligator Crack Index	99	99				
Longitudinal Crack Index	22	22				
Transverse Cracking Index	90	90				
Patching Index	98	98				
Rutting Index	97	97				
International Roughness Index (IRI)	192	192				
Lane & Width Information						
Number of Lanes	2	2				
Paved Width (ft)	22.5	22.5				
Lane Width (ft)	10.4	10.4
