DEWA Cycle 6

Final Report

Road Inventory and Condition Assessment of Paved Routes Delaware Water Gap National Recreation Area

Report Date: May 2020

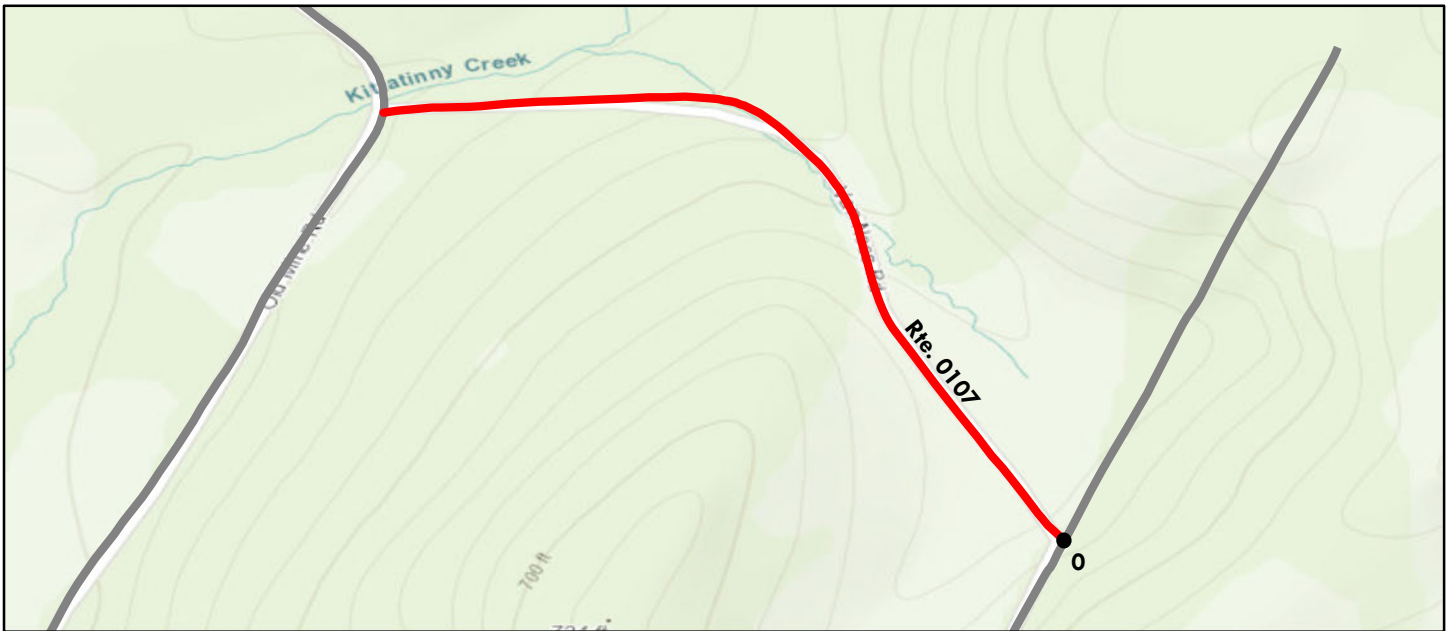
ROUTE 0107: FISHER SCHOOL HOUSE ROAD

Manual Rating

Route Condition Legend – Pavement Condition Rating (PCR)									
Poor (0 - 60)		Fair (61- 84)		Good (85 - 94)		Excellent (95 - 100)		Not Rated	
See Appendix for definitions and formulas									
Inspection Date:	7/9/2018	Beginning Section MP	0.00						
Paved Length (Miles):	0.54	Section Length (MI)	0.54						
Surface Type:	ASPHALT	Route Summary							
Roadway Condition Information									
Pavement Condition Rating (PCR)		30	30						
Surface Condition Rating (SCR)		30	30						
Roughness Condition Index (RCI)		N/A	N/A						
Distress Index Values									
Structural Crack Index		N/A	N/A						
Alligator Crack Index		30	30						
Longitudinal Crack Index		30	30						
Transverse Cracking Index		90	90						
Patching Index		73	73						
Rutting Index		53	53						
International Roughness Index (IRI)		N/A	N/A						
Lane & Width Information									
Number of Lanes		1	1						
Paved Width (ft)		12	12						
Lane Width (ft)		12	12

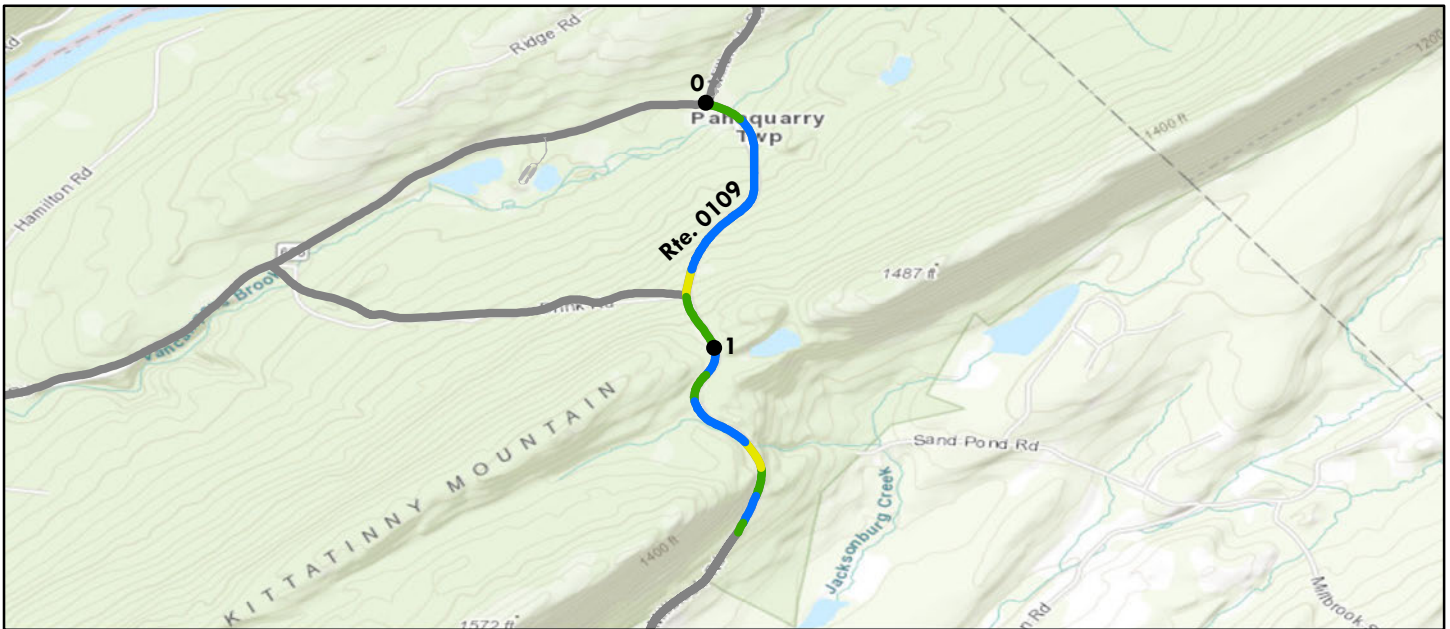
ROUTE 0109: NPS 602

Data Collection Vehicle (DCV) Rating

Colors on map represent condition scores at 0.10-mile intervals. See Appendix for definitions and formulas.

Inspection Date: 6/11/2018	Beginning Section MP	0	1			
Paved Length (Miles): 1.73	Section Length (MI)	1	0.73			
Surface Type: ASPHALT	Route Summary					
Roadway Condition Information						
Pavement Condition Rating (PCR)	94	95	92			
Surface Condition Rating (SCR)	91	92	90			
Roughness Condition Index (RCI)	99	100	95			
Distress Index Values						
Structural Crack Index	91	92	90			
Alligator Crack Index	100	100	100			
Longitudinal Crack Index	91	92	90			
Transverse Cracking Index	97	97	97			
Patching Index	100	100	100			
Rutting Index	99	99	99			
International Roughness Index (IRI)	117	111	127			
Lane & Width Information						
Number of Lanes	2	2	2			
Paved Width (ft)	24.6	24.9	24.4			
Lane Width (ft)	10.1	9.9	10.2

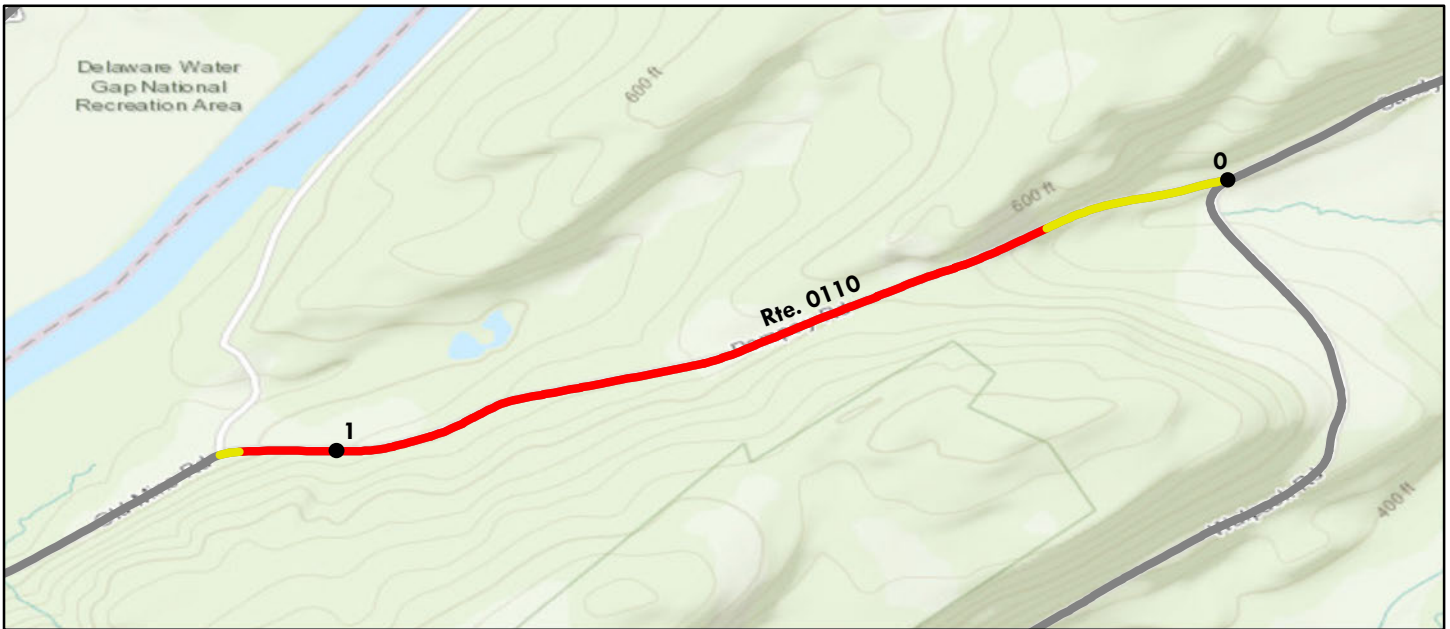
ROUTE 0110: POMPEY RIDGE ROAD

Data Collection Vehicle (DCV) Rating

Colors on map represent condition scores at 0.10-mile intervals. See Appendix for definitions and formulas.

Inspection Date: 6/12/2018		Beginning Section MP	0	1			
Paved Length (Miles): 1.12		Section Length (MI)	1	0.12			
Surface Type: ASPHALT		Route Summary					
Roadway Condition Information							
Pavement Condition Rating (PCR)	28	30	15				
Surface Condition Rating (SCR)	0	0	0				
Roughness Condition Index (RCI)	70	76	37				
Distress Index Values							
Structural Crack Index	0	0	0				
Alligator Crack Index	0	3	0				
Longitudinal Crack Index	30	27	58				
Transverse Cracking Index	89	89	90				
Patching Index	99	100	96				
Rutting Index	95	96	89				
International Roughness Index (IRI)	200	181	359				
Lane & Width Information							
Number of Lanes	2	2	2				
Paved Width (ft)	21	21	21.3				
Lane Width (ft)	9.5	9.4	9.9

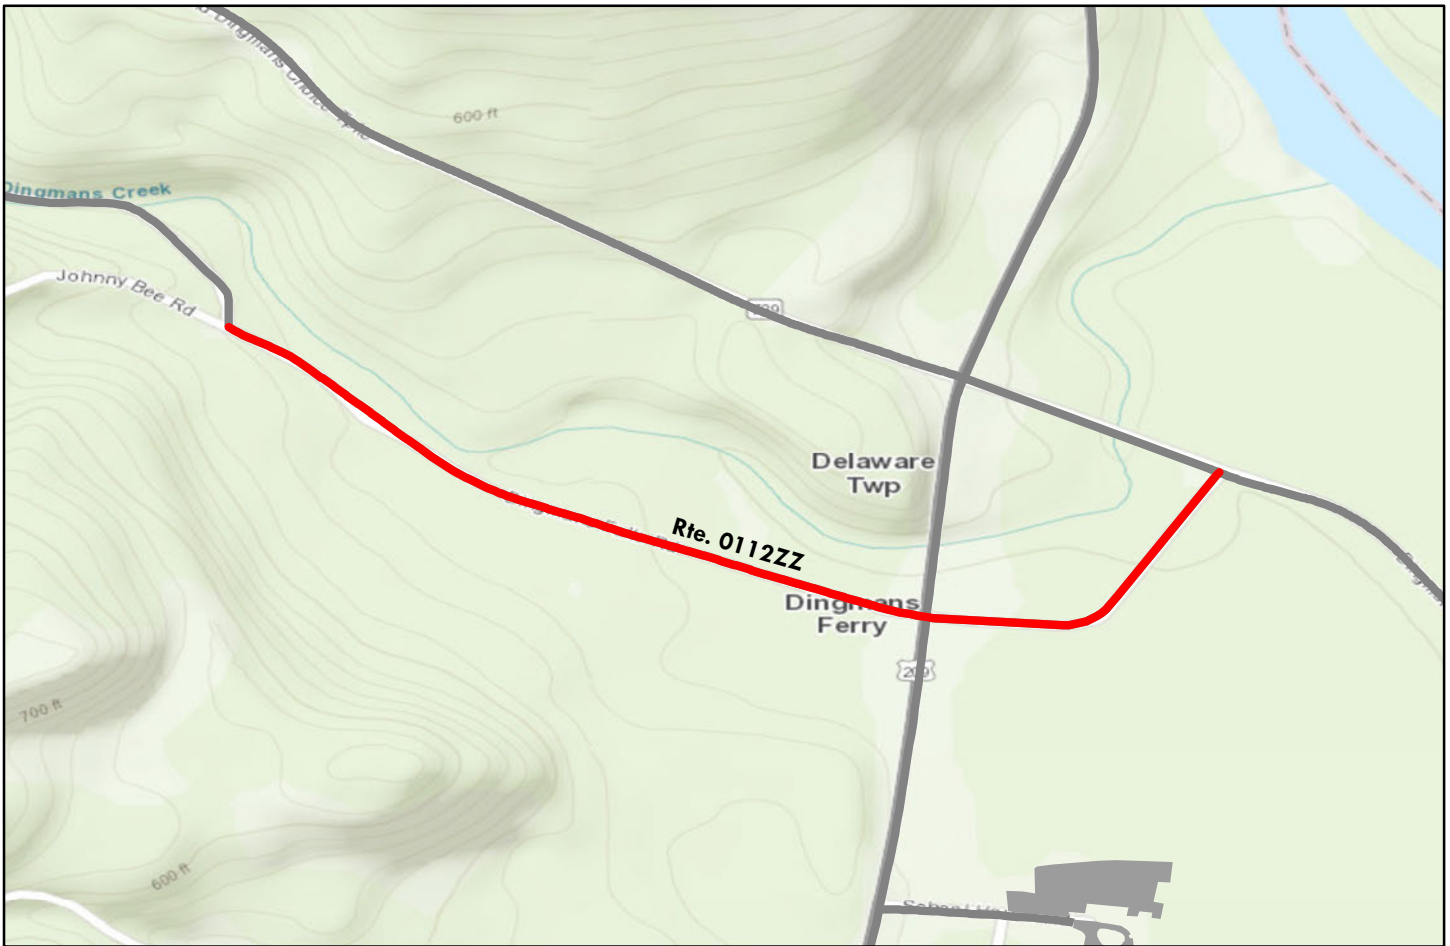
ROUTE 0112ZZ: JOHNNY BEE ROADS

Summary Route

Note: The weighted average summary PCR value is calculated from only the sections of road where the PCR was collected. The overall PCR for the summary route may not reflect individual subcomponent ratings.

Route Condition Legend – Pavement Condition Rating (PCR)						
Poor (0 - 60)	Fair (61- 84)	Good (85 - 94)	Excellent (95 - 100)	Not Rated		
See Appendix for definitions and formulas						
Inspection Date:	7/9/2018					
Paved Length (Miles):	0.72					
Surface Type:	ASPHALT	Route Summary				
Roadway Condition Information						
Pavement Condition Rating (PCR)	52					
Lane & Width Information						
Number of Lanes	2					
Paved Width (ft)	23					
Lane Width (ft)	10.5

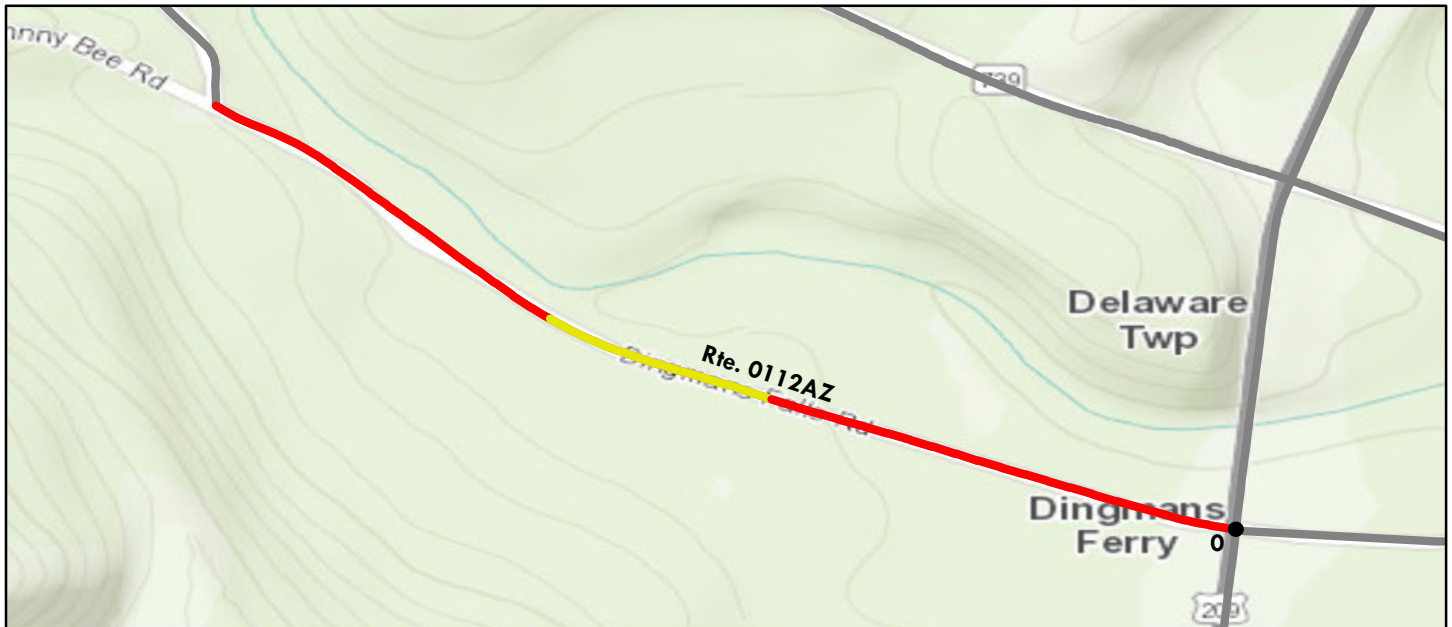
Subcomponent of Route DEWA-0112ZZ

Data Collection Vehicle (DCV) Rating

Colors on map represent condition scores at 0.10-mile intervals. See Appendix for definitions and formulas.

Inspection Date:	6/12/2018	Beginning Section MP	0				
Paved Length (Miles):	0.48	Section Length (MI)	0.48				
Surface Type:	ASPHALT	Route Summary					
Roadway Condition Information							
Pavement Condition Rating (PCR)		23	23				
Surface Condition Rating (SCR)		23	23				
Roughness Condition Index (RCI)		N/A	N/A				
Distress Index Values							
Structural Crack Index		23	23				
Alligator Crack Index		96	96				
Longitudinal Crack Index		27	27				
Transverse Cracking Index		90	90				
Patching Index		99	99				
Rutting Index		96	96				
International Roughness Index (IRI)		N/A	N/A				
Lane & Width Information							
Number of Lanes		2	2				
Paved Width (ft)		19.5	19.5				
Lane Width (ft)		8.3	8.3

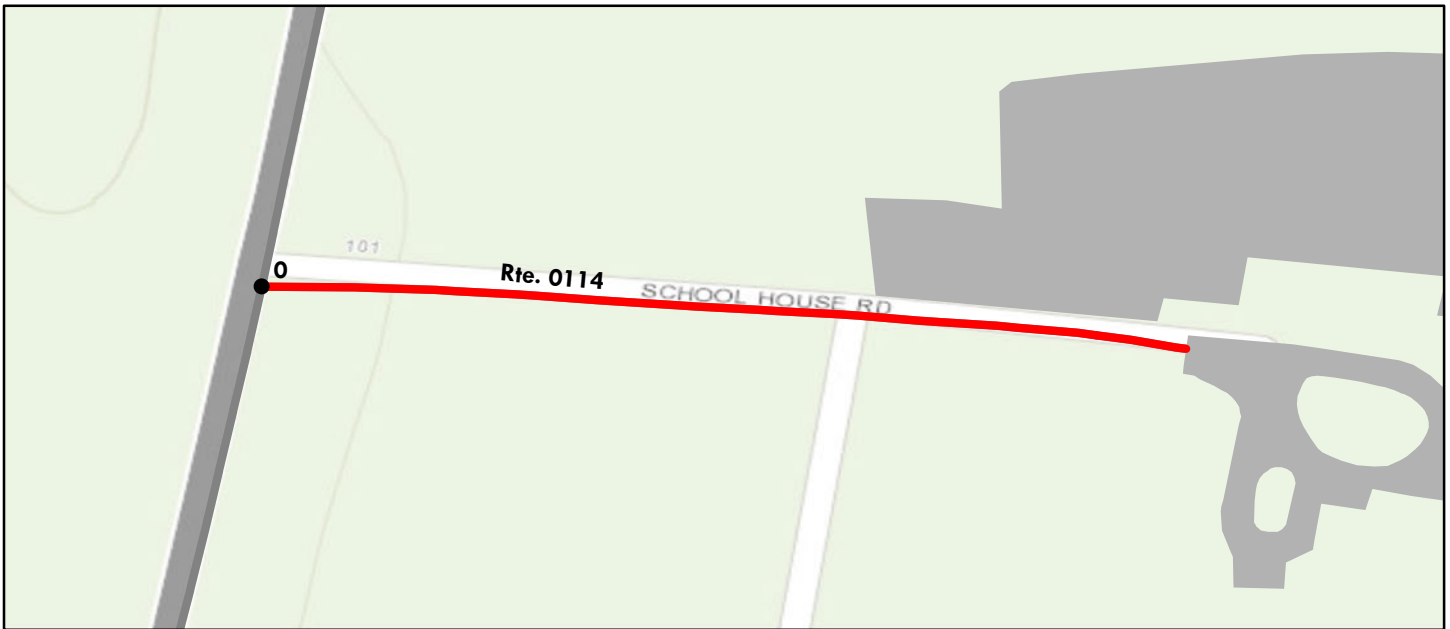
ROUTE 0114: SCHOOL HOUSE ROAD

Data Collection Vehicle (DCV) Rating

Colors on map represent condition scores at 0.10-mile intervals. See Appendix for definitions and formulas.

Inspection Date: 6/11/2018	Beginning Section MP	0				
Paved Length (Miles): 0.12	Section Length (MI)	0.12				
Surface Type: ASPHALT	Route Summary					
Roadway Condition Information						
Pavement Condition Rating (PCR)	0	0				
Surface Condition Rating (SCR)	0	0				
Roughness Condition Index (RCI)	N/A	N/A				
Distress Index Values						
Structural Crack Index	0	0				
Alligator Crack Index	0	0				
Longitudinal Crack Index	33	33				
Transverse Cracking Index	56	56				
Patching Index	93	93				
Rutting Index	89	89				
International Roughness Index (IRI)	N/A	N/A				
Lane & Width Information						
Number of Lanes	2	2				
Paved Width (ft)	22	22				
Lane Width (ft)	9.4	9.4

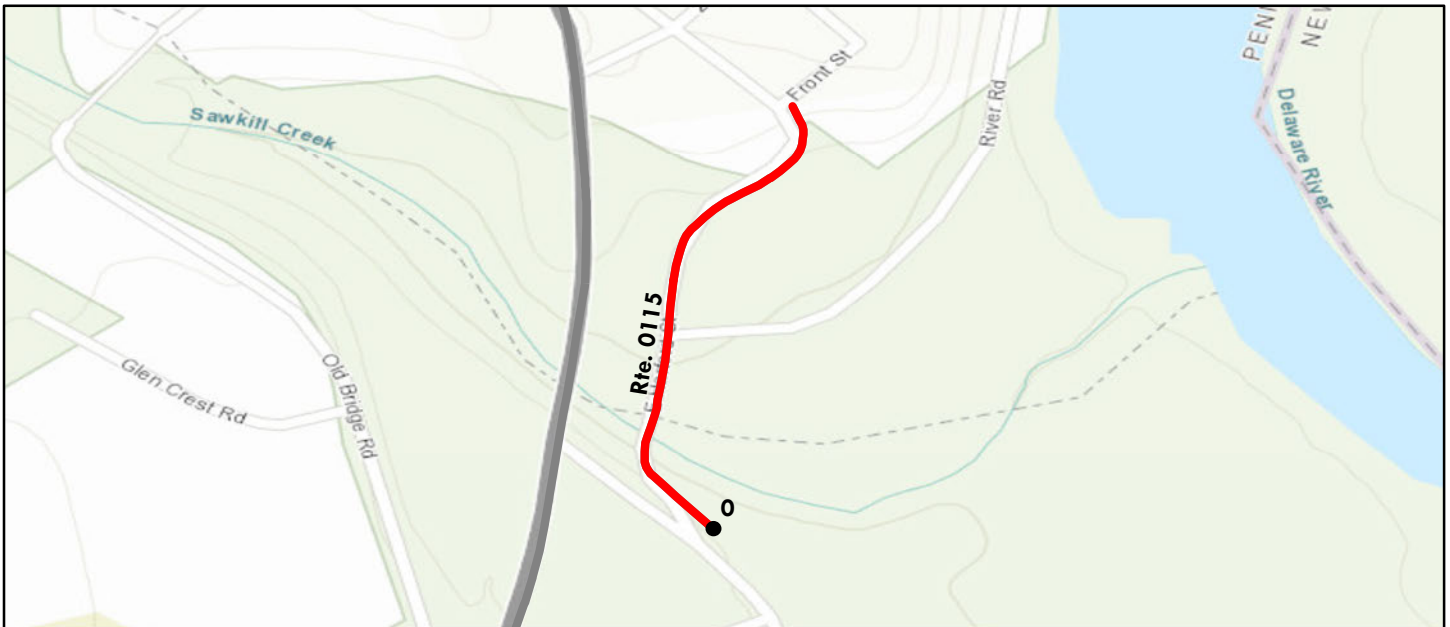
ROUTE 0115: ICE HOUSE ROAD

Data Collection Vehicle (DCV) Rating

Route Condition Legend – Pavement Condition Rating (PCR)										
Poor (0 - 60)		Fair (61- 84)		Good (85 - 94)		Excellent (95 - 100)		Not Rated		
Colors on map represent condition scores at 0.10-mile intervals. See Appendix for definitions and formulas.										
Inspection Date: 6/12/2018		Beginning Section MP		0						
Paved Length (Miles): 0.18		Section Length (MI)		0.18						
Surface Type: ASPHALT		Route Summary								
Roadway Condition Information										
Pavement Condition Rating (PCR)		25		25						
Surface Condition Rating (SCR)		25		25						
Roughness Condition Index (RCI)		N/A		N/A						
Distress Index Values										
Structural Crack Index		25		25						
Alligator Crack Index		100		100						
Longitudinal Crack Index		25		25						
Transverse Cracking Index		78		78						
Patching Index		94		94						
Rutting Index		95		95						
International Roughness Index (IRI)		N/A		N/A						
Lane & Width Information

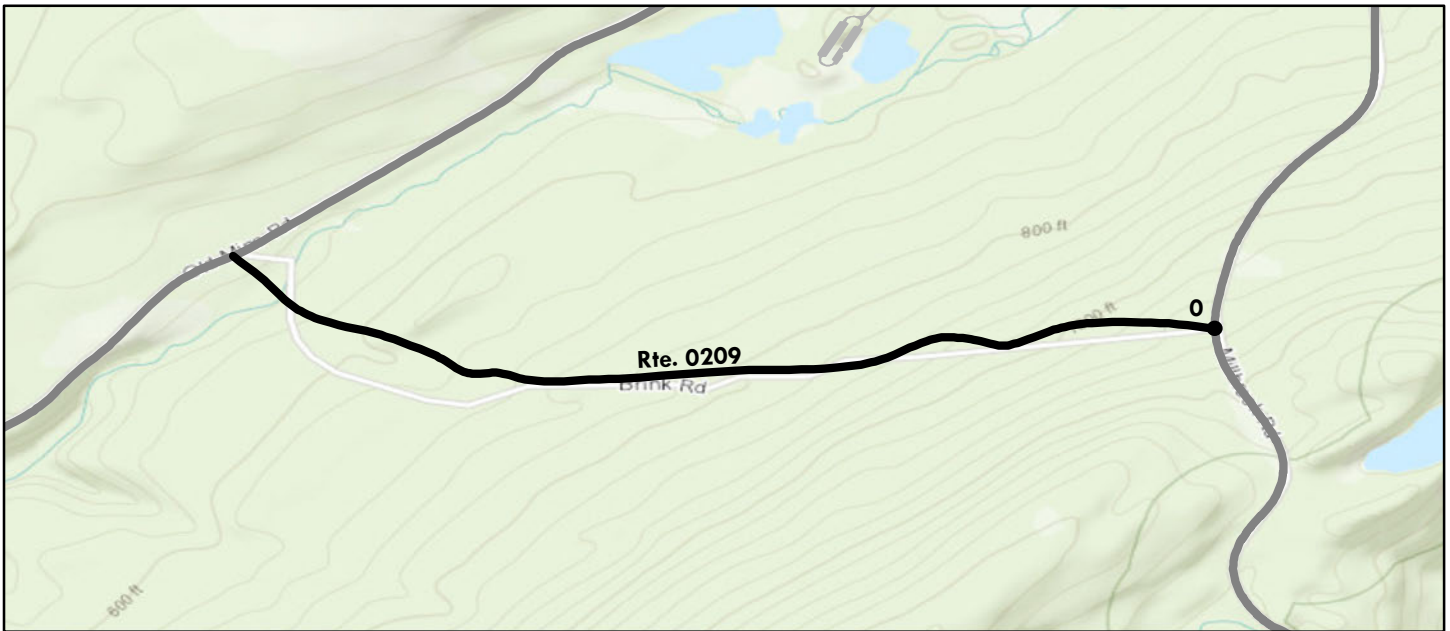
ROUTE 0209: CUTOFF ROAD

Manual Rating

Route Condition Legend – Pavement Condition Rating (PCR)						
Poor (0 - 60)	Fair (61- 84)	Good (85 - 94)	Excellent (95 - 100)	Not Rated		
See Appendix for definitions and formulas						
Inspection Date: 7/10/2018	Beginning Section MP	0.00				
Paved Length (Miles): 1.18	Section Length (MI)	1.18				
Surface Type: ASPHALT	Route Summary					
Roadway Condition Information						
Pavement Condition Rating (PCR)	N/A	N/A				
Surface Condition Rating (SCR)	N/A	N/A				
Roughness Condition Index (RCI)	N/A	N/A				
Distress Index Values						
Structural Crack Index	N/A	N/A				
Alligator Crack Index	N/A	N/A				
Longitudinal Crack Index	N/A	N/A				
Transverse Cracking Index	N/A	N/A				
Patching Index	N/A	N/A				
Rutting Index	N/A	N/A				
International Roughness Index (IRI)	N/A	N/A				
Lane & Width Information						
Number of Lanes	1	1				
Paved Width (ft)	10	10				
Lane Width (ft)	10	10

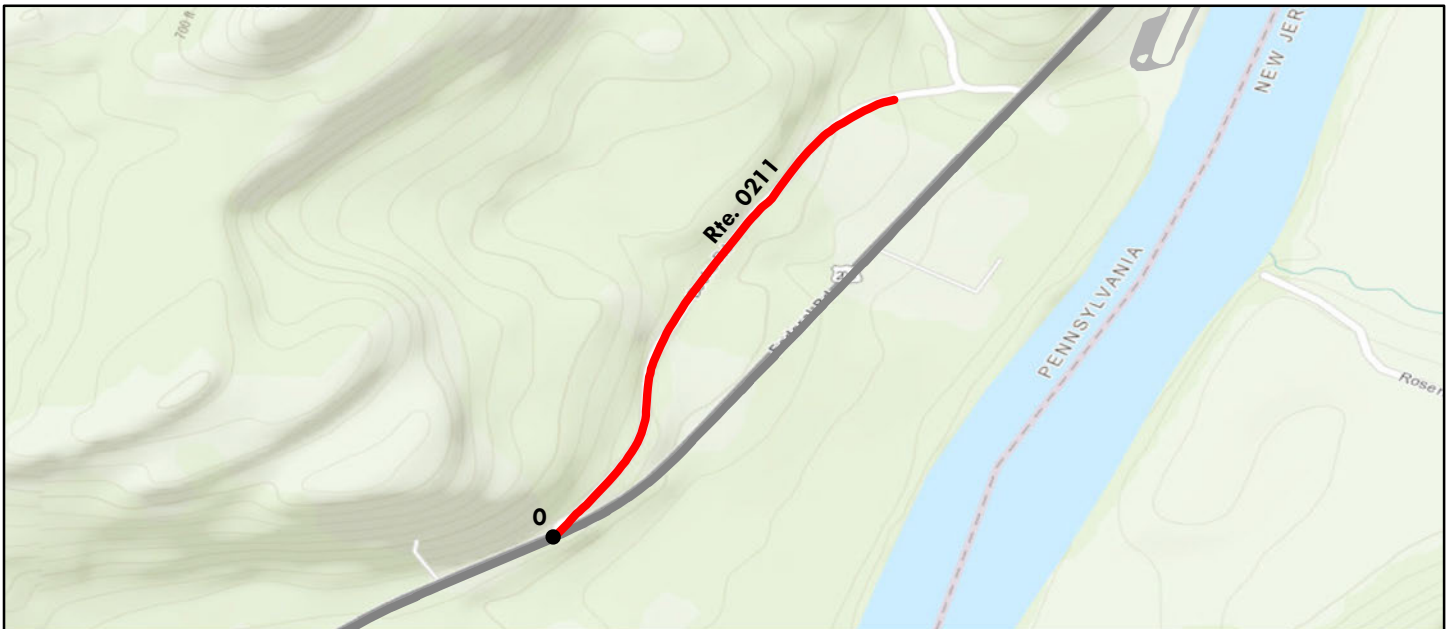
ROUTE 0211: BECK ROAD

Manual Rating

Route Condition Legend – Pavement Condition Rating (PCR)										
Poor (0 - 60)		Fair (61- 84)		Good (85 - 94)		Excellent (95 - 100)		Not Rated		
See Appendix for definitions and formulas										
Inspection Date:	7/9/2018	Beginning Section MP	0.00							
Paved Length (Miles):	0.49	Section Length (MI)	0.49							
Surface Type:	ASPHALT	Route Summary								
Roadway Condition Information										
Pavement Condition Rating (PCR)		0	0							
Surface Condition Rating (SCR)		0	0							
Roughness Condition Index (RCI)		N/A	N/A							
Distress Index Values										
Structural Crack Index		N/A	N/A							
Alligator Crack Index		N/A	N/A							
Longitudinal Crack Index		N/A	N/A							
Transverse Cracking Index		N/A	N/A							
Patching Index		N/A	N/A							
Rutting Index		N/A	N/A							
International Roughness Index (IRI)		N/A	N/A							
Lane & Width Information										
Number of Lanes		1	1							
Paved Width (ft)		10	10

Route rated failed - no pavement present.

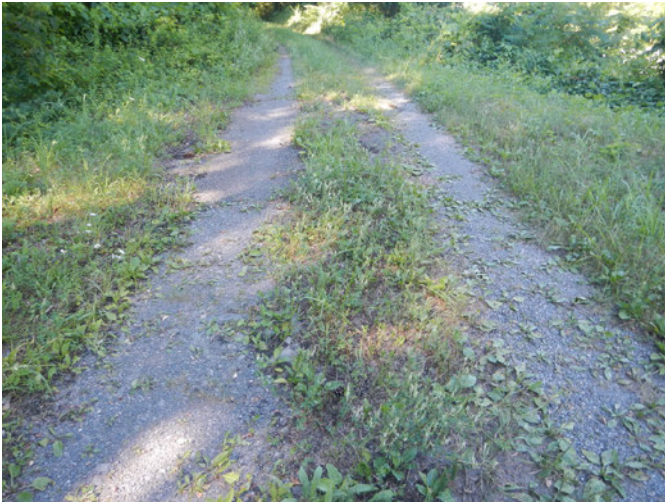
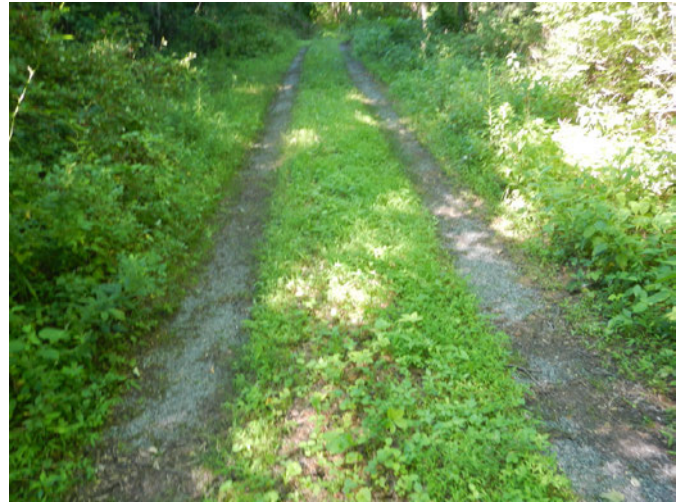
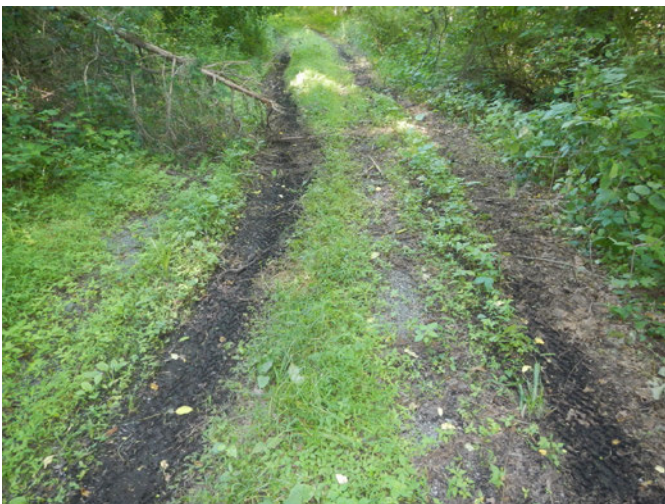
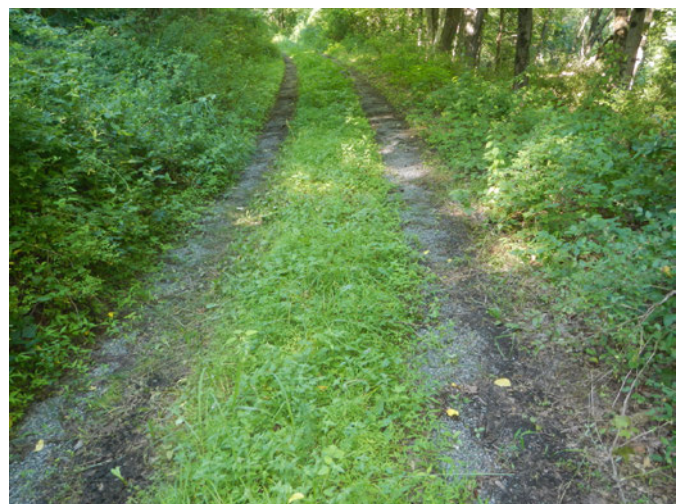
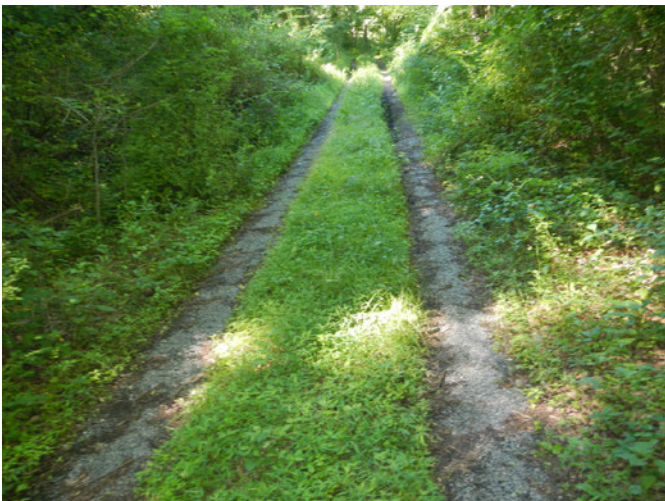
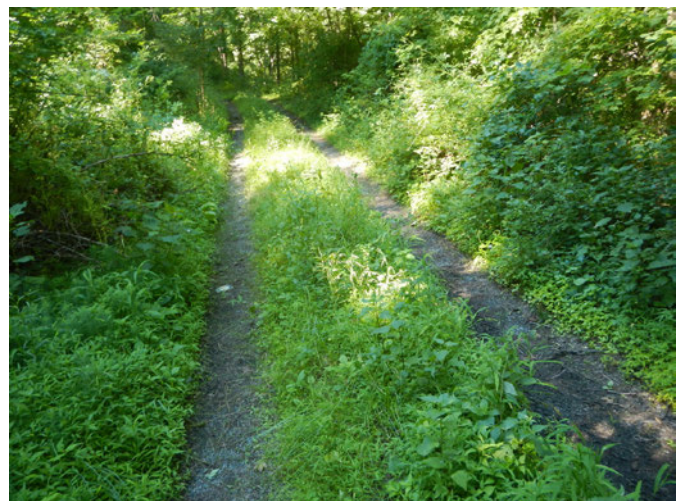
Condition photos are shown only for manually rated roads. Use the PathView program to see images of DCV rated roads.

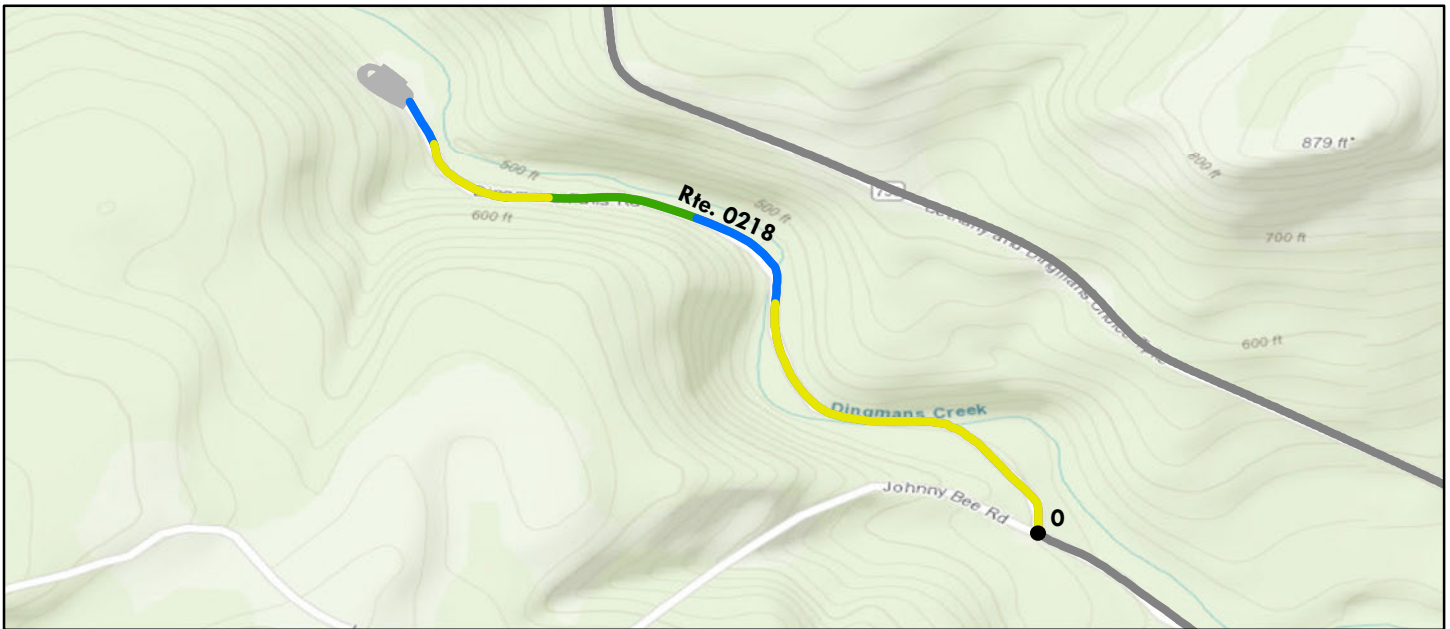
ROUTE 0218: DINGMANS FALLS ROAD

Data Collection Vehicle (DCV) Rating

Colors on map represent condition scores at 0.10-mile intervals. See Appendix for definitions and formulas.

Inspection Date: 6/12/2018	Beginning Section MP	0				
Paved Length (Miles): 0.63	Section Length (MI)	0.63				
Surface Type: ASPHALT	Route Summary					
Roadway Condition Information						
Pavement Condition Rating (PCR)	84	83				
Surface Condition Rating (SCR)	97	97				
Roughness Condition Index (RCI)	64	63				
Distress Index Values						
Structural Crack Index	97	97				
Alligator Crack Index	100	100				
Longitudinal Crack Index	97	97				
Transverse Cracking Index	99	99				
Patching Index	99	99				
Rutting Index	99	99				
International Roughness Index (IRI)	225	225				
Lane & Width Information						
Number of Lanes	2	2				
Paved Width (ft)	19.7	19.7				
Lane Width (ft)	8.5	8.5

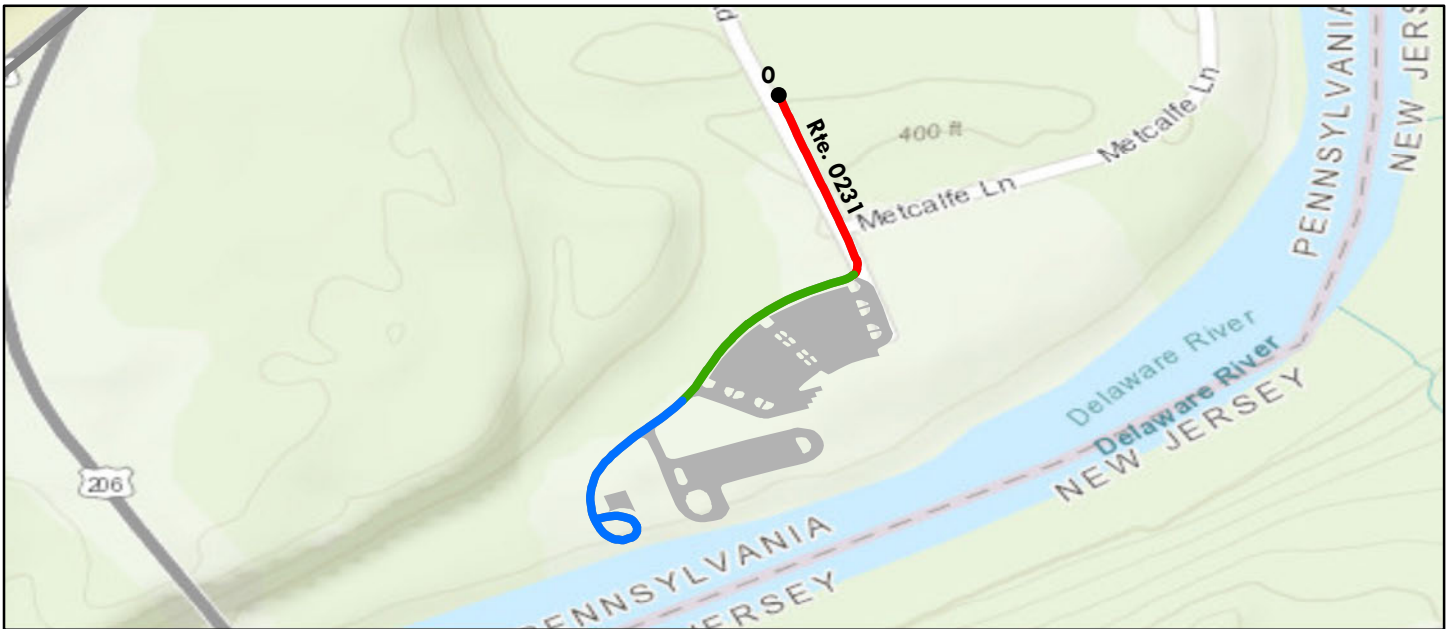
ROUTE 0231: MILFORD BEACH ACCESS ROAD

Data Collection Vehicle (DCV) Rating

Colors on map represent condition scores at 0.10-mile intervals. See Appendix for definitions and formulas.

Inspection Date: 6/12/2018	Beginning Section MP	0				
Paved Length (Miles): 0.32	Section Length (MI)	0.32				
Surface Type: ASPHALT	Route Summary					
Roadway Condition Information						
Pavement Condition Rating (PCR)	58	58				
Surface Condition Rating (SCR)	58	58				
Roughness Condition Index (RCI)	N/A	N/A				
Distress Index Values						
Structural Crack Index	58	58				
Alligator Crack Index	74	74				
Longitudinal Crack Index	84	84				
Transverse Cracking Index	88	88				
Patching Index	100	100				
Rutting Index	94	94				
International Roughness Index (IRI)	N/A	N/A				
Lane & Width Information						
Number of Lanes	2	2				
Paved Width (ft)	23.1	23.1				
Lane Width (ft)	11.5	11.5

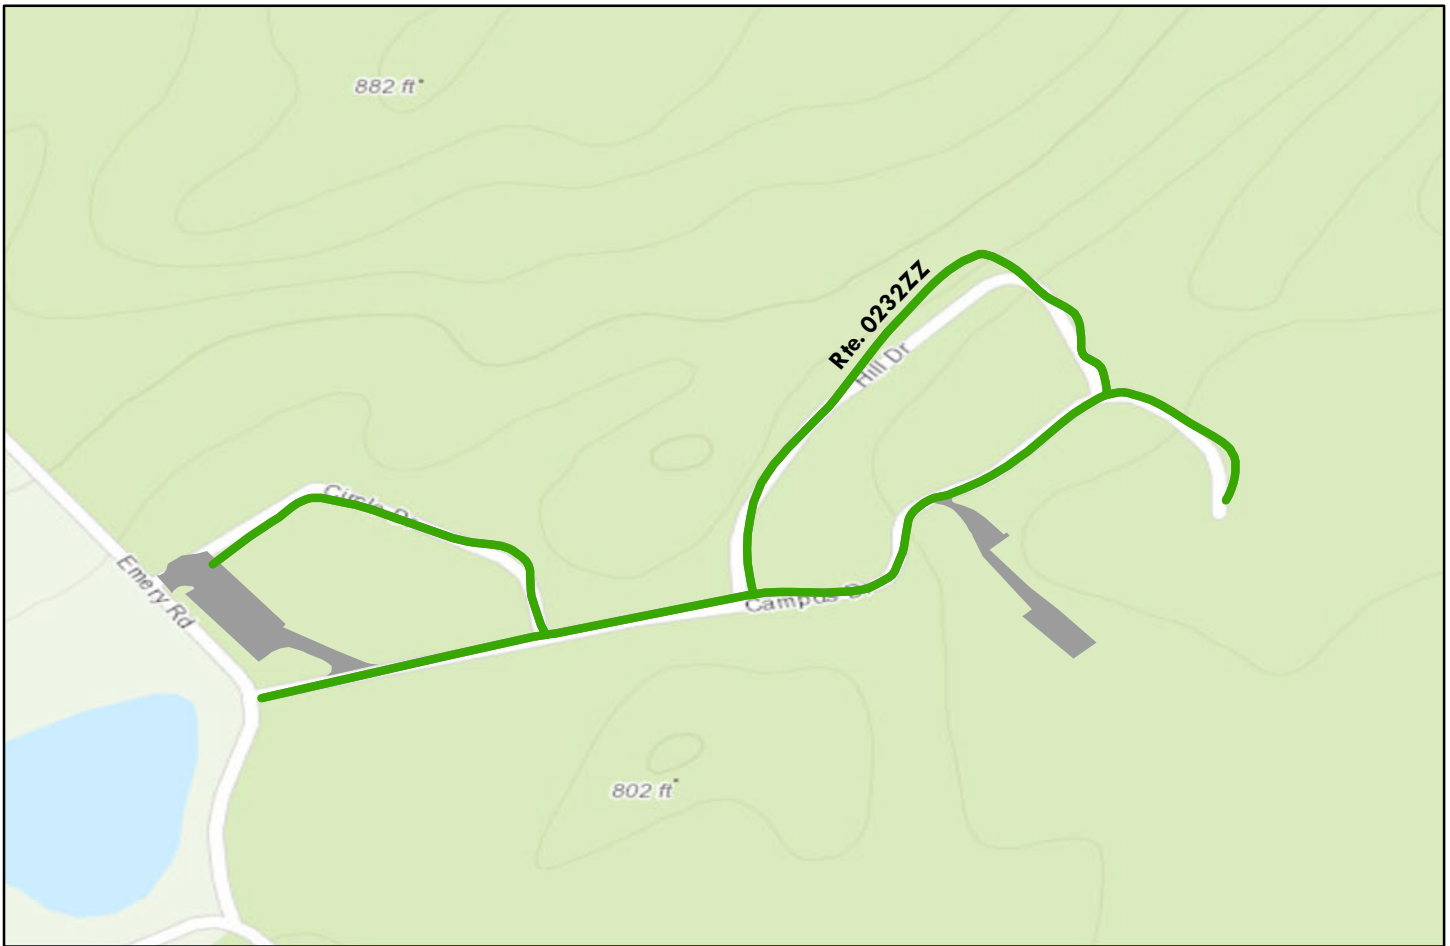
ROUTE 0232ZZ: PEEC CABIN ACCESS ROADS

Summary Route

Note: The weighted average summary PCR value is calculated from only the sections of road where the PCR was collected. The overall PCR for the summary route may not reflect individual subcomponent ratings.

Route Condition Legend – Pavement Condition Rating (PCR)						
Poor (0 - 60)	Fair (61- 84)	Good (85 - 94)	Excellent (95 - 100)	Not Rated		
See Appendix for definitions and formulas						
Inspection Date:	7/9/2018					
Paved Length (Miles):	0.61					
Surface Type:	ASPHALT	Route Summary				
Roadway Condition Information						
Pavement Condition Rating (PCR)	90					
Lane & Width Information						
Number of Lanes	2					
Paved Width (ft)	20					
Lane Width (ft)	10

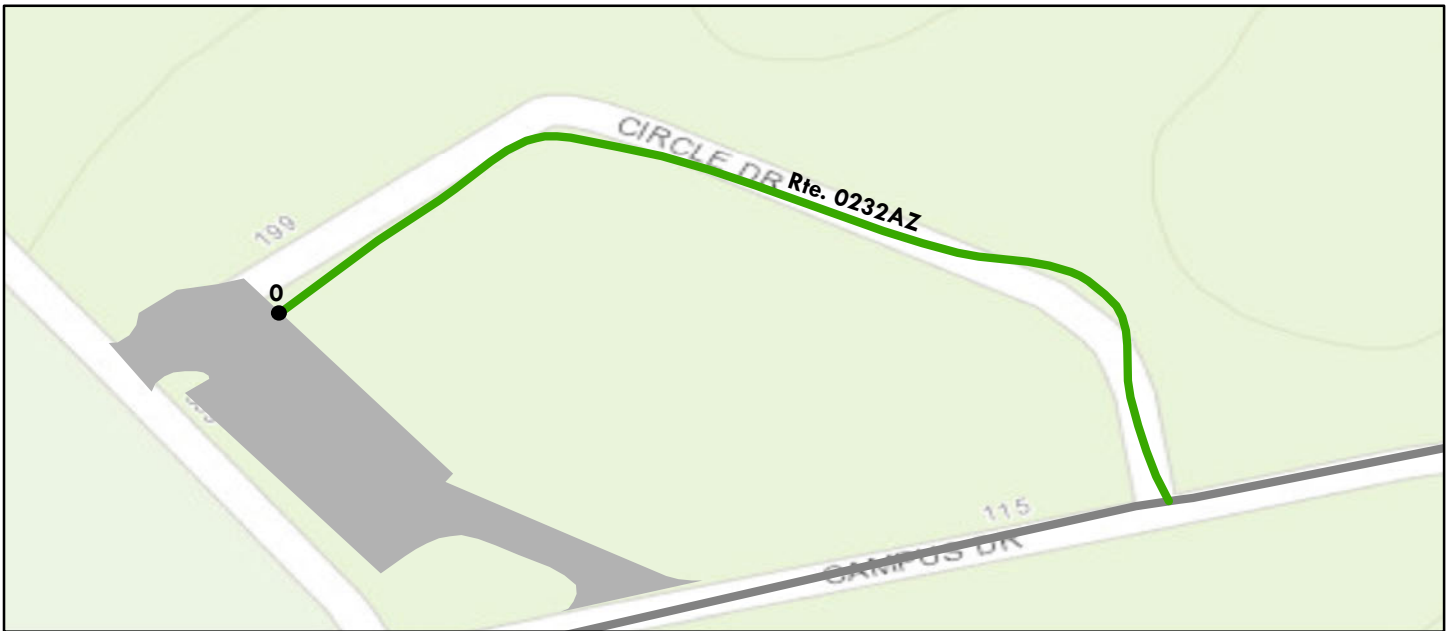
Subcomponent of Route DEWA-0232ZZ

Manual Rating

Inspection Date: 7/9/2018	Beginning Section MP	0.00				
Paved Length (Miles): 0.12	Section Length (MI)	0.12				
Surface Type: ASPHALT	Route Summary					
Roadway Condition Information						
Pavement Condition Rating (PCR)	90	90				
Surface Condition Rating (SCR)	90	90				
Roughness Condition Index (RCI)	N/A	N/A				
Distress Index Values						
Structural Crack Index	N/A	N/A				
Alligator Crack Index	90	90				
Longitudinal Crack Index	90	90				
Transverse Cracking Index	90	90				
Patching Index	97	97				
Rutting Index	97	97				
International Roughness Index (IRI)	N/A	N/A				
Lane & Width Information						
Number of Lanes	2	2				
Paved Width (ft)	20	20				
Lane Width (ft)	10	10

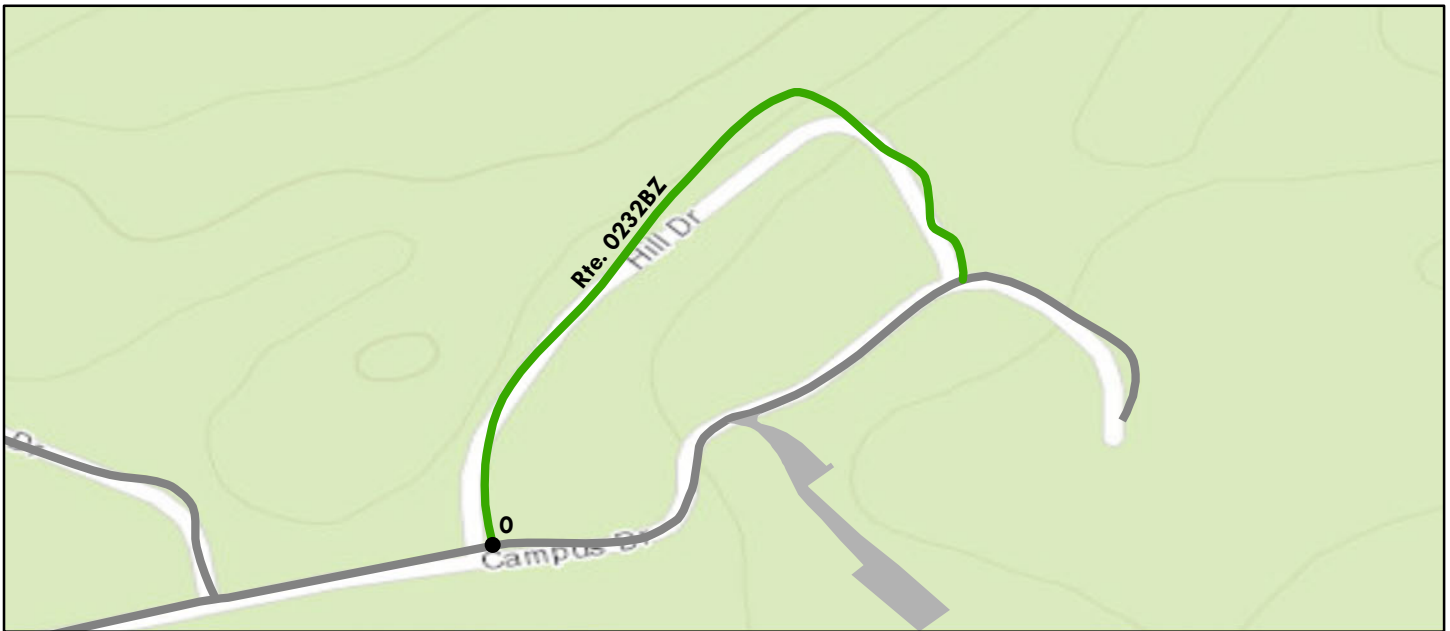
Subcomponent of Route DEWA-0232ZZ

Manual Rating

Inspection Date: 7/9/2018	Beginning Section MP	0.00				
Paved Length (Miles): 0.19	Section Length (MI)	0.19				
Surface Type: ASPHALT	Route Summary					
Roadway Condition Information						
Pavement Condition Rating (PCR)	90	90				
Surface Condition Rating (SCR)	90	90				
Roughness Condition Index (RCI)	N/A	N/A				
Distress Index Values						
Structural Crack Index	N/A	N/A				
Alligator Crack Index	90	90				
Longitudinal Crack Index	90	90				
Transverse Cracking Index	90	90				
Patching Index	90	90				
Rutting Index	97	97				
International Roughness Index (IRI)	N/A	N/A				
Lane & Width Information						
Number of Lanes	2	2				
Paved Width (ft)	20	20				
Lane Width (ft)	10	10

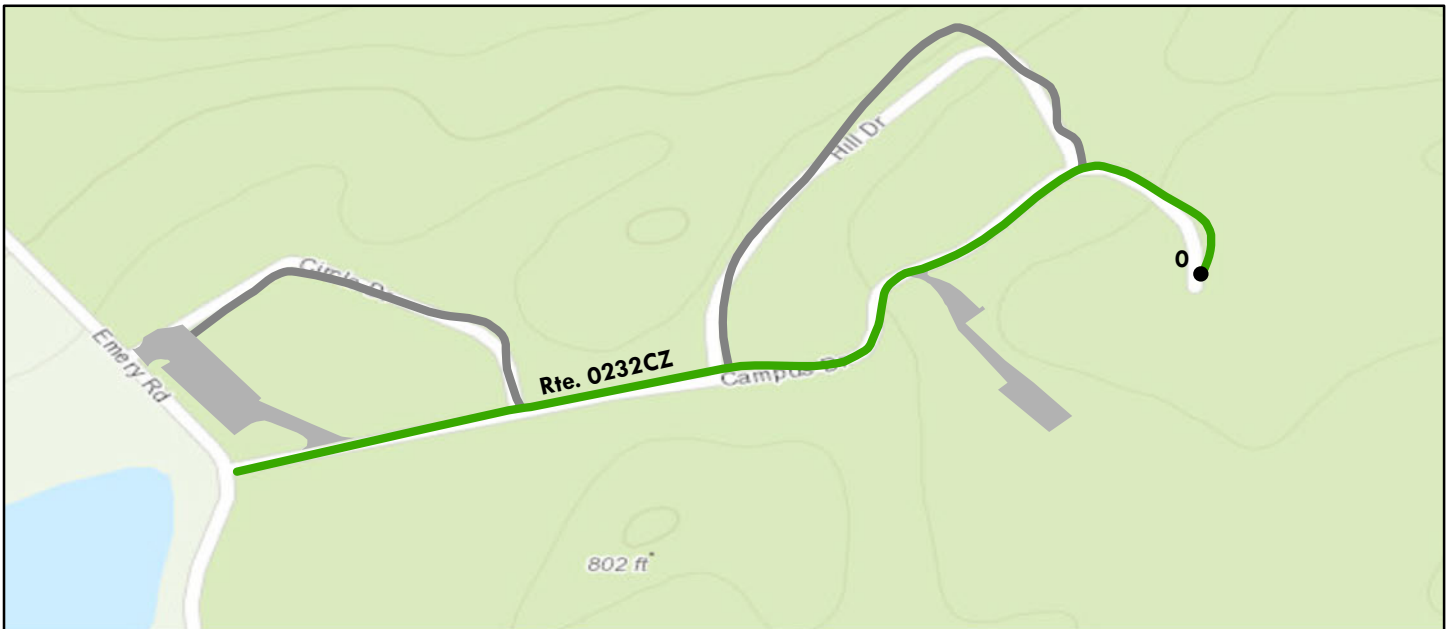
Subcomponent of Route DEWA-0232ZZ

Manual Rating

Inspection Date: 7/9/2018	Beginning Section MP	0.00				
Paved Length (Miles): 0.30	Section Length (MI)	0.30				
Surface Type: ASPHALT	Route Summary					
Roadway Condition Information						
Pavement Condition Rating (PCR)	90	90				
Surface Condition Rating (SCR)	90	90				
Roughness Condition Index (RCI)	N/A	N/A				
Distress Index Values						
Structural Crack Index	N/A	N/A				
Alligator Crack Index	90	90				
Longitudinal Crack Index	90	90				
Transverse Cracking Index	90	90				
Patching Index	97	97				
Rutting Index	97	97				
International Roughness Index (IRI)	N/A	N/A				
Lane & Width Information						
Number of Lanes	2	2				
Paved Width (ft)	20	20				
Lane Width (ft)	10	10

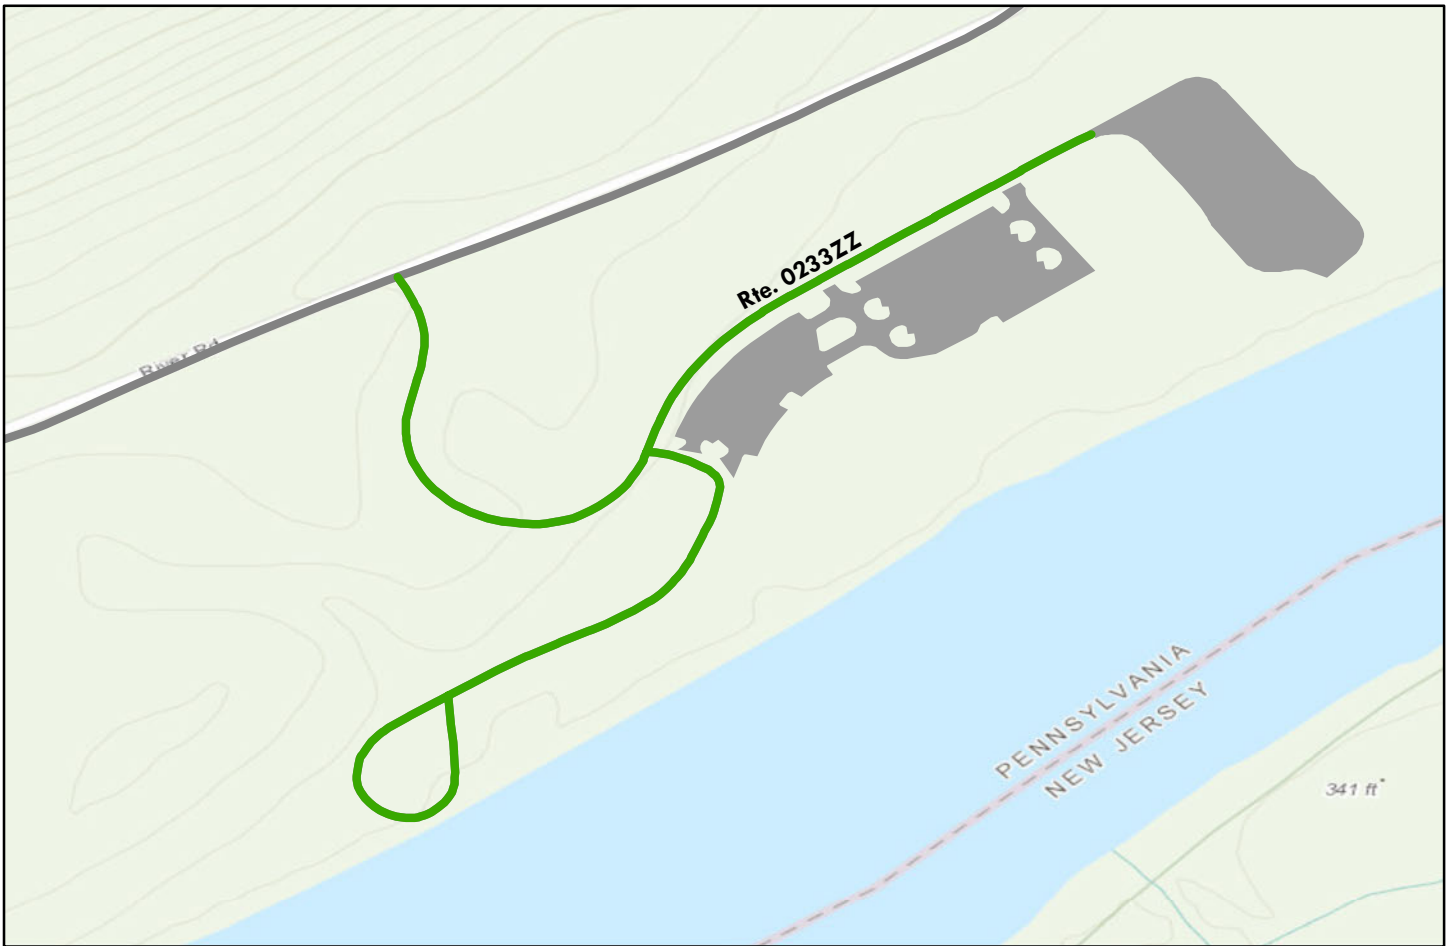
ROUTE 0233ZZ: SMITHFIELD BEACH ACCESS ROADS

Summary Route

Note: The weighted average summary PCR value is calculated from only the sections of road where the PCR was collected. The overall PCR for the summary route may not reflect individual subcomponent ratings.

Route Condition Legend – Pavement Condition Rating (PCR)						
Poor (0 - 60)	Fair (61- 84)	Good (85 - 94)	Excellent (95 - 100)	Not Rated		
See Appendix for definitions and formulas						
Inspection Date:	6/11/2018					
Paved Length (Miles):	0.59					
Surface Type:	ASPHALT	Route Summary				
Roadway Condition Information						
Pavement Condition Rating (PCR)	90					
Lane & Width Information						
Number of Lanes	2					
Paved Width (ft)	21.7					
Lane Width (ft)	10.3
