DEWA Cycle 6

Final Report

Road Inventory and Condition Assessment of Paved Routes Delaware Water Gap National Recreation Area

Report Date: May 2020

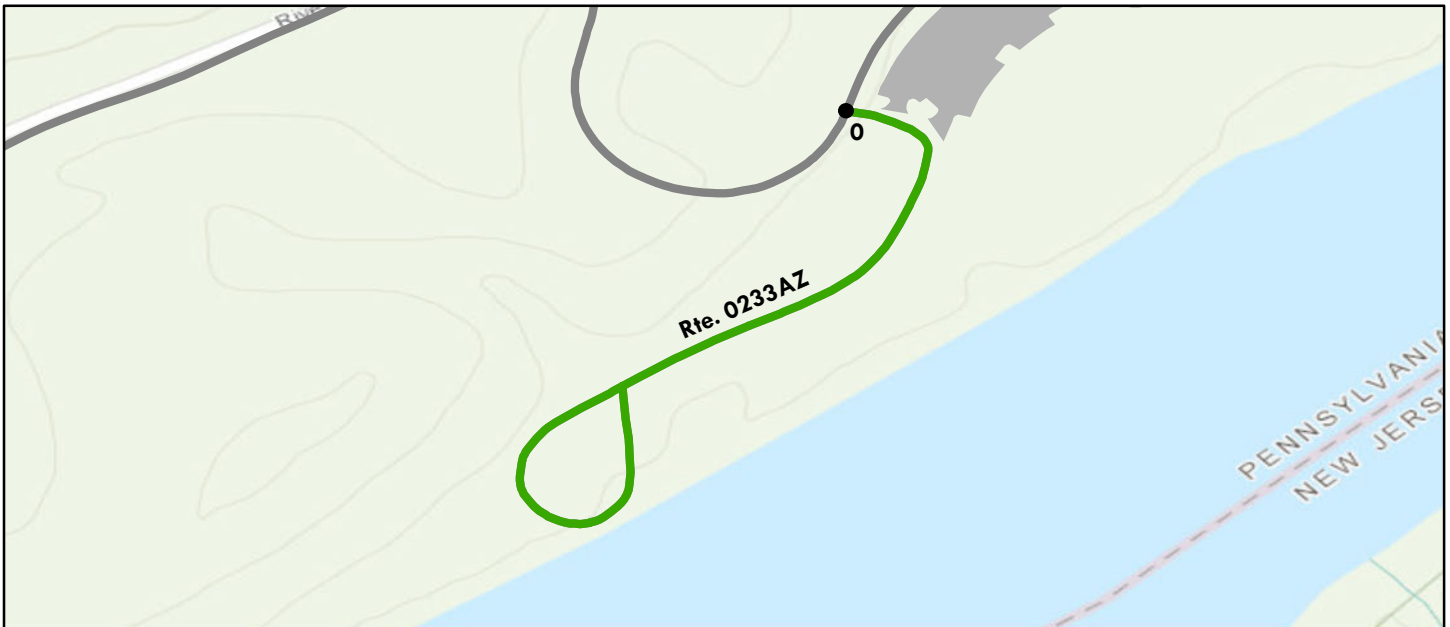
ROUTE 0233AZ: SMITHFIELD BEACH CANOE LAUNCH ACCESS ROAD

Subcomponent of Route DEWA-0233ZZ
Data Collection Vehicle (DCV) Rating

Route Condition Legend – Pavement Condition Rating (PCR)						
Poor (0 - 60)	Fair (61- 84)	Good (85 - 94)	Excellent (95 - 100)	Not Rated		
Colors on map represent condition scores at 0.10-mile intervals. See Appendix for definitions and formulas.						
Inspection Date: 6/11/2018	Beginning Section MP	0				
Paved Length (Miles): 0.25	Section Length (MI)	0.25				
Surface Type: ASPHALT	Route Summary					
Roadway Condition Information						
Pavement Condition Rating (PCR)	89	89				
Surface Condition Rating (SCR)	89	89				
Roughness Condition Index (RCI)	N/A	N/A				
Distress Index Values						
Structural Crack Index	99	99				
Alligator Crack Index	100	100				
Longitudinal Crack Index	99	99				
Transverse Cracking Index	96	96				
Patching Index	100	100				
Rutting Index	89	89				
International Roughness Index (IRI)	N/A	N/A				
Lane & Width Information						
Number of Lanes	2	2				
Paved Width (ft)	21.8	21.8				
Lane Width (ft)	11	11

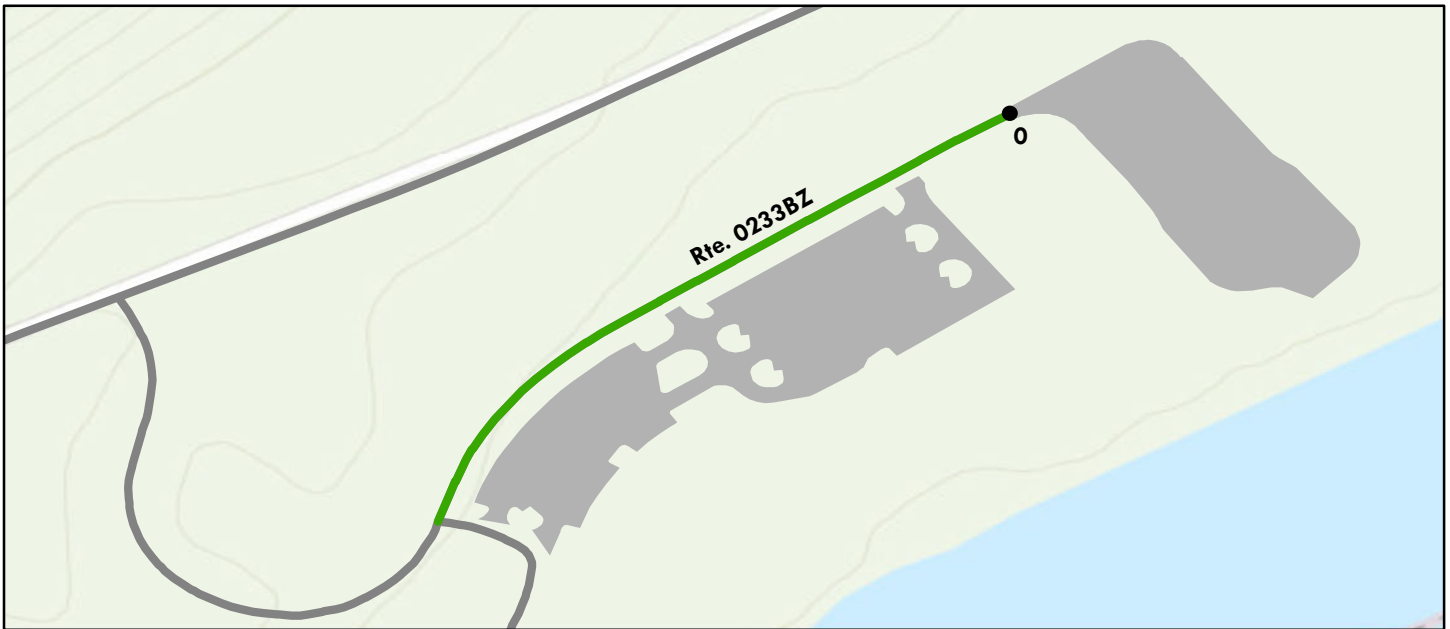
ROUTE 0233BZ: SMITHFIELD BEACH BOAT LAUNCH PARKING ACCESS

Subcomponent of Route DEWA-0233ZZ
Data Collection Vehicle (DCV) Rating

Route Condition Legend – Pavement Condition Rating (PCR)						
Poor (0 - 60)	Fair (61- 84)	Good (85 - 94)	Excellent (95 - 100)	Not Rated		
Colors on map represent condition scores at 0.10-mile intervals. See Appendix for definitions and formulas.						
Inspection Date: 6/11/2018	Beginning Section MP	0				
Paved Length (Miles): 0.18	Section Length (MI)	0.18				
Surface Type: ASPHALT	Route Summary					
Roadway Condition Information						
Pavement Condition Rating (PCR)	90	90				
Surface Condition Rating (SCR)	90	90				
Roughness Condition Index (RCI)	N/A	N/A				
Distress Index Values						
Structural Crack Index	95	95				
Alligator Crack Index	100	100				
Longitudinal Crack Index	95	95				
Transverse Cracking Index	95	95				
Patching Index	100	100				
Rutting Index	90	90				
International Roughness Index (IRI)	N/A	N/A				
Lane & Width Information						
Number of Lanes	2	2				
Paved Width (ft)	19.3	19.3				
Lane Width (ft)	8	8

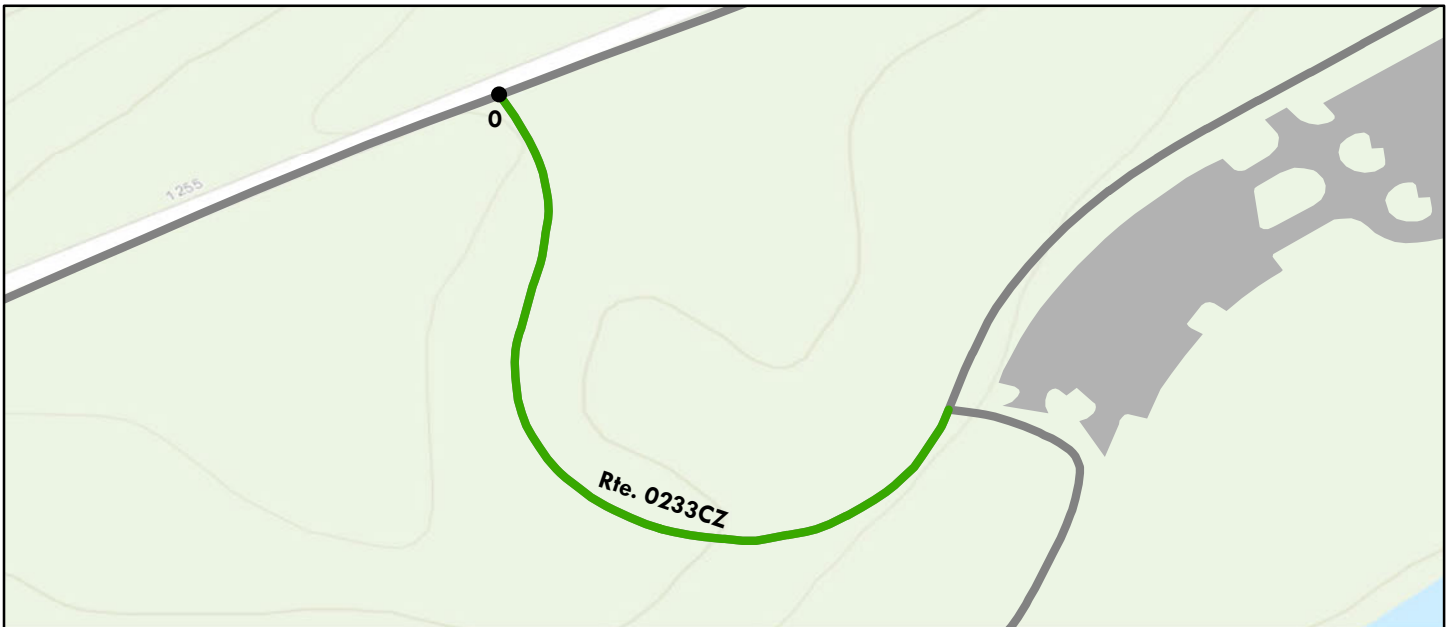
Subcomponent of Route DEWA-0233ZZ

Data Collection Vehicle (DCV) Rating

Colors on map represent condition scores at 0.10-mile intervals. See Appendix for definitions and formulas.

Inspection Date: 6/11/2018	Beginning Section MP	0				
Paved Length (Miles): 0.16	Section Length (MI)	0.16				
Surface Type: ASPHALT	Route Summary					
Roadway Condition Information						
Pavement Condition Rating (PCR)	90	90				
Surface Condition Rating (SCR)	90	90				
Roughness Condition Index (RCI)	N/A	N/A				
Distress Index Values						
Structural Crack Index	94	94				
Alligator Crack Index	100	100				
Longitudinal Crack Index	94	94				
Transverse Cracking Index	97	97				
Patching Index	100	100				
Rutting Index	90	90				
International Roughness Index (IRI)	N/A	N/A				
Lane & Width Information						
Number of Lanes	2	2				
Paved Width (ft)	24.2	24.2				
Lane Width (ft)	11.7	11.7

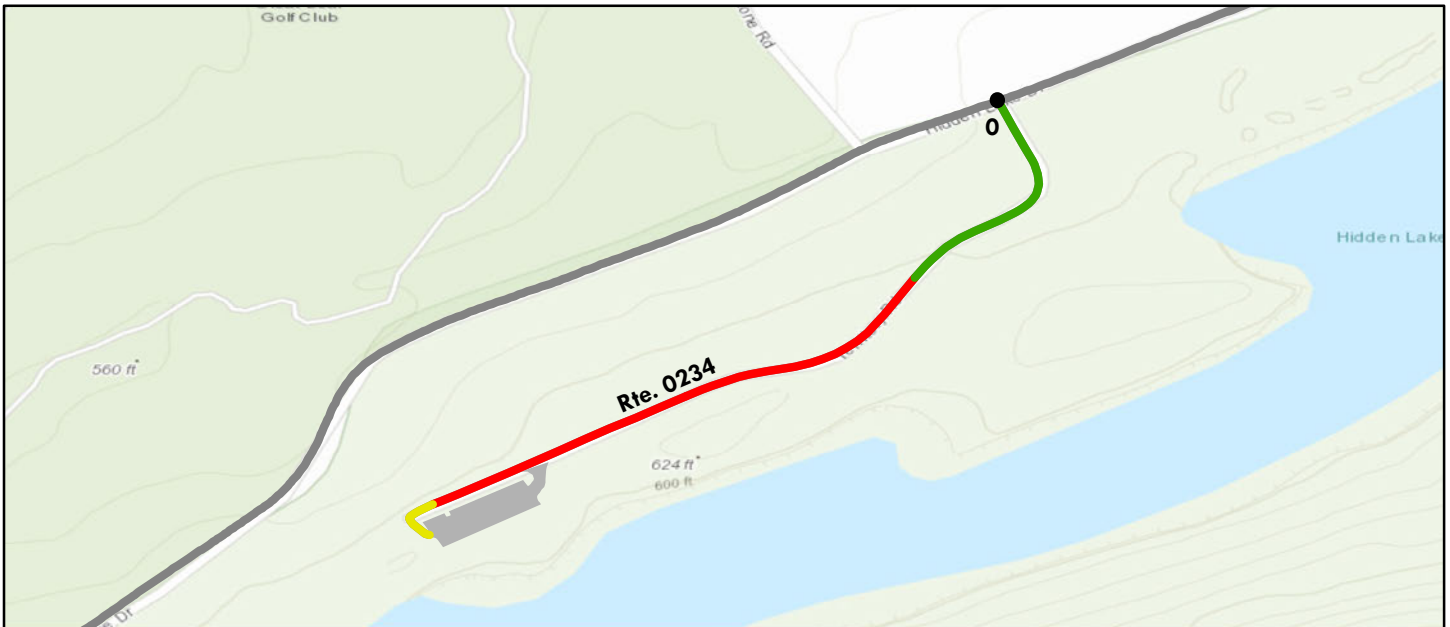
ROUTE 0234: HIDDEN LAKE ACCESS ROAD

Data Collection Vehicle (DCV) Rating

Colors on map represent condition scores at 0.10-mile intervals. See Appendix for definitions and formulas.

Inspection Date: 6/11/2018	Beginning Section MP	0				
Paved Length (Miles): 0.32	Section Length (MI)	0.32				
Surface Type: ASPHALT	Route Summary					
Roadway Condition Information						
Pavement Condition Rating (PCR)	0	0				
Surface Condition Rating (SCR)	0	0				
Roughness Condition Index (RCI)	N/A	N/A				
Distress Index Values						
Structural Crack Index	0	0				
Alligator Crack Index	24	24				
Longitudinal Crack Index	67	67				
Transverse Cracking Index	93	93				
Patching Index	100	100				
Rutting Index	95	95				
International Roughness Index (IRI)	N/A	N/A				
Lane & Width Information						
Number of Lanes	2	2				
Paved Width (ft)	20	20				
Lane Width (ft)	10.2	10.2

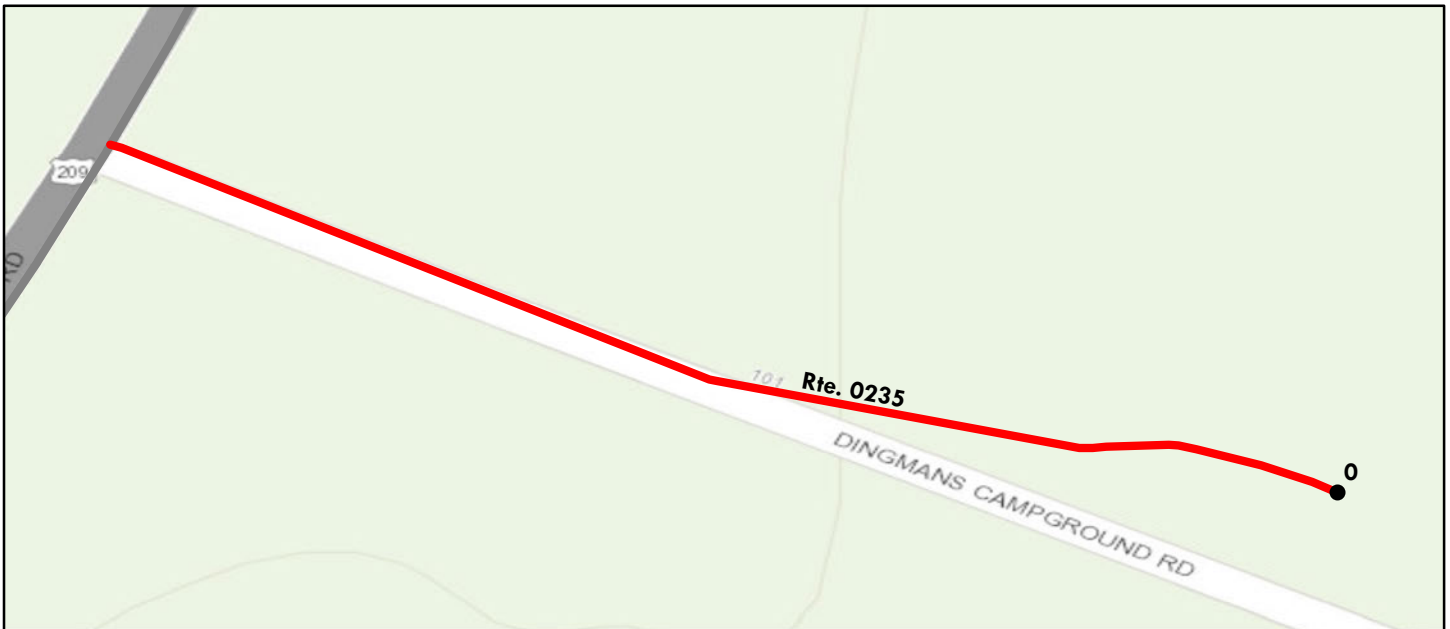
ROUTE 0235: DINGMAN'S CAMPGROUND ENTRY DRIVE

Manual Rating

Inspection Date: 7/9/2018	Beginning Section MP	0.00				
Paved Length (Miles): 0.08	Section Length (MI)	0.08				
Surface Type: ASPHALT	Route Summary					
Roadway Condition Information						
Pavement Condition Rating (PCR)	30	30				
Surface Condition Rating (SCR)	30	30				
Roughness Condition Index (RCI)	N/A	N/A				
Distress Index Values						
Structural Crack Index	N/A	N/A				
Alligator Crack Index	30	30				
Longitudinal Crack Index	90	90				
Transverse Cracking Index	90	90				
Patching Index	97	97				
Rutting Index	73	73				
International Roughness Index (IRI)	N/A	N/A				
Lane & Width Information						
Number of Lanes	1	1				
Paved Width (ft)	10	10				
Lane Width (ft)	10	10

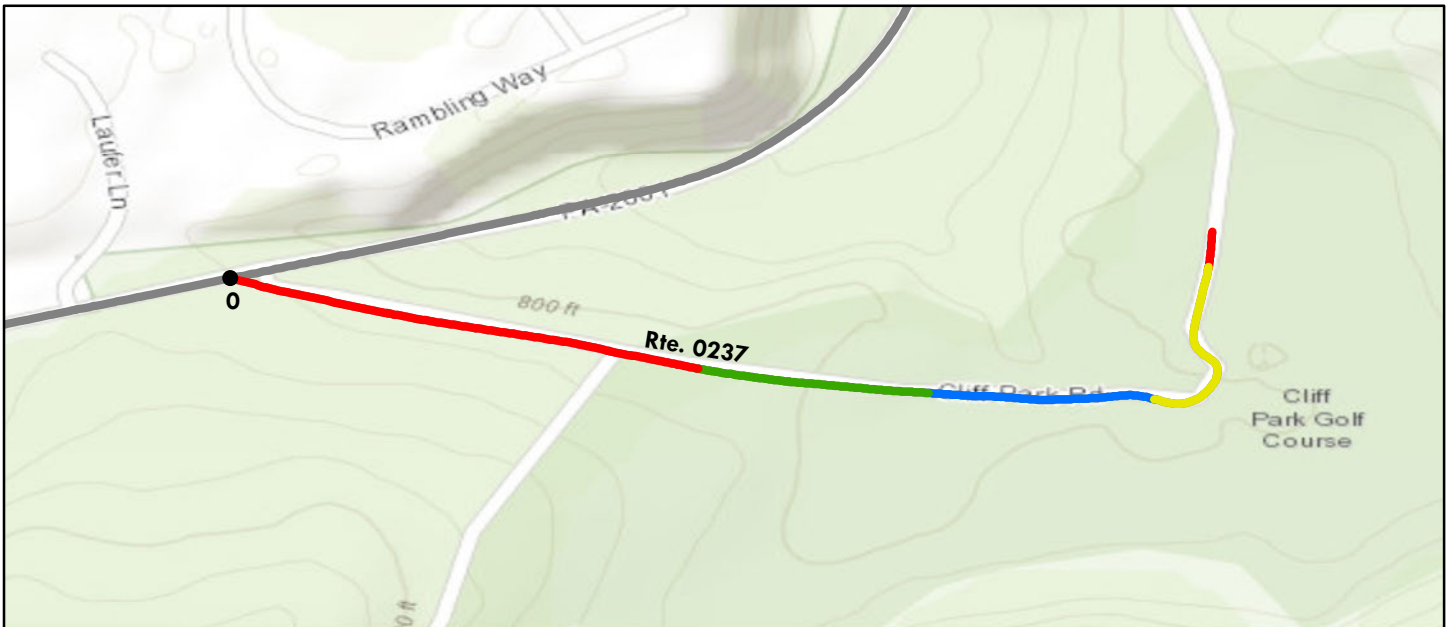
ROUTE 0237: CLIFF PARK ENTRANCE ROAD

Data Collection Vehicle (DCV) Rating

Colors on map represent condition scores at 0.10-mile intervals. See Appendix for definitions and formulas.

Inspection Date:	6/12/2018	Beginning Section MP	0				
Paved Length (Miles):	0.52	Section Length (MI)	0.52				
Surface Type:	ASPHALT	Route Summary					
Roadway Condition Information							
Pavement Condition Rating (PCR)	65	65					
Surface Condition Rating (SCR)	65	65					
Roughness Condition Index (RCI)	N/A	N/A					
Distress Index Values							
Structural Crack Index	65	65					
Alligator Crack Index	100	100					
Longitudinal Crack Index	65	65					
Transverse Cracking Index	93	93					
Patching Index	100	100					
Rutting Index	97	97					
International Roughness Index (IRI)	N/A	N/A					
Lane & Width Information							
Number of Lanes	2	2					
Paved Width (ft)	15.6	15.6					
Lane Width (ft)	9.2	9.2

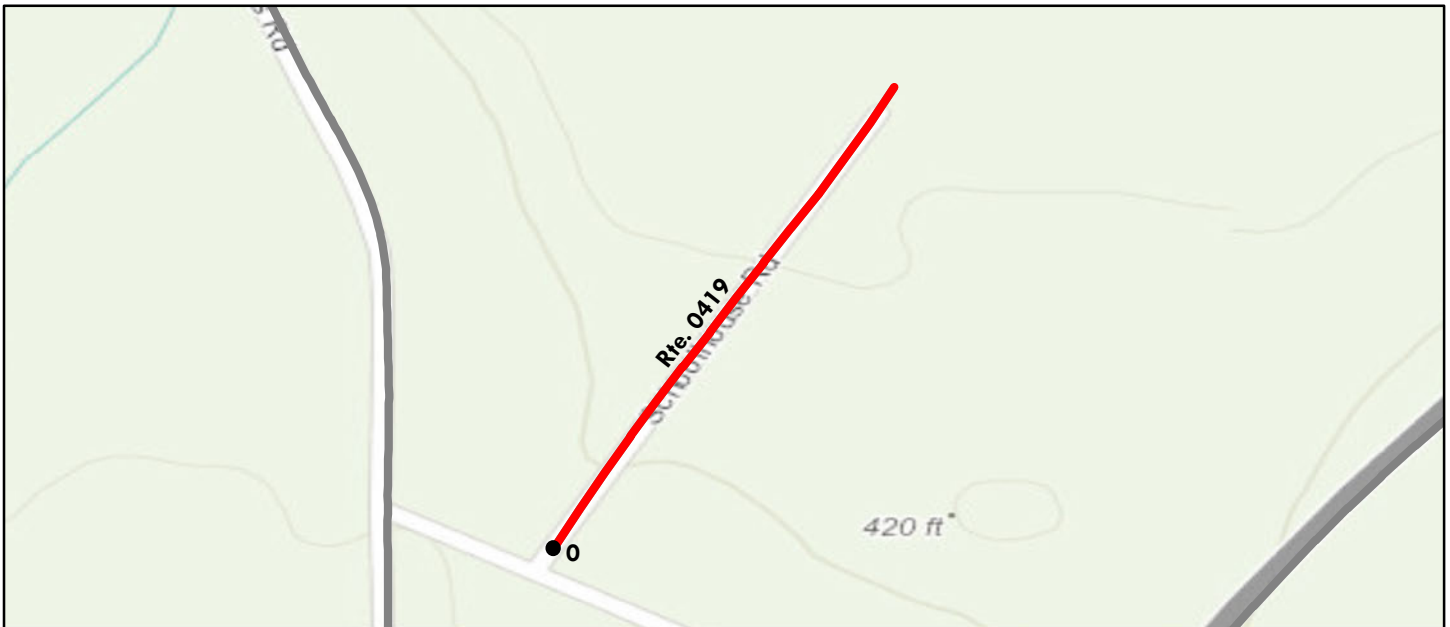
ROUTE 0419: BUSHKILL SCHOOL ACCESS ROAD

Data Collection Vehicle (DCV) Rating

Colors on map represent condition scores at 0.10-mile intervals. See Appendix for definitions and formulas.

Inspection Date: 6/12/2018	Beginning Section MP	0				
Paved Length (Miles): 0.13	Section Length (MI)	0.13				
Surface Type: ASPHALT	Route Summary					
Roadway Condition Information						
Pavement Condition Rating (PCR)	0	0				
Surface Condition Rating (SCR)	0	0				
Roughness Condition Index (RCI)	N/A	N/A				
Distress Index Values						
Structural Crack Index	0	0				
Alligator Crack Index	59	59				
Longitudinal Crack Index	17	17				
Transverse Cracking Index	53	53				
Patching Index	97	97				
Rutting Index	88	88				
International Roughness Index (IRI)	N/A	N/A				
Lane & Width Information						
Number of Lanes	2	2				
Paved Width (ft)	20.3	20.3				
Lane Width (ft)	10.2	10.2

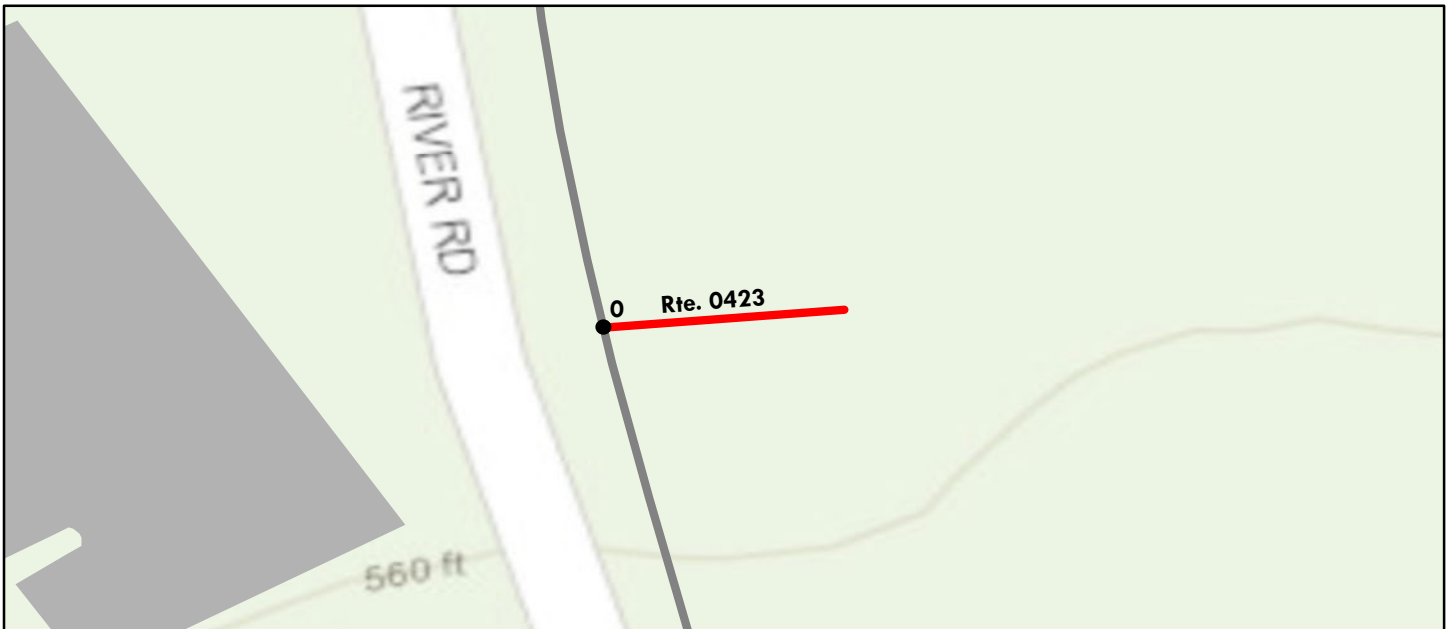
ROUTE 0423: HEADQUARTER SERVICE ROAD

Manual Rating

Inspection Date: 7/9/2018	Beginning Section MP	0.00				
Paved Length (Miles): 0.07	Section Length (MI)	0.07				
Surface Type: ASPHALT	Route Summary					
Roadway Condition Information						
Pavement Condition Rating (PCR)	53	53				
Surface Condition Rating (SCR)	53	53				
Roughness Condition Index (RCI)	N/A	N/A				
Distress Index Values						
Structural Crack Index	N/A	N/A				
Alligator Crack Index	53	53				
Longitudinal Crack Index	53	53				
Transverse Cracking Index	90	90				
Patching Index	90	90				
Rutting Index	73	73				
International Roughness Index (IRI)	N/A	N/A				
Lane & Width Information						
Number of Lanes	1	1				
Paved Width (ft)	10	10				
Lane Width (ft)	10	10

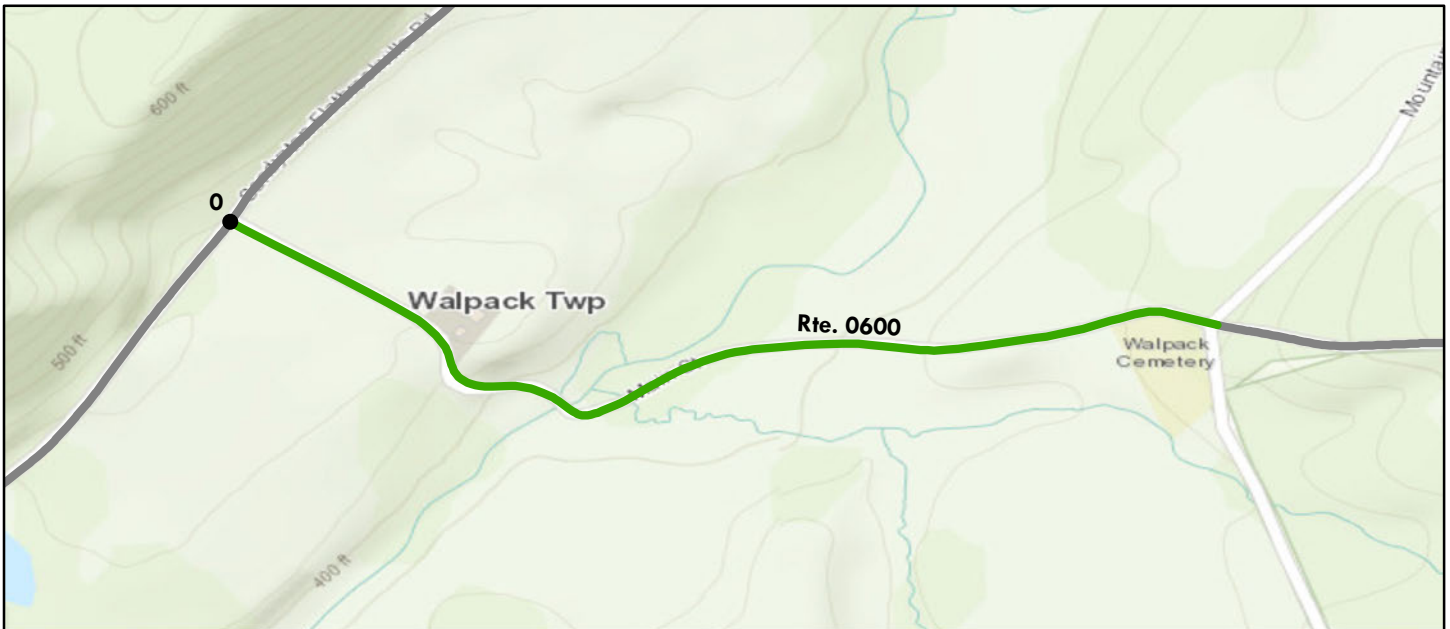
ROUTE 0600: MAIN STREET (WALPACK)

Manual Rating

Route Condition Legend – Pavement Condition Rating (PCR)						
Poor (0 - 60)	Fair (61- 84)	Good (85 - 94)	Excellent (95 - 100)	Not Rated		
See Appendix for definitions and formulas						
Inspection Date: 7/10/2018	Beginning Section MP	0.00				
Paved Length (Miles): 0.59	Section Length (MI)	0.59				
Surface Type: ASPHALT	Route Summary					
Roadway Condition Information						
Pavement Condition Rating (PCR)	90	90				
Surface Condition Rating (SCR)	90	90				
Roughness Condition Index (RCI)	N/A	N/A				
Distress Index Values						
Structural Crack Index	N/A	N/A				
Alligator Crack Index	90	90				
Longitudinal Crack Index	90	90				
Transverse Cracking Index	90	90				
Patching Index	90	90				
Rutting Index	97	97				
International Roughness Index (IRI)	N/A	N/A				
Lane & Width Information						
Number of Lanes	2	2				
Paved Width (ft)	20	20				
Lane Width (ft)	10	10

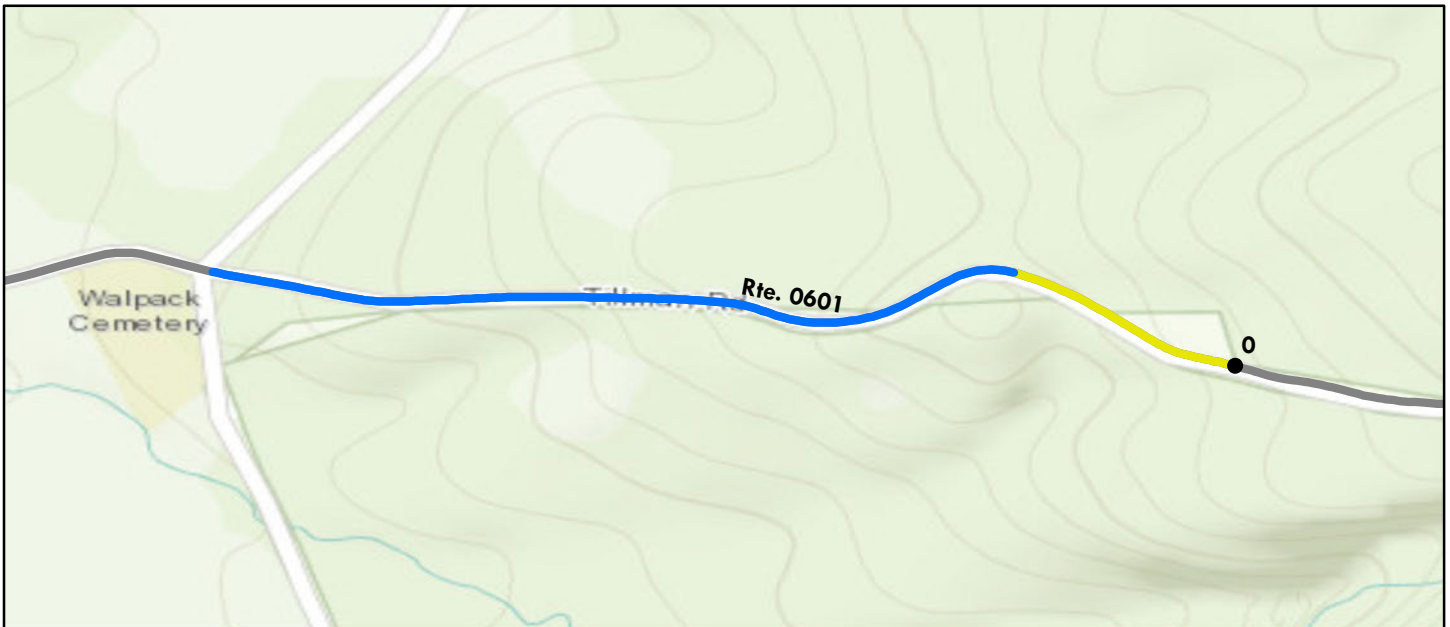
ROUTE 0601: STRUBLE ROAD

Data Collection Vehicle (DCV) Rating

Route Condition Legend – Pavement Condition Rating (PCR)						
Poor (0 - 60)	Fair (61- 84)	Good (85 - 94)	Excellent (95 - 100)	Not Rated		
Colors on map represent condition scores at 0.10-mile intervals. See Appendix for definitions and formulas.						
Inspection Date: 6/12/2018	Beginning Section MP	0				
Paved Length (Miles): 0.41	Section Length (MI)	0.41				
Surface Type: ASPHALT	Route Summary					
Roadway Condition Information						
Pavement Condition Rating (PCR)	94	94				
Surface Condition Rating (SCR)	94	94				
Roughness Condition Index (RCI)	N/A	N/A				
Distress Index Values						
Structural Crack Index	94	94				
Alligator Crack Index	100	100				
Longitudinal Crack Index	94	94				
Transverse Cracking Index	99	99				
Patching Index	100	100				
Rutting Index	99	99				
International Roughness Index (IRI)	N/A	N/A				
Lane & Width Information						
Number of Lanes	2	2				
Paved Width (ft)	16.1	16.1				
Lane Width (ft)	7.8	7.8

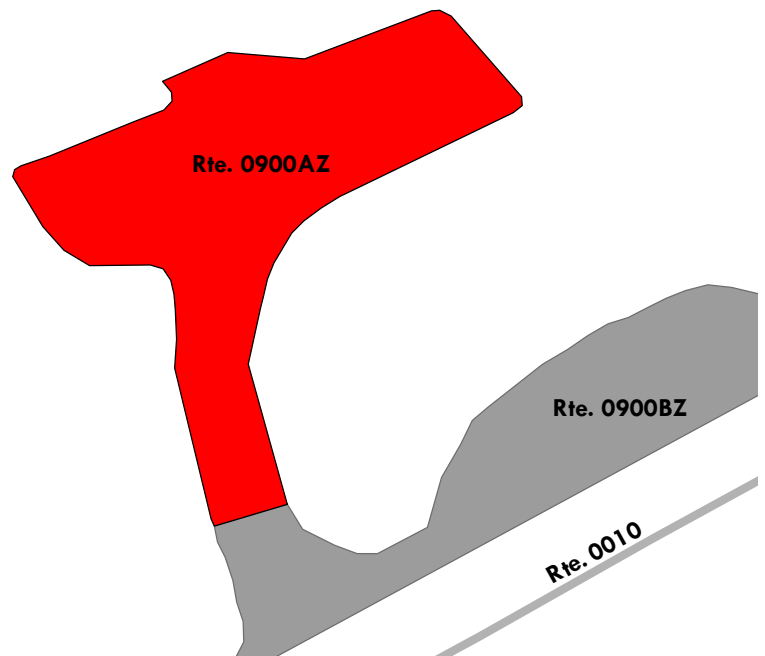
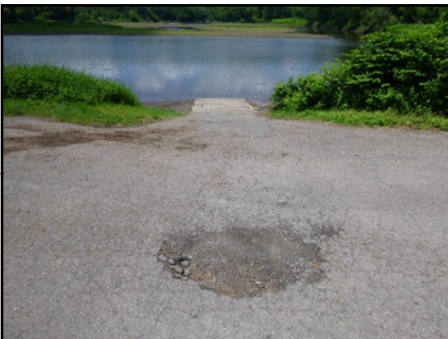
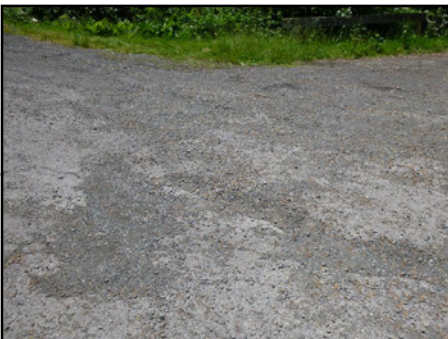
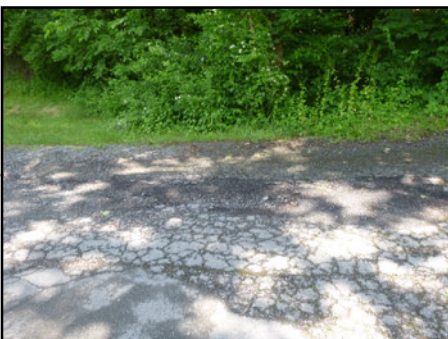
ROUTE 0900AZ: POXONO BOAT LAUNCH LOWER PARKING

Inspection Date	FMSS Number	User Access	Surface Type
6/11/2018	49365	PUBLIC	ASPHALT
Area (Sq. Ft.)	Lane Miles (11' Widths)	Curb Reveal (Inches)	Curb Recommendation
7,279	0.125	NOT APPLICABLE	NOT APPLICABLE
Curb Type		Curb & Gutter Type	
NO CURB		NO CURB AND GUTTER	
Pavement Recommendation		Condition Rating / PCR	
HEAVY 3R TREATMENTS		POOR / 53

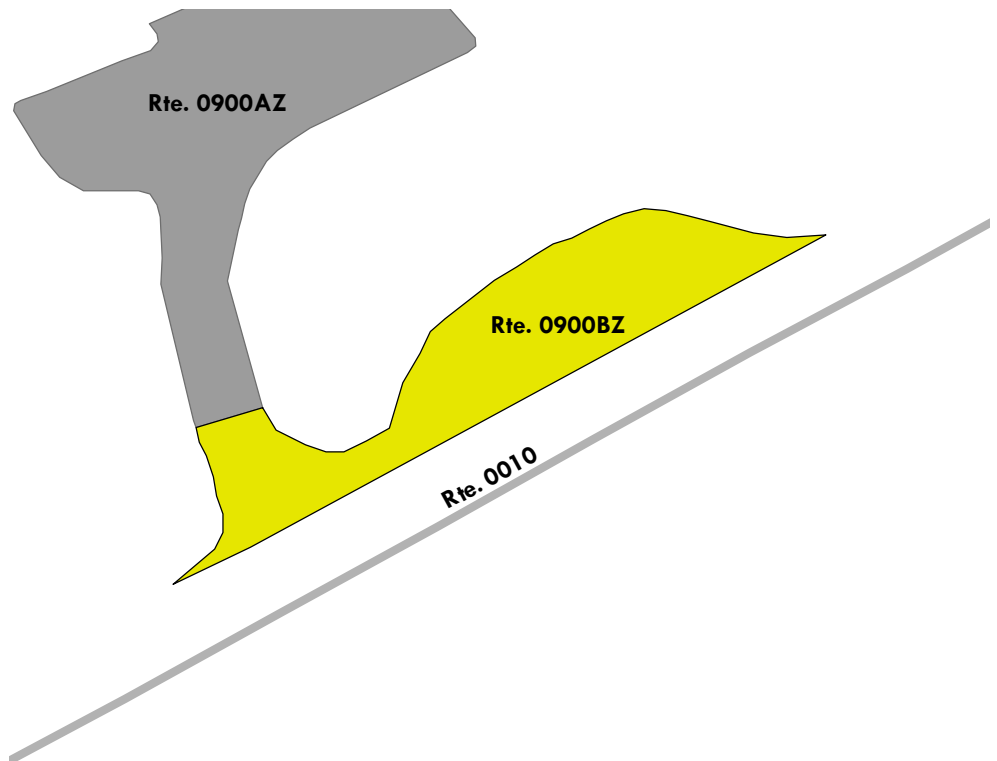
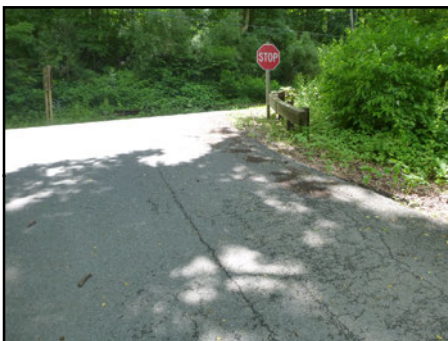
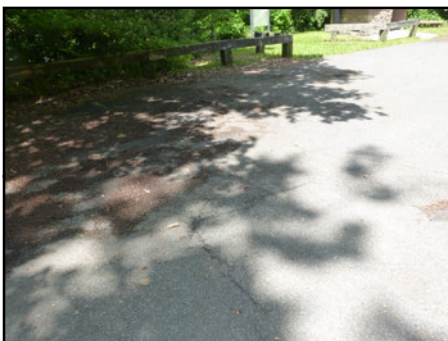
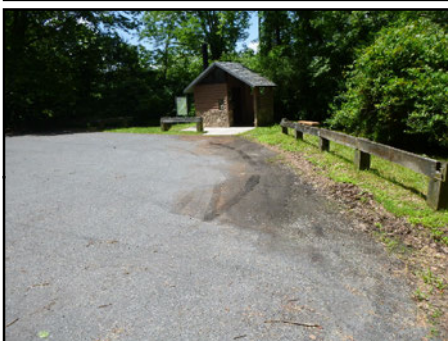
ROUTE 0900BZ: POXONO BOAT LAUNCH UPPER PARKING

Inspection Date	FMSS Number	User Access	Surface Type
6/11/2018	49365	PUBLIC	ASPHALT
Area (Sq. Ft.)	Lane Miles (11' Widths)	Curb Reveal (Inches)	Curb Recommendation
5,645	0.097	NOT APPLICABLE	NOT APPLICABLE
Curb Type		Curb & Gutter Type	
NO CURB		NO CURB AND GUTTER	
Pavement Recommendation		Condition Rating / PCR	
LIGHT 3R TREATMENTS		FAIR / 73

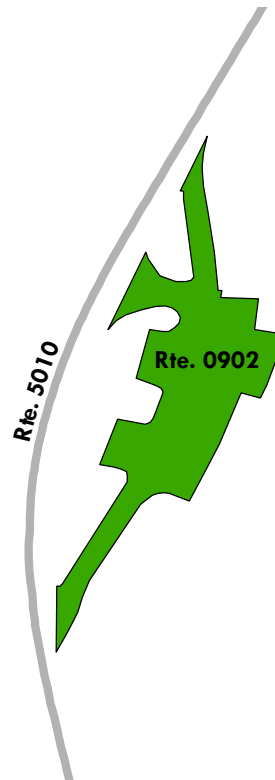
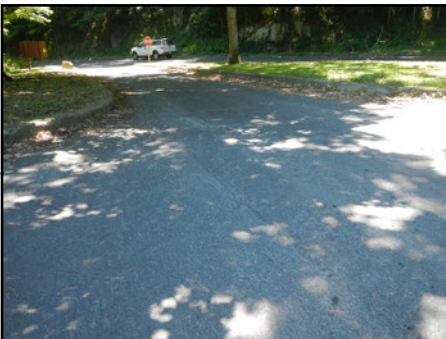
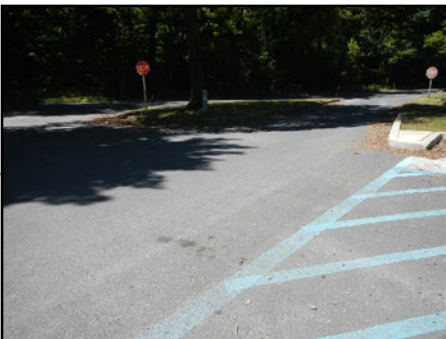
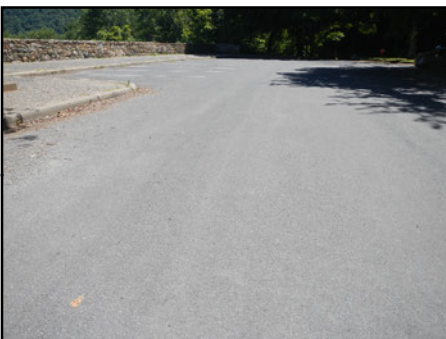
ROUTE 0902: RESORT POINT OVERLOOK

Inspection Date	FMSS Number	User Access	Surface Type
7/9/2018	31298	PUBLIC	ASPHALT
Area (Sq. Ft.)	Lane Miles (11' Widths)	Curb Reveal (Inches)	Curb Recommendation
13,874	0.239	6	DO NOTHING
Curb Type		Curb & Gutter Type	
CONCRETE		NO CURB AND GUTTER	
Pavement Recommendation		Condition Rating / PCR	
PREVENTIVE MAINTENANCE		GOOD / 90

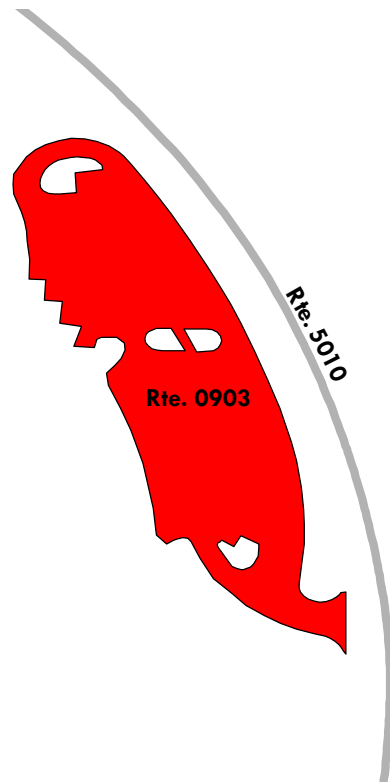
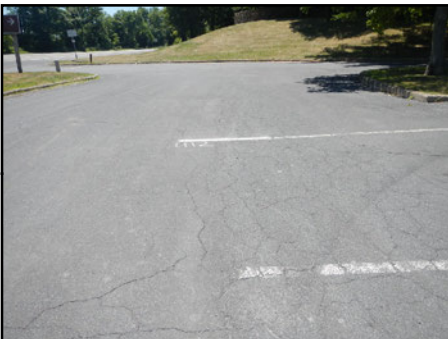
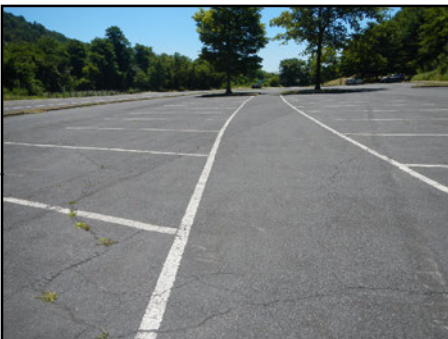
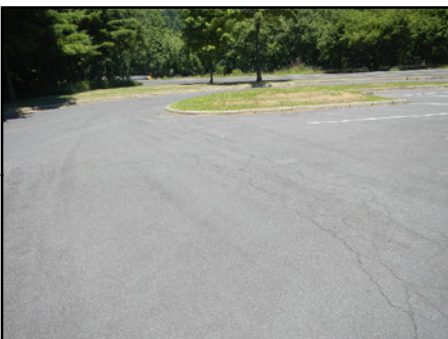
ROUTE 0903: POINT OF GAP OVERLOOK

Inspection Date	FMSS Number	User Access	Surface Type
7/9/2018	31297	PUBLIC	ASPHALT
Area (Sq. Ft.)	Lane Miles (11' Widths)	Curb Reveal (Inches)	Curb Recommendation
42,242	0.727	6	DO NOTHING
Curb Type		Curb & Gutter Type	
CONCRETE		NO CURB AND GUTTER	
Pavement Recommendation		Condition Rating / PCR	
HEAVY 3R TREATMENTS		POOR / 53

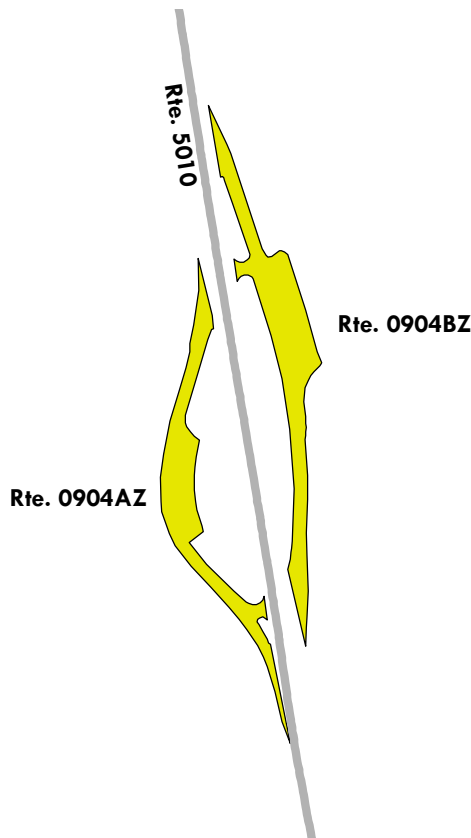
Rte. 0904ZZ
(2 Subcomponents)

The condition shown on this page reflects the overall route condition and may not reflect individual subcomponent ratings.

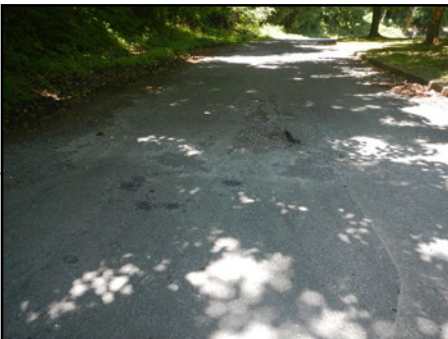
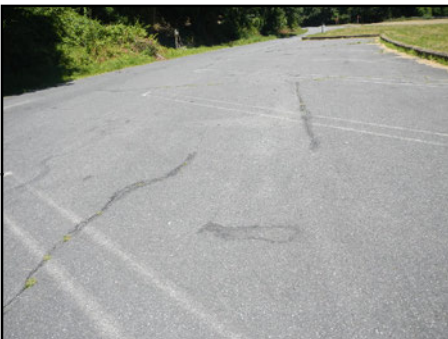
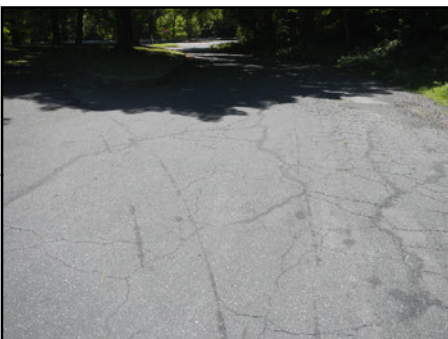
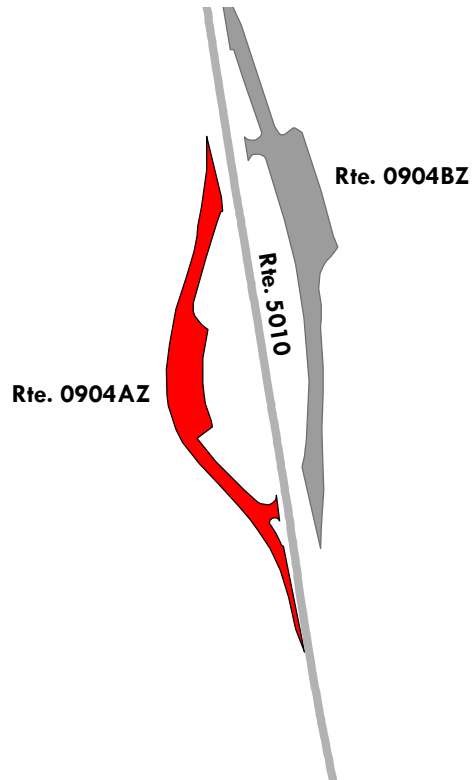
ROUTE 0904AZ: ARROW ISLAND OVERLOOK PARKING A

Inspection Date	FMSS Number	User Access	Surface Type
7/9/2018	31296	PUBLIC	ASPHALT
Area (Sq. Ft.)	Lane Miles (11' Widths)	Curb Reveal (Inches)	Curb Recommendation
10,656	0.183	8	DO NOTHING
Curb Type		Curb & Gutter Type	
CONCRETE		NO CURB AND GUTTER	
Pavement Recommendation		Condition Rating / PCR	
HEAVY 3R TREATMENTS		POOR / 53

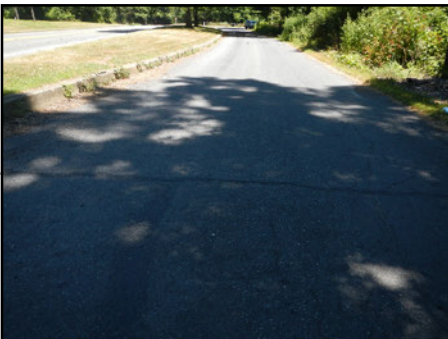
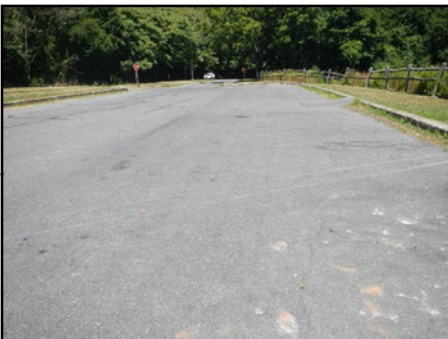
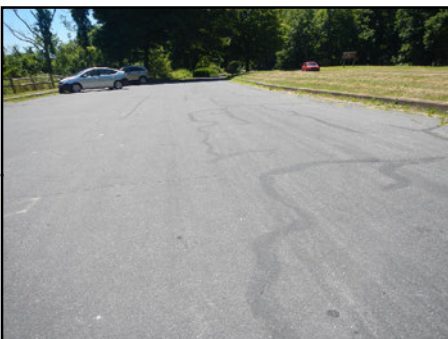
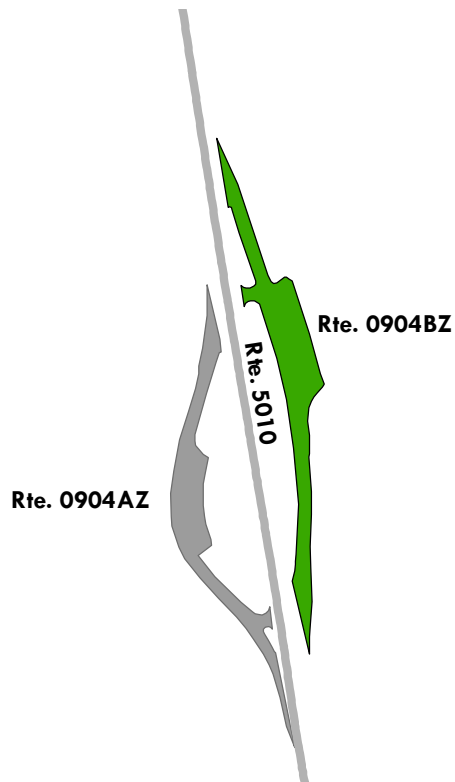
ROUTE 0904BZ: ARROW ISLAND OVERLOOK PARKING B

Inspection Date	FMSS Number	User Access	Surface Type
7/9/2018	31296	PUBLIC	ASPHALT
Area (Sq. Ft.)	Lane Miles (11' Widths)	Curb Reveal (Inches)	Curb Recommendation
14,067	0.242	8	DO NOTHING
Curb Type		Curb & Gutter Type	
CONCRETE		NO CURB AND GUTTER	
Pavement Recommendation		Condition Rating / PCR	
PREVENTIVE MAINTENANCE		GOOD / 90

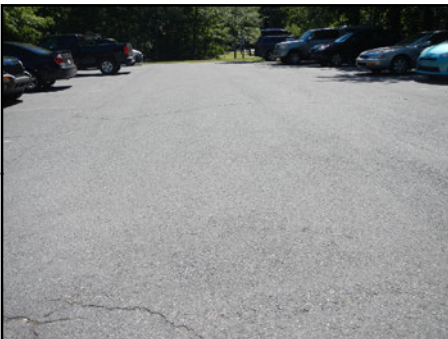
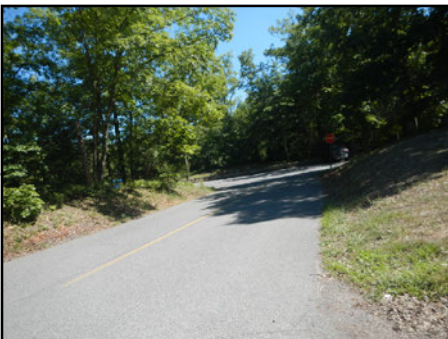
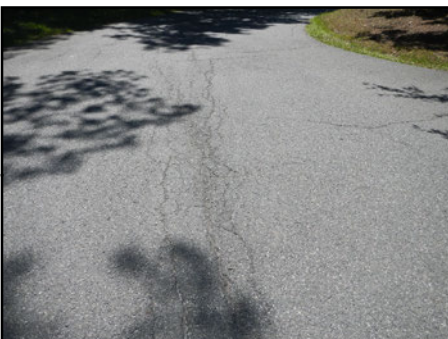
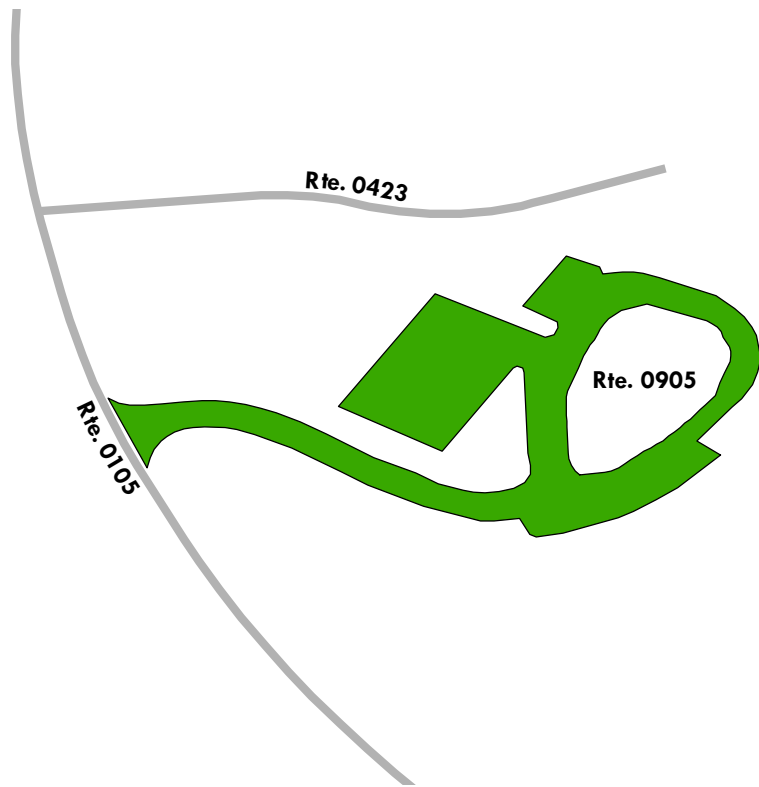
ROUTE 0905: HEADQUARTERS PARKING

Inspection Date	FMSS Number	User Access	Surface Type
7/9/2018	31918	PUBLIC	ASPHALT
Area (Sq. Ft.)	Lane Miles (11' Widths)	Curb Reveal (Inches)	Curb Recommendation
27,718	0.477	4	DO NOTHING
Curb Type		Curb & Gutter Type	
CONCRETE		NO CURB AND GUTTER	
Pavement Recommendation		Condition Rating / PCR	
PREVENTIVE MAINTENANCE		GOOD / 90

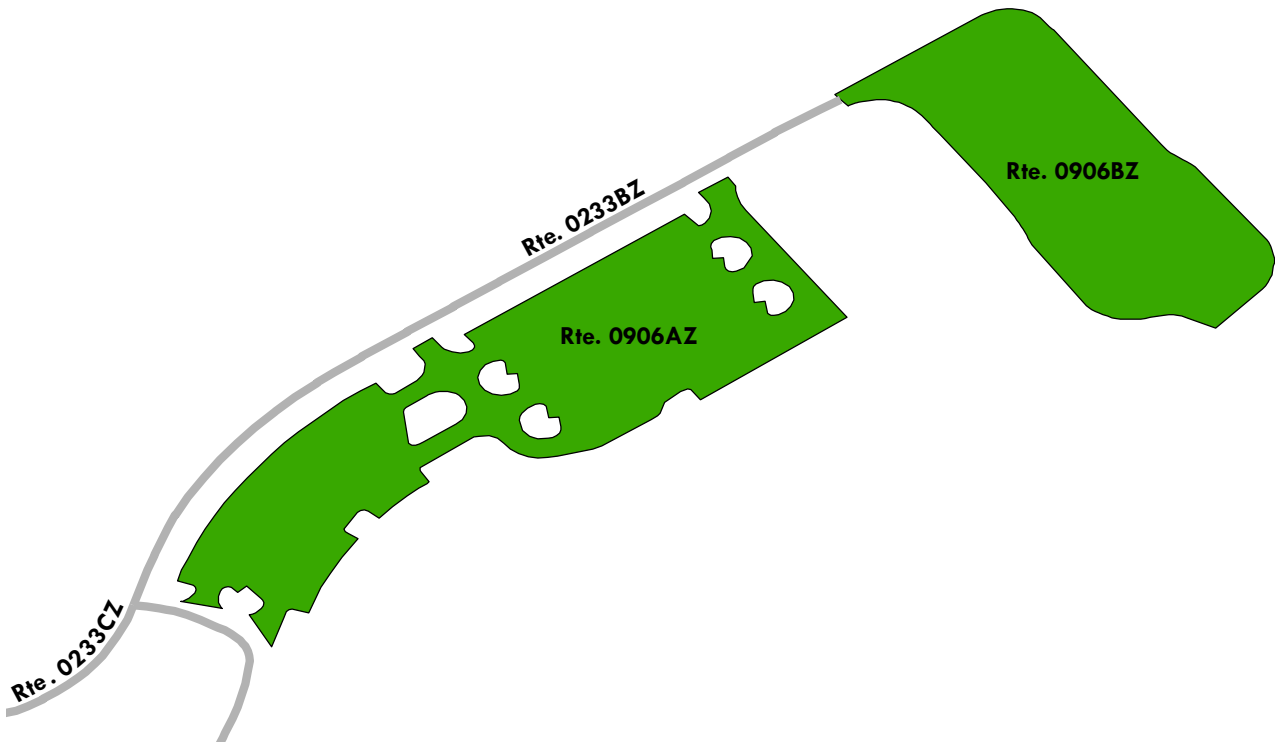
Rte. 0906ZZ
(2 Subcomponents)

Inspection Date	FMSS Number	User Access	Surface Type
7/9/2018	32276	PUBLIC	ASPHALT
Area (Sq. Ft.)	Lane Miles (11' Widths)	Condition Rating / PCR	
166,960	2.875	SUMMARY / 90

The condition shown on this page reflects the overall route condition and may not reflect individual subcomponent ratings.

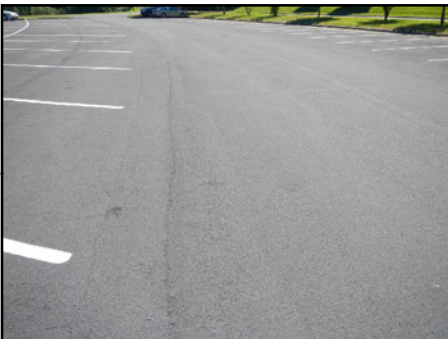
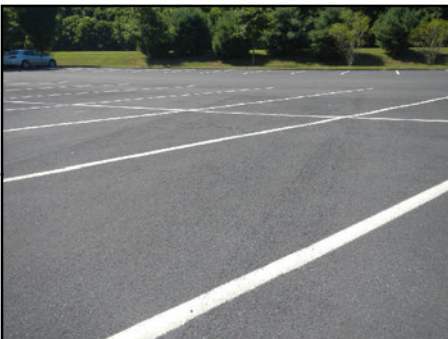
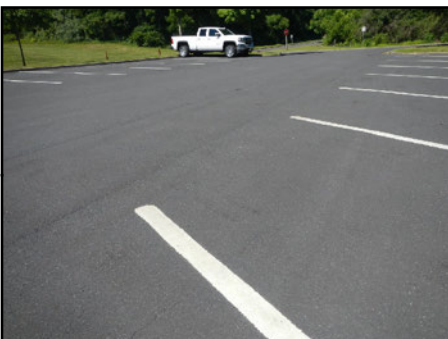
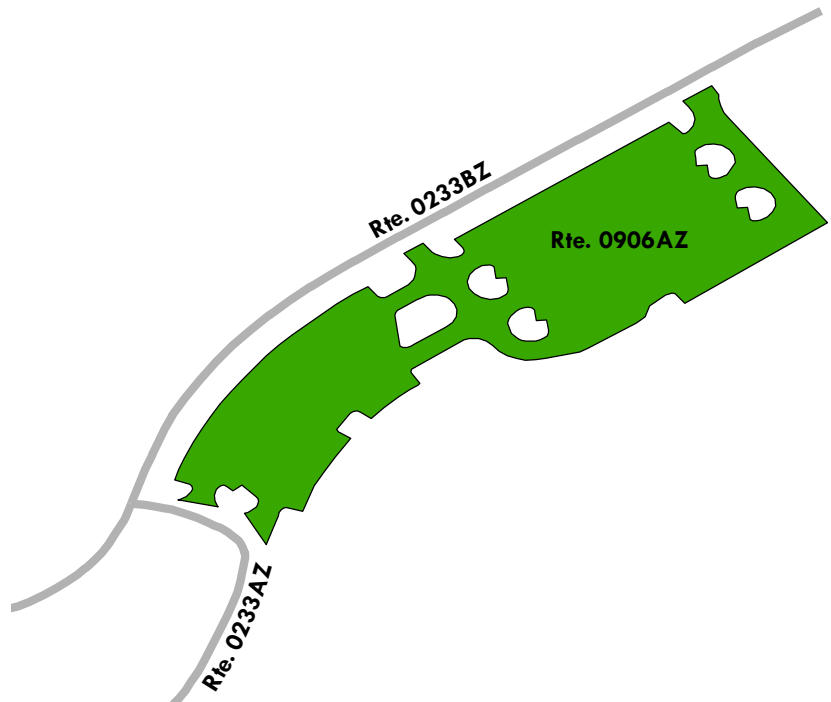
ROUTE 0906AZ: SMITHFIELD BEACH PARKING A

Inspection Date	FMSS Number	User Access	Surface Type
7/9/2018	32276	PUBLIC	ASPHALT
Area (Sq. Ft.)	Lane Miles (11' Widths)	Curb Reveal (Inches)	Curb Recommendation
96,514	1.662	NOT APPLICABLE	DO NOTHING
Curb Type		Curb & Gutter Type	
NO CURB		CONCRETE	
Pavement Recommendation		Condition Rating / PCR	
PREVENTIVE MAINTENANCE		GOOD / 90

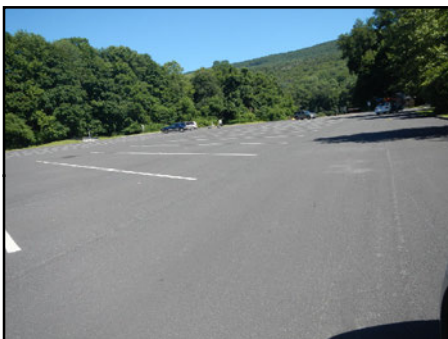
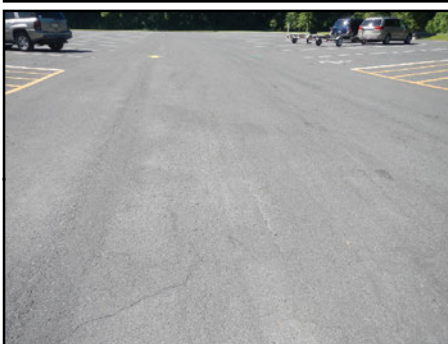
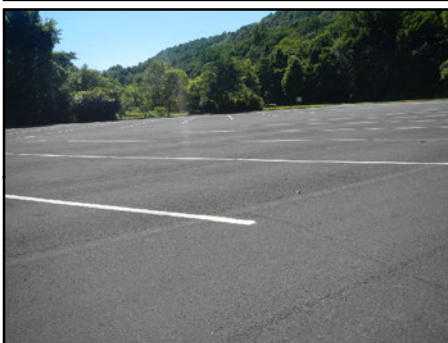
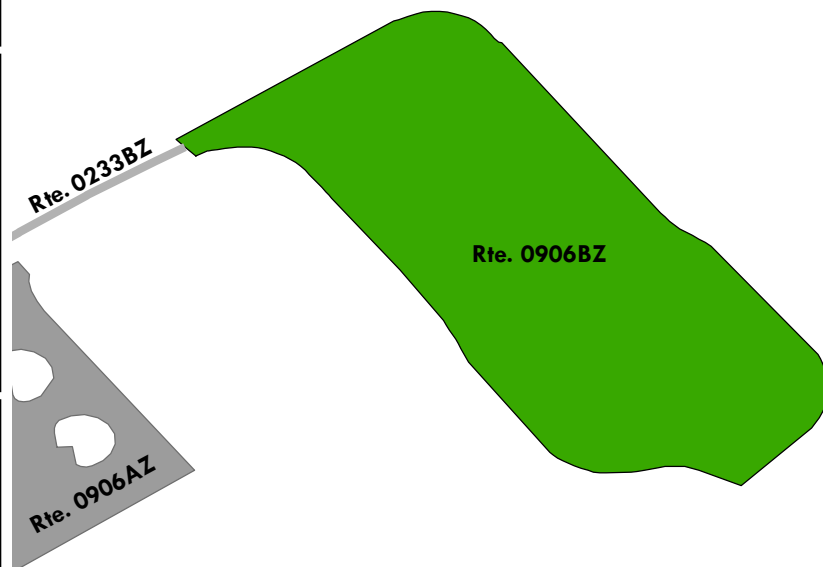
ROUTE 0906BZ: SMITHFIELD BEACH PARKING B

Inspection Date	FMSS Number	User Access	Surface Type
7/9/2018	32276	PUBLIC	ASPHALT
Area (Sq. Ft.)	Lane Miles (11' Widths)	Curb Reveal (Inches)	Curb Recommendation
70,446	1.213	NOT APPLICABLE	DO NOTHING
Curb Type		Curb & Gutter Type	
NO CURB		CONCRETE	
Pavement Recommendation		Condition Rating / PCR	
PREVENTIVE MAINTENANCE		GOOD / 90
