DEWA Cycle 6

Final Report

Road Inventory and Condition Assessment of Paved Routes Delaware Water Gap National Recreation Area

Report Date: May 2020

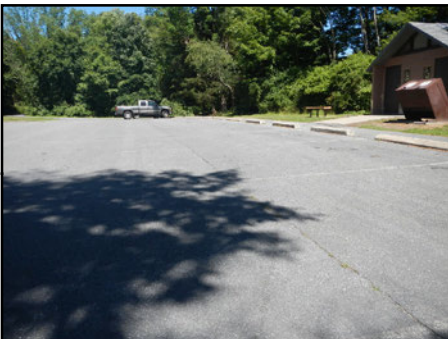
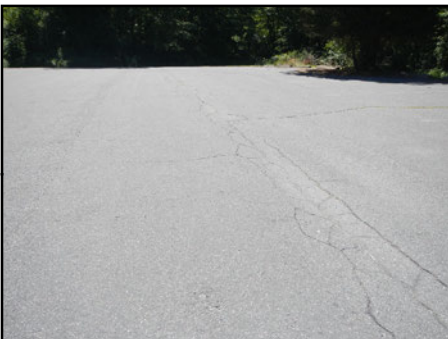
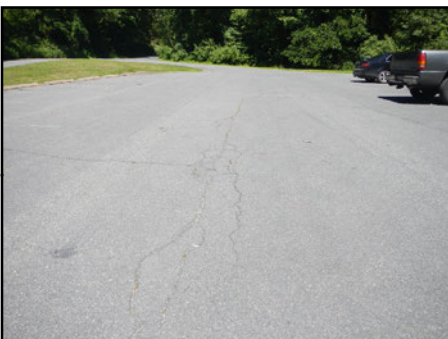
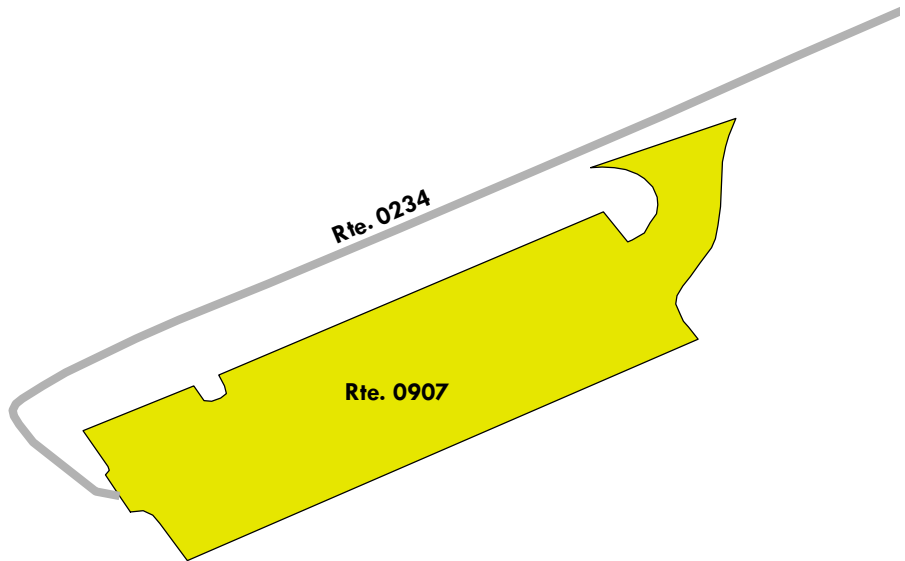
ROUTE 0907: HIDDEN LAKE PARKING

Inspection Date	FMSS Number	User Access	Surface Type
7/9/2018	31939	PUBLIC	ASPHALT
Area (Sq. Ft.)	Lane Miles (11' Widths)	Curb Reveal (Inches)	Curb Recommendation
15,801	0.272	NOT APPLICABLE	NOT APPLICABLE
Curb Type		Curb & Gutter Type	
NO CURB		NO CURB AND GUTTER	
Pavement Recommendation		Condition Rating / PCR	
LIGHT 3R TREATMENTS		FAIR / 73

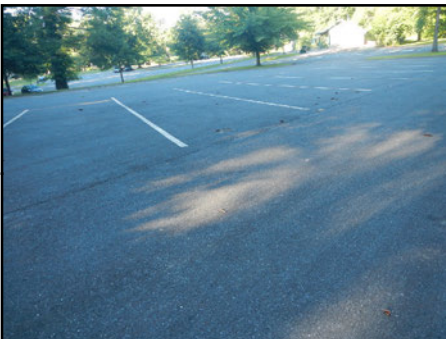
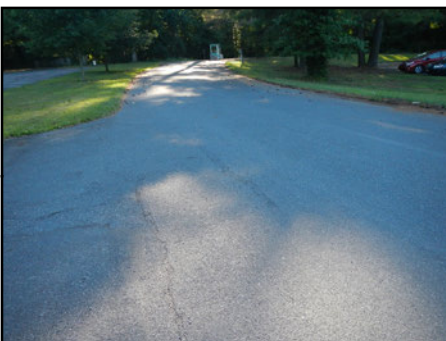
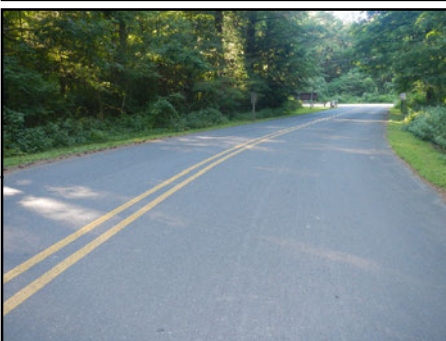
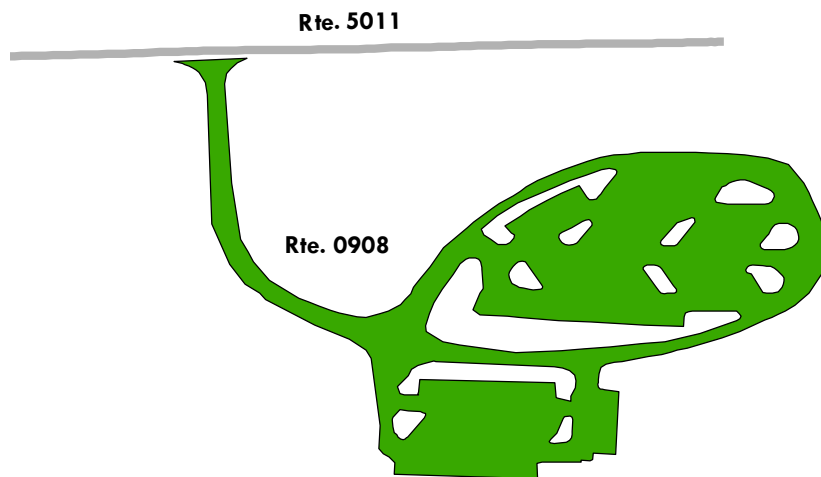
ROUTE 0908: DINGMAN'S FERRY ACCESS PARKING AREA

Inspection Date	FMSS Number	User Access	Surface Type
7/9/2018	31870	PUBLIC	ASPHALT
Area (Sq. Ft.)	Lane Miles (11' Widths)	Curb Reveal (Inches)	Curb Recommendation
106,064	1.826	NOT APPLICABLE	DO NOTHING
Curb Type		Curb & Gutter Type	
NO CURB		CONCRETE	
Pavement Recommendation		Condition Rating / PCR	
PREVENTIVE MAINTENANCE		GOOD / 90

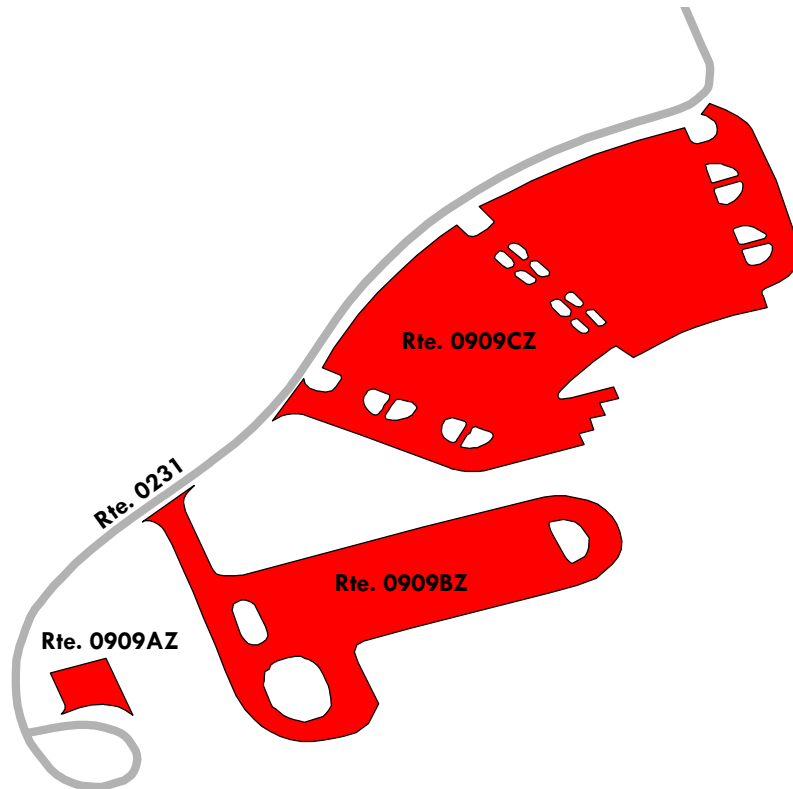
Rte. 0909ZZ
(3 Subcomponents)

Inspection Date	FMSS Number	User Access	Surface Type
7/10/2018	32003	PUBLIC	ASPHALT
Area (Sq. Ft.)	Lane Miles (11' Widths)	Condition Rating / PCR	
122,752	2.113	SUMMARY / 54	
Route Condition Legend – Pavement Condition Rating (PCR)			
Poor (0 - 60)	Fair (61- 84)	Good (85 - 94)	Excellent (95 - 100)
See Appendix for definitions and formulas

The condition shown on this page reflects the overall route condition and may not reflect individual subcomponent ratings.

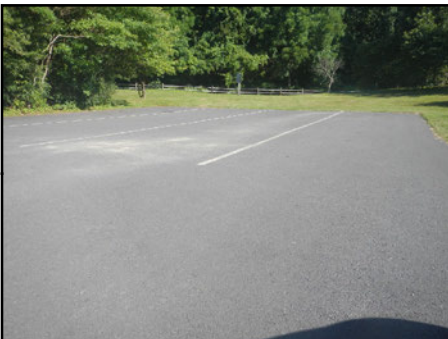
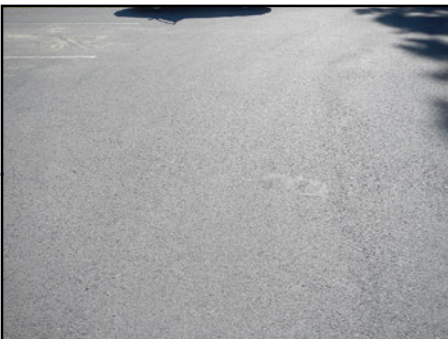
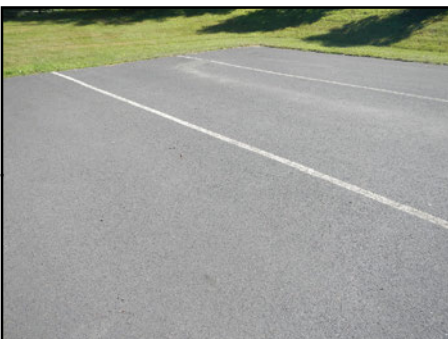
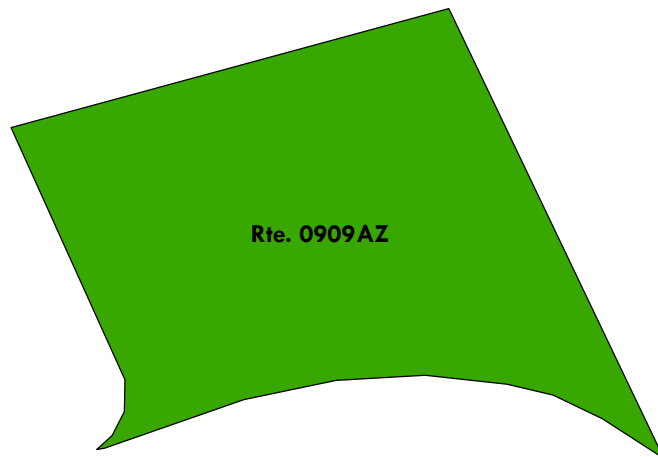
ROUTE 0909AZ: MILFORD BEACH CANOE LAUNCH PARKING

Inspection Date	FMISS Number	User Access	Surface Type
7/10/2018	32003	PUBLIC	ASPHALT
Area (Sq. Ft.)	Lane Miles (11' Widths)	Curb Reveal (Inches)	Curb Recommendation
2,326	0.04	NOT APPLICABLE	NOT APPLICABLE
Curb Type		Curb & Gutter Type	
NO CURB		NO CURB AND GUTTER	
Pavement Recommendation		Condition Rating / PCR	
PREVENTIVE MAINTENANCE		GOOD / 90

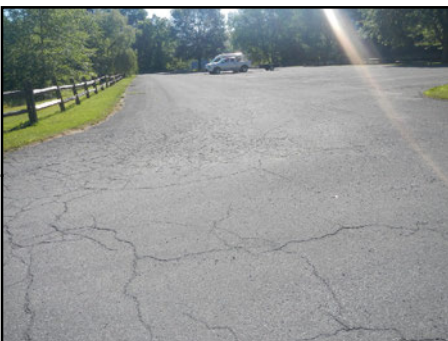
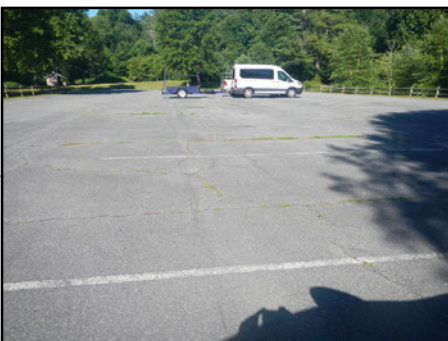
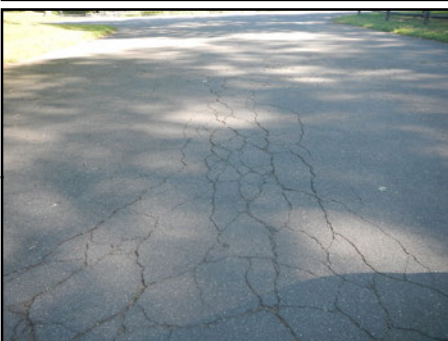
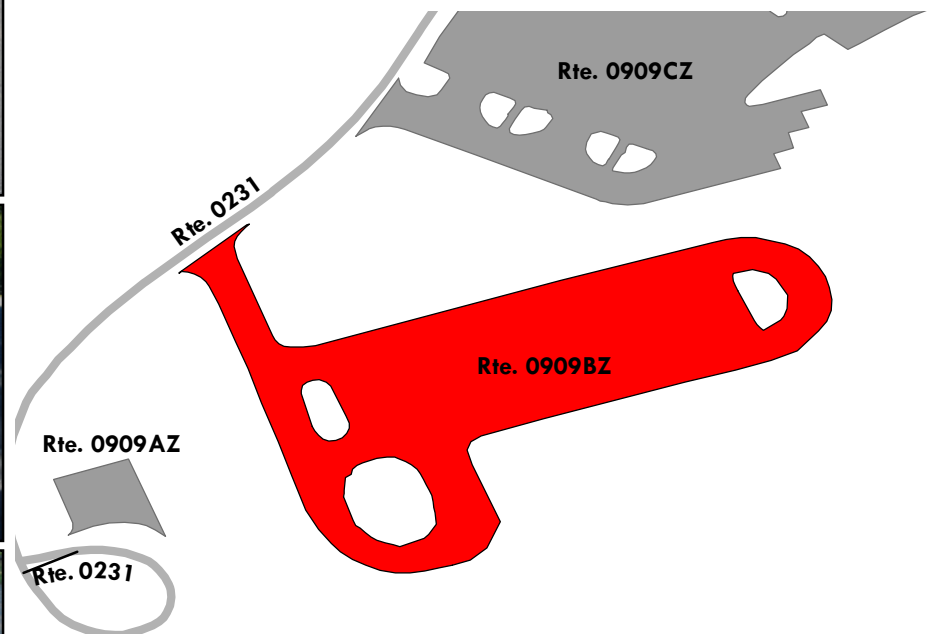
Inspection Date	FMSS Number	User Access	Surface Type
7/10/2018	32003	PUBLIC	ASPHALT
Area (Sq. Ft.)	Lane Miles (11' Widths)	Curb Reveal (Inches)	Curb Recommendation
40,330	0.694	NOT APPLICABLE	NOT APPLICABLE
Curb Type		Curb & Gutter Type	
NO CURB		NO CURB AND GUTTER	
Pavement Recommendation		Condition Rating / PCR	
HEAVY 3R TREATMENTS		POOR / 53

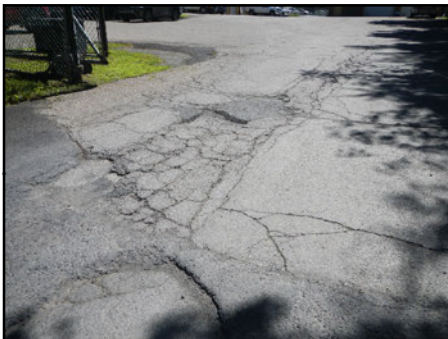
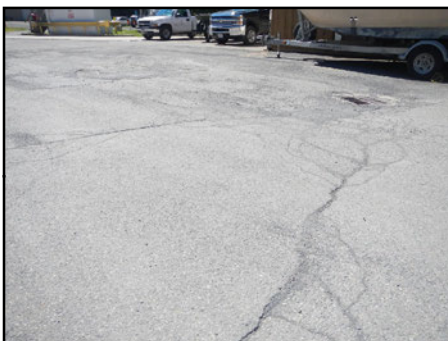
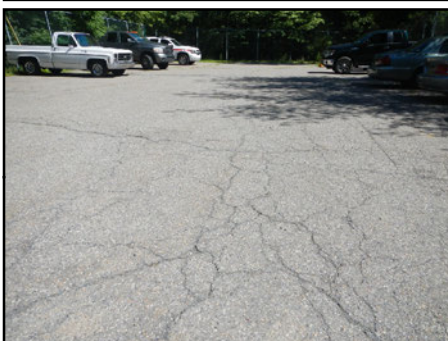
ROUTE 0916: DINGMAN'S MAINTENANCE FACILITY PARKING

Note: Parking area consists of multiple surface types: 1 part Asphalt at 29,512 square feet; 1 part Concrete at 916 square feet.

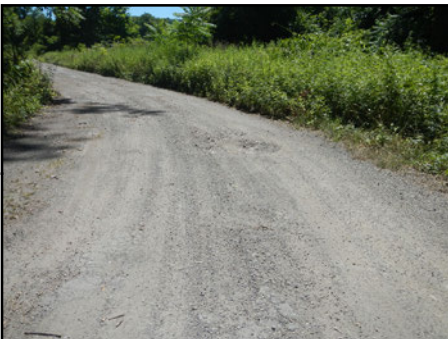
Asphalt deteriorated - appears gravel

Inspection Date	FMSS Number	User Access	Surface Type
7/9/2018	49443	NONPUBLIC	ASPHALT
Area (Sq. Ft.)	Lane Miles (11' Widths)	Curb Reveal (Inches)	Curb Recommendation
18,692	0.322	NOT APPLICABLE	NOT APPLICABLE
Curb Type		Curb & Gutter Type	
NO CURB		NO CURB AND GUTTER	
Pavement Recommendation		Condition Rating / PCR	
RECONSTRUCTION		POOR / 0

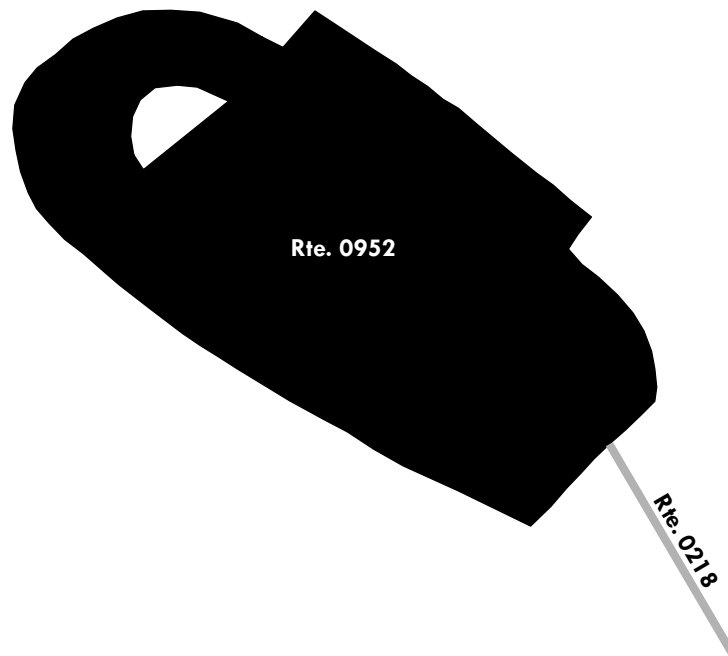
Note: Pavement condition not rated due to storm debris covering the paved surface.

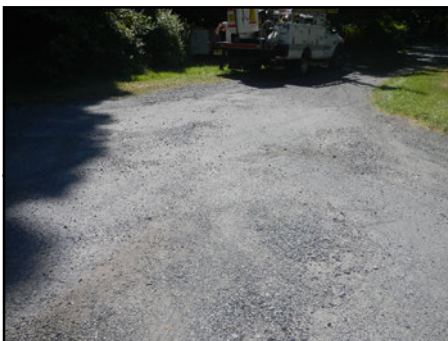
Asphalt deteriorated - appears gravel.
