EVER Cycle 6

Final Report

Road Inventory and Condition Assessment of Paved Routes Everglades National Park

Report Date: June 2020

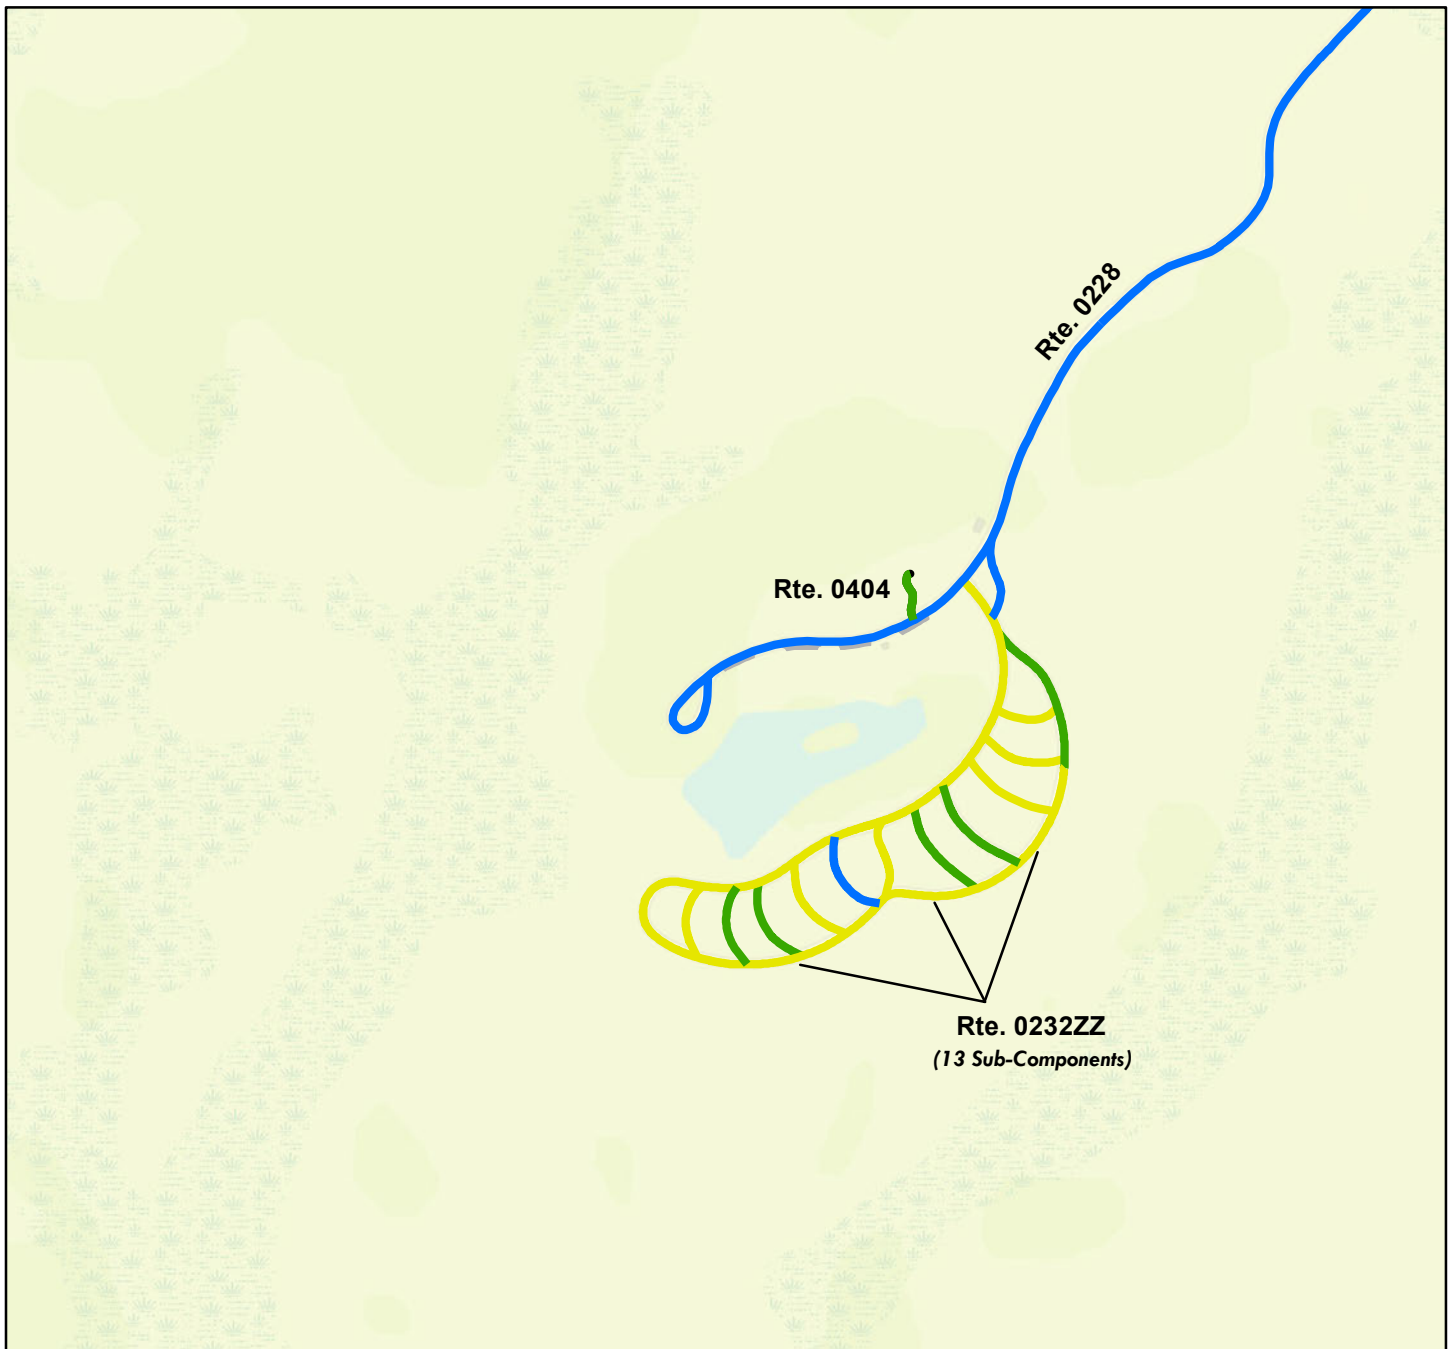
Area Map 4B

ROUTE CONDITION MAP

MILE BY MILE

Colors on map represent condition scores at 1-mile intervals. See Appendix for definitions and formulas
Only Data Collection Vehicle and Manually Rated Roads are displayed

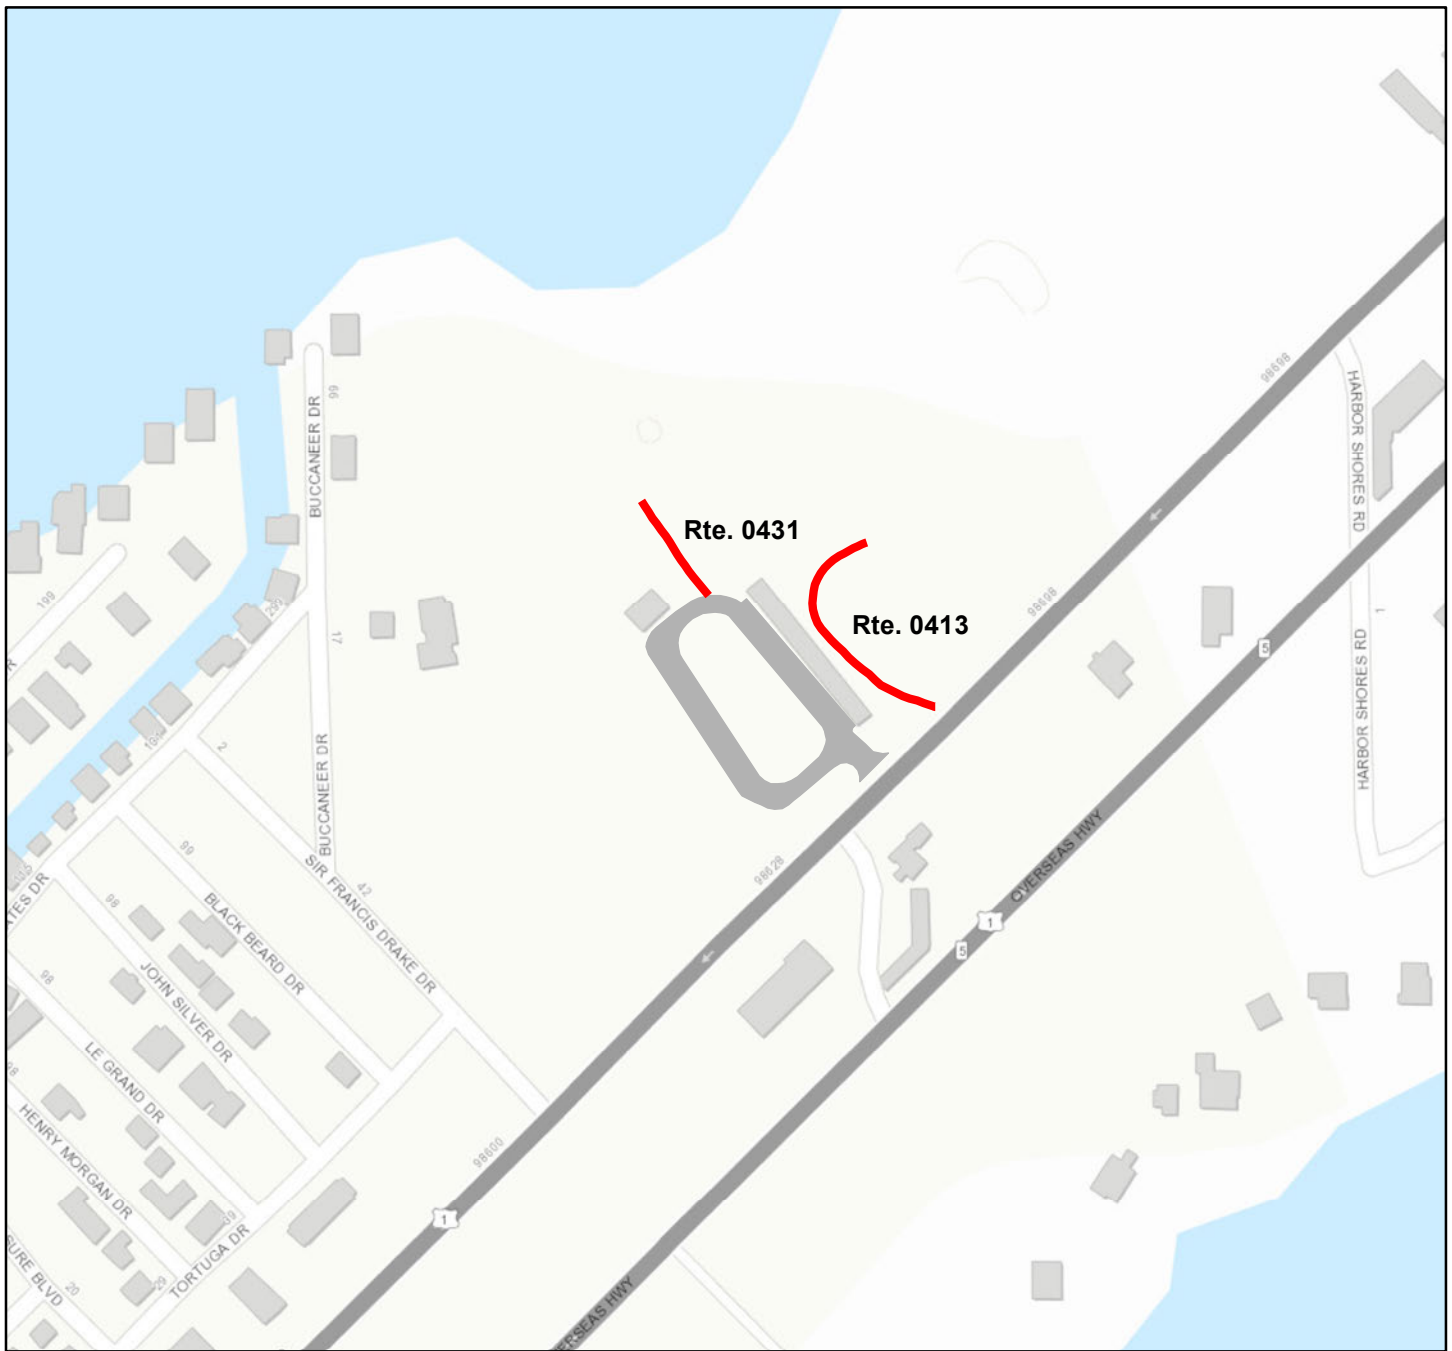
Area Map 7

MILE BY MILE

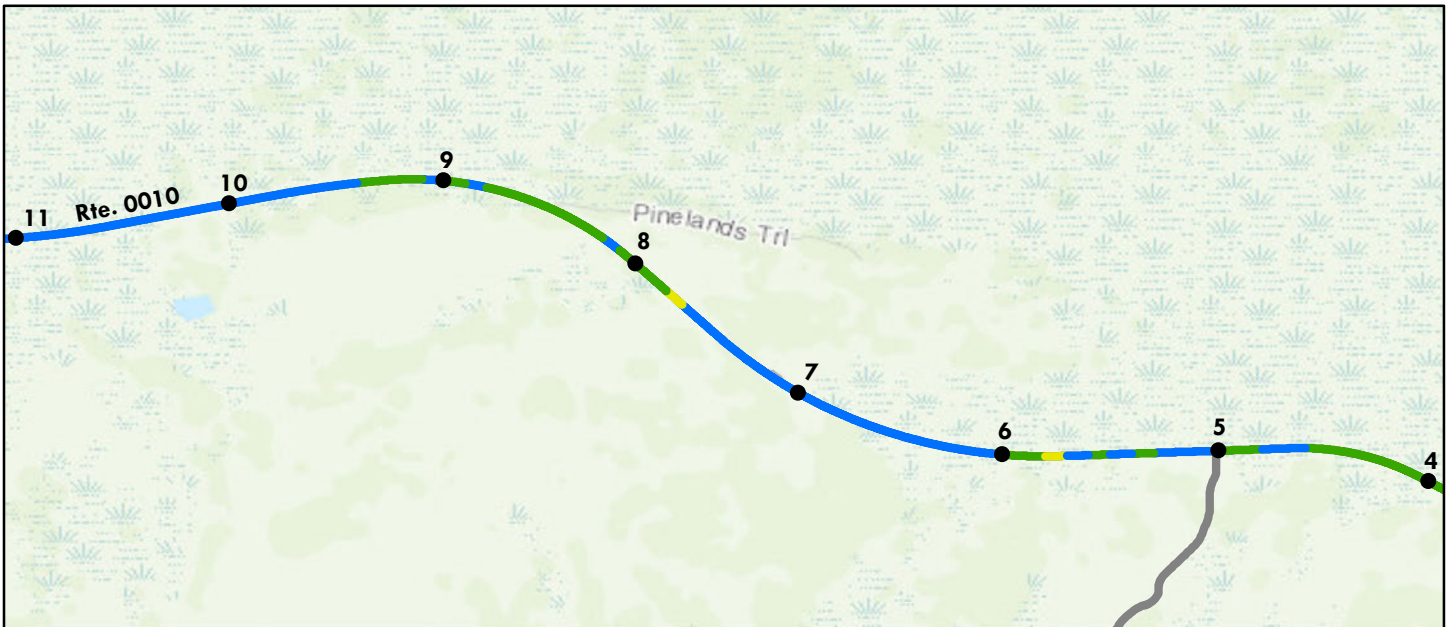
ROUTE 0010: MAIN PARK ROAD

Data Collection Vehicle (DCV) Rating

Route Condition Legend – Pavement Condition Rating (PCR)						
Poor (0 - 60)	Fair (61- 84)	Good (85 - 94)	Excellent (95 - 100)	Not Rated		
Colors on map represent condition scores at 0.10-mile intervals. See Appendix for definitions and formulas.						
Inspection Date: 4/6/2019	Beginning Section MP	5	6	7	8	9
Paved Length (Miles): 39.25	Section Length (MI)	1	1	1	1	1
Surface Type: ASPHALT	Route Summary					
Roadway Condition Information						
Pavement Condition Rating (PCR)	98	93	99	95	92	96
Surface Condition Rating (SCR)	96	89	98	92	86	94
Roughness Condition Index (RCI)	100	100	100	100	100	100
Distress Index Values						
Structural Crack Index	97	89	98	92	95	99
Alligator Crack Index	100	100	100	100	100	100
Longitudinal Crack Index	97	89	98	92	95	99
Transverse Cracking Index	96	95	99	93	86	94
Patching Index	100	100	100	99	100	100
Rutting Index	100	99	99	100	99	100
International Roughness Index (IRI)	82	105	90	96	89	93

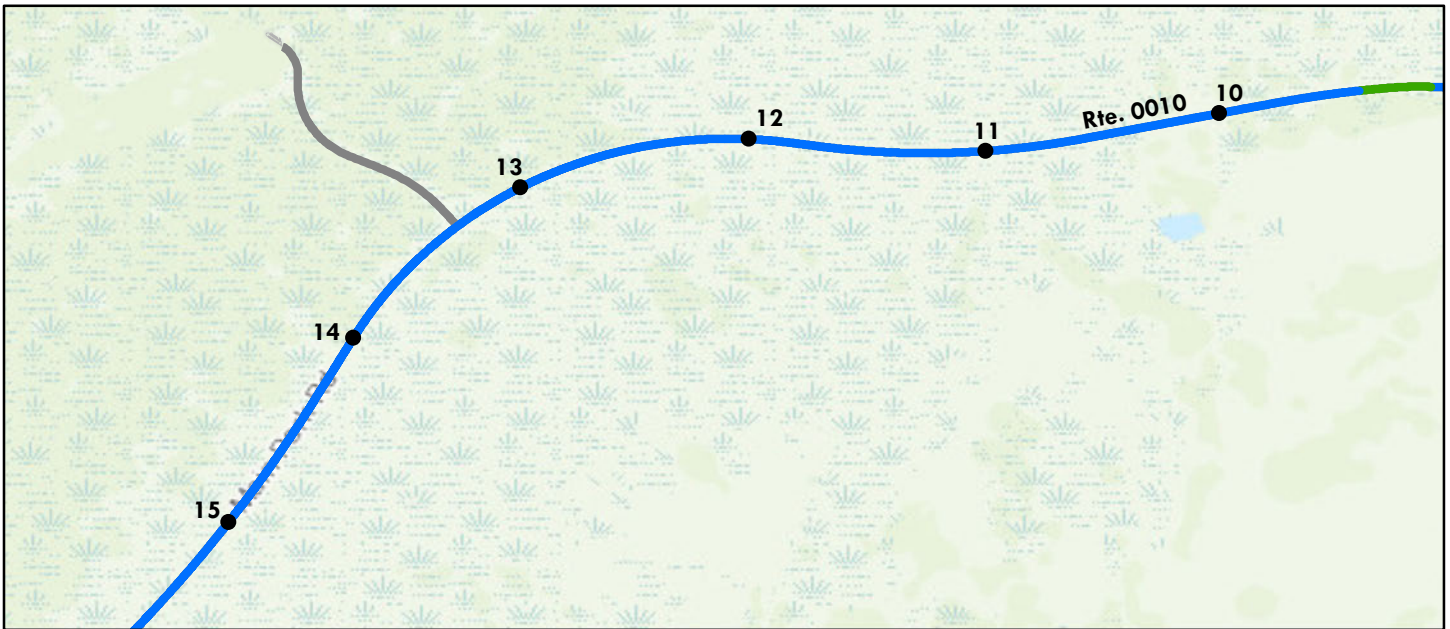
ROUTE 0010: MAIN PARK ROAD

Data Collection Vehicle (DCV) Rating

Route Condition Legend – Pavement Condition Rating (PCR)						
Poor (0 - 60)	Fair (61- 84)	Good (85 - 94)	Excellent (95 - 100)	Not Rated		
Colors on map represent condition scores at 0.10-mile intervals. See Appendix for definitions and formulas.						
Inspection Date: 4/6/2019	Beginning Section MP	10	11	12	13	14
Paved Length (Miles): 39.25	Section Length (MI)	1	1	1	1	1
Surface Type: ASPHALT	Route Summary					
Roadway Condition Information						
Pavement Condition Rating (PCR)	98	100	100	100	100	100
Surface Condition Rating (SCR)	96	100	100	100	100	100
Roughness Condition Index (RCI)	100	100	100	100	100	100
Distress Index Values						
Structural Crack Index	97	100	100	100	100	100
Alligator Crack Index	100	100	100	100	100	100
Longitudinal Crack Index	97	100	100	100	100	100
Transverse Cracking Index	96	100	100	100	100	100
Patching Index	100	100	100	100	100	100
Rutting Index	100	100	100	100	100	100
International Roughness Index (IRI)	82	74	74	77	88	73

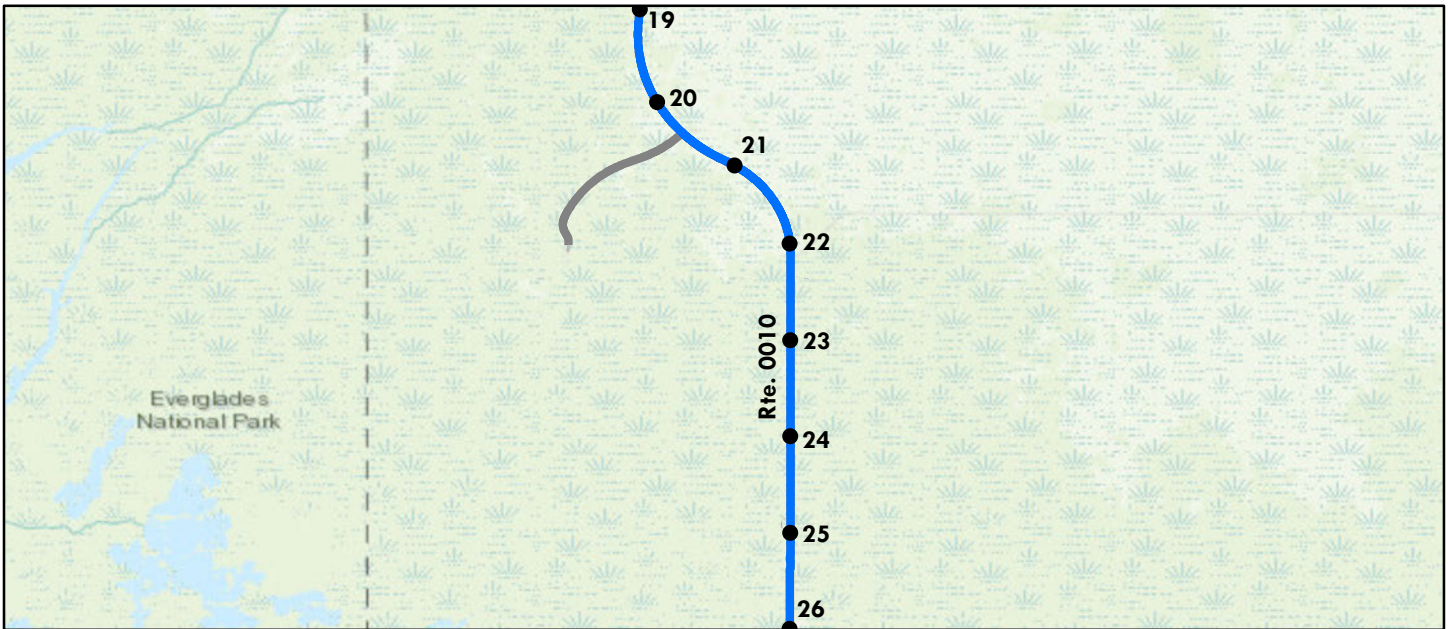
ROUTE 0010: MAIN PARK ROAD

Data Collection Vehicle (DCV) Rating

Route Condition Legend – Pavement Condition Rating (PCR)						
Poor (0 - 60)	Fair (61- 84)	Good (85 - 94)	Excellent (95 - 100)	Not Rated		
Colors on map represent condition scores at 0.10-mile intervals. See Appendix for definitions and formulas.						
Inspection Date: 4/6/2019	Beginning Section MP	20	21	22	23	24
Paved Length (Miles): 39.25	Section Length (MI)	1	1	1	1	1
Surface Type: ASPHALT	Route Summary					
Roadway Condition Information						
Pavement Condition Rating (PCR)	98	100	100	100	100	100
Surface Condition Rating (SCR)	96	100	100	100	100	100
Roughness Condition Index (RCI)	100	100	100	100	100	100
Distress Index Values						
Structural Crack Index	97	100	100	100	100	100
Alligator Crack Index	100	100	100	100	100	100
Longitudinal Crack Index	97	100	100	100	100	100
Transverse Cracking Index	96	100	100	100	100	100
Patching Index	100	100	100	100	100	100
Rutting Index	100	100	100	100	100	100
International Roughness Index (IRI)	82	55	54	52	58	65

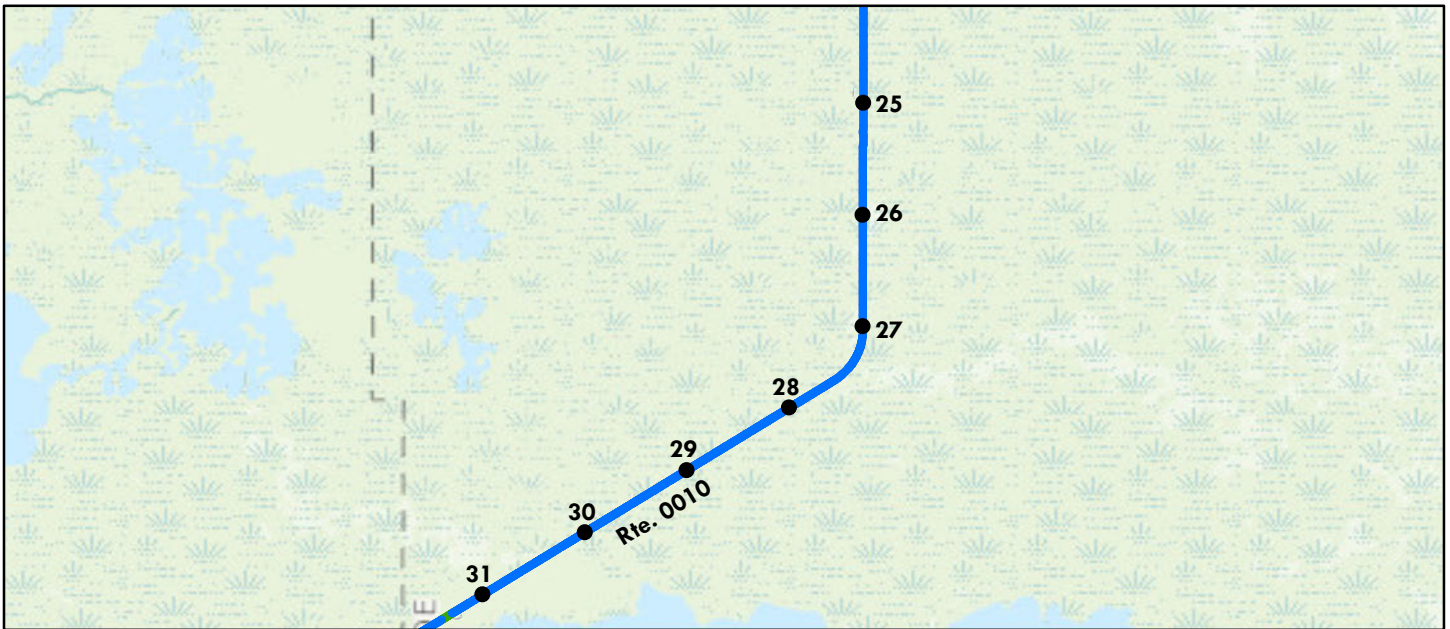
ROUTE 0010: MAIN PARK ROAD

Data Collection Vehicle (DCV) Rating

Route Condition Legend – Pavement Condition Rating (PCR)						
Poor (0 - 60)	Fair (61- 84)	Good (85 - 94)	Excellent (95 - 100)	Not Rated		
Colors on map represent condition scores at 0.10-mile intervals. See Appendix for definitions and formulas.						
Inspection Date: 4/6/2019	Beginning Section MP	25	26	27	28	29
Paved Length (Miles): 39.25	Section Length (MI)	1	1	1	1	1
Surface Type: ASPHALT	Route Summary					
Roadway Condition Information						
Pavement Condition Rating (PCR)	98	100	100	100	99	99
Surface Condition Rating (SCR)	96	100	100	100	99	98
Roughness Condition Index (RCI)	100	100	100	100	100	100
Distress Index Values						
Structural Crack Index	97	100	100	100	100	99
Alligator Crack Index	100	100	100	100	100	100
Longitudinal Crack Index	97	100	100	100	100	99
Transverse Cracking Index	96	100	100	100	99	98
Patching Index	100	100	100	100	100	100
Rutting Index	100	100	100	100	100	100
International Roughness Index (IRI)	82	66	76	69	66	69

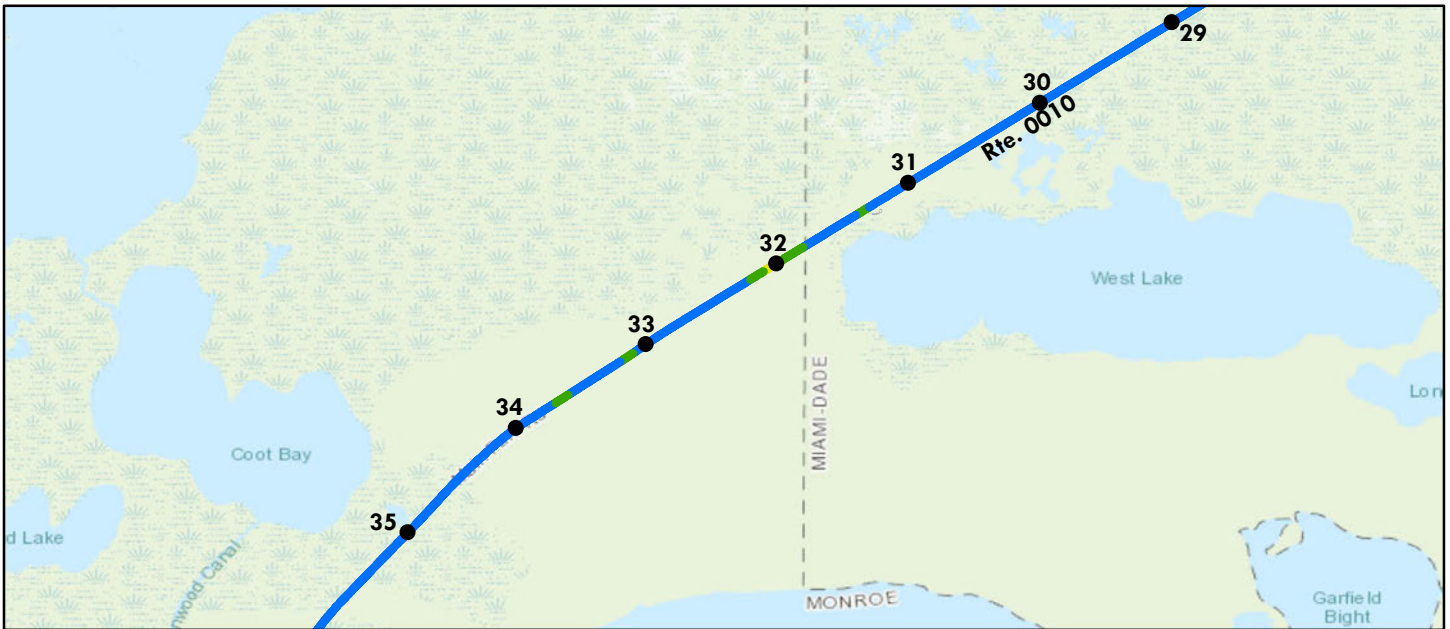
ROUTE 0010: MAIN PARK ROAD

Data Collection Vehicle (DCV) Rating

Colors on map represent condition scores at 0.10-mile intervals. See Appendix for definitions and formulas.

Inspection Date:	4/6/2019	Beginning Section MP	30	31	32	33	34
		Paved Length (Miles):	39.25	Section Length (MI)	1	1	1
Surface Type:	ASPHALT	Route Summary					
Roadway Condition Information							
Pavement Condition Rating (PCR)	98	99	95	97	98	99	
Surface Condition Rating (SCR)	96	98	91	95	97	99	
Roughness Condition Index (RCI)	100	100	100	100	100	100	
Distress Index Values							
Structural Crack Index	97	98	91	95	97	99	
Alligator Crack Index	100	100	100	100	100	100	
Longitudinal Crack Index	97	98	91	95	97	99	
Transverse Cracking Index	96	99	96	98	97	99	
Patching Index	100	100	100	100	100	100	
Rutting Index	100	100	100	100	100	100	
International Roughness Index (IRI)	82	77	88	82	73	80	
Lane & Width Information							
Number of Lanes	2	2	2	2	2	2	
Paved Width (ft)	22.2	21.8	22	22.1	22.2	22.6	
Lane Width (ft)	10.7	10.7	11.1	10.8	10.6	10.5

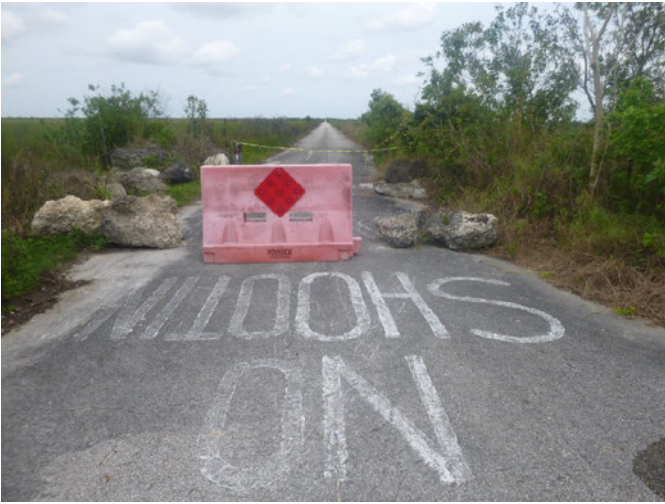
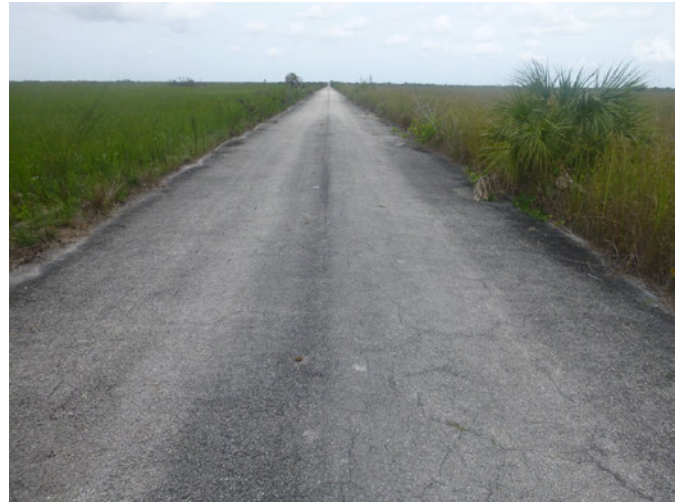
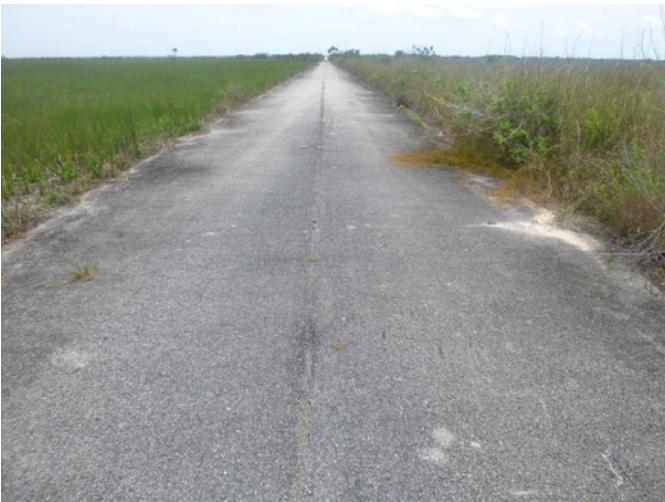
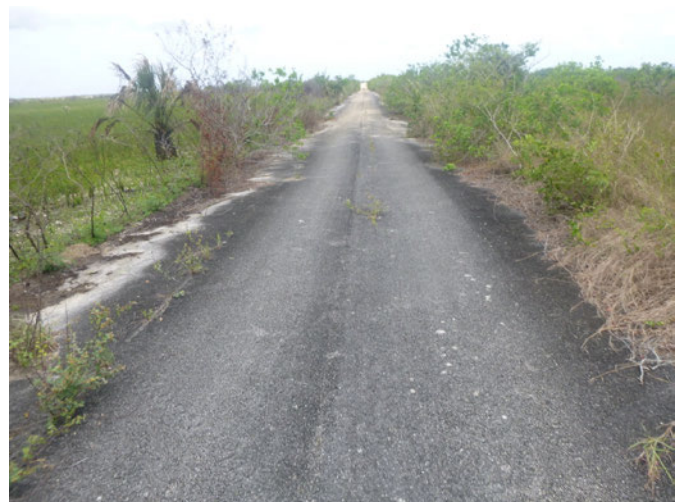
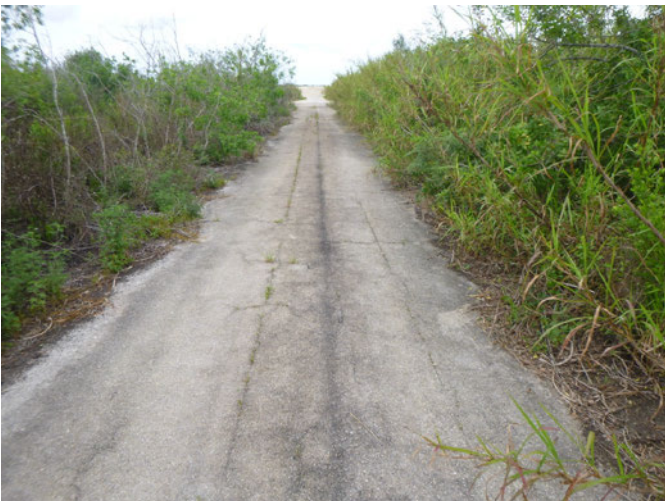
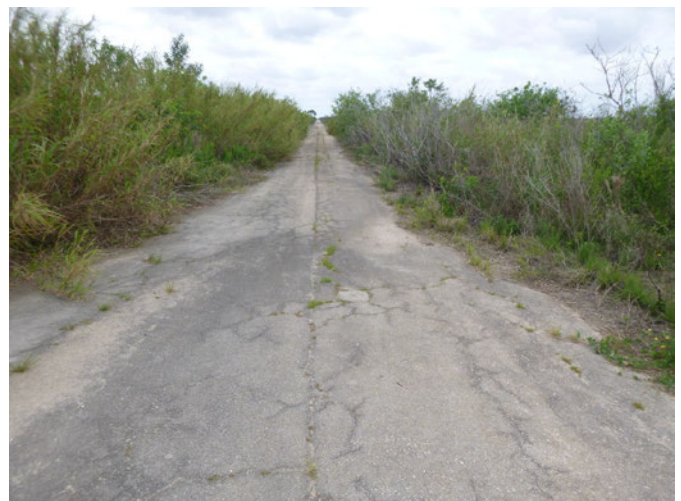
Condition Photos

Condition photos are shown only for manually rated roads. Use the PathView program to see images of DCV rated roads.

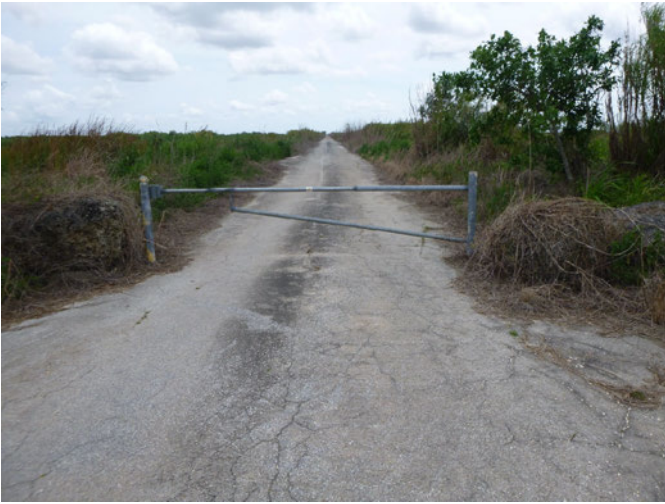
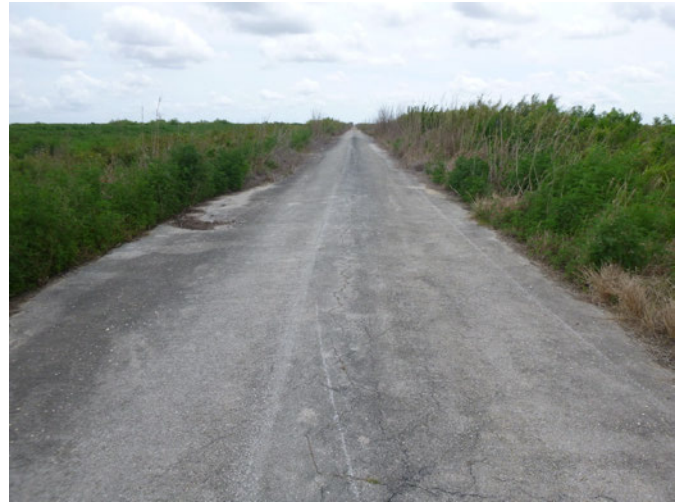
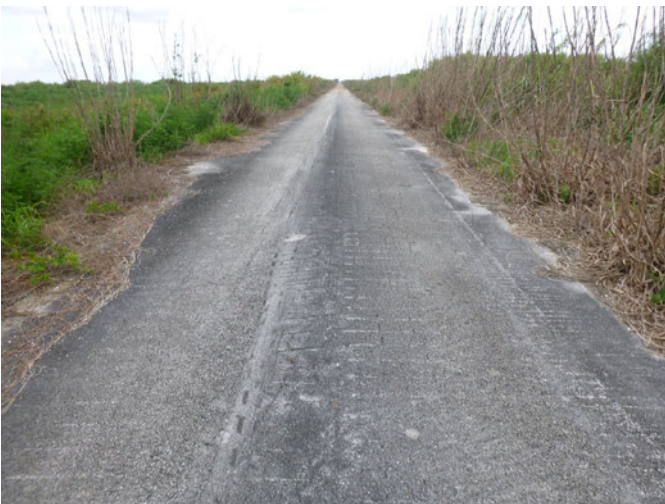
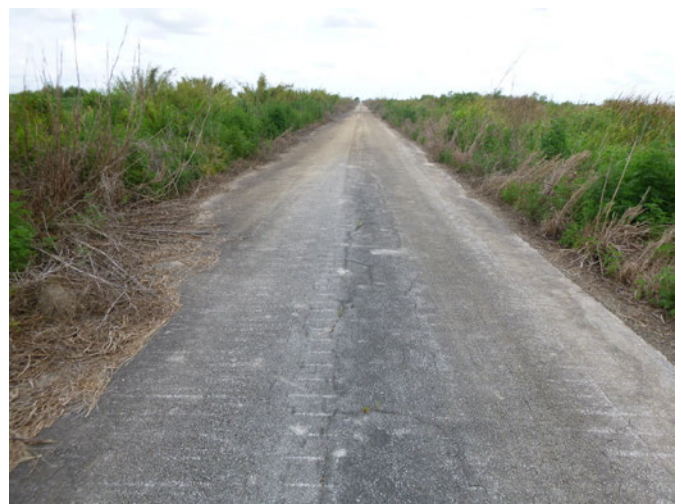
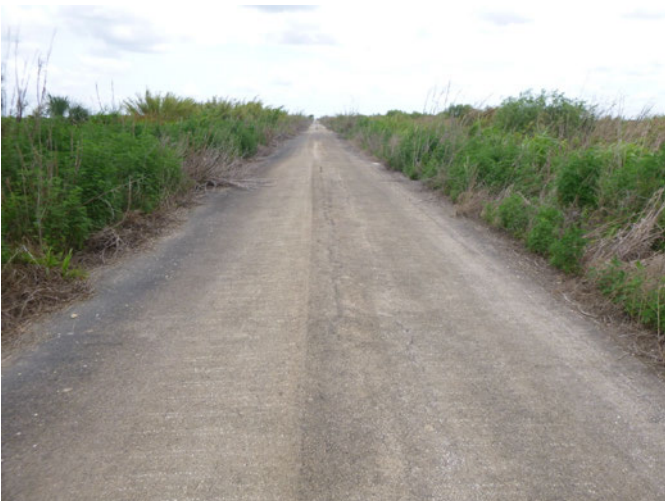
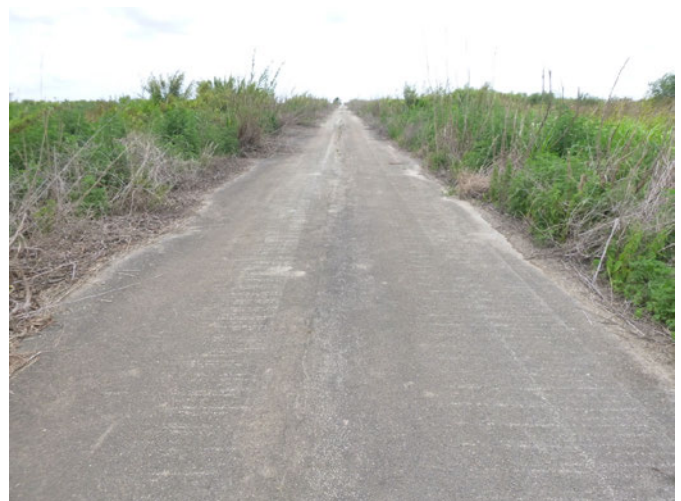
Condition Photos

Condition photos are shown only for manually rated roads. Use the PathView program to see images of DCV rated roads.

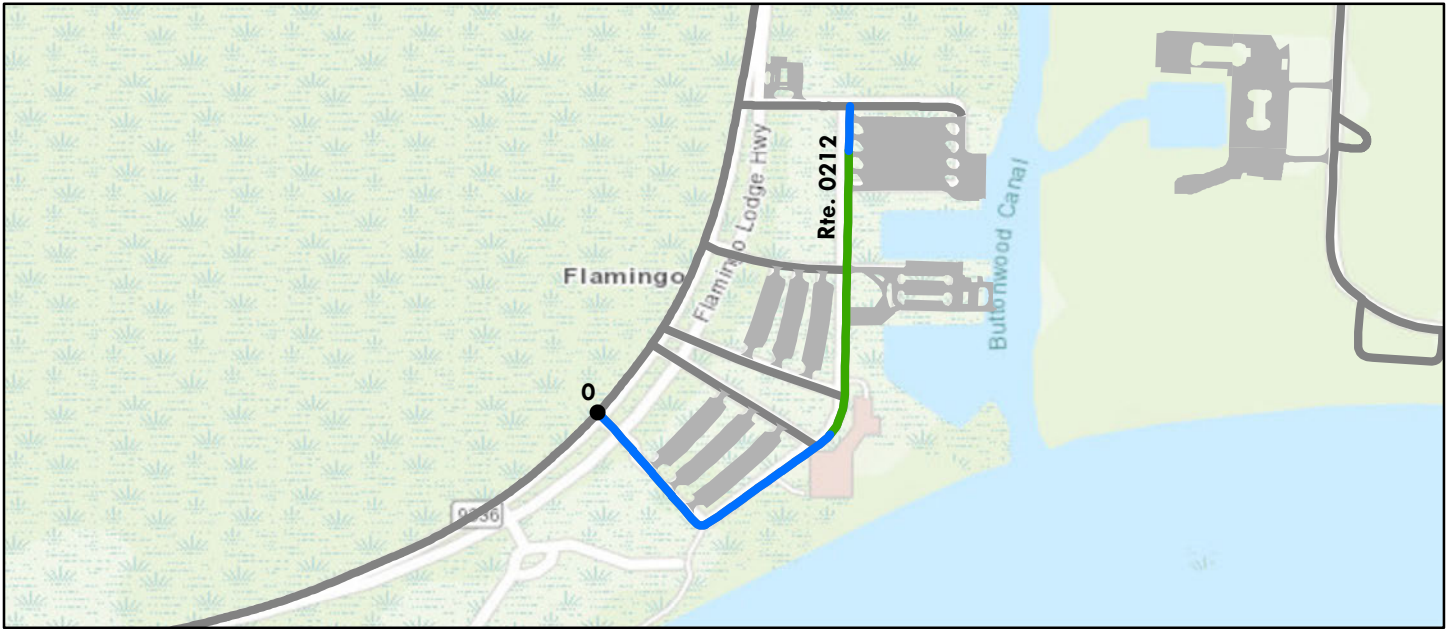
ROUTE 0212: FLAMINGO VISITOR CENTER ACCESS ROAD 1

Data Collection Vehicle (DCV) Rating

Colors on map represent condition scores at 0.10-mile intervals. See Appendix for definitions and formulas.

Inspection Date: 4/6/2019	Beginning Section MP	0				
Paved Length (Miles): 0.43	Section Length (MI)	0.43				
Surface Type: ASPHALT	Route Summary					
Roadway Condition Information						
Pavement Condition Rating (PCR)	93	93				
Surface Condition Rating (SCR)	93	93				
Roughness Condition Index (RCI)	N/A	N/A				
Distress Index Values						
Structural Crack Index	96	96				
Alligator Crack Index	100	100				
Longitudinal Crack Index	96	96				
Transverse Cracking Index	93	93				
Patching Index	100	100				
Rutting Index	99	99				
International Roughness Index (IRI)	N/A	N/A				
Lane & Width Information						
Number of Lanes	2	2				
Paved Width (ft)	21.7	21.7				
Lane Width (ft)	11.1	11.1

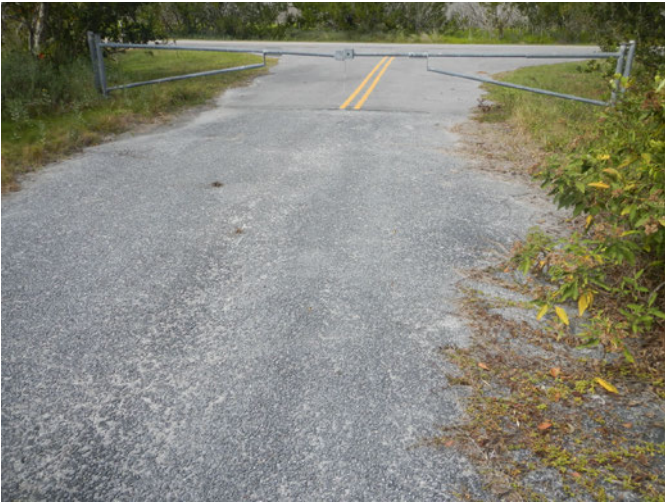
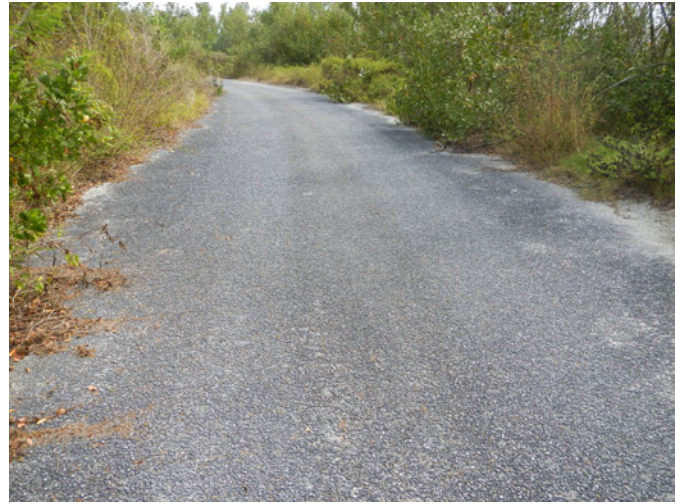
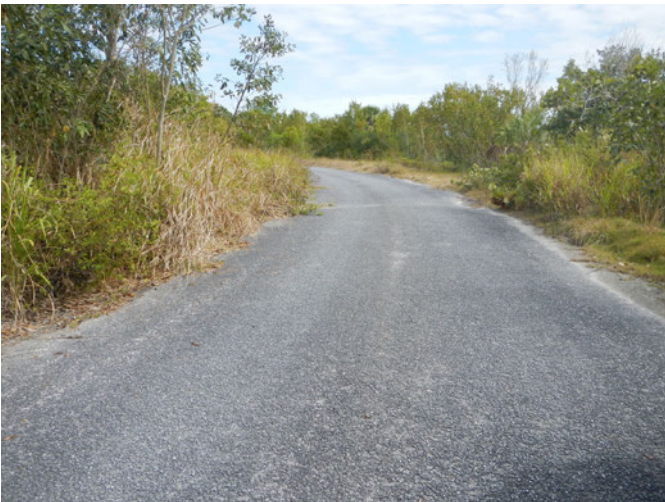
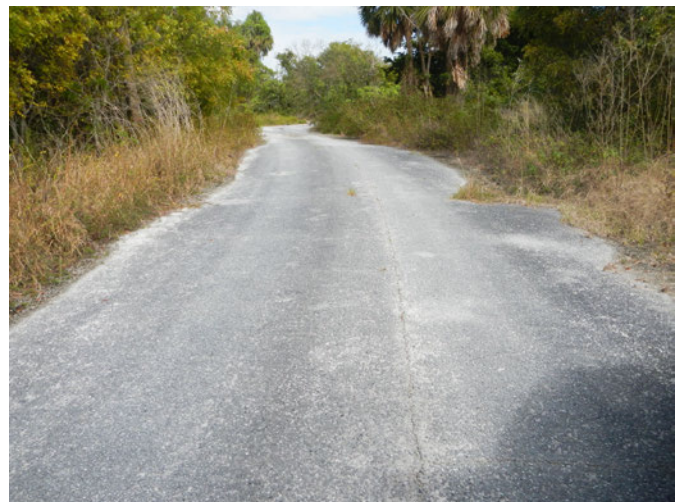
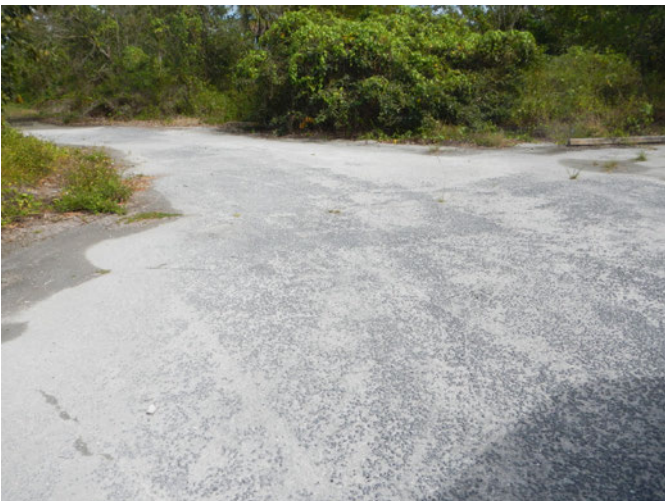
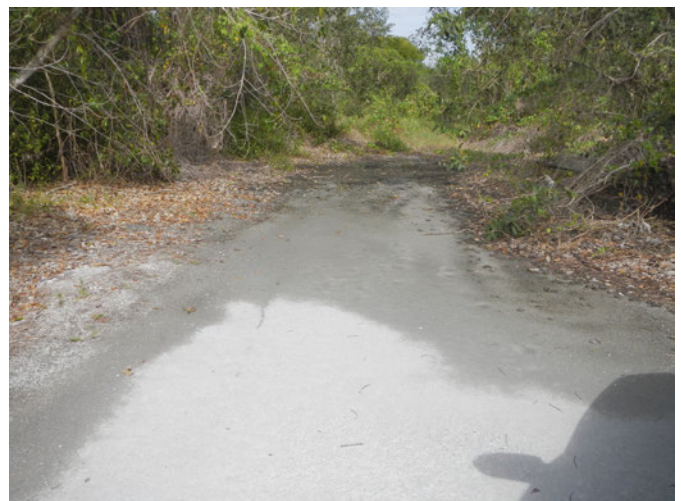
Condition Photos

Condition photos are shown only for manually rated roads. Use the PathView program to see images of DCV rated roads.

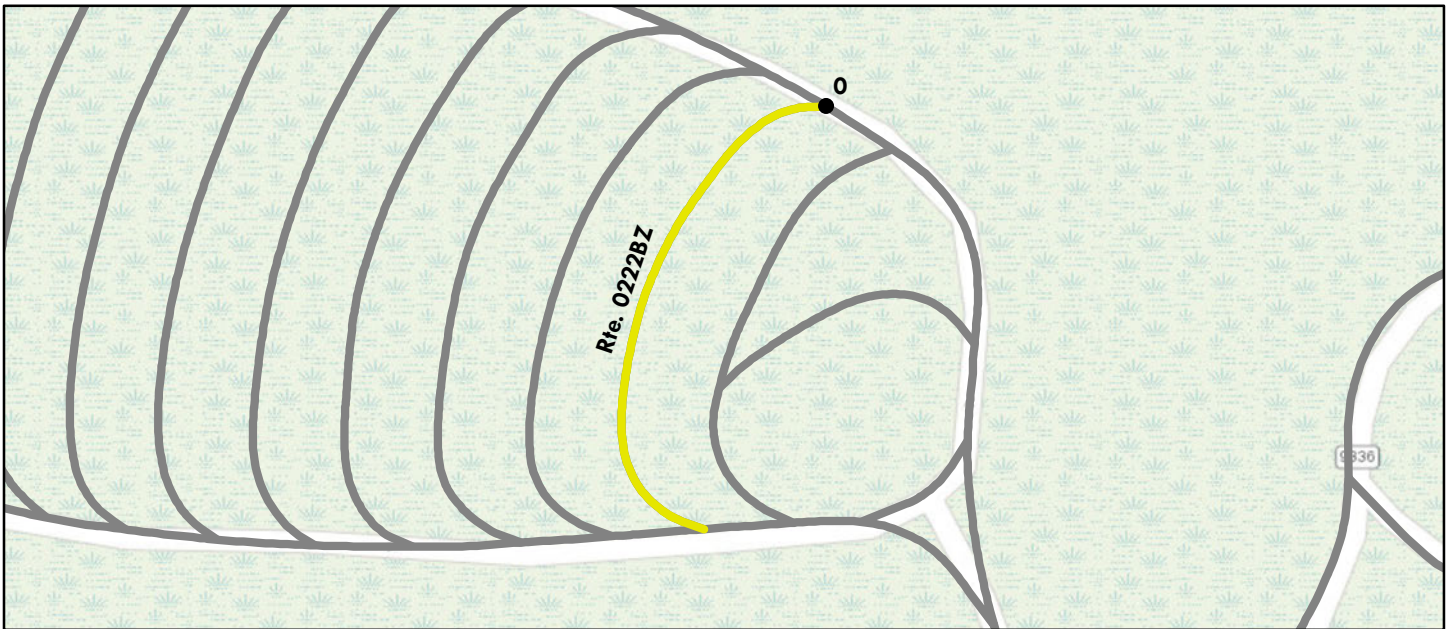
ROUTE 0222BZ: FLAMINGO TRAILER LOOP - SITES 4-8

Subcomponent of Route EVER-0222ZZ
Data Collection Vehicle (DCV) Rating

Colors on map represent condition scores at 0.10-mile intervals. See Appendix for definitions and formulas.

Inspection Date: 4/6/2019	Beginning Section MP	0				
Paved Length (Miles): 0.1	Section Length (MI)	0.1				
Surface Type: ASPHALT	Route Summary					
Roadway Condition Information						
Pavement Condition Rating (PCR)	85	85				
Surface Condition Rating (SCR)	85	85				
Roughness Condition Index (RCI)	N/A	N/A				
Distress Index Values						
Structural Crack Index	90	90				
Alligator Crack Index	100	100				
Longitudinal Crack Index	90	90				
Transverse Cracking Index	85	85				
Patching Index	100	100				
Rutting Index	98	98				
International Roughness Index (IRI)	N/A	N/A				
Lane & Width Information						
Number of Lanes	1	1				
Paved Width (ft)	10.2	10.2				
Lane Width (ft)	10.2	10.2

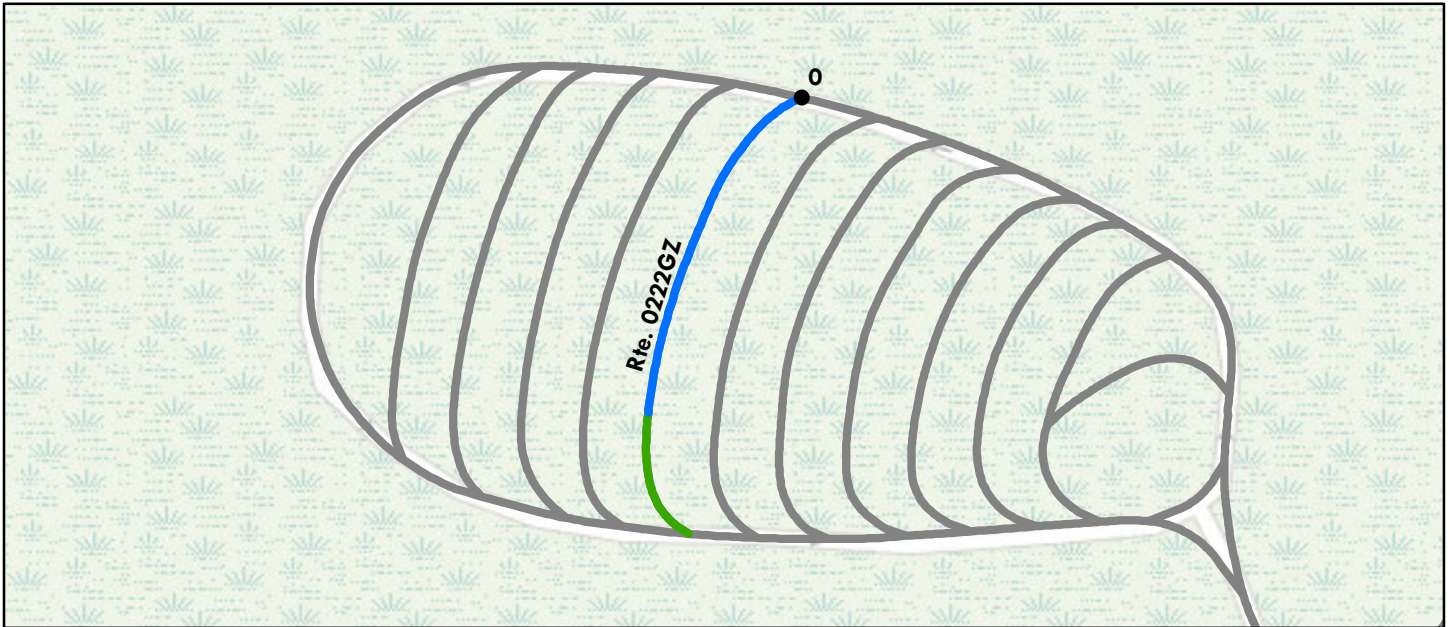
ROUTE 0222GZ: FLAMINGO TRAILER LOOP - SITES 35-41

Subcomponent of Route EVER-0222ZZ
Data Collection Vehicle (DCV) Rating

Colors on map represent condition scores at 0.10-mile intervals. See Appendix for definitions and formulas.

Inspection Date: 4/6/2019	Beginning Section MP	0				
Paved Length (Miles): 0.14	Section Length (MI)	0.14				
Surface Type: ASPHALT	Route Summary					
Roadway Condition Information						
Pavement Condition Rating (PCR)	96	96				
Surface Condition Rating (SCR)	96	96				
Roughness Condition Index (RCI)	N/A	N/A				
Distress Index Values						
Structural Crack Index	96	96				
Alligator Crack Index	100	100				
Longitudinal Crack Index	96	96				
Transverse Cracking Index	96	96				
Patching Index	99	99				
Rutting Index	98	98				
International Roughness Index (IRI)	N/A	N/A				
Lane & Width Information						
Number of Lanes	1	1				
Paved Width (ft)	11	11				
Lane Width (ft)	11	11

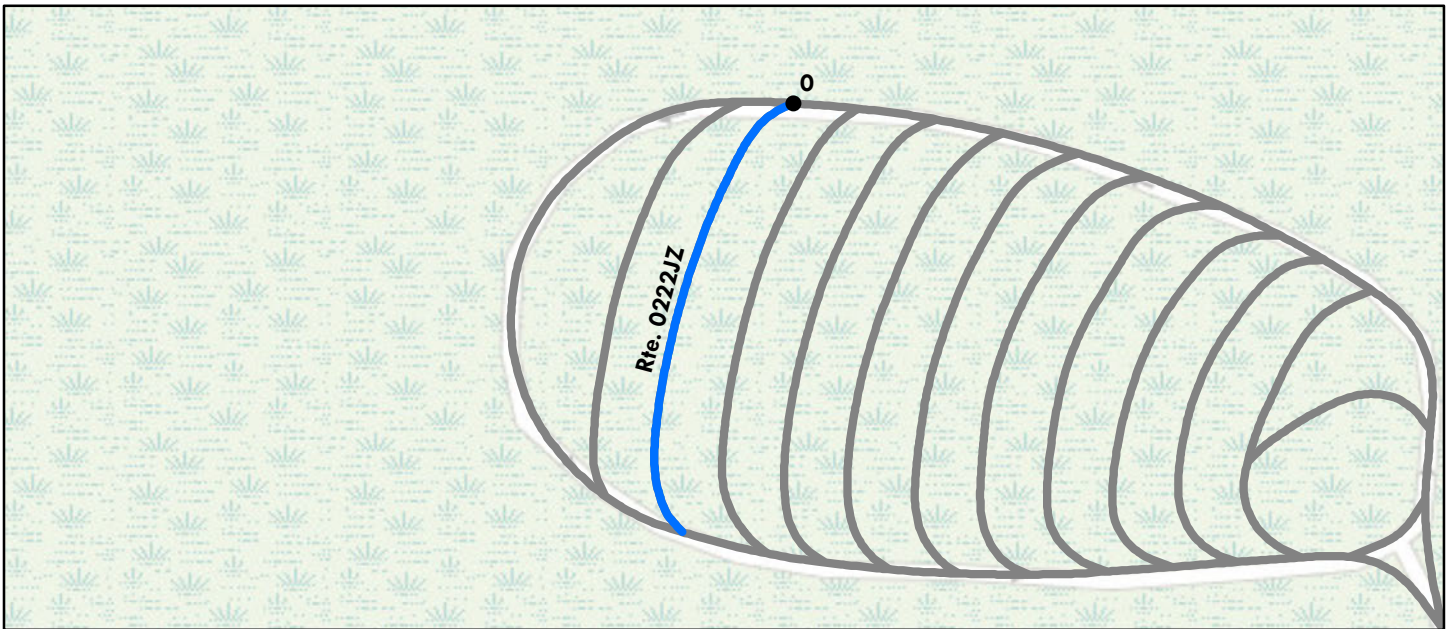
ROUTE 0222JZ: FLAMINGO TRAILER LOOP - SITES 55-60

Subcomponent of Route EVER-0222ZZ
Data Collection Vehicle (DCV) Rating

Colors on map represent condition scores at 0.10-mile intervals. See Appendix for definitions and formulas.

Inspection Date: 4/6/2019	Beginning Section MP	0				
Paved Length (Miles): 0.13	Section Length (MI)	0.13				
Surface Type: ASPHALT	Route Summary					
Roadway Condition Information						
Pavement Condition Rating (PCR)	98	98				
Surface Condition Rating (SCR)	98	98				
Roughness Condition Index (RCI)	N/A	N/A				
Distress Index Values						
Structural Crack Index	99	99				
Alligator Crack Index	100	100				
Longitudinal Crack Index	99	99				
Transverse Cracking Index	98	98				
Patching Index	100	100				
Rutting Index	99	99				
International Roughness Index (IRI)	N/A	N/A				
Lane & Width Information						
Number of Lanes	1	1				
Paved Width (ft)	10.7	10.7				
Lane Width (ft)	10.7	10.7

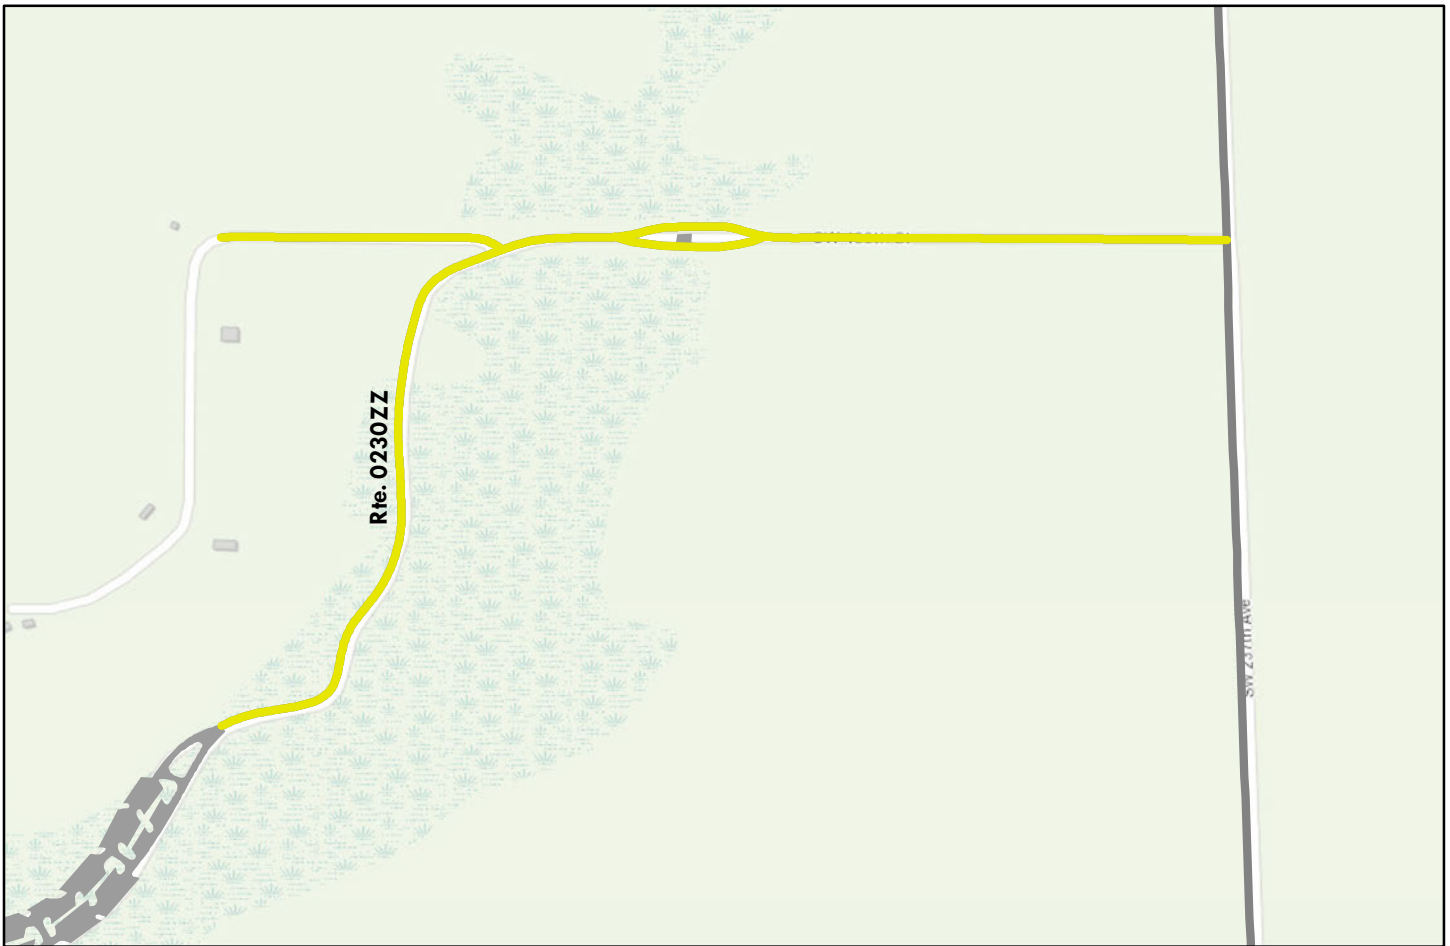
ROUTE 0230ZZ: CHEKIKA AREA ACCESS ROADS

Summary Route

Note: The weighted average summary PCR value is calculated from only the sections of road where the PCR was collected. The overall PCR for the summary route may not reflect individual subcomponent ratings.

Route Condition Legend – Pavement Condition Rating (PCR)						
Poor (0 - 60)	Fair (61- 84)	Good (85 - 94)	Excellent (95 - 100)	Not Rated		
See Appendix for definitions and formulas						
Inspection Date:	4/8/2019					
Paved Length (Miles):	0.81					
Surface Type:	ASPHALT	Route Summary				
Roadway Condition Information						
Pavement Condition Rating (PCR)	82					
Lane & Width Information						
Number of Lanes	2					
Paved Width (ft)	15.5					
Lane Width (ft)	9.6
