EVER Cycle 6

Final Report

Road Inventory and Condition Assessment of Paved Routes Everglades National Park

Report Date: June 2020

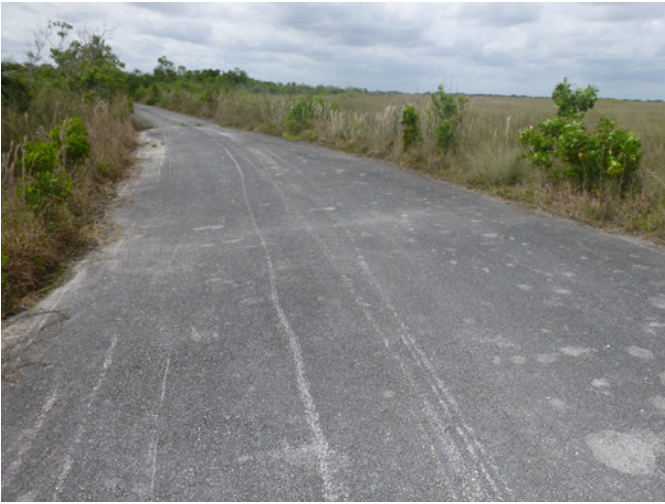
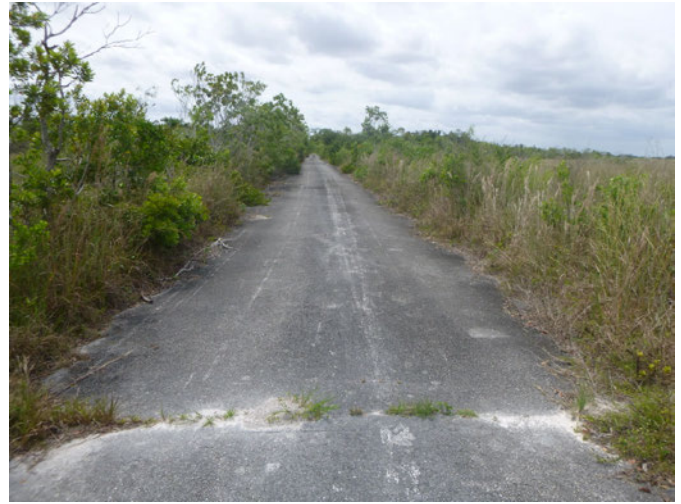
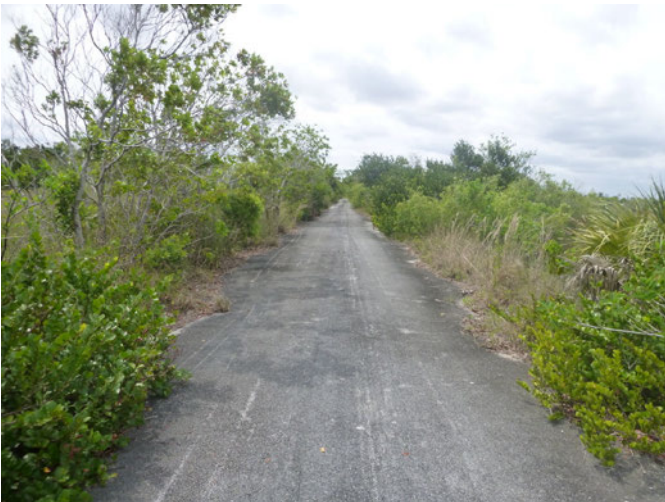
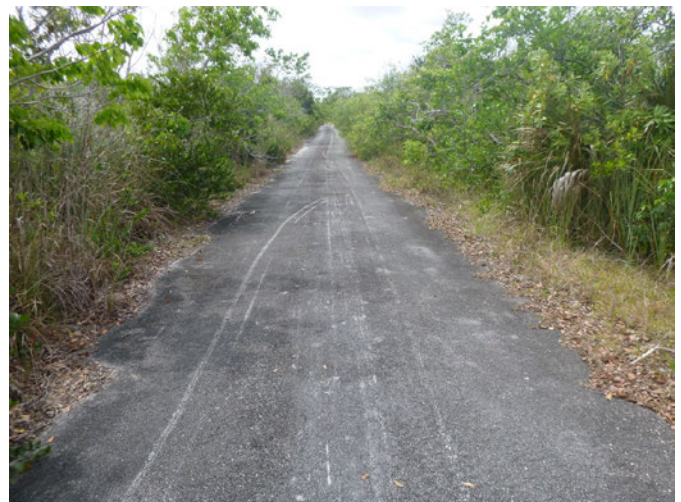
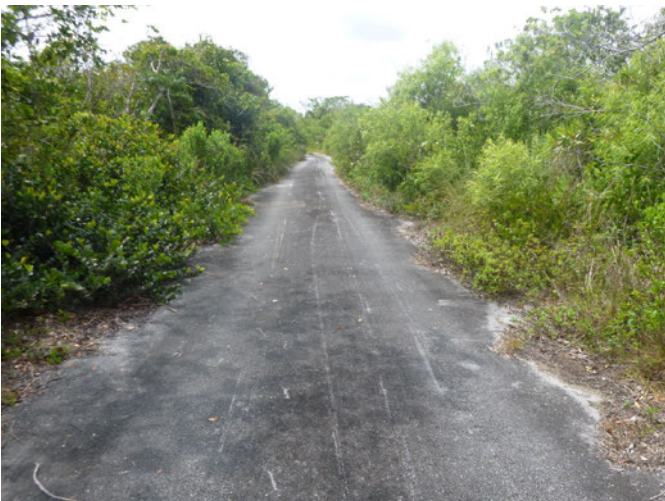
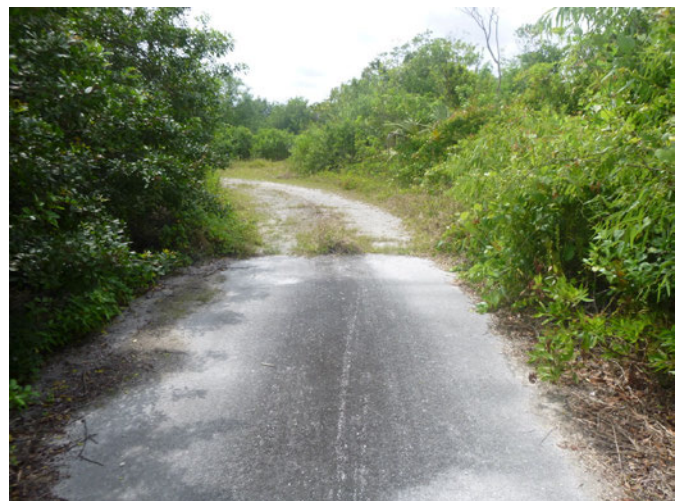
Condition Photos

Condition photos are shown only for manually rated roads. Use the PathView program to see images of DCV rated roads.

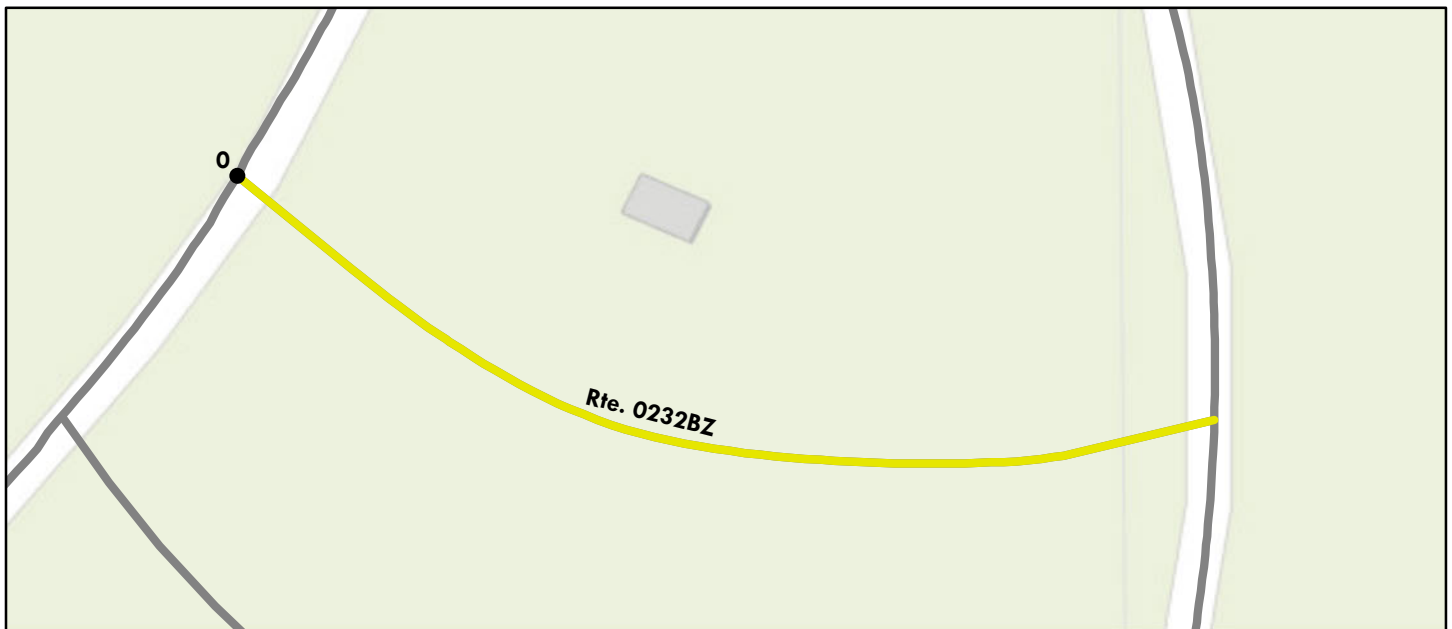
ROUTE 0232BZ: LONG PINE KEY CAMPGROUND LOOP B (4-8)

Subcomponent of Route EVER-0232ZZ
Data Collection Vehicle (DCV) Rating

Colors on map represent condition scores at 0.10-mile intervals. See Appendix for definitions and formulas.

Inspection Date: 4/6/2019	Beginning Section MP	0				
Paved Length (Miles): 0.08	Section Length (MI)	0.08				
Surface Type: ASPHALT	Route Summary					
Roadway Condition Information						
Pavement Condition Rating (PCR)	83	83				
Surface Condition Rating (SCR)	83	83				
Roughness Condition Index (RCI)	N/A	N/A				
Distress Index Values						
Structural Crack Index	83	83				
Alligator Crack Index	100	100				
Longitudinal Crack Index	83	83				
Transverse Cracking Index	89	89				
Patching Index	100	100				
Rutting Index	98	98				
International Roughness Index (IRI)	N/A	N/A				
Lane & Width Information						
Number of Lanes	1	1				
Paved Width (ft)	11.7	11.7				
Lane Width (ft)	11.7	11.7

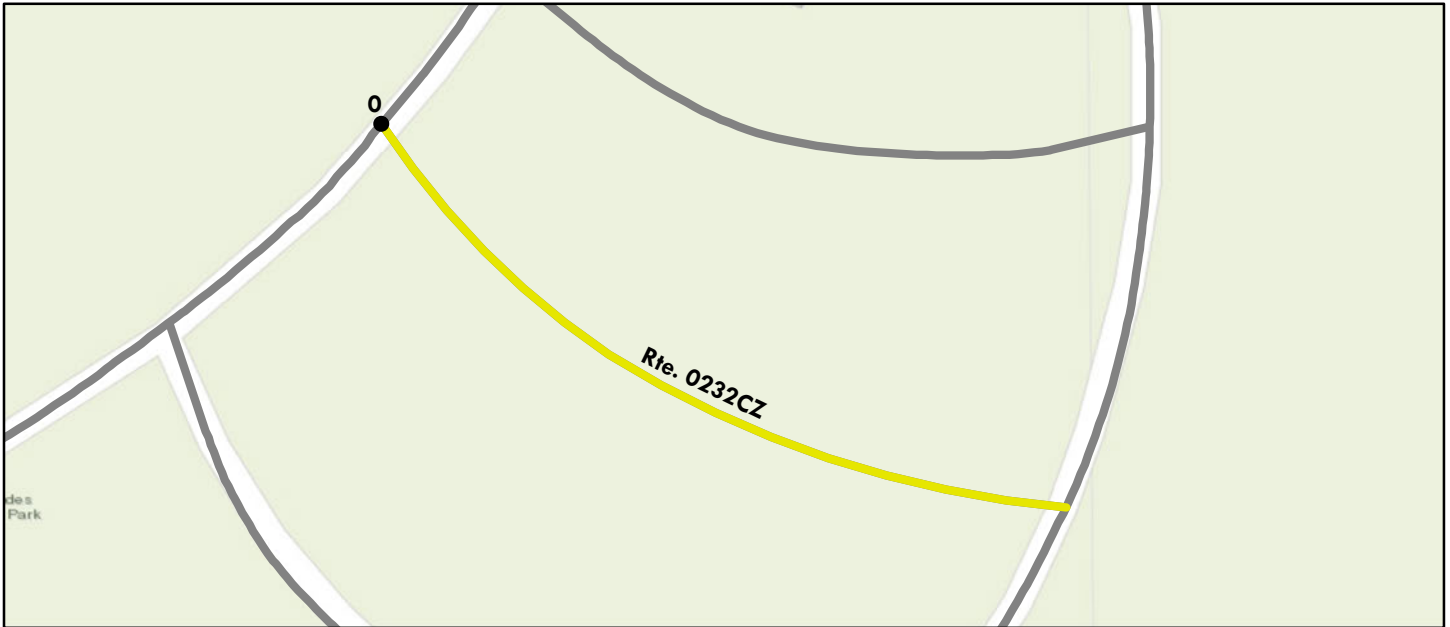
ROUTE 0232CZ: LONG PINE KEY CAMPGROUND LOOP C (9-15)

Subcomponent of Route EVER-0232ZZ
Data Collection Vehicle (DCV) Rating

Colors on map represent condition scores at 0.10-mile intervals. See Appendix for definitions and formulas.

Inspection Date: 4/6/2019	Beginning Section MP	0				
Paved Length (Miles): 0.09	Section Length (MI)	0.09				
Surface Type: ASPHALT	Route Summary					
Roadway Condition Information						
Pavement Condition Rating (PCR)	83	83				
Surface Condition Rating (SCR)	83	83				
Roughness Condition Index (RCI)	N/A	N/A				
Distress Index Values						
Structural Crack Index	83	83				
Alligator Crack Index	100	100				
Longitudinal Crack Index	83	83				
Transverse Cracking Index	97	97				
Patching Index	100	100				
Rutting Index	96	96				
International Roughness Index (IRI)	N/A	N/A				
Lane & Width Information						
Number of Lanes	1	1				
Paved Width (ft)	11.6	11.6				
Lane Width (ft)	11.6	11.6

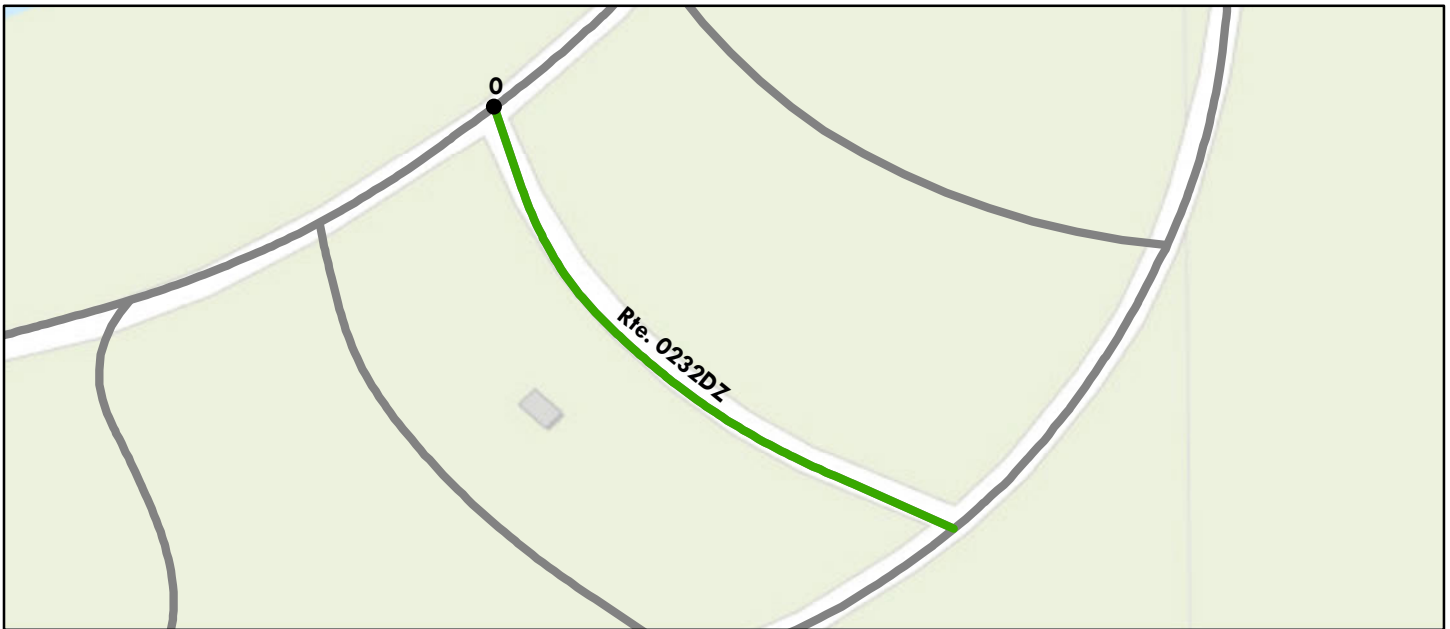
ROUTE 0232DZ: LONG PINE KEY CAMPGROUND LOOP D (16-22)

Subcomponent of Route EVER-0232ZZ
Data Collection Vehicle (DCV) Rating

Colors on map represent condition scores at 0.10-mile intervals. See Appendix for definitions and formulas.

Inspection Date: 4/6/2019	Beginning Section MP	0				
Paved Length (Miles): 0.1	Section Length (MI)	0.1				
Surface Type: ASPHALT	Route Summary					
Roadway Condition Information						
Pavement Condition Rating (PCR)	90	90				
Surface Condition Rating (SCR)	90	90				
Roughness Condition Index (RCI)	N/A	N/A				
Distress Index Values						
Structural Crack Index	90	90				
Alligator Crack Index	100	100				
Longitudinal Crack Index	90	90				
Transverse Cracking Index	98	98				
Patching Index	100	100				
Rutting Index	93	93				
International Roughness Index (IRI)	N/A	N/A				
Lane & Width Information						
Number of Lanes	1	1				
Paved Width (ft)	11.7	11.7				
Lane Width (ft)	11.7	11.7

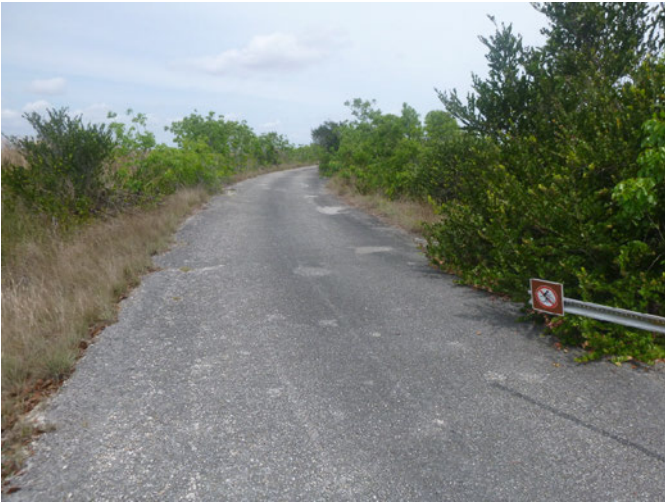
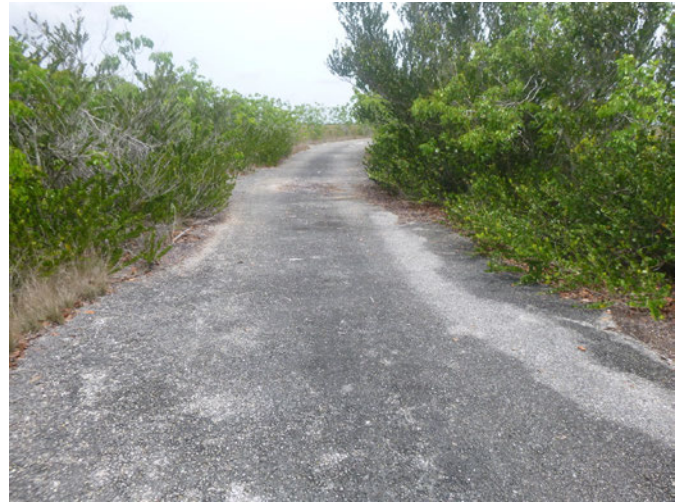
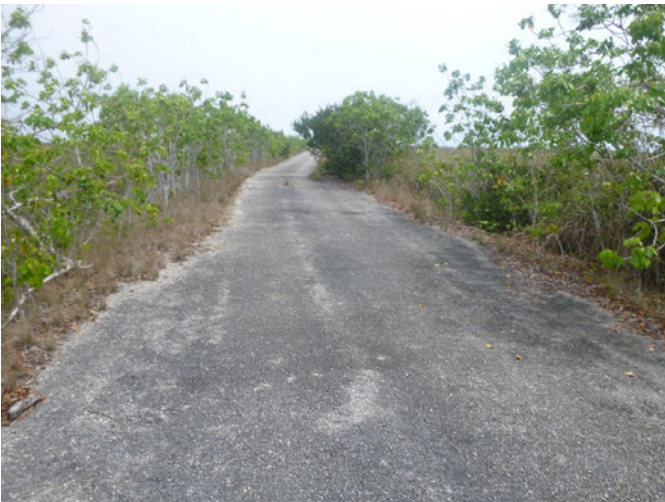
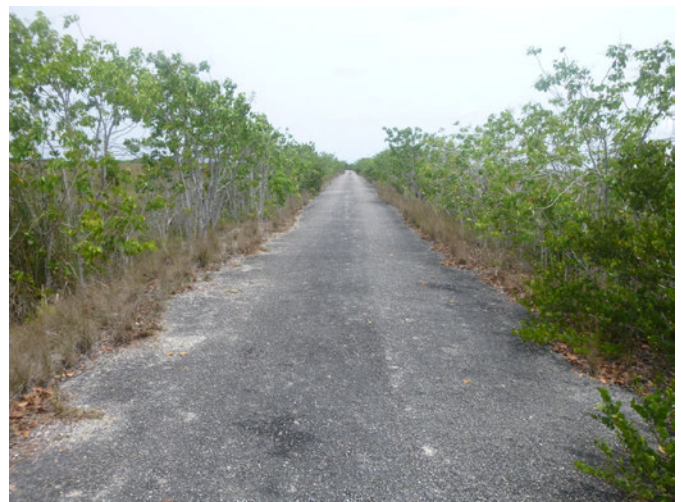
Condition Photos

Condition photos are shown only for manually rated roads. Use the PathView program to see images of DCV rated roads.

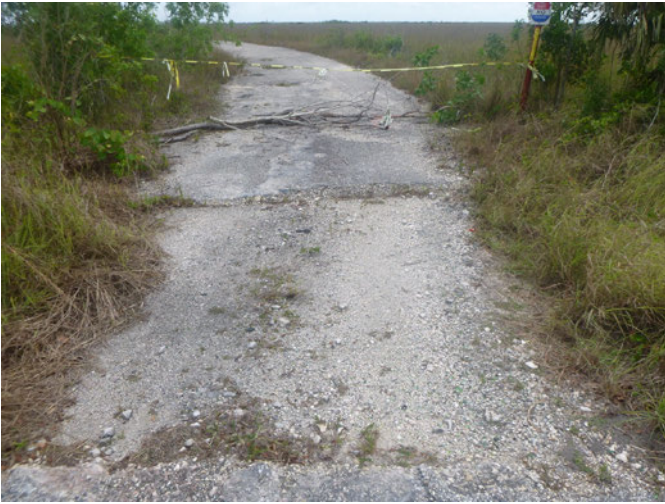
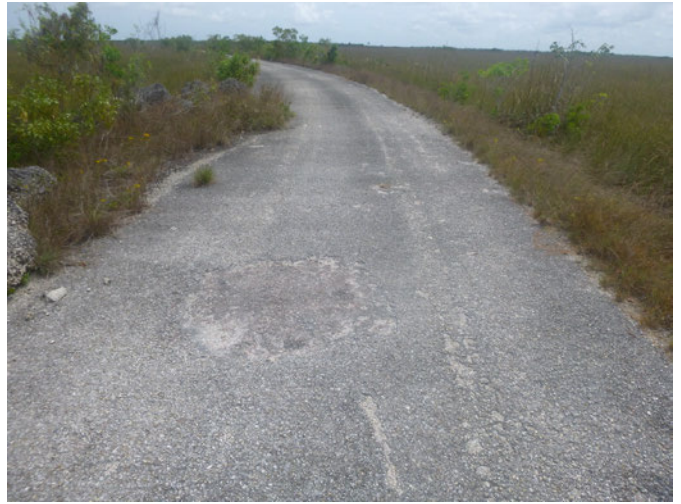
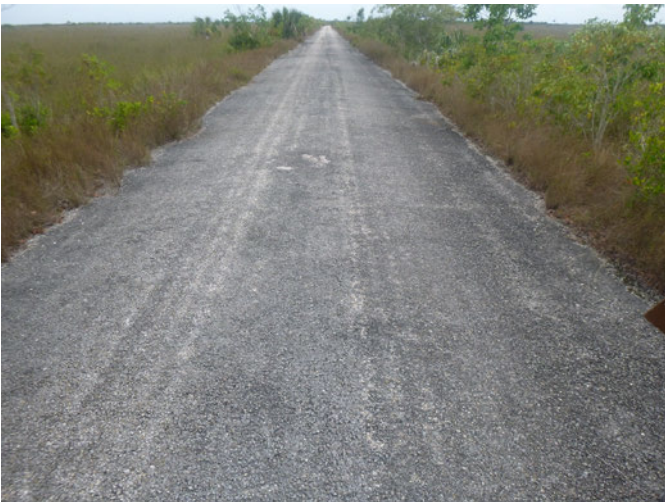
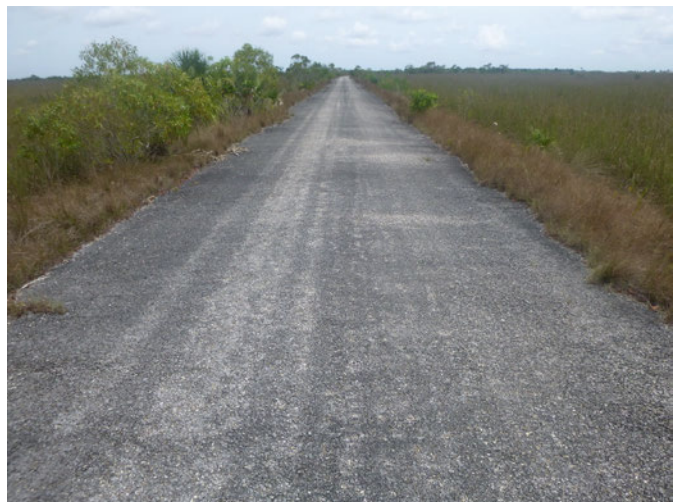
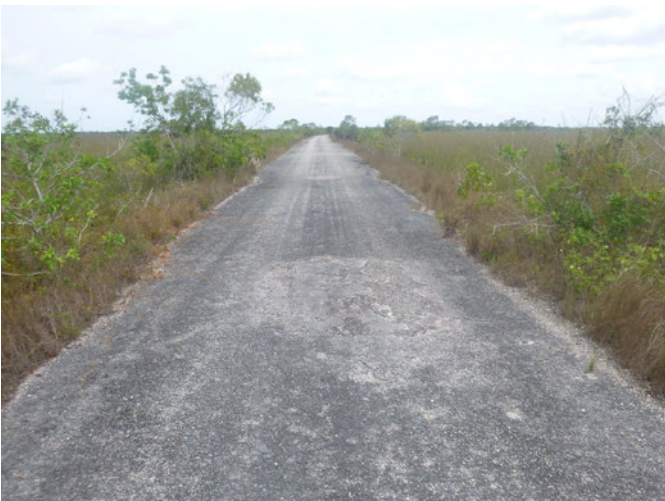
Condition Photos

Condition photos are shown only for manually rated roads. Use the PathView program to see images of DCV rated roads.

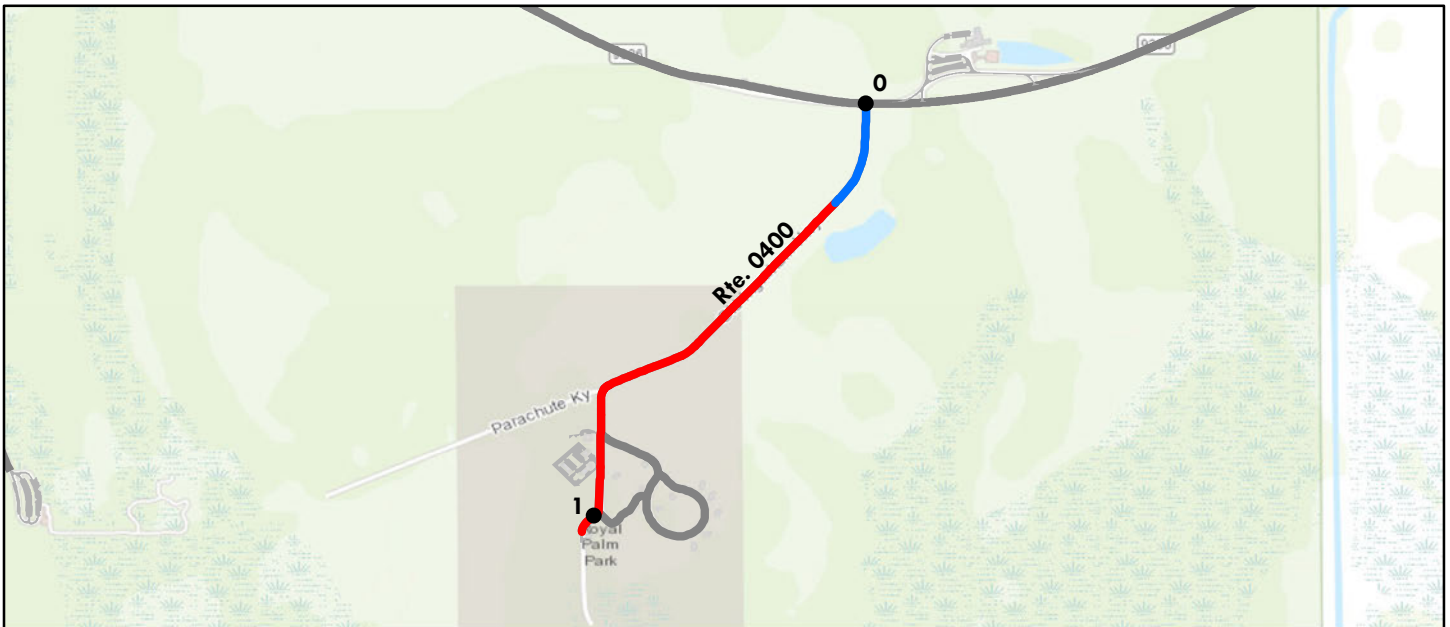
ROUTE 0400: PINE ISLAND MAINTENANCE ACCESS

Data Collection Vehicle (DCV) Rating

Route Condition Legend – Pavement Condition Rating (PCR)						
Poor (0 - 60)	Fair (61- 84)	Good (85 - 94)	Excellent (95 - 100)	Not Rated		
Colors on map represent condition scores at 0.10-mile intervals. See Appendix for definitions and formulas.						
Inspection Date: 4/6/2019	Beginning Section MP	0	1			
Paved Length (Miles): 1.04	Section Length (MI)	1	0.04			
Surface Type: ASPHALT	Route Summary					
Roadway Condition Information						
Pavement Condition Rating (PCR)	52	51	19			
Surface Condition Rating (SCR)	24	22	19			
Roughness Condition Index (RCI)	94	94	N/A			
Distress Index Values						
Structural Crack Index	68	70	19			
Alligator Crack Index	99	100	74			
Longitudinal Crack Index	69	70	45			
Transverse Cracking Index	24	22	58			
Patching Index	98	97	99			
Rutting Index	97	97	92			
International Roughness Index (IRI)	129	129	N/A			
Lane & Width Information						
Number of Lanes	2	2	2			
Paved Width (ft)	19.2	19.3	17.8

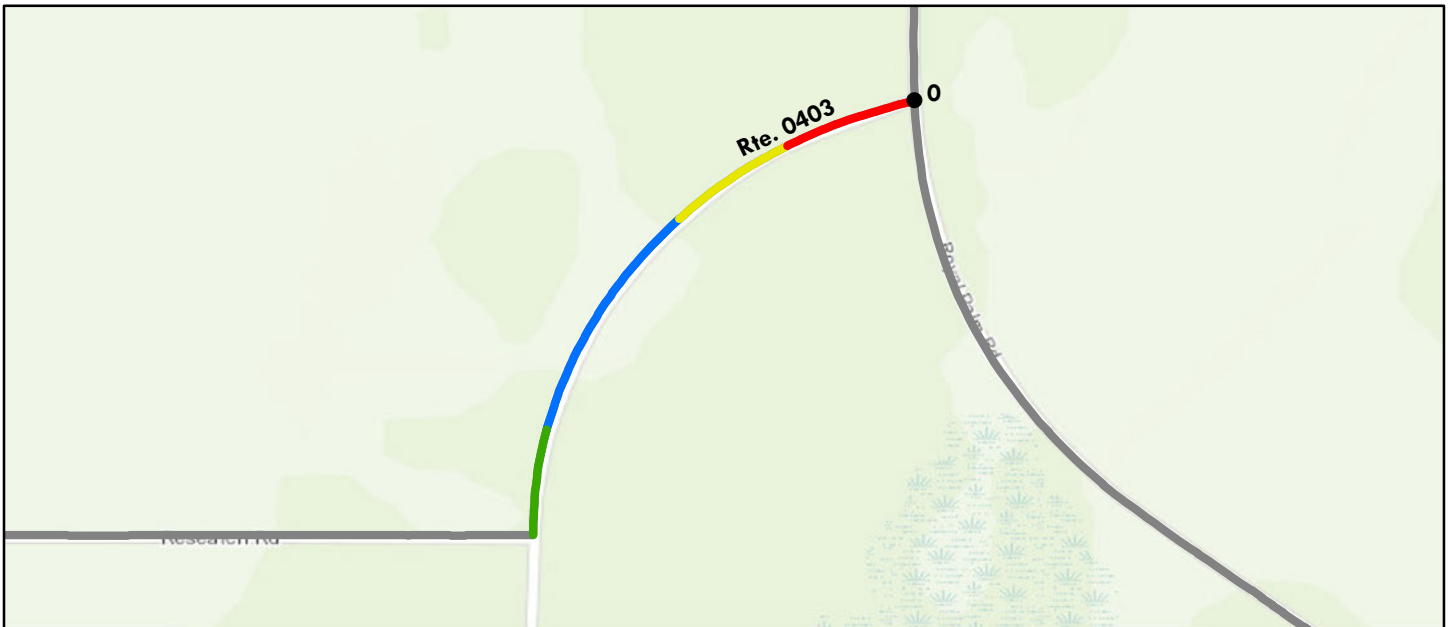
ROUTE 0403: PINE ISLAND DISTRICT SPUR ROAD

Data Collection Vehicle (DCV) Rating

Route Condition Legend – Pavement Condition Rating (PCR)						
Poor (0 - 60)	Fair (61- 84)	Good (85 - 94)	Excellent (95 - 100)	Not Rated		
Colors on map represent condition scores at 0.10-mile intervals. See Appendix for definitions and formulas.						
Inspection Date: 4/6/2019	Beginning Section MP	0				
Paved Length (Miles): 0.5	Section Length (MI)	0.5				
Surface Type: ASPHALT	Route Summary					
Roadway Condition Information						
Pavement Condition Rating (PCR)	87	87				
Surface Condition Rating (SCR)	87	87				
Roughness Condition Index (RCI)	86	86				
Distress Index Values						
Structural Crack Index	95	95				
Alligator Crack Index	100	100				
Longitudinal Crack Index	95	95				
Transverse Cracking Index	87	87				
Patching Index	100	100				
Rutting Index	97	97				
International Roughness Index (IRI)	151	151				
Lane & Width Information						
Number of Lanes	2	2				
Paved Width (ft)	18.8	18.8				
Lane Width (ft)	8.7	8.7

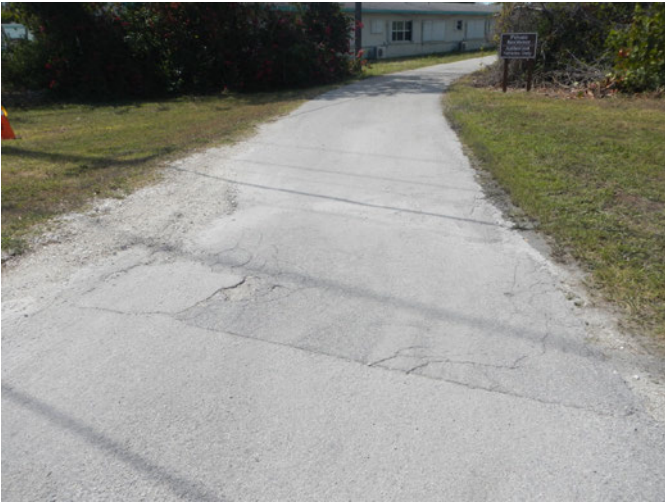
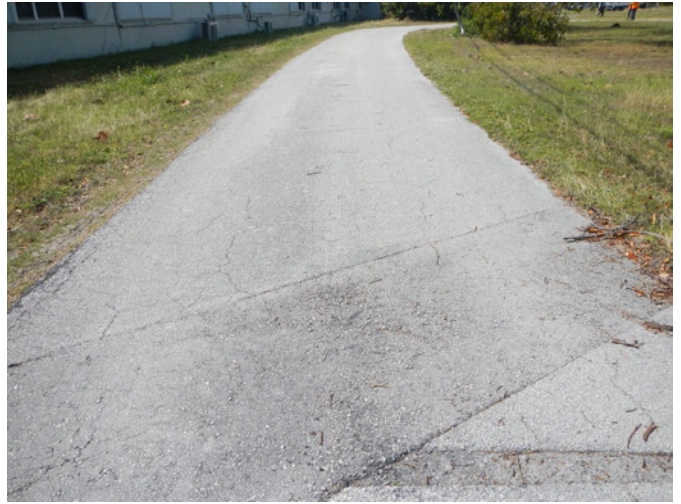
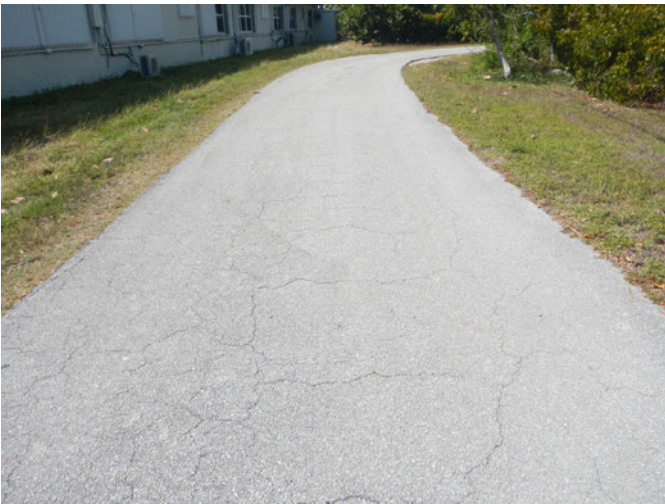
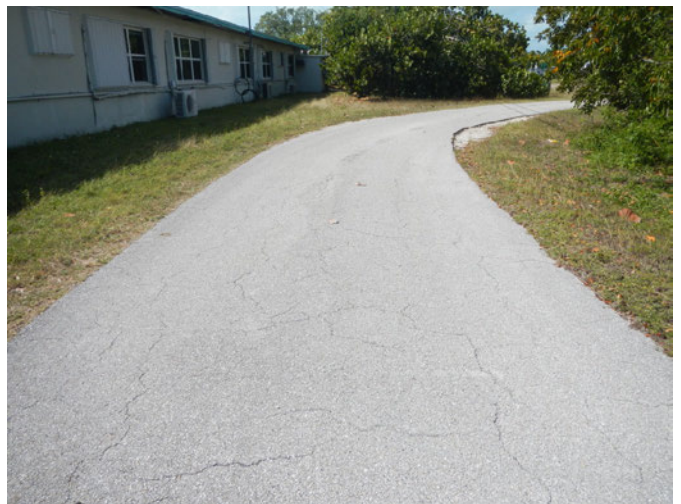
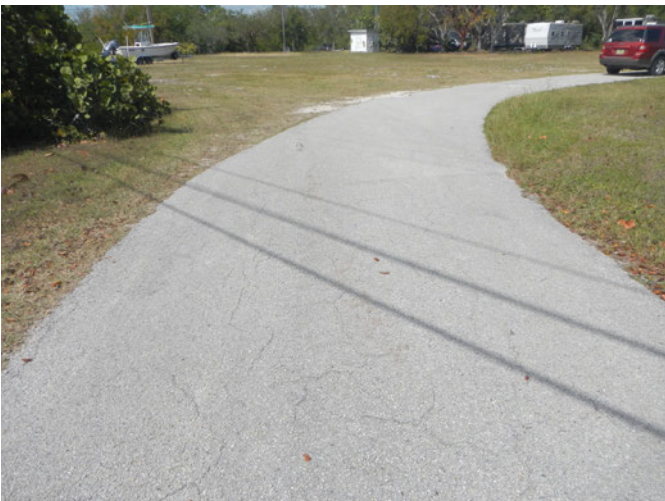
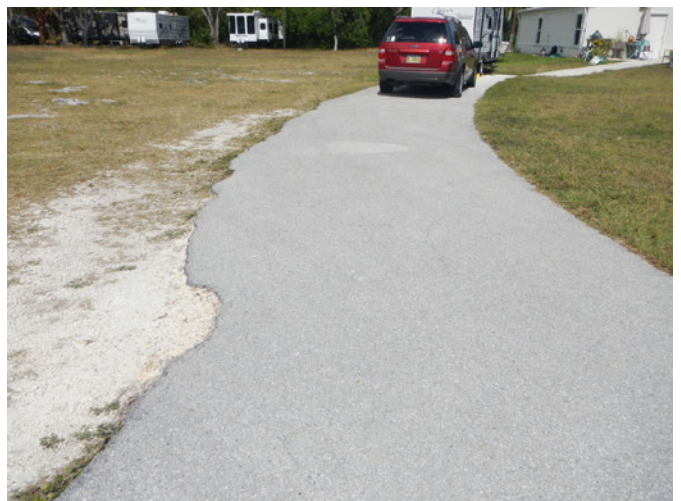
Condition Photos

Condition photos are shown only for manually rated roads. Use the PathView program to see images of DCV rated roads.

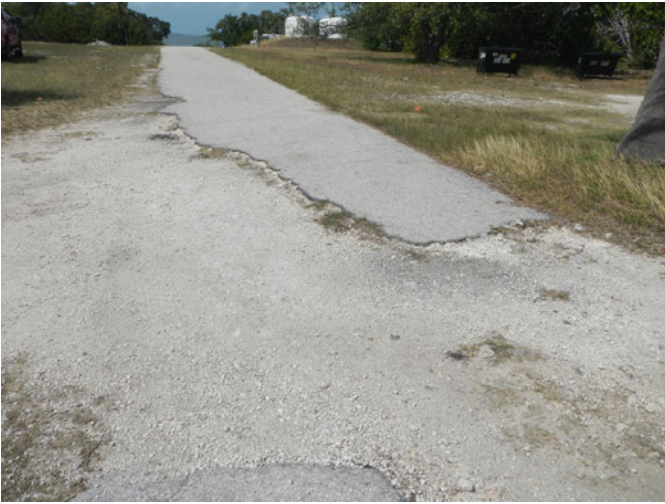
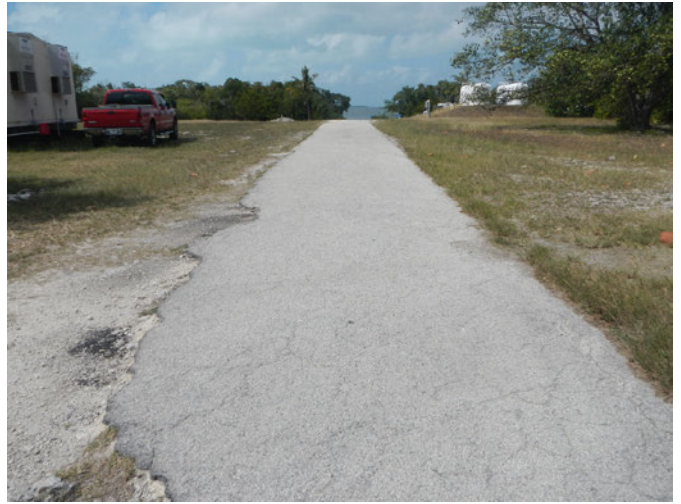
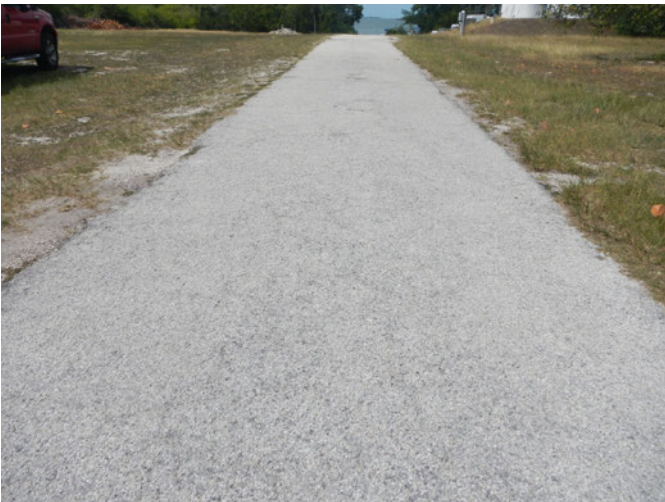
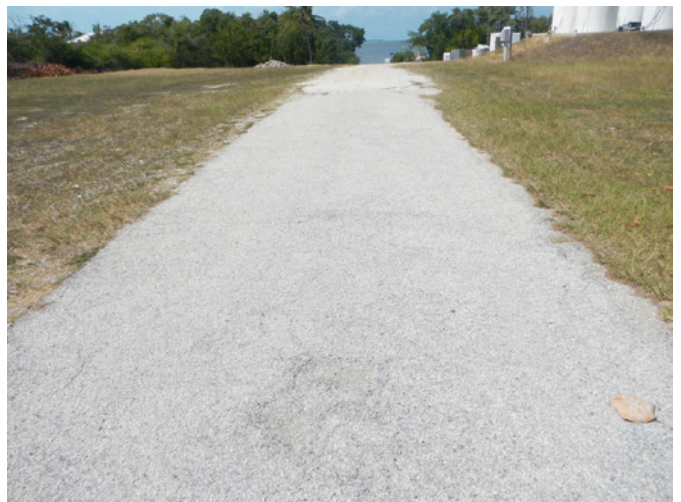
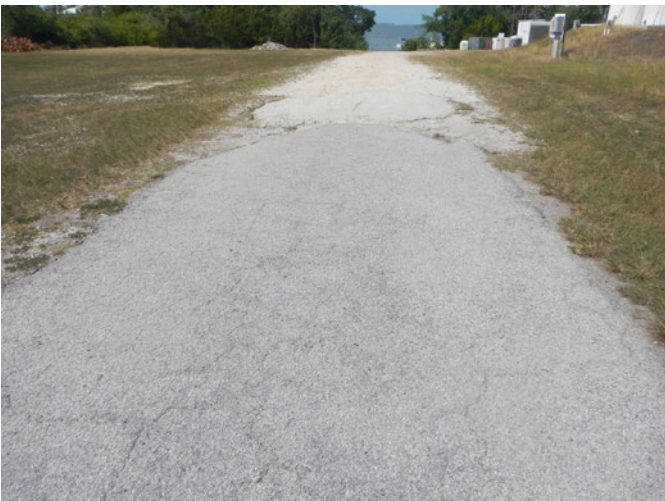
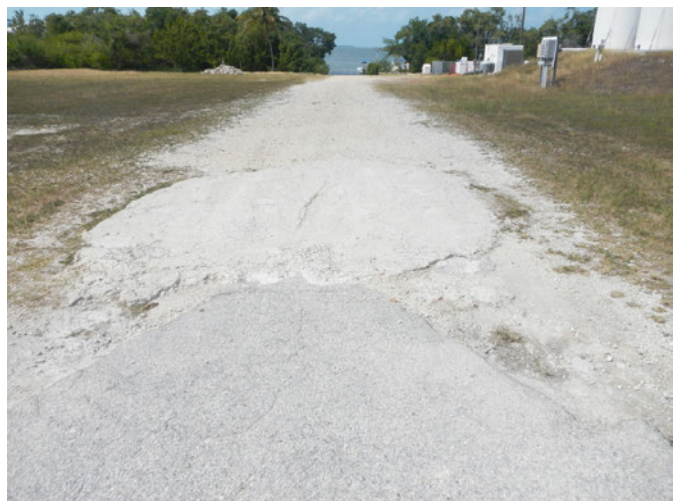
Condition Photos

Condition photos are shown only for manually rated roads. Use the PathView program to see images of DCV rated roads.

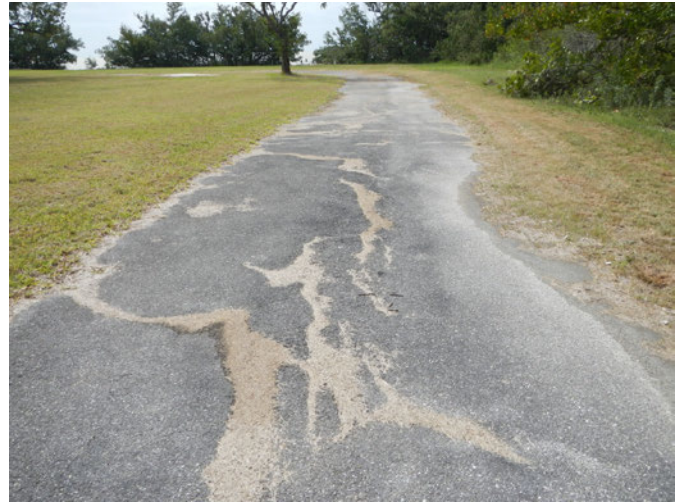
EVER_0437_2743.JPG

Condition photos are shown only for manually rated roads. Use the PathView program to see images of DCV rated roads.

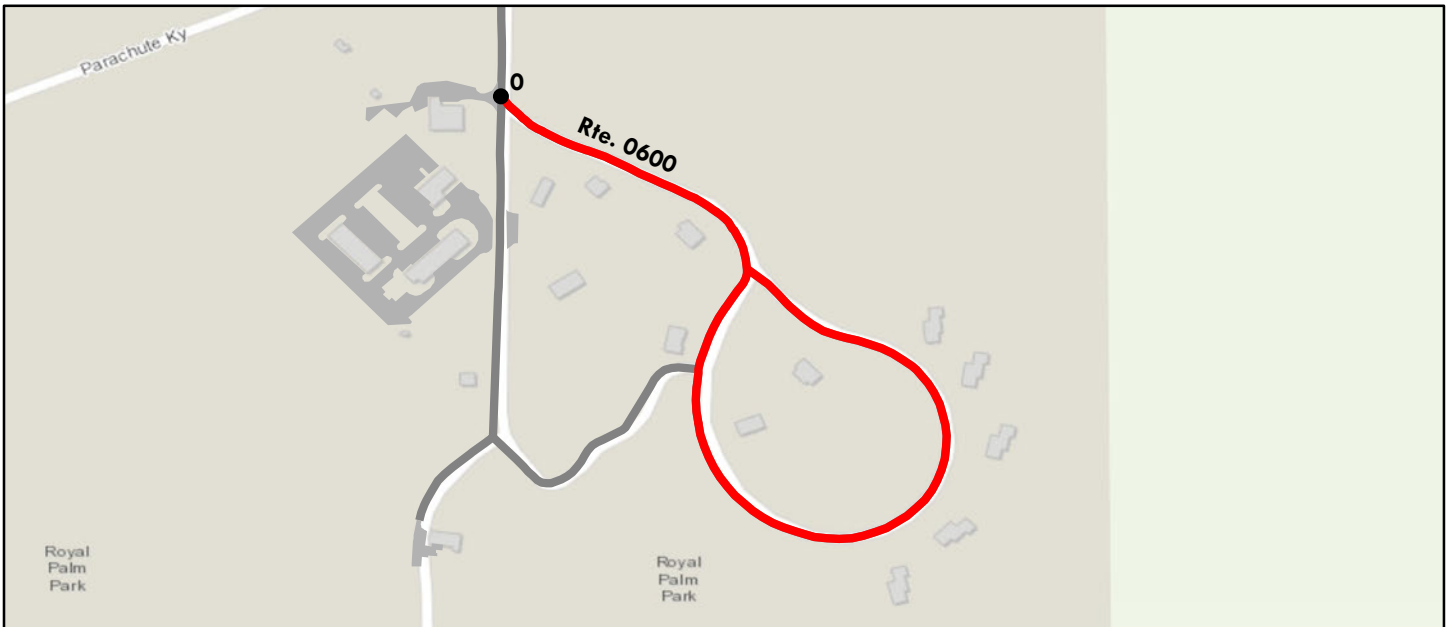
ROUTE 0600: PINE ISLAND RESIDENCE ROAD

Route Condition Legend – Pavement Condition Rating (PCR)						
Poor (0 - 60)	Fair (61- 84)	Good (85 - 94)	Excellent (95 - 100)	Not Rated		
Colors on map represent condition scores at 0.10-mile intervals. See Appendix for definitions and formulas.						
Inspection Date: 4/6/2019	Beginning Section MP	0				
Paved Length (Miles): 0.47	Section Length (MI)	0.47				
Surface Type: ASPHALT	Route Summary					
Roadway Condition Information						
Pavement Condition Rating (PCR)	0	0				
Surface Condition Rating (SCR)	0	0				
Roughness Condition Index (RCI)	N/A	N/A				
Distress Index Values						
Structural Crack Index	0	0				
Alligator Crack Index	99	99				
Longitudinal Crack Index	0	0				
Transverse Cracking Index	0	0				
Patching Index	99	99				
Rutting Index	98	98				
International Roughness Index (IRI)	N/A	N/A				
Lane & Width Information						
Number of Lanes	1	1				
Paved Width (ft)	16.6	16.6				
Lane Width (ft)	14.3	14.3

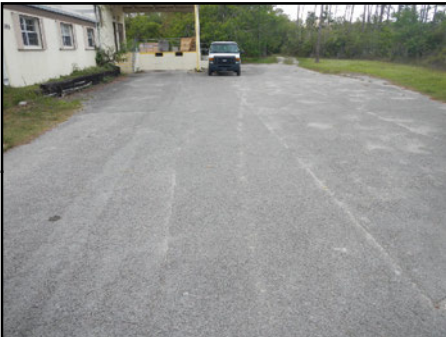
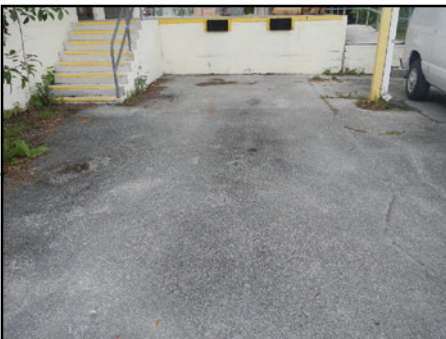
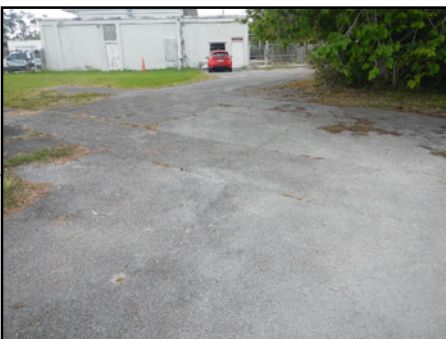
ROUTE 0901: EVERGLADES ASSOCIATION PARKING

Inspection Date	FMSS Number	User Access	Surface Type
3/14/2019	86585	PUBLIC	ASPHALT
Area (Sq. Ft.)	Lane Miles (11' Widths)	Curb Reveal (Inches)	Curb Recommendation
9,435	0.162	NOT APPLICABLE	NOT APPLICABLE
Curb Type		Curb & Gutter Type	
NO CURB		NO CURB AND GUTTER	
Pavement Recommendation		Condition Rating / PCR	
LIGHT 3R TREATMENTS		FAIR / 73

Note: Parking area consists of multiple surface types: 1 part Asphalt at 8,514 square feet; 1 part Concrete at 921 square feet.

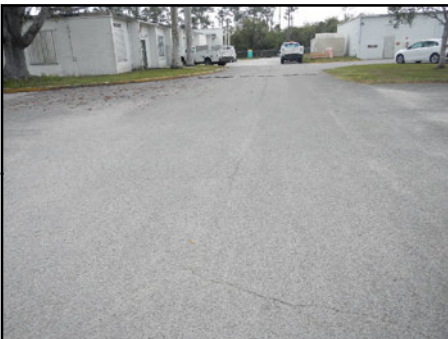
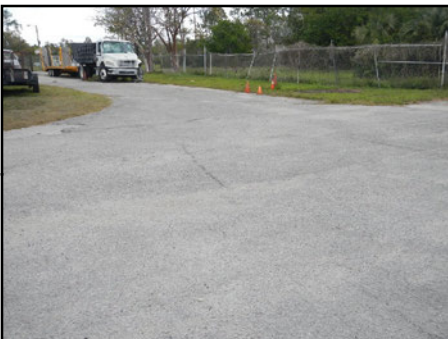
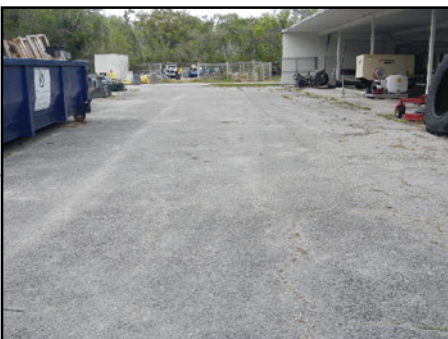
ROUTE 0902A: PINE ISLAND MAINTENANCE YARD

Inspection Date	FMSS Number	User Access	Surface Type
3/14/2019	86586	NONPUBLIC	ASPHALT
Area (Sq. Ft.)	Lane Miles (11' Widths)	Curb Reveal (Inches)	Curb Recommendation
70,731	1.218	5	DO NOTHING
Curb Type		Curb & Gutter Type	
CONCRETE		NOT APPLICABLE	
Pavement Recommendation		Condition Rating / PCR	
HEAVY 3R TREATMENTS		POOR / 53

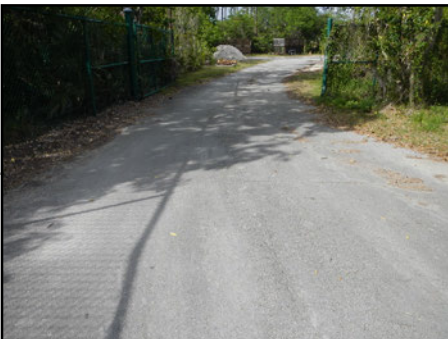
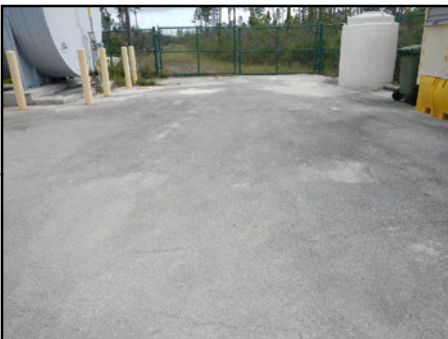
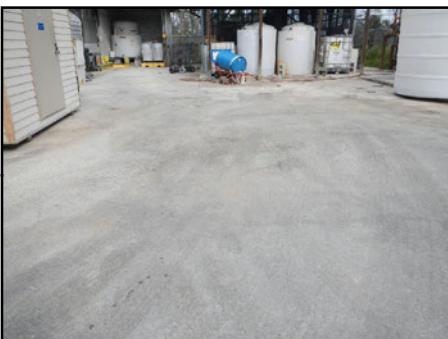
ROUTE 0902B: PINE ISLAND WWTP

Inspection Date	FMSS Number	User Access	Surface Type
3/14/2019	104037	NONPUBLIC	ASPHALT
Area (Sq. Ft.)	Lane Miles (11' Widths)	Curb Reveal (Inches)	Curb Recommendation
3,384	0.058	NOT APPLICABLE	NOT APPLICABLE
Curb Type		Curb & Gutter Type	
NO CURB		NO CURB AND GUTTER	
Pavement Recommendation		Condition Rating / PCR	
LIGHT 3R TREATMENTS		FAIR / 73

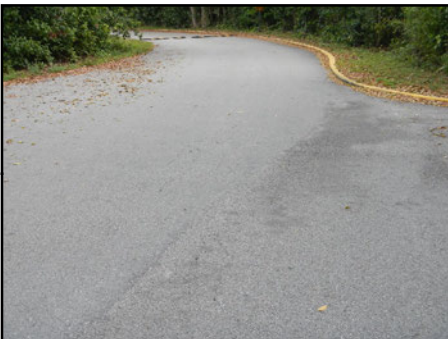
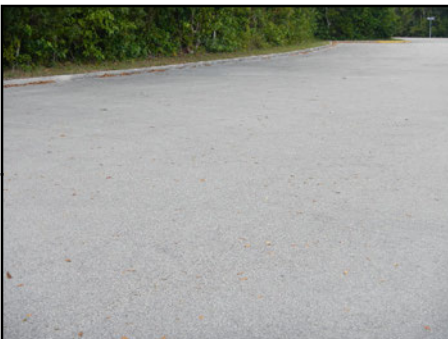
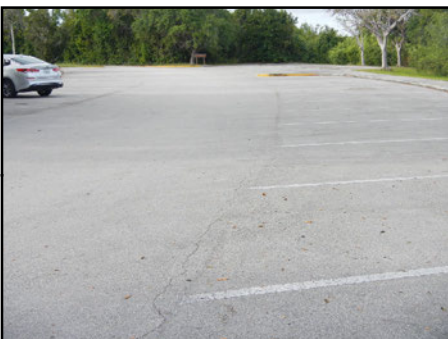
ROUTE 0903: ROYAL PALM VISITOR CENTER PARKING

Inspection Date	FMSS Number	User Access	Surface Type
3/14/2019	86587	PUBLIC	ASPHALT
Area (Sq. Ft.)	Lane Miles (11' Widths)	Curb Reveal (Inches)	Curb Recommendation
71,854	1.237	4	DO NOTHING
Curb Type		Curb & Gutter Type	
CONCRETE		NOT APPLICABLE	
Pavement Recommendation		Condition Rating / PCR	
PREVENTIVE MAINTENANCE		GOOD / 90

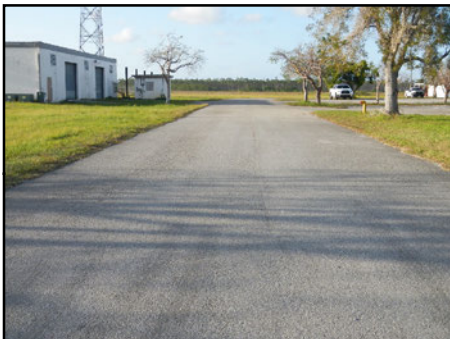
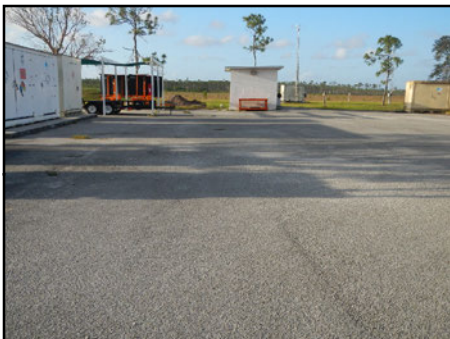
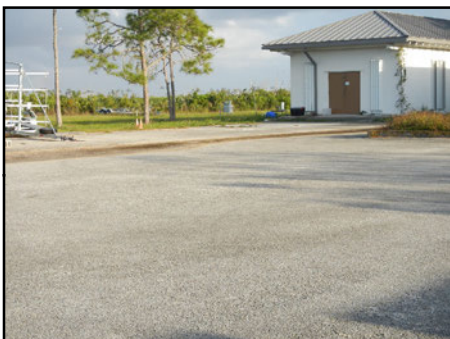
ROUTE 0904: BILL ROBERTSON PARKING

Inspection Date	FMSS Number	User Access	Surface Type
3/14/2019	86588	NONPUBLIC	ASPHALT
Area (Sq. Ft.)	Lane Miles (11' Widths)	Curb Reveal (Inches)	Curb Recommendation
41,607	0.716	7	DO NOTHING
Curb Type		Curb & Gutter Type	
CONCRETE		NOT APPLICABLE	
Pavement Recommendation		Condition Rating / PCR	
HEAVY 3R TREATMENTS		POOR / 53

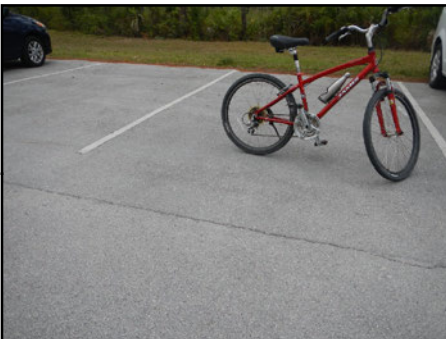
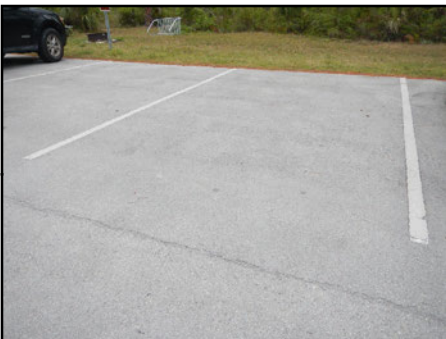
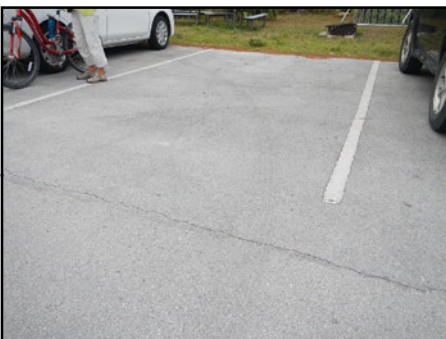
Inspection Date	FMSS Number	User Access	Surface Type
3/15/2019	86590	PUBLIC	ASPHALT
Area (Sq. Ft.)	Lane Miles (11' Widths)	Curb Reveal (Inches)	Curb Recommendation
3,186	0.055	NOT APPLICABLE	NOT APPLICABLE
Curb Type		Curb & Gutter Type	
NO CURB		NO CURB AND GUTTER	
Pavement Recommendation		Condition Rating / PCR	
LIGHT 3R TREATMENTS		FAIR / 73

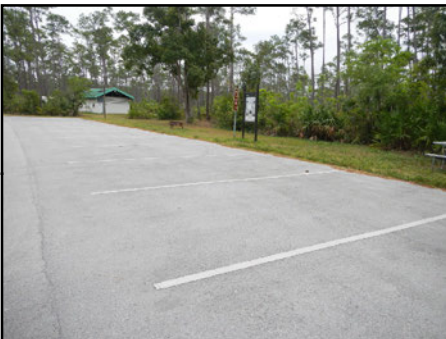
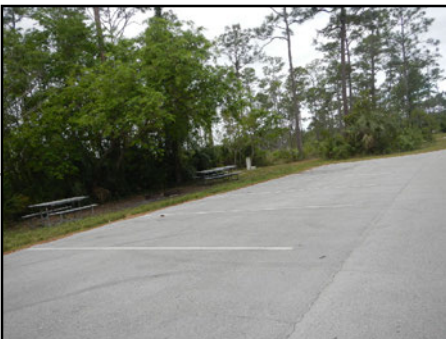
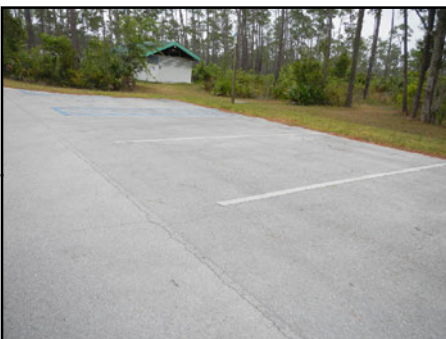
ROUTE 0907BZ: LONG PINE KEY PICNIC PARKING AREA B

Inspection Date	FMSS Number	User Access	Surface Type
3/15/2019	86590	PUBLIC	ASPHALT
Area (Sq. Ft.)	Lane Miles (11' Widths)	Curb Reveal (Inches)	Curb Recommendation
3,319	0.057	NOT APPLICABLE	NOT APPLICABLE
Curb Type		Curb & Gutter Type	
NO CURB		NO CURB AND GUTTER	
Pavement Recommendation		Condition Rating / PCR	
PREVENTIVE MAINTENANCE		GOOD / 90

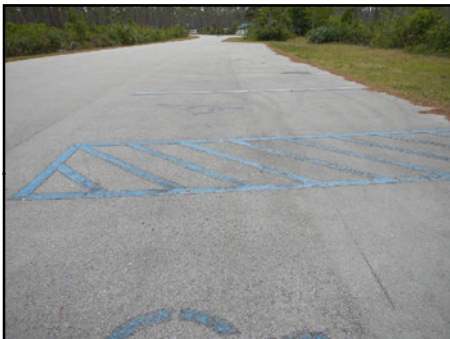
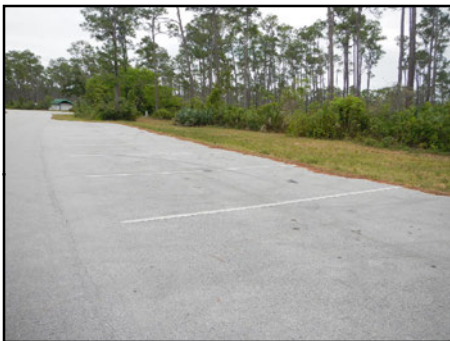
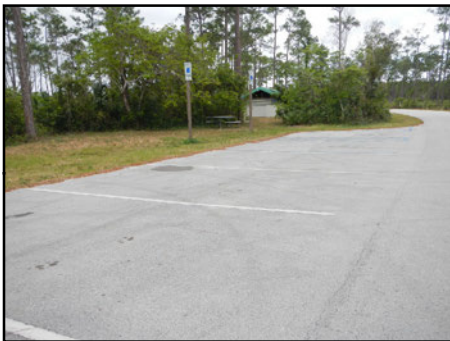
ROUTE 0907CZ: LONG PINE KEY PICNIC PARKING AREA C

Inspection Date	FMSS Number	User Access	Surface Type
3/15/2019	86590	PUBLIC	ASPHALT
Area (Sq. Ft.)	Lane Miles (11' Widths)	Curb Reveal (Inches)	Curb Recommendation
3,067	0.053	NOT APPLICABLE	NOT APPLICABLE
Curb Type		Curb & Gutter Type	
NO CURB		NO CURB AND GUTTER	
Pavement Recommendation		Condition Rating / PCR	
LIGHT 3R TREATMENTS		FAIR / 73

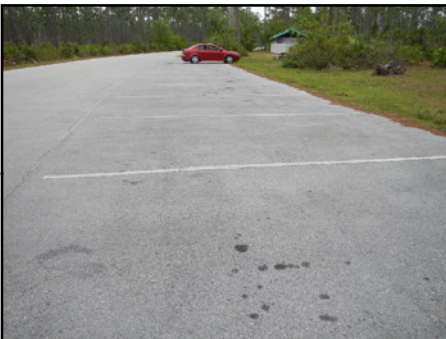
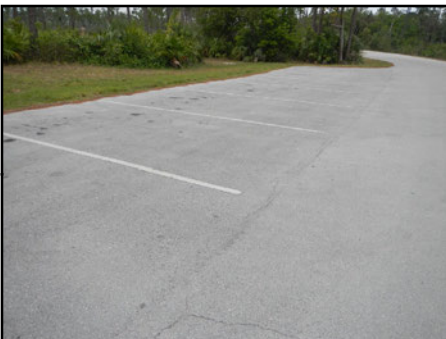
ROUTE 0907DZ: LONG PINE KEY PICNIC PARKING AREA D

Inspection Date	FMSS Number	User Access	Surface Type
3/15/2019	86590	PUBLIC	ASPHALT
Area (Sq. Ft.)	Lane Miles (11' Widths)	Curb Reveal (Inches)	Curb Recommendation
3,113	0.054	NOT APPLICABLE	NOT APPLICABLE
Curb Type		Curb & Gutter Type	
NO CURB		NO CURB AND GUTTER	
Pavement Recommendation		Condition Rating / PCR	
PREVENTIVE MAINTENANCE		GOOD / 90

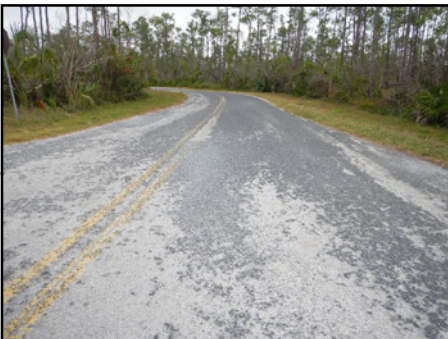
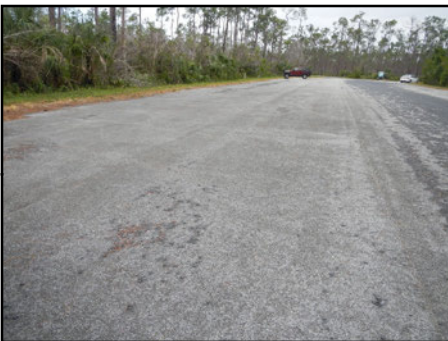
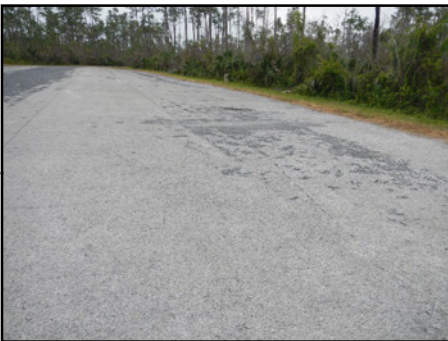
ROUTE 0909: PINELANDS TURNOUT PARKING

Inspection Date	FMSS Number	User Access	Surface Type
3/15/2019	86606	PUBLIC	ASPHALT
Area (Sq. Ft.)	Lane Miles (11' Widths)	Curb Reveal (Inches)	Curb Recommendation
29,345	0.505	NOT APPLICABLE	NOT APPLICABLE
Curb Type		Curb & Gutter Type	
NO CURB		NO CURB AND GUTTER	
Pavement Recommendation		Condition Rating / PCR	
HEAVY 3R TREATMENTS		POOR / 53

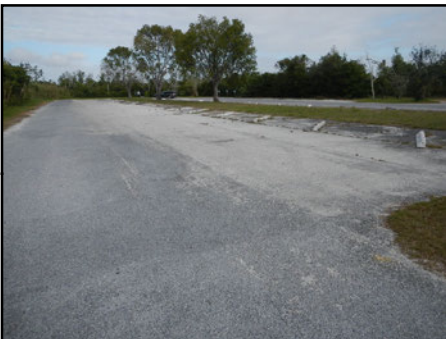
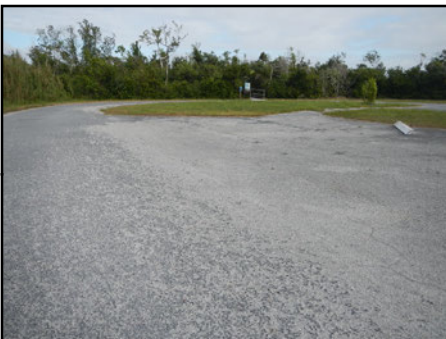
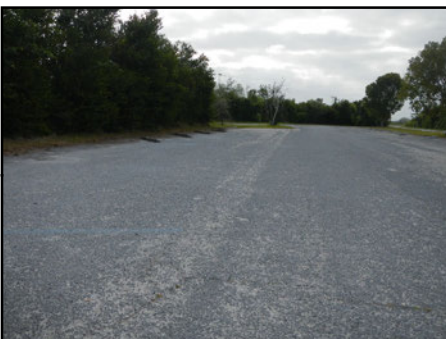
ROUTE 0910: PA-HAY-OKEE PARKING

Inspection Date	FMSS Number	User Access	Surface Type
3/15/2019	86607	PUBLIC	ASPHALT
Area (Sq. Ft.)	Lane Miles (11' Widths)	Curb Reveal (Inches)	Curb Recommendation
39,482	0.68	NOT APPLICABLE	NOT APPLICABLE
Curb Type		Curb & Gutter Type	
NO CURB		NO CURB AND GUTTER	
Pavement Recommendation		Condition Rating / PCR	
HEAVY 3R TREATMENTS		POOR / 53
