EVER Cycle 6

Final Report

Road Inventory and Condition Assessment of Paved Routes Everglades National Park

Report Date: June 2020

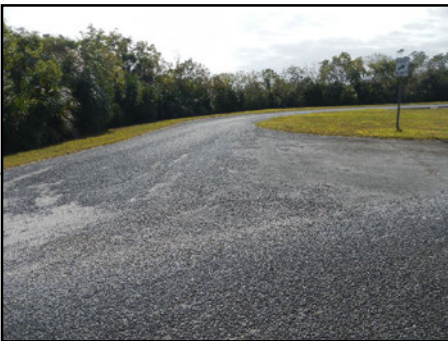
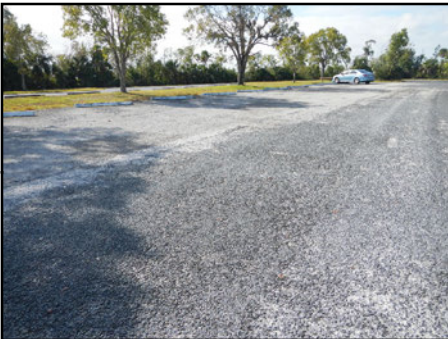
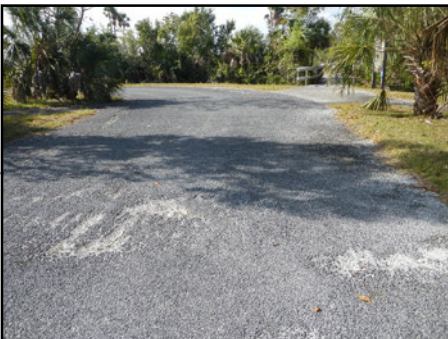
ROUTE 0911: MAHOGANY HAMMOCK PARKING

Inspection Date	FMSS Number	User Access	Surface Type
3/15/2019	86608	PUBLIC	ASPHALT
Area (Sq. Ft.)	Lane Miles (11' Widths)	Curb Reveal (Inches)	Curb Recommendation
43,158	0.743	NOT APPLICABLE	NOT APPLICABLE
Curb Type		Curb & Gutter Type	
NO CURB		NO CURB AND GUTTER	
Pavement Recommendation		Condition Rating / PCR	
LIGHT 3R TREATMENTS		FAIR / 73

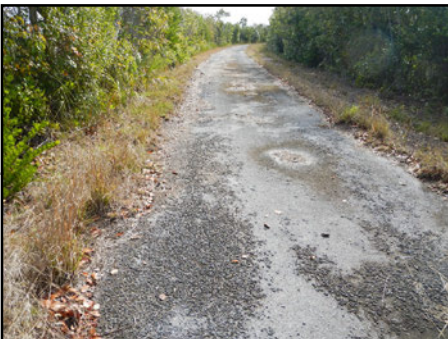
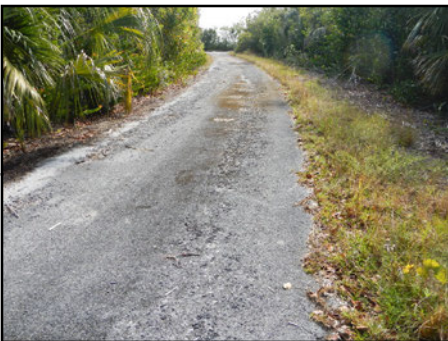
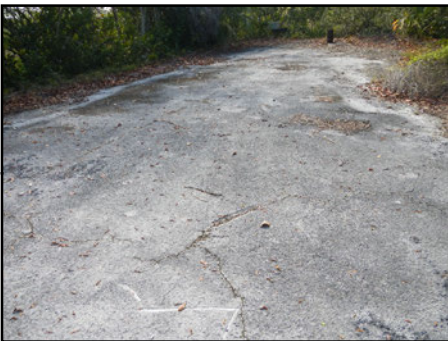
ROUTE 0912: MONITORING STATION 46 ACCESS

Inspection Date	FMSS Number	User Access	Surface Type
3/15/2019	86609	NONPUBLIC	ASPHALT
Area (Sq. Ft.)	Lane Miles (11' Widths)	Curb Reveal (Inches)	Curb Recommendation
12,111	0.209	NOT APPLICABLE	NOT APPLICABLE
Curb Type		Curb & Gutter Type	
NO CURB		NO CURB AND GUTTER	
Pavement Recommendation		Condition Rating / PCR	
PREVENTIVE MAINTENANCE		GOOD / 90

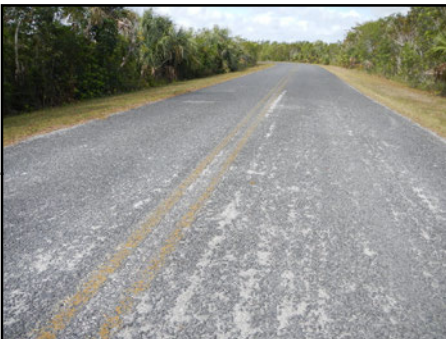
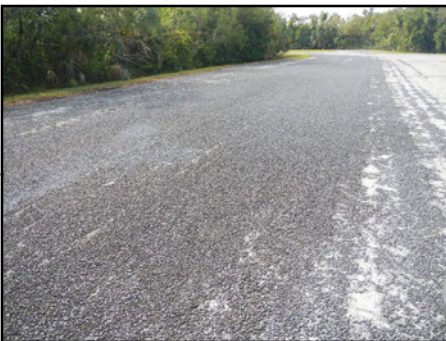
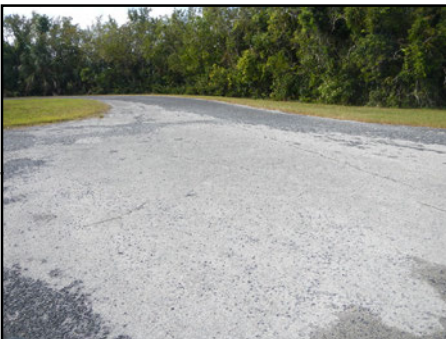
ROUTE 0913: PAUROTIS POND PARKING

Inspection Date	FMSS Number	User Access	Surface Type
3/15/2019	86657	PUBLIC	ASPHALT
Area (Sq. Ft.)	Lane Miles (11' Widths)	Curb Reveal (Inches)	Curb Recommendation
29,937	0.515	NOT APPLICABLE	NOT APPLICABLE
Curb Type		Curb & Gutter Type	
NO CURB		NO CURB AND GUTTER	
Pavement Recommendation		Condition Rating / PCR	
LIGHT 3R TREATMENTS		FAIR / 73

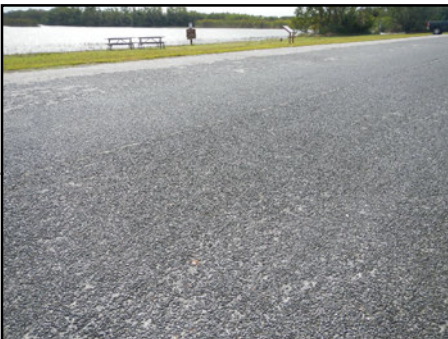
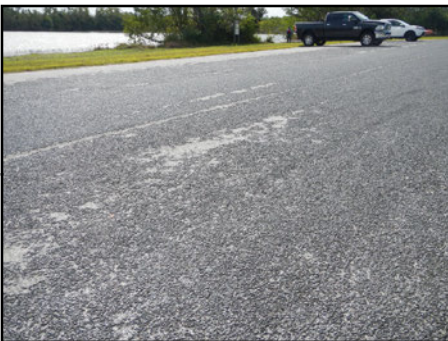
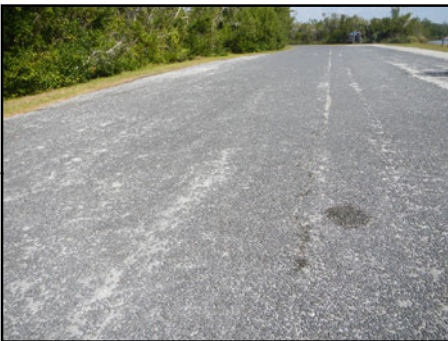
ROUTE 0914: NINE MILE POND PARKING

Inspection Date	FMSS Number	User Access	Surface Type
3/15/2019	86658	PUBLIC	ASPHALT
Area (Sq. Ft.)	Lane Miles (11' Widths)	Curb Reveal (Inches)	Curb Recommendation
24,260	0.418	NOT APPLICABLE	NOT APPLICABLE
Curb Type		Curb & Gutter Type	
NO CURB		NO CURB AND GUTTER	
Pavement Recommendation		Condition Rating / PCR	
PREVENTIVE MAINTENANCE		GOOD / 90

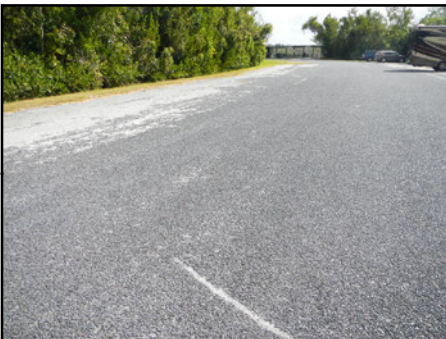
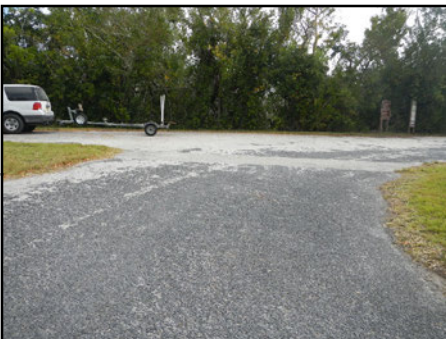
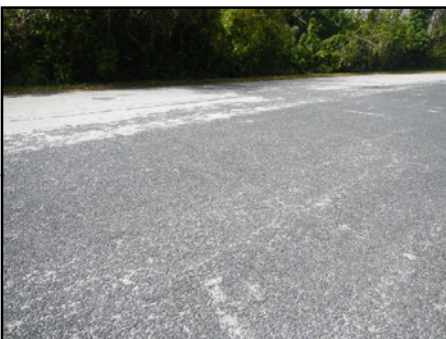
Inspection Date	FMSS Number	User Access	Surface Type
3/15/2019	85991	PUBLIC	ASPHALT
Area (Sq. Ft.)	Lane Miles (11' Widths)	Curb Reveal (Inches)	Curb Recommendation
33,325	0.574	NOT APPLICABLE	NOT APPLICABLE
Curb Type		Curb & Gutter Type	
NO CURB		NO CURB AND GUTTER	
Pavement Recommendation		Condition Rating / PCR	
LIGHT 3R TREATMENTS		FAIR / 73

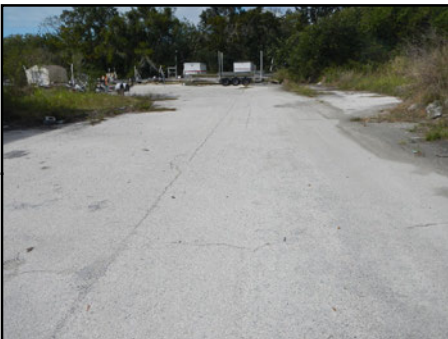
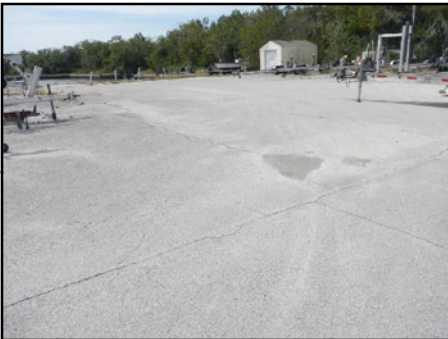
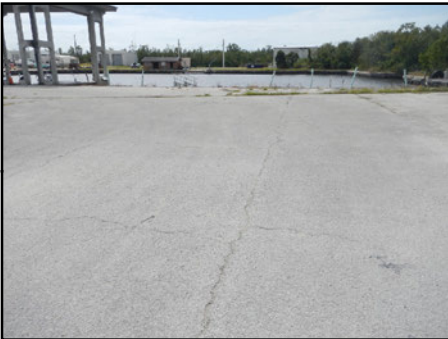
ROUTE 0916A: FLAMINGO BOAT SHELTER PARKING

Inspection Date	FMSS Number	User Access	Surface Type
3/15/2019	114191	NONPUBLIC	ASPHALT
Area (Sq. Ft.)	Lane Miles (11' Widths)	Curb Reveal (Inches)	Curb Recommendation
27,118	0.467	5	DO NOTHING
Curb Type		Curb & Gutter Type	
CONCRETE		NO CURB AND GUTTER	
Pavement Recommendation		Condition Rating / PCR	
PREVENTIVE MAINTENANCE		GOOD / 90

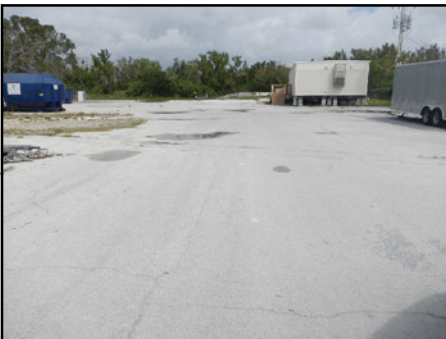
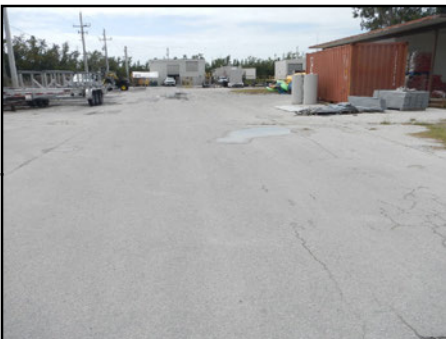
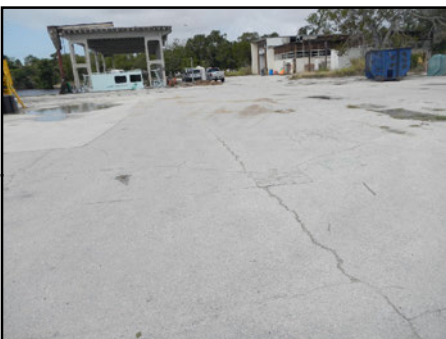
ROUTE 0916B: FLAMINGO CONCESSIONS MAINTENANCE PARKING

Inspection Date	FMSS Number	User Access	Surface Type
3/15/2019	86661	NONPUBLIC	ASPHALT
Area (Sq. Ft.)	Lane Miles (11' Widths)	Curb Reveal (Inches)	Curb Recommendation
67,061	1.155	6	DO NOTHING
Curb Type		Curb & Gutter Type	
CONCRETE		NO CURB AND GUTTER	
Pavement Recommendation		Condition Rating / PCR	
HEAVY 3R TREATMENTS		POOR / 53

Note: Parking area consists of multiple surface types: 1 part Asphalt at 60,403 square feet; 2 parts Concrete at 6,658 square feet.

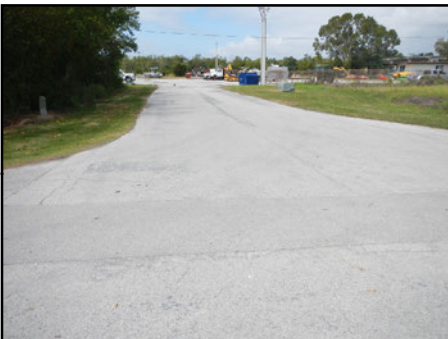
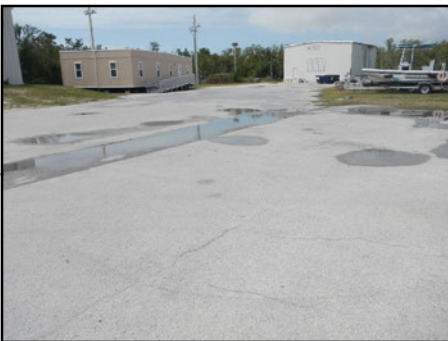
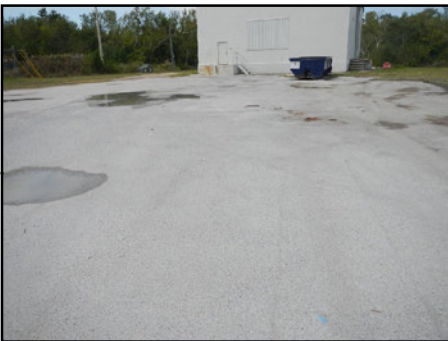
ROUTE 0917: FLAMINGO MAINTENANCE YARD

Inspection Date	FMSS Number	User Access	Surface Type
3/15/2019	86662	NONPUBLIC	ASPHALT
Area (Sq. Ft.)	Lane Miles (11' Widths)	Curb Reveal (Inches)	Curb Recommendation
35,773	0.616	NOT APPLICABLE	NOT APPLICABLE
Curb Type		Curb & Gutter Type	
NO CURB		NO CURB AND GUTTER	
Pavement Recommendation		Condition Rating / PCR	
RECONSTRUCTION		POOR / 30

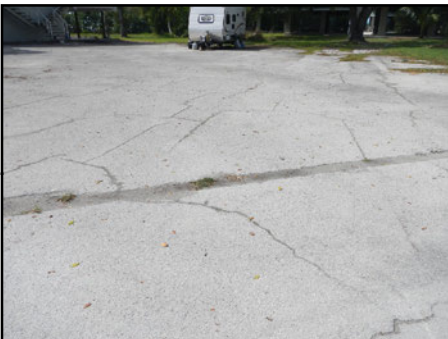
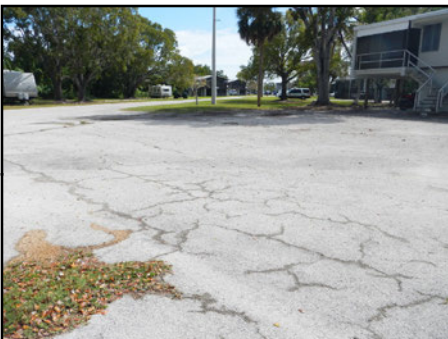
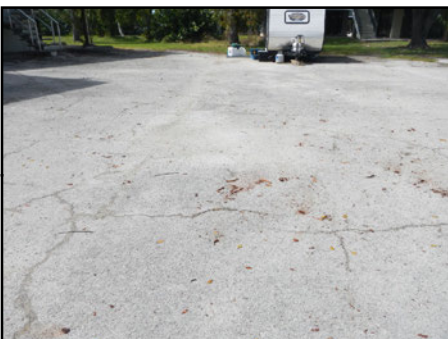
ROUTE 0919B: FLAMINGO HOUSING PARKING B (UNIT #416)

Inspection Date	FMSS Number	User Access	Surface Type
3/15/2019	242482	NONPUBLIC	ASPHALT
Area (Sq. Ft.)	Lane Miles (11' Widths)	Curb Reveal (Inches)	Curb Recommendation
6,379	0.11	NOT APPLICABLE	NOT APPLICABLE
Curb Type		Curb & Gutter Type	
NO CURB		NO CURB AND GUTTER	
Pavement Recommendation		Condition Rating / PCR	
HEAVY 3R TREATMENTS		POOR / 53

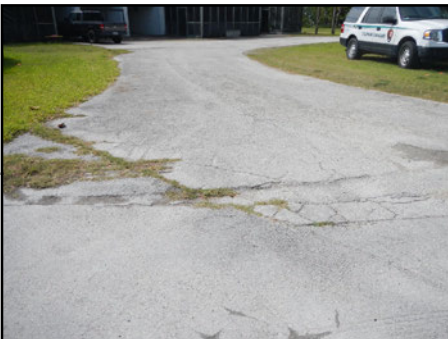
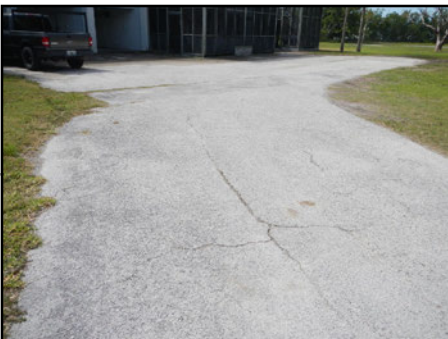
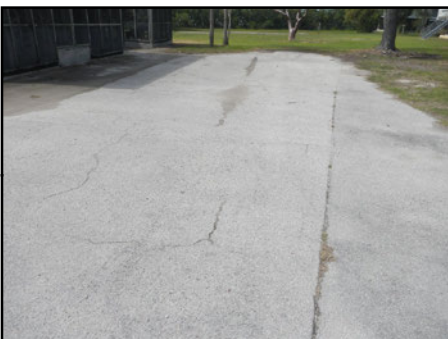
ROUTE 0919C: FLAMINGO HOUSING PARKING C (UNIT #439)

Inspection Date	FMSS Number	User Access	Surface Type
3/15/2019	242488	NONPUBLIC	ASPHALT
Area (Sq. Ft.)	Lane Miles (11' Widths)	Curb Reveal (Inches)	Curb Recommendation
3,782	0.065	NOT APPLICABLE	NOT APPLICABLE
Curb Type		Curb & Gutter Type	
NO CURB		NO CURB AND GUTTER	
Pavement Recommendation		Condition Rating / PCR	
HEAVY 3R TREATMENTS		POOR / 53

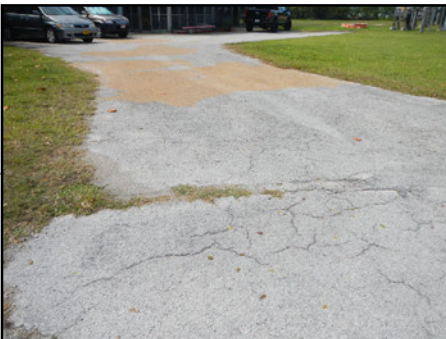
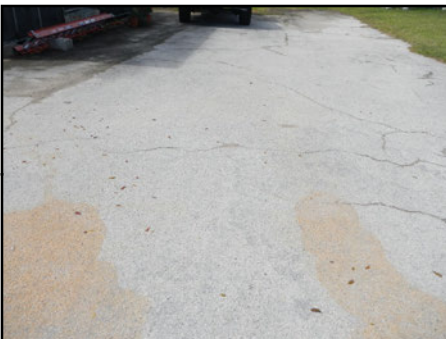
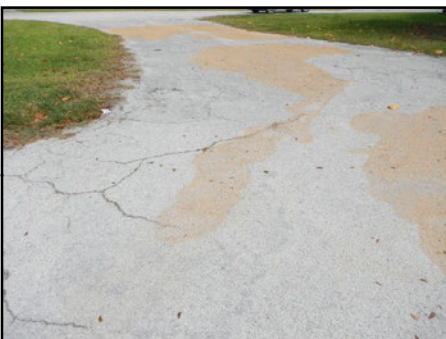
ROUTE 0919D: FLAMINGO HOUSING PARKING D (UNIT #440)

Inspection Date	FMSS Number	User Access	Surface Type
3/15/2019	242491	NONPUBLIC	ASPHALT
Area (Sq. Ft.)	Lane Miles (11' Widths)	Curb Reveal (Inches)	Curb Recommendation
3,551	0.061	NOT APPLICABLE	NOT APPLICABLE
Curb Type		Curb & Gutter Type	
NO CURB		NO CURB AND GUTTER	
Pavement Recommendation		Condition Rating / PCR	
RECONSTRUCTION		POOR / 30

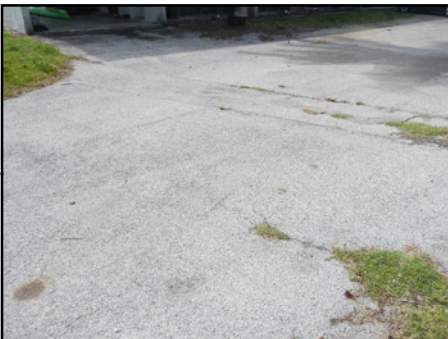
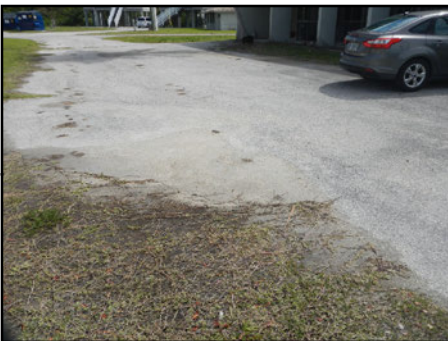
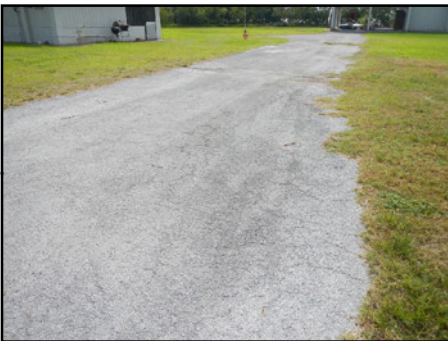
ROUTE 0919E: FLAMINGO HOUSING PARKING E (UNIT #442)

Inspection Date	FMSS Number	User Access	Surface Type
3/15/2019	242493	NONPUBLIC	ASPHALT
Area (Sq. Ft.)	Lane Miles (11' Widths)	Curb Reveal (Inches)	Curb Recommendation
5,976	0.103	NOT APPLICABLE	NOT APPLICABLE
Curb Type		Curb & Gutter Type	
NO CURB		NO CURB AND GUTTER	
Pavement Recommendation		Condition Rating / PCR	
RECONSTRUCTION		POOR / 30

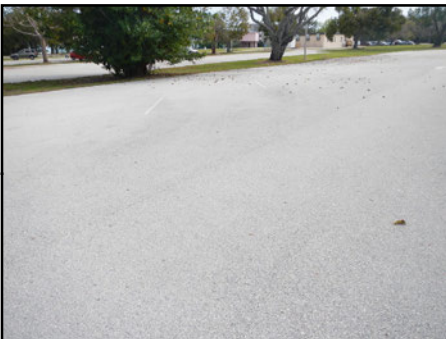
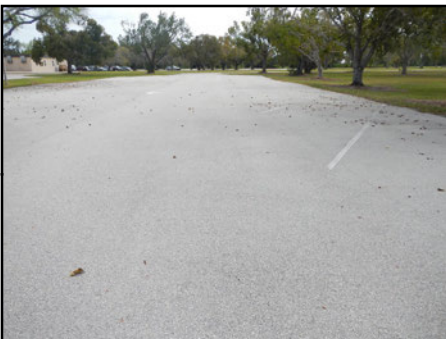
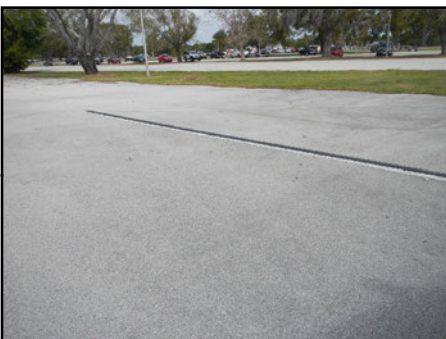
ROUTE 0920A: FLAMINGO VISITOR CENTER PARKING A

Inspection Date	FMSS Number	User Access	Surface Type
3/15/2019	86692	PUBLIC	ASPHALT
Area (Sq. Ft.)	Lane Miles (11' Widths)	Curb Reveal (Inches)	Curb Recommendation
20,764	0.358	NOT APPLICABLE	NOT APPLICABLE
Curb Type		Curb & Gutter Type	
NO CURB		NO CURB AND GUTTER	
Pavement Recommendation		Condition Rating / PCR	
PREVENTIVE MAINTENANCE		GOOD / 90

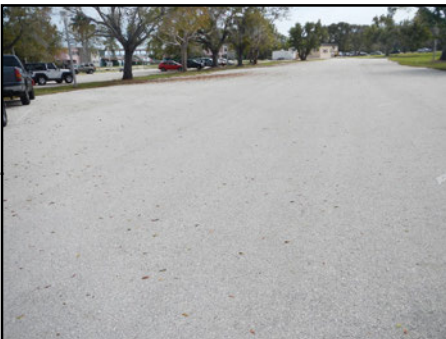
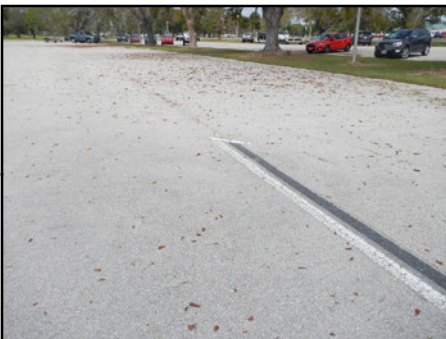
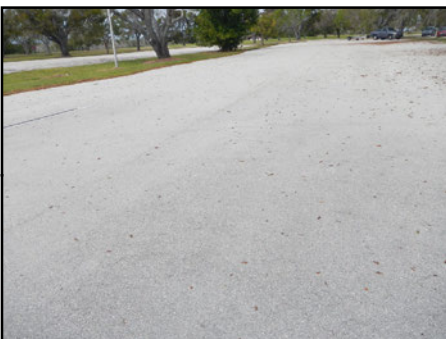
ROUTE 0920B: FLAMINGO VISITOR CENTER PARKING B

Inspection Date	FMSS Number	User Access	Surface Type
3/15/2019	103954	PUBLIC	ASPHALT
Area (Sq. Ft.)	Lane Miles (11' Widths)	Curb Reveal (Inches)	Curb Recommendation
21,423	0.369	NOT APPLICABLE	NOT APPLICABLE
Curb Type		Curb & Gutter Type	
NO CURB		NO CURB AND GUTTER	
Pavement Recommendation		Condition Rating / PCR	
PREVENTIVE MAINTENANCE		GOOD / 90

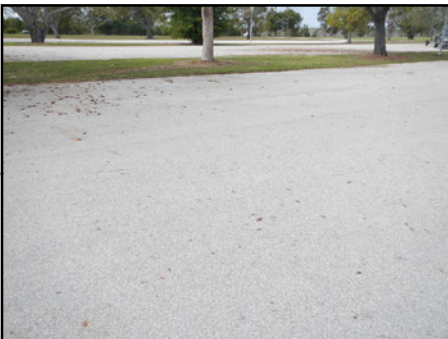
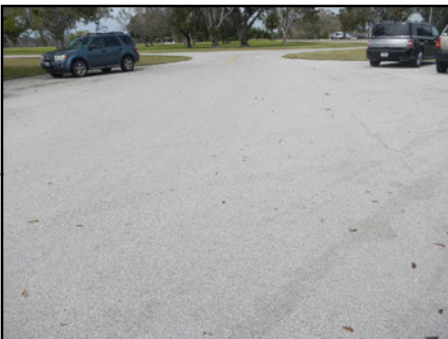
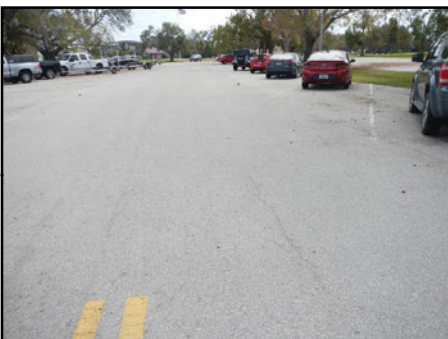
Inspection Date	FMSS Number	User Access	Surface Type
3/15/2019	103958	PUBLIC	ASPHALT
Area (Sq. Ft.)	Lane Miles (11' Widths)	Curb Reveal (Inches)	Curb Recommendation
24,102	0.415	NOT APPLICABLE	NOT APPLICABLE
Curb Type		Curb & Gutter Type	
NO CURB		NO CURB AND GUTTER	
Pavement Recommendation		Condition Rating / PCR	
PREVENTIVE MAINTENANCE		GOOD / 90

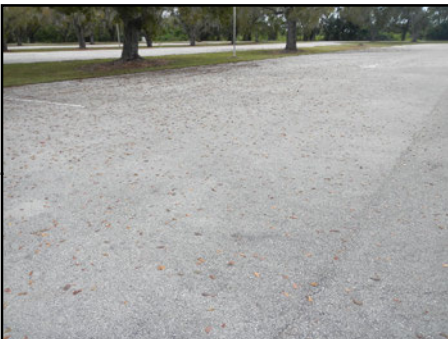
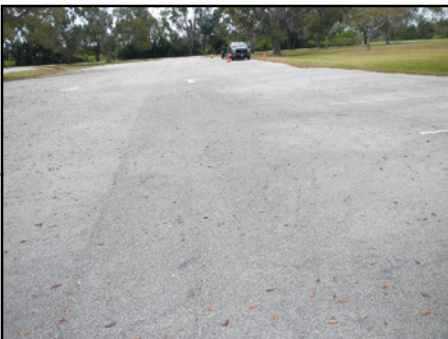
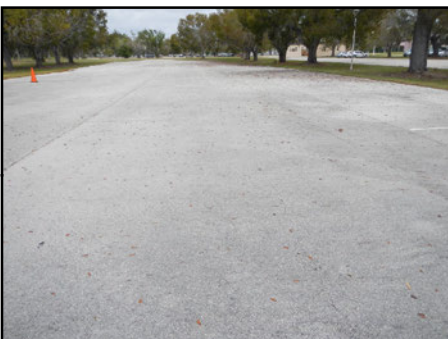
ROUTE 0920D: FLAMINGO VISITOR CENTER PARKING D

Inspection Date	FMSS Number	User Access	Surface Type
3/15/2019	103962	PUBLIC	ASPHALT
Area (Sq. Ft.)	Lane Miles (11' Widths)	Curb Reveal (Inches)	Curb Recommendation
22,535	0.388	NOT APPLICABLE	NOT APPLICABLE
Curb Type		Curb & Gutter Type	
NO CURB		NO CURB AND GUTTER	
Pavement Recommendation		Condition Rating / PCR	
LIGHT 3R TREATMENTS		FAIR / 73

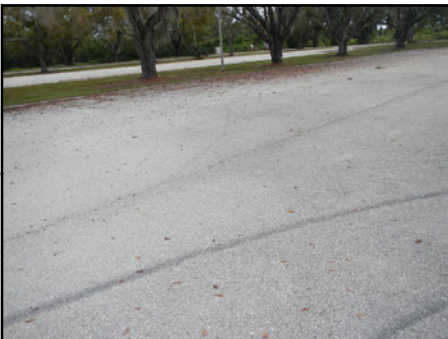
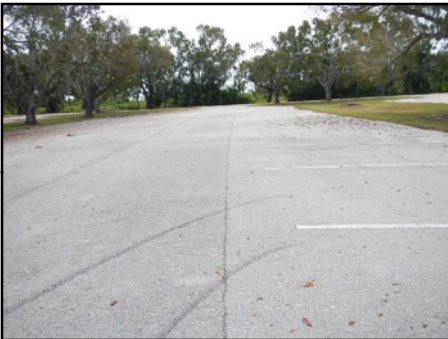
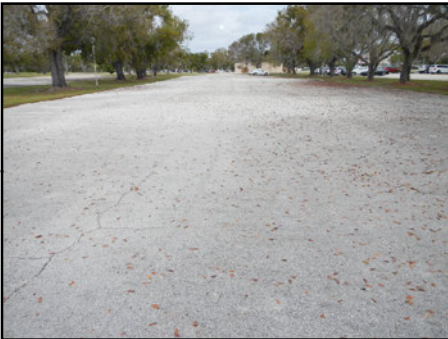
ROUTE 0920E: FLAMINGO VISITOR CENTER PARKING E

Inspection Date	FMSS Number	User Access	Surface Type
3/15/2019	103964	PUBLIC	ASPHALT
Area (Sq. Ft.)	Lane Miles (11' Widths)	Curb Reveal (Inches)	Curb Recommendation
23,630	0.407	NOT APPLICABLE	NOT APPLICABLE
Curb Type		Curb & Gutter Type	
NO CURB		NO CURB AND GUTTER	
Pavement Recommendation		Condition Rating / PCR	
PREVENTIVE MAINTENANCE		GOOD / 90

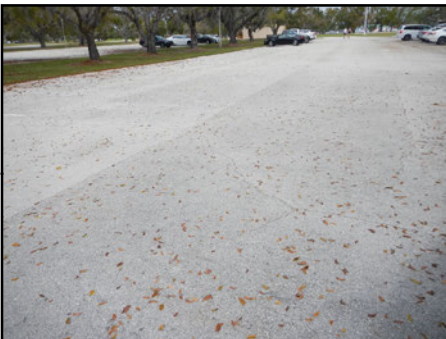
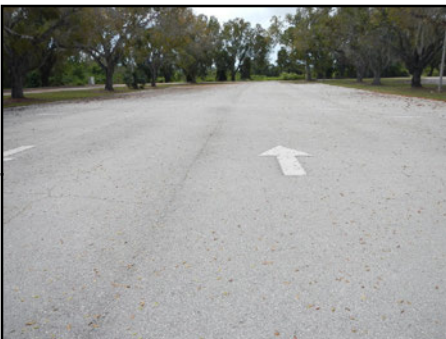
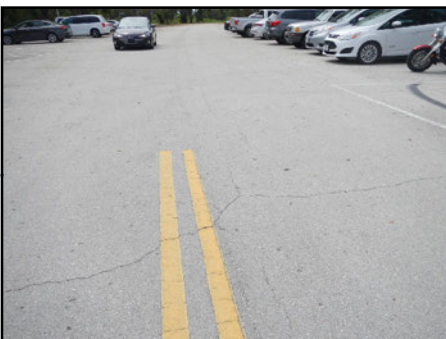
ROUTE 0920F: FLAMINGO VISITOR CENTER PARKING F

Inspection Date	FMSS Number	User Access	Surface Type
3/15/2019	103978	PUBLIC	ASPHALT
Area (Sq. Ft.)	Lane Miles (11' Widths)	Curb Reveal (Inches)	Curb Recommendation
25,866	0.445	NOT APPLICABLE	NOT APPLICABLE
Curb Type		Curb & Gutter Type	
NO CURB		NO CURB AND GUTTER	
Pavement Recommendation		Condition Rating / PCR	
PREVENTIVE MAINTENANCE		GOOD / 90

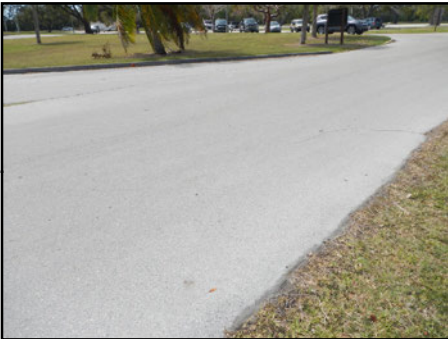
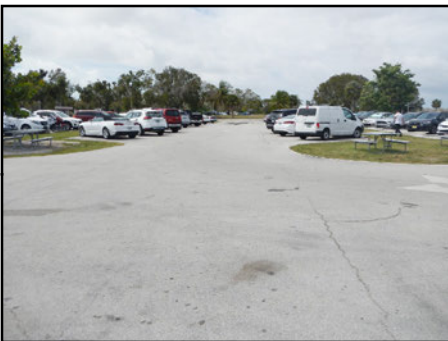
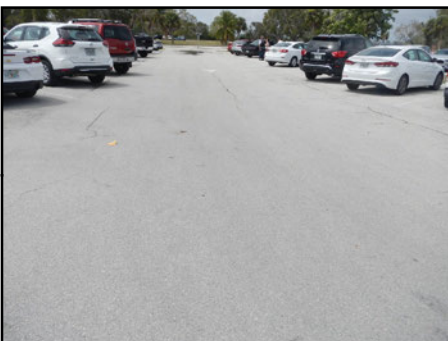
ROUTE 0921: FLAMINGO MARINA STORE PARKING

Inspection Date	FMSS Number	User Access	Surface Type
3/15/2019	86693	PUBLIC	ASPHALT
Area (Sq. Ft.)	Lane Miles (11' Widths)	Curb Reveal (Inches)	Curb Recommendation
60,141	1.035	6	DO NOTHING
Curb Type		Curb & Gutter Type	
ASPHALT AND CONCRETE		NO CURB AND GUTTER	
Pavement Recommendation		Condition Rating / PCR	
PREVENTIVE MAINTENANCE		GOOD / 90

Note: Parking area consists of multiple surface types: 1 part Asphalt at 56,535 square feet; 2 parts Concrete at 3,606 square feet.

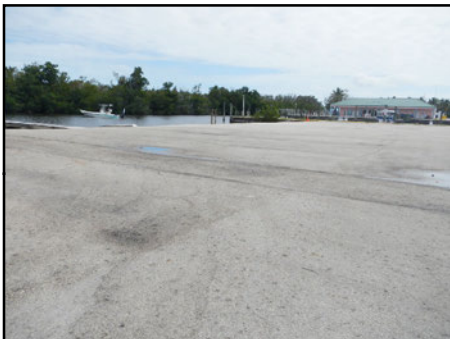
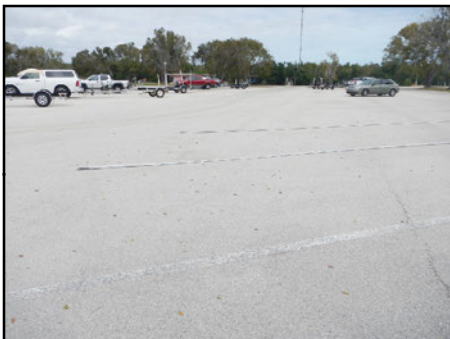
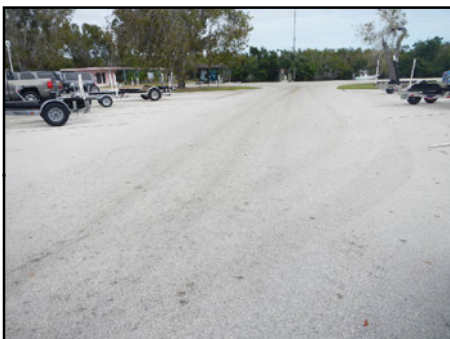
ROUTE 0922: WHITEWATER BAY PARKING AND RAMP

Inspection Date	FMSS Number	User Access	Surface Type
3/15/2019	86695	PUBLIC	ASPHALT
Area (Sq. Ft.)	Lane Miles (11' Widths)	Curb Reveal (Inches)	Curb Recommendation
107,852	1.857	NOT APPLICABLE	NOT APPLICABLE
Curb Type		Curb & Gutter Type	
NO CURB		NO CURB AND GUTTER	
Pavement Recommendation		Condition Rating / PCR	
PREVENTIVE MAINTENANCE		GOOD / 90

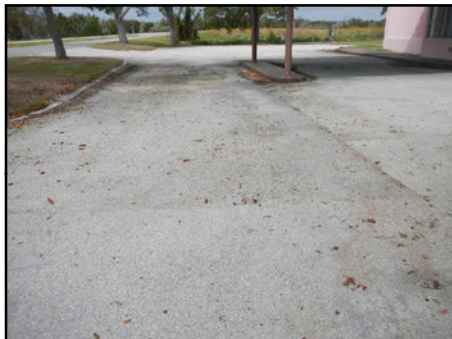
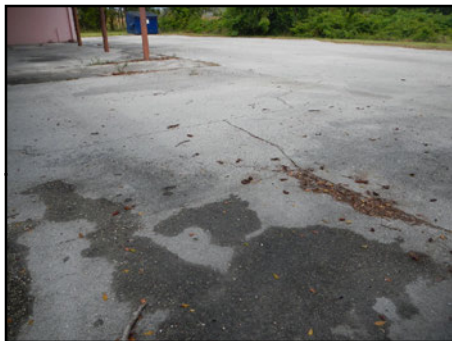
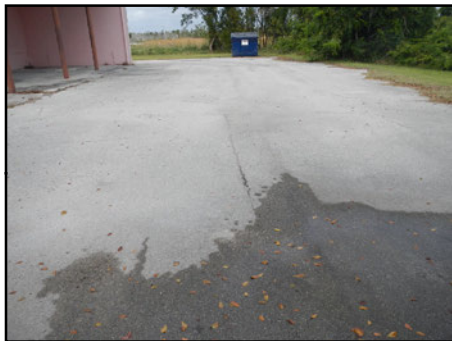
ROUTE 0924: FLAMINGO SERVICE STATION

Inspection Date	FMSS Number	User Access	Surface Type
3/15/2019	N/A	PUBLIC	ASPHALT
Area (Sq. Ft.)	Lane Miles (11' Widths)	Curb Reveal (Inches)	Curb Recommendation
14,210	0.245	5	LIGHT REPAIR
Curb Type		Curb & Gutter Type	
CONCRETE		NO CURB AND GUTTER	
Pavement Recommendation		Condition Rating / PCR	
LIGHT 3R TREATMENTS		FAIR / 73

Note: Parking area consists of multiple surface types: 1 part Asphalt at 13,522 square feet; 1 part Concrete at 688 square feet.

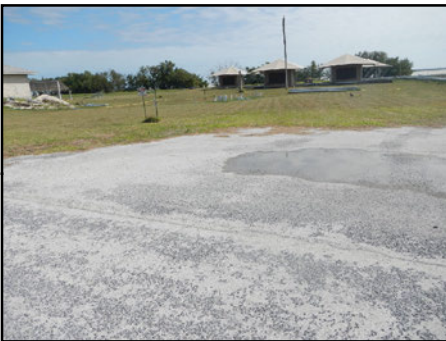
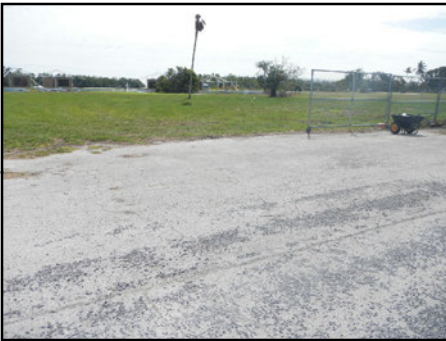
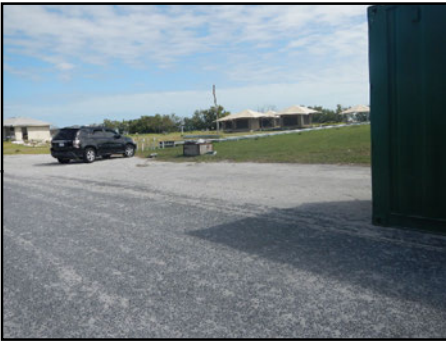
ROUTE 0925A: FLAMINGO PICNIC PARKING A

Inspection Date	FMSS Number	User Access	Surface Type
3/15/2019	103920	PUBLIC	ASPHALT
Area (Sq. Ft.)	Lane Miles (11' Widths)	Curb Reveal (Inches)	Curb Recommendation
5,720	0.098	NOT APPLICABLE	NOT APPLICABLE
Curb Type		Curb & Gutter Type	
NO CURB		NO CURB AND GUTTER	
Pavement Recommendation		Condition Rating / PCR	
LIGHT 3R TREATMENTS		FAIR / 73

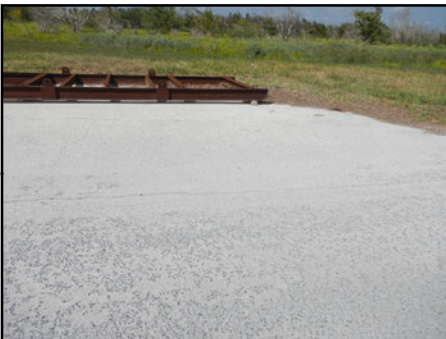
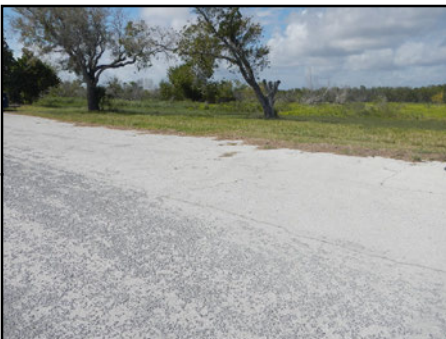
ROUTE 0925B: FLAMINGO PICNIC PARKING B

Inspection Date	FMSS Number	User Access	Surface Type
3/15/2019	103921	PUBLIC	ASPHALT
Area (Sq. Ft.)	Lane Miles (11' Widths)	Curb Reveal (Inches)	Curb Recommendation
2,798	0.048	NOT APPLICABLE	NOT APPLICABLE
Curb Type		Curb & Gutter Type	
NO CURB		NO CURB AND GUTTER	
Pavement Recommendation		Condition Rating / PCR	
LIGHT 3R TREATMENTS		FAIR / 73

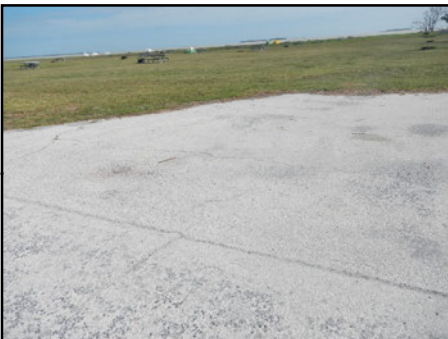
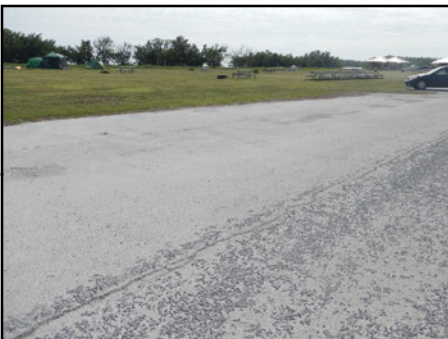
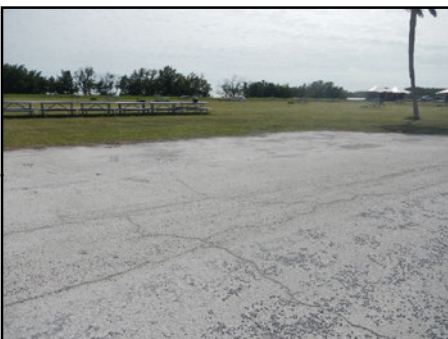
ROUTE 0925C: FLAMINGO PICNIC PARKING C

Inspection Date	FMSS Number	User Access	Surface Type
3/15/2019	103923	PUBLIC	ASPHALT
Area (Sq. Ft.)	Lane Miles (11' Widths)	Curb Reveal (Inches)	Curb Recommendation
4,526	0.078	NOT APPLICABLE	NOT APPLICABLE
Curb Type		Curb & Gutter Type	
NO CURB		NO CURB AND GUTTER	
Pavement Recommendation		Condition Rating / PCR	
LIGHT 3R TREATMENTS		FAIR / 73

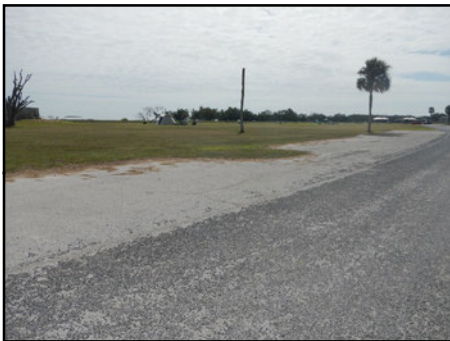
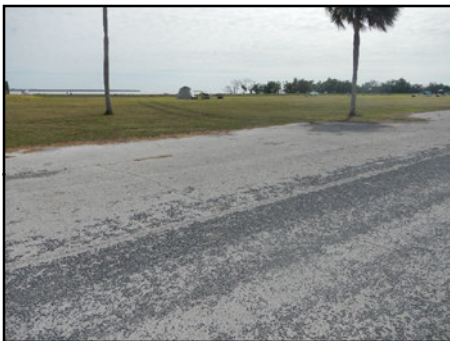
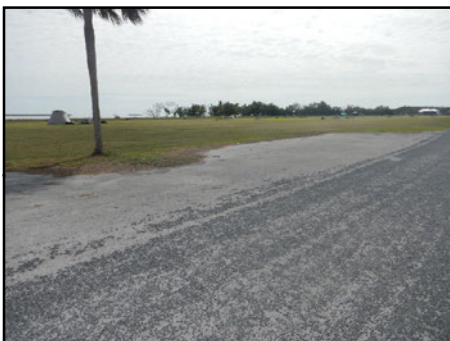
ROUTE 0925E: FLAMINGO PICNIC PARKING E

Inspection Date	FMSS Number	User Access	Surface Type
3/15/2019	103926	PUBLIC	ASPHALT
Area (Sq. Ft.)	Lane Miles (11' Widths)	Curb Reveal (Inches)	Curb Recommendation
4,063	0.07	NOT APPLICABLE	NOT APPLICABLE
Curb Type		Curb & Gutter Type	
NO CURB		NO CURB AND GUTTER	
Pavement Recommendation		Condition Rating / PCR	
LIGHT 3R TREATMENTS		FAIR / 73

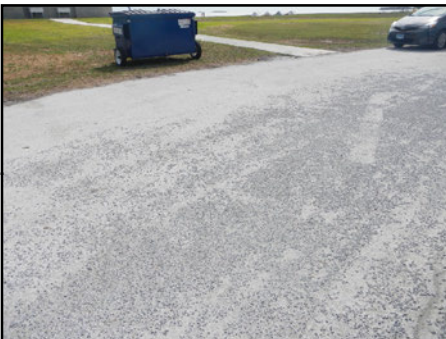
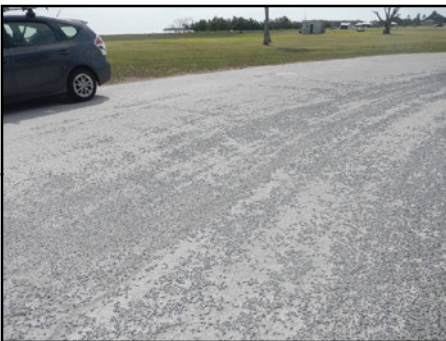
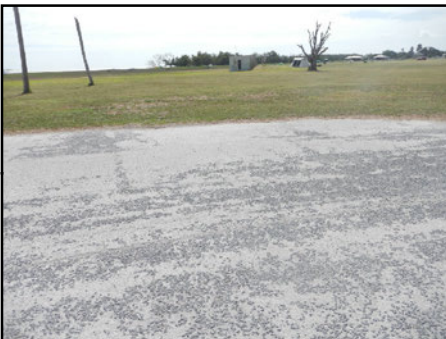
ROUTE 0925F: FLAMINGO PICNIC PARKING F

Inspection Date	FMSS Number	User Access	Surface Type
3/15/2019	103942	PUBLIC	ASPHALT
Area (Sq. Ft.)	Lane Miles (11' Widths)	Curb Reveal (Inches)	Curb Recommendation
4,079	0.07	NOT APPLICABLE	NOT APPLICABLE
Curb Type		Curb & Gutter Type	
NO CURB		NO CURB AND GUTTER	
Pavement Recommendation		Condition Rating / PCR	
HEAVY 3R TREATMENTS		POOR / 53

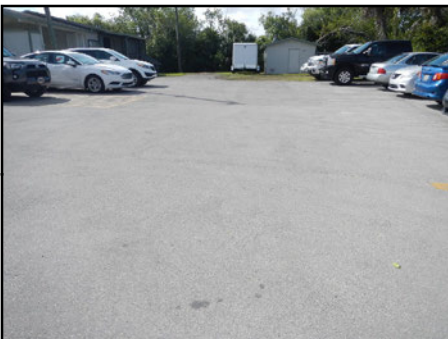
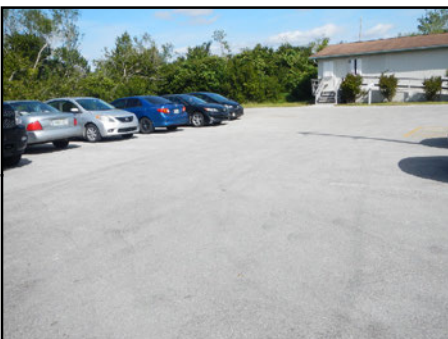
ROUTE 0929: SHARK VALLEY ADMINISTRATION PARKING

Inspection Date	FMSS Number	User Access	Surface Type
3/13/2019	86702	NONPUBLIC	ASPHALT
Area (Sq. Ft.)	Lane Miles (11' Widths)	Curb Reveal (Inches)	Curb Recommendation
7,317	0.126	NOT APPLICABLE	NOT APPLICABLE
Curb Type		Curb & Gutter Type	
NO CURB		NO CURB AND GUTTER	
Pavement Recommendation		Condition Rating / PCR	
PREVENTIVE MAINTENANCE		GOOD / 90

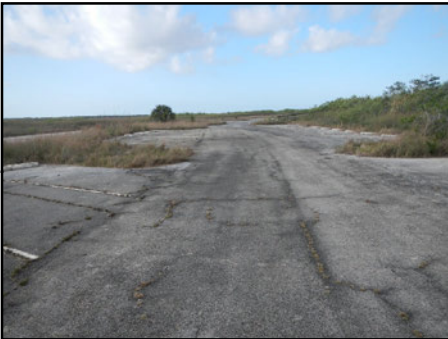
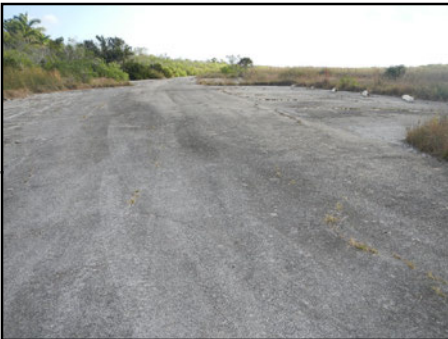
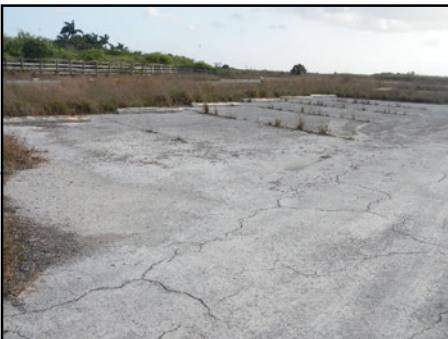
ROUTE 0930: CHEKIKA PARKING AREA

Inspection Date	FMSS Number	User Access	Surface Type
3/14/2019	86703	PUBLIC	ASPHALT
Area (Sq. Ft.)	Lane Miles (11' Widths)	Curb Reveal (Inches)	Curb Recommendation
72,629	1.25	NOT APPLICABLE	NOT APPLICABLE
Curb Type		Curb & Gutter Type	
NO CURB		NO CURB AND GUTTER	
Pavement Recommendation		Condition Rating / PCR	
RECONSTRUCTION		POOR / 30

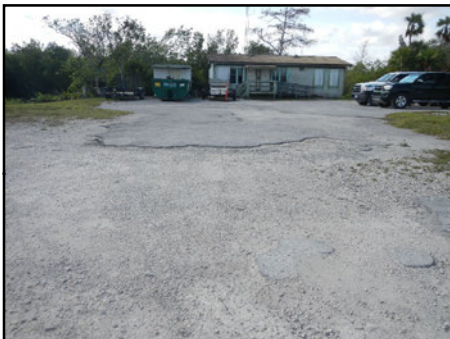
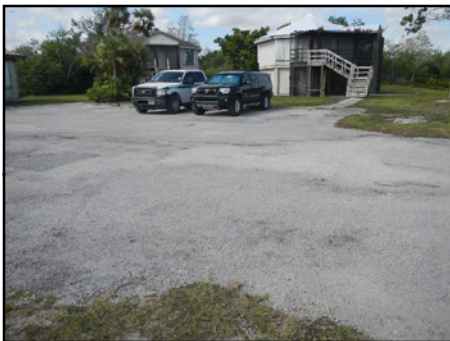
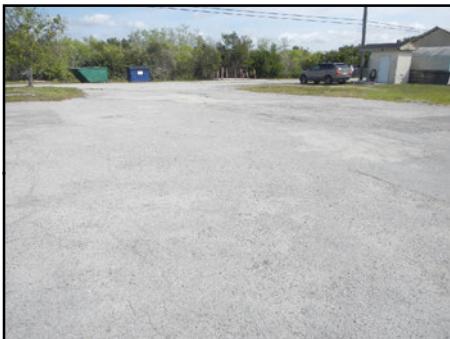
ROUTE 0931: TAMIAMI RANGER STATION

Inspection Date	FMSS Number	User Access	Surface Type
3/13/2019	86704	NONPUBLIC	ASPHALT
Area (Sq. Ft.)	Lane Miles (11' Widths)	Curb Reveal (Inches)	Curb Recommendation
5,260	0.091	NOT APPLICABLE	NOT APPLICABLE
Curb Type		Curb & Gutter Type	
NO CURB		NO CURB AND GUTTER	
Pavement Recommendation		Condition Rating / PCR	
RECONSTRUCTION		POOR / 30

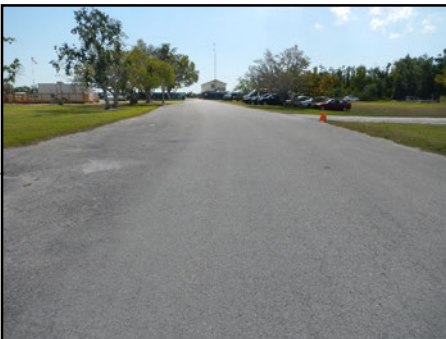
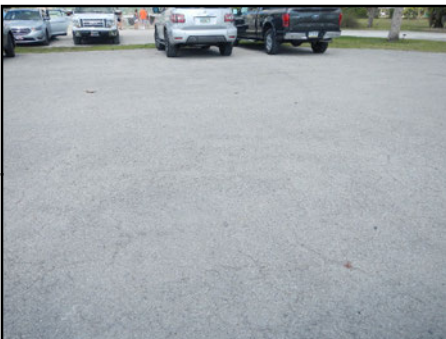
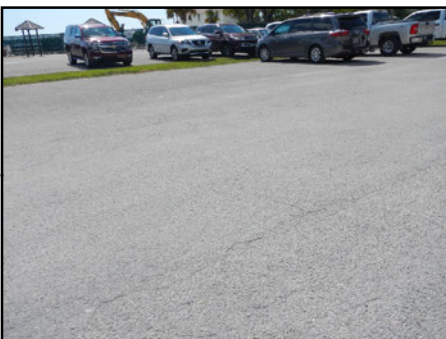
ROUTE 0933: GULF COAST PARKING

Inspection Date	FMSS Number	User Access	Surface Type
3/12/2019	85989	PUBLIC	ASPHALT
Area (Sq. Ft.)	Lane Miles (11' Widths)	Curb Reveal (Inches)	Curb Recommendation
66,380	1.143	NOT APPLICABLE	NOT APPLICABLE
Curb Type		Curb & Gutter Type	
NO CURB		NO CURB AND GUTTER	
Pavement Recommendation		Condition Rating / PCR	
HEAVY 3R TREATMENTS		POOR / 53

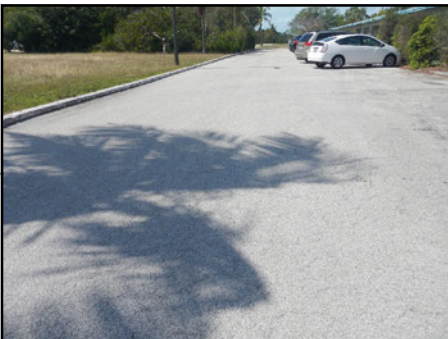
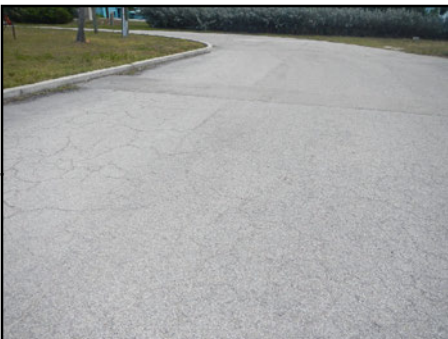
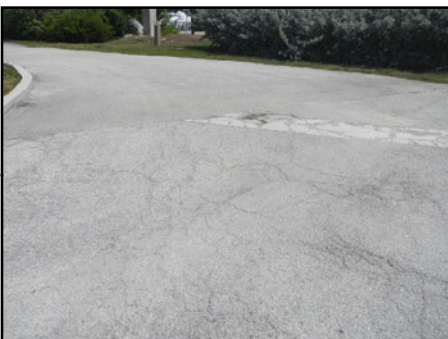
ROUTE 0941: KEY LARGO RANGER STATION PARKING

Inspection Date	FMSS Number	User Access	Surface Type
3/14/2019	86711	NONPUBLIC	ASPHALT
Area (Sq. Ft.)	Lane Miles (11' Widths)	Curb Reveal (Inches)	Curb Recommendation
23,428	0.403	6	LIGHT REPAIR
Curb Type		Curb & Gutter Type	
CONCRETE		NO CURB AND GUTTER	
Pavement Recommendation		Condition Rating / PCR	
RECONSTRUCTION		POOR / 30

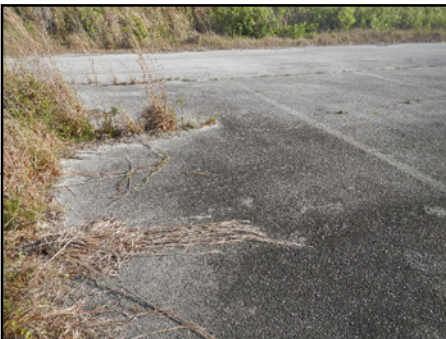
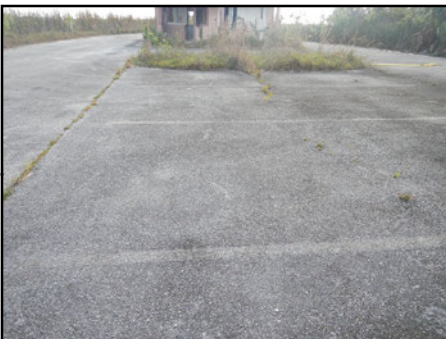
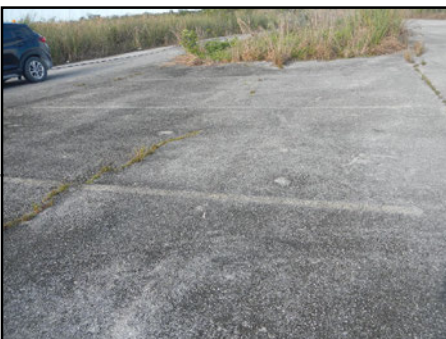
ROUTE 0950: CHEKIKA AREA ENTRANCE PARKING AREA

Inspection Date	FMSS Number	User Access	Surface Type
3/14/2019	N/A	PUBLIC	ASPHALT
Area (Sq. Ft.)	Lane Miles (11' Widths)	Curb Reveal (Inches)	Curb Recommendation
834	0.014	NOT APPLICABLE	NOT APPLICABLE
Curb Type		Curb & Gutter Type	
NO CURB		NO CURB AND GUTTER	
Pavement Recommendation		Condition Rating / PCR	
LIGHT 3R TREATMENTS		FAIR / 73
