Final Report

Road Inventory and Condition Assessment of Paved Routes Gateway National Recreation Area

Federal Lands Highway Road Inventory Program Prepared By: Federal Highway Administration Eastern Federal Lands Highway Division Road Inventory Program (RIP)

Report Date: September 2022

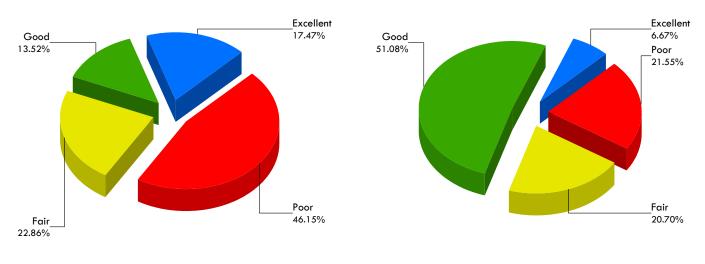
Parkwide Condition Percentages

Road Condition Percentages

Parking Area Condition Percentages

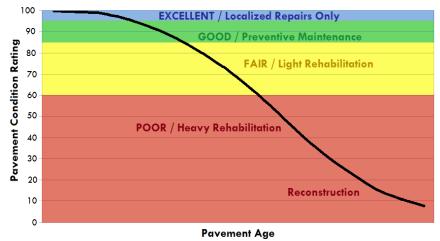
CONDITION CATEGORIES AND TREATMENTS

The Road Inventory Program aims to provide assistance in translating the excellent / good / fair / poor rating categories into pavement needs categories. The PCR can be used to indicate the place in the Pavement Life Cycle and the type of treatments that should be considered now and into the future.

- Excellent / New: PCR of 95-100
 - o Pavements in this range will require only spot repairs
- Good: PCR of 85-94
 - o Pavements in this range will likely be candidates for Preventive Maintenance. Examples include Chip and Slurry Seals, Micro Surfacing and Thin Overlays.
- Fair: PCR of 61-84
 - o Pavements in this range will likely be candidates of Light Rehabilitation (L3R). Examples include singlelift overlays up to 2.5 inches in total thickness, milling and overlays.
- Poor: PCR of 0-60
 - o Pavements in this range will likely be candidates of Heavy Rehabilitation or Reconstruction (H3R or 4R). Examples include Pulverization, Multiple Lift Overlays, and Reconstruction.

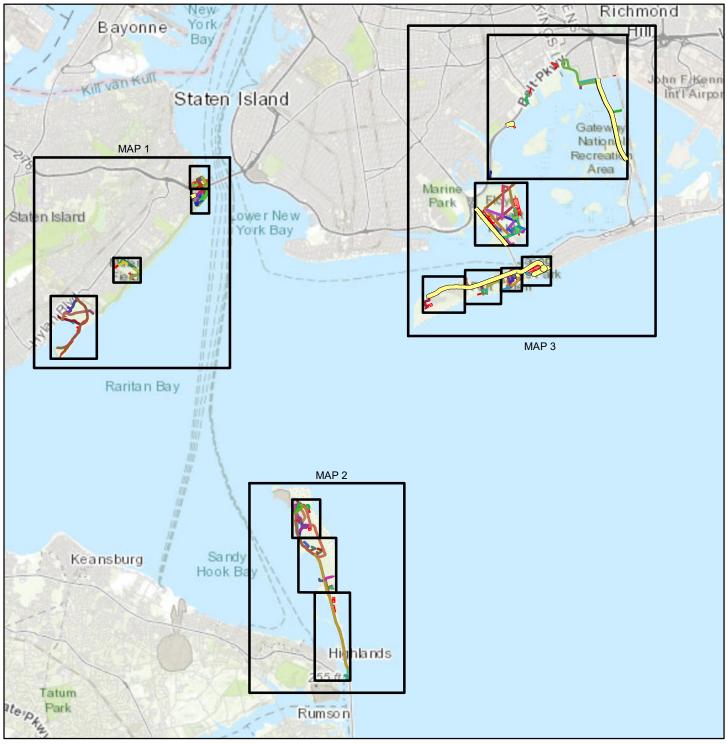
KEY MAP

Gateway National Recreation Area ROUTE LOCATION MAP

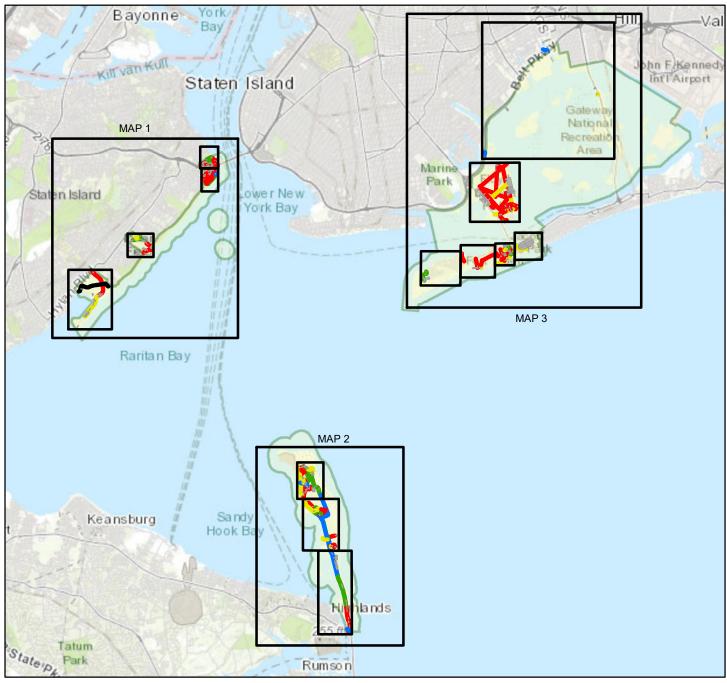
Gateway National Recreation Area ROUTE CONDITION MAP PCR - MILE BY MILE KEY MAP

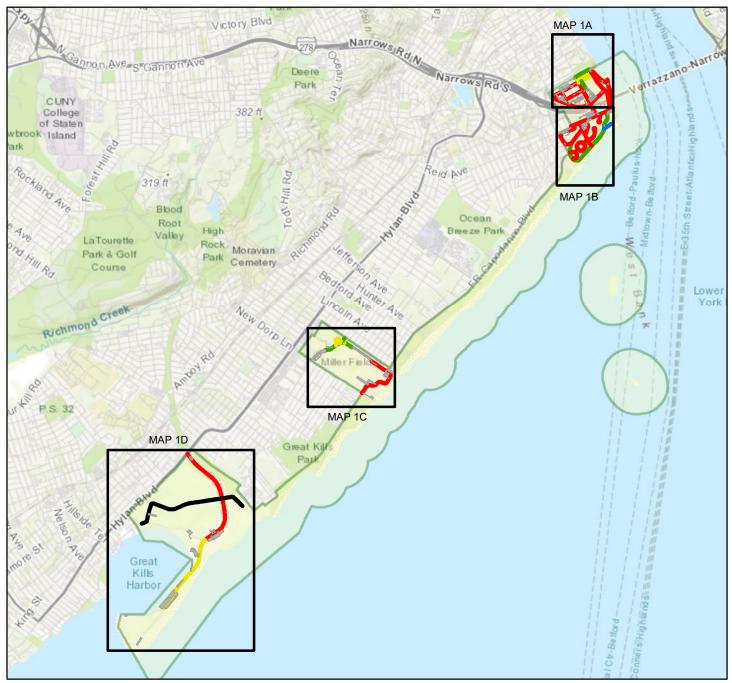
Gateway National Recreation Area ROUTE CONDITION MAP PCR - MILE BY MILE MAP 1

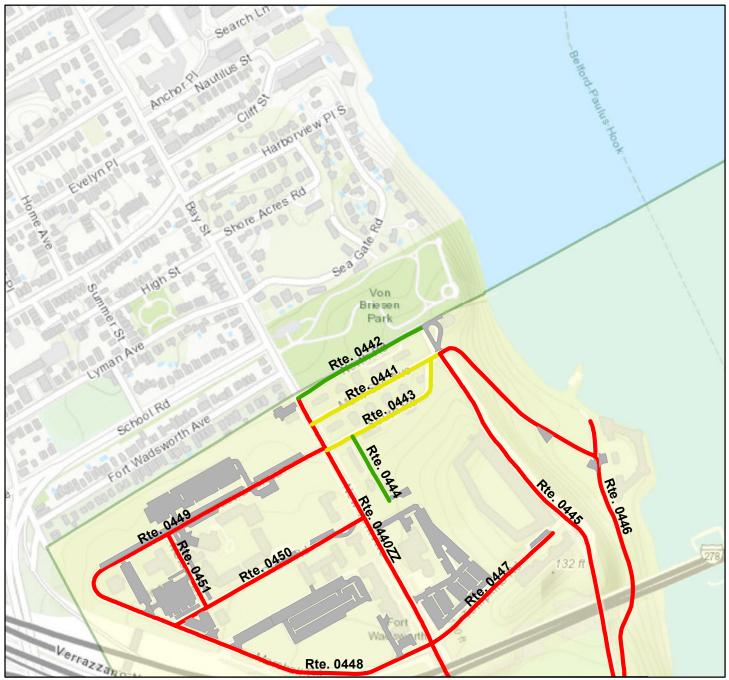
MAP 1A

ROUTE CONDITION MAP PCR - MILE BY MILE

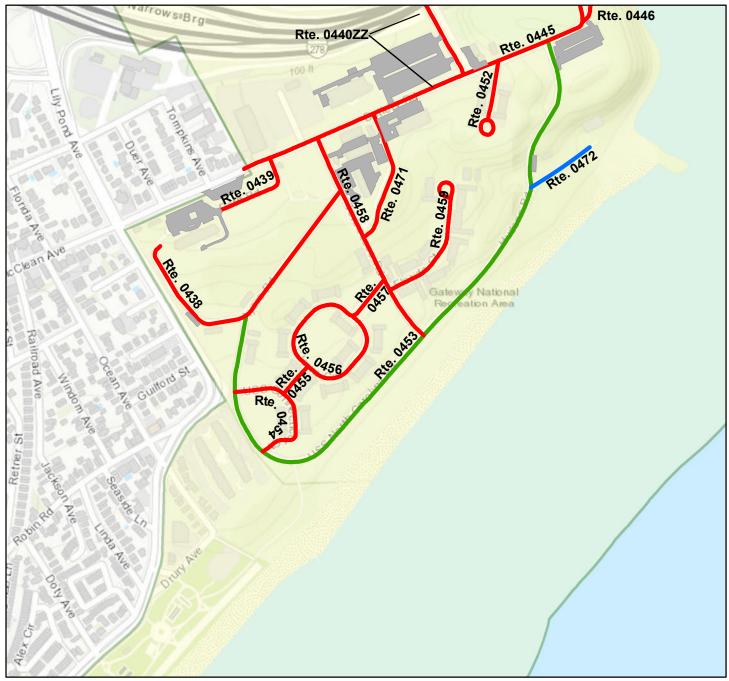
ROUTE CONDITION MAP PCR - MILE BY MILE MAP 1B

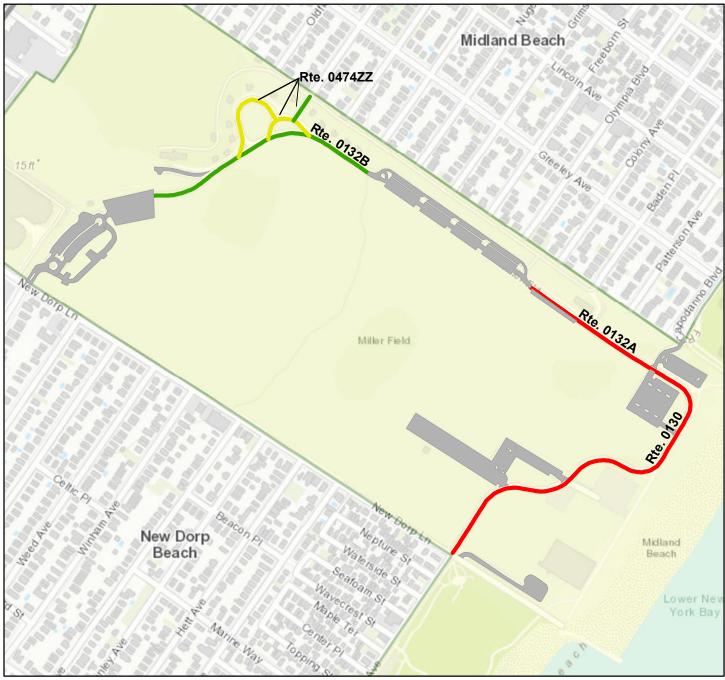
ROUTE CONDITION MAP PCR - MILE BY MILE MAP 1C

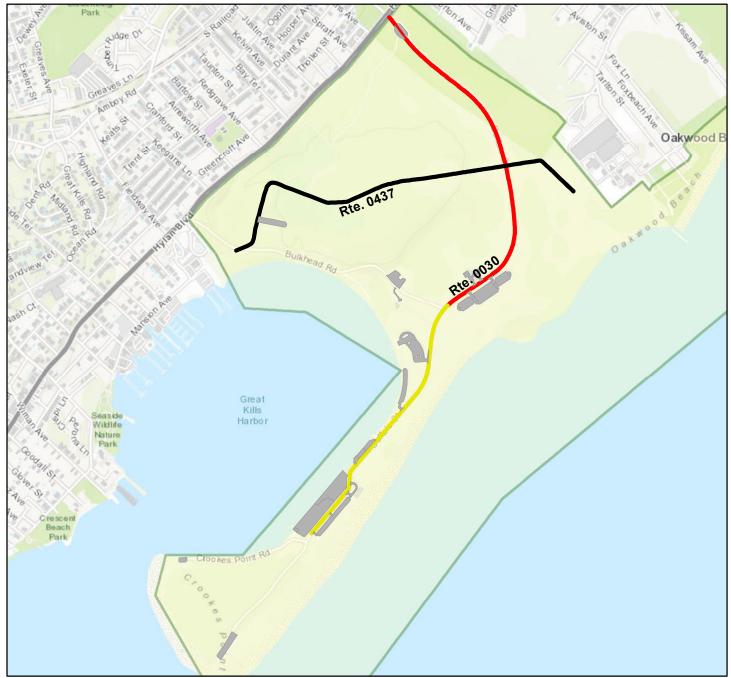
MAP 1D

ROUTE CONDITION MAP PCR - MILE BY MILE

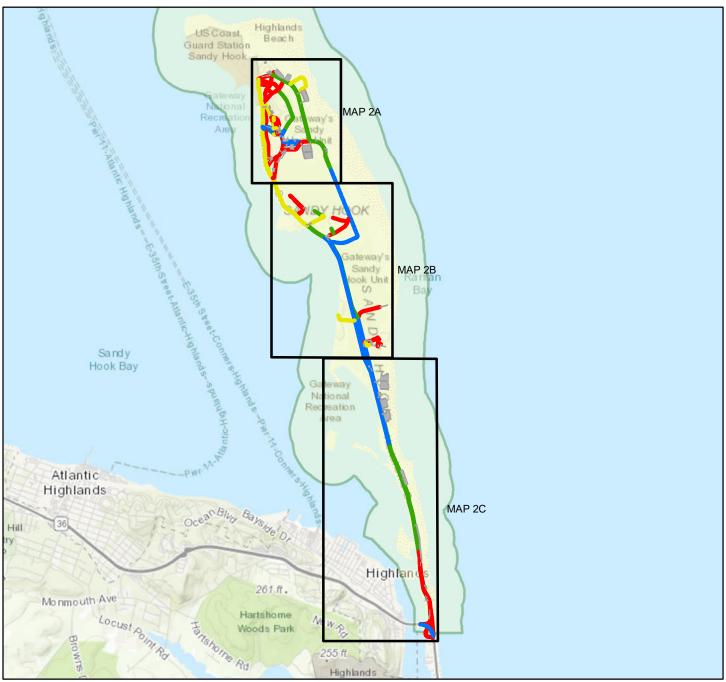
MAP 2

ROUTE CONDITION MAP PCR - MILE BY MILE

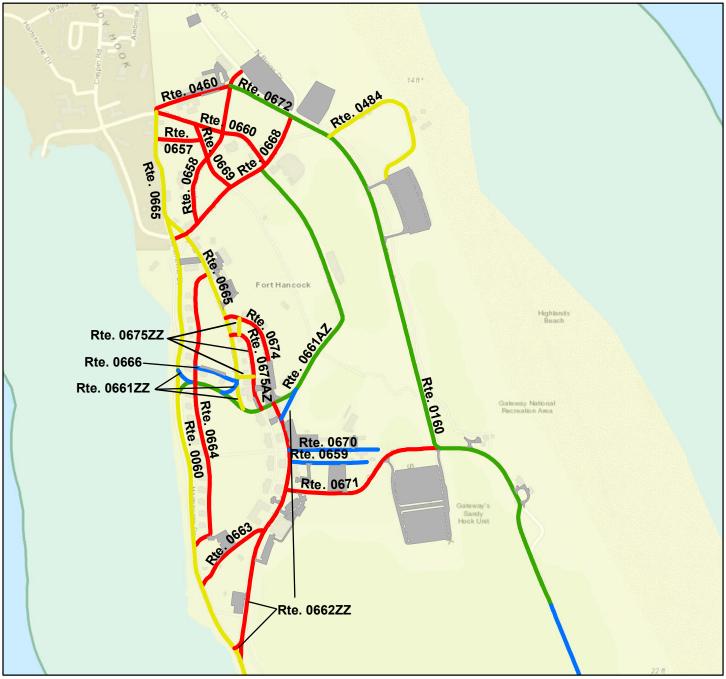
ROUTE CONDITION MAP PCR - MILE BY MILE MAP 2A

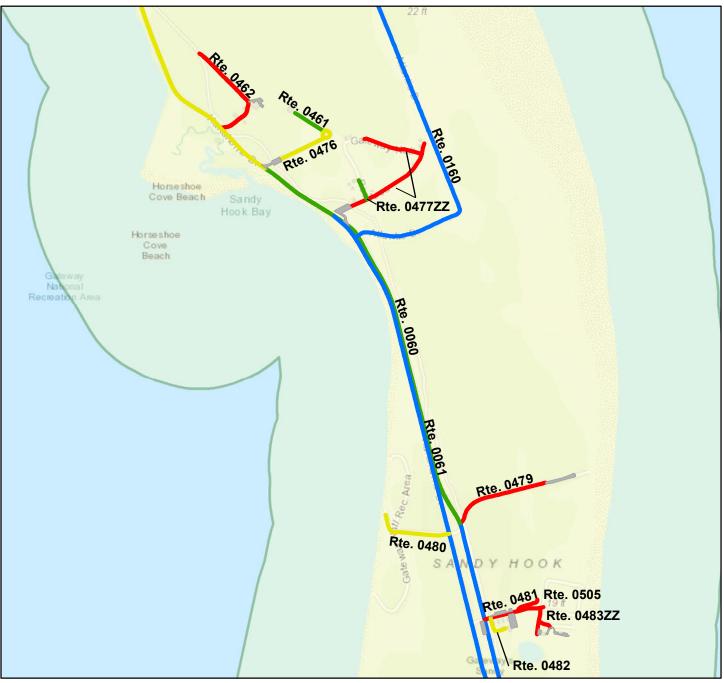
ROUTE CONDITION MAP PCR - MILE BY MILE MAP 2B

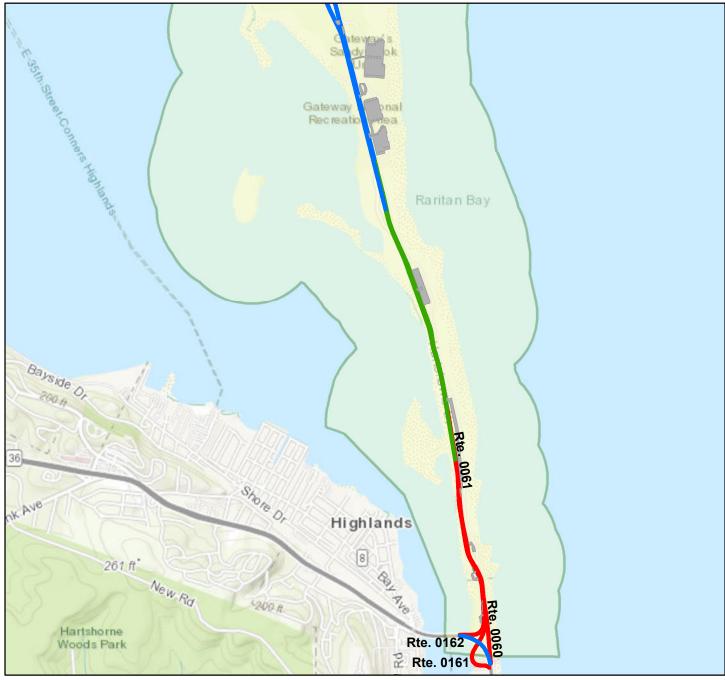
PCR - MILE BY MILE MAP 2C

ROUTE CONDITION MAP

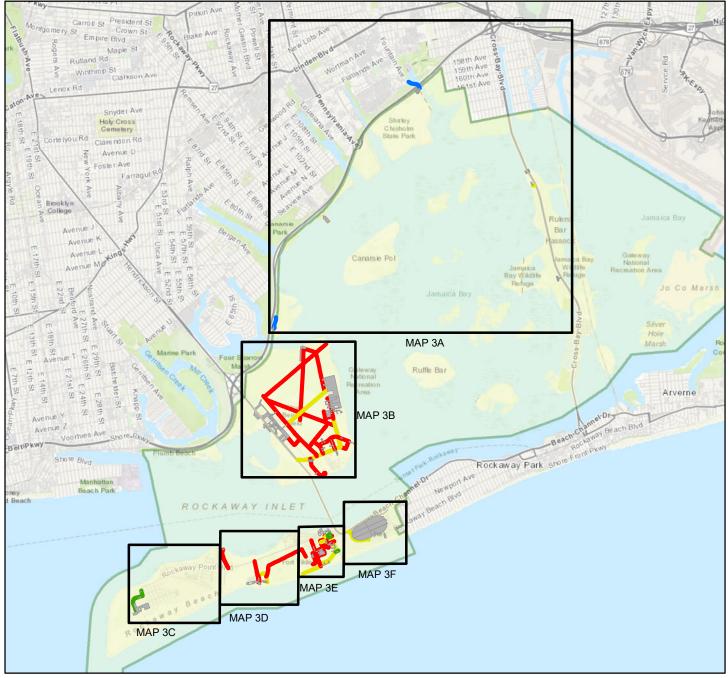
MAP 3

Gateway National Recreation Area ROUTE CONDITION MAP

PCR - MILE BY MILE

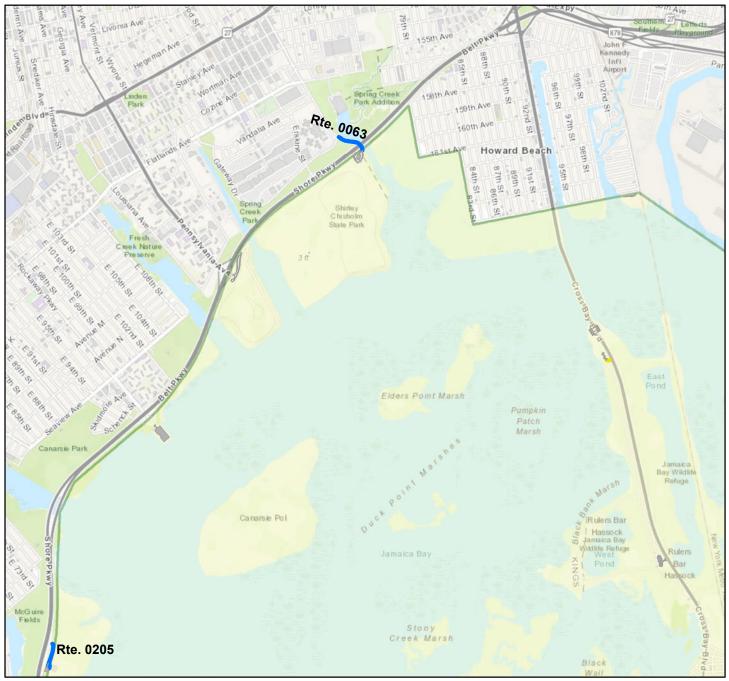
Gateway National Recreation Area ROUTE CONDITION MAP PCR - MILE BY MILE MAP 3A

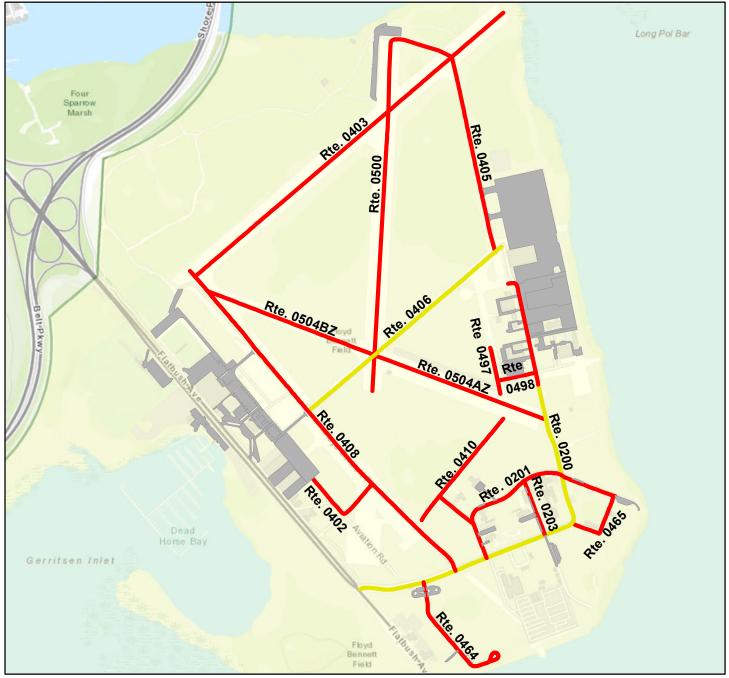
ROUTE CONDITION MAP PCR - MILE BY MILE MAP 3B

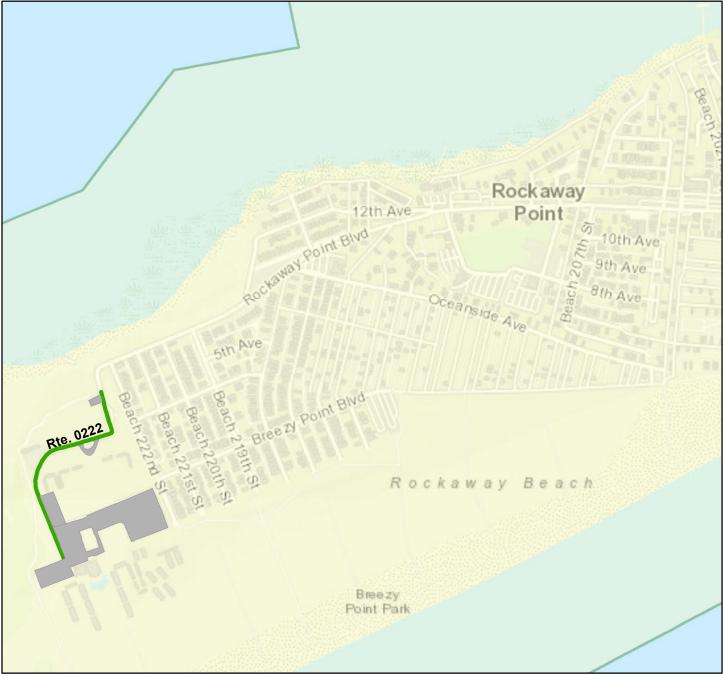
MAP 3C

ROUTE CONDITION MAP PCR - MILE BY MILE

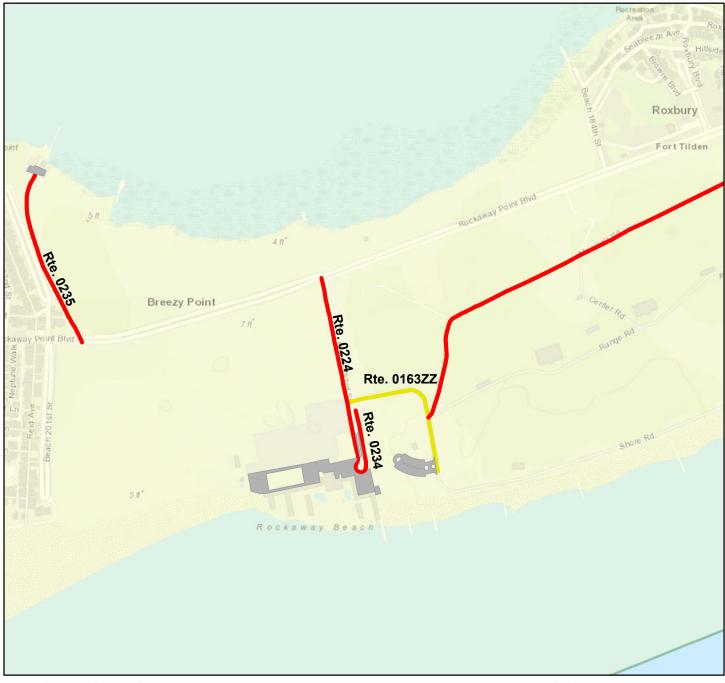
ROUTE CONDITION MAP PCR - MILE BY MILE MAP 3D

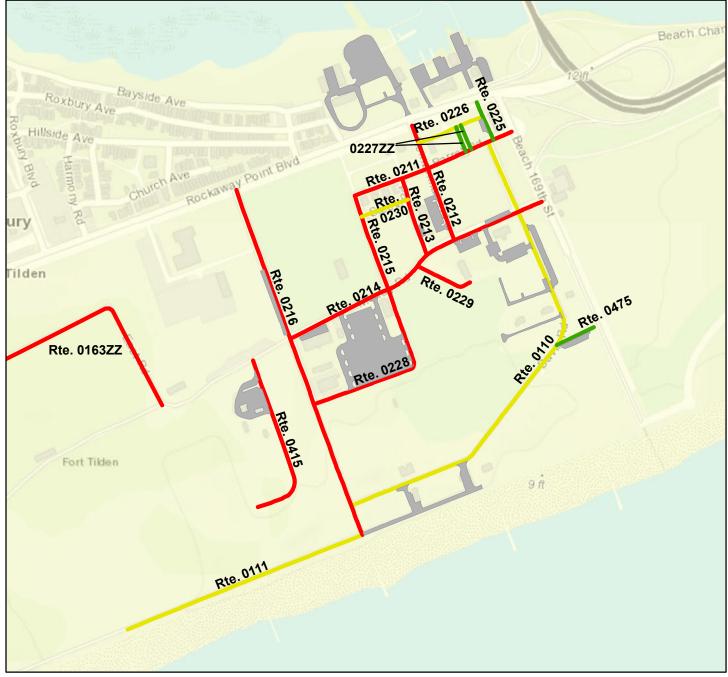
ROUTE CONDITION MAP PCR - MILE BY MILE

MAP 3E

Route Condition	Legend – Pavement Cond	lition Rating (PCR)		
	Poor (0 - 60)	Fair (61- 84)	Good (85 - 94)	Excellent (95 - 100)	Not Rated	
	Colors on map r			e Appendix for definitions ar	nd formulas	_
		Only Data Collection	n Vehicle and Manually Rat	ed Roads are displayed		
	Miles					N
0	0.15	0.3				A

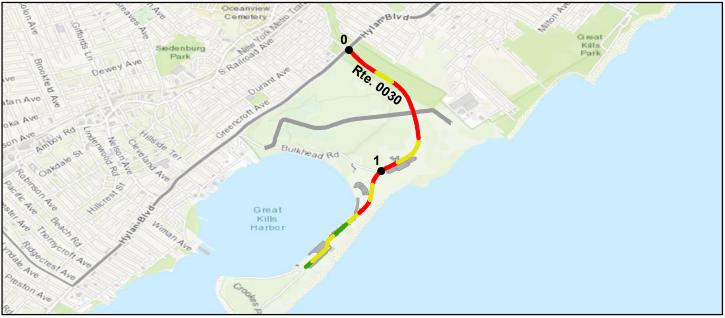
Gateway National Recreation Area ROUTE 0030: BUFFALO ROAD

Data Collection Vehicle (DCV) Rating

Route Condition Legend – Pavement Condition Rating (PCR)							
Poor (0 - 60) Fair (1- 84) Good (85 - 94)		Excellent (95 - 100)		Not Rated		
Colors on map represent con	ndition scores at 0.10-mile	tion scores at 0.10-mile intervals. See Appendix for definitions and formulas.					
Inspection Date: 4/24/2021	Beginning Section MP	0	1				
Paved Length (Miles): 1.75	Section Length (MI)	1	0.75				
Surface Type: ASPHALT	Route Summary				•		
Roadway Condition Information							
Pavement Condition Rating (PCR)	64	56	73				
Surface Condition Rating (SCR)	48	38	61				
Roughness Condition Index (RCI)	87	84	92				
Distress Index Values							
Structural Crack Index	69	57	84				
Alligator Crack Index	100	100	100				
Longitudinal Crack Index	69	57	84				
Transverse Cracking Index	48	38	61				
Patching Index	100	100	100				
Rutting Index	98	98	98				
International Roughness Index (IRI)	148	157	135				
Lane & Width Information

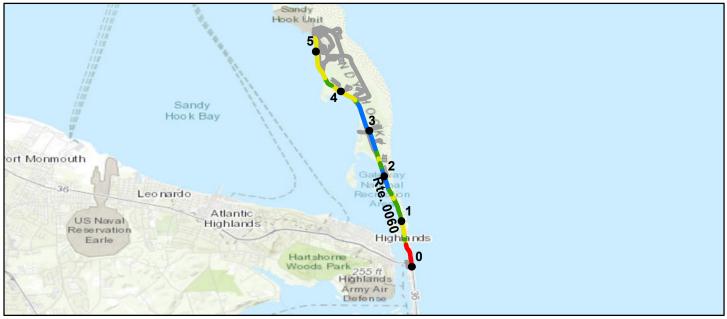
Gateway National Recreation Area ROUTE 0060: HARTSHORNE DRIVE (NORTHBOUND)

Data Collection Vehicle (DCV) Rating

Route Condition Legend – Pavement Condition Rating (PCR)							
Poor (0 - 60) Fair (1- 84) Good (85 - 94)		Excellent (95 - 100)		Not Rated		
Colors on map represent co	ndition scores at 0.10-mile	ition scores at 0.10-mile intervals. See Appendix for definitions and formulas.					
Inspection Date: 4/24/2021	Beginning Section MP	0	1	2	3	4	
Paved Length (Miles): 5.28	Section Length (MI)	1	1	1	1	1	
Surface Type: ASPHALT	Route Summary						
Roadway Condition Information							
Pavement Condition Rating (PCR)	82	38	91	95	92	75	
Surface Condition Rating (SCR)	78	7	87	94	86	75	
Roughness Condition Index (RCI)	88	84	97	96	100	75	
Distress Index Values							
Structural Crack Index	78	7	93	98	96	93	
Alligator Crack Index	100	100	100	100	100	100	
Longitudinal Crack Index	78	7	93	98	96	93	
Transverse Cracking Index	79	49	87	94	86	75	
Patching Index	100	100	100	100	100	100	
Rutting Index	98	96	99	99	99	98	
International Roughness Index (IRI)	147	158	121	124	109	184

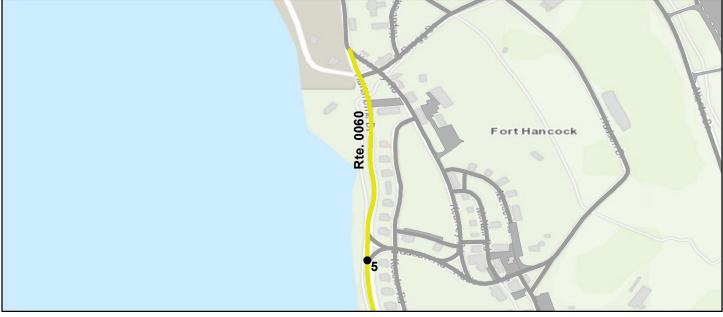
Gateway National Recreation Area ROUTE 0060: HARTSHORNE DRIVE (NORTHBOUND)

Data Collection Vehicle (DCV) Rating

Route Condition Legend – Pavement Condition Rating (PCR)							
Poor (0 - 60) Fair (6	Good (85 - 94)		Excellent (95 - 10	Not Rated			
Colors on map represent con	ition scores at 0.10-mile intervals. See Appendix for definitions and formulas.						
Inspection Date: 4/24/2021	Beginning Section MP	5					
Paved Length (Miles): 5.28	Section Length (MI)	0.28					
Surface Type: ASPHALT	Route Summary						
Roadway Condition Information							
Pavement Condition Rating (PCR)	82	73					
Surface Condition Rating (SCR)	78	88					
Roughness Condition Index (RCI)	88	50					
Distress Index Values							
Structural Crack Index	78	92					
Alligator Crack Index	100	100					
Longitudinal Crack Index	78	92					
Transverse Cracking Index	79	88					
Patching Index	100	100					
Rutting Index	98	92					
International Roughness Index (IRI)	147	285					
Lane & Width Information							
Number of Lanes	2	2					
Paved Width (ft)	27	18.9

Lane Width (ft)	10.8	10

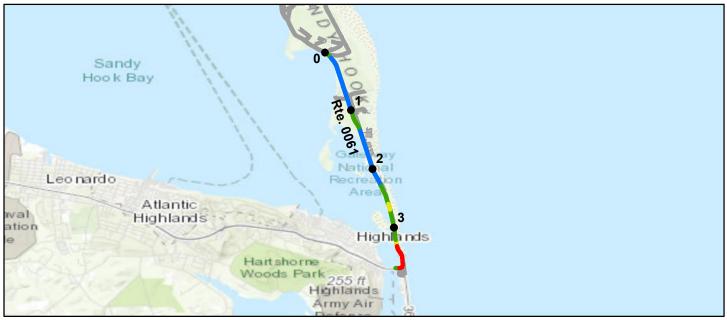
Gateway National Recreation Area ROUTE 0061: HARTSHORNE DRIVE (SOUTHBOUND)

Route	Condition Legend – Pav	ement Condi	tion Rating (PCR)		
Poor (0 - 60)	61- 84) Good	(85 - 94)	Excellent (95 - 100)	Not Ra	ted
Colors on map represent co	ndition scores at 0.10-mile	e intervals. Se	e Appendix fo	or definitions	and formulas.	
Inspection Date: 4/24/2021	Beginning Section MP	0	1	2	3	
Paved Length (Miles): 3.75	Section Length (MI)	1	1	1	0.75	
Surface Type: ASPHALT	Route Summary					
Roadway Condition Information						
Pavement Condition Rating (PCR)	89	99	96	92	60	
Surface Condition Rating (SCR)	82	98	93	86	39	
Roughness Condition Index (RCI)	100	100	100	100	91	
Distress Index Values						
Structural Crack Index	89	99	99	97	49	
Alligator Crack Index	100	100	100	100	100	
Longitudinal Crack Index	89	99	99	97	49	
Transverse Cracking Index	82	98	93	86	39	
Patching Index	100	100	100	100	100	
Rutting Index	99	100	100	97	98	
International Roughness Index (IRI)	103	89	89	104	138	
Lane & Width Information

Number of Lanes	2	2	2	2	2	
Paved Width (ft)	24.5	23.4	25.2	23.9	25.6	
Lane Width (ft)	10.5	10.5	10.5	10.4	10.4

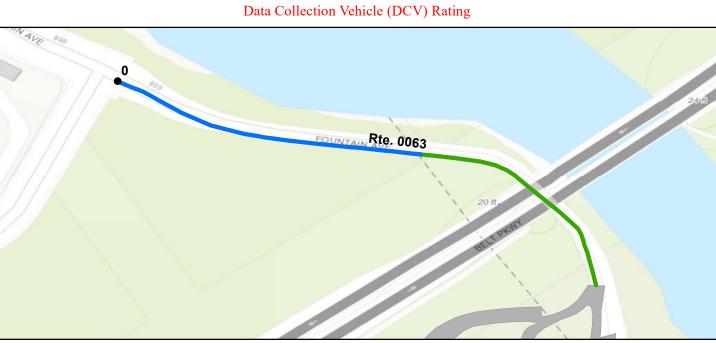
Gateway National Recreation Area ROUTE 0063: NS FOUNTAIN AVENUE LANDFILL ACCESS ROADS

Route	Condition Legend – Pav	ement Cond	ition Rating (PCR)		
Poor (0 - 60) Fair (61- 84) Good	(85 - 94)	Excellent (95 - 100)	Not Rated	
Colors on map represent condition scores at 0.10-mile intervals. See Appendix for definitions and formu					
Inspection Date: 4/23/2021	Beginning Section MP	0			
Paved Length (Miles): 0.18	Section Length (MI)	0.18			
Surface Type: ASPHALT	Route Summary		•		
Roadway Condition Information					
Pavement Condition Rating (PCR)	96	96			
Surface Condition Rating (SCR)	96	96			
Roughness Condition Index (RCI)	N/A	N/A			
Distress Index Values					
Structural Crack Index	100	100			
Alligator Crack Index	100	100			
Longitudinal Crack Index	100	100			
Transverse Cracking Index	100	100			
Patching Index	100	100			
Rutting Index	96	96			
International Roughness Index (IRI)	N/A	N/A			
Lane & Width Information					
Number of Lanes	2	2			
Paved Width (ft)	26.6	26.6			
Lane Width (ft)	12.3	12.3

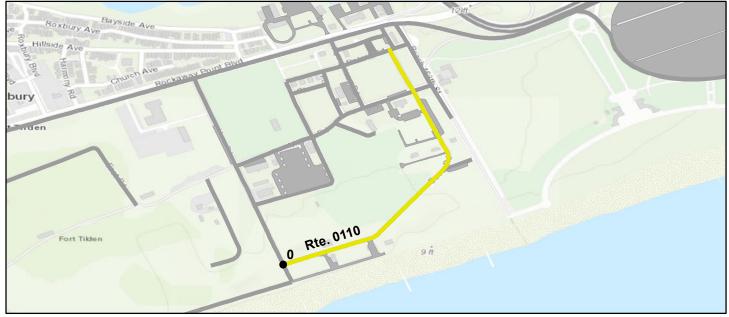
Gateway National Recreation Area ROUTE 0110: DAVIS ROAD

Data Collection Vehicle (DCV) Rating

Rou	te Condition Legend – Pav	ement Cond	ition Rating (PCR)				
Poor (0 - 60) Fai	r (61- 84) Good	(85 - 94)	Excellent (95 - 100)	Not Rated			
Colors on map represent	present condition scores at 0.10-mile intervals. See Appendix for definitions and formulas.						
Inspection Date: 4/23/2021	Beginning Section MP	0					
Paved Length (Miles): 0.5	Section Length (MI)	0.5					
Surface Type: CONCRETE	Route Summary		•	•			
Roadway Condition Information							
Pavement Condition Rating (PCR)	73	73					
Surface Condition Rating (SCR)	N/A	N/A					
Roughness Condition Index (RCI)	N/A	N/A					
Distress Index Values							
Structural Crack Index	N/A	N/A					
Alligator Crack Index	N/A	N/A					
Longitudinal Crack Index	N/A	N/A					
Transverse Cracking Index	N/A	N/A					
Patching Index	N/A	N/A					
Rutting Index	N/A	N/A					
International Roughness Index (IRI)	N/A	N/A					
Lane & Width Information							
Number of Lanes	1	1

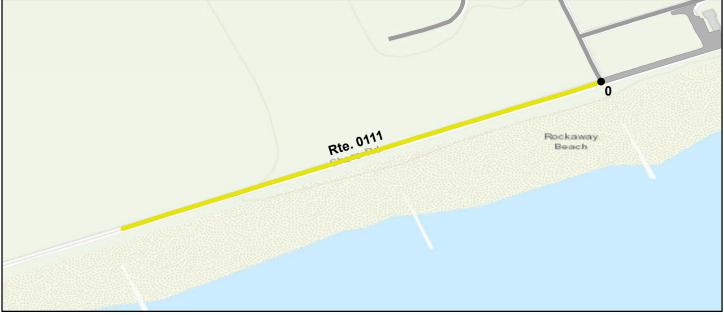
Gateway National Recreation Area ROUTE 0111: SHORE ROAD

Data Collection Vehicle (DCV) Rating

Route	Condition Legend – Pav	ement Condi	ition Rating (PCR)			
Poor (0 - 60) Fair (6	61-84) Good	(85 - 94)	Excellent (95 - 100)	Not Rated		
Colors on map represent condition scores at 0.10-mile intervals. See Appendix for definitions and formulas.						
Inspection Date: 4/23/2021	Beginning Section MP	0				
Paved Length (Miles): 0.26	Section Length (MI)	0.26				
Surface Type: CONCRETE	Route Summary					
Roadway Condition Information						
Pavement Condition Rating (PCR)	73	73				
Surface Condition Rating (SCR)	N/A	N/A				
Roughness Condition Index (RCI)	N/A	N/A				
Distress Index Values						
Structural Crack Index	N/A	N/A				
Alligator Crack Index	N/A	N/A				
Longitudinal Crack Index	N/A	N/A				
Transverse Cracking Index	N/A	N/A				
Patching Index	N/A	N/A				
Rutting Index	N/A	N/A				
International Roughness Index (IRI)	N/A	N/A				
Lane & Width Information						
Number of Lanes	1	1				
Paved Width (ft)	16.3	16.3

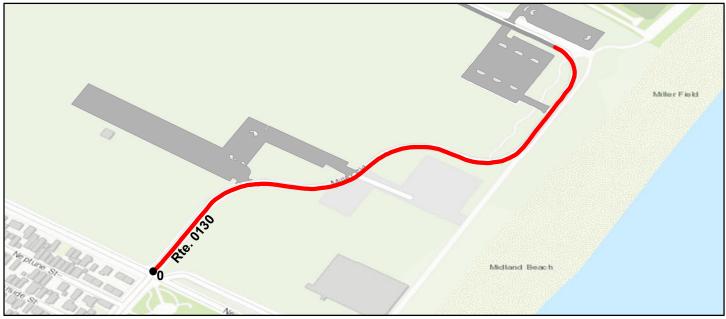
Gateway National Recreation Area ROUTE 0130: MILLER FIELD ENTRANCE ROAD

Route C	Condition Legend – Pav	ement Condi	tion Rating (PCR)				
Poor (0 - 60) Fair (6	1- 84) Good ((85 - 94)	Excellent (95 - 10	0) Not Rated			
Colors on map represent condition scores at 0.10-mile intervals. See Appendix for definitions and formulas.							
Inspection Date: 4/24/2021	Beginning Section MP	0					
Paved Length (Miles): 0.38	Section Length (MI)	0.38					
Surface Type: ASPHALT	Route Summary			• •			
Roadway Condition Information							
Pavement Condition Rating (PCR)	0	0					
Surface Condition Rating (SCR)	0	0					
Roughness Condition Index (RCI)	N/A	N/A					
Distress Index Values							
Structural Crack Index	0	0					
Alligator Crack Index	91	91					
Longitudinal Crack Index	0	0					
Transverse Cracking Index	17	17					
Patching Index	100	100					
Rutting Index	92	92					
International Roughness Index (IRI)	N/A	N/A					
Lane & Width Information							
Number of Lanes	2	2					
Paved Width (ft)	27.2	27.2

Lane Width (ft)	10.5	10.5

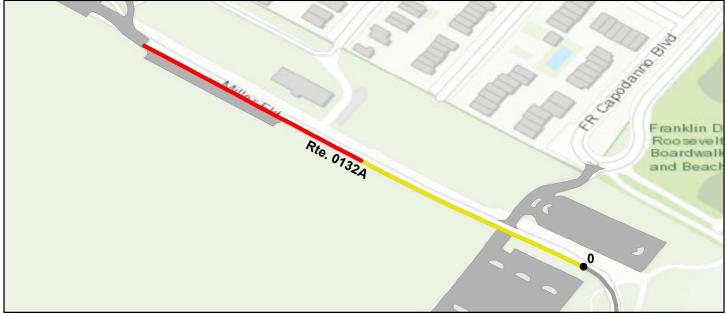
Gateway National Recreation Area ROUTE 0132A: VISITOR CENTER (SANCHEZ ROAD EAST)

Route C	Condition Legend – Pav	ement Condi	tion Rating (P	PCR)		
Poor (0 - 60) Fair (6	1- 84) Good ((85 - 94)	Excellent (9	5 - 100)	Not Ra	ted
Colors on map represent condition scores at 0.10-mile intervals. See Appendix for definitions and formulas.						
Inspection Date: 4/24/2021	Beginning Section MP	0				
Paved Length (Miles): 0.2	Section Length (MI)	0.2				
Surface Type: ASPHALT	Route Summary					
Roadway Condition Information						
Pavement Condition Rating (PCR)	59	59				
Surface Condition Rating (SCR)	59	59				
Roughness Condition Index (RCI)	N/A	N/A				
Distress Index Values						
Structural Crack Index	88	88				
Alligator Crack Index	100	100				
Longitudinal Crack Index	88	88				
Transverse Cracking Index	59	59				
Patching Index	100	100				
Rutting Index	96	96				
International Roughness Index (IRI)	N/A	N/A				
Lane & Width Information						
Number of Lanes	2	2				
Paved Width (ft)	22.6	22.6				
Lane Width (ft)	9.2	9.2

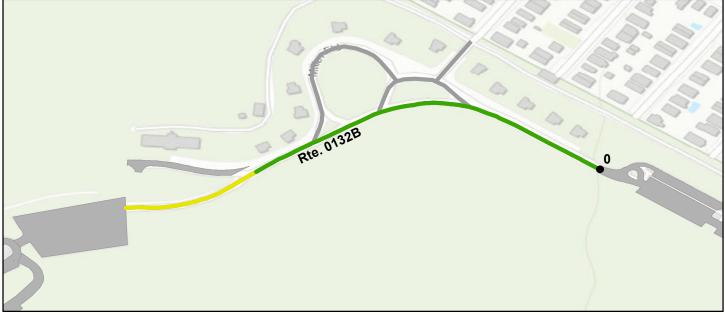
Gateway National Recreation Area ROUTE 0132B: HOUSING ACCESS (SANCHEZ ROAD WEST)

Route	Condition Legend – Pav	ement Cond	ition Rating (PCR)		
Poor (0 - 60) Fair (61- 84) Good	(85 - 94)	Excellent (95 - 100)	Not Rated	
Colors on map represent condition scores at 0.10-mile intervals. See Appendix for definitions and formulas.					
Inspection Date: 4/24/2021	Beginning Section MP	0			
Paved Length (Miles): 0.27	Section Length (MI)	0.27			
Surface Type: ASPHALT	Route Summary		•	• •	
Roadway Condition Information					
Pavement Condition Rating (PCR)	85	85			
Surface Condition Rating (SCR)	85	85			
Roughness Condition Index (RCI)	N/A	N/A			
Distress Index Values					
Structural Crack Index	100	100			
Alligator Crack Index	100	100			
Longitudinal Crack Index	100	100			
Transverse Cracking Index	85	85			
Patching Index	100	100			
Rutting Index	100	100			
International Roughness Index (IRI)	N/A	N/A			
Lane & Width Information					
Number of Lanes	2	2			
Paved Width (ft)	20.2	20.2			
Lane Width (ft)	8.8	8.8

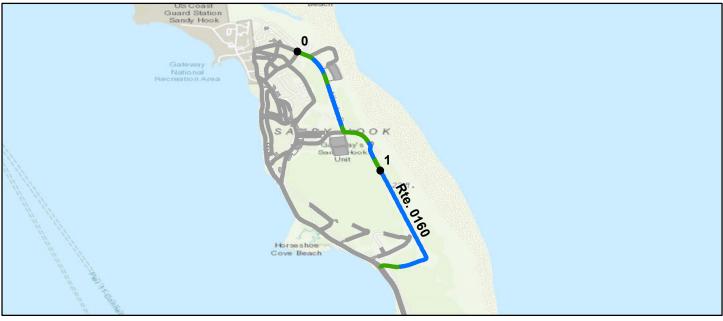
ROUTE 0160: ATLANTIC DRIVE

Route	Condition Legend – Pav	ement Condi	tion Rating (P	PCR)		
Poor (0 - 60) Fair (0	61- 84) Good ((85 - 94)	Excellent (9	5 - 100)	Not Rat	ed
Colors on map represent condition scores at 0.10-mile intervals. See Appendix for definitions and formulas.						
Inspection Date: 4/24/2021	Beginning Section MP	0	1			
Paved Length (Miles): 1.91	Section Length (MI)	1	0.91			
Surface Type: ASPHALT	Route Summary					
Roadway Condition Information						
Pavement Condition Rating (PCR)	95	93	99			
Surface Condition Rating (SCR)	99	99	99			
Roughness Condition Index (RCI)	90	84	98			
Distress Index Values						
Structural Crack Index	100	100	99			
Alligator Crack Index	100	100	100			
Longitudinal Crack Index	100	100	99			
Transverse Cracking Index	100	100	99			
Patching Index	100	100	100			
Rutting Index	99	99	99			
International Roughness Index (IRI)	139	157	120			
Lane & Width Information						
Number of Lanes	2	2	2			
Paved Width (ft)	22.5	27.4	22.2

Lane Width (ft)	11.4	12	10.7

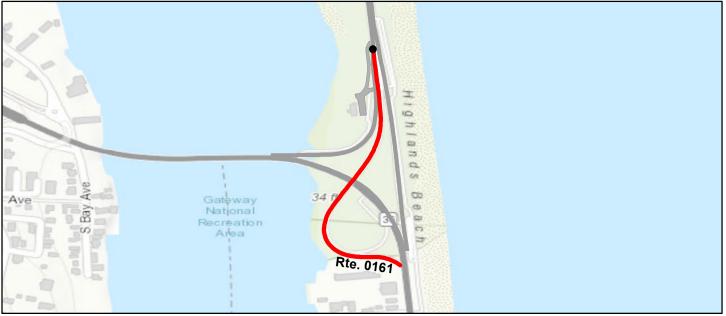
Gateway National Recreation Area ROUTE 0161: HARTSHORNE DRIVE (SOUTHBOUND) RAMP K

Route	e Condition Legend – Pav	ement Cond	ition Rating (PCR)	
Poor (0 - 60) Fair	(61- 84) Good	(85 - 94)	Excellent (95 - 100)	Not Rated
Colors on map represent co	ondition scores at 0.10-mile	e intervals. Se	e Appendix for definition	ns and formulas.
Inspection Date: 4/24/2021	Beginning Section MP	0		
Paved Length (Miles): 0.29	Section Length (MI)	0.29		
Surface Type: ASPHALT	Route Summary		•	• •
Roadway Condition Information				
Pavement Condition Rating (PCR)	6	6		
Surface Condition Rating (SCR)	6	6		
Roughness Condition Index (RCI)	N/A	N/A		
Distress Index Values				
Structural Crack Index	6	6		
Alligator Crack Index	100	100		
Longitudinal Crack Index	6	6		
Transverse Cracking Index	9	9		
Patching Index	100	100		
Rutting Index	97	97		
International Roughness Index (IRI)	N/A	N/A		
Lane & Width Information				
Number of Lanes	1	1		
Paved Width (ft)	14.2	14.2		
Lane Width (ft)	11.8	11.8

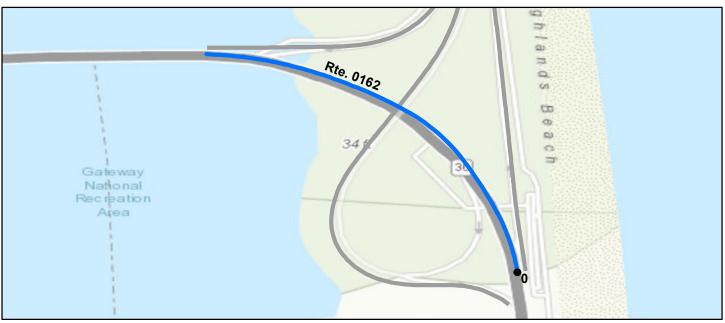
Gateway National Recreation Area ROUTE 0162: HARTSHORNE DRIVE (SOUTHBOUND) RAMP L

Data Collection Vehicle (DCV) Rating

Route	Condition Legend – Pav	ement Condi	tion Rating (PCR)			
Poor (0 - 60) Fair (6	1- 84) Good ((85 - 94)	Excellent (95 - 100)	Not Rated		
Colors on map represent condition scores at 0.10-mile intervals. See Appendix for definitions and formulas.						
Inspection Date: 4/24/2021	Beginning Section MP	0				
Paved Length (Miles): 0.18	Section Length (MI)	0.17				
Surface Type: CONCRETE	Route Summary					
Roadway Condition Information						
Pavement Condition Rating (PCR)	97	97				
Surface Condition Rating (SCR)	N/A	N/A				
Roughness Condition Index (RCI)	N/A	N/A				
Distress Index Values						
Structural Crack Index	N/A	N/A				
Alligator Crack Index	N/A	N/A				
Longitudinal Crack Index	N/A	N/A				
Transverse Cracking Index	N/A	N/A				
Patching Index	N/A	N/A				
Rutting Index	N/A	N/A				
International Roughness Index (IRI)	N/A	N/A				
Lane & Width Information						
Number of Lanes	1	1				
Paved Width (ft)	14.7	14.7

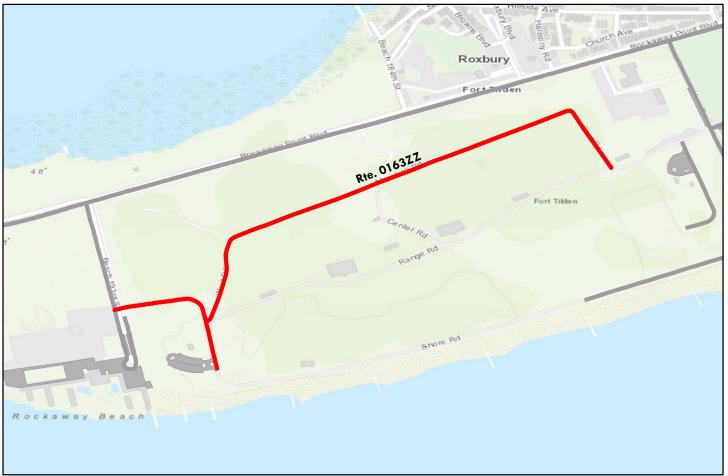
ROUTE 0163ZZ: RANGE ROADS

Summary Route

Note: The weighted average summary PCR value is calculated from only the sections of road where the PCR was collected. The overall PCR for the summary route may not reflect individual subcomponent ratings.

Route Condition Legend – Pavement Condition Rating (PCR)								
Poor (0 - 60) Fair (6	1- 84) Good	1- 84) Good (85 - 94)		Excellent (95 - 100)		ted		
	See Appendix for det	finitions and f	formulas					
Inspection Date: 4/23/2021								
Paved Length (Miles): 0.97								
Surface Type: ASPHALT	Route Summary				•			
Roadway Condition Information								
Pavement Condition Rating (PCR)	43							
Lane & Width Information								
Number of Lanes	1							
Paved Width (ft)	13.3							
Lane Width (ft)	11.3

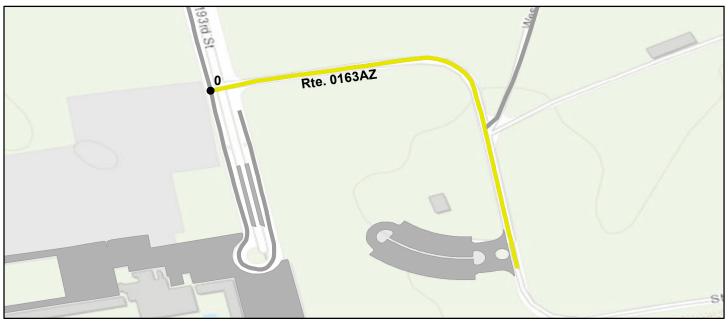
ROUTE 0163AZ: RANGE ROAD

Subcomponent of Route GATE-0163ZZ Data Collection Vehicle (DCV) Rating

Route (Condition Legend – Pav	ement Condi	tion Rating (PCR)		
Poor (0 - 60)	Fair (6	1- 84) Good	(85 - 94)	Excellent (95 - 100)	Not Ra	ted
Colors on	map represent con	dition scores at 0.10-mile	e intervals. Se	e Appendix fo	r definitions	s and formulas.	
Inspection Date:	4/23/2021	Beginning Section MP	0				
Paved Length (Miles):	: 0.21	Section Length (MI)	0.21				
Surface Type:	CONCRETE	Route Summary					
Roadway Condition I	nformation						
Pavement Condition H	Rating (PCR)	73	73				
Surface Condition Rati	ng (SCR)	N/A	N/A				
Roughness Condition I	ndex (RCI)	N/A	N/A				
Distress Index Values							
Structural Crack Index	X	N/A	N/A				
Alligator Crack Index		N/A	N/A				
Longitudinal Crack In	ıdex	N/A	N/A				
Transverse Cracking I	ndex	N/A	N/A				
Patching Index		N/A	N/A				
Rutting Index		N/A	N/A				
International Roughne	ess Index (IRI)	N/A	N/A				
Lane & Width Inform	ation						
Number of Lanes		2	2				
Paved Width (ft)		17.7	17.7

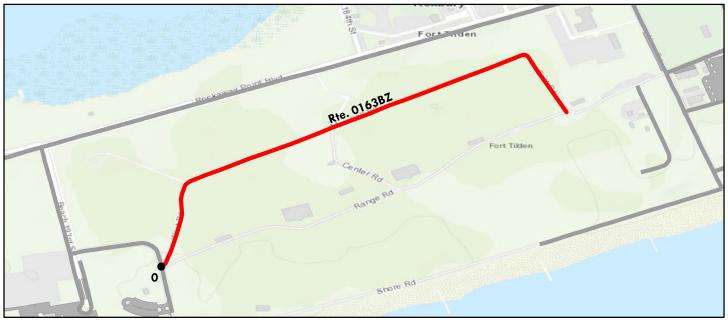
Subcomponent of Route GATE-0163ZZ

Manual Rating

Route	Condition Legend – Pav	ement Condi	tion Rating (PCR)					
Poor (0 - 60) Fair (0	61- 84) Good (84) Good (85 - 94) Excellent (95 - 100)		Not Rated				
See Appendix for definitions and formulas								
Inspection Date: 3/3/2021	Beginning Section MP	0.00						
Paved Length (Miles): 0.76	Section Length (MI)	0.76						
Surface Type: ASPHALT	Route Summary		•					
Roadway Condition Information								
Pavement Condition Rating (PCR)	30	30						
Surface Condition Rating (SCR)	30	30						
Roughness Condition Index (RCI)	N/A	N/A						
Distress Index Values								
Structural Crack Index	N/A	N/A						
Alligator Crack Index	30	30						
Longitudinal Crack Index	53	53						
Transverse Cracking Index	53	53						
Patching Index	73	73						
Rutting Index	90	90						
International Roughness Index (IRI)	N/A	N/A						
Lane & Width Information								
Number of Lanes	2	1						
Paved Width (ft)	12	12						
Lane Width (ft)	12	12

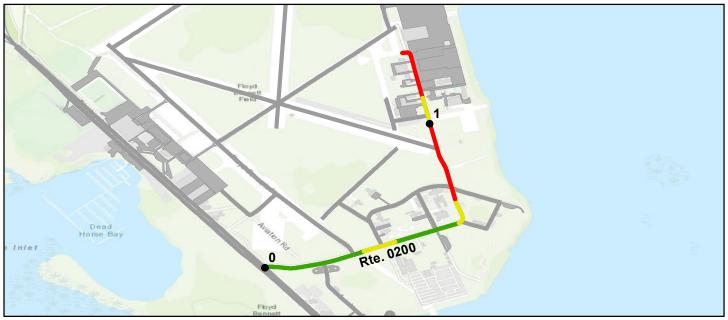
Gateway National Recreation Area ROUTE 0200: FLOYD BENNETT FIELD ENTRANCE ROAD

Route	Condition Legend – Pav	ement Condi	tion Rating (P	PCR)	
Poor (0 - 60) Fair (61- 84) Good (1- 84) Good (85 - 94)		5 - 100)	Not Rated
Colors on map represent co	ndition scores at 0.10-mile	e intervals. Se	e Appendix for	definitions	and formulas.
Inspection Date: 4/23/2021	Beginning Section MP	0	1		
Paved Length (Miles): 1.3	Section Length (MI)	1	0.29		
Surface Type: ASPHALT	Route Summary				•
Roadway Condition Information					
Pavement Condition Rating (PCR)	69	74	50		
Surface Condition Rating (SCR)	72	79	47		
Roughness Condition Index (RCI)	64	67	54		
Distress Index Values					
Structural Crack Index	82	86	69		
Alligator Crack Index	100	100	100		
Longitudinal Crack Index	82	86	69		
Transverse Cracking Index	72	79	47		
Patching Index	100	100	99		
Rutting Index	96	97	93		
International Roughness Index (IRI)	224	214	264		
Lane & Width Information					
Number of Lanes	2	2	2		
Paved Width (ft)	27.1	28	24.3

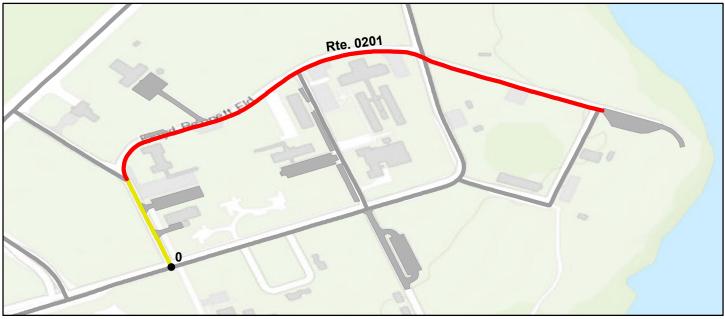
ROUTE 0201: RANGER ROAD

Route	Condition Legend – Pav	ement Cond	ition Rating (PCR)	
Poor (0 - 60) Fair (61- 84) Good	Good (85 - 94)		Not Rated
Colors on map represent co	ndition scores at 0.10-mile	e intervals. Se	e Appendix for definition	ns and formulas.
Inspection Date: 4/23/2021	Beginning Section MP	0		
Paved Length (Miles): 0.56	Section Length (MI)	0.56		
Surface Type: ASPHALT	Route Summary		•	
Roadway Condition Information				
Pavement Condition Rating (PCR)	21	21		
Surface Condition Rating (SCR)	21	21		
Roughness Condition Index (RCI)	N/A	N/A		
Distress Index Values				
Structural Crack Index	23	23		
Alligator Crack Index	96	96		
Longitudinal Crack Index	27	27		
Transverse Cracking Index	21	21		
Patching Index	97	97		
Rutting Index	95	95		
International Roughness Index (IRI)	N/A	N/A		
Lane & Width Information				
Number of Lanes	2	2		
Paved Width (ft)	24.7	24.7		
Lane Width (ft)	12.2	12.2

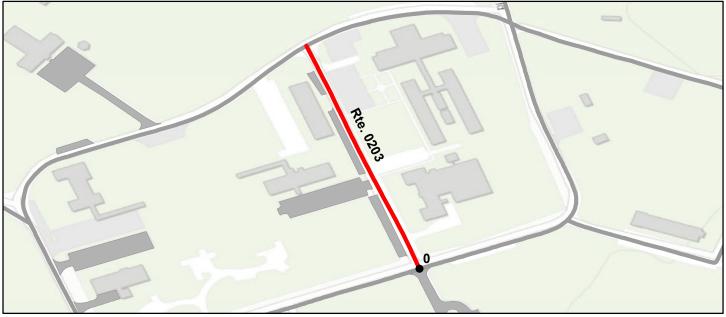
ROUTE 0203: ENTERPRISE AVENUE

Route	Condition Legend – Pav	ement Cond	ition Rating (PCR)	
Poor (0 - 60) Fair	(61- 84) Good	(85 - 94)	Excellent (95 - 100)	Not Rated
Colors on map represent co	ondition scores at 0.10-mile	e intervals. Se	e Appendix for definition	ns and formulas.
Inspection Date: 4/23/2021	Beginning Section MP	0		
Paved Length (Miles): 0.15	Section Length (MI)	0.15		
Surface Type: ASPHALT	Route Summary		• •	•
Roadway Condition Information				
Pavement Condition Rating (PCR)	20	20		
Surface Condition Rating (SCR)	20	20		
Roughness Condition Index (RCI)	N/A	N/A		
Distress Index Values				
Structural Crack Index	65	65		
Alligator Crack Index	100	100		
Longitudinal Crack Index	65	65		
Transverse Cracking Index	20	20		
Patching Index	98	98		
Rutting Index	99	99		
International Roughness Index (IRI)	N/A	N/A		
Lane & Width Information				
Number of Lanes	2	2		
Paved Width (ft)	27	27		
Lane Width (ft)	13.5	13.5

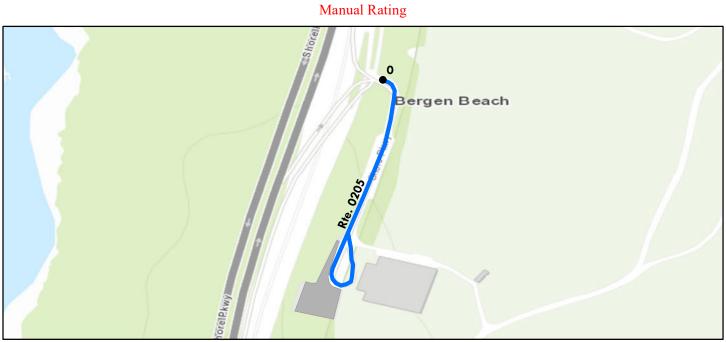
ROUTE 0205: RIDING ACADEMY ACCESS ROAD

Route Condition Legend – Pavement Condition Rating (PCR)						
Poor (0 - 60) Fair (6	1- 84) Good ((85 - 94)	Excellent (95 - 100)	Not Rated		
	See Appendix for def	initions and f	ormulas			
Inspection Date: 3/4/2021	Beginning Section MP	0.00				
Paved Length (Miles): 0.20	Section Length (MI)	0.20				
Surface Type: ASPHALT	Route Summary		•	•		
Roadway Condition Information						
Pavement Condition Rating (PCR)	97	97				
Surface Condition Rating (SCR)	97	97				
Roughness Condition Index (RCI)	N/A	N/A				
Distress Index Values						
Structural Crack Index	N/A	N/A				
Alligator Crack Index	97	97				
Longitudinal Crack Index	97	97				
Transverse Cracking Index	97	97				
Patching Index	97	97				
Rutting Index	97	97				
International Roughness Index (IRI)	N/A	N/A				
Lane & Width Information						
Number of Lanes	1	1				
Paved Width (ft)	11	11				
Lane Width (ft)	11	11

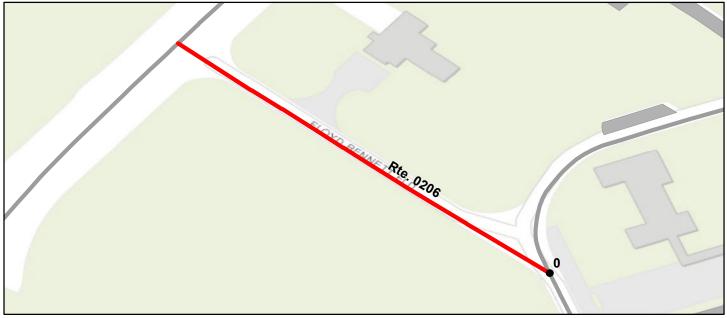
ROUTE 0206: TAXIWAY C ACCESS ROAD

Route C	Condition Legend – Pav	ement Condi	tion Rating (PCR)			
Poor (0 - 60) Fair (6	1- 84) Good ((85 - 94)	Excellent (95 - 100)	Not Rated		
Colors on map represent condition scores at 0.10-mile intervals. See Appendix for definitions and formulas.						
Inspection Date: 4/23/2021	Beginning Section MP	0				
Paved Length (Miles): 0.1	Section Length (MI)	0.1				
Surface Type: ASPHALT	Route Summary		•			
Roadway Condition Information						
Pavement Condition Rating (PCR)	17	17				
Surface Condition Rating (SCR)	17	17				
Roughness Condition Index (RCI)	N/A	N/A				
Distress Index Values						
Structural Crack Index	24	24				
Alligator Crack Index	100	100				
Longitudinal Crack Index	24	24				
Transverse Cracking Index	17	17				
Patching Index	100	100				
Rutting Index	96	96				
International Roughness Index (IRI)	N/A	N/A				
Lane & Width Information						
Number of Lanes	2	2				
Paved Width (ft)	24.8	24.8				
Lane Width (ft)	12.4	12.4

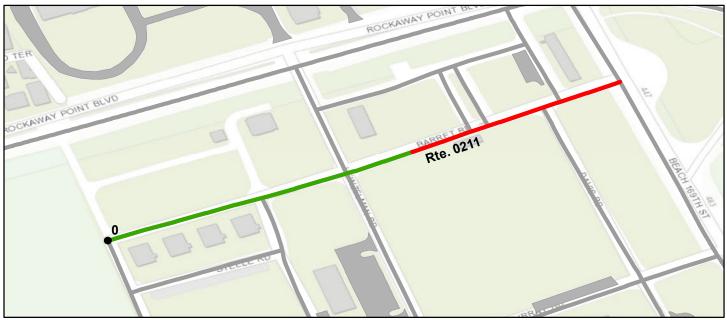
Gateway National Recreation Area ROUTE 0211: SOUTH BARRETT ROAD

Data Collection Vehicle (DCV) Rating

Route Condition Legend – Pavement Condition Rating (PCR)						
Poor (0 - 60) Fair (6	1- 84) Good ((85 - 94)	Excellent (95 - 100)	Not Rated		
Colors on map represent con	dition scores at 0.10-mile	intervals. Se	e Appendix for definition	ons and formulas.		
Inspection Date: 4/23/2021	Beginning Section MP	0				
Paved Length (Miles): 0.17	Section Length (MI)	0.17				
Surface Type: ASPHALT	Route Summary					
Roadway Condition Information						
Pavement Condition Rating (PCR)	53	53				
Surface Condition Rating (SCR)	88	88				
Roughness Condition Index (RCI)	N/A	N/A				
Distress Index Values						
Structural Crack Index	N/A	N/A				
Alligator Crack Index	N/A	N/A				
Longitudinal Crack Index	N/A	N/A				
Transverse Cracking Index	N/A	N/A				
Patching Index	N/A	N/A				
Rutting Index	N/A	N/A				
International Roughness Index (IRI)	N/A	N/A				
Lane & Width Information						
Number of Lanes	1	1				
Paved Width (ft)	15.5	15.5

NOTE: MANUALLY RATED CONCRETE SECTION

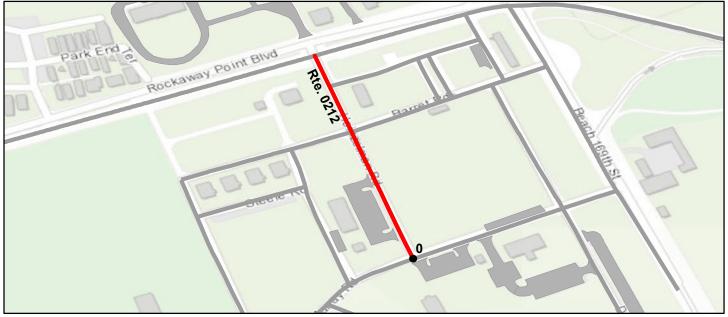
ROUTE 0212: HEINZELMAN ROAD

Route C	Condition Legend – Pav	ement Condi	tion Rating (PCI	R)	
Poor (0 - 60) Fair (6)	<mark>1- 84) Good (</mark>	(85 - 94)	Excellent (95 -	100) No	ot Rated
Colors on map represent condition scores at 0.10-mile intervals. See Appendix for definitions and formulas.					
Inspection Date: 4/23/2021	Beginning Section MP	0			
Paved Length (Miles): 0.12	Section Length (MI)	0.12			
Surface Type: ASPHALT	Route Summary			•	•
Roadway Condition Information					
Pavement Condition Rating (PCR)	0	0			
Surface Condition Rating (SCR)	0	0			
Roughness Condition Index (RCI)	N/A	N/A			
Distress Index Values					
Structural Crack Index	38	38			
Alligator Crack Index	95	95			
Longitudinal Crack Index	43	43			
Transverse Cracking Index	0	0			
Patching Index	99	99			
Rutting Index	86	86			
International Roughness Index (IRI)	N/A	N/A			
Lane & Width Information					
Number of Lanes	2	2			
Paved Width (ft)	19	19			
Lane Width (ft)	8.8	8.8

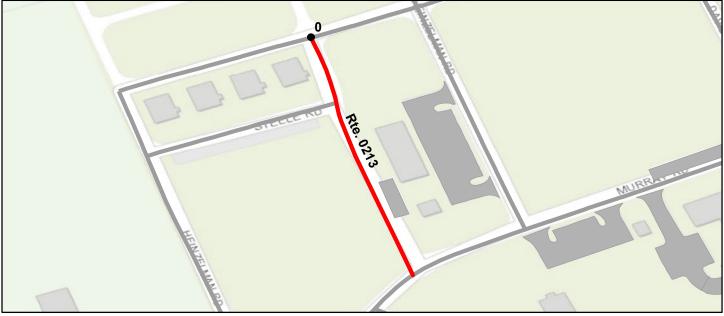
Gateway National Recreation Area ROUTE 0213: WORCESTER ROAD

Route C	Condition Legend – Pav	ement Condi	ition Rating (PCR)	
Poor (0 - 60) Fair (6	1- 84) Good ((85 - 94)	Excellent (95 - 100)	Not Rated
Colors on map represent con	dition scores at 0.10-mile	e intervals. Se	e Appendix for definitio	ns and formulas.
Inspection Date: 4/23/2021	Beginning Section MP	0		
Paved Length (Miles): 0.08	Section Length (MI)	0.08		
Surface Type: ASPHALT	Route Summary			
Roadway Condition Information				
Pavement Condition Rating (PCR)	0	0		
Surface Condition Rating (SCR)	0	0		
Roughness Condition Index (RCI)	N/A	N/A		
Distress Index Values				
Structural Crack Index	0	0		
Alligator Crack Index	80	80		
Longitudinal Crack Index	8	8		
Transverse Cracking Index	32	32		
Patching Index	99	99		
Rutting Index	93	93		
International Roughness Index (IRI)	N/A	N/A		
Lane & Width Information				
Number of Lanes	1	1		
Paved Width (ft)	14.9	14.9		
Lane Width (ft)	11.8	11.8

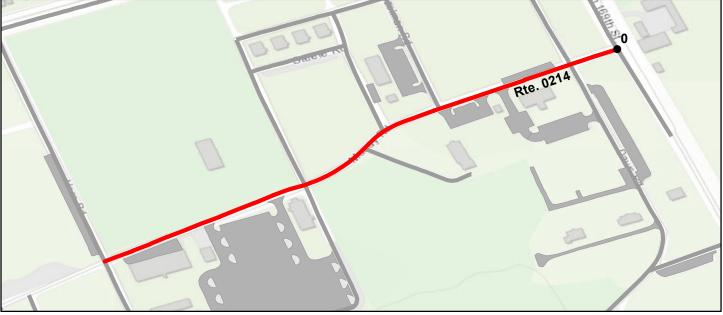
Gateway National Recreation Area ROUTE 0214: HAHN ROAD

Route C	Condition Legend – Pav	ement Condi	tion Rating (PCR)		
Poor (0 - 60) Fair (6	1- 84) Good (85 - 94)		Excellent (95 - 100)	Not Rated	
Colors on map represent condition scores at 0.10-mile intervals. See Appendix for definitions and formulas.					
Inspection Date: 4/23/2021	Beginning Section MP	0			
Paved Length (Miles): 0.29	Section Length (MI)	0.29			
Surface Type: ASPHALT	Route Summary				
Roadway Condition Information					
Pavement Condition Rating (PCR)	0	0			
Surface Condition Rating (SCR)	0	0			
Roughness Condition Index (RCI)	N/A	N/A			
Distress Index Values					
Structural Crack Index	15	15			
Alligator Crack Index	99	99			
Longitudinal Crack Index	16	16			
Transverse Cracking Index	0	0			
Patching Index	99	99			
Rutting Index	94	94			
International Roughness Index (IRI)	N/A	N/A			
Lane & Width Information					
Number of Lanes	2	2			
Paved Width (ft)	20.8	20.8			
Lane Width (ft)	9.8	9.8
