Final Report

Road Inventory and Condition Assessment of Paved Routes Gateway National Recreation Area

Federal Lands Highway Road Inventory Program Prepared By: Federal Highway Administration Eastern Federal Lands Highway Division Road Inventory Program (RIP)

Report Date: September 2022

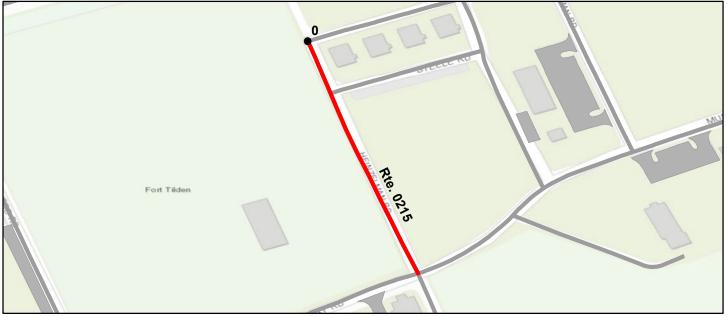
Gateway National Recreation Area ROUTE 0215: ATHLETIC DRIVE

Route C	Condition Legend – Pav	ement Condi	tion Rating (PCR	R)	
Poor (0 - 60) Fair (6	1- 84) Good (85 - 94)		Excellent (95 - 1	100) Not R	ated
Colors on map represent con	dition scores at 0.10-mile	e intervals. Se	e Appendix for det	finitions and formula	s.
Inspection Date: 4/23/2021	Beginning Section MP	0			
Paved Length (Miles): 0.1	Section Length (MI)	0.1			
Surface Type: ASPHALT	Route Summary				•
Roadway Condition Information					
Pavement Condition Rating (PCR)	36	36			
Surface Condition Rating (SCR)	36	36			
Roughness Condition Index (RCI)	N/A	N/A			
Distress Index Values					
Structural Crack Index	66	66			
Alligator Crack Index	100	100			
Longitudinal Crack Index	66	66			
Transverse Cracking Index	36	36			
Patching Index	99	99			
Rutting Index	96	96			
International Roughness Index (IRI)	N/A	N/A			
Lane & Width Information					
Number of Lanes	1	1			
Paved Width (ft)	14.1	14.1			
Lane Width (ft)	14.1	14.1

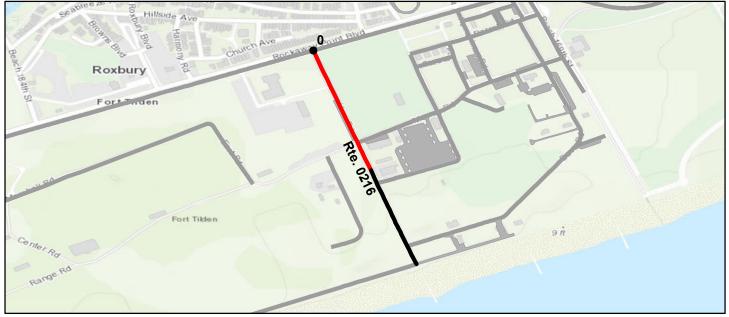
Gateway National Recreation Area ROUTE 0216: HERO ROAD

Data Collection Vehicle (DCV) Rating

Route C	Condition Legend – Pav	ement Condi	tion Rating (P	CR)			
Poor (0 - 60) Fair (6	1- 84) Good ((85 - 94)	Excellent (95	- 100)	Not Rated		
Colors on map represent con	dition scores at 0.10-mile	e intervals. Se	e Appendix for	definitions	and formulas.		
Inspection Date: 4/23/2021	Beginning Section MP	0					
Paved Length (Miles): 0.36	Section Length (MI)	0.36					
Surface Type: ASPHALT	Route Summary						
Roadway Condition Information							
Pavement Condition Rating (PCR)	29	29					
Surface Condition Rating (SCR)	29	29					
Roughness Condition Index (RCI)	N/A	N/A					
Distress Index Values							
Structural Crack Index	76	76					
Alligator Crack Index	100	100					
Longitudinal Crack Index	76	76					
Transverse Cracking Index	29	29					
Patching Index	99	99					
Rutting Index	98	98					
International Roughness Index (IRI)	N/A	N/A					
Lane & Width Information							
Number of Lanes	2	2					
Paved Width (ft)	19.5	19.5

NOTE: End of route is concrete starting at mile point 0.24.

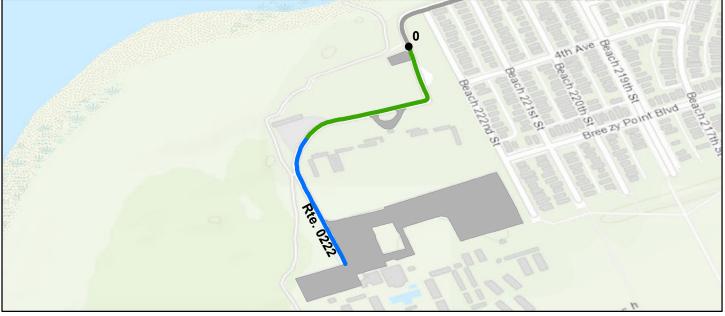
Gateway National Recreation Area ROUTE 0222: BREEZY POINT SURF CLUB ENTRANCE ROAD

Route Condition Legend – Pavement Condition Rating (PCR)						
Poor (0 - 60) Fair (6	61- 84) Good (85 - 94)		Excellent (95 -	100) Not Ra	Not Rated	
Colors on map represent con	dition scores at 0.10-mile	e intervals. Se	e Appendix for de	finitions and formulas		
Inspection Date: 4/23/2021	Beginning Section MP	0				
Paved Length (Miles): 0.38	Section Length (MI)	0.38				
Surface Type: ASPHALT	Route Summary			•	•	
Roadway Condition Information						
Pavement Condition Rating (PCR)	93	93				
Surface Condition Rating (SCR)	93	93				
Roughness Condition Index (RCI)	N/A	N/A				
Distress Index Values						
Structural Crack Index	100	100				
Alligator Crack Index	100	100				
Longitudinal Crack Index	100	100				
Transverse Cracking Index	98	98				
Patching Index	100	100				
Rutting Index	93	93				
International Roughness Index (IRI)	N/A	N/A				
Lane & Width Information						
Number of Lanes	2	2				
Paved Width (ft)	26.1	26.1

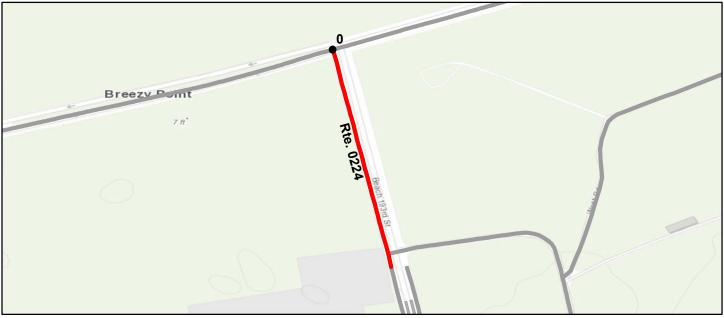
ROUTE 0224: BEACH 193RD STREET

Route	e Condition Legend – Pav	ement Condi	tion Rating (PCR)		
Poor (0 - 60) Fair	(61- 84) Good	61- 84) Good (85 - 94)		Not Rated	
Colors on map represent co	ondition scores at 0.10-mile	e intervals. Se	e Appendix for definitio	ns and formulas.	
Inspection Date: 4/23/2021	Beginning Section MP	0			
Paved Length (Miles): 0.2	Section Length (MI)	0.2			
Surface Type: ASPHALT	Route Summary		•		
Roadway Condition Information					
Pavement Condition Rating (PCR)	51	51			
Surface Condition Rating (SCR)	51	51			
Roughness Condition Index (RCI)	N/A	N/A			
Distress Index Values					
Structural Crack Index	61	61			
Alligator Crack Index	100	100			
Longitudinal Crack Index	61	61			
Transverse Cracking Index	51	51			
Patching Index	100	100			
Rutting Index	97	97			
International Roughness Index (IRI)	N/A	N/A			
Lane & Width Information					
Number of Lanes	2	2			
Paved Width (ft)	30.2	30.2			
Lane Width (ft)	15.1	15.1

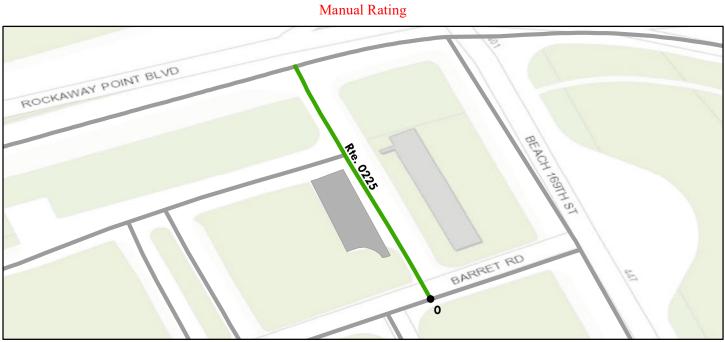
ROUTE 0225: POST OFFICE ROAD

Route Condition Legend – Pavement Condition Rating (PCR)							
Poor (0 - 60) Fai	r (61- 84) Good (1- 84) Good (85 - 94)		Not Rated			
See Appendix for definitions and formulas							
Inspection Date: 3/3/2021	Beginning Section MP	0.00					
Paved Length (Miles): 0.04	Section Length (MI)	0.04					
Surface Type: CONCRETE	Route Summary		• •	• •			
Roadway Condition Information							
Pavement Condition Rating (PCR)	90	90					
Surface Condition Rating (SCR)	90	90					
Roughness Condition Index (RCI)	N/A	N/A					
Distress Index Values							
Structural Crack Index	N/A	N/A					
Alligator Crack Index	N/A	N/A					
Longitudinal Crack Index	N/A	N/A					
Transverse Cracking Index	N/A	N/A					
Patching Index	N/A	N/A					
Rutting Index	N/A	N/A					
International Roughness Index (IRI)	N/A	N/A					
Lane & Width Information							
Number of Lanes	1	1					
Paved Width (ft)	15	15					
Lane Width (ft)	15	15

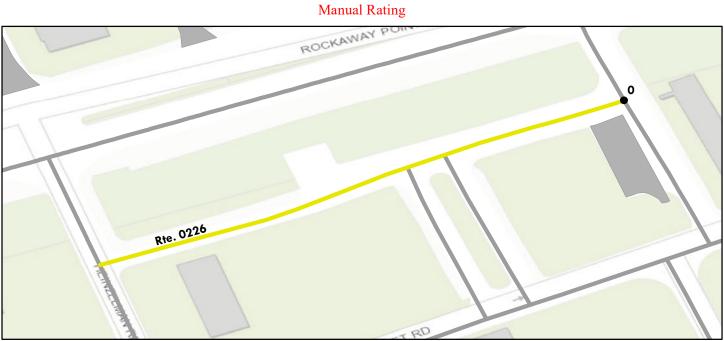
ROUTE 0226: NORTH BARETTE

Route Condition Legend – Pavement Condition Rating (PCR)						
Poor (0 - 60) Fair (6	Good (85 - 94)		Excellent (95 - 100)	Not Rated		
See Appendix for definitions and formulas						
Inspection Date: 3/3/2021	Beginning Section MP	0.00				
Paved Length (Miles): 0.07	Section Length (MI)	0.07				
Surface Type: CONCRETE	Route Summary			• •		
Roadway Condition Information						
Pavement Condition Rating (PCR)	73	73				
Surface Condition Rating (SCR)	73	73				
Roughness Condition Index (RCI)	N/A	N/A				
Distress Index Values						
Structural Crack Index	N/A	N/A				
Alligator Crack Index	N/A	N/A				
Longitudinal Crack Index	N/A	N/A				
Transverse Cracking Index	N/A	N/A				
Patching Index	N/A	N/A				
Rutting Index	N/A	N/A				
International Roughness Index (IRI)	N/A	N/A				
Lane & Width Information						
Number of Lanes	2	2				
Paved Width (ft)	20	20				
Lane Width (ft)	10	10

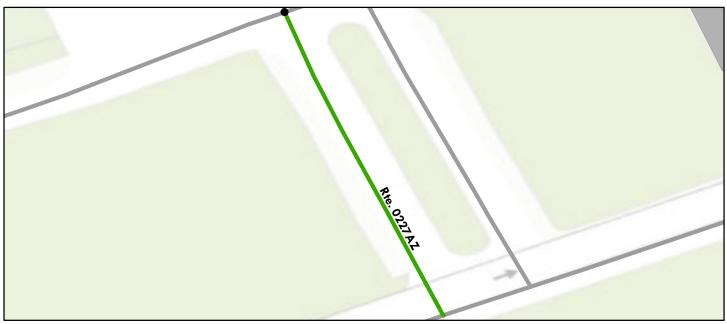
Gateway National Recreation Area ROUTE 0227AZ: ROMERO ROAD WEST

Subcomponent of Route GATE-0227ZZ Manual Rating

Route	Condition Legend – Pave	ement Condi	ition Rating (PCR)				
Poor (0 - 60) Fair (<mark>61- 84) Good (</mark>	85 - 94)	Excellent (95 - 100)	Not Rated			
See Appendix for definitions and formulas							
Inspection Date: 3/3/2021	Beginning Section MP	0.00					
Paved Length (Miles): 0.03	Section Length (MI)	0.03					
Surface Type: CONCRETE	Route Summary						
Roadway Condition Information							
Pavement Condition Rating (PCR)	90	90					
Surface Condition Rating (SCR)	90	90					
Roughness Condition Index (RCI)	N/A	N/A					
Distress Index Values							
Structural Crack Index	N/A	N/A					
Alligator Crack Index	N/A	N/A					
Longitudinal Crack Index	N/A	N/A					
Transverse Cracking Index	N/A	N/A					
Patching Index	N/A	N/A					
Rutting Index	N/A	N/A					
International Roughness Index (IRI)	N/A	N/A					
Lane & Width Information							
Number of Lanes	2	2					
Paved Width (ft)	20	20					
Lane Width (ft)	10	10

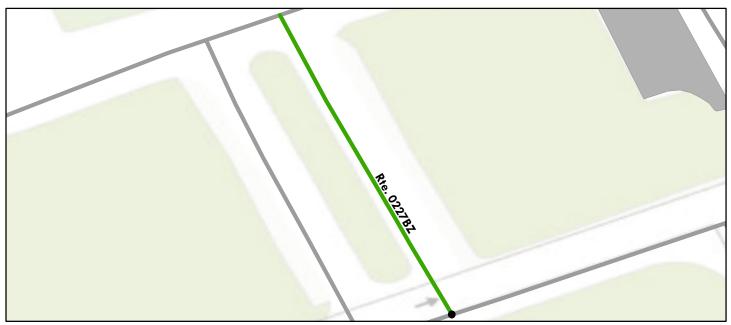
Gateway National Recreation Area ROUTE 0227BZ: ROMERO ROAD EAST

Subcomponent of Route GATE-0227ZZ Manual Rating

F	Route Condition Legend –	Pavement Cond	ition Rating (PCR)				
Poor (0 - 60)	Fair (61- 84) G	ood (85 - 94)	Excellent (95 - 100)	Not Rated			
See Appendix for definitions and formulas							
Inspection Date: 3/3/2021	Beginning Section	MP 0.00					
Paved Length (Miles): 0.03	Section Length (N	II) 0.03					
Surface Type: CONCRET	TE Route Summary		•	•			
Roadway Condition Information							
Pavement Condition Rating (PCR	.) 90	90					
Surface Condition Rating (SCR)	90	90					
Roughness Condition Index (RCI)	N/A	N/A					
Distress Index Values							
Structural Crack Index	N/A	N/A					
Alligator Crack Index	N/A	N/A					
Longitudinal Crack Index	N/A	N/A					
Transverse Cracking Index	N/A	N/A					
Patching Index	N/A	N/A					
Rutting Index	N/A	N/A					
International Roughness Index (II	RI) N/A	N/A					
Lane & Width Information							
Number of Lanes	2	2					
Paved Width (ft)	20	20					
Lane Width (ft)	10	10

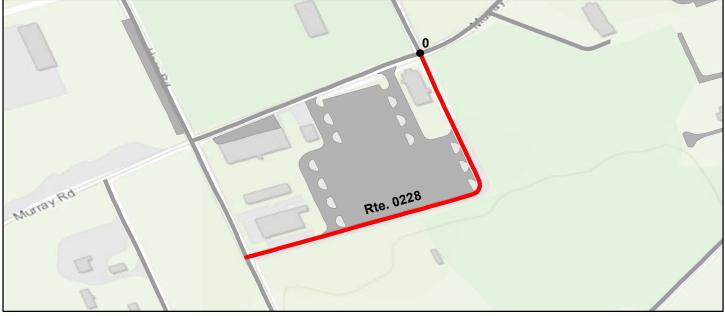
ROUTE 0228: THEATER ROAD

Rout	e Condition Legend – Pav	ement Cond	ition Rating (PCR)	
Poor (0 - 60) Fair	(61- 84) Good	(85 - 94)	Excellent (95 - 100)	Not Rated
Colors on map represent c	ondition scores at 0.10-mile	e intervals. Se	e Appendix for definition	ns and formulas.
Inspection Date: 4/23/2021	Beginning Section MP	0		
Paved Length (Miles): 0.19	Section Length (MI)	0.19		
Surface Type: ASPHALT	Route Summary			• •
Roadway Condition Information				
Pavement Condition Rating (PCR)	13	13		
Surface Condition Rating (SCR)	13	13		
Roughness Condition Index (RCI)	N/A	N/A		
Distress Index Values				
Structural Crack Index	54	54		
Alligator Crack Index	100	100		
Longitudinal Crack Index	54	54		
Transverse Cracking Index	13	13		
Patching Index	100	100		
Rutting Index	95	95		
International Roughness Index (IRI)	N/A	N/A		
Lane & Width Information				
Number of Lanes	2	2		
Paved Width (ft)	23.4	23.4		
Lane Width (ft)	11.7	11.7

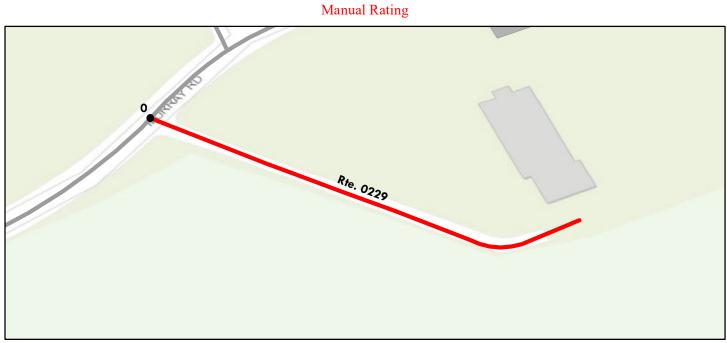
ROUTE 0229: CHAPEL ROAD

Route Condition Legend – Pavement Condition Rating (PCR)								
Poor (0 - 60) F a	ir (61- 84) Good	(85 - 94)	Excellent (95 - 100)	Not Rated				
	See Appendix for definitions and formulas							
Inspection Date: 3/3/2021	Beginning Section MP	0.00						
Paved Length (Miles): 0.06	Section Length (MI)	0.06						
Surface Type: ASPHALT	Route Summary							
Roadway Condition Information								
Pavement Condition Rating (PCR)	30	30						
Surface Condition Rating (SCR)	30	30						
Roughness Condition Index (RCI)	N/A	N/A						
Distress Index Values								
Structural Crack Index	N/A	N/A						
Alligator Crack Index	30	30						
Longitudinal Crack Index	90	90						
Transverse Cracking Index	90	90						
Patching Index	97	97						
Rutting Index	97	97						
International Roughness Index (IRI)) N/A	N/A						
Lane & Width Information								
Number of Lanes	1	1						
Paved Width (ft)	10	10						
Lane Width (ft)	10	10

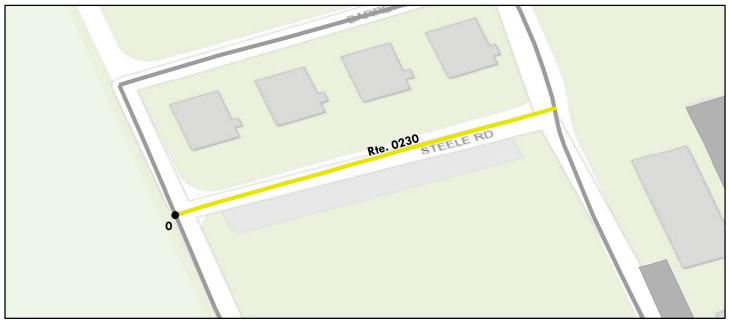
ROUTE 0230: STEELE ROAD

Manual Rating

Route Condition Legend – Pavement Condition Rating (PCR)							
Poor (0 - 60) Fair	(61- 84) Good	1- 84) Good (85 - 94)		Not Rated			
See Appendix for definitions and formulas							
Inspection Date: 3/3/2021	Beginning Section MP	0.00					
Paved Length (Miles): 0.05	Section Length (MI)	0.05					
Surface Type: ASPHALT	Route Summary						
Roadway Condition Information							
Pavement Condition Rating (PCR)	73	73					
Surface Condition Rating (SCR)	73	73					
Roughness Condition Index (RCI)	N/A	N/A					
Distress Index Values							
Structural Crack Index	N/A	N/A					
Alligator Crack Index	97	97					
Longitudinal Crack Index	90	90					
Transverse Cracking Index	73	73					
Patching Index	90	90					
Rutting Index	97	97					
International Roughness Index (IRI)	N/A	N/A					
Lane & Width Information							
Number of Lanes	2	2					
Paved Width (ft)	20	20					
Lane Width (ft)	10	10

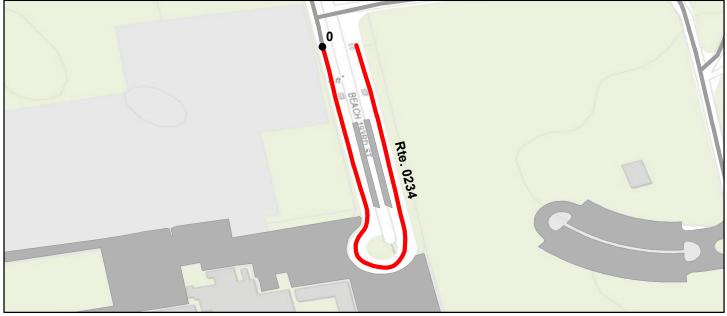
Gateway National Recreation Area ROUTE 0234: SILVER GULL BEACH CLUB ENTRANCE ROAD

Route C	Condition Legend – Pav	ement Condi	tion Rating (PCR)	
Poor (0 - 60) Fair (6	1- 84) Good ((85 - 94)	Excellent (95 - 10	0) Not Rated
Colors on map represent con	dition scores at 0.10-mile	e intervals. Se	e Appendix for defir	itions and formulas.
Inspection Date: 4/23/2021	Beginning Section MP	0		
Paved Length (Miles): 0.19	Section Length (MI)	0.19		
Surface Type: ASPHALT	Route Summary		•	
Roadway Condition Information				
Pavement Condition Rating (PCR)	1	1		
Surface Condition Rating (SCR)	1	1		
Roughness Condition Index (RCI)	N/A	N/A		
Distress Index Values				
Structural Crack Index	33	33		
Alligator Crack Index	100	100		
Longitudinal Crack Index	33	33		
Transverse Cracking Index	1	1		
Patching Index	97	97		
Rutting Index	91	91		
International Roughness Index (IRI)	N/A	N/A		
Lane & Width Information				
Number of Lanes	1	1		
Paved Width (ft)	32.6	32.6		
Lane Width (ft)	19.3	19.3

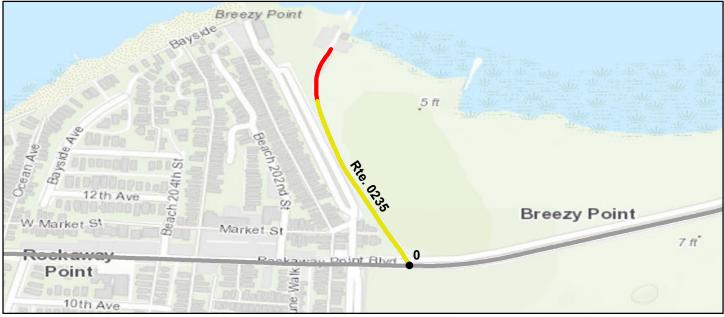
Gateway National Recreation Area ROUTE 0235: ROCKAWAY POINT YACHT CLUB ROAD

Route Condition Legend – Pavement Condition Rating (PCR)					
Poor (0 - 60) Fair (6	1- 84) Good ((85 - 94)	Excellent (95 - 100)	Not Rated	
Colors on map represent con	dition scores at 0.10-mile	e intervals. Se	e Appendix for definiti	ons and formulas.	
Inspection Date: 4/23/2021	Beginning Section MP	0			
Paved Length (Miles): 0.26	Section Length (MI)	0.26			
Surface Type: ASPHALT	Route Summary				
Roadway Condition Information					
Pavement Condition Rating (PCR)	51	51			
Surface Condition Rating (SCR)	51	51			
Roughness Condition Index (RCI)	N/A	N/A			
Distress Index Values					
Structural Crack Index	77	77			
Alligator Crack Index	98	98			
Longitudinal Crack Index	79	79			
Transverse Cracking Index	51	51			
Patching Index	100	100			
Rutting Index	93	93			
International Roughness Index (IRI)	N/A	N/A			
Lane & Width Information					
Number of Lanes	1	1			
Paved Width (ft)	14.4	14.4			
Lane Width (ft)	14.4	14.4

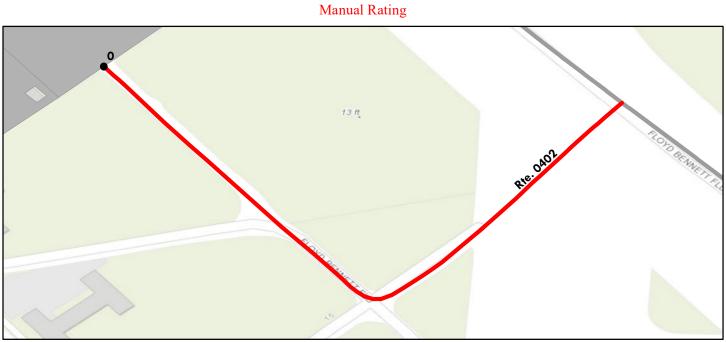
ROUTE 0402: COMMUNITY GARDEN ACCESS ROAD

Route Condition Legend – Pavement Condition Rating (PCR)							
Poor (0 - 60) Fair (6	61- 84) Good (1- 84) Good (85 - 94)		Not Rated			
See Appendix for definitions and formulas							
Inspection Date: 3/4/2021	Beginning Section MP	0.00					
Paved Length (Miles): 0.24	Section Length (MI)	0.24					
Surface Type: ASPHALT	Route Summary			• •			
Roadway Condition Information							
Pavement Condition Rating (PCR)	53	53					
Surface Condition Rating (SCR)	53	53					
Roughness Condition Index (RCI)	N/A	N/A					
Distress Index Values							
Structural Crack Index	N/A	N/A					
Alligator Crack Index	53	53					
Longitudinal Crack Index	90	90					
Transverse Cracking Index	90	90					
Patching Index	97	97					
Rutting Index	97	97					
International Roughness Index (IRI)	N/A	N/A					
Lane & Width Information							
Number of Lanes	1	1					
Paved Width (ft)	24	24					
Lane Width (ft)	24	24

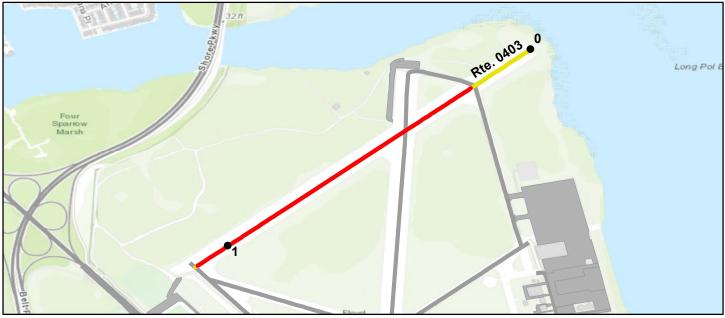
ROUTE 0403: RUNWAY C

Data Collection Vehicle (DCV) Rating

Route	Condition Legend – Pav	ement Condi	tion Rating (PCR)		
Poor (0 - 60) Fair (61- 84) Good (8		(85 - 94)	Excellent (9	95 - 100)	Not Rated	
Colors on map represent co	ndition scores at 0.10-mile	e intervals. Se	e Appendix fo	r definitions	and formulas.	
Inspection Date: 4/23/2021	Beginning Section MP	0	1			
Paved Length (Miles): 1.1	Section Length (MI)	1	0.1			
Surface Type: ASPHALT	Route Summary				• •	
Roadway Condition Information						
Pavement Condition Rating (PCR)	23	27	20			
Surface Condition Rating (SCR)	N/A	0	11			
Roughness Condition Index (RCI)	N/A	67	34			
Distress Index Values						
Structural Crack Index	N/A	0	11			
Alligator Crack Index	N/A	100	100			
Longitudinal Crack Index	N/A	0	11			
Transverse Cracking Index	N/A	0	22			
Patching Index	N/A	100	100			
Rutting Index	N/A	94	94			
International Roughness Index (IRI)	N/A	212	379			
Lane & Width Information						
Number of Lanes	4	4	4			
Paved Width (ft)	48	48	48

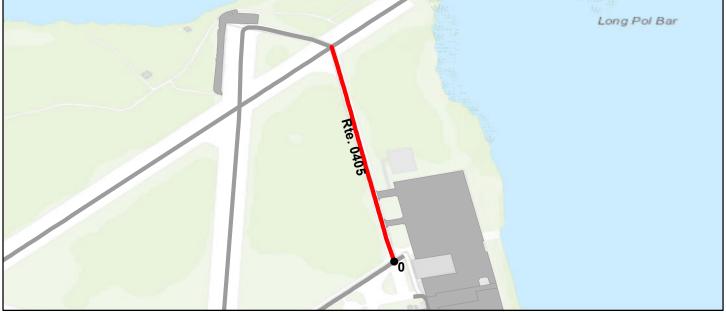
ROUTE 0405: TAXIWAY B

R	oute Condition Legend – Pa	vement Cond	ition Rating (PCR)	
Poor (0 - 60)	air (61- 84) Good	(85 - 94)	Excellent (95 - 100)	Not Rated
Colors on map represe	nt condition scores at 0.10-mil	e intervals. Se	e Appendix for definition	ns and formulas.
Inspection Date: 4/23/2021	Beginning Section MI	P 0		
Paved Length (Miles): 0.5	Section Length (MI)	0.5		
Surface Type: ASPHALT	Route Summary		•	•
Roadway Condition Information				
Pavement Condition Rating (PCR)	31	31		
Surface Condition Rating (SCR)	29	29		
Roughness Condition Index (RCI)	34	34		
Distress Index Values				
Structural Crack Index	30	30		
Alligator Crack Index	100	100		
Longitudinal Crack Index	30	30		
Transverse Cracking Index	29	29		
Patching Index	98	98		
Rutting Index	91	91		
International Roughness Index (IR	I) 380	380		
Lane & Width Information				
Number of Lanes	4	4		
Paved Width (ft)	48	48		
Lane Width (ft)	35.2	35.2

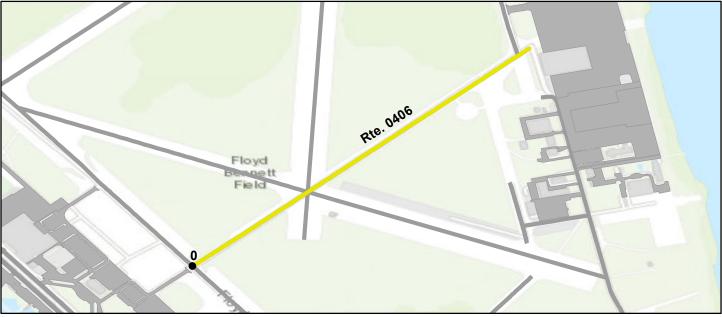
ROUTE 0406: TAXIWAY A

Data Collection Vehicle (DCV) Rating

Route Condition Legen	d – Pavement Cond	lition Rating (PCR)	
Poor (0 - 60)	Fair (61- 84)	Good (85 - 94)	Excellent (95 - 100)	Not Rated
Colors on map repres	sent condition scores at 0	.10-mile intervals. S	ee Appendix for definition	ns and formulas.
Inspection Date: 4/23/2021	Beginning Sect	ion MP 0		
Paved Length (Miles): 0.69	Section Length	(MI) 0.69		
Surface Type: CONCRE	TE Route Summar	·y	• •	
Roadway Condition Information	n			
Pavement Condition Rating (PC	R) 73	73		
Surface Condition Rating (SCR)	N/A	N/A		
Roughness Condition Index (RCI)	N/A	N/A		
Distress Index Values				
Structural Crack Index	N/A	N/A		
Alligator Crack Index	N/A	N/A		
Longitudinal Crack Index	N/A	N/A		
Transverse Cracking Index	N/A	N/A		
Patching Index	N/A	N/A		
Rutting Index	N/A	N/A		
International Roughness Index (I	(RI) N/A	N/A		
Lane & Width Information				
Number of Lanes	2	2		
Paved Width (ft)	48	48		
Lane Width (ft)	71.5	71.5

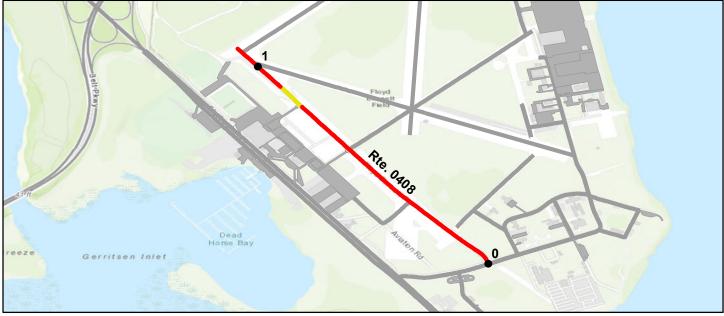
ROUTE 0408: RUNWAY A (SOUTHERN RUNWAY)

Rout	e Condition Legend – Pav	ement Condi	ition Rating (P	PCR)	
Poor (0 - 60) Fair	Poor (0 - 60) Fair (61- 84) Good (8		Excellent (9	5 - 100)	Not Rated
Colors on map represent c	ondition scores at 0.10-mile	e intervals. Se	e Appendix for	definitions	and formulas.
Inspection Date: 4/23/2021	Beginning Section MP	0	1		
Paved Length (Miles): 1.09	Section Length (MI)	1	0.09		
Surface Type: ASPHALT	Route Summary				
Roadway Condition Information					
Pavement Condition Rating (PCR)	42	39	46		
Surface Condition Rating (SCR)	28	21	56		
Roughness Condition Index (RCI)	63	67	31		
Distress Index Values					
Structural Crack Index	28	21	100		
Alligator Crack Index	100	100	100		
Longitudinal Crack Index	28	21	100		
Transverse Cracking Index	48	43	100		
Patching Index	100	100	100		
Rutting Index	80	82	56		
International Roughness Index (IRI)	228	213	398		
Lane & Width Information					
Number of Lanes	4	4	2		
Paved Width (ft)	86.5	82.6	129.4

Lane Width (ft)	23.2	19	64.7

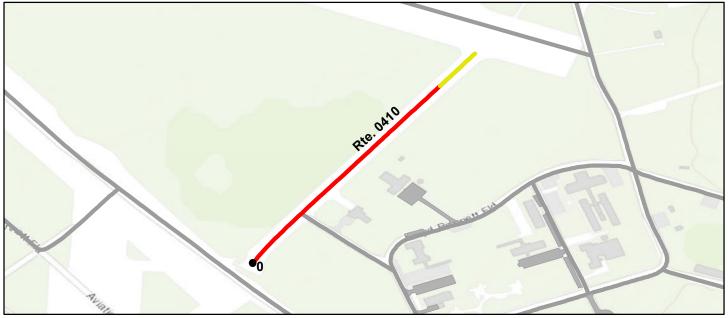
ROUTE 0410: TAXIWAY C

Route Condition Legend – Pa	vement Cond	ition Rating (PCR)	
Poor (0 - 60)	Fair (61- 84) Good	(85 - 94)	Excellent (95 - 100)	Not Rated
Colors on map repres	ent condition scores at 0.10-mi	le intervals. Se	e Appendix for definition	as and formulas.
Inspection Date: 4/23/2021	Beginning Section M	P 0		
Paved Length (Miles): 0.35	Section Length (MI)	0.35		
Surface Type: ASPHALT	Route Summary		•	
Roadway Condition Information	L			
Pavement Condition Rating (PCI	R) 26	26		
Surface Condition Rating (SCR)	26	26		
Roughness Condition Index (RCI)	N/A	N/A		
Distress Index Values				
Structural Crack Index	26	26		
Alligator Crack Index	100	100		
Longitudinal Crack Index	26	26		
Transverse Cracking Index	51	51		
Patching Index	100	100		
Rutting Index	94	94		
International Roughness Index (I	RI) N/A	N/A		
Lane & Width Information				
Number of Lanes	4	4		
Paved Width (ft)	48	48		
Lane Width (ft)	8.6	8.6

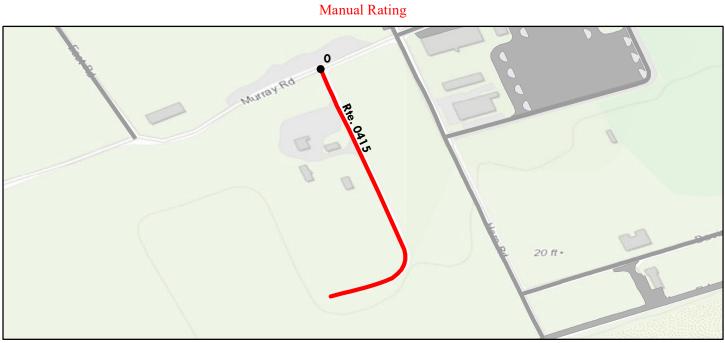
ROUTE 0415: NIKE MAINTENANCE ROAD

Route Condition Legend – Pavement Condition Rating (PCR)							
Poor (0 - 60) Fair (61- 84) Good ((85 - 94)	Excellent (95 - 100)	Not Rated			
See Appendix for definitions and formulas							
Inspection Date: 3/3/2021	Beginning Section MP	0.00					
Paved Length (Miles): 0.18	Section Length (MI)	0.18					
Surface Type: ASPHALT	Route Summary						
Roadway Condition Information							
Pavement Condition Rating (PCR)	53	53					
Surface Condition Rating (SCR)	53	53					
Roughness Condition Index (RCI)	N/A	N/A					
Distress Index Values							
Structural Crack Index	N/A	N/A					
Alligator Crack Index	53	53					
Longitudinal Crack Index	73	73					
Transverse Cracking Index	73	73					
Patching Index	90	90					
Rutting Index	90	90					
International Roughness Index (IRI)	N/A	N/A					
Lane & Width Information							
Number of Lanes	2	2					
Paved Width (ft)	20	20					
Lane Width (ft)	10	10

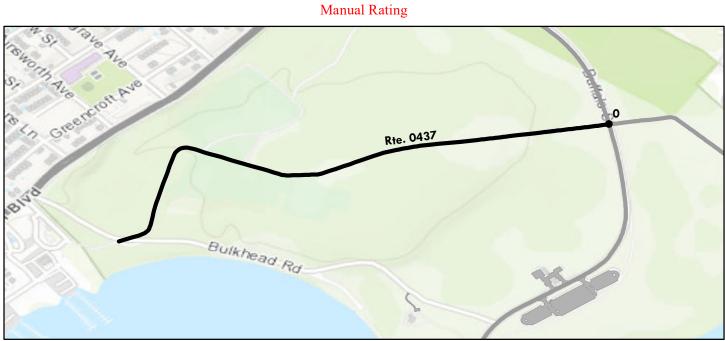
ROUTE 0437: ACCESS TO ATHLETIC FIELD ROAD

Route Condition Legend – Pavement Condition Rating (PCR)								
Poor (0 - 60) Fair (0	61- 84) Good (85 - 94)	Excellent (95 - 100)	Not Rated				
See Appendix for definitions and formulas								
Inspection Date: 3/4/2021	Beginning Section MP	0.00						
Paved Length (Miles): 0.89	Section Length (MI)	0.89						
Surface Type: ASPHALT	Route Summary		•	•				
Roadway Condition Information								
Pavement Condition Rating (PCR)	N/A	N/A						
Surface Condition Rating (SCR)	N/A	N/A						
Roughness Condition Index (RCI)	N/A	N/A						
Distress Index Values								
Structural Crack Index	N/A	N/A						
Alligator Crack Index	N/A	N/A						
Longitudinal Crack Index	N/A	N/A						
Transverse Cracking Index	N/A	N/A						
Patching Index	N/A	N/A						
Rutting Index	N/A	N/A						
International Roughness Index (IRI)	N/A	N/A						
Lane & Width Information								
Number of Lanes	1	1						
Paved Width (ft)	15	15						
Lane Width (ft)	15	15

NOTE: NOT COLLECTED DUE TO RADIATION ZONE. HAZARDOUS AREA, MENTIONED BY LOCAL PARK POLICE AND POSTED SIGNAGE TO KEEP OUT.

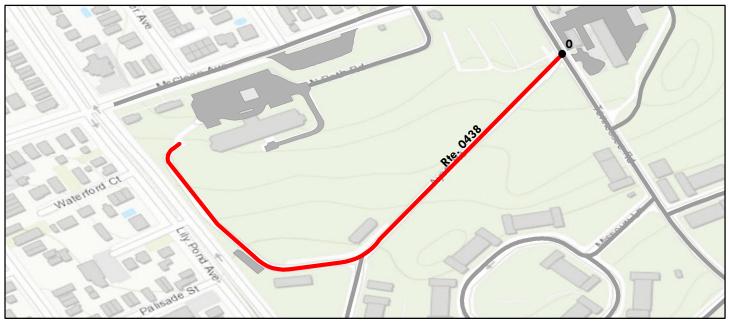
ROUTE 0438: AYERS ROAD

Manual Rating

Route C	Route Condition Legend – Pavement Condition Rating (PCR)						
Poor (0 - 60) Fair (6)	1- 84) Good ((85 - 94)	Excellent (95 - 100)	Not Rated			
See Appendix for definitions and formulas							
Inspection Date: 3/5/2021	Beginning Section MP	0.00					
Paved Length (Miles): 0.31	Section Length (MI)	0.31					
Surface Type: ASPHALT	Route Summary						
Roadway Condition Information							
Pavement Condition Rating (PCR)	30	30					
Surface Condition Rating (SCR)	30	30					
Roughness Condition Index (RCI)	N/A	N/A					
Distress Index Values							
Structural Crack Index	N/A	N/A					
Alligator Crack Index	30	30					
Longitudinal Crack Index	73	73					
Transverse Cracking Index	73	73					
Patching Index	73	73					
Rutting Index	90	90					
International Roughness Index (IRI)	N/A	N/A					
Lane & Width Information							
Number of Lanes	1	1					
Paved Width (ft)	20.2	20.2					
Lane Width (ft)	20.2	20.2

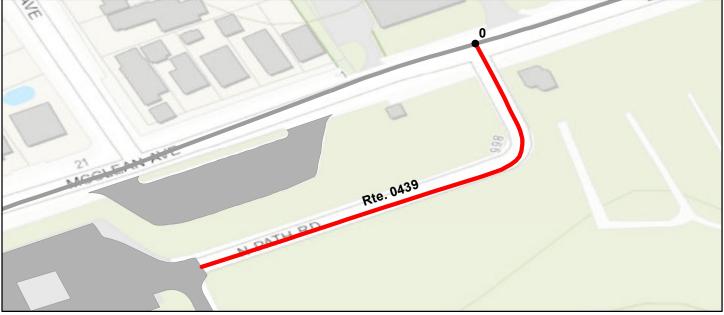
ROUTE 0439: PATH ROAD (NAVY LODGE)

Route Condition Legend – Pavement Condition Rating (PCR)						
Poor (0 - 60) Fair (6	1- 84) Good ((85 - 94)	Excellent (95 -	100)	Not Rated	
Colors on map represent con	dition scores at 0.10-mile	e intervals. Se	e Appendix for de	finitions and for	rmulas.	
Inspection Date: 4/24/2021	Beginning Section MP	0				
Paved Length (Miles): 0.09	Section Length (MI)	0.09				
Surface Type: ASPHALT	Route Summary			•	•	
Roadway Condition Information						
Pavement Condition Rating (PCR)	44	44				
Surface Condition Rating (SCR)	44	44				
Roughness Condition Index (RCI)	N/A	N/A				
Distress Index Values						
Structural Crack Index	44	44				
Alligator Crack Index	100	100				
Longitudinal Crack Index	44	44				
Transverse Cracking Index	59	59				
Patching Index	99	99				
Rutting Index	87	87				
International Roughness Index (IRI)	N/A	N/A				
Lane & Width Information						
Number of Lanes	2	2				
Paved Width (ft)	22.9	22.9				
Lane Width (ft)	10.9	10.9

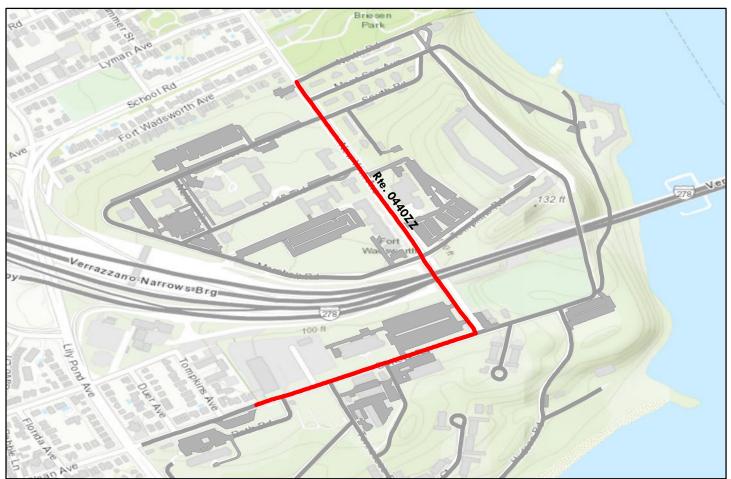
Gateway National Recreation Area ROUTE 0440ZZ: NY AVENUE / BATTERY ROAD

Summary Route

Note: The weighted average summary PCR value is calculated from only the sections of road where the PCR was collected. The overall PCR for the summary route may not reflect individual subcomponent ratings.

Route C	Condition Legend –	Pavement Cond	lition Rating (PCR)	
Poor (0 - 60) Fair (61		<mark>1- 84) Ga</mark>	od (85 - 94)	Excellent (95 - 100)	Not Rated
		See Appendix for	definitions and	formulas	
Inspection Date:	4/24/2021				
Paved Length (Mile	es): 0.65				
Surface Type:	ASPHALT	Route Summary			•
Roadway Condition	n Information				
Pavement Conditio	on Rating (PCR)	48			
Lane & Width Info	rmation				
Number of Lanes		2			
Paved Width (ft)		27.9			
Lane Width (ft)		14.7

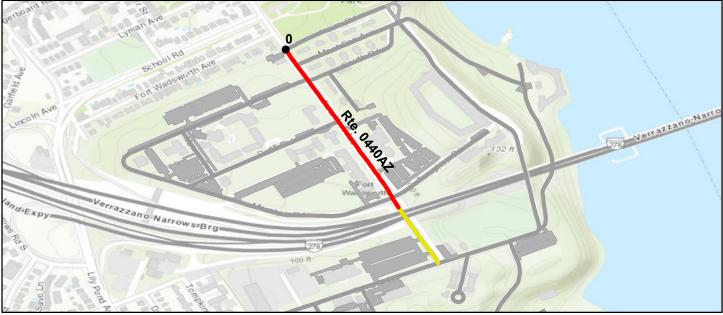
ROUTE 0440AZ: NY AVENUE

Subcomponent of Route GATE-0440ZZ Data Collection Vehicle (DCV) Rating

Route Condition Legend – Pavement Condition Rating (PCR)						
Poor (0 - 60) Fair (6	1- 84) Good ((85 - 94)	Excellent (95	5 - 100)	Not Ra	ted
Colors on map represent con	dition scores at 0.10-mile	e intervals. Se	e Appendix for	definitions	and formulas.	
Inspection Date: 4/24/2021	Beginning Section MP	0				
Paved Length (Miles): 0.4	Section Length (MI)	0.4				
Surface Type: ASPHALT	Route Summary					
Roadway Condition Information						
Pavement Condition Rating (PCR)	52	52				
Surface Condition Rating (SCR)	52	52				
Roughness Condition Index (RCI)	N/A	N/A				
Distress Index Values						
Structural Crack Index	52	52				
Alligator Crack Index	99	99				
Longitudinal Crack Index	53	53				
Transverse Cracking Index	76	76				
Patching Index	100	100				
Rutting Index	98	98				
International Roughness Index (IRI)	N/A	N/A				
Lane & Width Information						
Number of Lanes	2	2				
Paved Width (ft)	27	27				
Lane Width (ft)	14.4	14.4

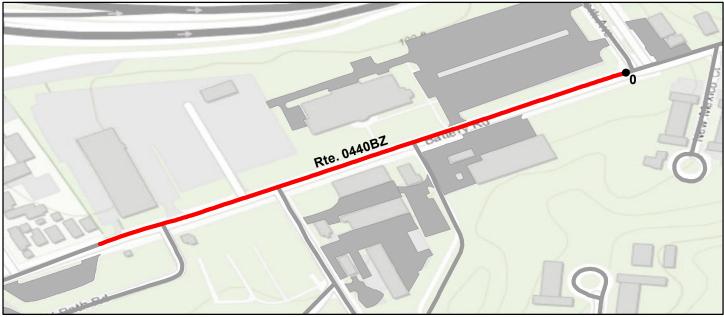
Gateway National Recreation Area ROUTE 0440BZ: BATTERY ROAD

Subcomponent of Route GATE-0440ZZ Data Collection Vehicle (DCV) Rating

R	oute Condition Legend – Pav	vement Cond	ition Rating (PCR)	
	, , , , , , , , , , , , , , , , , , ,	(85 - 94)	Excellent (95 - 100)	Not Rated
Colors on map represen	nt condition scores at 0.10-mil	e intervals. Se	ee Appendix for definition	ns and formulas.
Inspection Date: 4/24/2021	Beginning Section MF	0		
Paved Length (Miles): 0.25	Section Length (MI)	0.25		
Surface Type: ASPHALT	Route Summary		•	• •
Roadway Condition Information				
Pavement Condition Rating (PCR)	41	41		
Surface Condition Rating (SCR)	41	41		
Roughness Condition Index (RCI)	N/A	N/A		
Distress Index Values				
Structural Crack Index	41	41		
Alligator Crack Index	100	100		
Longitudinal Crack Index	41	41		
Transverse Cracking Index	49	49		
Patching Index	99	99		
Rutting Index	97	97		
International Roughness Index (IR	I) N/A	N/A		
Lane & Width Information				
Number of Lanes	2	2		
Paved Width (ft)	29.2	29.2		
Lane Width (ft)	15.1	15.1

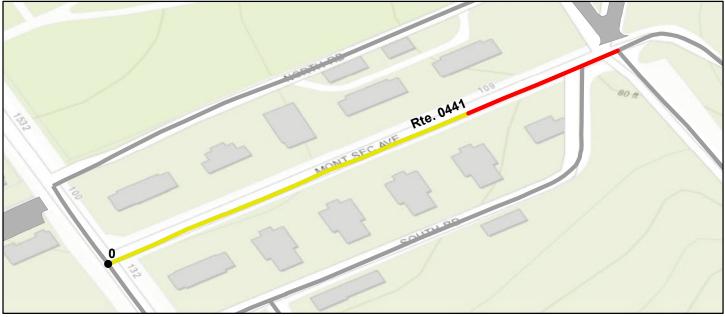
ROUTE 0441: MONT SEC AVENUE

Route Condition Legend – Pavement Condition Rating (PCR)						
Poor (0 - 60) Fair (6	1- 84) Good ((85 - 94)	Excellent (95 - 100)	Not Rated		
Colors on map represent con	dition scores at 0.10-mile	e intervals. Se	e Appendix for definiti	ons and formulas.		
Inspection Date: 4/24/2021	Beginning Section MP	0				
Paved Length (Miles): 0.14	Section Length (MI)	0.14				
Surface Type: ASPHALT	Route Summary					
Roadway Condition Information						
Pavement Condition Rating (PCR)	69	69				
Surface Condition Rating (SCR)	69	69				
Roughness Condition Index (RCI)	N/A	N/A				
Distress Index Values						
Structural Crack Index	69	69				
Alligator Crack Index	100	100				
Longitudinal Crack Index	69	69				
Transverse Cracking Index	89	89				
Patching Index	100	100				
Rutting Index	98	98				
International Roughness Index (IRI)	N/A	N/A				
Lane & Width Information						
Number of Lanes	2	2				
Paved Width (ft)	28.5	28.5				
Lane Width (ft)	14.1	14.1

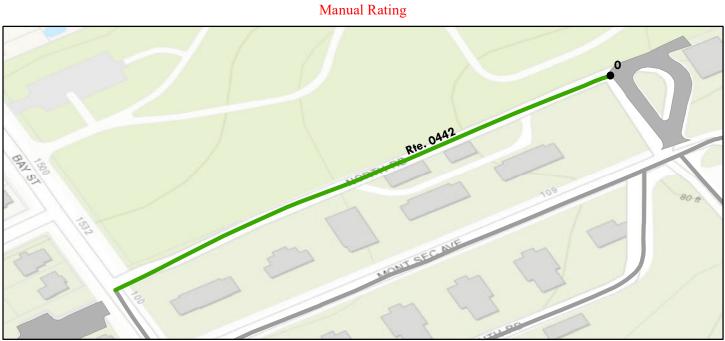
ROUTE 0442: NORTH ROAD

Route C	Route Condition Legend – Pavement Condition Rating (PCR)						
Poor (0 - 60) Fair (6)	1- 84) Good ((85 - 94)	Excellent (95 - 100)	Not Rated			
See Appendix for definitions and formulas							
Inspection Date: 3/5/2021	Beginning Section MP	0.00					
Paved Length (Miles): 0.14	Section Length (MI)	0.14					
Surface Type: ASPHALT	Route Summary						
Roadway Condition Information							
Pavement Condition Rating (PCR)	90	90					
Surface Condition Rating (SCR)	90	90					
Roughness Condition Index (RCI)	N/A	N/A					
Distress Index Values							
Structural Crack Index	N/A	N/A					
Alligator Crack Index	97	97					
Longitudinal Crack Index	90	90					
Transverse Cracking Index	90	90					
Patching Index	97	97					
Rutting Index	97	97					
International Roughness Index (IRI)	N/A	N/A					
Lane & Width Information							
Number of Lanes	2	2					
Paved Width (ft)	20	20					
Lane Width (ft)	10	10

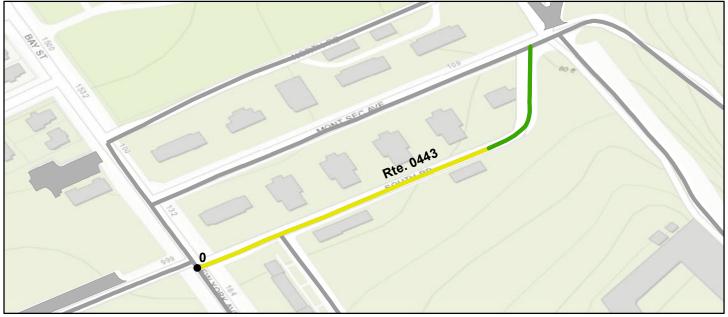
ROUTE 0443: SOUTH ROAD

Route Condition Legend – Pavement Condition Rating (PCR)						
Poor (0 - 60) Fair (6)	1- 84) Good ((85 - 94)	Excellent (95	- 100)	Not Ra	ted
Colors on map represent cond	lition scores at 0.10-mile	e intervals. Se	e Appendix for a	definitions	and formulas.	
Inspection Date: 4/24/2021	Beginning Section MP	0				
Paved Length (Miles): 0.14	Section Length (MI)	0.14				
Surface Type: ASPHALT	Route Summary					
Roadway Condition Information						
Pavement Condition Rating (PCR)	82	82				
Surface Condition Rating (SCR)	82	82				
Roughness Condition Index (RCI)	N/A	N/A				
Distress Index Values						
Structural Crack Index	87	87				
Alligator Crack Index	99	99				
Longitudinal Crack Index	88	88				
Transverse Cracking Index	82	82				
Patching Index	100	100				
Rutting Index	95	95				
International Roughness Index (IRI)	N/A	N/A				
Lane & Width Information						
Number of Lanes	2	2				
Paved Width (ft)	22	22				
Lane Width (ft)	11	11

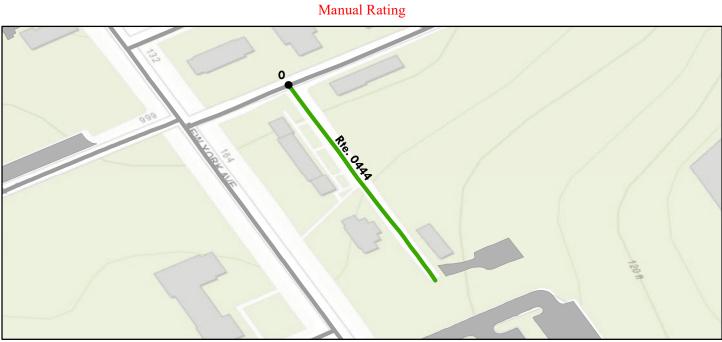
ROUTE 0444: CLIFTON ROAD

Route Condition Legend – Pavement Condition Rating (PCR)								
Poor (0 - 60) Fair (61- 84) Good	(85 - 94)	Excellent (95 - 100)	Not Rated				
	See Appendix for definitions and formulas							
Inspection Date: 3/5/2021	Beginning Section MP	0.00						
Paved Length (Miles): 0.07	Section Length (MI)	0.07						
Surface Type: ASPHALT	Route Summary		•	• •				
Roadway Condition Information								
Pavement Condition Rating (PCR)	90	90						
Surface Condition Rating (SCR)	90	90						
Roughness Condition Index (RCI)	N/A	N/A						
Distress Index Values								
Structural Crack Index	N/A	N/A						
Alligator Crack Index	97	97						
Longitudinal Crack Index	90	90						
Transverse Cracking Index	90	90						
Patching Index	97	97						
Rutting Index	97	97						
International Roughness Index (IRI)	N/A	N/A						
Lane & Width Information								
Number of Lanes	2	2						
Paved Width (ft)	20	20						
Lane Width (ft)	10	10

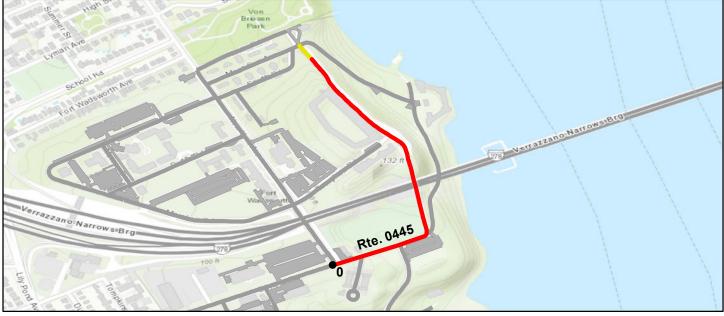
Gateway National Recreation Area ROUTE 0445: HUDSON ROAD / STATEN ISLAND

Route Condition Legend – Pavement Condition Rating (PCR)							
Poor (0 - 60) Fair (6	1- 84) Good ((85 - 94)	Excellent (95 - 10	0) Not Rated			
Colors on map represent condition scores at 0.10-mile intervals. See Appendix for definitions and formulas.							
Inspection Date: 4/24/2021	Beginning Section MP	0					
Paved Length (Miles): 0.53	Section Length (MI)	0.53					
Surface Type: ASPHALT	Route Summary		•	• •			
Roadway Condition Information							
Pavement Condition Rating (PCR)	8	8					
Surface Condition Rating (SCR)	0	0					
Roughness Condition Index (RCI)	21	21					
Distress Index Values							
Structural Crack Index	0	0					
Alligator Crack Index	90	90					
Longitudinal Crack Index	0	0					
Transverse Cracking Index	0	0					
Patching Index	100	100					
Rutting Index	91	91					
International Roughness Index (IRI)	490	490					
Lane & Width Information							
Number of Lanes	2	2					
Paved Width (ft)	19.6	19.6

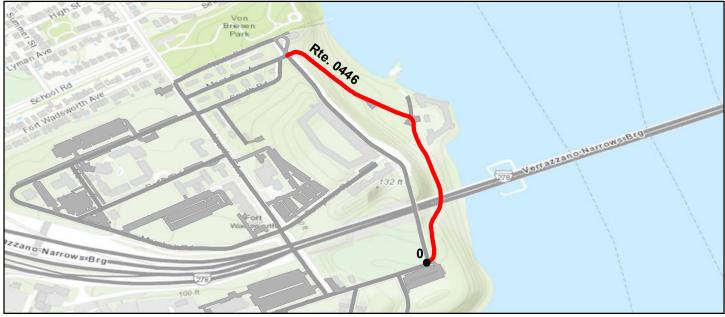
ROUTE 0446: BATTERY WEED ROAD

Route Condition Legend – Pavement Condition Rating (PCR)							
Poor (0 - 60) Fair (6	1- 84) Good ((85 - 94)	Excellent (95 - 1	00) Not Rated			
Colors on map represent condition scores at 0.10-mile intervals. See Appendix for definitions and formulas.							
Inspection Date: 4/24/2021	Beginning Section MP	0					
Paved Length (Miles): 0.44	Section Length (MI)	0.44					
Surface Type: ASPHALT	Route Summary		•	• •			
Roadway Condition Information							
Pavement Condition Rating (PCR)	0	0					
Surface Condition Rating (SCR)	0	0					
Roughness Condition Index (RCI)	N/A	N/A					
Distress Index Values							
Structural Crack Index	0	0					
Alligator Crack Index	81	81					
Longitudinal Crack Index	9	9					
Transverse Cracking Index	9	9					
Patching Index	99	99					
Rutting Index	84	84					
International Roughness Index (IRI)	N/A	N/A					
Lane & Width Information							
Number of Lanes	1	1					
Paved Width (ft)	12.3	12.3

Lane Width (ft)	12.3	12.3

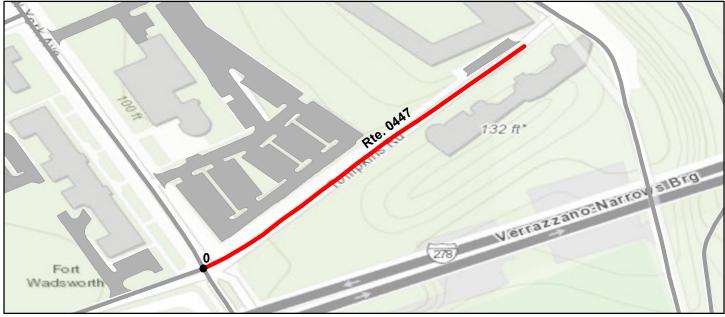
ROUTE 0447: TOMPKINS ROAD

Route Condition Legend – Pavement Condition Rating (PCR)							
Poor (0 - 60) Fair (61- 84) Good	(85 - 94)	Excellent (95 - 100)	Not Rated			
Colors on map represent condition scores at 0.10-mile intervals. See Appendix for definitions and formulas.							
Inspection Date: 4/24/2021	Beginning Section MP	0					
Paved Length (Miles): 0.15	Section Length (MI)	0.15					
Surface Type: ASPHALT	Route Summary						
Roadway Condition Information							
Pavement Condition Rating (PCR)	0	0					
Surface Condition Rating (SCR)	0	0					
Roughness Condition Index (RCI)	N/A	N/A					
Distress Index Values							
Structural Crack Index	32	32					
Alligator Crack Index	98	98					
Longitudinal Crack Index	34	34					
Transverse Cracking Index	0	0					
Patching Index	99	99					
Rutting Index	89	89					
International Roughness Index (IRI)	N/A	N/A					
Lane & Width Information							
Number of Lanes	2	2					
Paved Width (ft)	23.3	23.3

Lane Width (ft)	11.6	11.6

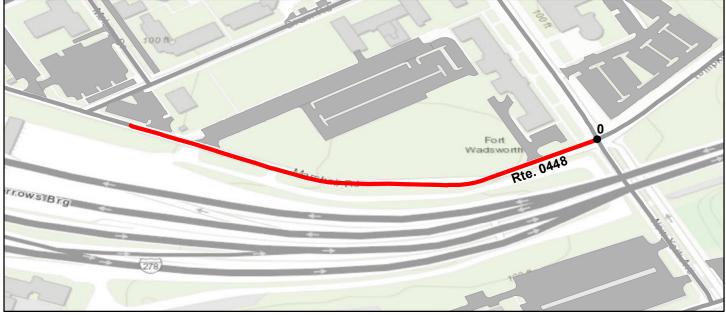
ROUTE 0448: MARSHALL ROAD

Route	Condition Legend – Pav	ement Condi	ition Rating (PCR)				
Poor (0 - 60)	61- 84) Good	(85 - 94)	Excellent (95 - 100)	Not Rated			
Colors on map represent co	ndition scores at 0.10-mile	ion scores at 0.10-mile intervals. See Appendix for definitions and formulas.					
Inspection Date: 4/24/2021	Beginning Section MP	0					
Paved Length (Miles): 0.24	Section Length (MI)	0.24					
Surface Type: ASPHALT	Route Summary		•				
Roadway Condition Information							
Pavement Condition Rating (PCR)	0	0					
Surface Condition Rating (SCR)	0	0					
Roughness Condition Index (RCI)	N/A	N/A					
Distress Index Values							
Structural Crack Index	0	0					
Alligator Crack Index	39	39					
Longitudinal Crack Index	0	0					
Transverse Cracking Index	0	0					
Patching Index	100	100					
Rutting Index	91	91					
International Roughness Index (IRI)	N/A	N/A					
Lane & Width Information							
Number of Lanes	2	2					
Paved Width (ft)	22	22

Lane Width (ft)	10.7	10.7

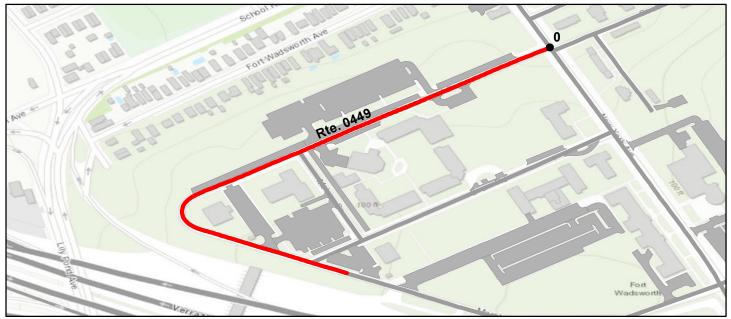
ROUTE 0449: COAST GUARD DRIVE

Route C	Condition Legend – Pav	ement Condi	tion Rating (PCR)	1		
Poor (0 - 60) Fair (6	1- 84) Good (85 - 94)		Excellent (95 - 1	Not Rated		
Colors on map represent con	dition scores at 0.10-mile	ion scores at 0.10-mile intervals. See Appendix for definitions and formulas.				
Inspection Date: 4/24/2021	Beginning Section MP	0				
Paved Length (Miles): 0.38	Section Length (MI)	0.38				
Surface Type: ASPHALT	Route Summary			• •		
Roadway Condition Information						
Pavement Condition Rating (PCR)	0	0				
Surface Condition Rating (SCR)	0	0				
Roughness Condition Index (RCI)	N/A	N/A				
Distress Index Values						
Structural Crack Index	0	0				
Alligator Crack Index	92	92				
Longitudinal Crack Index	0	0				
Transverse Cracking Index	0	0				
Patching Index	99	99				
Rutting Index	88	88				
International Roughness Index (IRI)	N/A	N/A				
Lane & Width Information						
Number of Lanes	2	2				
Paved Width (ft)	22.3	22.3

Lane Width (ft)	11.3	11.3

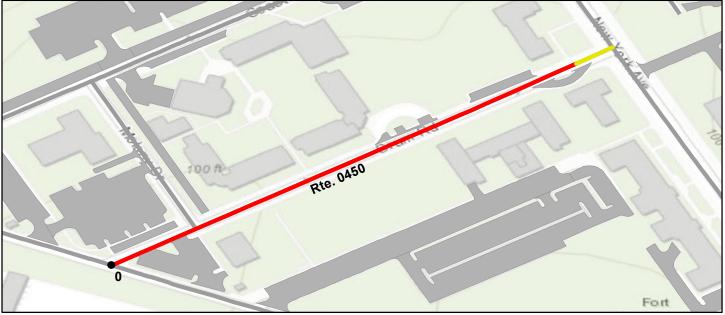
ROUTE 0450: DRUM AVENUE

Route C	Condition Legend – Pav	ement Condi	tion Rating (PCR)	
Poor (0 - 60) Fair (6	L- 84) Good (85 - 94)		Excellent (95 - 10	0) Not Rated
Colors on map represent con	dition scores at 0.10-mile	e intervals. Se	e Appendix for defir	nitions and formulas.
Inspection Date: 4/24/2021	Beginning Section MP	0		
Paved Length (Miles): 0.21	Section Length (MI)	0.21		
Surface Type: ASPHALT	Route Summary			
Roadway Condition Information				
Pavement Condition Rating (PCR)	0	0		
Surface Condition Rating (SCR)	0	0		
Roughness Condition Index (RCI)	N/A	N/A		
Distress Index Values				
Structural Crack Index	0	0		
Alligator Crack Index	54	54		
Longitudinal Crack Index	0	0		
Transverse Cracking Index	0	0		
Patching Index	100	100		
Rutting Index	90	90		
International Roughness Index (IRI)	N/A	N/A		
Lane & Width Information				
Number of Lanes	2	2		
Paved Width (ft)	20.2	20.2		
Lane Width (ft)	10.8	10.8

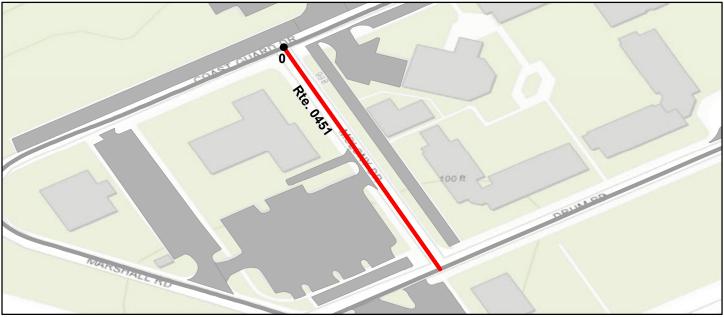
ROUTE 0451: MOLONY DRIVE

Ro	ute Condition Legend – Pav	vement Cond	ition Rating (PCR)	
Poor (0 - 60) F a	nir (61- 84) Good	(85 - 94)	Excellent (95 - 100)	Not Rated
Colors on map represen	t condition scores at 0.10-mil	e intervals. So	ee Appendix for definition	is and formulas.
Inspection Date: 4/24/2021	Beginning Section MF) 0		
Paved Length (Miles): 0.07	Section Length (MI)	0.07		
Surface Type: ASPHALT	Route Summary		• •	• •
Roadway Condition Information				
Pavement Condition Rating (PCR)	26	26		
Surface Condition Rating (SCR)	26	26		
Roughness Condition Index (RCI)	N/A	N/A		
Distress Index Values				
Structural Crack Index	35	35		
Alligator Crack Index	100	100		
Longitudinal Crack Index	35	35		
Transverse Cracking Index	26	26		
Patching Index	100	100		
Rutting Index	97	97		
International Roughness Index (IRI) N/A	N/A		
Lane & Width Information				
Number of Lanes	1	1		
Paved Width (ft)	15.5	15.5		
Lane Width (ft)	15.5	15.5

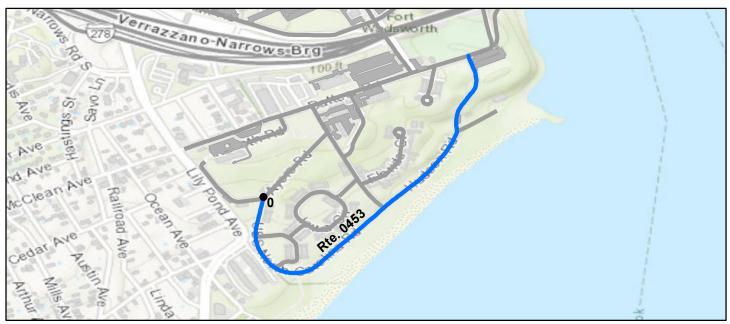
Gateway National Recreation Area ROUTE 0453: USS NORTH CAROLINA ROAD

Data Collection Vehicle (DCV) Rating

Route C	Condition Legend – Pav	ement Condi	tion Rating (PCR)	
Poor (0 - 60) Fair (6	1- 84) Good ((85 - 94)	Excellent (95 - 100)	Not Rated
Colors on map represent cond	lition scores at 0.10-mile	intervals. Se	e Appendix for definitior	ns and formulas.
Inspection Date: 4/24/2021	Beginning Section MP	0		
Paved Length (Miles): 0.74	Section Length (MI)	0.74		
Surface Type: ASPHALT	Route Summary			
Roadway Condition Information				
Pavement Condition Rating (PCR)	94	94		
Surface Condition Rating (SCR)	31	31		
Roughness Condition Index (RCI)	N/A	N/A		
Distress Index Values				
Structural Crack Index	N/A	N/A		
Alligator Crack Index	N/A	N/A		
Longitudinal Crack Index	N/A	N/A		
Transverse Cracking Index	N/A	N/A		
Patching Index	N/A	N/A		
Rutting Index	N/A	N/A		
International Roughness Index (IRI)	N/A	N/A		
Lane & Width Information				
Number of Lanes	2	2		
Paved Width (ft)	21.1	21.1		
Lane Width (ft)	8.6	8.6

NOTE: MANUALLY RATED PCR BEYOND BARRIER

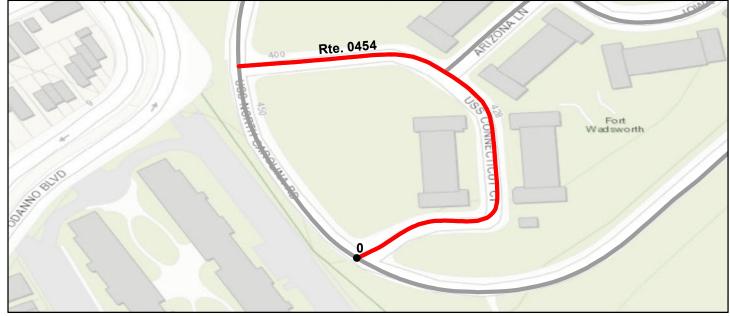
ROUTE 0454: USS CONNECTICUT COURT

Route	Condition Legend – Pav	ement Cond	ition Rating (PCR)	
Poor (0 - 60) Fair (61- 84) Good	(85 - 94)	Excellent (95 - 100)	Not Rated
Colors on map represent co	ndition scores at 0.10-mile	e intervals. Se	e Appendix for definition	ns and formulas.
Inspection Date: 4/24/2021	Beginning Section MP	0		
Paved Length (Miles): 0.14	Section Length (MI)	0.14		
Surface Type: ASPHALT	Route Summary		• •	•
Roadway Condition Information				
Pavement Condition Rating (PCR)	28	28		
Surface Condition Rating (SCR)	28	28		
Roughness Condition Index (RCI)	N/A	N/A		
Distress Index Values				
Structural Crack Index	49	49		
Alligator Crack Index	97	97		
Longitudinal Crack Index	52	52		
Transverse Cracking Index	28	28		
Patching Index	94	94		
Rutting Index	94	94		
International Roughness Index (IRI)	N/A	N/A		
Lane & Width Information				
Number of Lanes	2	2		
Paved Width (ft)	28.7	28.7		
Lane Width (ft)	14.2	14.2

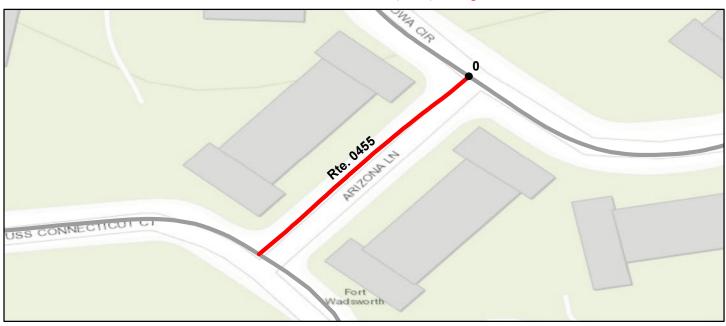
ROUTE 0455: USS ARIZONA LANE

Route	Condition Legend – Pav	ement Condi	tion Rating (P	CR)		
Poor (0 - 60) Fair (6	1- 84) Good (85 - 94)		Excellent (95	5 - 100)	Not Rat	ted
Colors on map represent con	dition scores at 0.10-mile	intervals. Se	e Appendix for	definitions	and formulas.	
Inspection Date: 4/24/2021	Beginning Section MP	0				
Paved Length (Miles): 0.03	Section Length (MI)	0.03				
Surface Type: ASPHALT	Route Summary					
Roadway Condition Information						
Pavement Condition Rating (PCR)	8	8				
Surface Condition Rating (SCR)	8	8				
Roughness Condition Index (RCI)	N/A	N/A				
Distress Index Values						
Structural Crack Index	12	12				
Alligator Crack Index	84	84				
Longitudinal Crack Index	28	28				
Transverse Cracking Index	8	8				
Patching Index	98	98				
Rutting Index	99	99				
International Roughness Index (IRI)	N/A	N/A				
Lane & Width Information						
Number of Lanes	2	2				
Paved Width (ft)	23	23				
Lane Width (ft)	8.2	8.2

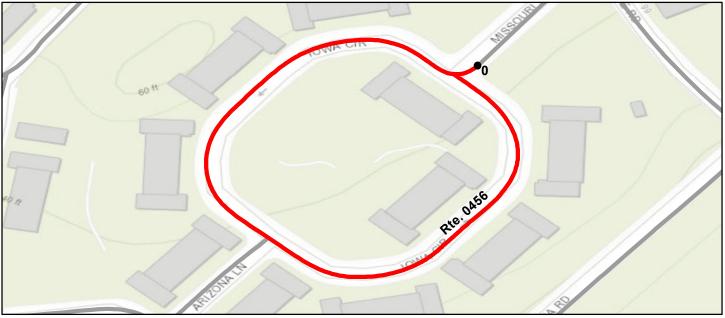
ROUTE 0456: USS IOWA CIRCLE

Rou	te Condition Legend – Pav	ement Cond	lition Rating (PCR)	
		(85 - 94)	Excellent (95 - 100)	Not Rated
Colors on map represent	condition scores at 0.10-mile	e intervals. Se	ee Appendix for definition	ns and formulas.
Inspection Date: 4/24/2021	Beginning Section MP	0		
Paved Length (Miles): 0.24	Section Length (MI)	0.24		
Surface Type: ASPHALT	Route Summary		• •	
Roadway Condition Information				
Pavement Condition Rating (PCR)	0	0		
Surface Condition Rating (SCR)	0	0		
Roughness Condition Index (RCI)	N/A	N/A		
Distress Index Values				
Structural Crack Index	0	0		
Alligator Crack Index	87	87		
Longitudinal Crack Index	0	0		
Transverse Cracking Index	0	0		
Patching Index	93	93		
Rutting Index	93	93		
International Roughness Index (IRI)	N/A	N/A		
Lane & Width Information				
Number of Lanes	2	2		
Paved Width (ft)	29.1	29.1		
Lane Width (ft)	14.6	14.6

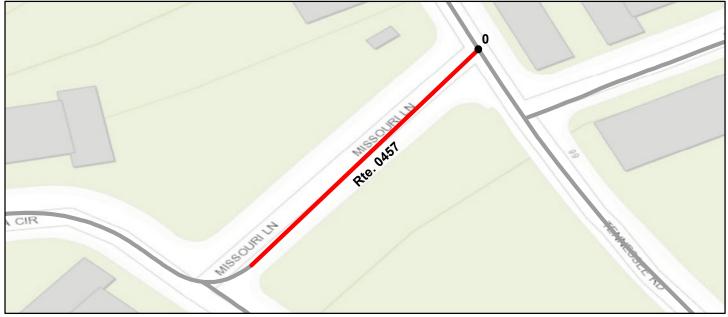
ROUTE 0457: USS MISSOURI LANE

Route	Condition Legend – Pav	ement Condi	tion Rating (PCR)				
Poor (0 - 60) Fair (0	61- 84) Good	(85 - 94)	Excellent (95 - 100)	Not Rated			
Colors on map represent cor	ndition scores at 0.10-mile	ion scores at 0.10-mile intervals. See Appendix for definitions and formulas.					
Inspection Date: 4/24/2021	Beginning Section MP	0					
Paved Length (Miles): 0.04	Section Length (MI)	0.04					
Surface Type: ASPHALT	Route Summary		•	• •			
Roadway Condition Information							
Pavement Condition Rating (PCR)	0	0					
Surface Condition Rating (SCR)	0	0					
Roughness Condition Index (RCI)	N/A	N/A					
Distress Index Values							
Structural Crack Index	0	0					
Alligator Crack Index	60	60					
Longitudinal Crack Index	0	0					
Transverse Cracking Index	0	0					
Patching Index	99	99					
Rutting Index	94	94					
International Roughness Index (IRI)	N/A	N/A					
Lane & Width Information							
Number of Lanes	2	2

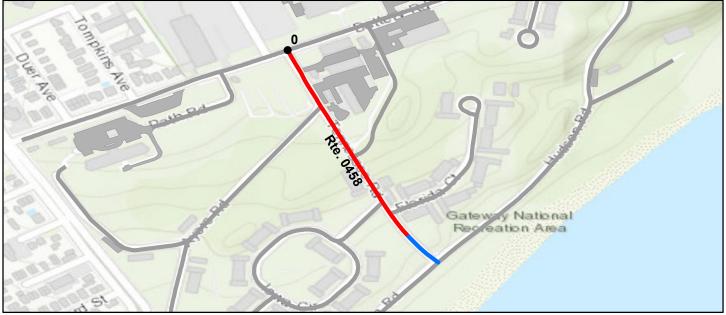
ROUTE 0458: USS TENNESSEE ROAD

Data Collection Vehicle (DCV) Rating

Rou	te Condition Legend – Pav	ement Cond	ition Rating (PCR)				
Poor (0 - 60)	r (61- 84) Good	(85 - 94)	Excellent (95 - 100)	Not Rated			
Colors on map represent	condition scores at 0.10-mile	on scores at 0.10-mile intervals. See Appendix for definitions and formulas.					
Inspection Date: 4/24/2021	Beginning Section MP	0					
Paved Length (Miles): 0.23	Section Length (MI)	0.23					
Surface Type: ASPHALT	Route Summary			•			
Roadway Condition Information							
Pavement Condition Rating (PCR)	4	4					
Surface Condition Rating (SCR)	0	0					
Roughness Condition Index (RCI)	N/A	N/A					
Distress Index Values							
Structural Crack Index	0	0					
Alligator Crack Index	84	84					
Longitudinal Crack Index	0	0					
Transverse Cracking Index	0	0					
Patching Index	99	99					
Rutting Index	93	93					
International Roughness Index (IRI)	N/A	N/A					
Lane & Width Information							
Number of Lanes	2	2					
Paved Width (ft)	25.3	25.3

NOTE: SECTION WITH MANUALLY RATED PCR DUE TO BARRIER
