Final Report

Road Inventory and Condition Assessment of Paved Routes Gateway National Recreation Area

Federal Lands Highway Road Inventory Program Prepared By: Federal Highway Administration Eastern Federal Lands Highway Division Road Inventory Program (RIP)

Report Date: September 2022

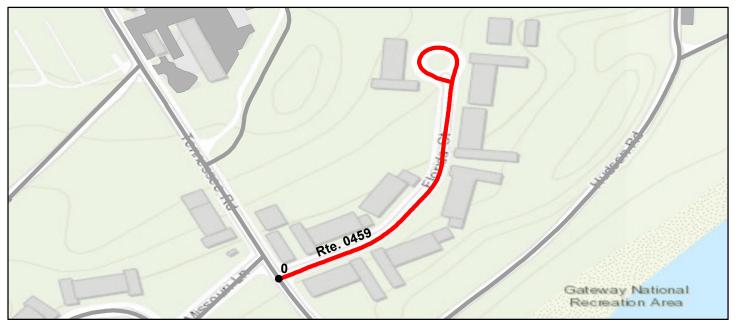
ROUTE 0459: USS FLORIDA COURT

Route	Condition Legend – Pav	ement Condi	tion Rating (PCR)	
Poor (0 - 60) Fair (0	61- 84) Good	(85 - 94)	Excellent (95 - 100)	Not Rated
Colors on map represent con	dition scores at 0.10-mile	e intervals. Se	e Appendix for definition	ns and formulas.
Inspection Date: 4/24/2021	Beginning Section MP	0		
Paved Length (Miles): 0.17	Section Length (MI)	0.17		
Surface Type: ASPHALT	Route Summary		•	
Roadway Condition Information				
Pavement Condition Rating (PCR)	0	0		
Surface Condition Rating (SCR)	0	0		
Roughness Condition Index (RCI)	N/A	N/A		
Distress Index Values				
Structural Crack Index	0	0		
Alligator Crack Index	75	75		
Longitudinal Crack Index	0	0		
Transverse Cracking Index	0	0		
Patching Index	98	98		
Rutting Index	88	88		
International Roughness Index (IRI)	N/A	N/A		
Lane & Width Information				
Number of Lanes	2	2		
Paved Width (ft)	23.3	23.3		
Lane Width (ft)	11.7	11.7

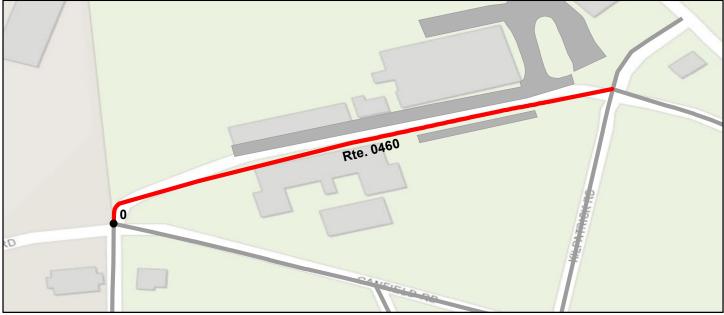
Gateway National Recreation Area ROUTE 0460: NORTH MAINTENANCE AREA ACCESS ROAD

Route	Condition Legend – Pav	ement Cond	ition Rating (PCR)	
Poor (0 - 60)	61- 84) Good	(85 - 94)	Excellent (95 - 100)	Not Rated
Colors on map represent co	ndition scores at 0.10-mile	e intervals. Se	e Appendix for definition	ns and formulas.
Inspection Date: 4/21/2021	Beginning Section MP	0		
Paved Length (Miles): 0.14	Section Length (MI)	0.14		
Surface Type: ASPHALT	Route Summary		• •	•
Roadway Condition Information				
Pavement Condition Rating (PCR)	0	0		
Surface Condition Rating (SCR)	0	0		
Roughness Condition Index (RCI)	N/A	N/A		
Distress Index Values				
Structural Crack Index	0	0		
Alligator Crack Index	96	96		
Longitudinal Crack Index	0	0		
Transverse Cracking Index	2	2		
Patching Index	95	95		
Rutting Index	89	89		
International Roughness Index (IRI)	N/A	N/A		
Lane & Width Information				
Number of Lanes	2	2		
Paved Width (ft)	47.3	47.3		
Lane Width (ft)	23.6	23.6

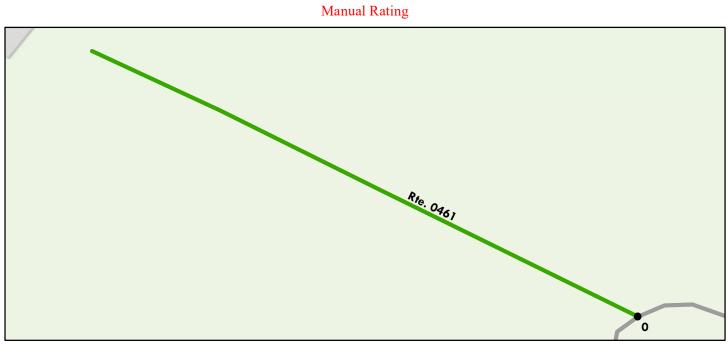
ROUTE 0461: SAND SHED ROAD

Route	Condition Legend – Pave	ement Cond	ition Rating (PCR)				
Poor (0 - 6 0) Fair (<mark>61- 84) Good (</mark>	85 - 94)	Excellent (95 - 100)	Not Rated			
See Appendix for definitions and formulas								
Inspection Date:	3/6/2021	Beginning Section MP	0.00					
Paved Length (Mile	es): 0.08	Section Length (MI)	0.08					
Surface Type:	CONCRETE	Route Summary		•	•			
Roadway Condition	n Information							
Pavement Condition	on Rating (PCR)	90	90					
Surface Condition R	Rating (SCR)	90	90					
Roughness Condition	on Index (RCI)	N/A	N/A					
Distress Index Valu	es							
Structural Crack In	dex	N/A	N/A					
Alligator Crack Inc	lex	N/A	N/A					
Longitudinal Crack	c Index	N/A	N/A					
Transverse Crackir	ng Index	N/A	N/A					
Patching Index		N/A	N/A					
Rutting Index		N/A	N/A					
International Roug	hness Index (IRI)	N/A	N/A					
Lane & Width Info	rmation							
Number of Lanes		1	1					
Paved Width (ft)		11	11

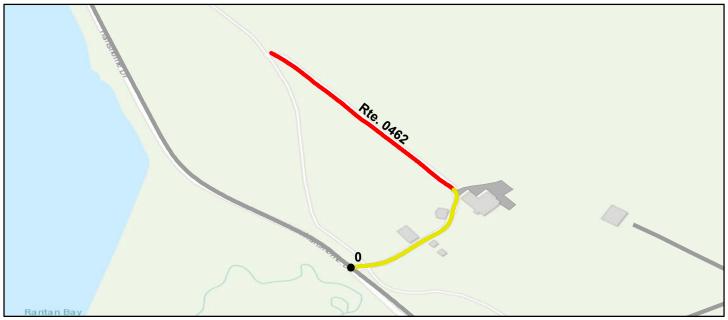
ROUTE 0462: RANDOLPH ROAD

Rou	te Condition Legend – Pav	ement Cond	ition Rating (PCR)	
Poor (0 - 60) Fair	: (61- 84) Good	(85 - 94)	Excellent (95 - 100)	Not Rated
Colors on map represent of	condition scores at 0.10-mile	e intervals. Se	e Appendix for definition	ns and formulas.
Inspection Date: 4/24/2021	Beginning Section MP	0		
Paved Length (Miles): 0.26	Section Length (MI)	0.26		
Surface Type: ASPHALT	Route Summary		•	
Roadway Condition Information				
Pavement Condition Rating (PCR)	12	12		
Surface Condition Rating (SCR)	12	12		
Roughness Condition Index (RCI)	N/A	N/A		
Distress Index Values				
Structural Crack Index	12	12		
Alligator Crack Index	57	57		
Longitudinal Crack Index	55	55		
Transverse Cracking Index	68	68		
Patching Index	100	100		
Rutting Index	79	79		
International Roughness Index (IRI)	N/A	N/A		
Lane & Width Information				
Number of Lanes	1	1		
Paved Width (ft)	14.4	14.4		
Lane Width (ft)	12.3	12.3

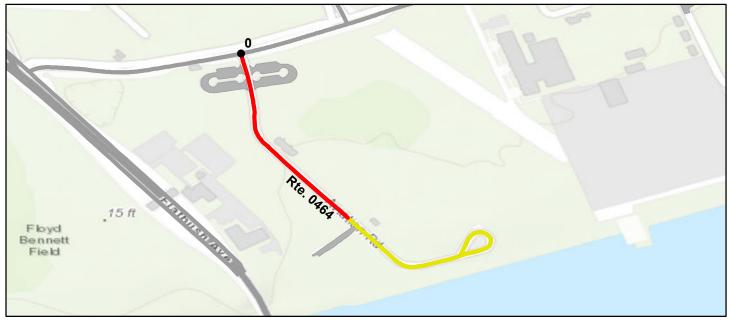
ROUTE 0464: AVIATION ROAD

Route	Condition Legend – Pav	ement Cond	ition Rating (PCR)	
Poor (0 - 60) Fair	(61- 84) Good	(85 - 94)	Excellent (95 - 100)	Not Rated
Colors on map represent co	ndition scores at 0.10-mile	e intervals. Se	e Appendix for definition	ns and formulas.
Inspection Date: 4/23/2021	Beginning Section MP	0		
Paved Length (Miles): 0.39	Section Length (MI)	0.39		
Surface Type: ASPHALT	Route Summary			• •
Roadway Condition Information				
Pavement Condition Rating (PCR)	50	50		
Surface Condition Rating (SCR)	23	23		
Roughness Condition Index (RCI)	N/A	N/A		
Distress Index Values				
Structural Crack Index	39	39		
Alligator Crack Index	96	96		
Longitudinal Crack Index	43	43		
Transverse Cracking Index	23	23		
Patching Index	98	98		
Rutting Index	96	96		
International Roughness Index (IRI)	N/A	N/A		
Lane & Width Information				
Number of Lanes	2	2		
Paved Width (ft)	18.8	18.8		
Lane Width (ft)	9.3	9.3

NOTE: MANUALLY RATED PCR DUE TO SAND ON THE REMAINDER OF THE ROUTE

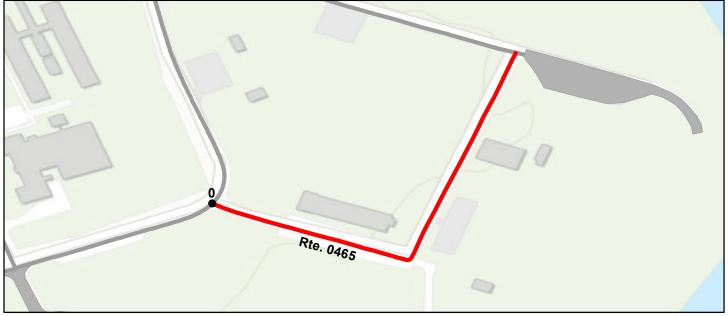
ROUTE 0465: BUILDING 272 ACCESS ROAD

Route Condition Legend – Pavement Condition Rating (PCR)							
Poor (0 - 60) Fair (6	61-84) Good	- 84) Good (85 - 94)		Not Rated			
Colors on map represent cor	dition scores at 0.10-mile	e intervals. Se	e Appendix for definitio	ns and formulas.			
Inspection Date: 4/23/2021	Beginning Section MP	0					
Paved Length (Miles): 0.18	Section Length (MI)	0.18					
Surface Type: ASPHALT	Route Summary						
Roadway Condition Information							
Pavement Condition Rating (PCR)	23	23					
Surface Condition Rating (SCR)	23	23					
Roughness Condition Index (RCI)	N/A	N/A					
Distress Index Values							
Structural Crack Index	36	36					
Alligator Crack Index	99	99					
Longitudinal Crack Index	37	37					
Transverse Cracking Index	23	23					
Patching Index	99	99					
Rutting Index	87	87					
International Roughness Index (IRI)	N/A	N/A					
Lane & Width Information							
Number of Lanes	2	2					
Paved Width (ft)	23.5	23.5

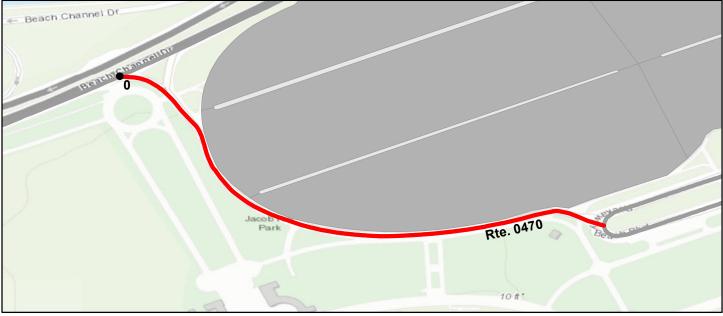
Gateway National Recreation Area ROUTE 0470: JACOB RIIS SERVICE ROAD

Route Condition Legend – Pavement Condition Rating (PCR)							
Poor (0 - 60) Fair (61- 84)		(85 - 94)	85 - 94) Excellent (95 - 100) Not F		Not Ra	ted	
Colors on map represent con	dition scores at 0.10-mile	intervals. Se	e Appendix for a	definitions	and formulas.		
Inspection Date: 4/23/2021	Beginning Section MP	0					
Paved Length (Miles): 0.32	Section Length (MI)	0.32					
Surface Type: CONCRETE	Route Summary						
Roadway Condition Information							
Pavement Condition Rating (PCR)	61	61					
Surface Condition Rating (SCR)	61	61					
Roughness Condition Index (RCI)	N/A	N/A					
Distress Index Values							
Structural Crack Index	64	64					
Alligator Crack Index	100	100					
Longitudinal Crack Index	64	64					
Transverse Cracking Index	61	61					
Patching Index	100	100					
Rutting Index	92	92					
International Roughness Index (IRI)	N/A	N/A					
Lane & Width Information							
Number of Lanes	2	2					
Paved Width (ft)	20.3	20.3

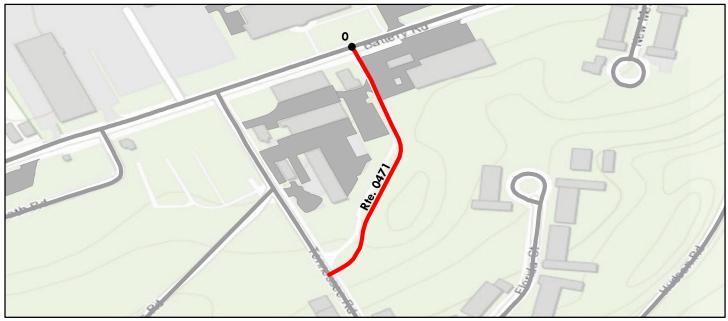
ROUTE 0471: LOOP ROAD

Route Condition Legend – Pavement Condition Rating (PCR)								
Poor (0 - 60) Fair (6	1- 84) Good (- 84) Good (85 - 94)		Not Rated				
See Appendix for definitions and formulas								
Inspection Date: 3/5/2021	Beginning Section MP	0.00						
Paved Length (Miles): 0.14	Section Length (MI)	0.14						
Surface Type: ASPHALT	Route Summary			• •				
Roadway Condition Information								
Pavement Condition Rating (PCR)	30	30						
Surface Condition Rating (SCR)	30	30						
Roughness Condition Index (RCI)	N/A	N/A						
Distress Index Values								
Structural Crack Index	N/A	N/A						
Alligator Crack Index	30	30						
Longitudinal Crack Index	73	73						
Transverse Cracking Index	73	73						
Patching Index	90	90						
Rutting Index	97	97						
International Roughness Index (IRI)	N/A	N/A						
Lane & Width Information								
Number of Lanes	2	2						
Paved Width (ft)	20	20						
Lane Width (ft)	10	10

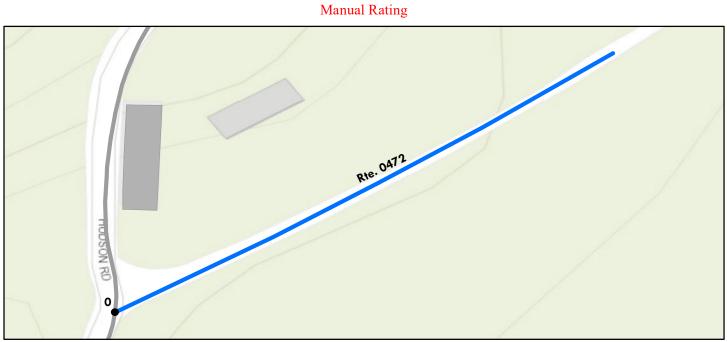
ROUTE 0472: RANGE ROAD (STATEN ISLAND)

Route Condition Legend –	Pavement Cond	ition Rating (PCR)					
Poor (0 - 60)	Fair (61- 84) Go	od (85 - 94)	Excellent (95 - 100)	Not Rated				
See Appendix for definitions and formulas								
Inspection Date: 3/5/2021	Beginning Section	MP 0.00						
Paved Length (Miles): 0.08	Section Length (M	I) 0.08						
Surface Type: ASPHAL	Route Summary		•					
Roadway Condition Information	1							
Pavement Condition Rating (PC)	R) 97	97						
Surface Condition Rating (SCR)	97	97						
Roughness Condition Index (RCI)	N/A	N/A						
Distress Index Values								
Structural Crack Index	N/A	N/A						
Alligator Crack Index	N/A	N/A						
Longitudinal Crack Index	N/A	N/A						
Transverse Cracking Index	N/A	N/A						
Patching Index	N/A	N/A						
Rutting Index	N/A	N/A						
International Roughness Index (I	RI) N/A	N/A						
Lane & Width Information								
Number of Lanes	2	2						
Paved Width (ft)	16	16						
Lane Width (ft)	8	8

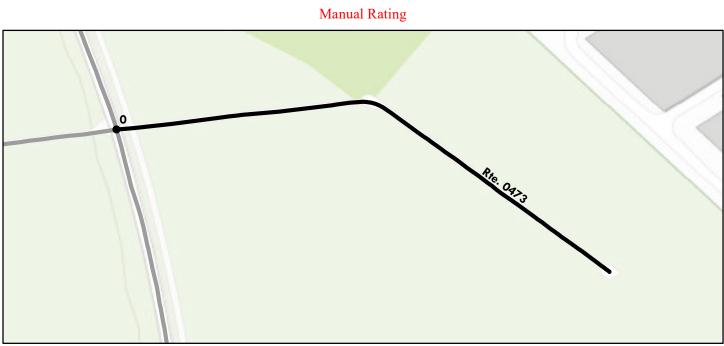
ROUTE 0473: HARBOR ROAD

Route Condition Legend – Pavement Condition Rating (PCR)								
Poor (0 - 60) Fair (6	1- 84) Good (*	I- 84) Good (85 - 94) Excellent (95 - 100)						
See Appendix for definitions and formulas								
Inspection Date: 3/4/2021	Beginning Section MP	0.00						
Paved Length (Miles): 0.22	Section Length (MI)	0.22						
Surface Type: ASPHALT	Route Summary							
Roadway Condition Information								
Pavement Condition Rating (PCR)	N/A	N/A						
Surface Condition Rating (SCR)	N/A	N/A						
Roughness Condition Index (RCI)	N/A	N/A						
Distress Index Values								
Structural Crack Index	N/A	N/A						
Alligator Crack Index	N/A	N/A						
Longitudinal Crack Index	N/A	N/A						
Transverse Cracking Index	N/A	N/A						
Patching Index	N/A	N/A						
Rutting Index	N/A	N/A						
International Roughness Index (IRI)	N/A	N/A						
Lane & Width Information								
Number of Lanes	1	1						
Paved Width (ft)	15	15						
Lane Width (ft)	15	15

NOTE: NOT COLLECTED DUE TO RADIATION ZONE. HAZARDOUS AREA, MENTIONED BY LOCAL PARK POLICE AND POSTED SIGNAGE TO KEEP OUT.

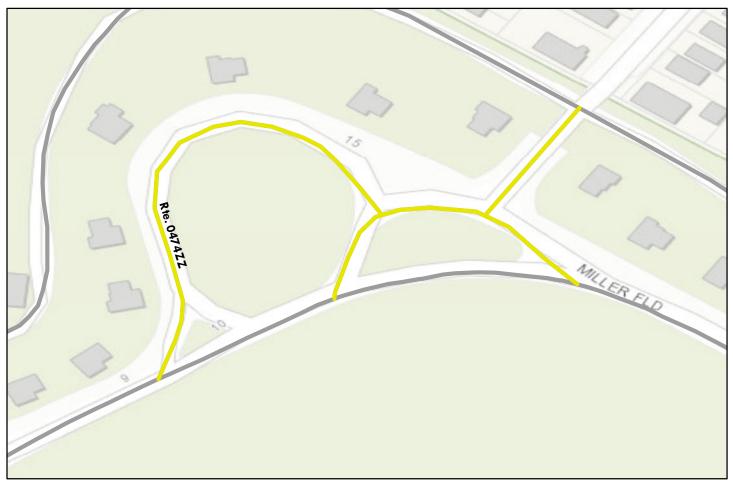
Gateway National Recreation Area ROUTE 0474ZZ: MILLER FIELD RESIDENCE ROAD

Note: The weighted average summary PCR value is calculated from only the sections of road where the PCR was collected. The overall PCR for the summary route may not reflect individual subcomponent ratings.

Route Condition Legend – Pavement Condition Rating (PCR)							
Poor (0 - 60)	Fair (61- 84)	1- 84) Good (85 - 9		Excellent (95 - 100)		Not Rated	
	See	Appendix for d	efinitions and	formulas			
Inspection Date: 3/5/2021							
Paved Length (Miles): 0.21							
Surface Type: ASPHAI	T Route	Summary					
Roadway Condition Informatio	n						
Pavement Condition Rating (PC	CR)	76					
Lane & Width Information							
Number of Lanes		1					
Paved Width (ft)		12					
Lane Width (ft)		12

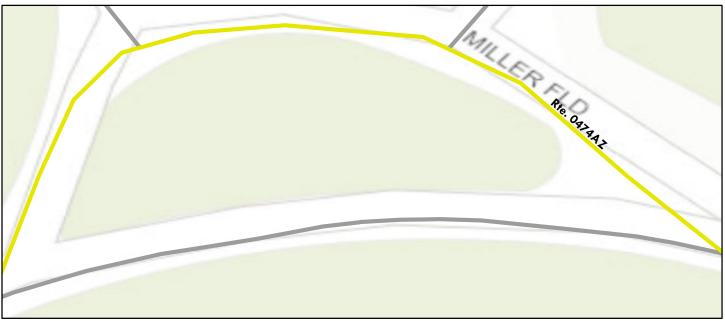
Gateway National Recreation Area ROUTE 0474AZ: MILLER FIELD RESIDENCE ROAD A

Route Condition Legend – Pavement Condition Rating (PCR)								
Poor (0 - 60) Fair (6)	1- 84) Good (85 - 94)		Excellent (95 - 100)	Not Rated				
See Appendix for definitions and formulas								
Inspection Date: 3/5/2021	Beginning Section MP	0.00						
Paved Length (Miles): 0.07	Section Length (MI)	0.07						
Surface Type: ASPHALT	Route Summary		•	• •				
Roadway Condition Information								
Pavement Condition Rating (PCR)	73	73						
Surface Condition Rating (SCR)	73	73						
Roughness Condition Index (RCI)	N/A	N/A						
Distress Index Values								
Structural Crack Index	N/A	N/A						
Alligator Crack Index	73	73						
Longitudinal Crack Index	90	90						
Transverse Cracking Index	90	90						
Patching Index	90	90						
Rutting Index	97	97						
International Roughness Index (IRI)	N/A	N/A						
Lane & Width Information								
Number of Lanes	1	1						
Paved Width (ft)	12	12						
Lane Width (ft)	12	12

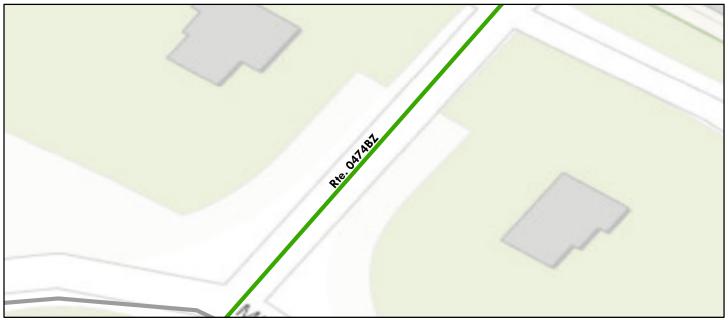
Gateway National Recreation Area ROUTE 0474BZ: MILLER FIELD RESIDENCE ROAD B

Route Condition Legend – Pavement Condition Rating (PCR)						
Poor (0 - 60) Fair (6)			Excellent (95 - 100)	Not Rated		
See Appendix for definitions and formulas						
Inspection Date: 3/5/2021	Beginning Section MP	0.00				
Paved Length (Miles): 0.03	Section Length (MI)	0.03				
Surface Type: ASPHALT	Route Summary			• •		
Roadway Condition Information						
Pavement Condition Rating (PCR)	90	90				
Surface Condition Rating (SCR)	90	90				
Roughness Condition Index (RCI)	N/A	N/A				
Distress Index Values						
Structural Crack Index	N/A	N/A				
Alligator Crack Index	90	90				
Longitudinal Crack Index	97	97				
Transverse Cracking Index	90	90				
Patching Index	90	90				
Rutting Index	97	97				
International Roughness Index (IRI)	N/A	N/A				
Lane & Width Information						
Number of Lanes	1	1				
Paved Width (ft)	12	12				
Lane Width (ft)	12	12

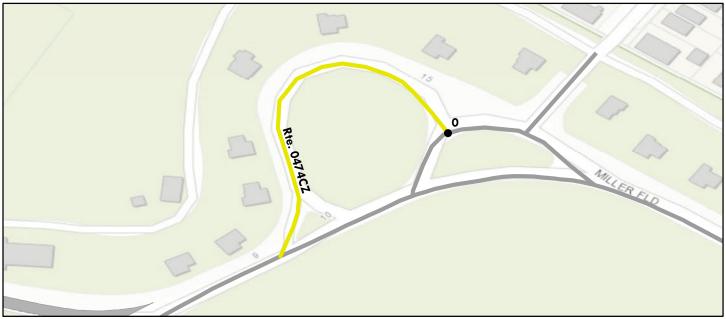
Gateway National Recreation Area ROUTE 0474CZ: MILLER FIELD RESIDENCE ROAD C

Route Condition Legend – Pavement Condition Rating (PCR)						
Poor (0 - 60)	ir (61- 84) Good	1- 84) Good (85 - 94)		Not Rated		
See Appendix for definitions and formulas						
Inspection Date: 3/5/2021	Beginning Section MP	0.00				
Paved Length (Miles): 0.11	Section Length (MI)	0.11				
Surface Type: ASPHALT	Route Summary			• •		
Roadway Condition Information						
Pavement Condition Rating (PCR)	73	73				
Surface Condition Rating (SCR)	73	73				
Roughness Condition Index (RCI)	N/A	N/A				
Distress Index Values						
Structural Crack Index	N/A	N/A				
Alligator Crack Index	73	73				
Longitudinal Crack Index	90	90				
Transverse Cracking Index	90	90				
Patching Index	97	97				
Rutting Index	97	97				
International Roughness Index (IRI)	N/A	N/A				
Lane & Width Information						
Number of Lanes	1	1				
Paved Width (ft)	12	12				
Lane Width (ft)	12	12

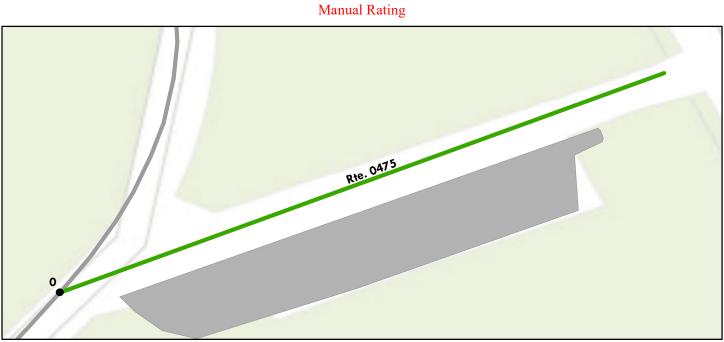
ROUTE 0475: DAVIS ACCESS ROAD

Route Condition Legend – Pavement Condition Rating (PCR)						
Poor (0 - 60) Fair (6	Poor (0 - 60) Fair (61- 84) Good (Excellent (95 - 100)	Not Rated		
See Appendix for definitions and formulas						
Inspection Date: 3/3/2021	Beginning Section MP	0.00				
Paved Length (Miles): 0.04	Section Length (MI)	0.04				
Surface Type: CONCRETE	Route Summary					
Roadway Condition Information						
Pavement Condition Rating (PCR)	90	90				
Surface Condition Rating (SCR)	90	90				
Roughness Condition Index (RCI)	N/A	N/A				
Distress Index Values						
Structural Crack Index	N/A	N/A				
Alligator Crack Index	N/A	N/A				
Longitudinal Crack Index	N/A	N/A				
Transverse Cracking Index	N/A	N/A				
Patching Index	N/A	N/A				
Rutting Index	N/A	N/A				
International Roughness Index (IRI)	N/A	N/A				
Lane & Width Information						
Number of Lanes	2	2				
Paved Width (ft)	15	15				
Lane Width (ft)	7.5	7.5

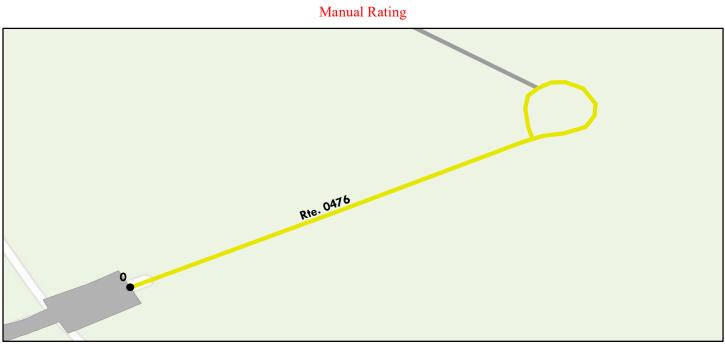
ROUTE 0476: CAMPSITE ROAD

Route Condition Leg	end – Pavement Cond	lition Rating (PCR)				
Poor (0 - 60)	Fair (61- 84)	Good (85 - 94)	Excellent (95 - 100)	Not Rated			
See Appendix for definitions and formulas							
Inspection Date: 3/6/2021	Beginning Se	ection MP 0.00					
Paved Length (Miles): 0.17	Section Leng	th (MI) 0.17					
Surface Type: ASPHALT	Route Summ	ary	•				
Roadway Condition Information							
Pavement Condition Rating (PCF	R) 73	73					
Surface Condition Rating (SCR)	73	73					
Roughness Condition Index (RCI)	N/A	. N/A					
Distress Index Values							
Structural Crack Index	N/A	. N/A					
Alligator Crack Index	73	73					
Longitudinal Crack Index	73	73					
Transverse Cracking Index	73	73					
Patching Index	97	97					
Rutting Index	97	97					
International Roughness Index (II	RI) N/A	. N/A					
Lane & Width Information							
Number of Lanes	1	1					
Paved Width (ft)	11	11					
Lane Width (ft)	11	11

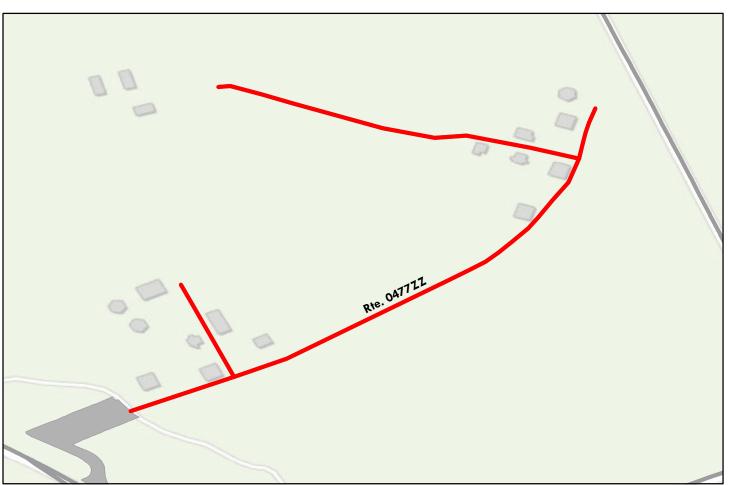
Gateway National Recreation Area ROUTE 0477ZZ: NIKE RADAR SITE ROADS

Note: The weighted average summary PCR value is calculated from only the sections of road where the PCR was collected. The overall PCR for the summary route may not reflect individual subcomponent ratings.

Route Condition Legend – Pavement Condition Rating (PCR)								
Poor (0 - 60) Fair (6	1- 84) Good (85 - 94)		Excellent (95 - 100)		Not Rated			
	See Appendix for det	finitions and f	formulas					
Inspection Date: 3/6/2021								
Paved Length (Miles): 0.43								
Surface Type: ASPHALT	Route Summary							
Roadway Condition Information								
Pavement Condition Rating (PCR)	57							
Lane & Width Information								
Number of Lanes	1							
Paved Width (ft)	16							
Lane Width (ft)	16

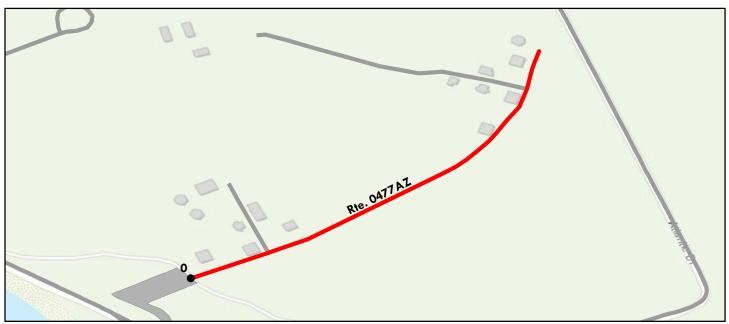
Gateway National Recreation Area ROUTE 0477AZ: NIKE RADAR SITE ROAD A

Route Condition Legend – Pavement Condition Rating (PCR)									
Poor (0 - 60) Fair (61- 84) Good ((85 - 94)	Excellent (95 - 100)	Not Rated					
See Appendix for definitions and formulas									
Inspection Date: 3/6/2021	Beginning Section MP	0.00							
Paved Length (Miles): 0.24	Section Length (MI)	0.24							
Surface Type: ASPHALT	Route Summary			• •					
Roadway Condition Information									
Pavement Condition Rating (PCR)	53	53							
Surface Condition Rating (SCR)	53	53							
Roughness Condition Index (RCI)	N/A	N/A							
Distress Index Values									
Structural Crack Index	N/A	N/A							
Alligator Crack Index	53	53							
Longitudinal Crack Index	73	73							
Transverse Cracking Index	73	73							
Patching Index	90	90							
Rutting Index	90	90							
International Roughness Index (IRI)	N/A	N/A							
Lane & Width Information									
Number of Lanes	1	1							
Paved Width (ft)	16	16							
Lane Width (ft)	16	16

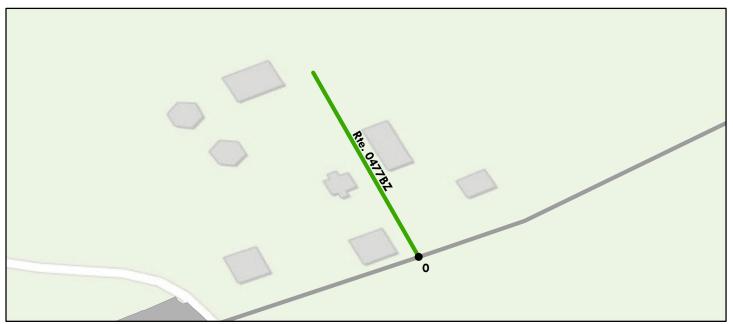
Gateway National Recreation Area ROUTE 0477BZ: NIKE RADAR SITE ROAD B

Route C	Route Condition Legend – Pavement Condition Rating (PCR)								
Poor (0 - 60) Fair (6	1- 84) Good ((85 - 94) Excellent (95 - 100)		Not Rated					
See Appendix for definitions and formulas									
Inspection Date: 3/6/2021	Beginning Section MP	0.00							
Paved Length (Miles): 0.05	Section Length (MI)	0.05							
Surface Type: ASPHALT	Route Summary		•	• •					
Roadway Condition Information									
Pavement Condition Rating (PCR)	90	90							
Surface Condition Rating (SCR)	90	90							
Roughness Condition Index (RCI)	N/A	N/A							
Distress Index Values									
Structural Crack Index	N/A	N/A							
Alligator Crack Index	90	90							
Longitudinal Crack Index	90	90							
Transverse Cracking Index	90	90							
Patching Index	97	97							
Rutting Index	97	97							
International Roughness Index (IRI)	N/A	N/A							
Lane & Width Information									
Number of Lanes	1	1							
Paved Width (ft)	16	16

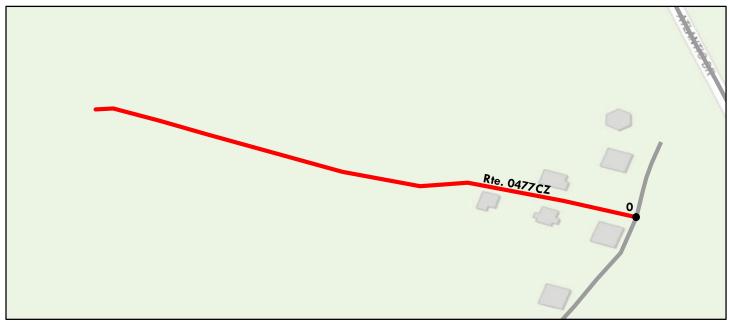
Gateway National Recreation Area ROUTE 0477CZ: NIKE RADAR SITE ROAD C

Route Condition Legend – Pavement Condition Rating (PCR)									
Poor (0 - 60) Fair (6	1- 84) Good (85 - 94)	Excellent (95 - 100)	Not Rated					
See Appendix for definitions and formulas									
Inspection Date: 3/6/2021	Beginning Section MP	0.00							
Paved Length (Miles): 0.14	Section Length (MI)	0.14							
Surface Type: ASPHALT	Route Summary								
Roadway Condition Information									
Pavement Condition Rating (PCR)	53	53							
Surface Condition Rating (SCR)	53	53							
Roughness Condition Index (RCI)	N/A	N/A							
Distress Index Values									
Structural Crack Index	N/A	N/A							
Alligator Crack Index	73	73							
Longitudinal Crack Index	53	53							
Transverse Cracking Index	53	53							
Patching Index	90	90							
Rutting Index	90	90							
International Roughness Index (IRI)	N/A	N/A							
Lane & Width Information									
Number of Lanes	1	1							
Paved Width (ft)	16	16							
Lane Width (ft)	16	16

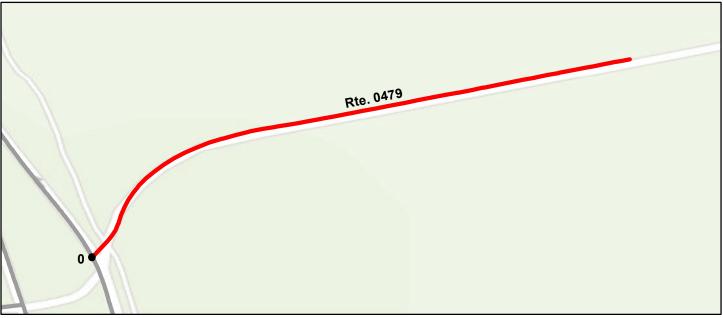
ROUTE 0479: FISHERMAN'S PARKING ACCESS

Route	Condition Legend – Pav	ement Cond	ition Rating (PCR)	
Poor (0 - 60) Fair	(61- 84) Good	(85 - 94)	Excellent (95 - 100)	Not Rated
Colors on map represent co	ndition scores at 0.10-mile	e intervals. Se	e Appendix for definition	ns and formulas.
Inspection Date: 4/24/2021	Beginning Section MP	0		
Paved Length (Miles): 0.24	Section Length (MI)	0.24		
Surface Type: ASPHALT	Route Summary		• •	
Roadway Condition Information				
Pavement Condition Rating (PCR)	21	21		
Surface Condition Rating (SCR)	21	21		
Roughness Condition Index (RCI)	N/A	N/A		
Distress Index Values				
Structural Crack Index	56	56		
Alligator Crack Index	100	100		
Longitudinal Crack Index	56	56		
Transverse Cracking Index	21	21		
Patching Index	100	100		
Rutting Index	98	98		
International Roughness Index (IRI)	N/A	N/A		
Lane & Width Information				
Number of Lanes	2	2		
Paved Width (ft)	18.7	18.7		
Lane Width (ft)	9.8	9.8

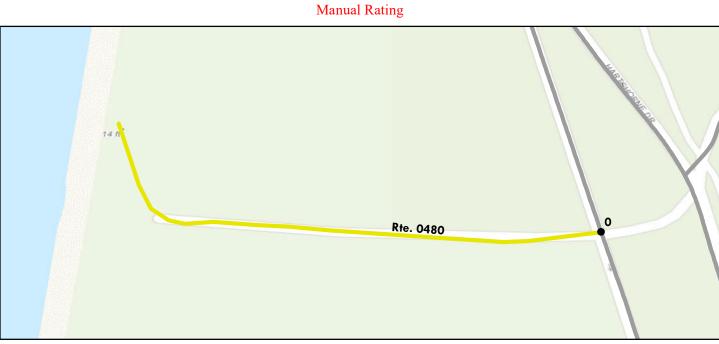
Gateway National Recreation Area ROUTE 0480: SERVICE ROAD / KINGMAN AND MILLS ROAD

Route Condition Legend – Pavement Condition Rating (PCR)										
Poor (0 - 60)	Fair (6	1- 84) Good (85 - 94) Excellent (95 - 100)			5 - 100)	Not Rated				
See Appendix for definitions and formulas										
Inspection Date: 3/6/2	2021	Beginning Section MP	0.00							
Paved Length (Miles): 0.18		Section Length (MI)	0.18							
Surface Type: ASP	HALT	Route Summary		··						
Roadway Condition Inform	nation									
Pavement Condition Rating	g (PCR)	73	73							
Surface Condition Rating (S	CR)	73	73							
Roughness Condition Index	(RCI)	N/A	N/A							
Distress Index Values										
Structural Crack Index		N/A	N/A							
Alligator Crack Index		73	73							
Longitudinal Crack Index		73	73							
Transverse Cracking Index		73	73							
Patching Index		97	97							
Rutting Index		97	97							
International Roughness In	dex (IRI)	N/A	N/A							
Lane & Width Information	1									
Number of Lanes	Number of Lanes		1

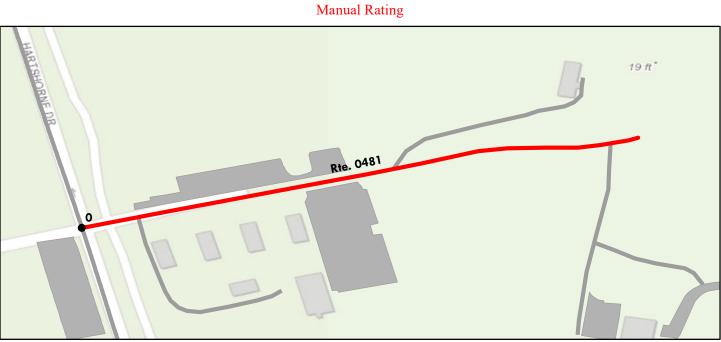
ROUTE 0481: SOUTH MAINTENANCE SHOP ROAD A

Route Condition Legend – Pavement Condition Rating (PCR)									
Poor (0 - 60) Fa	air (61- 84) Good	(85 - 94)	Excellent (95 - 100)	Not Rated					
See Appendix for definitions and formulas									
Inspection Date: 3/6/2021	Beginning Section MI	P 0.00							
Paved Length (Miles): 0.14	Section Length (MI)	0.14							
Surface Type: ASPHALT	Route Summary		• •	• •					
Roadway Condition Information									
Pavement Condition Rating (PCR)	30	30							
Surface Condition Rating (SCR)	30	30							
Roughness Condition Index (RCI)	N/A	N/A							
Distress Index Values									
Structural Crack Index	N/A	N/A							
Alligator Crack Index	30	30							
Longitudinal Crack Index	30	30							
Transverse Cracking Index	53	53							
Patching Index	90	90							
Rutting Index	73	73							
International Roughness Index (IRI) N/A	N/A							
Lane & Width Information									
Number of Lanes	1	1							
Paved Width (ft)	11	11							
Lane Width (ft)	11	11

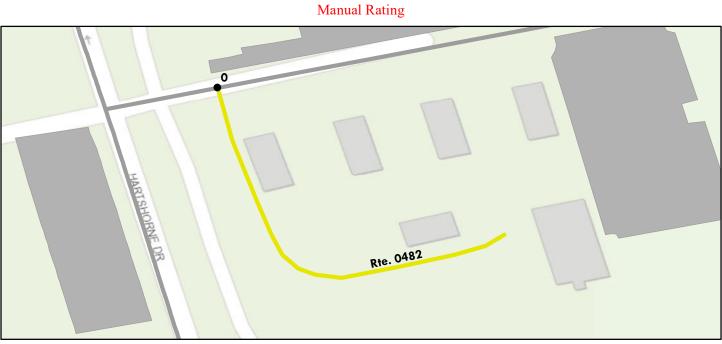
ROUTE 0482: SOUTH MAINTENANCE SHOP ROAD B

Rout	e Condition Legend – Pav	ement Cond	ition Rating (PCR)							
Poor (0 - 60) Fair	(61- 84) Good ((85 - 94)	Excellent (95 - 100)	Not Rated						
See Appendix for definitions and formulas										
Inspection Date: 3/6/2021	Beginning Section MP	0.00								
Paved Length (Miles): 0.06	Section Length (MI)	0.06								
Surface Type: ASPHALT	Route Summary			•						
Roadway Condition Information										
Pavement Condition Rating (PCR)	73	73								
Surface Condition Rating (SCR)	73	73								
Roughness Condition Index (RCI)	N/A	N/A								
Distress Index Values										
Structural Crack Index	N/A	N/A								
Alligator Crack Index	73	73								
Longitudinal Crack Index	90	90								
Transverse Cracking Index	73	73								
Patching Index	73	73								
Rutting Index	90	90								
International Roughness Index (IRI)	N/A	N/A								
Lane & Width Information										
Number of Lanes	1	1								
Paved Width (ft)	11	11

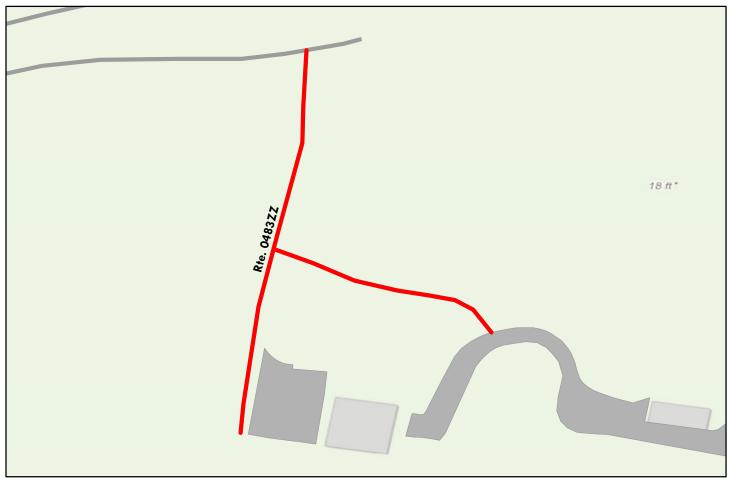
Gateway National Recreation Area ROUTE 0483ZZ: SOUTH MAINTENANCE SHOP ROAD C

Note: The weighted average summary PCR value is calculated from only the sections of road where the PCR was collected. The overall PCR for the summary route may not reflect individual subcomponent ratings.

Route Condition Legend – Pavement Condition Rating (PCR)								
Poor (0 - 60) Fair (61		1- 84) Good (85 - 94)		Excellent (95 - 100)		Not Rated			
		See Appendix for de	finitions and f	formulas					
Inspection Date:	3/6/2021								
Paved Length (Mile	s): 0.1								
Surface Type:	ASPHALT	Route Summary		•					
Roadway Condition	Information								
Pavement Condition	n Rating (PCR)	30							
Lane & Width Infor	rmation								
Number of Lanes		1							
Paved Width (ft)		11							
Lane Width (ft)		11

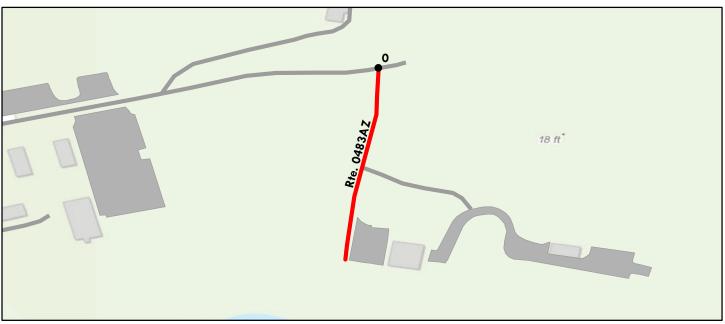
Subcomponent of Route GATE-0483ZZ

Route Condition Legend – Pavement Condition Rating (PCR)									
Poor (0 - 60) Fair	(61- 84) Good ((85 - 94)	Excellent (95 - 100)	Not Rated					
See Appendix for definitions and formulas									
Inspection Date: 3/6/2021	Beginning Section MP	0.00							
Paved Length (Miles): 0.06	Section Length (MI)	0.06							
Surface Type: ASPHALT	Route Summary			•					
Roadway Condition Information									
Pavement Condition Rating (PCR)	30	30							
Surface Condition Rating (SCR)	30	30							
Roughness Condition Index (RCI)	N/A	N/A							
Distress Index Values									
Structural Crack Index	N/A	N/A							
Alligator Crack Index	30	30							
Longitudinal Crack Index	30	30							
Transverse Cracking Index	53	53							
Patching Index	97	97							
Rutting Index	97	97							
International Roughness Index (IRI)	N/A	N/A							
Lane & Width Information									
Number of Lanes	1	1							
Paved Width (ft)	11	11							
Lane Width (ft)	11	11

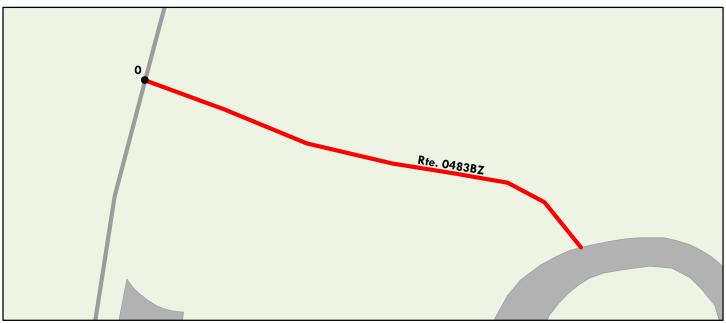
Gateway National Recreation Area ROUTE 0483BZ: SOUTH MAINTENANCE SHOP ROAD C - SPUR

Route Cond	ition Legend – Pav	ement Cond	ition Rating (PC	R)					
Poor (0 - 60)	Fair (61- 84) Good	(85 - 94)	Excellent (95 -	- 100)	Not Rat	ted			
See Appendix for definitions and formulas										
Inspection Date: 3/6/20	021 Beg	inning Section MF	0.00							
Paved Length (Miles): 0.03	Sect	tion Length (MI)	0.03							
Surface Type: ASPH	IALT Rou	ite Summary								
Roadway Condition Informa	ation									
Pavement Condition Rating	(PCR)	30	30							
Surface Condition Rating (SC	R)	30	30							
Roughness Condition Index (F	RCI)	N/A	N/A							
Distress Index Values										
Structural Crack Index		N/A	N/A							
Alligator Crack Index		30	30							
Longitudinal Crack Index		30	30							
Transverse Cracking Index		53	53							
Patching Index		97	97							
Rutting Index		53	53							
International Roughness Inde	ex (IRI)	N/A	N/A							
Lane & Width Information										
Number of Lanes		1	1							
Paved Width (ft)		11	11

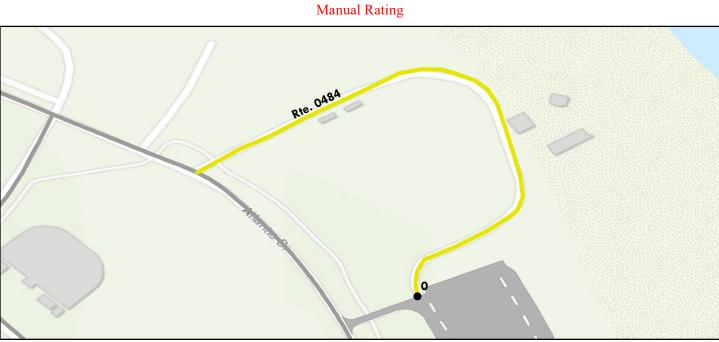
ROUTE 0484: NORTH BEACH SERVICE ROAD

Route	Condition Legend – Pav	ement Condi	ition Rating (PCR)							
Poor (0 - 60) Fair (61- 84) Good ((85 - 94)	Excellent (95 - 100)	Not Rated						
See Appendix for definitions and formulas										
Inspection Date: 3/6/2021	Beginning Section MP	0.00								
Paved Length (Miles): 0.29	Section Length (MI)	0.28								
Surface Type: ASPHALT	Route Summary			•						
Roadway Condition Information										
Pavement Condition Rating (PCR)	73	73								
Surface Condition Rating (SCR)	73	73								
Roughness Condition Index (RCI)	N/A	N/A								
Distress Index Values										
Structural Crack Index	N/A	N/A								
Alligator Crack Index	73	73								
Longitudinal Crack Index	90	90								
Transverse Cracking Index	90	90								
Patching Index	73	73								
Rutting Index	97	97								
International Roughness Index (IRI)	N/A	N/A								
Lane & Width Information										
Number of Lanes	1	1								
Paved Width (ft)	11	11

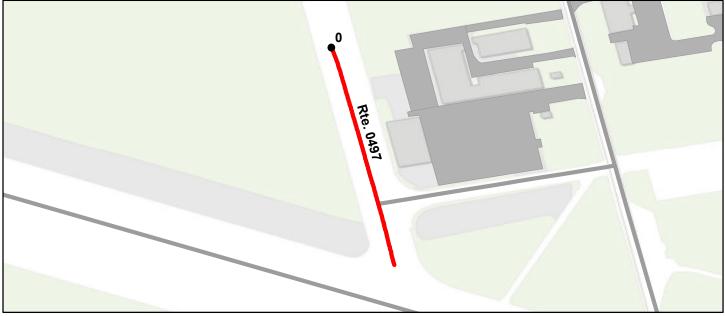
ROUTE 0497: NYPD ROAD 1

Rou	te Condition Legend – Pav	ement Cond	ition Rating (PCR)	
Poor (0 - 60) Fai	r (61- 84) Good	(85 - 94)	Excellent (95 - 100)	Not Rated
Colors on map represent	condition scores at 0.10-mile	e intervals. Se	e Appendix for definition	ns and formulas.
Inspection Date: 4/23/2021	Beginning Section MP	0		
Paved Length (Miles): 0.12	Section Length (MI)	0.12		
Surface Type: ASPHALT	Route Summary		•	
Roadway Condition Information				
Pavement Condition Rating (PCR)	21	21		
Surface Condition Rating (SCR)	21	21		
Roughness Condition Index (RCI)	N/A	N/A		
Distress Index Values				
Structural Crack Index	21	21		
Alligator Crack Index	100	100		
Longitudinal Crack Index	21	21		
Transverse Cracking Index	69	69		
Patching Index	100	100		
Rutting Index	97	97		
International Roughness Index (IRI)	N/A	N/A		
Lane & Width Information				
Number of Lanes	4	4		
Paved Width (ft)	48	48		
Lane Width (ft)	19.6	19.6

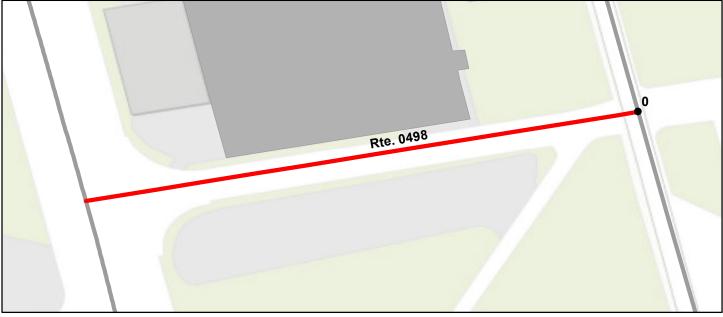
ROUTE 0498: NYPD ROAD 2

Route Condition Legend – Pavement Condition Rating (PCR)					
Poor (0 - 60)	61- 84) Good	(85 - 94)	Excellent (95 - 100)	Not Rated	
Colors on map represent co	ndition scores at 0.10-mile	e intervals. Se	e Appendix for definition	ns and formulas.	
Inspection Date: 4/23/2021	Beginning Section MP	0			
Paved Length (Miles): 0.09	Section Length (MI)	0.09			
Surface Type: ASPHALT	Route Summary		•		
Roadway Condition Information					
Pavement Condition Rating (PCR)	13	13			
Surface Condition Rating (SCR)	13	13			
Roughness Condition Index (RCI)	N/A	N/A			
Distress Index Values					
Structural Crack Index	13	13			
Alligator Crack Index	100	100			
Longitudinal Crack Index	13	13			
Transverse Cracking Index	48	48			
Patching Index	98	98			
Rutting Index	97	97			
International Roughness Index (IRI)	N/A	N/A			
Lane & Width Information					
Number of Lanes	2	2			
Paved Width (ft)	40	40			
Lane Width (ft)	21.3	21.3

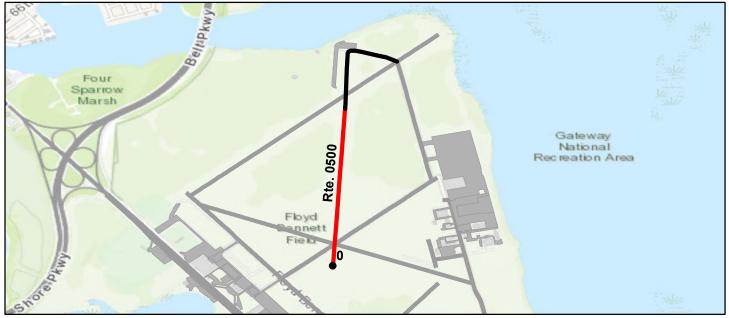
ROUTE 0500: CENTRAL RUNWAY

Route	Condition Legend – Pav	ement Condi	ition Rating (PCR)	
Poor (0 - 60)	61- 84) Good	(85 - 94)	Excellent (95 - 100)	Not Rated
Colors on map represent co	ndition scores at 0.10-mile	e intervals. Se	e Appendix for definition	ns and formulas.
Inspection Date: 4/23/2021	Beginning Section MP	0		
Paved Length (Miles): 0.95	Section Length (MI)	0.95		
Surface Type: ASPHALT	Route Summary		• •	
Roadway Condition Information				
Pavement Condition Rating (PCR)	25	25		
Surface Condition Rating (SCR)	0	0		
Roughness Condition Index (RCI)	63	63		
Distress Index Values				
Structural Crack Index	0	0		
Alligator Crack Index	94	94		
Longitudinal Crack Index	0	0		
Transverse Cracking Index	0	0		
Patching Index	97	97		
Rutting Index	92	92		
International Roughness Index (IRI)	229	229		
Lane & Width Information				
Number of Lanes	4	4		
Paved Width (ft)	48	48		
Lane Width (ft)	9.6	9.6

NOTE: End of route is was not rated because it was a portion transferred from a parking area to Route 0500 after data collection.

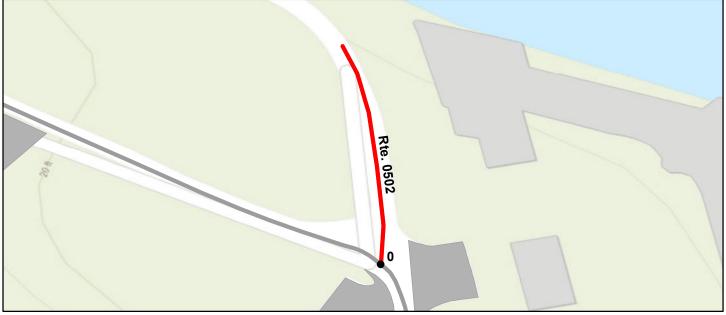
ROUTE 0502: DOCK ROAD

Route Condition Legend – Pavement Condition Rating (PCR)					
Poor (0 - 60) Fair (6	1- 84) Good ((85 - 94)	Excellent (95 - 100)	Not Rated	
Colors on map represent con	dition scores at 0.10-mile	e intervals. Se	e Appendix for definiti	ons and formulas.	
Inspection Date: 4/24/2021	Beginning Section MP	0			
Paved Length (Miles): 0.03	Section Length (MI)	0.03			
Surface Type: ASPHALT	Route Summary		•	• •	
Roadway Condition Information					
Pavement Condition Rating (PCR)	16	16			
Surface Condition Rating (SCR)	16	16			
Roughness Condition Index (RCI)	N/A	N/A			
Distress Index Values					
Structural Crack Index	45	45			
Alligator Crack Index	100	100			
Longitudinal Crack Index	45	45			
Transverse Cracking Index	16	16			
Patching Index	100	100			
Rutting Index	98	98			
International Roughness Index (IRI)	N/A	N/A			
Lane & Width Information					
Number of Lanes	1	1			
Paved Width (ft)	14.2	14.2			
Lane Width (ft)	14.2	14.2

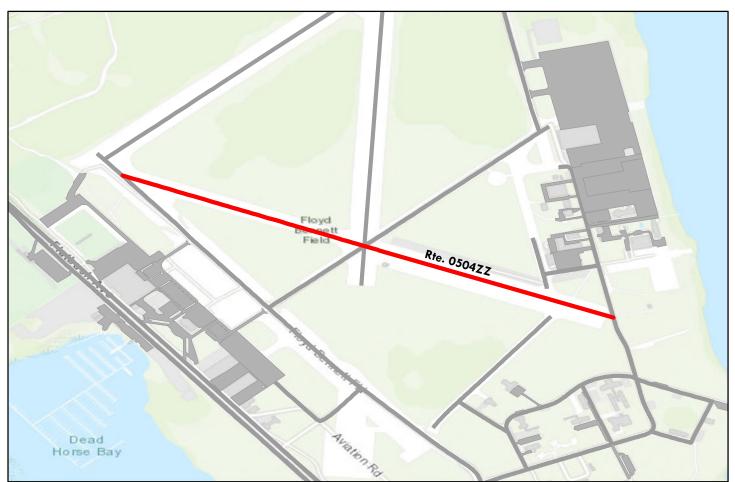
ROUTE 0504ZZ: SOUTHERN RUNWAY

Note: The weighted average summary PCR value is calculated from only the sections of road where the PCR was collected. The overall PCR for the summary route may not reflect individual subcomponent ratings.

Route C	Condition Legend – Pay	vement Cond	ition Rating (l	PCR)		
Poor (0 - 60) Fair (6	1- 84) Good	(85 - 94)	Excellent (9	95 - 100)	Not Ra	ted
		See Appendix for de	finitions and	formulas			
Inspection Date:	4/23/2021						
Paved Length (Mile	s): 0.95						
Surface Type:	ASPHALT	Route Summary				•	
Roadway Condition	Information						
Pavement Condition	n Rating (PCR)	26					
Lane & Width Info	rmation						
Number of Lanes		4					
Paved Width (ft)		48					
Lane Width (ft)		10.9

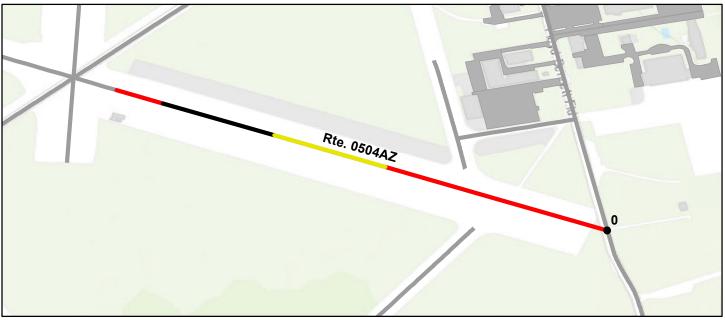
ROUTE 0504AZ: SOUTHERN RUNWAY A

Route	Condition Legend – Pav	ement Cond	ition Rating (PCR)	
Poor (0 - 60) Fair	(61- 84) Good	(85 - 94)	Excellent (95 - 100)	Not Rated
Colors on map represent co	ondition scores at 0.10-mile	e intervals. Se	e Appendix for definition	ns and formulas.
Inspection Date: 4/23/2021	Beginning Section MP	0		
Paved Length (Miles): 0.44	Section Length (MI)	0.44		
Surface Type: ASPHALT	Route Summary			• •
Roadway Condition Information				
Pavement Condition Rating (PCR)	47	47		
Surface Condition Rating (SCR)	47	47		
Roughness Condition Index (RCI)	N/A	N/A		
Distress Index Values				
Structural Crack Index	60	60		
Alligator Crack Index	100	100		
Longitudinal Crack Index	60	60		
Transverse Cracking Index	47	47		
Patching Index	100	100		
Rutting Index	95	95		
International Roughness Index (IRI)	N/A	N/A		
Lane & Width Information				
Number of Lanes	4	4		
Paved Width (ft)	48	48		
Lane Width (ft)	11.6	11.6

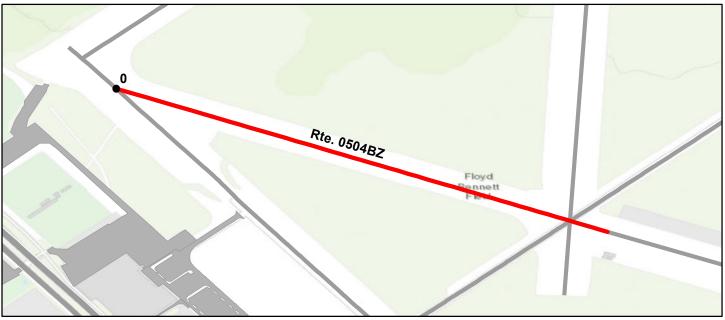
Gateway National Recreation Area ROUTE 0504BZ: SOUTHERN RUNWAY B

Route Condition Legend – Pavement Condition Rating (PCR)						
Poor (0 - 60) Fair (6	1- 84) Good ((85 - 94)	Excellent (95	- 100)	Not Ra	ted
Colors on map represent con	dition scores at 0.10-mile	e intervals. Se	e Appendix for d	lefinitions a	and formulas.	
Inspection Date: 4/23/2021	Beginning Section MP	0				
Paved Length (Miles): 0.51	Section Length (MI)	0.51				
Surface Type: ASPHALT	Route Summary					
Roadway Condition Information						
Pavement Condition Rating (PCR)	7	7				
Surface Condition Rating (SCR)	0	0				
Roughness Condition Index (RCI)	17	17				
Distress Index Values						
Structural Crack Index	0	0				
Alligator Crack Index	99	99				
Longitudinal Crack Index	0	0				
Transverse Cracking Index	0	0				
Patching Index	26	26				
Rutting Index	93	93				
International Roughness Index (IRI)	325	325				
Lane & Width Information						
Number of Lanes	4	4				
Paved Width (ft)	48	48				
Lane Width (ft)	10.3	10.3

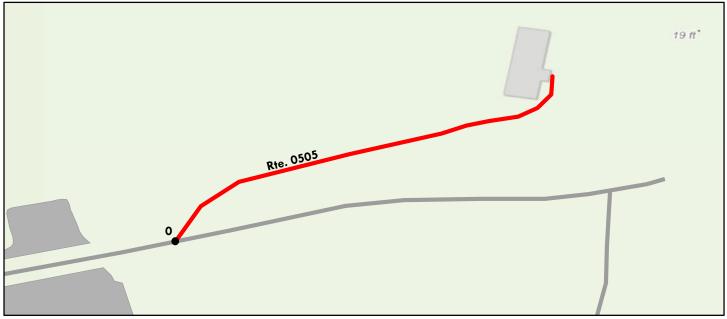
ROUTE 0505: MAINTENANCE GAS STATION ROAD

Route Condition Legend – Pavement Condition Rating (PCR)							
Poor (0 - 60) Fa	air (61- 84) Good	(85 - 94)	Excellent (95 - 100)	Not Rated			
See Appendix for definitions and formulas							
Inspection Date: 3/6/2021	Beginning Section MP	0.00					
Paved Length (Miles): 0.06	Section Length (MI)	0.06					
Surface Type: ASPHALT	Route Summary		• •	•			
Roadway Condition Information							
Pavement Condition Rating (PCR)	53	53					
Surface Condition Rating (SCR)	53	53					
Roughness Condition Index (RCI)	N/A	N/A					
Distress Index Values							
Structural Crack Index	N/A	N/A					
Alligator Crack Index	53	53					
Longitudinal Crack Index	73	73					
Transverse Cracking Index	90	90					
Patching Index	90	90					
Rutting Index	97	97					
International Roughness Index (IRI) N/A	N/A					
Lane & Width Information							
Number of Lanes	1	1					
Paved Width (ft)	11	11					
Lane Width (ft)	11	11

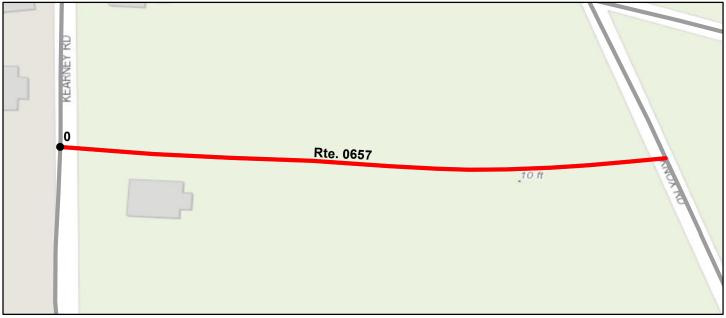
ROUTE 0657: HANAKI ROAD

Route	Condition Legend – Pav	ement Condi	ition Rating (PCR)	
Poor (0 - 60) Fair	(61- 84) Good	(85 - 94)	Excellent (95 - 100)	Not Rated
Colors on map represent co	ondition scores at 0.10-mile	e intervals. Se	e Appendix for definition	ns and formulas.
Inspection Date: 4/24/2021	Beginning Section MP	0		
Paved Length (Miles): 0.07	Section Length (MI)	0.07		
Surface Type: ASPHALT	Route Summary		•	
Roadway Condition Information				
Pavement Condition Rating (PCR)	52	52		
Surface Condition Rating (SCR)	52	52		
Roughness Condition Index (RCI)	N/A	N/A		
Distress Index Values				
Structural Crack Index	93	93		
Alligator Crack Index	100	100		
Longitudinal Crack Index	93	93		
Transverse Cracking Index	52	52		
Patching Index	100	100		
Rutting Index	95	95		
International Roughness Index (IRI)	N/A	N/A		
Lane & Width Information				
Number of Lanes	2	2		
Paved Width (ft)	17.2	17.2		
Lane Width (ft)	8.6	8.6

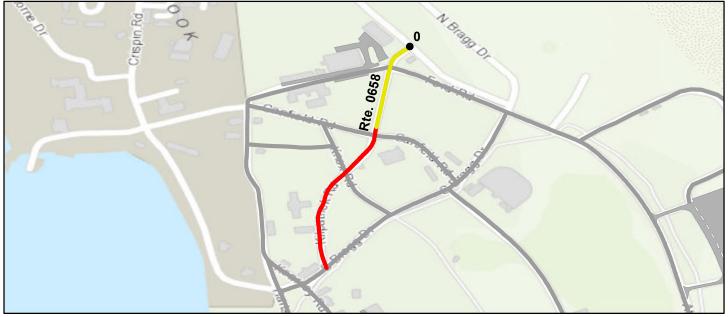
ROUTE 0658: KILPATRICK ROAD

Rout	e Condition Legend – Pav	ement Cond	ition Rating (PCR)	
Poor (0 - 60) Fair	(61- 84) Good	(85 - 94)	Excellent (95 - 100)	Not Rated
Colors on map represent of	ondition scores at 0.10-mil	e intervals. Se	e Appendix for definition	ns and formulas.
Inspection Date: 4/24/2021	Beginning Section MP	0		
Paved Length (Miles): 0.27	Section Length (MI)	0.27		
Surface Type: ASPHALT	Route Summary		•	• •
Roadway Condition Information				
Pavement Condition Rating (PCR)	46	46		
Surface Condition Rating (SCR)	46	46		
Roughness Condition Index (RCI)	N/A	N/A		
Distress Index Values				
Structural Crack Index	78	78		
Alligator Crack Index	100	100		
Longitudinal Crack Index	78	78		
Transverse Cracking Index	46	46		
Patching Index	98	98		
Rutting Index	95	95		
International Roughness Index (IRI)	N/A	N/A		
Lane & Width Information				
Number of Lanes	2	2		
Paved Width (ft)	21.2	21.2		
Lane Width (ft)	11.1	11.1

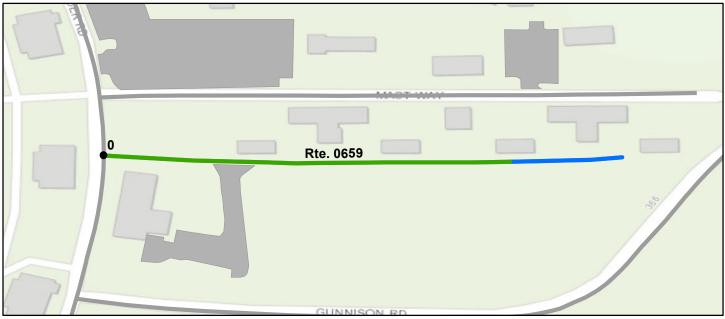
ROUTE 0659: OLD TRAILER CAMP LANE MAST

Route Condition Legend – Pavement Condition Rating (PCR)					
Poor (0 - 60)	(61- 84) Good	(85 - 94)	Excellent (95 - 100)	Not Rated	
Colors on map represent co	ndition scores at 0.10-mile	e intervals. Se	e Appendix for definition	ns and formulas.	
Inspection Date: 4/24/2021	Beginning Section MP	0			
Paved Length (Miles): 0.13	Section Length (MI)	0.13			
Surface Type: ASPHALT	Route Summary				
Roadway Condition Information					
Pavement Condition Rating (PCR)	95	95			
Surface Condition Rating (SCR)	95	95			
Roughness Condition Index (RCI)	N/A	N/A			
Distress Index Values					
Structural Crack Index	97	97			
Alligator Crack Index	100	100			
Longitudinal Crack Index	97	97			
Transverse Cracking Index	95	95			
Patching Index	99	99			
Rutting Index	98	98			
International Roughness Index (IRI)	N/A	N/A			
Lane & Width Information					
Number of Lanes	2	2			
Paved Width (ft)	20.2	20.2			
Lane Width (ft)	9.9	9.9

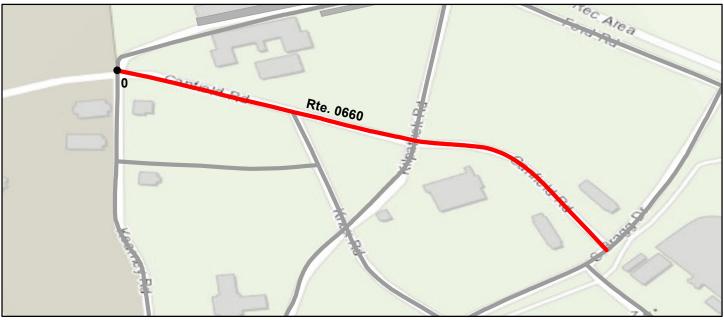
ROUTE 0660: CANFIELD ROAD

Route Condition Legend – Pavement Condition Rating (PCR)					
Poor (0 - 60) Fair (6	1- 84) Good ((85 - 94)	Excellent (95 - 100)	Not Rated	
Colors on map represent cond	dition scores at 0.10-mile	intervals. Se	e Appendix for definition	ons and formulas.	
Inspection Date: 4/24/2021	Beginning Section MP	0			
Paved Length (Miles): 0.21	Section Length (MI)	0.21			
Surface Type: ASPHALT	Route Summary				
Roadway Condition Information					
Pavement Condition Rating (PCR)	20	20			
Surface Condition Rating (SCR)	20	20			
Roughness Condition Index (RCI)	N/A	N/A			
Distress Index Values					
Structural Crack Index	58	58			
Alligator Crack Index	100	100			
Longitudinal Crack Index	58	58			
Transverse Cracking Index	20	20			
Patching Index	99	99			
Rutting Index	97	97			
International Roughness Index (IRI)	N/A	N/A			
Lane & Width Information					
Number of Lanes	2	2			
Paved Width (ft)	18.5	18.5			
Lane Width (ft)	9.2	9.2

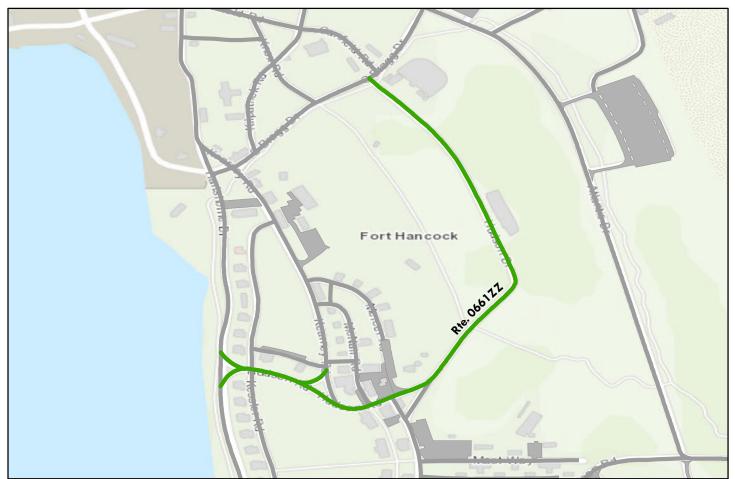
ROUTE 0661ZZ: HUDSON ROADS

Note: The weighted average summary PCR value is calculated from only the sections of road where the PCR was collected. The overall PCR for the summary route may not reflect individual subcomponent ratings.

Route Condition Legend – Pavement Condition Rating (PCR)											
Poor (0 - 60) Fair (6	61- 84) Good	Good (85 - 94)		Excellent (95 - 100)		Not Rated					
See Appendix for definitions and formulas											
Inspection Date: 4/24/2021											
Paved Length (Miles): 0.72											
Surface Type: ASPHALT	Route Summary										
Roadway Condition Information											
Pavement Condition Rating (PCR)	90										
Lane & Width Information											
Number of Lanes	2										
Paved Width (ft)	21.3										
Lane Width (ft)	10.8

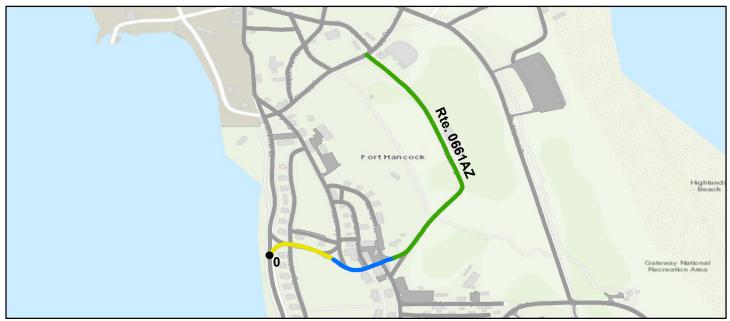
ROUTE 0661AZ: HUDSON ROAD

Route Condition Legend – Pavement Condition Rating (PCR)										
Poor (0 - 60) Fair (6	61- 84) Good (85 - 94)		Excellent (95 - 100)		Not Rated					
Colors on map represent condition scores at 0.10-mile intervals. See Appendix for definitions and formulas.										
Inspection Date: 4/24/2021	Beginning Section MP	0								
Paved Length (Miles): 0.66	Section Length (MI)	0.66								
Surface Type: ASPHALT	Route Summary				•					
Roadway Condition Information										
Pavement Condition Rating (PCR)	89	89								
Surface Condition Rating (SCR)	97	97								
Roughness Condition Index (RCI)	77	77								
Distress Index Values										
Structural Crack Index	98	98								
Alligator Crack Index	100	100								
Longitudinal Crack Index	98	98								
Transverse Cracking Index	98	98								
Patching Index	99	99								
Rutting Index	97	97								
International Roughness Index (IRI)	180	180								
Lane & Width Information

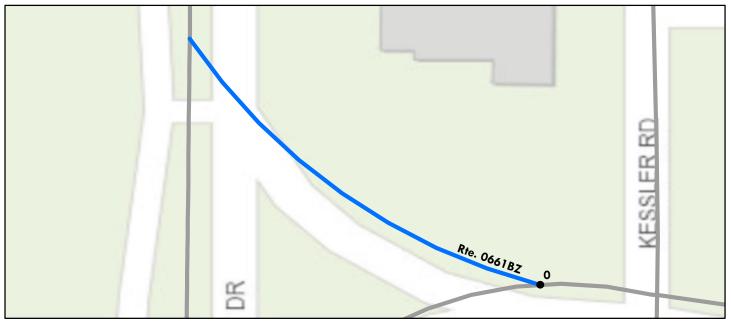
Gateway National Recreation Area ROUTE 0661BZ: HUDSON ROAD SPUR

Route Condition Legend – Pavement Condition Rating (PCR)					
Poor (0 - 60)	(61- 84) Good	(85 - 94)	Excellent (95 - 100)	Not Rated	
	See Appendix for def	finitions and	formulas		
Inspection Date: 3/6/2021	Beginning Section MP	0.00			
Paved Length (Miles): 0.03	Section Length (MI)	0.03			
Surface Type: ASPHALT	Route Summary		• •	•	
Roadway Condition Information					
Pavement Condition Rating (PCR)	100	100			
Surface Condition Rating (SCR)	100	100			
Roughness Condition Index (RCI)	N/A	N/A			
Distress Index Values					
Structural Crack Index	100	100			
Alligator Crack Index	100	100			
Longitudinal Crack Index	100	100			
Transverse Cracking Index	100	100			
Patching Index	100	100			
Rutting Index	100	100			
International Roughness Index (IRI)	N/A	N/A			
Lane & Width Information					
Number of Lanes	2	2			
Paved Width (ft)	19	19			
Lane Width (ft)	9.5	9.5
