Final Report

Road Inventory and Condition Assessment of Paved Routes Gateway National Recreation Area

Federal Lands Highway Road Inventory Program Prepared By: Federal Highway Administration Eastern Federal Lands Highway Division Road Inventory Program (RIP)

Report Date: September 2022

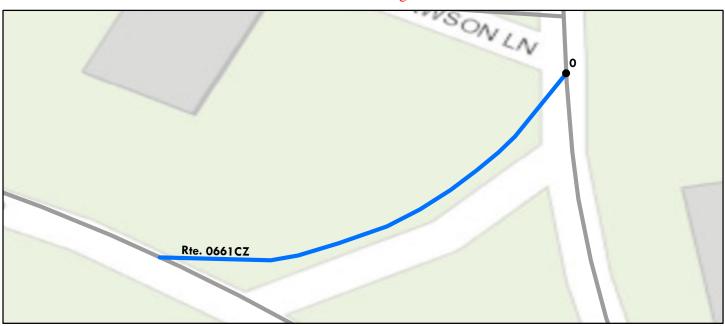
Gateway National Recreation Area ROUTE 0661CZ: HUDSON ROAD CUT-THRU

Route Condition Legend – Pavement Condition Rating (PCR)						
Poor (0 - 60) Fai	r (61- 84) Good	(85 - 94)	Excellent (95 - 100)	Not Rated		
	See Appendix for det	finitions and	formulas			
Inspection Date: 3/6/2021	Beginning Section MP	0.00				
Paved Length (Miles): 0.03	Section Length (MI)	0.03				
Surface Type: ASPHALT	Route Summary			•		
Roadway Condition Information						
Pavement Condition Rating (PCR)	98	98				
Surface Condition Rating (SCR)	98	98				
Roughness Condition Index (RCI)	N/A	N/A				
Distress Index Values						
Structural Crack Index	100	100				
Alligator Crack Index	100	100				
Longitudinal Crack Index	100	100				
Transverse Cracking Index	100	100				
Patching Index	98	98				
Rutting Index	100	100				
International Roughness Index (IRI)	N/A	N/A				
Lane & Width Information						
Number of Lanes	2	2				
Paved Width (ft)	19	19				
Lane Width (ft)	9.5	9.5

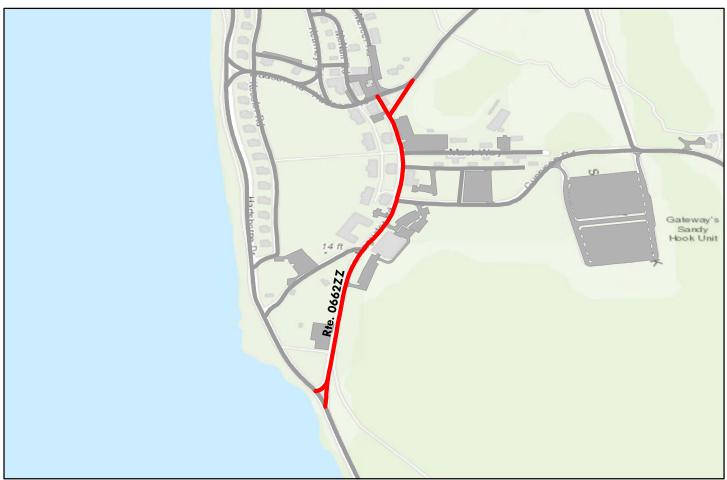
Gateway National Recreation Area ROUTE 0662ZZ: MAGRUDER ROADS

Note: The weighted average summary PCR value is calculated from only the sections of road where the PCR was collected. The overall PCR for the summary route may not reflect individual subcomponent ratings.

Route C	Condition Legend –	Pavement Con	dition Rating (PCR)	
Poor (0 - 60) Fair (61		<mark>1- 84) Go</mark>	od (85 - 94)	Excellent (95 - 100)	Not Rated
See Appendix for definitions and formulas					
Inspection Date:	4/24/2021				
Paved Length (Mile	es): 0.53				
Surface Type:	ASPHALT	Route Summary		• •	
Roadway Condition	1 Information				
Pavement Conditio	n Rating (PCR)	34			
Lane & Width Info	rmation				
Number of Lanes		2			
Paved Width (ft)		30.8			
Lane Width (ft)		14.4

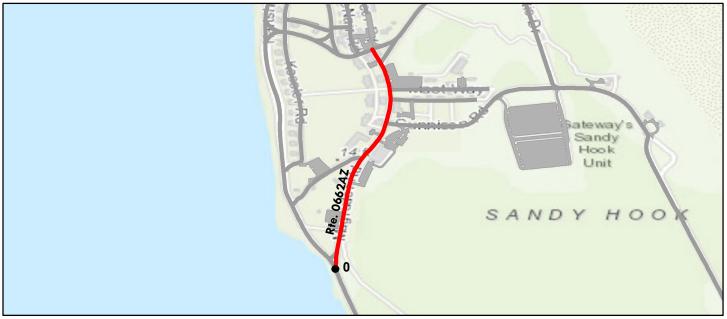
Gateway National Recreation Area ROUTE 0662AZ: MAGRUDER ROAD

Subcomponent of Route GATE-0662ZZ Data Collection Vehicle (DCV) Rating

Route Condition Legend – Pavement Condition Rating (PCR)					
Poor (0 - 60) Fair (0	61- 84) Good	(85 - 94)	Excellent (95 - 100)	Not Rated	
Colors on map represent cor	dition scores at 0.10-mile	e intervals. Se	e Appendix for definition	ons and formulas.	
Inspection Date: 4/24/2021	Beginning Section MP	0			
Paved Length (Miles): 0.45	Section Length (MI)	0.45			
Surface Type: ASPHALT	Route Summary		• •		
Roadway Condition Information					
Pavement Condition Rating (PCR)	28	28			
Surface Condition Rating (SCR)	28	28			
Roughness Condition Index (RCI)	N/A	N/A			
Distress Index Values					
Structural Crack Index	49	49			
Alligator Crack Index	100	100			
Longitudinal Crack Index	49	49			
Transverse Cracking Index	28	28			
Patching Index	96	96			
Rutting Index	95	95			
International Roughness Index (IRI)	N/A	N/A			
Lane & Width Information					
Number of Lanes	2	2			
Paved Width (ft)	32.3	32.3			
Lane Width (ft)	15	15

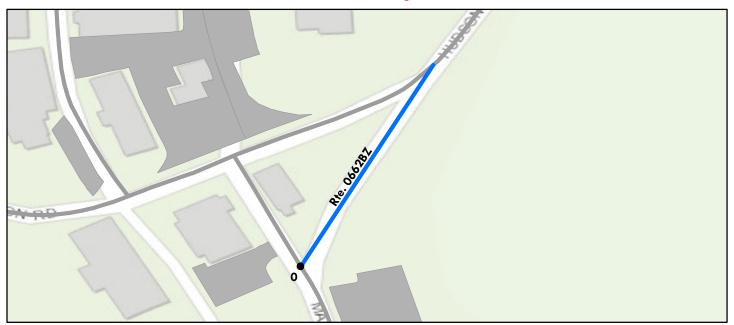
Gateway National Recreation Area ROUTE 0662BZ: MAGRUDER ROAD SPUR 1

Subcomponent of Route GATE-0662ZZ Manual Rating

Route Condition Legend – Pavement Condition Rating (PCR)					
Poor (0 - 60) Fair (6	1- 84) Good ((85 - 94)	Excellent (95 - 100)	Not Rated	
	See Appendix for def	initions and f	ormulas		
Inspection Date: 3/6/2021	Beginning Section MP	0.00			
Paved Length (Miles): 0.06	Section Length (MI)	0.06			
Surface Type: ASPHALT	Route Summary			• •	
Roadway Condition Information					
Pavement Condition Rating (PCR)	100	100			
Surface Condition Rating (SCR)	100	100			
Roughness Condition Index (RCI)	N/A	N/A			
Distress Index Values					
Structural Crack Index	100	100			
Alligator Crack Index	100	100			
Longitudinal Crack Index	100	100			
Transverse Cracking Index	100	100			
Patching Index	100	100			
Rutting Index	100	100			
International Roughness Index (IRI)	N/A	N/A			
Lane & Width Information					
Number of Lanes	2	2			
Paved Width (ft)	24	24			
Lane Width (ft)	12	12

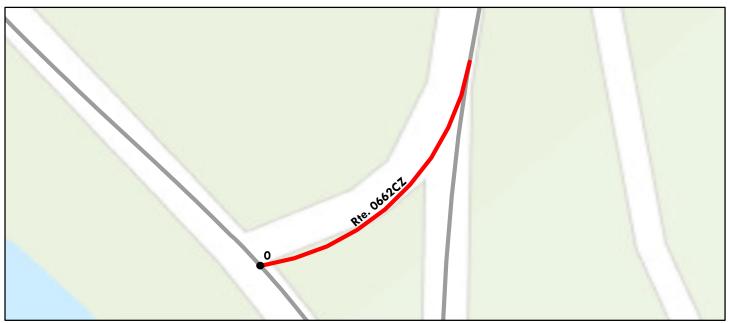
Gateway National Recreation Area ROUTE 0662CZ: MAGRUDER ROAD SPUR 2

Subcomponent of Route GATE-0662ZZ Manual Rating

Route Condition Legend – Pavement Condition Rating (PCR)					
Poor (0 - 60) Fair (61- 84) Good	(85 - 94)	Excellent (95 - 100)	Not Rated	
	See Appendix for def	finitions and f	ormulas		
Inspection Date: 3/6/2021	Beginning Section MP	0.00			
Paved Length (Miles): 0.02	Section Length (MI)	0.02			
Surface Type: ASPHALT	Route Summary				
Roadway Condition Information					
Pavement Condition Rating (PCR)	45	45			
Surface Condition Rating (SCR)	45	45			
Roughness Condition Index (RCI)	N/A	N/A			
Distress Index Values					
Structural Crack Index	45	45			
Alligator Crack Index	56	56			
Longitudinal Crack Index	89	89			
Transverse Cracking Index	90	90			
Patching Index	100	100			
Rutting Index	100	100			
International Roughness Index (IRI)	N/A	N/A			
Lane & Width Information					
Number of Lanes	2	2			
Paved Width (ft)	18	18			
Lane Width (ft)	9	9

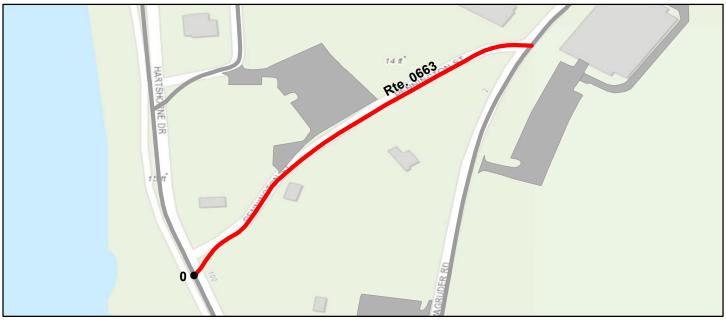
ROUTE 0663: PENNINGTON STREET

Route Condition Legend – Pavement Condition Rating (PCR)					
Poor (0 - 60) Fair (6	1- 84) Good ((85 - 94)	Excellent (95 - 100	D) Not Rated	
Colors on map represent con	dition scores at 0.10-mile	e intervals. Se	e Appendix for defini	itions and formulas.	
Inspection Date: 4/24/2021	Beginning Section MP	0			
Paved Length (Miles): 0.14	Section Length (MI)	0.14			
Surface Type: ASPHALT	Route Summary				
Roadway Condition Information					
Pavement Condition Rating (PCR)	16	16			
Surface Condition Rating (SCR)	16	16			
Roughness Condition Index (RCI)	N/A	N/A			
Distress Index Values					
Structural Crack Index	33	33			
Alligator Crack Index	96	96			
Longitudinal Crack Index	37	37			
Transverse Cracking Index	16	16			
Patching Index	100	100			
Rutting Index	96	96			
International Roughness Index (IRI)	N/A	N/A			
Lane & Width Information					
Number of Lanes	2	2			
Paved Width (ft)	19.5	19.5			
Lane Width (ft)	9.8	9.8

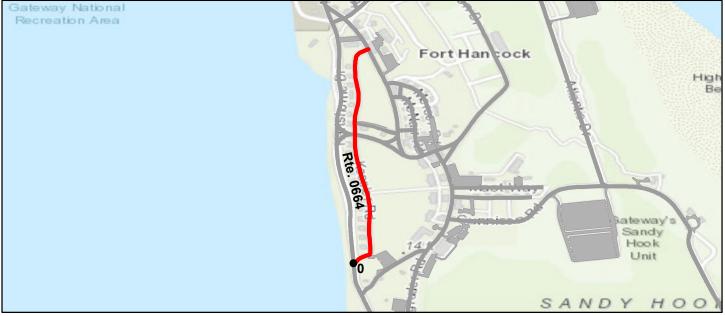
ROUTE 0664: KESSLER ROAD

Route Condition Legend – Pavement Condition Rating (PCR)						
Poor (0 - 60) Fair (6	1- 84) Good ((85 - 94)	Excellent (95	- 100)	Not Rat	ted
Colors on map represent con-	dition scores at 0.10-mile	intervals. Se	e Appendix for	definitions	and formulas.	
Inspection Date: 4/24/2021	Beginning Section MP	0				
Paved Length (Miles): 0.48	Section Length (MI)	0.48				
Surface Type: ASPHALT	Route Summary				•	
Roadway Condition Information						
Pavement Condition Rating (PCR)	12	12				
Surface Condition Rating (SCR)	12	12				
Roughness Condition Index (RCI)	N/A	N/A				
Distress Index Values						
Structural Crack Index	32	32				
Alligator Crack Index	92	92				
Longitudinal Crack Index	40	40				
Transverse Cracking Index	12	12				
Patching Index	98	98				
Rutting Index	81	81				
International Roughness Index (IRI)	N/A	N/A				
Lane & Width Information						
Number of Lanes	2	2				
Paved Width (ft)	15.2	15.2				
Lane Width (ft)	7.6	7.6

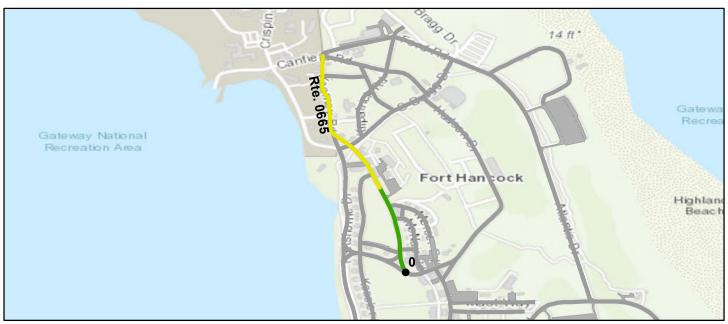
ROUTE 0665: KEARNY DRIVE

Route Condition Legend – Pavement Condition Rating (PCR)					
Poor (0 - 60) Fa	ir (61- 84) Good	(85 - 94)	Excellent (95 - 100)	Not Rated	
Colors on map represent	condition scores at 0.10-mile	e intervals. Se	ee Appendix for definition	ns and formulas.	
Inspection Date: 4/24/2021	Beginning Section MP	0			
Paved Length (Miles): 0.53	Section Length (MI)	0.53			
Surface Type: ASPHALT	Route Summary		•	•	
Roadway Condition Information					
Pavement Condition Rating (PCR)	80	80			
Surface Condition Rating (SCR)	97	97			
Roughness Condition Index (RCI)	55	55			
Distress Index Values					
Structural Crack Index	99	99			
Alligator Crack Index	100	100			
Longitudinal Crack Index	99	99			
Transverse Cracking Index	99	99			
Patching Index	100	100			
Rutting Index	97	97			
International Roughness Index (IRI)	259	259			
Lane & Width Information					
Number of Lanes	2	2			
Paved Width (ft)	26.6	26.6			
Lane Width (ft)	13.1	13.1

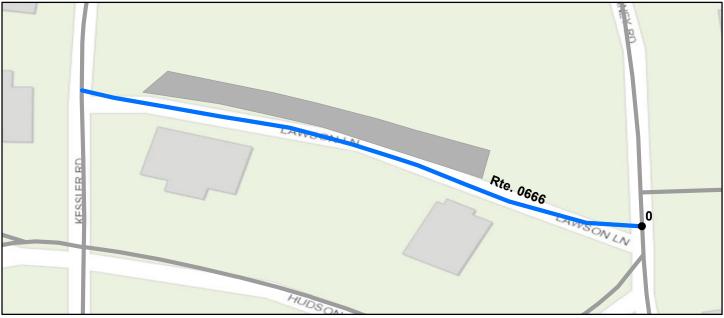
ROUTE 0666: LAWSON LANE

Rou	te Condition Legend – Pav	ement Cond	ition Rating (PCR)	
		(85 - 94)	Excellent (95 - 100)	Not Rated
Colors on map represent	condition scores at 0.10-mile	e intervals. Se	ee Appendix for definition	ns and formulas.
Inspection Date: 4/24/2021	Beginning Section MP	0		
Paved Length (Miles): 0.07	Section Length (MI)	0.07		
Surface Type: ASPHALT	Route Summary		•	• •
Roadway Condition Information				
Pavement Condition Rating (PCR)	97	97		
Surface Condition Rating (SCR)	97	97		
Roughness Condition Index (RCI)	N/A	N/A		
Distress Index Values				
Structural Crack Index	99	99		
Alligator Crack Index	100	100		
Longitudinal Crack Index	99	99		
Transverse Cracking Index	97	97		
Patching Index	100	100		
Rutting Index	98	98		
International Roughness Index (IRI)	N/A	N/A		
Lane & Width Information				
Number of Lanes	1	1		
Paved Width (ft)	15.8	15.8		
Lane Width (ft)	15.8	15.8

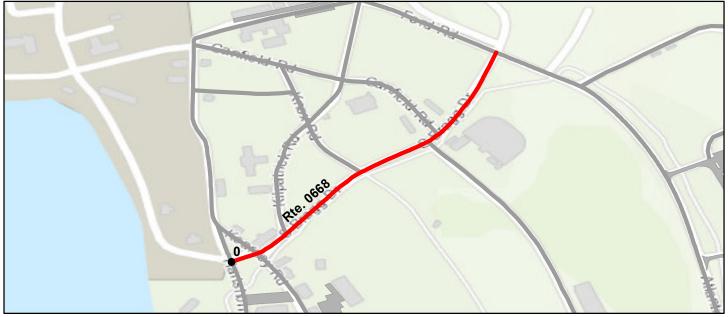
ROUTE 0668: SOUTH BRAGG DRIVE

Route Condition Legend – Pavement Condition Rating (PCR)					
Poor (0 - 60) Fair (6	1- 84) Good ((85 - 94)	Excellent (95 - 100)	Not Rated	
Colors on map represent con	dition scores at 0.10-mile	e intervals. Se	e Appendix for definition	ons and formulas.	
Inspection Date: 4/24/2021	Beginning Section MP	0			
Paved Length (Miles): 0.29	Section Length (MI)	0.29			
Surface Type: ASPHALT	Route Summary		•		
Roadway Condition Information					
Pavement Condition Rating (PCR)	0	0			
Surface Condition Rating (SCR)	0	0			
Roughness Condition Index (RCI)	N/A	N/A			
Distress Index Values					
Structural Crack Index	0	0			
Alligator Crack Index	99	99			
Longitudinal Crack Index	0	0			
Transverse Cracking Index	0	0			
Patching Index	99	99			
Rutting Index	92	92			
International Roughness Index (IRI)	N/A	N/A			
Lane & Width Information					
Number of Lanes	2	2			
Paved Width (ft)	22.7	22.7			
Lane Width (ft)	12.9	12.9

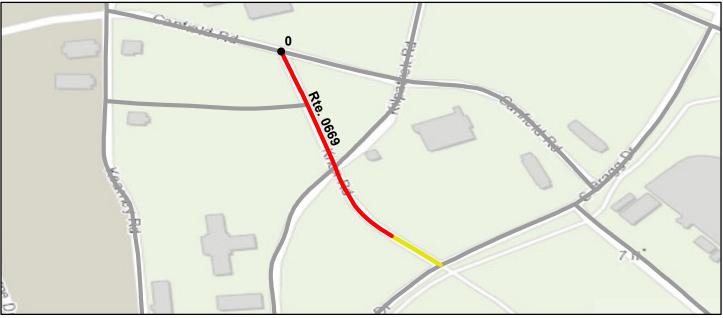
ROUTE 0669: KNOX ROAD NORTH

Route Condition Legend – Pavement Condition Rating (PCR)					
Poor (0 - 60) Fair	(61- 84) Good	(85 - 94)	Excellent (95 - 100)	Not Rated	
Colors on map represent co	ondition scores at 0.10-mile	e intervals. Se	e Appendix for definition	ns and formulas.	
Inspection Date: 4/24/2021	Beginning Section MP	0			
Paved Length (Miles): 0.12	Section Length (MI)	0.12			
Surface Type: ASPHALT	Route Summary		•	• •	
Roadway Condition Information					
Pavement Condition Rating (PCR)	55	55			
Surface Condition Rating (SCR)	55	55			
Roughness Condition Index (RCI)	N/A	N/A			
Distress Index Values					
Structural Crack Index	73	73			
Alligator Crack Index	100	100			
Longitudinal Crack Index	73	73			
Transverse Cracking Index	55	55			
Patching Index	100	100			
Rutting Index	97	97			
International Roughness Index (IRI)	N/A	N/A			
Lane & Width Information					
Number of Lanes	2	2			
Paved Width (ft)	19.8	19.8			
Lane Width (ft)	9.9	9.9

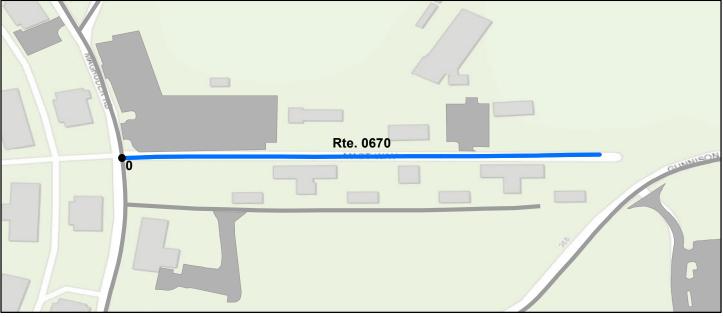
ROUTE 0670: OLD GUNNISON ROAD/MAST WAY

R	oute Condition Legend – Pav	vement Cond	ition Rating (PCR)	
	, , , , , , , , , , , , , , , , , , ,	(85 - 94)	Excellent (95 - 100)	Not Rated
Colors on map represen	nt condition scores at 0.10-mil	e intervals. Se	ee Appendix for definition	1s and formulas.
Inspection Date: 4/24/2021	Beginning Section MI) 0		
Paved Length (Miles): 0.15	Section Length (MI)	0.15		
Surface Type: ASPHALT	Route Summary		•	• •
Roadway Condition Information				
Pavement Condition Rating (PCR)	100	100		
Surface Condition Rating (SCR)	100	100		
Roughness Condition Index (RCI)	N/A	N/A		
Distress Index Values				
Structural Crack Index	100	100		
Alligator Crack Index	100	100		
Longitudinal Crack Index	100	100		
Transverse Cracking Index	100	100		
Patching Index	100	100		
Rutting Index	100	100		
International Roughness Index (IR	I) N/A	N/A		
Lane & Width Information				
Number of Lanes	2	2		
Paved Width (ft)	23	23		
Lane Width (ft)	11.6	11.6

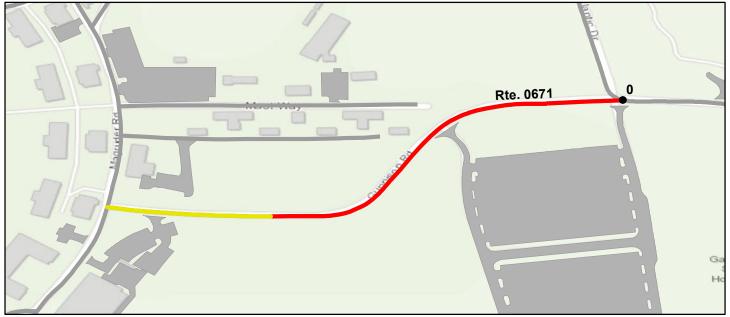
ROUTE 0671: NEW GUNNISON ROAD

Route Condition Legend – Pavement Condition Rating (PCR)						
Poor (0 - 60) Fair (61- 84) Good (85 - 94)		Excellent (95 - 100)	Not Rated		
Colors on map represent con	ndition scores at 0.10-mile	ion scores at 0.10-mile intervals. See Appendix for definitions and formulas.				
Inspection Date: 4/24/2021	Beginning Section MP	0				
Paved Length (Miles): 0.28	Section Length (MI)	0.28				
Surface Type: ASPHALT	Route Summary		•	•		
Roadway Condition Information						
Pavement Condition Rating (PCR)	44	44				
Surface Condition Rating (SCR)	44	44				
Roughness Condition Index (RCI)	N/A	N/A				
Distress Index Values						
Structural Crack Index	69	69				
Alligator Crack Index	100	100				
Longitudinal Crack Index	69	69				
Transverse Cracking Index	44	44				
Patching Index	99	99				
Rutting Index	97	97				
International Roughness Index (IRI)	N/A	N/A				
Lane & Width Information						
Number of Lanes	2	2				
Paved Width (ft)	22.6	22.6

Lane Width (ft)	10.7	10.7

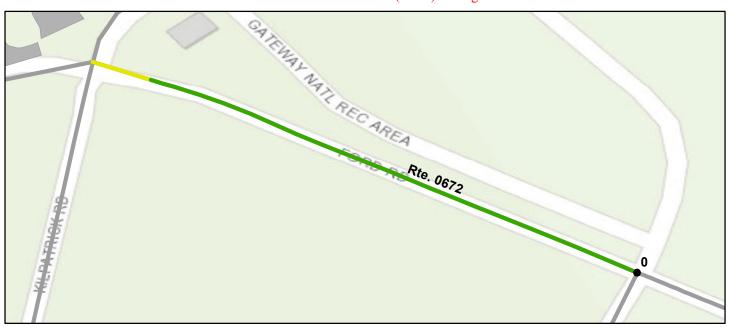
ROUTE 0672: FORD ROAD

Route Condition Legend – Pavement Condition Rating (PCR)						
Poor (0 - 60) Fair (6	1- 84) Good ((85 - 94)	Excellent (95 - 100)	Not Rated		
Colors on map represent con	dition scores at 0.10-mile	ion scores at 0.10-mile intervals. See Appendix for definitions and formulas.				
Inspection Date: 4/24/2021	Beginning Section MP	0				
Paved Length (Miles): 0.11	Section Length (MI)	0.11				
Surface Type: ASPHALT	Route Summary					
Roadway Condition Information						
Pavement Condition Rating (PCR)	89	89				
Surface Condition Rating (SCR)	89	89				
Roughness Condition Index (RCI)	N/A	N/A				
Distress Index Values						
Structural Crack Index	100	100				
Alligator Crack Index	100	100				
Longitudinal Crack Index	100	100				
Transverse Cracking Index	89	89				
Patching Index	100	100				
Rutting Index	100	100				
International Roughness Index (IRI)	N/A	N/A				
Lane & Width Information						
Number of Lanes	2	2				
Paved Width (ft)	30.1	30.1

Lane Width (ft)	12.5	12.5

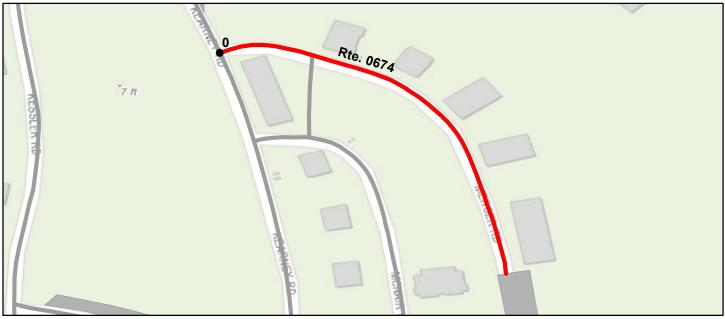
ROUTE 0674: MERCER ROAD

Rou	te Condition Legend – Pav	ement Cond	ition Rating (PCR)				
Poor (0 - 60) Fai	r (61- 84) Good	(85 - 94)	Excellent (95 - 100)	Not Rated			
Colors on map represent	condition scores at 0.10-mile	ion scores at 0.10-mile intervals. See Appendix for definitions and formulas.					
Inspection Date: 4/24/2021	Beginning Section MP	0					
Paved Length (Miles): 0.11	Section Length (MI)	0.11					
Surface Type: ASPHALT	Route Summary		•	•			
Roadway Condition Information							
Pavement Condition Rating (PCR)	23	23					
Surface Condition Rating (SCR)	23	23					
Roughness Condition Index (RCI)	N/A	N/A					
Distress Index Values							
Structural Crack Index	59	59					
Alligator Crack Index	100	100					
Longitudinal Crack Index	59	59					
Transverse Cracking Index	23	23					
Patching Index	100	100					
Rutting Index	97	97					
International Roughness Index (IRI)	N/A	N/A					
Lane & Width Information							
Number of Lanes	2	2

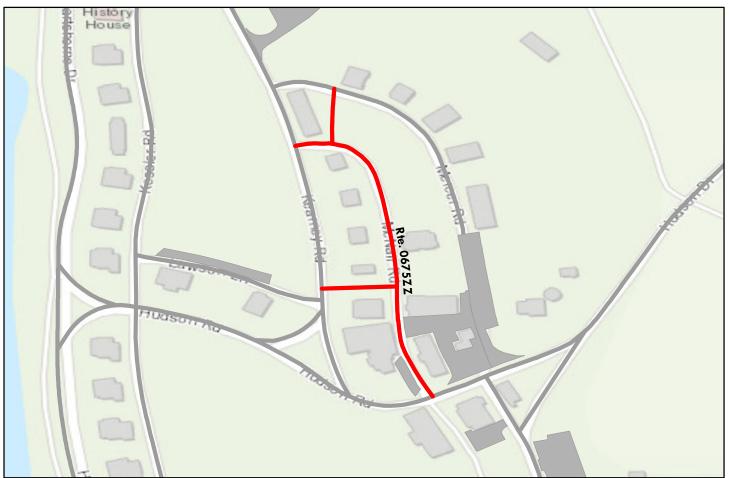
ROUTE 0675ZZ: MCNAIR ROADS

Note: The weighted average summary PCR value is calculated from only the sections of road where the PCR was collected. The overall PCR for the summary route may not reflect individual subcomponent ratings.

Route Condition Legend – Pavement Condition Rating (PCR)						
Poor (0 - 60) Fair (6	1- 84) Good (85 - 94)		Excellent (95 - 100)		Not Rated	
	See Appendix for det	finitions and f	formulas			
Inspection Date: 4/24/2021						
Paved Length (Miles): 0.2						
Surface Type: ASPHALT	Route Summary		• • •			
Roadway Condition Information						
Pavement Condition Rating (PCR)	19					
Lane & Width Information						
Number of Lanes	1					
Paved Width (ft)	16.1					
Lane Width (ft)	16.1

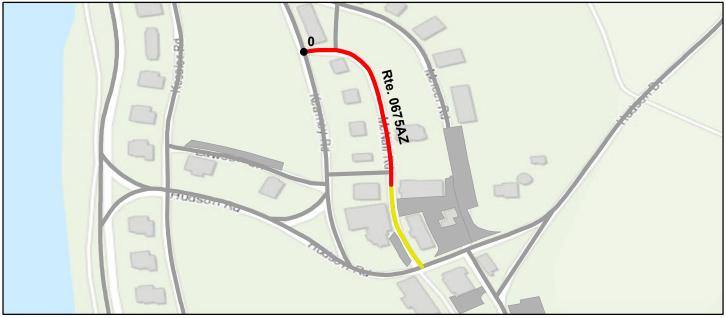
ROUTE 0675AZ: MCNAIR ROAD

Subcomponent of Route GATE-0675ZZ Data Collection Vehicle (DCV) Rating

Route Condition Legend – Pavement Condition Rating (PCR)						
Poor (0 - 60) Fair (61- 84) Good (85 - 94)		Excellent (95 - 100)	Not Rated		
Colors on map represent co	ndition scores at 0.10-mile	ion scores at 0.10-mile intervals. See Appendix for definitions and formulas.				
Inspection Date: 4/24/2021	Beginning Section MP	0				
Paved Length (Miles): 0.15	Section Length (MI)	0.15				
Surface Type: ASPHALT	Route Summary		•	• •		
Roadway Condition Information						
Pavement Condition Rating (PCR)	0	0				
Surface Condition Rating (SCR)	0	0				
Roughness Condition Index (RCI)	N/A	N/A				
Distress Index Values						
Structural Crack Index	7	7				
Alligator Crack Index	97	97				
Longitudinal Crack Index	10	10				
Transverse Cracking Index	0	0				
Patching Index	100	100				
Rutting Index	97	97				
International Roughness Index (IRI)	N/A	N/A				
Lane & Width Information						
Number of Lanes	1	1				
Paved Width (ft)	16.2	16.2

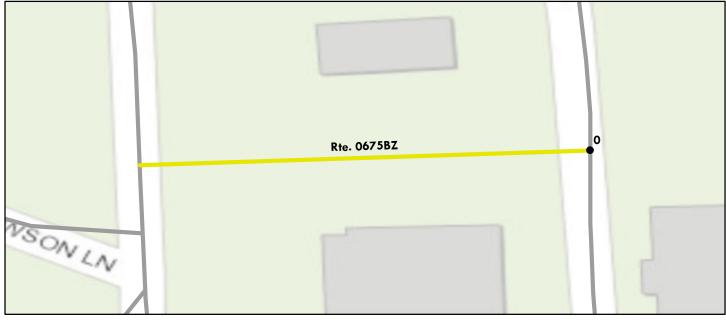
Gateway National Recreation Area ROUTE 0675BZ: MCNAIR ROAD CUT-THRU B

Subcomponent of Route GATE-0675ZZ Manual Rating

Route Condition Legend – Pavement Condition Rating (PCR)								
Poor (0 - 60) Fair (6	6 <mark>1- 84) Good (</mark>	85 - 94)	Excellent (9	5 - 100)	Not Ra	ted	
	See Appendix for definitions and formulas							
Inspection Date:	3/6/2021	Beginning Section MP	0.00					
Paved Length (Mile	es): 0.03	Section Length (MI)	0.03					
Surface Type:	ASPHALT	Route Summary		•		•		
Roadway Condition	1 Information							
Pavement Conditio	n Rating (PCR)	73	73					
Surface Condition R	ating (SCR)	73	73					
Roughness Conditio	n Index (RCI)	N/A	N/A					
Distress Index Valu	es							
Structural Crack In	dex	N/A	N/A					
Alligator Crack Ind	lex	90	90					
Longitudinal Crack	Index	90	90					
Transverse Crackin	g Index	73	73					
Patching Index		90	90					
Rutting Index		97	97					
International Rough	hness Index (IRI)	N/A	N/A					
Lane & Width Info	rmation							
Number of Lanes		1	1					
Paved Width (ft)		16	16					
Lane Width (ft)		16	16

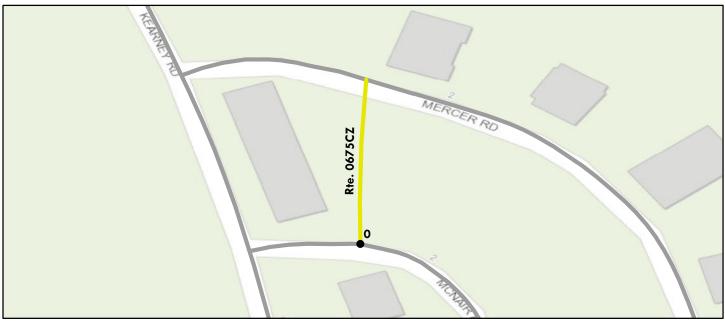
Gateway National Recreation Area ROUTE 0675CZ: MCNAIR ROAD CUT-THRU C

Subcomponent of Route GATE-0675ZZ Manual Rating

Route Condition Legend – Pavement Condition Rating (PCR)						
Poor (0 - 60) Fair (6	1- 84) Good ((85 - 94)	Excellent (95 - 100)	Not Rated		
	See Appendix for def	initions and f	formulas			
Inspection Date: 3/6/2021	Beginning Section MP	0.00				
Paved Length (Miles): 0.03	Section Length (MI)	0.03				
Surface Type: ASPHALT	Route Summary		•			
Roadway Condition Information						
Pavement Condition Rating (PCR)	73	73				
Surface Condition Rating (SCR)	73	73				
Roughness Condition Index (RCI)	N/A	N/A				
Distress Index Values						
Structural Crack Index	N/A	N/A				
Alligator Crack Index	73	73				
Longitudinal Crack Index	90	90				
Transverse Cracking Index	90	90				
Patching Index	97	97				
Rutting Index	97	97				
International Roughness Index (IRI)	N/A	N/A				
Lane & Width Information						
Number of Lanes	1	1				
Paved Width (ft)	16	16				
Lane Width (ft)	16	16

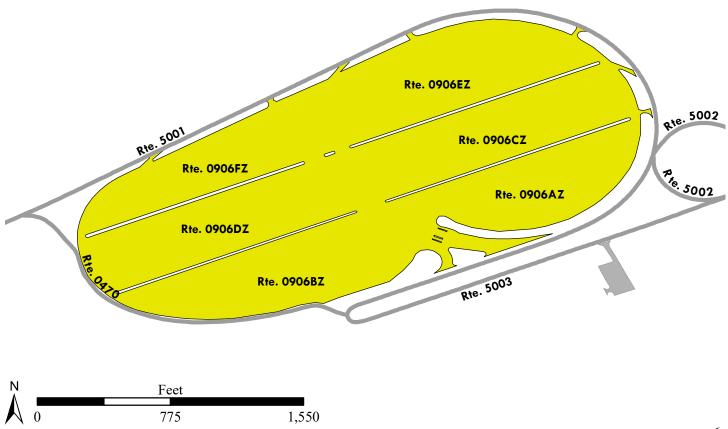
Rte. 0906ZZ (6 Subcomponents)

ROUTE 0906ZZ: JACOB RIIS PARKING

Inspection Date	FMSS Number	User Access	Surface Type			
3/3/2021	36107	PUBLIC	CONCRETE			
Area (Sq. Ft.)	Lane Miles (11' Widths)	Condition Rating / PCR				
2,641,982	45.488	SUMMARY / 84				
Route Condition Legend – Pavement Condition Rating (PCR)						
Poor (0 - 60)	Fair (61- 84) Good ((85 - 94) Excellent (95 - 10	0) Not Rated			
See Appendix for definitions and formulas

The condition shown on this page reflects the overall route condition and may not reflect individual subcomponent ratings.

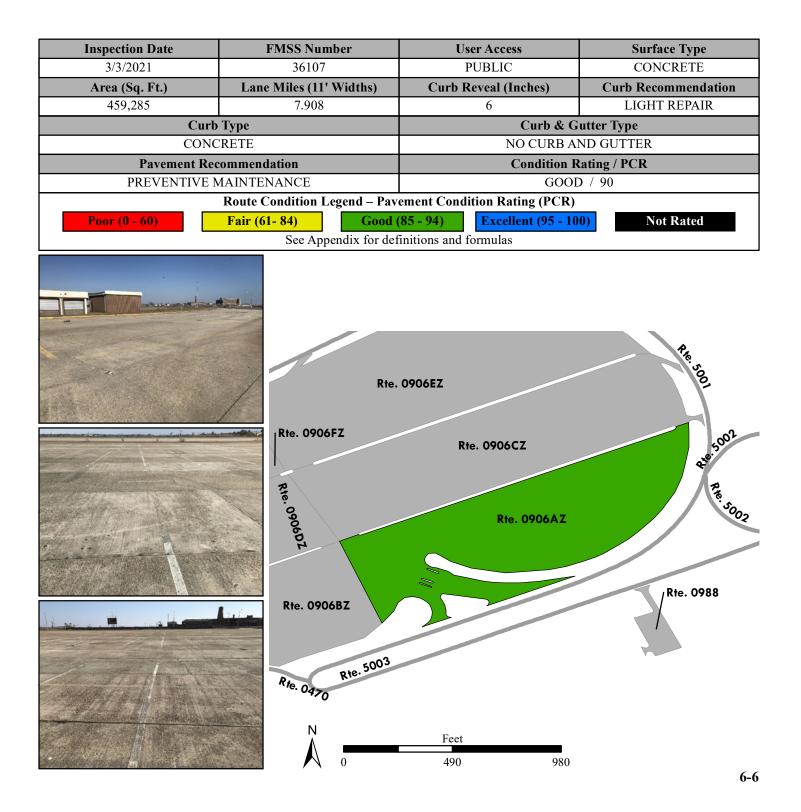
Gateway National Recreation Area ROUTE 0906AZ: JACOB RIIS PARKING A

Subcomponent of Route GATE-0906ZZ Manual Rating

FROM ROUTE 5003 (ROCKAWAY BEACH BOULEVARD)

TO ROUTE 0906BZ (JACOB RIIS PARKING B)

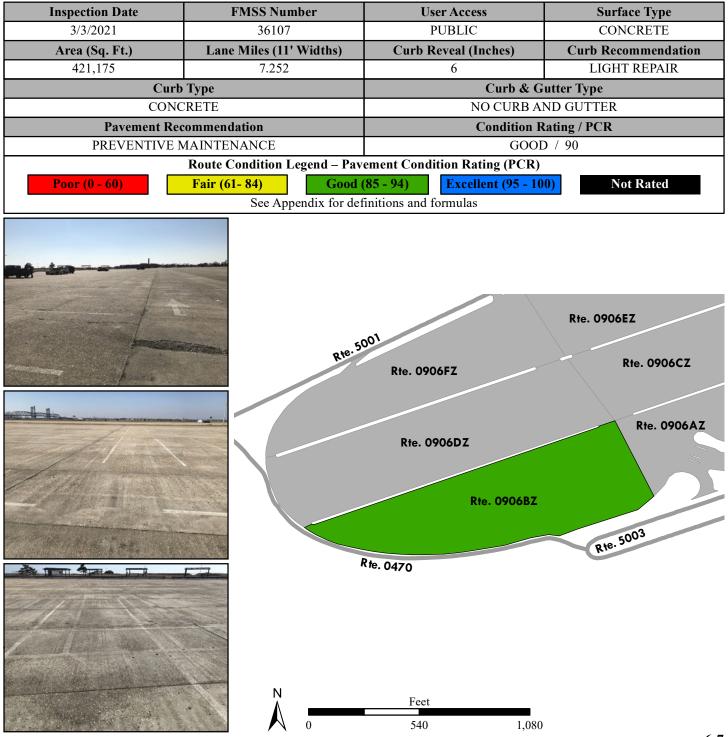
Gateway National Recreation Area ROUTE 0906BZ: JACOB RIIS PARKING B

Subcomponent of Route GATE-0906ZZ Manual Rating

FROM ROUTE 0906AZ (JACOB RIIS PARKING A)

TO ROUTE 0906DZ (JACOB RIIS PARKING D)

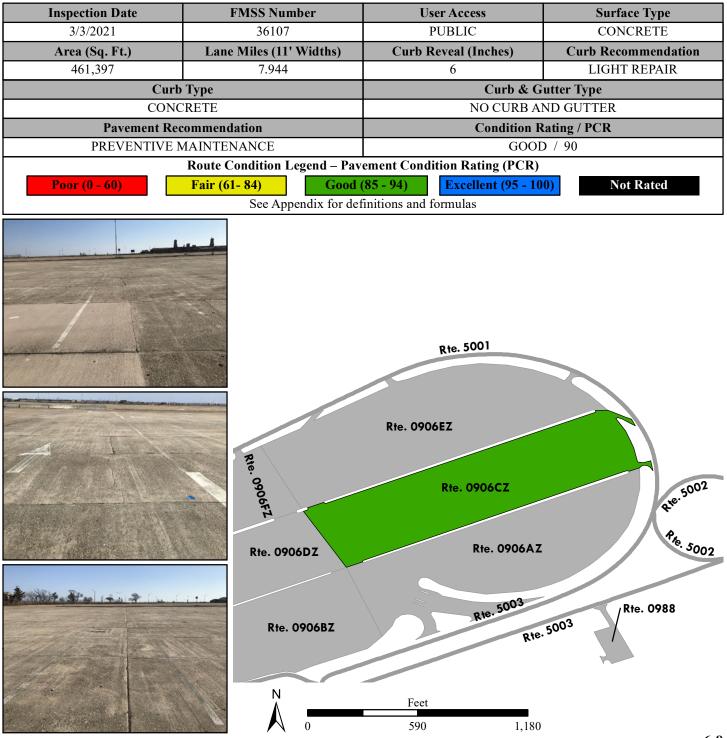
Gateway National Recreation Area ROUTE 0906CZ: JACOB RIIS PARKING C

Subcomponent of Route GATE-0906ZZ Manual Rating

FROM ROUTE 0906AZ (JACOB RIIS PARKING A)

TO ROUTE 0906EZ (JACOB RIIS PARKING E)

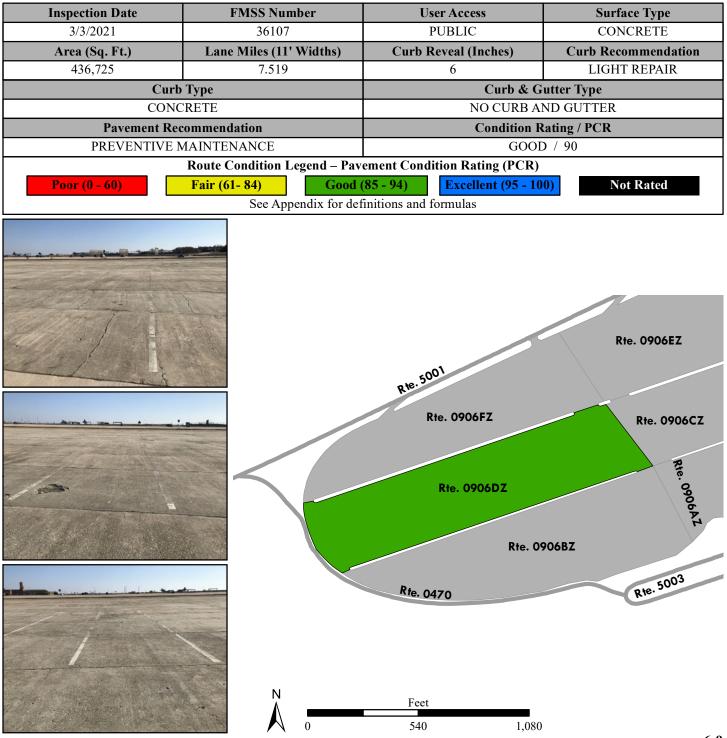
Gateway National Recreation Area ROUTE 0906DZ: JACOB RIIS PARKING D

Subcomponent of Route GATE-0906ZZ Manual Rating

FROM ROUTE 0906BZ (JACOB RIIS PARKING B)

TO ROUTE 0906FZ (JACOB RIIS PARKING F)

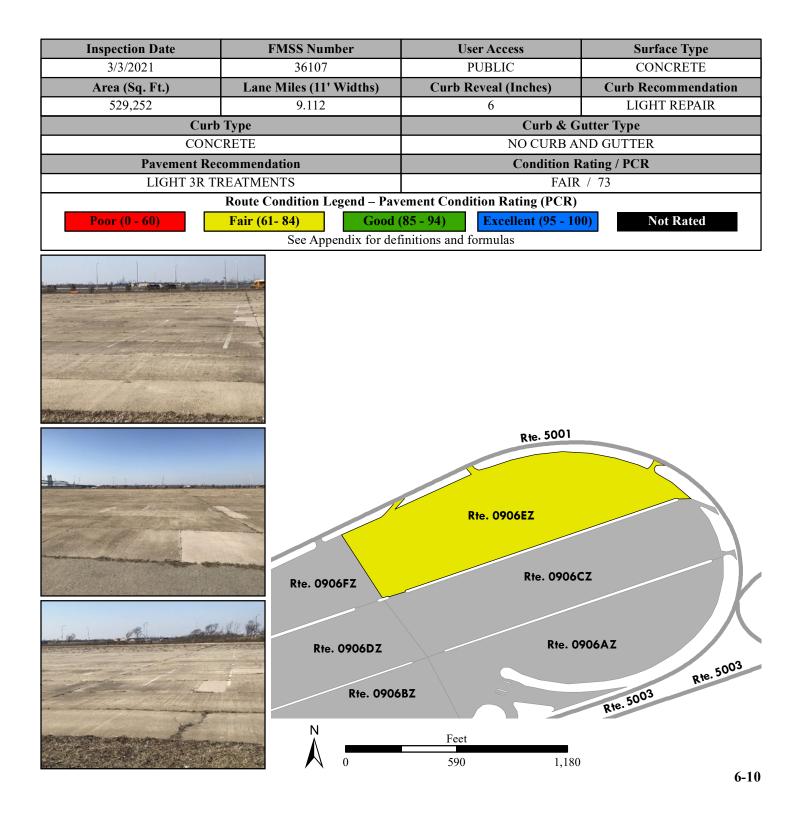
Gateway National Recreation Area ROUTE 0906EZ: JACOB RIIS PARKING E

Subcomponent of Route GATE-0906ZZ Manual Rating

FROM ROUTE 0906CZ (JACOB RIIS PARKING C)

TO ROUTE 5000 (ROCKAWAY POINT BOULEVARD)

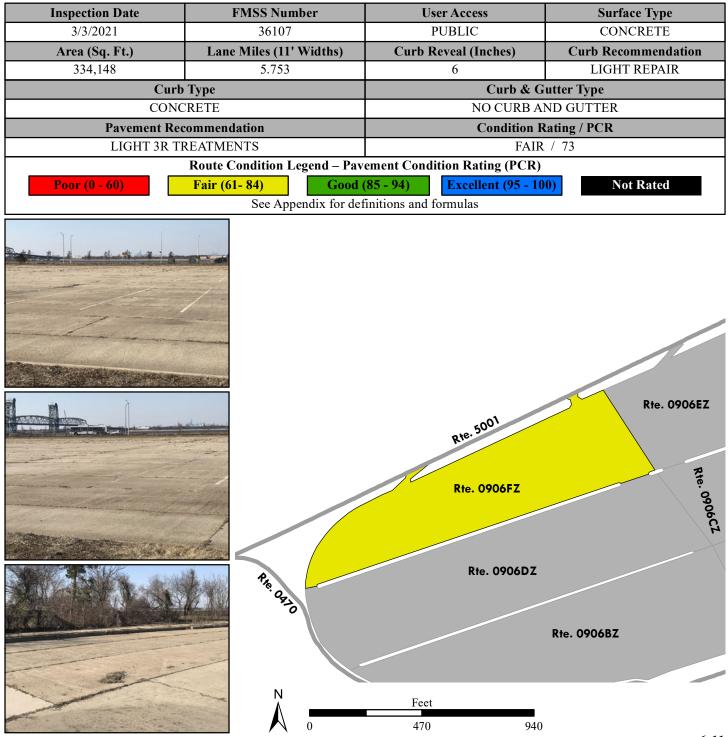
Gateway National Recreation Area ROUTE 0906FZ: JACOB RIIS PARKING F

Subcomponent of Route GATE-0906ZZ Manual Rating

FROM ROUTE 0906DZ (JACOB RIIS PARKING D)

TO ROUTE 5000 (ROCKAWAY POINT BOULEVARD)

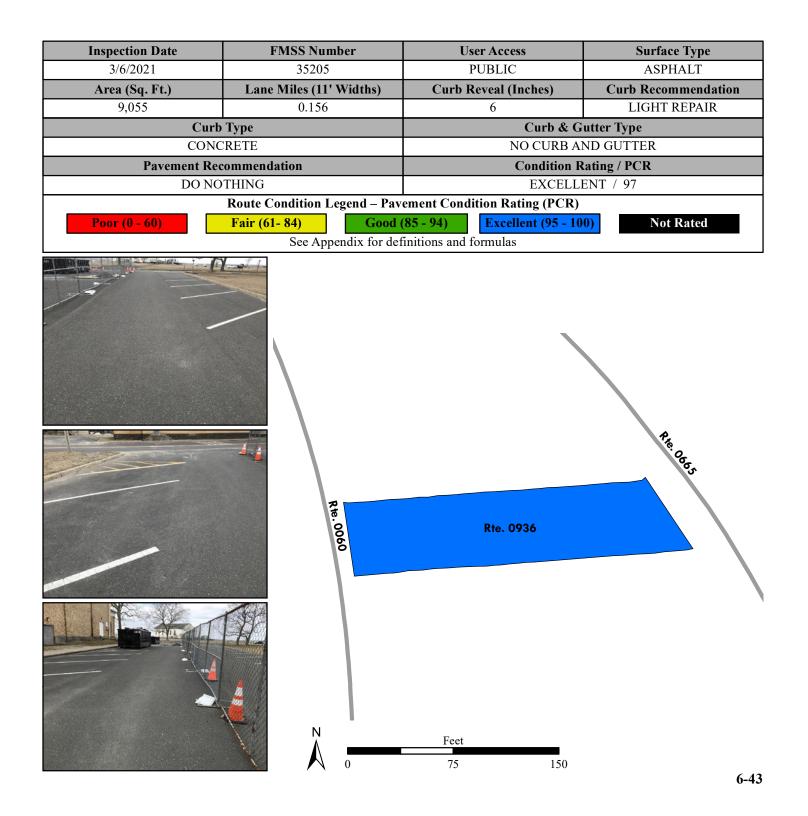
Gateway National Recreation Area ROUTE 0936: FORT HANCOCK THEATER PARKING

FROM ROUTE 0060 (HARTSHORNE DRIVE (NORTHBOUND)) AT MP 5.20

TO ROUTE 0665 (KEARNY DRIVE)

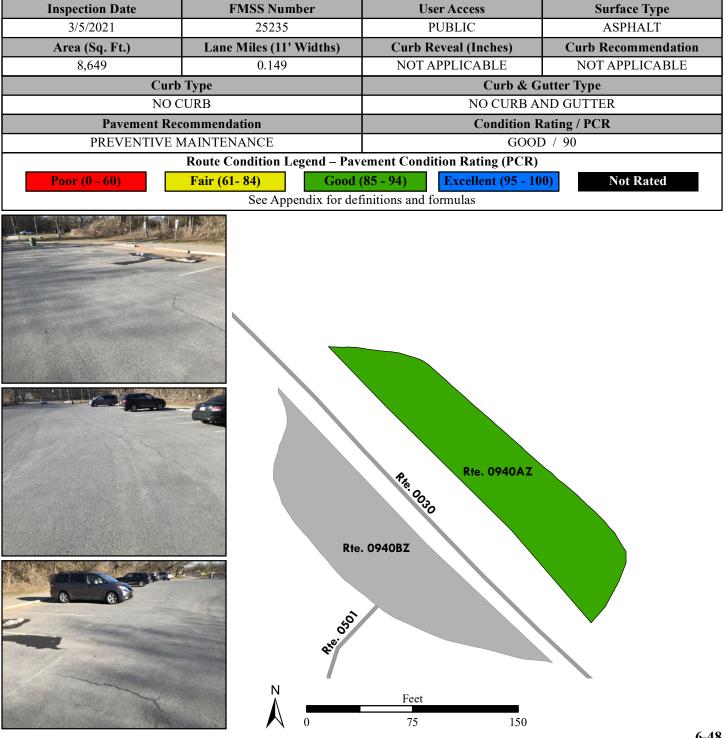
Gateway National Recreation Area ROUTE 0940AZ: GREAT KILLS ENTRANCE PARKING A

Subcomponent of Route GATE-0940ZZ Manual Rating

ADJACENT TO ROUTE 0030 (BUFFALO ROAD) AT MP 0.05 ON LEFT

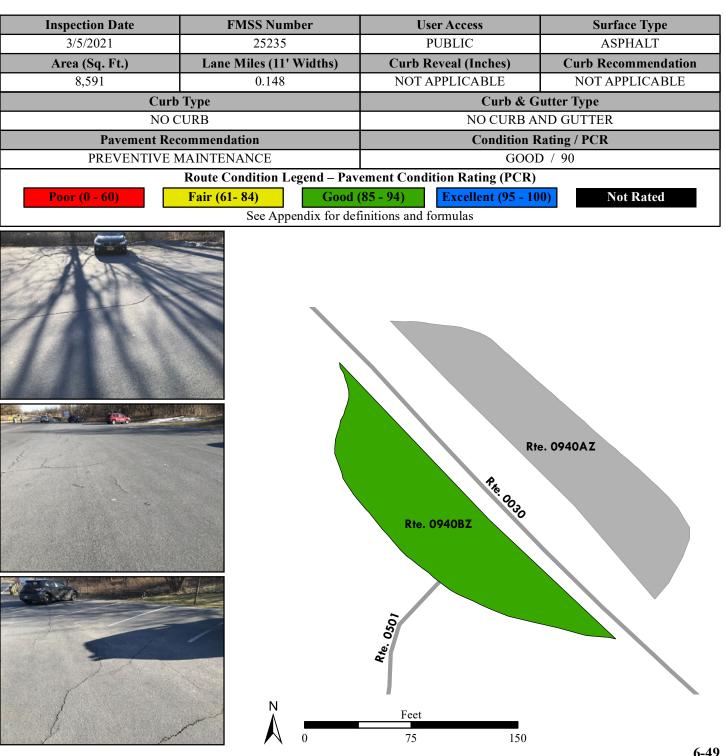
Gateway National Recreation Area ROUTE 0940BZ: GREAT KILLS ENTRANCE PARKING B

Subcomponent of Route GATE-0940ZZ Manual Rating

ADJACENT TO ROUTE 0030 (BUFFALO ROAD) AT MP 0.05 ON RIGHT

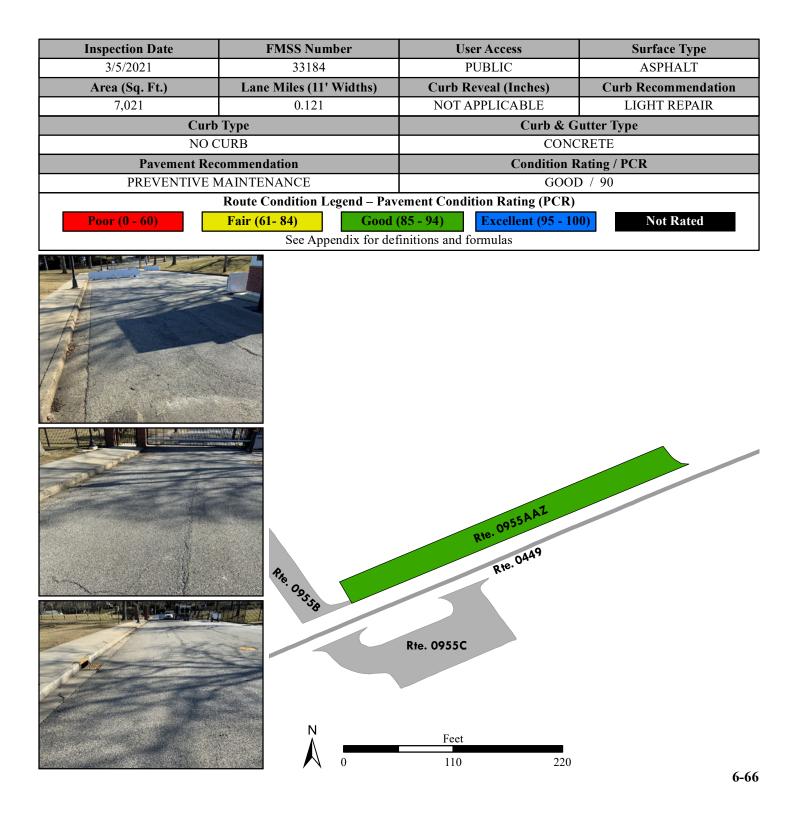
Gateway National Recreation Area ROUTE 0955AAZ: COAST GUARD AREA PARKING AAZ

Subcomponent of Route GATE-0955AZZ Manual Rating

ADJACENT TO ROUTE 0449 (COAST GUARD DRIVE) ON RIGHT

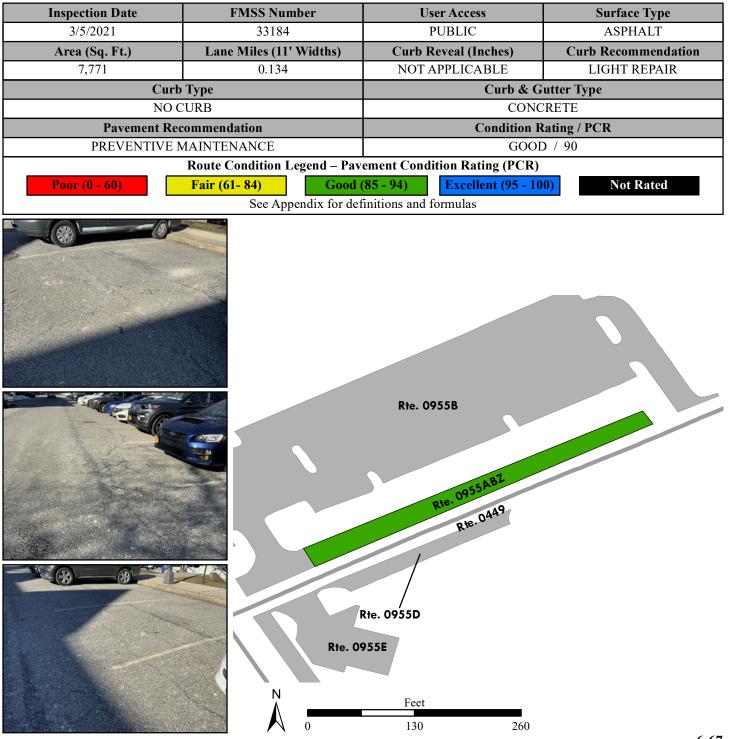
Gateway National Recreation Area ROUTE 0955ABZ: COAST GUARD AREA PARKING ABZ

Subcomponent of Route GATE-0955AZZ Manual Rating

ADJACENT TO ROUTE 0449 (COAST GUARD DRIVE) ON RIGHT

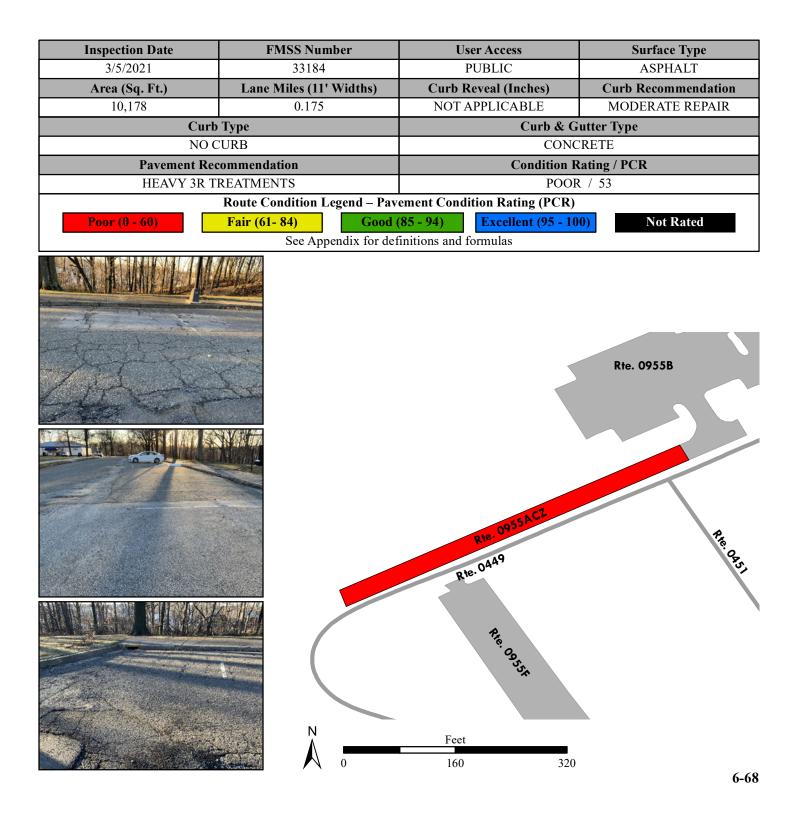
Gateway National Recreation Area ROUTE 0955ACZ: COAST GUARD AREA PARKING ACZ

Subcomponent of Route GATE-0955AZZ Manual Rating

ADJACENT TO ROUTE 0449 (COAST GUARD DRIVE) ON RIGHT

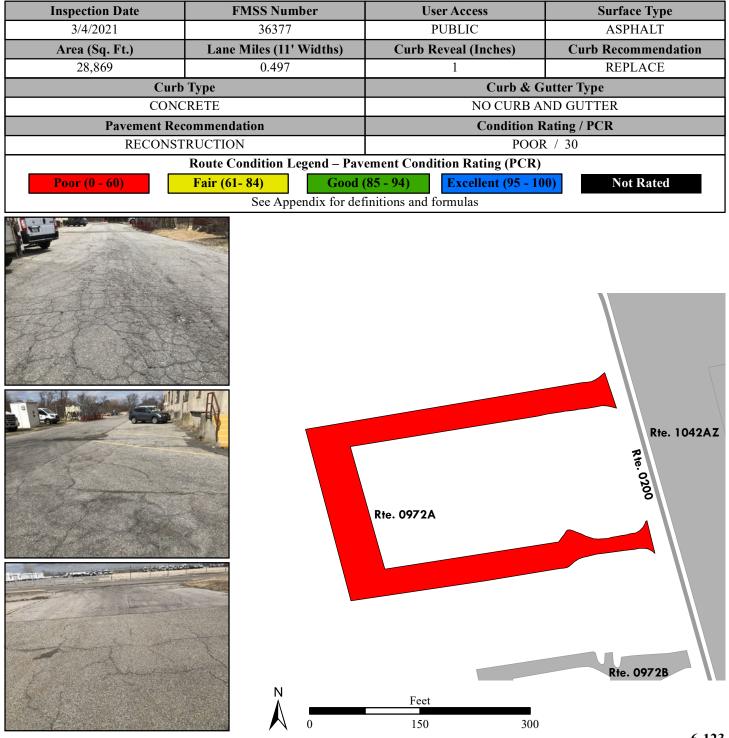
ROUTE 0972A: BUILDING 98 PARKING

Manual Rating

FROM ROUTE 0200 (FLOYD BENNETT FIELD ENTRANCE ROAD) AT MP 0.07 ON LEFT

TO ROUTE 0200 (FLOYD BENNETT FIELD ENTRANCE ROAD)

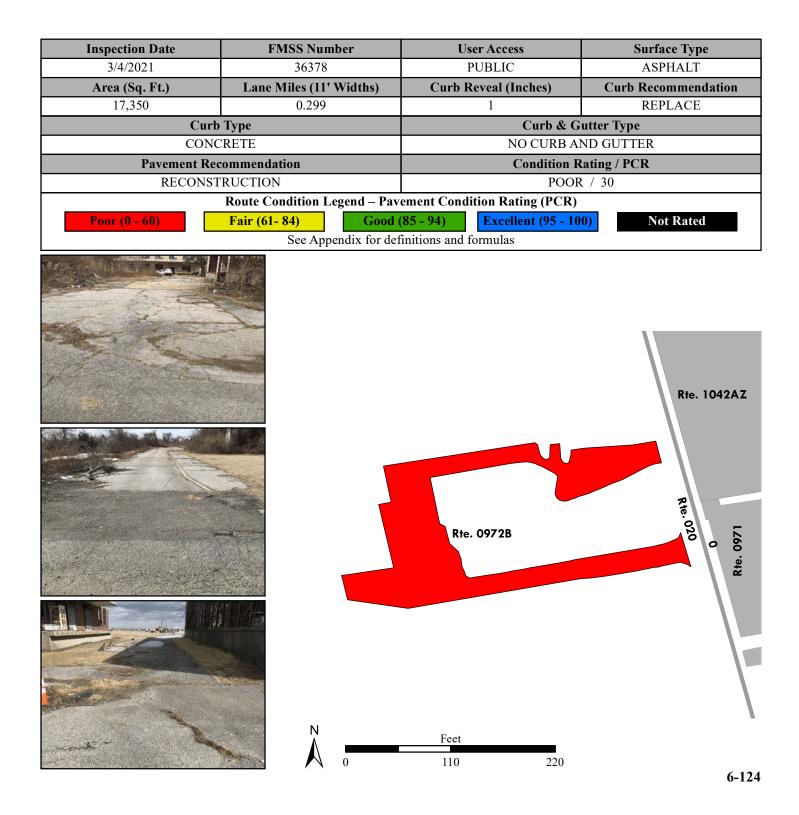
ROUTE 0972B: BUILDING 95 PARKING

Manual Rating

FROM ROUTE 0200 (FLOYD BENNETT FIELD ENTRANCE ROAD) AT MP 0.04 ON LEFT

TO ROUTE 0200 (FLOYD BENNETT FIELD ENTRANCE ROAD)

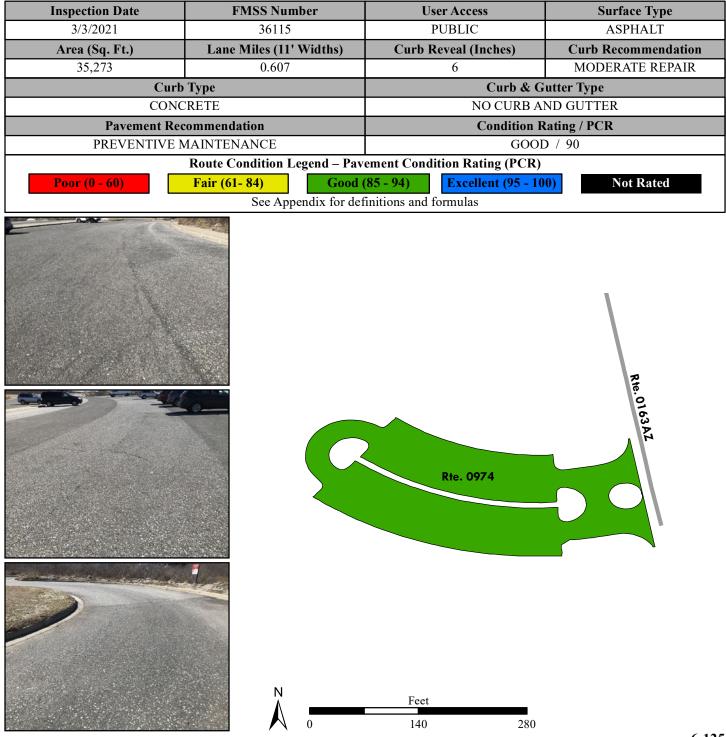
Gateway National Recreation Area ROUTE 0974: FT. TILDEN FISHERMEN'S PARKING

Manual Rating

FROM ROUTE 0111 (SHORE ROAD)

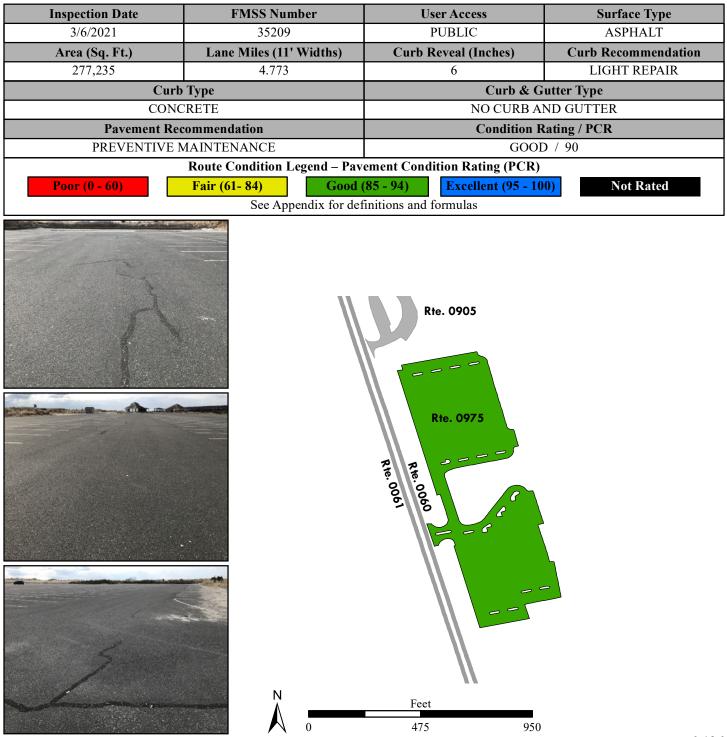
Gateway National Recreation Area ROUTE 0975: AREA D BEACH CENTER PARKING

Manual Rating

FROM ROUTE 0060 (HARTSHORNE DRIVE (NORTHBOUND)) AT MP 2.04

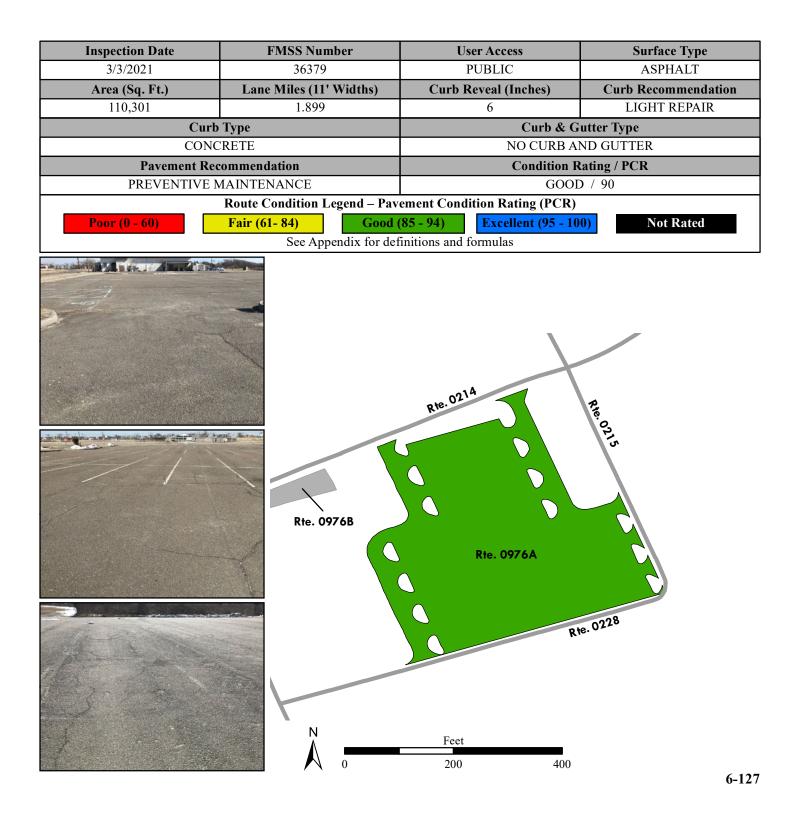
ROUTE 0976A: THEATER PARKING A

Manual Rating

FROM ROUTE 0214 (HAHN ROAD)

TO ROUTE 0228 (THEATER ROAD)

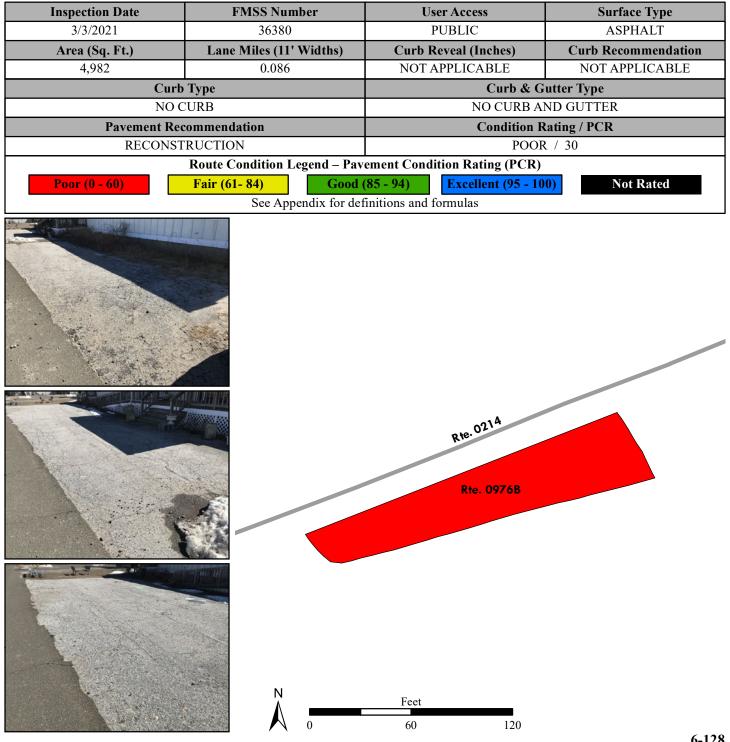
ROUTE 0976B: RAA T-7 PARKING B

```
Manual Rating
```

ADJACENT TO ROUTE 0214 (HAHN ROAD)

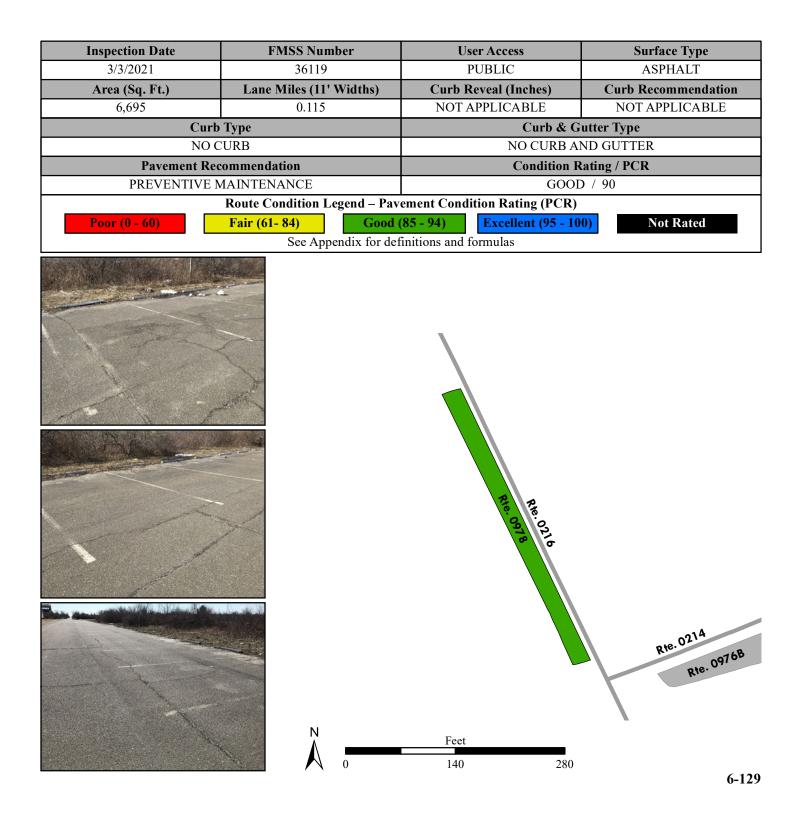
Gateway National Recreation Area ROUTE 0978: BALL FIELD PARKING

Manual Rating

ADJACENT TO ROUTE 0216 (HERO ROAD)
