Final Report

Road Inventory and Condition Assessment of Paved Routes Gateway National Recreation Area

Federal Lands Highway Road Inventory Program Prepared By: Federal Highway Administration Eastern Federal Lands Highway Division Road Inventory Program (RIP)

Report Date: September 2022

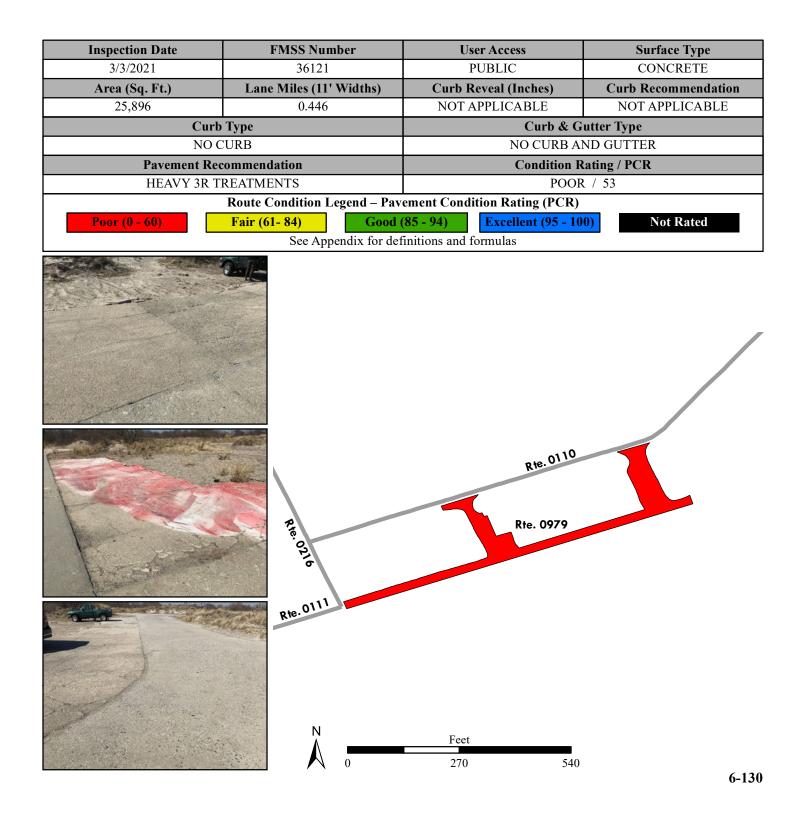
ROUTE 0979: BAY 17/18 PARKING AREA

Manual Rating

FROM ROUTE 0110 (DAVIS ROAD)

TO ROUTE 0110 (DAVIS ROAD) AND 0216 (HERO ROAD)

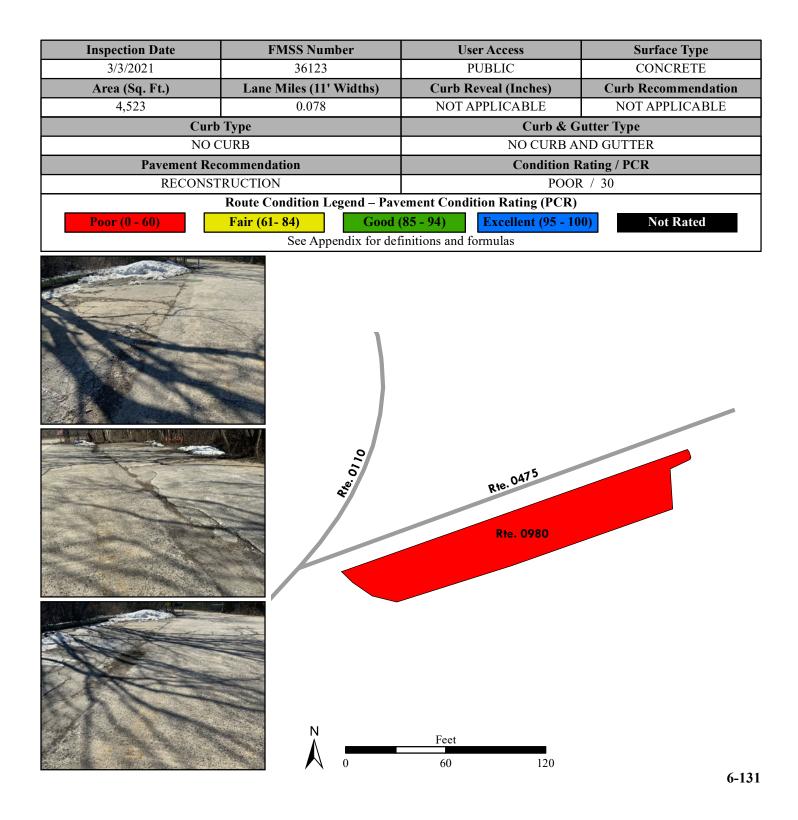
ROUTE 0980: DAVIS ACCESS ROAD PARKING

Manual Rating

ADJACENT TO ROUTE 0475 (DAVIS ACCESS ROAD)

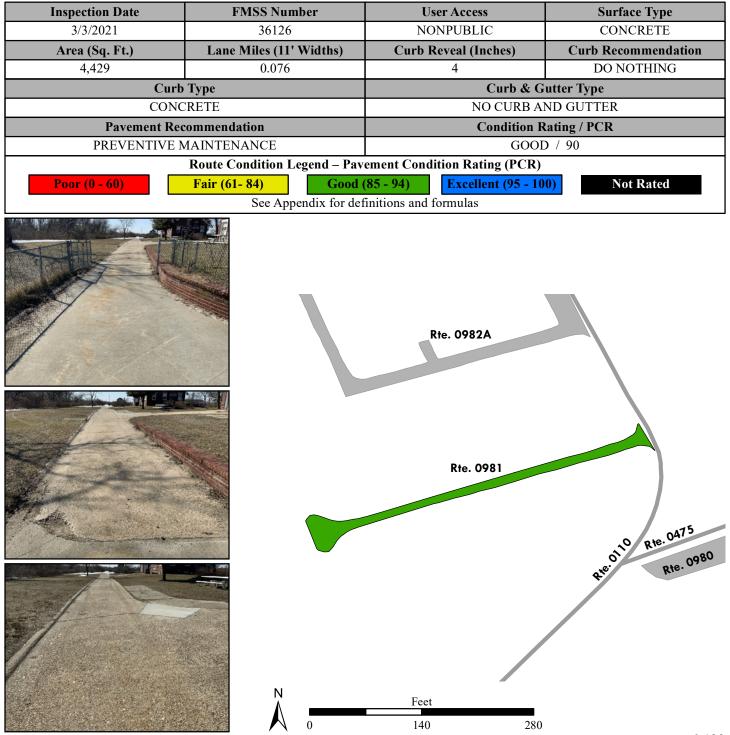
ROUTE 0981: QTS. 22/23 RESIDENCE ACCESS PARKING

Manual Rating

FROM ROUTE 0110 (DAVIS ROAD)

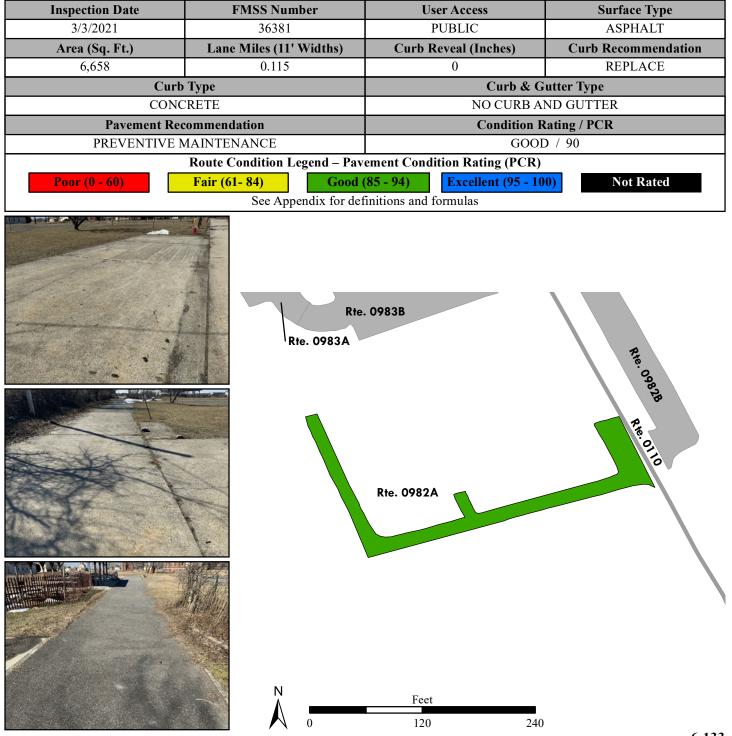
ROUTE 0982A: PICNIC PARKING A

Manual Rating

FROM ROUTE 0110 (DAVIS ROAD)

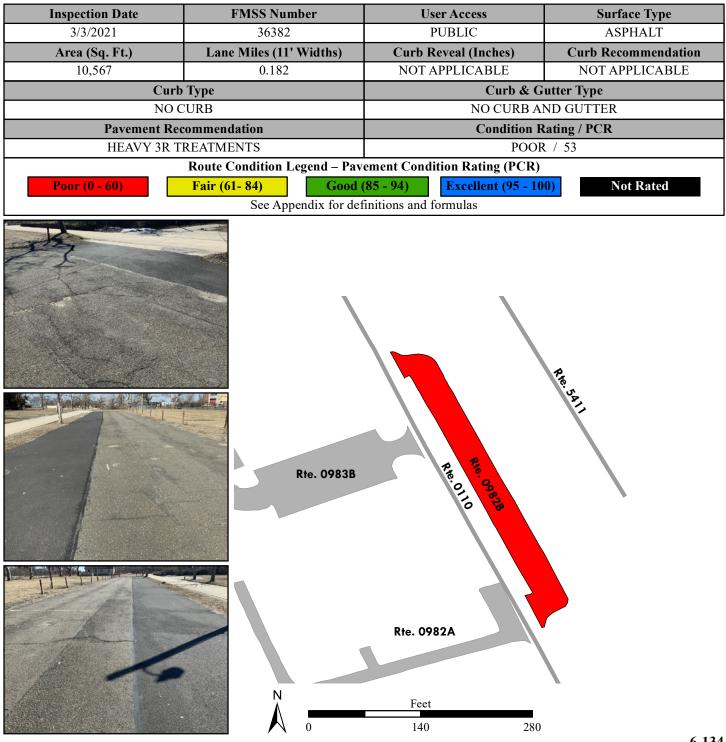
ROUTE 0982B: PICNIC PARKING B

Manual Rating

FROM ROUTE 0110 (DAVIS ROAD)

TO ROUTE 0110 (DAVIS ROAD)

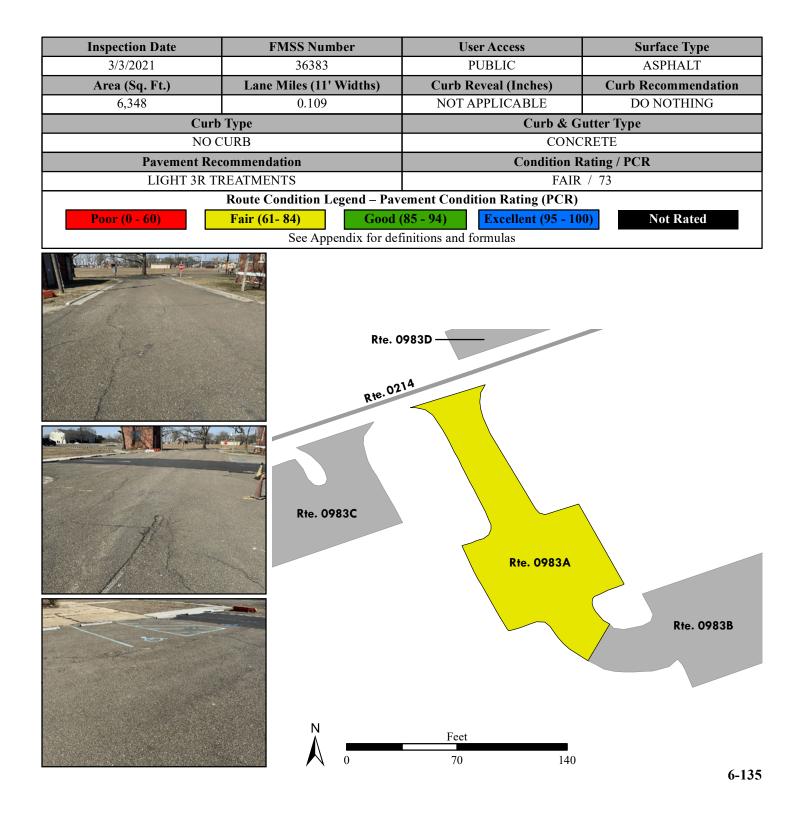
Gateway National Recreation Area ROUTE 0983A: BUILDING 1 PARKING AREA A

Manual Rating

FROM ROUTE 0214 (HAHN ROAD)

TO ROUTE 0983B (BUILDING 1 SOUTHSIDE PARKING AREA B)

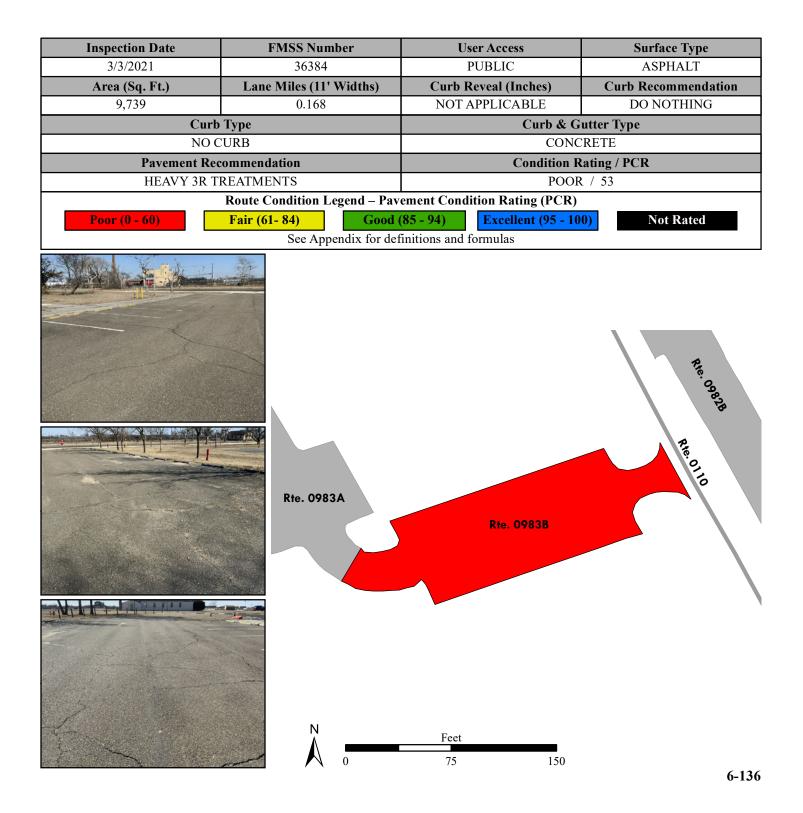
Gateway National Recreation Area ROUTE 0983B: BUILDING 1 SOUTHSIDE PARKING AREA B

Manual Rating

FROM ROUTE 0110 (DAVIS ROAD)

TO ROUTE 0983A (BUILDING 1 PARKING AREA A)

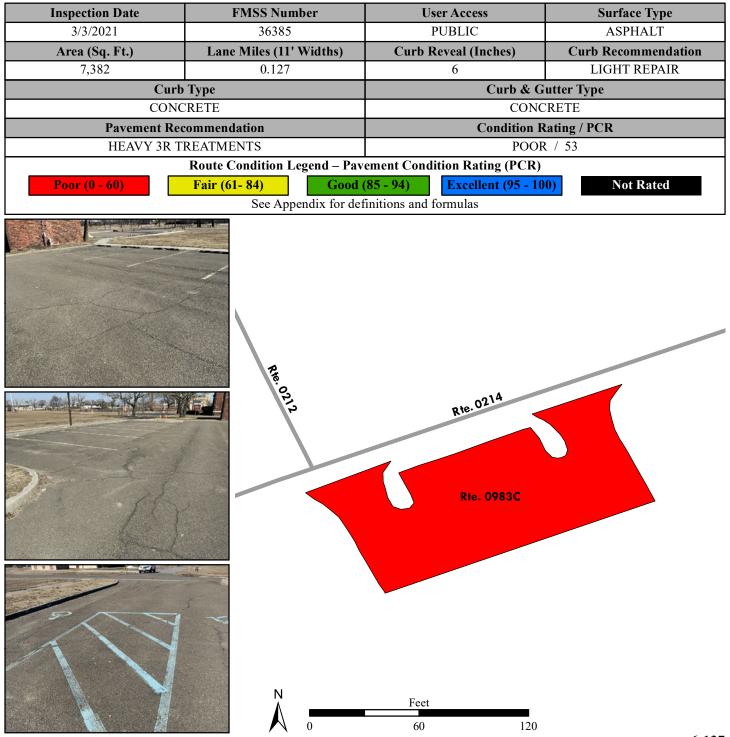
Gateway National Recreation Area ROUTE 0983C: BUILDING 1 NORTHSIDE PARKING AREA C

Manual Rating

FROM INTERSECTION OF ROUTE 0214 (HAHN ROAD) AND ROUTE 0212 (HEINZELMAN ROAD)

TO ROUTE 0214 (HAHN ROAD)

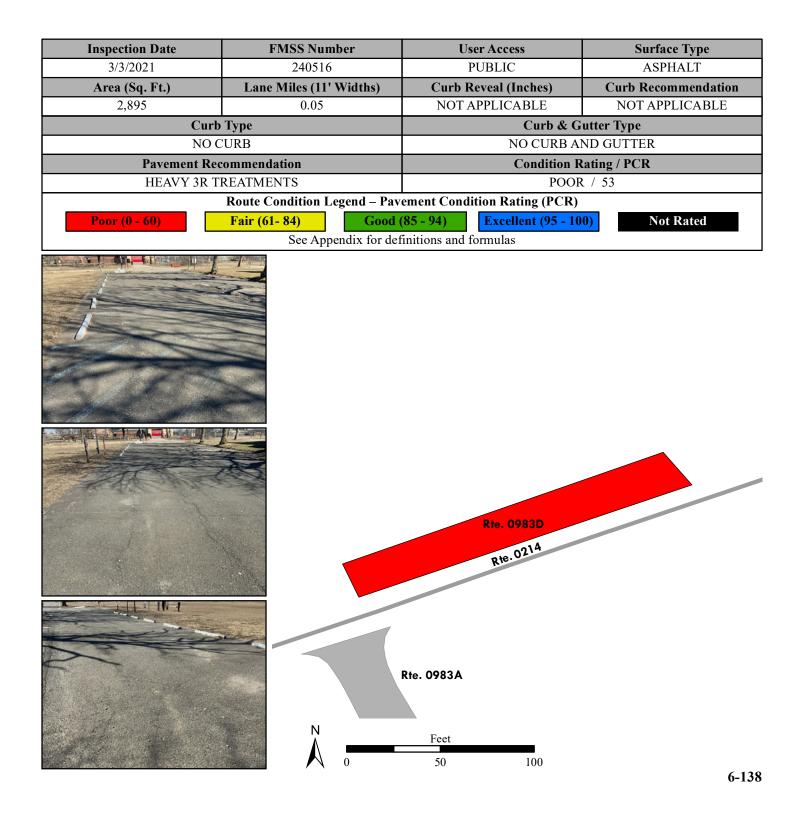
Gateway National Recreation Area ROUTE 0983D: BUILDING 1 PARKING NORTH

Manual Rating

ADJACENT TO ROUTE 0214 (HAHN ROAD)

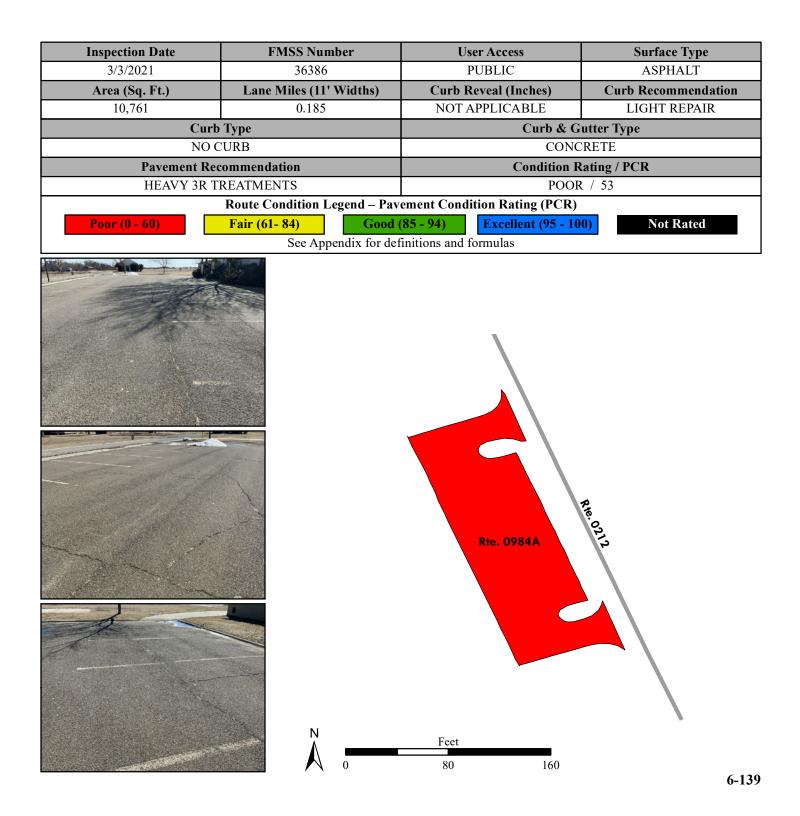
ROUTE 0984A: BUILDING 149 PARKING AREA

Manual Rating

FROM ROUTE 0212 (HEINZELMAN ROAD)

TO ROUTE 0212 (HEINZELMAN ROAD)

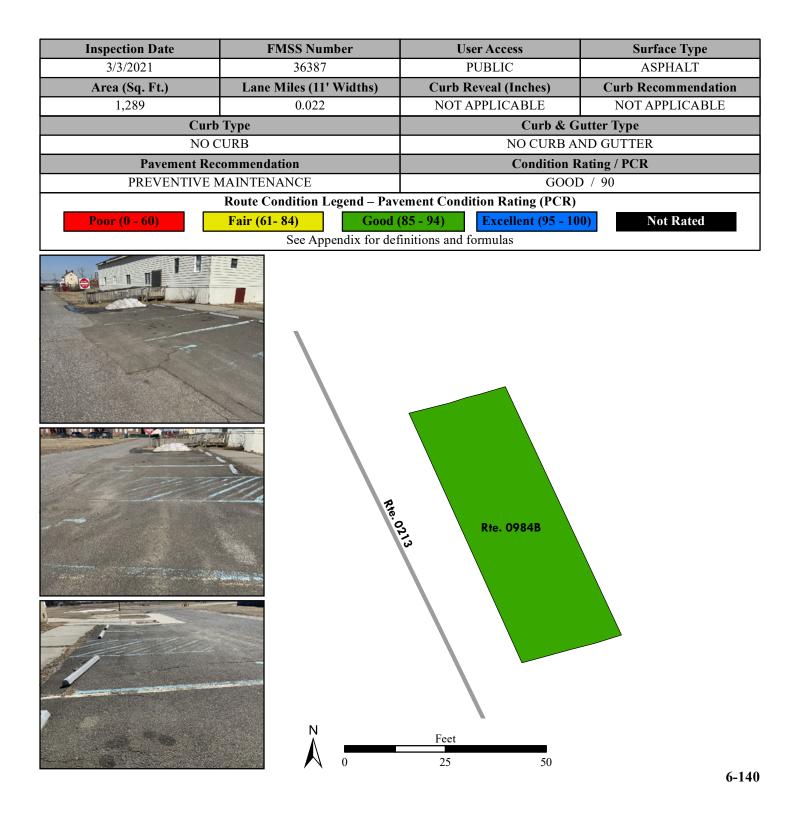
Gateway National Recreation Area ROUTE 0984B: COMMUNITY GARDEN AREA PARKING B

Manual Rating

ADJACENT TO ROUTE 0213 (WORCESTER ROAD)

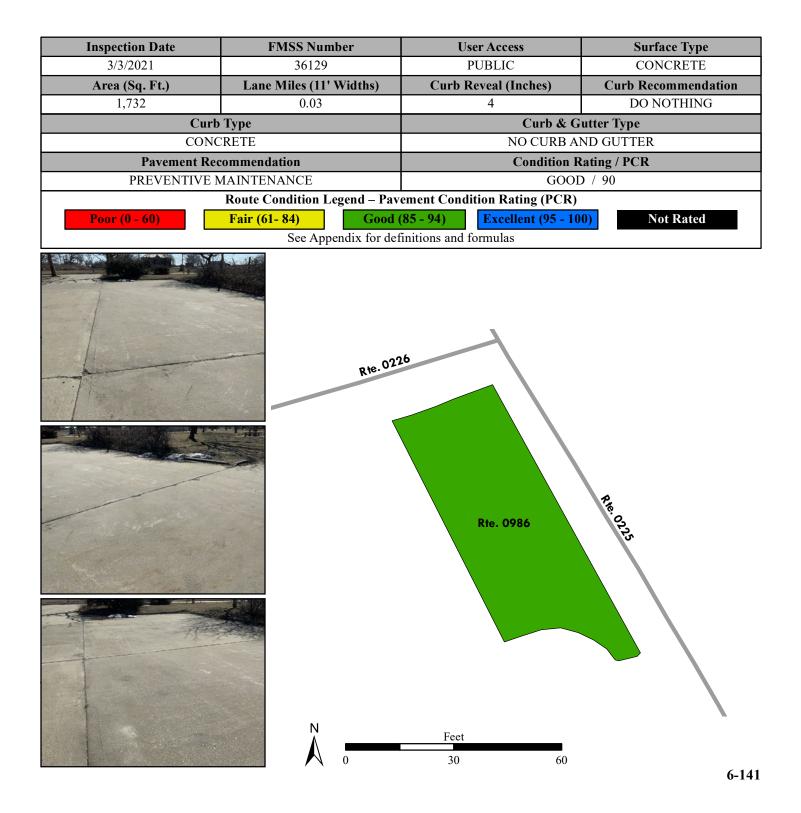
ROUTE 0986: POST OFFICE PARKING

Manual Rating

ADJACENT TO ROUTE 0225 (POST OFFICE ROAD)

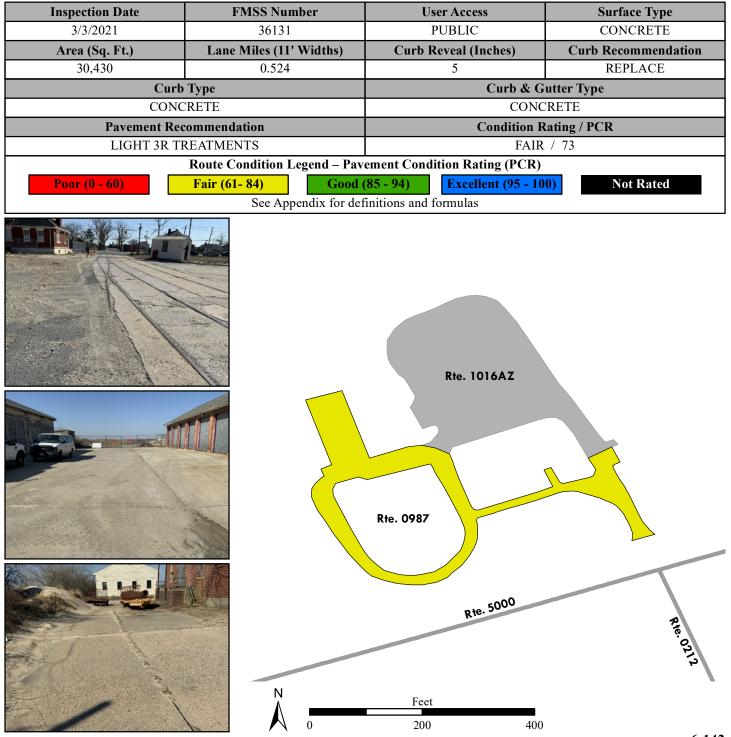
Gateway National Recreation Area ROUTE 0987: MAINTENANCE AREA PARKING (RIIS LDG)

Manual Rating

FROM ROUTE 5000 (ROCKAWAY POINT BOULEVARD)

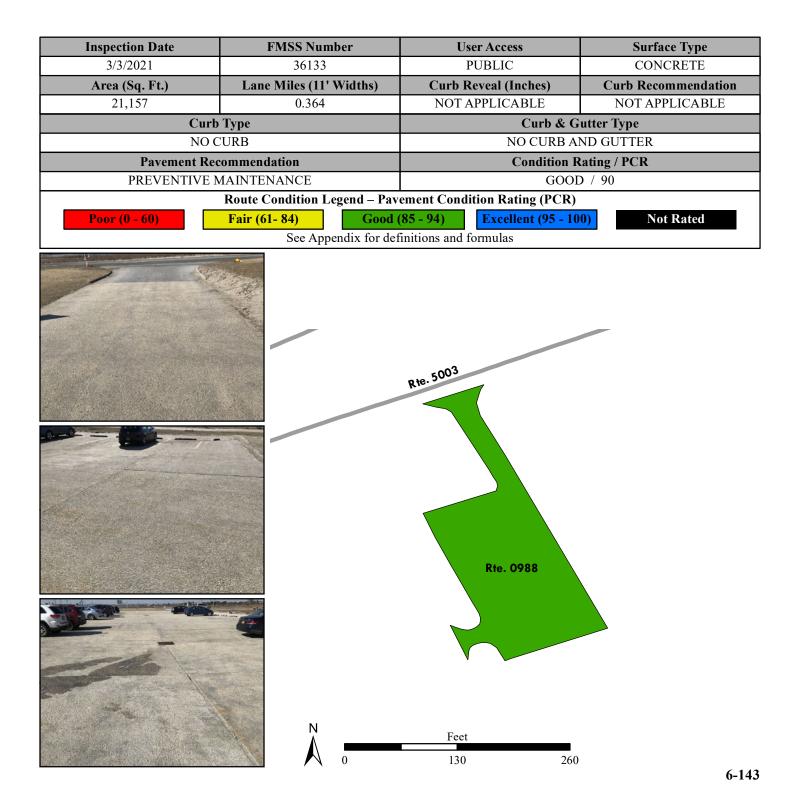
Gateway National Recreation Area ROUTE 0988: RIIS PARK BAY 3 EAST PARKING

Manual Rating

FROM ROUTE 5003 (ROCKAWAY BEACH BOULEVARD)

TO BOARDWALK ACCESS ROAD

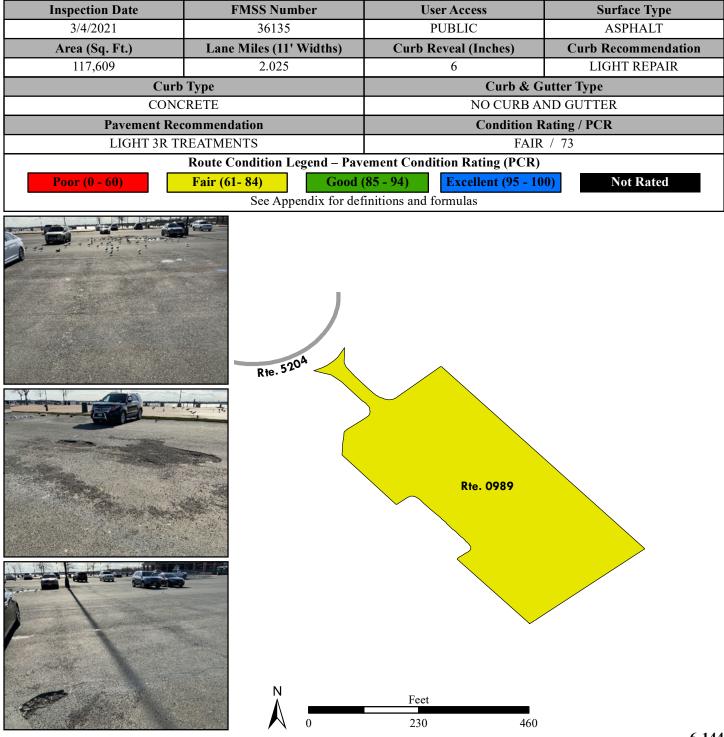
Gateway National Recreation Area ROUTE 0989: CANARSIE PIER PARKING

Manual Rating

FROM ROUTE 5204 (CANARSIE PIER)

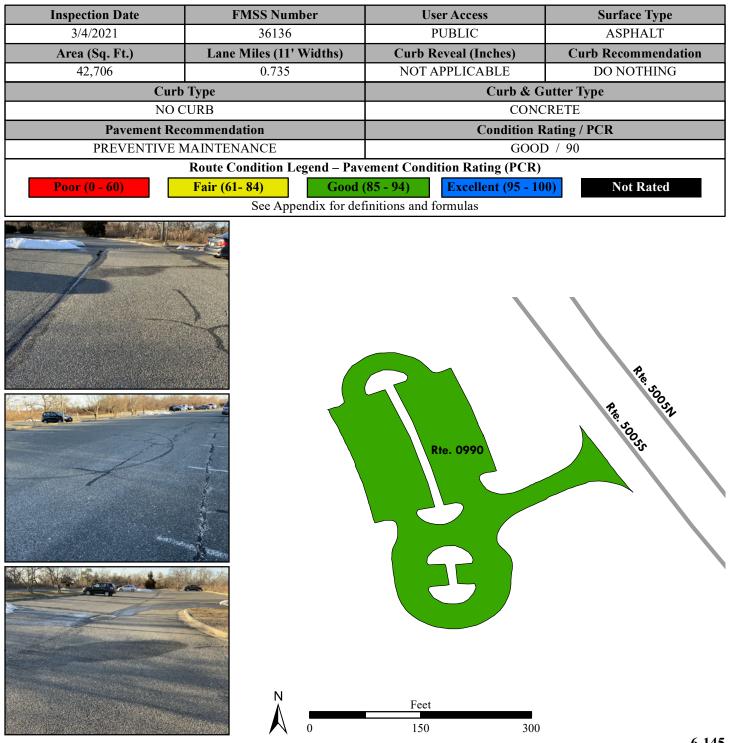
Gateway National Recreation Area ROUTE 0990: WILDLIFE REFUGE VISITOR PARKING

Manual Rating

FROM ROUTE 5005S (CROSS BAY BOULEVARD (SOUTHBOUND))

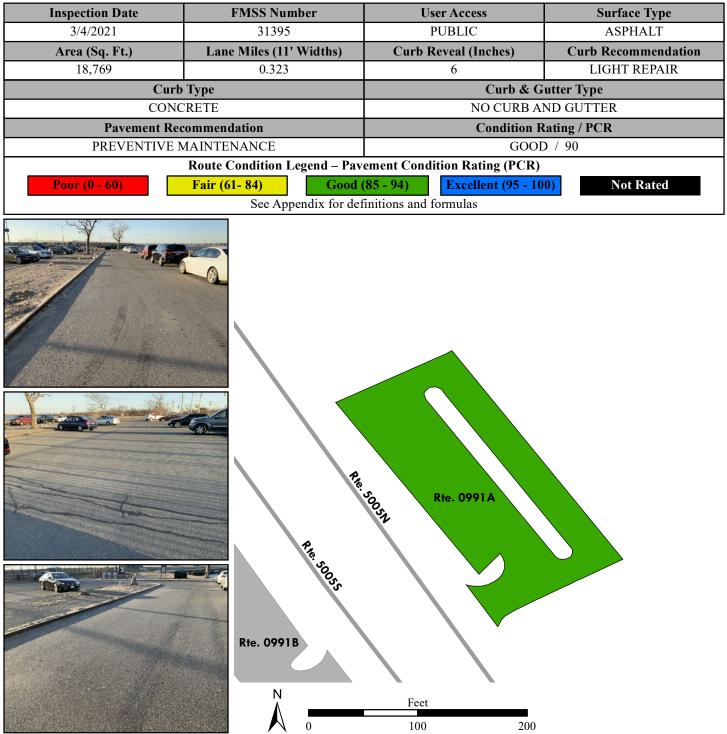
Gateway National Recreation Area ROUTE 0991A: NORTH CHANNEL BRIDGE PARKING / EASTSIDE

Manual Rating

FROM ROUTE 5005N (CROSS BAY BOULEVARD (NORTHBOUND))

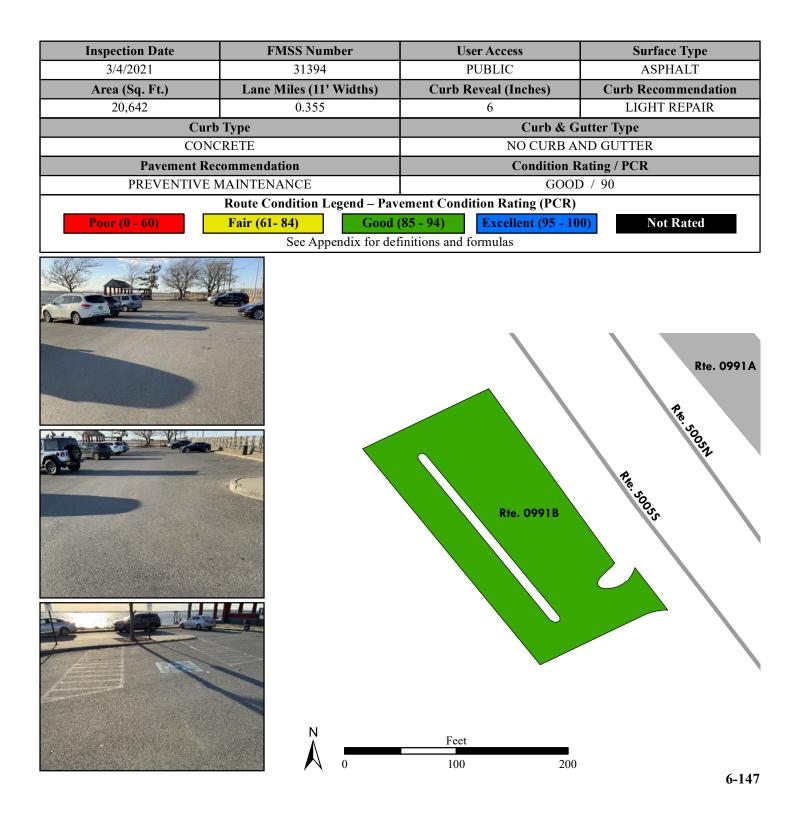
Gateway National Recreation Area ROUTE 0991B: NORTH CHANNEL BRIDGE PARKING / WESTSIDE

Manual Rating

FROM ROUTE 5005S (CROSS BAY BOULEVARD (SOUTHBOUND))

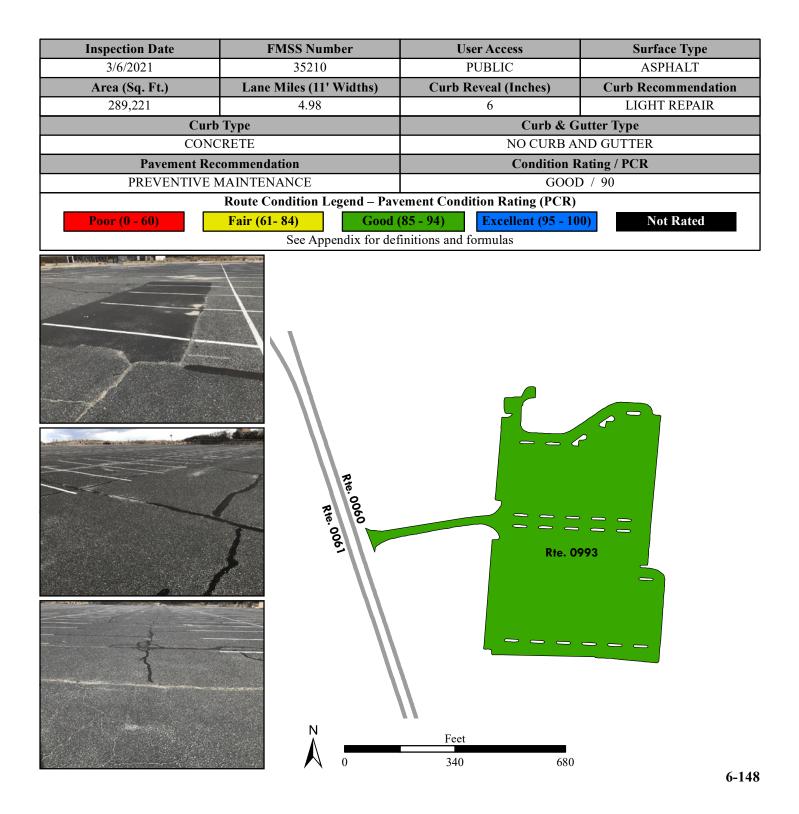
ROUTE 0993: PARKING LOT E

Manual Rating

FROM ROUTE 0060 (HARTSHORNE DRIVE (NORTHBOUND)) AT MP 2.35

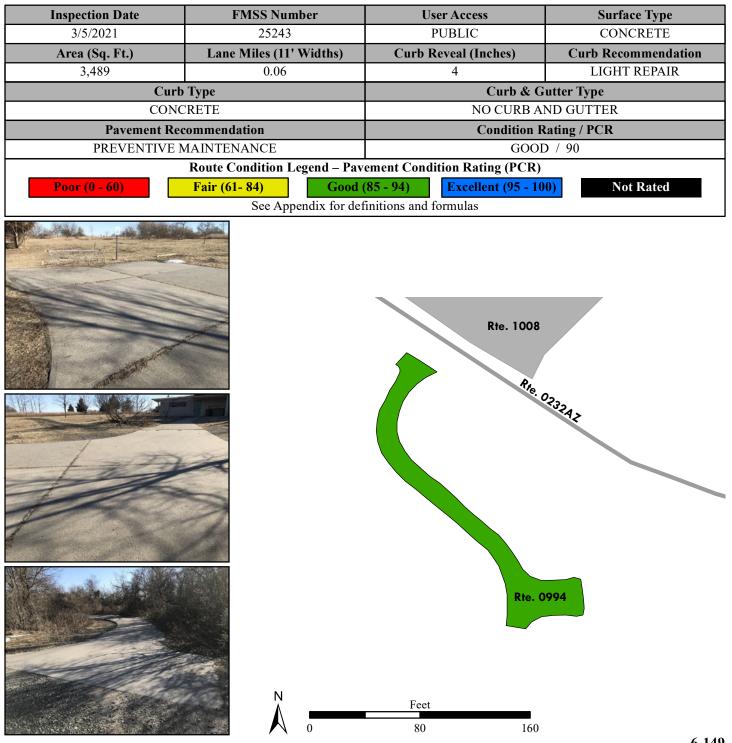
Gateway National Recreation Area ROUTE 0994: GREAT KILLS EDUCATION CENTER PARKING

Manual Rating

FROM ROUTE 0232ZZ (BULKHEAD ROADS)

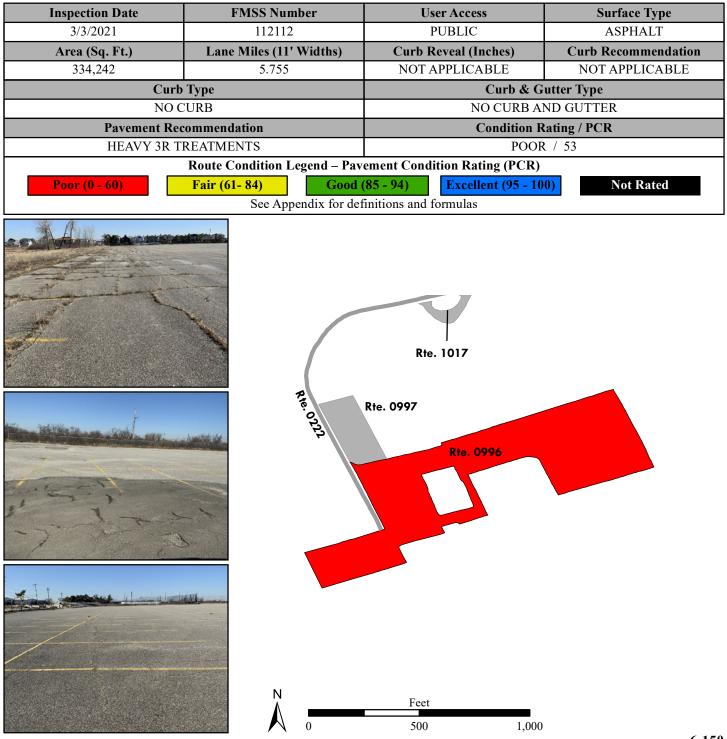
Gateway National Recreation Area ROUTE 0996: BREEZY POINT SURF CLUB PARKING

Manual Rating

FROM END OF ROUTE 0222 (BREEZY POINT SURF CLUB ENTRANCE ROAD)

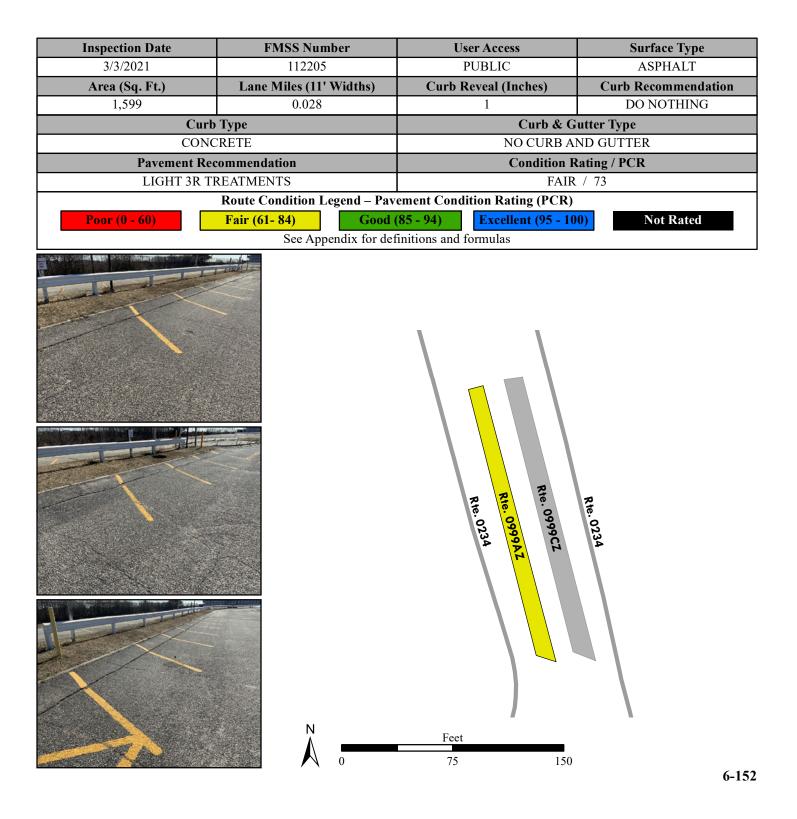
Gateway National Recreation Area ROUTE 0999AZ: SILVER GULL BEACH CLUB PARKING A

Subcomponent of Route GATE-0999ZZ Manual Rating

ADJACENT TO ROUTE 0234 (SILVER GULL BEACH CLUB ENTRANCE ROAD) ON LEFT

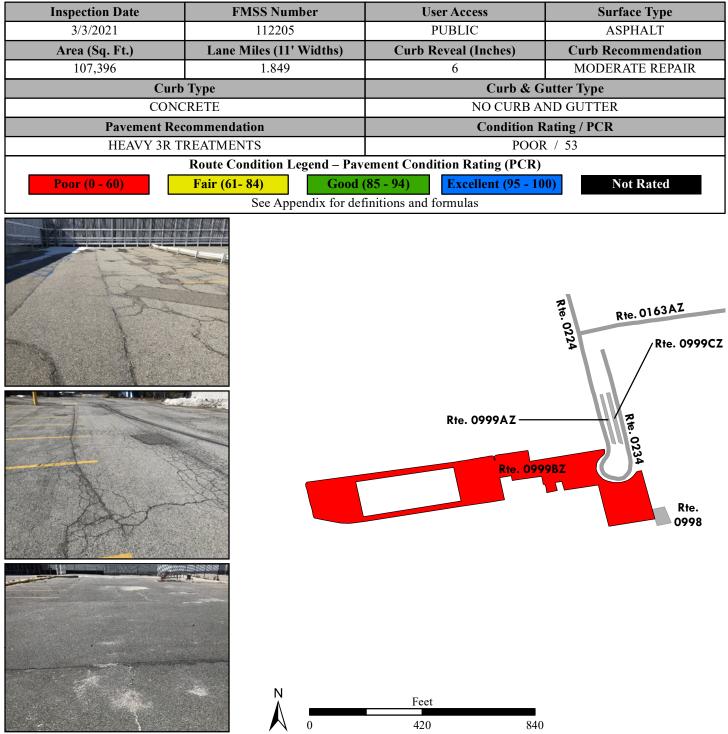
Gateway National Recreation Area ROUTE 0999BZ: SILVER GULL BEACH CLUB PARKING B

Subcomponent of Route GATE-0999ZZ Manual Rating

FROM ROUTE 0234 (SILVER GULL BEACH CLUB ENTRANCE ROAD) ON RIGHT

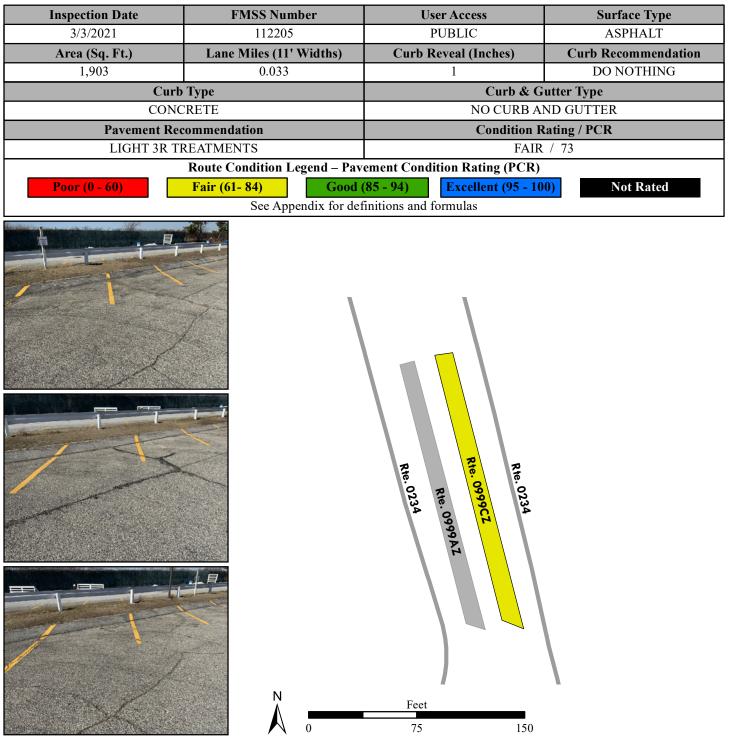
Gateway National Recreation Area ROUTE 0999CZ: SILVER GULL BEACH CLUB PARKING C

Subcomponent of Route GATE-0999ZZ Manual Rating

FROM ROUTE 0234 (SILVER GULL BEACH CLUB ENTRANCE ROAD) ON LEFT

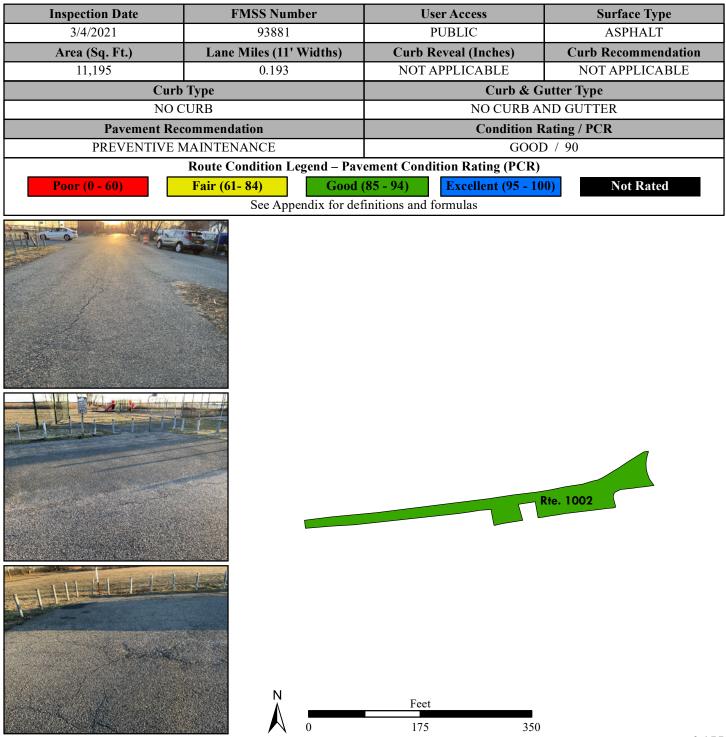
Gateway National Recreation Area ROUTE 1002: HAMILTON BEACH PARKING

Manual Rating

FROM LOCKWOOD COURT

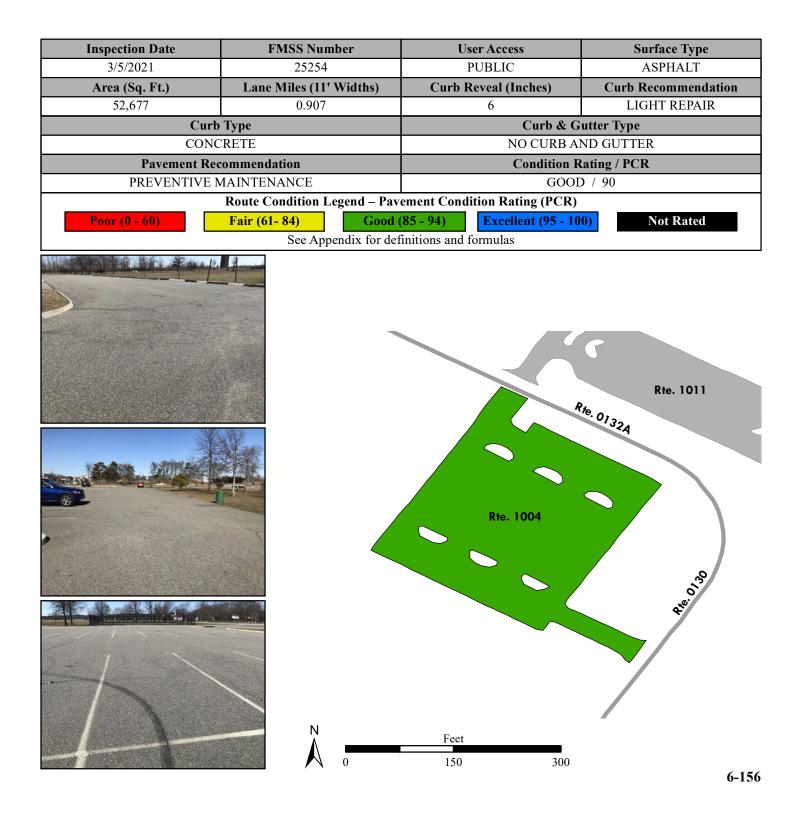
Gateway National Recreation Area ROUTE 1004: PICNIC/BEACH AREA PARKING LOT E

Manual Rating

FROM ROUTE 0130 (MILLER FIELD ENTRANCE ROAD)

TO ROUTE 0132A (VISITOR CENTER (SANCHEZ ROAD EAST))

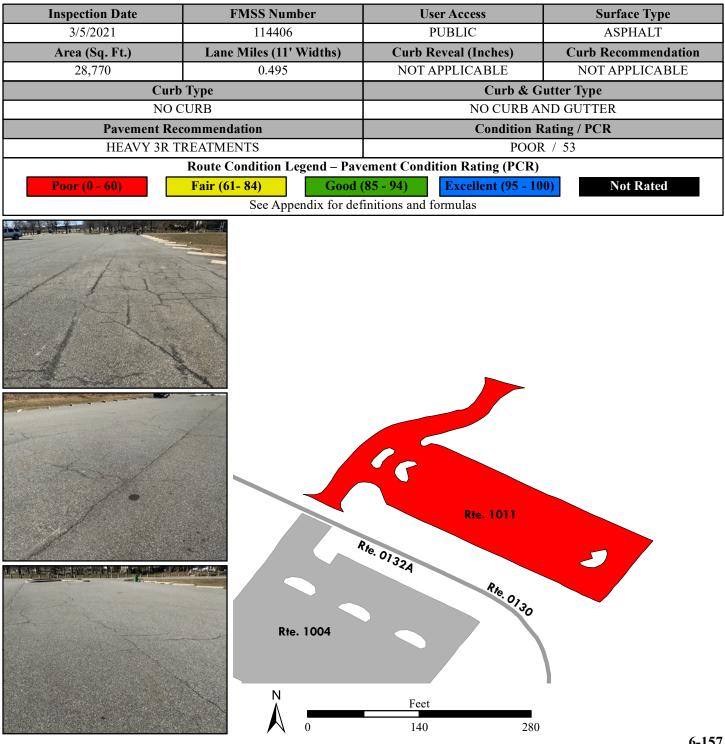
Gateway National Recreation Area ROUTE 1011: MILLER FIELD AREA D PARKING LOT (FT. CAPODANO)

Manual Rating

FROM ROUTE 0132A (VISITOR CENTER (SANCHEZ ROAD EAST))

TO FATHER CAPODANNO BOULEVARD

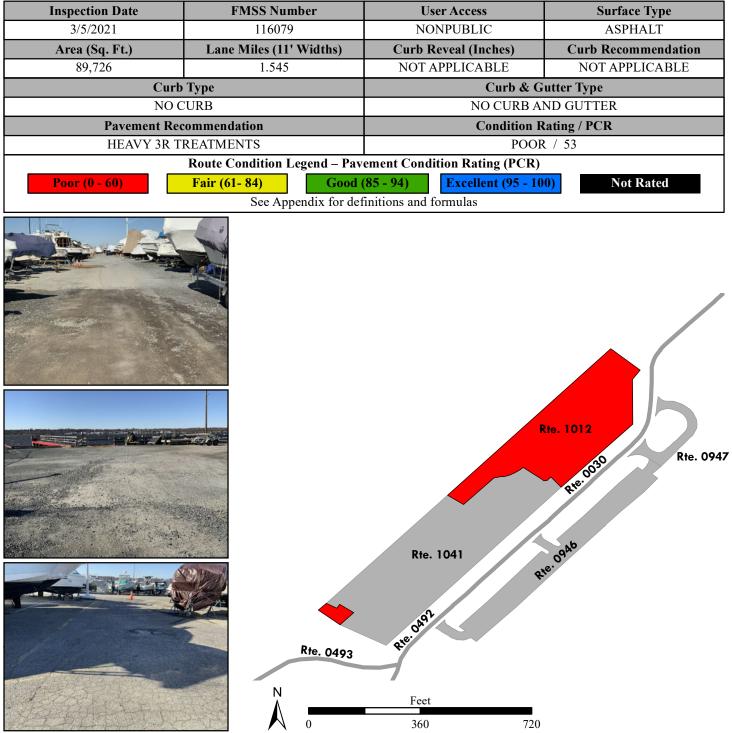
Gateway National Recreation Area ROUTE 1012: GREAT KILLS MARINA PARKING

Manual Rating

FROM ROUTE 0030 (BUFFALO ROAD)

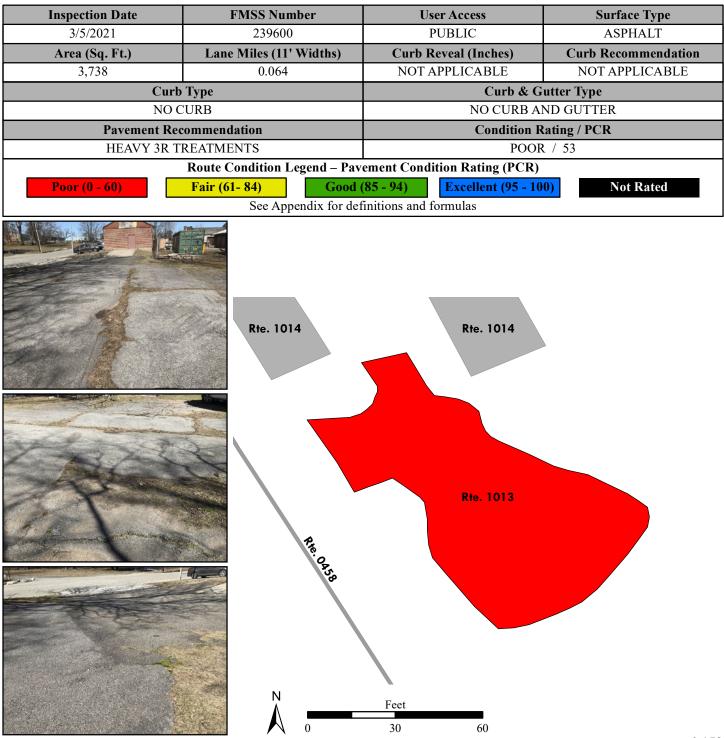
Gateway National Recreation Area ROUTE 1013: USPP STABLE PARKING

Manual Rating

FROM ROUTE 0458 (USS TENNESSEE ROAD)

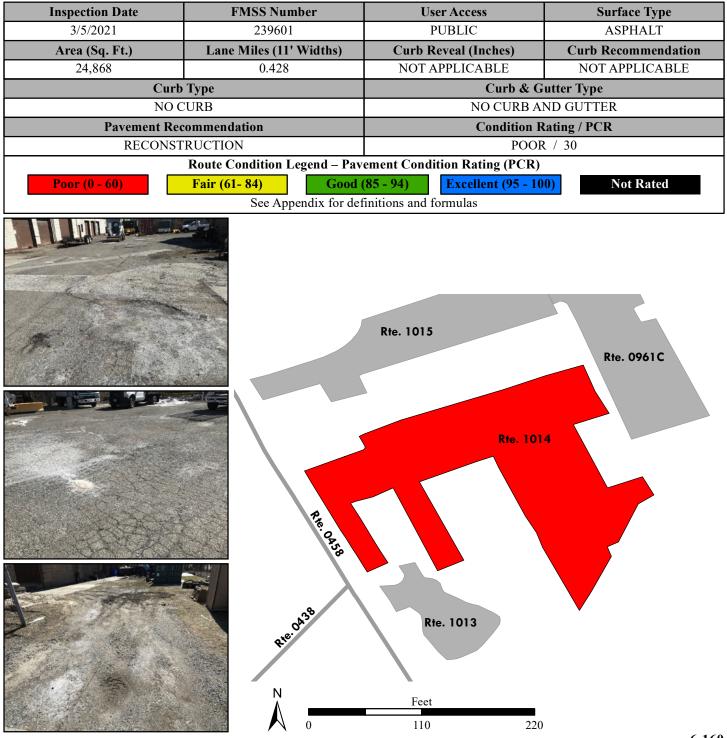
Gateway National Recreation Area ROUTE 1014: BUILDING 302 L-SHAPED PARKING

Manual Rating

FROM ROUTE 0458 (USS TENNESSEE ROAD)

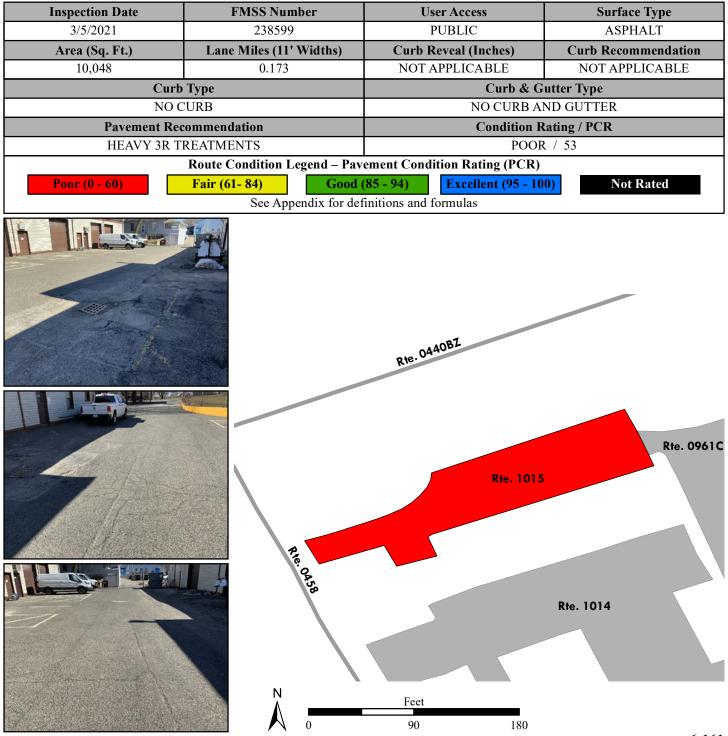
Gateway National Recreation Area ROUTE 1015: BUILDING 301 MAINTENANCE PARKING

Manual Rating

FROM ROUTE 0458 (USS TENNESSEE ROAD)

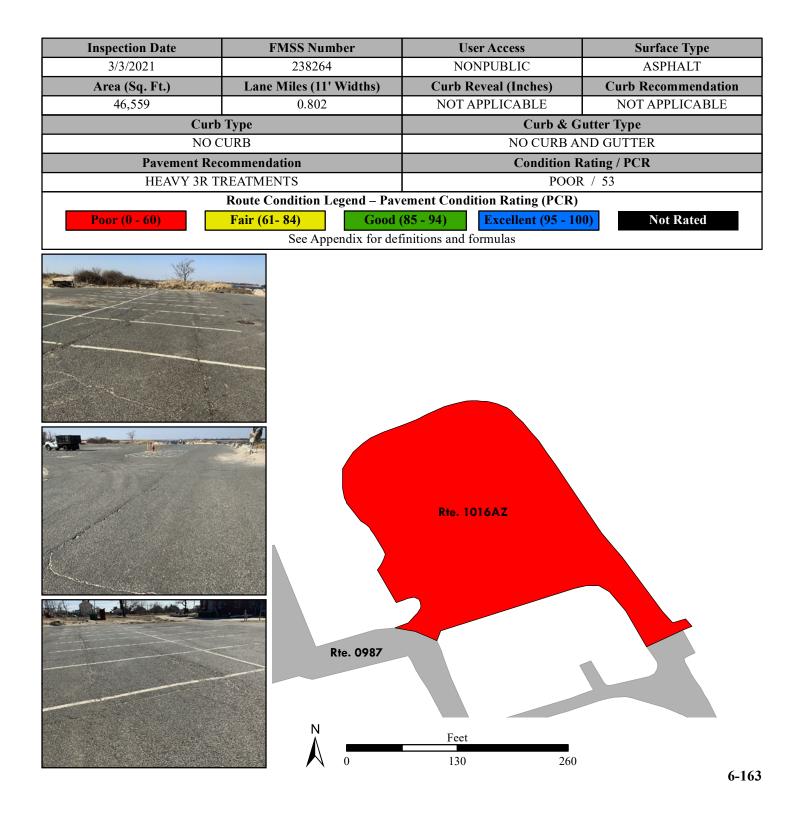
Gateway National Recreation Area ROUTE 1016AZ: RIIS LANDING PARKING A

Subcomponent of Route GATE-1016ZZ Manual Rating

FROM ROUTE 0987 (MAINTENANCE AREA PARKING (RIIS LDG))

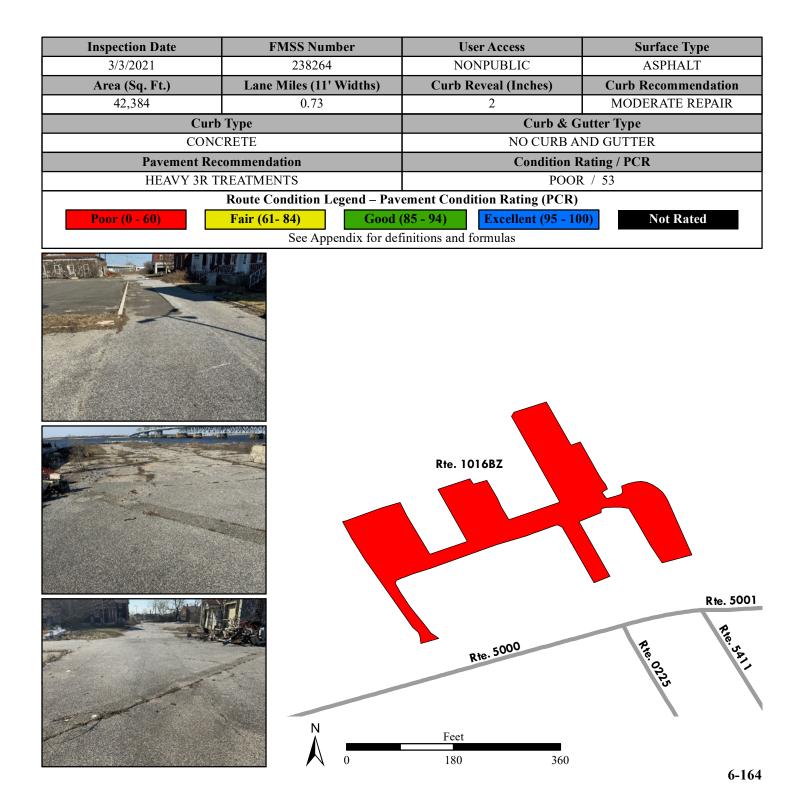
Gateway National Recreation Area ROUTE 1016BZ: RIIS LANDING PARKING B

Subcomponent of Route GATE-1016ZZ Manual Rating

FROM ROUTE 5000 (ROCKAWAY POINT BOULEVARD)

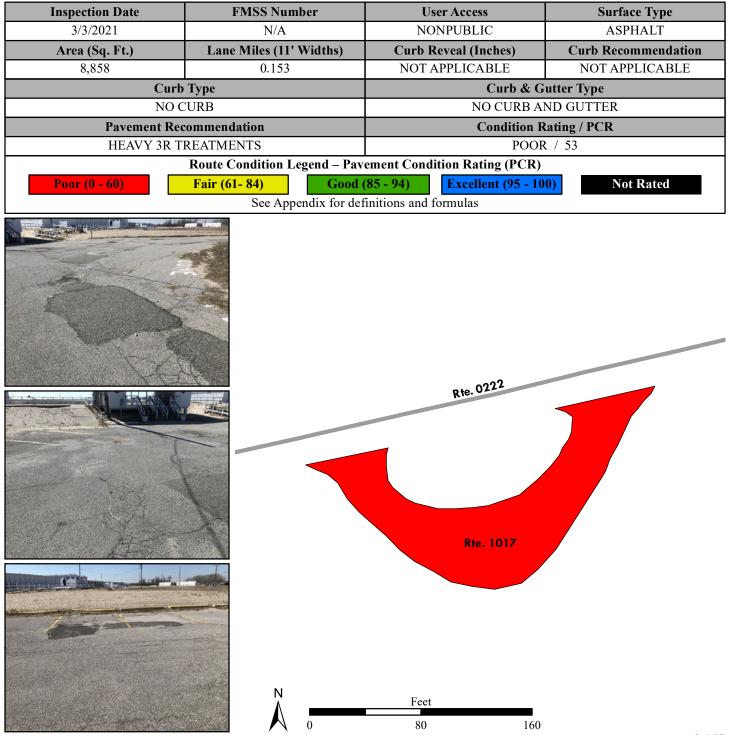
Gateway National Recreation Area ROUTE 1017: BREEZY POINT SURF CLUB ENTRANCE PARKING

Manual Rating

FROM ROUTE 0222 (BREEZY POINT SURF CLUB ENTRANCE ROAD)

TO ROUTE 0222 (BREEZY POINT SURF CLUB ENTRANCE ROAD)

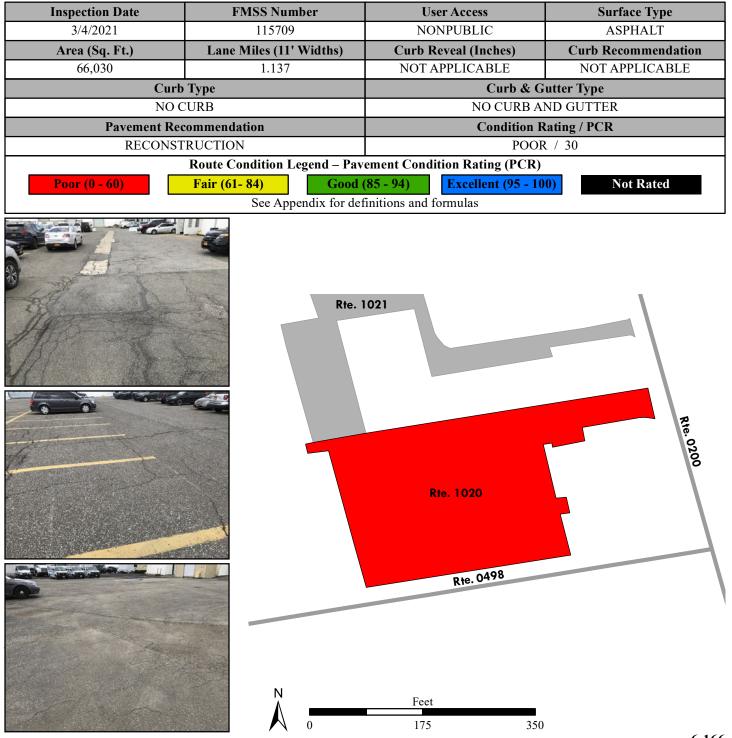
Gateway National Recreation Area ROUTE 1020: NYPD PARKING 1

Manual Rating

FROM ROUTE 0200 (FLOYD BENNETT FIELD ENTRANCE ROAD)

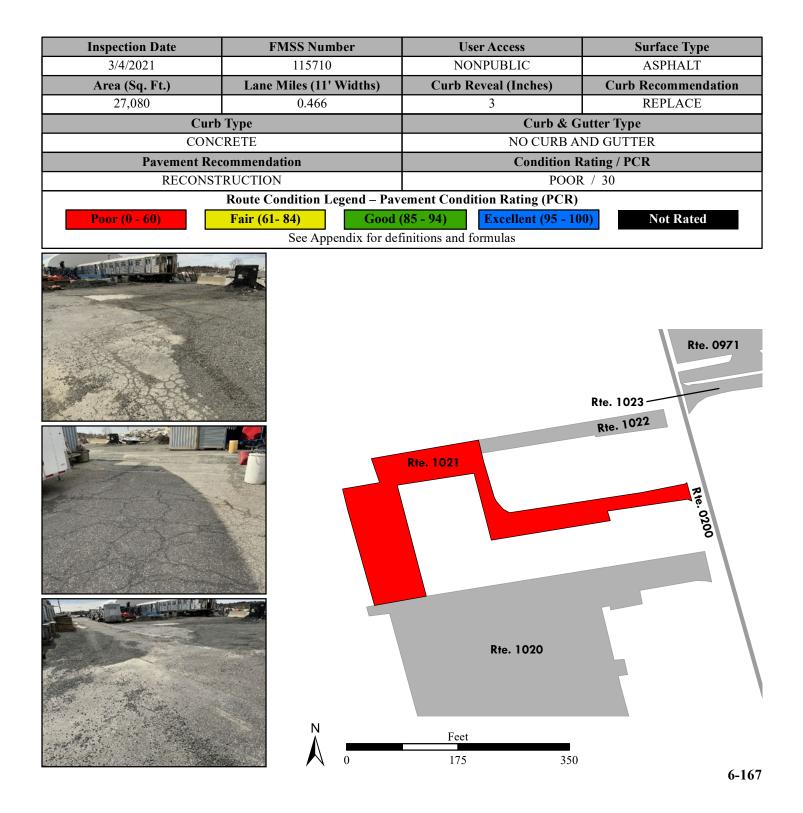
Gateway National Recreation Area ROUTE 1021: NYPD PARKING 2

Manual Rating

FROM ROUTE 0200 (FLOYD BENNETT FIELD ENTRANCE ROAD)

TO ROUTE 1020 (NYPD PARKING 1) AND ROUTE 1022 (NYPD PARKING 3)
