Final Report

Road Inventory and Condition Assessment of Paved Routes Gateway National Recreation Area

Federal Lands Highway Road Inventory Program Prepared By: Federal Highway Administration Eastern Federal Lands Highway Division Road Inventory Program (RIP)

Report Date: September 2022

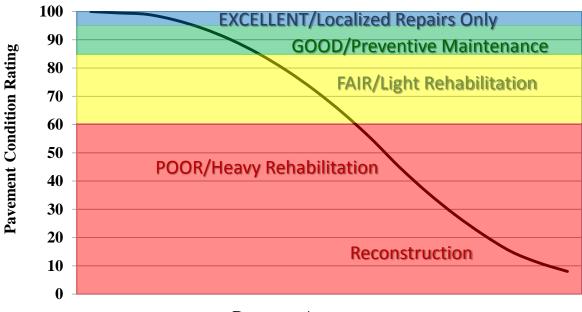
Condition Categories and Treatments

- Excellent/New: PCR of 95-100. Pavements in this range will require only spot repairs
- Good: PCR of 85-94. Pavements in this range will likely be candidates for preventive maintenance. Examples include Chip and Slurry Seals, Micro Surfacing and Thin Overlays.
- Fair: PCR of 61-84. Pavements in this range will likely be candidates of Light Rehabilitation (L3R). Examples include single-lift overlays up to 2.5 inches in total thickness, milling and overlays.
- Poor: PCR of 60 or below. Pavements in this range will likely be candidates of Heavy Rehabilitation or Reconstruction (H3R or 4R). Examples include Pulverization, Multiple Lift Overlays, and Reconstruction.

Pavement Age

- 1. **Preventive Maintenance** is a planned strategy of cost-effective treatments to an existing roadway system and its appurtenances that preserves the system, retards future deterioration, and maintains or improves the functional condition of the system (without significantly increasing the structural capacity). Preventive maintenance is typically applied to pavements in good condition having significant remaining service life. As a major component of pavement preservation, preventive maintenance is a strategy of extending the service life by applying cost-effective treatments to the surface or near-surface of structurally sound pavements. Examples of preventive treatments include asphalt crack sealing, chip sealing, slurry or micro-surfacing, thin and ultrathin hot-mix asphalt overlay, concrete joint sealing, diamond grinding, dowel-bar retrofit, and isolated, partial and/or full-depth concrete repairs to restore functionality of individual slabs.

- 2. Pavement Rehabilitation consists of structural enhancements that extend the service life of an existing pavement and/or improve its load carrying capacity. Rehabilitation techniques include restoration treatments and structural overlays. Rehabilitation projects extend the life of existing pavement structures either by restoring existing structural capacity through the elimination of age-related, environmental cracking of embrittled pavement surface or by increasing pavement thickness to strengthen existing pavement sections to accommodate existing or projected traffic loading conditions. Two sub-categories result from these distinctions, which are directly related to the restoration or increase of structural capacity.
