GETT Cycle 6

Final Report

Road Inventory and Condition Assessment of Paved Routes Gettysburg National Military Park

**Federal Highway Administration
Eastern Federal Lands Highway Division
Road Inventory Program (RIP)**

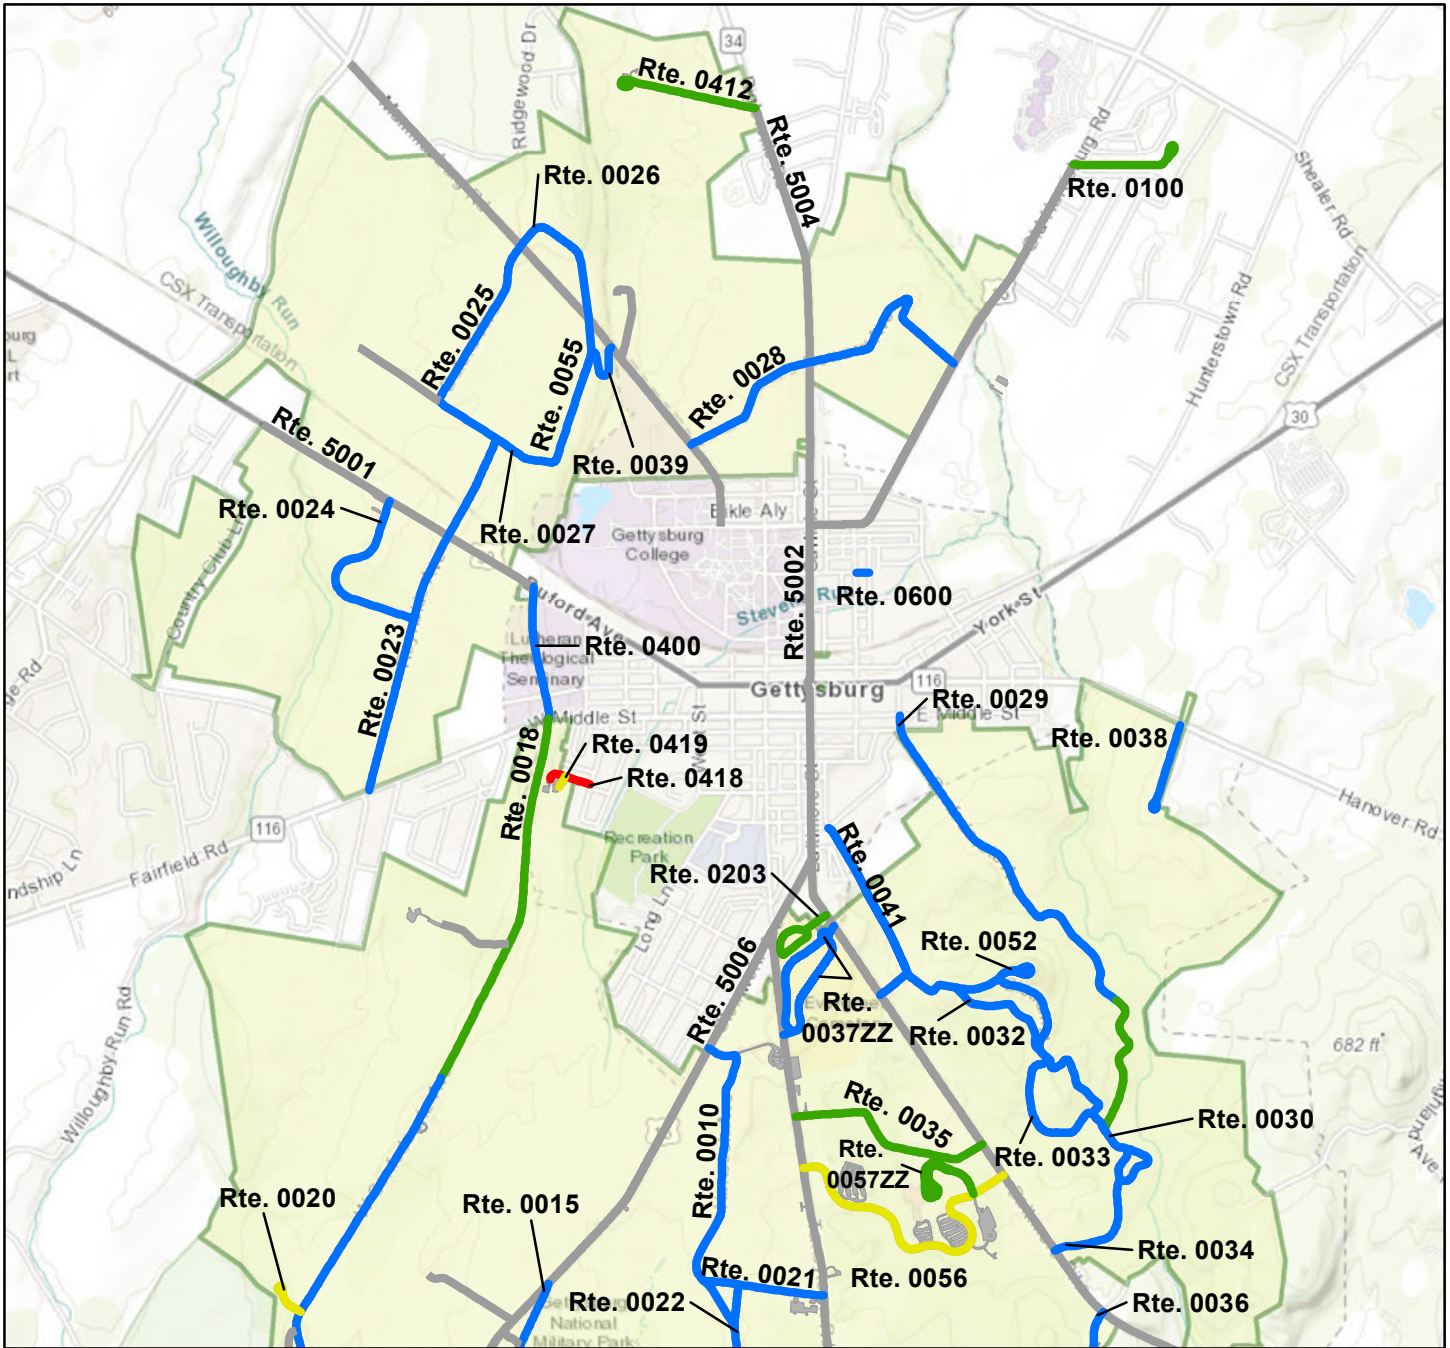
Area Map 1

ROUTE CONDITION MAP

PCR - MILE BY MILE

Colors on map represent condition scores at 1-mile intervals. See Appendix for definitions and formulas
 Only Data Collection Vehicle and Manually Rated Roads are displayed

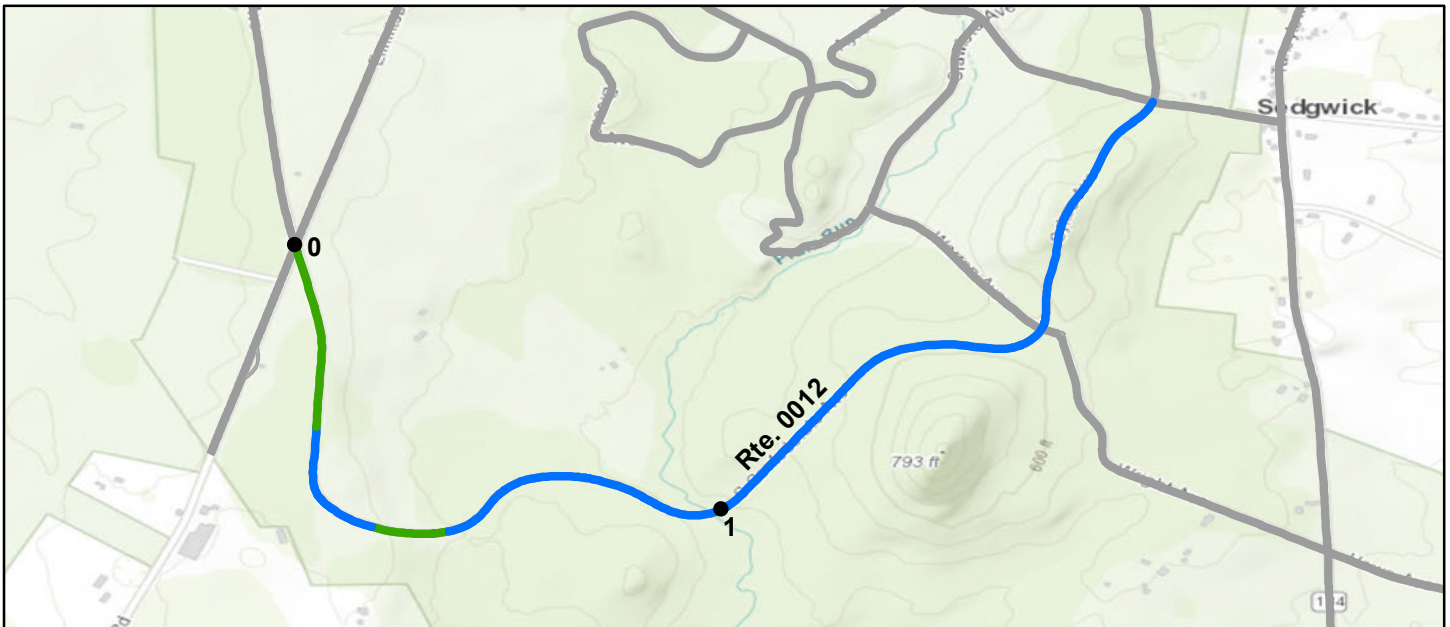
ROUTE 0012: SOUTH CONFEDERATE-SYKES AVENUE

Data Collection Vehicle (DCV) Rating

Route Condition Legend – Pavement Condition Rating (PCR)						
Poor (0 - 60)	Fair (61- 84)	Good (85 - 94)	Excellent (95 - 100)	Not Rated		
Colors on map represent condition scores at 0.10-mile intervals. See Appendix for definitions and formulas.						
Inspection Date: 11/19/2020	Beginning Section MP	0	1			
Paved Length (Miles): 1.96	Section Length (MI)	1	0.96			
Surface Type: ASPHALT	Route Summary					
Roadway Condition Information						
Pavement Condition Rating (PCR)	98	96	99			
Surface Condition Rating (SCR)	98	97	99			
Roughness Condition Index (RCI)	99	95	100			
Distress Index Values						
Structural Crack Index	100	99	100			
Alligator Crack Index	100	100	100			
Longitudinal Crack Index	100	99	100			
Transverse Cracking Index	98	97	100			
Patching Index	100	100	100			
Rutting Index	99	99	99			
International Roughness Index (IRI)	117	127	105			
Lane & Width Information						
Number of Lanes	1	1	1			
Paved Width (ft)	18.6	18.9	18.3

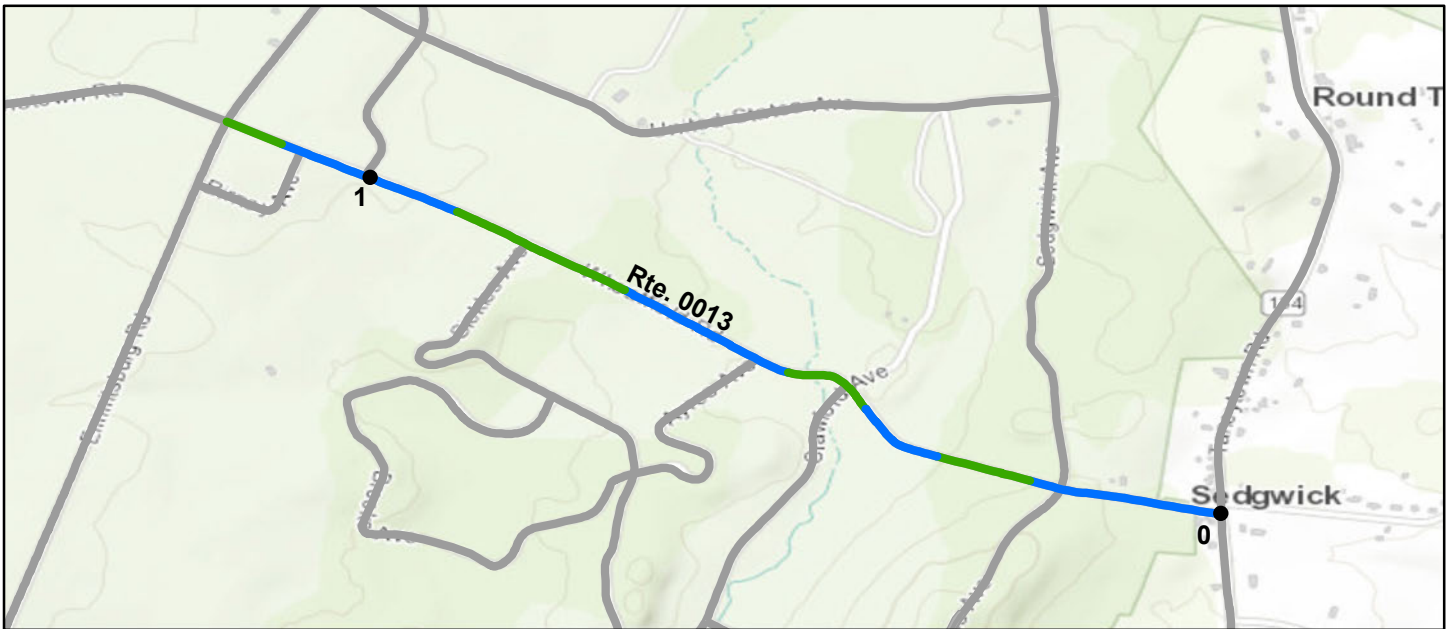
ROUTE 0013: WHEATFIELD ROAD

Data Collection Vehicle (DCV) Rating

Colors on map represent condition scores at 0.10-mile intervals. See Appendix for definitions and formulas.

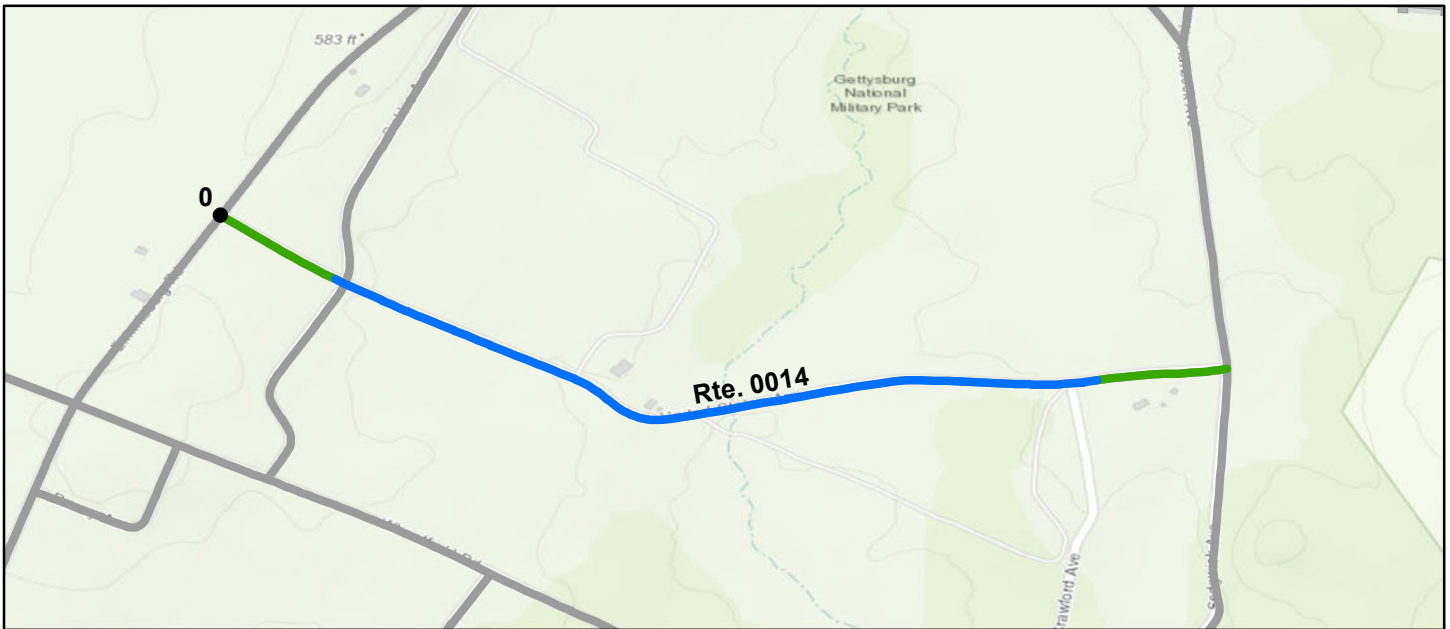
ROUTE 0014: UNITED STATES AVENUE

Data Collection Vehicle (DCV) Rating

Colors on map represent condition scores at 0.10-mile intervals. See Appendix for definitions and formulas.

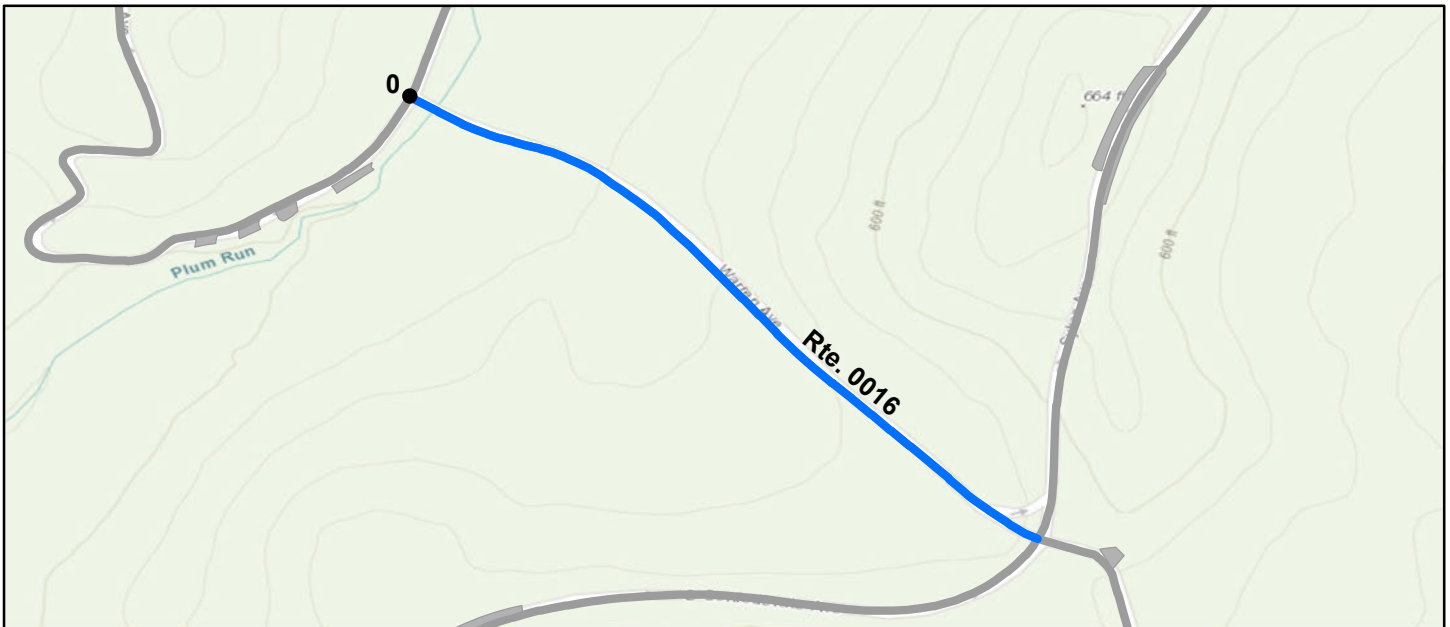
ROUTE 0016: WARREN AVENUE

Data Collection Vehicle (DCV) Rating

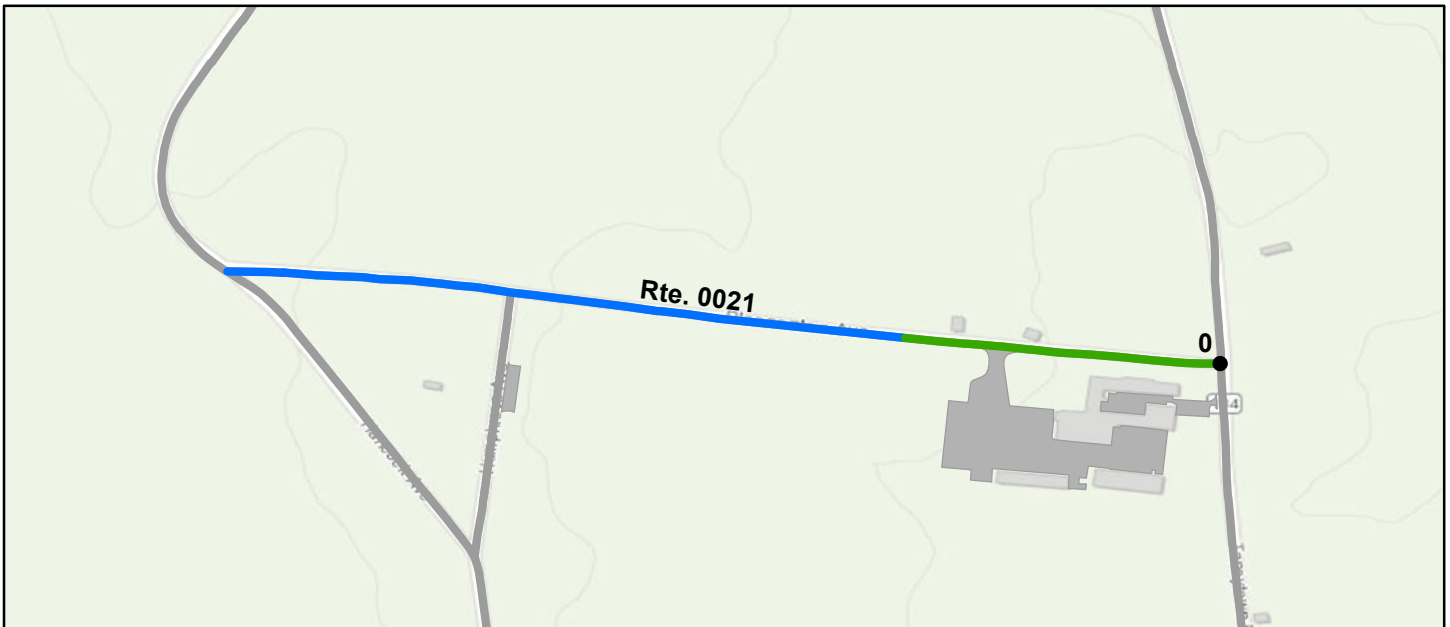
ROUTE 0021: PLEASONTON AVENUE

Data Collection Vehicle (DCV) Rating

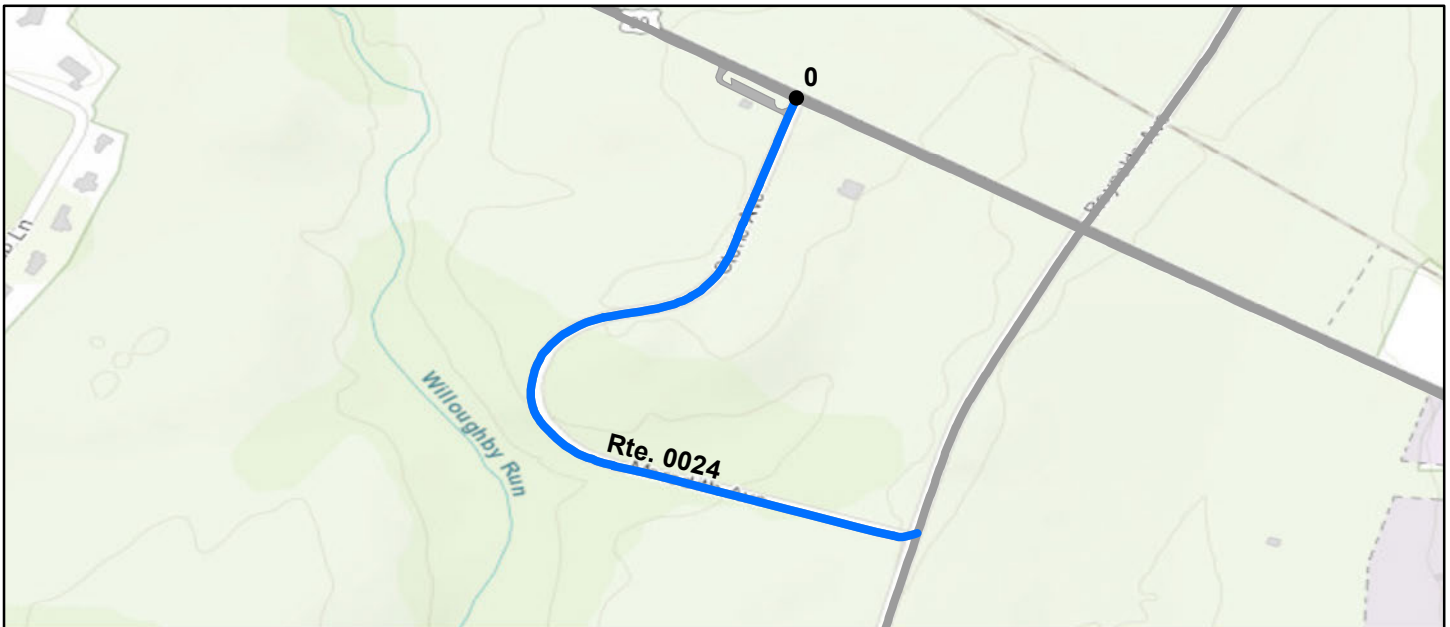
ROUTE 0024: STONE-MEREDITH AVENUE

Data Collection Vehicle (DCV) Rating

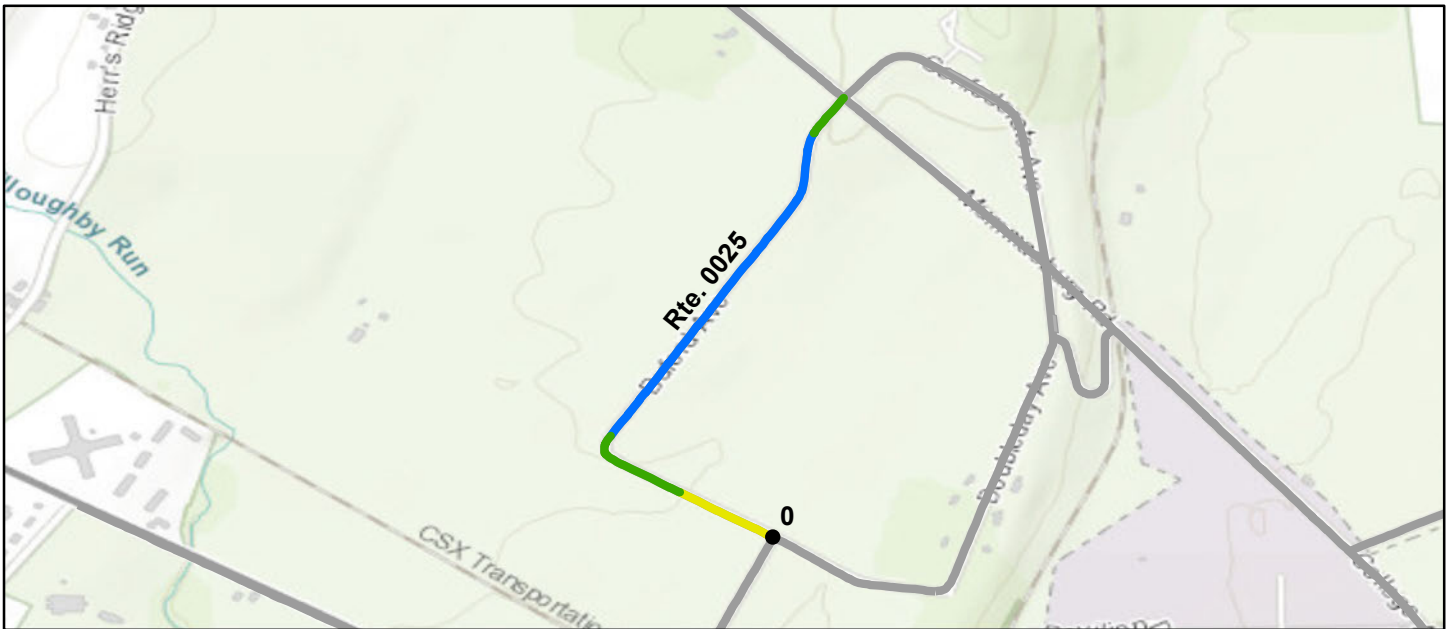
ROUTE 0025: BUFORD AVENUE

Data Collection Vehicle (DCV) Rating

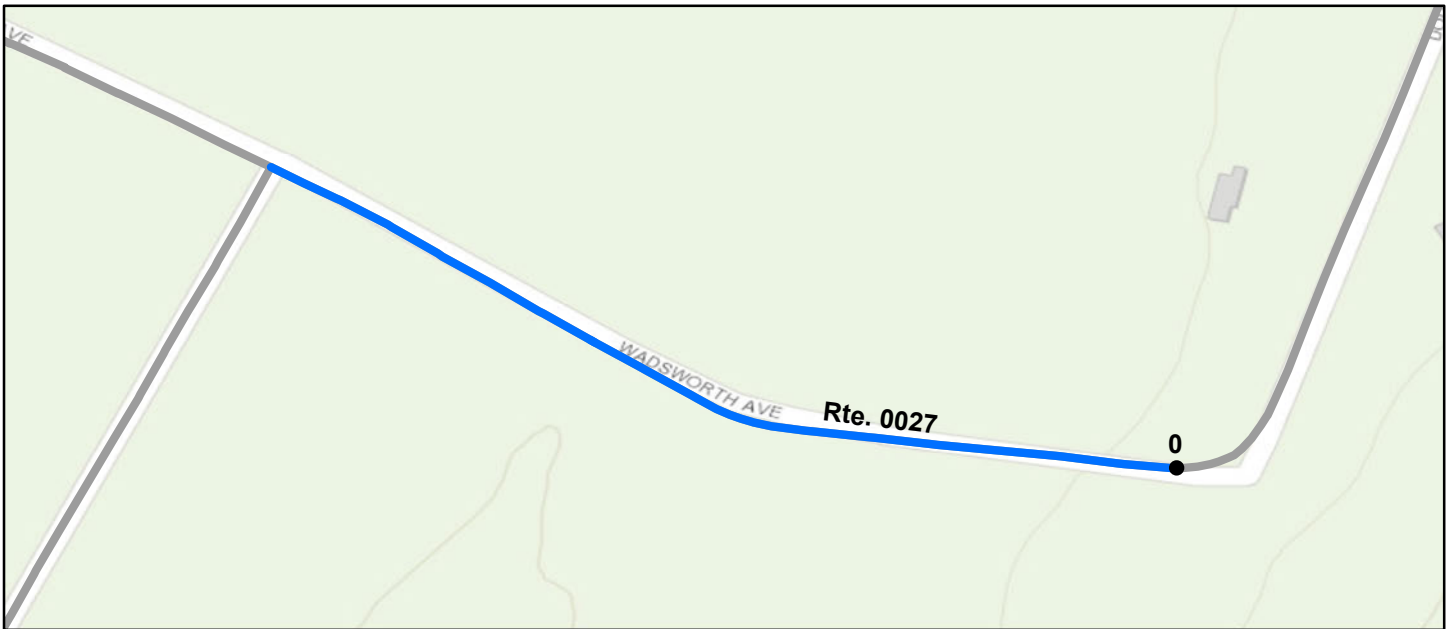
ROUTE 0027: WADSWORTH AVENUE

Data Collection Vehicle (DCV) Rating

Colors on map represent condition scores at 0.10-mile intervals. See Appendix for definitions and formulas.

Inspection Date:	11/20/2020	Beginning Section MP	0				
Paved Length (Miles):	0.16	Section Length (MI)	0.16				
Surface Type:	ASPHALT	Route Summary					
Roadway Condition Information							
Pavement Condition Rating (PCR)		100	100				
Surface Condition Rating (SCR)		100	100				
Roughness Condition Index (RCI)		N/A	N/A				
Distress Index Values							
Structural Crack Index		100	100				
Alligator Crack Index		100	100				
Longitudinal Crack Index		100	100				
Transverse Cracking Index		100	100				
Patching Index		100	100				
Rutting Index		100	100				
International Roughness Index (IRI)		N/A	N/A				
Lane & Width Information							
Number of Lanes		2	2				
Paved Width (ft)		18.5	18.5				
Lane Width (ft)		9.2	9.2

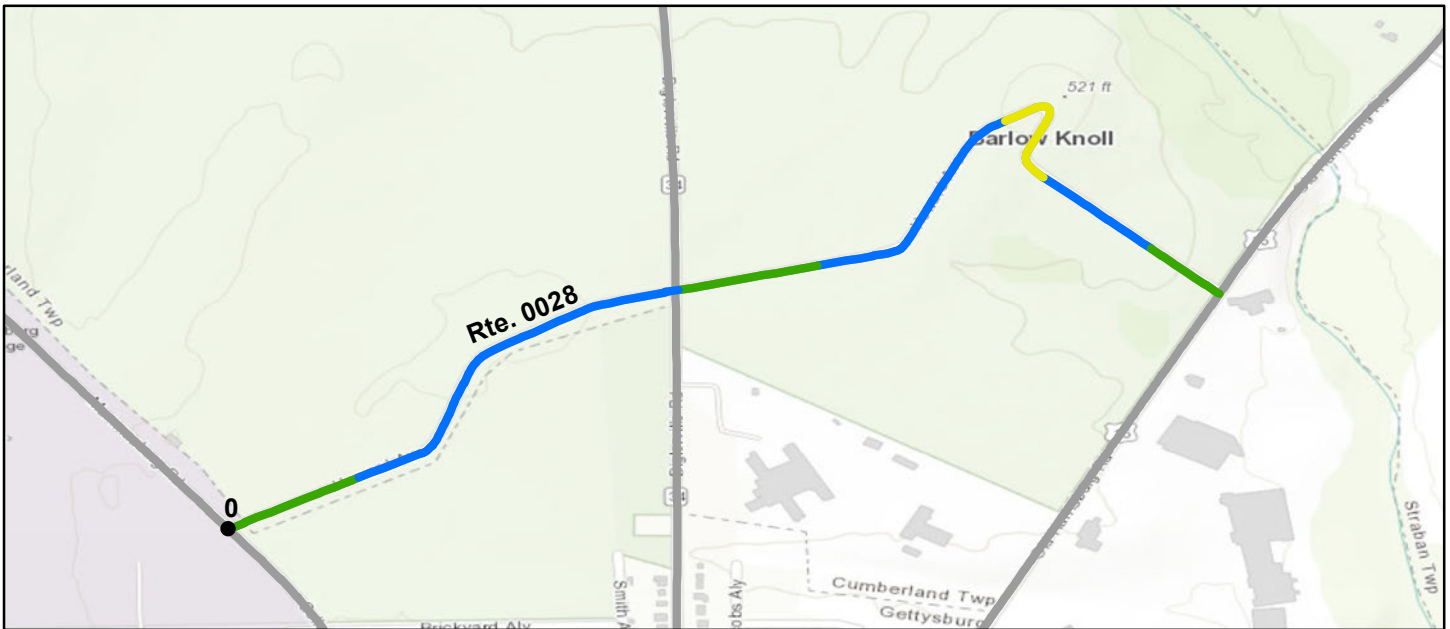
ROUTE 0028: HOWARD AVENUE

Data Collection Vehicle (DCV) Rating

Colors on map represent condition scores at 0.10-mile intervals. See Appendix for definitions and formulas.

Inspection Date:	11/20/2020	Beginning Section MP	0				
Paved Length (Miles):	0.96	Section Length (MI)	0.96				
Surface Type:	ASPHALT	Route Summary					
Roadway Condition Information							
Pavement Condition Rating (PCR)		99	99				
Surface Condition Rating (SCR)		99	99				
Roughness Condition Index (RCI)		99	99				
Distress Index Values							
Structural Crack Index		100	100				
Alligator Crack Index		100	100				
Longitudinal Crack Index		100	100				
Transverse Cracking Index		100	100				
Patching Index		100	100				
Rutting Index		99	99				
International Roughness Index (IRI)		117	117				
Lane & Width Information							
Number of Lanes		1	1				
Paved Width (ft)		19.7	19.7				
Lane Width (ft)		15.7	15.7

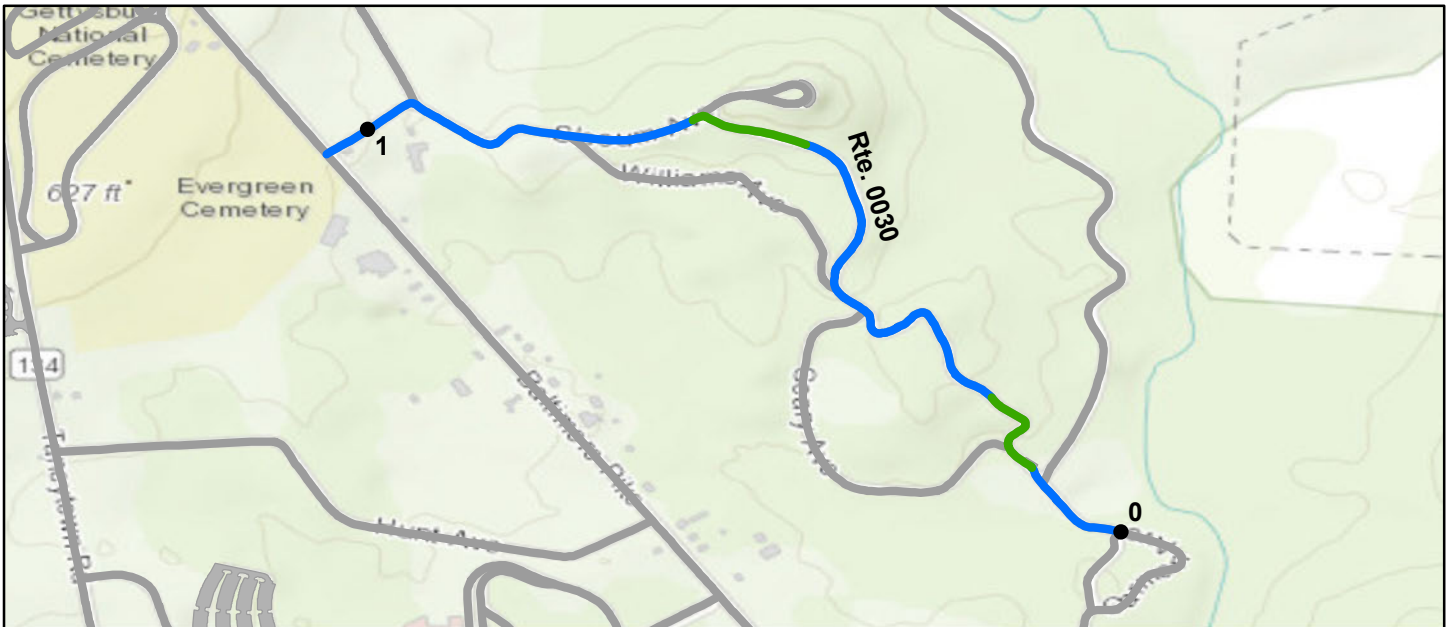
ROUTE 0030: SLOCUM AVENUE

Data Collection Vehicle (DCV) Rating

Colors on map represent condition scores at 0.10-mile intervals. See Appendix for definitions and formulas.

Inspection Date: 11/19/2020		Beginning Section MP	0	1			
Paved Length (Miles): 1.04		Section Length (MI)	1	0.04			
Surface Type: ASPHALT		Route Summary					
Roadway Condition Information							
Pavement Condition Rating (PCR)		97	97	97			
Surface Condition Rating (SCR)		97	97	97			
Roughness Condition Index (RCI)		N/A	N/A	N/A			
Distress Index Values							
Structural Crack Index		100	100	100			
Alligator Crack Index		100	100	100			
Longitudinal Crack Index		100	100	100			
Transverse Cracking Index		100	100	99			
Patching Index		100	100	100			
Rutting Index		97	97	97			
International Roughness Index (IRI)		N/A	N/A	N/A			
Lane & Width Information							
Number of Lanes		1	1	1			
Paved Width (ft)		16.5	16.5	16.7			
Lane Width (ft)		16.5	16.5	16.7

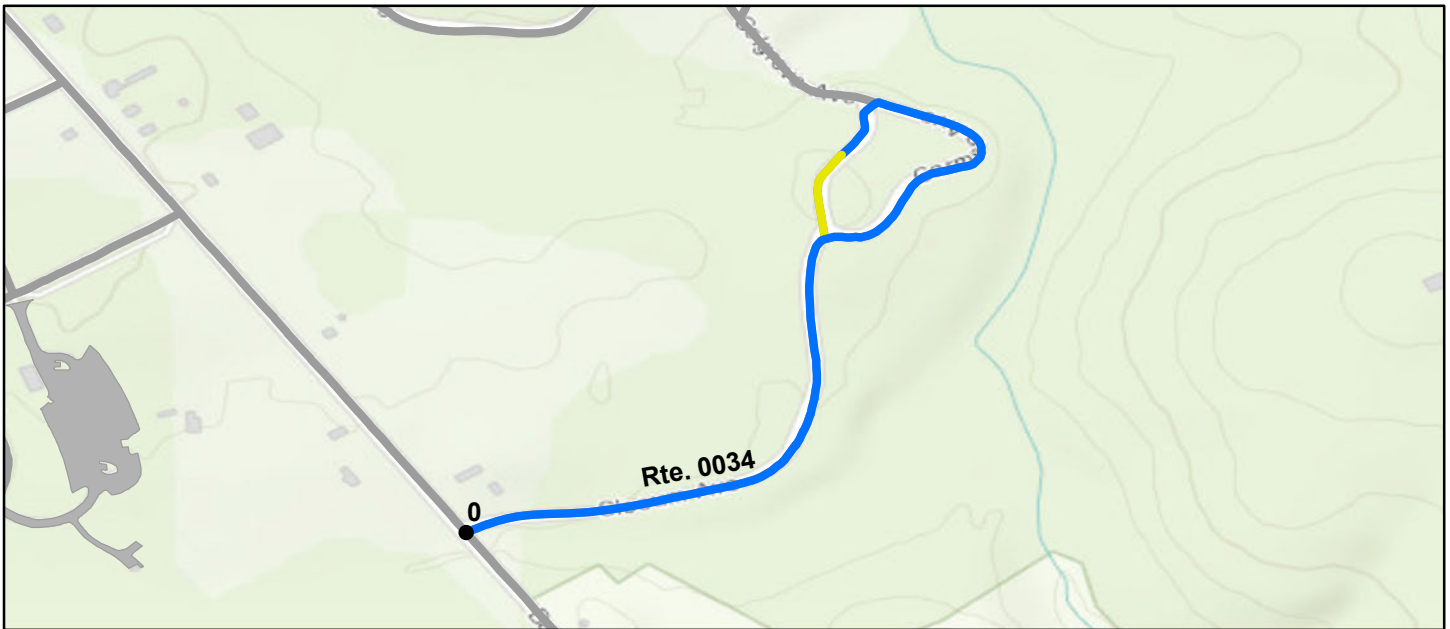
ROUTE 0034: COLGROVE-CARMAN AVENUE

Data Collection Vehicle (DCV) Rating

Colors on map represent condition scores at 0.10-mile intervals. See Appendix for definitions and formulas.

Inspection Date:	11/19/2020	Beginning Section MP	0				
Paved Length (Miles):	0.55	Section Length (MI)	0.55				
Surface Type:	ASPHALT	Route Summary					
Roadway Condition Information							
Pavement Condition Rating (PCR)	96	96					
Surface Condition Rating (SCR)	96	96					
Roughness Condition Index (RCI)	N/A	N/A					
Distress Index Values							
Structural Crack Index	100	100					
Alligator Crack Index	100	100					
Longitudinal Crack Index	100	100					
Transverse Cracking Index	100	100					
Patching Index	100	100					
Rutting Index	96	96					
International Roughness Index (IRI)	N/A	N/A					
Lane & Width Information							
Number of Lanes	1	1					
Paved Width (ft)	15.6	15.6					
Lane Width (ft)	15.6	15.6

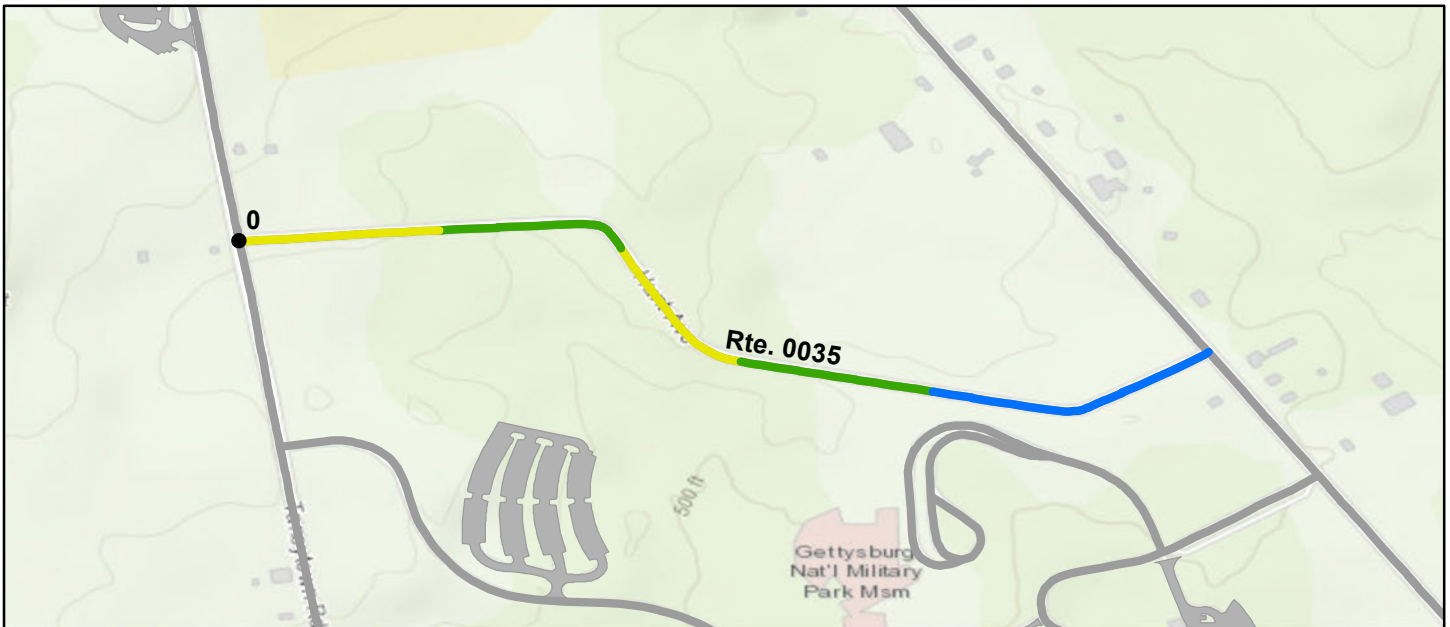
ROUTE 0035: HUNT AVENUE

Data Collection Vehicle (DCV) Rating

Colors on map represent condition scores at 0.10-mile intervals. See Appendix for definitions and formulas.

Inspection Date:	11/19/2020	Beginning Section MP	0				
Paved Length (Miles):	0.54	Section Length (MI)	0.54				
Surface Type:	ASPHALT	Route Summary					
Roadway Condition Information							
Pavement Condition Rating (PCR)		88	88				
Surface Condition Rating (SCR)		95	95				
Roughness Condition Index (RCI)		78	78				
Distress Index Values							
Structural Crack Index		95	95				
Alligator Crack Index		97	97				
Longitudinal Crack Index		98	98				
Transverse Cracking Index		97	97				
Patching Index		100	100				
Rutting Index		99	99				
International Roughness Index (IRI)		174	174				
Lane & Width Information							
Number of Lanes		2	2				
Paved Width (ft)		16.1	16.1				
Lane Width (ft)		8	8

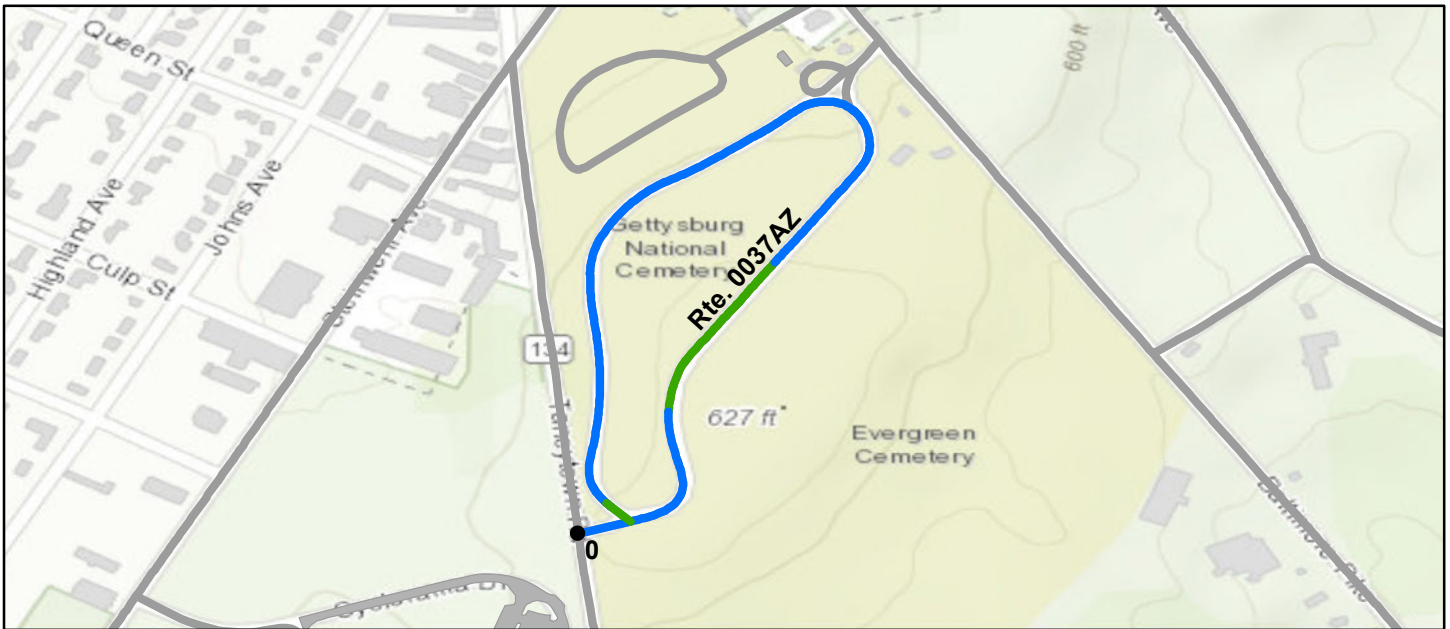
ROUTE 0037AZ: NATIONAL CEMETERY DRIVE LOOP

Subcomponent of Route GETT-0037ZZ
Data Collection Vehicle (DCV) Rating

Route Condition Legend – Pavement Condition Rating (PCR)						
Poor (0 - 60)	Fair (61- 84)	Good (85 - 94)	Excellent (95 - 100)	Not Rated		
Colors on map represent condition scores at 0.10-mile intervals. See Appendix for definitions and formulas.						
Inspection Date:	11/19/2020	Beginning Section MP	0			
Paved Length (Miles):	0.61	Section Length (MI)	0.61			
Surface Type:	ASPHALT	Route Summary				
Roadway Condition Information						
Pavement Condition Rating (PCR)	97	97				
Surface Condition Rating (SCR)	97	97				
Roughness Condition Index (RCI)	N/A	N/A				
Distress Index Values						
Structural Crack Index	100	100				
Alligator Crack Index	100	100				
Longitudinal Crack Index	100	100				
Transverse Cracking Index	100	100				
Patching Index	100	100				
Rutting Index	97	97				
International Roughness Index (IRI)	N/A	N/A				
Lane & Width Information						
Number of Lanes	1	1				
Paved Width (ft)	18.3	18.3

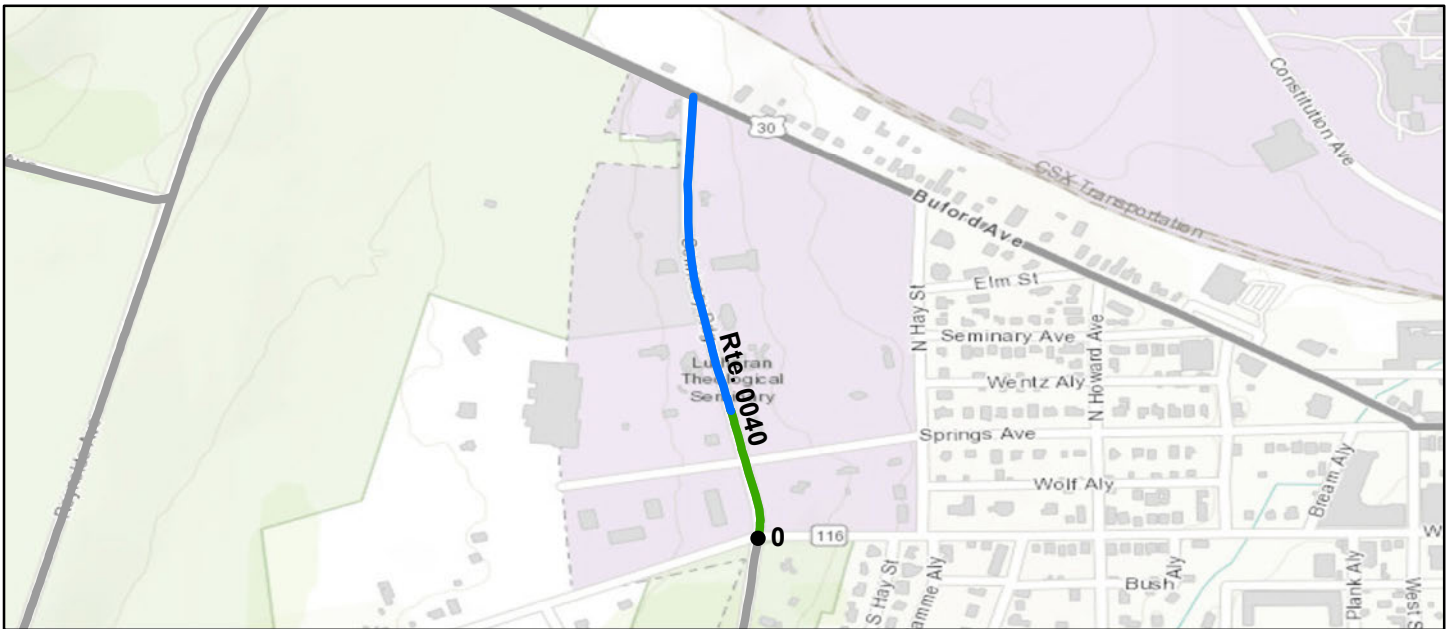
ROUTE 0040: SEMINARY RIDGE AVENUE

Data Collection Vehicle (DCV) Rating

Colors on map represent condition scores at 0.10-mile intervals. See Appendix for definitions and formulas.

Inspection Date: 11/20/2020	Beginning Section MP	0				
Paved Length (Miles): 0.34	Section Length (MI)	0.34				
Surface Type: ASPHALT	Route Summary					
Roadway Condition Information						
Pavement Condition Rating (PCR)	97	97				
Surface Condition Rating (SCR)	97	97				
Roughness Condition Index (RCI)	N/A	N/A				
Distress Index Values						
Structural Crack Index	99	99				
Alligator Crack Index	100	100				
Longitudinal Crack Index	99	99				
Transverse Cracking Index	98	98				
Patching Index	100	100				
Rutting Index	97	97				
International Roughness Index (IRI)	N/A	N/A				
Lane & Width Information						
Number of Lanes	2	2				
Paved Width (ft)	23.6	23.6				
Lane Width (ft)	11.8	11.8

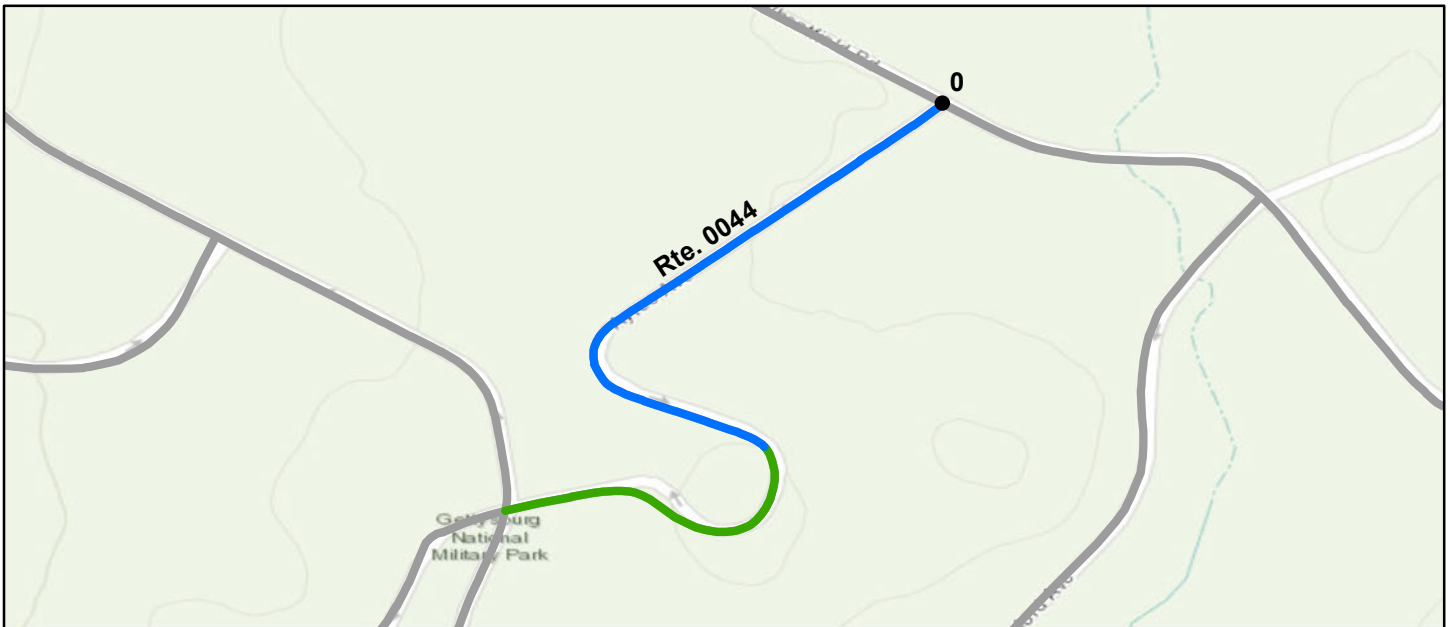
ROUTE 0044: AYERS AVENUE

Data Collection Vehicle (DCV) Rating

Colors on map represent condition scores at 0.10-mile intervals. See Appendix for definitions and formulas.

Inspection Date:	11/20/2020	Beginning Section MP	0				
Paved Length (Miles):	0.3	Section Length (MI)	0.3				
Surface Type:	ASPHALT	Route Summary					
Roadway Condition Information							
Pavement Condition Rating (PCR)	97	97					
Surface Condition Rating (SCR)	97	97					
Roughness Condition Index (RCI)	N/A	N/A					
Distress Index Values							
Structural Crack Index	99	99					
Alligator Crack Index	100	100					
Longitudinal Crack Index	99	99					
Transverse Cracking Index	100	100					
Patching Index	100	100					
Rutting Index	97	97					
International Roughness Index (IRI)	N/A	N/A					
Lane & Width Information							
Number of Lanes	1	1					
Paved Width (ft)	14	14					
Lane Width (ft)	14	14

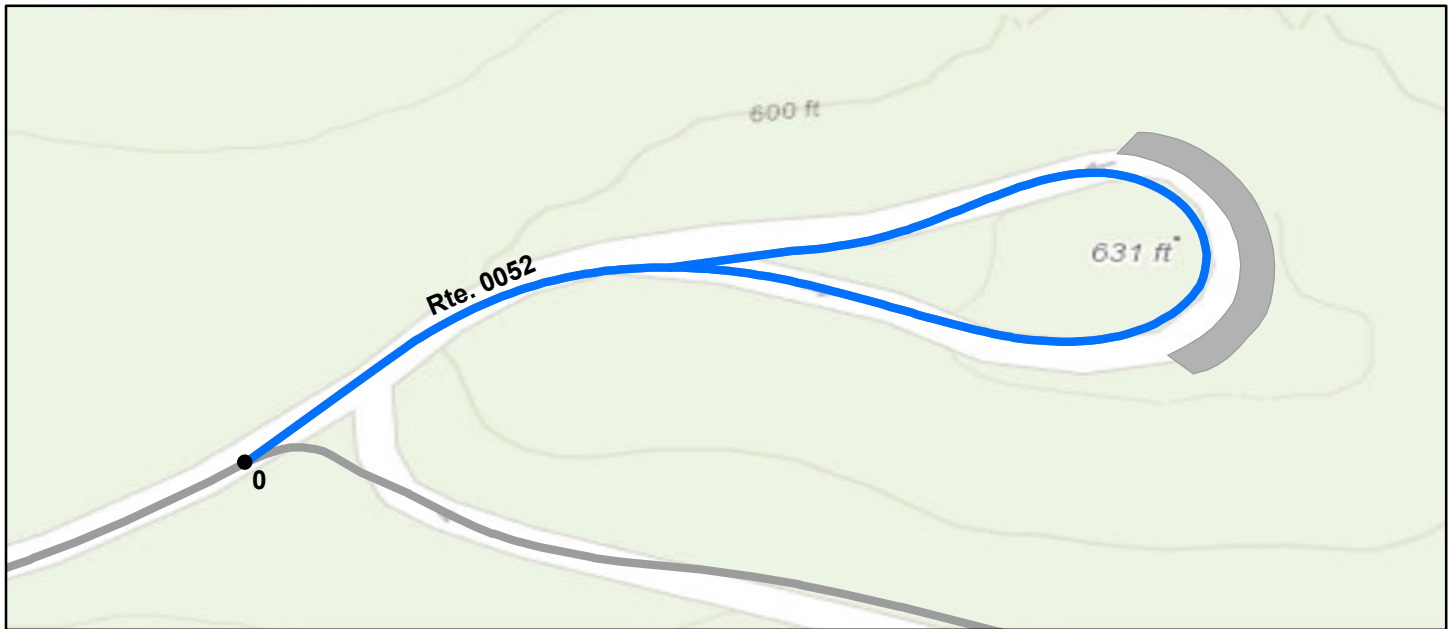
ROUTE 0052: CULPS HILL TOWER ROAD

Data Collection Vehicle (DCV) Rating

Colors on map represent condition scores at 0.10-mile intervals. See Appendix for definitions and formulas.

Inspection Date:	11/19/2020	Beginning Section MP	0				
Paved Length (Miles):	0.15	Section Length (MI)	0.15				
Surface Type:	ASPHALT	Route Summary					
Roadway Condition Information							
Pavement Condition Rating (PCR)	97	97					
Surface Condition Rating (SCR)	97	97					
Roughness Condition Index (RCI)	N/A	N/A					
Distress Index Values							
Structural Crack Index	100	100					
Alligator Crack Index	100	100					
Longitudinal Crack Index	100	100					
Transverse Cracking Index	100	100					
Patching Index	100	100					
Rutting Index	97	97					
International Roughness Index (IRI)	N/A	N/A					
Lane & Width Information							
Number of Lanes	1	1					
Paved Width (ft)	19.3	19.3					
Lane Width (ft)	14.2	14.2

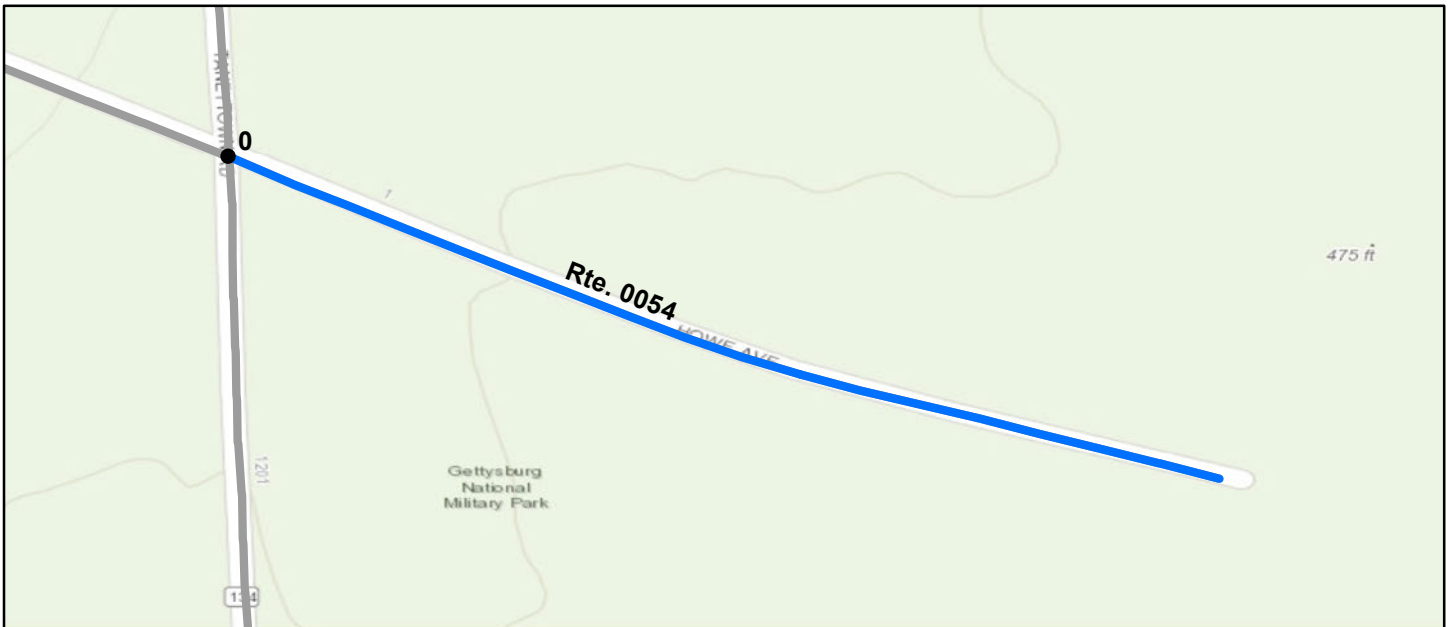
ROUTE 0054: HOWE AVENUE

Data Collection Vehicle (DCV) Rating

Colors on map represent condition scores at 0.10-mile intervals. See Appendix for definitions and formulas.

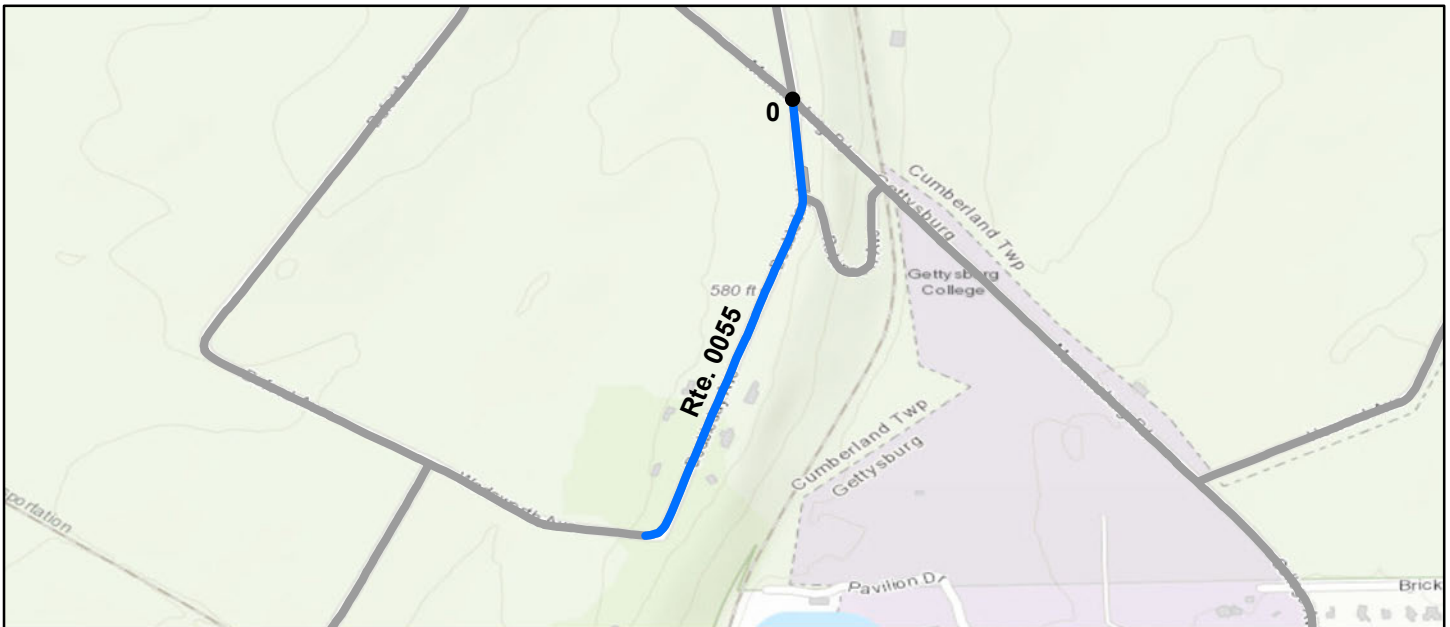
ROUTE 0055: DOUBLEDAY AVENUE

Data Collection Vehicle (DCV) Rating

Colors on map represent condition scores at 0.10-mile intervals. See Appendix for definitions and formulas.

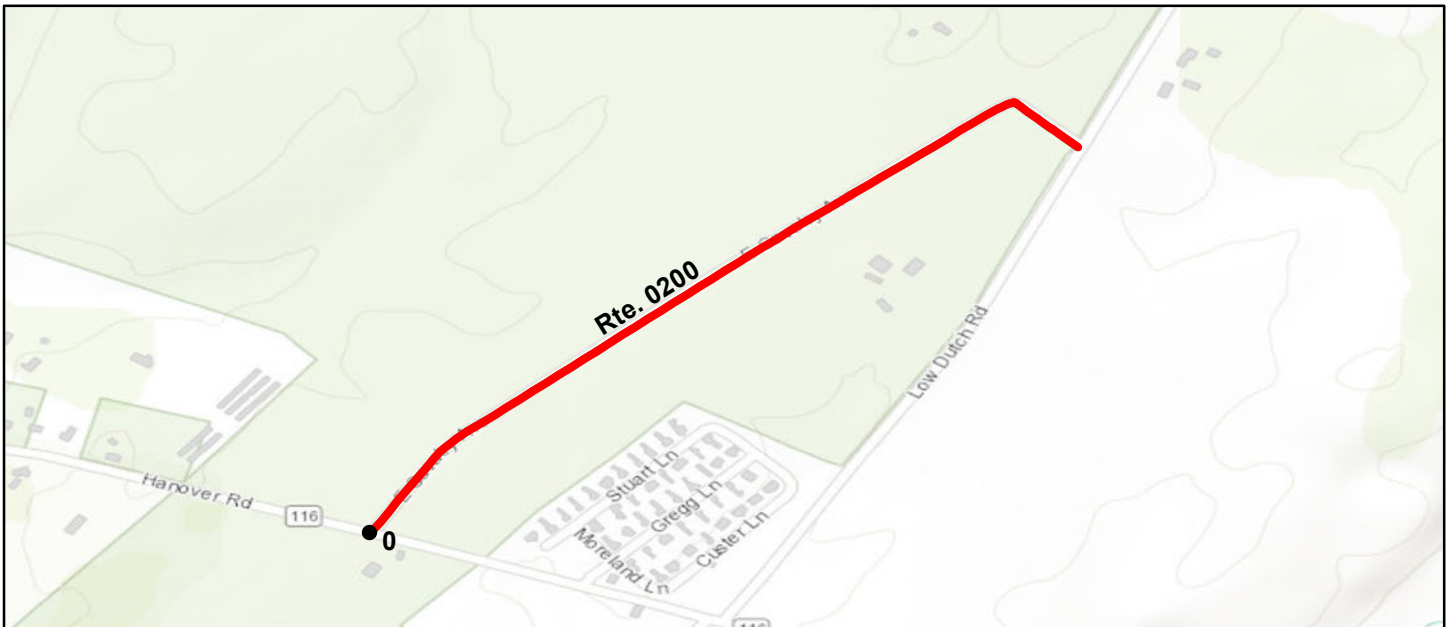
ROUTE 0200: UNITED STATES CAVALRY AVENUE

Data Collection Vehicle (DCV) Rating
