GETT Cycle 6

Final Report

Road Inventory and Condition Assessment of Paved Routes Gettysburg National Military Park

**Federal Highway Administration
Eastern Federal Lands Highway Division
Road Inventory Program (RIP)**

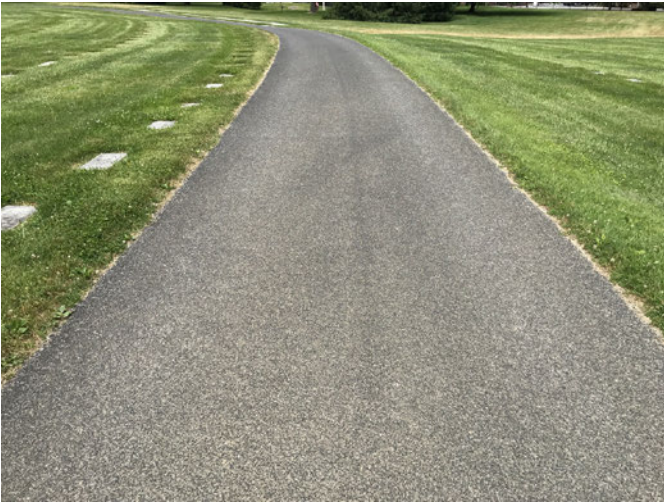
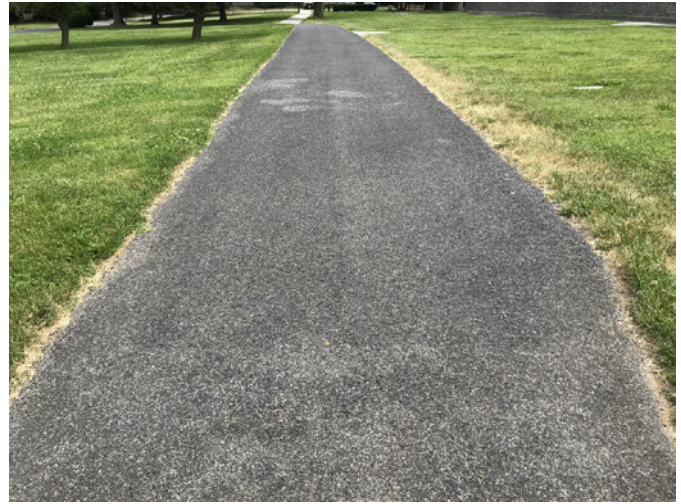
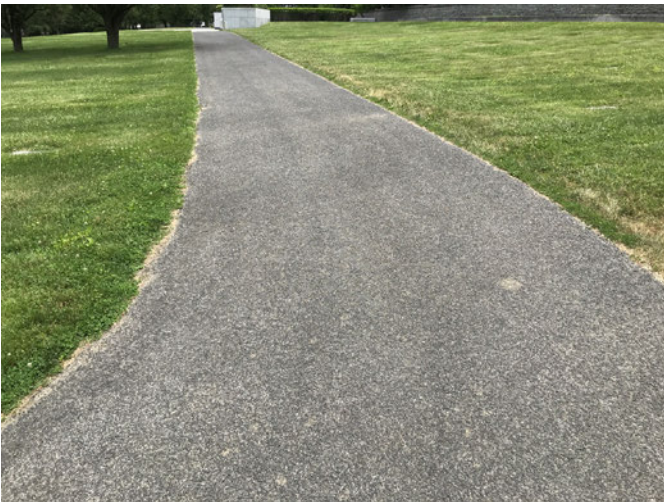
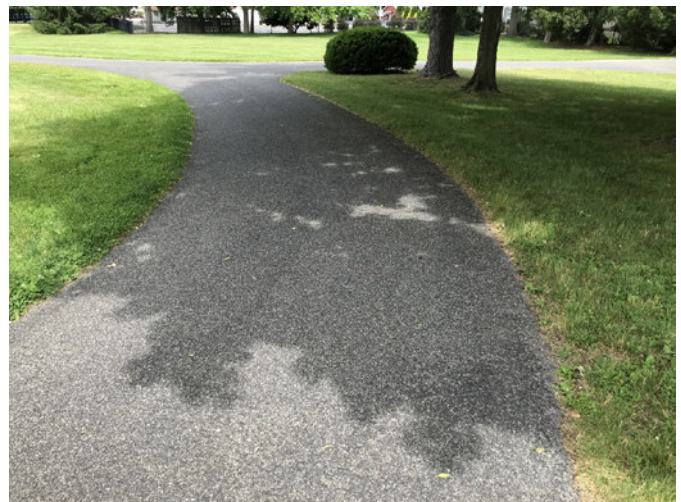
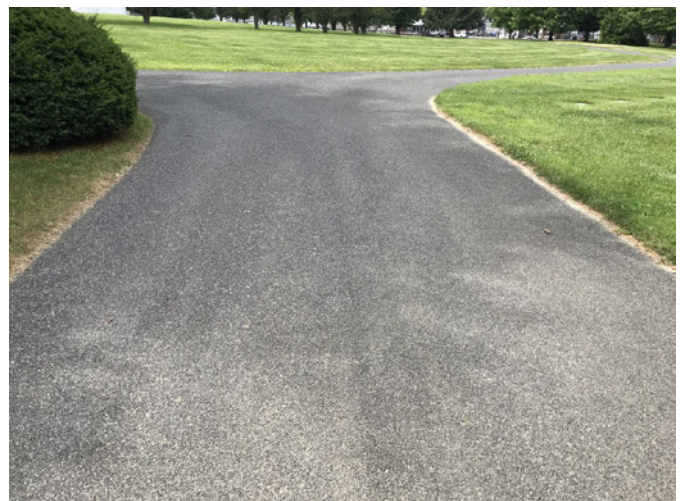
Condition Photos

Condition photos are shown only for manually rated roads. Use the PathView program to see images of DCV rated roads.

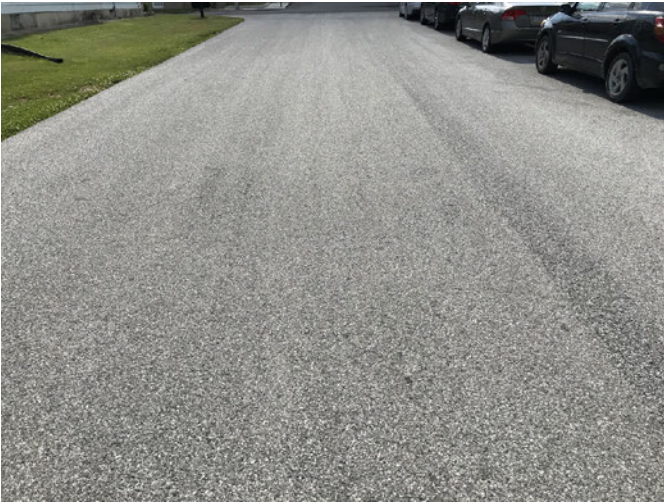
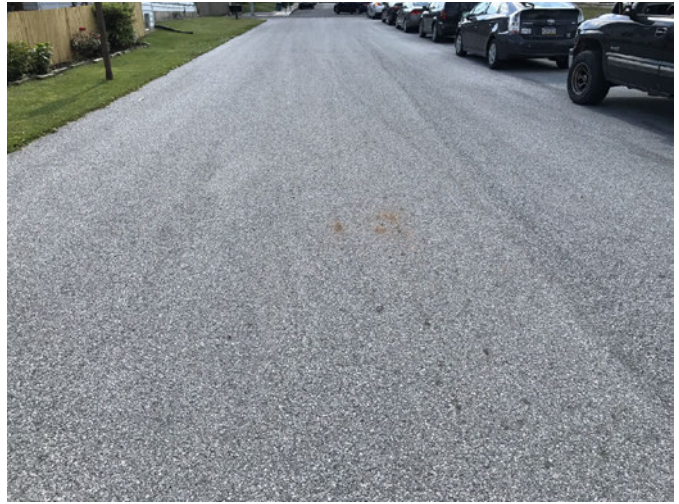
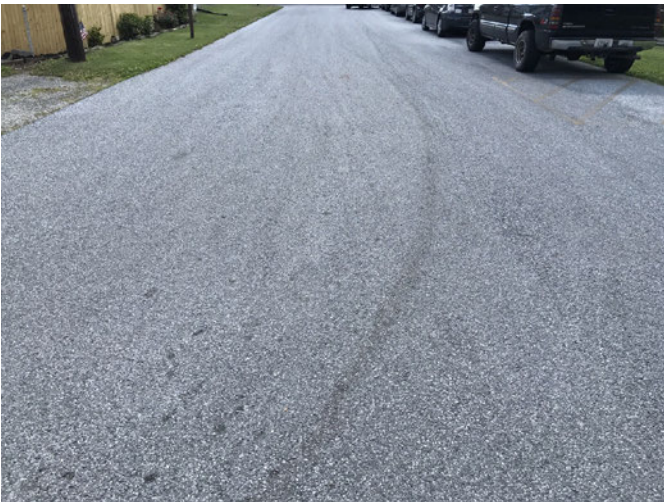
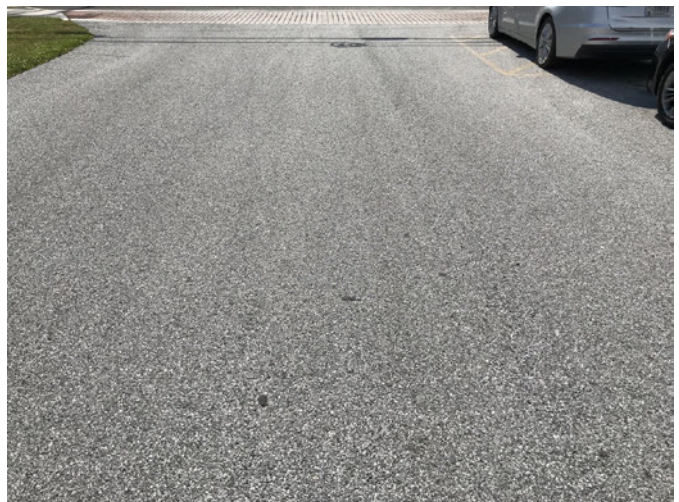
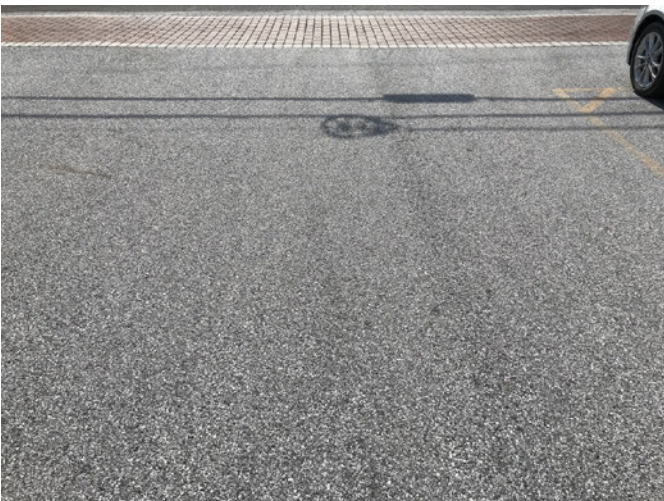
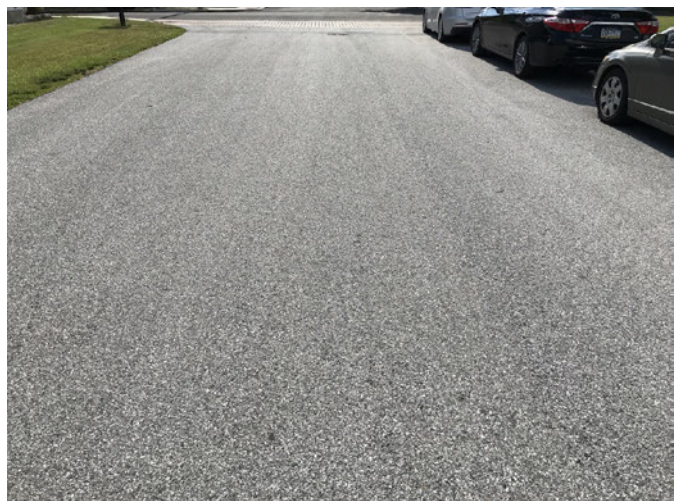
Condition Photos

Condition photos are shown only for manually rated roads. Use the PathView program to see images of DCV rated roads.

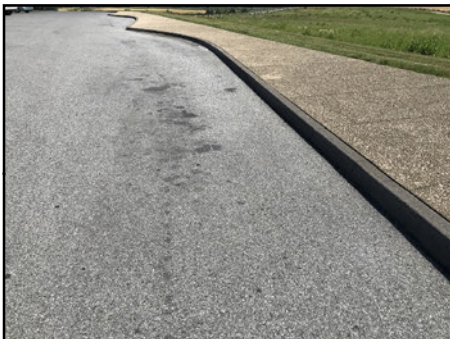
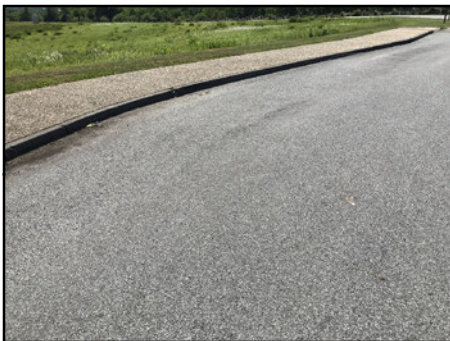
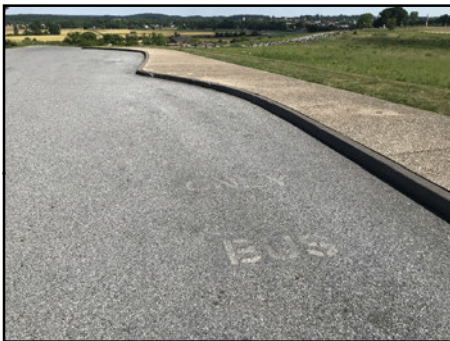
ROUTE 0900AZ: ETERNAL PEACE LIGHT MEMORIAL PARKING A

Inspection Date	FMSS Number	User Access	Surface Type
6/15/2020	63411	PUBLIC	ASPHALT
Area (Sq. Ft.)	Lane Miles (11' Widths)	Curb Reveal (Inches)	Curb Recommendation
3,943	0.068	5	DO NOTHING
Curb Type		Curb & Gutter Type	
CONCRETE		NO CURB AND GUTTER	
Pavement Recommendation		Condition Rating / PCR	
PREVENTIVE MAINTENANCE		GOOD / 90

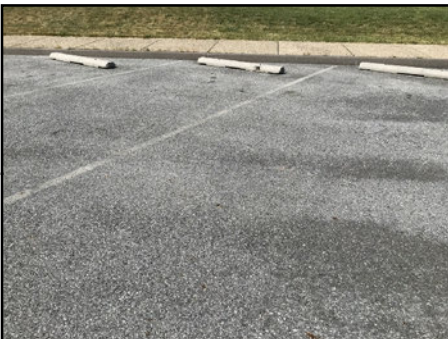
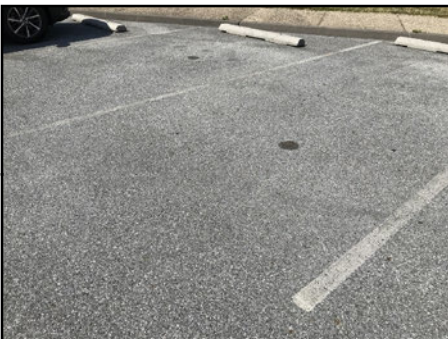
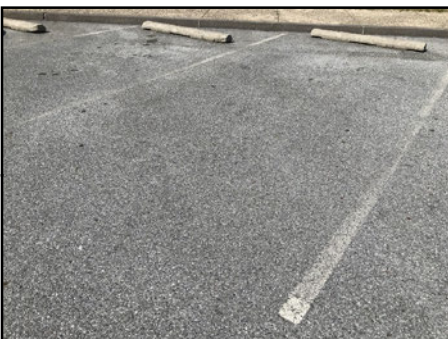
ROUTE 0900BZ: ETERNAL PEACE LIGHT MEMORIAL PARKING B

Inspection Date	FMSS Number	User Access	Surface Type
6/15/2020	63411	PUBLIC	ASPHALT
Area (Sq. Ft.)	Lane Miles (11' Widths)	Curb Reveal (Inches)	Curb Recommendation
5,238	0.09	5	DO NOTHING
Curb Type		Curb & Gutter Type	
CONCRETE		NO CURB AND GUTTER	
Pavement Recommendation		Condition Rating / PCR	
PREVENTIVE MAINTENANCE		GOOD / 90

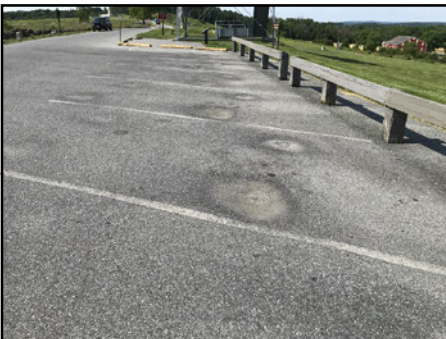
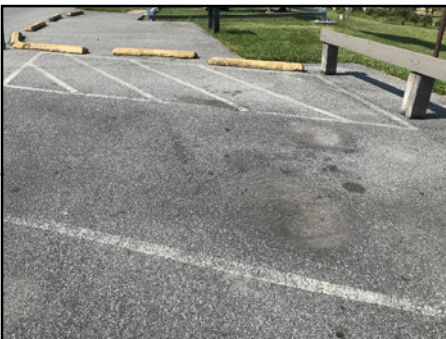
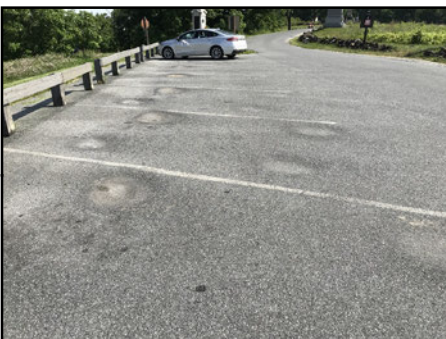
ROUTE 0901: OAK RIDGE TOWER PARKING

Inspection Date	FMSS Number	User Access	Surface Type
6/15/2020	69442	PUBLIC	ASPHALT
Area (Sq. Ft.)	Lane Miles (11' Widths)	Curb Reveal (Inches)	Curb Recommendation
2,351	0.04	NOT APPLICABLE	NOT APPLICABLE
Curb Type		Curb & Gutter Type	
NO CURB		NO CURB AND GUTTER	
Pavement Recommendation		Condition Rating / PCR	
PREVENTIVE MAINTENANCE		GOOD / 90

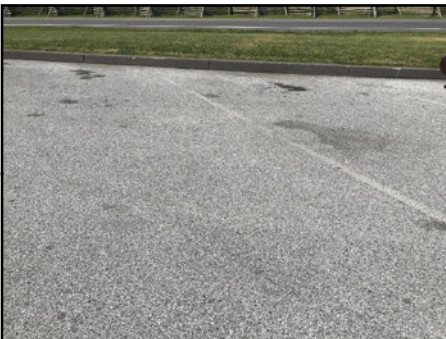
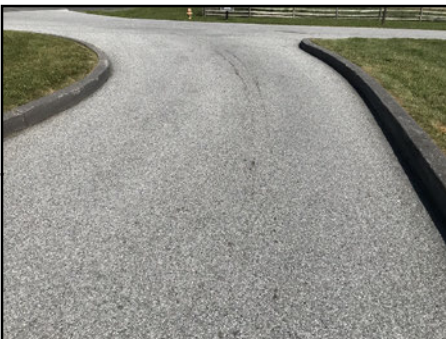
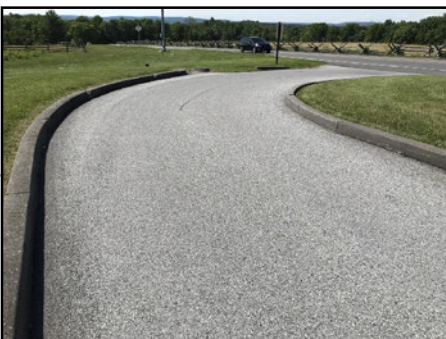
ROUTE 0902: WEST END GUIDE STATION PARKING

Inspection Date	FMSS Number	User Access	Surface Type
6/15/2020	66140	PUBLIC	ASPHALT
Area (Sq. Ft.)	Lane Miles (11' Widths)	Curb Reveal (Inches)	Curb Recommendation
7,147	0.123	7	DO NOTHING
Curb Type		Curb & Gutter Type	
CONCRETE		NO CURB AND GUTTER	
Pavement Recommendation		Condition Rating / PCR	
PREVENTIVE MAINTENANCE		GOOD / 90

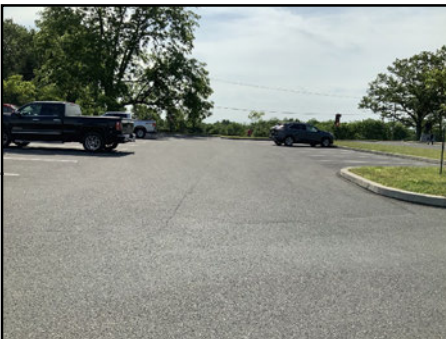
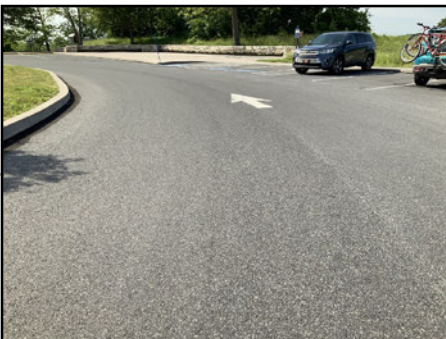
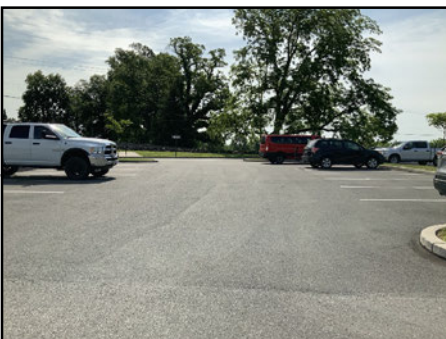
ROUTE 0904: NATIONAL CEMETERY PARKING

Inspection Date	FMSS Number	User Access	Surface Type
6/15/2020	67404	PUBLIC	ASPHALT
Area (Sq. Ft.)	Lane Miles (11' Widths)	Curb Reveal (Inches)	Curb Recommendation
53,984	0.929	NOT APPLICABLE	DO NOTHING
Curb Type		Curb & Gutter Type	
NO CURB		CONCRETE	
Pavement Recommendation		Condition Rating / PCR	
PREVENTIVE MAINTENANCE		GOOD / 90

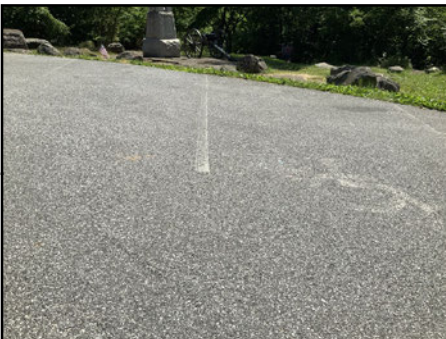
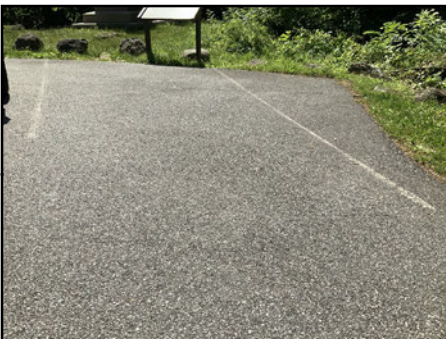
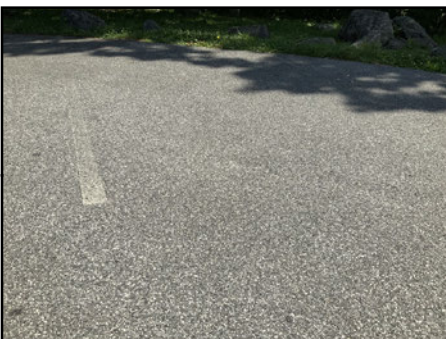
ROUTE 0906: SPANGLER'S SPRING PARKING

Inspection Date	FMSS Number	User Access	Surface Type
6/15/2020	68574	PUBLIC	ASPHALT
Area (Sq. Ft.)	Lane Miles (11' Widths)	Curb Reveal (Inches)	Curb Recommendation
1,207	0.021	NOT APPLICABLE	NOT APPLICABLE
Curb Type		Curb & Gutter Type	
NO CURB		NO CURB AND GUTTER	
Pavement Recommendation		Condition Rating / PCR	
PREVENTIVE MAINTENANCE		GOOD / 90

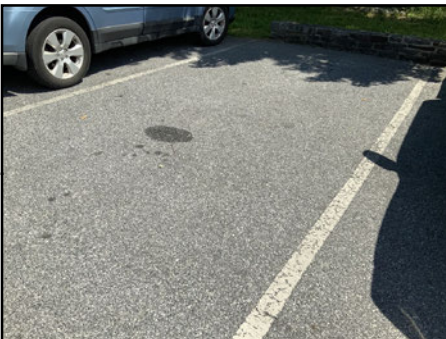
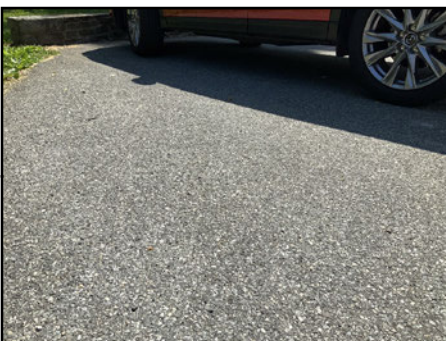
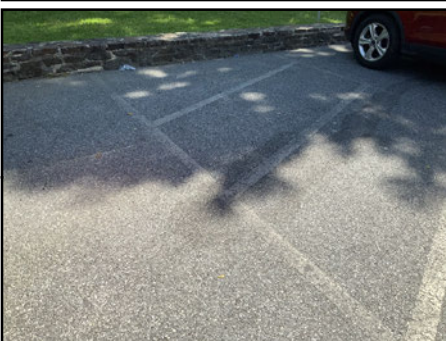
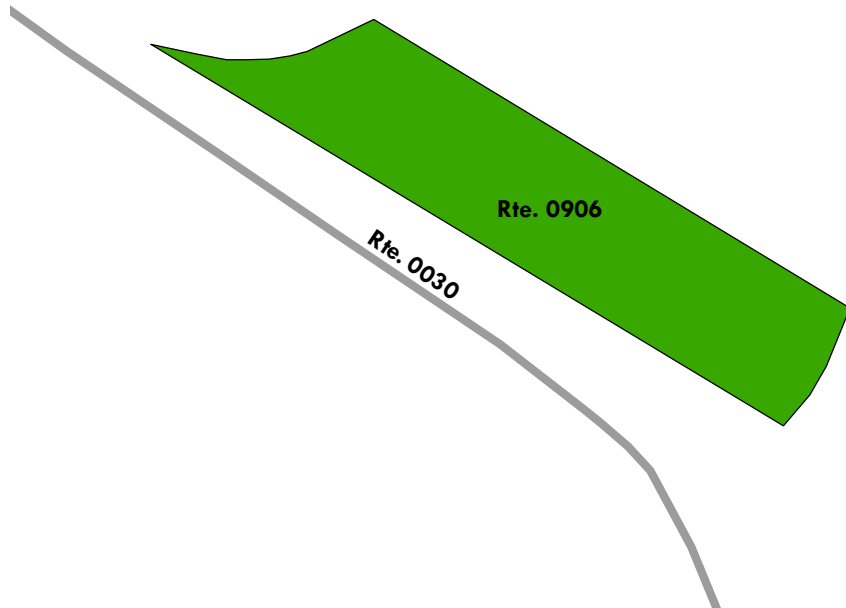
ROUTE 0908: VIRGINIA MEMORIAL LOOP PARKING

Inspection Date	FMSS Number	User Access	Surface Type
6/15/2020	67366	PUBLIC	ASPHALT
Area (Sq. Ft.)	Lane Miles (11' Widths)	Curb Reveal (Inches)	Curb Recommendation
8,991	0.155	3	LIGHT REPAIR
Curb Type		Curb & Gutter Type	
CONCRETE		NO CURB AND GUTTER	
Pavement Recommendation		Condition Rating / PCR	
PREVENTIVE MAINTENANCE		GOOD / 90

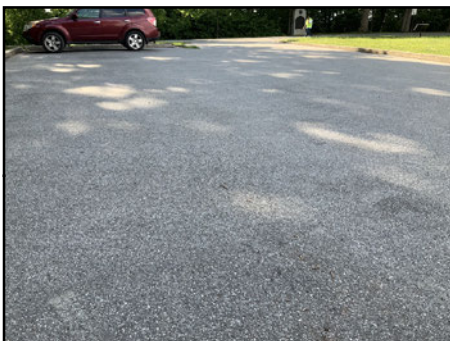
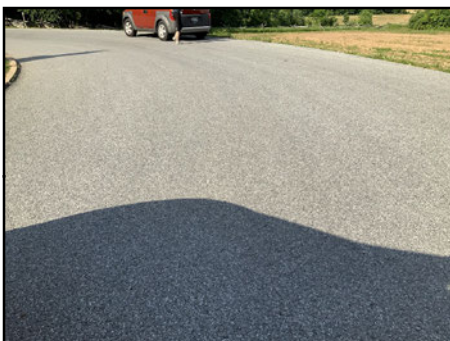
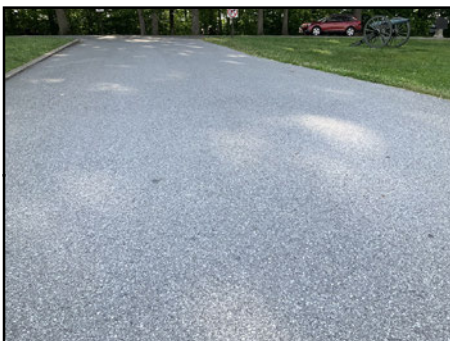
ROUTE 0909: PENNSYLVANIA MONUMENT PARKING

Inspection Date	FMSS Number	User Access	Surface Type
6/15/2020	69448	PUBLIC	ASPHALT
Area (Sq. Ft.)	Lane Miles (11' Widths)	Curb Reveal (Inches)	Curb Recommendation
2,101	0.036	6	DO NOTHING
Curb Type		Curb & Gutter Type	
CONCRETE		NO CURB AND GUTTER	
Pavement Recommendation		Condition Rating / PCR	
PREVENTIVE MAINTENANCE		GOOD / 90

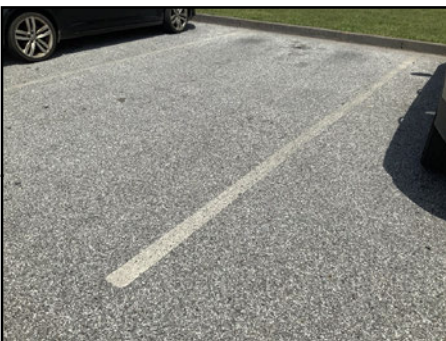
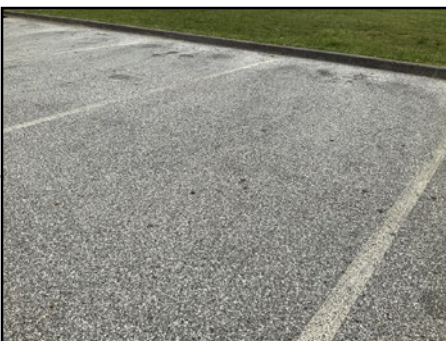
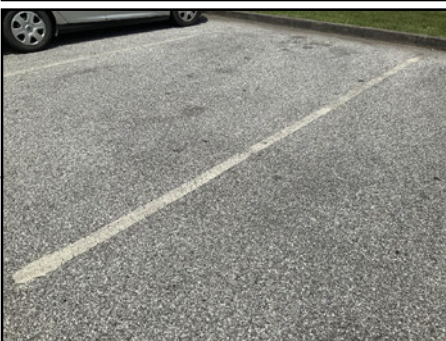
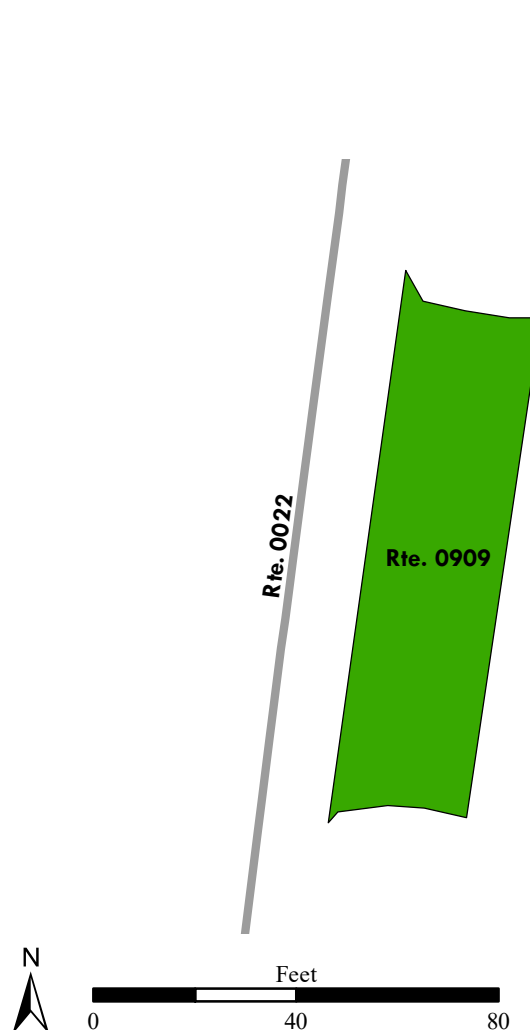
ROUTE 0910ZZ: MAINTENANCE PARKING AREAS

Inspection Date	FMSS Number	User Access	Surface Type
6/15/2020	69571	PUBLIC	ASPHALT
Area (Sq. Ft.)	Lane Miles (11' Widths)	Condition Rating / PCR	
53,121	0.915	SUMMARY / 75

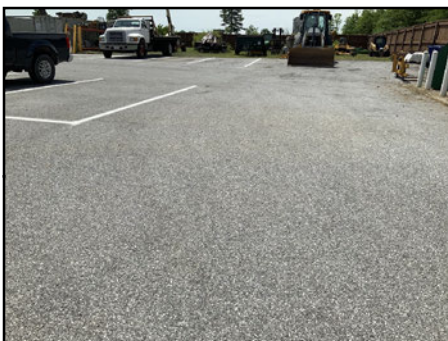
ROUTE 0910AZ: MAINTENANCE PARKING A

Inspection Date	FMSS Number	User Access	Surface Type
6/15/2020	69571	PUBLIC	ASPHALT
Area (Sq. Ft.)	Lane Miles (11' Widths)	Curb Reveal (Inches)	Curb Recommendation
47,377	0.816	4	DO NOTHING
Curb Type		Curb & Gutter Type	
CONCRETE		NO CURB AND GUTTER	
Pavement Recommendation		Condition Rating / PCR	
LIGHT 3R TREATMENTS		FAIR / 73

MULTIPLE SURFACE TYPES: ASPHALT = 46,358 SQ FT; CONCRETE = 1,019 SQ FT.

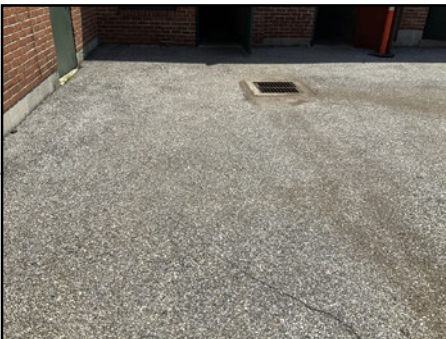
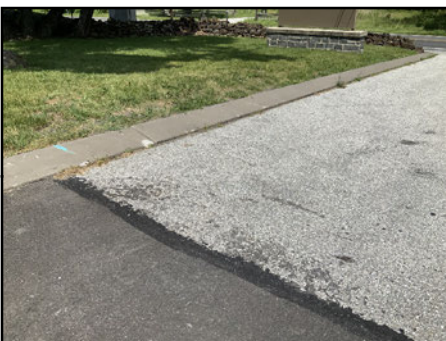
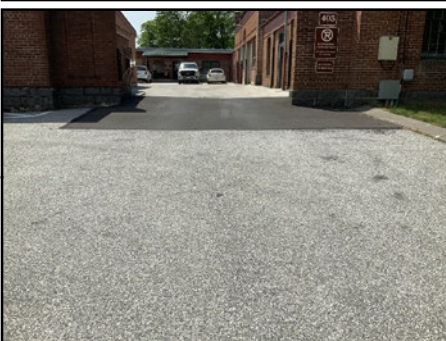
ROUTE 0910BZ: MAINTENANCE PARKING B

Inspection Date	FMSS Number	User Access	Surface Type
6/15/2020	69571	PUBLIC	ASPHALT
Area (Sq. Ft.)	Lane Miles (11' Widths)	Curb Reveal (Inches)	Curb Recommendation
5,744	0.099	2	DO NOTHING
Curb Type		Curb & Gutter Type	
CONCRETE		NO CURB AND GUTTER	
Pavement Recommendation		Condition Rating / PCR	
PREVENTIVE MAINTENANCE		GOOD / 90

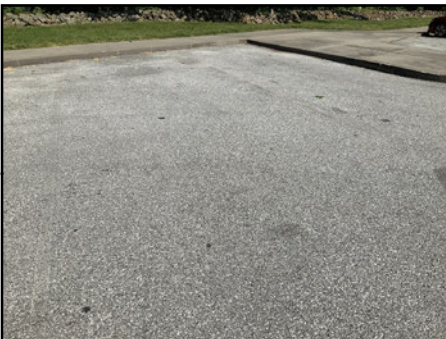
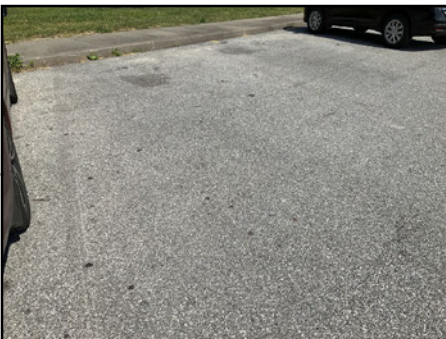
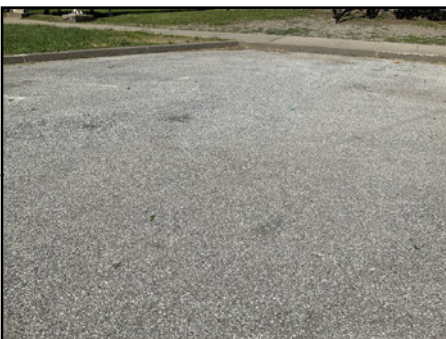
ROUTE 0912: LONGSTREET TOWER PARKING

Inspection Date	FMSS Number	User Access	Surface Type
6/15/2020	69543	PUBLIC	ASPHALT
Area (Sq. Ft.)	Lane Miles (11' Widths)	Curb Reveal (Inches)	Curb Recommendation
7,844	0.135	6	DO NOTHING
Curb Type		Curb & Gutter Type	
CONCRETE		NO CURB AND GUTTER	
Pavement Recommendation		Condition Rating / PCR	
PREVENTIVE MAINTENANCE		GOOD / 90

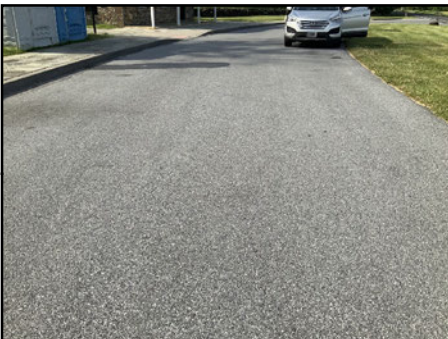
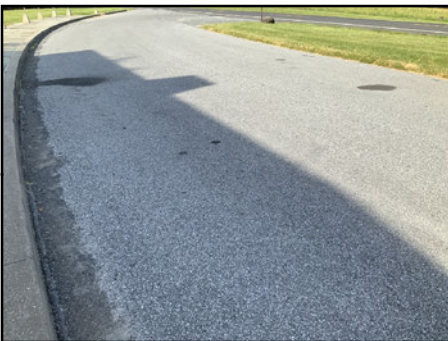
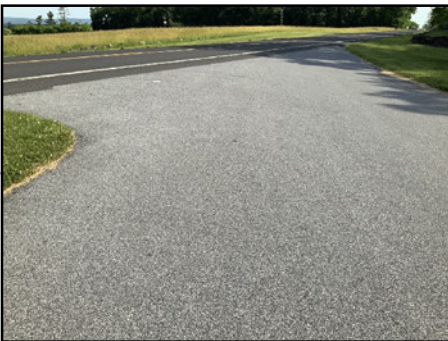
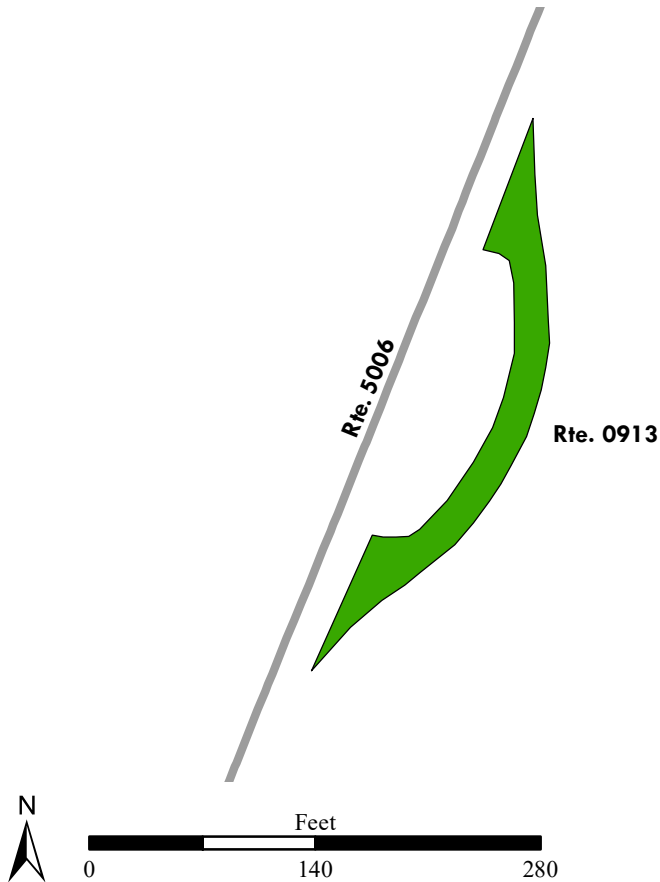
ROUTE 0913: SOUTH END GUIDE STATION PARKING

Inspection Date	FMSS Number	User Access	Surface Type
6/15/2020	69215	PUBLIC	ASPHALT
Area (Sq. Ft.)	Lane Miles (11' Widths)	Curb Reveal (Inches)	Curb Recommendation
5,964	0.103	7	DO NOTHING
Curb Type		Curb & Gutter Type	
CONCRETE		NO CURB AND GUTTER	
Pavement Recommendation		Condition Rating / PCR	
PREVENTIVE MAINTENANCE		GOOD / 90

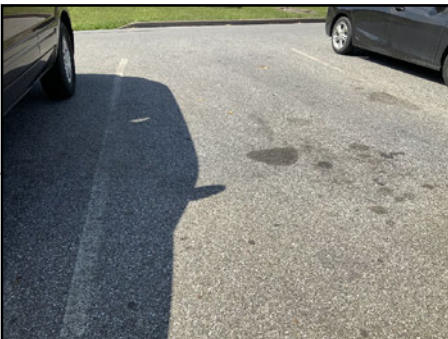
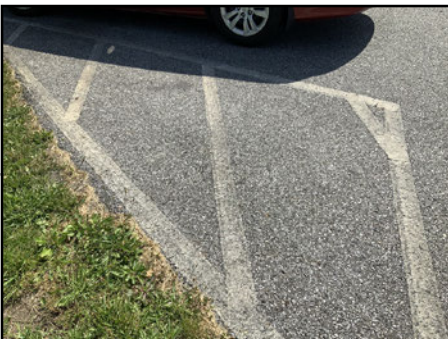
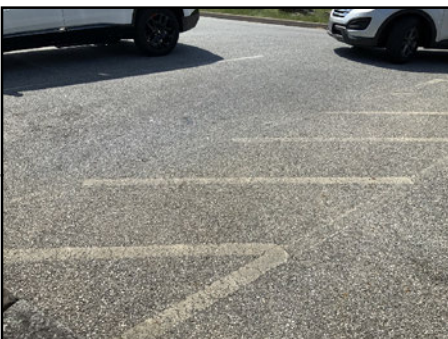
ROUTE 0914AZ: DEVIL'S DEN PARKING A

Inspection Date	FMSS Number	User Access	Surface Type
6/15/2020	69309	PUBLIC	ASPHALT
Area (Sq. Ft.)	Lane Miles (11' Widths)	Curb Reveal (Inches)	Curb Recommendation
1,499	0.026	NOT APPLICABLE	NOT APPLICABLE
Curb Type		Curb & Gutter Type	
NO CURB		NO CURB AND GUTTER	
Pavement Recommendation		Condition Rating / PCR	
PREVENTIVE MAINTENANCE		GOOD / 90

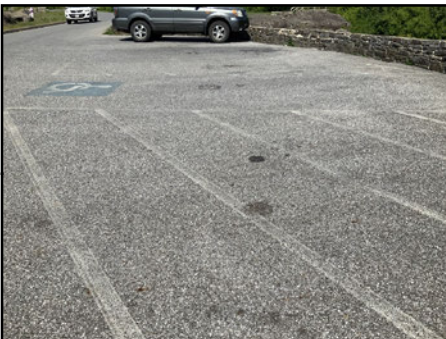
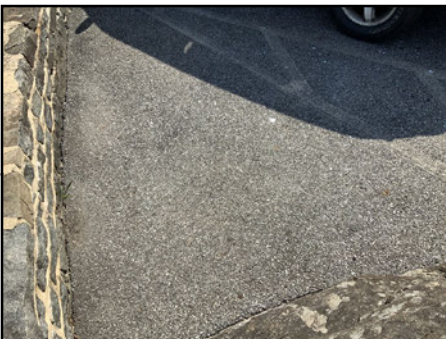
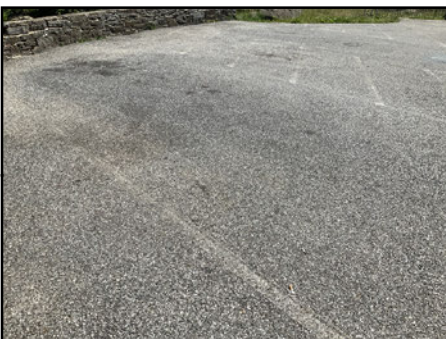
ROUTE 0914CZ: DEVIL'S DEN PARKING C

Inspection Date	FMSS Number	User Access	Surface Type
6/15/2020	69309	PUBLIC	ASPHALT
Area (Sq. Ft.)	Lane Miles (11' Widths)	Curb Reveal (Inches)	Curb Recommendation
817	0.014	NOT APPLICABLE	NOT APPLICABLE
Curb Type		Curb & Gutter Type	
NO CURB		NO CURB AND GUTTER	
Pavement Recommendation		Condition Rating / PCR	
PREVENTIVE MAINTENANCE		GOOD / 90

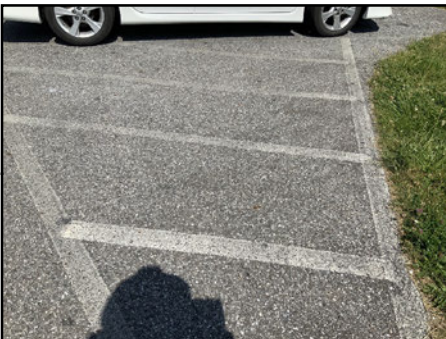
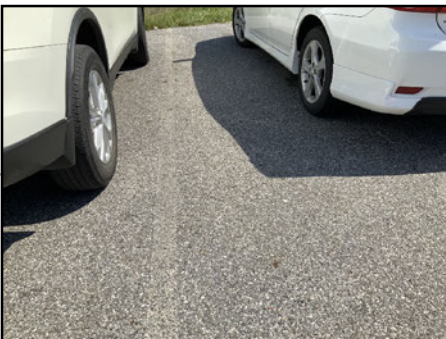
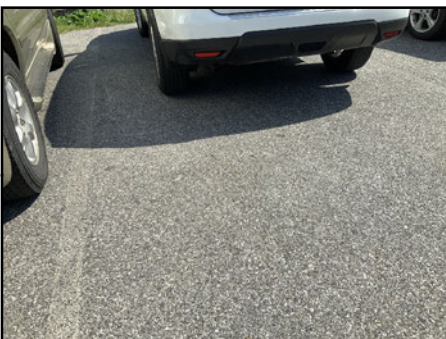
ROUTE 0914DZ: DEVIL'S DEN PARKING D

Inspection Date	FMSS Number	User Access	Surface Type
6/15/2020	69309	PUBLIC	ASPHALT
Area (Sq. Ft.)	Lane Miles (11' Widths)	Curb Reveal (Inches)	Curb Recommendation
830	0.014	NOT APPLICABLE	NOT APPLICABLE
Curb Type		Curb & Gutter Type	
NO CURB		NO CURB AND GUTTER	
Pavement Recommendation		Condition Rating / PCR	
PREVENTIVE MAINTENANCE		GOOD / 90

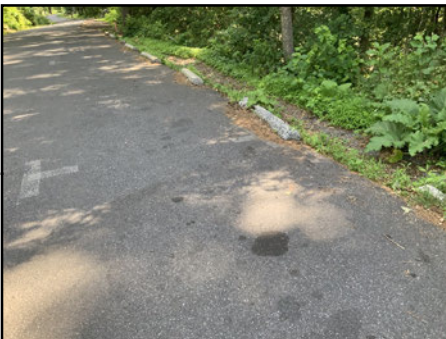
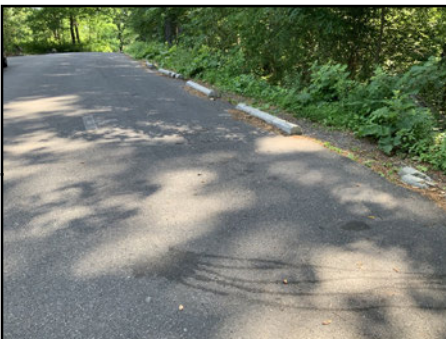
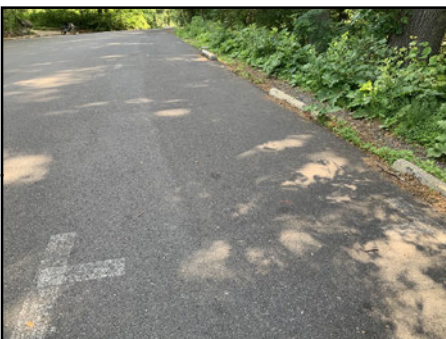
ROUTE 0915AZ: LITTLE ROUND TOP PARKING A

Inspection Date	FMSS Number	User Access	Surface Type
6/15/2020	69300	PUBLIC	ASPHALT
Area (Sq. Ft.)	Lane Miles (11' Widths)	Curb Reveal (Inches)	Curb Recommendation
2,702	0.047	NOT APPLICABLE	NOT APPLICABLE
Curb Type		Curb & Gutter Type	
NO CURB		NO CURB AND GUTTER	
Pavement Recommendation		Condition Rating / PCR	
PREVENTIVE MAINTENANCE		GOOD / 90

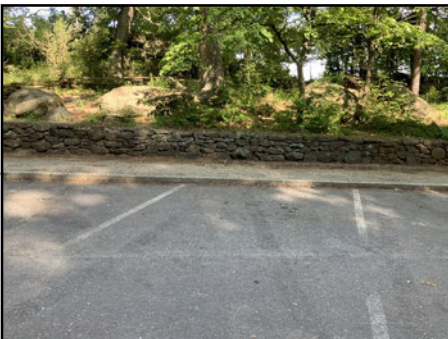
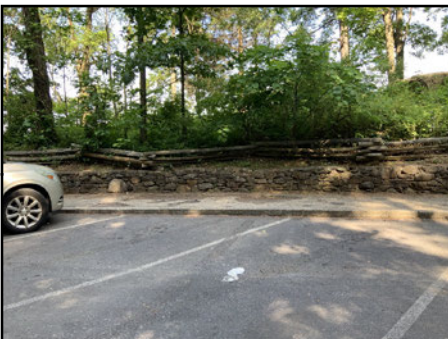
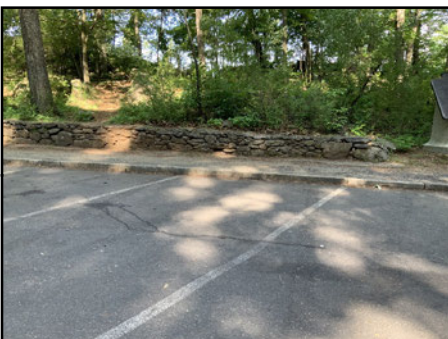
ROUTE 0915BZ: LITTLE ROUND TOP PARKING B

Inspection Date	FMSS Number	User Access	Surface Type
6/15/2020	69300	PUBLIC	ASPHALT
Area (Sq. Ft.)	Lane Miles (11' Widths)	Curb Reveal (Inches)	Curb Recommendation
4,925	0.085	3	DO NOTHING
Curb Type		Curb & Gutter Type	
STONE		NO CURB AND GUTTER	
Pavement Recommendation		Condition Rating / PCR	
PREVENTIVE MAINTENANCE		GOOD / 90

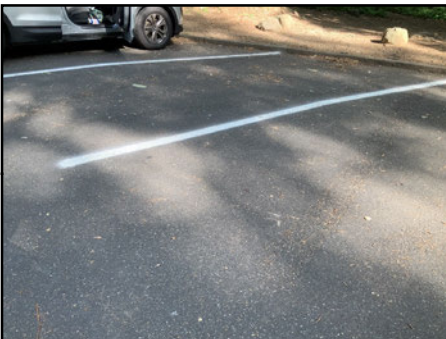
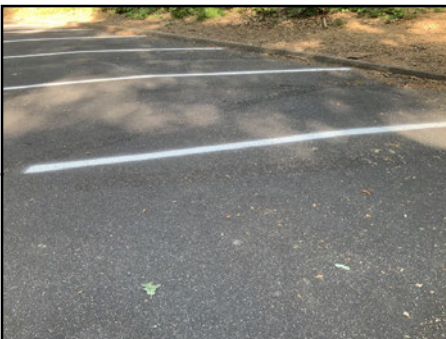
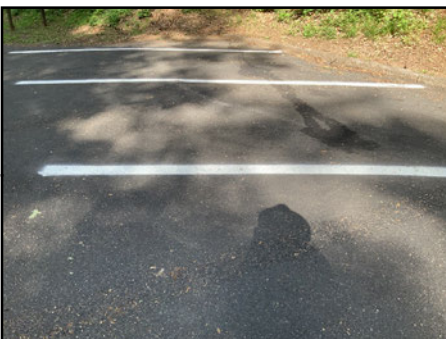
ROUTE 0916: BIG ROUND TOP PARKING

Inspection Date	FMSS Number	User Access	Surface Type
6/15/2020	69290	PUBLIC	ASPHALT
Area (Sq. Ft.)	Lane Miles (11' Widths)	Curb Reveal (Inches)	Curb Recommendation
3,411	0.059	3	DO NOTHING
Curb Type		Curb & Gutter Type	
STONE		NO CURB AND GUTTER	
Pavement Recommendation		Condition Rating / PCR	
PREVENTIVE MAINTENANCE		GOOD / 90

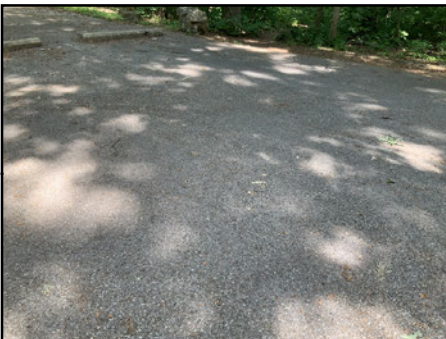
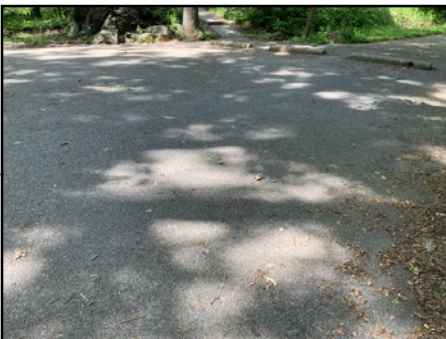
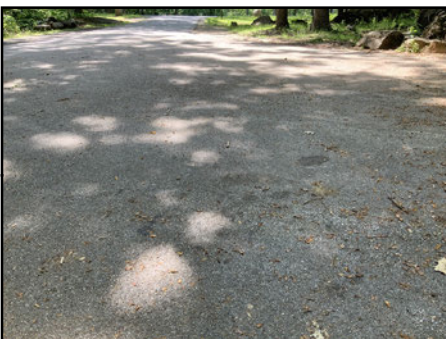
ROUTE 0917: 20TH MAINE MONUMENT PARKING

Inspection Date	FMSS Number	User Access	Surface Type
6/15/2020	69435	PUBLIC	ASPHALT
Area (Sq. Ft.)	Lane Miles (11' Widths)	Curb Reveal (Inches)	Curb Recommendation
1,206	0.021	NOT APPLICABLE	NOT APPLICABLE
Curb Type		Curb & Gutter Type	
NO CURB		NO CURB AND GUTTER	
Pavement Recommendation		Condition Rating / PCR	
PREVENTIVE MAINTENANCE		GOOD / 90

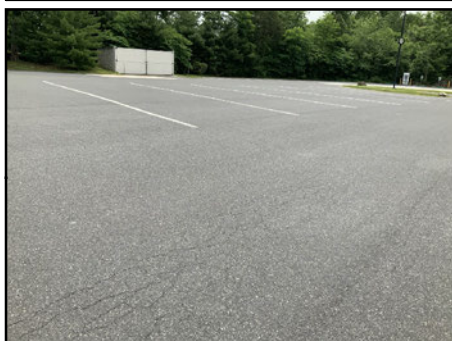
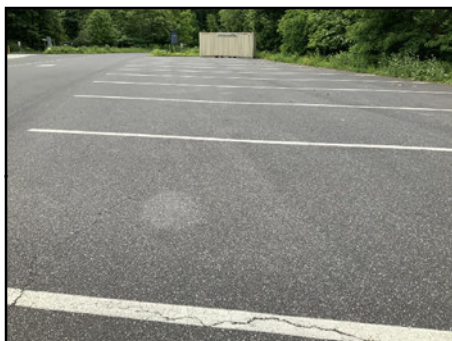
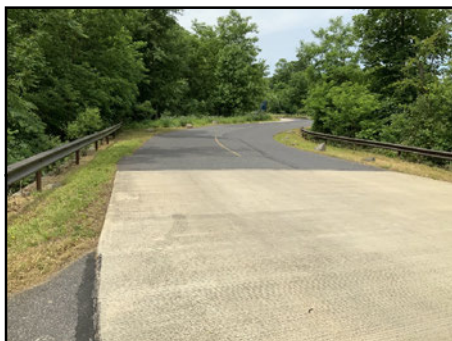
ROUTE 0920: VISITOR CENTER BUS PARKING AREA

Inspection Date	FMSS Number	User Access	Surface Type
6/15/2020	115829	PUBLIC	ASPHALT
Area (Sq. Ft.)	Lane Miles (11' Widths)	Curb Reveal (Inches)	Curb Recommendation
100,640	1.733	6	DO NOTHING
Curb Type		Curb & Gutter Type	
CONCRETE		NO CURB AND GUTTER	
Pavement Recommendation		Condition Rating / PCR	
HEAVY 3R TREATMENTS		POOR / 53

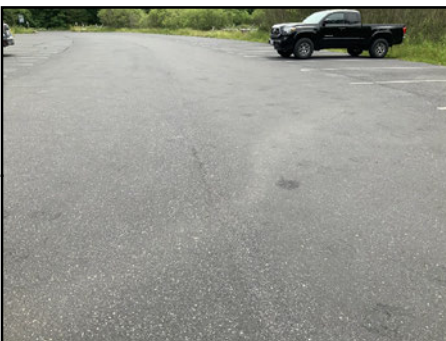
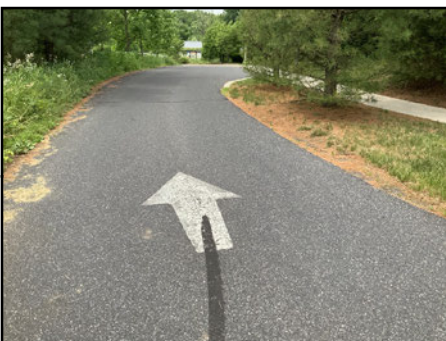
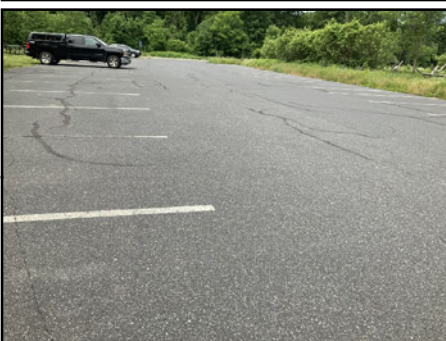
ROUTE 0921: VISITOR CENTER PARKING AREA 1

Inspection Date	FMSS Number	User Access	Surface Type
6/15/2020	115830	PUBLIC	ASPHALT
Area (Sq. Ft.)	Lane Miles (11' Widths)	Curb Reveal (Inches)	Curb Recommendation
97,506	1.679	6	DO NOTHING
Curb Type		Curb & Gutter Type	
CONCRETE		NO CURB AND GUTTER	
Pavement Recommendation		Condition Rating / PCR	
LIGHT 3R TREATMENTS		FAIR / 73

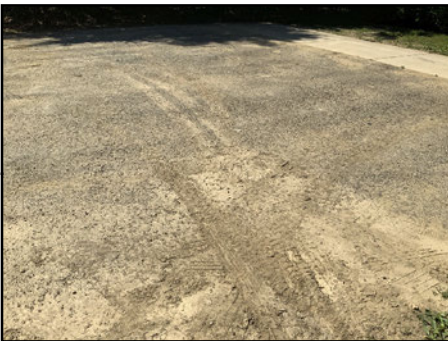
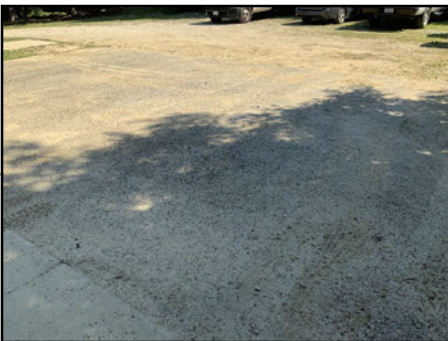
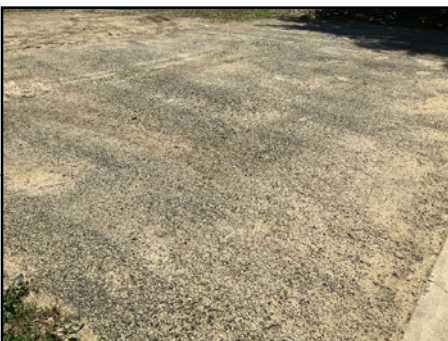
ROUTE 0937: GETTYSBURG ARMORY PARKING AREA B

NOT RATED BECAUSE MAJORITY OF SURFACE WAS COVERED WITH GRAVEL.

Inspection Date	FMSS Number	User Access	Surface Type
6/15/2020	241824	PUBLIC	ASPHALT
Area (Sq. Ft.)	Lane Miles (11' Widths)	Curb Reveal (Inches)	Curb Recommendation
7,286	0.125	NOT APPLICABLE	NOT APPLICABLE
Curb Type		Curb & Gutter Type	
NO CURB		NO CURB AND GUTTER	
Pavement Recommendation		Condition Rating / PCR	
HEAVY 3R TREATMENTS		POOR / 53

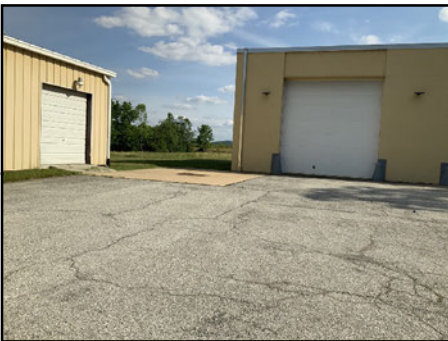
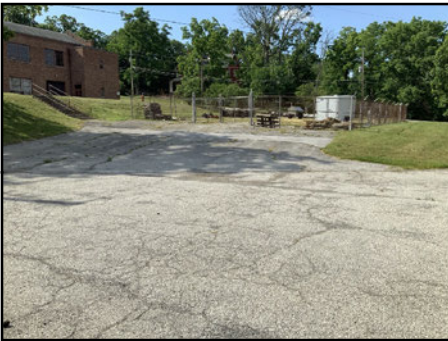
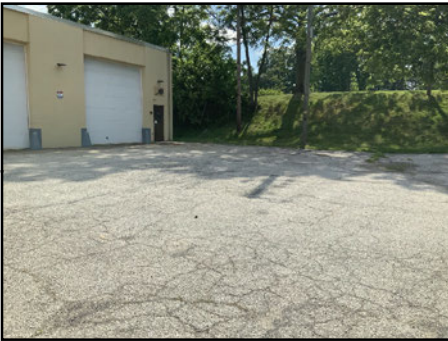
ROUTE 0938: GETTYSBURG ARMORY FENCED PARKING CAMPGROUND

Inspection Date	FMSS Number	User Access	Surface Type
6/15/2020	241827	PUBLIC	ASPHALT
Area (Sq. Ft.)	Lane Miles (11' Widths)	Curb Reveal (Inches)	Curb Recommendation
7,246	0.125	NOT APPLICABLE	NOT APPLICABLE
Curb Type		Curb & Gutter Type	
NO CURB		NO CURB AND GUTTER	
Pavement Recommendation		Condition Rating / PCR	
RECONSTRUCTION		POOR / 30

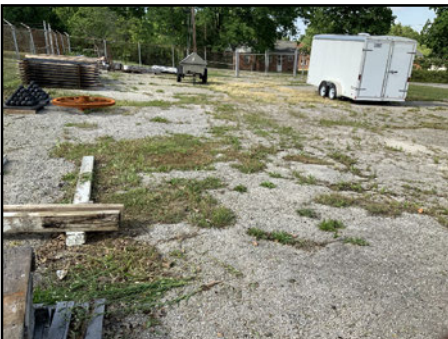
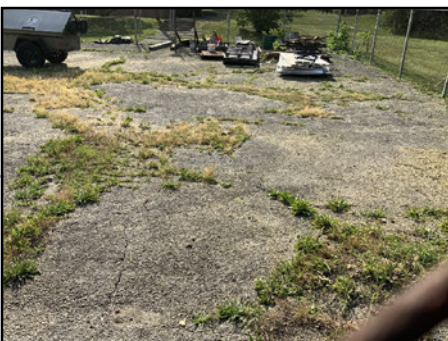
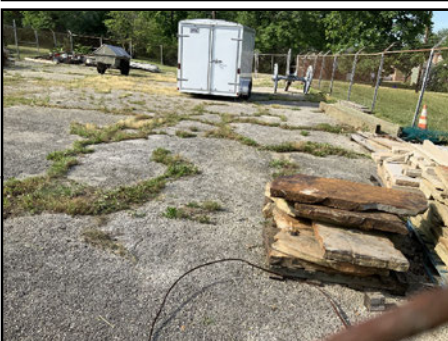
ROUTE 0942: GETTYSBURG ARMORY CONCRETE PARKING APRON

Inspection Date	FMSS Number	User Access	Surface Type
6/15/2020	241826	PUBLIC	CONCRETE
Area (Sq. Ft.)	Lane Miles (11' Widths)	Curb Reveal (Inches)	Curb Recommendation
2,776	0.048	NOT APPLICABLE	NOT APPLICABLE
Curb Type		Curb & Gutter Type	
NO CURB		NO CURB AND GUTTER	
Pavement Recommendation		Condition Rating / PCR	
HEAVY 3R TREATMENTS		POOR / 53

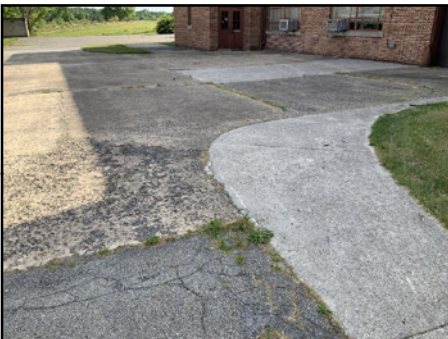
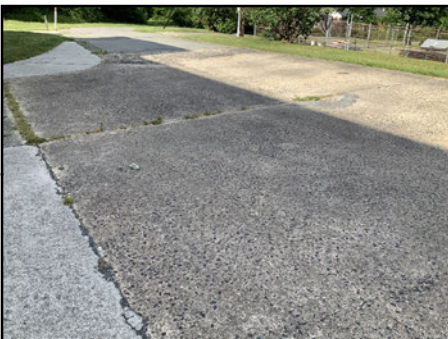
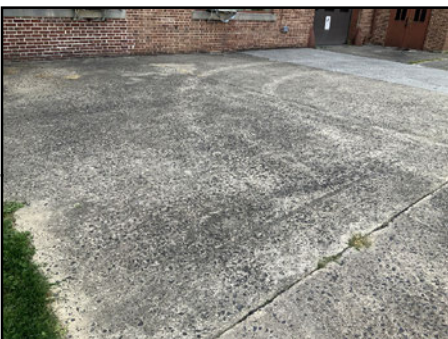
ROUTE 0943: GETTYSBURG ARMORY PARKING AREA A

Inspection Date	FMSS Number	User Access	Surface Type
6/15/2020	241823	PUBLIC	ASPHALT
Area (Sq. Ft.)	Lane Miles (11' Widths)	Curb Reveal (Inches)	Curb Recommendation
7,465	0.129	NOT APPLICABLE	NOT APPLICABLE
Curb Type		Curb & Gutter Type	
NO CURB		NO CURB AND GUTTER	
Pavement Recommendation		Condition Rating / PCR	
PREVENTIVE MAINTENANCE		GOOD / 90
