GLAC Cycle 6

Final Report

Road Inventory and Condition Assessment of Paved Routes Glacier National Park

Report Date: February 2017

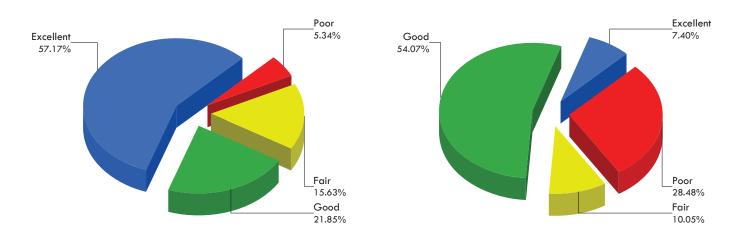
Figure 1: Pavement Condition Rating Breakdown for Paved Roads and Parking Areas

Road Condition Percentages

Parking Area Condition Percentages

- Excellent / New: PCR of 95-100
 - o Pavements in this range will require only spot repairs
- Good: PCR of 85-94
 - o Pavements in this range will likely be candidates for Preventive Maintenance. Examples include Chip and Slurry Seals, Micro Surfacing and Thin Overlays.
- Fair: PCR of 61-84
 - o Pavements in this range will likely be candidates of Light Rehabilitation (L3R). Examples include singlelift overlays up to 2.5 inches in total thickness, milling and overlays.
- Poor: PCR of 0-60
 - o Pavements in this range will likely be candidates of Heavy Rehabilitation or Reconstruction (H3R or 4R). Examples include Pulverization, Multiple Lift Overlays, and Reconstruction.

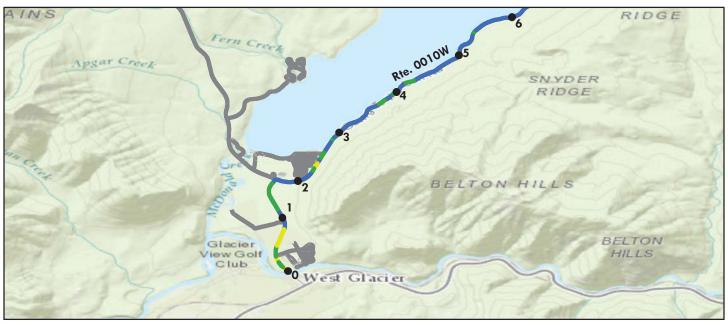
ROUTE 0010W: GOING TO THE SUN ROAD WEST

Data Collection Vehicle (DCV) Rating

| | Route Condition Legend – Pavement Condition Rating (PCR) | | | | | | | |
|---|--|---|---|---|---|---|---|--|
| Pavement Condition Rating (| (PCR) | 99 | 89 | 94 | 95 | 97 | 99 | |
| Surface Condition Rating (SCI | R) | 99 | 90 | 91 | 91 | 95 | 99 | |
| Roughness Condition Index (R | CI) | 100 | 87 | 98 | 100 | 100 | 100 | |

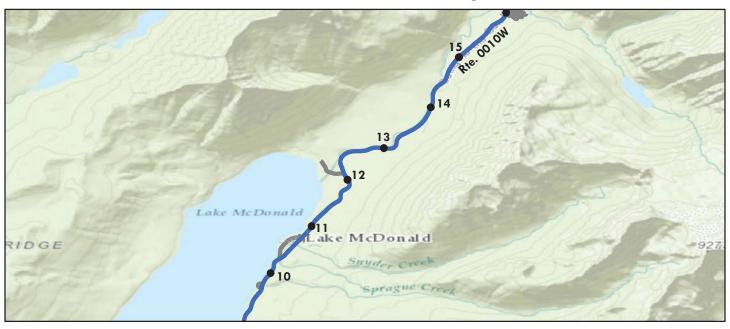
ROUTE 0010W: GOING TO THE SUN ROAD WEST

Data Collection Vehicle (DCV) Rating

| | Route Condition Legend – Pavement Condition Rating (PCR) | | | | | | | |
|---|--|---|---|---|---|---|--|--|
| Pavement Condition Rating (PCR |) 99 | 100 | 99 | 100 | 100 | 100 | | |
| Surface Condition Rating (SCR) | 99 | 100 | 99 | 100 | 100 | 100 | | |
| Roughness Condition Index (RCI) | 100 | 100 | 100 | 100 | 100 | 100 | | |

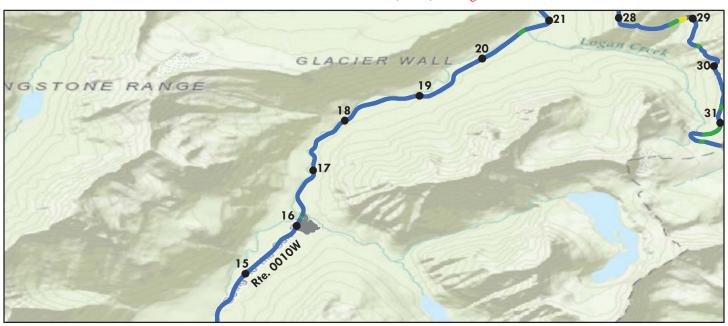
ROUTE 0010W: GOING TO THE SUN ROAD WEST

Data Collection Vehicle (DCV) Rating

| | Route Condition Legend – Pavement Condition Rating (PCR) | | | | | | | |
|---|--|---|---|---|---|---|---|--|
| Pavement Condition Rating | g (PCR) | 99 | 100 | 100 | 100 | 100 | 100 | |
| Surface Condition Rating (So | CR) | 99 | 100 | 100 | 100 | 100 | 100 | |
| Roughness Condition Index | (RCI) | 100 | 100 | 100 | 100 | 100 | 100 | |

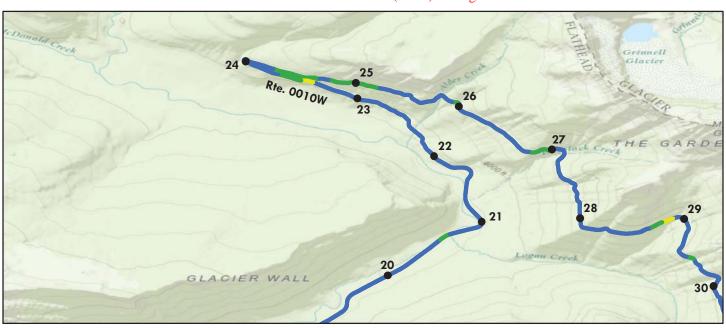
ROUTE 0010W: GOING TO THE SUN ROAD WEST

Data Collection Vehicle (DCV) Rating

| R | Route Condition Legend – Pavement Condition Rating (PCR) | | | | | | | |
|---|--|---|---|---|---|---|--|--|
| Pavement Condition Rating (PCR) | 99 | 99 | 100 | 100 | 99 | 95 | | |
| Surface Condition Rating (SCR) | 99 | 99 | 100 | 100 | 100 | 98 | | |
| Roughness Condition Index (RCI) | 100 | 100 | 100 | 100 | 98 | 90 | | |

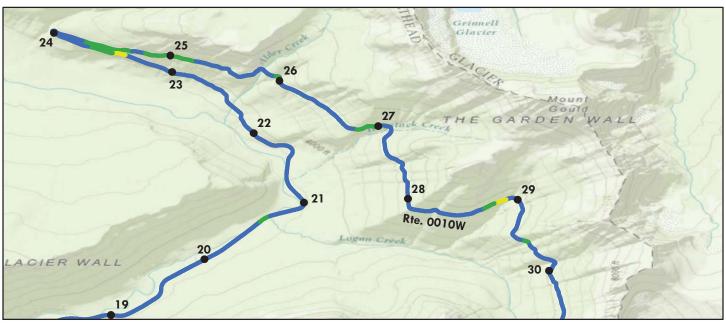
ROUTE 0010W: GOING TO THE SUN ROAD WEST

Data Collection Vehicle (DCV) Rating

| Ro | Route Condition Legend – Pavement Condition Rating (PCR) | | | | | | | |
|---|--|---|---|---|---|---|--|--|
| Pavement Condition Rating (PCR) | 99 | 96 | 98 | 99 | 99 | 98 | | |
| Surface Condition Rating (SCR) | 99 | 98 | 99 | 99 | 99 | 100 | | |
| Roughness Condition Index (RCI) | 100 | 94 | 97 | 100 | 100 | 96 | | |

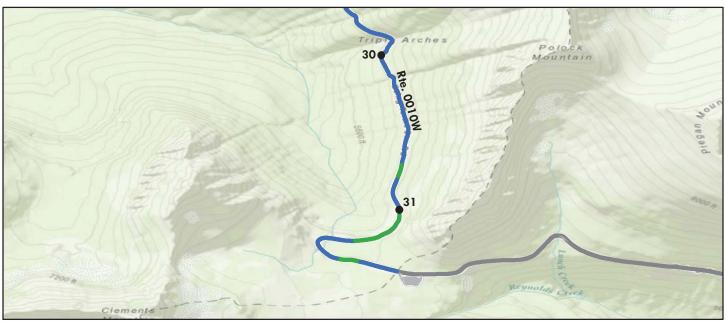
ROUTE 0010W: GOING TO THE SUN ROAD WEST

Data Collection Vehicle (DCV) Rating

| Route Condition Legend – Pavement Condition Rating (PCR) | | | | | | | | | |
|--|---|---|---|---|---|--|--|--|--|
| Pavement Condition Rating (PCR) | 99 | 99 | 94 | | | | | | |
| Surface Condition Rating (SCR) | 99 | 99 | 99 | | | | | | |
| Roughness Condition Index (RCI) | 100 | 100 | 87 | | | | | | |

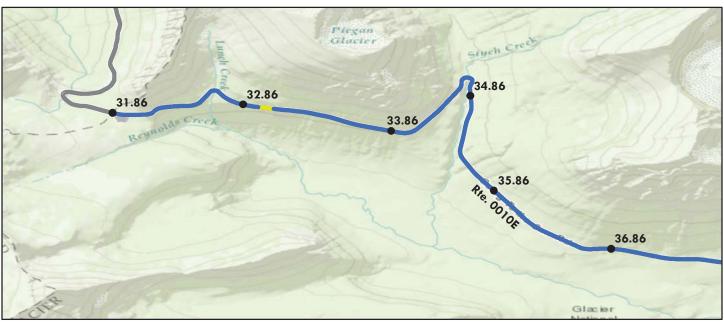
ROUTE 0010E: GOING TO THE SUN ROAD EAST

Data Collection Vehicle (DCV) Rating

| Route Condition Legend – Pavement Condition Rating (PCR) | | | | | | | | |
|--|---|---|---|---|---|---|--|--|
| Pavement Condition Rating (PCR) | 100 | 99 | 100 | 100 | 100 | 100 | | |
| Surface Condition Rating (SCR) | 100 | 99 | 100 | 100 | 100 | 100 | | |
| Roughness Condition Index (RCI) | 100 | 100 | 100 | 100 | 100 | 100 | | |

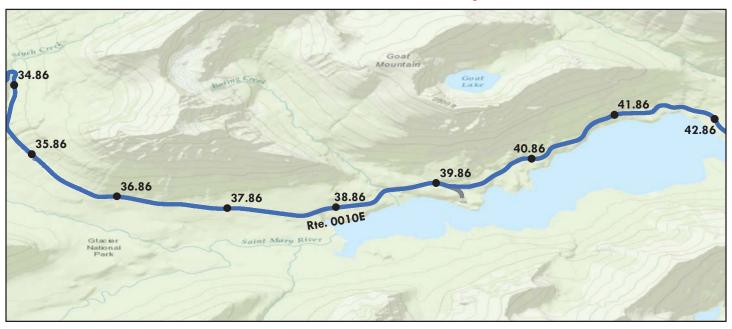
ROUTE 0010E: GOING TO THE SUN ROAD EAST

Data Collection Vehicle (DCV) Rating

| Route | Route Condition Legend – Pavement Condition Rating (PCR) | | | | | | | | |
|---|--|---|---|---|---|---|--|--|--|
| Pavement Condition Rating (PCR) | 100 | 100 | 100 | 100 | 100 | 100 | | | |
| Surface Condition Rating (SCR) | 100 | 100 | 100 | 100 | 100 | 100 | | | |
| Roughness Condition Index (RCI) | 100 | 100 | 100 | 100 | 100 | 100 | | | |

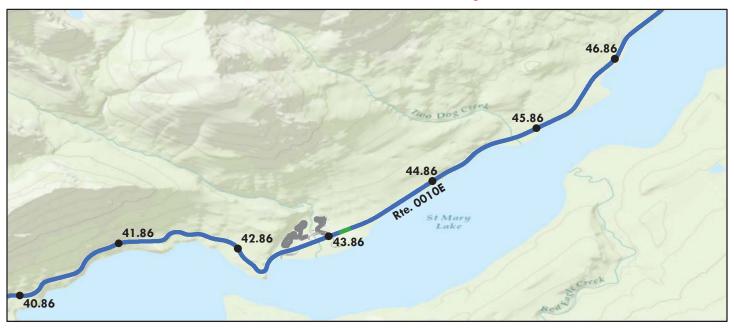
ROUTE 0010E: GOING TO THE SUN ROAD EAST

Data Collection Vehicle (DCV) Rating

| Route Condition Legend – Pavement Condition Rating (PCR) | | | | | | | | |
|--|---|---|---|---|---|---|--|--|
| Pavement Condition Rating (PCR) | 100 | 100 | 100 | 99 | 100 | 100 | | |
| Surface Condition Rating (SCR) | 100 | 100 | 100 | 99 | 100 | 100 | | |
| Roughness Condition Index (RCI) | 100 | 100 | 100 | 100 | 100 | 100 | | |

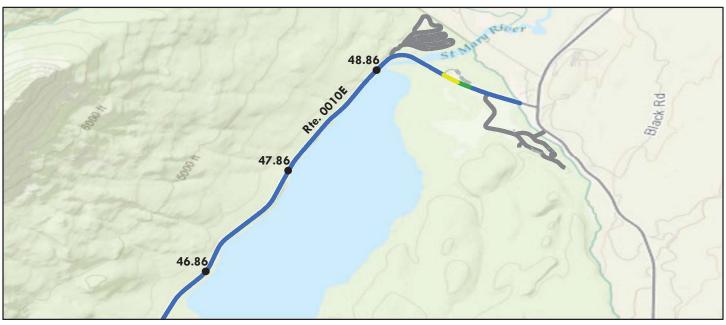
ROUTE 0010E: GOING TO THE SUN ROAD EAST

Data Collection Vehicle (DCV) Rating

| Route Condition Legend – Pavement Condition Rating (PCR) | | | | | | | | |
|--|---|---|---|---|---|--|--|--|
| Pavement Condition Rating (PCR) | 100 | 100 | 100 | 98 | | | | |
| Surface Condition Rating (SCR) | 100 | 100 | 100 | 96 | | | | |
| Roughness Condition Index (RCI) | 100 | 100 | 100 | 100 | | | | |

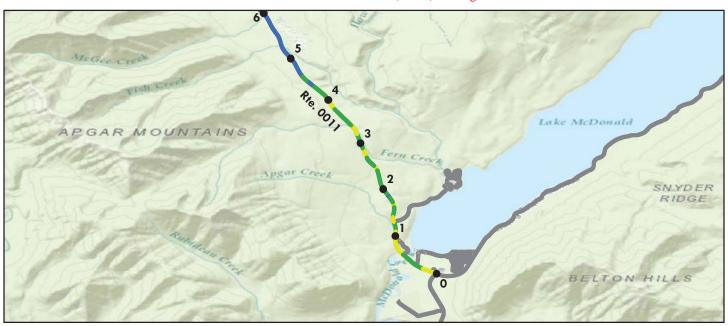
ROUTE 0011: CAMAS ROAD

Data Collection Vehicle (DCV) Rating

| Route Condition Legend – Pavement Condition Rating (PCR) | | | | | | | | |
|--|---|---|---|---|---|---|---|--|
| Pavement Condition Rating (P | CR) | 97 | 84 | 87 | 87 | 85 | 94 | |
| Surface Condition Rating (SCR) | | 95 | 89 | 86 | 90 | 86 | 90 | |
| Roughness Condition Index (RC | I) | 100 | 77 | 88 | 82 | 84 | 100 | |

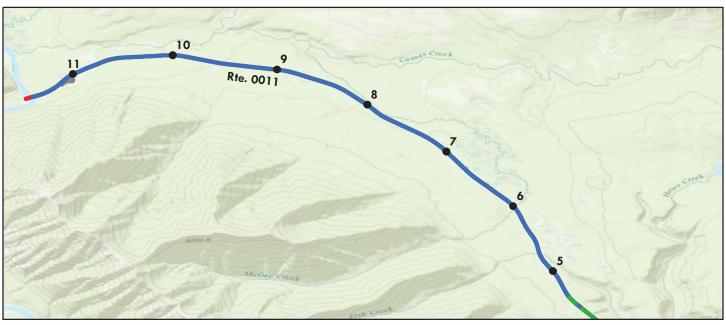
ROUTE 0011: CAMAS ROAD

Data Collection Vehicle (DCV) Rating

| Route Condition Legend – Pavement Condition Rating (PCR) | | | | | | | | |
|--|---|---|---|---|---|---|---|--|
| Pavement Condition Rat | ting (PCR) | 97 | 99 | 99 | 100 | 100 | 100 | |
| Surface Condition Rating | (SCR) | 95 | 99 | 99 | 100 | 100 | 100 | |
| Roughness Condition Inde | ex (RCI) | 100 | 100 | 100 | 100 | 100 | 100 | |

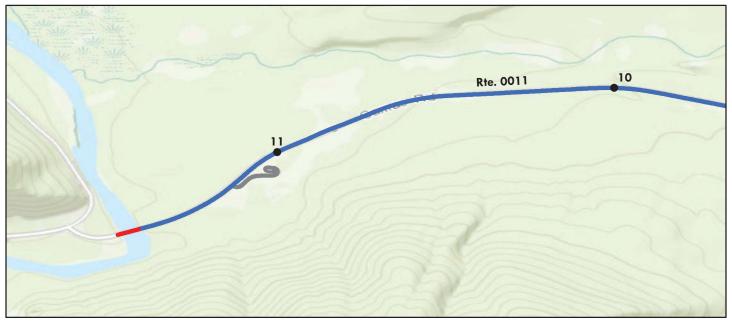
ROUTE 0011: CAMAS ROAD

Data Collection Vehicle (DCV) Rating

| Route Condition Legend – Pavement Condition Rating (PCR) | | | | | | | | |
|--|---|---|---|---|---|--|--|--|
| Pavement Condition Rating (PCR) | 97 | 100 | 100 | | | | | |
| Surface Condition Rating (SCR) | 95 | 100 | 100 | | | | | |
| Roughness Condition Index (RCI) | 100 | 100 | 100 | | | | | |

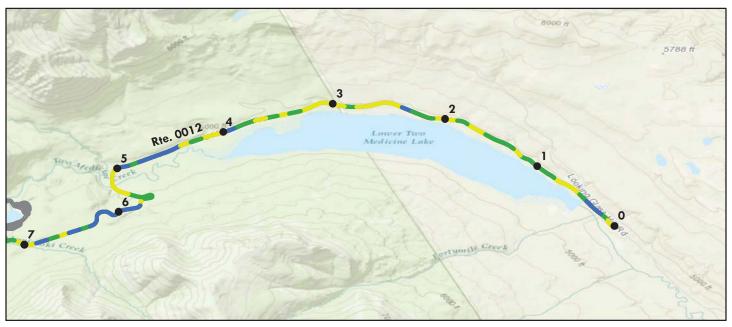
ROUTE 0012: TWO MEDICINE ROAD

Data Collection Vehicle (DCV) Rating

| Route Condition Legend – Pavement Condition Rating (PCR) | | | | | | | | |
|--|---|---|---|---|---|---|---|--|
| Pavement Condition | n Rating (PCR) | 85 | 82 | 83 | 81 | 86 | 89 | |
| Surface Condition R | ating (SCR) | 92 | 94 | 91 | 91 | 90 | 90 | |
| Roughness Condition | n Index (RCI) | 74 | 64 | 70 | 66 | 79 | 88 | |

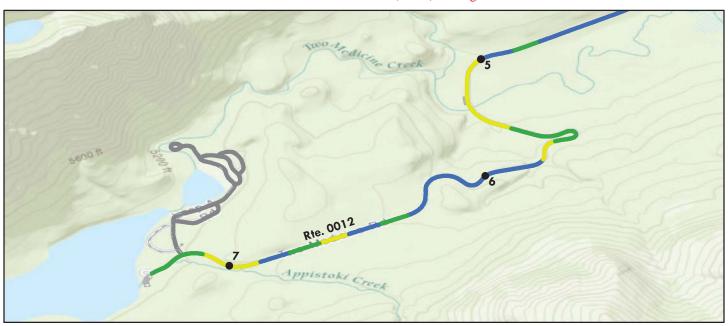
ROUTE 0012: TWO MEDICINE ROAD

Data Collection Vehicle (DCV) Rating

| Route Condition Legend – Pavement Condition Rating (PCR) | | | | | | | |
|--|---|---|---|---|---|---|---|
| Pavement Condition | n Rating (PCR) | 85 | 85 | 92 | 82 | | |
| Surface Condition Ra | ating (SCR) | 92 | 93 | 95 | 93 | | |
| Roughness Condition | n Index (RCI) | 74 | 72 | 87 | 66 | | |

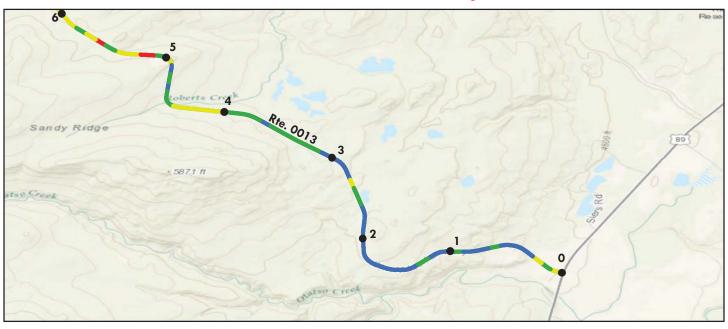
ROUTE 0013: CHIEF MOUNTAIN INTERNATIONAL HIGHWAY

Data Collection Vehicle (DCV) Rating

| Route Condition Legend – Pavement Condition Rating (PCR) | | | | | | | | |
|--|---|---|---|---|---|---|--|--|
| Pavement Condition Rating (PCR) | 90 | 95 | 98 | 95 | 92 | 85 | | |
| Surface Condition Rating (SCR) | 92 | 97 | 96 | 91 | 94 | 90 | | |
| Roughness Condition Index (RCI) | 87 | 91 | 100 | 100 | 89 | 78 | | |

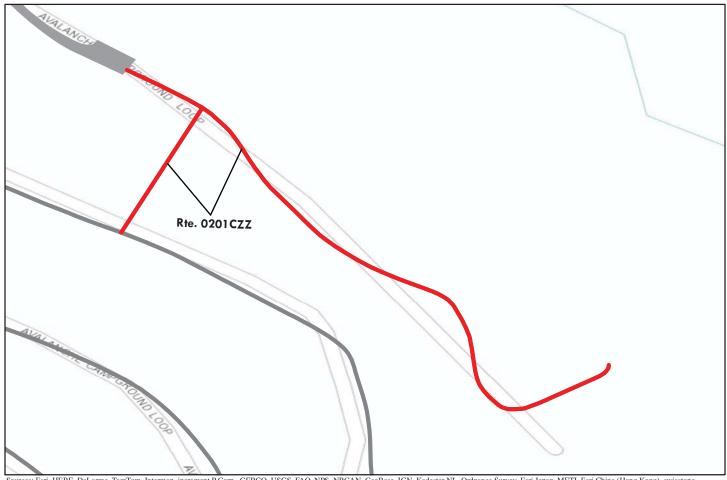
ROUTE 0201CZZ: AVALANCHE CAMPGROUND SERVICE ROAD AND SPUR

Summary Route

Note: The weighted average summary PCR value is calculated from only the sections of road where the PCR was collected. The overall PCR for the summary route may not reflect individual subcomponent ratings.

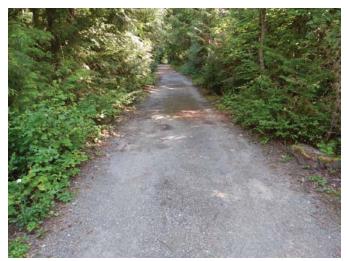
GLAC_0201CBZ_3939.JPG

Condition photos are shown only for manually rated roads. Use the PathView program to see images of DCV rated roads.

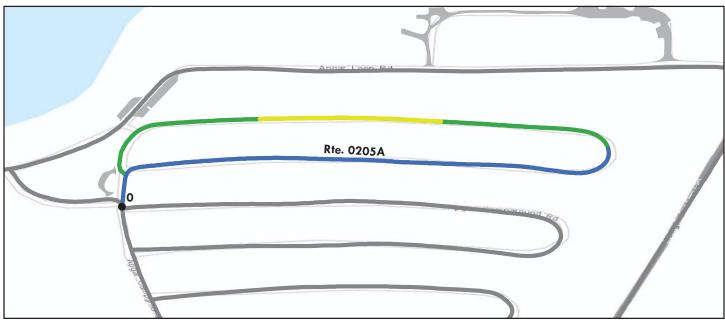
ROUTE 0205A: APGAR CAMPGROUND LOOPA

Data Collection Vehicle (DCV) Rating

| Davido | Condition Locand Don | | ition Doting (DCD) | |
|---|---|---|---|---|
| Pavement Condition Rating (PCR) | 93 | 93 | | |
| Surface Condition Rating (SCR) | 93 | 93 | | |
| Structural Crack Index | 100 | 100 | | |

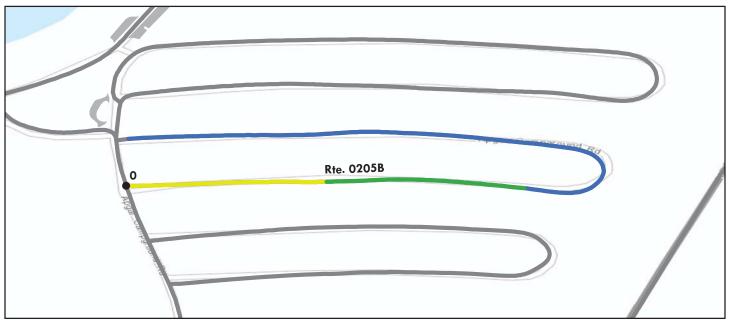
ROUTE 0205B: APGAR CAMPGROUND LOOP B

Data Collection Vehicle (DCV) Rating

| | Route (| Condition Legend – Pav | vement Condi | ition Rating (| PCR) | | |
|---|---|---|---|---|---|---|---|
| Pavement Condition F | Rating (PCR) | 92 | 92 | | | | |
| Surface Condition Ratio | ng (SCR) | 92 | 92 | | | | |
| Structural Crack Index | X | 100 | 100 | | | | |

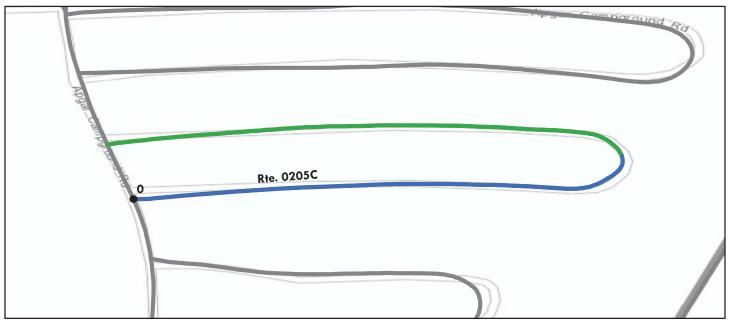
ROUTE 0205C: APGAR CAMPGROUND LOOP C

Data Collection Vehicle (DCV) Rating

| Donto | Condition Learned Day | | tion Doting (DCD) | |
|---|---|---|---|---|
| Pavement Condition Rating (PCR) | 95 | 95 | | |
| Surface Condition Rating (SCR) | 95 | 95 | | |
| Structural Crack Index | 100 | 100 | | |

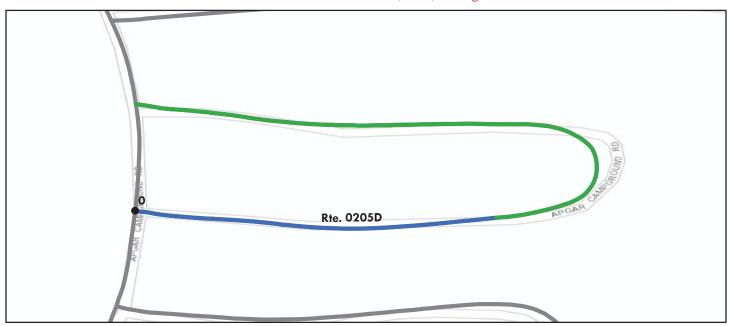
ROUTE 0205D: APGAR CAMPGROUND LOOP D

Data Collection Vehicle (DCV) Rating

| | Route (| Condition Legen | d – Pavement Cond | ition Rating (| PCR) | | |
|---|---|---|---|---|---|---|---|
| Pavement Condition Rati | ing (PCR) | 94 | 94 | | | | |
| Surface Condition Rating | (SCR) | 94 | 94 | | | | |
| Structural Crack Index | | 100 | 100 | | | | |

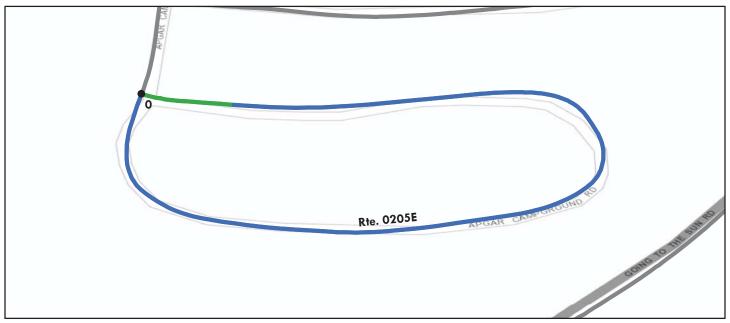
ROUTE 0205E: APGAR CAMPGROUND LOOP E (GROUP SITES)

Data Collection Vehicle (DCV) Rating

| | Route (| Condition Legend – Pav | ement Condi | ition Rating (| PCR) | | |
|---|---|---|---|---|---|---|---|
| Pavement Condition | Rating (PCR) | 97 | 97 | | | | |
| Surface Condition Rat | ting (SCR) | 97 | 97 | | | | |
| Structural Crack Inde | ex | 100 | 100 | | | | |

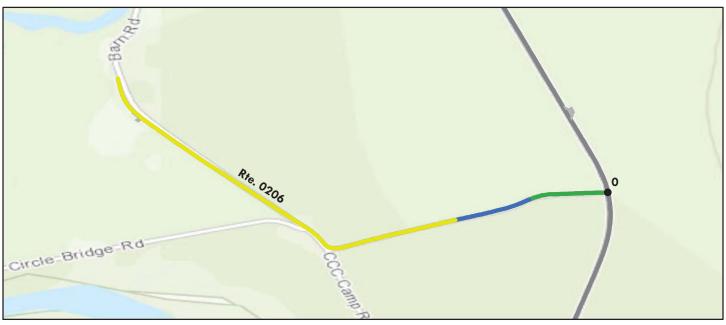
ROUTE 0206: WASTEWATER TREATMENT PLANT ROAD

Data Collection Vehicle (DCV) Rating

| | Route (| Condition Legend – Pav | ement Condi | tion Rating (| PCR) | | |
|---|---|---|---|---|---|---|---|
| Pavement Condition | n Rating (PCR) | 76 | 76 | | | | |
| Surface Condition R | ating (SCR) | 91 | 91 | | | | |
| Roughness Condition | n Index (RCI) | 54 | 54 | | | | |
| Structural Crack Inc | dex | 91 | 91 | | | | |

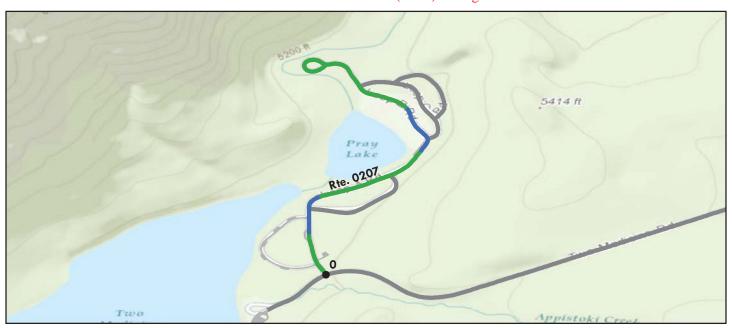
ROUTE 0207: TWO MEDICINE CAMPGROUND ENTRANCE ROAD

Data Collection Vehicle (DCV) Rating

| | Route (| Condition Legend – Pav | ement Condi | ition Rating (| PCR) | | |
|---|---|---|---|---|---|---|---|
| Pavement Condition | n Rating (PCR) | 92 | 92 | | | | |
| Surface Condition Ra | ating (SCR) | 92 | 92 | | | | |
| Transverse Cracking | g Index | 99 | 99 | | | | |

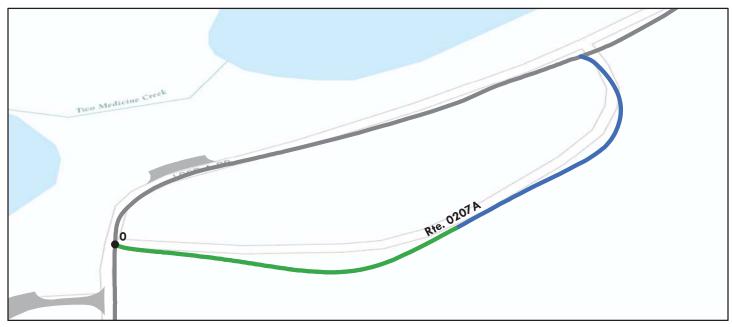
ROUTE 0207A: TWO MEDICINE CAMPGROUND LOOPA

Data Collection Vehicle (DCV) Rating

| | Route (| Condition Legend – Pav | ement Condi | ition Rating (| PCR) | | |
|---|---|---|---|---|---|---|---|
| Pavement Condition | n Rating (PCR) | 94 | 94 | | | | |
| Surface Condition Ra | ating (SCR) | 94 | 94 | | | | |

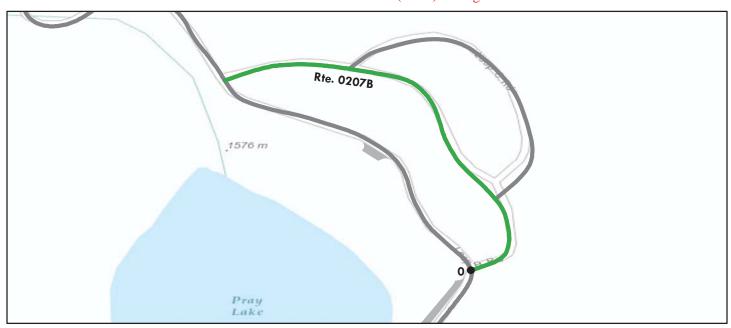
ROUTE 0207B: TWO MEDICINE CAMPGROUND LOOP B

Data Collection Vehicle (DCV) Rating

| | Route (| Condition Legend – Pav | ement Cond | ition Rating (I | PCR) | | |
|---|---|---|---|---|---|---|---|
| Pavement Condition | Rating (PCR) | 93 | 93 | | | | |
| Surface Condition Rat | ing (SCR) | 93 | 93 | | | | |

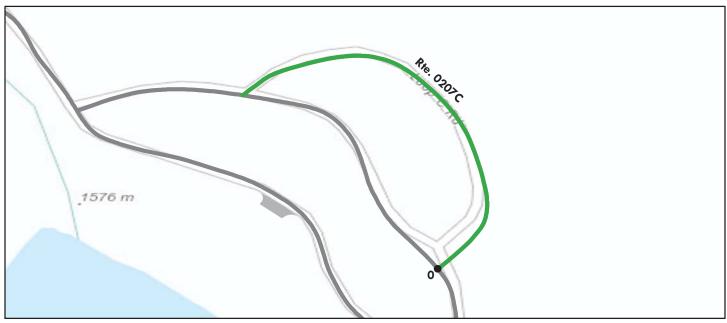
ROUTE 0207C: TWO MEDICINE CAMPGROUND LOOP C

Data Collection Vehicle (DCV) Rating

| | Route (| Condition Legend – Pav | ement Condi | ition Rating (I | PCR) | | |
|---|---|---|---|---|---|---|---|
| Pavement Condition | n Rating (PCR) | 90 | 90 | | | | |
| Surface Condition R | ating (SCR) | 90 | 90 | | | | |

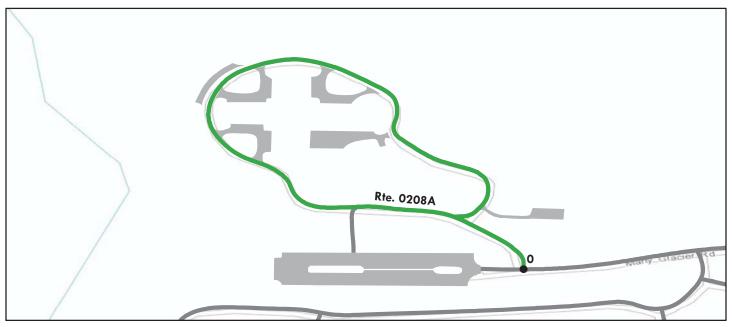
ROUTE 0208A: SWIFTCURRENT CABINS LOOP ROAD

Data Collection Vehicle (DCV) Rating

| | Route (| Condition Legend – Pav | ement Condi | ition Rating (| PCR) | | |
|---|---|---|---|---|---|---|---|
| Pavement Condition | on Rating (PCR) | 92 | 92 | | | | |
| Surface Condition R | Rating (SCR) | 92 | 92 | | | | |

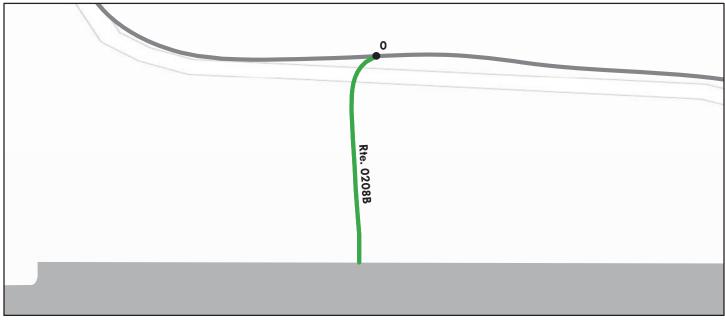
ROUTE 0208B: SWIFTCURRENT CABINS CUTOFF ROAD

Data Collection Vehicle (DCV) Rating

| | Route (| Condition Legend – Pav | ement Condi | ition Rating (P | PCR) | |
|---|---|---|---|---|---|---|
| Pavement Condition | Rating (PCR) | 90 | 90 | | | |
| Surface Condition Ra | ating (SCR) | 90 | 90 | | | |
| Structural Crack Ind | lex | 97 | 97 | | | |

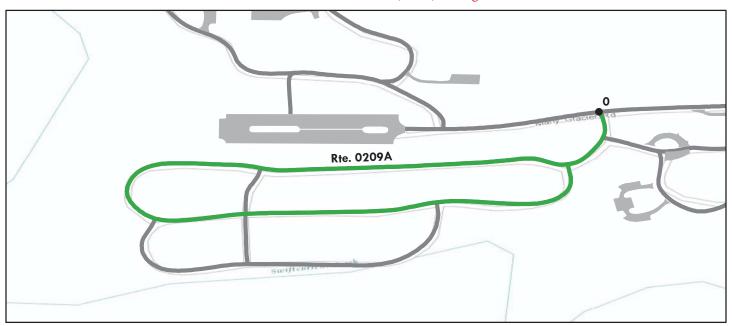
ROUTE 0209A: MANY GLACIER CAMPGROUND LOOPA

Data Collection Vehicle (DCV) Rating

| | Route Condition Legend | d – Pavement Cond | lition Rating (PCR) | |
|---|---|---|---|---|
| Pavement Condition Rating (PCF | 91 | 91 | | |
| Surface Condition Rating (SCR) | 91 | 91 | | |

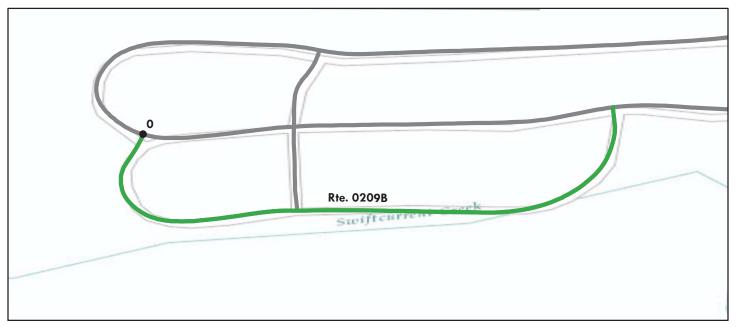
ROUTE 0209B: MANY GLACIER CAMPGROUND LOOP B

Data Collection Vehicle (DCV) Rating

| | Route (| Condition Legend – Pav | ement Condi | ition Rating (| PCR) | | |
|---|---|---|---|---|---|---|---|
| Pavement Condition | Rating (PCR) | 93 | 93 | | | | |
| Surface Condition Rat | ting (SCR) | 93 | 93 | | | | |

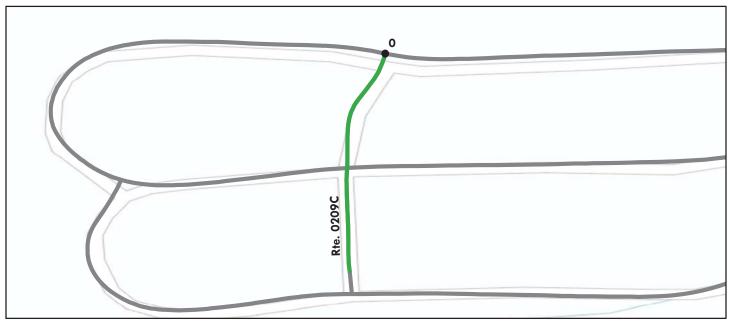
ROUTE 0209C: MANY GLACIER CAMPGROUND CUT THROUGH ROAD

Data Collection Vehicle (DCV) Rating

| | Route (| Condition Legend – Pav | ement Condi | ition Rating (F | PCR) | | |
|---|---|---|---|---|---|---|---|
| Pavement Condition | Rating (PCR) | 89 | 89 | | | | |
| Surface Condition Rati | ing (SCR) | 89 | 89 | | | | |

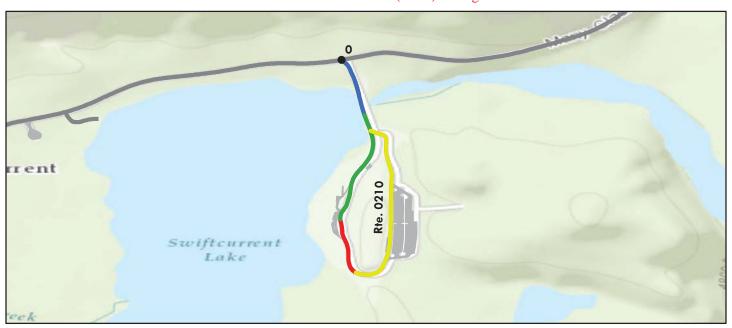
ROUTE 0210: MANY GLACIER HOTEL ROAD

Data Collection Vehicle (DCV) Rating

| | Route (| Condition Legend – Pav | ement Condi | tion Rating (| PCR) | | |
|---|---|---|---|---|---|---|---|
| Pavement Condition | Rating (PCR) | 83 | 83 | | | | |
| Surface Condition Rat | ting (SCR) | 88 | 88 | | | | |
| Structural Crack Inde | ex | 88 | 88 | | | | |

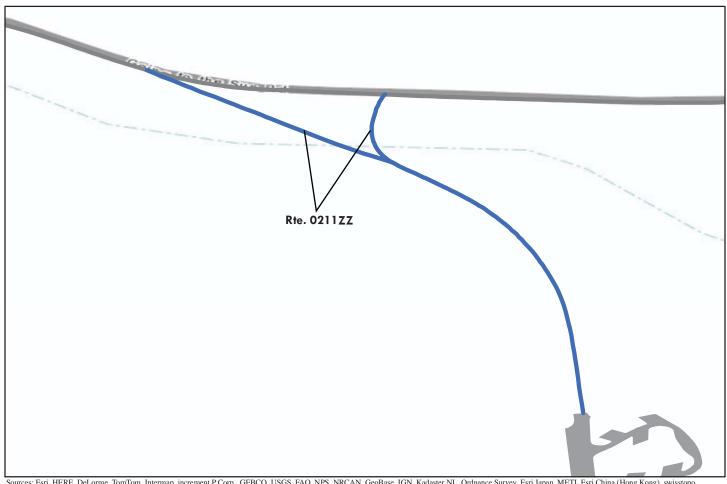
ROUTE 0211ZZ: SUN POINT ROAD

Summary Route

Note: The weighted average summary PCR value is calculated from only the sections of road where the PCR was collected. The overall PCR for the summary route may not reflect individual subcomponent ratings.

| Toute may not reflect murv | bute may not reflect individual subcomponent ratings. | | | | | | | |
|---|---|---|---|---|---|---|---|--|
| Pavement Condition | Rating (PCR) | 95 | | | | | | |

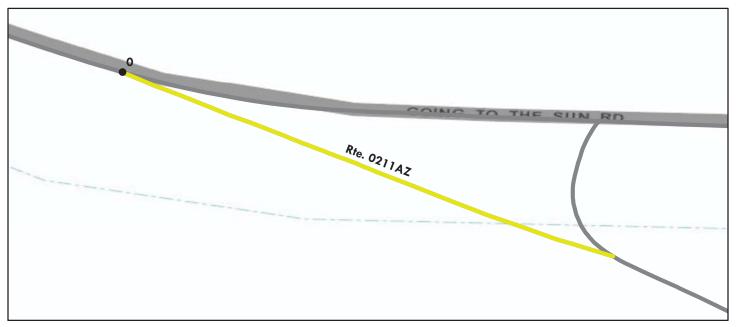
Subcomponent of Route GLAC-0211ZZ

Data Collection Vehicle (DCV) Rating

| | Route (| Condition Legend – Pav | ement Condi | tion Rating (| PCR) | | |
|---|---|---|---|---|---|---|---|
| Pavement Condition | on Rating (PCR) | 83 | 83 | | | | |
| Surface Condition R | Rating (SCR) | 83 | 83 | | | | |

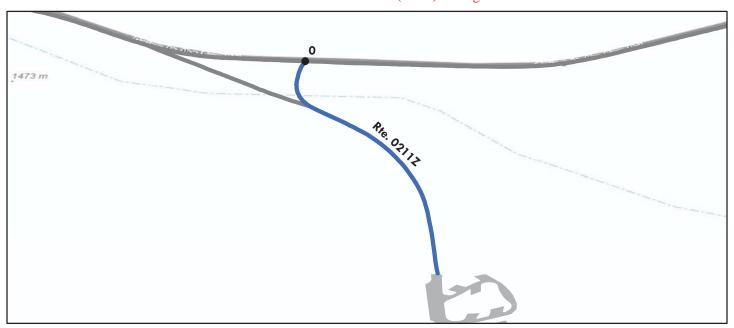
ROUTE 0211Z: SUN POINT ROAD (MAIN ROAD)

Subcomponent of Route GLAC-0211ZZ Data Collection Vehicle (DCV) Rating

| | Route (| Condition Legend – Pav | ement Condi | ition Rating (| PCR) | | |
|---|---|---|---|---|---|---|---|
| Pavement Condition R | ating (PCR) | 98 | 98 | | | | |
| Surface Condition Ratin | ng (SCR) | 98 | 98 | | | | |

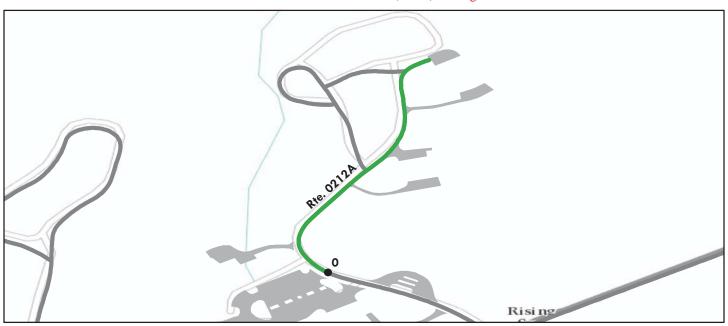
ROUTE 0212A: RISING SUN LODGE ROAD A

Data Collection Vehicle (DCV) Rating

| R | Soute Condition Legend | – Pavement Cond | lition Rating (PCR) | |
|---|---|---|---|---|
| Pavement Condition Rating (PCR | 87 | 87 | | |
| Surface Condition Rating (SCR) | 87 | 87 | | |

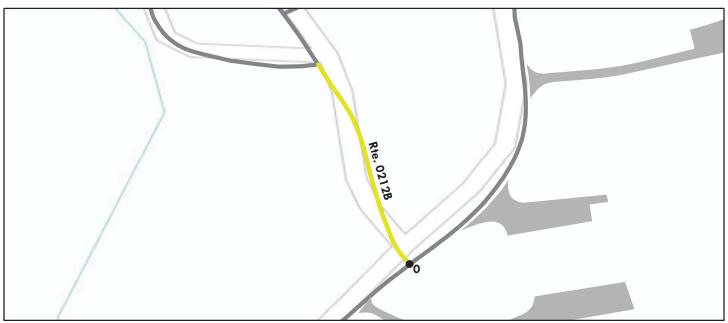
ROUTE 0212B: RISING SUN LODGE ROAD B

Data Collection Vehicle (DCV) Rating

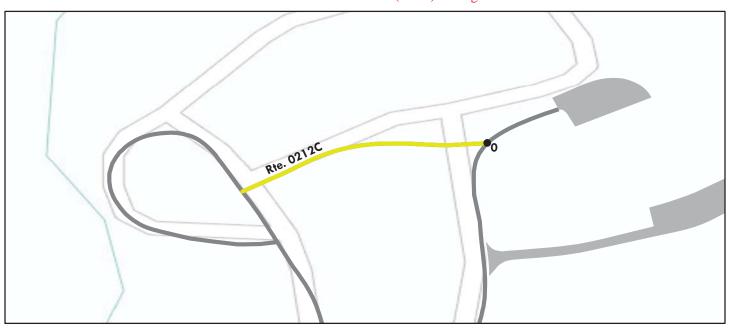
ROUTE 0212C: RISING SUN LODGE ROAD C

Data Collection Vehicle (DCV) Rating

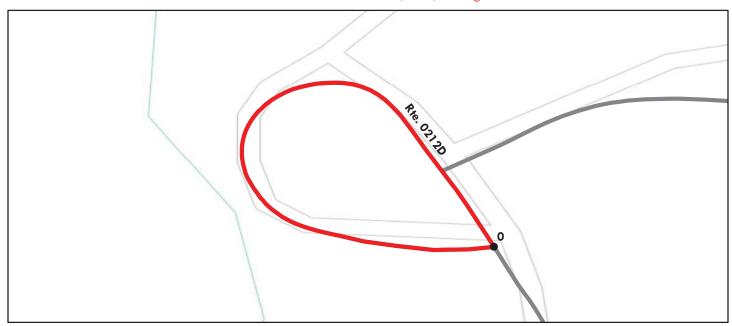
ROUTE 0212D: RISING SUN LODGE ROAD D

Data Collection Vehicle (DCV) Rating

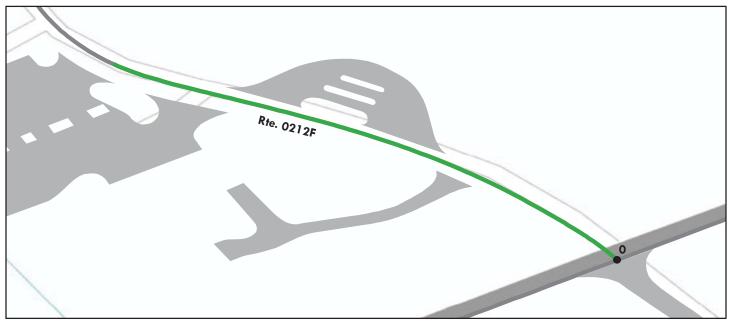
ROUTE 0212F: RISING SUN LODGE ROAD F

Data Collection Vehicle (DCV) Rating

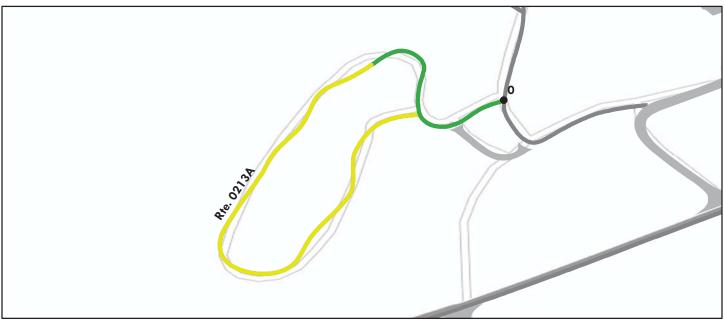
ROUTE 0213A: RISING SUN CAMPGROUND ROAD A

Data Collection Vehicle (DCV) Rating

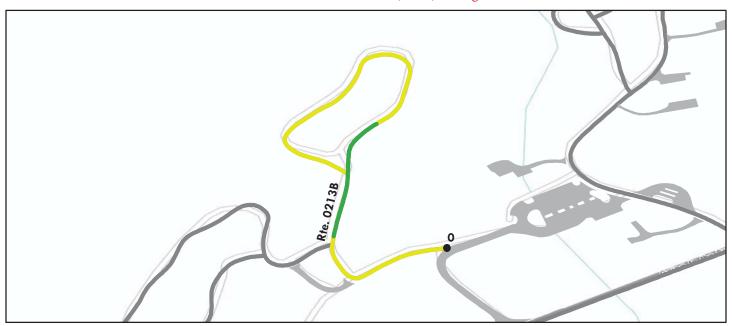
ROUTE 0213B: RISING SUN CAMPGROUND ROAD B

Data Collection Vehicle (DCV) Rating

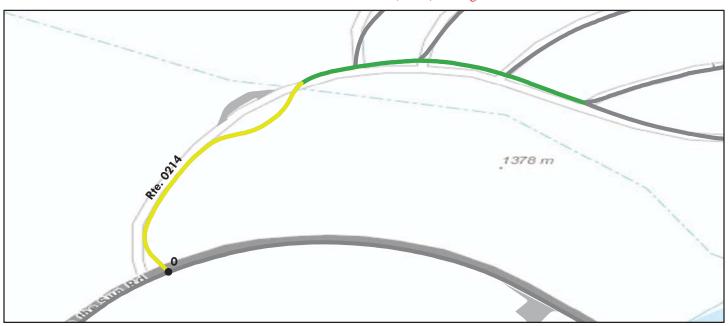
ROUTE 0214: ST. MARY CAMPGROUND ENTRANCE ROAD

Data Collection Vehicle (DCV) Rating

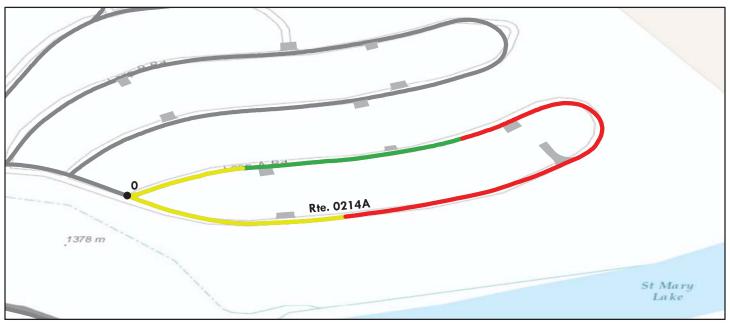
ROUTE 0214A: ST. MARY CAMPGROUND LOOPA

Data Collection Vehicle (DCV) Rating

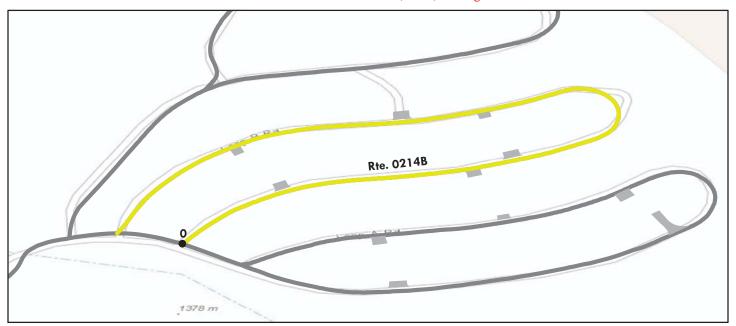
ROUTE 0214B: ST. MARY CAMPGROUND LOOP B

Data Collection Vehicle (DCV) Rating

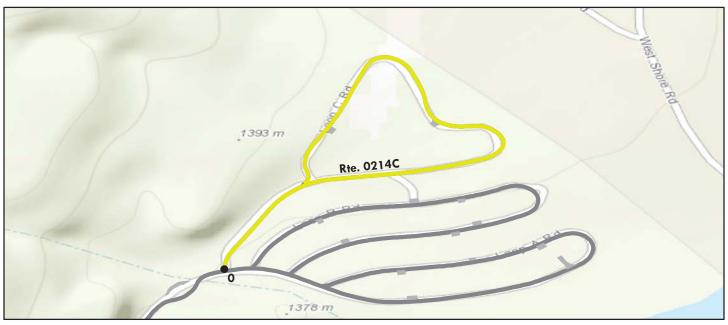
ROUTE 0214C: ST. MARY CAMPGROUND LOOP C

Data Collection Vehicle (DCV) Rating

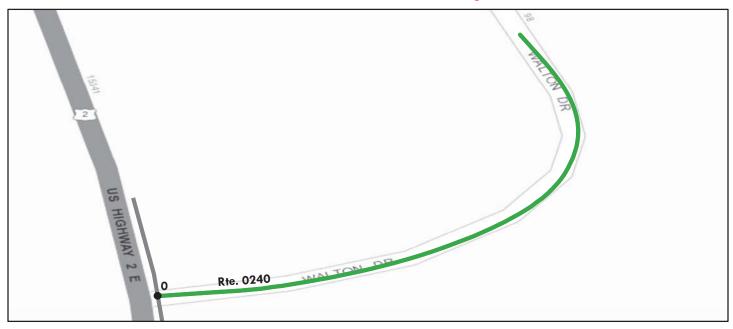
ROUTE 0240: WALTON RANGER STATION ROAD

Data Collection Vehicle (DCV) Rating

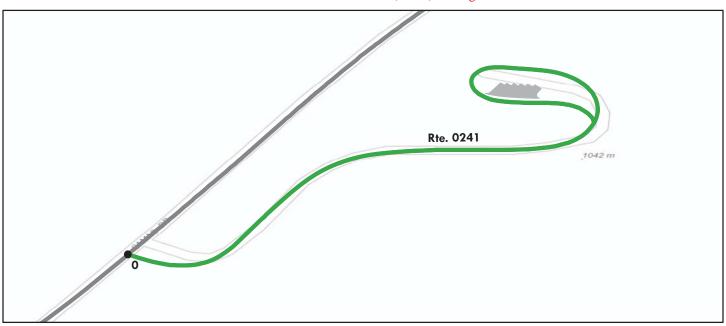
ROUTE 0241: HUCKLEBERRY MOUNTAIN ROAD

Data Collection Vehicle (DCV) Rating

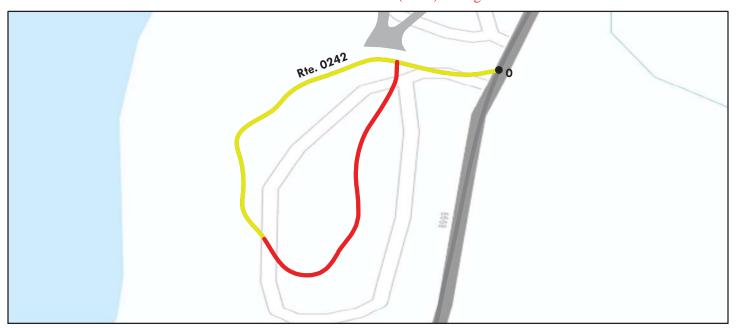
ROUTE 0242: SPRAGUE CREEK CAMPGROUND ROAD

Data Collection Vehicle (DCV) Rating

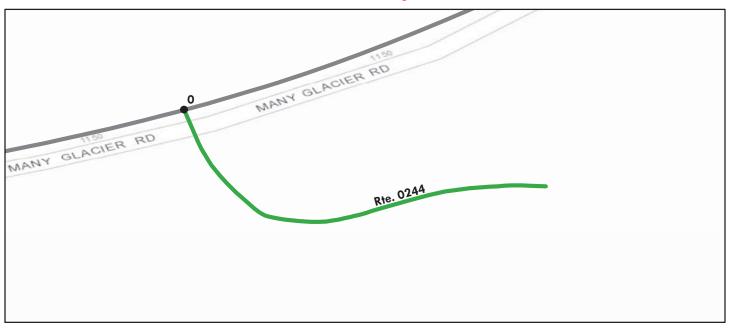
ROUTE 0244: MANY GLACIER BOAT RAMP ACCESS ROAD

Manual Rating

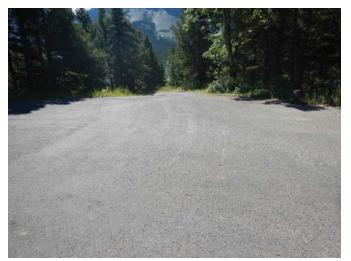
GLAC_0244_4488.JPG

Condition Photos

Condition photos are shown only for manually rated roads. Use the PathView program to see images of DCV rated roads.

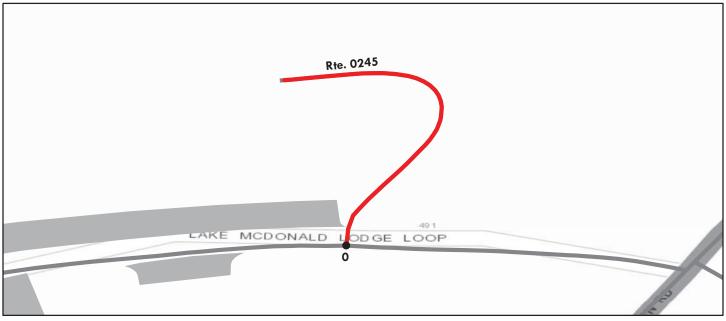
ROUTE 0245: STEWART MOTEL ROAD

Data Collection Vehicle (DCV) Rating

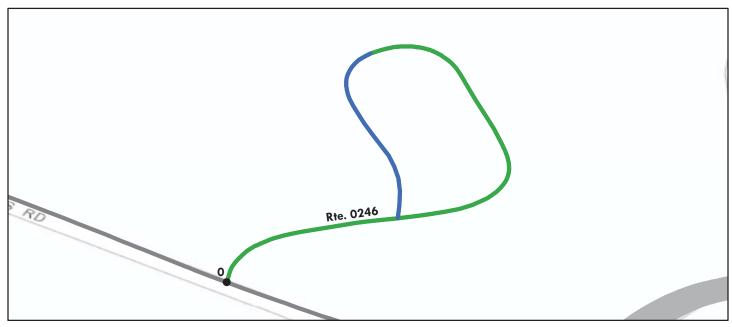
ROUTE 0246: APGAR TRANSIT CENTER SHUTTLE LOOP

Data Collection Vehicle (DCV) Rating

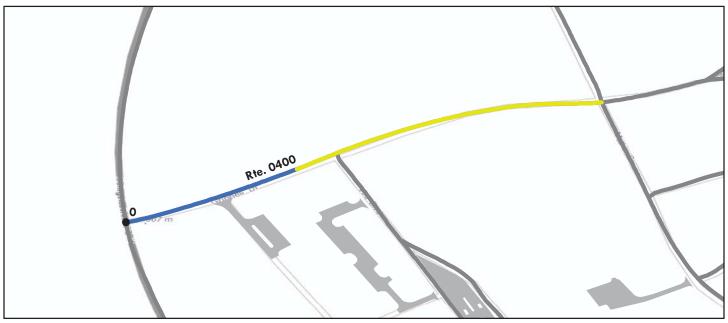
ROUTE 0400: HEADQUARTERS ROAD

Data Collection Vehicle (DCV) Rating

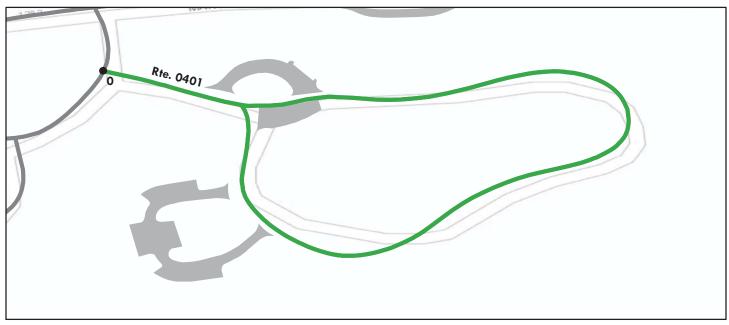
ROUTE 0401: MANY GLACIER HOUSING AREA ROAD

Data Collection Vehicle (DCV) Rating

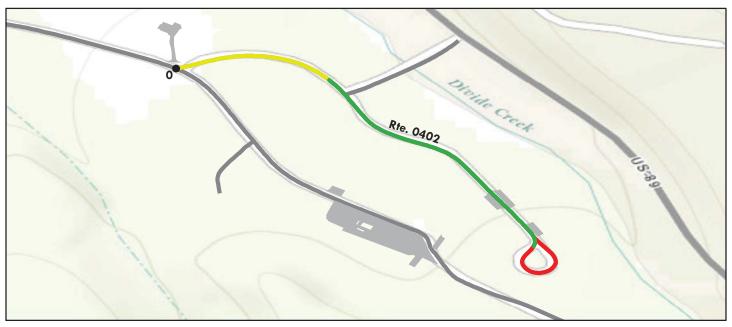
ROUTE 0402: ST. MARY HOUSING AREA ROAD

Data Collection Vehicle (DCV) Rating

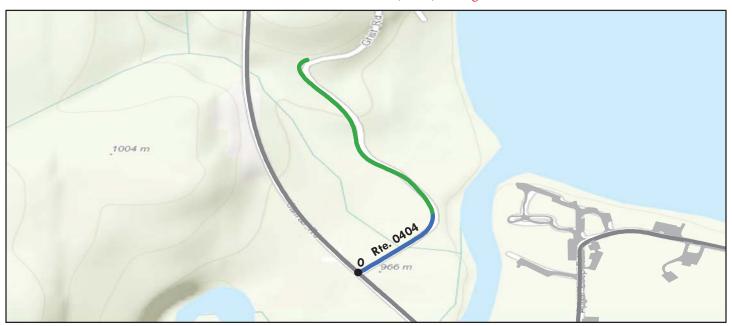
ROUTE 0404: GRIST ROAD

Data Collection Vehicle (DCV) Rating

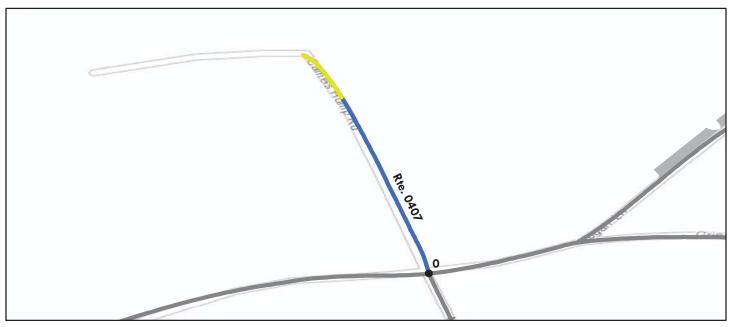
ROUTE 0407: CAMEL'S HUMP ROAD

Data Collection Vehicle (DCV) Rating

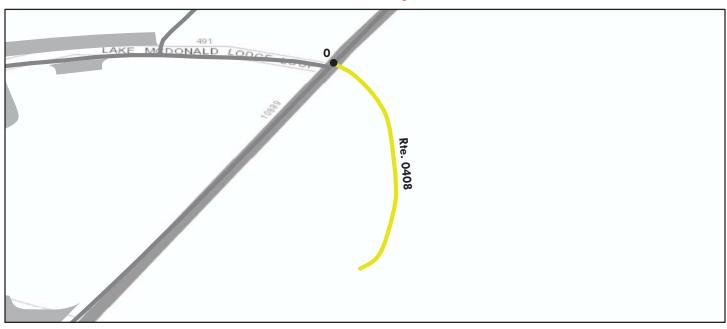
ROUTE 0408: LAKE MCDONALD HORSE STABLES ROAD

Manual Rating

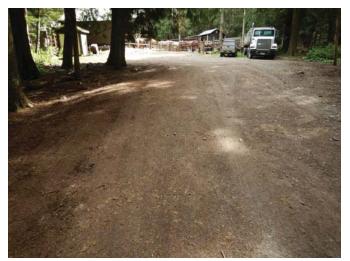
GLAC_0408_3878.JPG

Condition photos are shown only for manually rated roads. Use the PathView program to see images of DCV rated roads.

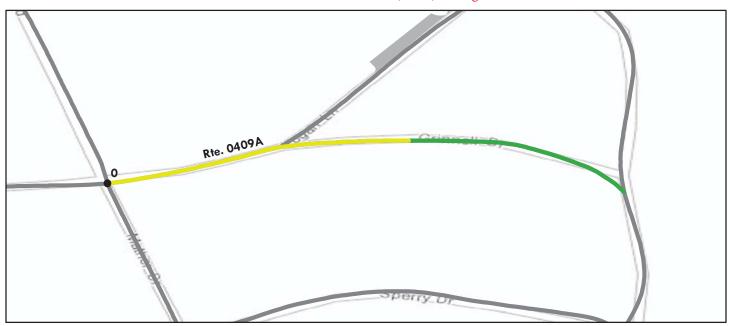
ROUTE 0409A: GRINNELL DRIVE

Data Collection Vehicle (DCV) Rating

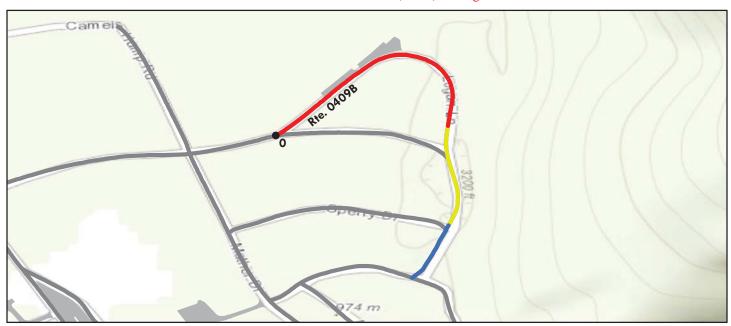
ROUTE 0409B: LOGAN LANE

Data Collection Vehicle (DCV) Rating

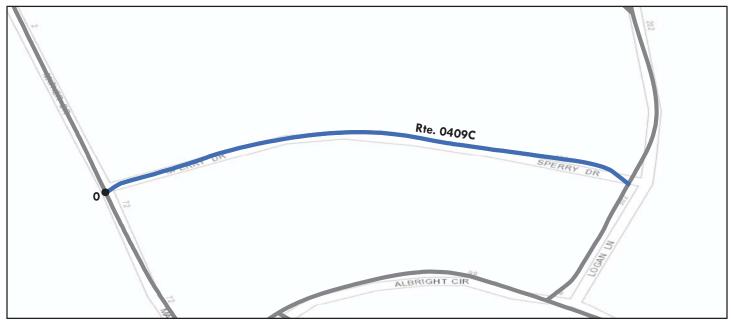
ROUTE 0409C: SPERRY DRIVE

Data Collection Vehicle (DCV) Rating

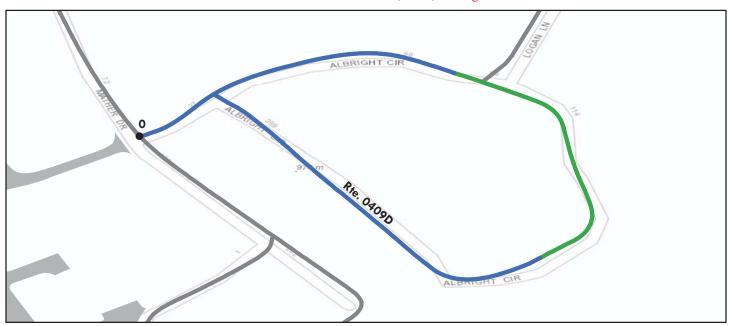
ROUTE 0409D: ALBRIGHT CIRCLE

Data Collection Vehicle (DCV) Rating

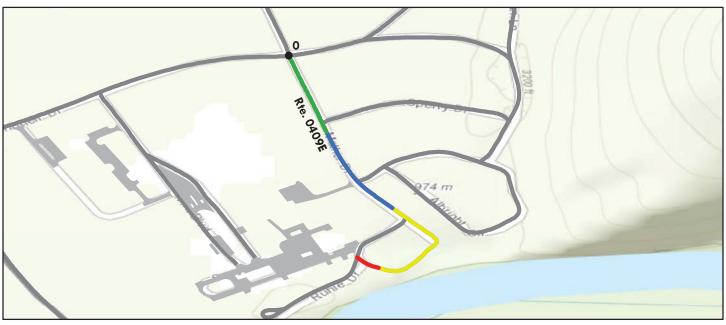
ROUTE 0409E: MATHER DRIVE

Data Collection Vehicle (DCV) Rating

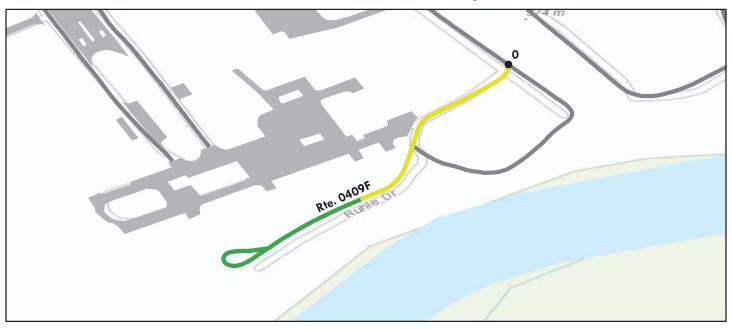
ROUTE 0409F: RUHLE DRIVE

Data Collection Vehicle (DCV) Rating

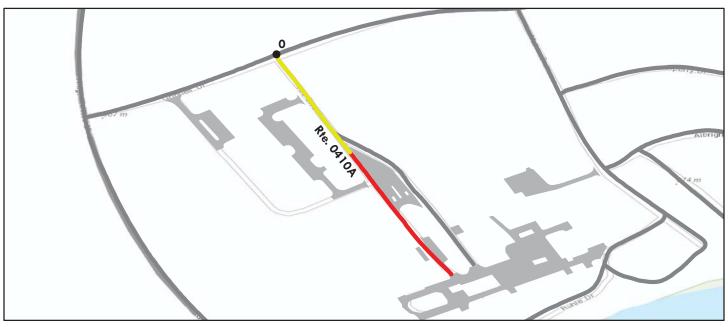
ROUTE 0410A: HEADQUARTERS ADMINISTRATIVE ROAD A

Data Collection Vehicle (DCV) Rating

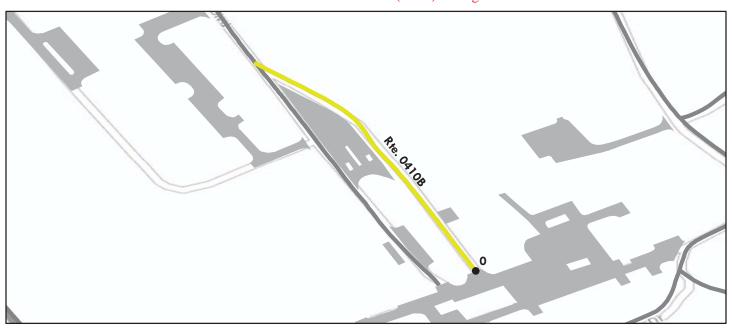
ROUTE 0410B: HEADQUARTERS ADMINISTRATIVE ROAD B (VINT BOULEVARD)

Data Collection Vehicle (DCV) Rating

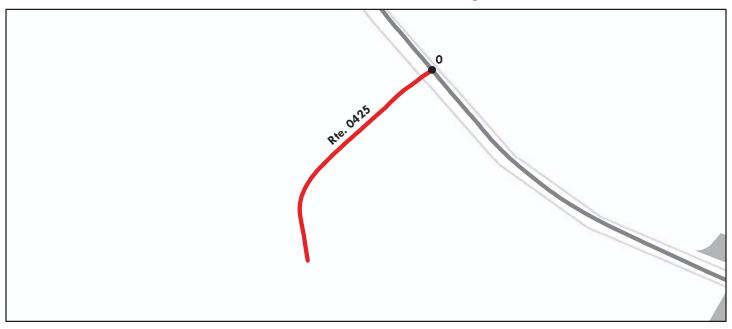
ROUTE 0425: ST. MARY RESIDENCE AND HORSE STABLES ROAD

Data Collection Vehicle (DCV) Rating

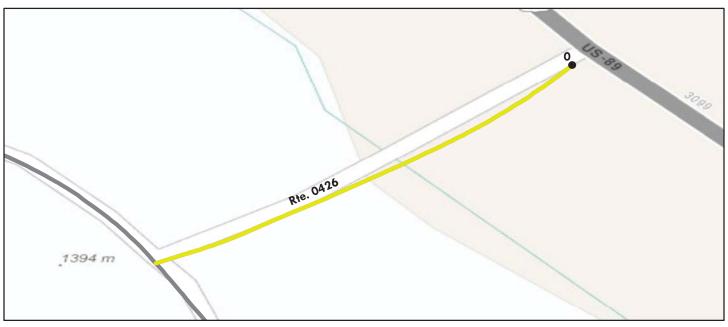
ROUTE 0426: ST. MARY RESIDENCE / DIVIDE CREEK ACCESS

Data Collection Vehicle (DCV) Rating

NOTE: Route has a very short section with deteriorated asphalt.
