GOGA Cycle 6

Final Report

Road Inventory and Condition Assessment of Paved Routes Golden Gate National Recreation Area

Report Date: October 2015

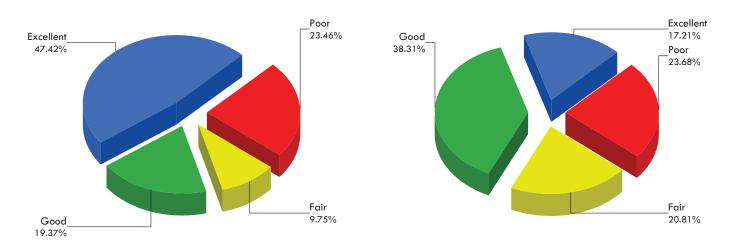
Figure 1: Pavement Condition Rating Breakdown for Paved Roads and Parking Areas

Road Condition Percentages

Parking Area Condition Percentages

- Excellent / New: PCR of 95-100
 - o Pavements in this range will require only spot repairs
- Good: PCR of 85-94
 - o Pavements in this range will likely be candidates for Preventive Maintenance. Examples include Chip and Slurry Seals, Micro Surfacing and Thin Overlays.
- Fair: PCR of 61-84
 - o Pavements in this range will likely be candidates of Light Rehabilitation (L3R). Examples include singlelift overlays up to 2.5 inches in total thickness, milling and overlays.
- Poor: PCR of 0-60
 - o Pavements in this range will likely be candidates of Heavy Rehabilitation or Reconstruction (H3R or 4R). Examples include Pulverization, Multiple Lift Overlays, and Reconstruction.

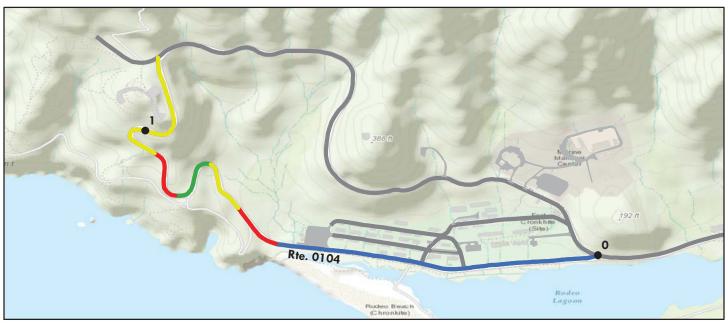
ROUTE 0104: MITCHELL ROAD

Data Collection Vehicle (DCV) Rating

| | Route (| Condition Legend – Pav | ement Condi | tion Rating (| PCR) | | |

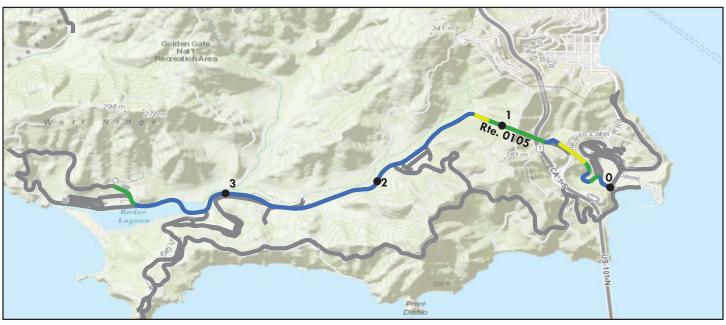
ROUTE 0105: BUNKER ROAD

Data Collection Vehicle (DCV) Rating

| | Route C | Condition Legend – Pav | ement Condi | tion Rating (| PCR) | | |

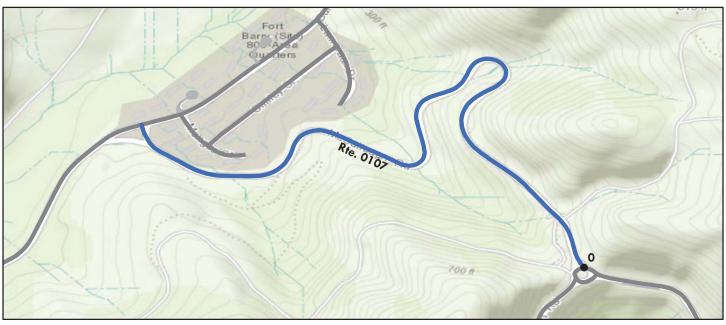
ROUTE 0107: MCCULLOUGH ROAD

Data Collection Vehicle (DCV) Rating

| | Route (| Condition Legend – Pa | vement Condi | ition Rating (| PCR) | | |

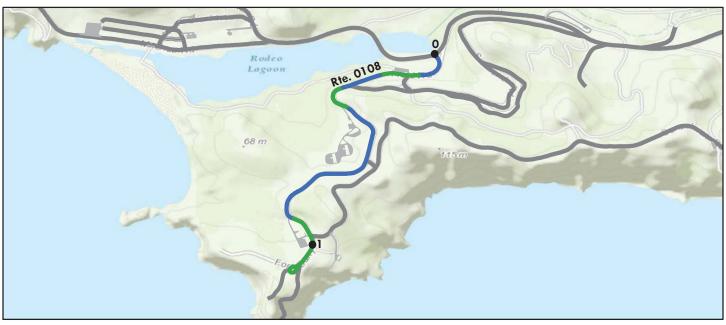
ROUTE 0108: FIELD ROAD

Data Collection Vehicle (DCV) Rating

| Route | Condition Legend – Pav | ement Condi | tion Rating (F | PCR) | |

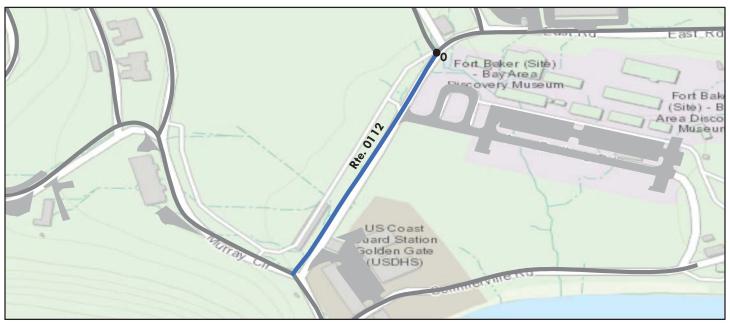
ROUTE 0112: CENTER ROAD

Data Collection Vehicle (DCV) Rating

| | Route (| Condition Legend – Pay | zement Condi | ition Rating (| PCR) | | |

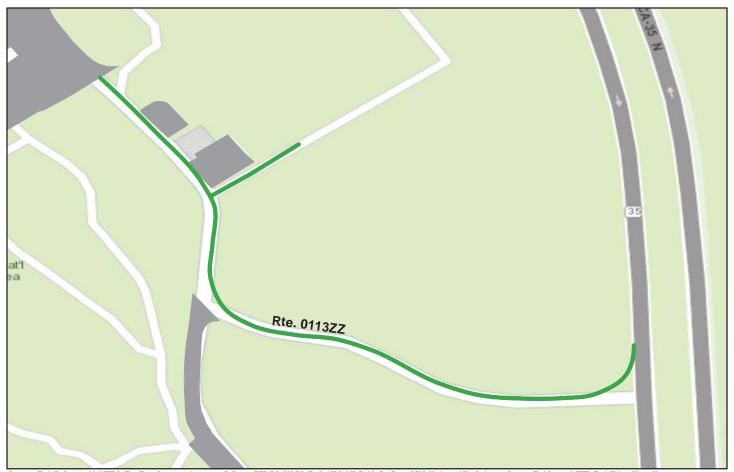
ROUTE 0113ZZ: FORT FUNSTON ROADS

Summary Route

The condition shown on this page reflects the overall route condition; it might not reflect individual subcomponent ratings.

| | | | | <u>, </u> | | | - |
|---|---|---|---|--|---|---|---|
| Pavement Condition | Rating (PCR) | 93 | | | | | |

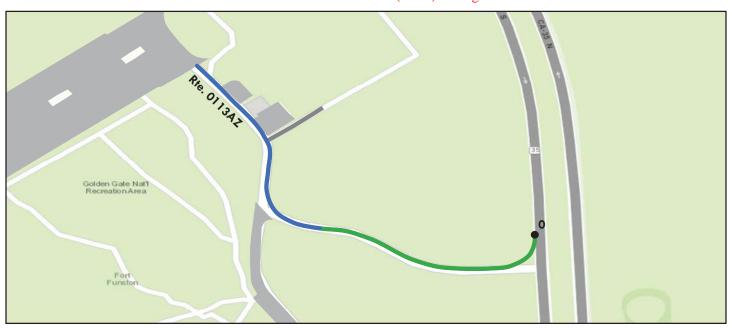
Subcomponent of Route GOGA-0113ZZ

Data Collection Vehicle (DCV) Rating

| | Route (| Condition Legend – Pav | ement Condi | tion Rating (| PCR) | | |
|---|---|---|---|---|---|---|---|
| Pavement Condition | on Rating (PCR) | 95 | 95 | | | | |
| Surface Condition R | Rating (SCR) | 95 | 95 | | | | |

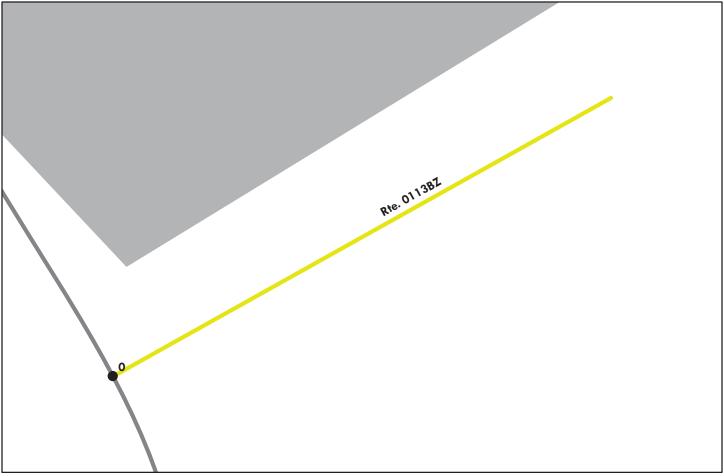
Subcomponent of Route GOGA-0113ZZ

Manual Rating

| | Route C | Condition Legend – Pave | ement Condi | tion Rating (| PCR) | | |
|---|---|---|---|---|---|---|---|
| Pavement Condition | Rating (PCR) | 73 | 73 | | | | |

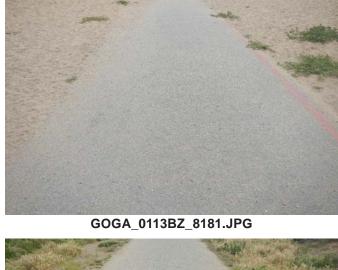
GOGA_0113BZ_8180.JPG

Condition photos are shown only for manually rated roads. Use the PathView program to see images of DCV rated roads.

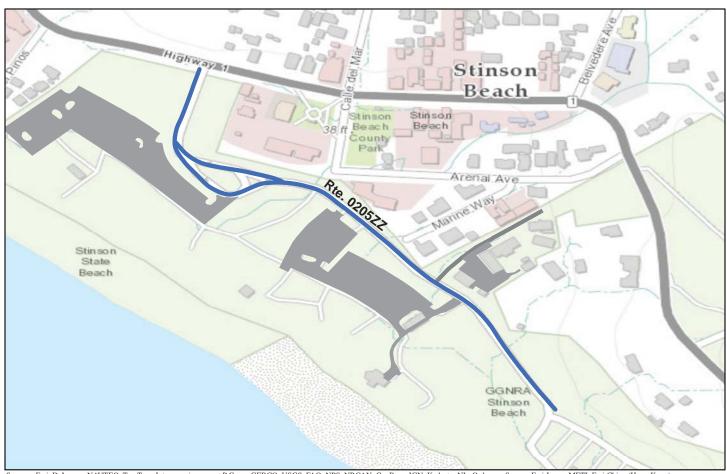
ROUTE 0205ZZ: STINSON BEACH ACCESS ROADS

Summary Route

The condition shown on this page reflects the overall route condition; it might not reflect individual subcomponent ratings.

| | The condition shown on this page refrees the overtain route condition, it might not refree marviadar subcomponent rutings. | | | | | | | | | | |
|---|--|---|---|---|---|---|---|--|--|--|--|
| Pavement Condition | Rating (PCR) | 96 | | | | | | | | | |

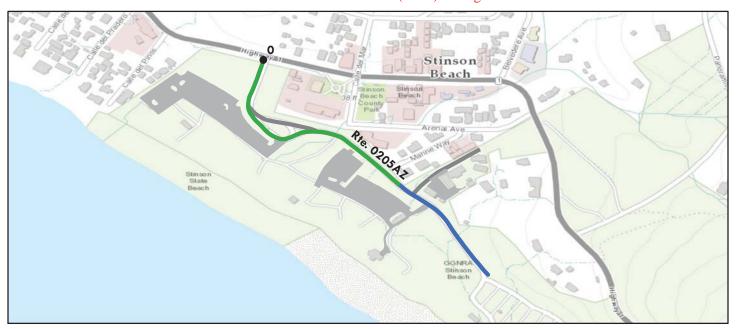
Subcomponent of Route GOGA-0205ZZ

Data Collection Vehicle (DCV) Rating

| | Route (| Condition Legend – Pav | ement Condi | tion Rating (| PCR) | | |
|---|---|---|---|---|---|---|---|
| Pavement Condition | Rating (PCR) | 96 | 96 | | | | |
| Surface Condition Rat | ing (SCR) | 96 | 96 | | | | |

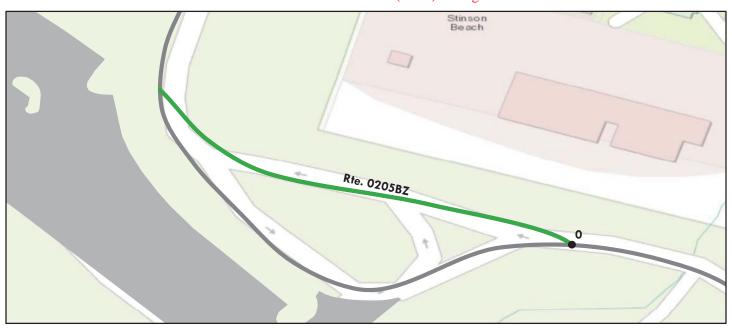
Subcomponent of Route GOGA-0205ZZ

Data Collection Vehicle (DCV) Rating

| Ro | oute Condition Legend – Pa | vement Cond | lition Rating (PCR) | |
|---|---|---|---|---|
| Pavement Condition Rating (PCR) | 93 | 93 | | |
| Surface Condition Rating (SCR) | 93 | 93 | | |

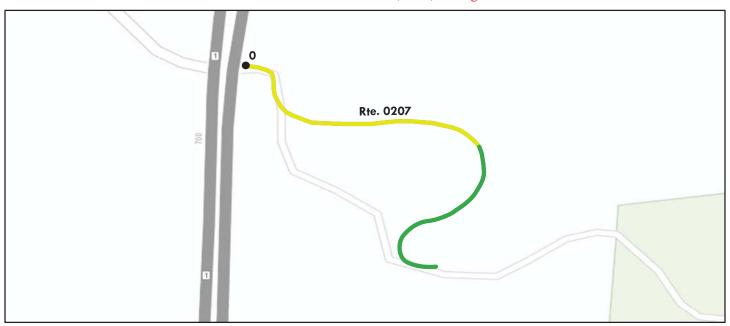
ROUTE 0207: SHELLDANCE ROAD

Data Collection Vehicle (DCV) Rating

| | Route (| Condition Legend – Pav | ement Condi | ition Rating (I | PCR) | | |
|---|---|---|---|---|---|---|---|
| Pavement Condition | n Rating (PCR) | 86 | 86 | | | | |
| Surface Condition Ra | ating (SCR) | 86 | 86 | | | | |

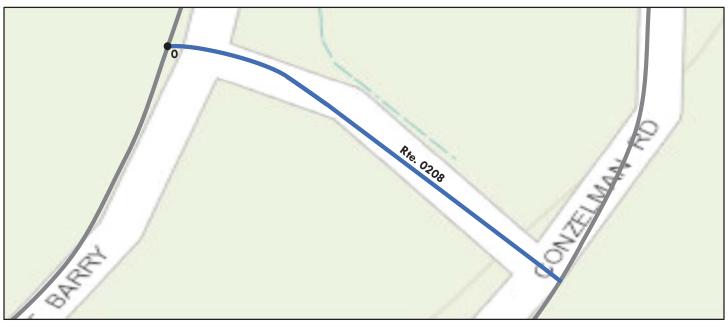
ROUTE 0208: CONZELMAN-FIELD CONNECTOR ROAD

Data Collection Vehicle (DCV) Rating

| | Route (| Condition Legend – Pav | ement Condi | ition Rating (| PCR) | | |
|---|---|---|---|---|---|---|---|
| Pavement Condition R | Rating (PCR) | 100 | 100 | | | | |

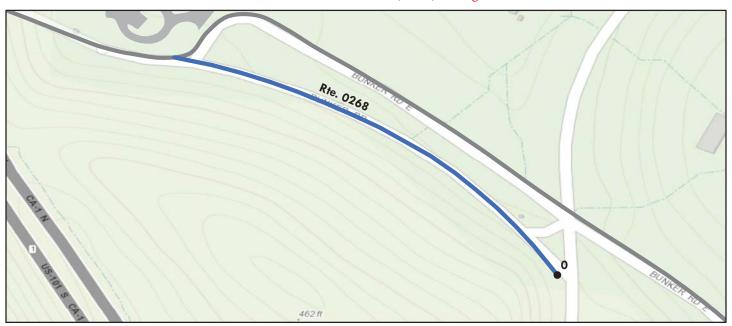
ROUTE 0268: DANES ROAD

Data Collection Vehicle (DCV) Rating

| | Route (| Condition Legend – Pav | ement Condi | ition Rating (| PCR) | | |
|---|---|---|---|---|---|---|---|
| Pavement Condition | on Rating (PCR) | 99 | 99 | | | | |

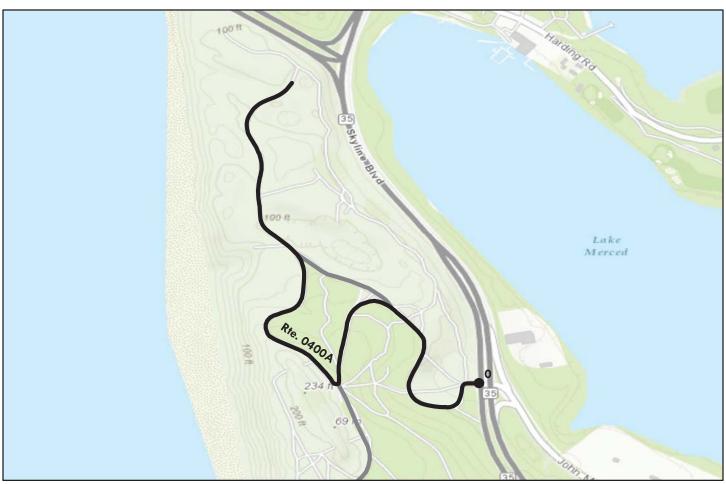
ROUTE 0400A: FORT FUNSTON/BATTERY DAVIS ROAD A

Manual Rating

Route is very poor condition and much of it is covered by sand and therefore un-ratable.

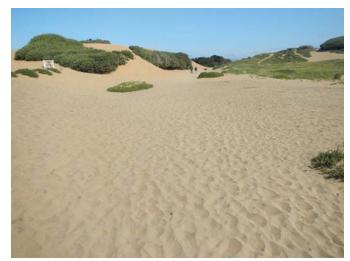
GOGA_0400A_8198.JPG

Condition photos are shown only for manually rated roads. Use the PathView program to see images of DCV rated roads.

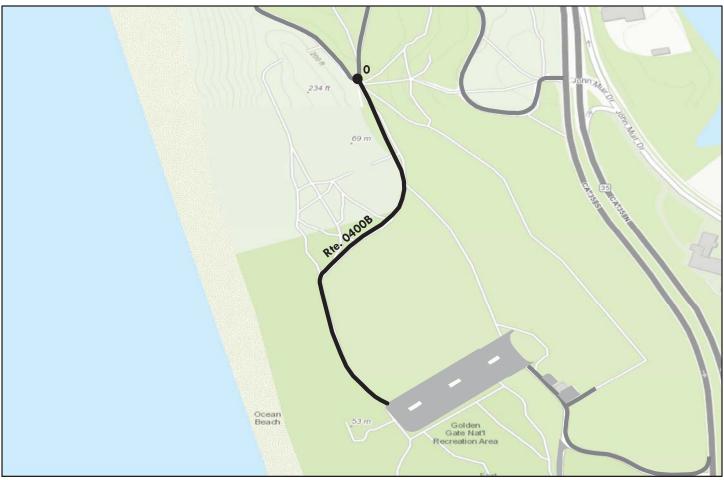
ROUTE 0400B: FORT FUNSTON/BATTERY DAVIS ROAD B

Manual Rating

Route is very poor condition and much of it is covered by sand and therefore un-ratable.

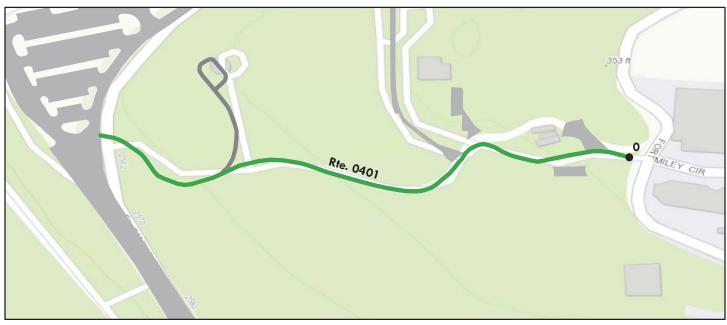
ROUTE 0401: FORT MILEY WEST ACCESS ROAD

Data Collection Vehicle (DCV) Rating

| | Route (| Condition Legend – Pav | ement Condi | ition Rating (| PCR) | | |
|---|---|---|---|---|---|---|---|
| Pavement Condition | n Rating (PCR) | 94 | 94 | | | | |

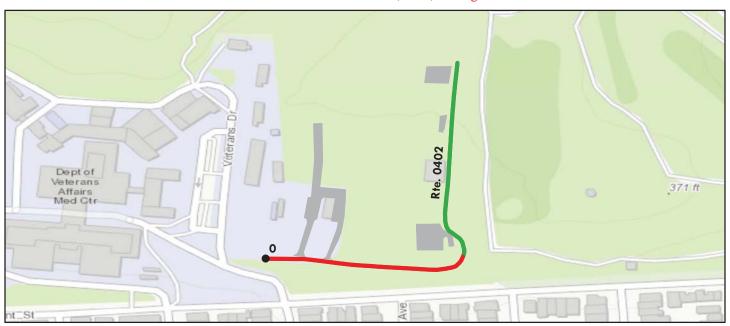
ROUTE 0402: FORT MILEY EAST ROAD

Data Collection Vehicle (DCV) Rating

| | Route (| Condition Legend – Pav | ement Condi | tion Rating (| PCR) | | |
|---|---|---|---|---|---|---|---|
| Pavement Condition | n Rating (PCR) | 63 | 63 | | | | |

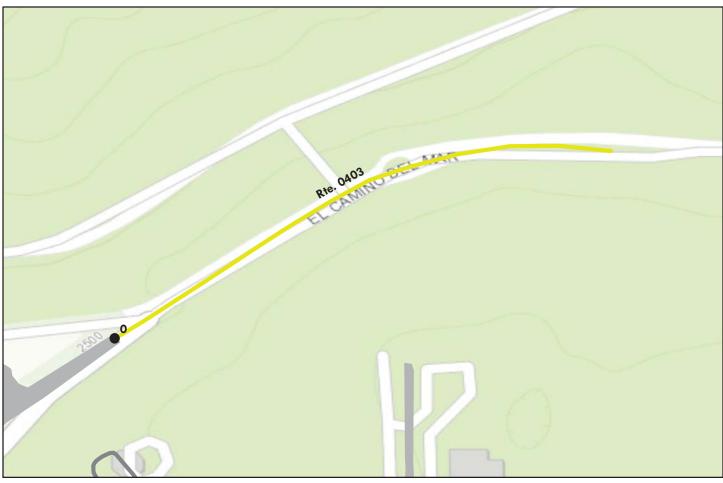
ROUTE 0403: FORT MILEY WEST NPS ACCESS ROAD

Manual Rating

| Route Condition Legend – Pavement Condition Rating (PCR) | | | | | | | | |
|--|---|---|---|---|---|--|--|--|
| Pavement Condition Rating (PCR) | | 73 | 73 | | | | | |

Route was manually rated in cycle 6 due to the condition of the road.

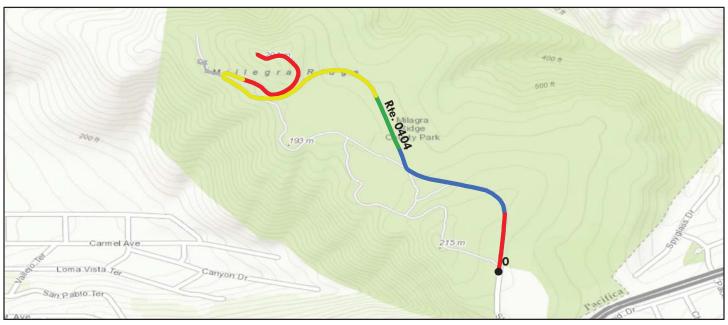
ROUTE 0404: MILAGRA RIDGE ROAD

Data Collection Vehicle (DCV) Rating

| | Route (| Condition Legend – Pav | ement Condi | ition Rating (| PCR) | | |
|---|---|---|---|---|---|---|--|
| Pavement Condition | n Rating (PCR) | 74 | 74 | | | | |

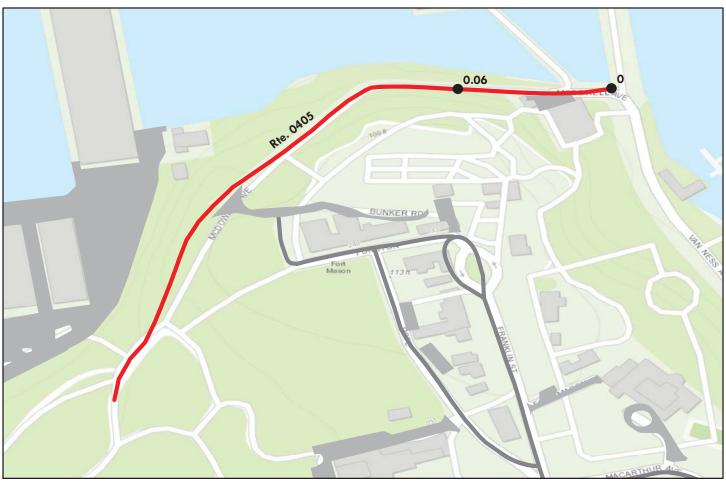
ROUTE 0405: MCDOWELL AVENUE

Manual Rating

| Route Condition Legend – Pavement Condition Rating (PCR) | | | | | | | | |
|--|---|---|---|---|--|---|--|--|
| Pavement Condition Rating (PCR) | | 53 | 53 | 53 | | | | |

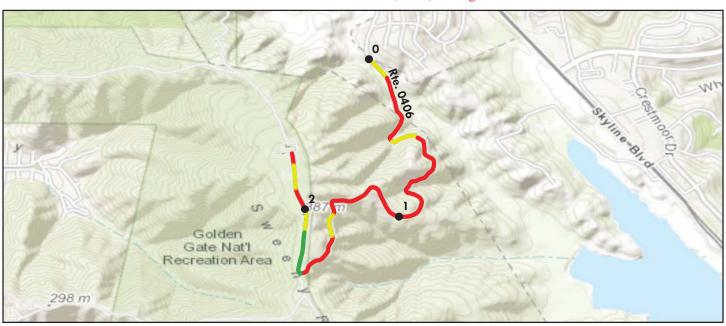
ROUTE 0406: SWEENEY RIDGE ROAD

Data Collection Vehicle (DCV) Rating

| | Route (| Condition Legend – Pav | ement Condi | tion Rating (| PCR) | | |
|---|---|---|---|---|---|---|---|
| Pavement Condition | n Rating (PCR) | 31 | 11 | 47 | 52 | | |

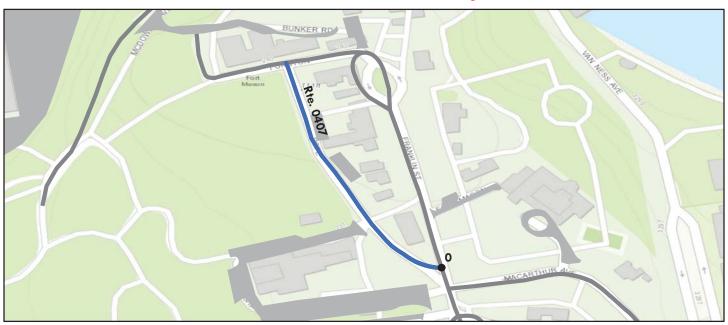
ROUTE 0407: POPE ROAD

Data Collection Vehicle (DCV) Rating

| | Route (| Condition Legend – Pav | ement Condi | ition Rating (| PCR) | | |
|---|---|---|---|---|---|---|---|
| Pavement Condition | n Rating (PCR) | 99 | 99 | | | | |

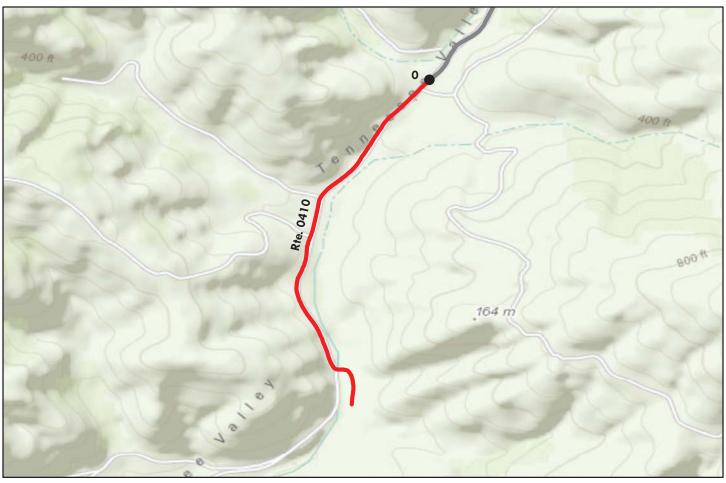
ROUTE 0410: TENNESSEE VALLEY UPPER ROAD

Manual Rating

| | Route C | Condition Legend – Pave | ement Condi | tion Rating (| PCR) | | |
|---|---|---|---|---|---|---|---|
| Pavement Condition | Rating (PCR) | 30 | 30 | | | | |

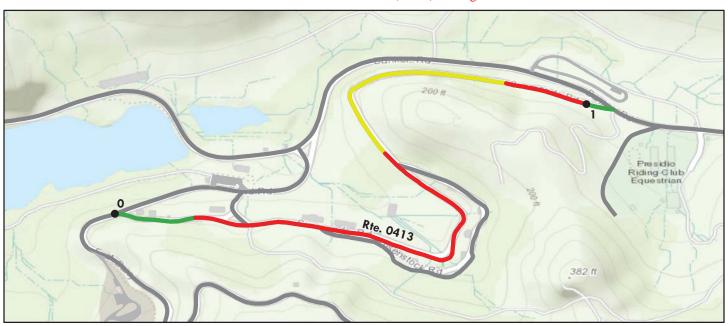
ROUTE 0413: SIMMONDS ROAD

Data Collection Vehicle (DCV) Rating

| | Route (| Condition Legend – Pay | vement Condi | tion Rating (| PCR) | | |
|---|---|---|---|---|---|---|---|
| Pavement Condition Ra | ting (PCR) | 47 | 46 | 86 | | | |

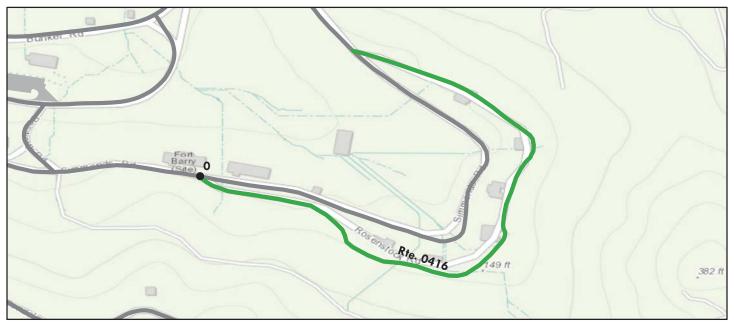
ROUTE 0416: ROSENSTOCK ROAD

Data Collection Vehicle (DCV) Rating

| | Route (| Condition Legend – Pav | ement Condi | ition Rating (I | PCR) | | |
|---|---|---|---|---|---|---|---|
| Pavement Condition | n Rating (PCR) | 91 | 91 | | | | |

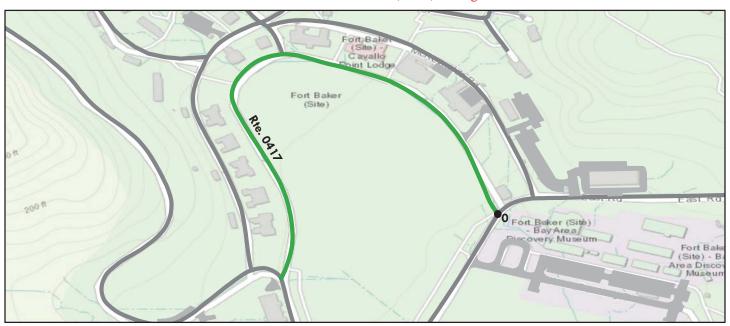
ROUTE 0417: MURRAY CIRCLE

Data Collection Vehicle (DCV) Rating

| | Route (| Condition Legend – Pav | ement Condi | ition Rating (| PCR) | | |
|---|---|---|---|---|---|---|---|
| Pavement Condition | Rating (PCR) | 91 | 91 | | | | |

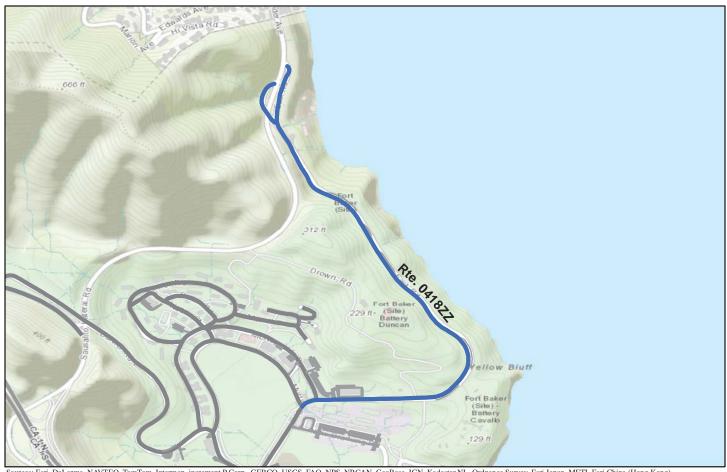
ROUTE 0418ZZ: EAST ROADS

Summary Route

The condition shown on this page reflects the overall route condition; it might not reflect individual subcomponent ratings.

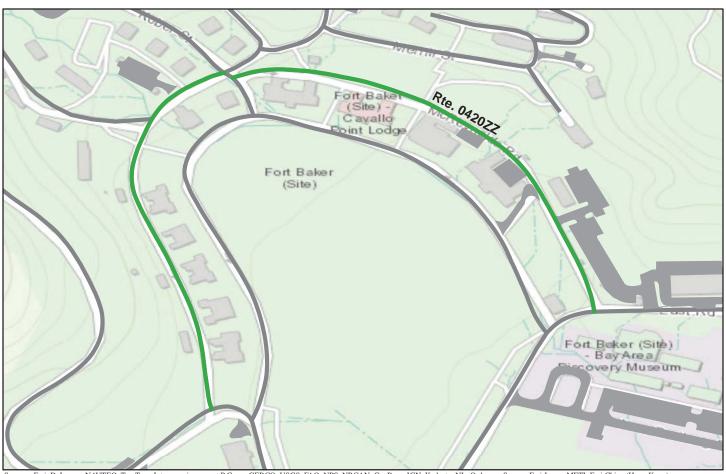
ROUTE 0420ZZ: MCREYNOLDS ROADS

Summary Route

The condition shown on this page reflects the overall route condition; it might not reflect individual subcomponent ratings.

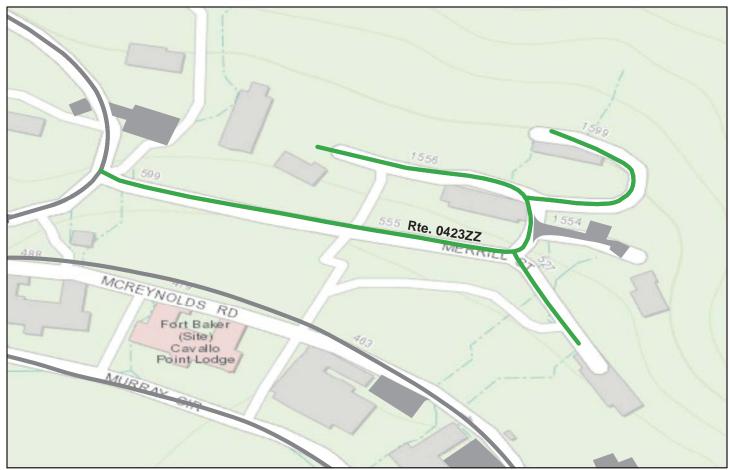
ROUTE 0423ZZ: MERRILL STREETS

Summary Route

The condition shown on this page reflects the overall route condition; it might not reflect individual subcomponent ratings.

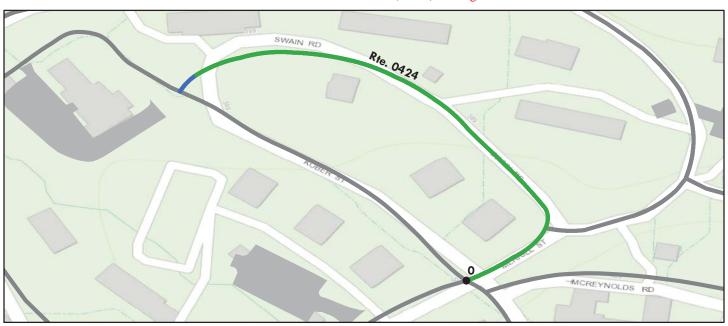
ROUTE 0424: SWAIN ROAD

Data Collection Vehicle (DCV) Rating

| | Route (| Condition Legend – Pav | ement Condi | ition Rating (I | PCR) | | |
|---|---|---|---|---|---|---|---|
| Pavement Condition | n Rating (PCR) | 87 | 87 | | | | |
| Surface Condition Ra | ating (SCR) | 87 | 87 | | | | |

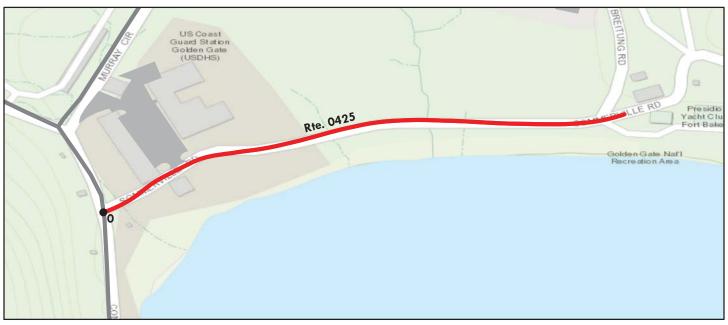
ROUTE 0425: SOMMERVILLE ROAD

Data Collection Vehicle (DCV) Rating

| | Route (| Condition Legend – Pay | ement Condi | tion Rating (| PCR) | | |
|---|---|---|---|---|---|---|---|
| Pavement Condition 1 | Rating (PCR) | 0 | 0 | | | | |
| Surface Condition Rati | ng (SCR) | 0 | 0 | | | | |

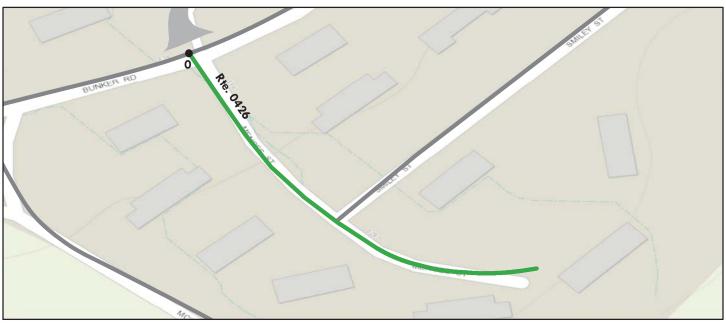
ROUTE 0426: MENGES STREET

Data Collection Vehicle (DCV) Rating

| | Route (| Condition Legend – Pav | ement Condi | ition Rating (I | PCR) | | |
|---|---|---|---|---|---|---|---|
| Pavement Condition | Rating (PCR) | 93 | 93 | | | | |

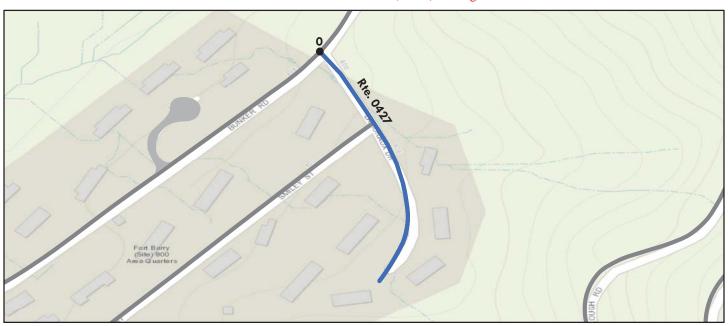
ROUTE 0427: LAMORAUX DRIVE

Data Collection Vehicle (DCV) Rating

| | Route (| Condition Legend – Pav | ement Condi | tion Rating (| PCR) | | |
|---|---|---|---|---|---|---|---|
| Pavement Condition | on Rating (PCR) | 95 | 95 | | | | |

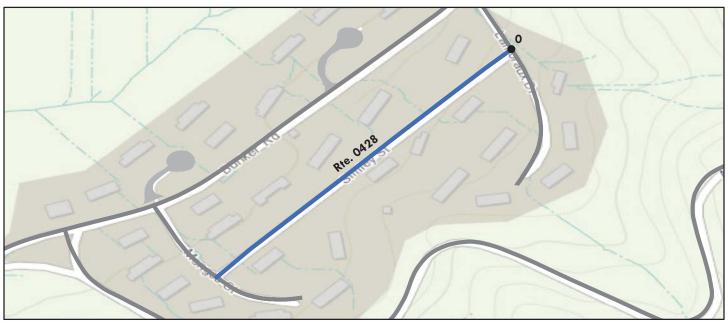
ROUTE 0428: SMILEY STREET

Data Collection Vehicle (DCV) Rating

| | Route (| Condition Legend – Pav | ement Condi | tion Rating (| PCR) | | |
|---|---|---|---|---|---|---|---|
| Pavement Condition | Rating (PCR) | 98 | 98 | | | | |

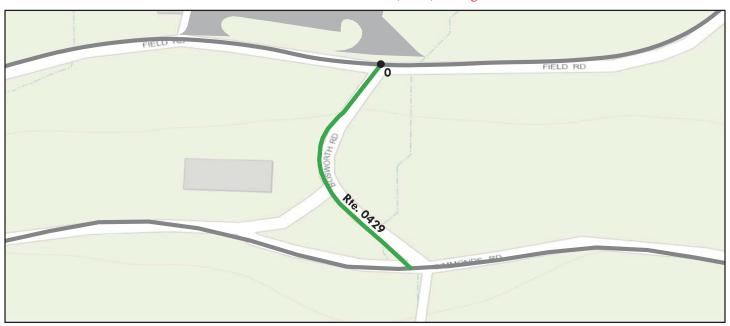
ROUTE 0429: BODSWORTH ROAD

Data Collection Vehicle (DCV) Rating

| Rou | te Condition Legend – Pav | ement Cond | ition Rating (PCR) | |
|---|---|---|---|---|
| Pavement Condition Rating (PCR) | 93 | 93 | | |

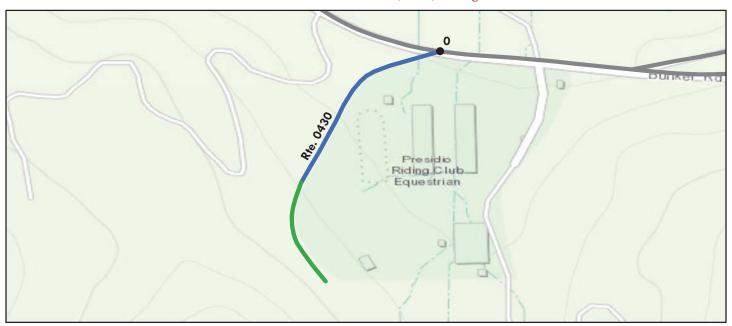
ROUTE 0430: DEBRIS DISPOSAL/ STABLE ROAD

Data Collection Vehicle (DCV) Rating

| | Route (| Condition Legend – Pay | zement Condi | ition Rating (1 | PCR) | | |
|---|---|---|---|---|---|---|---|
| Pavement Condition R | ating (PCR) | 95 | 95 | | | | |

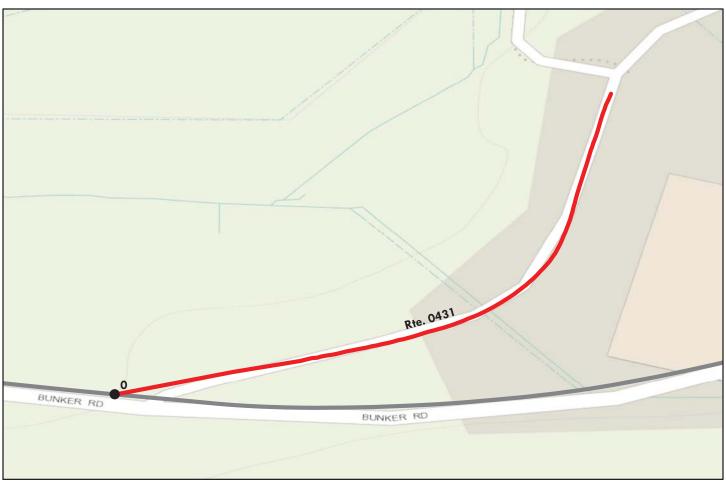
ROUTE 0431: SMITH ROAD

Manual Rating

| Route Condition Legend – Pavement Condition Rating (PCR) | | | | | | | |
|--|---|---|---|---|--|---|---|
| Pavement Condition | Rating (PCR) | 30 | 30 | | | | |

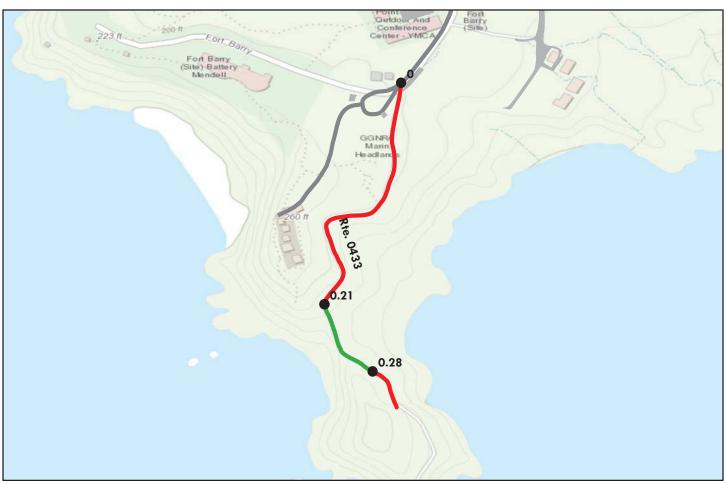
ROUTE 0433: POINT BONITA LIGHTHOUSE ROAD

Manual Rating

| Route Condition Legend – Pavement Condition Rating (PCR) | | | | | | | |
|--|---|---|---|---|---|---|---|
| Pavement Condition Ratin | ig (PCR) | 58 | 53 | 90 | 30 | | |

Route has a concrete section (green line on the map) that is good condition.

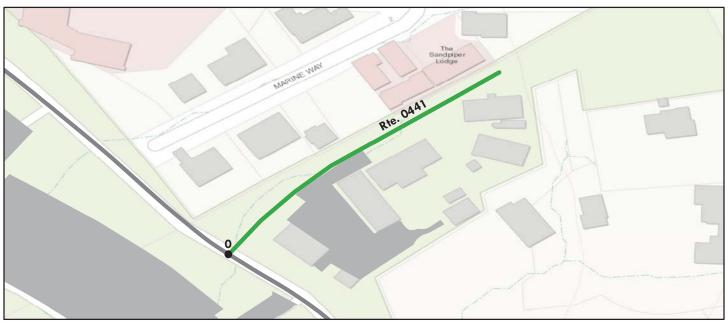
ROUTE 0441: STINSON BEACH ADMINISTRATION ROAD

Data Collection Vehicle (DCV) Rating

| Rou | te Condition Legend – Pay | ement Cond | ition Rating (PCR) | |
|---|---|---|---|---|
| Pavement Condition Rating (PCR) | 90 | 90 | | |

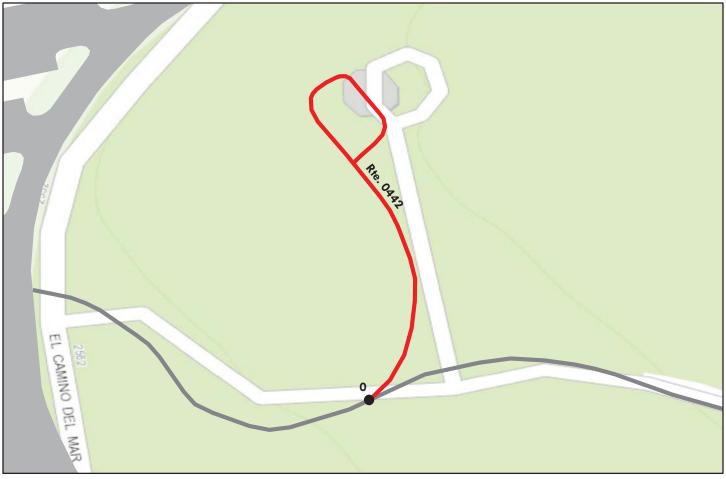
ROUTE 0442: OCTAGON HOUSE ROAD

Manual Rating

| | Route Condition Legend – Pavement Condition Rating (PCR) | | | | | | | | |
|---|--|---|---|---|---|---|---|--|--|
| Pavement Condition | Rating (PCR) | 30 | 30 | | | | | | |

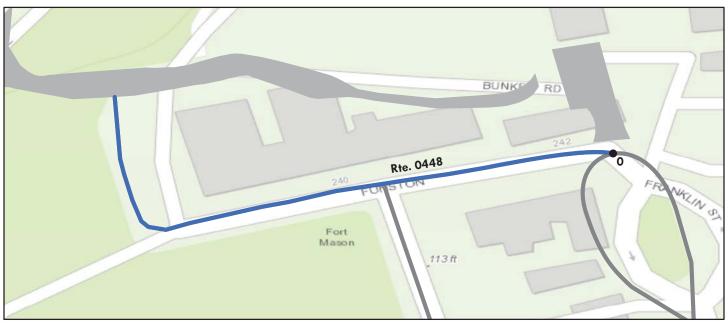
ROUTE 0448: FUNSTON STREET (FORT MASON)

Data Collection Vehicle (DCV) Rating

| | Route Condition Legend – Pavement Condition Rating (PCR) | | | | | | | |
|---|--|---|---|---|---|---|---|--|
| Pavement Condition | Rating (PCR) | 99 | 99 | | | | | |

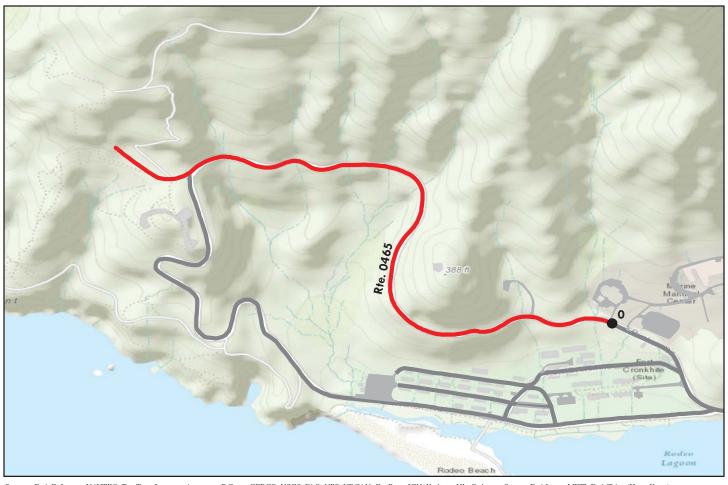
ROUTE 0465: OLD BUNKER ROAD

Manual Rating

| | Route Condition Legend – Pavement Condition Rating (PCR) | | | | | | | |
|---|--|---|---|---|---|--|--|--|
| Pavement Condition | Rating (PCR) | 30 | 30 | | | | | |

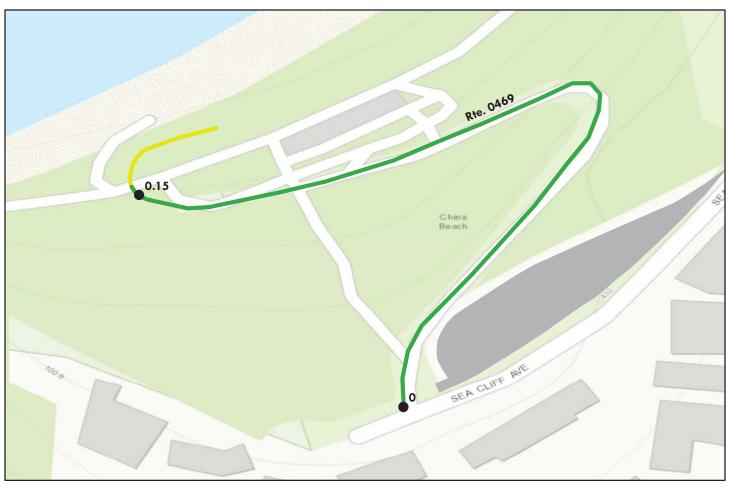
ROUTE 0469: CHINA BEACH ACCESS ROAD

Manual Rating

| | Route Condition Legend – Pavement Condition Rating (PCR) | | | | | | | | |
|---|--|---|---|---|---|---|---|--|--|
| Pavement Condition | Rating (PCR) | 88 | 90 | 73 | | | | | |

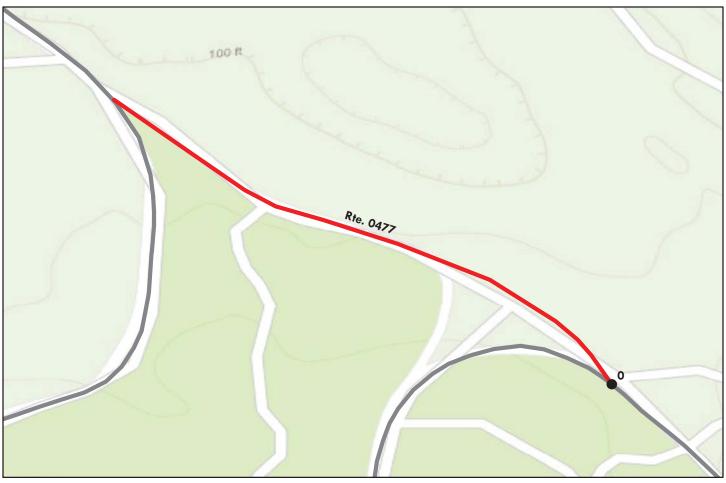
ROUTE 0477: MUIR DRIVE RIDGE FIRE ROAD

Manual Rating

| | Route Condition Legend – Pavement Condition Rating (PCR) | | | | | | | |
|---|--|---|---|---|---|---|---|--|
| Pavement Condition Ra | ting (PCR) | 30 | 30 | | | | | |

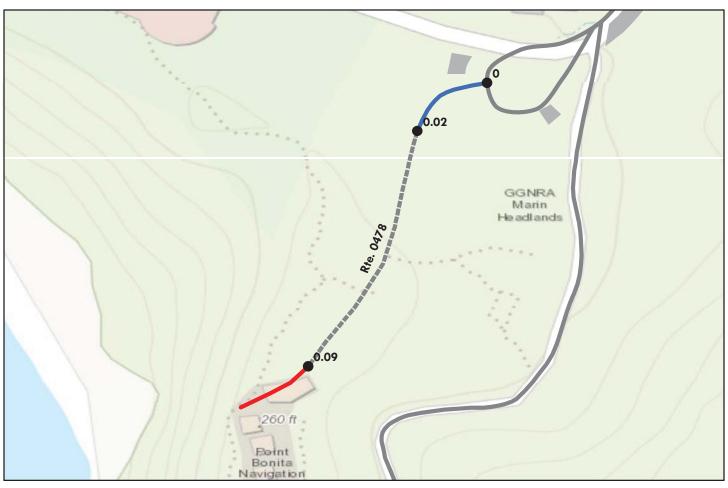
ROUTE 0478: POINT BONITA RADIO TOWER ROAD

Manual Rating

| Route Condition Legend – Pavement Condition Rating (PCR) | | | | | | | | |
|--|---|---|---|---|---|---|--|--|
| Pavement Condition I | Rating (PCR) | 66 | 97 | N/A | 30 | | | |

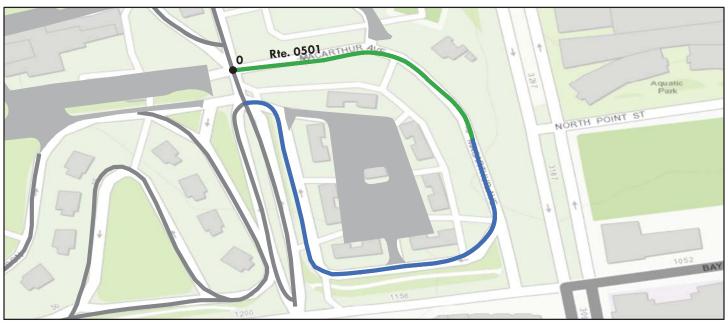
ROUTE 0501: MACARTHUR AVENUE LOOP EAST

Data Collection Vehicle (DCV) Rating

| | Route (| Condition Legend – Pav | ement Condi | ition Rating (| PCR) | | |
|---|---|---|---|---|---|---|---|
| Pavement Condition | n Rating (PCR) | 95 | 95 | | | | |

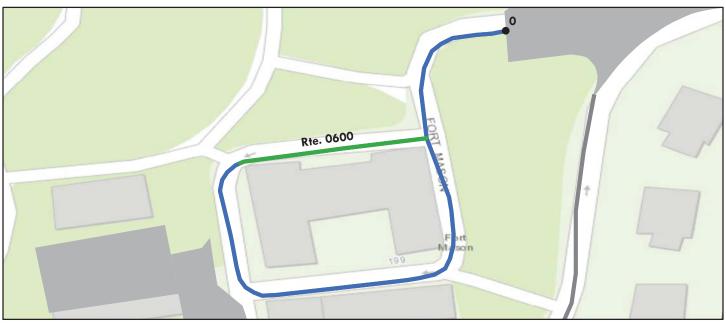
ROUTE 0600: MACARTHUR AVENUE LOOP WEST (FORT MASON)

Data Collection Vehicle (DCV) Rating

| | Route Condition | n Legend – Pa | vement Condi | tion Rating (| PCR) | | |
|---|---|---|---|---|---|---|---|
| Pavement Condition Rating (F | PCR) | 96 | 96 | | | | |

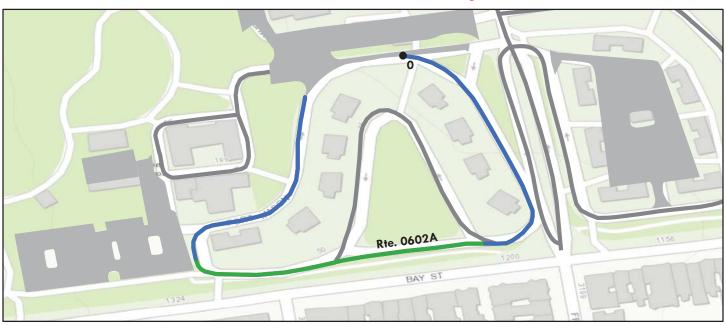
ROUTE 0602A: COLONEL'S ROW LOOP A (OUTSIDE LOOP)

| | Route Condition | Legend – Pay | vement Condi | tion Rating (| PCR) | | |
|---|---|---|---|---|---|---|---|
| Pavement Condition Rating (Po | CR) | 96 | 96 | | | | |

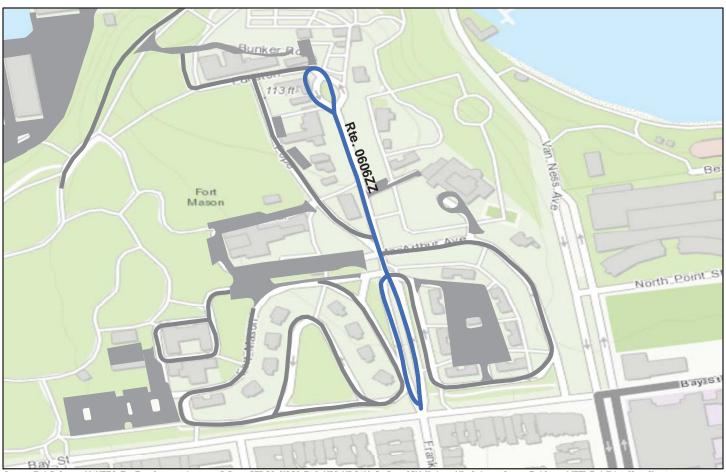
ROUTE 0606ZZ: FRANKLIN STREET AND SPUR

Summary Route

The condition shown on this page reflects the overall route condition; it might not reflect individual subcomponent ratings.

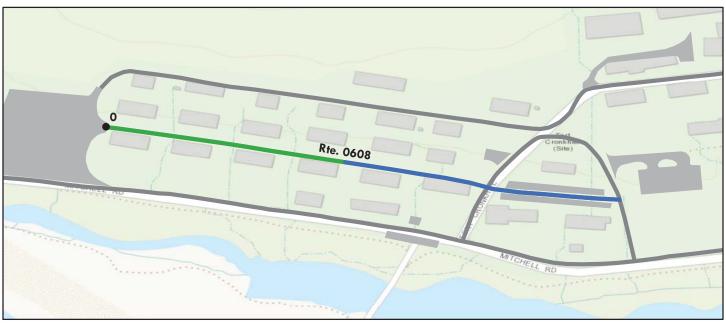
ROUTE 0608: EDISON STREET

Data Collection Vehicle (DCV) Rating

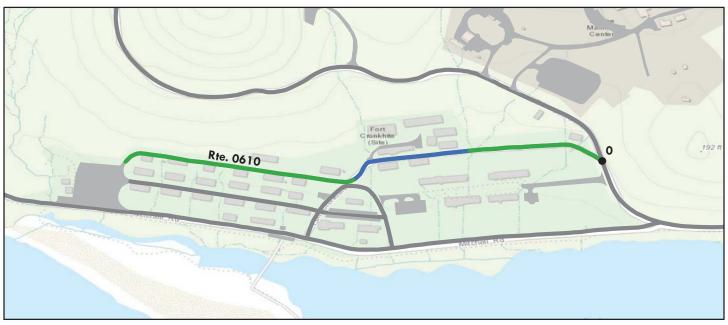
ROUTE 0610: KIRKPATRICK STREET

Data Collection Vehicle (DCV) Rating

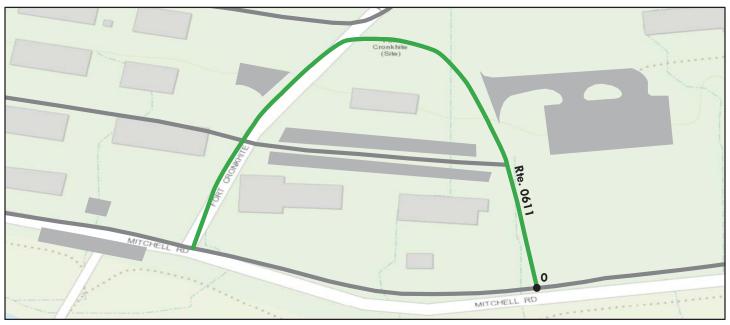
ROUTE 0611: HAGGET-GLASSBURN LOOP

Data Collection Vehicle (DCV) Rating
