GREE Cycle 6

Final Report

Road Inventory and Condition Assessment of Paved Routes Greenbelt Park Part of the National Capital Parks - East

Prepared By: Federal Highway Administration Eastern Federal Lands Highway Division Road Inventory Program (RIP)

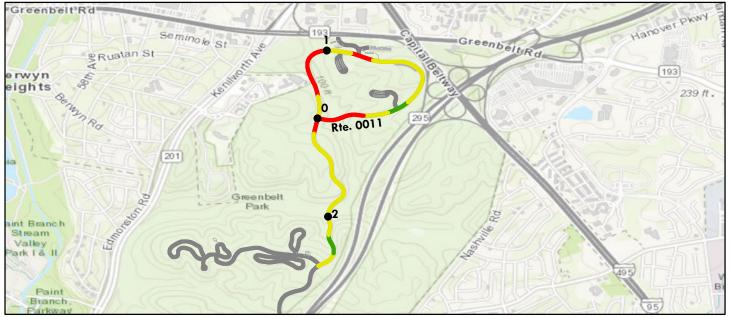
Greenbelt Park ROUTE 0011: PARK CENTRAL ROAD

Route Condition Legend – Pavement Condition Rating (PCR)										
Poor (0 - 60) Fair (61- 84) Good	(85 - 94)	Excellent (95 - 100)	Not Rated					
Colors on map represent con	ndition scores at 0.10-mile	e intervals. Se	e Appendix fo	or definitions	and formulas.					
Inspection Date: 6/8/2018	Beginning Section MP	0	1	2						
Paved Length (Miles): 2.3	Section Length (MI)	1	1	0.3						
Surface Type: ASPHALT	Route Summary									
Roadway Condition Information										
Pavement Condition Rating (PCR)	67	65	66	80						
Surface Condition Rating (SCR)	68	68	63	87						
Roughness Condition Index (RCI)	66	60	70	70						
Distress Index Values										
Structural Crack Index	68	68	63	87						
Alligator Crack Index	97	97	96	100						
Longitudinal Crack Index	71	71	67	87						
Transverse Cracking Index	77	75	75	92						
Patching Index	100	100	100	100						
Rutting Index	96	96	96	95						
International Roughness Index (IRI)	217	238	202	202

Lane & Width Information										
Number of Lanes	2	2	2	2						
Paved Width (ft)	20.8	20.4	20.9	21.8						
Lane Width (ft)	10	9.9	10.3	9.8

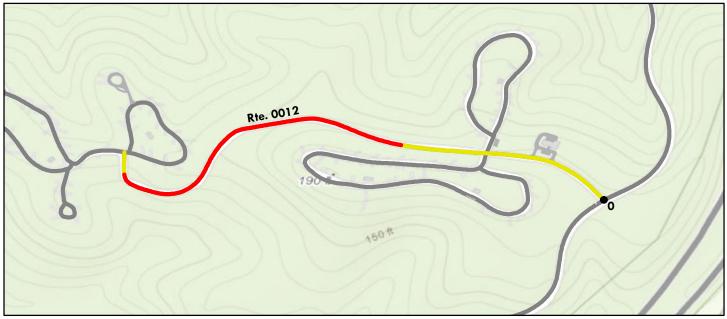
Greenbelt Park ROUTE 0012: CAMPGROUND ACCESS

Route Condition Legend – Pa	vement Cond	ition Rating (PCR)	
		(85 - 94)	Excellent (95 - 100)	Not Rated
Colors on map repres	ent condition scores at 0.10-mi	le intervals. Se	e Appendix for definition	ns and formulas.
Inspection Date: 6/8/2018	Beginning Section MI	P 0		
Paved Length (Miles): 0.52	Section Length (MI)	0.52		
Surface Type: ASPHAL1	Route Summary		• •	
Roadway Condition Information				
Pavement Condition Rating (PCF	R) 44	44		
Surface Condition Rating (SCR)	44	44		
Roughness Condition Index (RCI)	N/A	N/A		
Distress Index Values				
Structural Crack Index	44	44		
Alligator Crack Index	92	92		
Longitudinal Crack Index	52	52		
Transverse Cracking Index	81	81		
Patching Index	99	99		
Rutting Index	98	98		
International Roughness Index (II	RI) N/A	N/A		
Lane & Width Information				
Number of Lanes	2	2		
Paved Width (ft)	19.1	19.1		
Lane Width (ft)	9.4	9.4

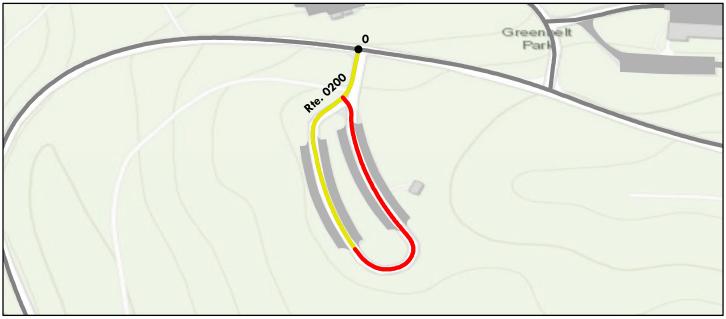
Greenbelt Park ROUTE 0200: SWEETGUM PICNIC LOOP

Route Condition Legend – Pavement Condition Rating (PCR)									
Poor (0 - 60)	Cair (61- 84) Good	(85 - 94)	Excellent (95 - 100)	Not Rated					
Colors on map represe	nt condition scores at 0.10-mil	le intervals. Se	e Appendix for definition	ns and formulas.					
Inspection Date: 6/8/2018	Beginning Section MI	P 0							
Paved Length (Miles): 0.21	Section Length (MI)	0.21							
Surface Type: ASPHALT	Route Summary			• •					
Roadway Condition Information									
Pavement Condition Rating (PCR)	33	33							
Surface Condition Rating (SCR)	33	33							
Roughness Condition Index (RCI)	N/A	N/A							
Distress Index Values									
Structural Crack Index	48	48							
Alligator Crack Index	97	97							
Longitudinal Crack Index	51	51							
Transverse Cracking Index	33	33							
Patching Index	100	100							
Rutting Index	99	99							
International Roughness Index (IR	I) N/A	N/A							
Lane & Width Information

Number of Lanes	1	1							
Paved Width (ft)	19.9	19.9							
Lane Width (ft)	16.7	16.7

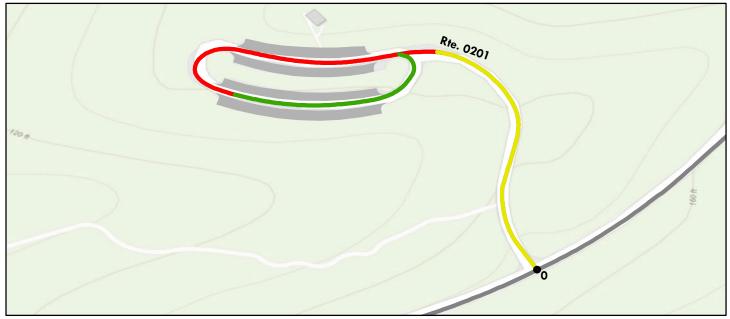
Greenbelt Park ROUTE 0201: LAUREL PICNIC AREA

Route Condition Legend – Pavement Condition Rating (PCR)									
Poor (0 - 60) Fa	ir (61- 84) Good	(85 - 94)	Excellent (95 - 100)	Not Rated					
Colors on map represen	t condition scores at 0.10-mil	e intervals. Se	e Appendix for definition	ns and formulas.					
Inspection Date: 6/8/2018	Beginning Section MP	0							
Paved Length (Miles): 0.27	Section Length (MI)	0.27							
Surface Type: ASPHALT	Route Summary		•	•					
Roadway Condition Information									
Pavement Condition Rating (PCR)	72	72							
Surface Condition Rating (SCR)	72	72							
Roughness Condition Index (RCI)	N/A	N/A							
Distress Index Values									
Structural Crack Index	72	72							
Alligator Crack Index	98	98							
Longitudinal Crack Index	74	74							
Transverse Cracking Index	89	89							
Patching Index	100	100							
Rutting Index	97	97							
International Roughness Index (IRI)	N/A	N/A							
Lane & Width Information

Number of Lanes	2	2							
Paved Width (ft)	21.2	21.2							
Lane Width (ft)	9.8	9.8

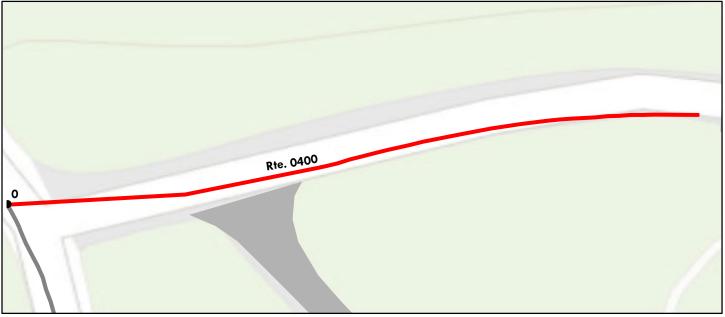
Greenbelt Park ROUTE 0400: MAINTENANCE AREA ACCESS

Route C	Condition Legend – Pav	ement Condi	tion Rating (PCR)			
Poor (0 - 60) Fair (6			Excellent (95 - 100)	Not Rated		
Colors on map represent con	ition scores at 0.10-mile intervals. See Appendix for definitions and formulas.					
Inspection Date: 6/8/2018	Beginning Section MP	0				
Paved Length (Miles): 0.04	Section Length (MI)	0.04				
Surface Type: ASPHALT	Route Summary					
Roadway Condition Information						
Pavement Condition Rating (PCR)	59	59				
Surface Condition Rating (SCR)	59	59				
Roughness Condition Index (RCI)	N/A	N/A				
Distress Index Values						
Structural Crack Index	59	59				
Alligator Crack Index	98	98				
Longitudinal Crack Index	61	61				
Transverse Cracking Index	62	62				
Patching Index	100	100				
Rutting Index	97	97				
International Roughness Index (IRI)	N/A	N/A				
Lane & Width Information						
Number of Lanes	2	2				
Paved Width (ft)	19.5	19.5				
Lane Width (ft)	9.8	9.8

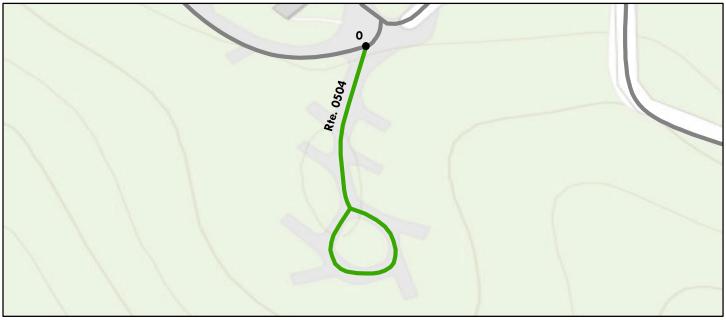
Manual Rating

Route	Condition Legend – Pave	ement Condi	tion Rating (PCR))
Poor (0 - 60) Fair (6	61- 84) Good ((85 - 94)	Excellent (95 - 1	00) Not Rated
	See Appendix for def	initions and f	ormulas	
Inspection Date: 10/4/2018	Beginning Section MP	0.00		
Paved Length (Miles): 0.09	Section Length (MI)	0.09		
Surface Type: ASPHALT	Route Summary		•	ł ł
Roadway Condition Information				
Pavement Condition Rating (PCR)	90	90		
Surface Condition Rating (SCR)	90	90		
Roughness Condition Index (RCI)	N/A	N/A		
Distress Index Values				
Structural Crack Index	N/A	N/A		
Alligator Crack Index	90	90		
Longitudinal Crack Index	97	97		
Transverse Cracking Index	97	97		
Patching Index	97	97		
Rutting Index	97	97		
International Roughness Index (IRI)	N/A	N/A		
Lane & Width Information				
Number of Lanes	2	2		
Paved Width (ft)	20.9	20.9		
Lane Width (ft)	10.4	10.4

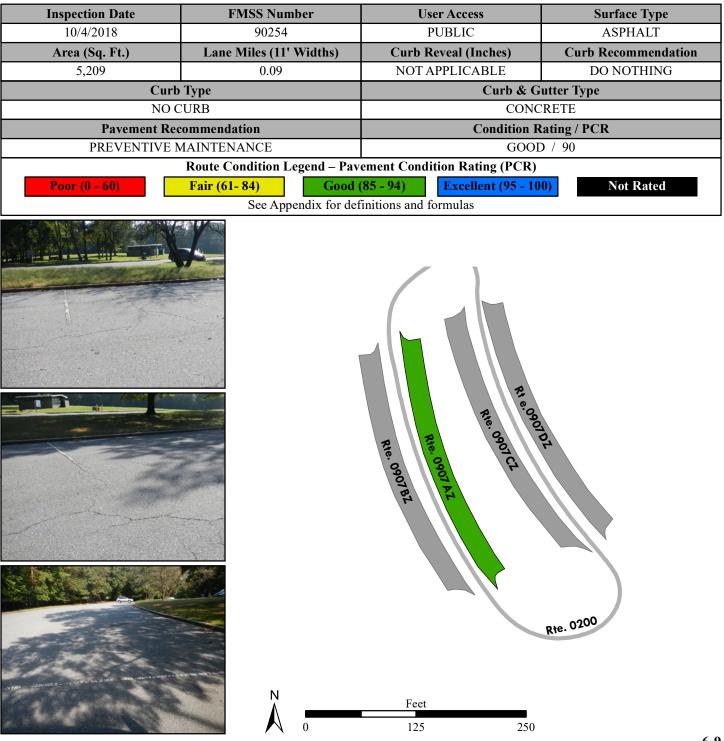
Greenbelt Park ROUTE 0907AZ: SWEET GUM PICNIC PARKING A

Subcomponent of Route GREE-0907ZZ Manual Rating

ADJACENT TO ROUTE 0200 (SWEETGUM PICNIC LOOP) ON LEFT

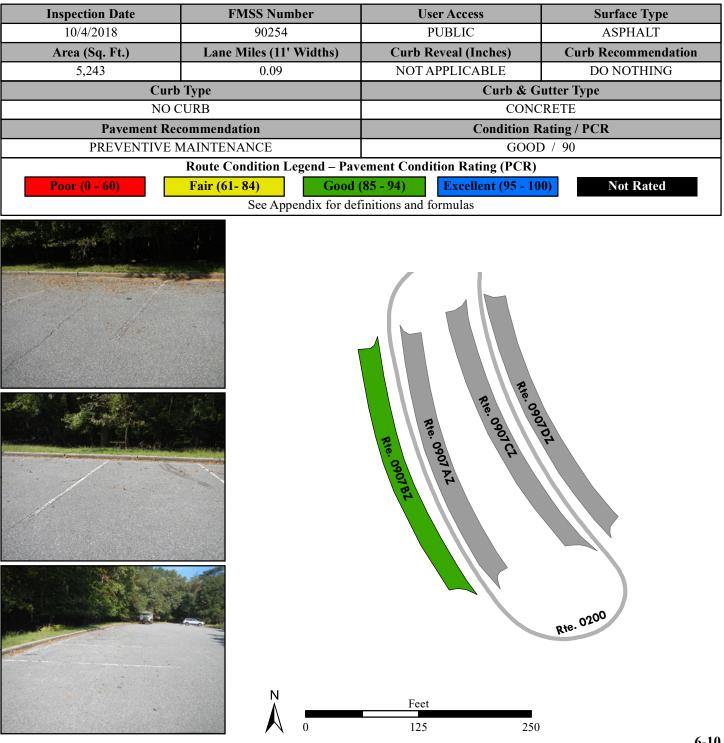
Greenbelt Park ROUTE 0907BZ: SWEET GUM PICNIC PARKING B

Subcomponent of Route GREE-0907ZZ Manual Rating

ADJACENT TO ROUTE 0200 (SWEETGUM PICNIC LOOP) ON RIGHT

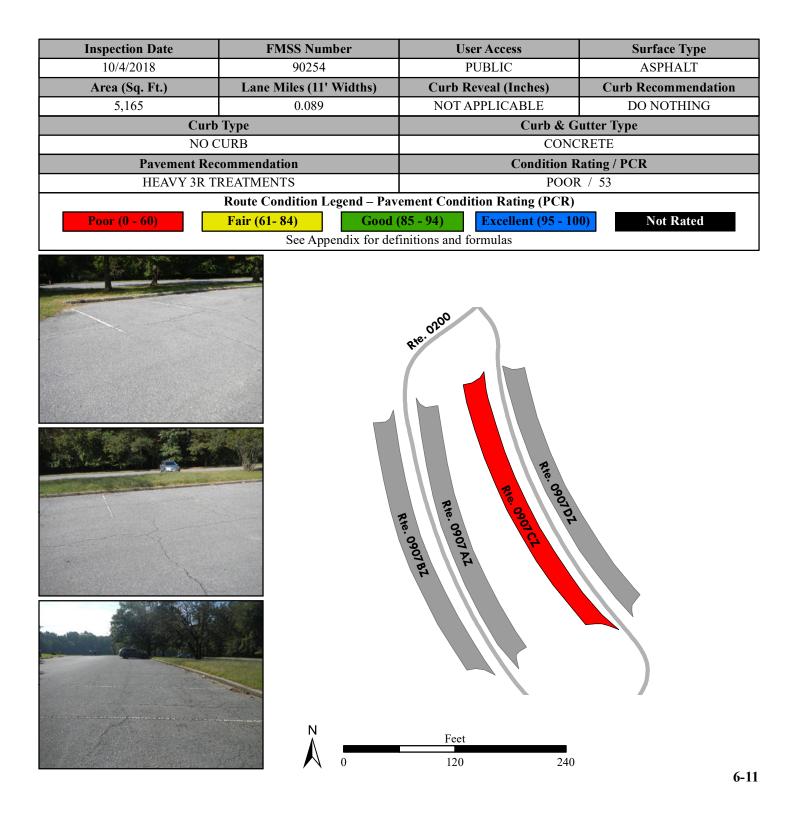
Greenbelt Park ROUTE 0907CZ: SWEET GUM PICNIC PARKING C

Subcomponent of Route GREE-0907ZZ Manual Rating

ADJACENT TO ROUTE 0200 (SWEETGUM PICNIC LOOP) ON LEFT

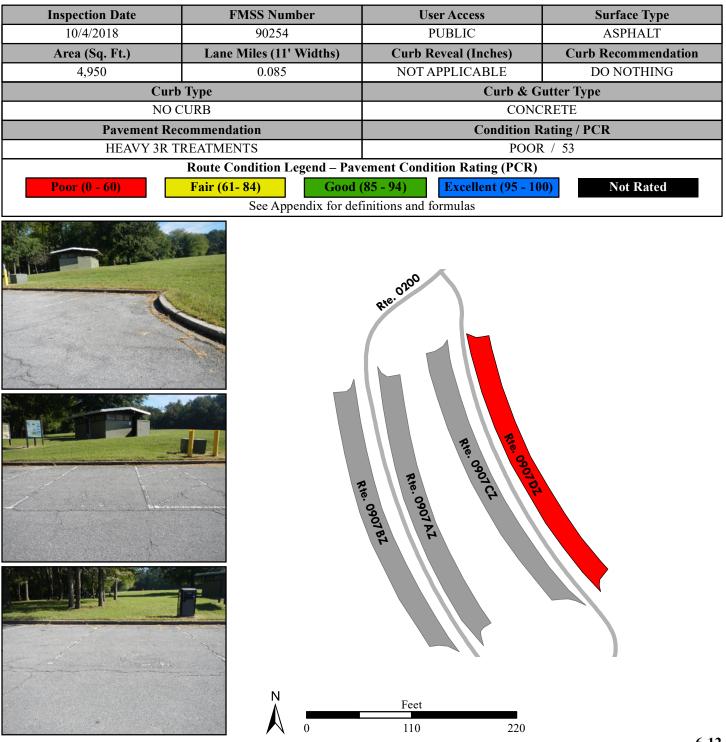
Greenbelt Park ROUTE 0907DZ: SWEET GUM PICNIC PARKING D

Subcomponent of Route GREE-0907ZZ Manual Rating

ADJACENT TO ROUTE 0200 (SWEETGUM PICNIC LOOP) ON RIGHT

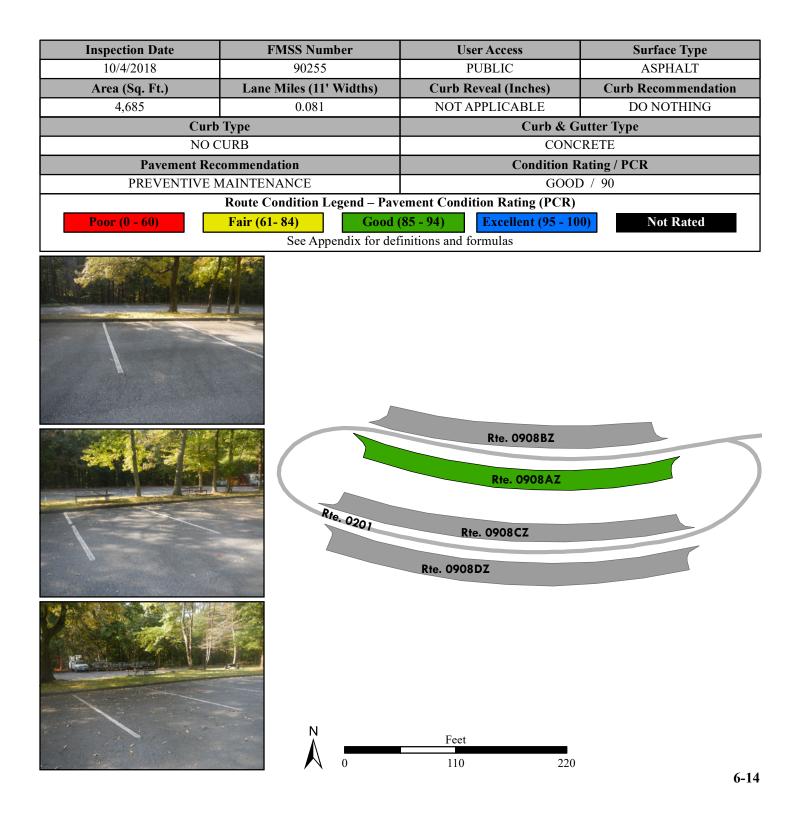
Greenbelt Park ROUTE 0908AZ: LAUREL PICNIC AREA PARKING A

Subcomponent of Route GREE-0908ZZ Manual Rating

ADJACENT TO ROUTE 0201 (LAUREL PICNIC AREA) ON LEFT

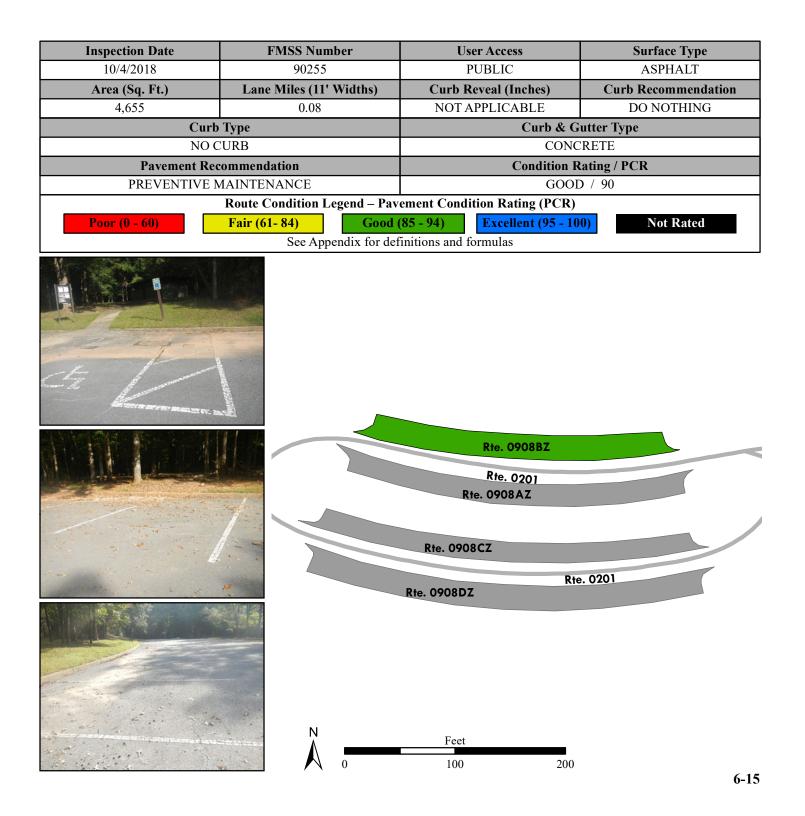
Greenbelt Park ROUTE 0908BZ: LAUREL PICNIC AREA PARKING B

Subcomponent of Route GREE-0908ZZ Manual Rating

ADJACENT TO ROUTE 0201 (LAUREL PICNIC AREA) ON RIGHT

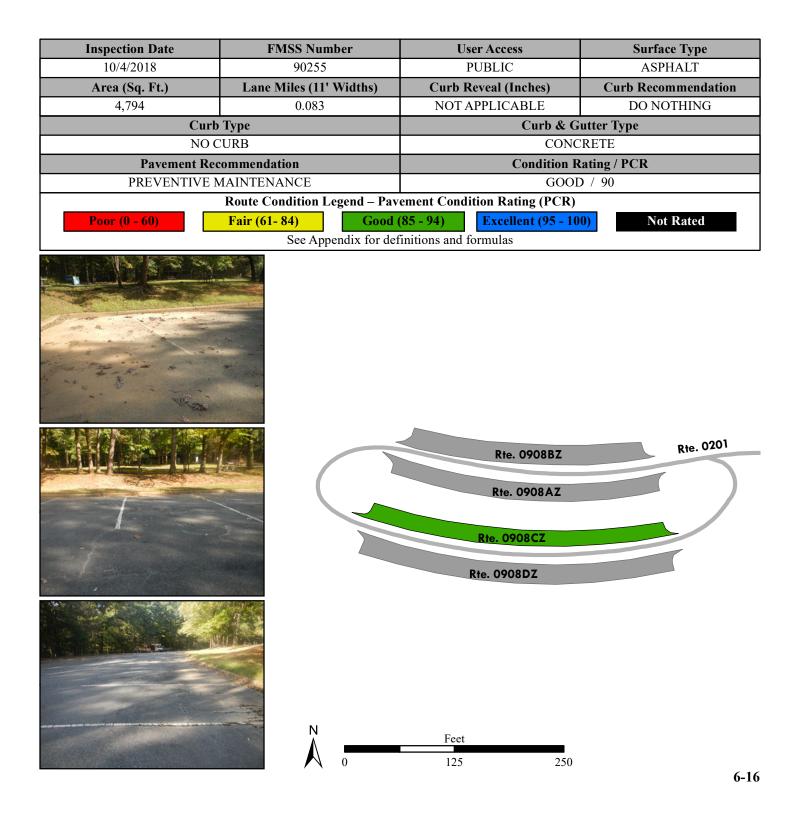
Greenbelt Park ROUTE 0908CZ: LAUREL PICNIC AREA PARKING C

Subcomponent of Route GREE-0908ZZ Manual Rating

ADJACENT TO ROUTE 0201 (LAUREL PICNIC AREA) ON LEFT

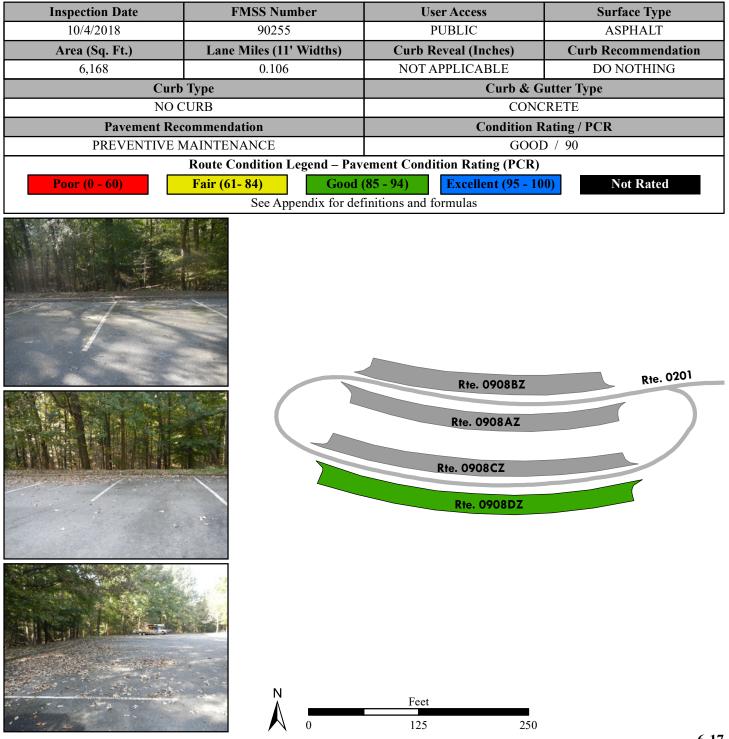
Greenbelt Park ROUTE 0908DZ: LAUREL PICNIC AREA PARKING D

Subcomponent of Route GREE-0908ZZ Manual Rating

ADJACENT TO ROUTE 0201 (LAUREL PICNIC AREA) ON RIGHT

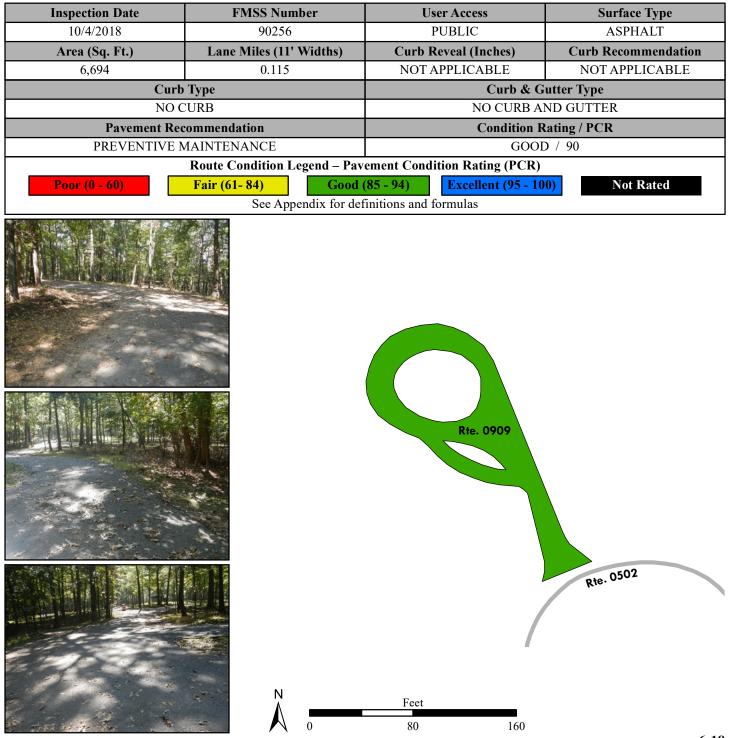
Greenbelt Park ROUTE 0909: CAMPGROUND DUMP STATION

Manual Rating

FROM ROUTE 0502 (GREENBELT CAMPGROUND LOOP C)

TO PARKING

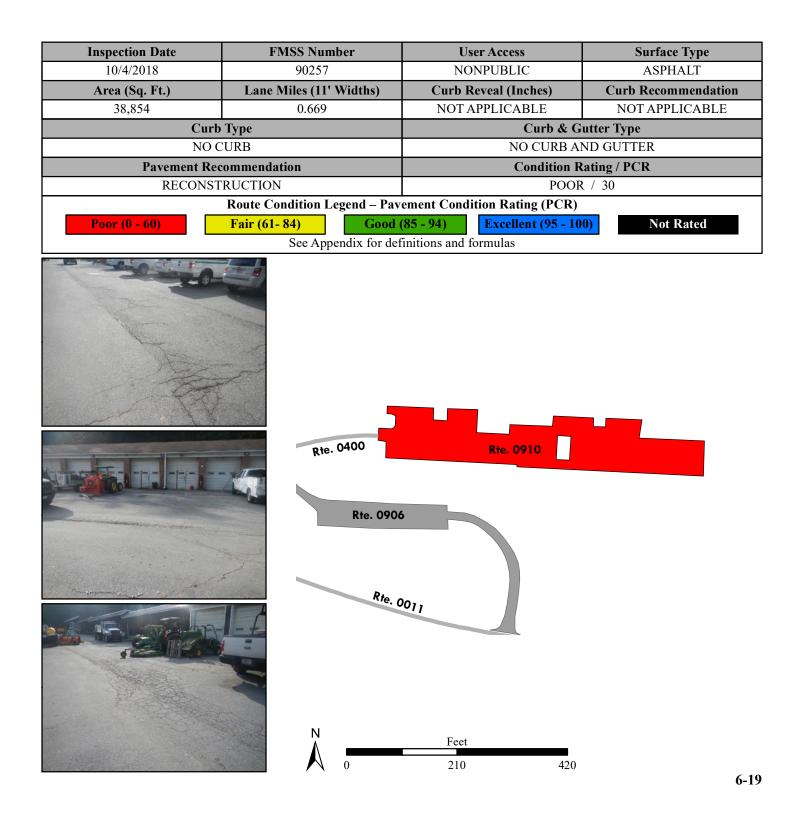
Greenbelt Park ROUTE 0910: GREENBELT MAINTENANCE AREA

Manual Rating

FROM END OF ROUTE 0400 (MAINTENANCE AREA ACCESS)

TO PARKING

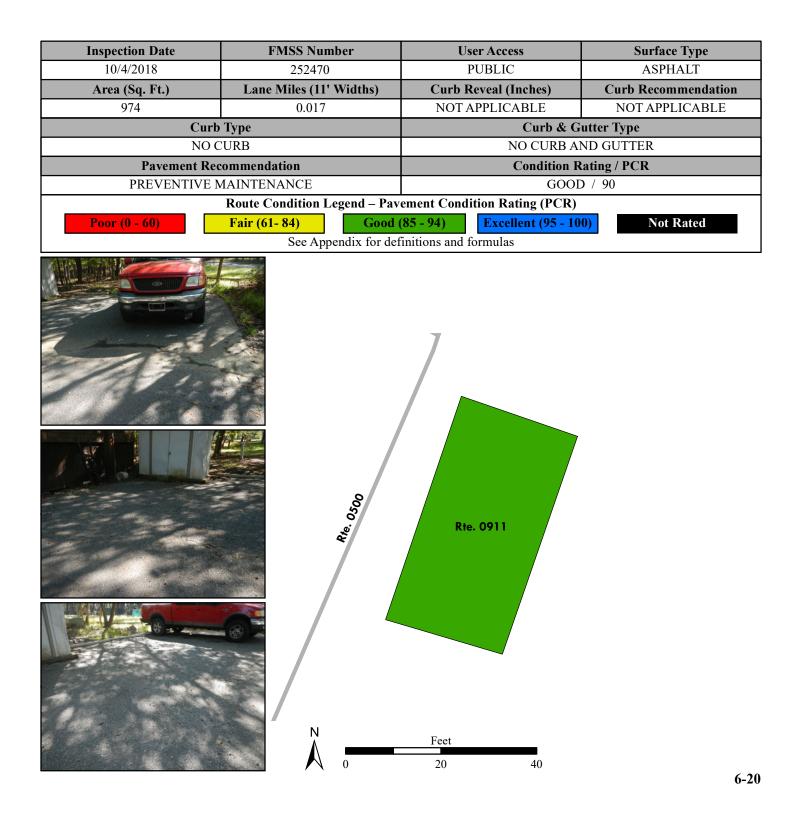
Greenbelt Park ROUTE 0911: RANGER CAMPGROUND PARKING

Manual Rating

ADJACENT TO ROUTE 0500 (GREENBELT CAMPGROUND LOOP A)

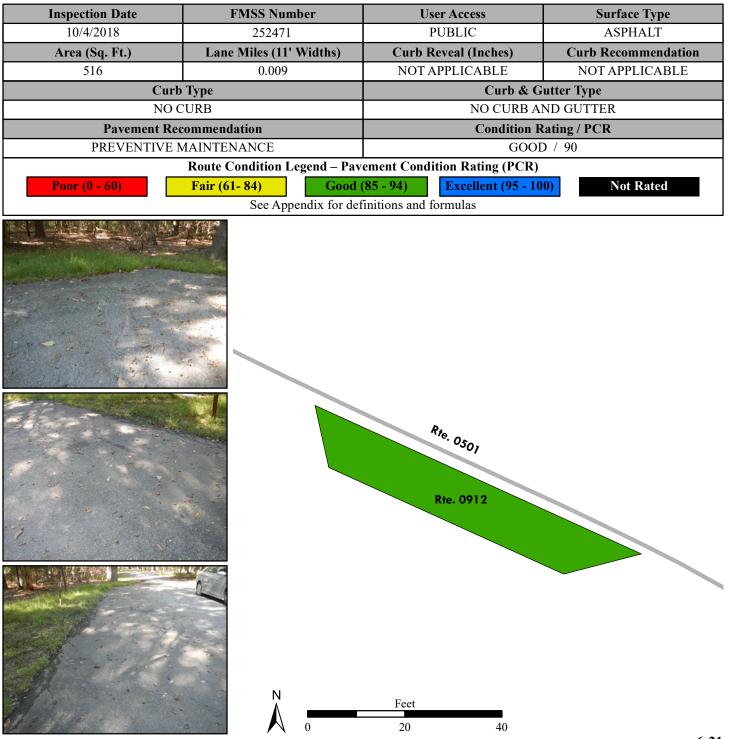
Greenbelt Park ROUTE 0912: CAMPGROUND LOOP B HANDICAP PARKING

Manual Rating

ADJACENT TO ROUTE 0501 (GREENBELT CAMPGROUND LOOP B)
