HALE Cycle 6

Final Report

Road Inventory and Condition Assessments for Haleakala National Park

**Federal Highway Administration
Eastern Federal Lands Highway Division
Road Inventory Program (RIP)**

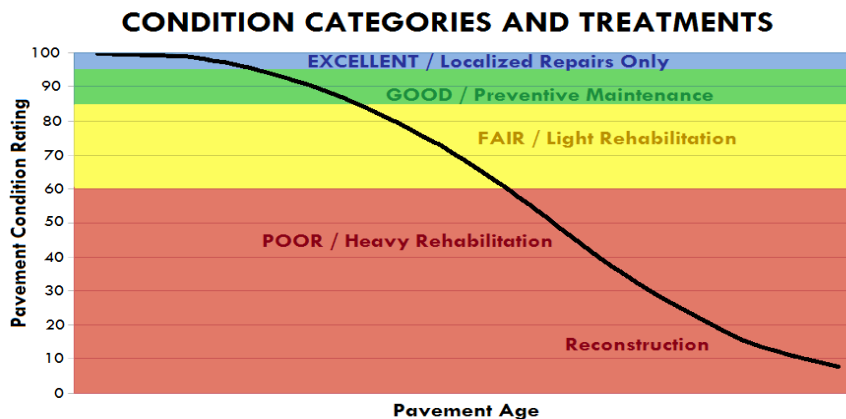
- Excellent / New: PCR of 95-100
 - o Pavements in this range will require only spot repairs
- Good: PCR of 85-94
 - o Pavements in this range will likely be candidates for Preventive Maintenance. Examples include Chip and Slurry Seals, Micro Surfacing and Thin Overlays.
- Fair: PCR of 61-84
 - o Pavements in this range will likely be candidates of Light Rehabilitation (L3R). Examples include singlelift overlays up to 2.5 inches in total thickness, milling and overlays.
- Poor: PCR of 0-60
 - o Pavements in this range will likely be candidates of Heavy Rehabilitation or Reconstruction (H3R or 4R). Examples include Pulverization, Multiple Lift Overlays, and Reconstruction.

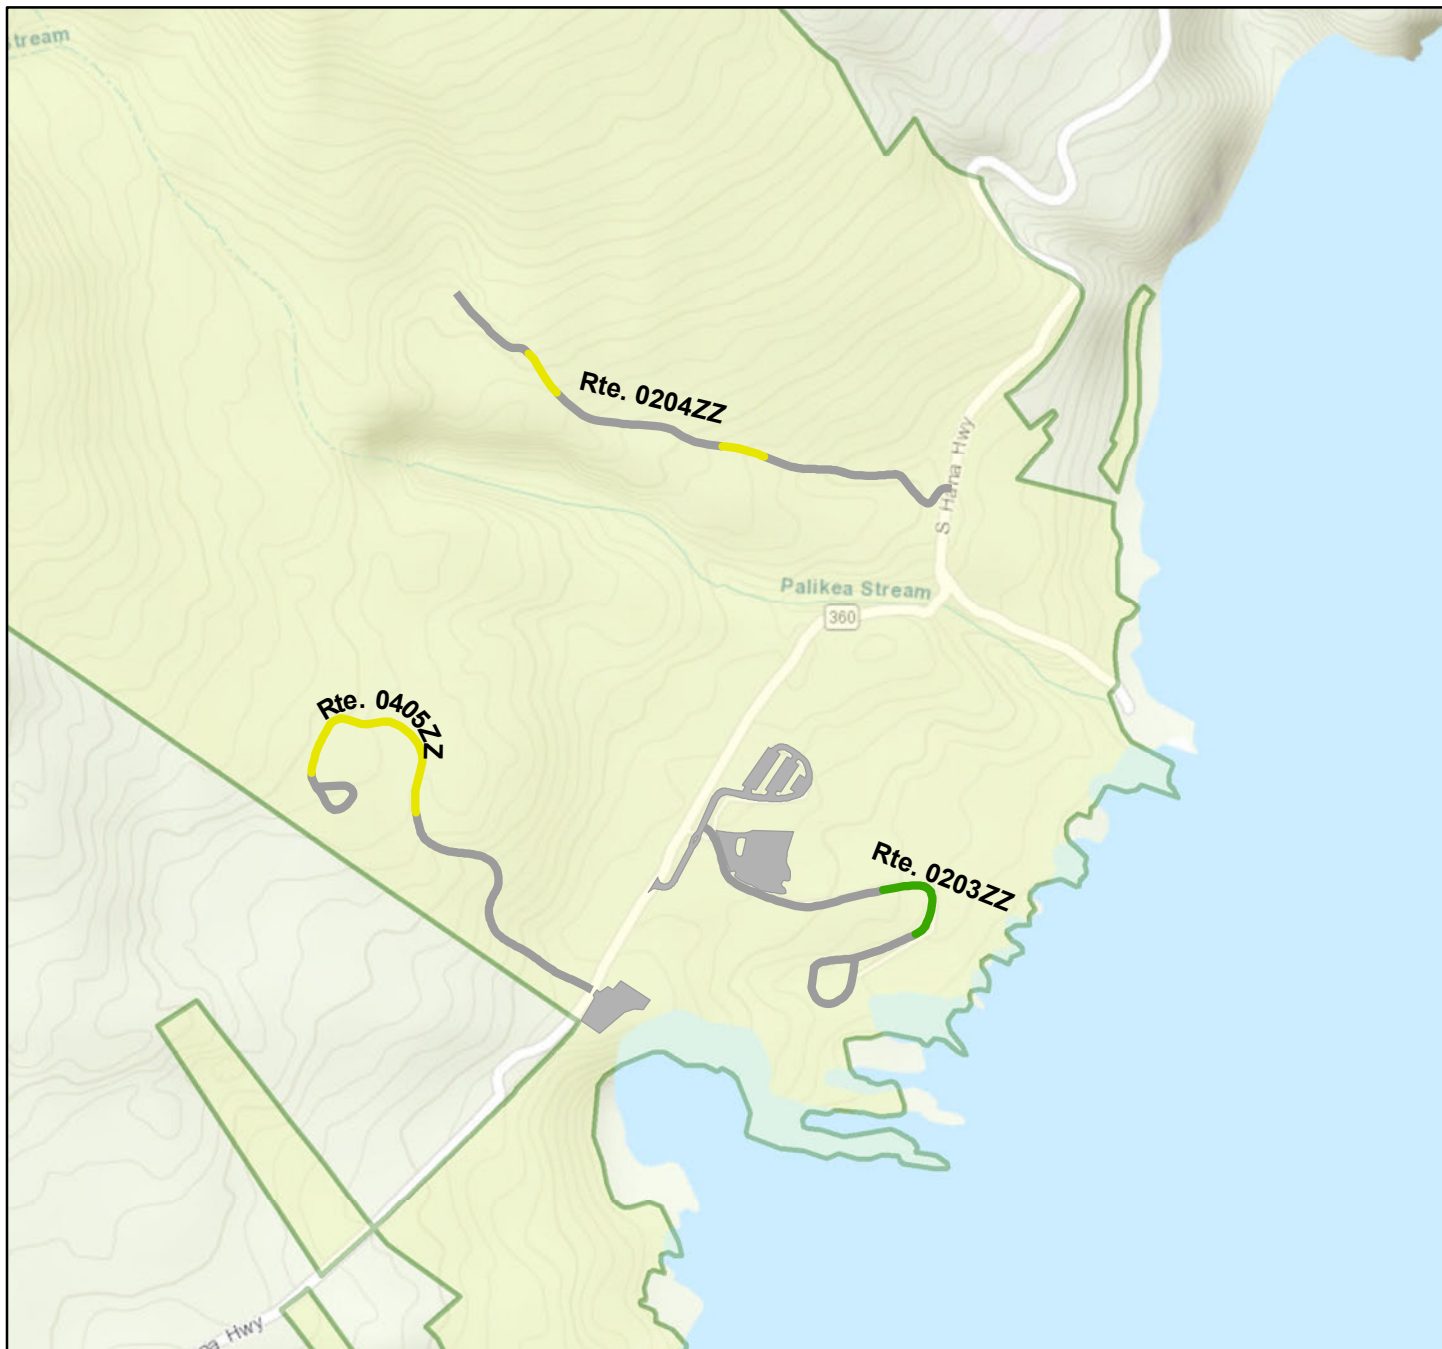
Area Map 2

ROUTE CONDITION MAP

PCR - MILE BY MILE

Colors on map represent condition scores at 1-mile intervals. See Appendix for definitions and formulas
Only Data Collection Vehicle and Manually Rated Roads are displayed

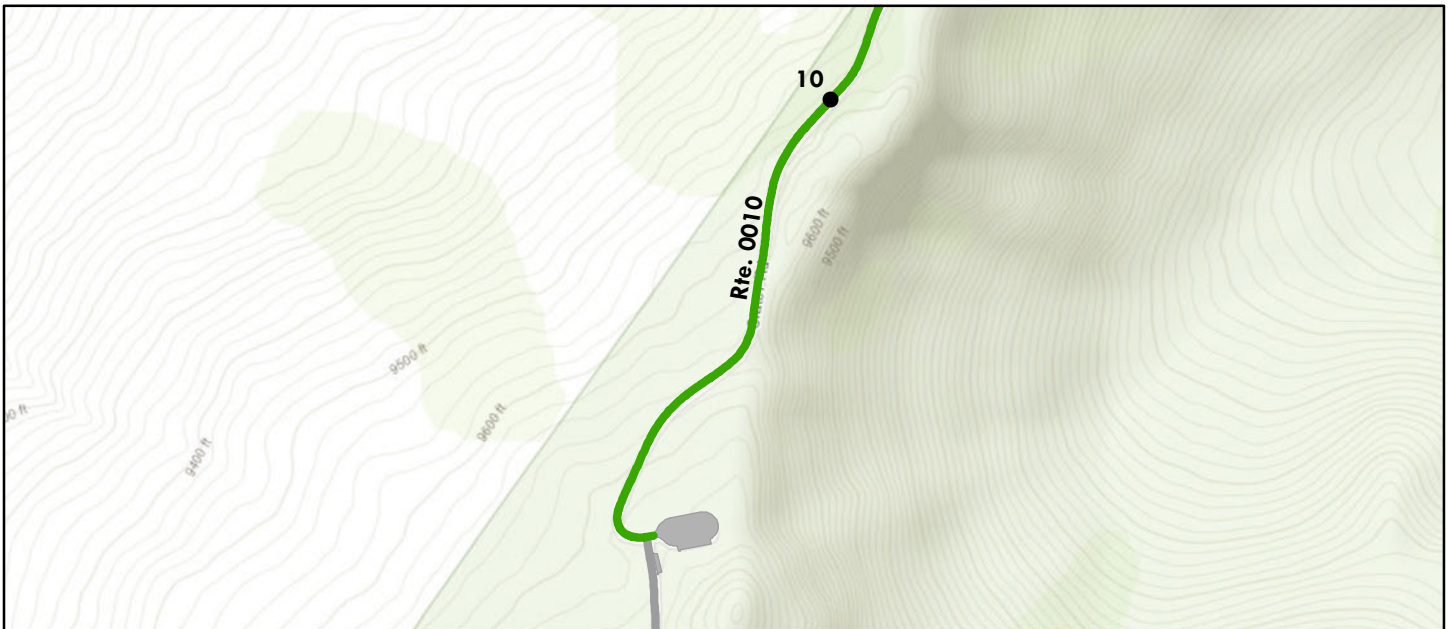
ROUTE 0010: HALEAKALA PARK ROAD

Route Condition Legend – Pavement Condition Rating (PCR)						
Poor (0 - 60)	Fair (61- 84)	Good (85 - 94)	Excellent (95 - 100)	Not Rated		
See Appendix for definitions and formulas						
Inspection Date: 2/28/2022	Beginning Section MP	10.00				
Paved Length (Miles): 10.51	Section Length (MI)	0.51				
Surface Type: ASPHALT	Route Summary					
Roadway Condition Information						
Pavement Condition Rating (PCR)	94	90				
Surface Condition Rating (SCR)	94	90				
Roughness Condition Index (RCI)	N/A	N/A				
Distress Index Values						
Structural Crack Index	N/A	N/A				
Alligator Crack Index	97	97				
Longitudinal Crack Index	96	90				
Transverse Cracking Index	94	90				
Patching Index	96	90				
Rutting Index	97	97				
International Roughness Index (IRI)	N/A	N/A				
Lane & Width Information						
Number of Lanes	2	2				
Paved Width (ft)	21.4	21				
Lane Width (ft)	9	9

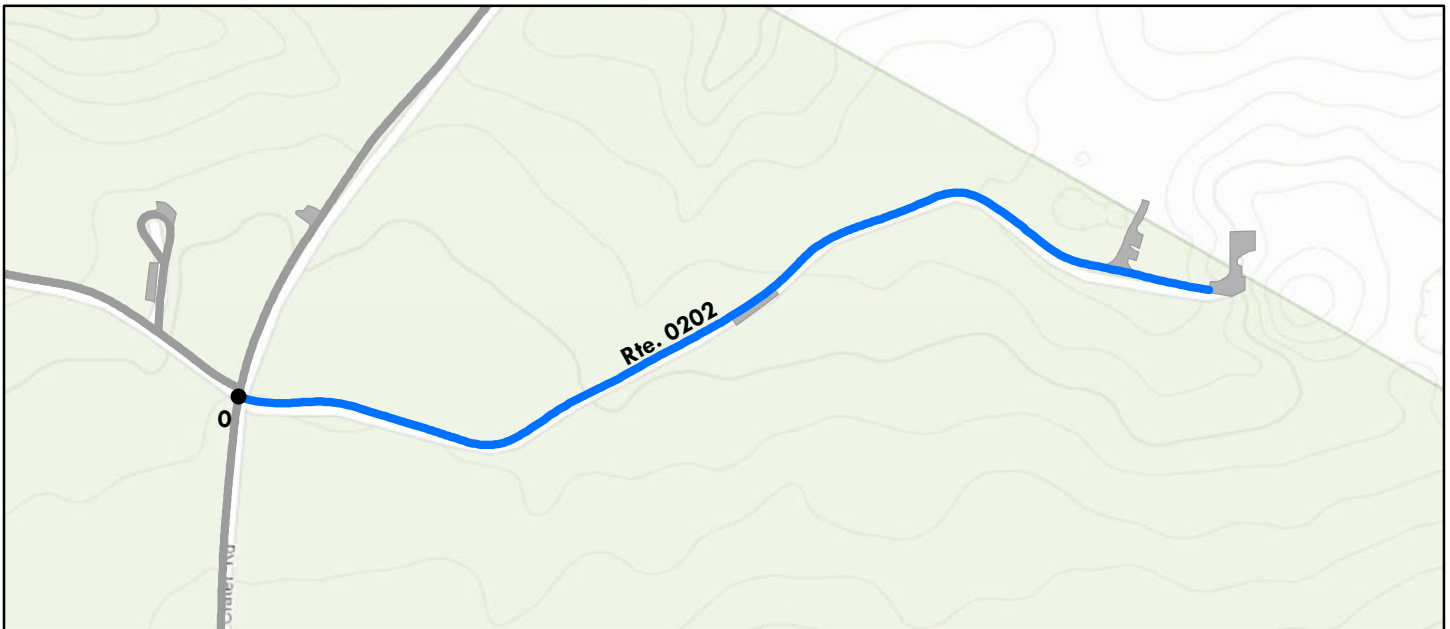
ROUTE 0202: HOSMER GROVE SPUR ROAD

Route Condition Legend – Pavement Condition Rating (PCR)						
Poor (0 - 60)	Fair (61- 84)	Good (85 - 94)	Excellent (95 - 100)	Not Rated		
See Appendix for definitions and formulas						
Inspection Date: 2/28/2022	Beginning Section MP	0.00				
Paved Length (Miles): 0.45	Section Length (MI)	0.45				
Surface Type: ASPHALT	Route Summary					
Roadway Condition Information						
Pavement Condition Rating (PCR)	97	97				
Surface Condition Rating (SCR)	97	97				
Roughness Condition Index (RCI)	N/A	N/A				
Distress Index Values						
Structural Crack Index	N/A	N/A				
Alligator Crack Index	97	97				
Longitudinal Crack Index	97	97				
Transverse Cracking Index	97	97				
Patching Index	97	97				
Rutting Index	97	97				
International Roughness Index (IRI)	N/A	N/A				
Lane & Width Information						
Number of Lanes	2	2				
Paved Width (ft)	17	17				
Lane Width (ft)	8	8

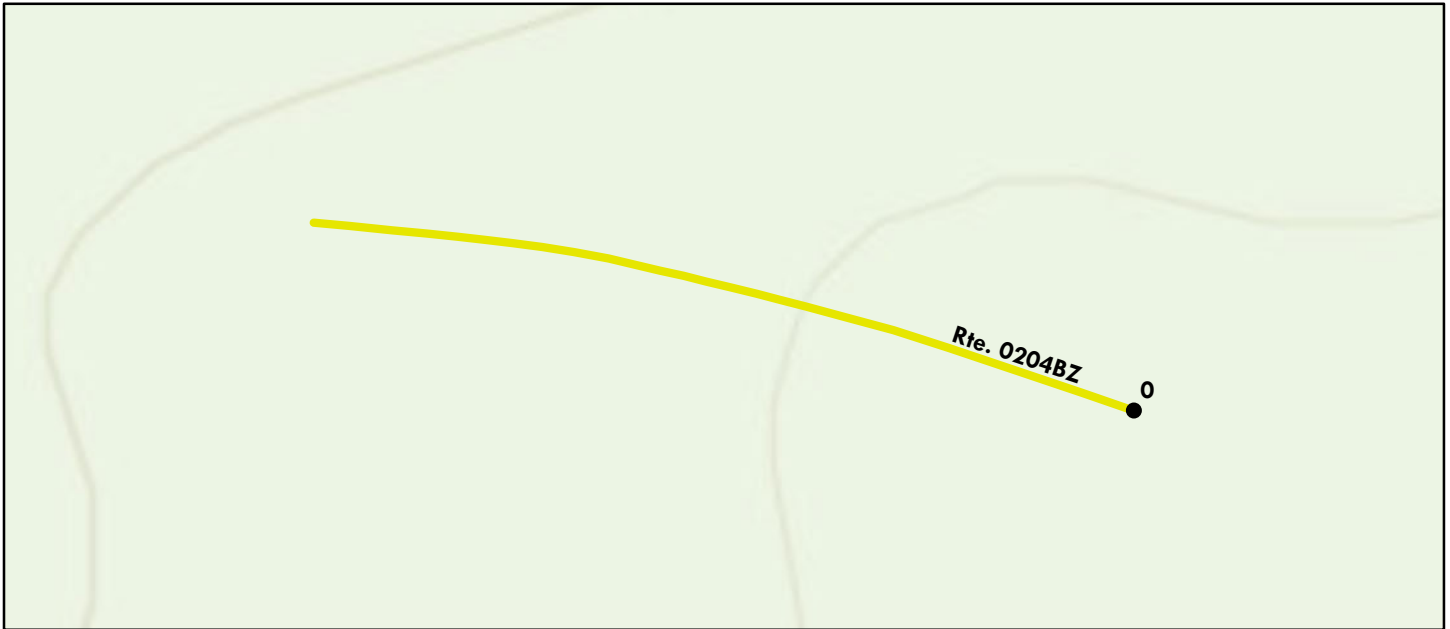
Subcomponent of Route HALE-0204ZZ

Route Condition Legend – Pavement Condition Rating (PCR)						
Poor (0 - 60)	Fair (61- 84)	Good (85 - 94)	Excellent (95 - 100)	Not Rated		
See Appendix for definitions and formulas						
Inspection Date: 3/1/2022	Beginning Section MP	0.00				
Paved Length (Miles): 0.03	Section Length (MI)	0.03				
Surface Type: CONCRETE	Route Summary					
Roadway Condition Information						
Pavement Condition Rating (PCR)	73	73				
Surface Condition Rating (SCR)	73	73				
Roughness Condition Index (RCI)	N/A	N/A				
Distress Index Values						
Structural Crack Index	N/A	N/A				
Alligator Crack Index	N/A	N/A				
Longitudinal Crack Index	N/A	N/A				
Transverse Cracking Index	N/A	N/A				
Patching Index	N/A	N/A				
Rutting Index	N/A	N/A				
International Roughness Index (IRI)	N/A	N/A				
Lane & Width Information						
Number of Lanes	1	1				
Paved Width (ft)	10	10				
Lane Width (ft)	10	10

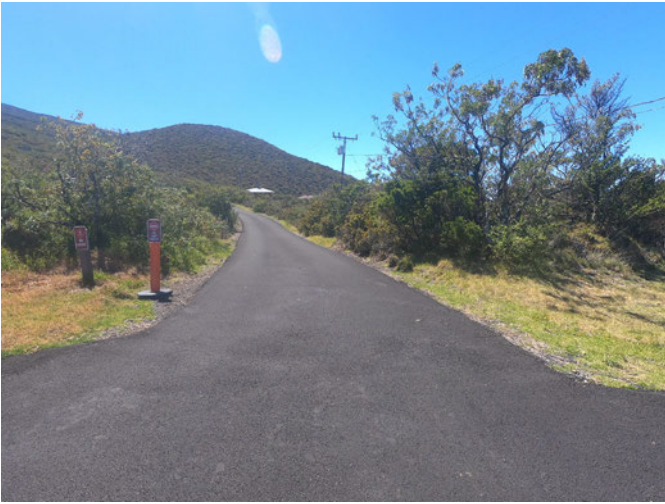
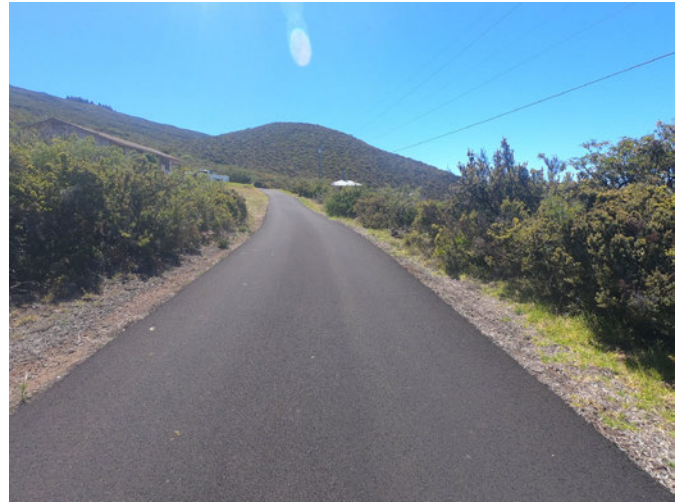
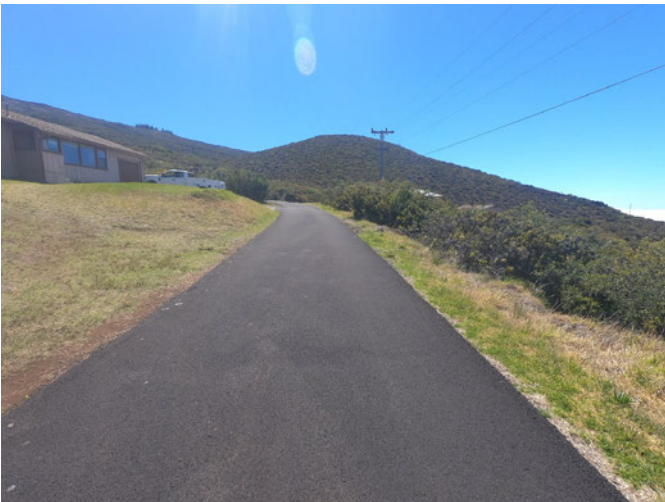
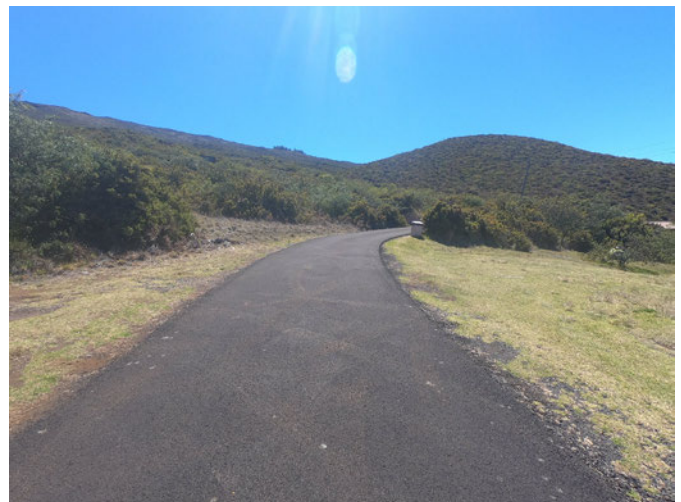
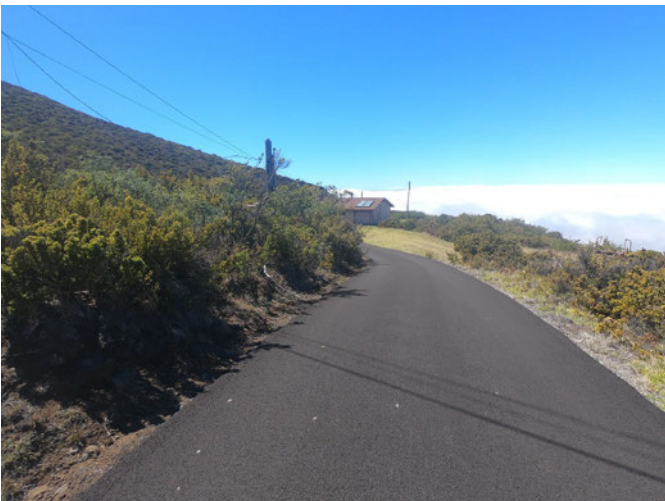
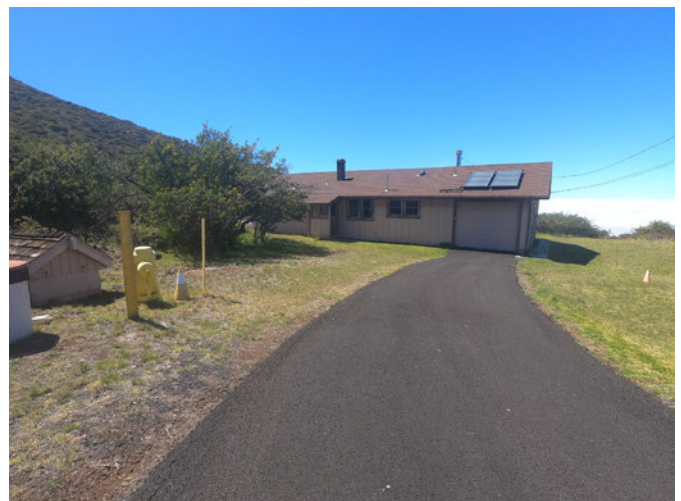
Condition Photos

HALE_0400_0.000.jpg

HALE_0400_0.017.jpg

HALE_0400_0.034.jpg

HALE_0400_0.062.jpg

HALE_0400_0.087.jpg

HALE_0400_0.113.jpg

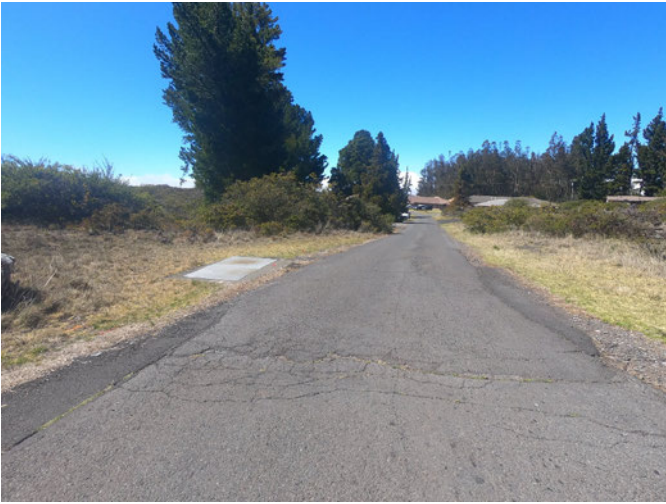
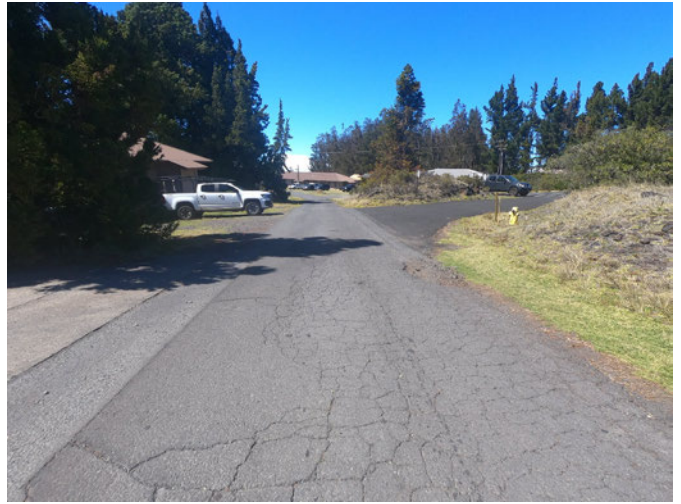
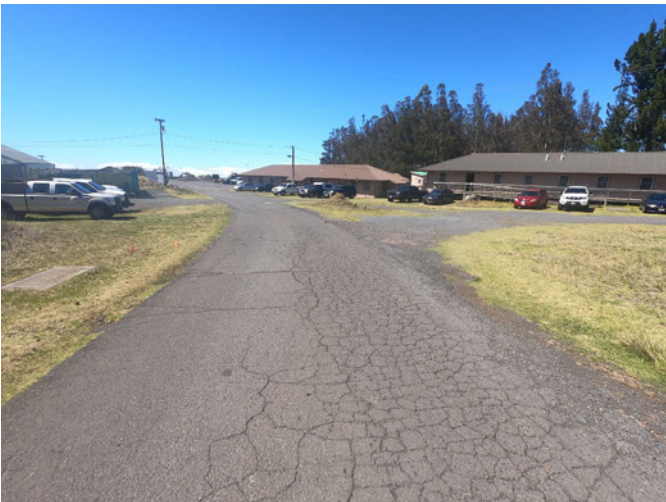
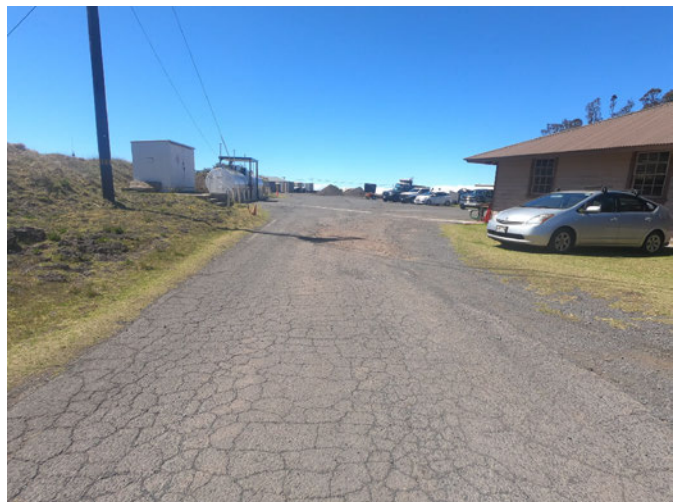
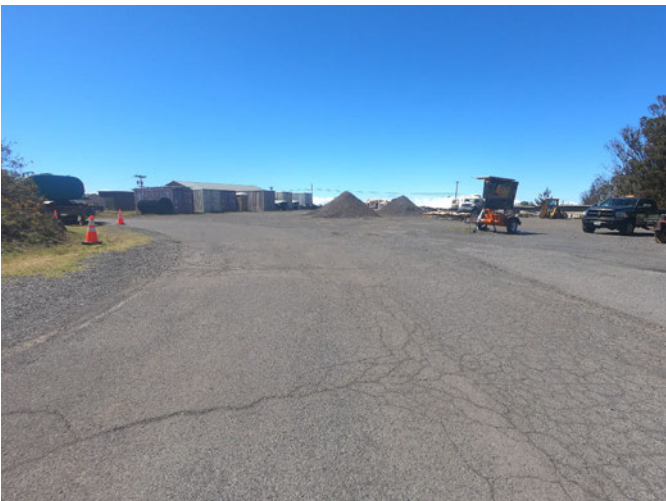
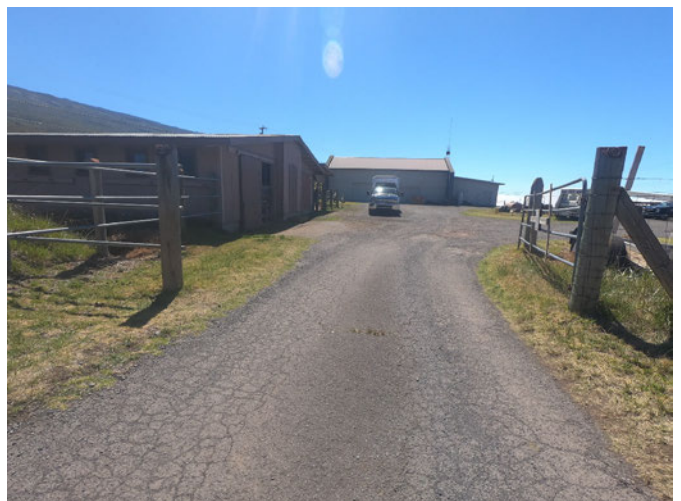
Condition Photos

HALE_0401_0.010.jpg

HALE_0401_0.038.jpg

HALE_0401_0.068.jpg

HALE_0401_0.101.jpg

HALE_0401_0.126.jpg

HALE_0401_0.147.jpg

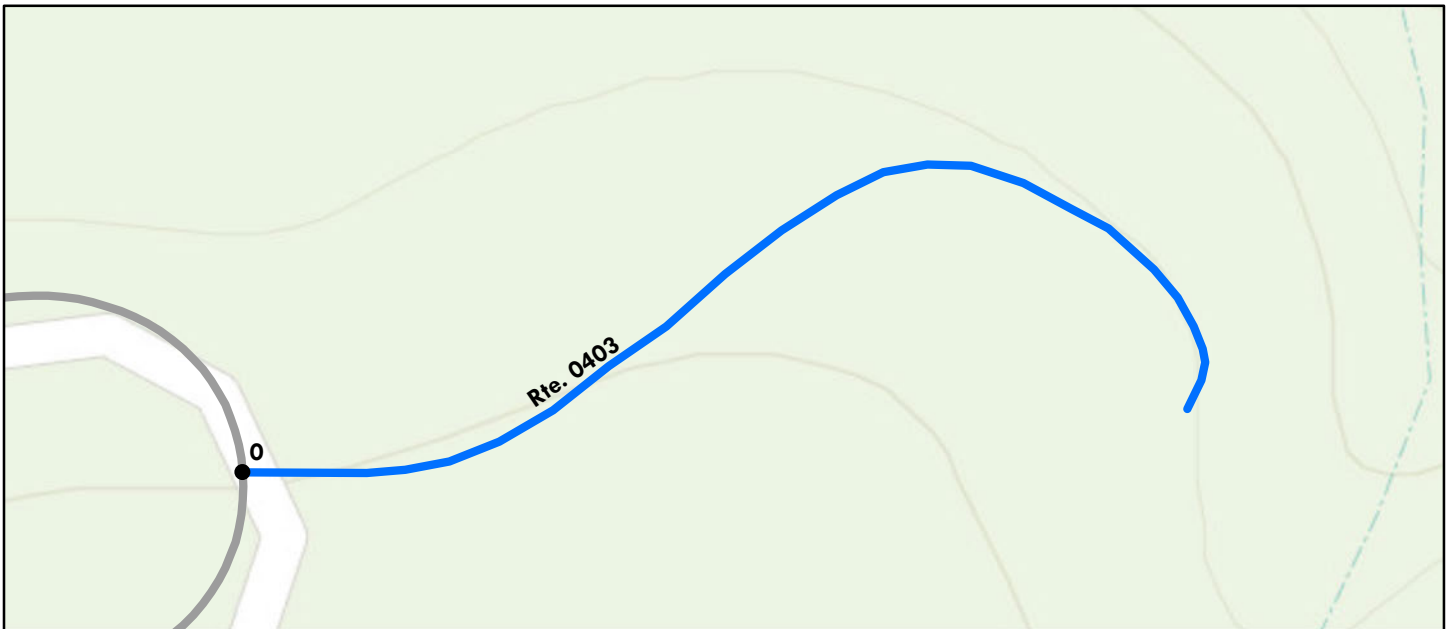
ROUTE 0403: RAIN SHED SERVICE ROAD

Route Condition Legend – Pavement Condition Rating (PCR)						
Poor (0 - 60)	Fair (61- 84)	Good (85 - 94)	Excellent (95 - 100)	Not Rated		
See Appendix for definitions and formulas						
Inspection Date: 2/28/2022	Beginning Section MP	0.00				
Paved Length (Miles): 0.09	Section Length (MI)	0.09				
Surface Type: ASPHALT	Route Summary					
Roadway Condition Information						
Pavement Condition Rating (PCR)	97	97				
Surface Condition Rating (SCR)	97	97				
Roughness Condition Index (RCI)	N/A	N/A				
Distress Index Values						
Structural Crack Index	N/A	N/A				
Alligator Crack Index	97	97				
Longitudinal Crack Index	97	97				
Transverse Cracking Index	97	97				
Patching Index	97	97				
Rutting Index	97	97				
International Roughness Index (IRI)	N/A	N/A				
Lane & Width Information						
Number of Lanes	1	1				
Paved Width (ft)	11	11				
Lane Width (ft)	11	11

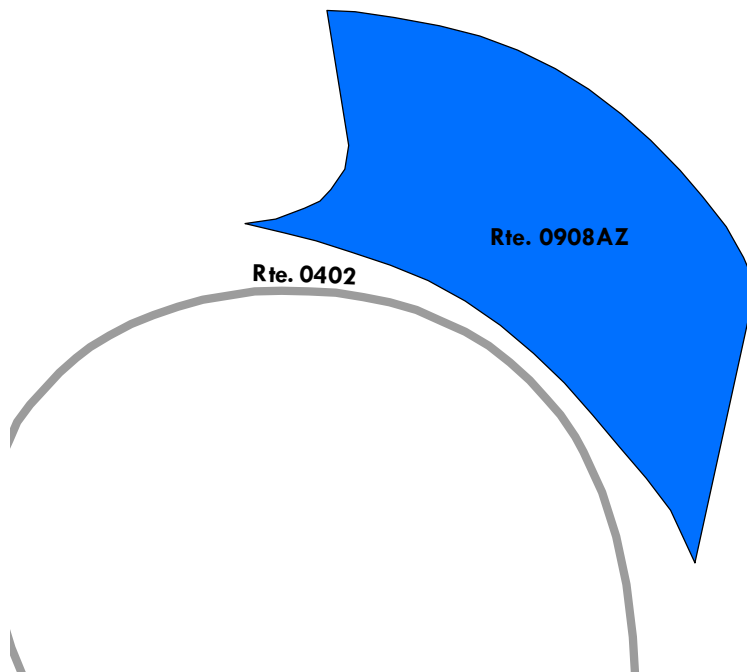
ROUTE 0908AZ: PU'U NIANIAU RESIDENCE PARKING

Inspection Date	FMSS Number	User Access	Surface Type
2/28/2022	102613	NONPUBLIC	ASPHALT
Area (Sq. Ft.)	Lane Miles (11' Widths)	Curb Reveal (Inches)	Curb Recommendation
1,311	0.023	NOT APPLICABLE	NOT APPLICABLE
Curb Type		Curb & Gutter Type	
NO CURB		NO CURB AND GUTTER	
Pavement Recommendation		Condition Rating / PCR	
DO NOTHING		EXCELLENT / 97
