Road Inventory and Condition Assessment of Paved Routes Hawaii Volcanoes National Park

**Federal Lands Highway
Road Inventory Program**

**Federal Highway Administration
Eastern Federal Lands Highway Division
Road Inventory Program (RIP)**

Report Date: December 2022

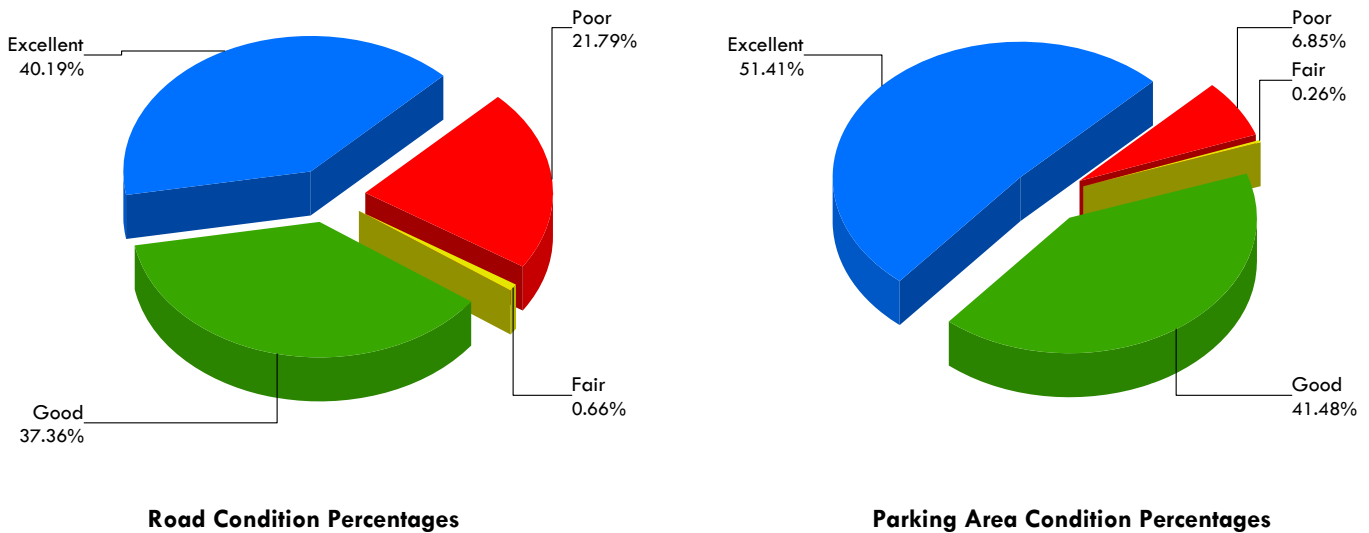
Figure 1: Pavement Condition Rating Breakdown for Paved Roads and Parking Areas

The Road Inventory Program aims to provide assistance in translating the excellent / good / fair / poor rating categories into pavement needs categories. The PCR can be used to indicate the place in the Pavement Life Cycle and the type of treatments that should be considered now and into the future.

- Excellent / New: PCR of 95-100
 - Pavements in this range will require only spot repairs
- Good: PCR of 85-94
 - Pavements in this range will likely be candidates for Preventive Maintenance. Examples include Chip and Slurry Seals, Micro Surfacing and Thin Overlays.
- Fair: PCR of 61-84
 - Pavements in this range will likely be candidates of Light Rehabilitation (L3R). Examples include singlelift overlays up to 2.5 inches in total thickness, milling and overlays.
- Poor: PCR of 0-60
 - Pavements in this range will likely be candidates of Heavy Rehabilitation or Reconstruction (H3R or 4R). Examples include Pulverization, Multiple Lift Overlays, and Reconstruction.

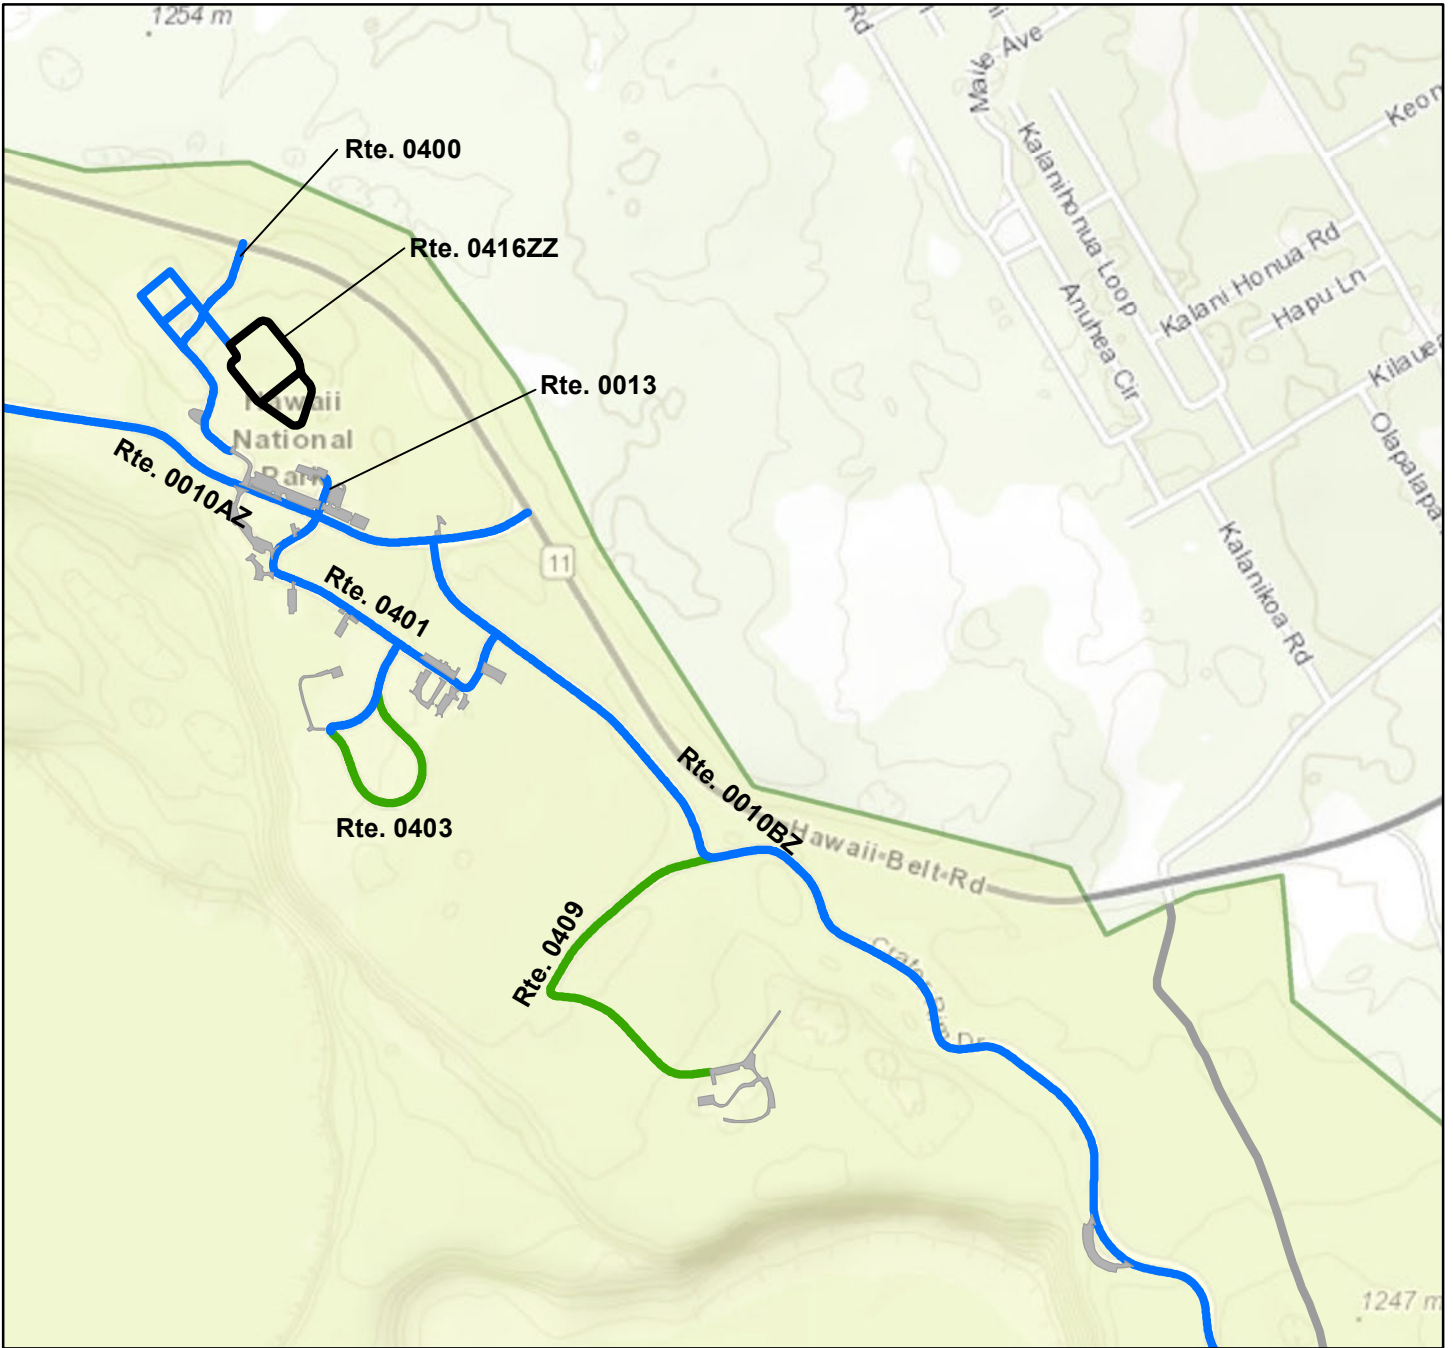
Area Map 1A

ROUTE CONDITION MAP

PCR - MILE BY MILE

Colors on map represent condition scores at 1-mile intervals. See Appendix for definitions and formulas
Only Data Collection Vehicle and Manually Rated Roads are displayed

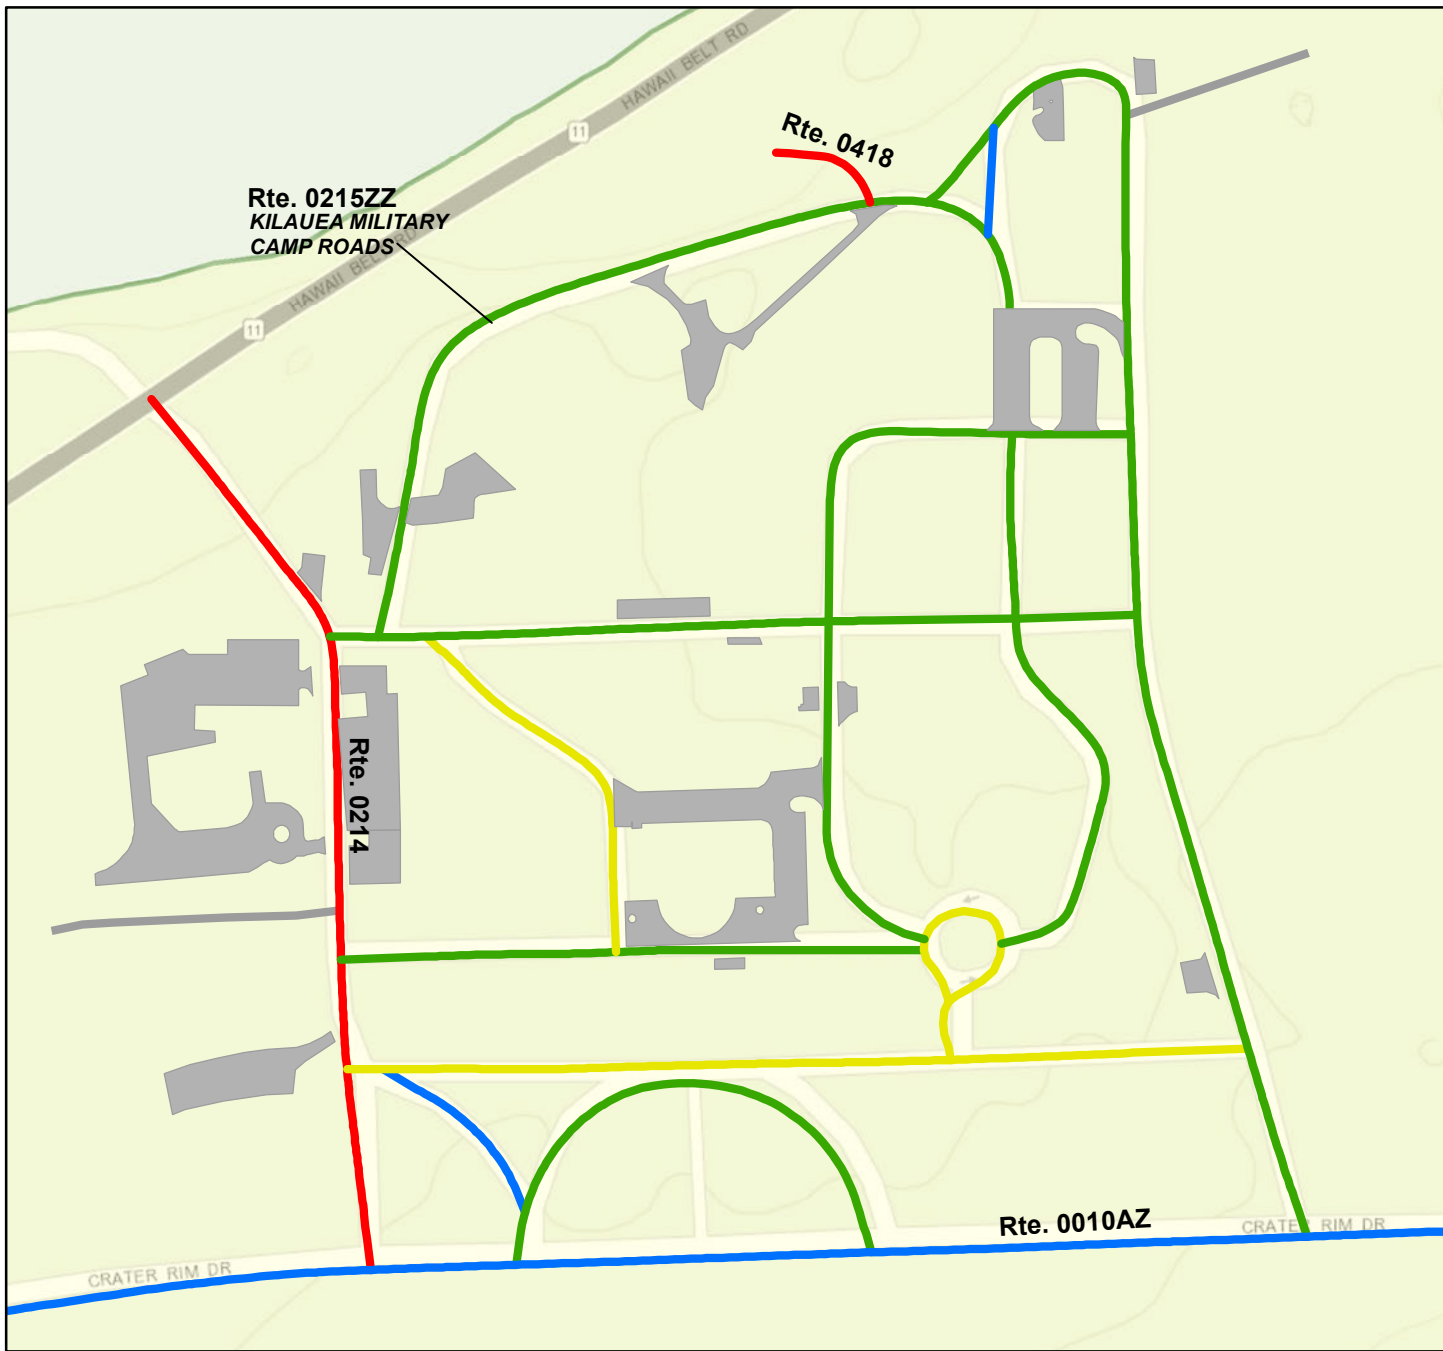
Area Map 1B

ROUTE CONDITION MAP

PCR - MILE BY MILE

Colors on map represent condition scores at 1-mile intervals. See Appendix for definitions and formulas
Only Data Collection Vehicle and Manually Rated Roads are displayed

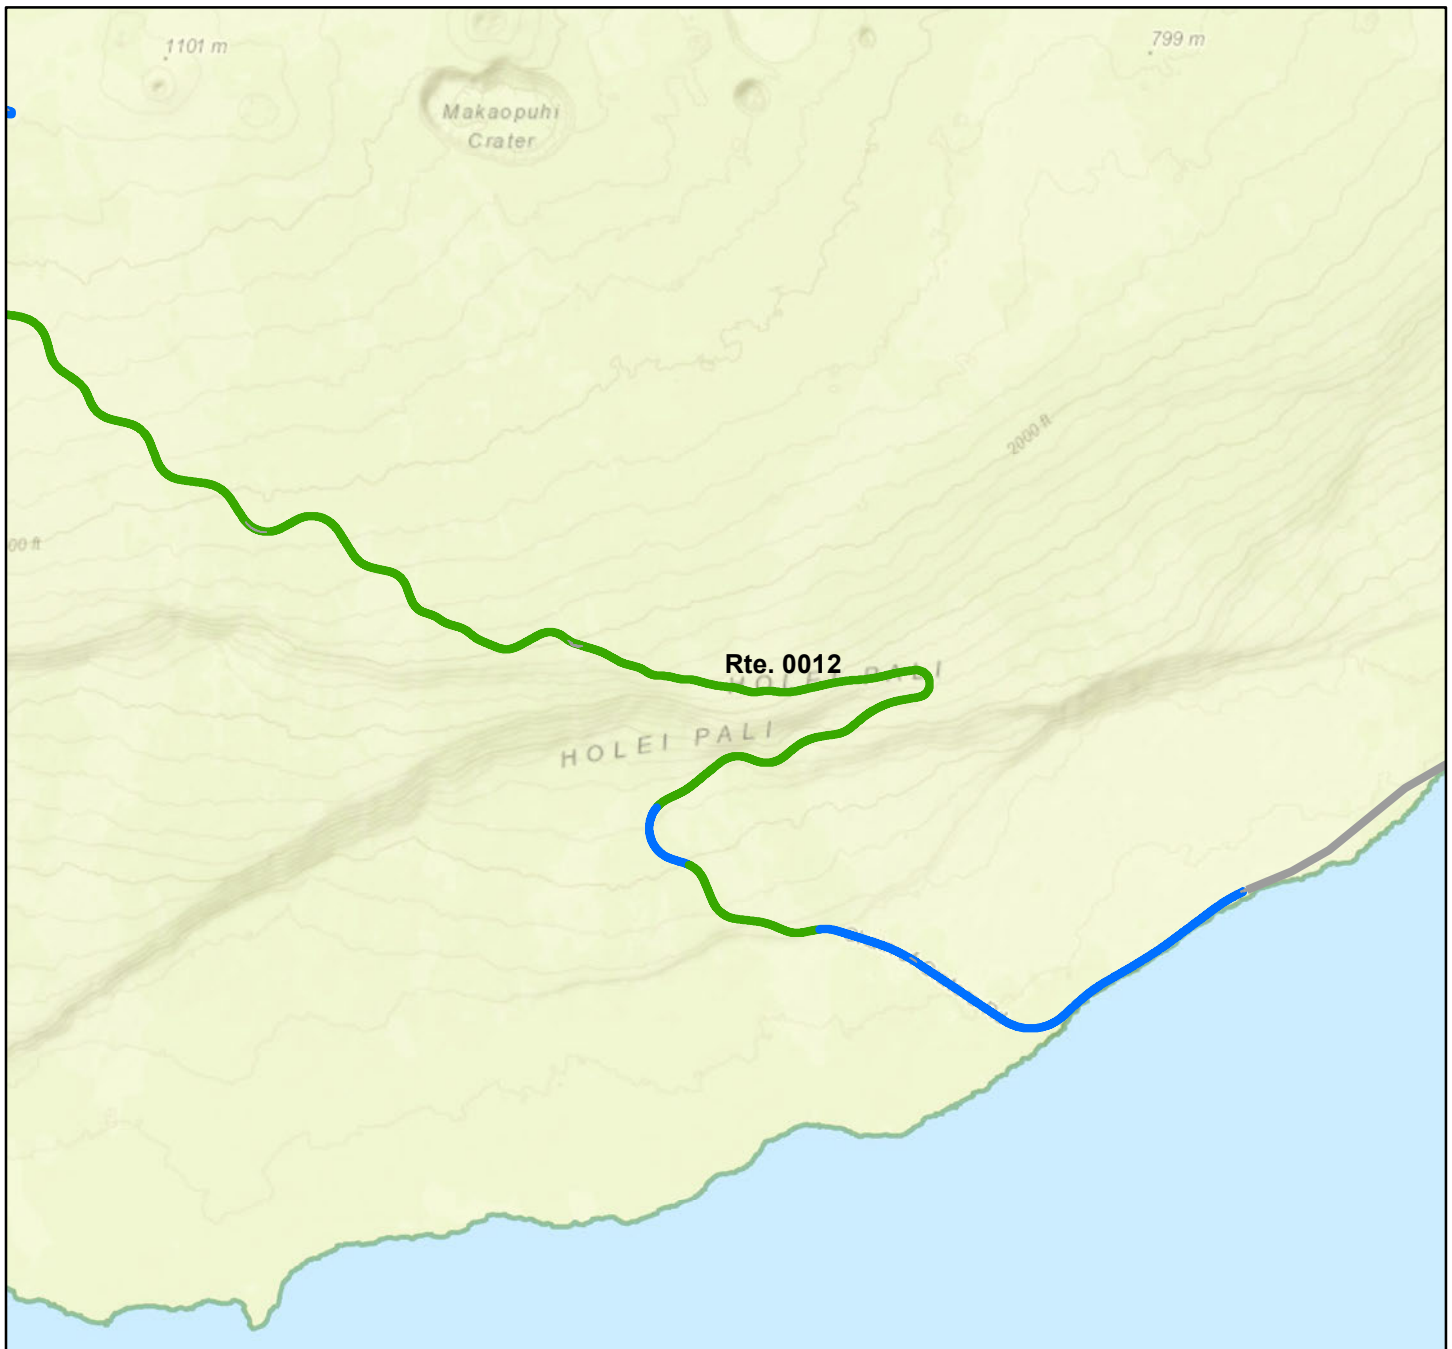
Area Map 3

ROUTE CONDITION MAP

PCR - MILE BY MILE

Colors on map represent condition scores at 1-mile intervals. See Appendix for definitions and formulas
Only Data Collection Vehicle and Manually Rated Roads are displayed

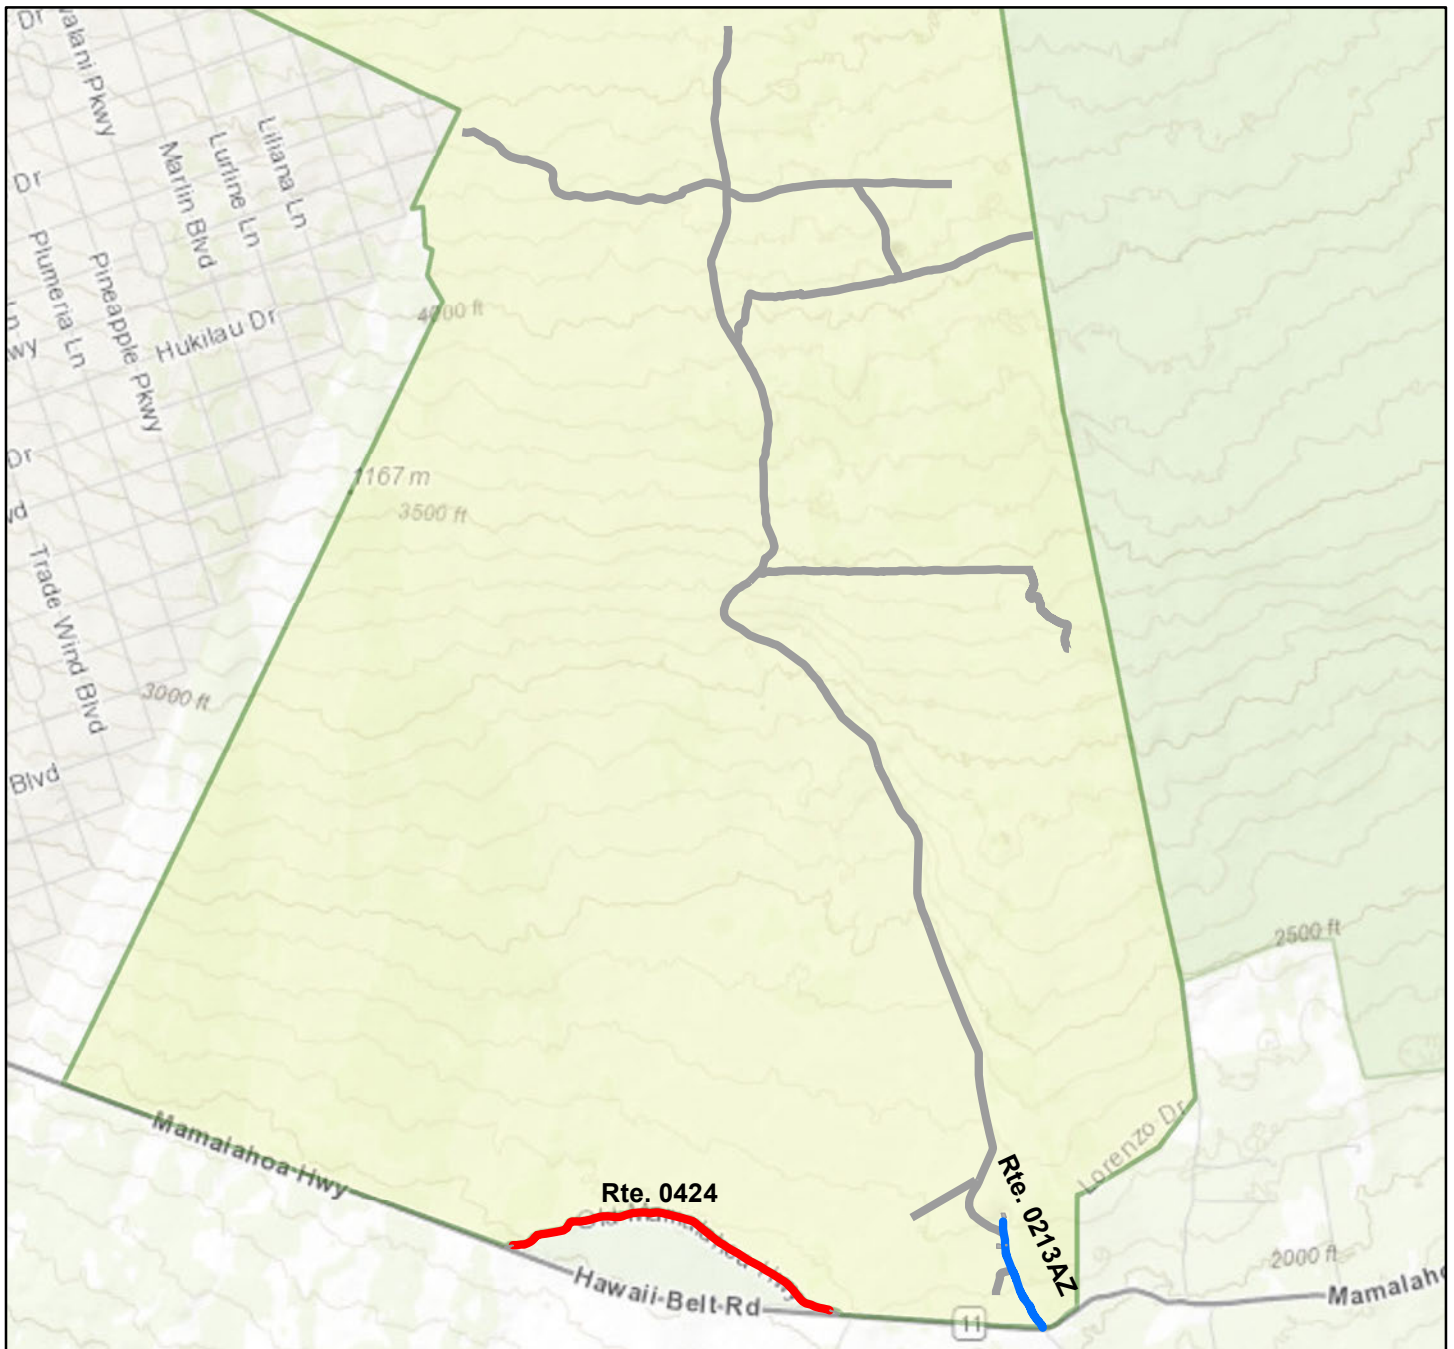
Area Map 5

ROUTE CONDITION MAP

PCR - MILE BY MILE

Colors on map represent condition scores at 1-mile intervals. See Appendix for definitions and formulas
 Only Data Collection Vehicle and Manually Rated Roads are displayed

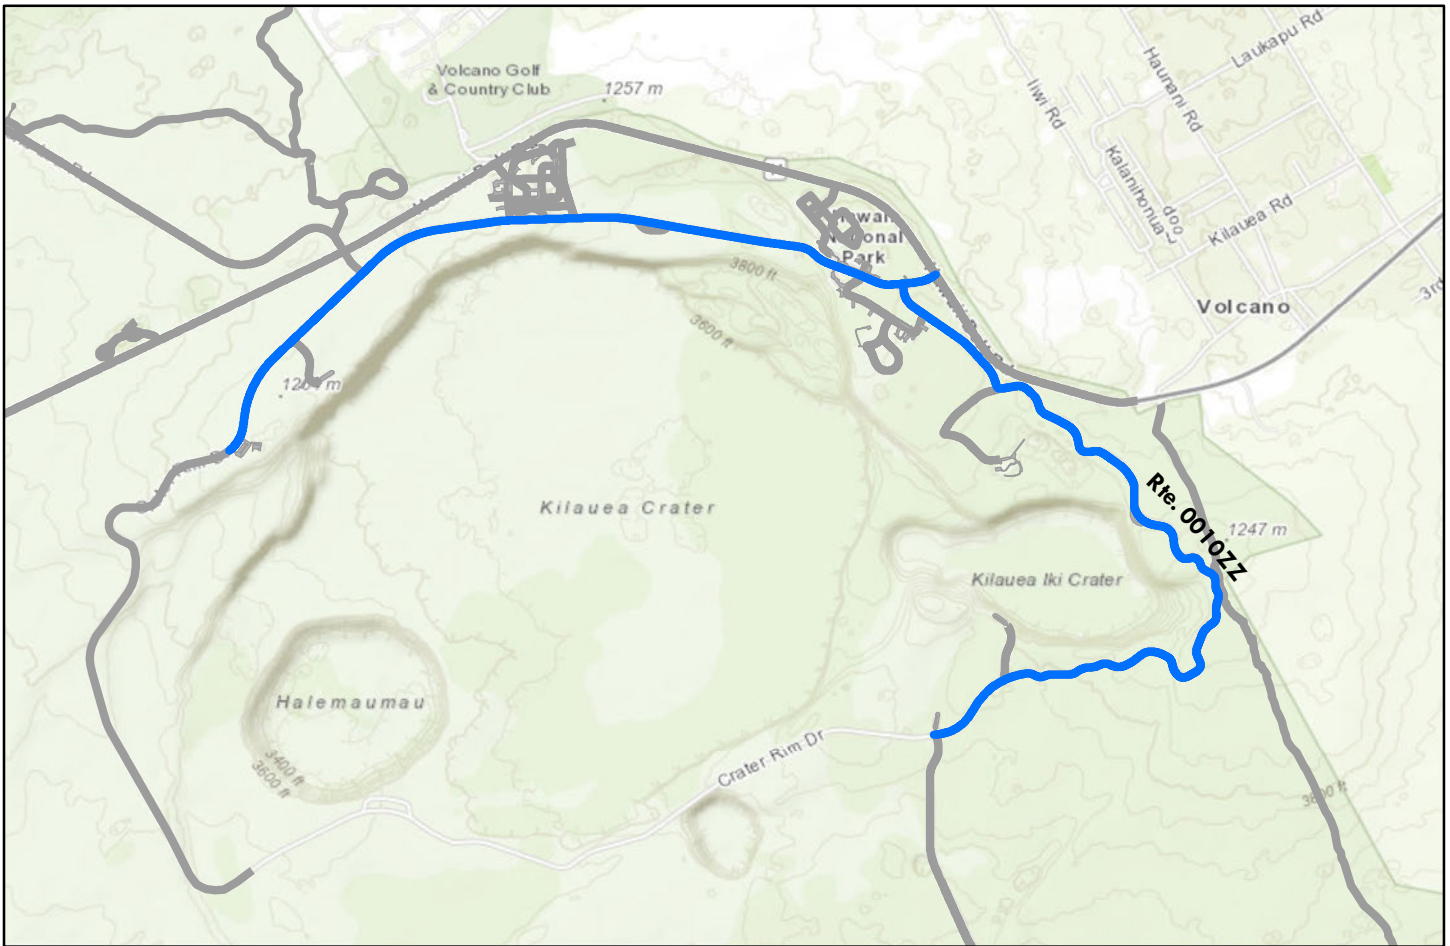
ROUTE 0010ZZ: CRATER RIM DRIVE

Summary Route

Note: The weighted average summary PCR value is calculated from only the sections of road where the PCR was collected. The overall PCR for the summary route may not reflect individual subcomponent ratings.

Inspection Date: 3/8/2022						
Paved Length (Miles): 5.89						
Surface Type: ASPHALT	Route Summary					
Roadway Condition Information						
Pavement Condition Rating (PCR)	95					
Lane & Width Information						
Number of Lanes	2					
Paved Width (ft)	22.3					
Lane Width (ft)	10

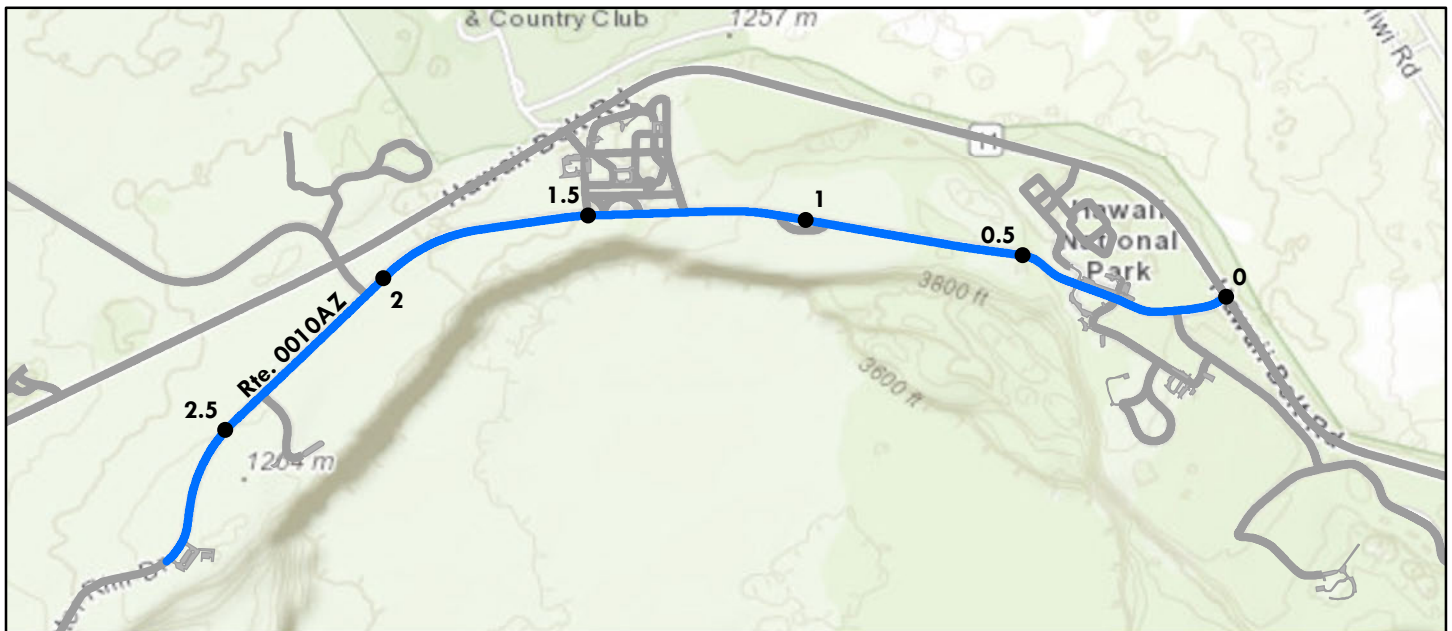
Subcomponent of Route HAVO-0010ZZ

Manual Rating

Inspection Date:	3/8/2022	Beginning Section MP	0.00	0.50	1.00	1.50	2.00
		Paved Length (Miles):	2.83	Section Length (MI)	0.50	0.50	0.50
Surface Type:	ASPHALT	Route Summary					
Roadway Condition Information							
Pavement Condition Rating (PCR)	97	97	97	97	97	97	97
Surface Condition Rating (SCR)	97	97	97	97	97	97	97
Roughness Condition Index (RCI)	N/A	N/A	N/A	N/A	N/A	N/A	N/A
Distress Index Values							
Structural Crack Index	N/A	N/A	N/A	N/A	N/A	N/A	N/A
Alligator Crack Index	97	97	97	97	97	97	97
Longitudinal Crack Index	97	97	97	97	97	97	97
Transverse Cracking Index	97	97	97	97	97	97	97
Patching Index	97	97	97	97	97	97	97
Rutting Index	97	97	97	97	97	97	97
International Roughness Index (IRI)	N/A	N/A	N/A	N/A	N/A	N/A	N/A
Lane & Width Information							
Number of Lanes	2	2	2	2	2	2	2
Paved Width (ft)	22	22	22	22	22	22	22
Lane Width (ft)	10	10	10	10	10	10	10

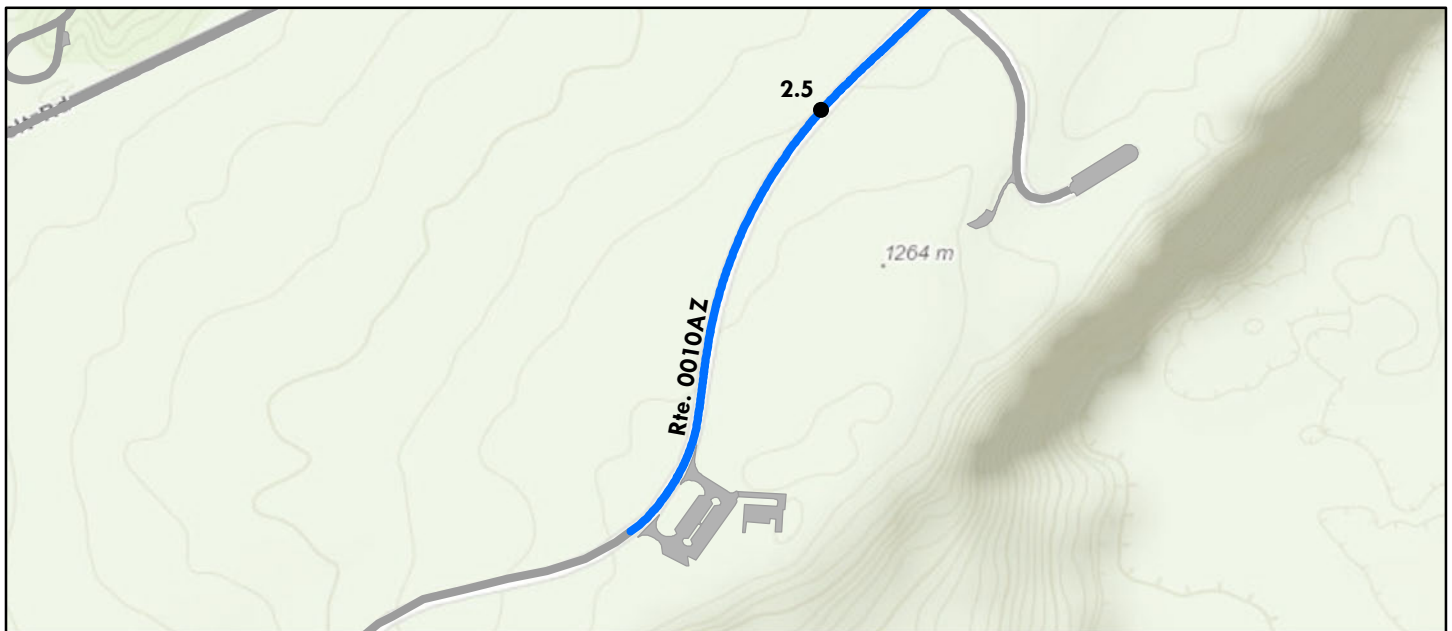
Subcomponent of Route HAVO-0010ZZ

Manual Rating

Inspection Date: 3/8/2022	Beginning Section MP	2.50				
Paved Length (Miles): 2.83	Section Length (MI)	0.33				
Surface Type: ASPHALT	Route Summary					
Roadway Condition Information						
Pavement Condition Rating (PCR)	97	97				
Surface Condition Rating (SCR)	97	97				
Roughness Condition Index (RCI)	N/A	N/A				
Distress Index Values						
Structural Crack Index	N/A	N/A				
Alligator Crack Index	97	97				
Longitudinal Crack Index	97	97				
Transverse Cracking Index	97	97				
Patching Index	97	97				
Rutting Index	97	97				
International Roughness Index (IRI)	N/A	N/A				
Lane & Width Information						
Number of Lanes	2	2				
Paved Width (ft)	22	22				
Lane Width (ft)	10	10

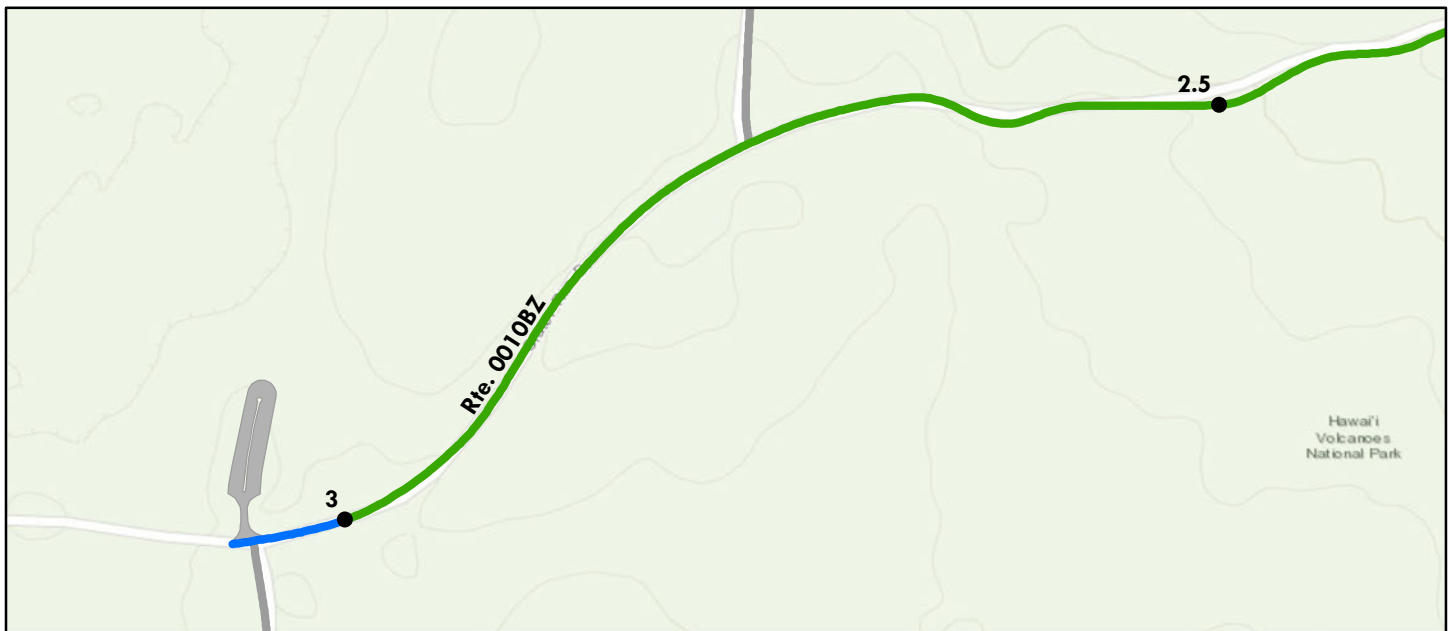
Subcomponent of Route HAVO-0010ZZ

Manual Rating

Inspection Date: 3/8/2022	Beginning Section MP	2.50	3.00			
Paved Length (Miles): 3.06	Section Length (MI)	0.50	0.06			
Surface Type: ASPHALT	Route Summary					
Roadway Condition Information						
Pavement Condition Rating (PCR)	94	90	97			
Surface Condition Rating (SCR)	94	90	97			
Roughness Condition Index (RCI)	N/A	N/A	N/A			
Distress Index Values						
Structural Crack Index	N/A	N/A	N/A			
Alligator Crack Index	97	97	97			
Longitudinal Crack Index	97	97	97			
Transverse Cracking Index	94	90	97			
Patching Index	97	97	97			
Rutting Index	97	97	97			
International Roughness Index (IRI)	N/A	N/A	N/A			
Lane & Width Information						
Number of Lanes	2	2	2			
Paved Width (ft)	22.5	22	22			
Lane Width (ft)	10	10	10

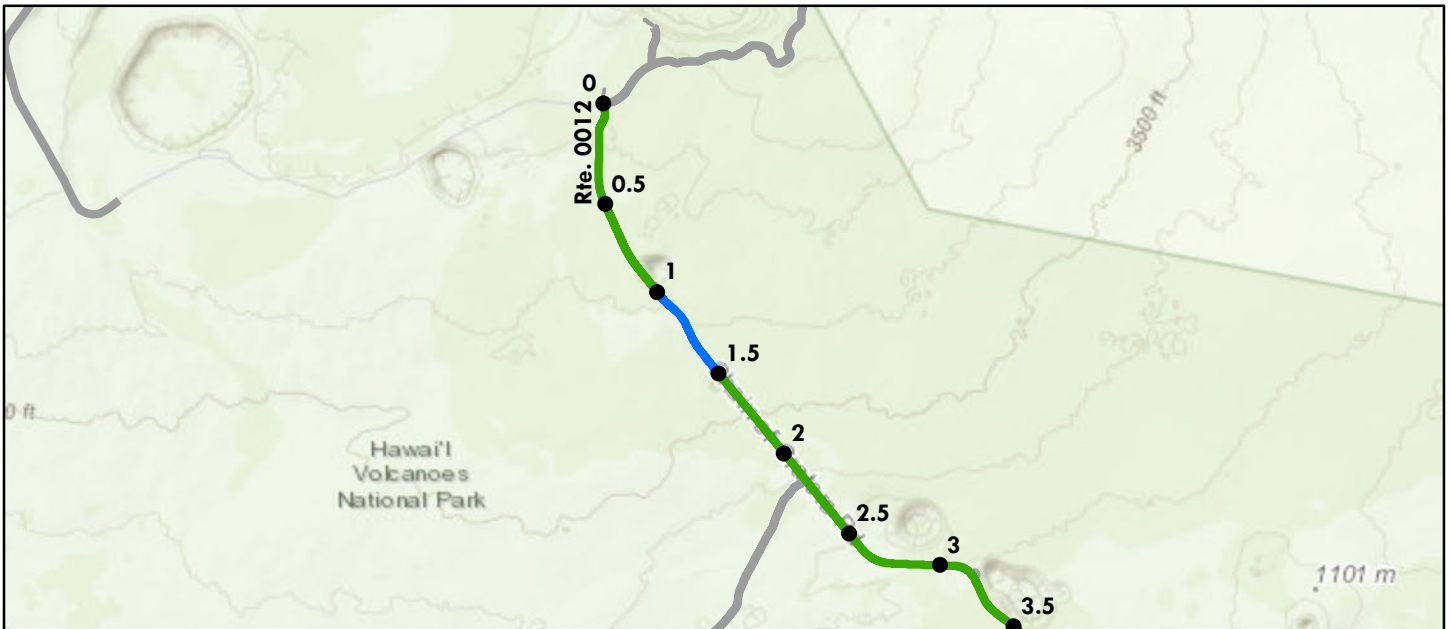
Manual Rating

ROUTE 0012: CHAIN OF CRATERS ROAD

Inspection Date:	3/8/2022	Beginning Section MP	0.00	0.50	1.00	1.50	2.00
Paved Length (Miles):	18.56	Section Length (MI)	0.50	0.50	0.50	0.50	0.50
Surface Type:	ASPHALT	Route Summary					
Roadway Condition Information							
Pavement Condition Rating (PCR)	92	90	90	97	90	90	
Surface Condition Rating (SCR)	92	90	90	97	90	90	
Roughness Condition Index (RCI)	N/A	N/A	N/A	N/A	N/A	N/A	
Distress Index Values							
Structural Crack Index	N/A	N/A	N/A	N/A	N/A	N/A	
Alligator Crack Index	97	97	97	97	97	97	
Longitudinal Crack Index	96	97	97	97	97	97	
Transverse Cracking Index	92	90	90	97	90	90	
Patching Index	97	97	97	97	97	97	
Rutting Index	97	97	97	97	97	97	
International Roughness Index (IRI)	N/A	N/A	N/A	N/A	N/A	N/A	
Lane & Width Information							
Number of Lanes	2	2	2	2	2	2	
Paved Width (ft)	22	22	22	22	22	22	
Lane Width (ft)	10	10	10	10	10	10

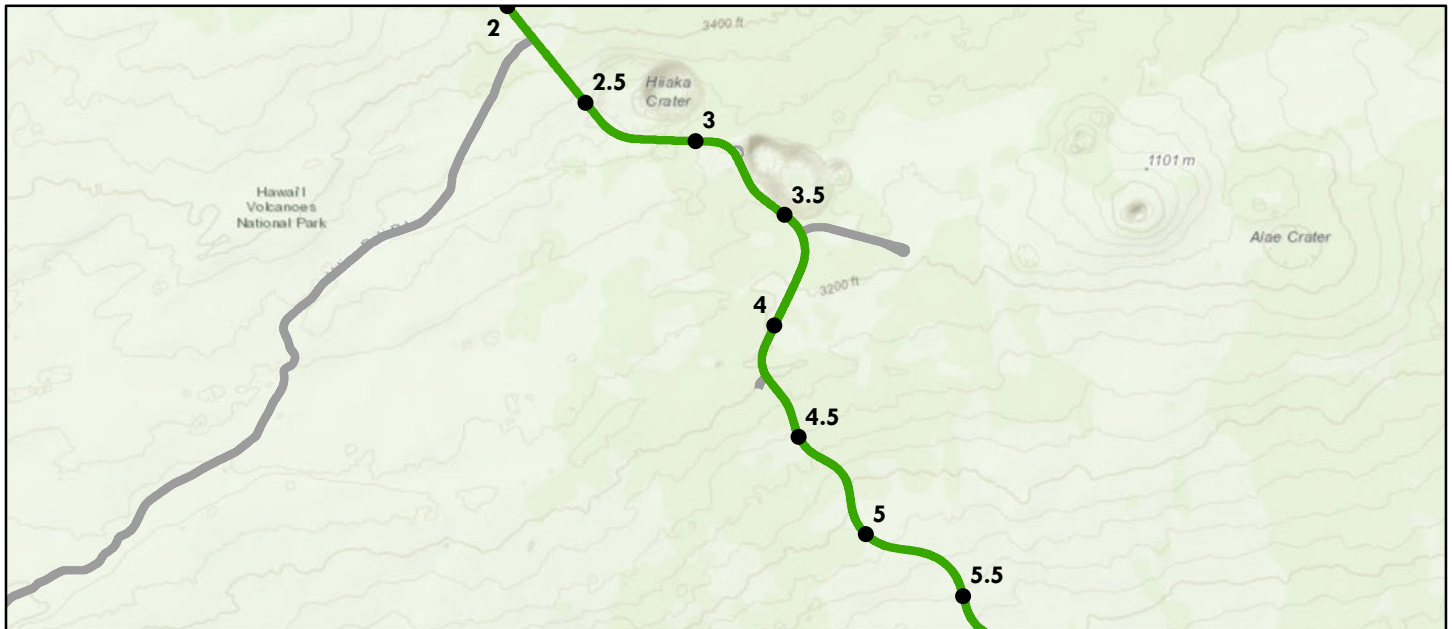
Manual Rating

ROUTE 0012: CHAIN OF CRATERS ROAD

Beginning Section MP	2.50	3.00	3.50	4.00	4.50
Inspection Date:	3/8/2022	Section Length (MI)	0.50	0.50	0.50	0.50	0.50
Paved Length (Miles):	18.56	Route Summary					
Surface Type:	ASPHALT						
Roadway Condition Information							
Pavement Condition Rating (PCR)	92	90	90	90	90	90	90
Surface Condition Rating (SCR)	92	90	90	90	90	90	90
Roughness Condition Index (RCI)	N/A	N/A	N/A	N/A	N/A	N/A	N/A
Distress Index Values							
Structural Crack Index	N/A	N/A	N/A	N/A	N/A	N/A	N/A
Alligator Crack Index	97	97	97	97	97	97	97
Longitudinal Crack Index	96	90	90	90	97	90	90
Transverse Cracking Index	92	90	90	90	90	90	90
Patching Index	97	97	97	97	97	97	97
Rutting Index	97	97	97	97	97	97	97
International Roughness Index (IRI)	N/A	N/A	N/A	N/A	N/A	N/A	N/A
Lane & Width Information							
Number of Lanes	2	2	2	2	2	2	2
Paved Width (ft)	22	22	22	22	22	22	22
Lane Width (ft)	10	10	10	10	10	10	10

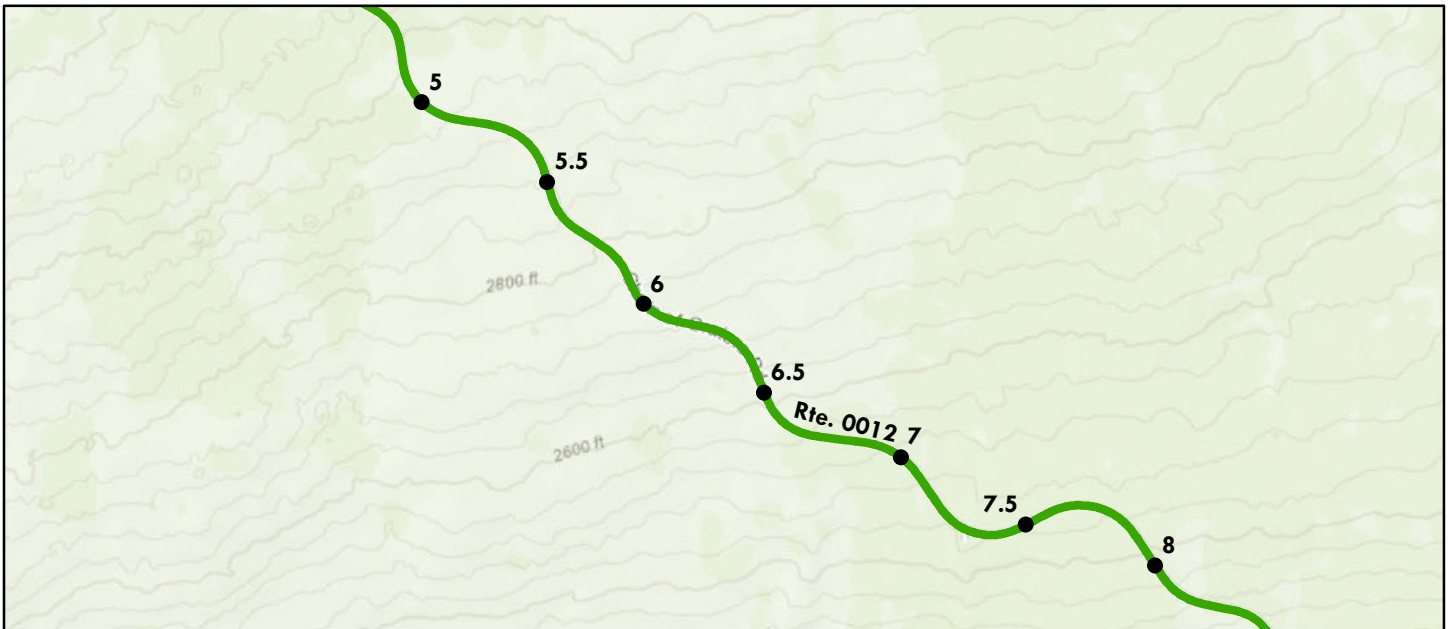
Manual Rating

ROUTE 0012: CHAIN OF CRATERS ROAD

Route Condition Legend – Pavement Condition Rating (PCR)						
Poor (0 - 60)	Fair (61- 84)	Good (85 - 94)	Excellent (95 - 100)	Not Rated		
See Appendix for definitions and formulas						
Inspection Date: 3/8/2022	Beginning Section MP	5.00	5.50	6.00	6.50	7.00
Paved Length (Miles): 18.56	Section Length (MI)	0.50	0.50	0.50	0.50	0.50
Surface Type: ASPHALT	Route Summary					
Roadway Condition Information						
Pavement Condition Rating (PCR)	92	90	90	90	90	90
Surface Condition Rating (SCR)	92	90	90	90	90	90
Roughness Condition Index (RCI)	N/A	N/A	N/A	N/A	N/A	N/A
Distress Index Values						
Structural Crack Index	N/A	N/A	N/A	N/A	N/A	N/A
Alligator Crack Index	97	97	97	97	97	97
Longitudinal Crack Index	96	97	90	97	97	97
Transverse Cracking Index	92	90	90	90	90	90
Patching Index	97	97	97	97	97	97
Rutting Index	97	97	97	97	97	97
International Roughness Index (IRI)	N/A	N/A	N/A	N/A	N/A	N/A
Lane & Width Information

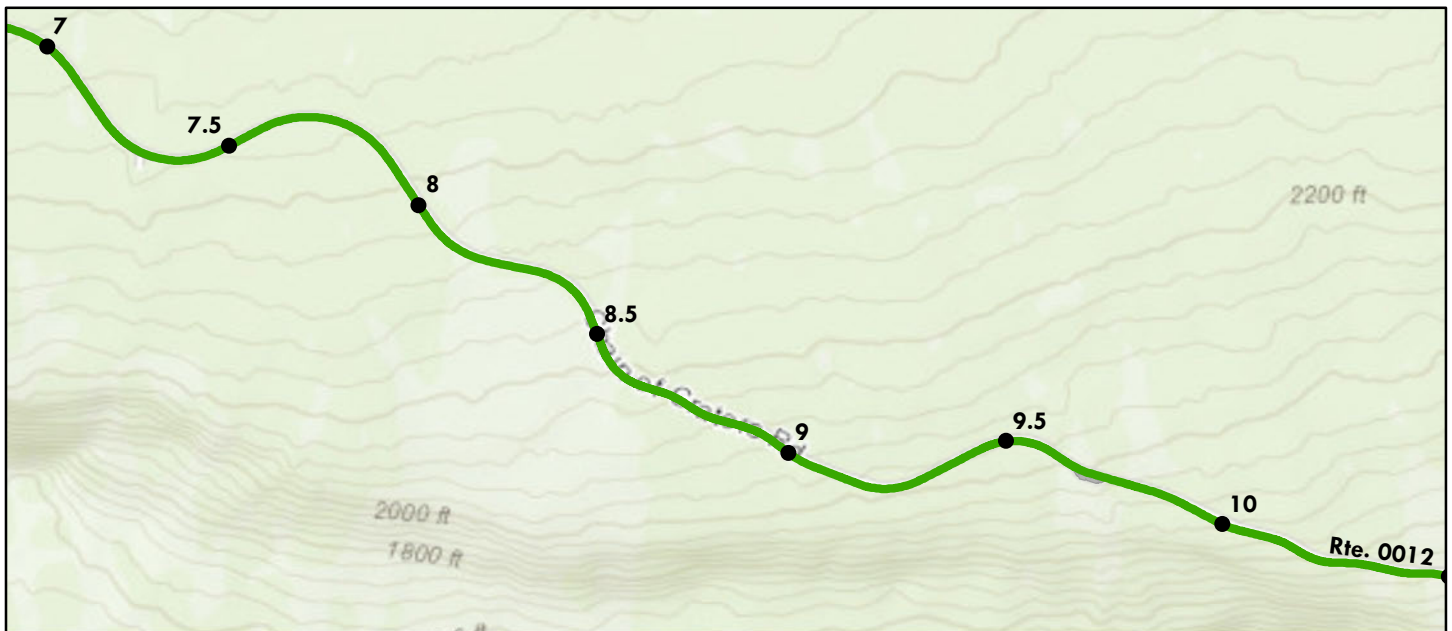
Manual Rating

ROUTE 0012: CHAIN OF CRATERS ROAD

Route Condition Legend – Pavement Condition Rating (PCR)						
Poor (0 - 60)	Fair (61- 84)	Good (85 - 94)	Excellent (95 - 100)	Not Rated		
See Appendix for definitions and formulas						
Inspection Date: 3/8/2022	Beginning Section MP	7.50	8.00	8.50	9.00	9.50
Paved Length (Miles): 18.56	Section Length (MI)	0.50	0.50	0.50	0.50	0.50
Surface Type: ASPHALT	Route Summary					
Roadway Condition Information						
Pavement Condition Rating (PCR)	92	90	90	90	90	90
Surface Condition Rating (SCR)	92	90	90	90	90	90
Roughness Condition Index (RCI)	N/A	N/A	N/A	N/A	N/A	N/A
Distress Index Values						
Structural Crack Index	N/A	N/A	N/A	N/A	N/A	N/A
Alligator Crack Index	97	97	97	97	97	97
Longitudinal Crack Index	96	97	97	97	97	97
Transverse Cracking Index	92	90	90	90	90	90
Patching Index	97	97	97	97	97	97
Rutting Index	97	97	97	97	97	97
International Roughness Index (IRI)	N/A	N/A	N/A	N/A	N/A	N/A
Lane & Width Information

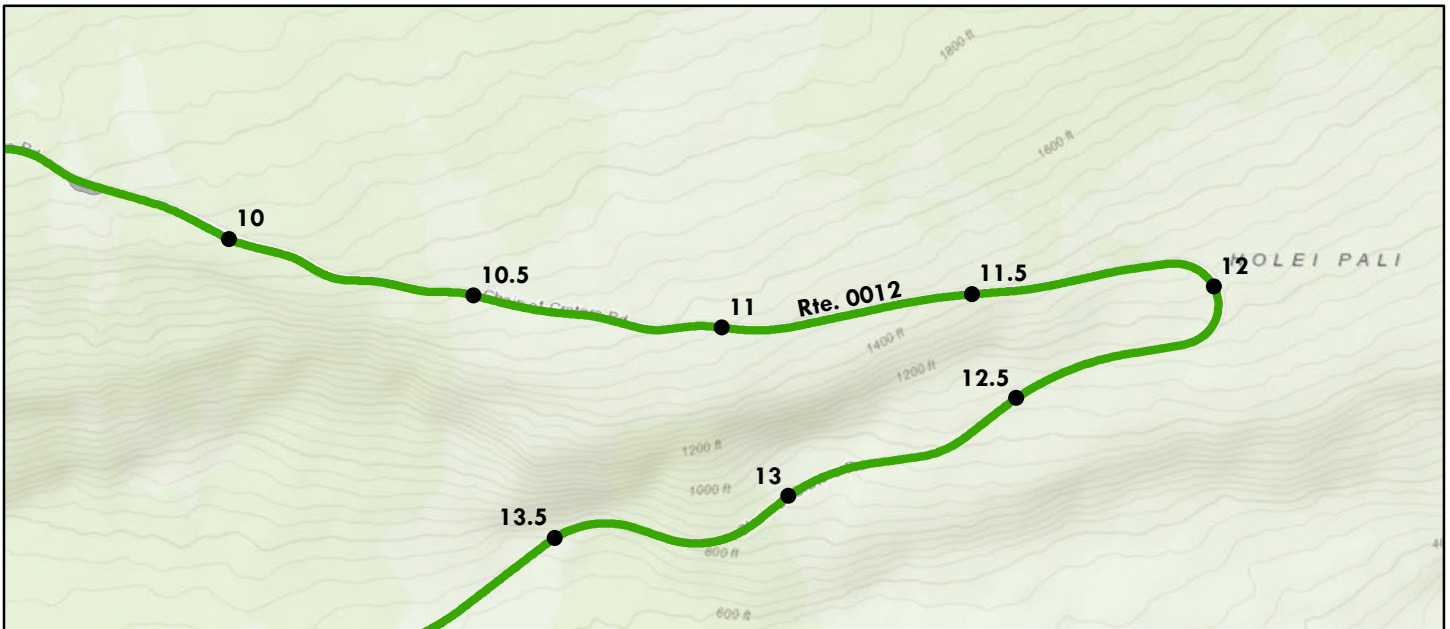
Manual Rating

ROUTE 0012: CHAIN OF CRATERS ROAD

Inspection Date:	3/8/2022	Beginning Section MP	10.00	10.50	11.00	11.50	12.00
Paved Length (Miles):	18.56	Section Length (MI)	0.50	0.50	0.50	0.50	0.50
Surface Type:	ASPHALT	Route Summary					
Roadway Condition Information							
Pavement Condition Rating (PCR)	92	90	90	90	90	90	90
Surface Condition Rating (SCR)	92	90	90	90	90	90	90
Roughness Condition Index (RCI)	N/A	N/A	N/A	N/A	N/A	N/A	N/A
Distress Index Values							
Structural Crack Index	N/A	N/A	N/A	N/A	N/A	N/A	N/A
Alligator Crack Index	97	97	97	97	97	97	97
Longitudinal Crack Index	96	97	97	97	97	97	97
Transverse Cracking Index	92	90	90	90	90	90	90
Patching Index	97	97	97	97	97	97	97
Rutting Index	97	97	97	97	97	97	97
International Roughness Index (IRI)	N/A	N/A	N/A	N/A	N/A	N/A	N/A
Lane & Width Information							
Number of Lanes	2	2	2	2	2	2	2
Paved Width (ft)	22	22	22	22	22	22	22
Lane Width (ft)	10	10	10	10	10	10	10

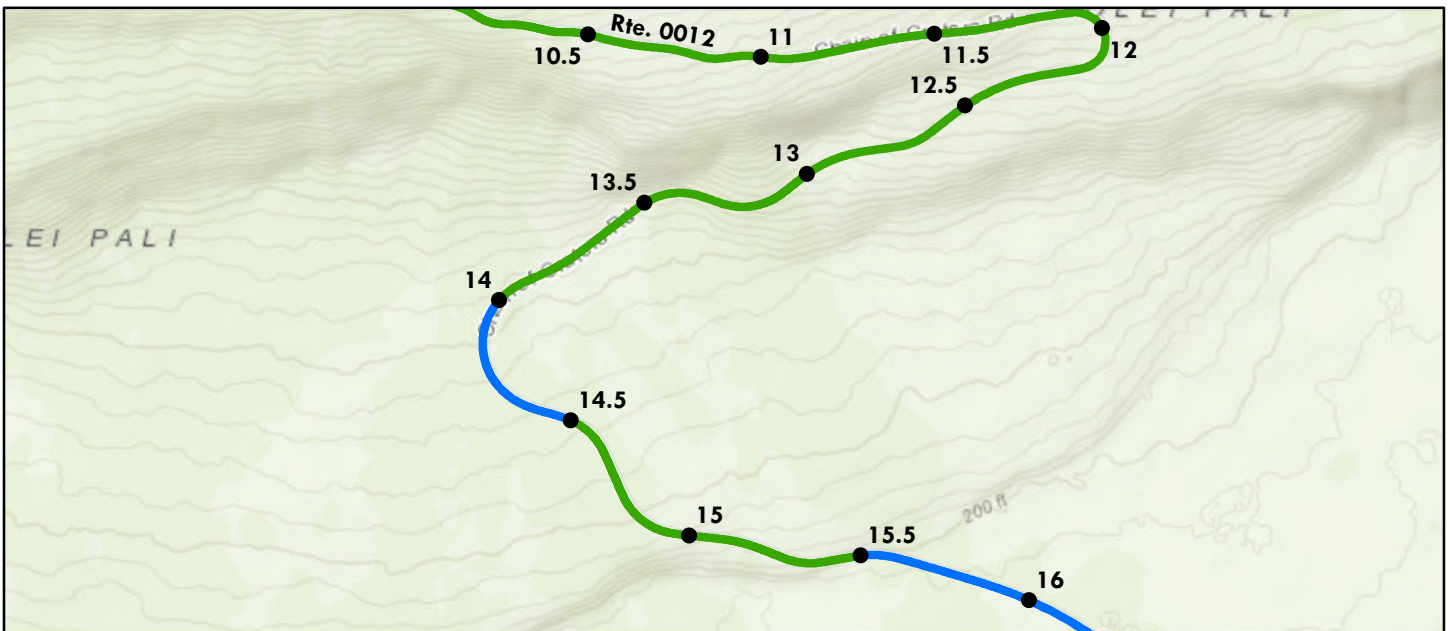
Manual Rating

ROUTE 0012: CHAIN OF CRATERS ROAD

Inspection Date:	3/8/2022	Beginning Section MP	12.50	13.00	13.50	14.00	14.50
Paved Length (Miles):	18.56	Section Length (MI)	0.50	0.50	0.50	0.50	0.50
Surface Type:	ASPHALT	Route Summary					
Roadway Condition Information							
Pavement Condition Rating (PCR)	92	90	90	90	97	90	
Surface Condition Rating (SCR)	92	90	90	90	97	90	
Roughness Condition Index (RCI)	N/A	N/A	N/A	N/A	N/A	N/A	
Distress Index Values							
Structural Crack Index	N/A	N/A	N/A	N/A	N/A	N/A	
Alligator Crack Index	97	97	97	97	97	97	
Longitudinal Crack Index	96	97	97	97	97	97	
Transverse Cracking Index	92	90	90	90	97	90	
Patching Index	97	97	97	97	97	97	
Rutting Index	97	97	97	97	97	97	
International Roughness Index (IRI)	N/A	N/A	N/A	N/A	N/A	N/A	
Lane & Width Information							
Number of Lanes	2	2	2	2	2	2	
Paved Width (ft)	22	22	22	22	22	22	
Lane Width (ft)	10	10	10	10	10	10

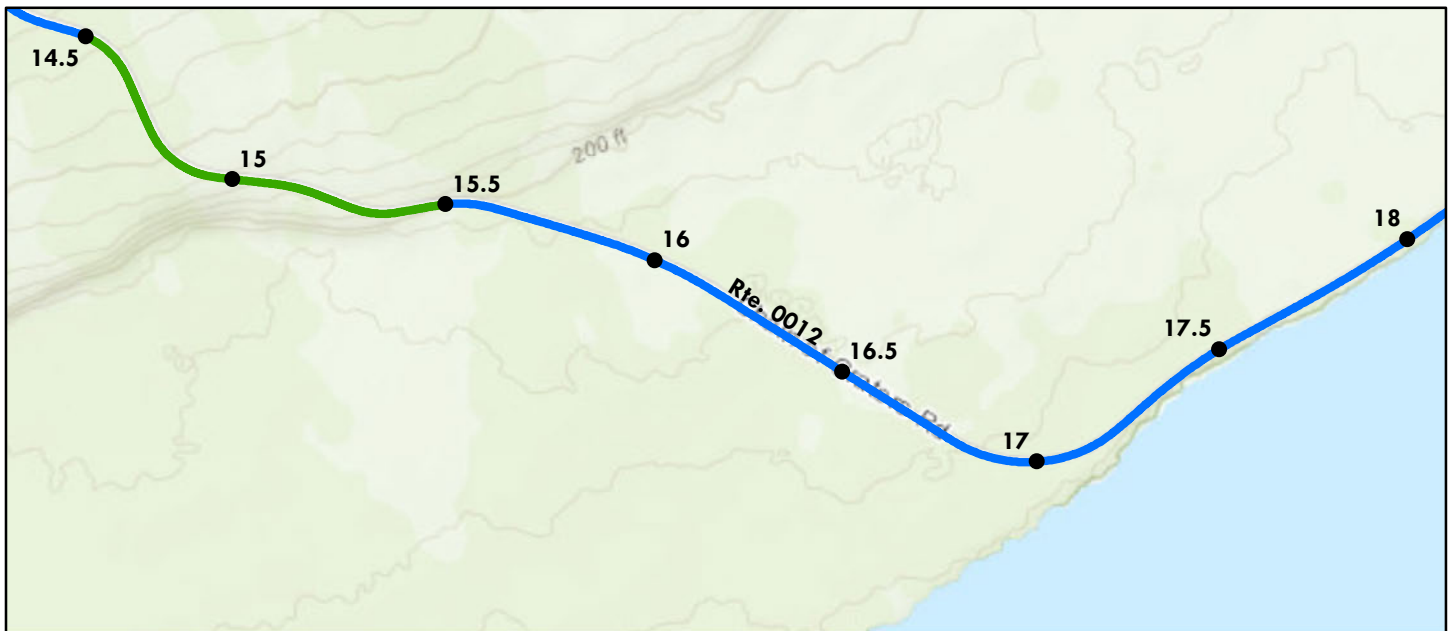
Manual Rating

ROUTE 0012: CHAIN OF CRATERS ROAD

Inspection Date:	3/8/2022	Beginning Section MP	15.00	15.50	16.00	16.50	17.00
Paved Length (Miles): 18.56		Section Length (MI)	0.50	0.50	0.50	0.50	0.50
Surface Type: ASPHALT		Route Summary					
Roadway Condition Information							
Pavement Condition Rating (PCR)	92	90	97	97	97	97	
Surface Condition Rating (SCR)	92	90	97	97	97	97	
Roughness Condition Index (RCI)	N/A	N/A	N/A	N/A	N/A	N/A	
Distress Index Values							
Structural Crack Index	N/A	N/A	N/A	N/A	N/A	N/A	
Alligator Crack Index	97	97	97	97	97	97	
Longitudinal Crack Index	96	97	97	97	97	97	
Transverse Cracking Index	92	90	97	97	97	97	
Patching Index	97	97	97	97	97	97	
Rutting Index	97	97	97	97	97	97	
International Roughness Index (IRI)	N/A	N/A	N/A	N/A	N/A	N/A	
Lane & Width Information							
Number of Lanes	2	2	2	2	2	2	
Paved Width (ft)	22	22	22	22	22	22	
Lane Width (ft)	10	10	10	10	10	10
