Road Inventory and Condition Assessment of Paved Routes Hawaii Volcanoes National Park

**Federal Lands Highway
Road Inventory Program**

**Federal Highway Administration
Eastern Federal Lands Highway Division
Road Inventory Program (RIP)**

Report Date: December 2022

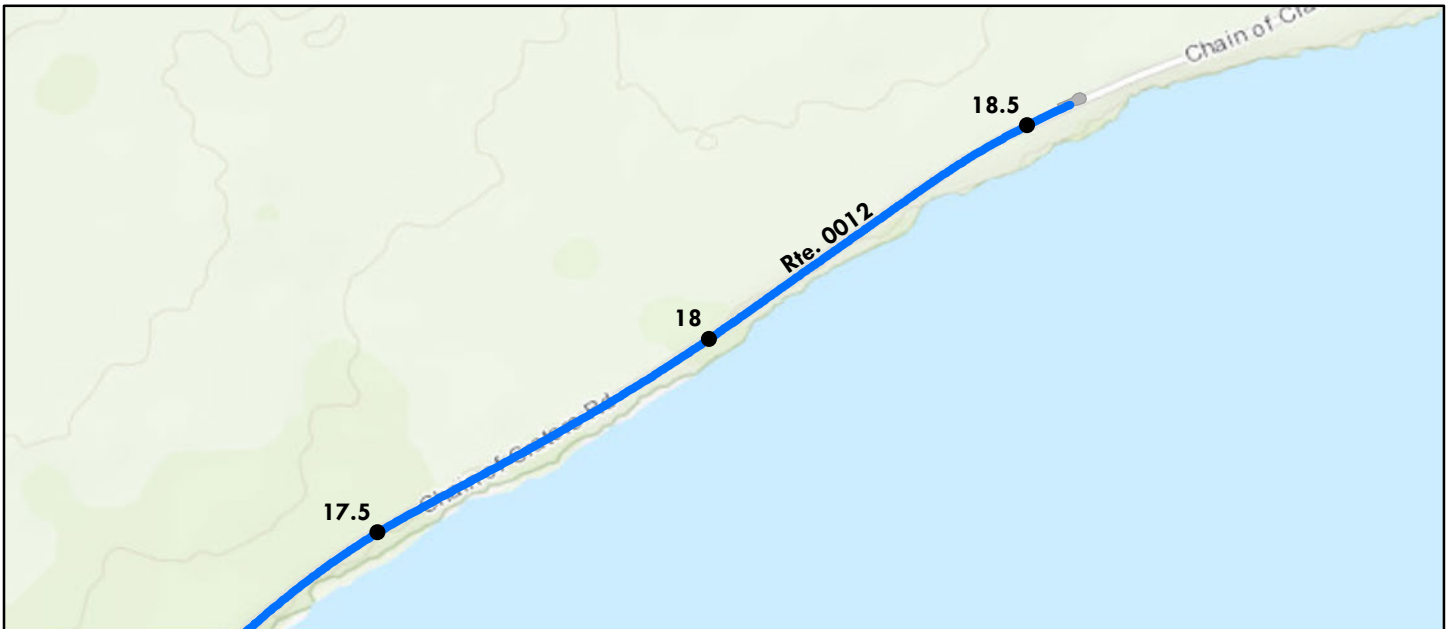
Manual Rating

ROUTE 0012: CHAIN OF CRATERS ROAD

Route Condition Legend – Pavement Condition Rating (PCR)									
Poor (0 - 60)		Fair (61- 84)		Good (85 - 94)		Excellent (95 - 100)		Not Rated	
See Appendix for definitions and formulas									
Inspection Date:	3/8/2022	Beginning Section MP	17.50	18.00	18.50				
Paved Length (Miles):	18.56	Section Length (MI)	0.50	0.50	0.06				
Surface Type:	ASPHALT	Route Summary							
Roadway Condition Information									
Pavement Condition Rating (PCR)		92	97	97	97				
Surface Condition Rating (SCR)		92	97	97	97				
Roughness Condition Index (RCI)		N/A	N/A	N/A	N/A				
Distress Index Values									
Structural Crack Index		N/A	N/A	N/A	N/A				
Alligator Crack Index		97	97	97	97				
Longitudinal Crack Index		96	97	97	97				
Transverse Cracking Index		92	97	97	97				
Patching Index		97	97	97	97				
Rutting Index		97	97	97	97				
International Roughness Index (IRI)		N/A	N/A	N/A	N/A				
Lane & Width Information									
Number of Lanes		2	2	2	2

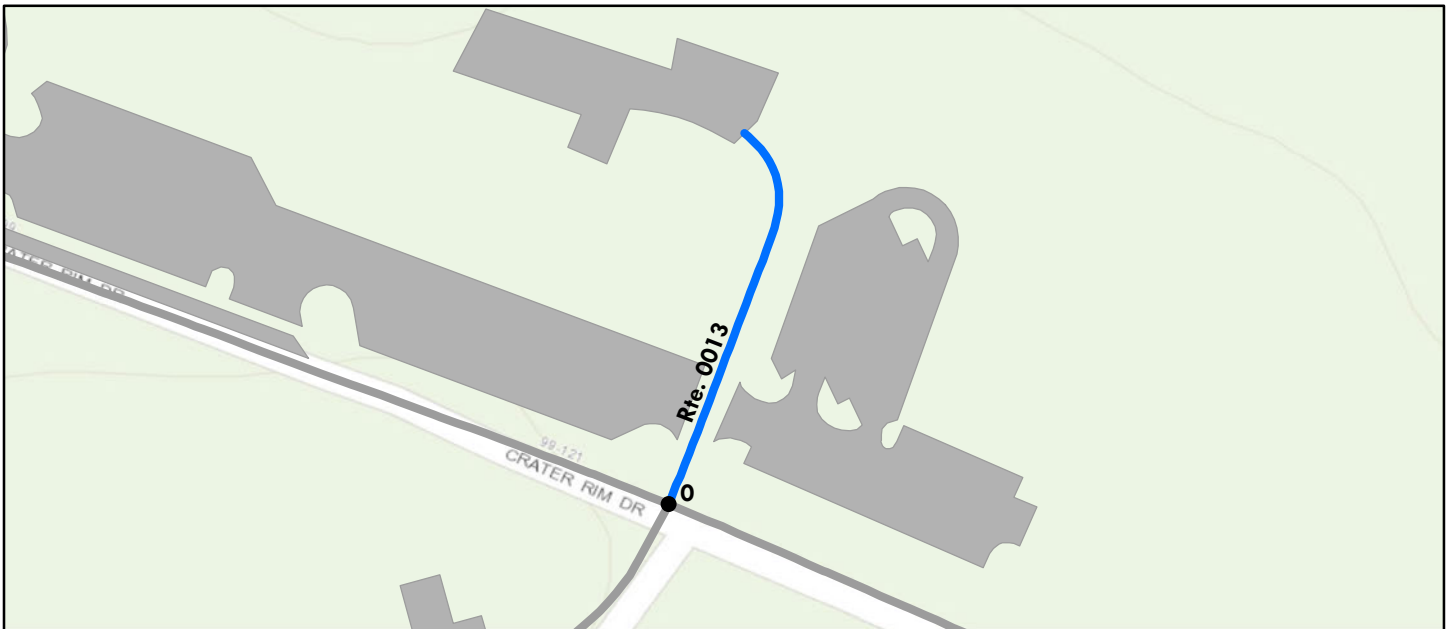
Manual Rating

ROUTE 0013: OFFICE AREA STREET

Route Condition Legend – Pavement Condition Rating (PCR)						
Poor (0 - 60)	Fair (61- 84)	Good (85 - 94)	Excellent (95 - 100)	Not Rated		
See Appendix for definitions and formulas						
Inspection Date: 3/8/2022	Beginning Section MP	0.00				
Paved Length (Miles): 0.05	Section Length (MI)	0.05				
Surface Type: ASPHALT	Route Summary					
Roadway Condition Information						
Pavement Condition Rating (PCR)	97	97				
Surface Condition Rating (SCR)	97	97				
Roughness Condition Index (RCI)	N/A	N/A				
Distress Index Values						
Structural Crack Index	N/A	N/A				
Alligator Crack Index	97	97				
Longitudinal Crack Index	97	97				
Transverse Cracking Index	97	97				
Patching Index	97	97				
Rutting Index	97	97				
International Roughness Index (IRI)	N/A	N/A				
Lane & Width Information						
Number of Lanes	2	2				
Paved Width (ft)	21	21				
Lane Width (ft)	10	10

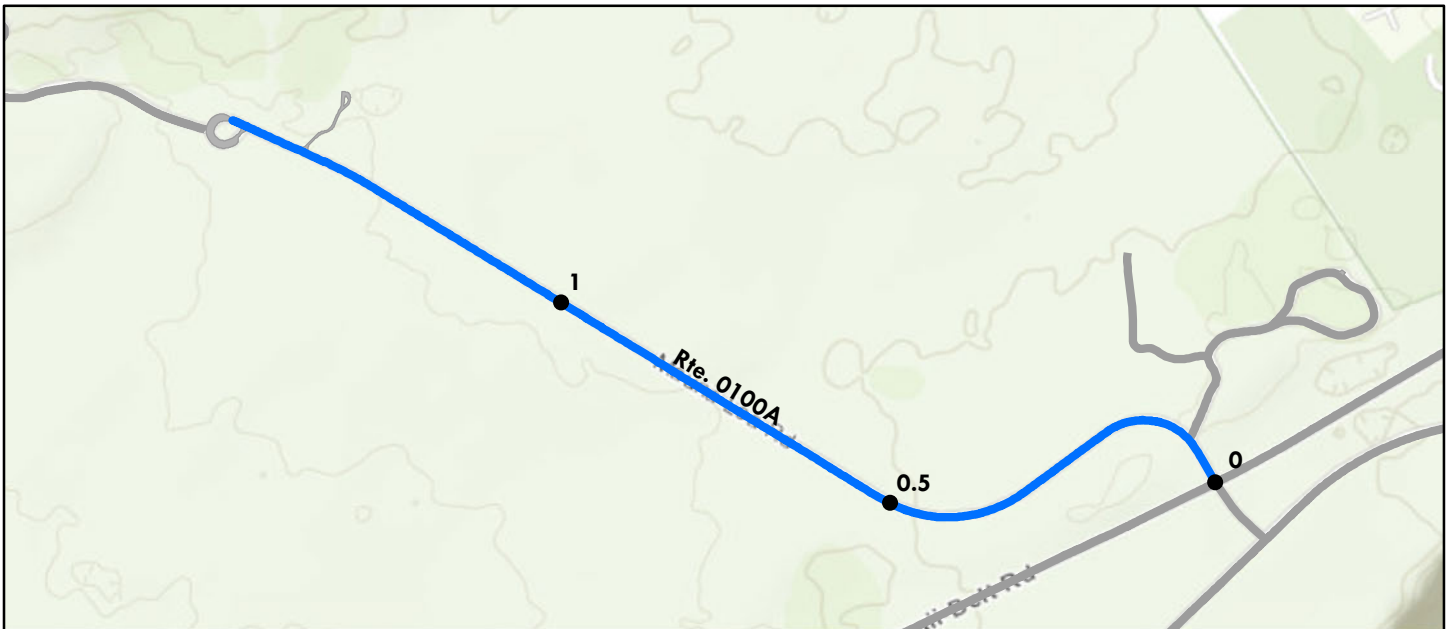
Manual Rating

ROUTE 0100A: MAUNA LOA ROAD

Route Condition Legend – Pavement Condition Rating (PCR)										
Poor (0 - 60)		Fair (61- 84)		Good (85 - 94)		Excellent (95 - 100)		Not Rated		
See Appendix for definitions and formulas										
Inspection Date:	3/8/2022	Beginning Section MP	0.00	0.50	1.00					
Paved Length (Miles):	1.49	Section Length (MI)	0.50	0.50	0.49					
Surface Type:	ASPHALT	Route Summary								
Roadway Condition Information										
Pavement Condition Rating (PCR)	97	97	97	97	97					
Surface Condition Rating (SCR)	97	97	97	97	97					
Roughness Condition Index (RCI)	N/A	N/A	N/A	N/A	N/A					
Distress Index Values										
Structural Crack Index	N/A	N/A	N/A	N/A	N/A					
Alligator Crack Index	97	97	97	97	97					
Longitudinal Crack Index	97	97	97	97	97					
Transverse Cracking Index	97	97	97	97	97					
Patching Index	97	97	97	97	97					
Rutting Index	97	97	97	97	97					
International Roughness Index (IRI)	N/A	N/A	N/A	N/A	N/A

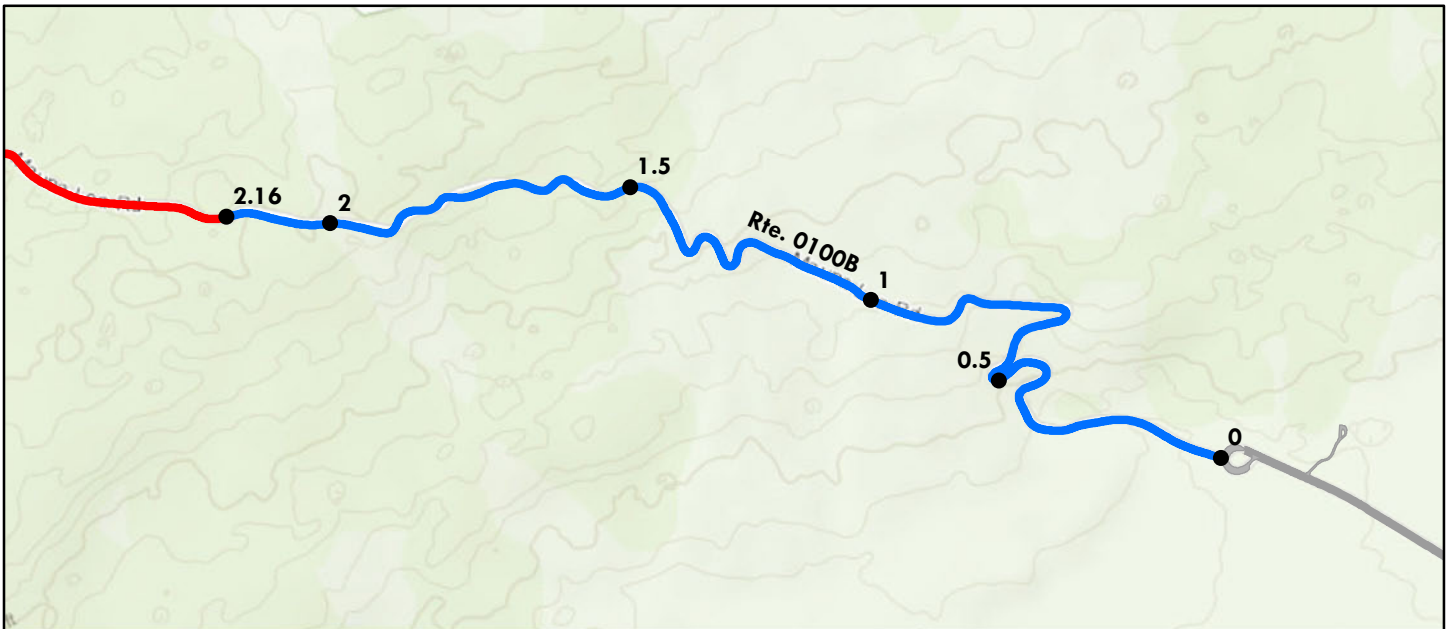
Manual Rating

ROUTE 0100B: MAUNA LOA LOOKOUT ROAD

Route Condition Legend – Pavement Condition Rating (PCR)						
Poor (0 - 60)	Fair (61- 84)	Good (85 - 94)	Excellent (95 - 100)	Not Rated		
See Appendix for definitions and formulas						
Inspection Date: 3/8/2022	Beginning Section MP	0.00	0.50	1.00	1.50	2.00
Paved Length (Miles): 9.81	Section Length (MI)	0.50	0.50	0.50	0.50	0.16
Surface Type: ASPHALT	Route Summary					
Roadway Condition Information						
Pavement Condition Rating (PCR)	48	97	97	97	97	97
Surface Condition Rating (SCR)	48	97	97	97	97	97
Roughness Condition Index (RCI)	N/A	N/A	N/A	N/A	N/A	N/A
Distress Index Values						
Structural Crack Index	N/A	N/A	N/A	N/A	N/A	N/A
Alligator Crack Index	36	97	97	97	97	97
Longitudinal Crack Index	60	97	97	97	97	97
Transverse Cracking Index	53	90	97	97	97	97
Patching Index	74	97	97	97	97	97
Rutting Index	86	97	97	97	97	97
International Roughness Index (IRI)	N/A	N/A	N/A	N/A	N/A	N/A
Lane & Width Information

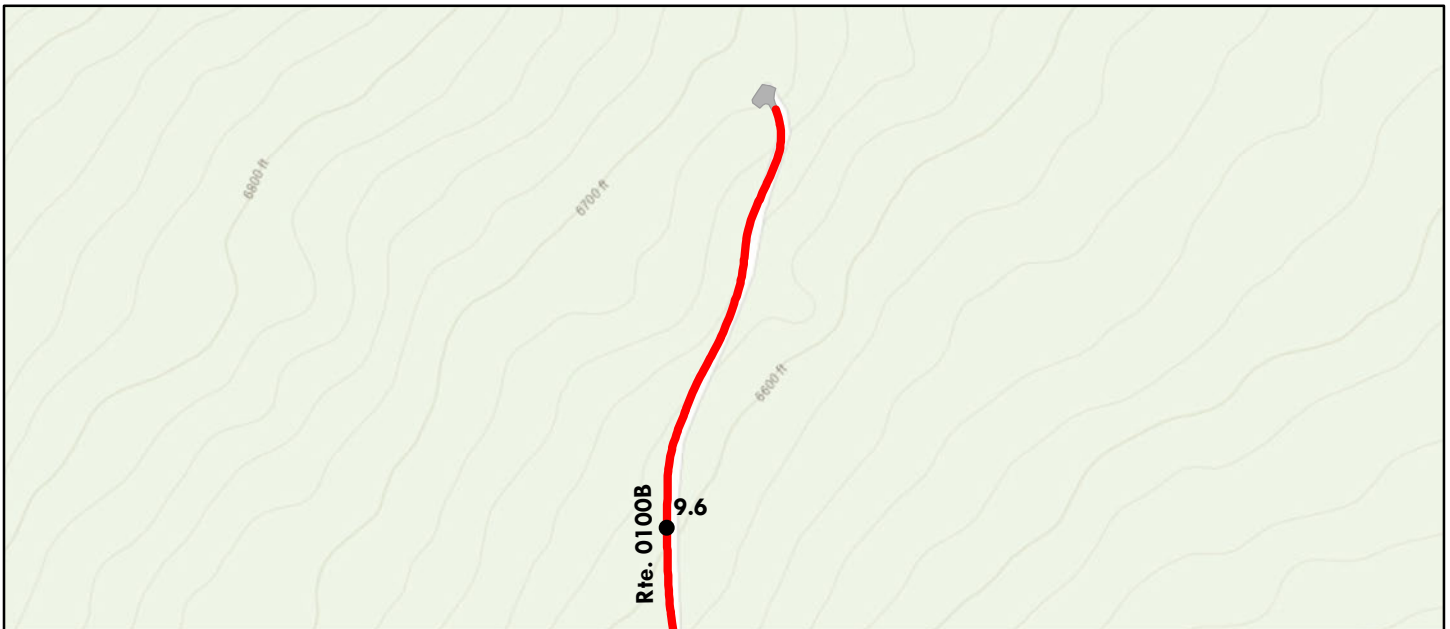
ROUTE 0100B: MAUNA LOA LOOKOUT ROAD

Inspection Date: 3/8/2022	Beginning Section MP	9.60				
Paved Length (Miles): 9.81	Section Length (MI)	0.21				
Surface Type: ASPHALT	Route Summary					
Roadway Condition Information						
Pavement Condition Rating (PCR)	48	30				
Surface Condition Rating (SCR)	48	30				
Roughness Condition Index (RCI)	N/A	N/A				
Distress Index Values						
Structural Crack Index	N/A	N/A				
Alligator Crack Index	36	30				
Longitudinal Crack Index	60	73				
Transverse Cracking Index	53	53				
Patching Index	74	73				
Rutting Index	86	73				
International Roughness Index (IRI)	N/A	N/A				
Lane & Width Information						
Number of Lanes	1	1				
Paved Width (ft)	10.9	10				
Lane Width (ft)	9.3	10

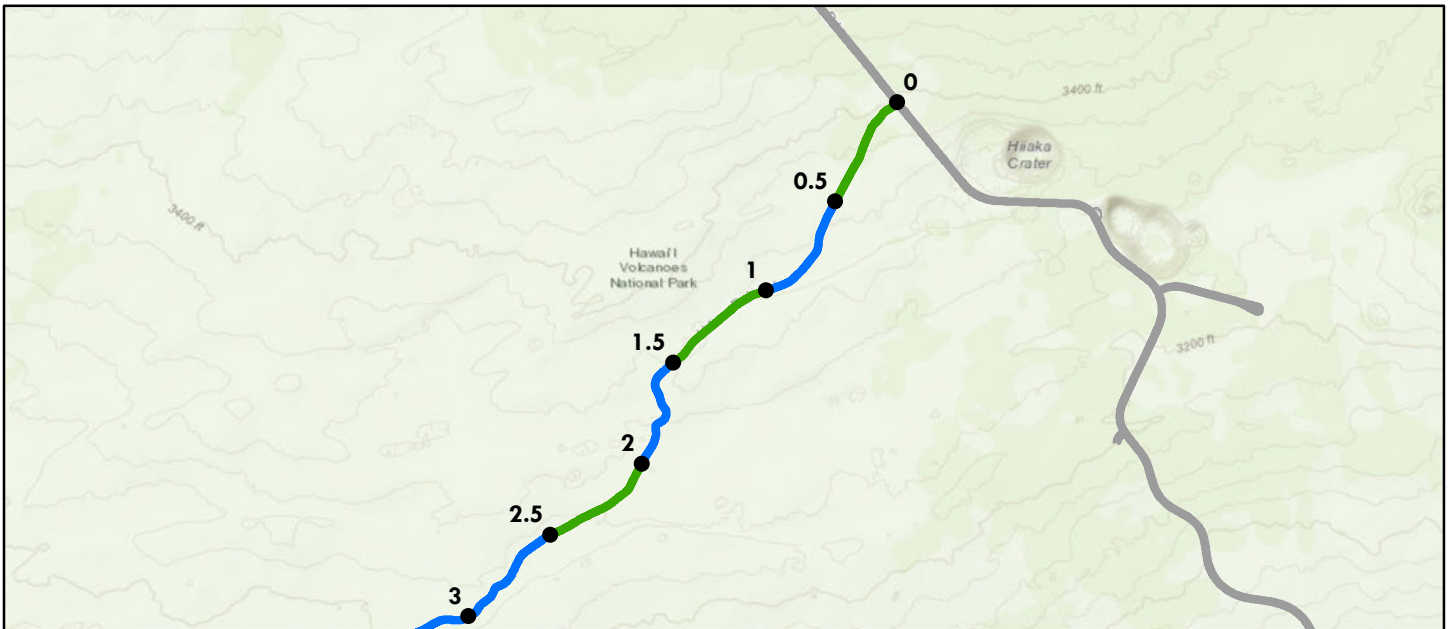
ROUTE 0101: HILINA PALI ROAD

Route Condition Legend – Pavement Condition Rating (PCR)						
Poor (0 - 60)	Fair (61- 84)	Good (85 - 94)	Excellent (95 - 100)	Not Rated		
See Appendix for definitions and formulas						
Inspection Date: 3/8/2022	Beginning Section MP	0.00	0.50	1.00	1.50	2.00
Paved Length (Miles): 8.50	Section Length (MI)	0.50	0.50	0.50	0.50	0.50
Surface Type: ASPHALT	Route Summary					
Roadway Condition Information						
Pavement Condition Rating (PCR)	96	90	97	90	97	90
Surface Condition Rating (SCR)	96	90	97	90	97	90
Roughness Condition Index (RCI)	N/A	N/A	N/A	N/A	N/A	N/A
Distress Index Values						
Structural Crack Index	N/A	N/A	N/A	N/A	N/A	N/A
Alligator Crack Index	97	97	97	97	97	97
Longitudinal Crack Index	97	97	97	97	97	97
Transverse Cracking Index	97	97	97	97	97	97
Patching Index	96	90	97	90	97	90
Rutting Index	97	97	97	97	97	97
International Roughness Index (IRI)	N/A	N/A	N/A	N/A	N/A	N/A
Lane & Width Information

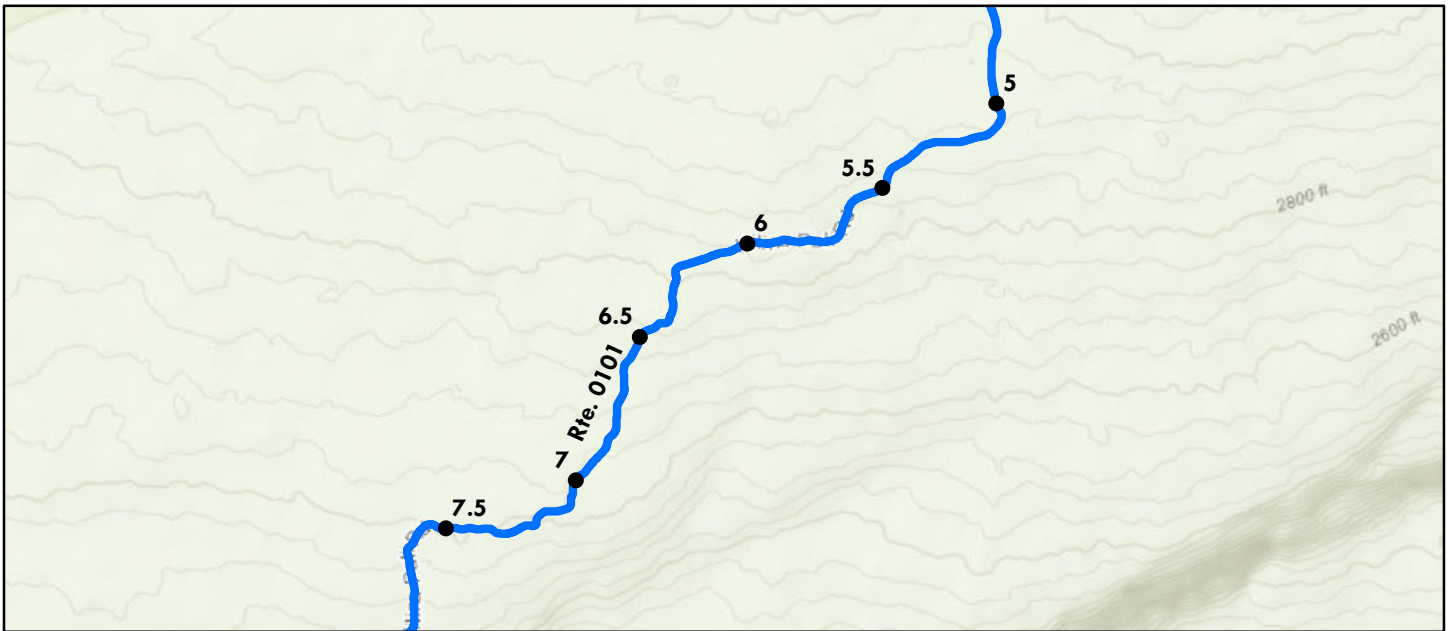
ROUTE 0101: HILINA PALI ROAD

Route Condition Legend – Pavement Condition Rating (PCR)									
Poor (0 - 60)		Fair (61- 84)		Good (85 - 94)		Excellent (95 - 100)		Not Rated	
See Appendix for definitions and formulas									
Inspection Date:	3/8/2022	Beginning Section MP	5.00	5.50	6.00	6.50	7.00		
Paved Length (Miles):	8.50	Section Length (MI)	0.50	0.50	0.50	0.50	0.50		
Surface Type:	ASPHALT	Route Summary							
Roadway Condition Information									
Pavement Condition Rating (PCR)	96	97	97	97	97	97	97		
Surface Condition Rating (SCR)	96	97	97	97	97	97	97		
Roughness Condition Index (RCI)	N/A	N/A	N/A	N/A	N/A	N/A	N/A		
Distress Index Values									
Structural Crack Index	N/A	N/A	N/A	N/A	N/A	N/A	N/A		
Alligator Crack Index	97	97	97	97	97	97	97		
Longitudinal Crack Index	97	97	97	97	97	97	97		
Transverse Cracking Index	97	97	97	97	97	97	97		
Patching Index	96	97	97	97	97	97	97		
Rutting Index	97	97	97	97	97	97	97		
International Roughness Index (IRI)	N/A	N/A	N/A	N/A	N/A	N/A	N/A

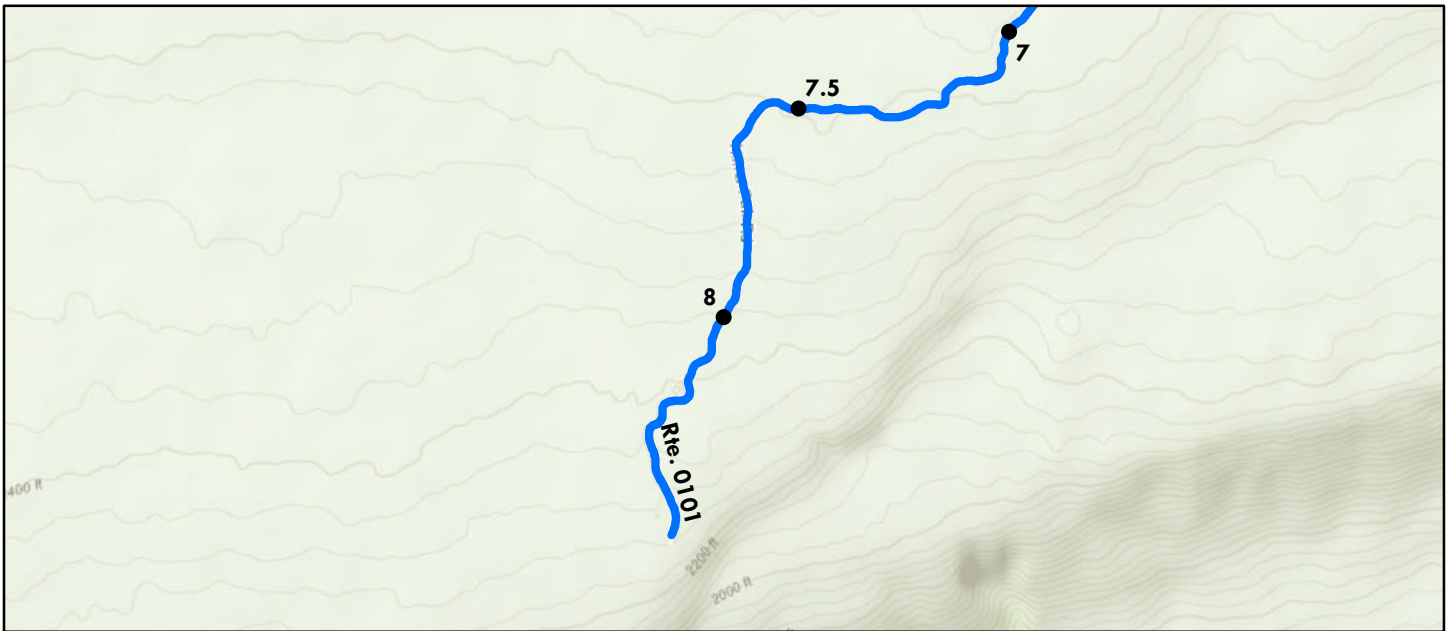
ROUTE 0101: HILINA PALI ROAD

Inspection Date: 3/8/2022	Beginning Section MP	7.50	8.00			
Paved Length (Miles): 8.50	Section Length (MI)	0.50	0.50			
Surface Type: ASPHALT	Route Summary					
Roadway Condition Information						
Pavement Condition Rating (PCR)	96	97	97			
Surface Condition Rating (SCR)	96	97	97			
Roughness Condition Index (RCI)	N/A	N/A	N/A			
Distress Index Values						
Structural Crack Index	N/A	N/A	N/A			
Alligator Crack Index	97	97	97			
Longitudinal Crack Index	97	97	97			
Transverse Cracking Index	97	97	97			
Patching Index	96	97	97			
Rutting Index	97	97	97			
International Roughness Index (IRI)	N/A	N/A	N/A			
Lane & Width Information						
Number of Lanes	1	1	1			
Paved Width (ft)	11	11	11			
Lane Width (ft)	11	11	11

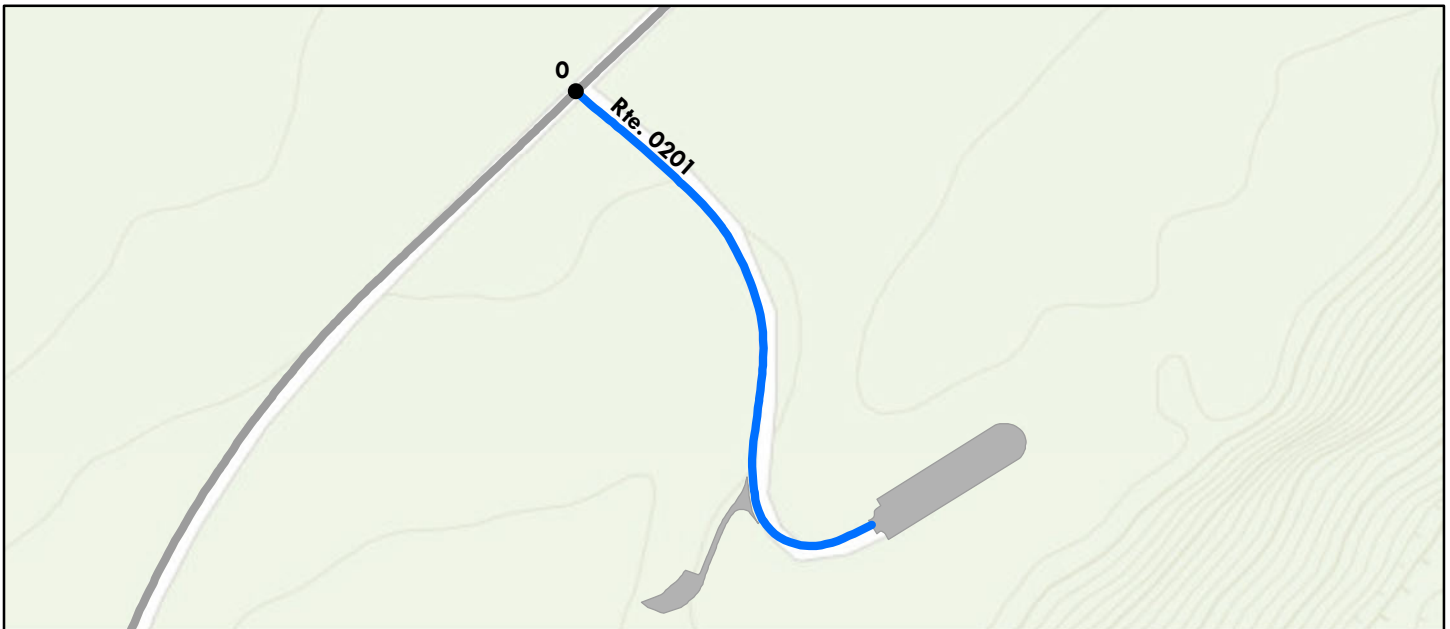
ROUTE 0201: KILAUEA OVERLOOK ROAD

Inspection Date: 3/8/2022	Beginning Section MP	0.00				
Paved Length (Miles): 0.20	Section Length (MI)	0.20				
Surface Type: ASPHALT	Route Summary					
Roadway Condition Information						
Pavement Condition Rating (PCR)	97	97				
Surface Condition Rating (SCR)	97	97				
Roughness Condition Index (RCI)	N/A	N/A				
Distress Index Values						
Structural Crack Index	N/A	N/A				
Alligator Crack Index	97	97				
Longitudinal Crack Index	97	97				
Transverse Cracking Index	97	97				
Patching Index	97	97				
Rutting Index	97	97				
International Roughness Index (IRI)	N/A	N/A				
Lane & Width Information						
Number of Lanes	2	2				
Paved Width (ft)	21	21				
Lane Width (ft)	10	10

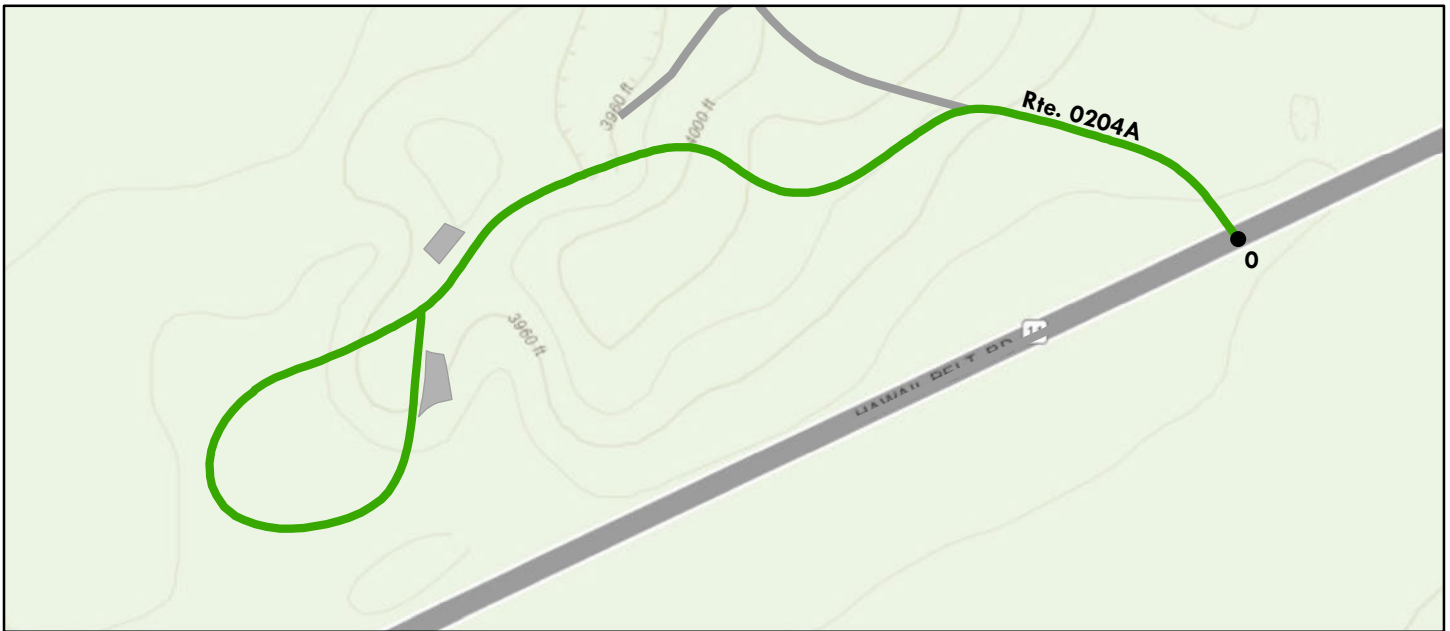
ROUTE 0204A: NAMA KANI PAIO CAMPGROUND ROAD

Route Condition Legend – Pavement Condition Rating (PCR)						
Poor (0 - 60)	Fair (61- 84)	Good (85 - 94)	Excellent (95 - 100)	Not Rated		
See Appendix for definitions and formulas						
Inspection Date: 3/8/2022	Beginning Section MP	0.00				
Paved Length (Miles): 0.32	Section Length (MI)	0.32				
Surface Type: ASPHALT	Route Summary					
Roadway Condition Information						
Pavement Condition Rating (PCR)	90	90				
Surface Condition Rating (SCR)	90	90				
Roughness Condition Index (RCI)	N/A	N/A				
Distress Index Values						
Structural Crack Index	N/A	N/A				
Alligator Crack Index	97	97				
Longitudinal Crack Index	90	90				
Transverse Cracking Index	90	90				
Patching Index	97	97				
Rutting Index	97	97				
International Roughness Index (IRI)	N/A	N/A				
Lane & Width Information						
Number of Lanes	2	2				
Paved Width (ft)	16	16				
Lane Width (ft)	8	8

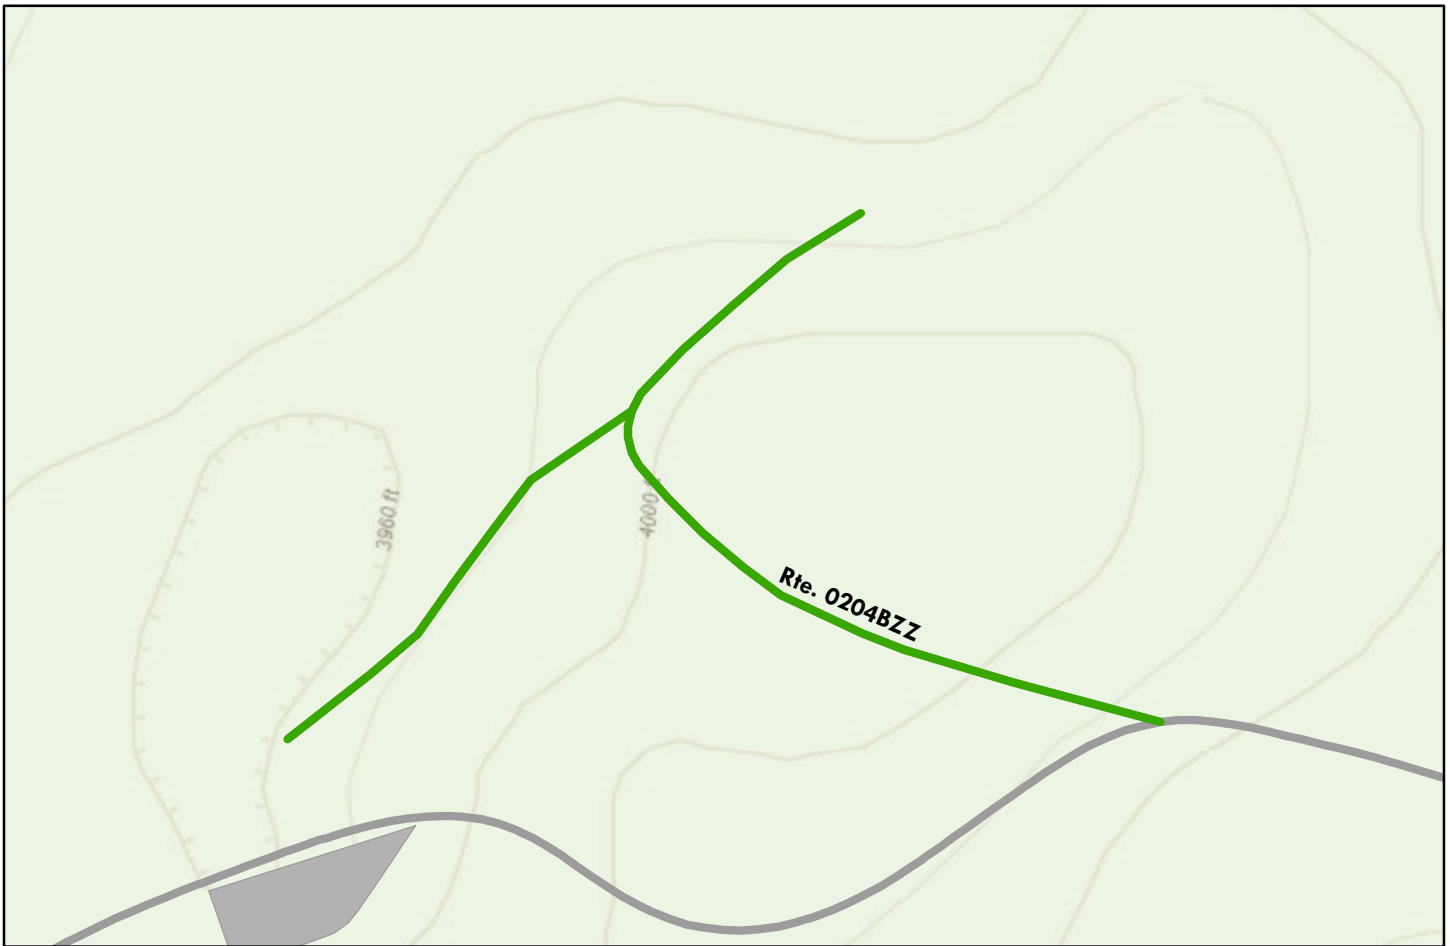
ROUTE 0204BZZ: NAMAKANI PAIO RENTAL CABIN ACCESS ROADS

Note: The weighted average summary PCR value is calculated from only the sections of road where the PCR was collected. The overall PCR for the summary route may not reflect individual subcomponent ratings.

Route Condition Legend – Pavement Condition Rating (PCR)						
Poor (0 - 60)	Fair (61- 84)	Good (85 - 94)	Excellent (95 - 100)	Not Rated		
See Appendix for definitions and formulas						
Inspection Date: 3/8/2022						
Paved Length (Miles): 0.11						
Surface Type: ASPHALT	Route Summary					
Roadway Condition Information						
Pavement Condition Rating (PCR)	90					
Lane & Width Information						
Number of Lanes	2					
Paved Width (ft)	18.7					
Lane Width (ft)	9.3

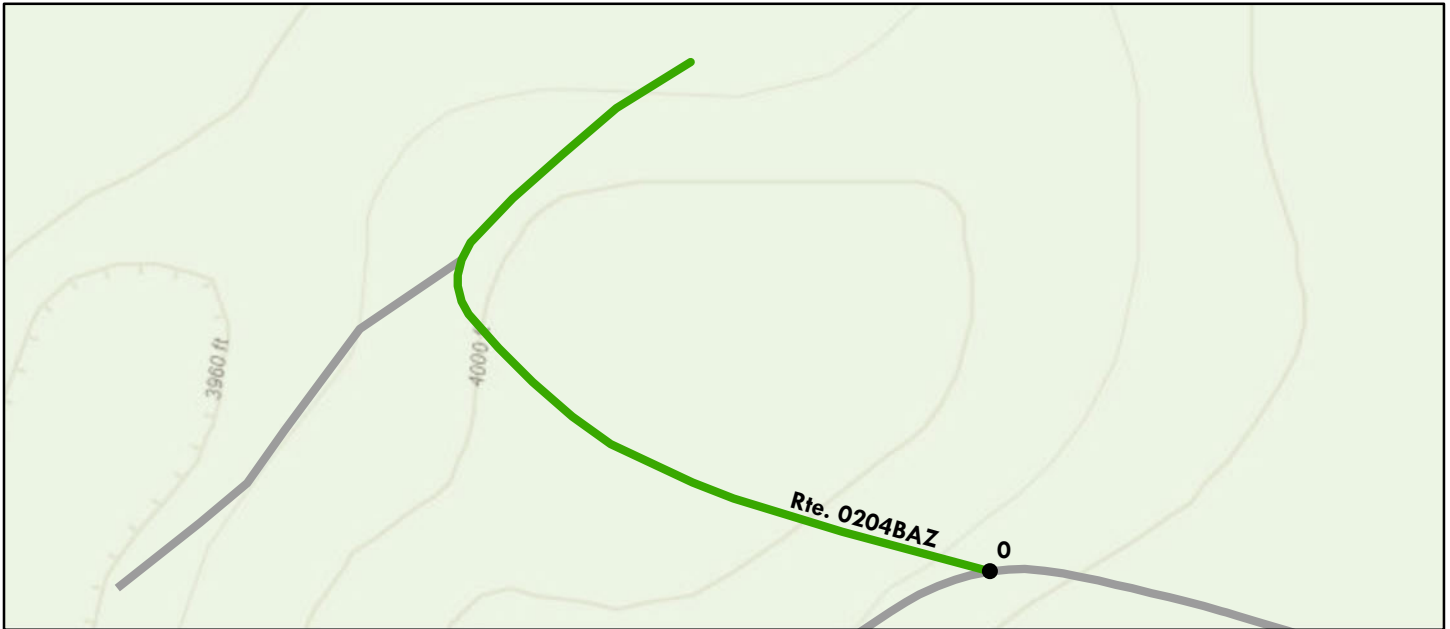
Subcomponent of Route HAVO-0204BZZ

Route Condition Legend – Pavement Condition Rating (PCR)						
Poor (0 - 60)	Fair (61- 84)	Good (85 - 94)	Excellent (95 - 100)	Not Rated		
See Appendix for definitions and formulas						
Inspection Date: 3/8/2022	Beginning Section MP	0.00				
Paved Length (Miles): 0.08	Section Length (MI)	0.08				
Surface Type: ASPHALT	Route Summary					
Roadway Condition Information						
Pavement Condition Rating (PCR)	90	90				
Surface Condition Rating (SCR)	90	90				
Roughness Condition Index (RCI)	N/A	N/A				
Distress Index Values						
Structural Crack Index	N/A	N/A				
Alligator Crack Index	97	97				
Longitudinal Crack Index	90	90				
Transverse Cracking Index	90	90				
Patching Index	97	97				
Rutting Index	97	97				
International Roughness Index (IRI)	N/A	N/A				
Lane & Width Information						
Number of Lanes	2	2				
Paved Width (ft)	20	20				
Lane Width (ft)	10	10

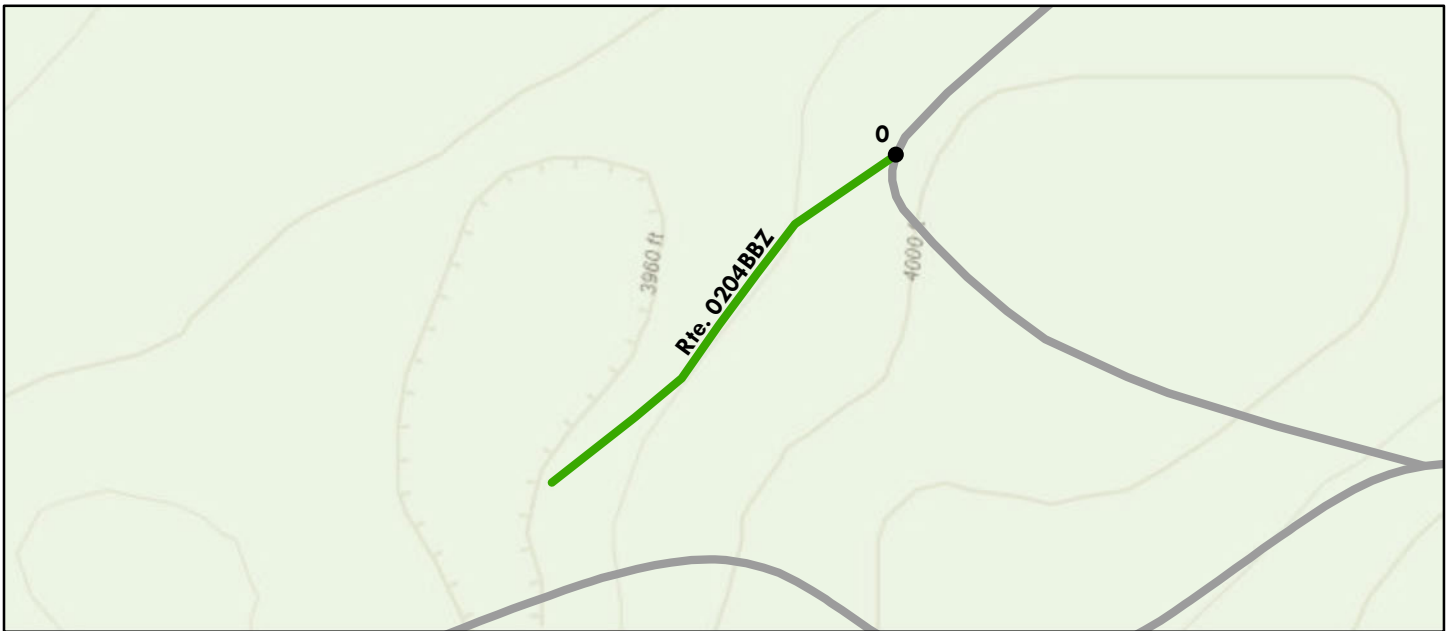
Subcomponent of Route HAVO-0204BZZ

Inspection Date: 3/8/2022	Beginning Section MP	0.00				
Paved Length (Miles): 0.04	Section Length (MI)	0.04				
Surface Type: ASPHALT	Route Summary					
Roadway Condition Information						
Pavement Condition Rating (PCR)	90	90				
Surface Condition Rating (SCR)	90	90				
Roughness Condition Index (RCI)	N/A	N/A				
Distress Index Values						
Structural Crack Index	N/A	N/A				
Alligator Crack Index	97	97				
Longitudinal Crack Index	90	90				
Transverse Cracking Index	90	90				
Patching Index	97	97				
Rutting Index	97	97				
International Roughness Index (IRI)	N/A	N/A				
Lane & Width Information						
Number of Lanes	2	2				
Paved Width (ft)	16	16				
Lane Width (ft)	8	8

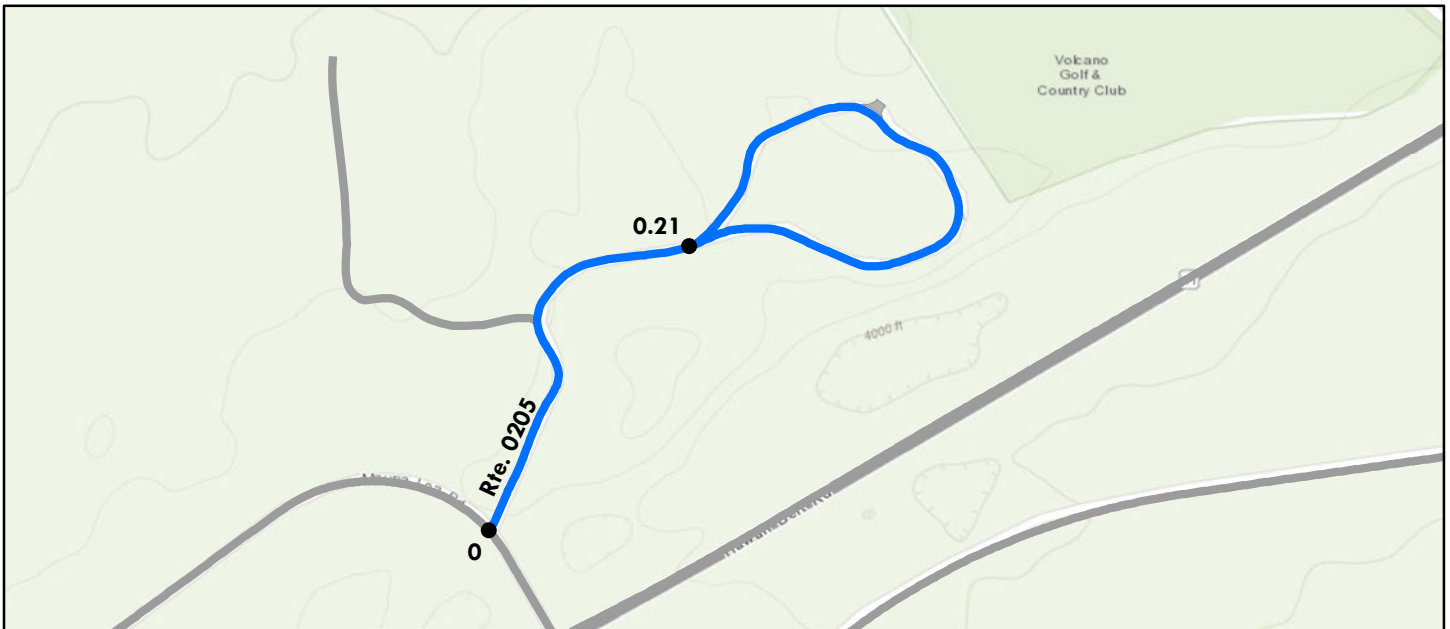
ROUTE 0205: TREE MOLDS ROAD

Route Condition Legend – Pavement Condition Rating (PCR)									
Poor (0 - 60)		Fair (61- 84)		Good (85 - 94)		Excellent (95 - 100)		Not Rated	
See Appendix for definitions and formulas									
Inspection Date:	3/8/2022	Beginning Section MP	0.00	0.21					
Paved Length (Miles):	0.56	Section Length (MI)	0.21	0.35					
Surface Type:	ASPHALT	Route Summary							
Roadway Condition Information									
Pavement Condition Rating (PCR)		97	97	97					
Surface Condition Rating (SCR)		97	97	97					
Roughness Condition Index (RCI)		N/A	N/A	N/A					
Distress Index Values									
Structural Crack Index		N/A	N/A	N/A					
Alligator Crack Index		97	97	97					
Longitudinal Crack Index		97	97	97					
Transverse Cracking Index		97	97	97					
Patching Index		97	97	97					
Rutting Index		97	97	97					
International Roughness Index (IRI)		N/A	N/A	N/A					
Lane & Width Information									
Number of Lanes		1	1	1					
Paved Width (ft)		10.7	12	10

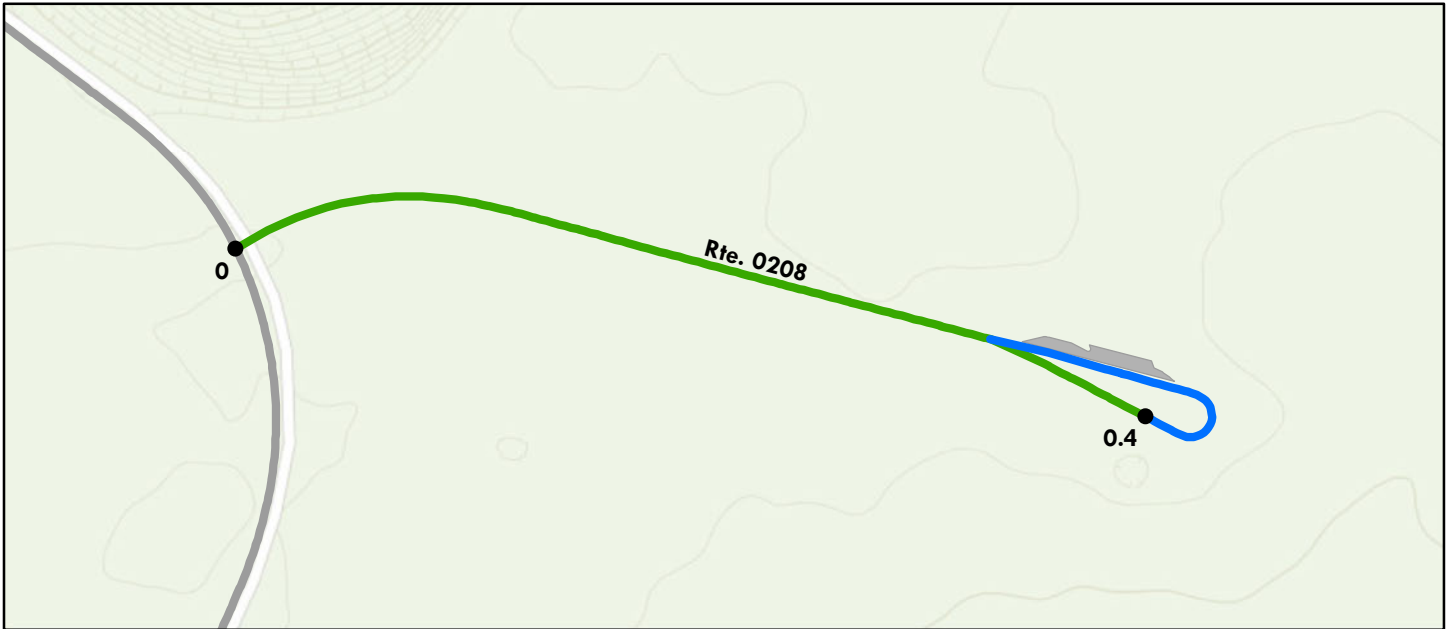
ROUTE 0208: MAUNA ULU ACCESS ROAD

Route Condition Legend – Pavement Condition Rating (PCR)						
Poor (0 - 60)	Fair (61- 84)	Good (85 - 94)	Excellent (95 - 100)	Not Rated		
See Appendix for definitions and formulas						
Inspection Date: 3/8/2022	Beginning Section MP	0.00	0.40			
Paved Length (Miles): 0.54	Section Length (MI)	0.40	0.14			
Surface Type: ASPHALT	Route Summary					
Roadway Condition Information						
Pavement Condition Rating (PCR)	92	90	97			
Surface Condition Rating (SCR)	92	90	97			
Roughness Condition Index (RCI)	N/A	N/A	N/A			
Distress Index Values						
Structural Crack Index	N/A	N/A	N/A			
Alligator Crack Index	97	97	97			
Longitudinal Crack Index	97	97	97			
Transverse Cracking Index	92	90	97			
Patching Index	97	97	97			
Rutting Index	97	97	97			
International Roughness Index (IRI)	N/A	N/A	N/A			
Lane & Width Information						
Number of Lanes	2	2	1			
Paved Width (ft)	18.7	21	12			
Lane Width (ft)	10.5	10	12

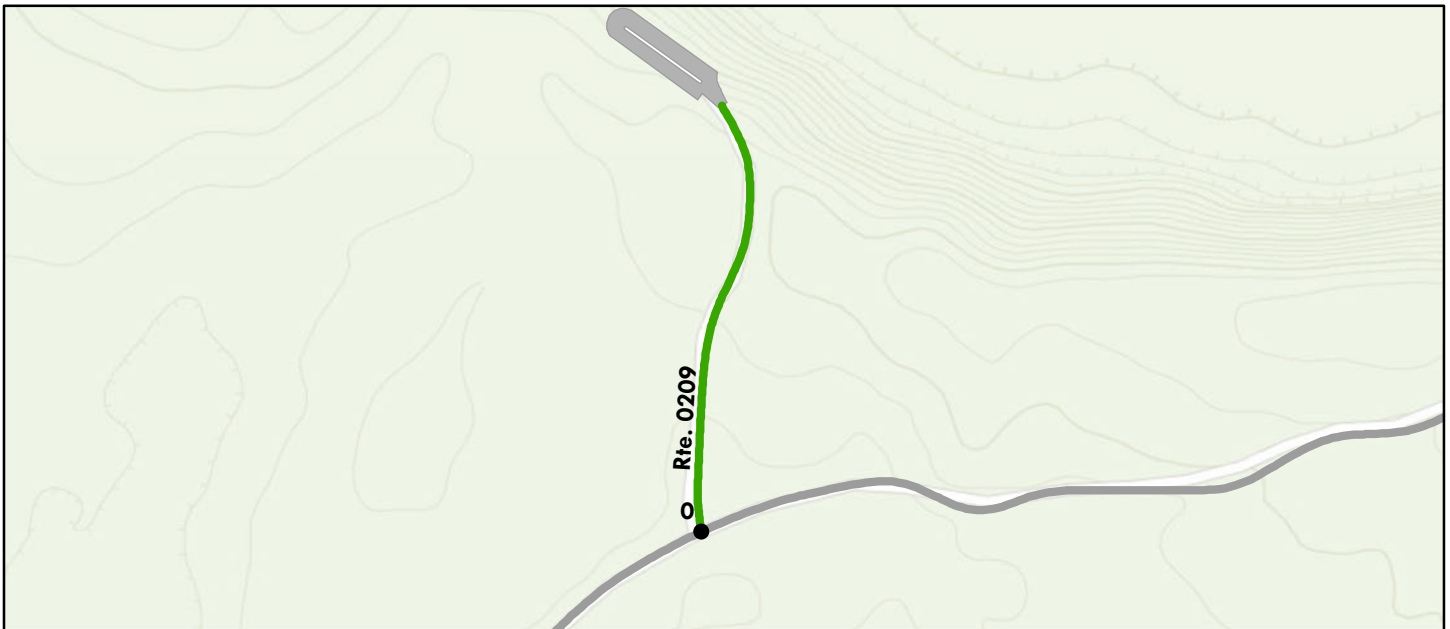
ROUTE 0209: PUU PAUI OVERLOOK ROAD

Inspection Date: 3/8/2022	Beginning Section MP	0.00				
Paved Length (Miles): 0.20	Section Length (MI)	0.20				
Surface Type: ASPHALT	Route Summary					
Roadway Condition Information						
Pavement Condition Rating (PCR)	90	90				
Surface Condition Rating (SCR)	90	90				
Roughness Condition Index (RCI)	N/A	N/A				
Distress Index Values						
Structural Crack Index	N/A	N/A				
Alligator Crack Index	97	97				
Longitudinal Crack Index	97	97				
Transverse Cracking Index	90	90				
Patching Index	97	97				
Rutting Index	97	97				
International Roughness Index (IRI)	N/A	N/A				
Lane & Width Information						
Number of Lanes	2	2				
Paved Width (ft)	21	21				
Lane Width (ft)	10	10

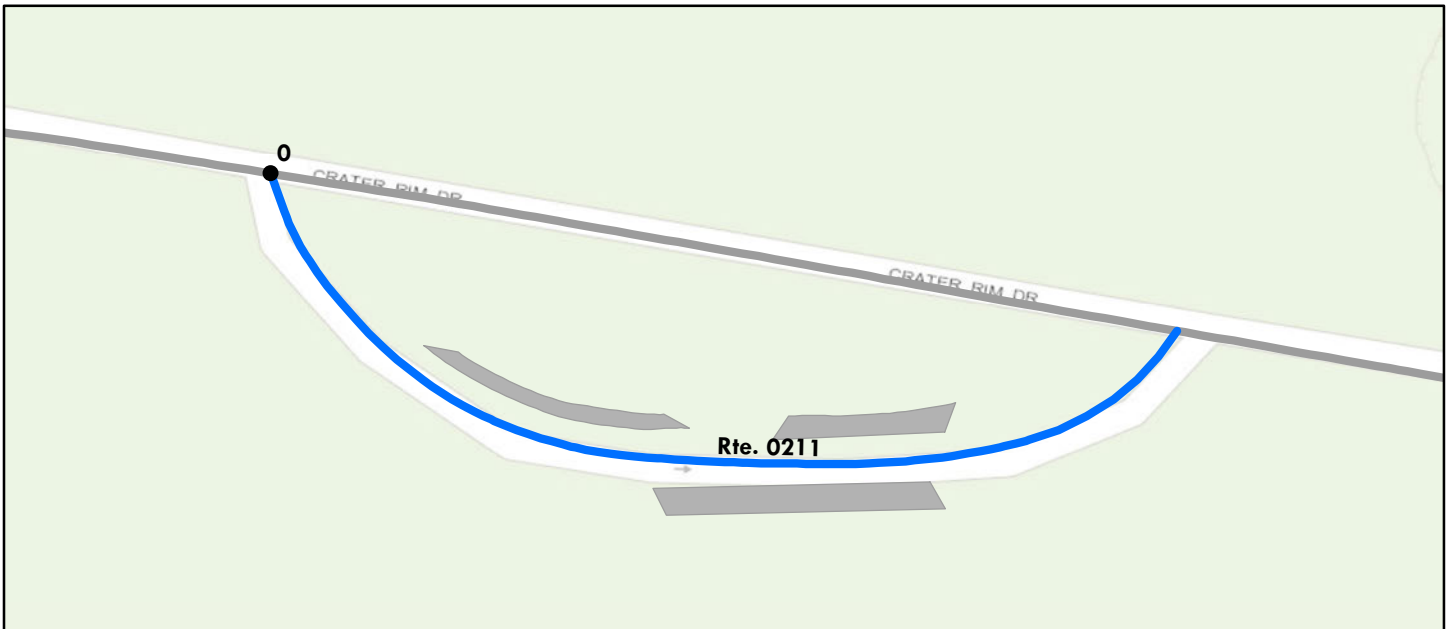
ROUTE 0211: STEAM VENTS ROAD

Inspection Date: 3/8/2022	Beginning Section MP	0.00				
Paved Length (Miles): 0.12	Section Length (MI)	0.12				
Surface Type: ASPHALT	Route Summary					
Roadway Condition Information						
Pavement Condition Rating (PCR)	97	97				
Surface Condition Rating (SCR)	97	97				
Roughness Condition Index (RCI)	N/A	N/A				
Distress Index Values						
Structural Crack Index	N/A	N/A				
Alligator Crack Index	97	97				
Longitudinal Crack Index	97	97				
Transverse Cracking Index	97	97				
Patching Index	97	97				
Rutting Index	97	97				
International Roughness Index (IRI)	N/A	N/A				
Lane & Width Information						
Number of Lanes	1	1				
Paved Width (ft)	12	12				
Lane Width (ft)	12	12

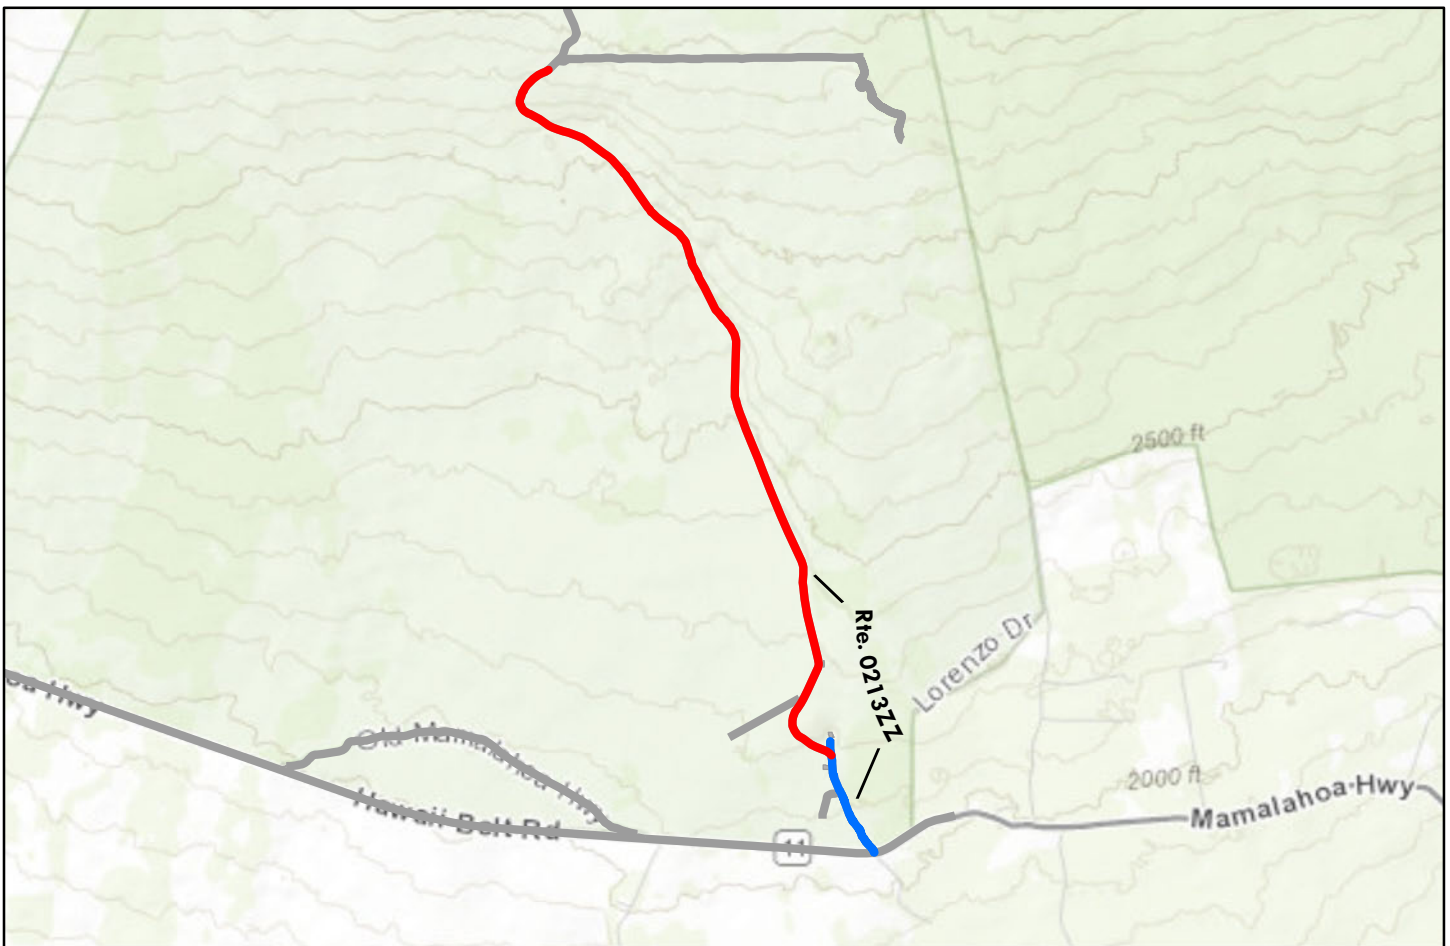
ROUTE 0213ZZ: KAHUKU ENTRANCE ROAD

Note: The weighted average summary PCR value is calculated from only the sections of road where the PCR was collected. The overall PCR for the summary route may not reflect individual subcomponent ratings.

Route Condition Legend – Pavement Condition Rating (PCR)						
Poor (0 - 60)	Fair (61- 84)	Good (85 - 94)	Excellent (95 - 100)	Not Rated		
See Appendix for definitions and formulas						
Inspection Date: 3/8/2022						
Paved Length (Miles): 0.56						
Surface Type: ASPHALT	Route Summary					
Roadway Condition Information						
Pavement Condition Rating (PCR)	97					
Lane & Width Information						
Number of Lanes	2					
Paved Width (ft)	22					
Lane Width (ft)	11

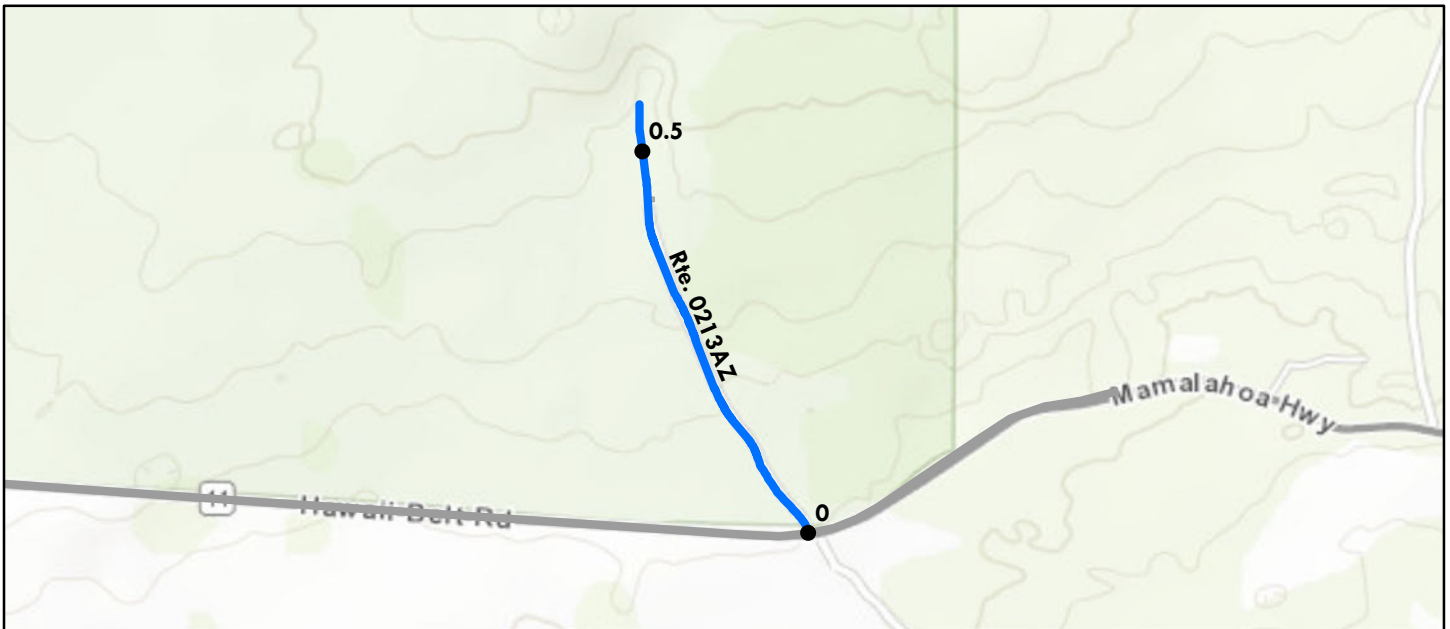
Subcomponent of Route HAVO-0213ZZ

Route Condition Legend – Pavement Condition Rating (PCR)						
Poor (0 - 60)	Fair (61- 84)	Good (85 - 94)	Excellent (95 - 100)	Not Rated		
See Appendix for definitions and formulas						
Inspection Date: 3/8/2022	Beginning Section MP	0.00	0.50			
Paved Length (Miles): 0.56	Section Length (MI)	0.50	0.06			
Surface Type: ASPHALT	Route Summary					
Roadway Condition Information						
Pavement Condition Rating (PCR)	97	97	97			
Surface Condition Rating (SCR)	97	97	97			
Roughness Condition Index (RCI)	N/A	N/A	N/A			
Distress Index Values						
Structural Crack Index	N/A	N/A	N/A			
Alligator Crack Index	97	97	97			
Longitudinal Crack Index	97	97	97			
Transverse Cracking Index	97	97	97			
Patching Index	97	97	97			
Rutting Index	97	97	97			
International Roughness Index (IRI)	N/A	N/A	N/A			
Lane & Width Information						
Number of Lanes	2	2	2			
Paved Width (ft)	22	22	22			
Lane Width (ft)	11	11	11
