Road Inventory and Condition Assessment of Paved Routes Hawaii Volcanoes National Park

**Federal Lands Highway
Road Inventory Program**

**Federal Highway Administration
Eastern Federal Lands Highway Division
Road Inventory Program (RIP)**

Report Date: December 2022

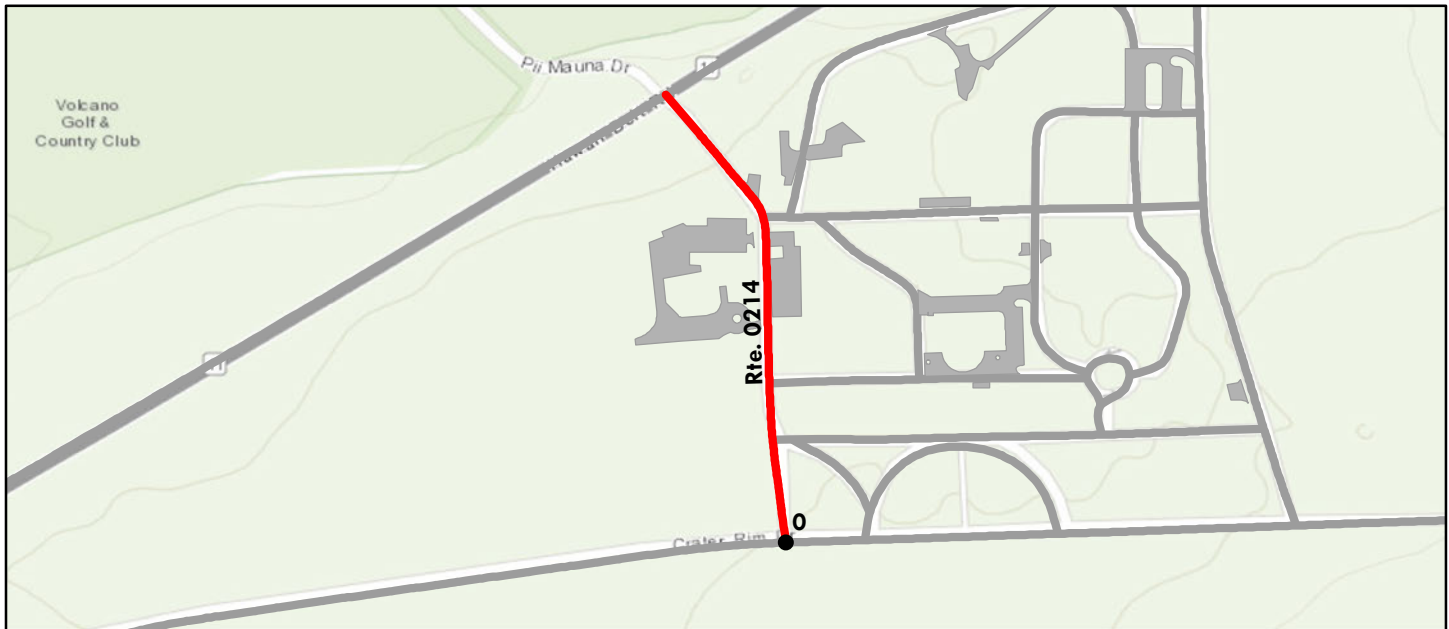
ROUTE 0214: KILAUEA MILITARY CAMP ROAD

Manual Rating

Route Condition Legend – Pavement Condition Rating (PCR)

Inspection Date: 3/8/2022	Beginning Section MP	0.00				
Paved Length (Miles): 0.20	Section Length (MI)	0.20				
Surface Type: ASPHALT	Route Summary					
Roadway Condition Information						
Pavement Condition Rating (PCR)	53	53				
Surface Condition Rating (SCR)	53	53				
Roughness Condition Index (RCI)	N/A	N/A				
Distress Index Values						
Structural Crack Index	N/A	N/A				
Alligator Crack Index	73	73				
Longitudinal Crack Index	53	53				
Transverse Cracking Index	53	53				
Patching Index	97	97				
Rutting Index	97	97				
International Roughness Index (IRI)	N/A	N/A				
Lane & Width Information						
Number of Lanes	2	2				
Paved Width (ft)	16	16				
Lane Width (ft)	8	8

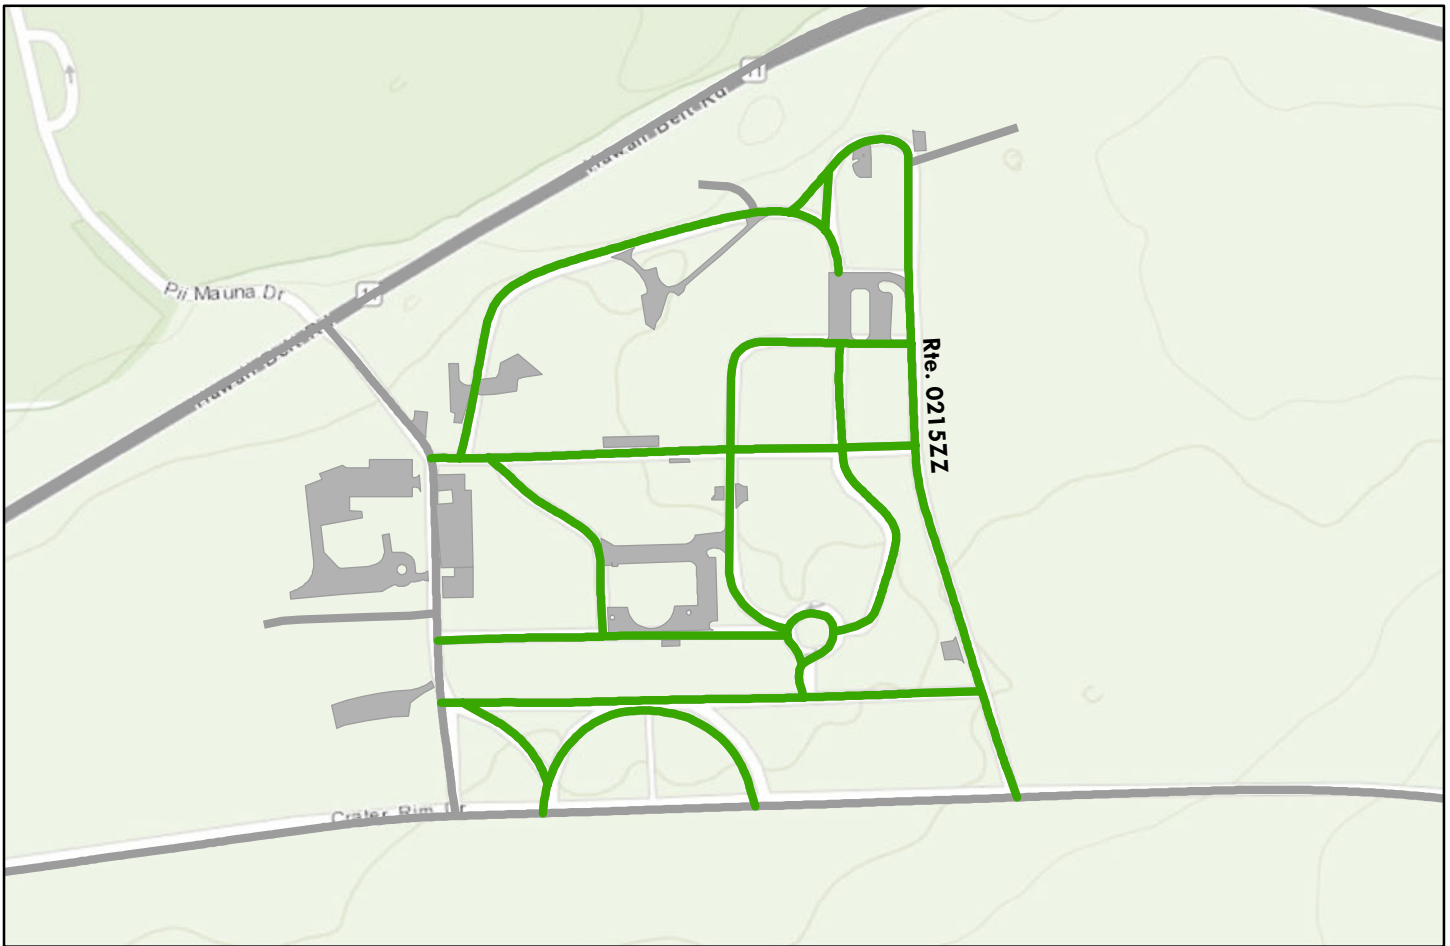
ROUTE 0215ZZ: KILAUEA MILITARY CAMP ROADS

Summary Route

Note: The weighted average summary PCR value is calculated from only the sections of road where the PCR was collected. The overall PCR for the summary route may not reflect individual subcomponent ratings.

Route Condition Legend – Pavement Condition Rating (PCR)						
Poor (0 - 60)	Fair (61- 84)	Good (85 - 94)	Excellent (95 - 100)	Not Rated		
See Appendix for definitions and formulas						
Inspection Date: 3/8/2022						
Paved Length (Miles): 1.71						
Surface Type: ASPHALT	Route Summary					
Roadway Condition Information						
Pavement Condition Rating (PCR)	87					
Lane & Width Information						
Number of Lanes	2					
Paved Width (ft)	18.7					
Lane Width (ft)	10

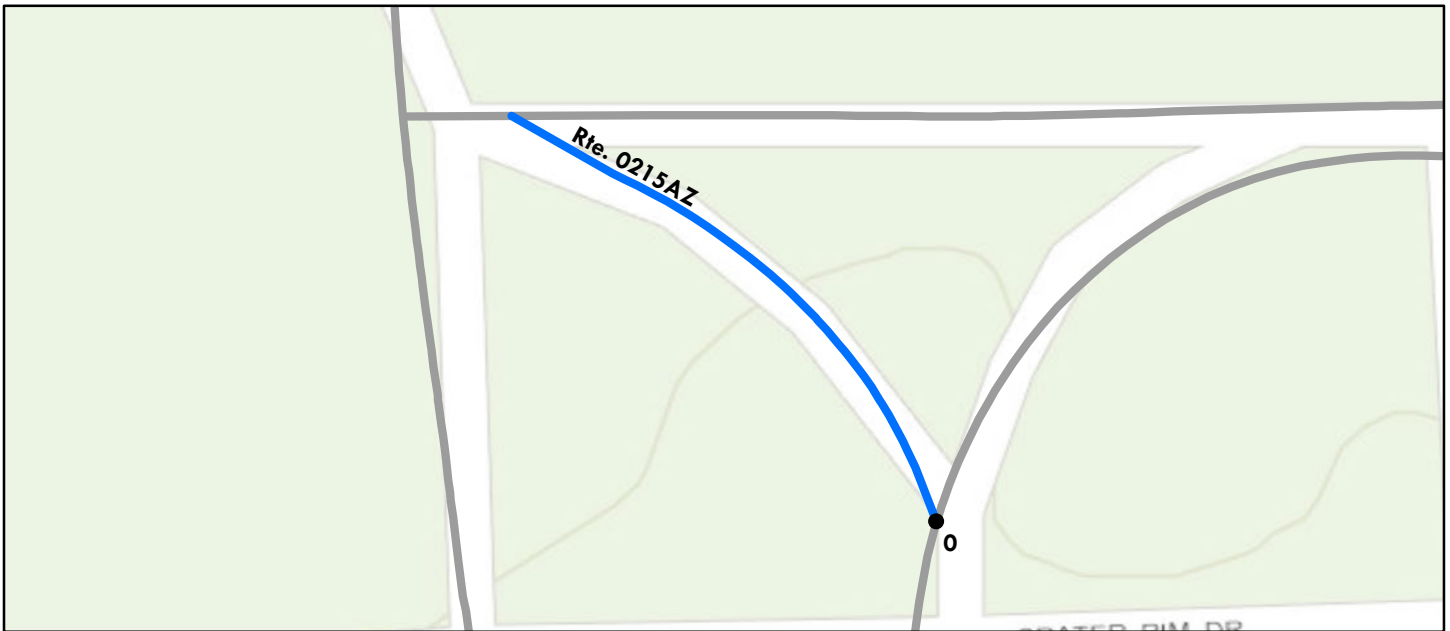
Subcomponent of Route HAVO-0215ZZ

Manual Rating

Route Condition Legend – Pavement Condition Rating (PCR)						
Poor (0 - 60)	Fair (61- 84)	Good (85 - 94)	Excellent (95 - 100)	Not Rated		
See Appendix for definitions and formulas						
Inspection Date: 3/8/2022	Beginning Section MP	0.00				
Paved Length (Miles): 0.04	Section Length (MI)	0.04				
Surface Type: ASPHALT	Route Summary					
Roadway Condition Information						
Pavement Condition Rating (PCR)	97	97				
Surface Condition Rating (SCR)	97	97				
Roughness Condition Index (RCI)	N/A	N/A				
Distress Index Values						
Structural Crack Index	N/A	N/A				
Alligator Crack Index	97	97				
Longitudinal Crack Index	97	97				
Transverse Cracking Index	97	97				
Patching Index	97	97				
Rutting Index	97	97				
International Roughness Index (IRI)	N/A	N/A				
Lane & Width Information						
Number of Lanes	2	2				
Paved Width (ft)	28	28				
Lane Width (ft)	12	12

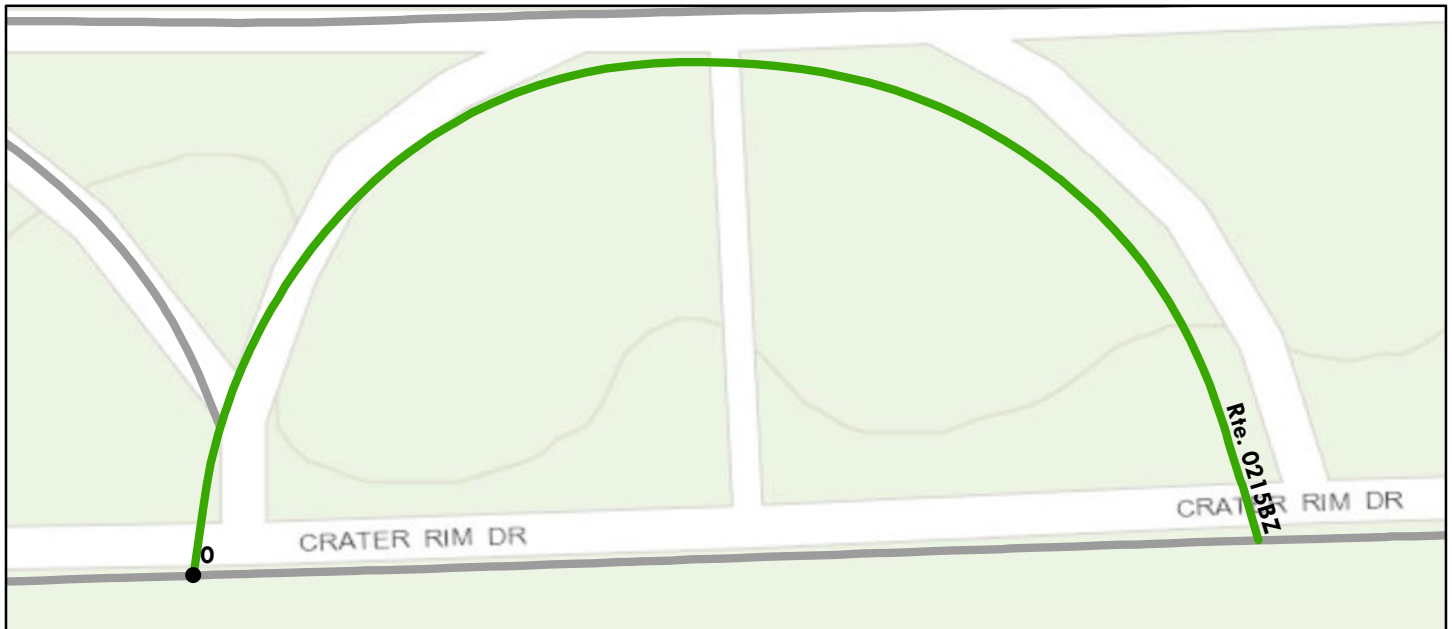
Subcomponent of Route HAVO-0215ZZ

Manual Rating

Route Condition Legend – Pavement Condition Rating (PCR)						
Poor (0 - 60)	Fair (61- 84)	Good (85 - 94)	Excellent (95 - 100)	Not Rated		
See Appendix for definitions and formulas						
Inspection Date: 3/8/2022	Beginning Section MP	0.00				
Paved Length (Miles): 0.12	Section Length (MI)	0.12				
Surface Type: ASPHALT	Route Summary					
Roadway Condition Information						
Pavement Condition Rating (PCR)	90	90				
Surface Condition Rating (SCR)	90	90				
Roughness Condition Index (RCI)	N/A	N/A				
Distress Index Values						
Structural Crack Index	N/A	N/A				
Alligator Crack Index	97	97				
Longitudinal Crack Index	90	90				
Transverse Cracking Index	90	90				
Patching Index	97	97				
Rutting Index	97	97				
International Roughness Index (IRI)	N/A	N/A				
Lane & Width Information						
Number of Lanes	2	2				
Paved Width (ft)	28	28				
Lane Width (ft)	12	12

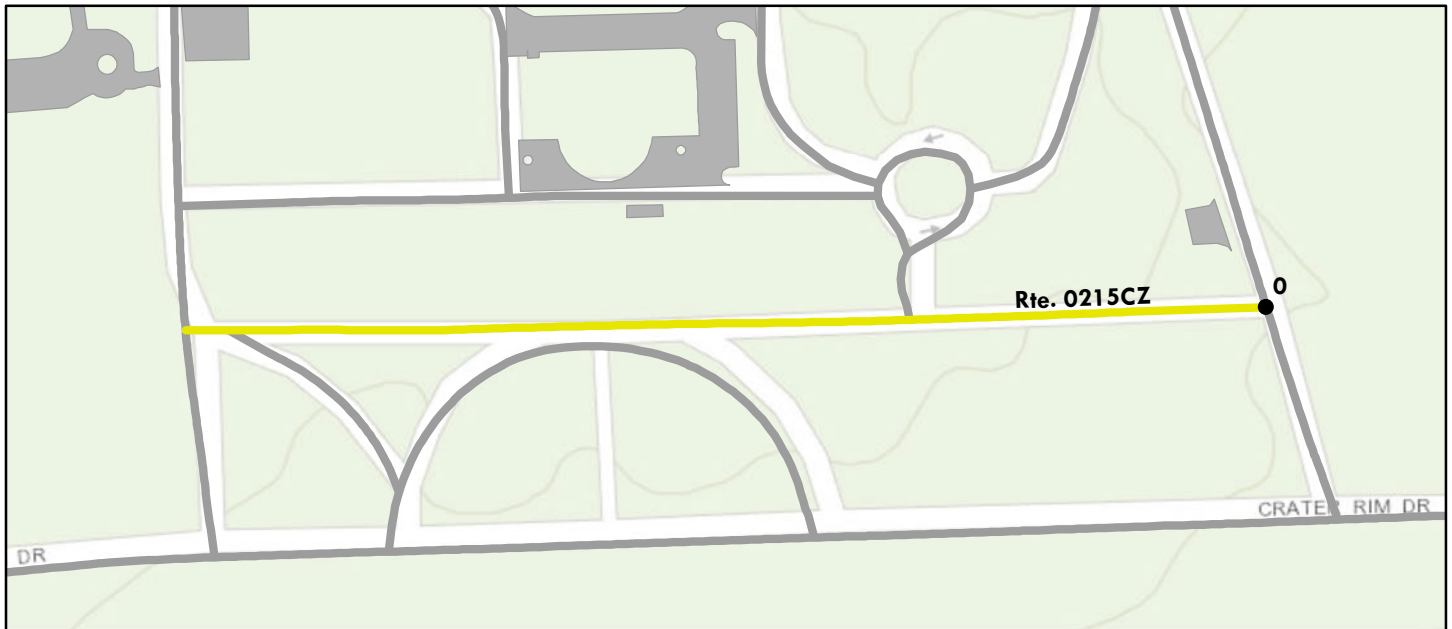
Subcomponent of Route HAVO-0215ZZ

Manual Rating

Route Condition Legend – Pavement Condition Rating (PCR)						
Poor (0 - 60)	Fair (61- 84)	Good (85 - 94)	Excellent (95 - 100)	Not Rated		
See Appendix for definitions and formulas						
Inspection Date: 3/8/2022	Beginning Section MP	0.00				
Paved Length (Miles): 0.20	Section Length (MI)	0.20				
Surface Type: ASPHALT	Route Summary					
Roadway Condition Information						
Pavement Condition Rating (PCR)	73	73				
Surface Condition Rating (SCR)	73	73				
Roughness Condition Index (RCI)	N/A	N/A				
Distress Index Values						
Structural Crack Index	N/A	N/A				
Alligator Crack Index	73	73				
Longitudinal Crack Index	73	73				
Transverse Cracking Index	73	73				
Patching Index	90	90				
Rutting Index	97	97				
International Roughness Index (IRI)	N/A	N/A				
Lane & Width Information						
Number of Lanes	2	2				
Paved Width (ft)	22	22				
Lane Width (ft)	11	11

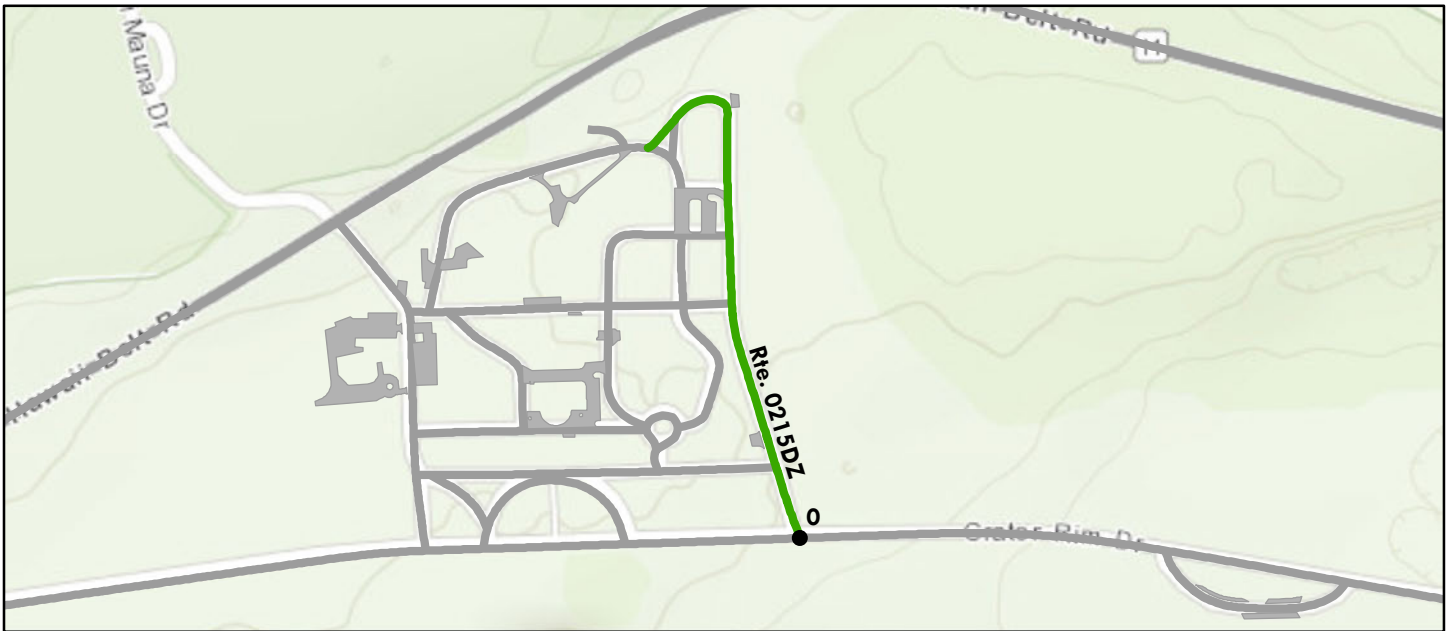
Subcomponent of Route HAVO-0215ZZ

Manual Rating

Route Condition Legend – Pavement Condition Rating (PCR)						
Poor (0 - 60)	Fair (61- 84)	Good (85 - 94)	Excellent (95 - 100)	Not Rated		
See Appendix for definitions and formulas						
Inspection Date: 3/8/2022	Beginning Section MP	0.00				
Paved Length (Miles): 0.33	Section Length (MI)	0.33				
Surface Type: ASPHALT	Route Summary					
Roadway Condition Information						
Pavement Condition Rating (PCR)	90	90				
Surface Condition Rating (SCR)	90	90				
Roughness Condition Index (RCI)	N/A	N/A				
Distress Index Values						
Structural Crack Index	N/A	N/A				
Alligator Crack Index	97	97				
Longitudinal Crack Index	90	90				
Transverse Cracking Index	90	90				
Patching Index	90	90				
Rutting Index	97	97				
International Roughness Index (IRI)	N/A	N/A				
Lane & Width Information						
Number of Lanes	2	2				
Paved Width (ft)	20	20				
Lane Width (ft)	10	10

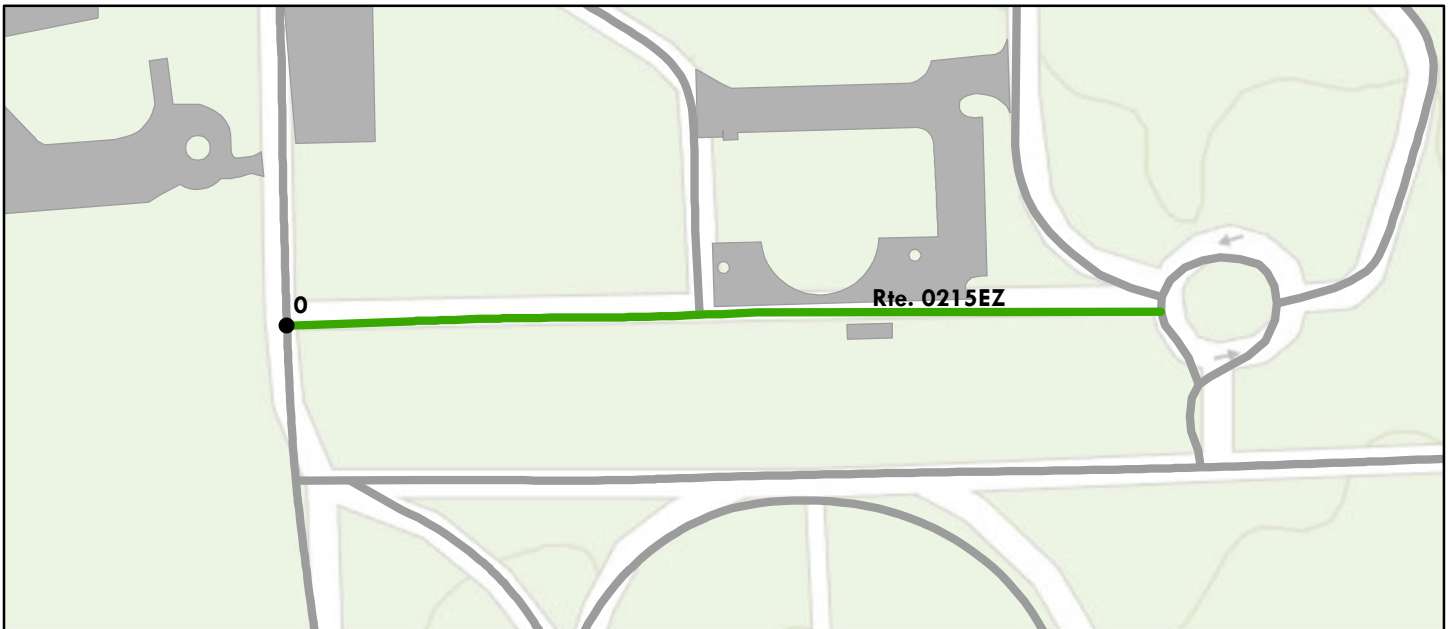
Route Condition Legend – Pavement Condition Rating (PCR)						
Poor (0 - 60)	Fair (61- 84)	Good (85 - 94)	Excellent (95 - 100)	Not Rated		
See Appendix for definitions and formulas						
Inspection Date: 3/8/2022	Beginning Section MP	0.00				
Paved Length (Miles): 0.12	Section Length (MI)	0.12				
Surface Type: ASPHALT	Route Summary					
Roadway Condition Information						
Pavement Condition Rating (PCR)	90	90				
Surface Condition Rating (SCR)	90	90				
Roughness Condition Index (RCI)	N/A	N/A				
Distress Index Values						
Structural Crack Index	N/A	N/A				
Alligator Crack Index	97	97				
Longitudinal Crack Index	90	90				
Transverse Cracking Index	90	90				
Patching Index	90	90				
Rutting Index	90	90				
International Roughness Index (IRI)	N/A	N/A				
Lane & Width Information						
Number of Lanes	2	2				
Paved Width (ft)	20	20				
Lane Width (ft)	10	10

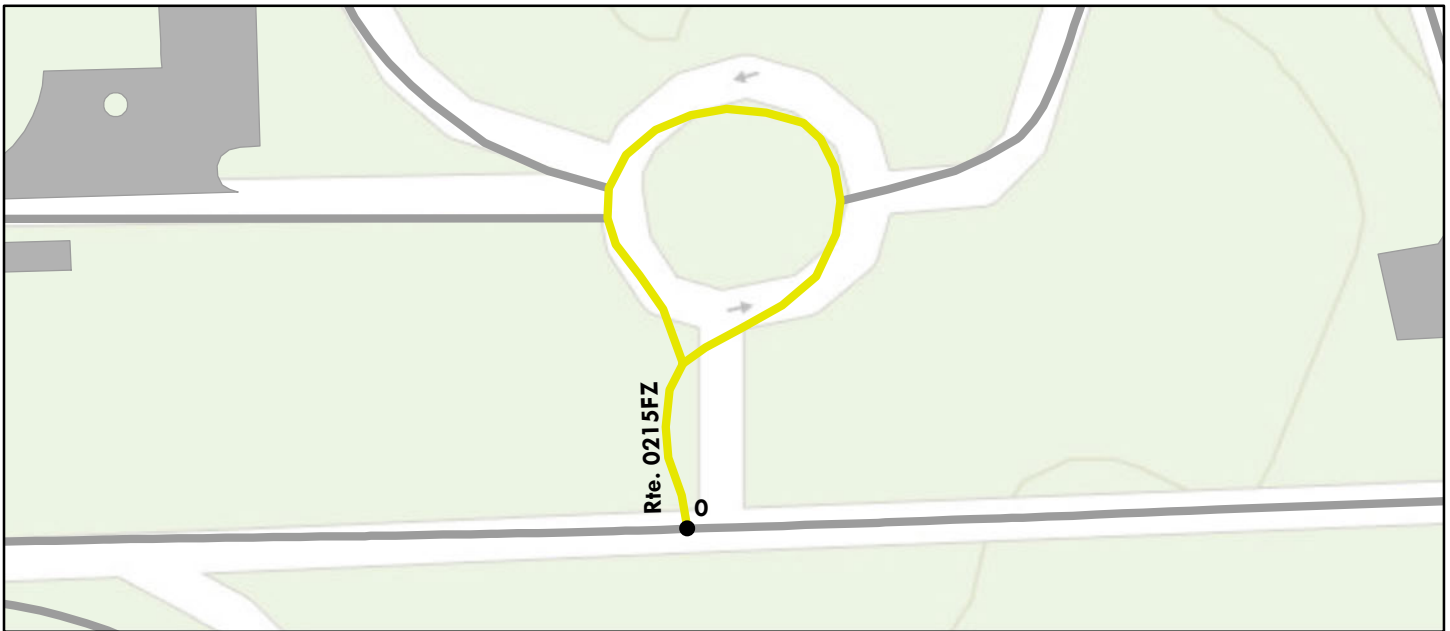
Route Condition Legend – Pavement Condition Rating (PCR)						
Poor (0 - 60)	Fair (61- 84)	Good (85 - 94)	Excellent (95 - 100)	Not Rated		
See Appendix for definitions and formulas						
Inspection Date: 3/8/2022	Beginning Section MP	0.00				
Paved Length (Miles): 0.07	Section Length (MI)	0.07				
Surface Type: ASPHALT	Route Summary					
Roadway Condition Information						
Pavement Condition Rating (PCR)	73	73				
Surface Condition Rating (SCR)	73	73				
Roughness Condition Index (RCI)	N/A	N/A				
Distress Index Values						
Structural Crack Index	N/A	N/A				
Alligator Crack Index	90	90				
Longitudinal Crack Index	90	90				
Transverse Cracking Index	73	73				
Patching Index	90	90				
Rutting Index	97	97				
International Roughness Index (IRI)	N/A	N/A				
Lane & Width Information						
Number of Lanes	2	2				
Paved Width (ft)	16	16				
Lane Width (ft)	8	8

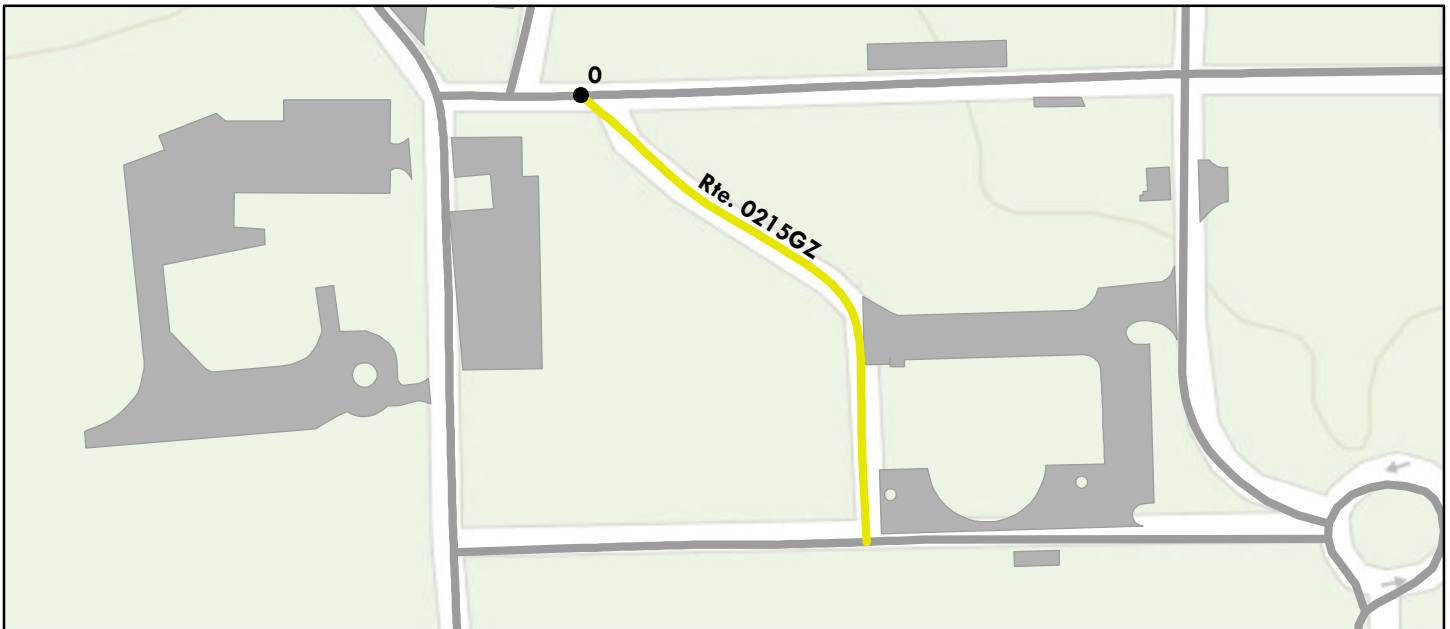
Route Condition Legend – Pavement Condition Rating (PCR)						
Poor (0 - 60)	Fair (61- 84)	Good (85 - 94)	Excellent (95 - 100)	Not Rated		
See Appendix for definitions and formulas						
Inspection Date: 3/8/2022	Beginning Section MP	0.00				
Paved Length (Miles): 0.09	Section Length (MI)	0.09				
Surface Type: ASPHALT	Route Summary					
Roadway Condition Information						
Pavement Condition Rating (PCR)	73	73				
Surface Condition Rating (SCR)	73	73				
Roughness Condition Index (RCI)	N/A	N/A				
Distress Index Values						
Structural Crack Index	N/A	N/A				
Alligator Crack Index	90	90				
Longitudinal Crack Index	73	73				
Transverse Cracking Index	73	73				
Patching Index	90	90				
Rutting Index	90	90				
International Roughness Index (IRI)	N/A	N/A				
Lane & Width Information						
Number of Lanes	2	2				
Paved Width (ft)	16	16				
Lane Width (ft)	8	8

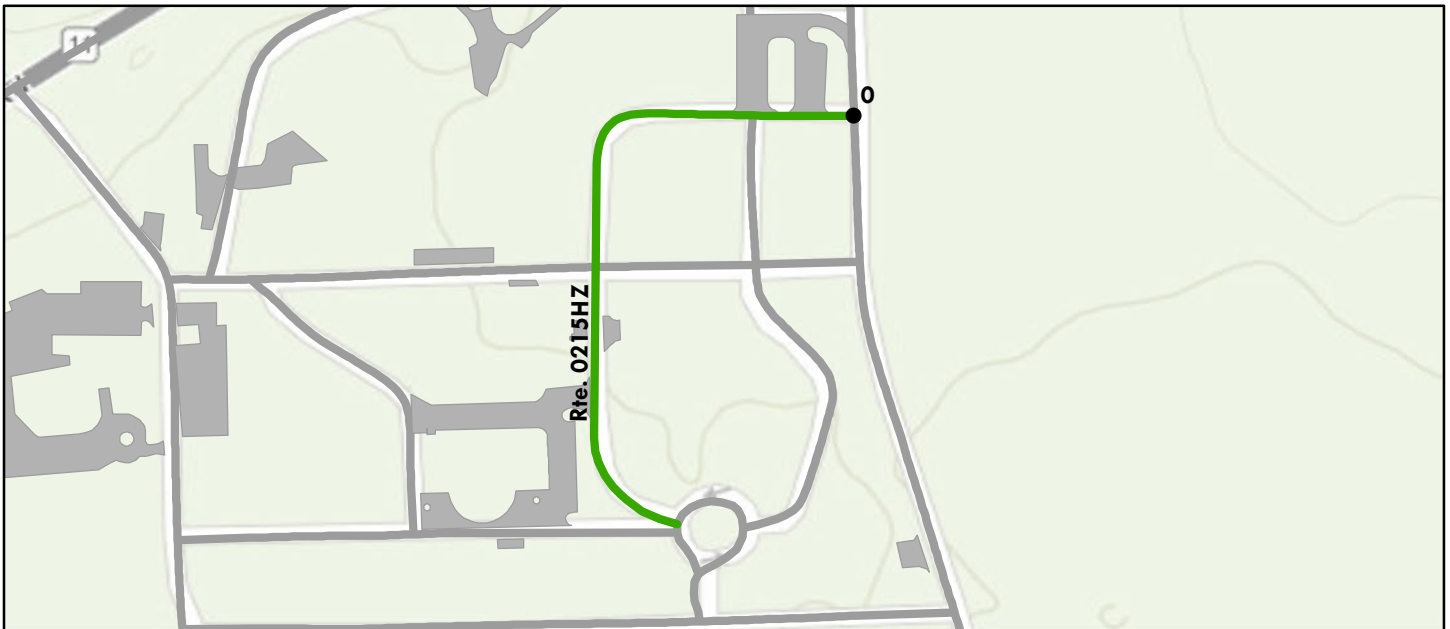
Route Condition Legend – Pavement Condition Rating (PCR)						
Poor (0 - 60)	Fair (61- 84)	Good (85 - 94)	Excellent (95 - 100)	Not Rated		
See Appendix for definitions and formulas						
Inspection Date: 3/8/2022	Beginning Section MP	0.00				
Paved Length (Miles): 0.18	Section Length (MI)	0.18				
Surface Type: ASPHALT	Route Summary					
Roadway Condition Information						
Pavement Condition Rating (PCR)	90	90				
Surface Condition Rating (SCR)	90	90				
Roughness Condition Index (RCI)	N/A	N/A				
Distress Index Values						
Structural Crack Index	N/A	N/A				
Alligator Crack Index	97	97				
Longitudinal Crack Index	90	90				
Transverse Cracking Index	90	90				
Patching Index	90	90				
Rutting Index	97	97				
International Roughness Index (IRI)	N/A	N/A				
Lane & Width Information						
Number of Lanes	2	2				
Paved Width (ft)	16	16				
Lane Width (ft)	8	8

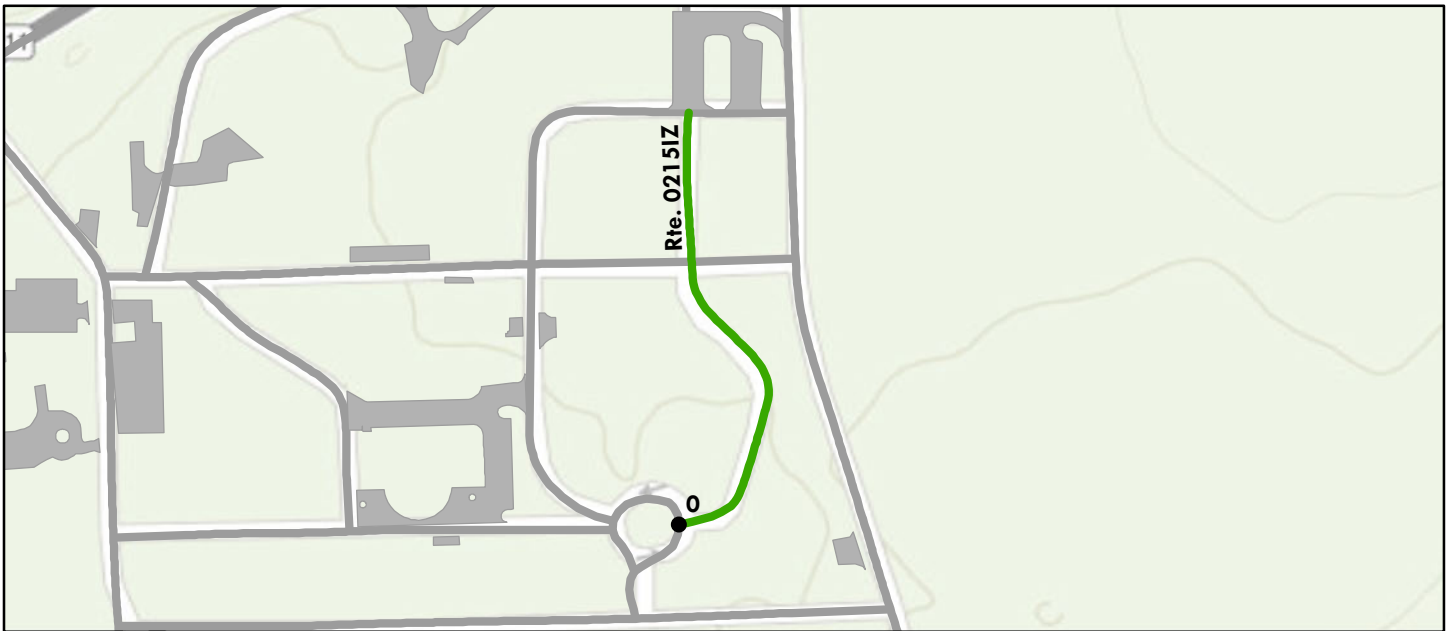
Route Condition Legend – Pavement Condition Rating (PCR)						
Poor (0 - 60)	Fair (61- 84)	Good (85 - 94)	Excellent (95 - 100)	Not Rated		
See Appendix for definitions and formulas						
Inspection Date: 3/8/2022	Beginning Section MP	0.00				
Paved Length (Miles): 0.13	Section Length (MI)	0.13				
Surface Type: ASPHALT	Route Summary					
Roadway Condition Information						
Pavement Condition Rating (PCR)	90	90				
Surface Condition Rating (SCR)	90	90				
Roughness Condition Index (RCI)	N/A	N/A				
Distress Index Values						
Structural Crack Index	N/A	N/A				
Alligator Crack Index	97	97				
Longitudinal Crack Index	97	97				
Transverse Cracking Index	90	90				
Patching Index	90	90				
Rutting Index	97	97				
International Roughness Index (IRI)	N/A	N/A				
Lane & Width Information						
Number of Lanes	2	2				
Paved Width (ft)	16	16				
Lane Width (ft)	8	8

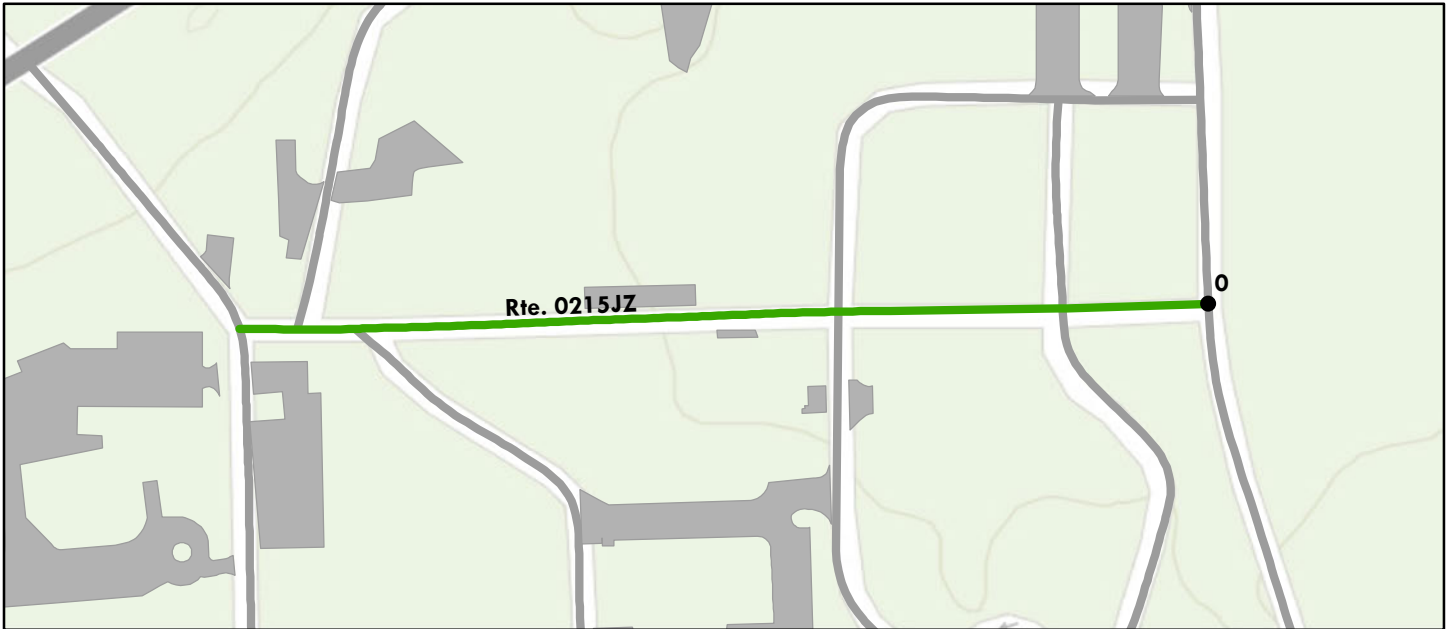
Route Condition Legend – Pavement Condition Rating (PCR)						
Poor (0 - 60)	Fair (61- 84)	Good (85 - 94)	Excellent (95 - 100)	Not Rated		
See Appendix for definitions and formulas						
Inspection Date: 3/8/2022	Beginning Section MP	0.00				
Paved Length (Miles): 0.18	Section Length (MI)	0.18				
Surface Type: ASPHALT	Route Summary					
Roadway Condition Information						
Pavement Condition Rating (PCR)	90	90				
Surface Condition Rating (SCR)	90	90				
Roughness Condition Index (RCI)	N/A	N/A				
Distress Index Values						
Structural Crack Index	N/A	N/A				
Alligator Crack Index	97	97				
Longitudinal Crack Index	90	90				
Transverse Cracking Index	90	90				
Patching Index	90	90				
Rutting Index	97	97				
International Roughness Index (IRI)	N/A	N/A				
Lane & Width Information						
Number of Lanes	2	2				
Paved Width (ft)	20	20				
Lane Width (ft)	10	10

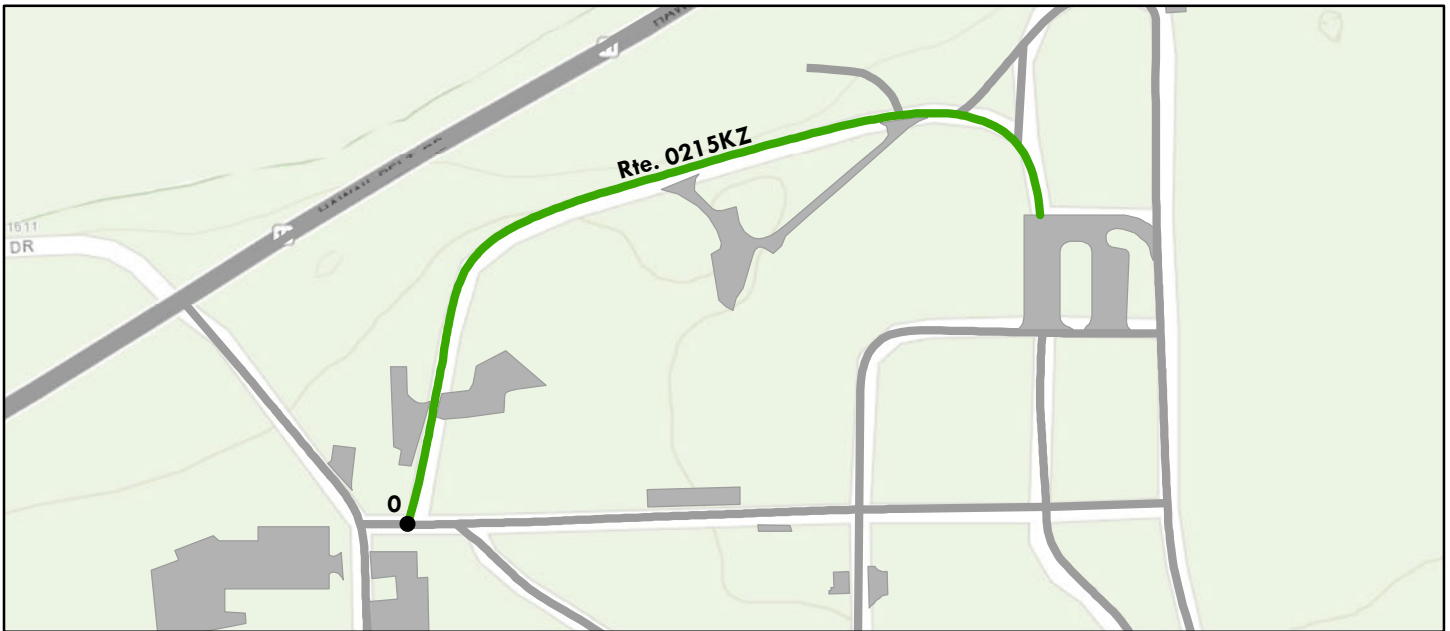
Manual Rating

Route Condition Legend – Pavement Condition Rating (PCR)						
Poor (0 - 60)	Fair (61- 84)	Good (85 - 94)	Excellent (95 - 100)	Not Rated		
See Appendix for definitions and formulas						
Inspection Date: 3/8/2022	Beginning Section MP	0.00				
Paved Length (Miles): 0.23	Section Length (MI)	0.23				
Surface Type: ASPHALT	Route Summary					
Roadway Condition Information						
Pavement Condition Rating (PCR)	90	90				
Surface Condition Rating (SCR)	90	90				
Roughness Condition Index (RCI)	N/A	N/A				
Distress Index Values						
Structural Crack Index	N/A	N/A				
Alligator Crack Index	97	97				
Longitudinal Crack Index	97	97				
Transverse Cracking Index	90	90				
Patching Index	90	90				
Rutting Index	97	97				
International Roughness Index (IRI)	N/A	N/A				
Lane & Width Information						
Number of Lanes	1	1				
Paved Width (ft)	12	12				
Lane Width (ft)	12	12

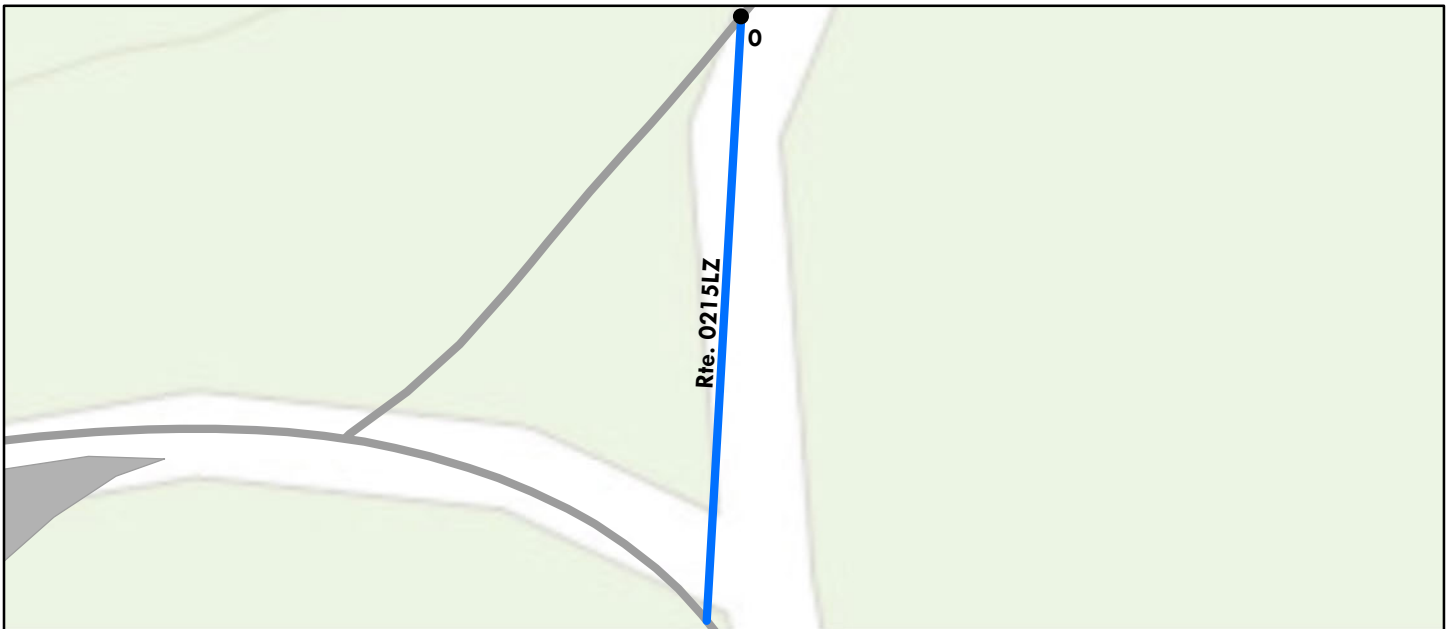
Manual Rating

Route Condition Legend – Pavement Condition Rating (PCR)						
Poor (0 - 60)	Fair (61- 84)	Good (85 - 94)	Excellent (95 - 100)	Not Rated		
See Appendix for definitions and formulas						
Inspection Date: 3/8/2022	Beginning Section MP	0.00				
Paved Length (Miles): 0.02	Section Length (MI)	0.02				
Surface Type: ASPHALT	Route Summary					
Roadway Condition Information						
Pavement Condition Rating (PCR)	97	97				
Surface Condition Rating (SCR)	97	97				
Roughness Condition Index (RCI)	N/A	N/A				
Distress Index Values						
Structural Crack Index	N/A	N/A				
Alligator Crack Index	97	97				
Longitudinal Crack Index	97	97				
Transverse Cracking Index	97	97				
Patching Index	97	97				
Rutting Index	97	97				
International Roughness Index (IRI)	N/A	N/A				
Lane & Width Information						
Number of Lanes	2	2				
Paved Width (ft)	14	14				
Lane Width (ft)	7	7

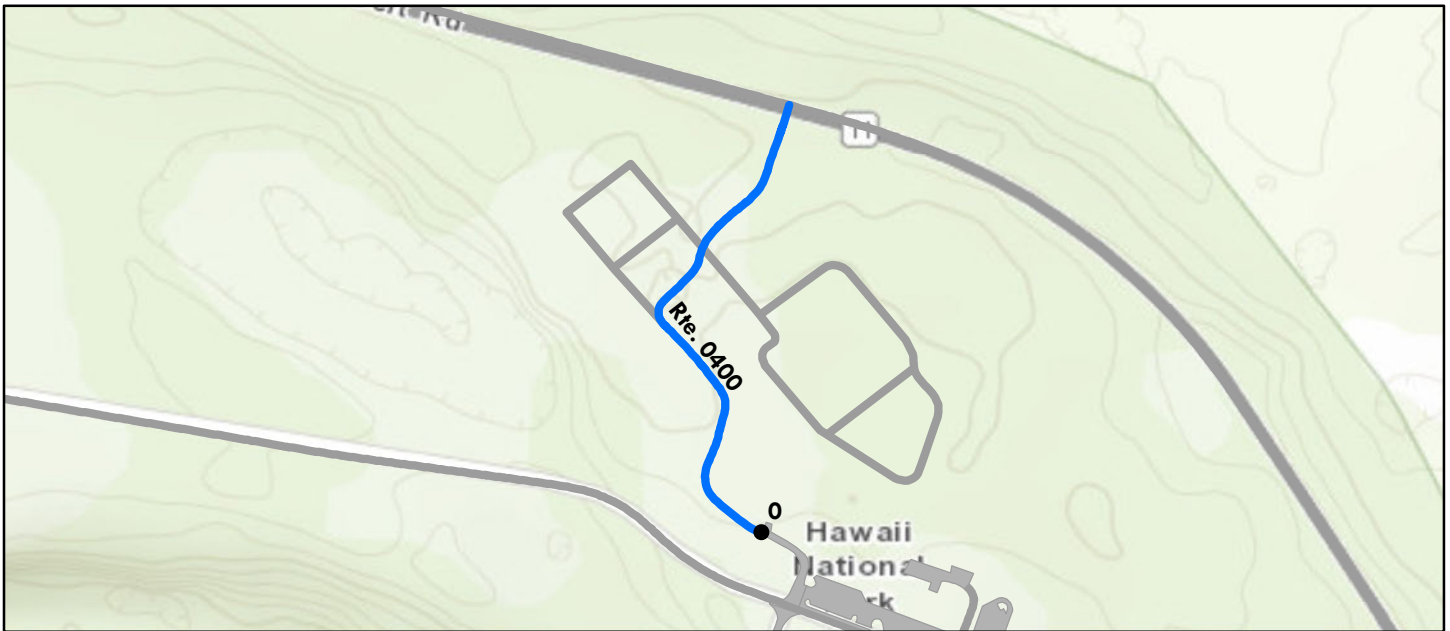
ROUTE 0400: WATER TANK ROAD

Route Condition Legend – Pavement Condition Rating (PCR)						
Poor (0 - 60)	Fair (61- 84)	Good (85 - 94)	Excellent (95 - 100)	Not Rated		
See Appendix for definitions and formulas						
Inspection Date: 3/8/2022	Beginning Section MP	0.00				
Paved Length (Miles): 0.34	Section Length (MI)	0.34				
Surface Type: ASPHALT	Route Summary					
Roadway Condition Information						
Pavement Condition Rating (PCR)	97	97				
Surface Condition Rating (SCR)	97	97				
Roughness Condition Index (RCI)	N/A	N/A				
Distress Index Values						
Structural Crack Index	N/A	N/A				
Alligator Crack Index	97	97				
Longitudinal Crack Index	97	97				
Transverse Cracking Index	97	97				
Patching Index	97	97				
Rutting Index	97	97				
International Roughness Index (IRI)	N/A	N/A				
Lane & Width Information						
Number of Lanes	1	1				
Paved Width (ft)	12	12				
Lane Width (ft)	12	12

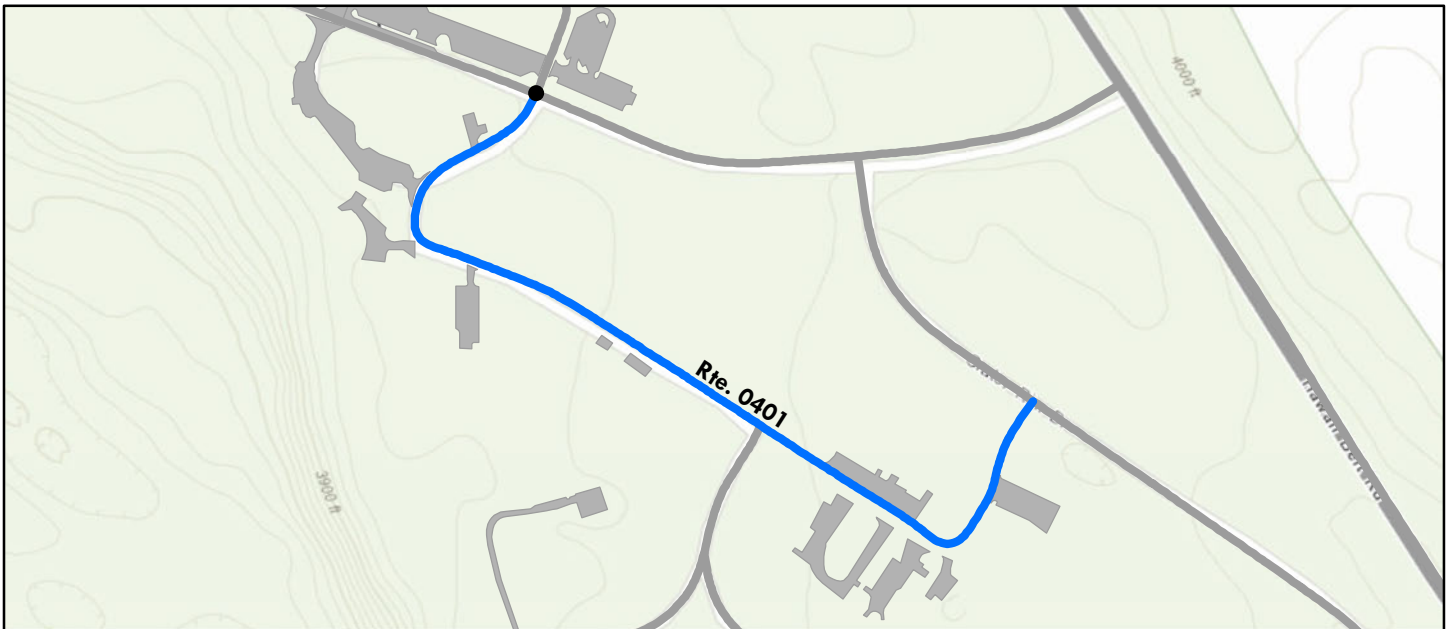
ROUTE 0401: NORTH RESIDENCE ROAD

Inspection Date: 3/8/2022	Beginning Section MP	0.00				
Paved Length (Miles): 0.43	Section Length (MI)	0.43				
Surface Type: ASPHALT	Route Summary					
Roadway Condition Information						
Pavement Condition Rating (PCR)	97	97				
Surface Condition Rating (SCR)	97	97				
Roughness Condition Index (RCI)	N/A	N/A				
Distress Index Values						
Structural Crack Index	N/A	N/A				
Alligator Crack Index	97	97				
Longitudinal Crack Index	97	97				
Transverse Cracking Index	97	97				
Patching Index	97	97				
Rutting Index	97	97				
International Roughness Index (IRI)	N/A	N/A				
Lane & Width Information						
Number of Lanes	2	2				
Paved Width (ft)	18	18				
Lane Width (ft)	9	9

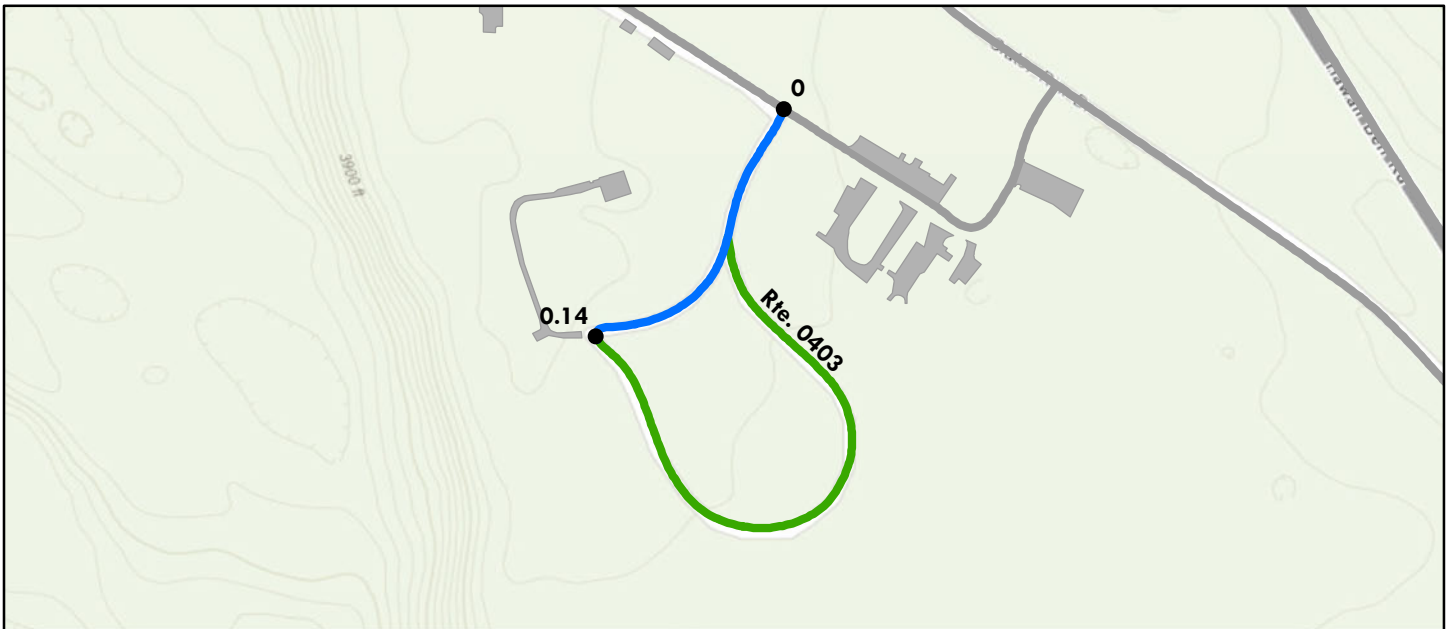
ROUTE 0403: SOUTH RESIDENCE LOOP

Inspection Date: 3/8/2022	Beginning Section MP	0.00	0.14			
Paved Length (Miles): 0.42	Section Length (MI)	0.14	0.28			
Surface Type: ASPHALT	Route Summary					
Roadway Condition Information						
Pavement Condition Rating (PCR)	92	97	90			
Surface Condition Rating (SCR)	92	97	90			
Roughness Condition Index (RCI)	N/A	N/A	N/A			
Distress Index Values						
Structural Crack Index	N/A	N/A	N/A			
Alligator Crack Index	97	97	97			
Longitudinal Crack Index	97	97	97			
Transverse Cracking Index	92	97	90			
Patching Index	97	97	97			
Rutting Index	97	97	97			
International Roughness Index (IRI)	N/A	N/A	N/A			
Lane & Width Information						
Number of Lanes	1	2	1			
Paved Width (ft)	14.6	20	12			
Lane Width (ft)	11.3	10	12

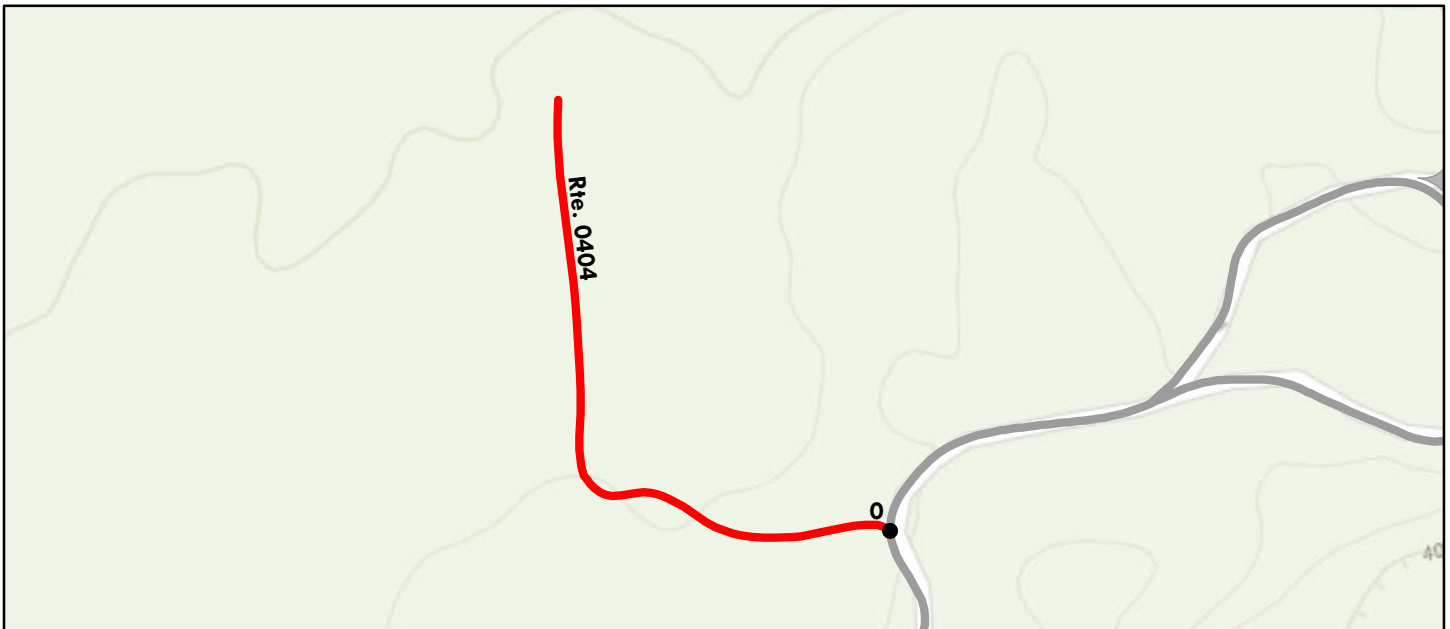
ROUTE 0404: TREE MOLDS STABLE ROAD

Route Condition Legend – Pavement Condition Rating (PCR)						
Poor (0 - 60)	Fair (61- 84)	Good (85 - 94)	Excellent (95 - 100)	Not Rated		
See Appendix for definitions and formulas						
Inspection Date: 3/8/2022	Beginning Section MP	0.00				
Paved Length (Miles): 0.23	Section Length (MI)	0.23				
Surface Type: ASPHALT	Route Summary					
Roadway Condition Information						
Pavement Condition Rating (PCR)	0	0				
Surface Condition Rating (SCR)	0	0				
Roughness Condition Index (RCI)	N/A	N/A				
Distress Index Values						
Structural Crack Index	N/A	N/A				
Alligator Crack Index	N/A	N/A				
Longitudinal Crack Index	N/A	N/A				
Transverse Cracking Index	N/A	N/A				
Patching Index	N/A	N/A				
Rutting Index	N/A	N/A				
International Roughness Index (IRI)	N/A	N/A				
Lane & Width Information						
Number of Lanes	1	1				
Paved Width (ft)	10	10				
Lane Width (ft)	10	10

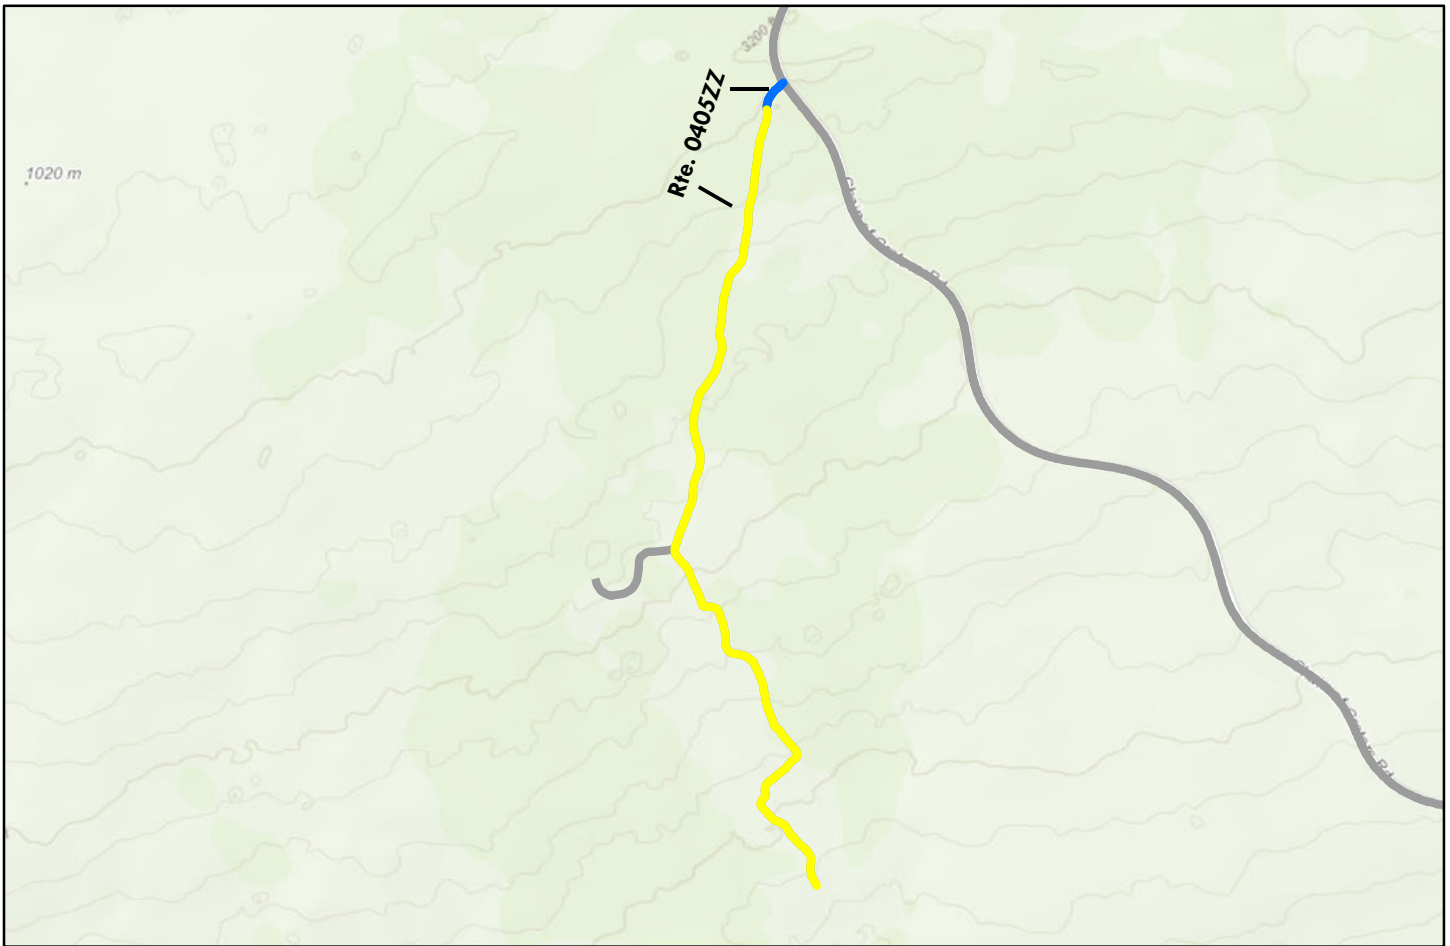
Summary Route

ROUTE 0405ZZ: AINAHOU ROAD

Route Condition Legend – Pavement Condition Rating (PCR)						
Poor (0 - 60)	Fair (61- 84)	Good (85 - 94)	Excellent (95 - 100)	Not Rated		
See Appendix for definitions and formulas						
Inspection Date: 3/8/2022						
Paved Length (Miles): 0.06						
Surface Type: ASPHALT	Route Summary					
Roadway Condition Information						
Pavement Condition Rating (PCR)	97					
Lane & Width Information						
Number of Lanes	2					
Paved Width (ft)	18					
Lane Width (ft)	9
