Road Inventory and Condition Assessment of Paved Routes Hawaii Volcanoes National Park

**Federal Lands Highway
Road Inventory Program**

**Federal Highway Administration
Eastern Federal Lands Highway Division
Road Inventory Program (RIP)**

Report Date: December 2022

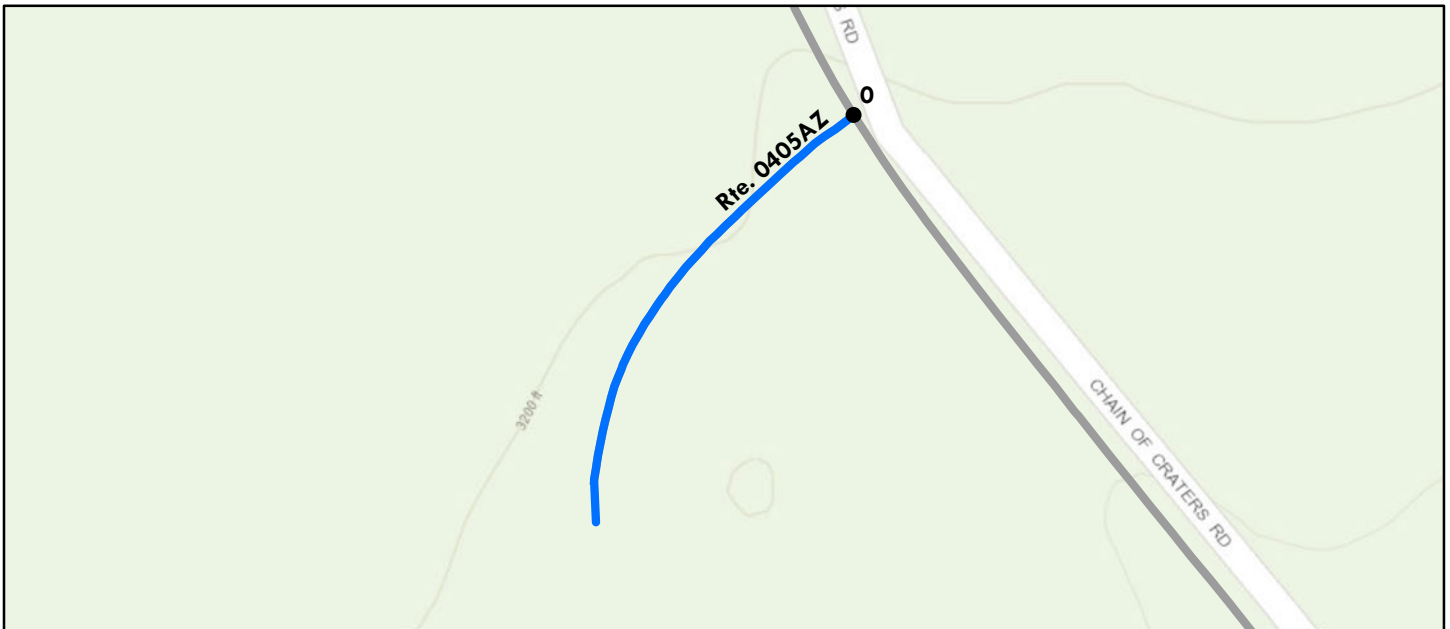
Manual Rating

Subcomponent of Route HAVO-0405ZZ

Inspection Date: 3/8/2022	Beginning Section MP	0.00				
Paved Length (Miles): 0.06	Section Length (MI)	0.06				
Surface Type: ASPHALT	Route Summary					
Roadway Condition Information						
Pavement Condition Rating (PCR)	97	97				
Surface Condition Rating (SCR)	97	97				
Roughness Condition Index (RCI)	N/A	N/A				
Distress Index Values						
Structural Crack Index	N/A	N/A				
Alligator Crack Index	97	97				
Longitudinal Crack Index	97	97				
Transverse Cracking Index	97	97				
Patching Index	97	97				
Rutting Index	97	97				
International Roughness Index (IRI)	N/A	N/A				
Lane & Width Information						
Number of Lanes	2	2				
Paved Width (ft)	18	18				
Lane Width (ft)	9	9

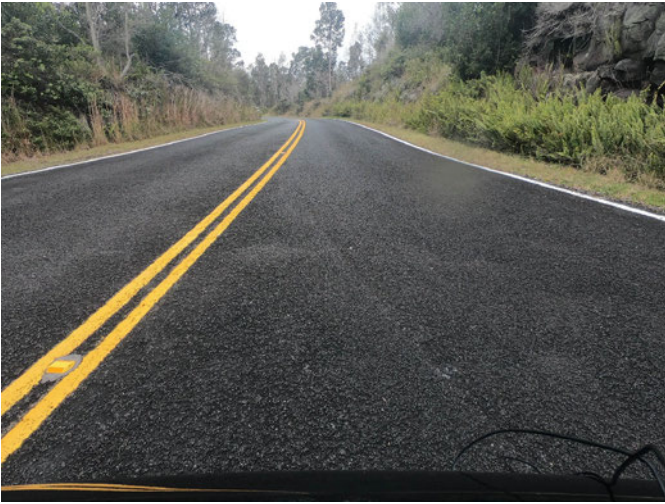
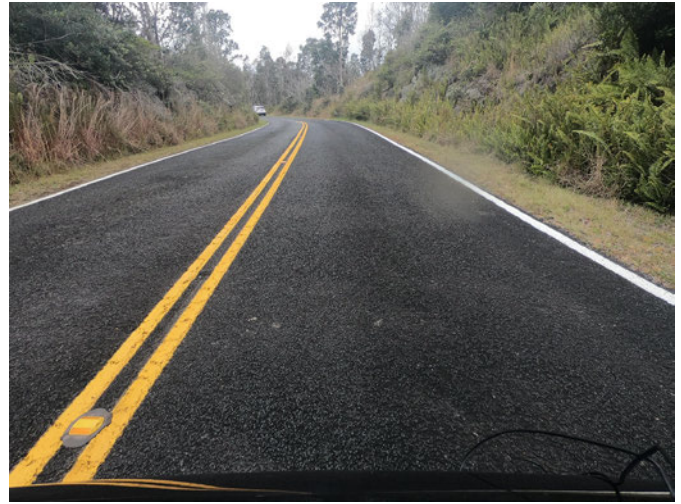
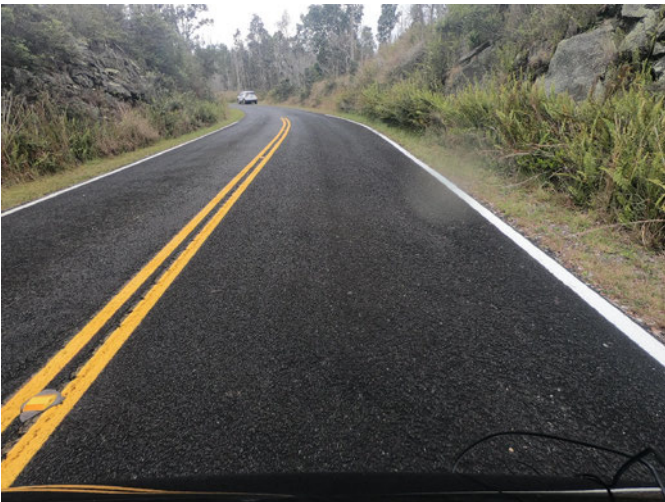
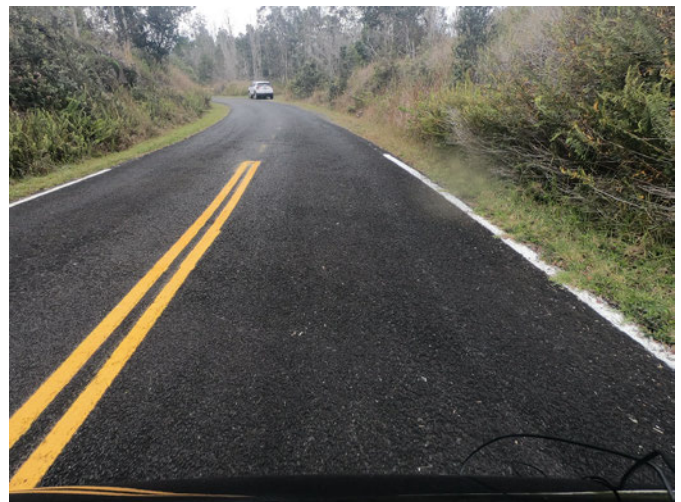
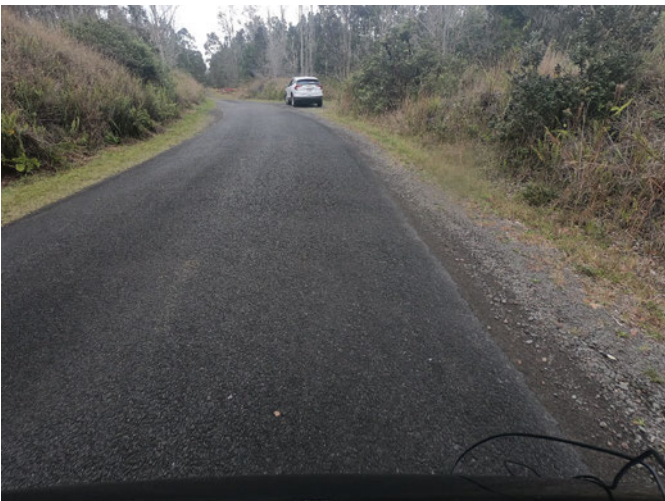
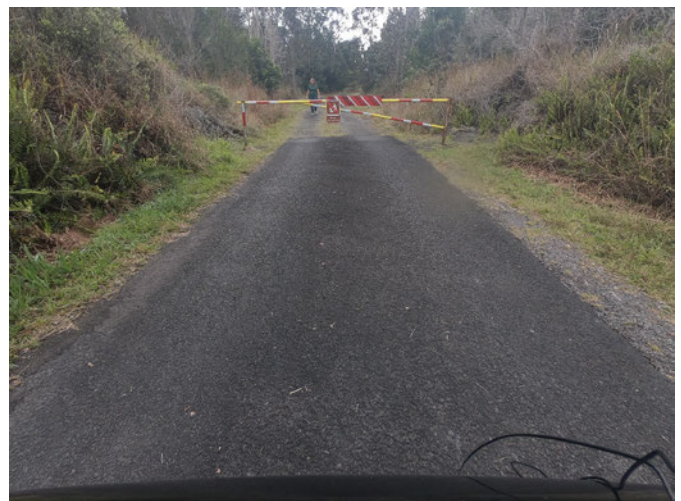
Condition Photos

ROUTE 0405AZ: AINAHOU ROAD PAVED

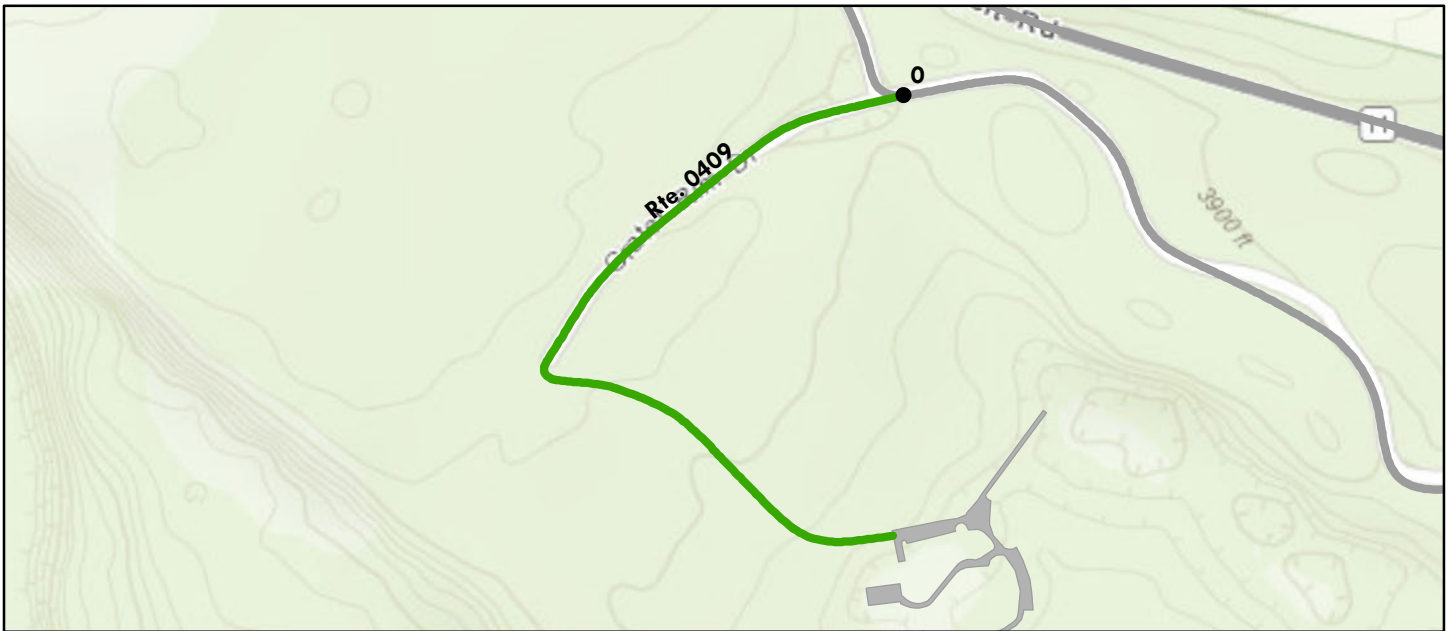
Manual Rating

ROUTE 0409: RESOURCE MANAGEMENT ROAD

Route Condition Legend – Pavement Condition Rating (PCR)						
Poor (0 - 60)	Fair (61- 84)	Good (85 - 94)	Excellent (95 - 100)	Not Rated		
See Appendix for definitions and formulas						
Inspection Date: 3/8/2022	Beginning Section MP	0.00				
Paved Length (Miles): 0.47	Section Length (MI)	0.47				
Surface Type: ASPHALT	Route Summary					
Roadway Condition Information						
Pavement Condition Rating (PCR)	90	90				
Surface Condition Rating (SCR)	90	90				
Roughness Condition Index (RCI)	N/A	N/A				
Distress Index Values						
Structural Crack Index	N/A	N/A				
Alligator Crack Index	97	97				
Longitudinal Crack Index	97	97				
Transverse Cracking Index	90	90				
Patching Index	97	97				
Rutting Index	97	97				
International Roughness Index (IRI)	N/A	N/A				
Lane & Width Information						
Number of Lanes	2	2				
Paved Width (ft)	20	20				
Lane Width (ft)	10	10

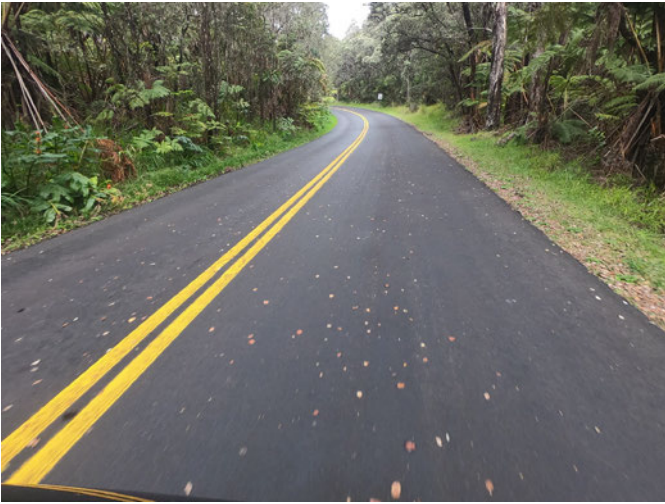
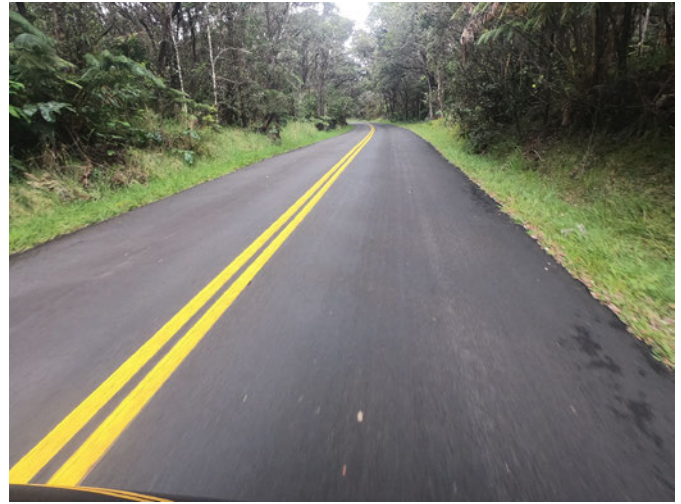
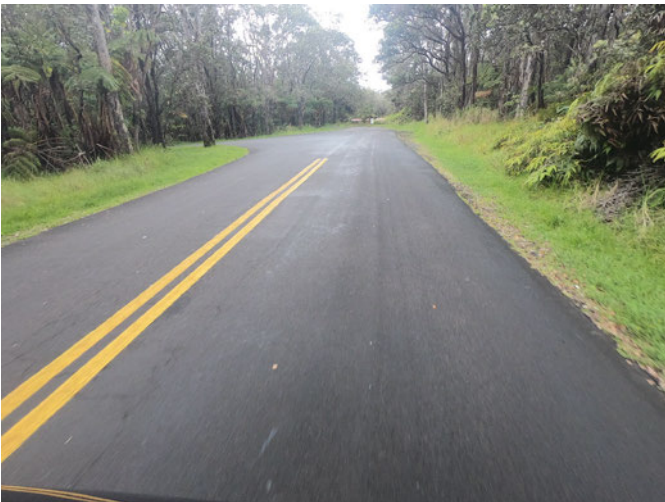
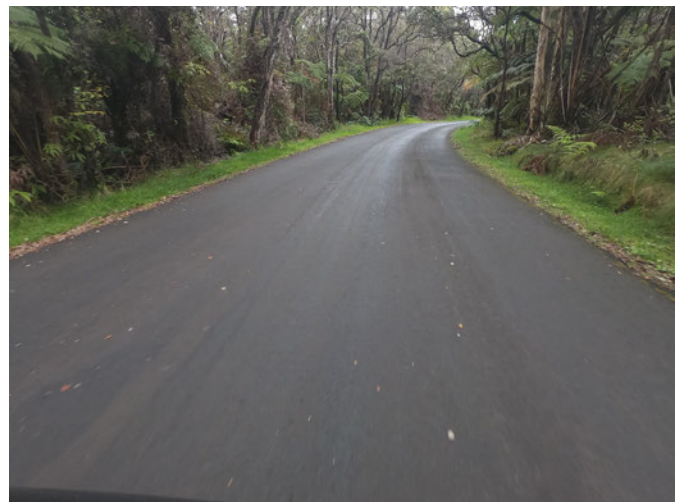
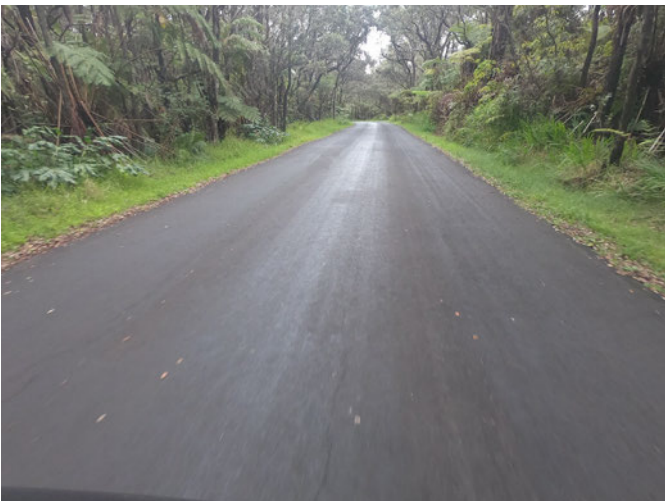
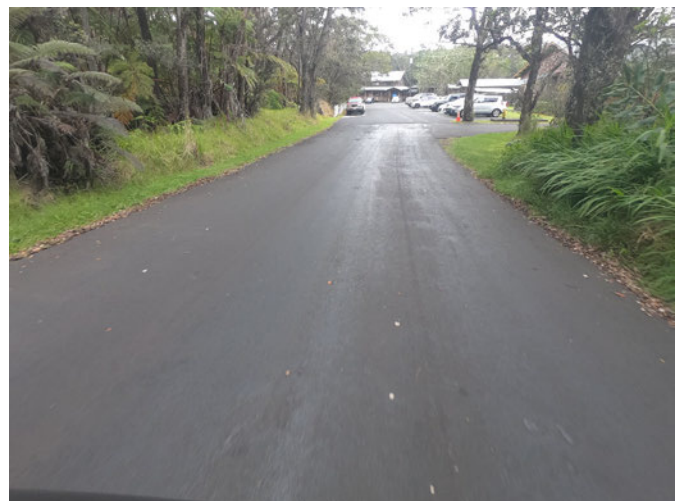
Condition Photos

ROUTE 0409: RESOURCE MANAGEMENT ROAD

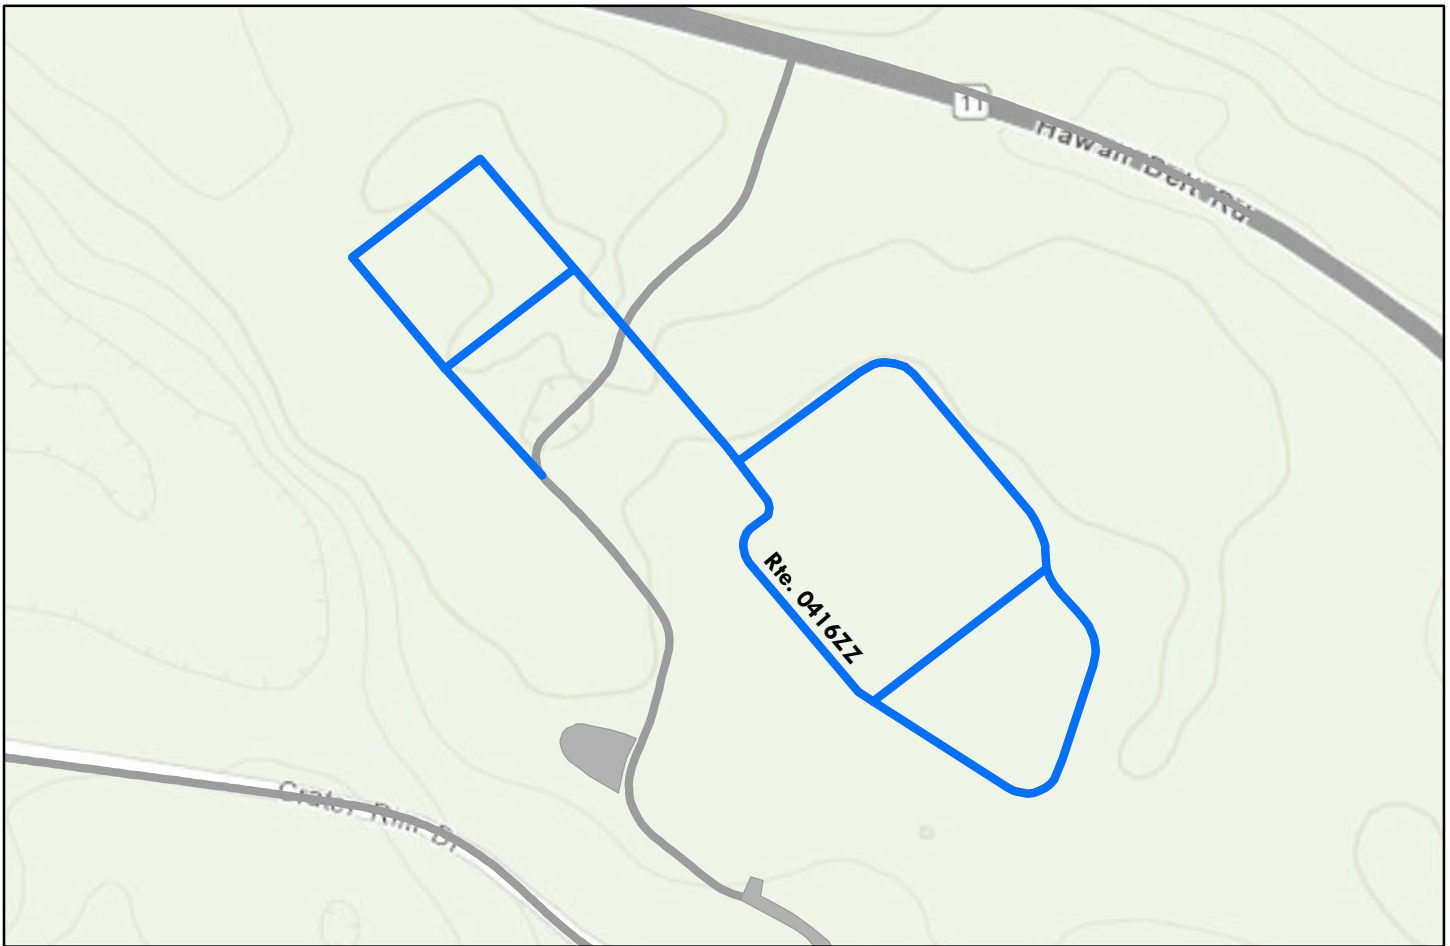
Summary Route

ROUTE 0416ZZ: KILAUEA WATER TANKS AREA ROADS

Route Condition Legend – Pavement Condition Rating (PCR)						
Poor (0 - 60)	Fair (61- 84)	Good (85 - 94)	Excellent (95 - 100)	Not Rated		
See Appendix for definitions and formulas						
Inspection Date: 3/8/2022						
Paved Length (Miles): 0.68						
Surface Type: ASPHALT	Route Summary					
Roadway Condition Information						
Pavement Condition Rating (PCR)	97					
Lane & Width Information						
Number of Lanes	1					
Paved Width (ft)	13.7					
Lane Width (ft)	10.3

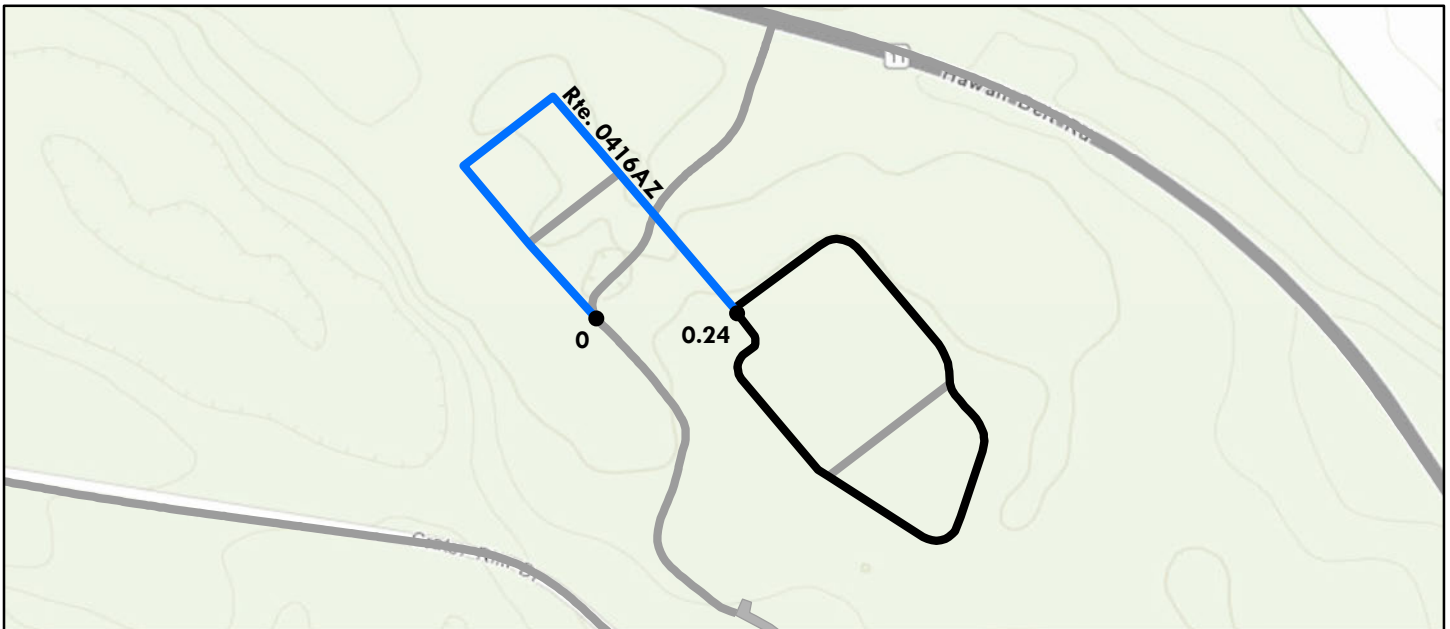
Manual Rating

Subcomponent of Route HAVO-0416ZZ

Route Condition Legend – Pavement Condition Rating (PCR)						
Poor (0 - 60)	Fair (61- 84)	Good (85 - 94)	Excellent (95 - 100)	Not Rated		
See Appendix for definitions and formulas						
Inspection Date: 3/8/2022	Beginning Section MP	0.00	0.24			
Paved Length (Miles): 0.58	Section Length (MI)	0.24	0.34			
Surface Type: ASPHALT	Route Summary					
Roadway Condition Information						
Pavement Condition Rating (PCR)	97	97	N/A			
Surface Condition Rating (SCR)	97	97	N/A			
Roughness Condition Index (RCI)	N/A	N/A	N/A			
Distress Index Values						
Structural Crack Index	N/A	N/A	N/A			
Alligator Crack Index	97	97	N/A			
Longitudinal Crack Index	97	97	N/A			
Transverse Cracking Index	97	97	N/A			
Patching Index	97	97	N/A			
Rutting Index	97	97	N/A			
International Roughness Index (IRI)	N/A	N/A	N/A			
Lane & Width Information						
Number of Lanes	1	2	1			
Paved Width (ft)	13.7	16	12			
Lane Width (ft)	10.3	8	12

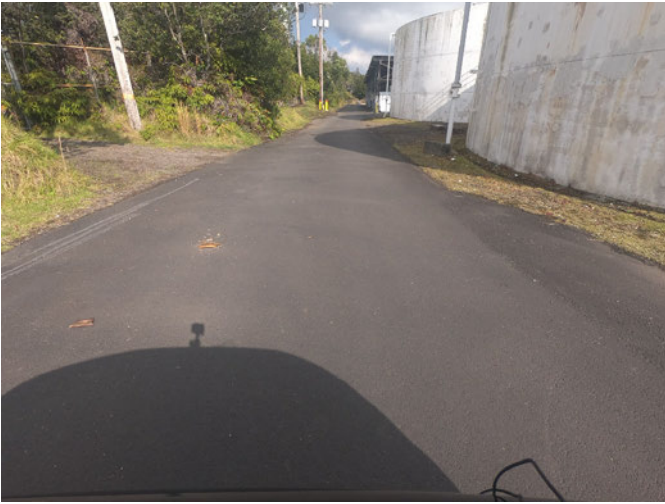
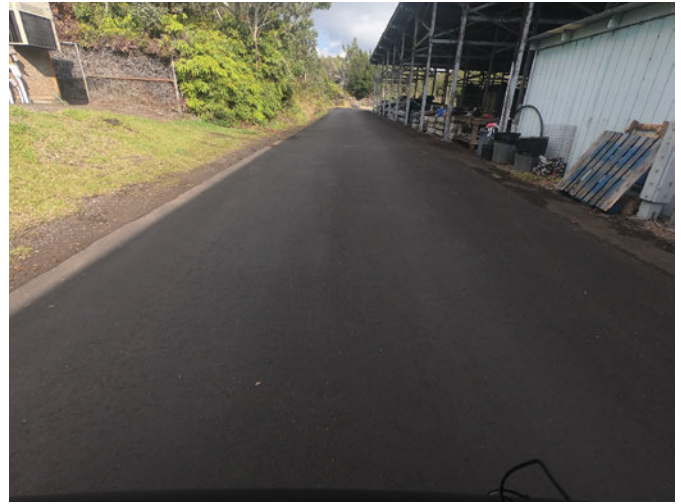
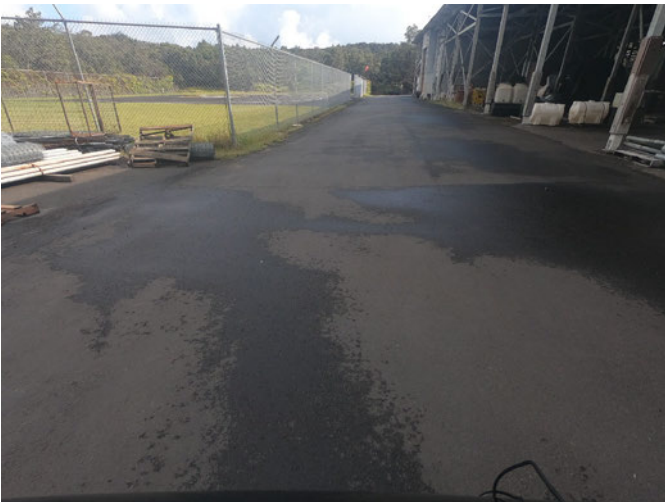
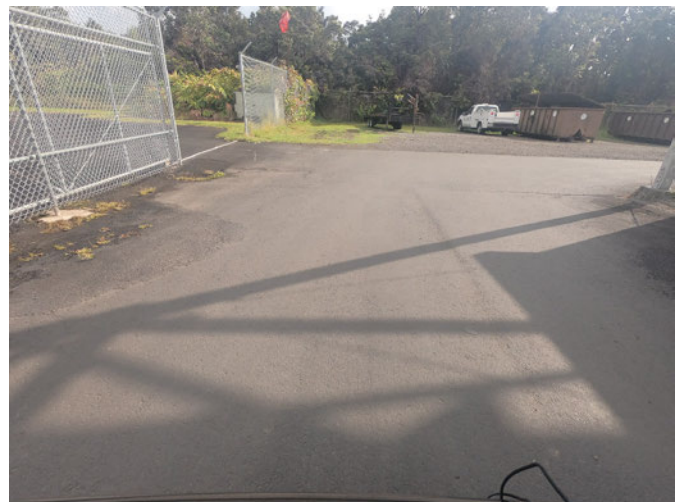
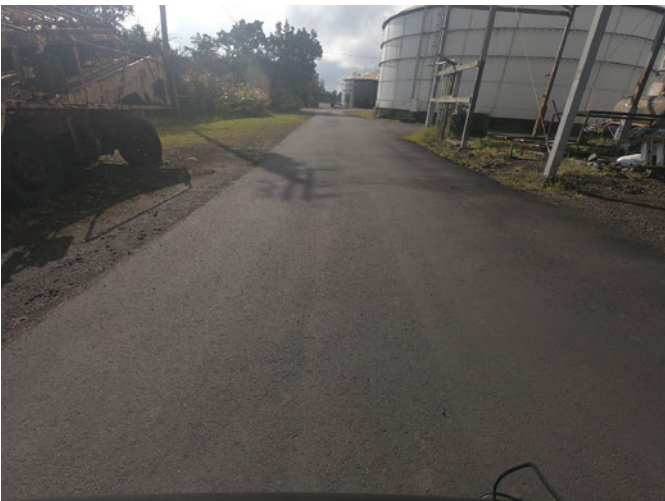
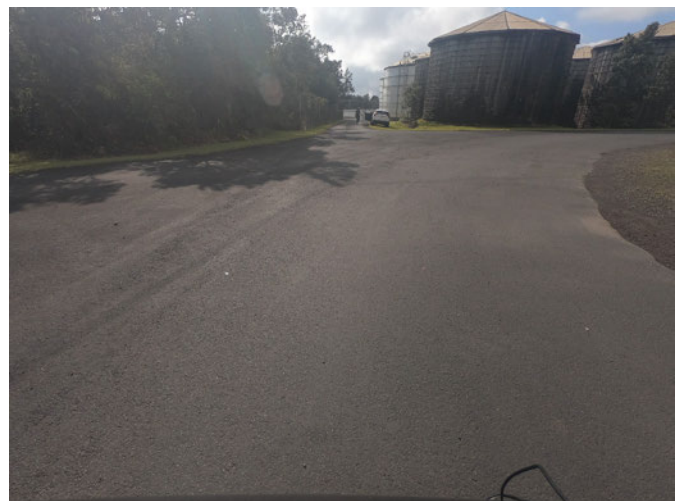
Condition Photos

ROUTE 0416AZ: KILAUEA WATER TANKS AREA ROAD A

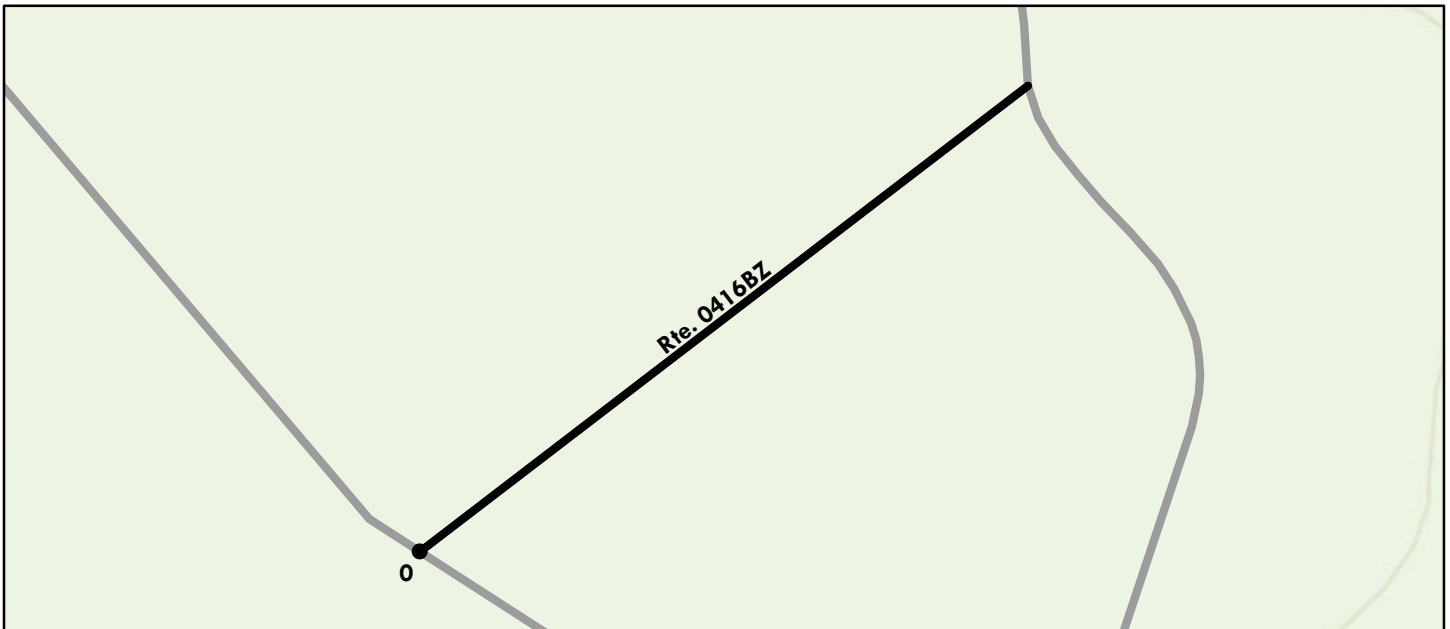
Manual Rating

Subcomponent of Route HAVO-0416ZZ

Route Condition Legend – Pavement Condition Rating (PCR)						
Poor (0 - 60)	Fair (61- 84)	Good (85 - 94)	Excellent (95 - 100)	Not Rated		
See Appendix for definitions and formulas						
Inspection Date: 3/8/2022	Beginning Section MP	0.00				
Paved Length (Miles): 0.06	Section Length (MI)	0.06				
Surface Type: ASPHALT	Route Summary					
Roadway Condition Information						
Pavement Condition Rating (PCR)	N/A	N/A				
Surface Condition Rating (SCR)	N/A	N/A				
Roughness Condition Index (RCI)	N/A	N/A				
Distress Index Values						
Structural Crack Index	N/A	N/A				
Alligator Crack Index	N/A	N/A				
Longitudinal Crack Index	N/A	N/A				
Transverse Cracking Index	N/A	N/A				
Patching Index	N/A	N/A				
Rutting Index	N/A	N/A				
International Roughness Index (IRI)	N/A	N/A				
Lane & Width Information						
Number of Lanes	1	1				
Paved Width (ft)	12	12				
Lane Width (ft)	12	12

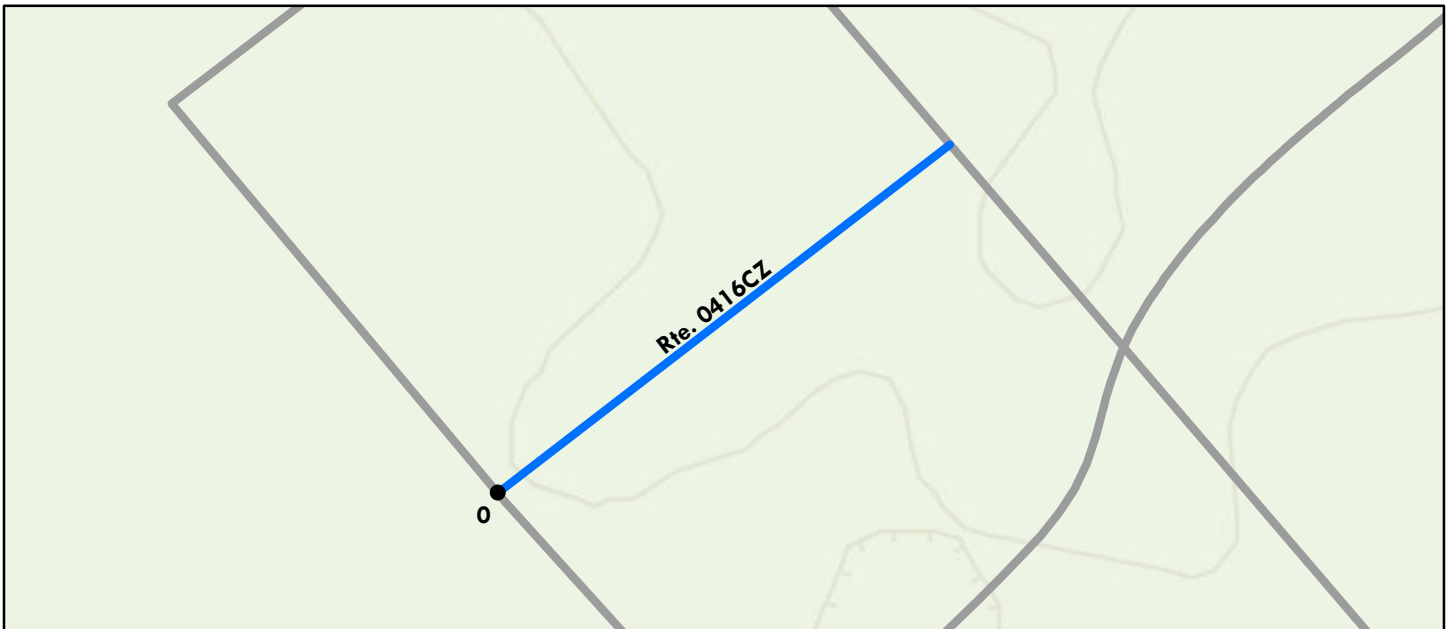
Manual Rating

Subcomponent of Route HAVO-0416ZZ

Route Condition Legend – Pavement Condition Rating (PCR)						
Poor (0 - 60)	Fair (61- 84)	Good (85 - 94)	Excellent (95 - 100)	Not Rated		
See Appendix for definitions and formulas						
Inspection Date: 3/8/2022	Beginning Section MP	0.00				
Paved Length (Miles): 0.05	Section Length (MI)	0.05				
Surface Type: ASPHALT	Route Summary					
Roadway Condition Information						
Pavement Condition Rating (PCR)	97	97				
Surface Condition Rating (SCR)	97	97				
Roughness Condition Index (RCI)	N/A	N/A				
Distress Index Values						
Structural Crack Index	N/A	N/A				
Alligator Crack Index	97	97				
Longitudinal Crack Index	97	97				
Transverse Cracking Index	97	97				
Patching Index	97	97				
Rutting Index	97	97				
International Roughness Index (IRI)	N/A	N/A				
Lane & Width Information						
Number of Lanes	2	2				
Paved Width (ft)	16	16				
Lane Width (ft)	8	8

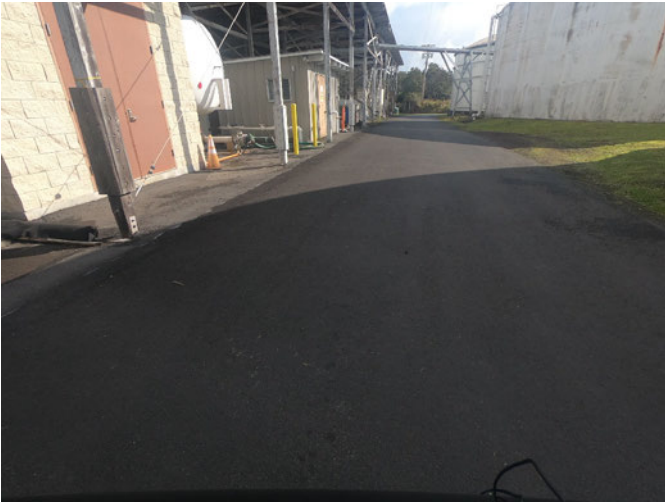
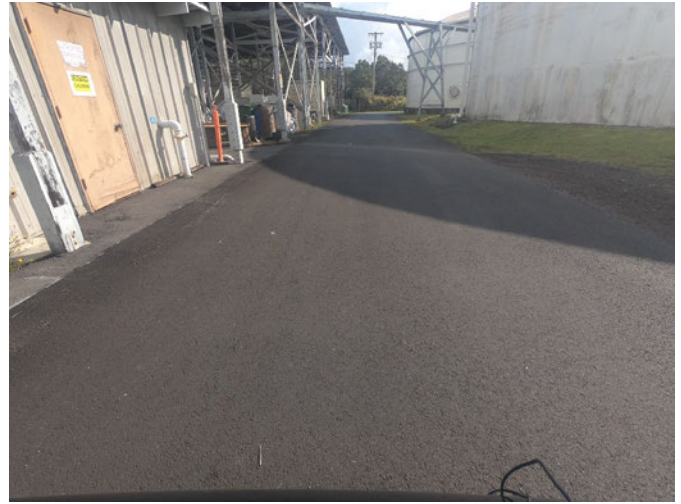
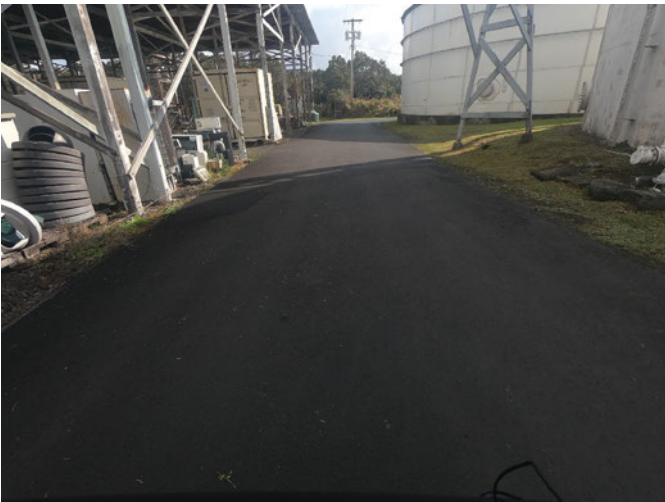
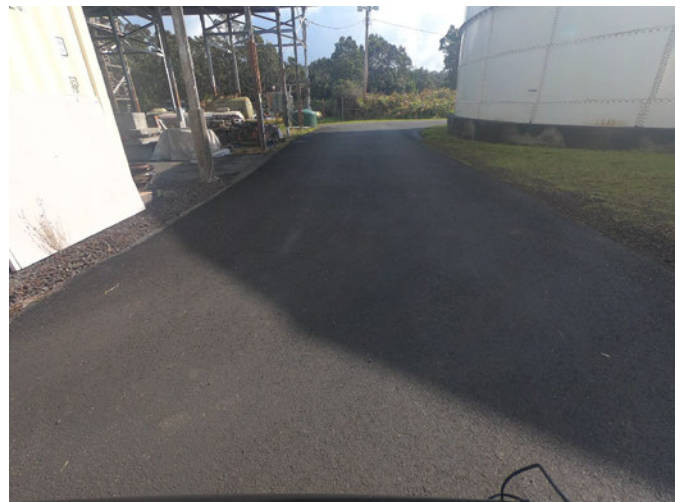
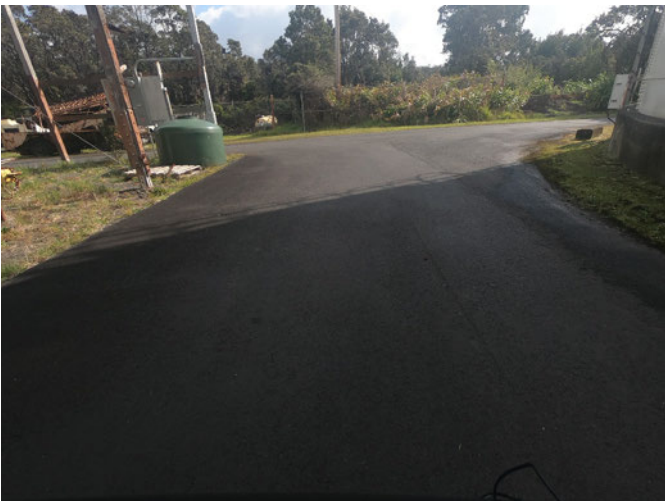
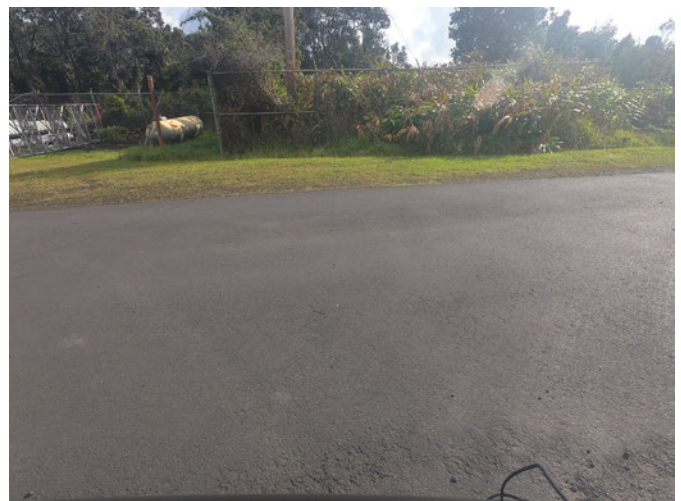
Condition Photos

ROUTE 0416CZ: KILAUEA WATER TANKS AREA ROAD C

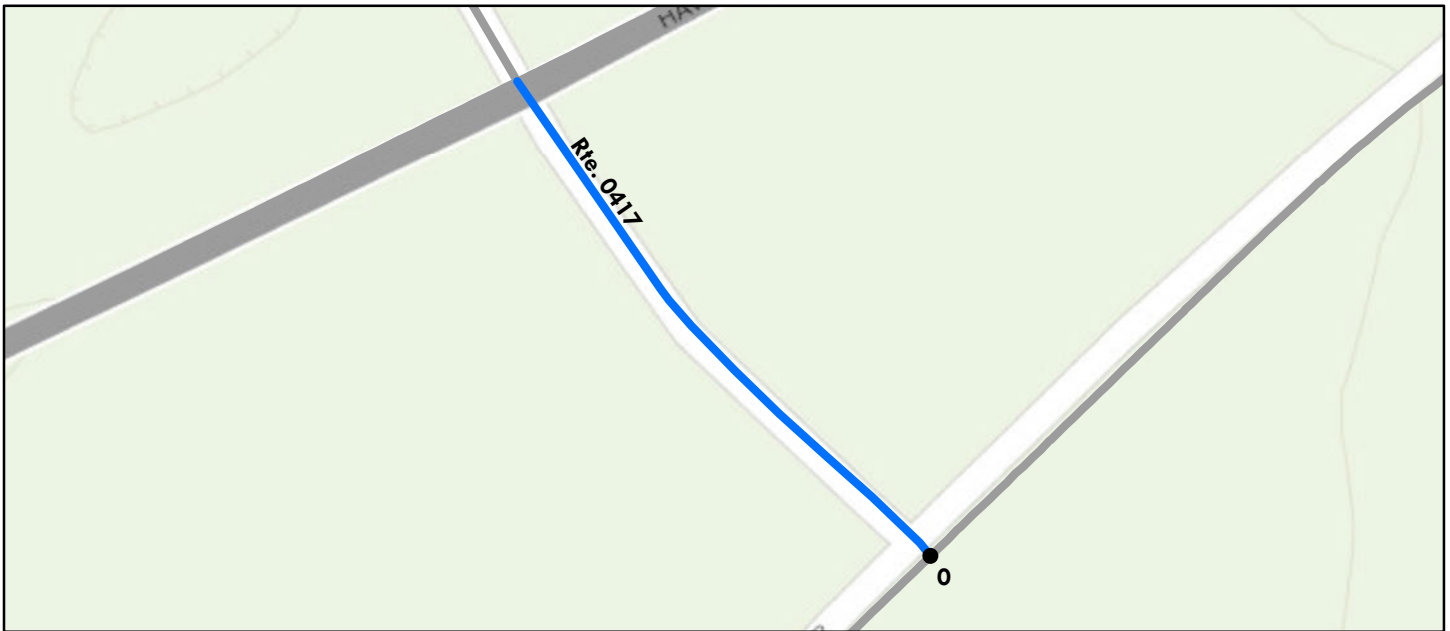
Manual Rating

ROUTE 0417: MAUNA LOA EMERGENCY ACCESS ROAD

Route Condition Legend – Pavement Condition Rating (PCR)						
Poor (0 - 60)	Fair (61- 84)	Good (85 - 94)	Excellent (95 - 100)	Not Rated		
See Appendix for definitions and formulas						
Inspection Date: 3/8/2022	Beginning Section MP	0.00				
Paved Length (Miles): 0.10	Section Length (MI)	0.10				
Surface Type: ASPHALT	Route Summary					
Roadway Condition Information						
Pavement Condition Rating (PCR)	97	97				
Surface Condition Rating (SCR)	97	97				
Roughness Condition Index (RCI)	N/A	N/A				
Distress Index Values						
Structural Crack Index	N/A	N/A				
Alligator Crack Index	97	97				
Longitudinal Crack Index	97	97				
Transverse Cracking Index	97	97				
Patching Index	97	97				
Rutting Index	97	97				
International Roughness Index (IRI)	N/A	N/A				
Lane & Width Information						
Number of Lanes	2	2				
Paved Width (ft)	21	21				
Lane Width (ft)	9	9

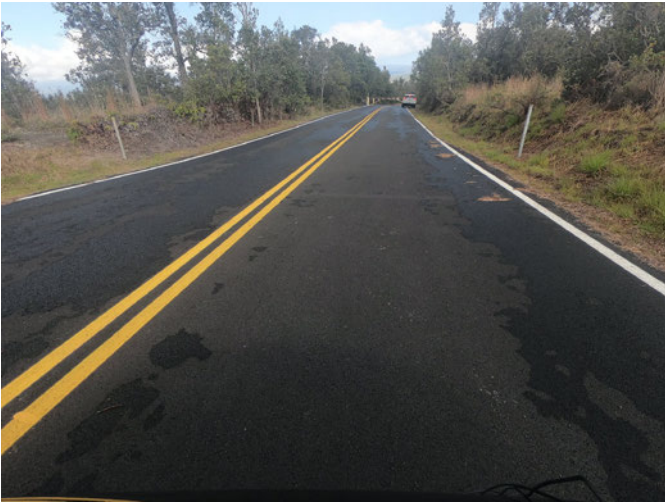
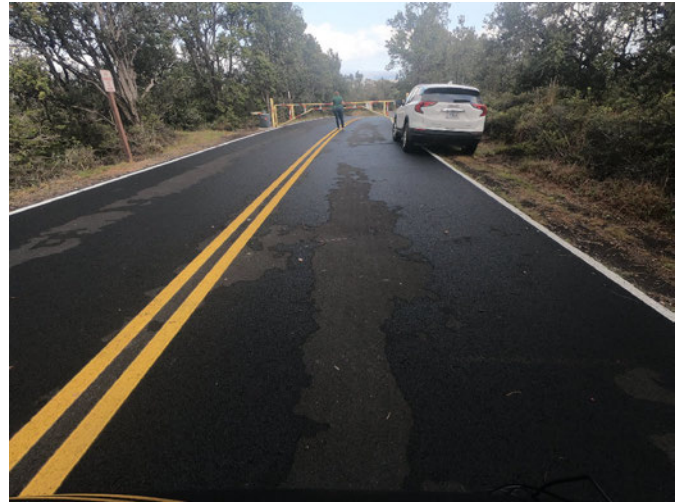
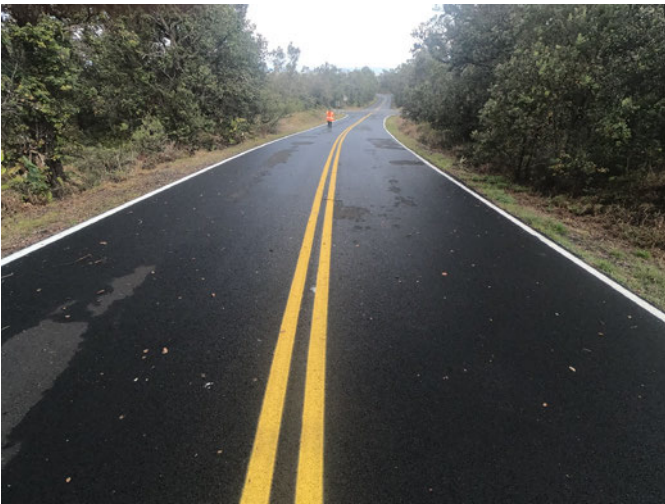
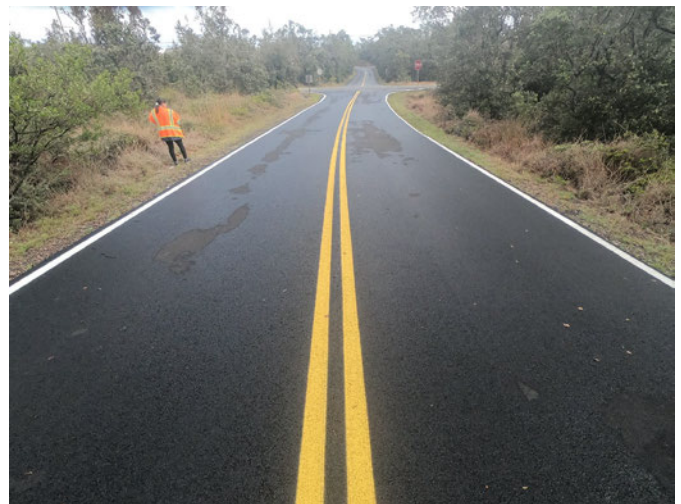
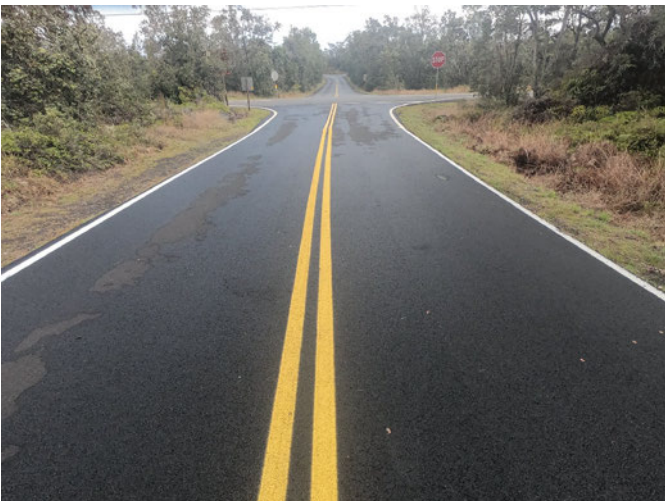
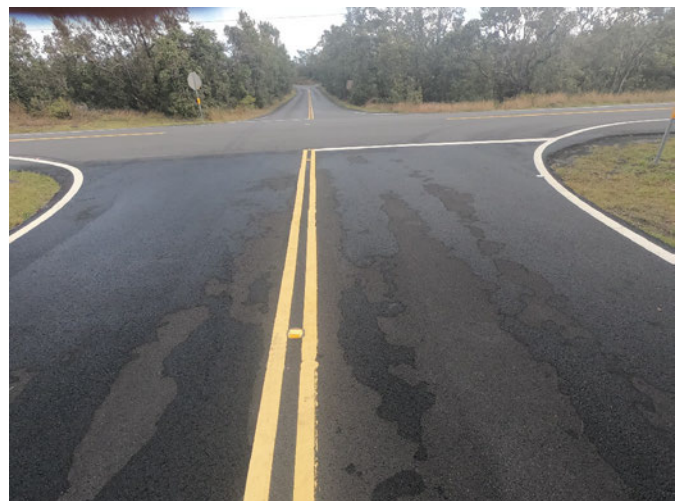
Condition Photos

ROUTE 0417: MAUNA LOA EMERGENCY ACCESS ROAD

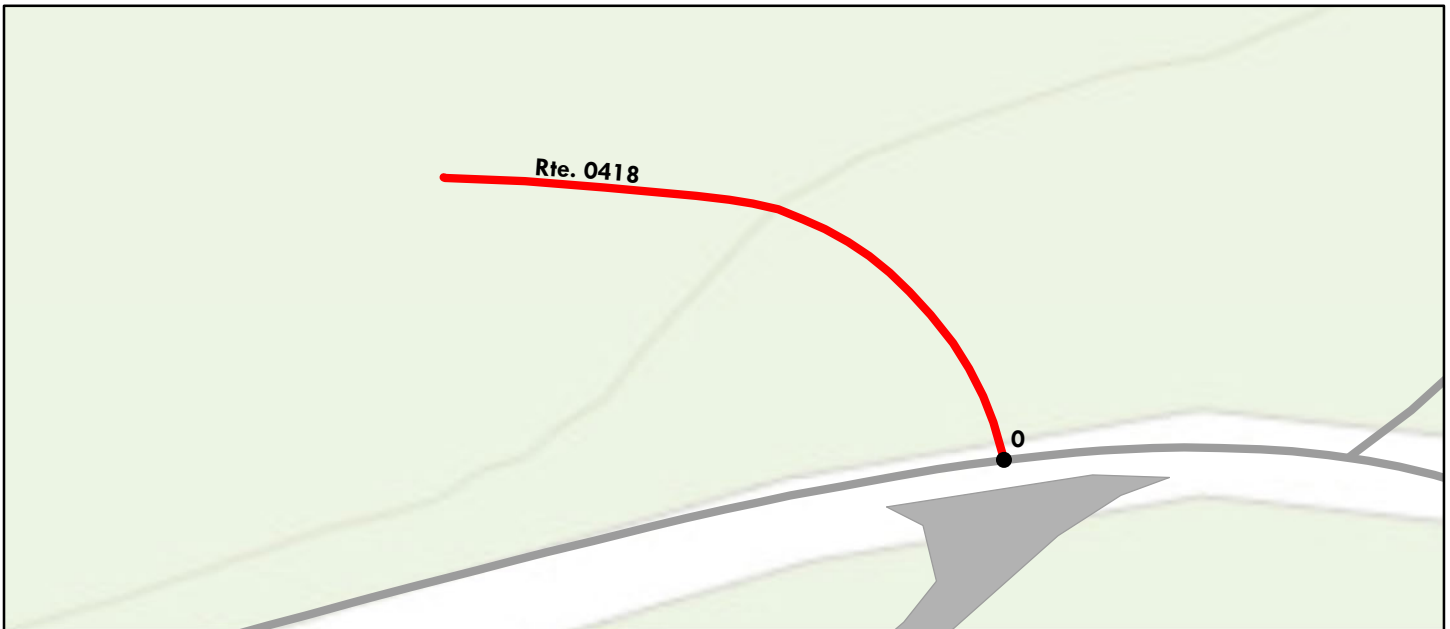
ROUTE 0418: KILAUEA MILITARY CAMP WATER TANK ROAD

Route Condition Legend – Pavement Condition Rating (PCR)						
Poor (0 - 60)	Fair (61- 84)	Good (85 - 94)	Excellent (95 - 100)	Not Rated		
See Appendix for definitions and formulas						
Inspection Date: 3/8/2022	Beginning Section MP	0.00				
Paved Length (Miles): 0.03	Section Length (MI)	0.03				
Surface Type: CONCRETE	Route Summary					
Roadway Condition Information						
Pavement Condition Rating (PCR)	0	0				
Surface Condition Rating (SCR)	0	0				
Roughness Condition Index (RCI)	N/A	N/A				
Distress Index Values						
Structural Crack Index	N/A	N/A				
Alligator Crack Index	N/A	N/A				
Longitudinal Crack Index	N/A	N/A				
Transverse Cracking Index	N/A	N/A				
Patching Index	N/A	N/A				
Rutting Index	N/A	N/A				
International Roughness Index (IRI)	N/A	N/A				
Lane & Width Information						
Number of Lanes	1	1				
Paved Width (ft)	12	12				
Lane Width (ft)	12	12

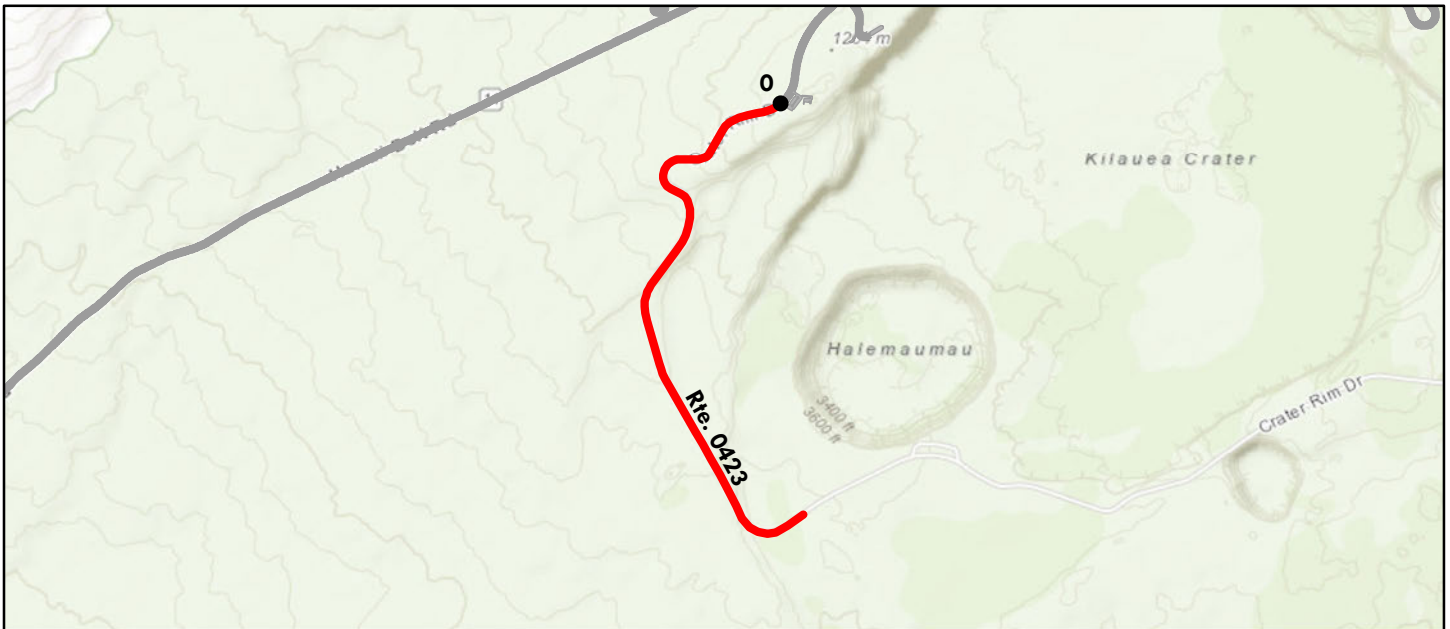
ROUTE 0423: CRATER RIM DRIVE - ADMINISTRATIVE

Route Condition Legend – Pavement Condition Rating (PCR)						
Poor (0 - 60)	Fair (61- 84)	Good (85 - 94)	Excellent (95 - 100)	Not Rated		
See Appendix for definitions and formulas						
Inspection Date: 3/8/2022	Beginning Section MP	0.00				
Paved Length (Miles): 2.19	Section Length (MI)	2.19				
Surface Type: ASPHALT	Route Summary					
Roadway Condition Information						
Pavement Condition Rating (PCR)	0	0				
Surface Condition Rating (SCR)	0	0				
Roughness Condition Index (RCI)	N/A	N/A				
Distress Index Values						
Structural Crack Index	N/A	N/A				
Alligator Crack Index	N/A	N/A				
Longitudinal Crack Index	N/A	N/A				
Transverse Cracking Index	N/A	N/A				
Patching Index	N/A	N/A				
Rutting Index	N/A	N/A				
International Roughness Index (IRI)	N/A	N/A				
Lane & Width Information						
Number of Lanes	2	2				
Paved Width (ft)	16	16				
Lane Width (ft)	8	8

Note: Route heavily damaged by volcanic activity and is dangerous to drive.

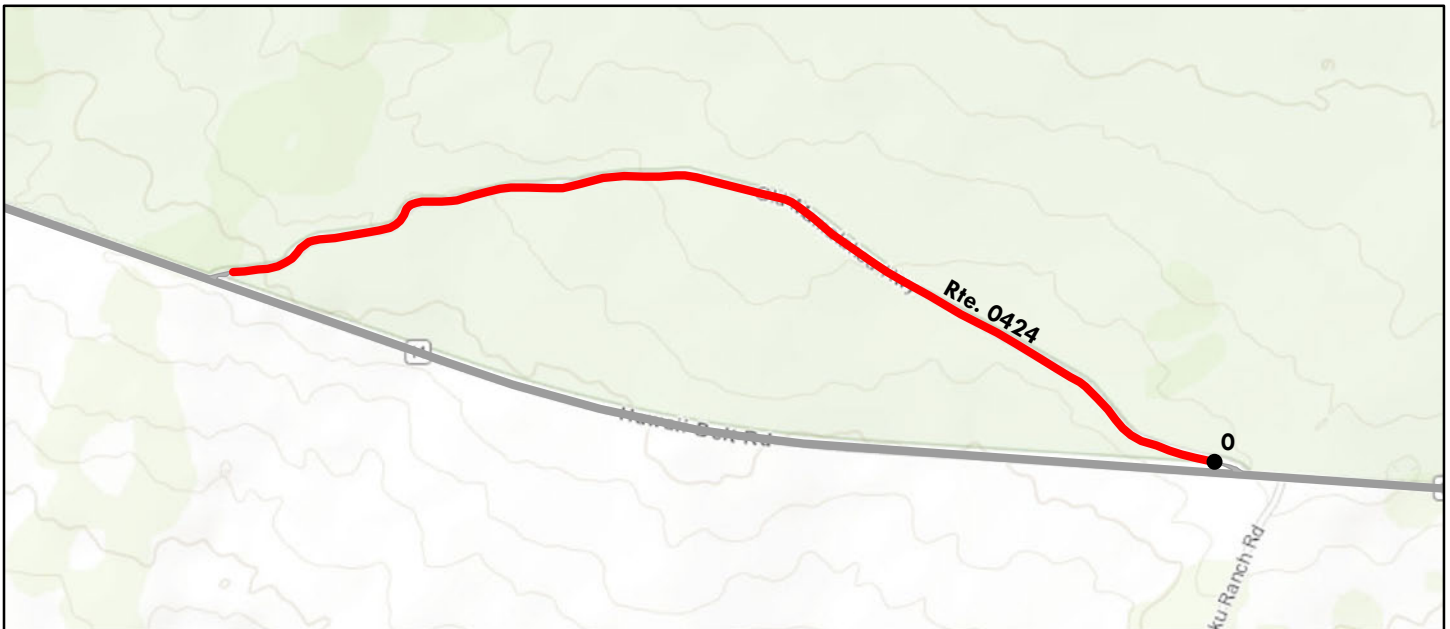
ROUTE 0424: KAHUKU OLD MAMALAHOA HIGHWAY

Route Condition Legend – Pavement Condition Rating (PCR)						
Poor (0 - 60)	Fair (61- 84)	Good (85 - 94)	Excellent (95 - 100)	Not Rated		
See Appendix for definitions and formulas						
Inspection Date: 3/8/2022	Beginning Section MP	0.00				
Paved Length (Miles): 1.71	Section Length (MI)	1.71				
Surface Type: ASPHALT	Route Summary					
Roadway Condition Information						
Pavement Condition Rating (PCR)	0	0				
Surface Condition Rating (SCR)	0	0				
Roughness Condition Index (RCI)	N/A	N/A				
Distress Index Values						
Structural Crack Index	N/A	N/A				
Alligator Crack Index	N/A	N/A				
Longitudinal Crack Index	N/A	N/A				
Transverse Cracking Index	N/A	N/A				
Patching Index	N/A	N/A				
Rutting Index	N/A	N/A				
International Roughness Index (IRI)	N/A	N/A				
Lane & Width Information						
Number of Lanes	2	2				
Paved Width (ft)	17	17				
Lane Width (ft)	8	8
