Road Inventory and Condition Assessment of Paved Routes Hawaii Volcanoes National Park

**Federal Lands Highway
Road Inventory Program**

**Federal Highway Administration
Eastern Federal Lands Highway Division
Road Inventory Program (RIP)**

Report Date: December 2022

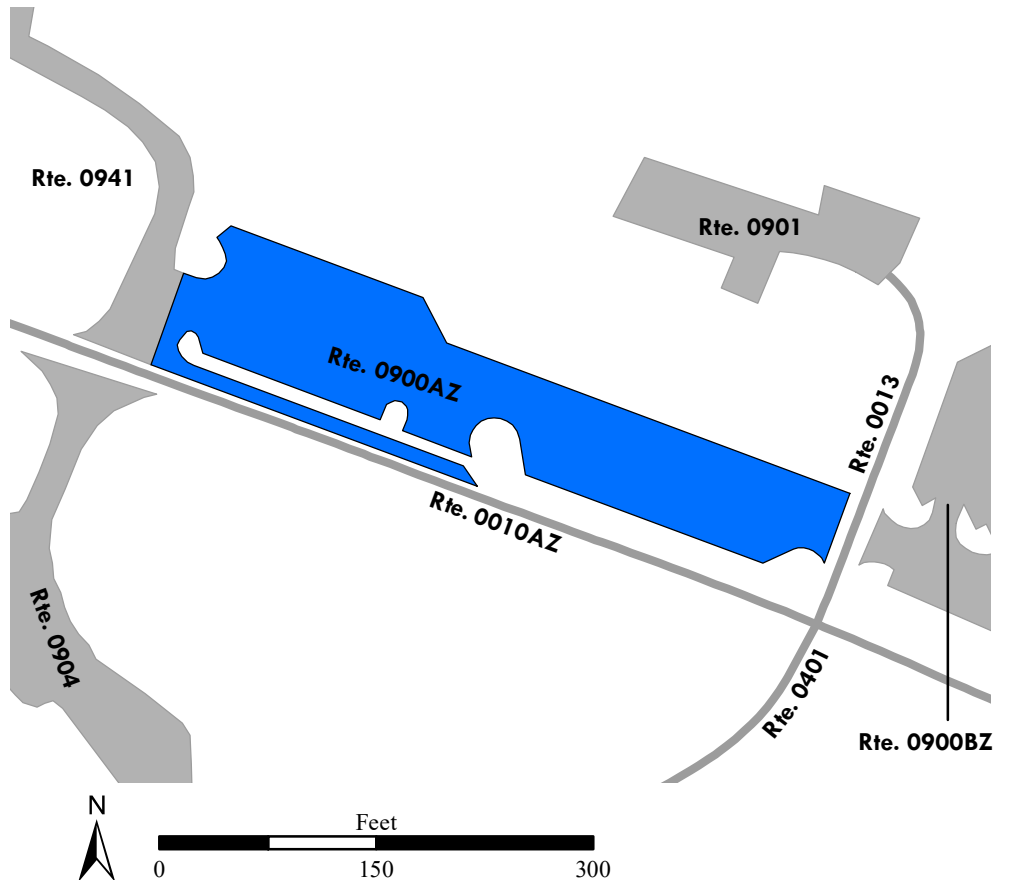
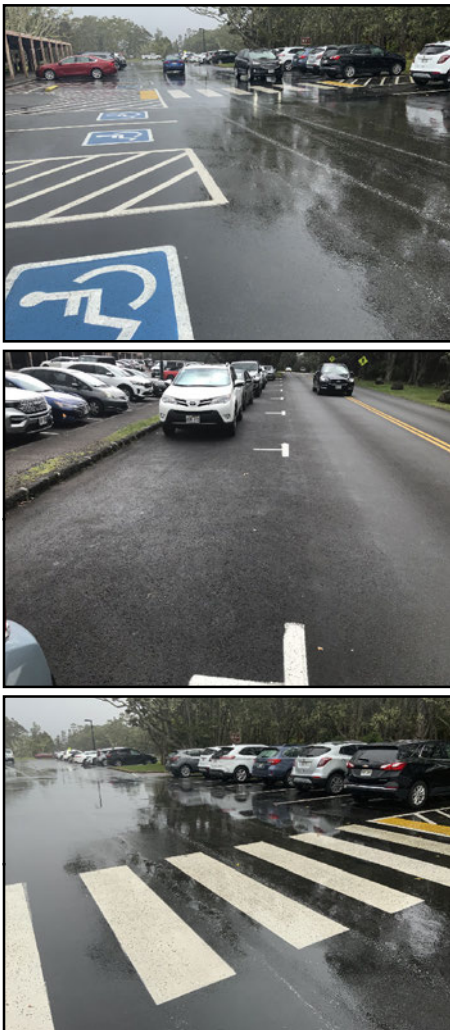
ROUTE 0900AZ: KILAUEA VISITORS CENTER PARKING

Inspection Date	FMSS Number	User Access	Surface Type
3/8/2022	22571	PUBLIC	ASPHALT
Area (Sq. Ft.)	Lane Miles (11' Widths)	Curb Reveal (Inches)	Curb Recommendation
33,911	0.584	6	LIGHT REPAIR
Curb Type		Curb & Gutter Type	
STONE		NO CURB AND GUTTER	
Pavement Recommendation		Condition Rating / PCR	
DO NOTHING		EXCELLENT / 97

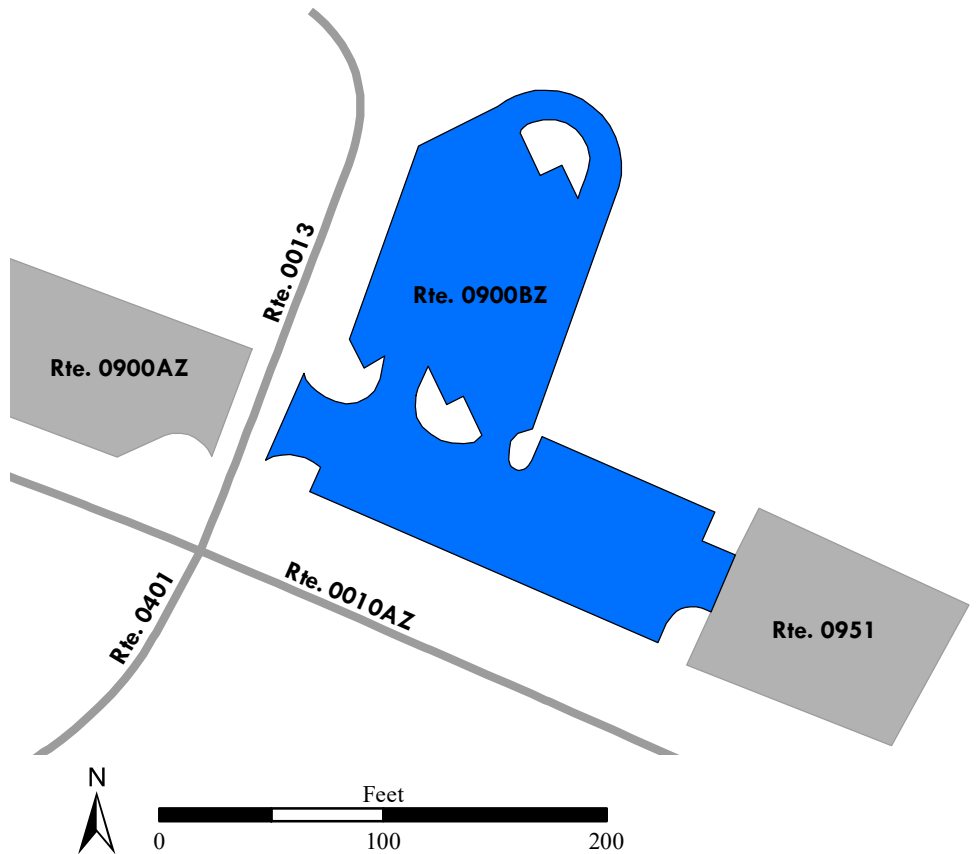
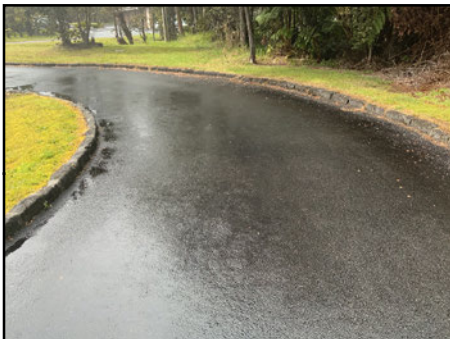
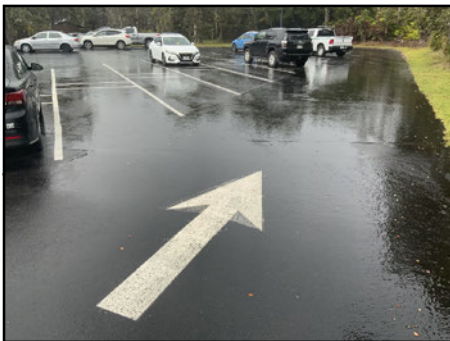
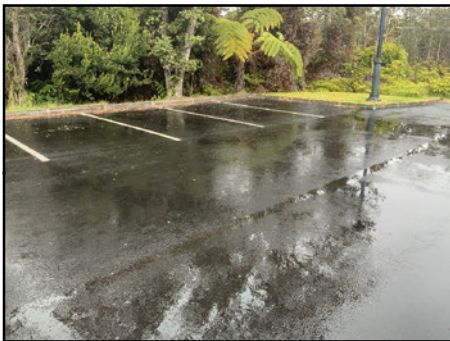
ROUTE 0900BZ: KILAUEA VISITORS CENTER B PARKING

Inspection Date	FMSS Number	User Access	Surface Type
3/8/2022	22571	PUBLIC	ASPHALT
Area (Sq. Ft.)	Lane Miles (11' Widths)	Curb Reveal (Inches)	Curb Recommendation
21,195	0.365	5	LIGHT REPAIR
Curb Type		Curb & Gutter Type	
STONE		NO CURB AND GUTTER	
Pavement Recommendation		Condition Rating / PCR	
DO NOTHING		EXCELLENT / 97

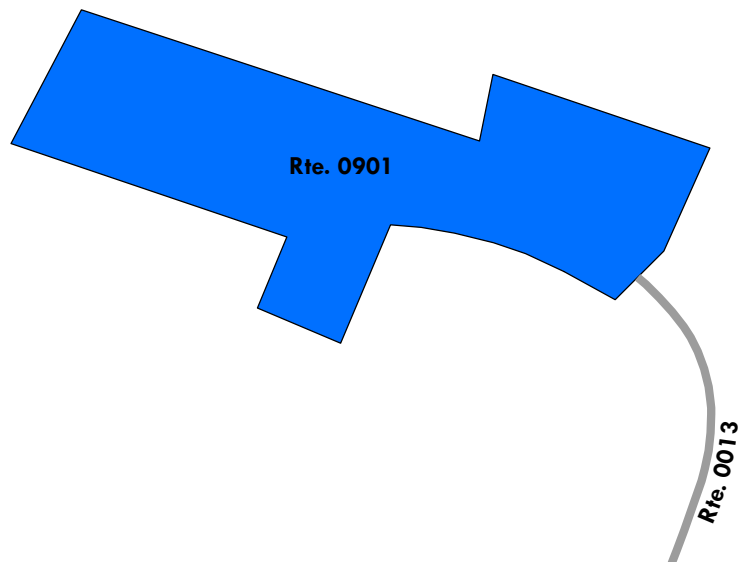
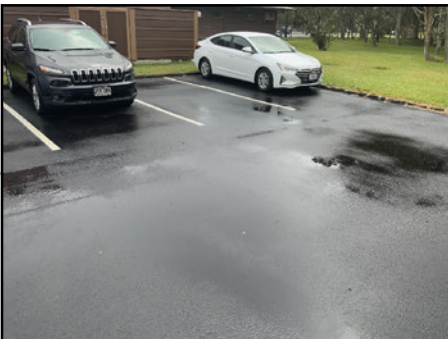
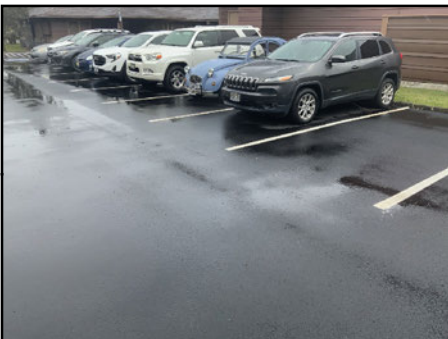
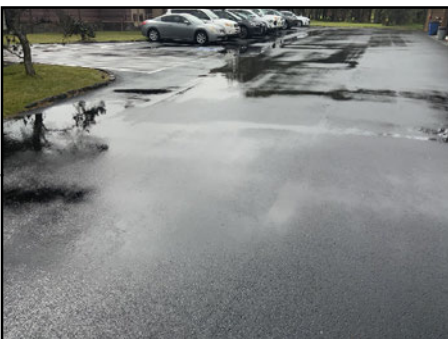
ROUTE 0901: KILAUEA VISITORS CENTER ADMINISTRATIVE PARKING

Inspection Date	FMSS Number	User Access	Surface Type
3/8/2022	42652	NONPUBLIC	ASPHALT
Area (Sq. Ft.)	Lane Miles (11' Widths)	Curb Reveal (Inches)	Curb Recommendation
8,974	0.155	3	LIGHT REPAIR
Curb Type		Curb & Gutter Type	
STONE		NO CURB AND GUTTER	
Pavement Recommendation		Condition Rating / PCR	
DO NOTHING		EXCELLENT / 97

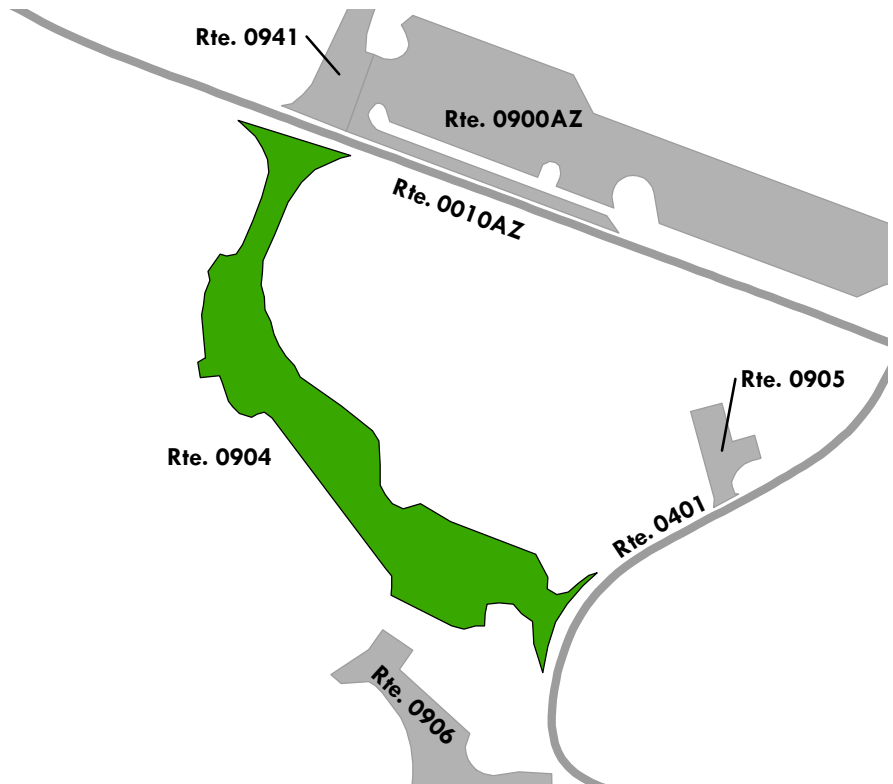
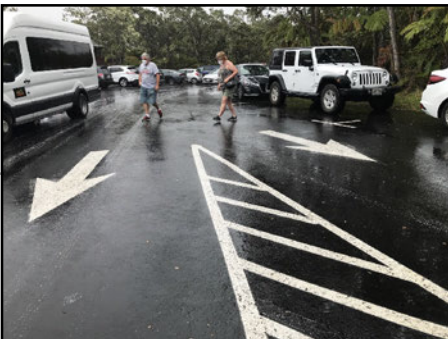
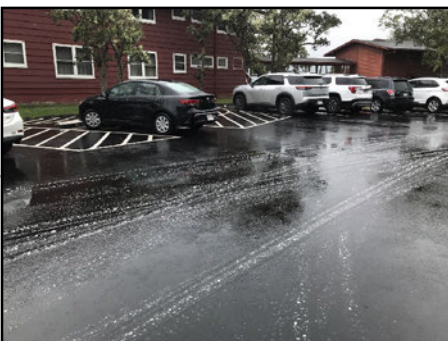
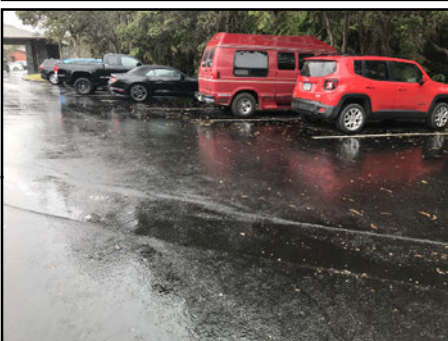
ROUTE 0904: VOLCANO HOUSE PARKING

Inspection Date	FMSS Number	User Access	Surface Type
3/8/2022	22490	PUBLIC	ASPHALT
Area (Sq. Ft.)	Lane Miles (11' Widths)	Curb Reveal (Inches)	Curb Recommendation
25,881	0.446	6	DO NOTHING
Curb Type		Curb & Gutter Type	
STONE		NO CURB AND GUTTER	
Pavement Recommendation		Condition Rating / PCR	
PREVENTIVE MAINTENANCE		GOOD / 90

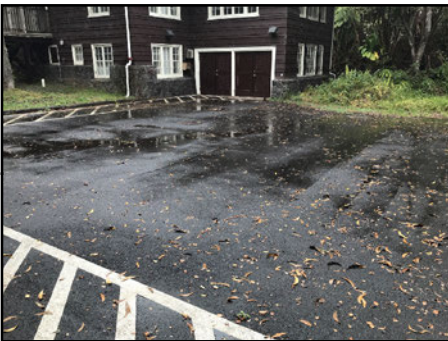
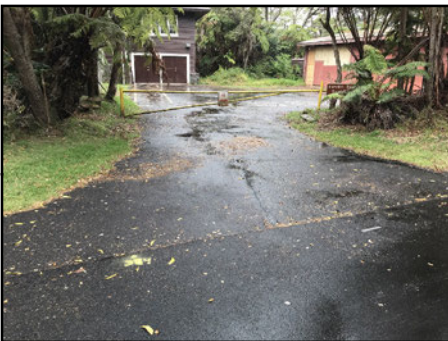
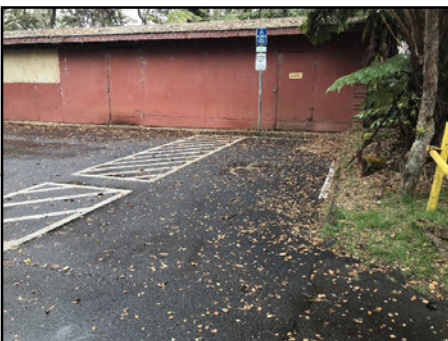
ROUTE 0906: VOLCANO HOUSE HOTEL SERVICE AREA (BUILDING #B167)

Inspection Date	FMSS Number	User Access	Surface Type
3/8/2022	42657	NONPUBLIC	ASPHALT
Area (Sq. Ft.)	Lane Miles (11' Widths)	Curb Reveal (Inches)	Curb Recommendation
8,396	0.145	NOT APPLICABLE	NOT APPLICABLE
Curb Type		Curb & Gutter Type	
NO CURB		NO CURB AND GUTTER	
Pavement Recommendation		Condition Rating / PCR	
RECONSTRUCTION		POOR / 30

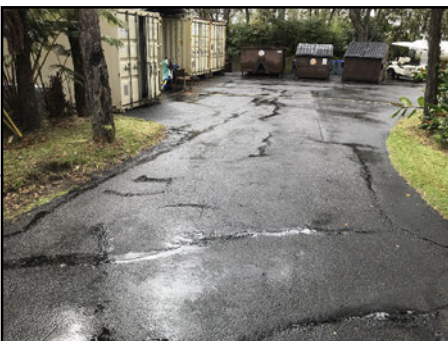
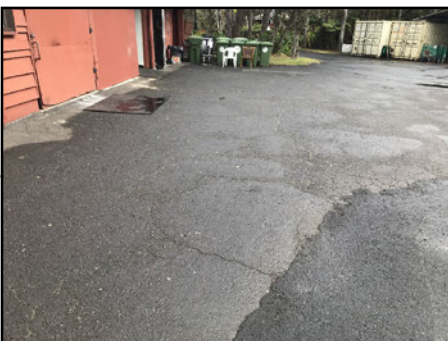
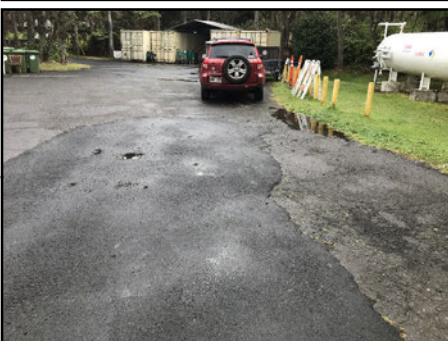
ROUTE 0907: VOLCANO HOUSE DORM B2 PARKING

Inspection Date	FMSS Number	User Access	Surface Type
3/8/2022	42658	NONPUBLIC	ASPHALT
Area (Sq. Ft.)	Lane Miles (11' Widths)	Curb Reveal (Inches)	Curb Recommendation
7,848	0.135	NOT APPLICABLE	NOT APPLICABLE
Curb Type		Curb & Gutter Type	
NO CURB		NO CURB AND GUTTER	
Pavement Recommendation		Condition Rating / PCR	
PREVENTIVE MAINTENANCE		GOOD / 90

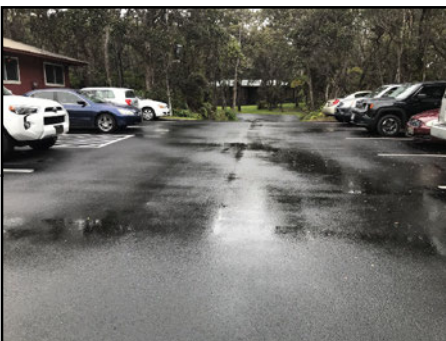
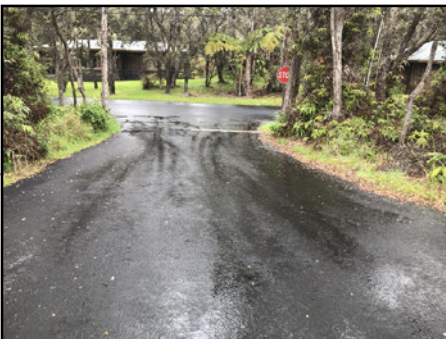
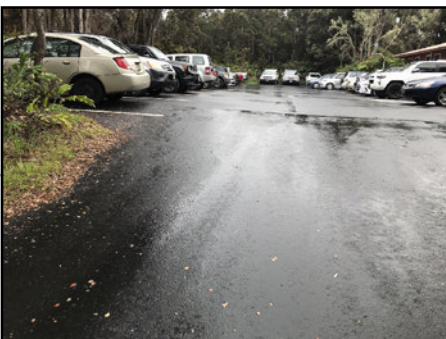
ROUTE 0908ZZ: KILAUEA MAINTENANCE YARD PARKING

Inspection Date	FMSS Number	User Access	Surface Type
3/8/2022	22831	NONPUBLIC	ASPHALT
Area (Sq. Ft.)	Lane Miles (11' Widths)	Condition Rating / PCR	
41,374	0.714	SUMMARY / 90

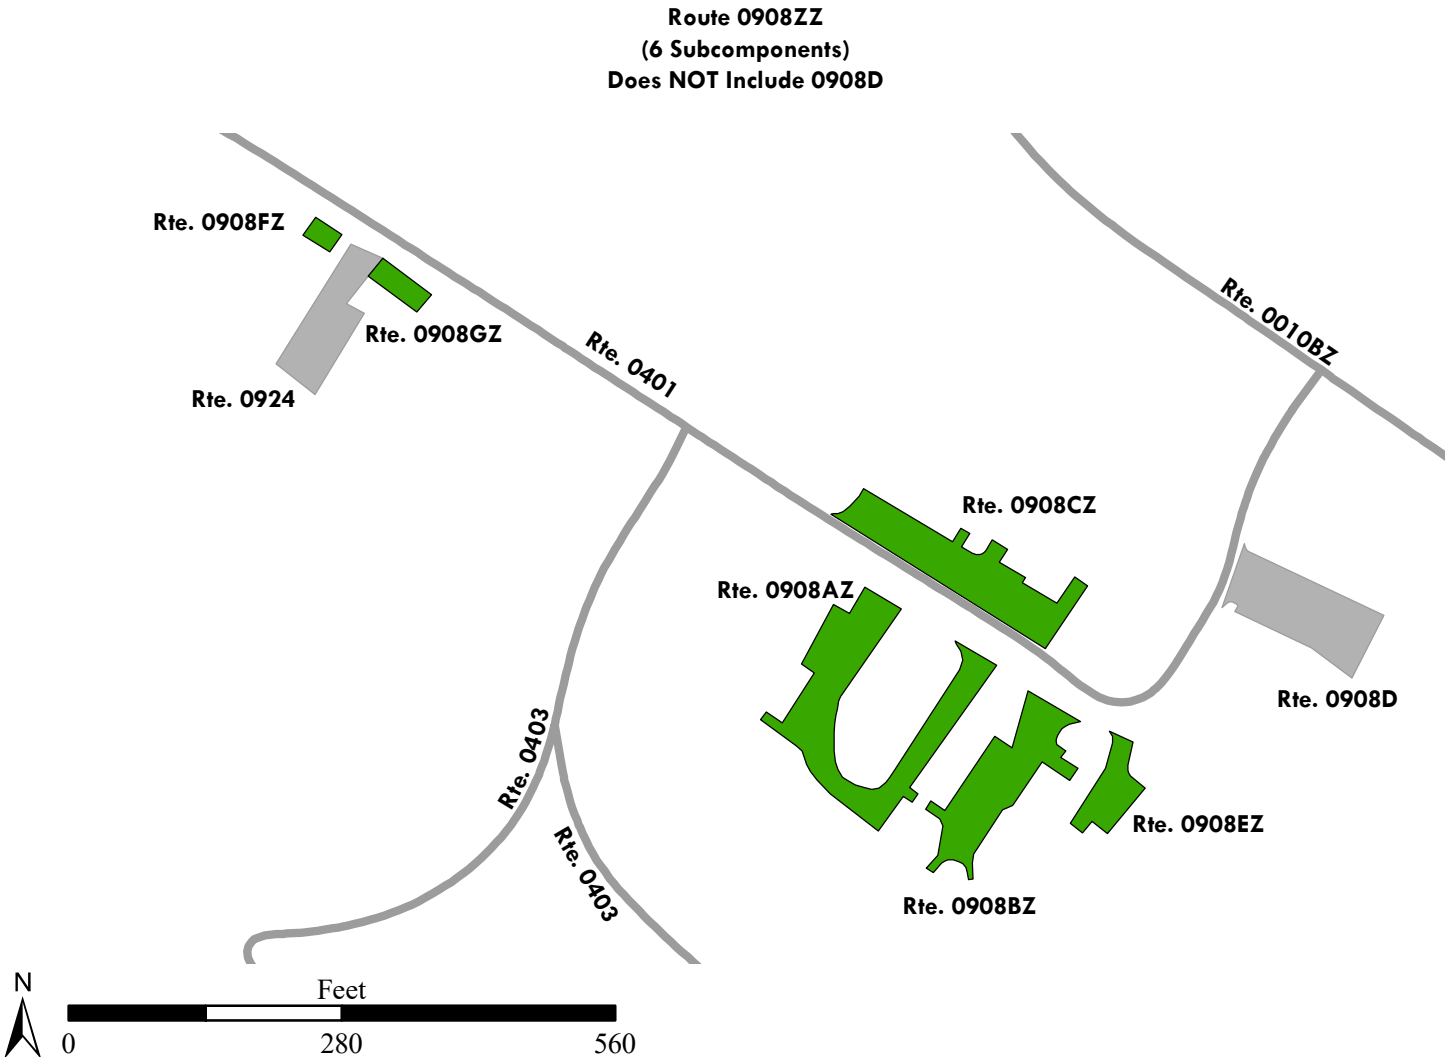
The condition shown on this page reflects the overall route condition and may not reflect individual subcomponent ratings.

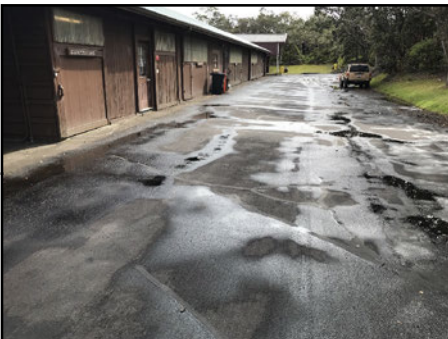
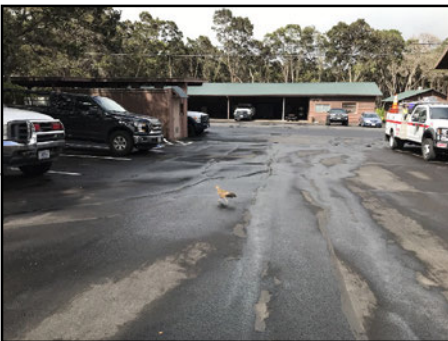
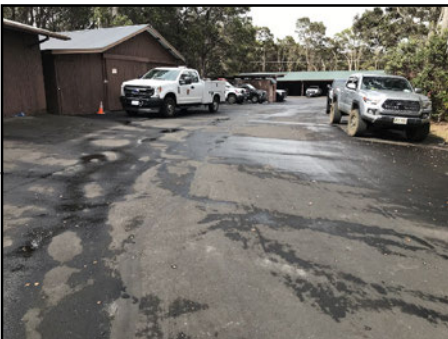
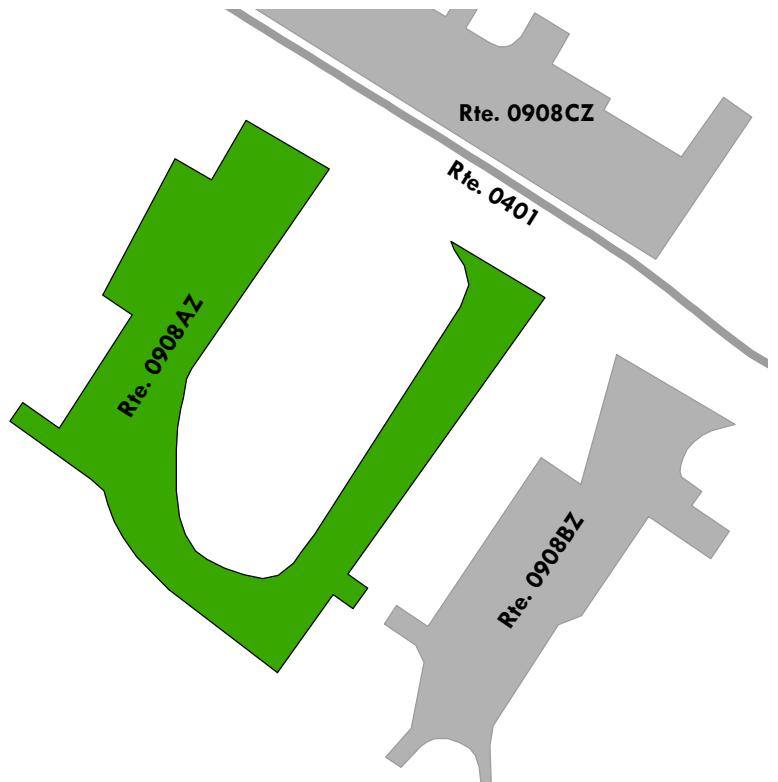
ROUTE 0908AZ: KILAUEA MAINTENANCE YARD A PARKING

Inspection Date	FMSS Number	User Access	Surface Type
3/8/2022	22831	NONPUBLIC	ASPHALT
Area (Sq. Ft.)	Lane Miles (11' Widths)	Curb Reveal (Inches)	Curb Recommendation
15,389	0.265	NOT APPLICABLE	NOT APPLICABLE
Curb Type		Curb & Gutter Type	
NO CURB		NO CURB AND GUTTER	
Pavement Recommendation		Condition Rating / PCR	
PREVENTIVE MAINTENANCE		GOOD / 90

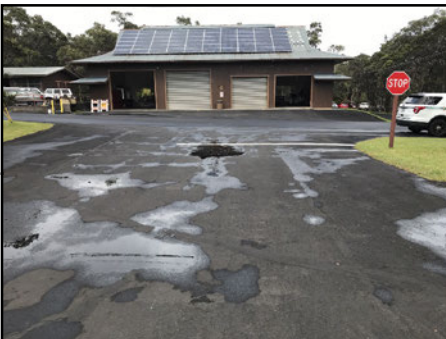
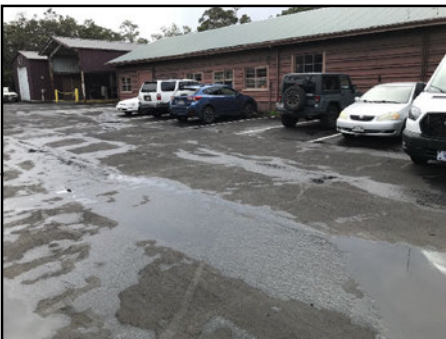
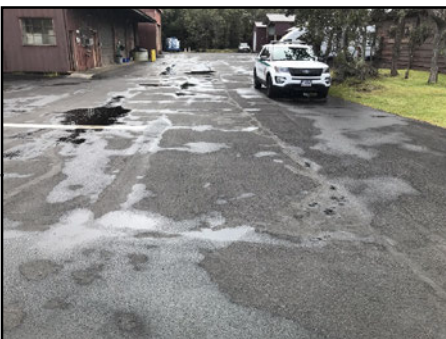
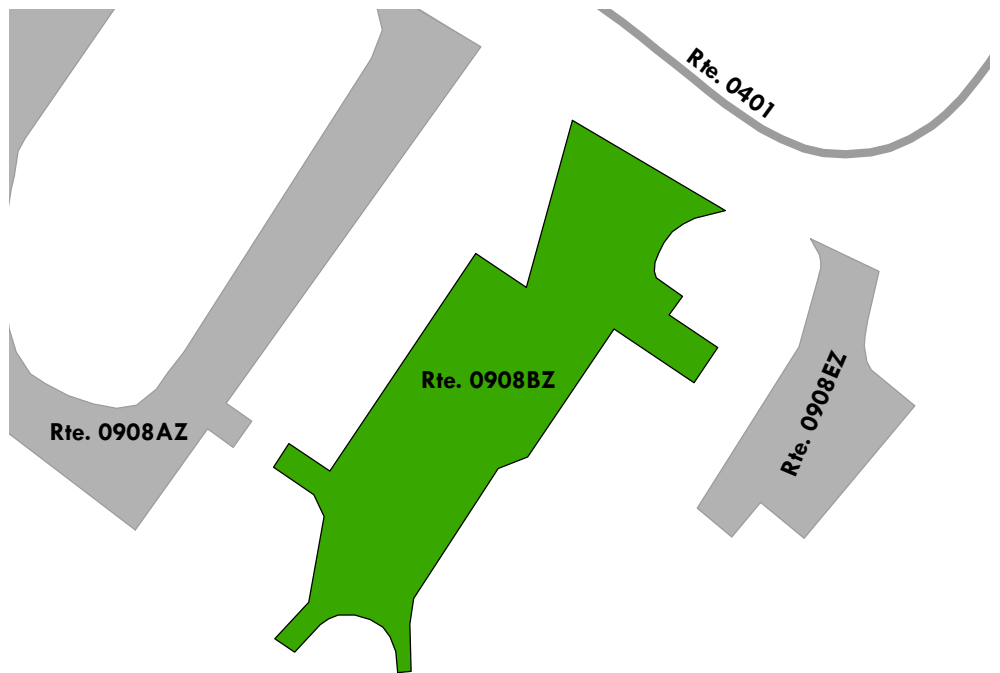
ROUTE 0908BZ: KILAUEA MAINTENANCE YARD B PARKING

Inspection Date	FMSS Number	User Access	Surface Type
3/8/2022	22831	NONPUBLIC	ASPHALT
Area (Sq. Ft.)	Lane Miles (11' Widths)	Curb Reveal (Inches)	Curb Recommendation
9,444	0.163	NOT APPLICABLE	NOT APPLICABLE
Curb Type		Curb & Gutter Type	
NO CURB		NO CURB AND GUTTER	
Pavement Recommendation		Condition Rating / PCR	
PREVENTIVE MAINTENANCE		GOOD / 90

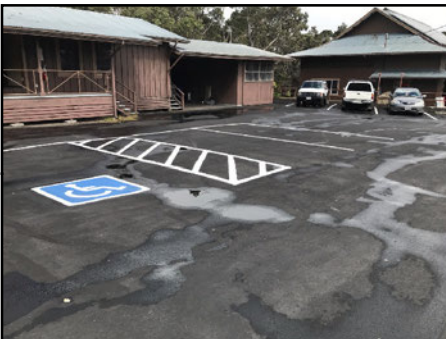
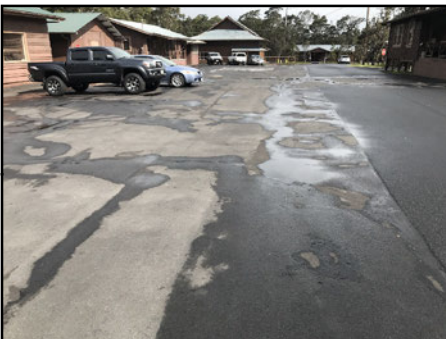
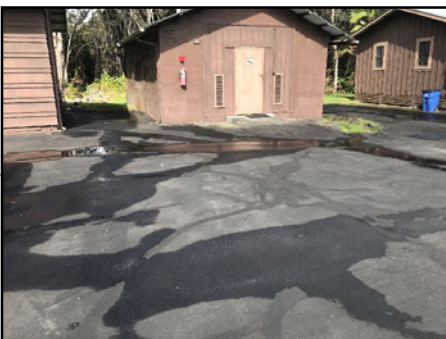
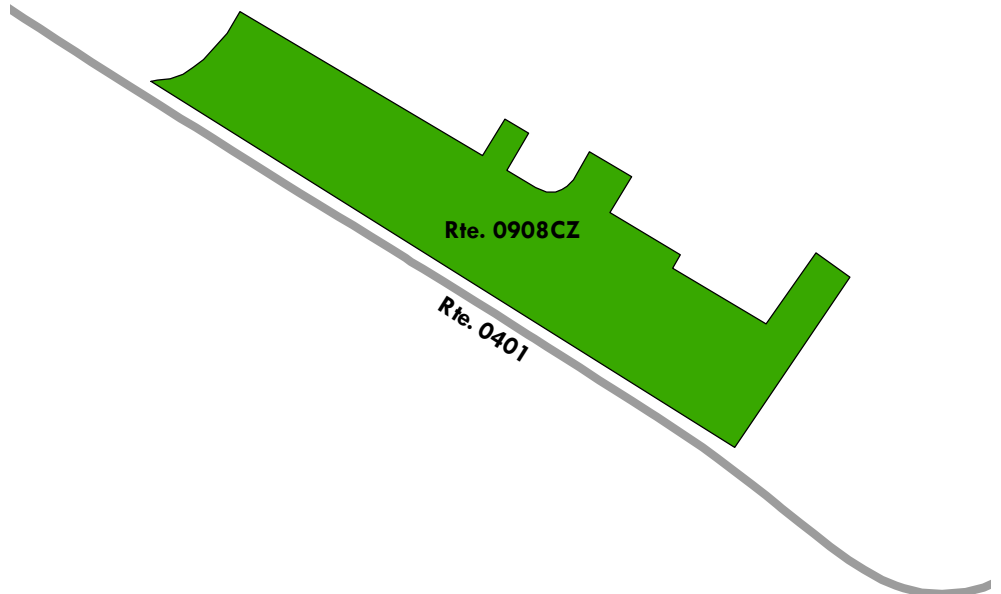
ROUTE 0908CZ: KILAUEA MAINTENANCE YARD C PARKING

Inspection Date	FMSS Number	User Access	Surface Type
3/8/2022	22831	NONPUBLIC	ASPHALT
Area (Sq. Ft.)	Lane Miles (11' Widths)	Curb Reveal (Inches)	Curb Recommendation
11,250	0.194	NOT APPLICABLE	NOT APPLICABLE
Curb Type		Curb & Gutter Type	
NO CURB		NO CURB AND GUTTER	
Pavement Recommendation		Condition Rating / PCR	
PREVENTIVE MAINTENANCE		GOOD / 90

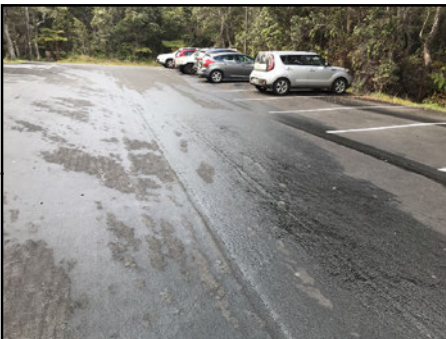
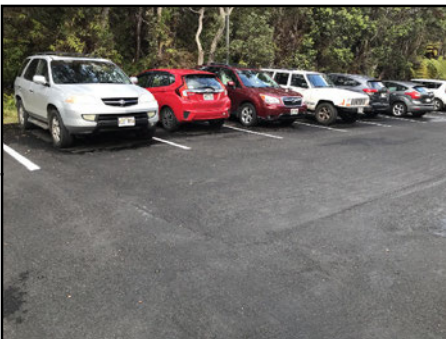
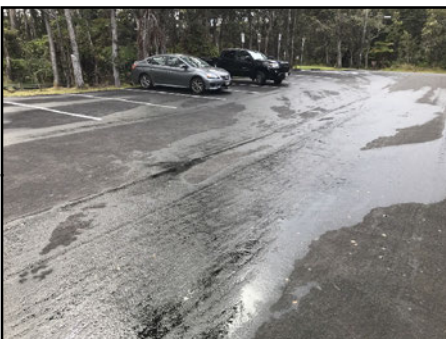
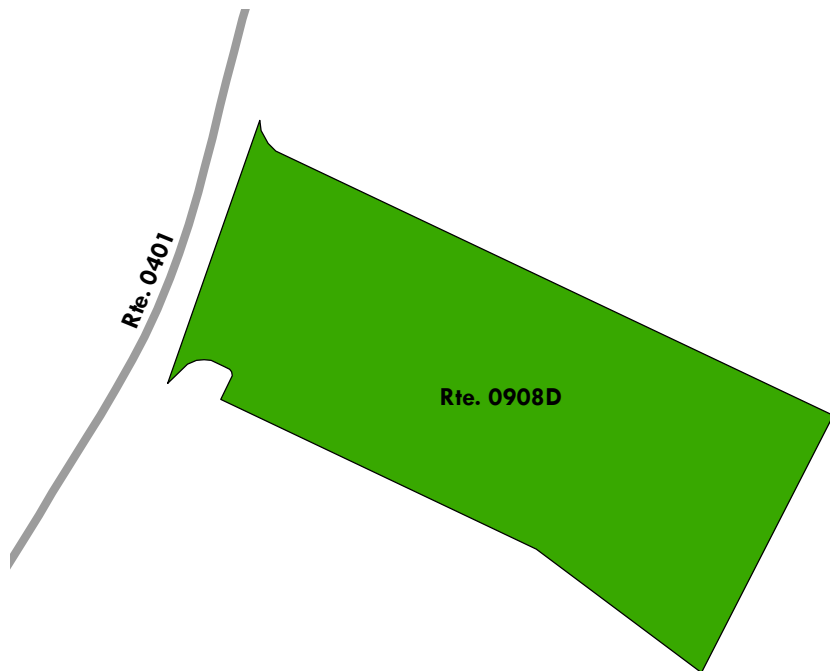
ROUTE 0908D: VISITORS EMERGENCY OPERATIONS CENTER PARKING

Inspection Date	FMSS Number	User Access	Surface Type
3/8/2022	244097	PUBLIC	ASPHALT
Area (Sq. Ft.)	Lane Miles (11' Widths)	Curb Reveal (Inches)	Curb Recommendation
9,263	0.159	NOT APPLICABLE	NOT APPLICABLE
Curb Type		Curb & Gutter Type	
NO CURB		NO CURB AND GUTTER	
Pavement Recommendation		Condition Rating / PCR	
PREVENTIVE MAINTENANCE		GOOD / 90

NOTE: 0908D IS NOT COMBINED WITH 0908ZZ.

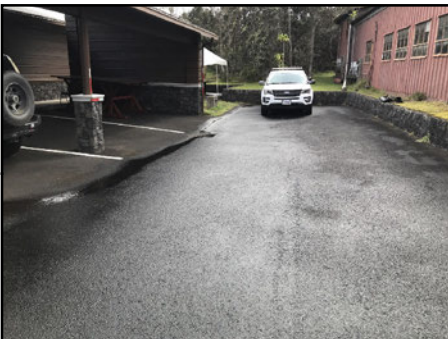
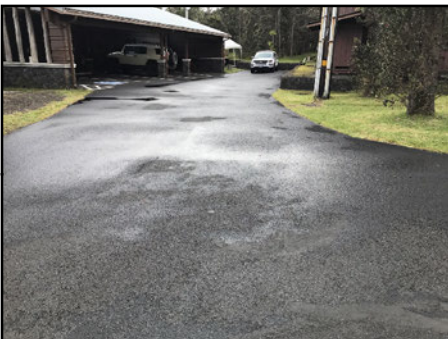
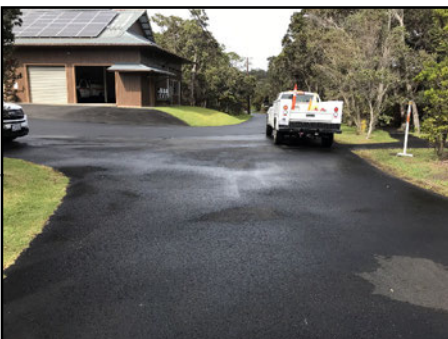
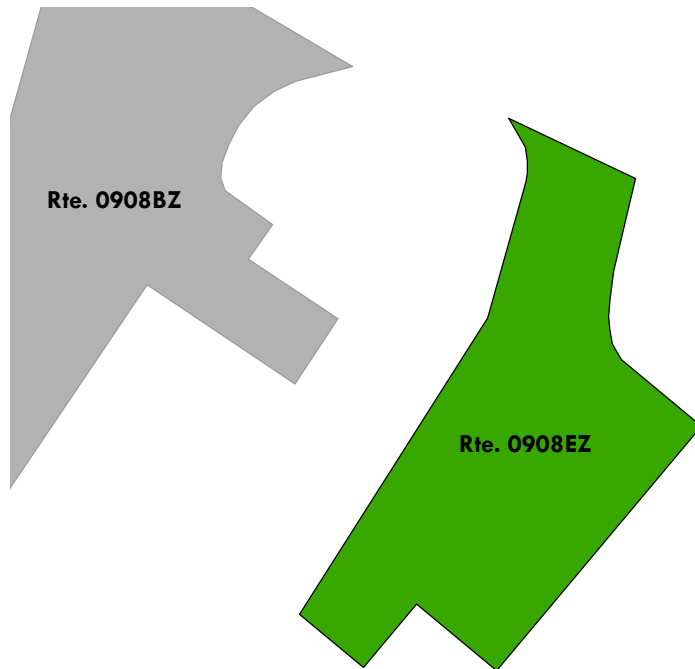
ROUTE 0908EZ: KILAUEA MAINTENANCE YARD E PARKING

Inspection Date	FMSS Number	User Access	Surface Type
3/8/2022	22831	NONPUBLIC	ASPHALT
Area (Sq. Ft.)	Lane Miles (11' Widths)	Curb Reveal (Inches)	Curb Recommendation
3,227	0.056	NOT APPLICABLE	NOT APPLICABLE
Curb Type		Curb & Gutter Type	
NO CURB		NO CURB AND GUTTER	
Pavement Recommendation		Condition Rating / PCR	
PREVENTIVE MAINTENANCE		GOOD / 90

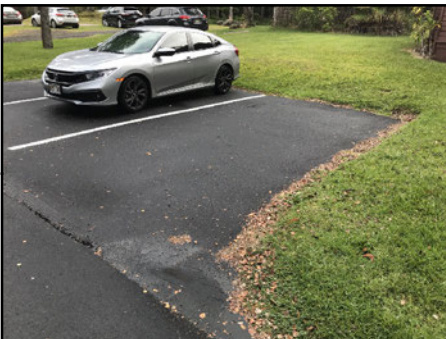
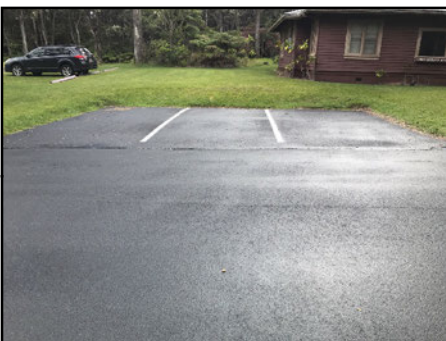
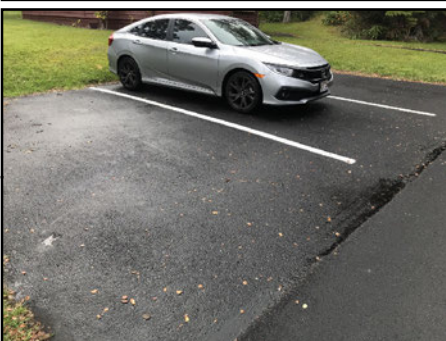
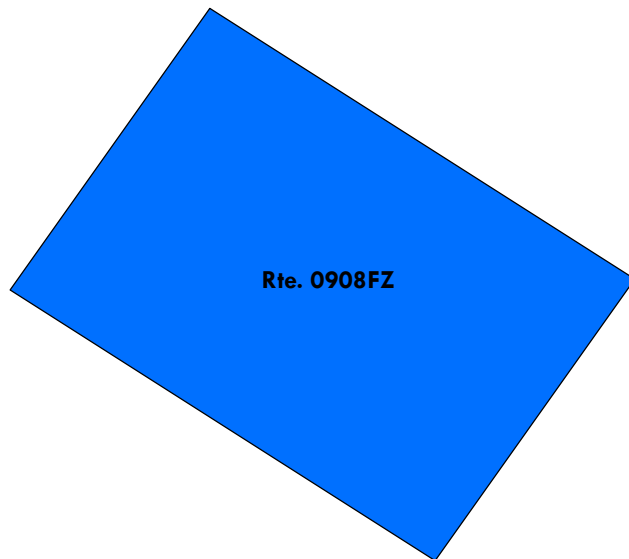
ROUTE 0908FZ: RESIDENCE ROAD A PARKING

Inspection Date	FMSS Number	User Access	Surface Type
3/8/2022	22831	NONPUBLIC	ASPHALT
Area (Sq. Ft.)	Lane Miles (11' Widths)	Curb Reveal (Inches)	Curb Recommendation
673	0.012	NOT APPLICABLE	NOT APPLICABLE
Curb Type		Curb & Gutter Type	
NO CURB		NO CURB AND GUTTER	
Pavement Recommendation		Condition Rating / PCR	
DO NOTHING		EXCELLENT / 97

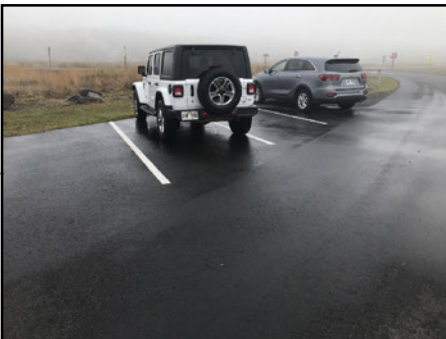
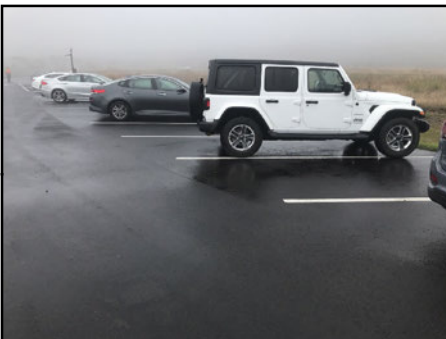
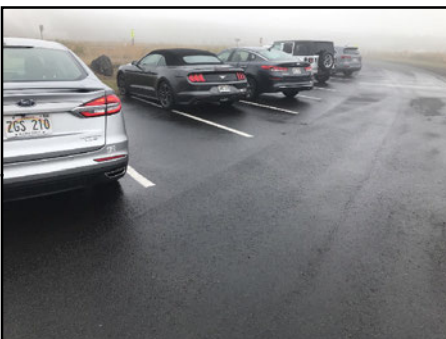
ROUTE 0909AZ: STEAM VENTS A PARKING

Inspection Date	FMSS Number	User Access	Surface Type
3/8/2022	22292	PUBLIC	ASPHALT
Area (Sq. Ft.)	Lane Miles (11' Widths)	Curb Reveal (Inches)	Curb Recommendation
1,515	0.026	NOT APPLICABLE	NOT APPLICABLE
Curb Type		Curb & Gutter Type	
NO CURB		NO CURB AND GUTTER	
Pavement Recommendation		Condition Rating / PCR	
DO NOTHING		EXCELLENT / 97

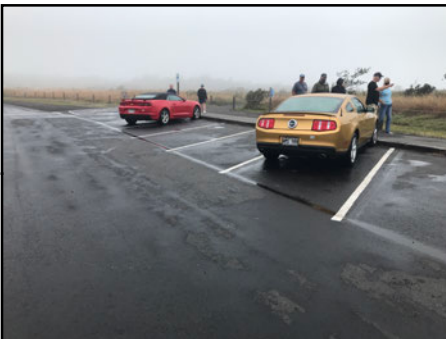
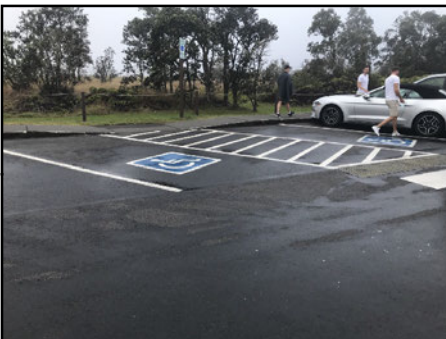
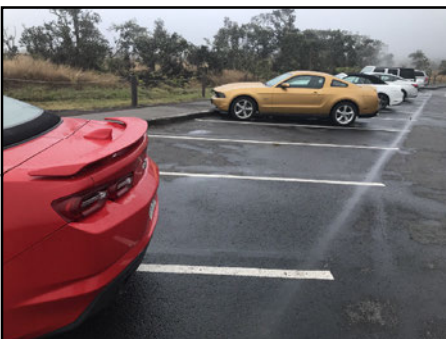
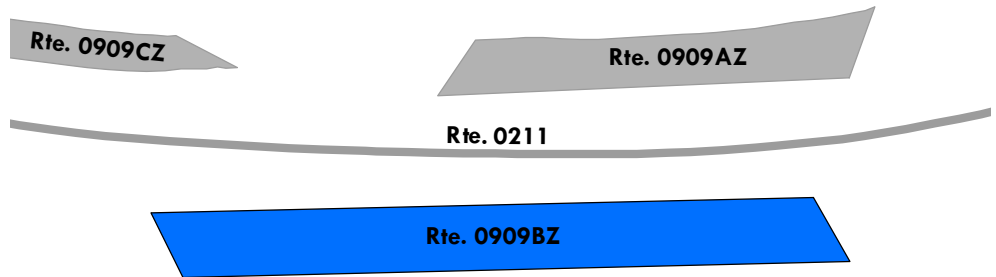
ROUTE 0909BZ: STEAM VENTS B PARKING

Inspection Date	FMSS Number	User Access	Surface Type
3/8/2022	22292	PUBLIC	ASPHALT
Area (Sq. Ft.)	Lane Miles (11' Widths)	Curb Reveal (Inches)	Curb Recommendation
3,017	0.052	5	DO NOTHING
Curb Type		Curb & Gutter Type	
STONE		NO CURB AND GUTTER	
Pavement Recommendation		Condition Rating / PCR	
DO NOTHING		EXCELLENT / 97

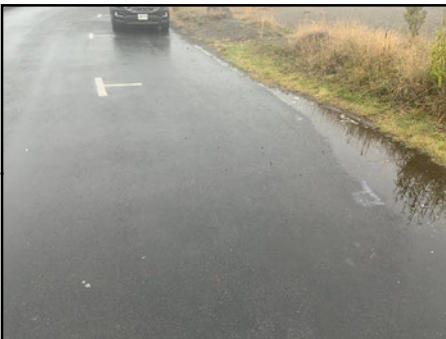
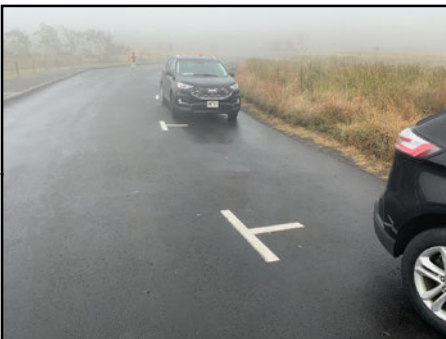
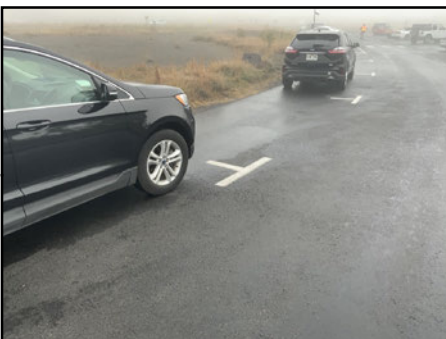
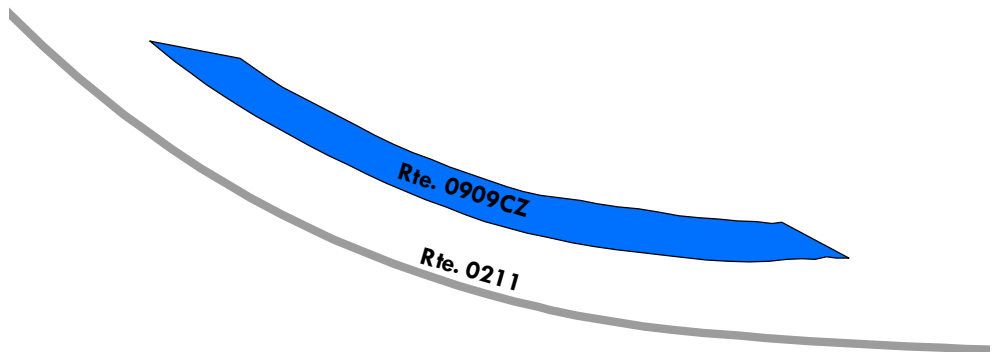
ROUTE 0909CZ: STEAM VENTS C PARKING

Inspection Date	FMSS Number	User Access	Surface Type
3/8/2022	22292	PUBLIC	ASPHALT
Area (Sq. Ft.)	Lane Miles (11' Widths)	Curb Reveal (Inches)	Curb Recommendation
1,522	0.026	NOT APPLICABLE	NOT APPLICABLE
Curb Type		Curb & Gutter Type	
NO CURB		NO CURB AND GUTTER	
Pavement Recommendation		Condition Rating / PCR	
DO NOTHING		EXCELLENT / 97

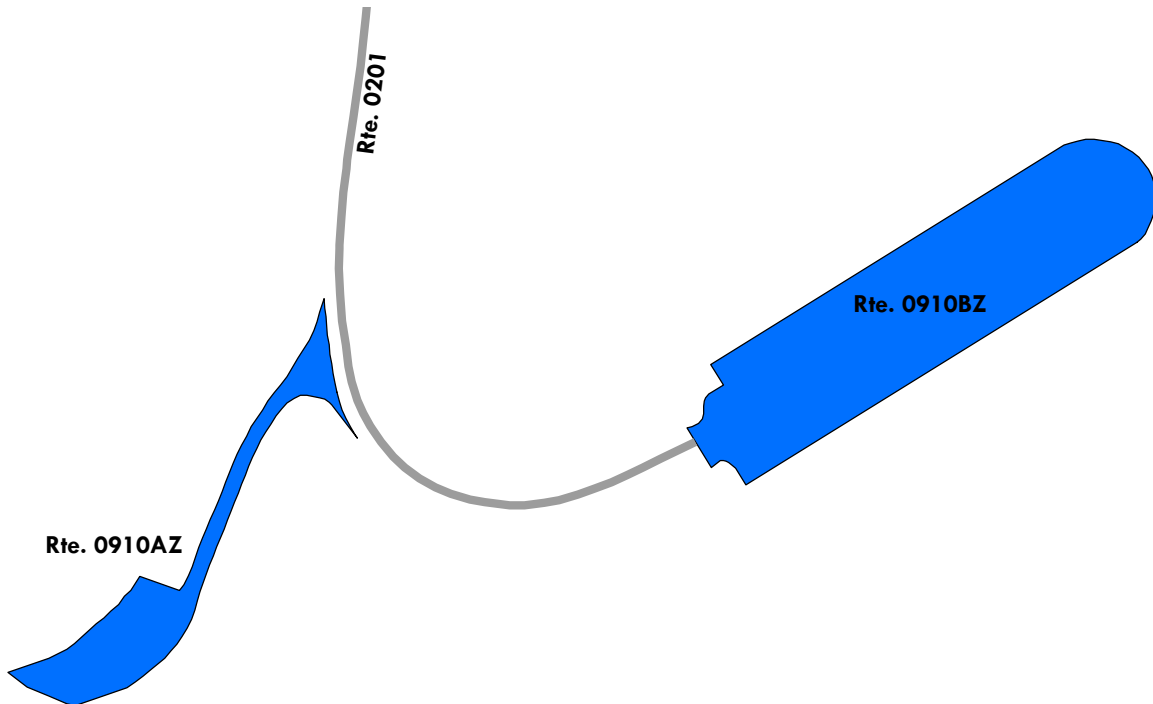
ROUTE 0910ZZ: KILAUEA OVERLOOK AND PICNIC AREA PARKING

Inspection Date	FMSS Number	User Access	Surface Type
3/8/2022	22245	PUBLIC	ASPHALT
Area (Sq. Ft.)	Lane Miles (11' Widths)	Condition Rating / PCR	
24,623	0.424	SUMMARY / 97

Route 0910ZZ
(2 Subcomponents)

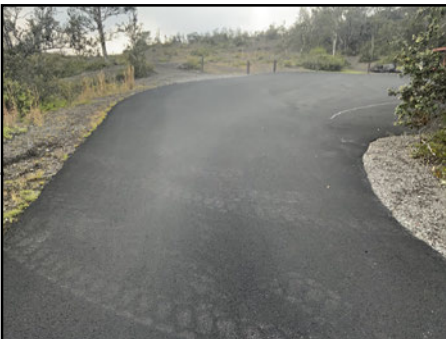
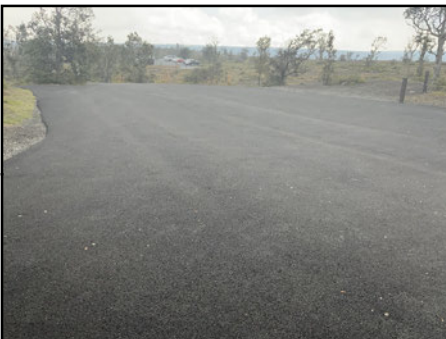
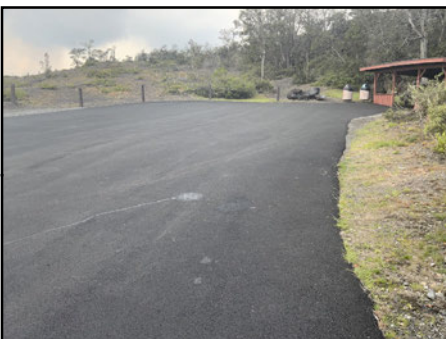
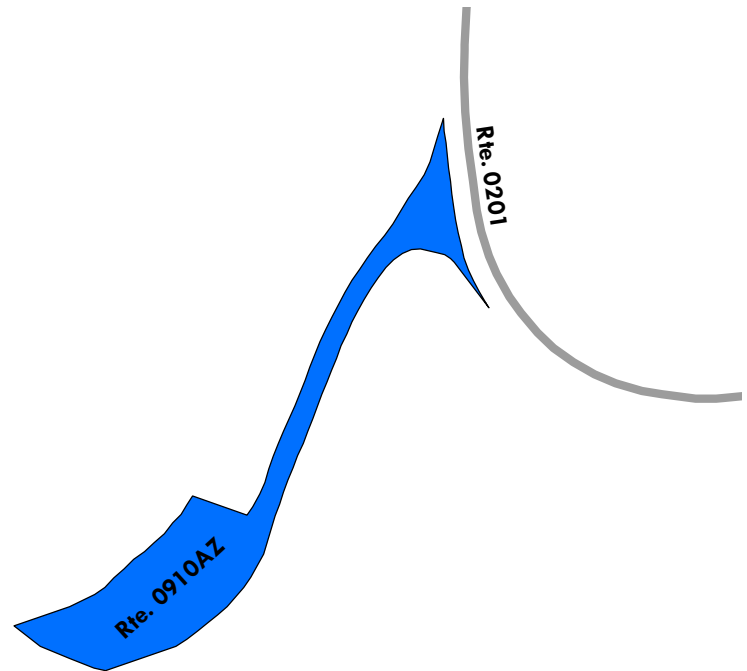
ROUTE 0910AZ: KILAUEA PICNIC AREA PARKING

Inspection Date	FMSS Number	User Access	Surface Type
3/8/2022	22245	PUBLIC	ASPHALT
Area (Sq. Ft.)	Lane Miles (11' Widths)	Curb Reveal (Inches)	Curb Recommendation
5,543	0.095	NOT APPLICABLE	NOT APPLICABLE
Curb Type		Curb & Gutter Type	
NO CURB		NO CURB AND GUTTER	
Pavement Recommendation		Condition Rating / PCR	
DO NOTHING		EXCELLENT / 97

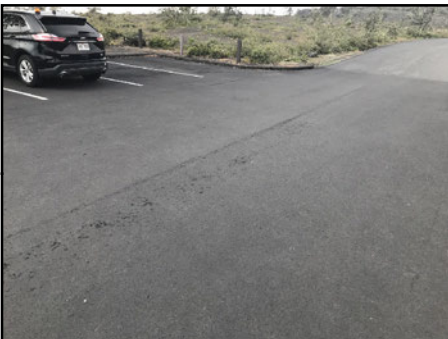
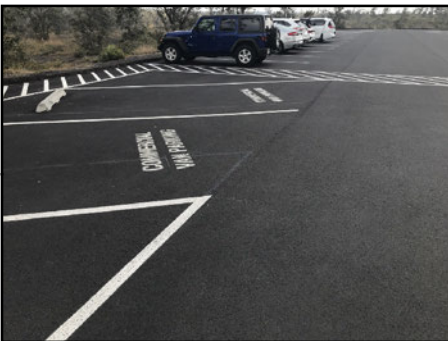
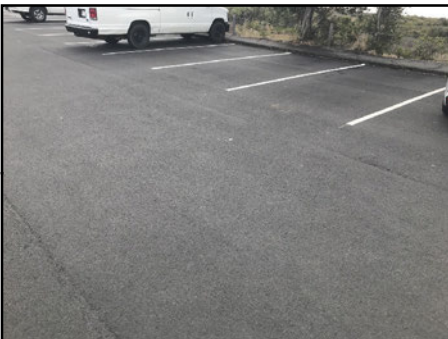
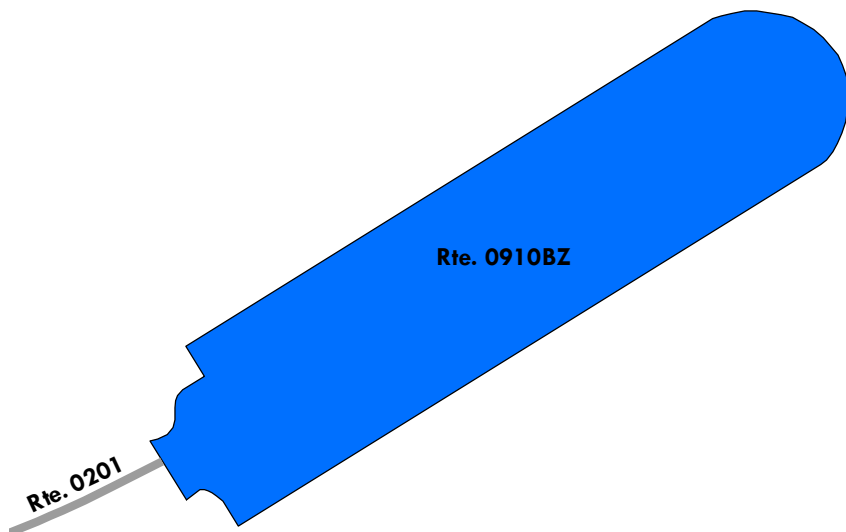
ROUTE 0910BZ: KILAUEA OVERLOOK PARKING

Inspection Date	FMSS Number	User Access	Surface Type
3/8/2022	22245	PUBLIC	ASPHALT
Area (Sq. Ft.)	Lane Miles (11' Widths)	Curb Reveal (Inches)	Curb Recommendation
19,080	0.329	6	DO NOTHING
Curb Type		Curb & Gutter Type	
STONE		NO CURB AND GUTTER	
Pavement Recommendation		Condition Rating / PCR	
DO NOTHING		EXCELLENT / 97

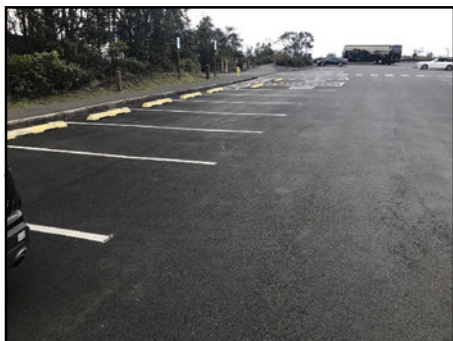
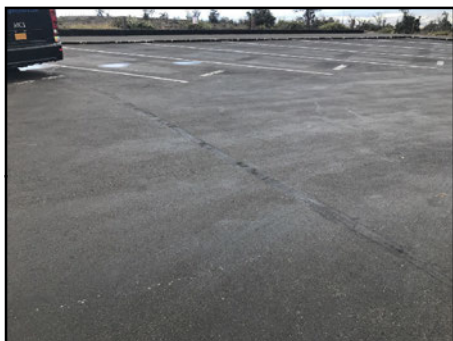
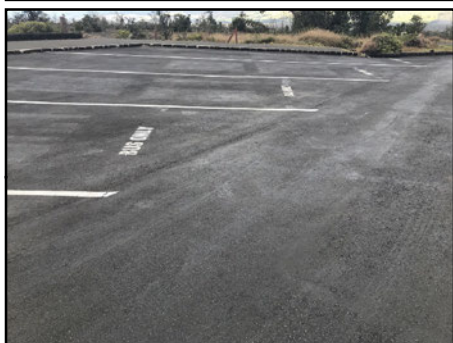
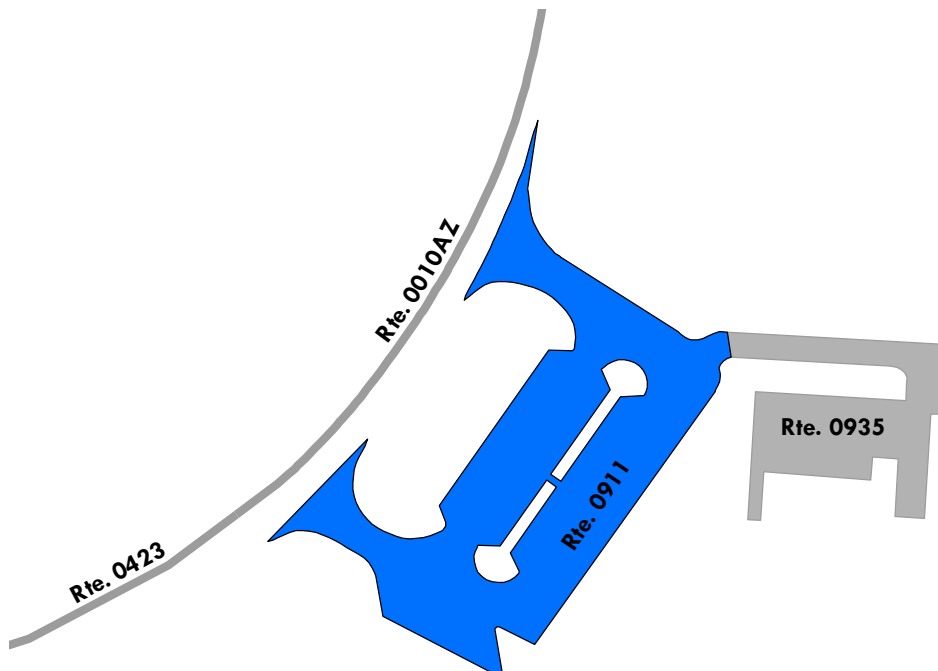
ROUTE 0911: VOLCANO OBSERVATORY PARKING

Inspection Date	FMSS Number	User Access	Surface Type
3/8/2022	22266	PUBLIC	ASPHALT
Area (Sq. Ft.)	Lane Miles (11' Widths)	Curb Reveal (Inches)	Curb Recommendation
47,271	0.814	7	DO NOTHING
Curb Type		Curb & Gutter Type	
STONE		NO CURB AND GUTTER	
Pavement Recommendation		Condition Rating / PCR	
DO NOTHING		EXCELLENT / 97

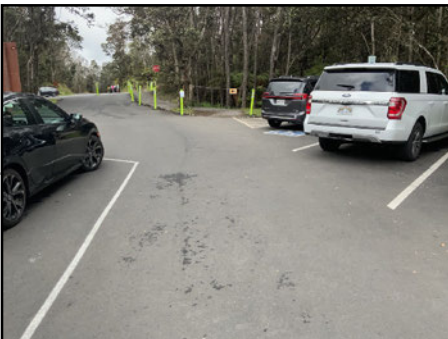
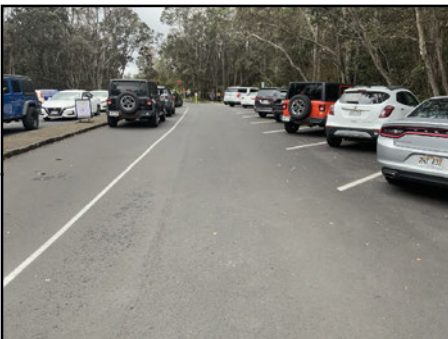
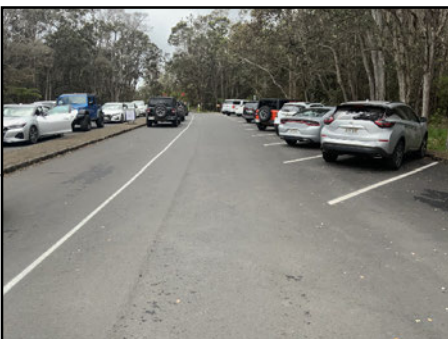
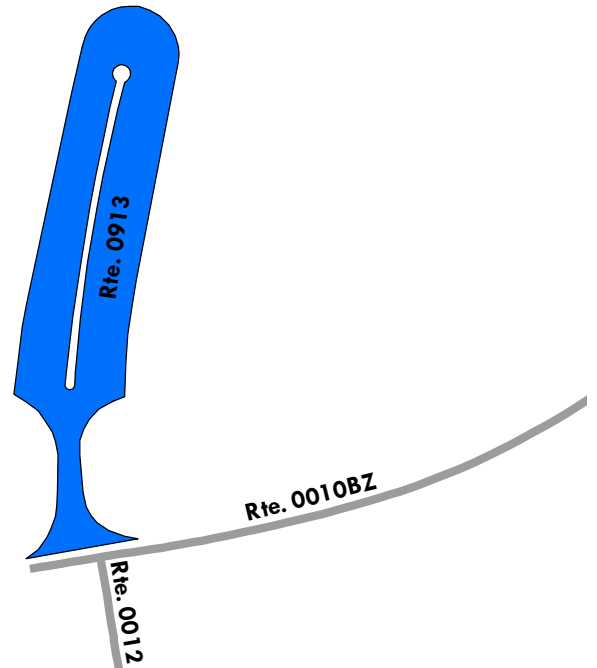
ROUTE 0913: DEVASTATION TRAIL PARKING

Inspection Date	FMSS Number	User Access	Surface Type
3/8/2022	42663	PUBLIC	ASPHALT
Area (Sq. Ft.)	Lane Miles (11' Widths)	Curb Reveal (Inches)	Curb Recommendation
23,316	0.401	4	MODERATE REPAIR
Curb Type		Curb & Gutter Type	
STONE		NO CURB AND GUTTER	
Pavement Recommendation		Condition Rating / PCR	
DO NOTHING		EXCELLENT / 97
