Road Inventory and Condition Assessment of Paved Routes Hawaii Volcanoes National Park

**Federal Lands Highway
Road Inventory Program**

**Federal Highway Administration
Eastern Federal Lands Highway Division
Road Inventory Program (RIP)**

Report Date: December 2022

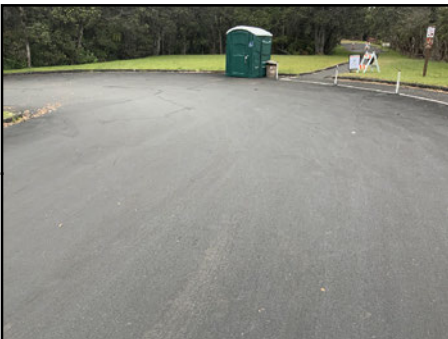
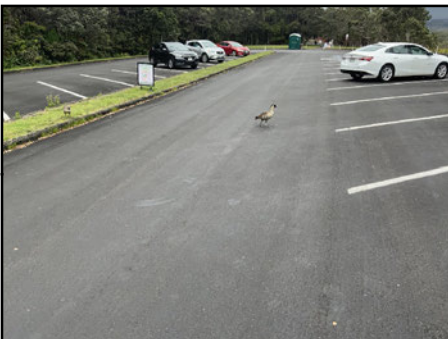
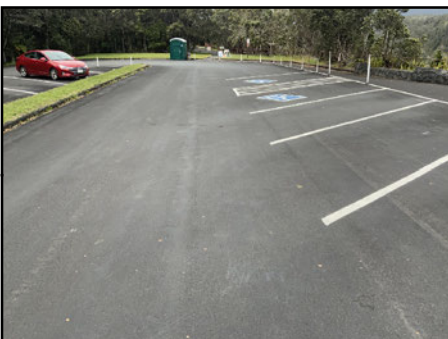
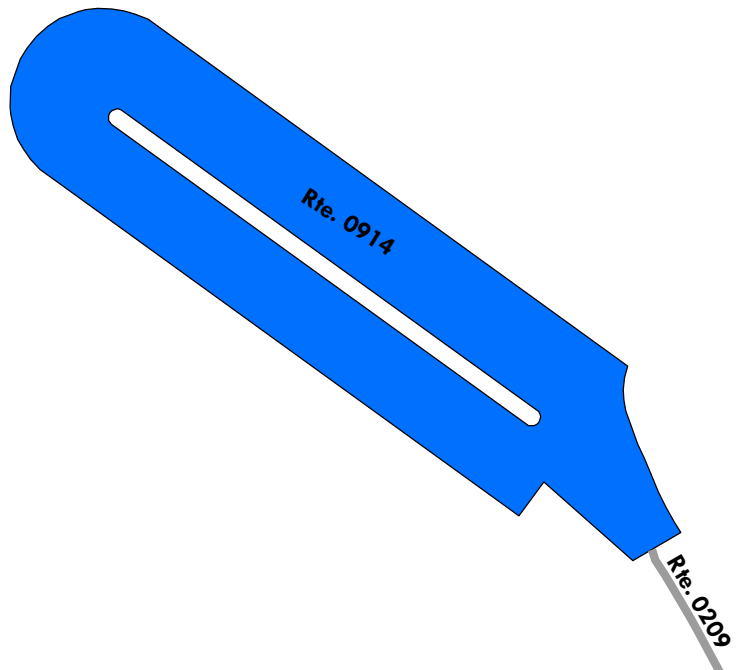
ROUTE 0914: PUU PUI PUBLISHING

Inspection Date	FMSS Number	User Access	Surface Type
3/8/2022	22302	PUBLIC	ASPHALT
Area (Sq. Ft.)	Lane Miles (11' Widths)	Curb Reveal (Inches)	Curb Recommendation
21,347	0.368	6	LIGHT REPAIR
Curb Type		Curb & Gutter Type	
STONE		NO CURB AND GUTTER	
Pavement Recommendation		Condition Rating / PCR	
DO NOTHING		EXCELLENT / 97

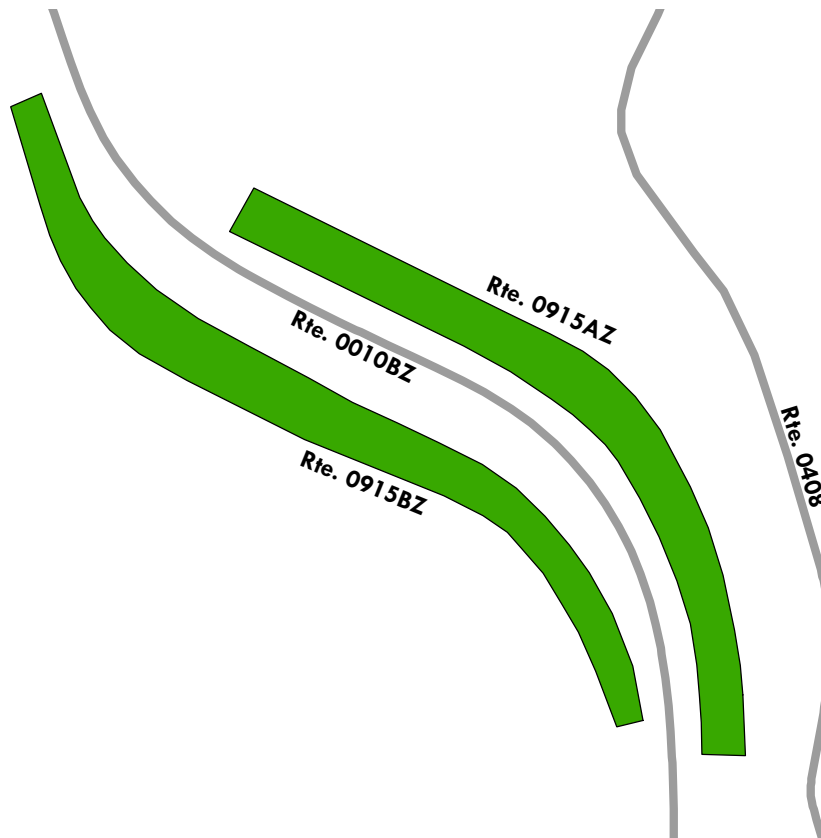
ROUTE 0915ZZ: THURSTON LAVA TUBE PARKING

Inspection Date	FMSS Number	User Access	Surface Type
3/8/2022	42665	PUBLIC	ASPHALT
Area (Sq. Ft.)	Lane Miles (11' Widths)	Condition Rating / PCR	
16,588	0.286	SUMMARY / 90

Route 0915ZZ
(2 Subcomponents)

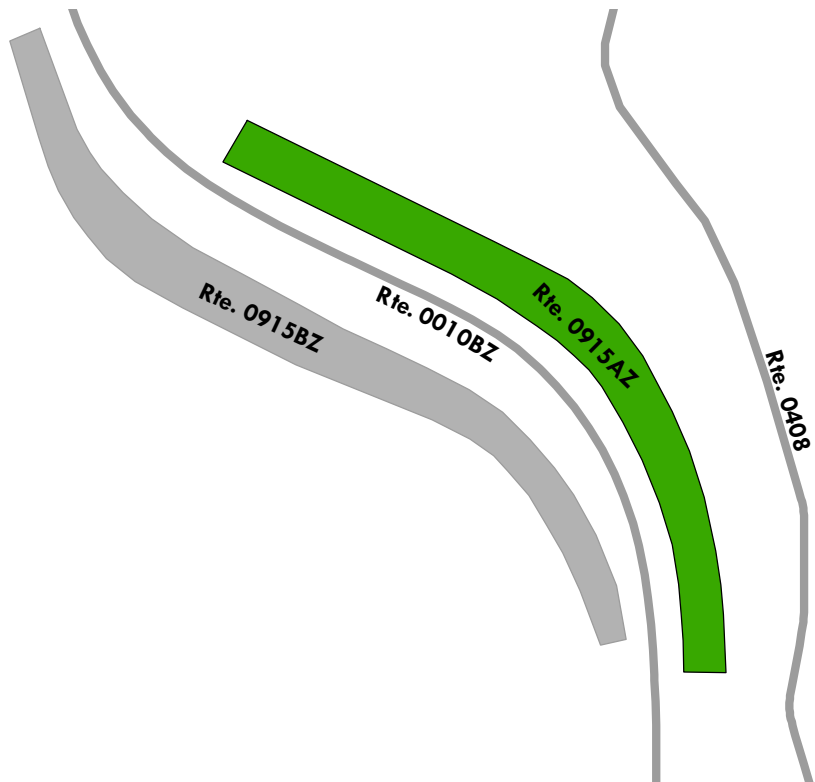
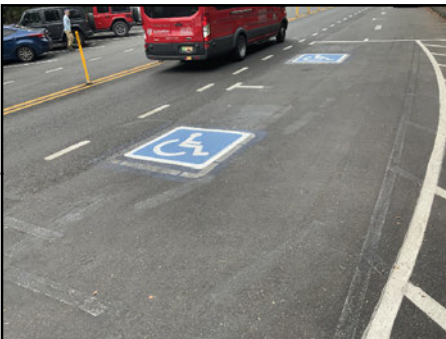
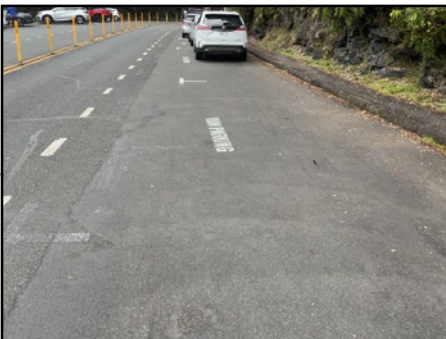
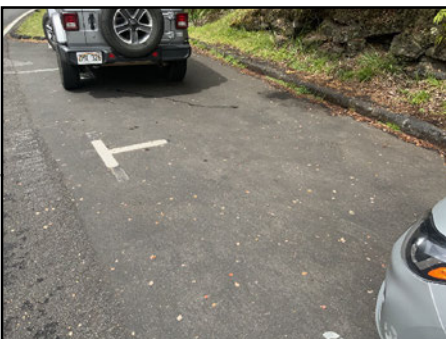
Inspection Date	FMSS Number	User Access	Surface Type
3/8/2022	42665	PUBLIC	ASPHALT
Area (Sq. Ft.)	Lane Miles (11' Widths)	Curb Reveal (Inches)	Curb Recommendation
7,886	0.136	5	DO NOTHING
Curb Type		Curb & Gutter Type	
STONE		NO CURB AND GUTTER	
Pavement Recommendation		Condition Rating / PCR	
PREVENTIVE MAINTENANCE		GOOD / 90

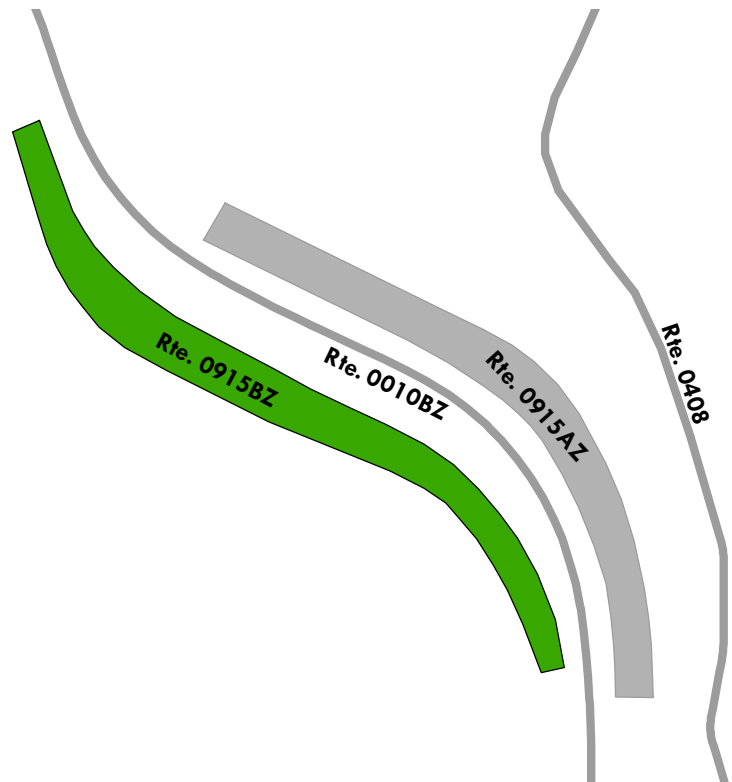
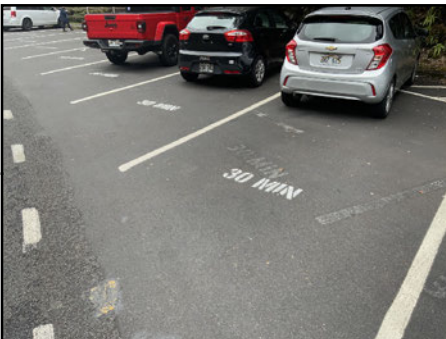
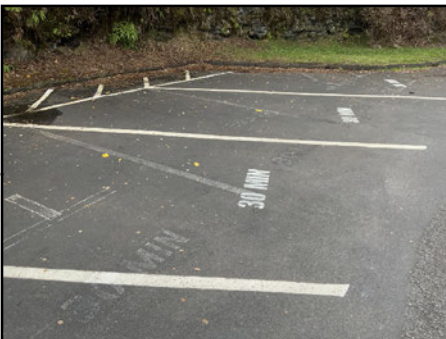
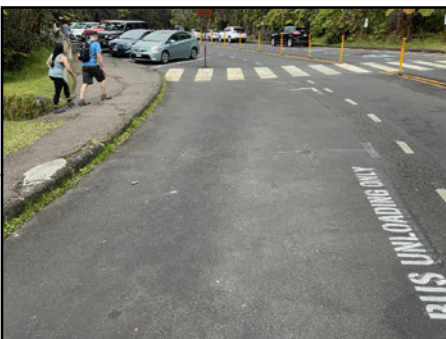
ROUTE 0915BZ: THURSTON LAVA TUBE B PARKING

Inspection Date	FMSS Number	User Access	Surface Type
3/8/2022	42665	PUBLIC	ASPHALT
Area (Sq. Ft.)	Lane Miles (11' Widths)	Curb Reveal (Inches)	Curb Recommendation
8,702	0.15	6	LIGHT REPAIR
Curb Type		Curb & Gutter Type	
STONE		NO CURB AND GUTTER	
Pavement Recommendation		Condition Rating / PCR	
PREVENTIVE MAINTENANCE		GOOD / 90

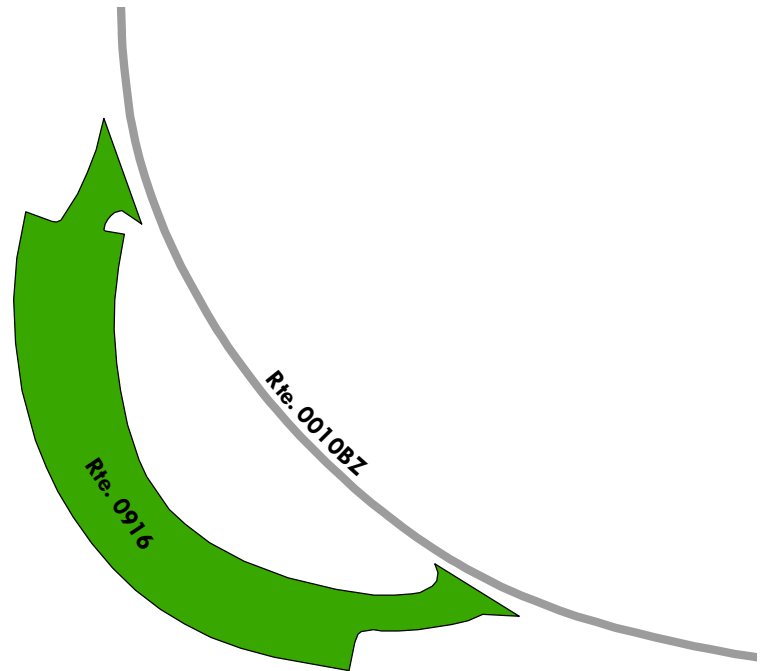
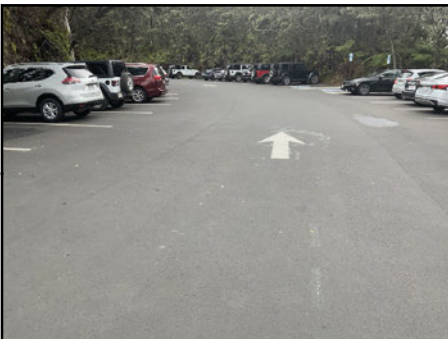
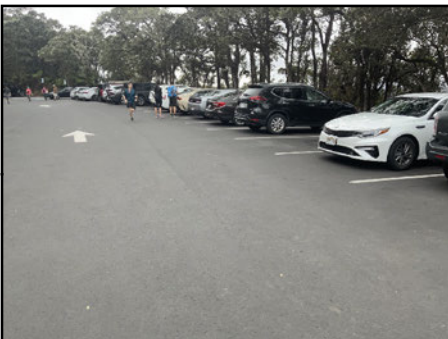
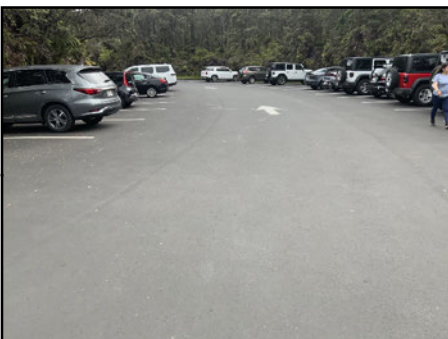
ROUTE 0916: KILAUEA IKI PARKING

Inspection Date	FMSS Number	User Access	Surface Type
3/8/2022	42666	PUBLIC	ASPHALT
Area (Sq. Ft.)	Lane Miles (11' Widths)	Curb Reveal (Inches)	Curb Recommendation
24,415	0.42	5	LIGHT REPAIR
Curb Type		Curb & Gutter Type	
STONE		NO CURB AND GUTTER	
Pavement Recommendation		Condition Rating / PCR	
PREVENTIVE MAINTENANCE		GOOD / 90

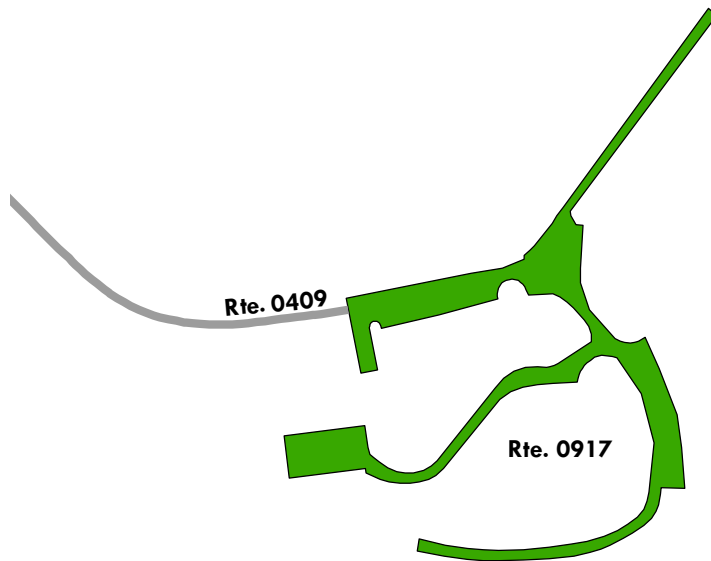
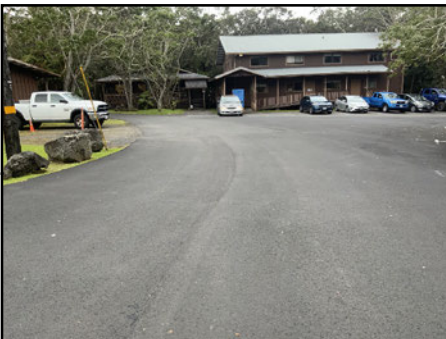
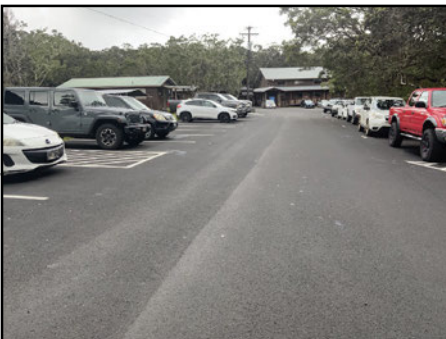
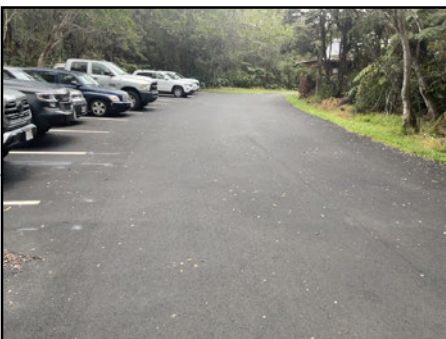
ROUTE 0917: RESOURCE MANAGEMENT AREA PARKING

Inspection Date	FMSS Number	User Access	Surface Type
3/8/2022	42667	NONPUBLIC	ASPHALT
Area (Sq. Ft.)	Lane Miles (11' Widths)	Curb Reveal (Inches)	Curb Recommendation
42,787	0.737	NOT APPLICABLE	NOT APPLICABLE
Curb Type		Curb & Gutter Type	
NO CURB		NO CURB AND GUTTER	
Pavement Recommendation		Condition Rating / PCR	
PREVENTIVE MAINTENANCE		GOOD / 90

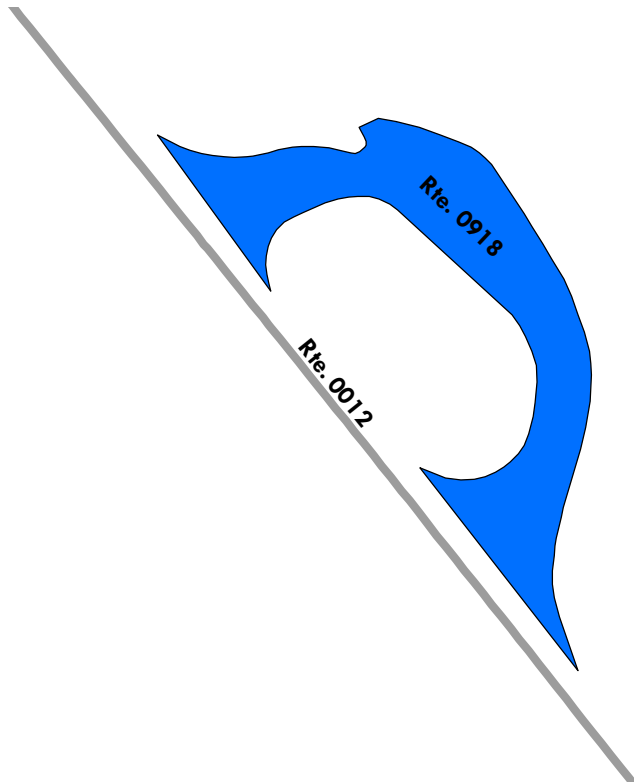
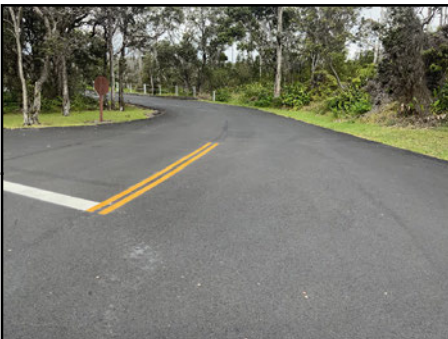
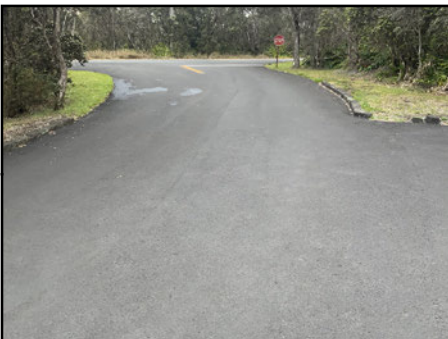
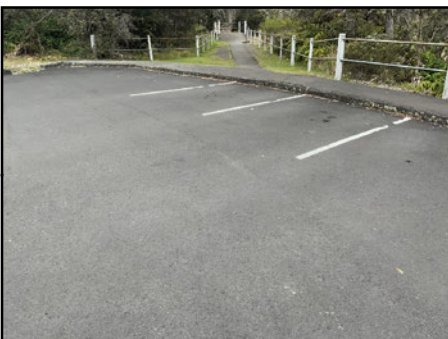
ROUTE 0918: PUHIMAU CRATER PARKING

Inspection Date	FMSS Number	User Access	Surface Type
3/8/2022	23394	PUBLIC	ASPHALT
Area (Sq. Ft.)	Lane Miles (11' Widths)	Curb Reveal (Inches)	Curb Recommendation
13,447	0.232	5	LIGHT REPAIR
Curb Type		Curb & Gutter Type	
STONE		NO CURB AND GUTTER	
Pavement Recommendation		Condition Rating / PCR	
DO NOTHING		EXCELLENT / 97

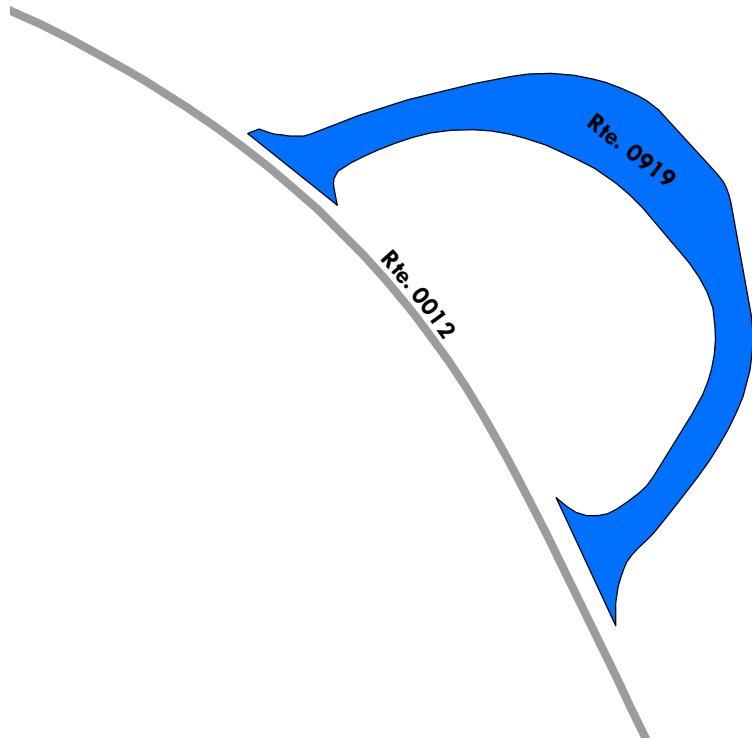
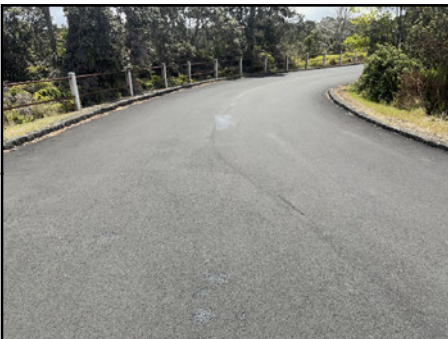
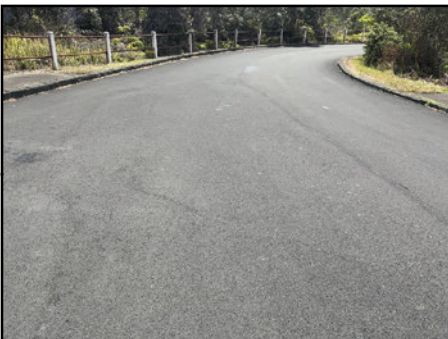
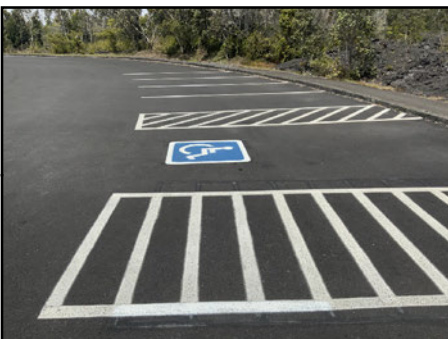
ROUTE 0919: PAUAHI CRATER PARKING

Inspection Date	FMSS Number	User Access	Surface Type
3/8/2022	42670	PUBLIC	ASPHALT
Area (Sq. Ft.)	Lane Miles (11' Widths)	Curb Reveal (Inches)	Curb Recommendation
16,886	0.291	6	DO NOTHING
Curb Type		Curb & Gutter Type	
STONE		NO CURB AND GUTTER	
Pavement Recommendation		Condition Rating / PCR	
DO NOTHING		EXCELLENT / 97

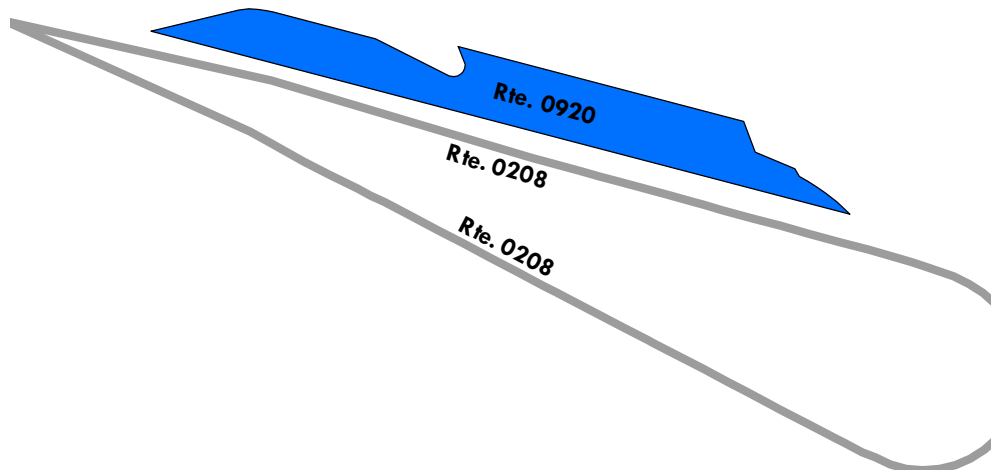
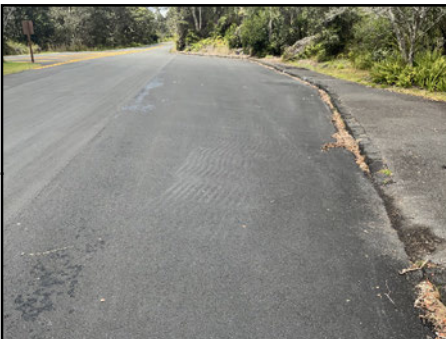
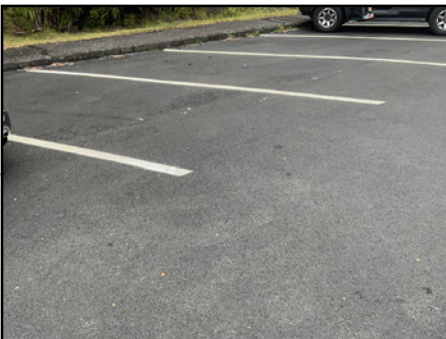
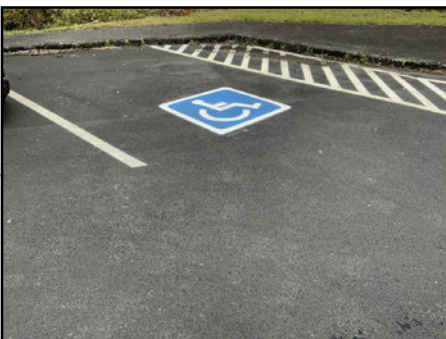
ROUTE 0920: MAUNA ULU LAVA SHIELD PARKING

Inspection Date	FMSS Number	User Access	Surface Type
3/8/2022	23422	PUBLIC	ASPHALT
Area (Sq. Ft.)	Lane Miles (11' Widths)	Curb Reveal (Inches)	Curb Recommendation
8,508	0.146	7	DO NOTHING
Curb Type		Curb & Gutter Type	
STONE		NO CURB AND GUTTER	
Pavement Recommendation		Condition Rating / PCR	
DO NOTHING		EXCELLENT / 97

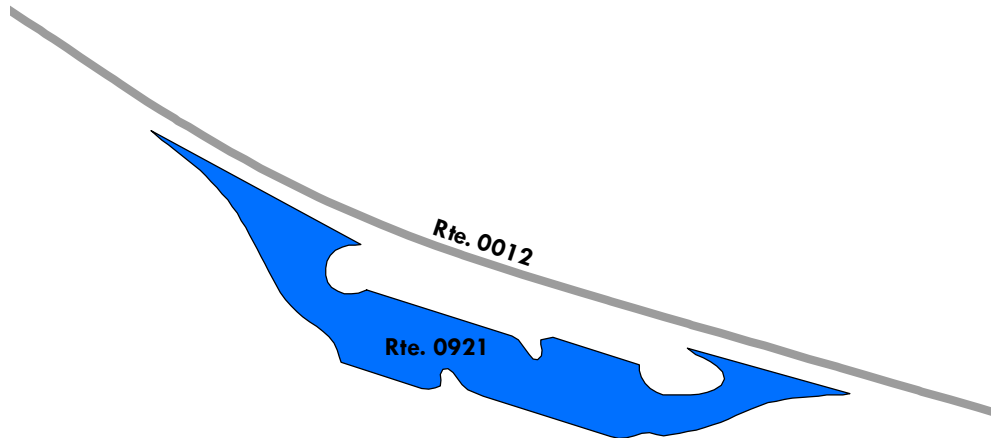
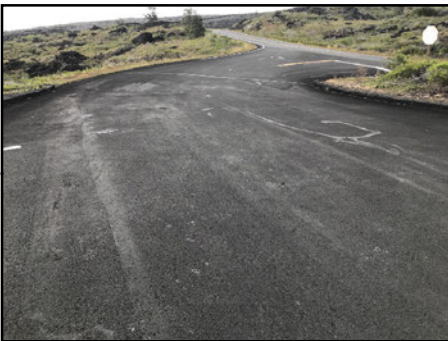
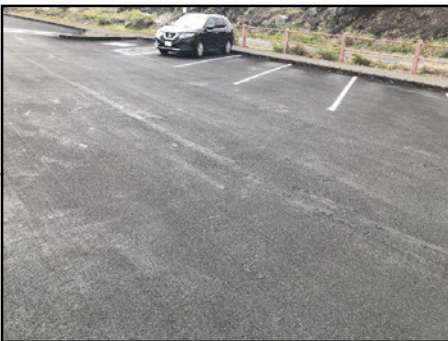
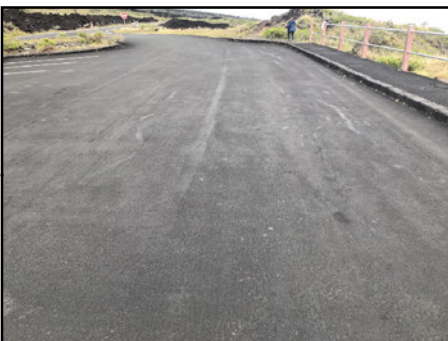
ROUTE 0921: KEALAKOMO PICNIC AREA PARKING

Inspection Date	FMSS Number	User Access	Surface Type
3/8/2022	23446	PUBLIC	ASPHALT
Area (Sq. Ft.)	Lane Miles (11' Widths)	Curb Reveal (Inches)	Curb Recommendation
17,919	0.309	7	DO NOTHING
Curb Type		Curb & Gutter Type	
STONE		NO CURB AND GUTTER	
Pavement Recommendation		Condition Rating / PCR	
DO NOTHING		EXCELLENT / 97

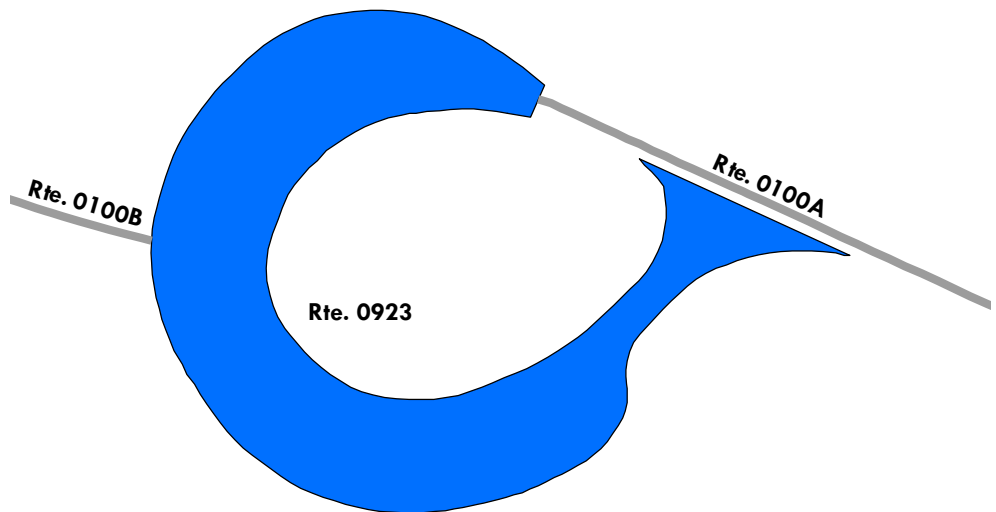
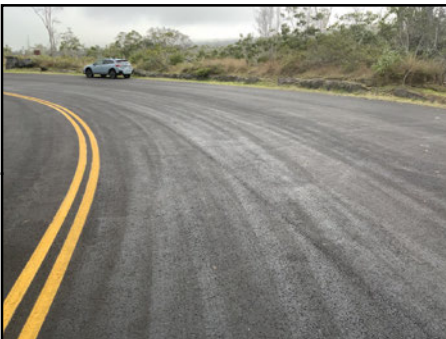
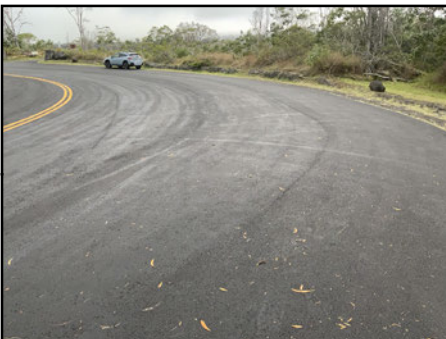
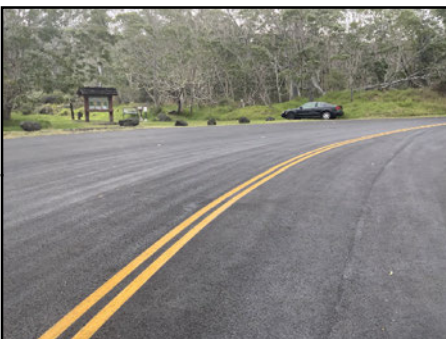
ROUTE 0923: KIPUKA PUAULU TRAILHEAD PARKING

Inspection Date	FMSS Number	User Access	Surface Type
3/8/2022	42676	PUBLIC	ASPHALT
Area (Sq. Ft.)	Lane Miles (11' Widths)	Curb Reveal (Inches)	Curb Recommendation
26,506	0.456	NOT APPLICABLE	NOT APPLICABLE
Curb Type		Curb & Gutter Type	
NO CURB		NO CURB AND GUTTER	
Pavement Recommendation		Condition Rating / PCR	
DO NOTHING		EXCELLENT / 97

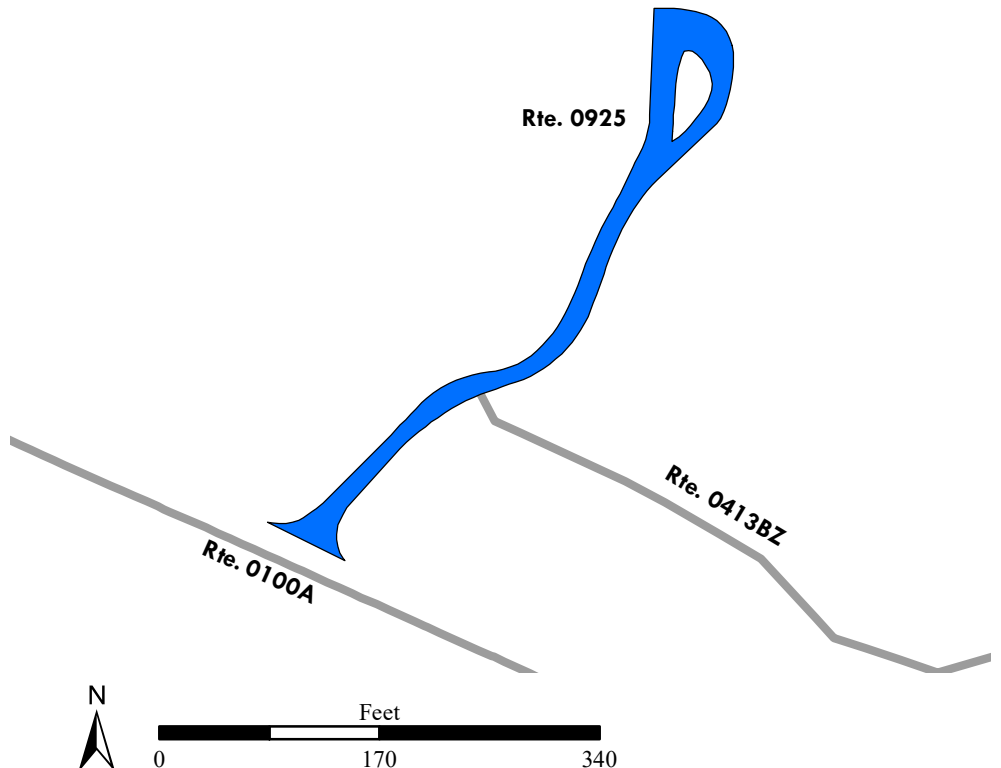
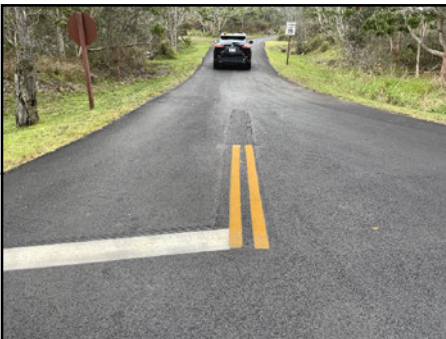
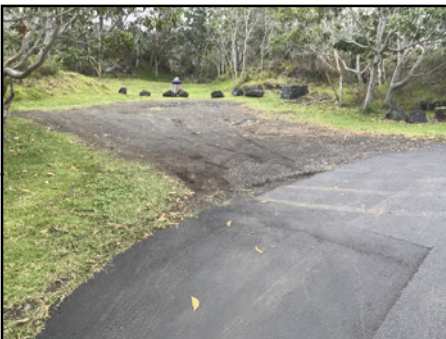
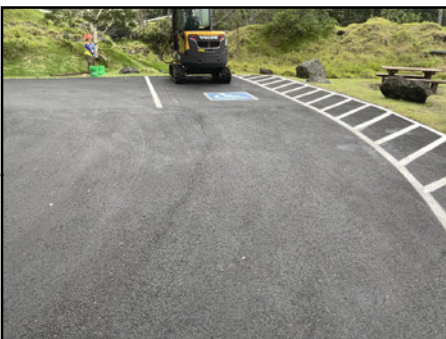
ROUTE 0925: KIPUKA PUAULU DAY USE AREA PARKING

Inspection Date	FMSS Number	User Access	Surface Type
3/8/2022	42671	PUBLIC	ASPHALT
Area (Sq. Ft.)	Lane Miles (11' Widths)	Curb Reveal (Inches)	Curb Recommendation
11,123	0.192	NOT APPLICABLE	NOT APPLICABLE
Curb Type		Curb & Gutter Type	
NO CURB		NO CURB AND GUTTER	
Pavement Recommendation		Condition Rating / PCR	
DO NOTHING		EXCELLENT / 97

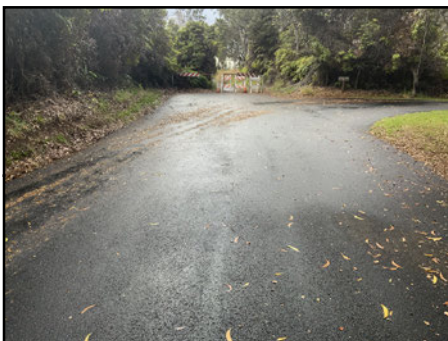
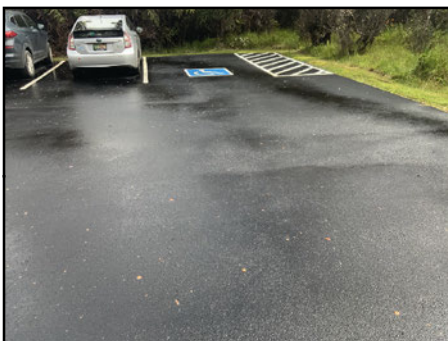
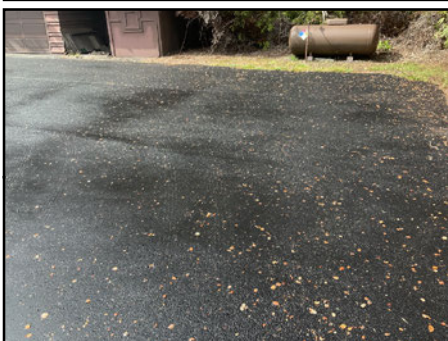
ROUTE 0927: ERUPTION SITE TURN-AROUND PARKING

Inspection Date	FMSS Number	User Access	Surface Type
3/8/2022	23493	PUBLIC	ASPHALT
Area (Sq. Ft.)	Lane Miles (11' Widths)	Curb Reveal (Inches)	Curb Recommendation
9,989	0.172	4	DO NOTHING
Curb Type		Curb & Gutter Type	
STONE		NO CURB AND GUTTER	
Pavement Recommendation		Condition Rating / PCR	
PREVENTIVE MAINTENANCE		GOOD / 90

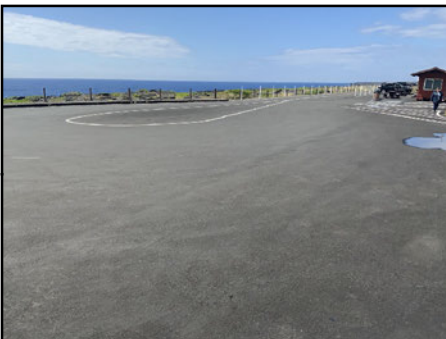
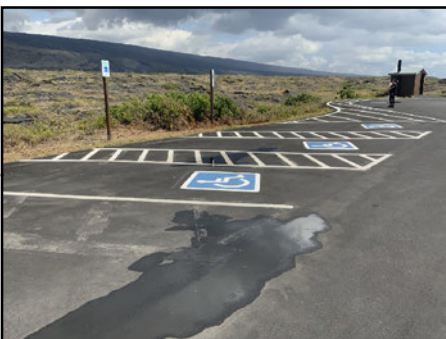
ROUTE 0928: TREE MOLDS PARKING

Inspection Date	FMSS Number	User Access	Surface Type
3/8/2022	113875	PUBLIC	ASPHALT
Area (Sq. Ft.)	Lane Miles (11' Widths)	Curb Reveal (Inches)	Curb Recommendation
1,046	0.018	NOT APPLICABLE	NOT APPLICABLE
Curb Type		Curb & Gutter Type	
NO CURB		NO CURB AND GUTTER	
Pavement Recommendation		Condition Rating / PCR	
DO NOTHING		EXCELLENT / 97

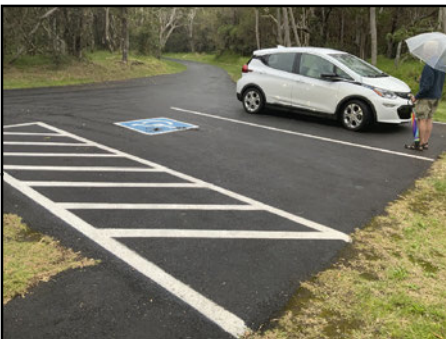
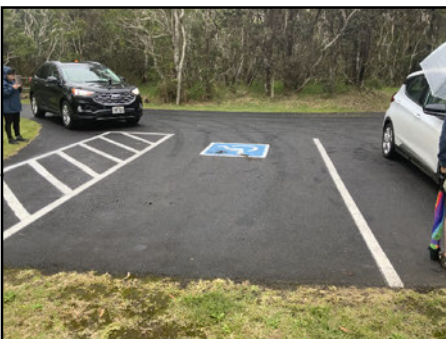
ROUTE 0930: FOOTPRINTS TRAILHEAD PARKING

Inspection Date	FMSS Number	User Access	Surface Type
3/8/2022	22876	PUBLIC	ASPHALT
Area (Sq. Ft.)	Lane Miles (11' Widths)	Curb Reveal (Inches)	Curb Recommendation
2,636	0.045	NOT APPLICABLE	NOT APPLICABLE
Curb Type		Curb & Gutter Type	
NO CURB		NO CURB AND GUTTER	
Pavement Recommendation		Condition Rating / PCR	
PREVENTIVE MAINTENANCE		GOOD / 90

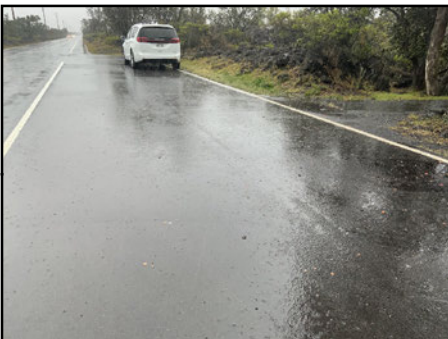
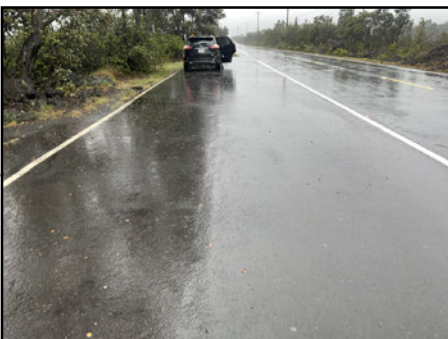
ROUTE 0933: KULANAOKUAIKI CAMPGROUND PARKING

Inspection Date	FMSS Number	User Access	Surface Type
3/8/2022	42511	PUBLIC	ASPHALT
Area (Sq. Ft.)	Lane Miles (11' Widths)	Curb Reveal (Inches)	Curb Recommendation
10,533	0.181	NOT APPLICABLE	NOT APPLICABLE
Curb Type		Curb & Gutter Type	
NO CURB		NO CURB AND GUTTER	
Pavement Recommendation		Condition Rating / PCR	
DO NOTHING		EXCELLENT / 97

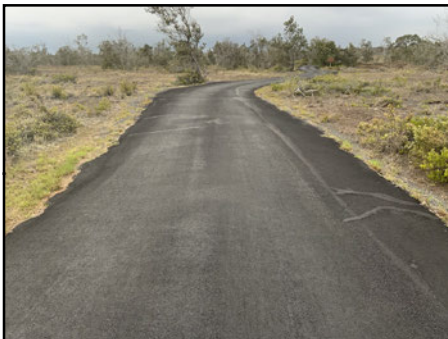
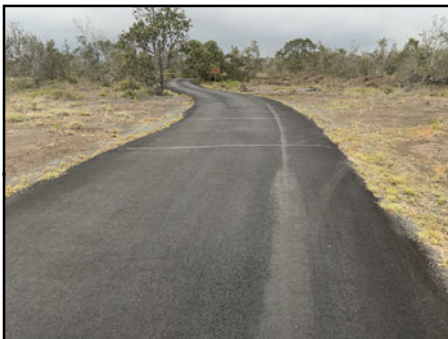
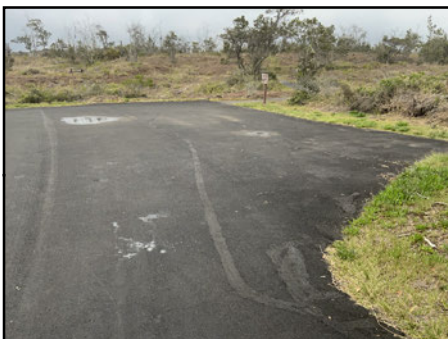
ROUTE 0935: JAGGAR EMPLOYEE PARKING

Inspection Date	FMSS Number	User Access	Surface Type
3/8/2022	239122	NONPUBLIC	ASPHALT
Area (Sq. Ft.)	Lane Miles (11' Widths)	Curb Reveal (Inches)	Curb Recommendation
15,207	0.262	6	LIGHT REPAIR
Curb Type		Curb & Gutter Type	
STONE		NO CURB AND GUTTER	
Pavement Recommendation		Condition Rating / PCR	
HEAVY 3R TREATMENTS		POOR / 53

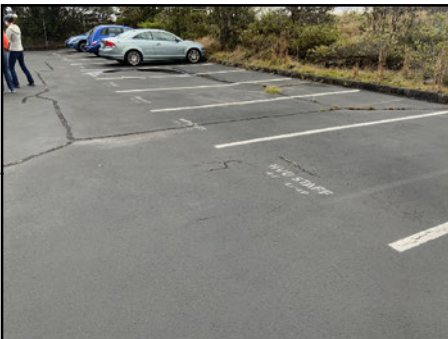
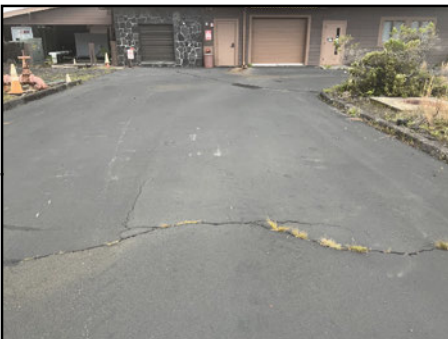
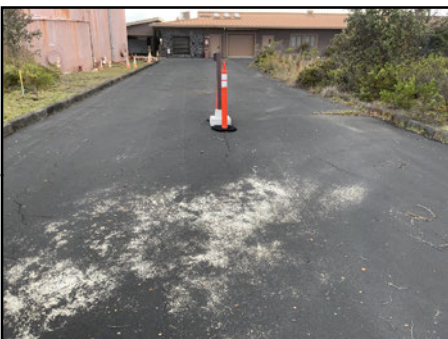
ROUTE 0936: PU'U LOA PETROGLYPHS TRAIL PARKING

Inspection Date	FMSS Number	User Access	Surface Type
3/8/2022	239124	PUBLIC	ASPHALT
Area (Sq. Ft.)	Lane Miles (11' Widths)	Curb Reveal (Inches)	Curb Recommendation
4,129	0.071	6	DO NOTHING
Curb Type		Curb & Gutter Type	
STONE		NO CURB AND GUTTER	
Pavement Recommendation		Condition Rating / PCR	
PREVENTIVE MAINTENANCE		GOOD / 90

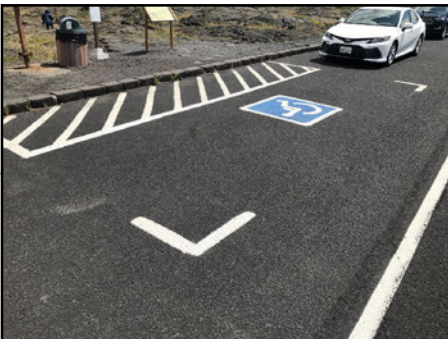
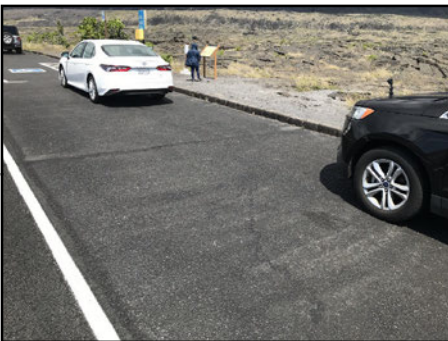
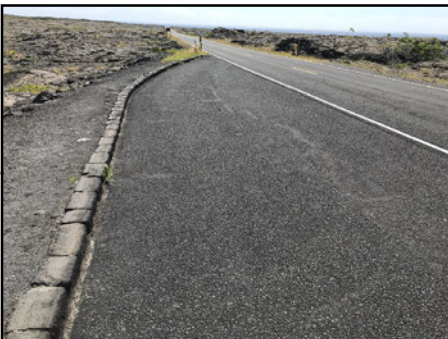
ROUTE 0937ZZ: KILAUEA MILITARY CAMP PARKING AREAS

Inspection Date	FMSS Number	User Access	Surface Type
3/8/2022	239125	PUBLIC	ASPHALT
Area (Sq. Ft.)	Lane Miles (11' Widths)	Condition Rating / PCR	
114,055	1.963	SUMMARY / 84

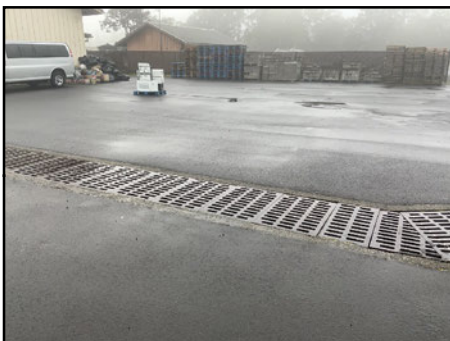
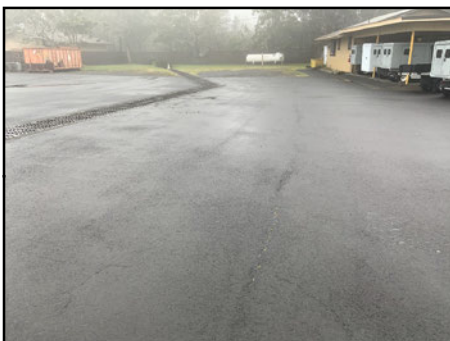
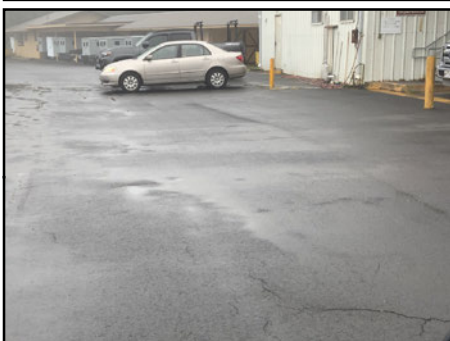
ROUTE 0937BZ: KILAUEA MILITARY CAMP B PARKING

Inspection Date	FMSS Number	User Access	Surface Type
3/8/2022	239125	PUBLIC	ASPHALT
Area (Sq. Ft.)	Lane Miles (11' Widths)	Curb Reveal (Inches)	Curb Recommendation
12,556	0.216	NOT APPLICABLE	NOT APPLICABLE
Curb Type		Curb & Gutter Type	
NO CURB		NO CURB AND GUTTER	
Pavement Recommendation		Condition Rating / PCR	
PREVENTIVE MAINTENANCE		GOOD / 90

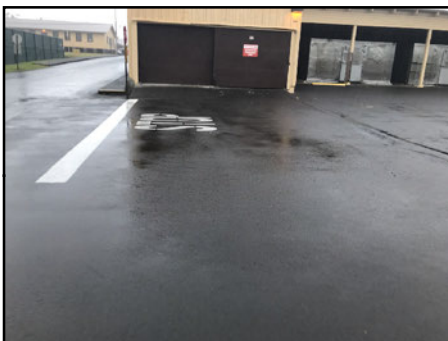
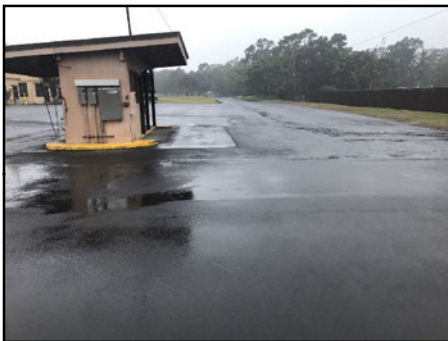
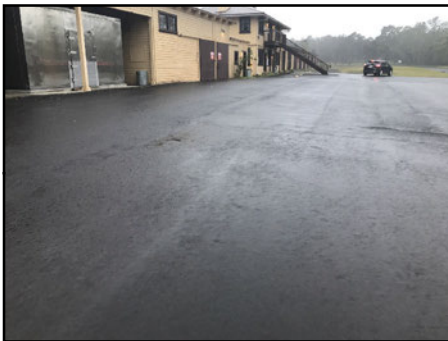
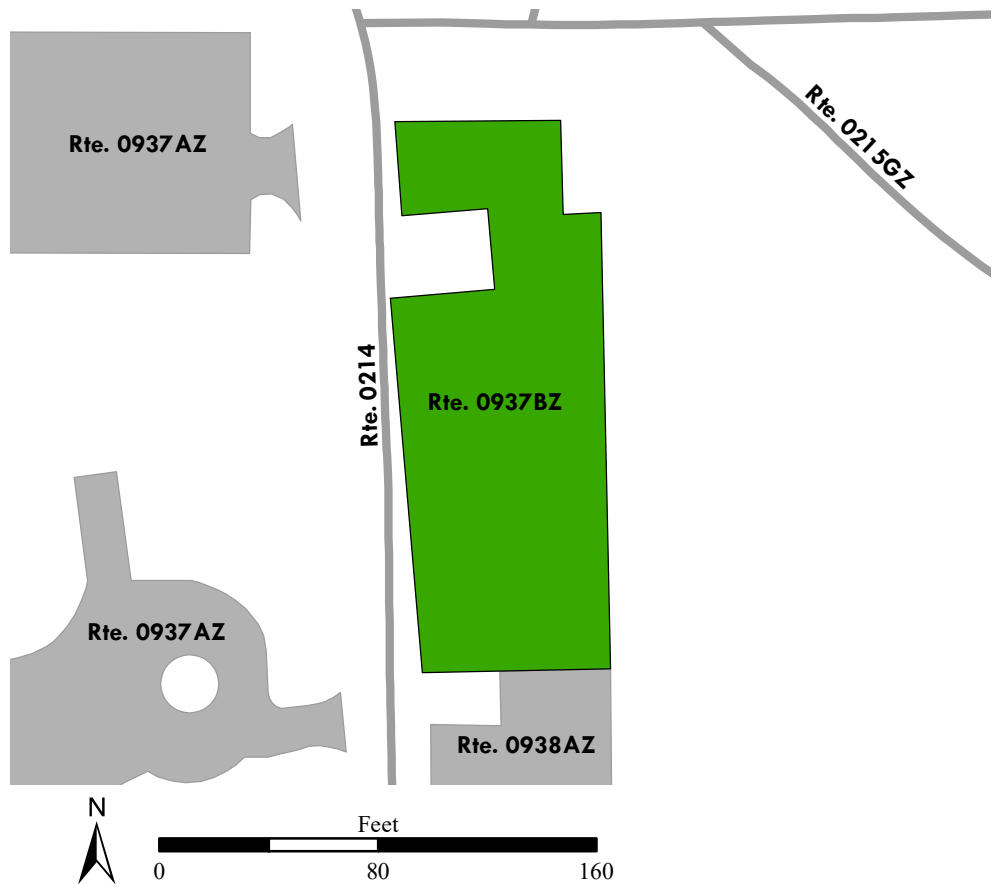
ROUTE 0937CZ: KILAUEA MILITARY CAMP C PARKING

Inspection Date	FMSS Number	User Access	Surface Type
3/8/2022	239125	PUBLIC	ASPHALT
Area (Sq. Ft.)	Lane Miles (11' Widths)	Curb Reveal (Inches)	Curb Recommendation
23,002	0.396	6	LIGHT REPAIR
Curb Type		Curb & Gutter Type	
STONE		NO CURB AND GUTTER	
Pavement Recommendation		Condition Rating / PCR	
PREVENTIVE MAINTENANCE		GOOD / 90

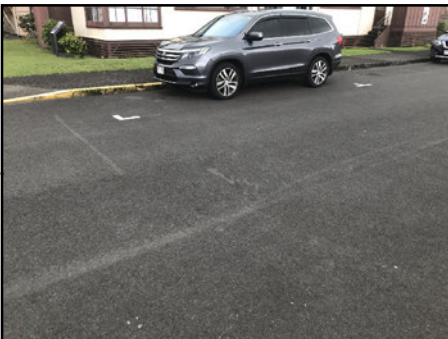
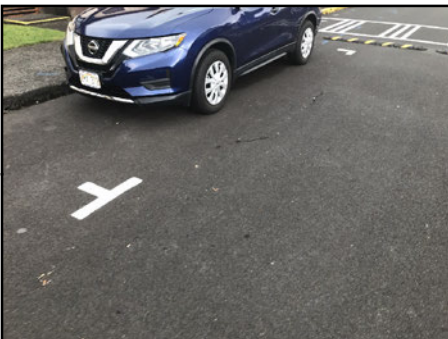
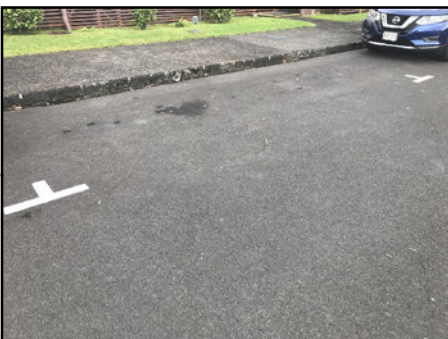
Inspection Date	FMSS Number	User Access	Surface Type
3/8/2022	239125	PUBLIC	ASPHALT
Area (Sq. Ft.)	Lane Miles (11' Widths)	Curb Reveal (Inches)	Curb Recommendation
476	0.008	7	LIGHT REPAIR
Curb Type		Curb & Gutter Type	
STONE		NO CURB AND GUTTER	
Pavement Recommendation		Condition Rating / PCR	
PREVENTIVE MAINTENANCE		GOOD / 90

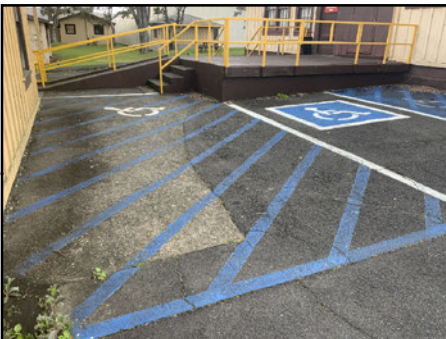
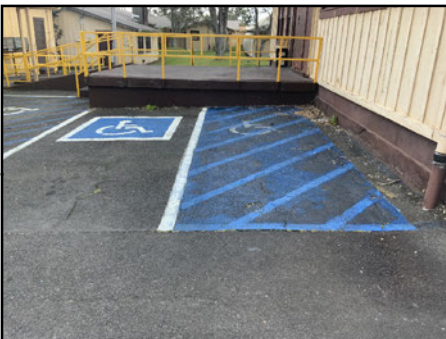
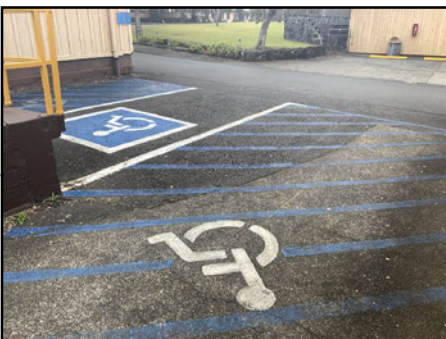
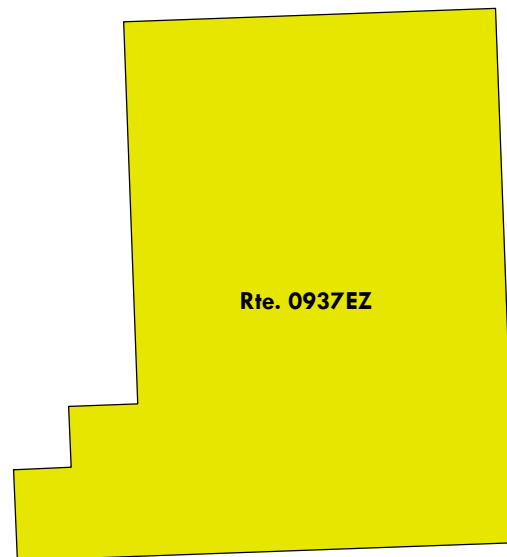
Inspection Date	FMSS Number	User Access	Surface Type
3/8/2022	239125	PUBLIC	ASPHALT
Area (Sq. Ft.)	Lane Miles (11' Widths)	Curb Reveal (Inches)	Curb Recommendation
566	0.01	NOT APPLICABLE	NOT APPLICABLE
Curb Type		Curb & Gutter Type	
NO CURB		NO CURB AND GUTTER	
Pavement Recommendation		Condition Rating / PCR	
LIGHT 3R TREATMENTS		FAIR / 73

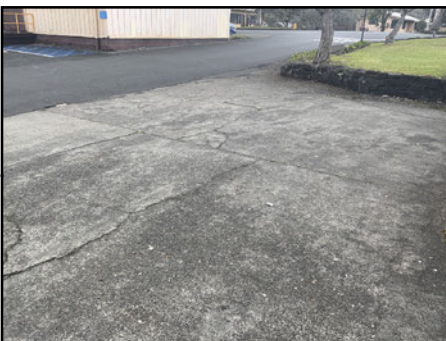
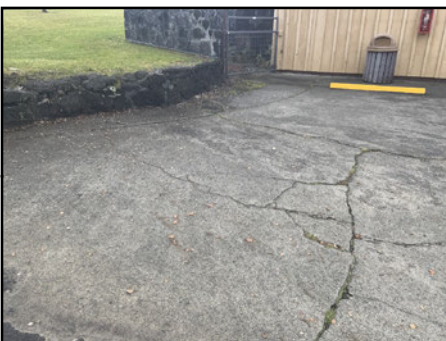
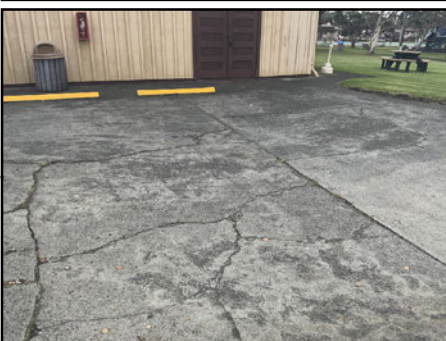
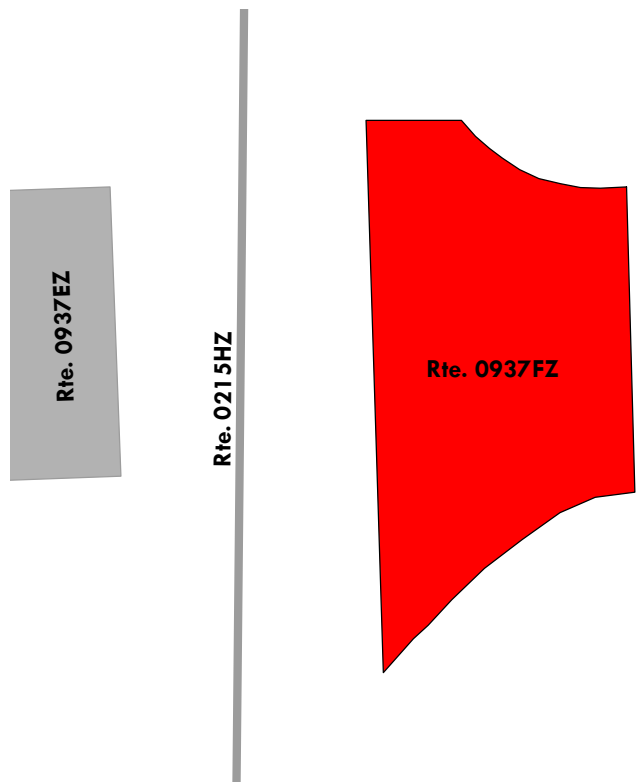
Inspection Date	FMSS Number	User Access	Surface Type
3/8/2022	239125	PUBLIC	CONCRETE
Area (Sq. Ft.)	Lane Miles (11' Widths)	Curb Reveal (Inches)	Curb Recommendation
943	0.016	5	REPLACE
Curb Type		Curb & Gutter Type	
STONE		NO CURB AND GUTTER	
Pavement Recommendation		Condition Rating / PCR	
RECONSTRUCTION		POOR / 30

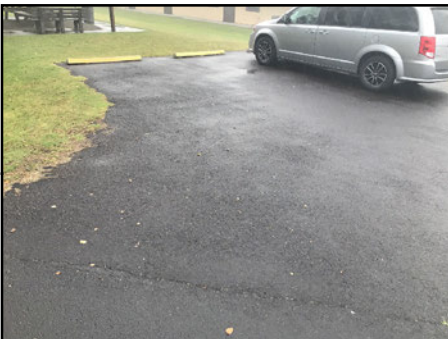
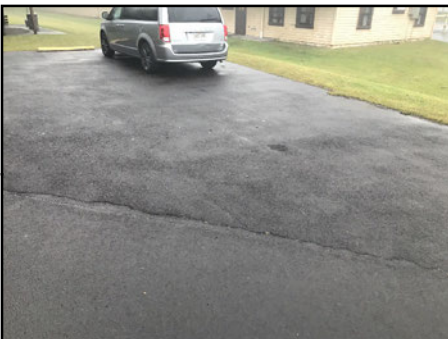
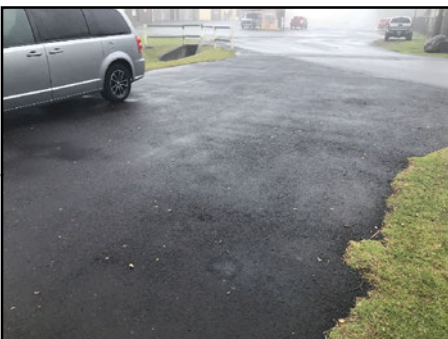
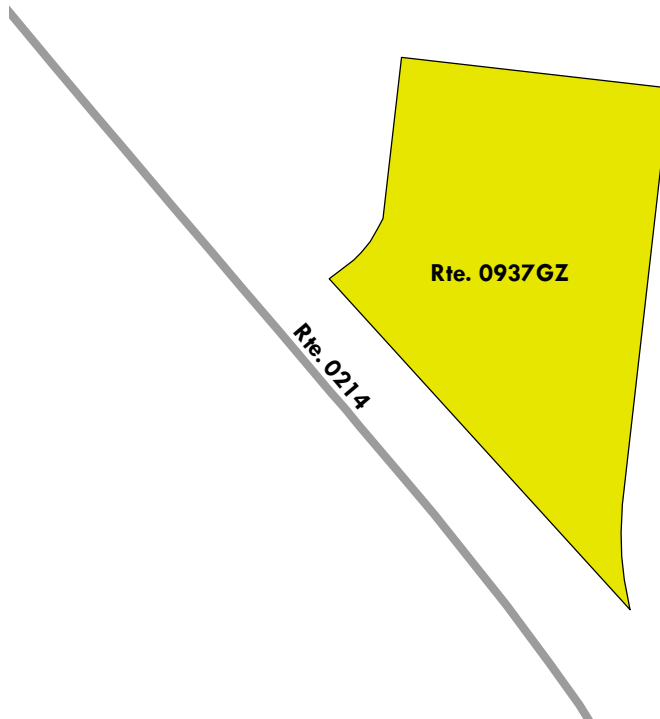
Inspection Date	FMSS Number	User Access	Surface Type
3/8/2022	239125	PUBLIC	ASPHALT
Area (Sq. Ft.)	Lane Miles (11' Widths)	Curb Reveal (Inches)	Curb Recommendation
1,136	0.02	NOT APPLICABLE	NOT APPLICABLE
Curb Type		Curb & Gutter Type	
NO CURB		NO CURB AND GUTTER	
Pavement Recommendation		Condition Rating / PCR	
LIGHT 3R TREATMENTS		FAIR / 73

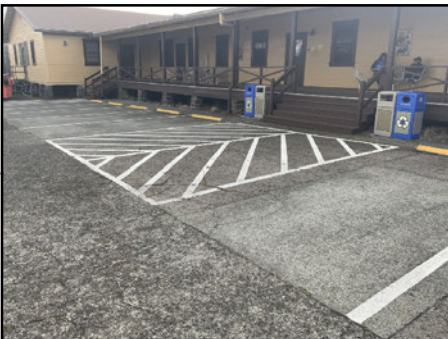
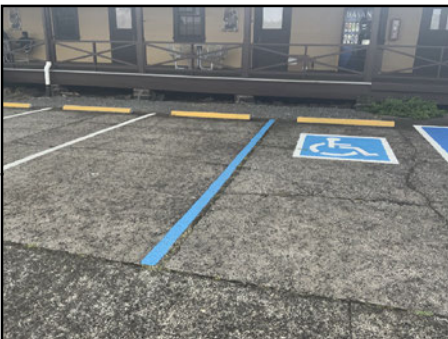
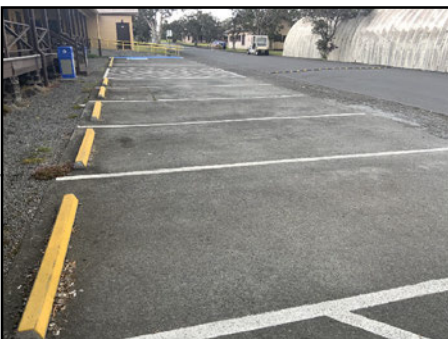
Inspection Date	FMSS Number	User Access	Surface Type
3/8/2022	239125	PUBLIC	CONCRETE
Area (Sq. Ft.)	Lane Miles (11' Widths)	Curb Reveal (Inches)	Curb Recommendation
2,549	0.044	NOT APPLICABLE	NOT APPLICABLE
Curb Type		Curb & Gutter Type	
NO CURB		NO CURB AND GUTTER	
Pavement Recommendation		Condition Rating / PCR	
HEAVY 3R TREATMENTS		POOR / 53

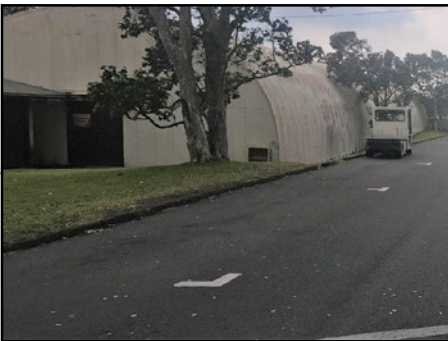
Inspection Date	FMSS Number	User Access	Surface Type
3/8/2022	239125	PUBLIC	ASPHALT
Area (Sq. Ft.)	Lane Miles (11' Widths)	Curb Reveal (Inches)	Curb Recommendation
322	0.006	5	LIGHT REPAIR
Curb Type		Curb & Gutter Type	
STONE		NO CURB AND GUTTER	
Pavement Recommendation		Condition Rating / PCR	
PREVENTIVE MAINTENANCE		GOOD / 90
