Road Inventory and Condition Assessment of Paved Routes Hawaii Volcanoes National Park

**Federal Lands Highway
Road Inventory Program**

**Federal Highway Administration
Eastern Federal Lands Highway Division
Road Inventory Program (RIP)**

Report Date: December 2022

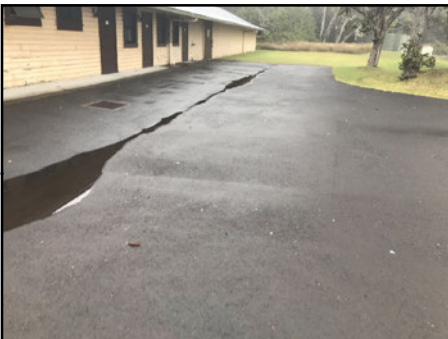
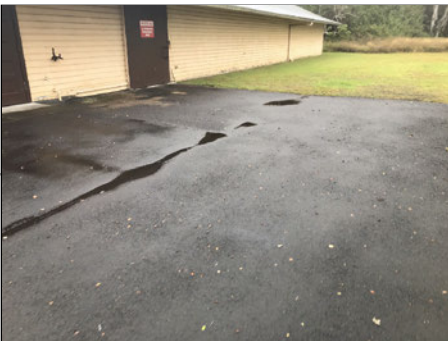
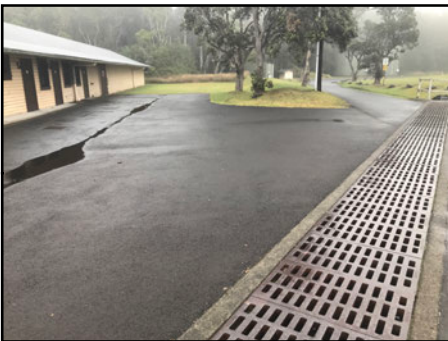
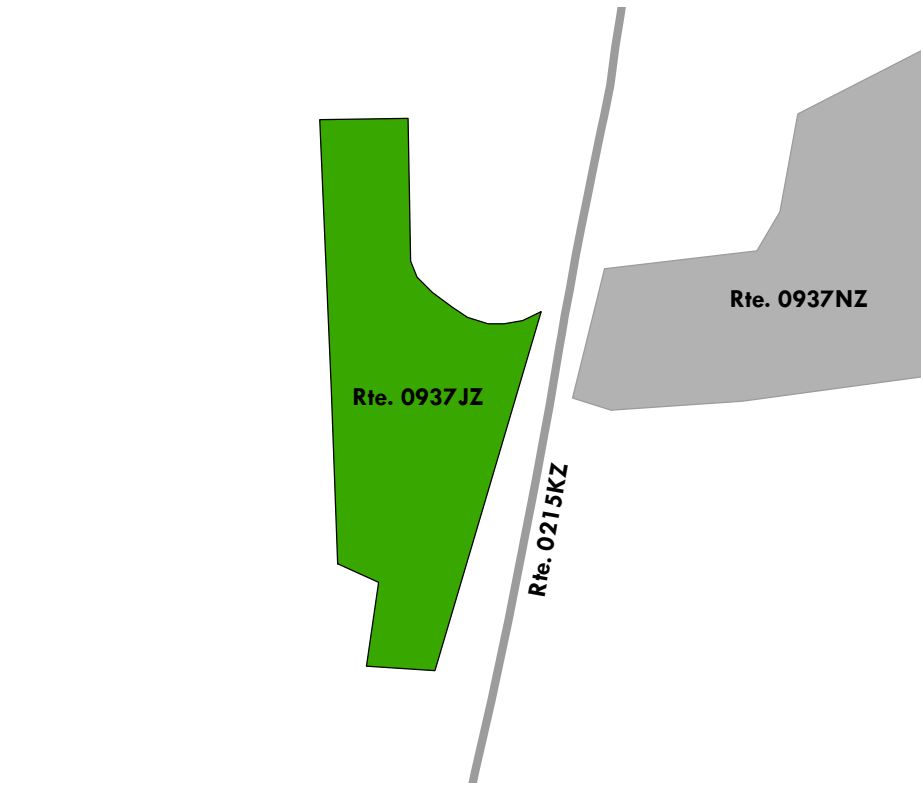
Inspection Date	FMSS Number	User Access	Surface Type
3/8/2022	239125	PUBLIC	ASPHALT
Area (Sq. Ft.)	Lane Miles (11' Widths)	Curb Reveal (Inches)	Curb Recommendation
3,513	0.06	NOT APPLICABLE	NOT APPLICABLE
Curb Type		Curb & Gutter Type	
NO CURB		NO CURB AND GUTTER	
Pavement Recommendation		Condition Rating / PCR	
PREVENTIVE MAINTENANCE		GOOD / 90

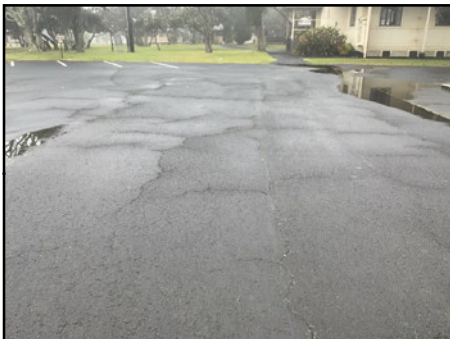
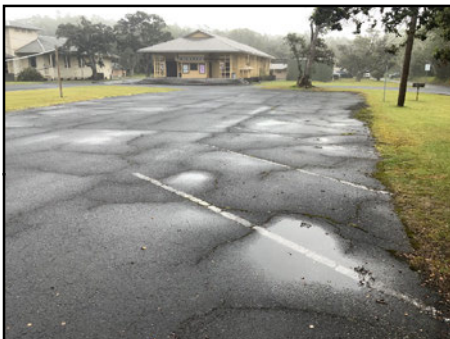
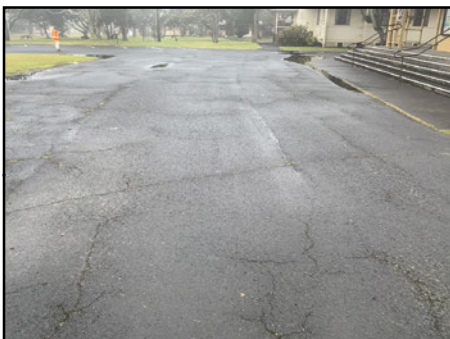
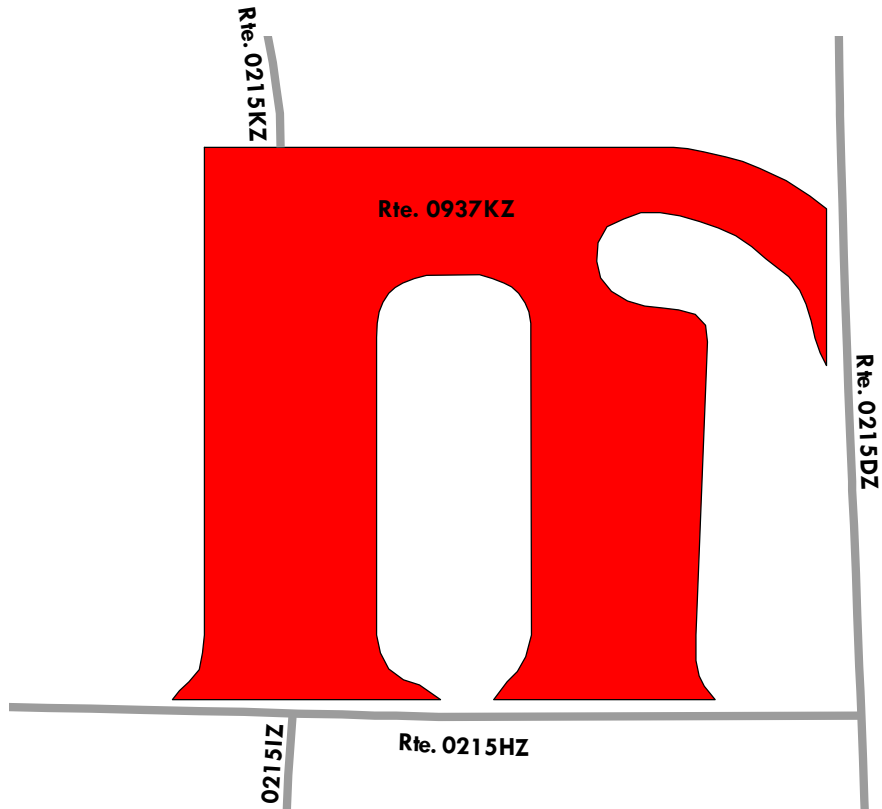
Inspection Date	FMSS Number	User Access	Surface Type
3/8/2022	239125	PUBLIC	ASPHALT
Area (Sq. Ft.)	Lane Miles (11' Widths)	Curb Reveal (Inches)	Curb Recommendation
14,942	0.257	NOT APPLICABLE	NOT APPLICABLE
Curb Type		Curb & Gutter Type	
NO CURB		NO CURB AND GUTTER	
Pavement Recommendation		Condition Rating / PCR	
HEAVY 3R TREATMENTS		POOR / 53

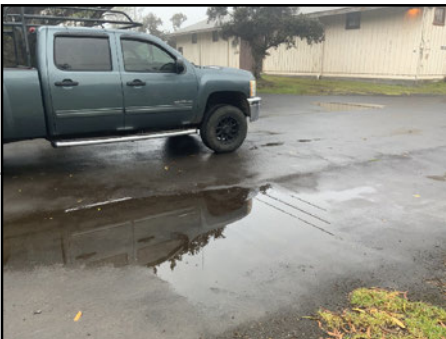
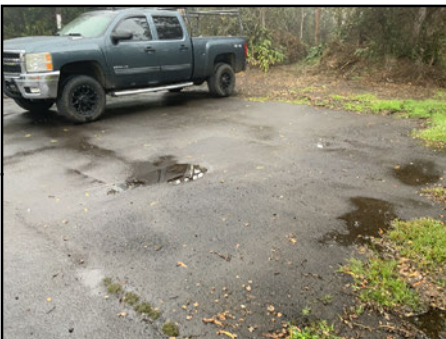
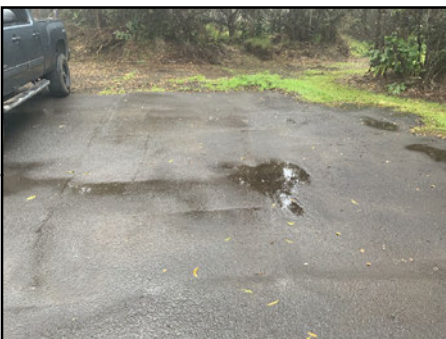
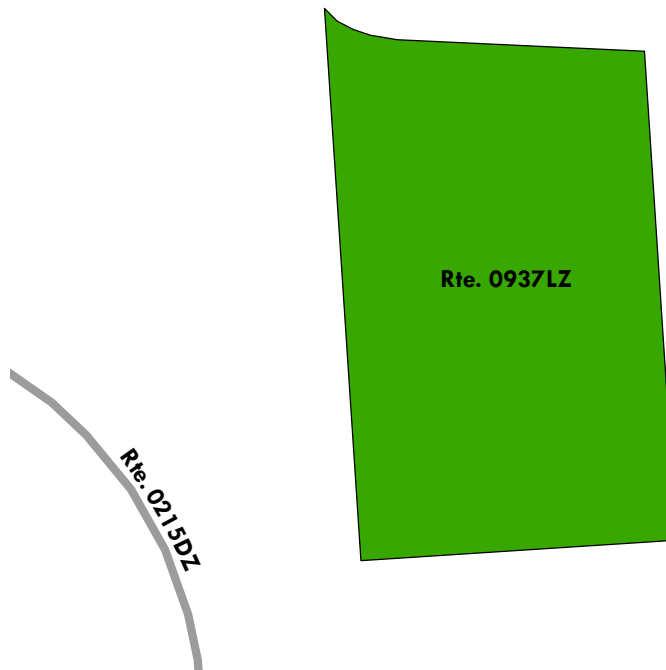
Inspection Date	FMSS Number	User Access	Surface Type
3/8/2022	239125	PUBLIC	ASPHALT
Area (Sq. Ft.)	Lane Miles (11' Widths)	Curb Reveal (Inches)	Curb Recommendation
1,033	0.018	NOT APPLICABLE	NOT APPLICABLE
Curb Type		Curb & Gutter Type	
NO CURB		NO CURB AND GUTTER	
Pavement Recommendation		Condition Rating / PCR	
PREVENTIVE MAINTENANCE		GOOD / 90

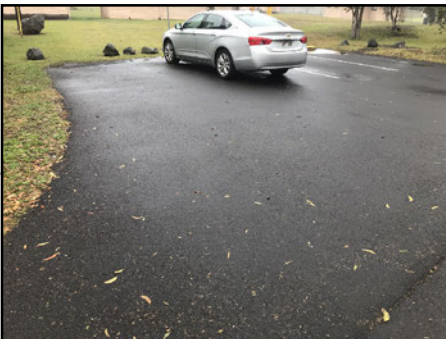
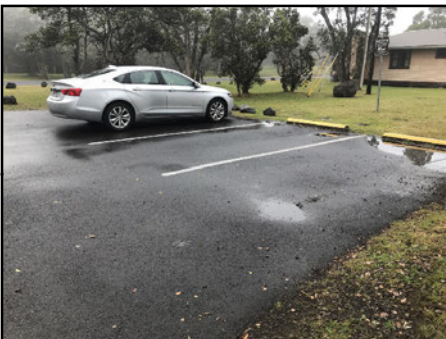
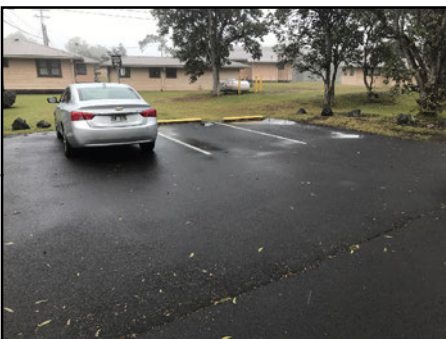
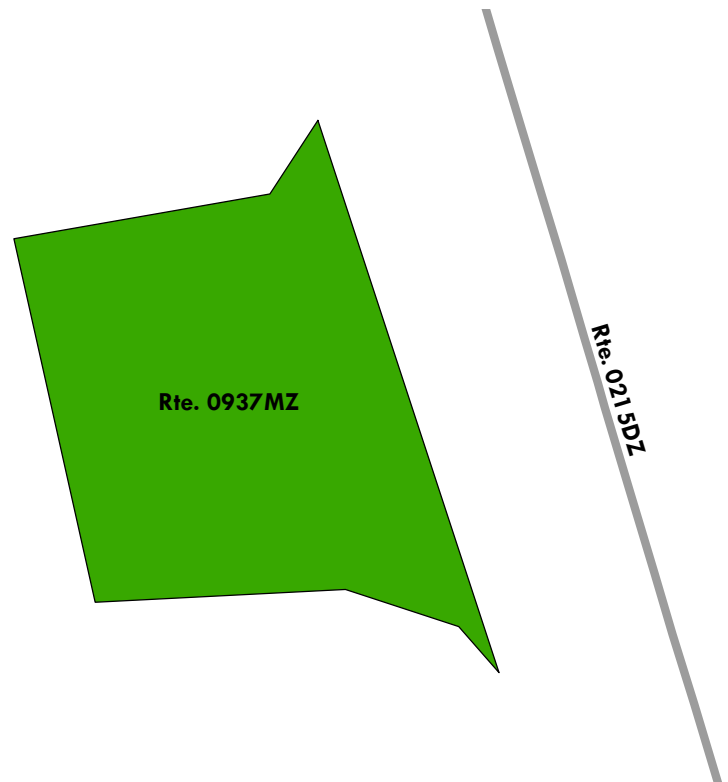
Inspection Date	FMSS Number	User Access	Surface Type
3/8/2022	239125	PUBLIC	ASPHALT
Area (Sq. Ft.)	Lane Miles (11' Widths)	Curb Reveal (Inches)	Curb Recommendation
1,411	0.024	NOT APPLICABLE	NOT APPLICABLE
Curb Type		Curb & Gutter Type	
NO CURB		NO CURB AND GUTTER	
Pavement Recommendation		Condition Rating / PCR	
PREVENTIVE MAINTENANCE		GOOD / 90

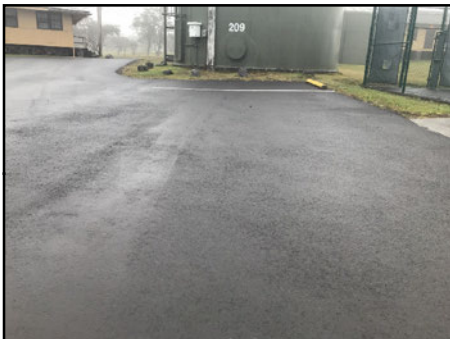
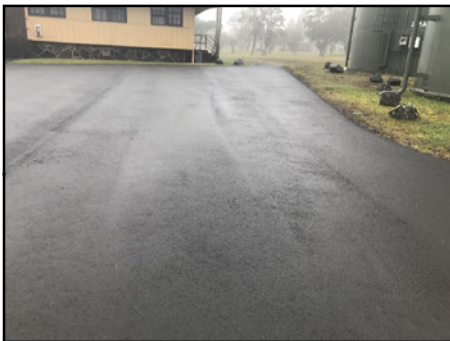
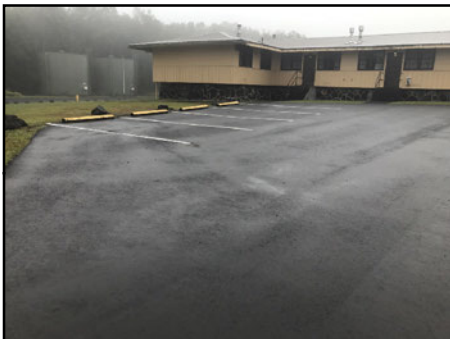
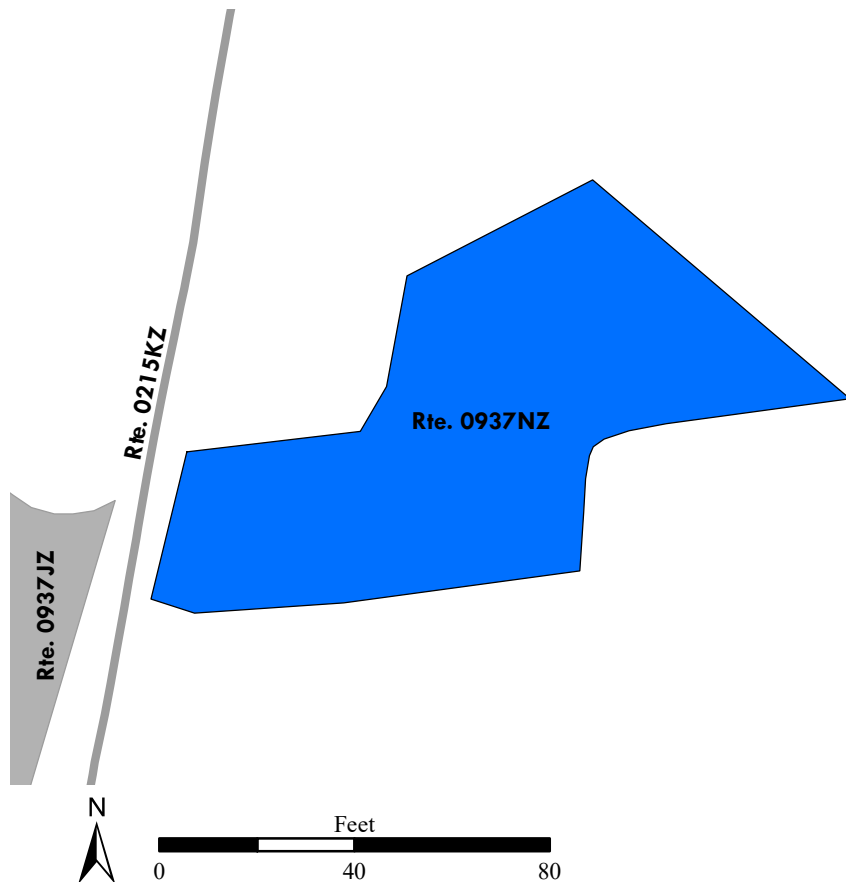
Inspection Date	FMSS Number	User Access	Surface Type
3/8/2022	239125	PUBLIC	ASPHALT
Area (Sq. Ft.)	Lane Miles (11' Widths)	Curb Reveal (Inches)	Curb Recommendation
5,527	0.095	NOT APPLICABLE	NOT APPLICABLE
Curb Type		Curb & Gutter Type	
NO CURB		NO CURB AND GUTTER	
Pavement Recommendation		Condition Rating / PCR	
DO NOTHING		EXCELLENT / 97

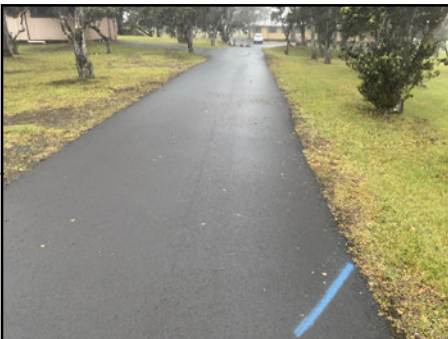
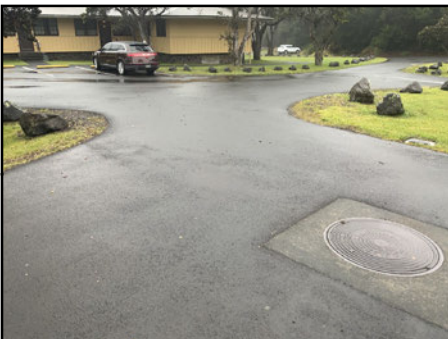
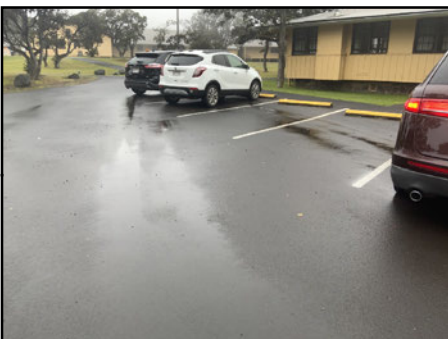
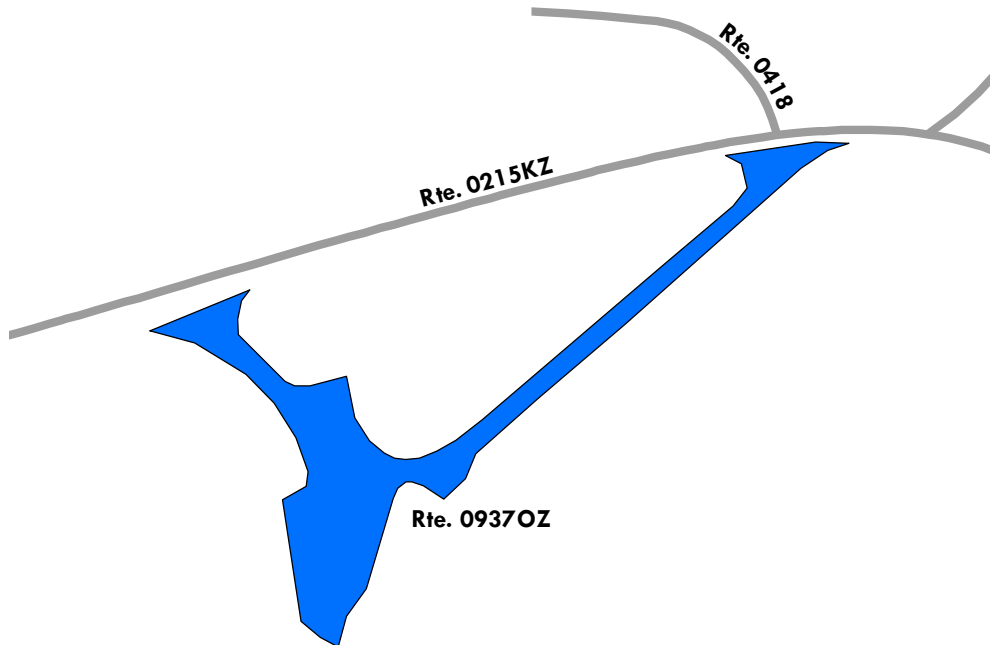
ROUTE 0937OZ: KILAUEA MILITARY CAMP O PARKING

Inspection Date	FMSS Number	User Access	Surface Type
3/8/2022	239125	PUBLIC	ASPHALT
Area (Sq. Ft.)	Lane Miles (11' Widths)	Curb Reveal (Inches)	Curb Recommendation
8,661	0.149	NOT APPLICABLE	NOT APPLICABLE
Curb Type		Curb & Gutter Type	
NO CURB		NO CURB AND GUTTER	
Pavement Recommendation		Condition Rating / PCR	
DO NOTHING		EXCELLENT / 97

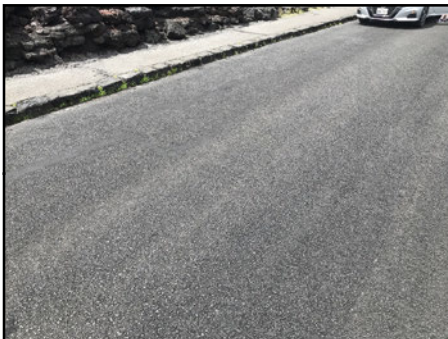
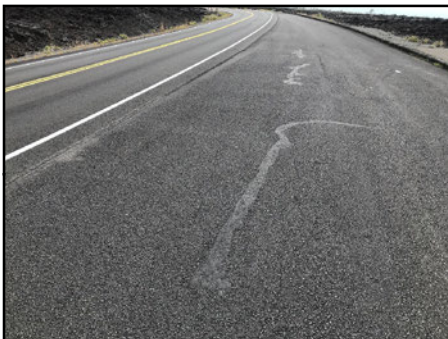
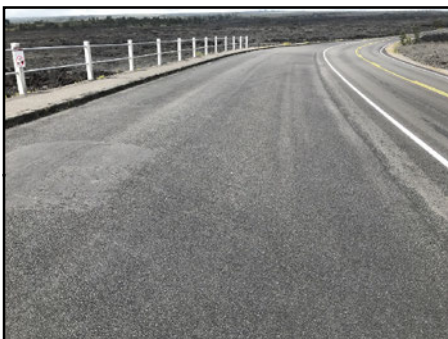
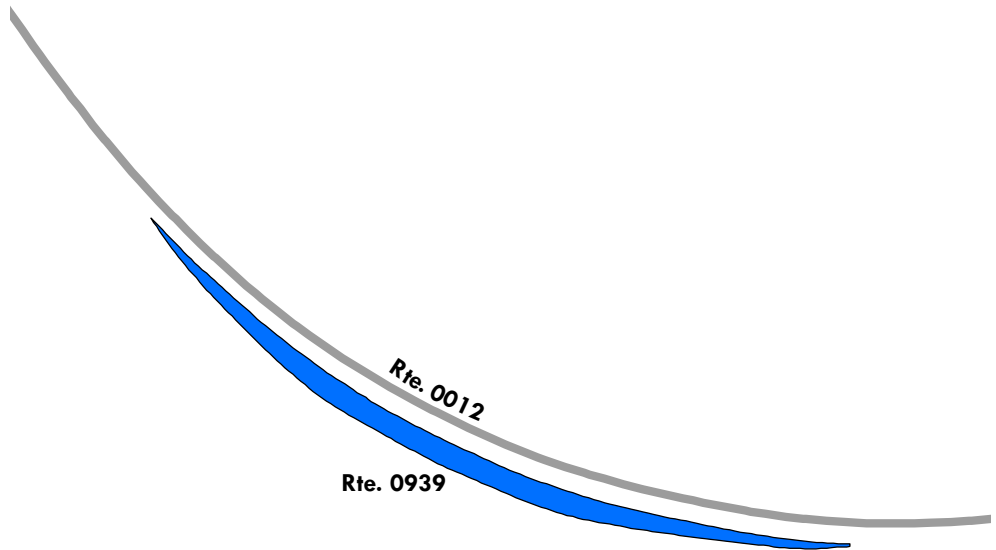
ROUTE 0939: MULAWAI A PELE TRAILHEAD PARKING

Inspection Date	FMSS Number	User Access	Surface Type
3/8/2022	240234	PUBLIC	ASPHALT
Area (Sq. Ft.)	Lane Miles (11' Widths)	Curb Reveal (Inches)	Curb Recommendation
13,055	0.225	6	DO NOTHING
Curb Type		Curb & Gutter Type	
STONE		NO CURB AND GUTTER	
Pavement Recommendation		Condition Rating / PCR	
DO NOTHING		EXCELLENT / 97

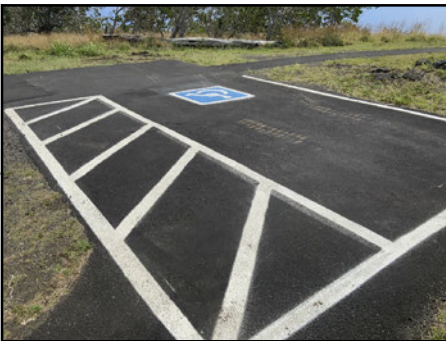
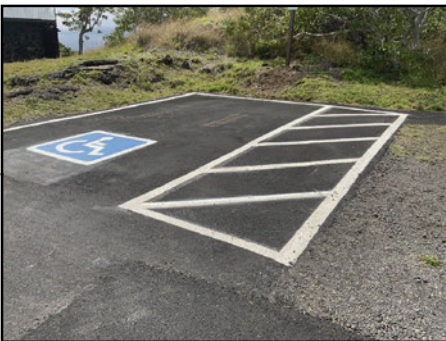
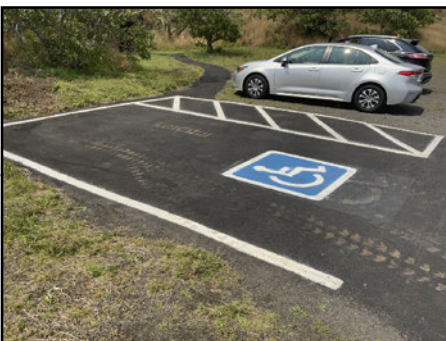
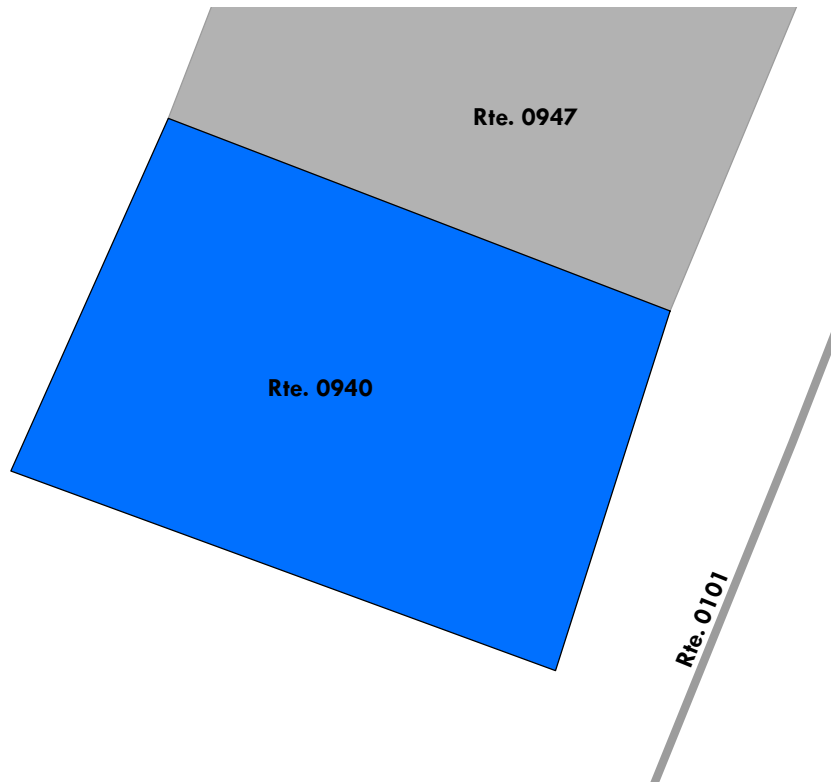
ROUTE 0940: HILINA PALI HANDICAP OVERLOOK PARKING

Inspection Date	FMSS Number	User Access	Surface Type
3/8/2022	240235	PUBLIC	ASPHALT
Area (Sq. Ft.)	Lane Miles (11' Widths)	Curb Reveal (Inches)	Curb Recommendation
406	0.007	NOT APPLICABLE	NOT APPLICABLE
Curb Type		Curb & Gutter Type	
NO CURB		NO CURB AND GUTTER	
Pavement Recommendation		Condition Rating / PCR	
DO NOTHING		EXCELLENT / 97

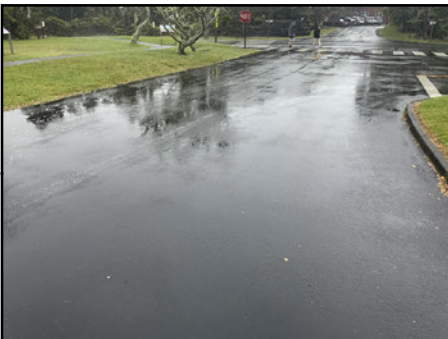
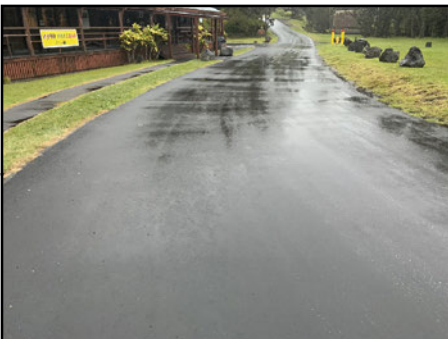
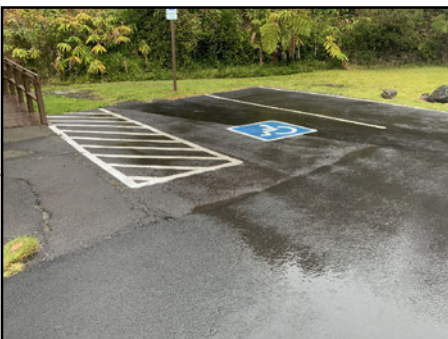
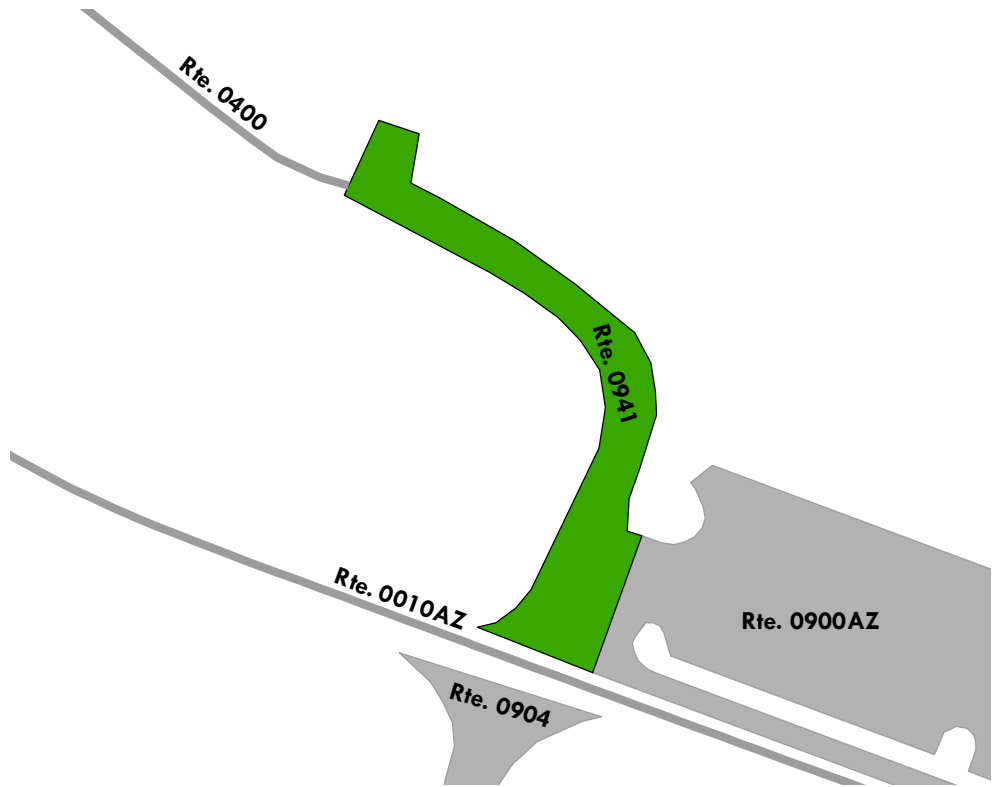
ROUTE 0941: VOLCANO ART CENTER PARKING

Inspection Date	FMSS Number	User Access	Surface Type
3/8/2022	240236	PUBLIC	ASPHALT
Area (Sq. Ft.)	Lane Miles (11' Widths)	Curb Reveal (Inches)	Curb Recommendation
7,440	0.128	5	DO NOTHING
Curb Type		Curb & Gutter Type	
STONE		NO CURB AND GUTTER	
Pavement Recommendation		Condition Rating / PCR	
PREVENTIVE MAINTENANCE		GOOD / 90

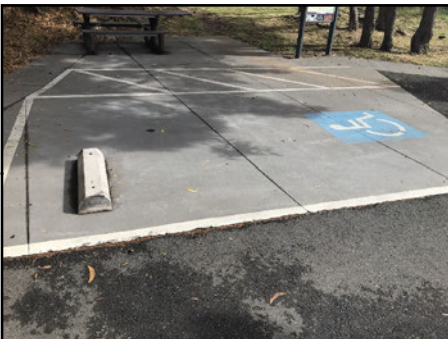
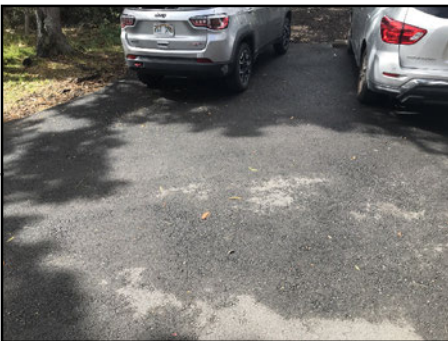
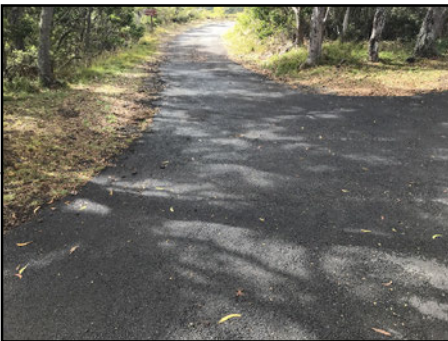
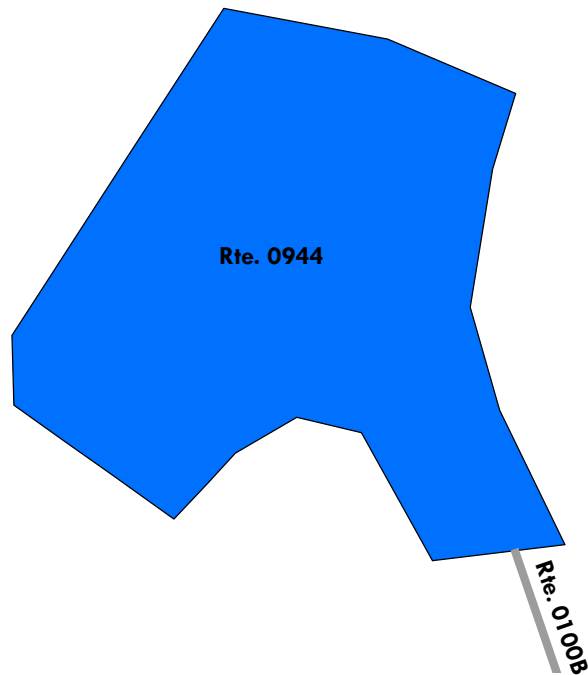
ROUTE 0944: MAUNA LOA LOOKOUT PARKING

Inspection Date	FMSS Number	User Access	Surface Type
3/8/2022	240231	PUBLIC	ASPHALT
Area (Sq. Ft.)	Lane Miles (11' Widths)	Curb Reveal (Inches)	Curb Recommendation
3,468	0.06	NOT APPLICABLE	NOT APPLICABLE
Curb Type		Curb & Gutter Type	
NO CURB		NO CURB AND GUTTER	
Pavement Recommendation		Condition Rating / PCR	
DO NOTHING		EXCELLENT / 97

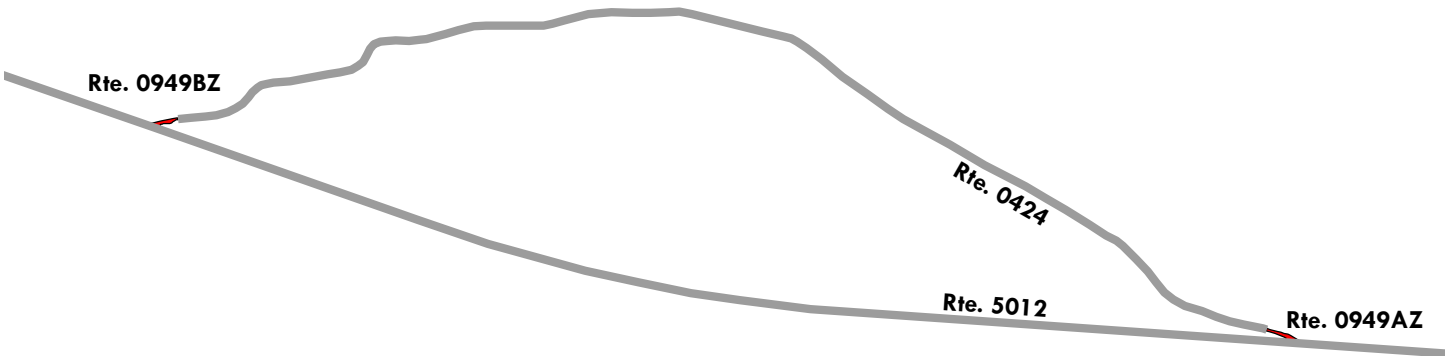
Route 0949ZZ
(2 Subcomponents)

Inspection Date	FMSS Number	User Access	Surface Type
3/8/2022	256423	PUBLIC	ASPHALT
Area (Sq. Ft.)	Lane Miles (11' Widths)	Condition Rating / PCR	
3,162	0.054	SUMMARY / 0

The condition shown on this page reflects the overall route condition and may not reflect individual subcomponent ratings.

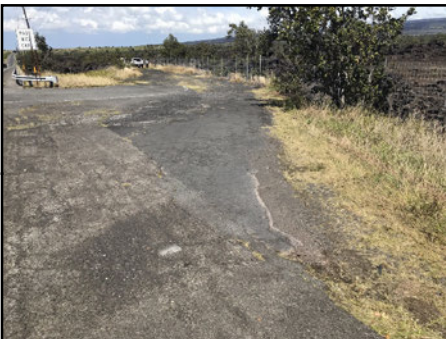
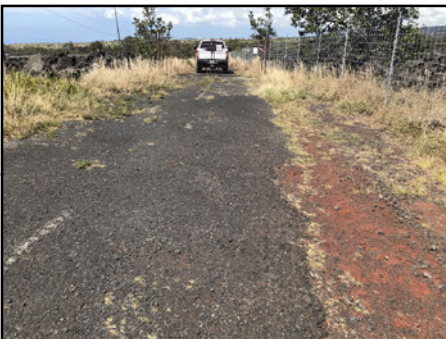
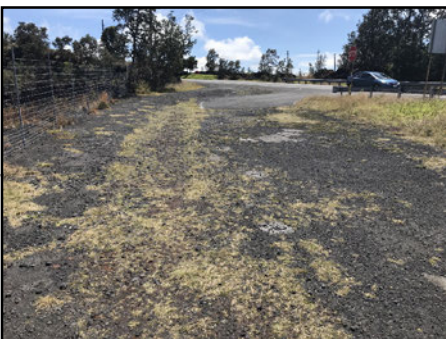
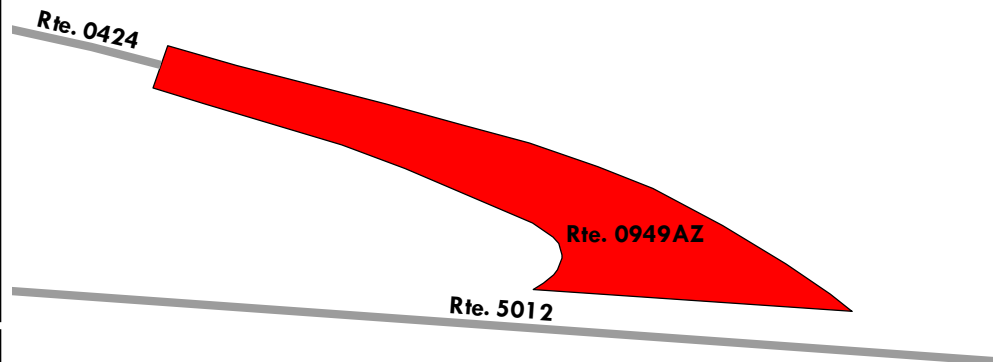
ROUTE 0949AZ: KAHUKU OLD MAMALAHOA HIGHWAY PARKING SOUTH

Inspection Date	FMSS Number	User Access	Surface Type
3/8/2022	256423	PUBLIC	ASPHALT
Area (Sq. Ft.)	Lane Miles (11' Widths)	Curb Reveal (Inches)	Curb Recommendation
1,698	0.029	NOT APPLICABLE	NOT APPLICABLE
Curb Type		Curb & Gutter Type	
NO CURB		NO CURB AND GUTTER	
Pavement Recommendation		Condition Rating / PCR	
RECONSTRUCTION		POOR / 0

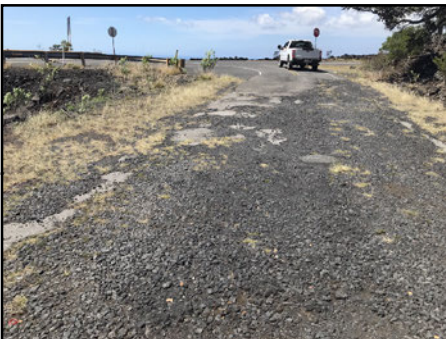
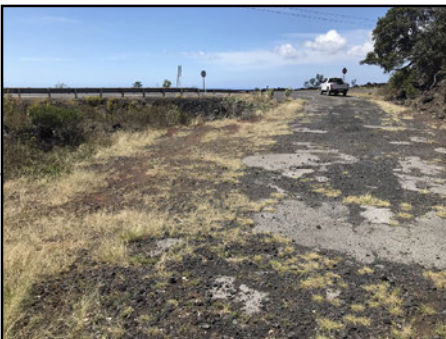
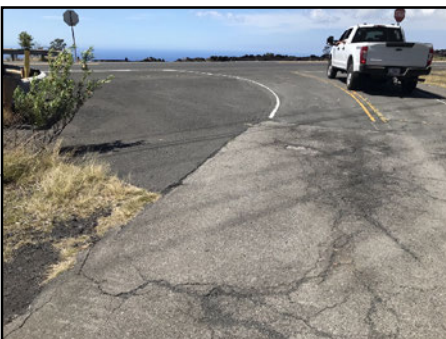
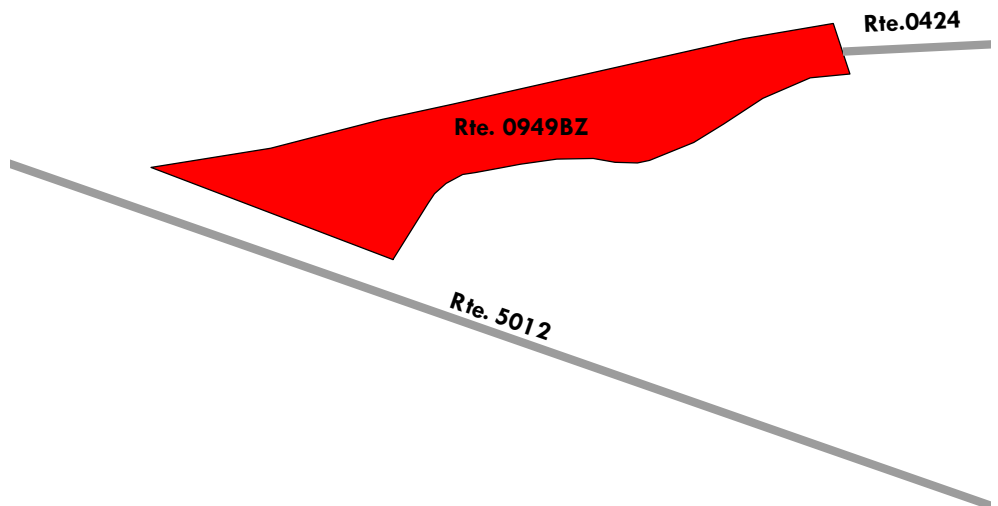
ROUTE 0949BZ: KAHUKU OLD MAMALAHOA HIGHWAY PARKING NORTH

Inspection Date	FMSS Number	User Access	Surface Type
3/8/2022	256423	PUBLIC	ASPHALT
Area (Sq. Ft.)	Lane Miles (11' Widths)	Curb Reveal (Inches)	Curb Recommendation
1,464	0.025	NOT APPLICABLE	NOT APPLICABLE
Curb Type		Curb & Gutter Type	
NO CURB		NO CURB AND GUTTER	
Pavement Recommendation		Condition Rating / PCR	
RECONSTRUCTION		POOR / 0

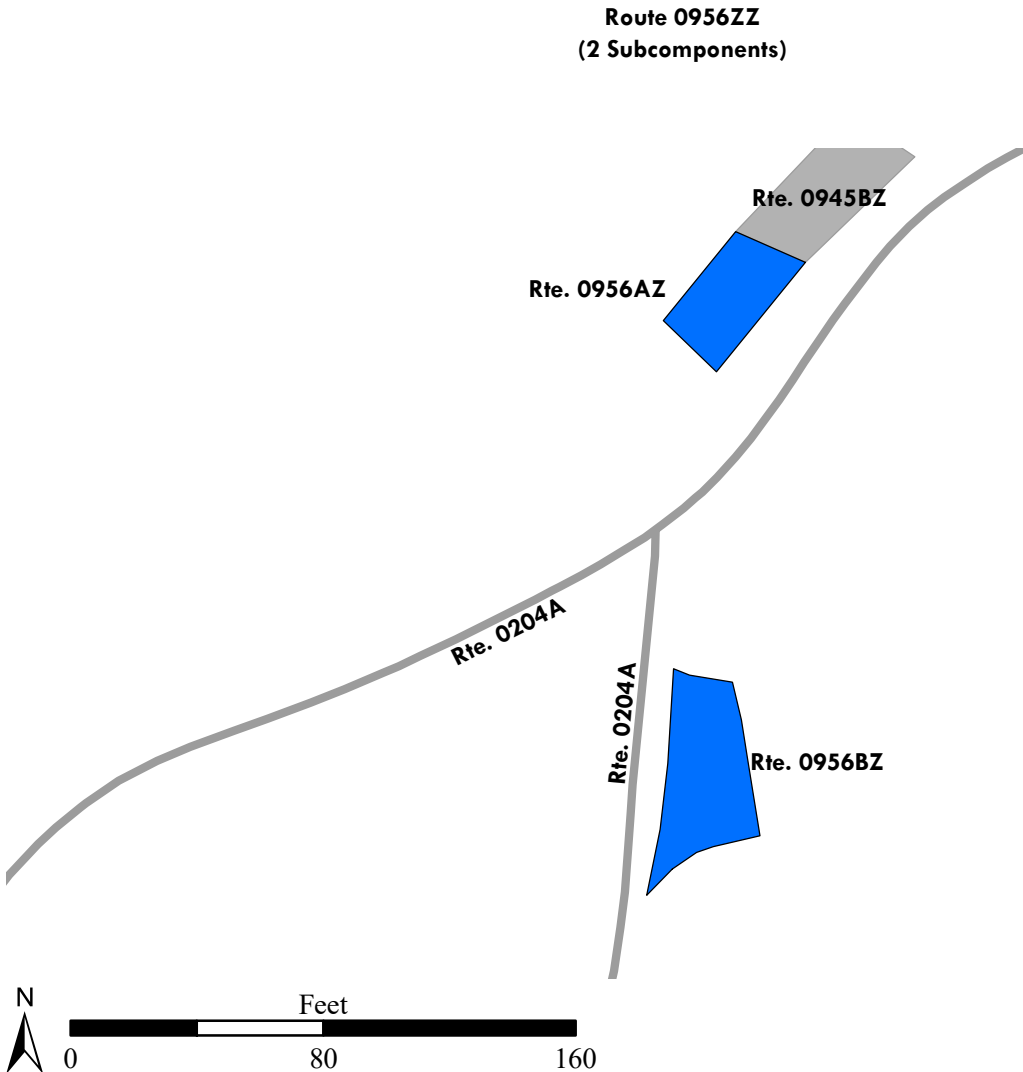
ROUTE 0956ZZ: NAMAKANI PAIO CAMPGROUND PAVED PARKING

Inspection Date	FMSS Number	User Access	Surface Type
3/8/2022	N/A	PUBLIC	ASPHALT
Area (Sq. Ft.)	Lane Miles (11' Widths)	Condition Rating / PCR	
2,257	0.039	SUMMARY / 97

The condition shown on this page reflects the overall route condition and may not reflect individual subcomponent ratings.

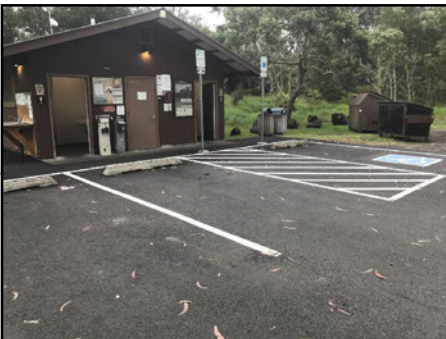
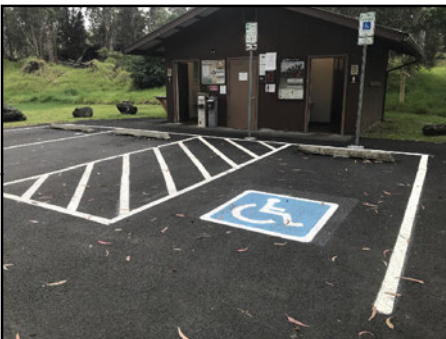
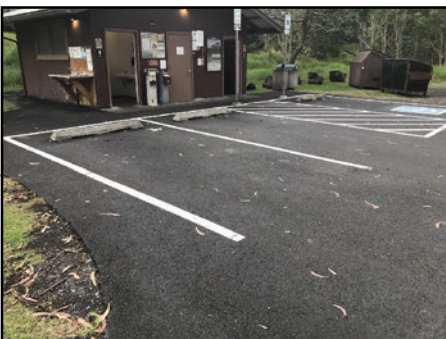
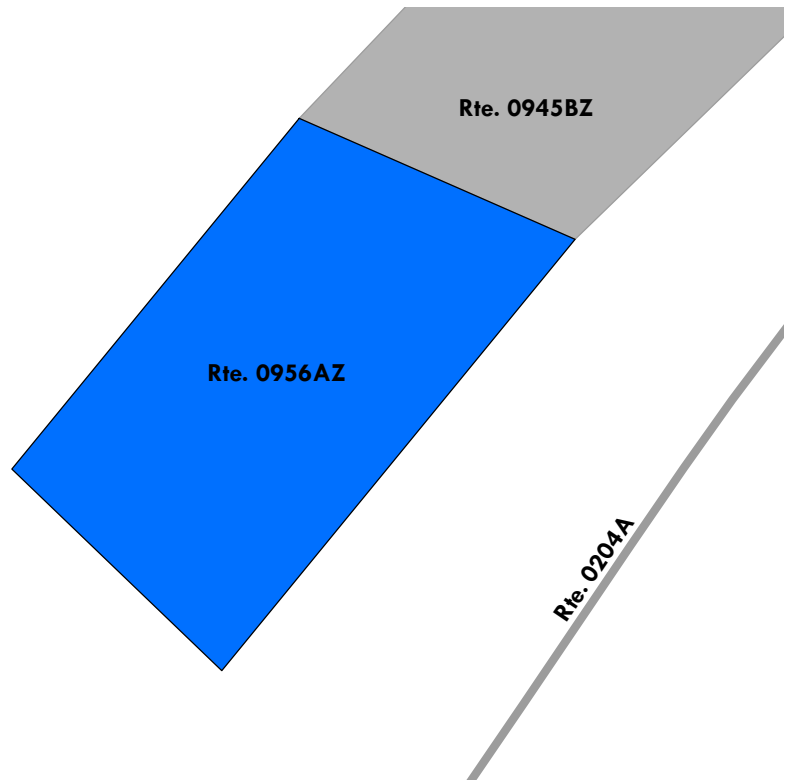
ROUTE 0956AZ: NAMAKANI PAIO CAMPGROUND RESTROOM PARKING

Inspection Date	FMSS Number	User Access	Surface Type
3/8/2022	N/A	PUBLIC	ASPHALT
Area (Sq. Ft.)	Lane Miles (11' Widths)	Curb Reveal (Inches)	Curb Recommendation
884	0.015	NOT APPLICABLE	NOT APPLICABLE
Curb Type		Curb & Gutter Type	
NO CURB		NO CURB AND GUTTER	
Pavement Recommendation		Condition Rating / PCR	
DO NOTHING		EXCELLENT / 97

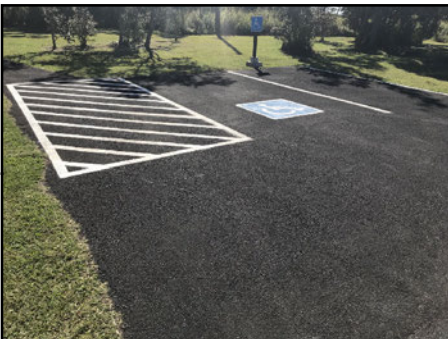
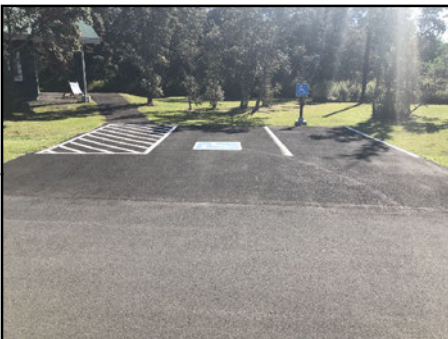
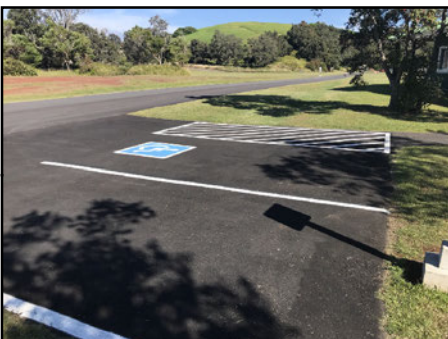
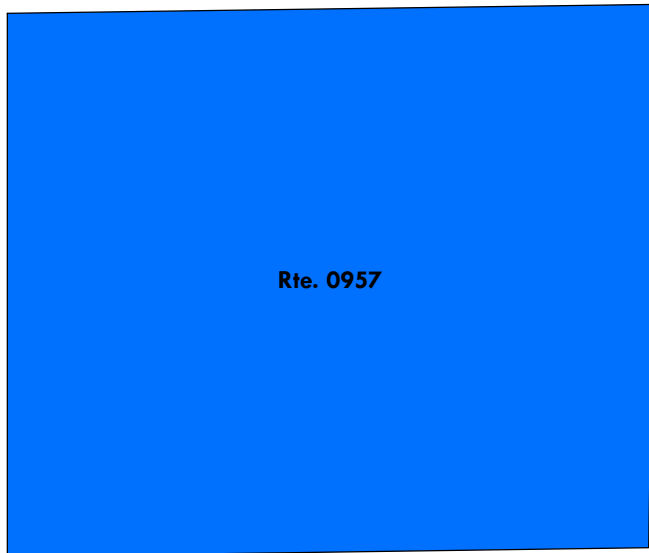
ROUTE 0957: KAHUKU VISTOR CENTER HANDICAP PARKING

Inspection Date	FMSS Number	User Access	Surface Type
3/8/2022	N/A	PUBLIC	ASPHALT
Area (Sq. Ft.)	Lane Miles (11' Widths)	Curb Reveal (Inches)	Curb Recommendation
786	0.014	NOT APPLICABLE	NOT APPLICABLE
Curb Type		Curb & Gutter Type	
NO CURB		NO CURB AND GUTTER	
Pavement Recommendation		Condition Rating / PCR	
DO NOTHING		EXCELLENT / 97
