JELA Cycle 6

Final Report

Road Inventory and Condition Assessment of Paved Routes Jean Lafitte National Historical Park and Preserve

**Federal Lands Highway
Road Inventory Program**

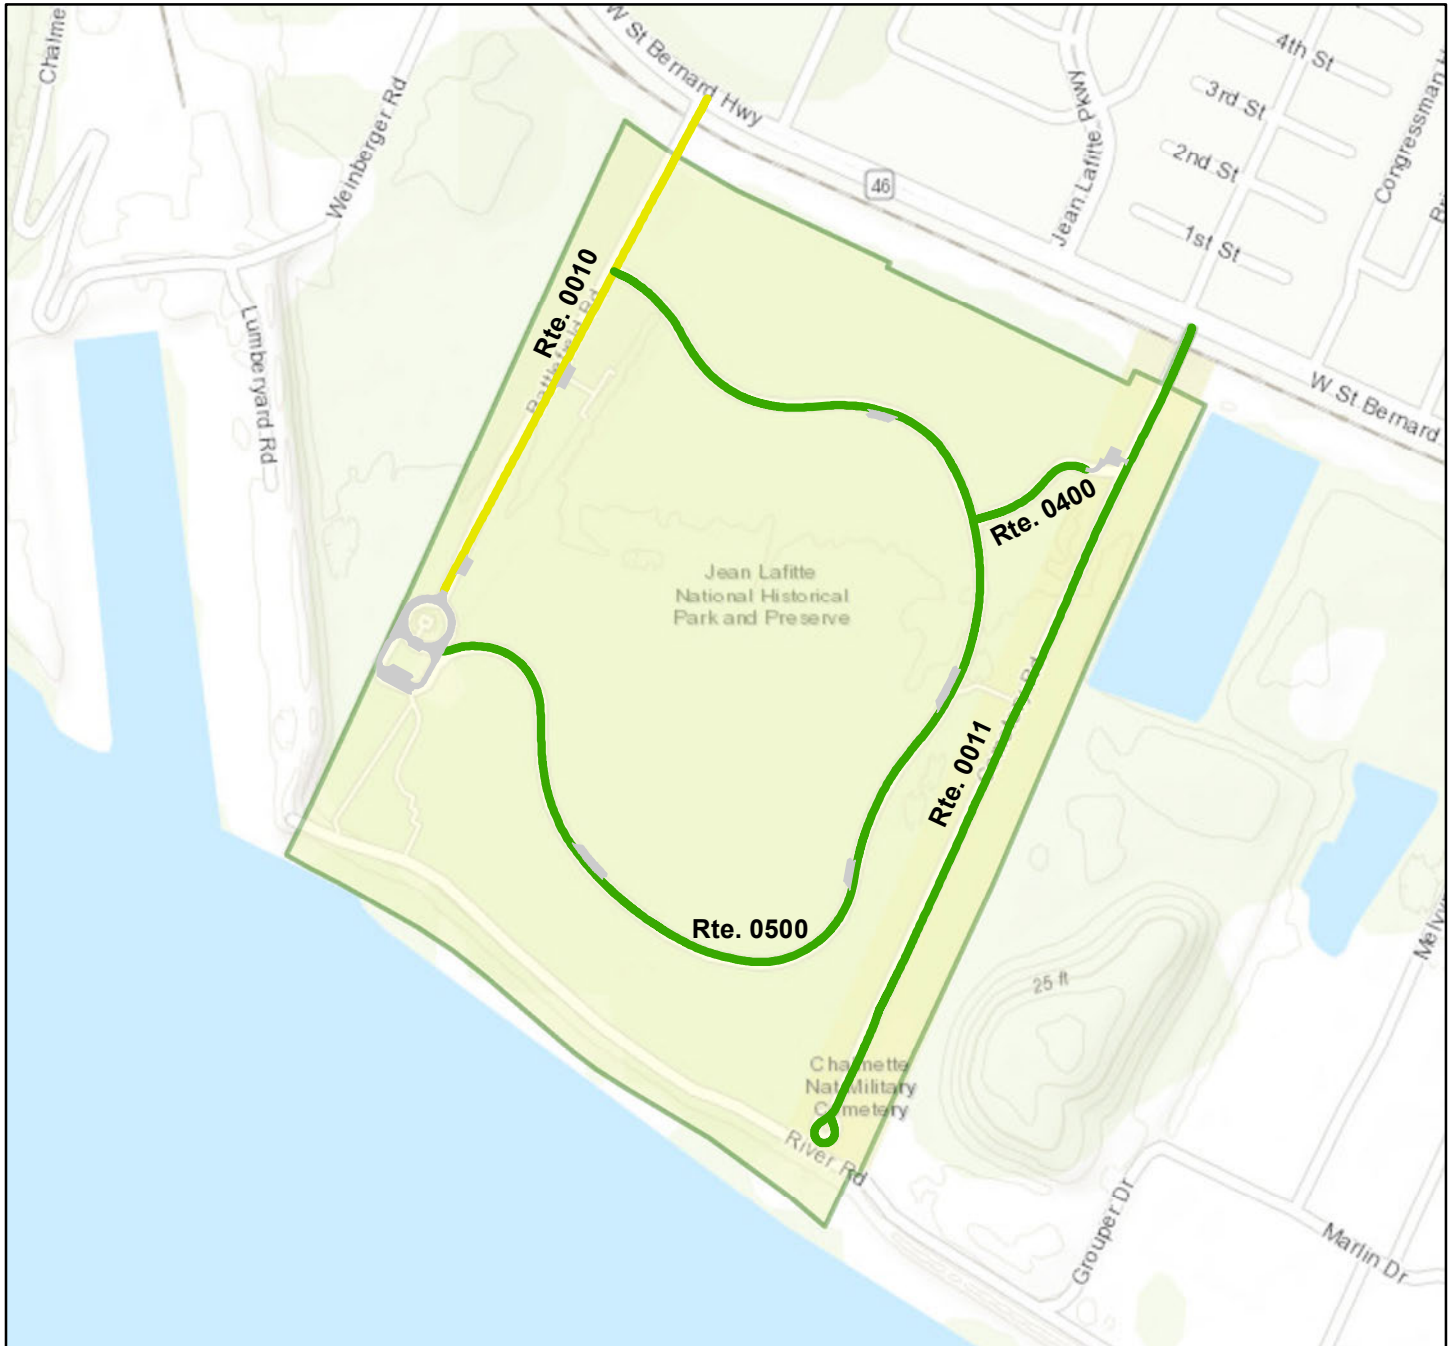
ROUTE CONDITION MAP

PCR - MILE BY MILE

Area Map 5

Colors on map represent condition scores at 1-mile intervals. See Appendix for definitions and formulas
Only Data Collection Vehicle and Manually Rated Roads are displayed

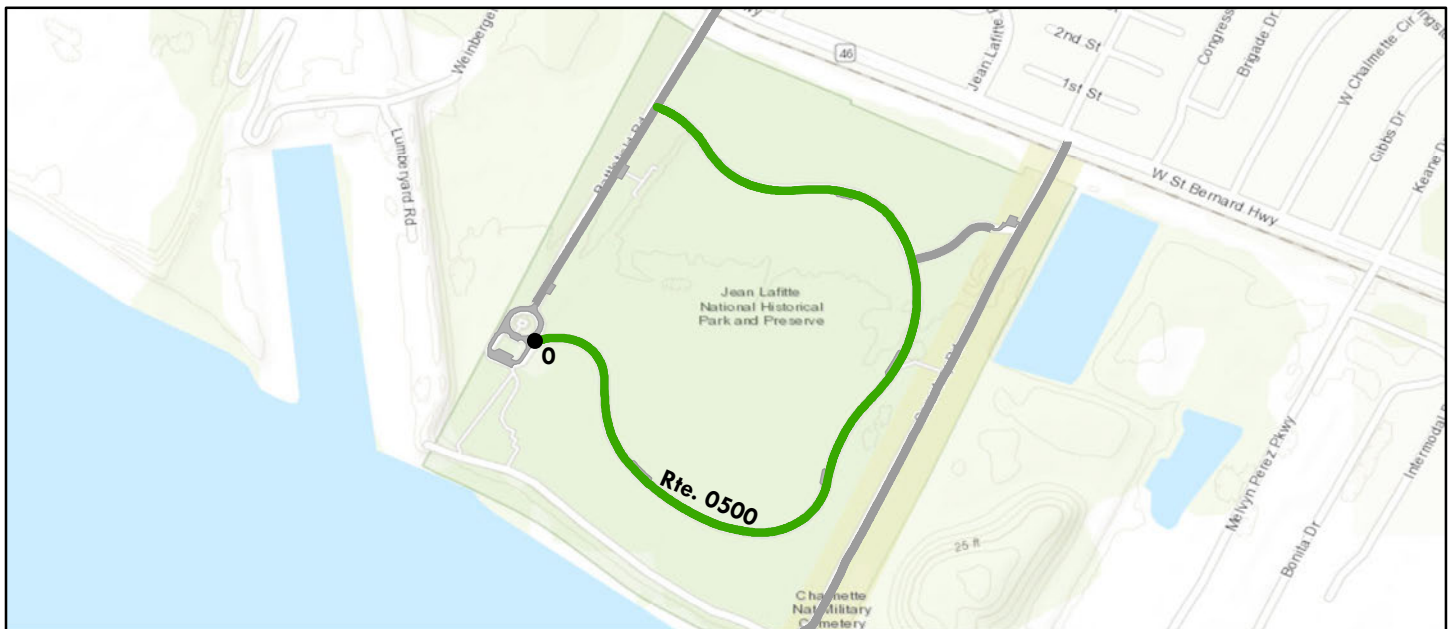
ROUTE 0500: BATTLEFIELD TOUR LOOP ROAD

| Route Condition Legend – Pavement Condition Rating (PCR) | | | | | | |
|---|---|---|---|---|--|--|
| Colors on map represent condition scores at 0.10-mile intervals. See Appendix for definitions and formulas. | | | | | | |
| Pavement Condition Rating (PCR) | 90 | 90 | | | | |

Note: Concrete road was manually rated, but driven with the Data Collection Vehicle (DCV) for video and GPS (the distress indexes listed in the table above are for asphalt surfaces by default).

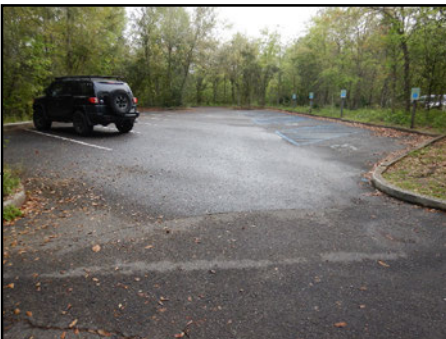
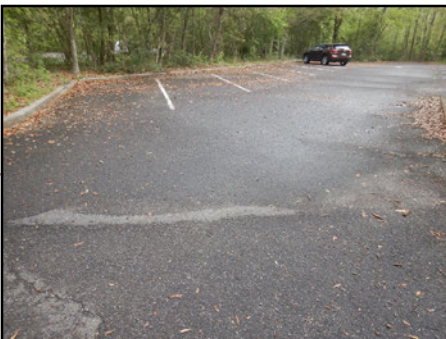
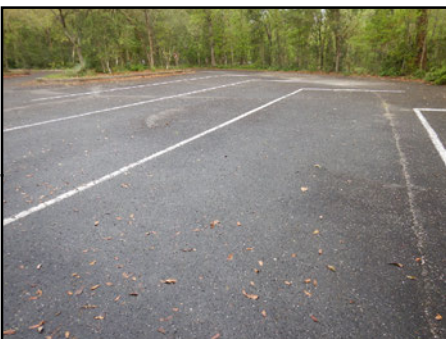
ROUTE 0909: BARATARIA VISITOR CENTER PARKING

| Inspection Date | FMSS Number | User Access | Surface Type |
|---|---|---|---|
| 47,086 | 0.811 | 6 | LIGHT REPAIR |

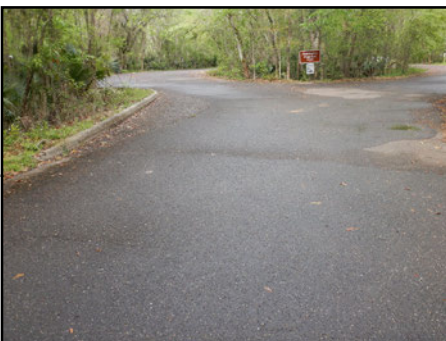
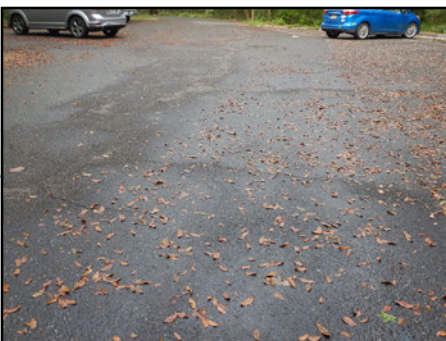
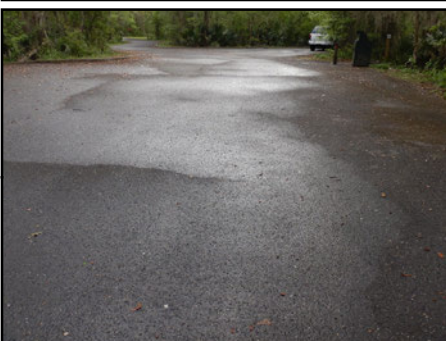
ROUTE 0914: BAYOU COQUILLE FOOT TRAIL PARKING

| Inspection Date | FMSS Number | User Access | Surface Type |
|---|---|---|---|
| 23,222 | 0.4 | 5 | MODERATE REPAIR |
