KICA Cycle 6

Final Report

Road Inventory and Condition Assessment of Paved Routes Kings Canyon National Park

**Federal Highway Administration
Eastern Federal Lands Highway Division
Road Inventory Program (RIP)**

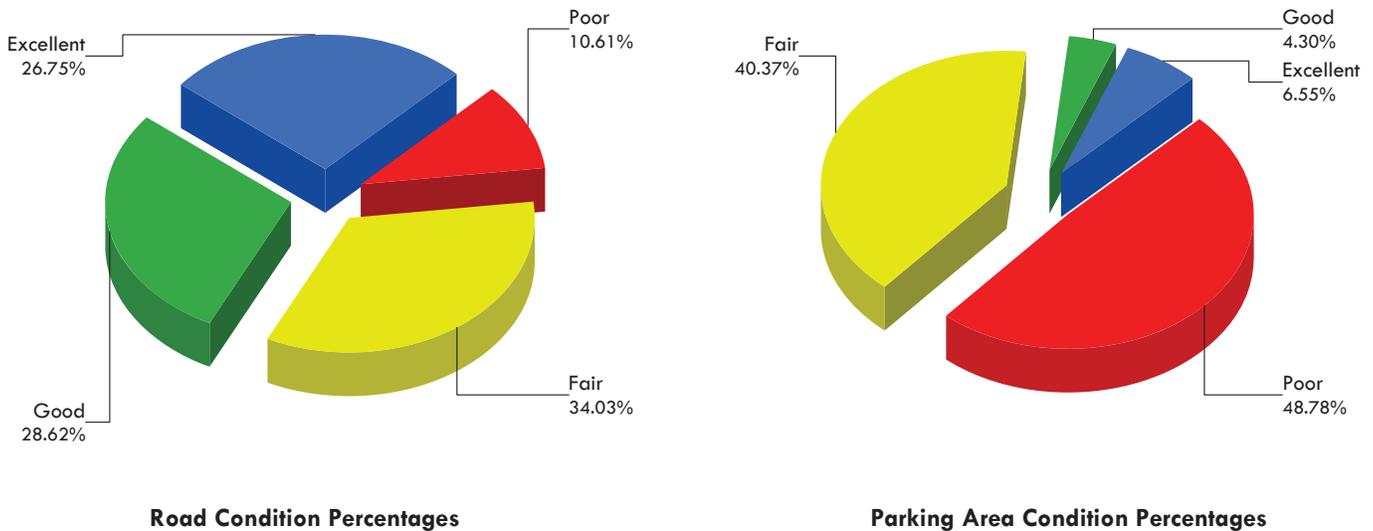
Figure 1: Pavement Condition Rating Breakdown for Paved Roads and Parking Areas

Parkwide Condition Percentages

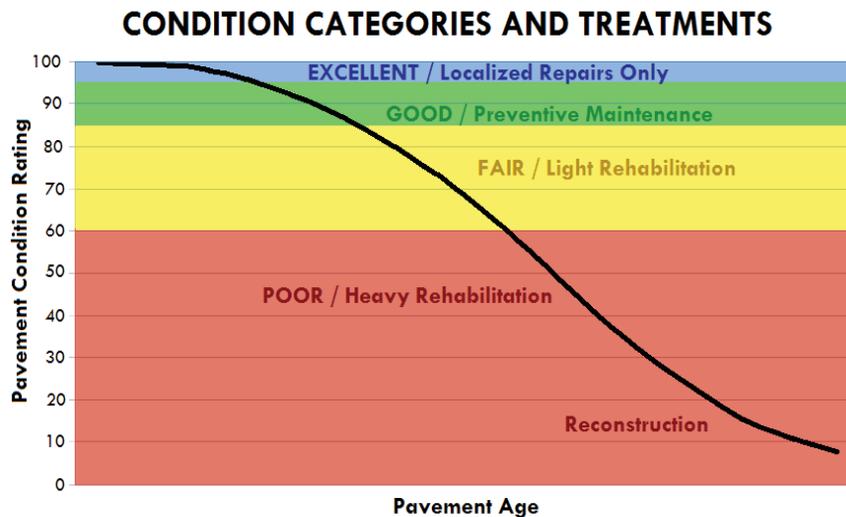
The Road Inventory Program aims to provide assistance in translating the excellent / good / fair / poor rating categories into pavement needs categories. The PCR can be used to indicate the place in the Pavement Life Cycle and the type of treatments that should be considered now and into the future.

- Excellent / New: PCR of 95-100
 - o Pavements in this range will require only spot repairs
- Good: PCR of 85-94
 - o Pavements in this range will likely be candidates for Preventive Maintenance. Examples include Chip and Slurry Seals, Micro Surfacing and Thin Overlays.
- Fair: PCR of 61-84
 - o Pavements in this range will likely be candidates of Light Rehabilitation (L3R). Examples include singlelift overlays up to 2.5 inches in total thickness, milling and overlays.
- Poor: PCR of 0-60
 - o Pavements in this range will likely be candidates of Heavy Rehabilitation or Reconstruction (H3R or 4R). Examples include Pulverization, Multiple Lift Overlays, and Reconstruction.

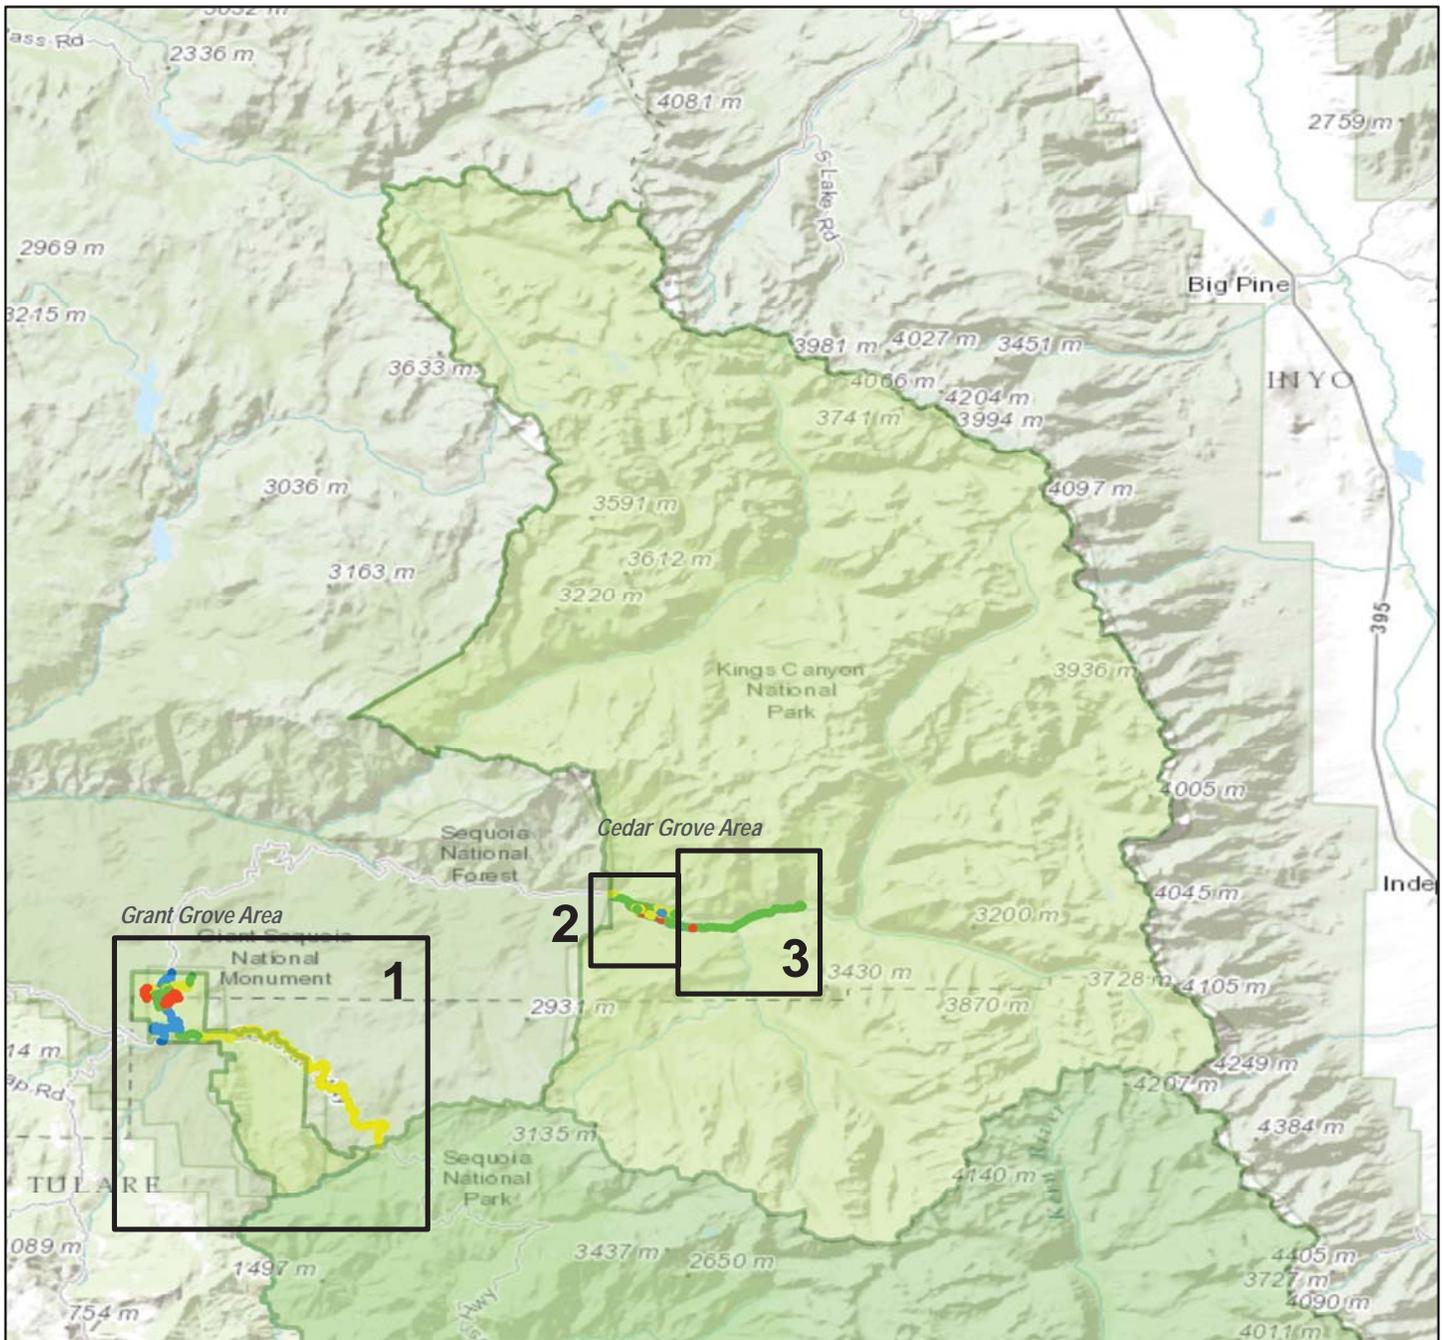
Key Map

ROUTE CONDITION MAP

PCR - MILE BY MILE

Route Condition Legend – Pavement Condition Rating (PCR)

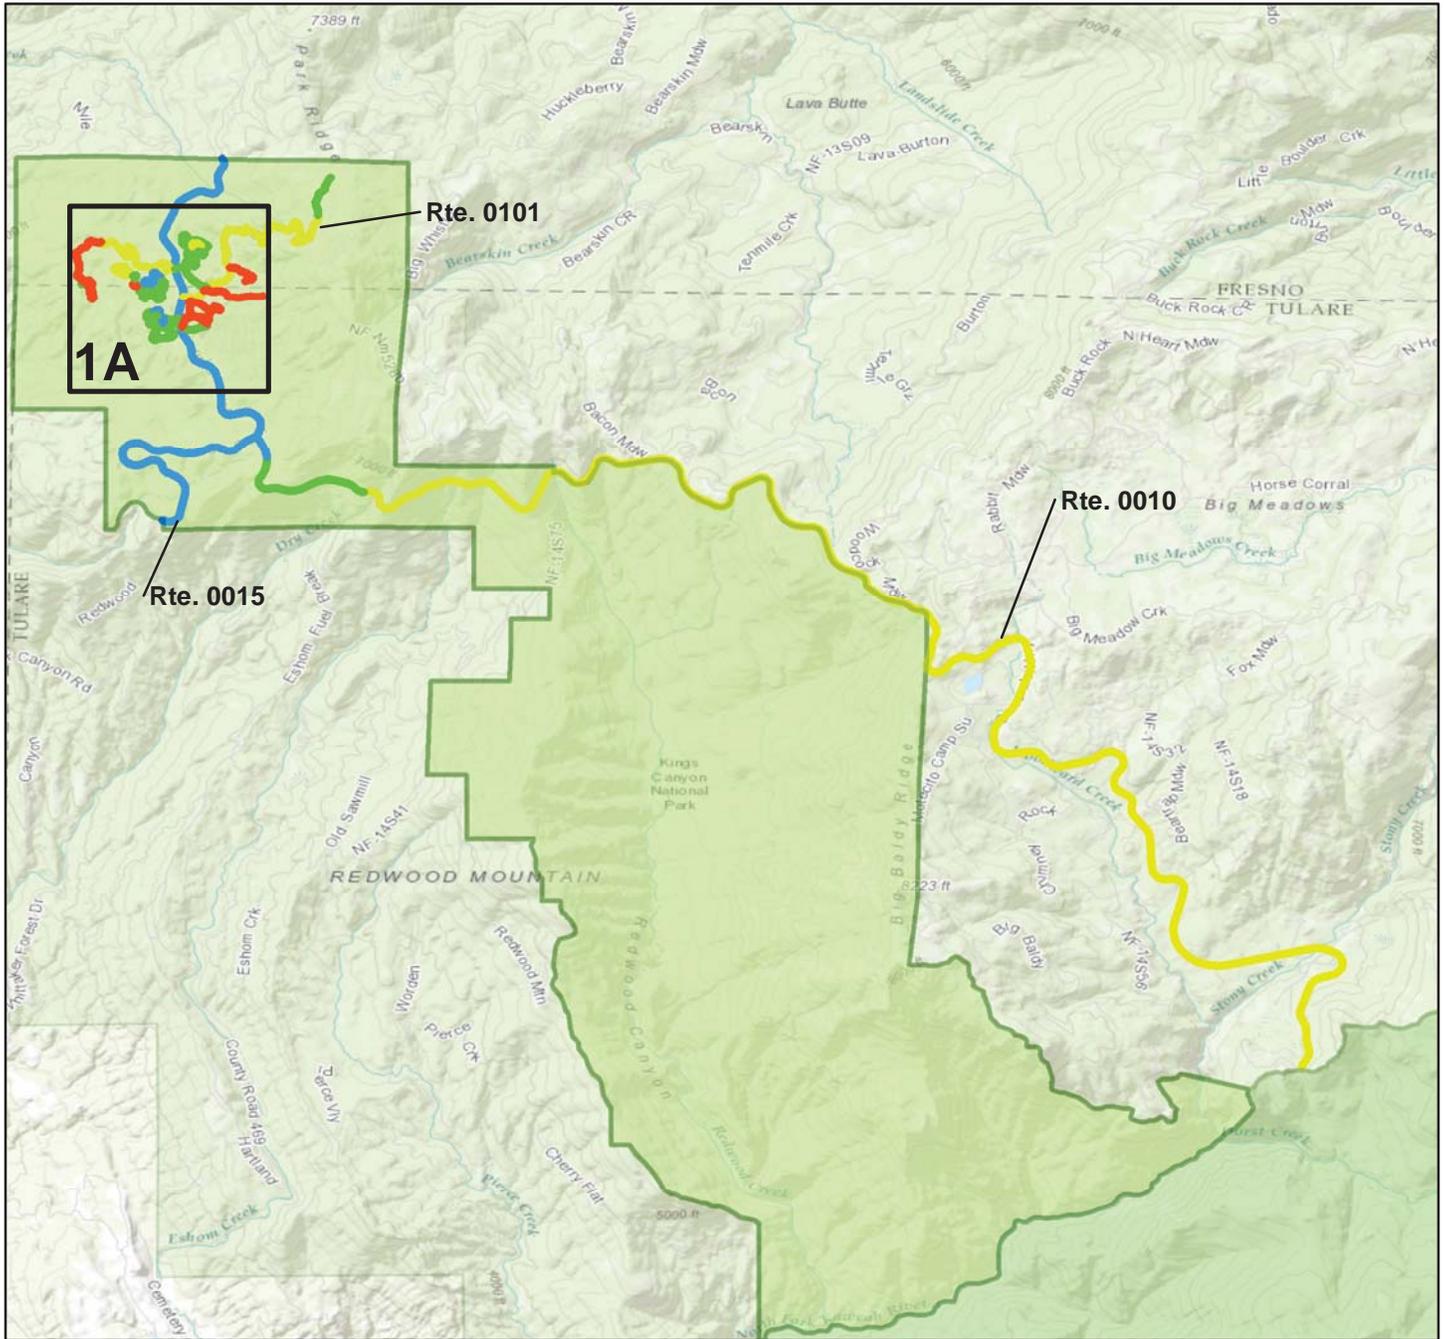
Area Map 1

ROUTE CONDITION MAP

PCR - MILE BY MILE

Route Condition Legend – Pavement Condition Rating (PCR)

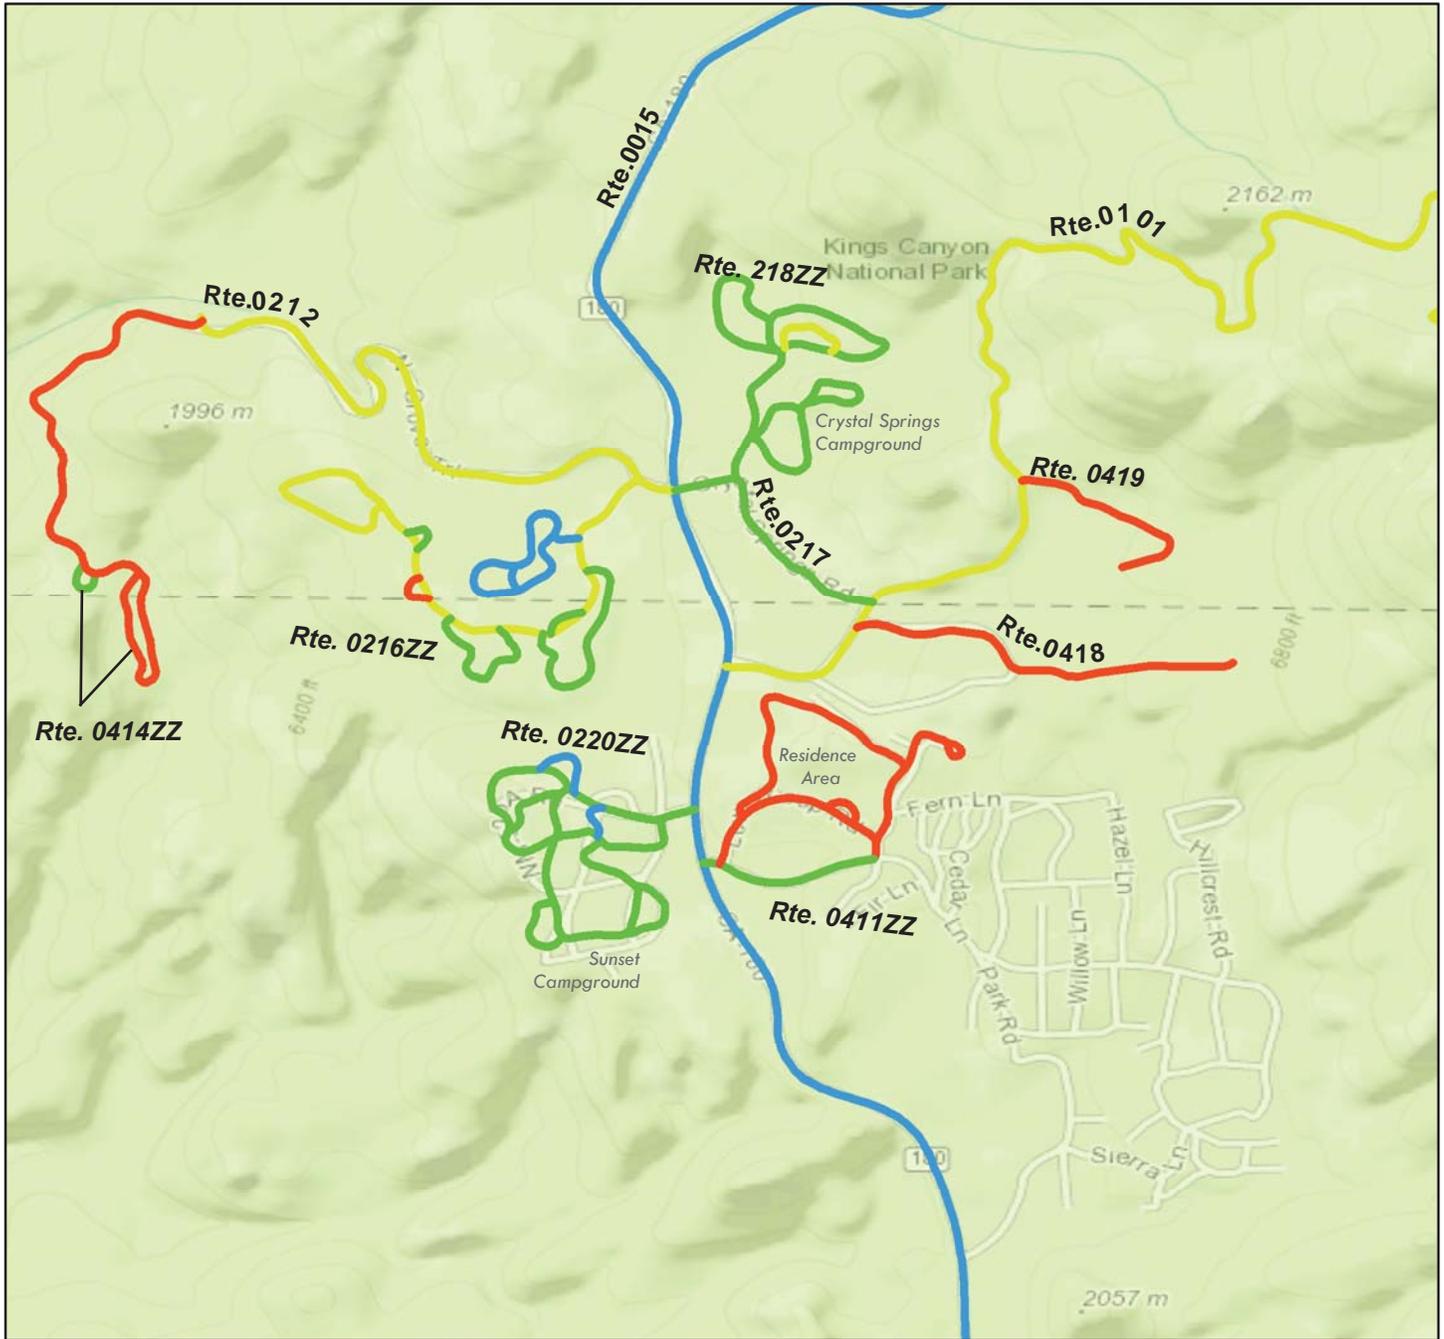
Map 1A

ROUTE CONDITION MAP

PCR - MILE BY MILE

Route Condition Legend – Pavement Condition Rating (PCR)

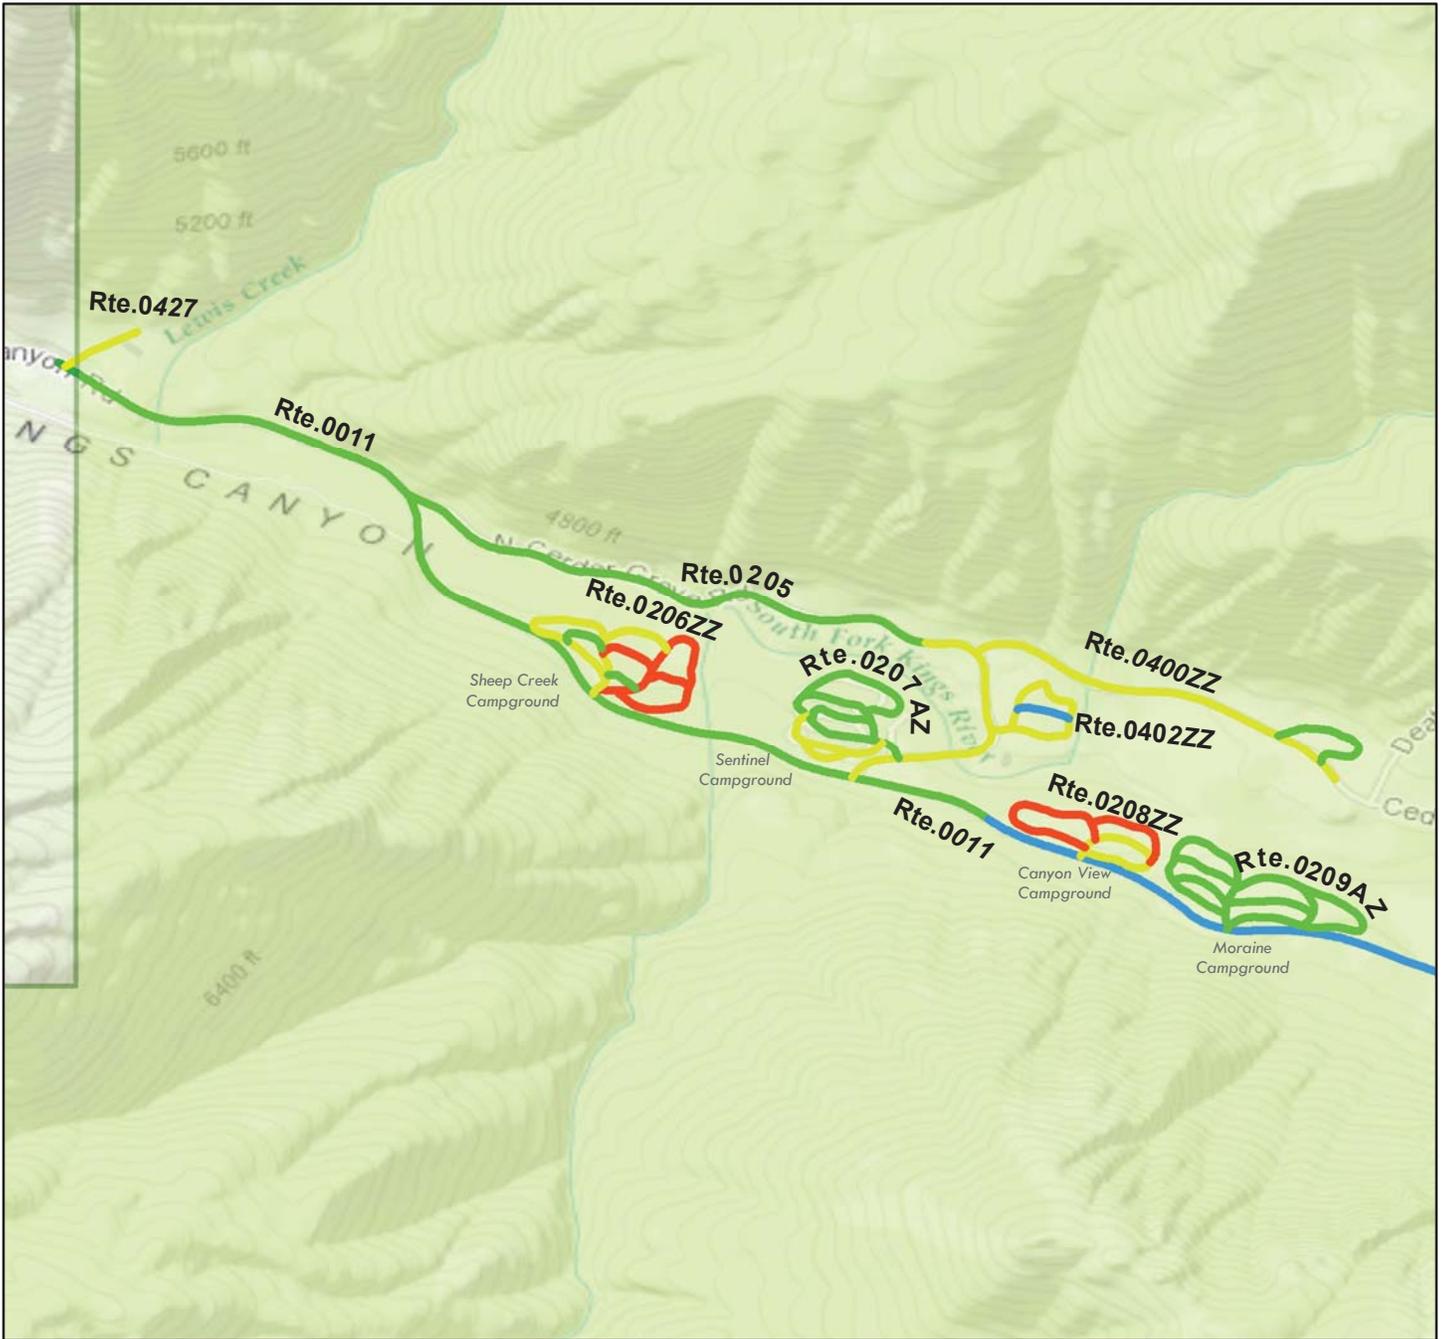
Map 2

ROUTE CONDITION MAP

PCR - MILE BY MILE

Route Condition Legend – Pavement Condition Rating (PCR)

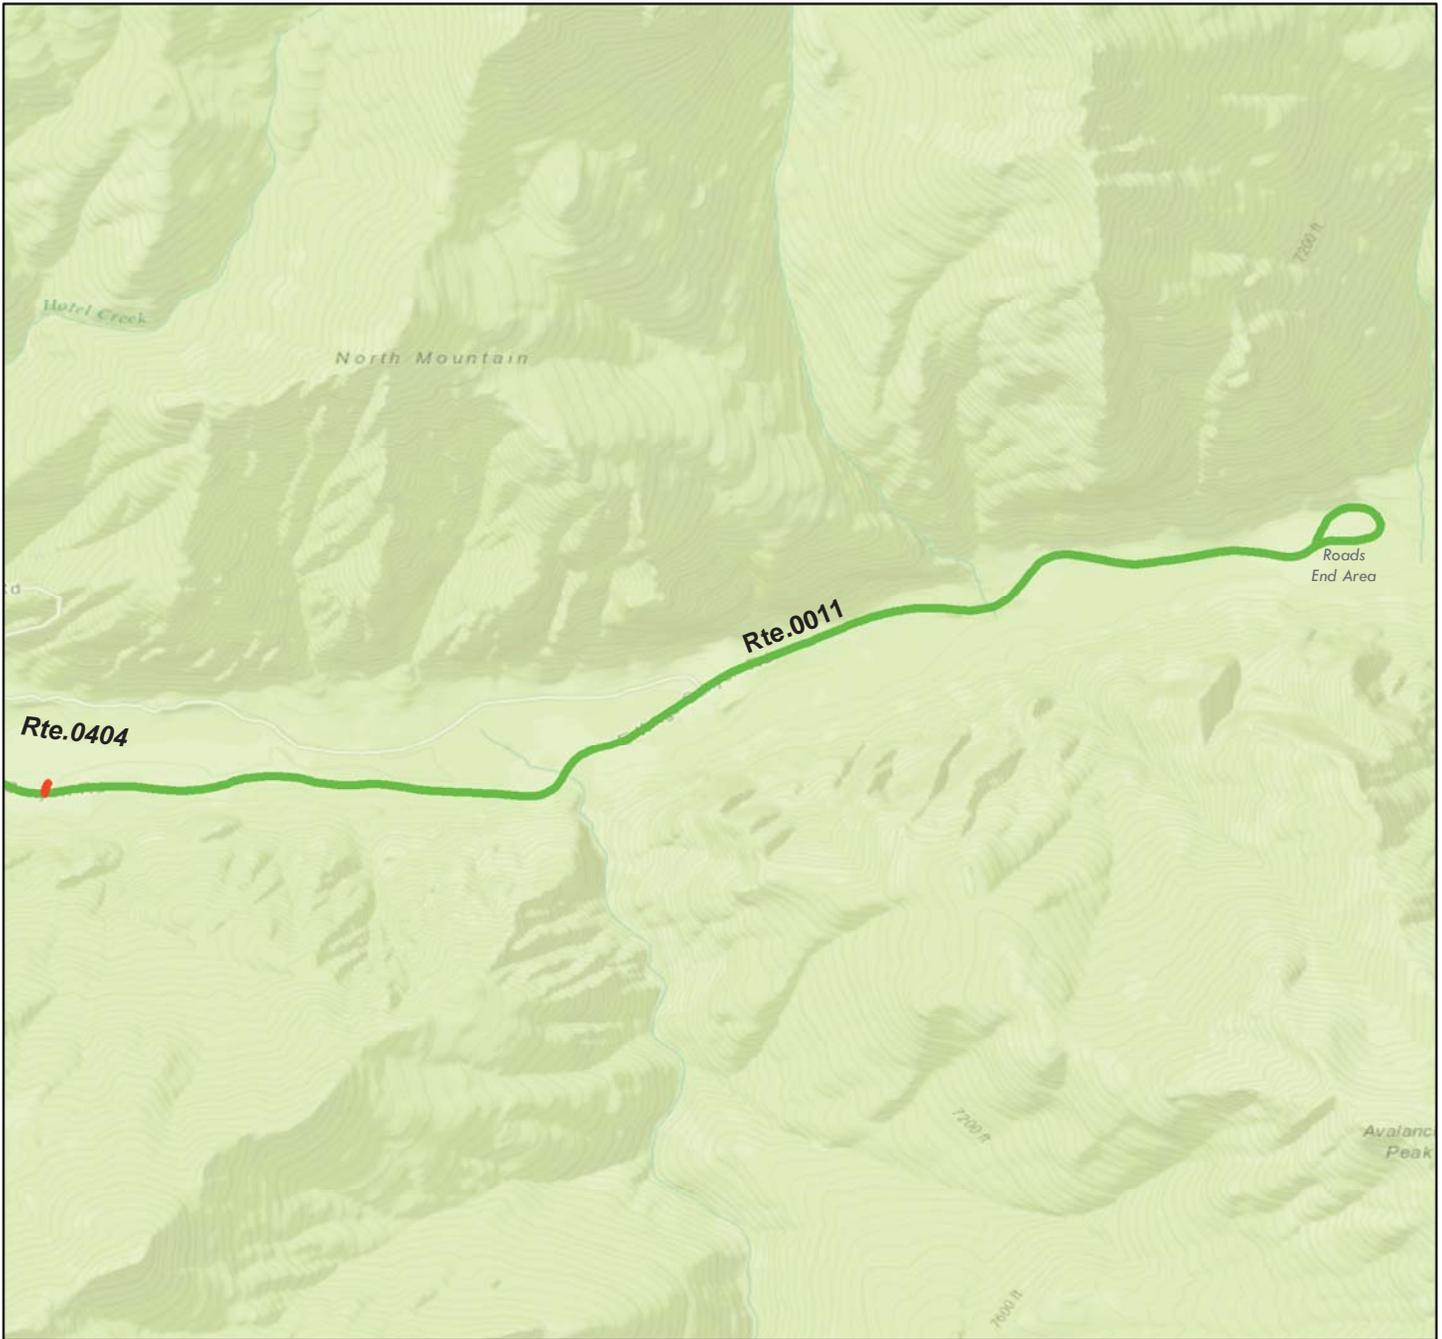
Map 3

ROUTE CONDITION MAP

PCR - MILE BY MILE

Route Condition Legend – Pavement Condition Rating (PCR)

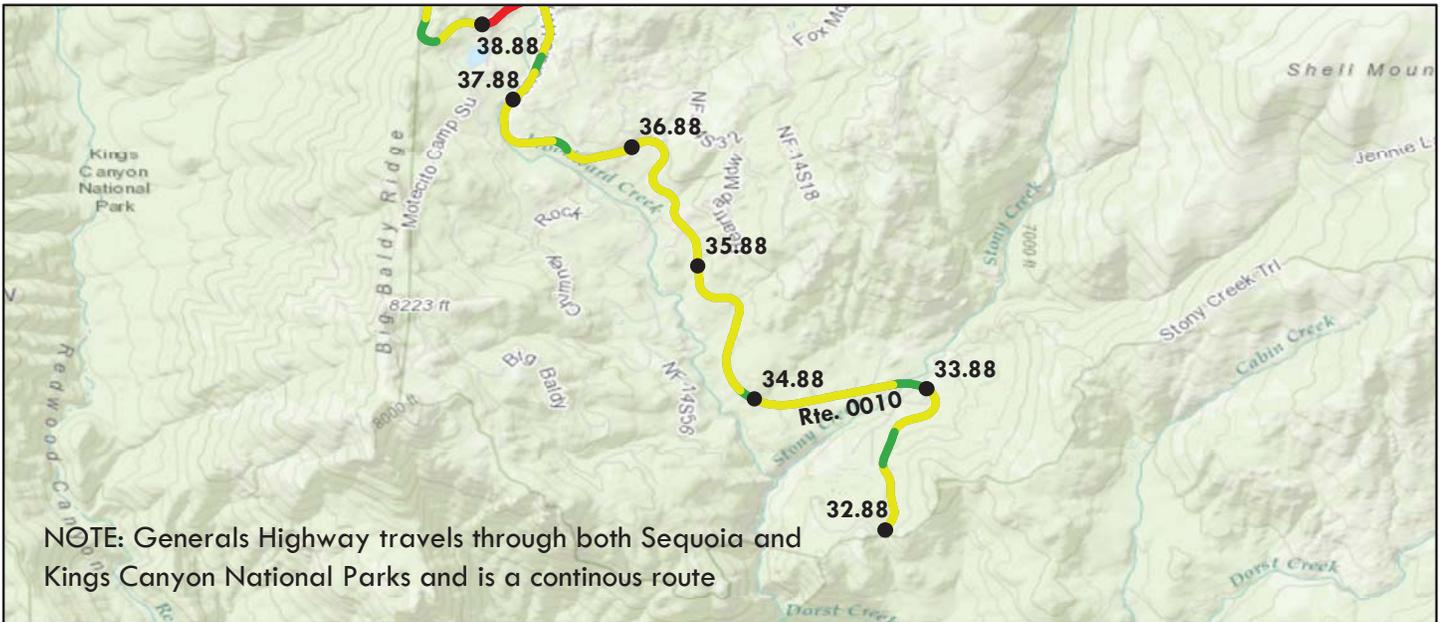
ROUTE 0010: GENERALS HIGHWAY HISTORIC

Data Collection Vehicle (DCV) Rating

Route Condition Legend – Pavement Condition Rating (PCR)						
Poor (0 - 60)	Fair (61- 84)	Good (85 - 94)	Excellent (95 - 100)	Not Rated		
See Appendix for definitions and formulas						
Inspection Date: 5/28/2015	Beginning Section MP	32.88	33.88	34.88	35.88	36.88
Paved Length (Miles): 13.21	Section Length (MI)	1	1	1	1	1
Surface Type: ASPHALT	Route Summary					
Roadway Condition Information						
Pavement Condition Rating (PCR)	79	78	75	79	76	76
Surface Condition Rating (SCR)	90	96	87	91	86	86
Roughness Condition Index (RCI)	63	51	56	61	61	62
Distress Index Values						
Structural Crack Index	94	96	95	91	86	87
Alligator Crack Index	100	100	100	100	100	100
Longitudinal Crack Index	94	96	95	91	86	87
Transverse Cracking Index	90	96	87	94	86	86
Patching Index	100	100	100	100	100	99
Rutting Index	98	98	99	98	98	98
International Roughness Index (IRI)	228	280	256	236	234	232
Lane & Width Information						
Number of Lanes	2	2	2	2	2	2

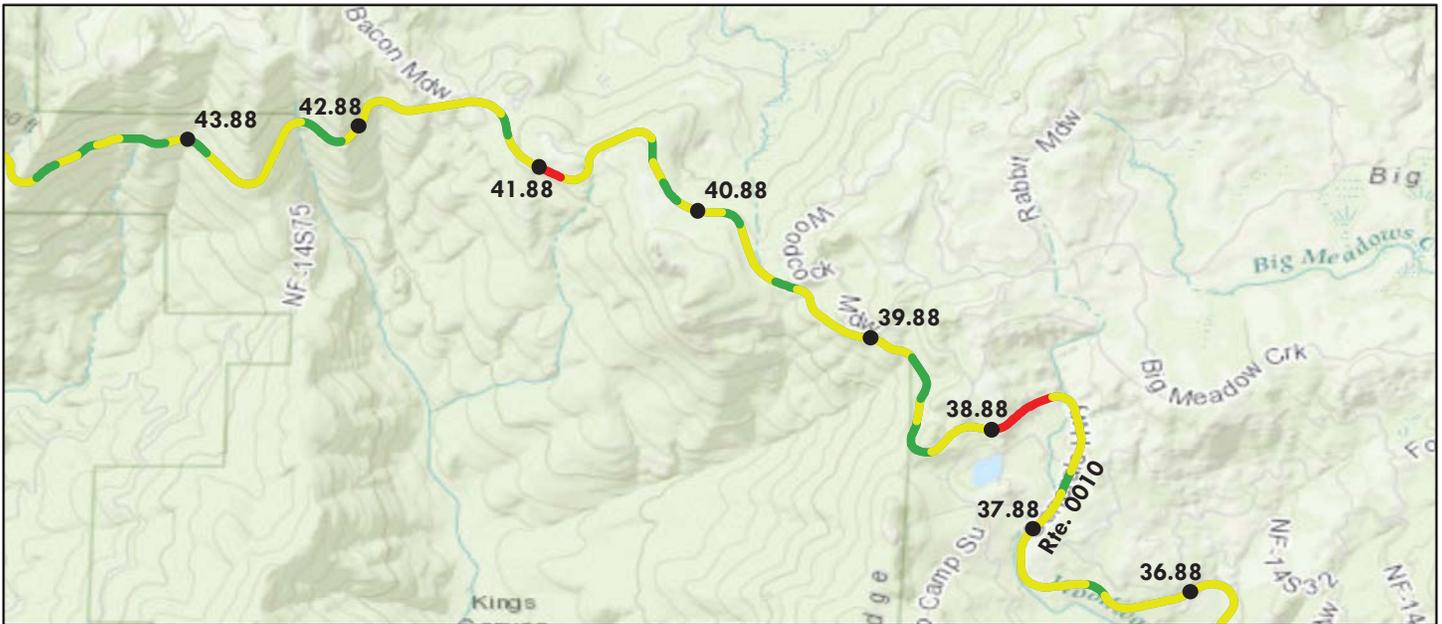
ROUTE 0010: GENERALS HIGHWAY HISTORIC

Data Collection Vehicle (DCV) Rating

Route Condition Legend – Pavement Condition Rating (PCR)						
Poor (0 - 60)	Fair (61- 84)	Good (85 - 94)	Excellent (95 - 100)	Not Rated		
See Appendix for definitions and formulas						
Inspection Date: 5/28/2015	Beginning Section MP	37.88	38.88	39.88	40.88	41.88
Paved Length (Miles): 13.21	Section Length (MI)	1	1	1	1	1
Surface Type: ASPHALT	Route Summary					
Roadway Condition Information						
Pavement Condition Rating (PCR)	79	71	82	79	75	77
Surface Condition Rating (SCR)	90	75	94	93	85	84
Roughness Condition Index (RCI)	63	65	63	58	60	67
Distress Index Values						
Structural Crack Index	94	92	96	95	95	94
Alligator Crack Index	100	100	100	100	100	100
Longitudinal Crack Index	94	92	96	95	95	94
Transverse Cracking Index	90	75	94	93	85	84
Patching Index	100	100	100	100	100	100
Rutting Index	98	99	98	97	98	99
International Roughness Index (IRI)	228	220	226	247	238	212
Lane & Width Information						
Number of Lanes	2	2	2	2	2	2

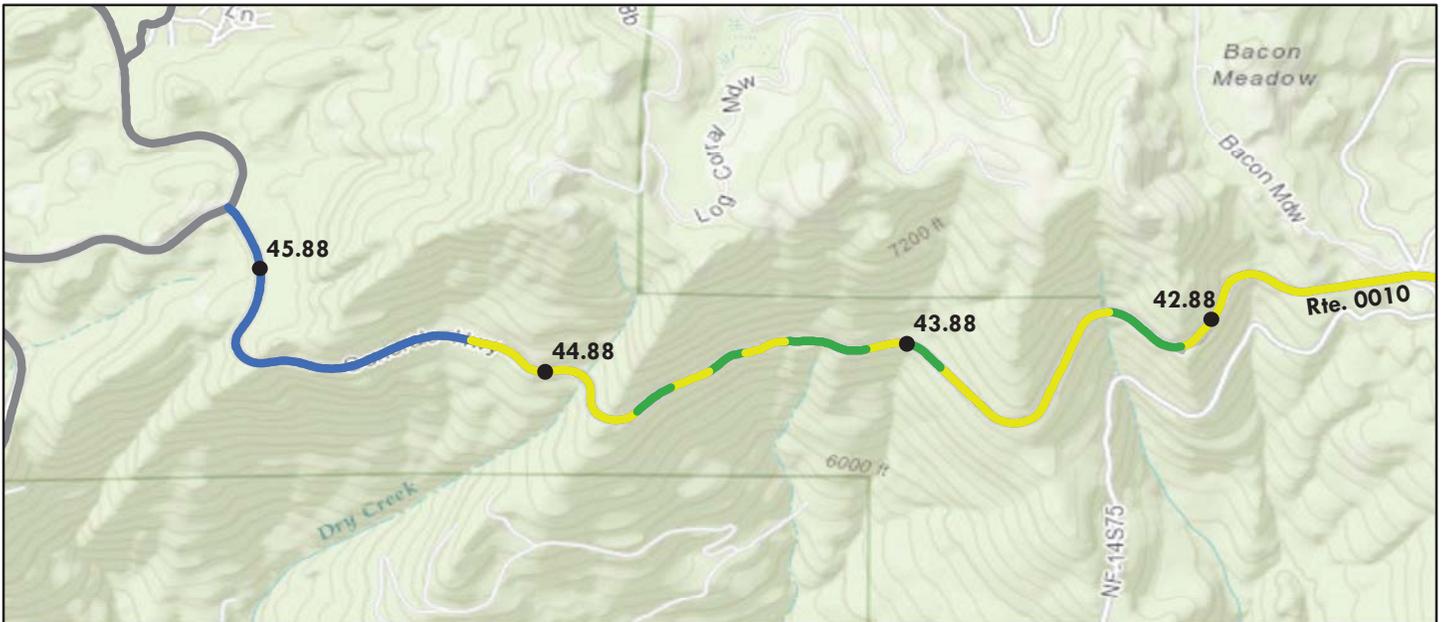
ROUTE 0010: GENERALS HIGHWAY HISTORIC

Data Collection Vehicle (DCV) Rating

Route Condition Legend – Pavement Condition Rating (PCR)						
Poor (0 - 60)	Fair (61- 84)	Good (85 - 94)	Excellent (95 - 100)	Not Rated		
See Appendix for definitions and formulas						
Inspection Date: 5/28/2015	Beginning Section MP	42.88	43.88	44.88	45.88	
Paved Length (Miles): 13.21	Section Length (MI)	1	1	1	0.21	
Surface Type: ASPHALT	Route Summary					
Roadway Condition Information						
Pavement Condition Rating (PCR)	79	82	82	93	97	
Surface Condition Rating (SCR)	90	96	94	98	97	
Roughness Condition Index (RCI)	63	62	64	86	98	
Distress Index Values						
Structural Crack Index	94	96	94	98	98	
Alligator Crack Index	100	98	97	100	100	
Longitudinal Crack Index	94	98	97	98	98	
Transverse Cracking Index	90	97	97	99	100	
Patching Index	100	100	100	100	100	
Rutting Index	98	98	98	98	97	
International Roughness Index (IRI)	228	232	225	153	119	
Lane & Width Information						
Number of Lanes	2	2	2	2	2	
Paved Width (ft)	22.5	23.8	25.9	22.9	23.6

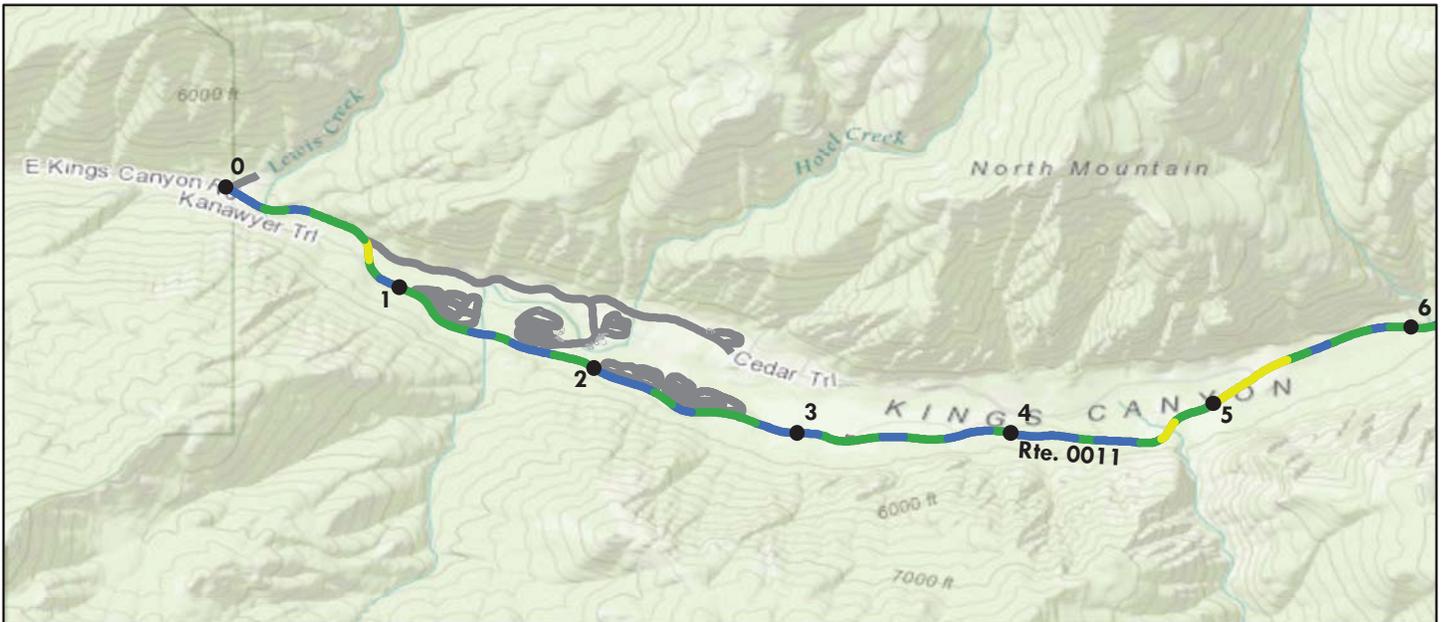
ROUTE 0011: CEDAR GROVE ROAD

Data Collection Vehicle (DCV) Rating

Route Condition Legend – Pavement Condition Rating (PCR)						
Poor (0 - 60)	Fair (61- 84)	Good (85 - 94)	Excellent (95 - 100)	Not Rated		
See Appendix for definitions and formulas						
Inspection Date: 5/28/2015	Beginning Section MP	0	1	2	3	4
Paved Length (Miles): 7.58	Section Length (MI)	1	1	1	1	1
Surface Type: ASPHALT	Route Summary					
Roadway Condition Information						
Pavement Condition Rating (PCR)	91	92	94	97	94	93
Surface Condition Rating (SCR)	97	98	99	98	98	97
Roughness Condition Index (RCI)	83	84	87	95	88	88
Distress Index Values						
Structural Crack Index	100	100	100	99	100	100
Alligator Crack Index	100	100	100	100	100	100
Longitudinal Crack Index	100	100	100	99	100	100
Transverse Cracking Index	97	98	100	98	98	97
Patching Index	100	100	99	100	100	100
Rutting Index	99	99	100	98	98	98
International Roughness Index (IRI)	159	156	150	128	147	146
Lane & Width Information						
Number of Lanes	2	2	2	2	2	2

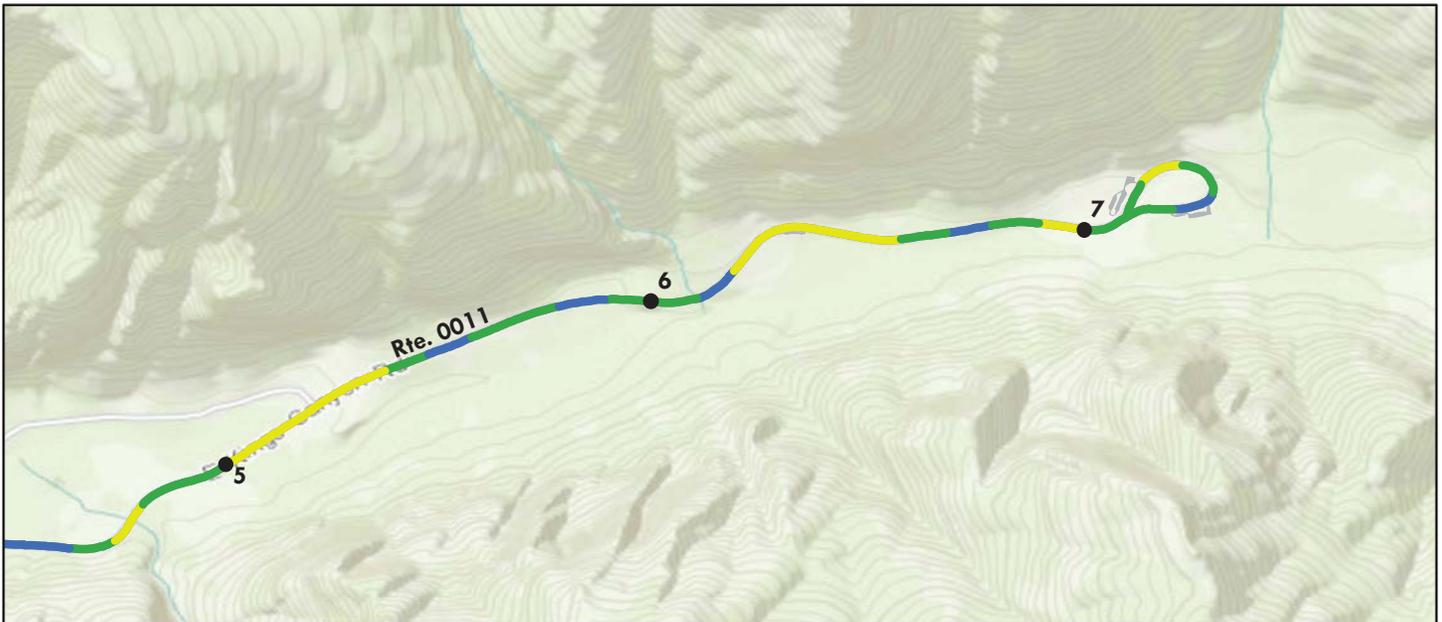
ROUTE 0011: CEDAR GROVE ROAD

Data Collection Vehicle (DCV) Rating

Route Condition Legend – Pavement Condition Rating (PCR)						
Poor (0 - 60)	Fair (61- 84)	Good (85 - 94)	Excellent (95 - 100)	Not Rated		
See Appendix for definitions and formulas						
Inspection Date: 5/28/2015	Beginning Section MP	5	6	7		
Paved Length (Miles): 7.58	Section Length (MI)	1	1	0.58		
Surface Type: ASPHALT	Route Summary					
Roadway Condition Information						
Pavement Condition Rating (PCR)	91	86	86	90		
Surface Condition Rating (SCR)	97	94	95	96		
Roughness Condition Index (RCI)	83	74	73	80		
Distress Index Values						
Structural Crack Index	100	100	100	100		
Alligator Crack Index	100	100	100	100		
Longitudinal Crack Index	100	100	100	100		
Transverse Cracking Index	97	94	95	96		
Patching Index	100	100	100	100		
Rutting Index	99	98	98	99		
International Roughness Index (IRI)	159	190	192	168		
Lane & Width Information						
Number of Lanes	2	2	2	2		
Paved Width (ft)	23.9	22.2	22	21.9		
Lane Width (ft)	11.2	10.7	10.2	10.4

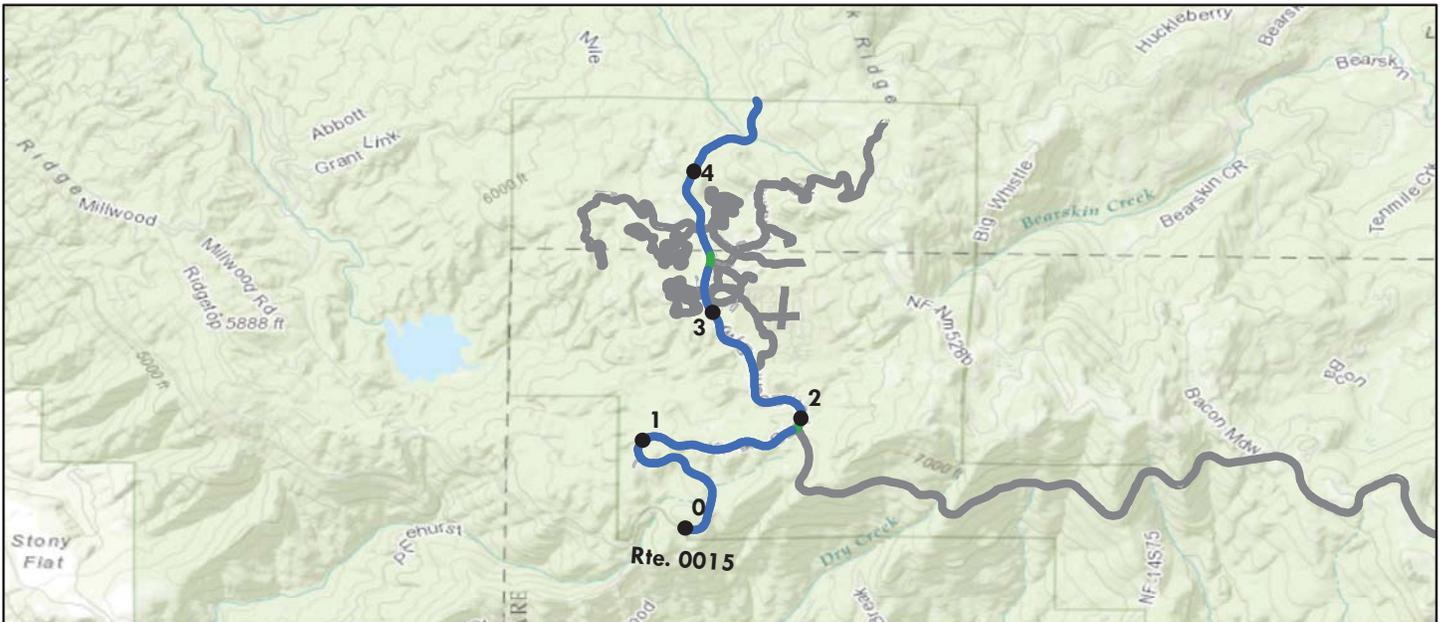
ROUTE 0015: GRANT GROVE ROAD

Data Collection Vehicle (DCV) Rating

Route Condition Legend – Pavement Condition Rating (PCR)						
Poor (0 - 60)	Fair (61- 84)	Good (85 - 94)	Excellent (95 - 100)	Not Rated		
See Appendix for definitions and formulas						
Inspection Date: 5/30/2015	Beginning Section MP	0	1	2	3	4
Paved Length (Miles): 4.7	Section Length (MI)	1	1	1	1	0.7
Surface Type: ASPHALT	Route Summary					
Roadway Condition Information						
Pavement Condition Rating (PCR)	99	97	99	99	100	99
Surface Condition Rating (SCR)	99	98	98	99	100	99
Roughness Condition Index (RCI)	100	96	100	100	100	100
Distress Index Values						
Structural Crack Index	100	100	100	100	100	100
Alligator Crack Index	100	100	100	100	100	100
Longitudinal Crack Index	100	100	100	100	100	100
Transverse Cracking Index	100	100	99	100	100	100
Patching Index	100	100	100	100	100	100
Rutting Index	99	98	98	99	100	99
International Roughness Index (IRI)	109	124	108	107	108	92
Lane & Width Information						
Number of Lanes	2	2	2	2	2	2

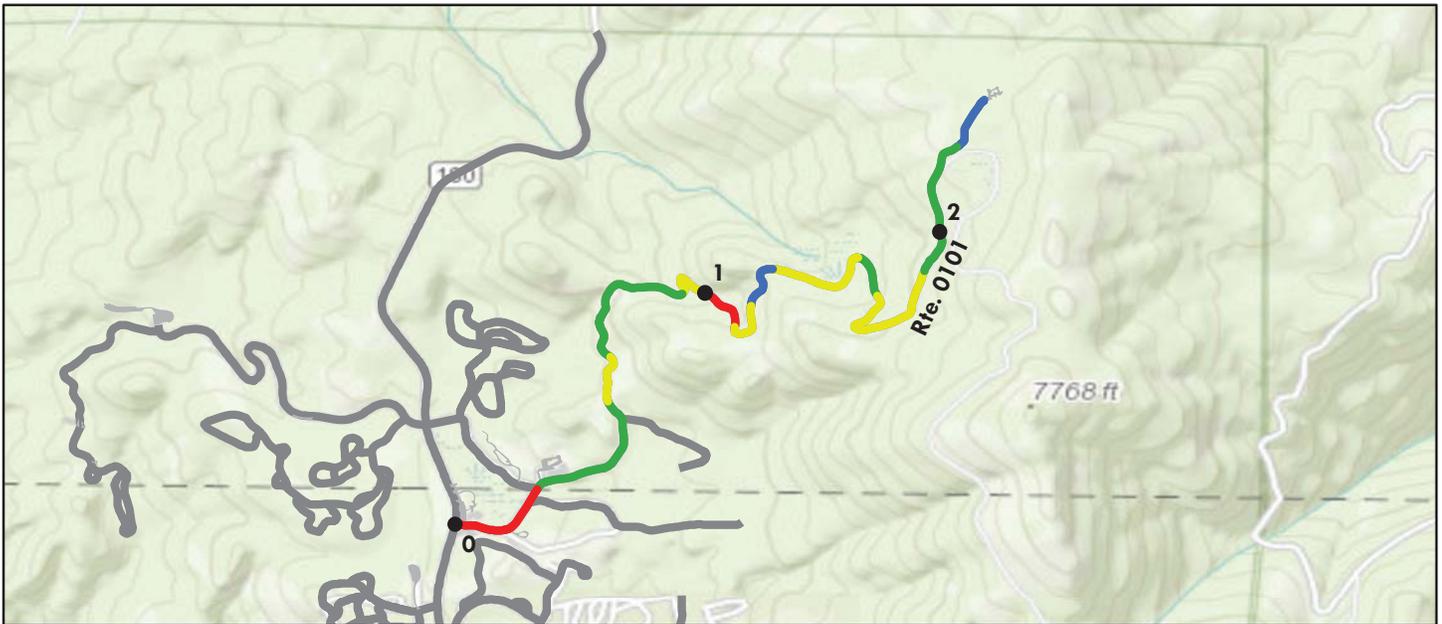
ROUTE 0101: PANORAMIC ROAD

Data Collection Vehicle (DCV) Rating

Route Condition Legend – Pavement Condition Rating (PCR)									
Poor (0 - 60)		Fair (61- 84)		Good (85 - 94)		Excellent (95 - 100)		Not Rated	
See Appendix for definitions and formulas									
Inspection Date:	5/30/2015	Beginning Section MP	0	1	2				
Paved Length (Miles):	2.31	Section Length (MI)	1	1	0.31				
Surface Type:	ASPHALT	Route Summary							
Roadway Condition Information									
Pavement Condition Rating (PCR)	82	83	78	94					
Surface Condition Rating (SCR)	82	83	78	94					
Roughness Condition Index (RCI)	N/A	N/A	N/A	N/A					
Distress Index Values									
Structural Crack Index	82	83	78	95					
Alligator Crack Index	96	95	96	99					
Longitudinal Crack Index	86	88	82	96					
Transverse Cracking Index	93	87	96	99					
Patching Index	100	100	100	100					
Rutting Index	89	89	87	94					
International Roughness Index (IRI)	N/A	N/A	N/A	N/A					
Lane & Width Information									
Number of Lanes	1	2	1	1

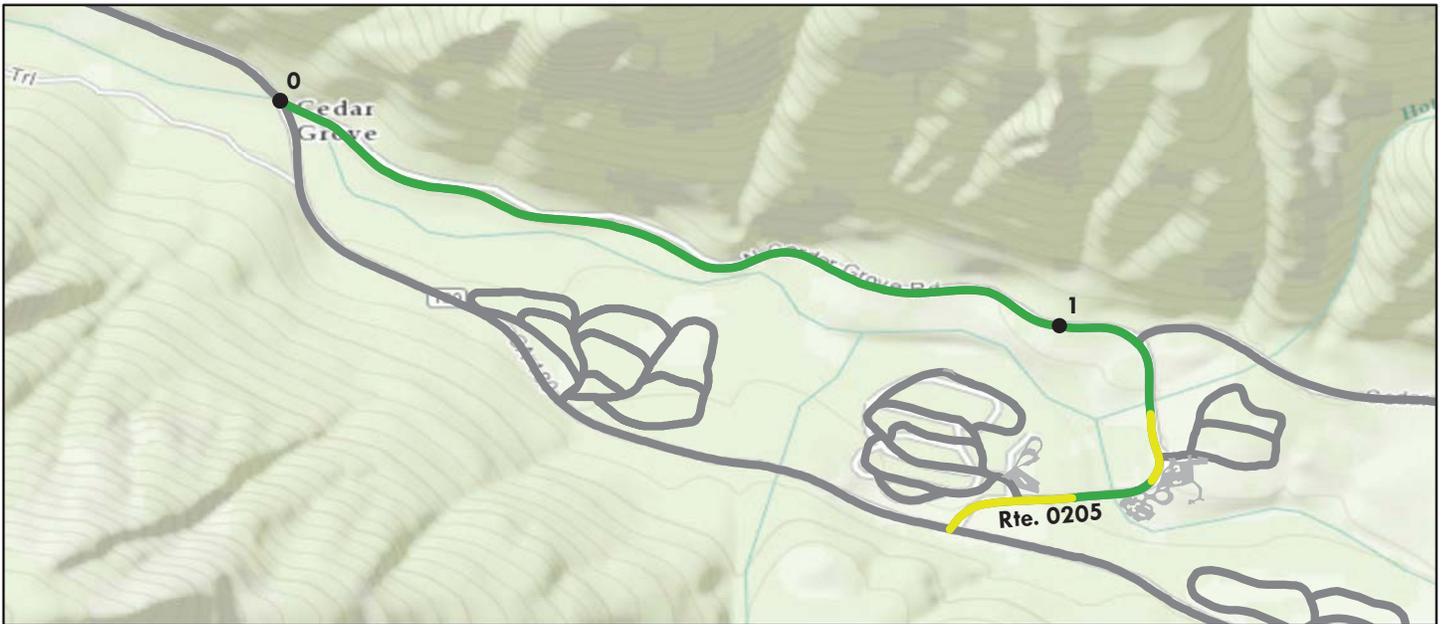
ROUTE 0205: NORTH SIDE ROAD

Data Collection Vehicle (DCV) Rating

Route Condition Legend – Pavement Condition Rating (PCR)						
Poor (0 - 60)	Fair (61- 84)	Good (85 - 94)	Excellent (95 - 100)	Not Rated		
See Appendix for definitions and formulas						
Inspection Date: 5/28/2015	Beginning Section MP	0	1			
Paved Length (Miles): 1.56	Section Length (MI)	1	0.56			
Surface Type: ASPHALT	Route Summary					
Roadway Condition Information						
Pavement Condition Rating (PCR)	87	89	83			
Surface Condition Rating (SCR)	98	99	94			
Roughness Condition Index (RCI)	71	74	66			
Distress Index Values						
Structural Crack Index	99	100	98			
Alligator Crack Index	100	100	100			
Longitudinal Crack Index	99	100	98			
Transverse Cracking Index	98	100	94			
Patching Index	100	100	100			
Rutting Index	98	99	98			
International Roughness Index (IRI)	197	187	217			
Lane & Width Information						
Number of Lanes	2	2	2			
Paved Width (ft)	18	17.7	18.6			
Lane Width (ft)	8.7	8.8	8.6

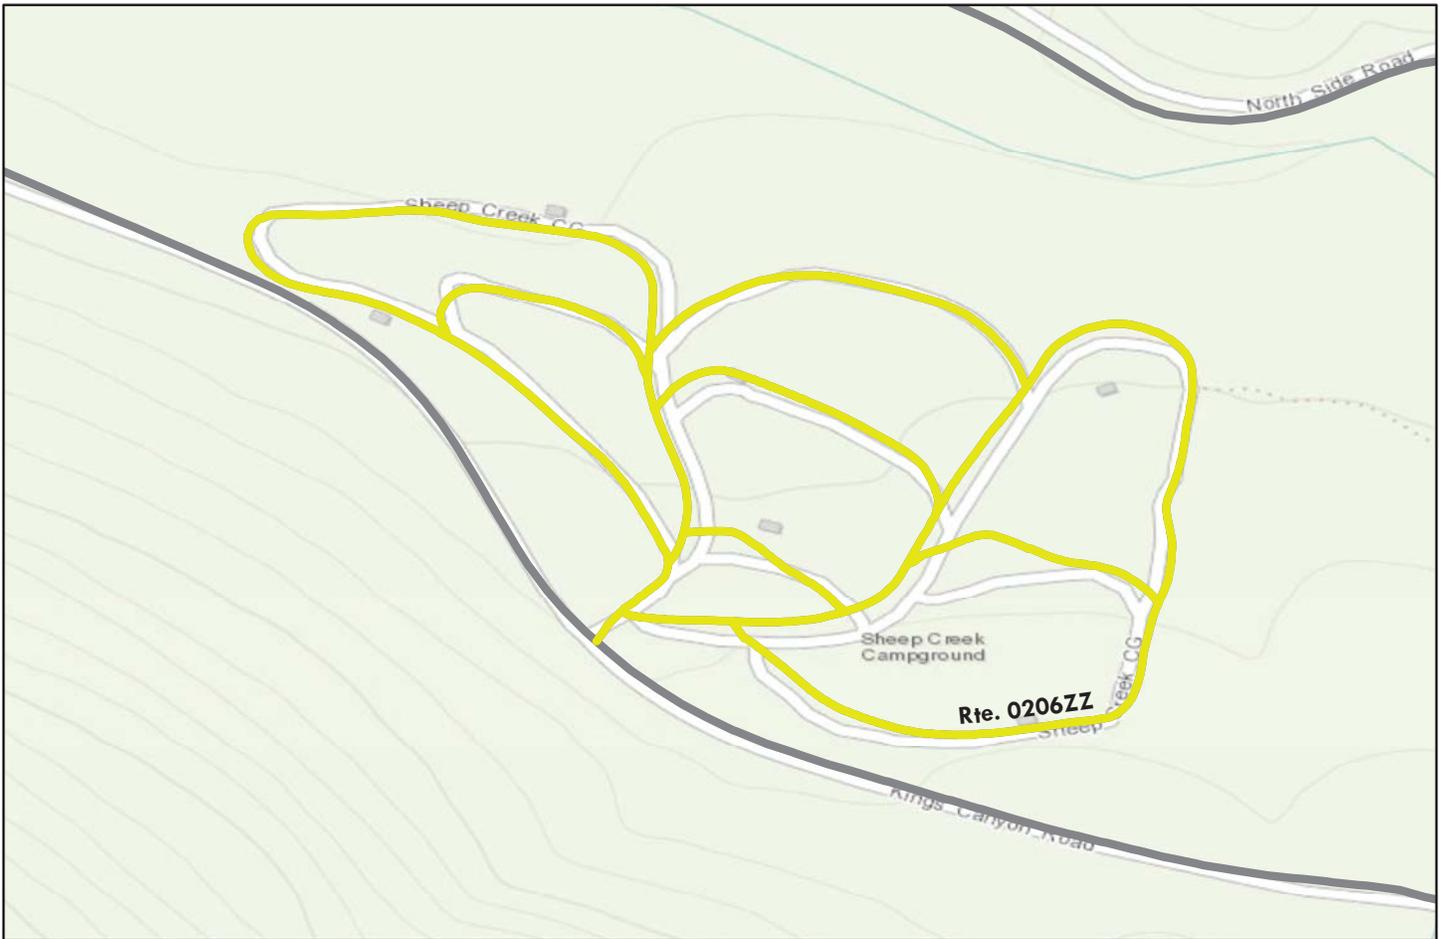
ROUTE 0206ZZ: SHEEP CREEK CAMPGROUND ROADS

Summary Route

Note: The weighted average summary PCR value is calculated from only the sections of road where the PCR was collected. The overall PCR for the summary route may not reflect individual subcomponent ratings.

Route Condition Legend – Pavement Condition Rating (PCR)						
Poor (0 - 60)	Fair (61- 84)	Good (85 - 94)	Excellent (95 - 100)	Not Rated		
See Appendix for definitions and formulas						
Inspection Date:	5/28/2015					
Paved Length (Miles):	1.43					
Surface Type:	ASPHALT	Route Summary				
Roadway Condition Information						
Pavement Condition Rating (PCR)	70					
Lane & Width Information						
Number of Lanes	1					
Paved Width (ft)	12.7					
Lane Width (ft)	11.8
