KICA Cycle 6

Final Report

Road Inventory and Condition Assessment of Paved Routes Kings Canyon National Park

**Federal Highway Administration
Eastern Federal Lands Highway Division
Road Inventory Program (RIP)**

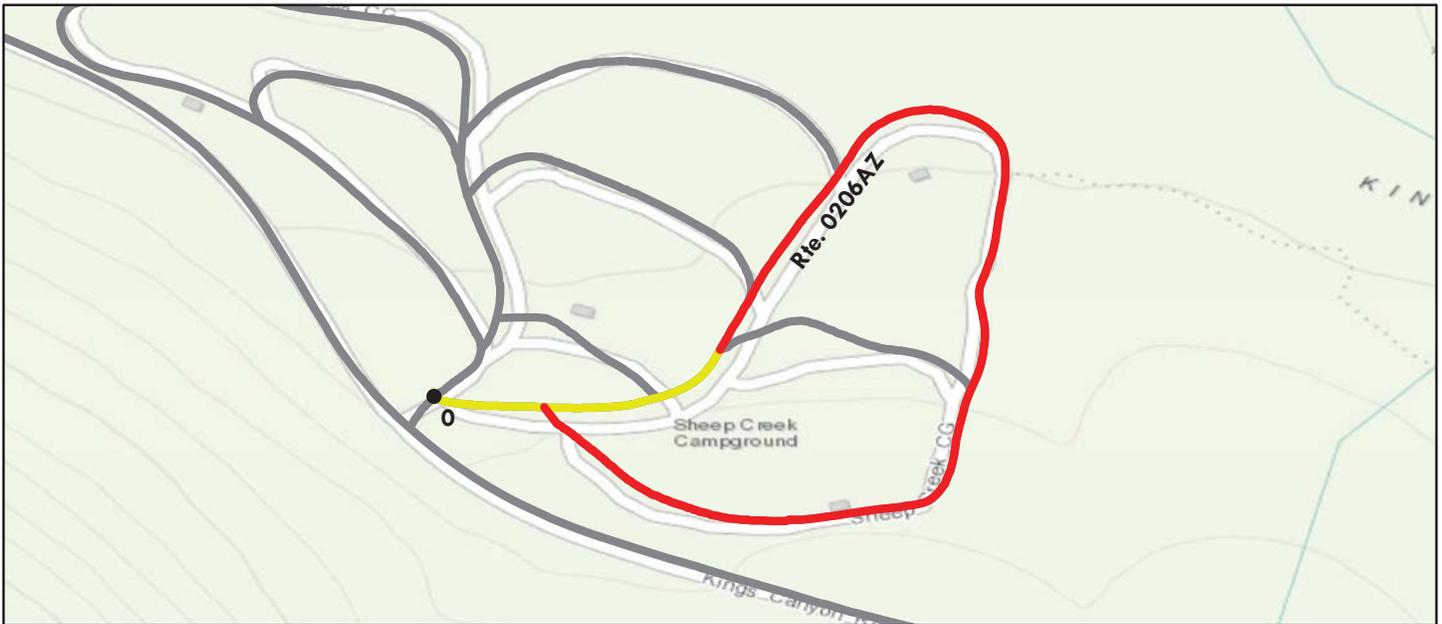
ROUTE 0206AZ: SHEEP CREEK CAMPGROUND ROAD A

Subcomponent of Route KICA-0206ZZ
Data Collection Vehicle (DCV) Rating

Route Condition Legend – Pavement Condition Rating (PCR)						
Poor (0 - 60)	Fair (61- 84)	Good (85 - 94)	Excellent (95 - 100)	Not Rated		
See Appendix for definitions and formulas						
Inspection Date: 5/28/2015	Beginning Section MP	0				
Paved Length (Miles): 0.49	Section Length (MI)	0.49				
Surface Type: ASPHALT	Route Summary					
Roadway Condition Information						
Pavement Condition Rating (PCR)	53	53				
Surface Condition Rating (SCR)	53	53				
Roughness Condition Index (RCI)	N/A	N/A				
Distress Index Values						
Structural Crack Index	91	91				
Alligator Crack Index	100	100				
Longitudinal Crack Index	91	91				
Transverse Cracking Index	53	53				
Patching Index	100	100				
Rutting Index	93	93				
International Roughness Index (IRI)	N/A	N/A				
Lane & Width Information						
Number of Lanes	1	1				
Paved Width (ft)	11.8	11.8				
Lane Width (ft)	10.9	10.9

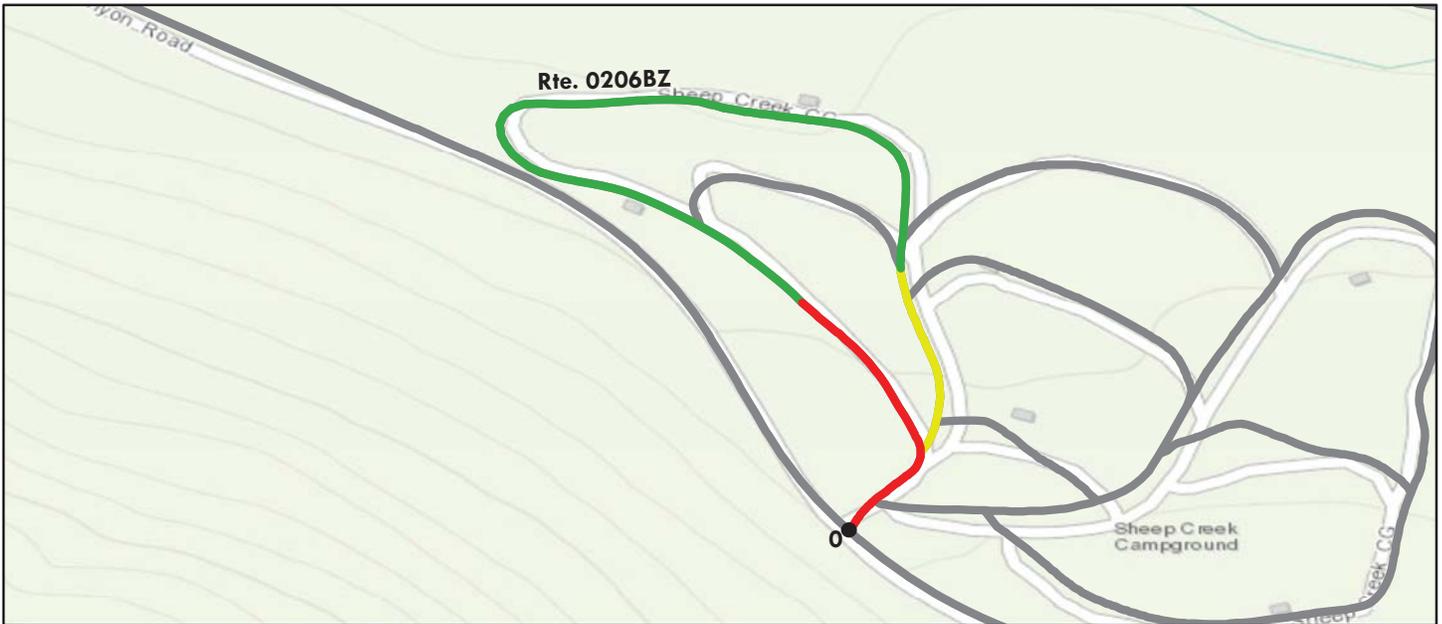
ROUTE 0206BZ: SHEEP CREEK CAMPGROUND ROAD B

Subcomponent of Route KICA-0206ZZ
Data Collection Vehicle (DCV) Rating

Route Condition Legend – Pavement Condition Rating (PCR)						
Poor (0 - 60)	Fair (61- 84)	Good (85 - 94)	Excellent (95 - 100)	Not Rated		
See Appendix for definitions and formulas						
Inspection Date: 5/28/2015	Beginning Section MP	0				
Paved Length (Miles): 0.47	Section Length (MI)	0.47				
Surface Type: ASPHALT	Route Summary					
Roadway Condition Information						
Pavement Condition Rating (PCR)	81	81				
Surface Condition Rating (SCR)	81	81				
Roughness Condition Index (RCI)	N/A	N/A				
Distress Index Values						
Structural Crack Index	95	95				
Alligator Crack Index	100	100				
Longitudinal Crack Index	95	95				
Transverse Cracking Index	81	81				
Patching Index	100	100				
Rutting Index	93	93				
International Roughness Index (IRI)	N/A	N/A				
Lane & Width Information						
Number of Lanes	1	1				
Paved Width (ft)	13.8	13.8				
Lane Width (ft)	12	12

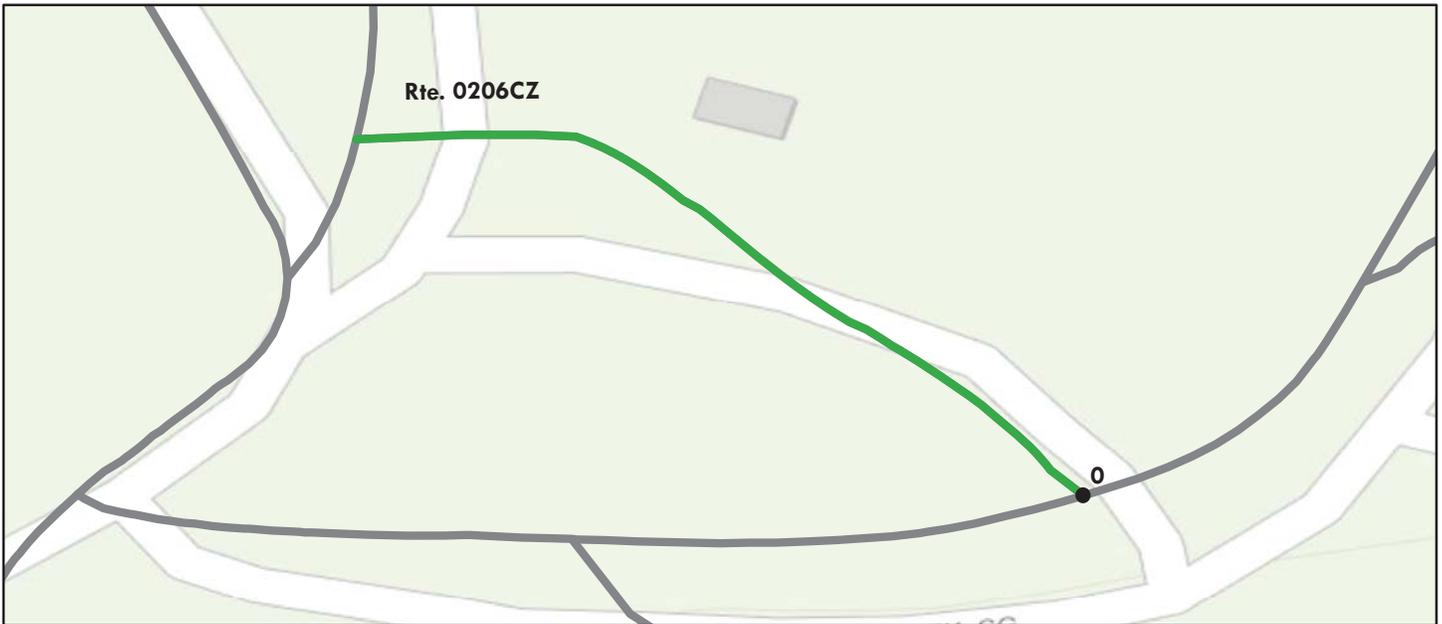
ROUTE 0206CZ: SHEEP CREEK CAMPGROUND ROAD C

Subcomponent of Route KICA-0206ZZ
Data Collection Vehicle (DCV) Rating

Route Condition Legend – Pavement Condition Rating (PCR)						
Poor (0 - 60)	Fair (61- 84)	Good (85 - 94)	Excellent (95 - 100)	Not Rated		
See Appendix for definitions and formulas						
Inspection Date: 5/28/2015	Beginning Section MP	0				
Paved Length (Miles): 0.07	Section Length (MI)	0.07				
Surface Type: ASPHALT	Route Summary					
Roadway Condition Information						
Pavement Condition Rating (PCR)	90	90				
Surface Condition Rating (SCR)	90	90				
Roughness Condition Index (RCI)	N/A	N/A				
Distress Index Values						
Structural Crack Index	99	99				
Alligator Crack Index	100	100				
Longitudinal Crack Index	99	99				
Transverse Cracking Index	90	90				
Patching Index	100	100				
Rutting Index	96	96				
International Roughness Index (IRI)	N/A	N/A				
Lane & Width Information						
Number of Lanes	1	1				
Paved Width (ft)	14.7	14.7				
Lane Width (ft)	14.7	14.7

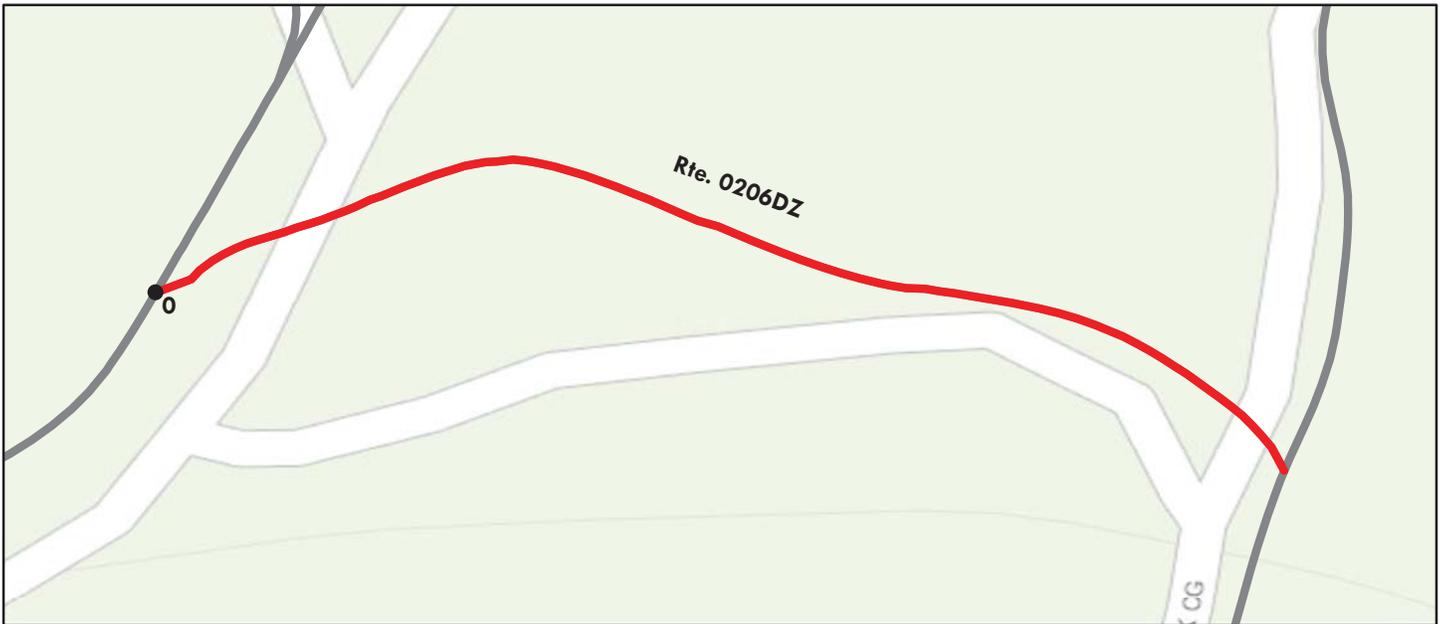
ROUTE 0206DZ: SHEEP CREEK CAMPGROUND ROAD D

Subcomponent of Route KICA-0206ZZ
Data Collection Vehicle (DCV) Rating

Route Condition Legend – Pavement Condition Rating (PCR)						
Poor (0 - 60)	Fair (61- 84)	Good (85 - 94)	Excellent (95 - 100)	Not Rated		
See Appendix for definitions and formulas						
Inspection Date: 5/28/2015	Beginning Section MP	0				
Paved Length (Miles): 0.08	Section Length (MI)	0.08				
Surface Type: ASPHALT	Route Summary					
Roadway Condition Information						
Pavement Condition Rating (PCR)	58	58				
Surface Condition Rating (SCR)	58	58				
Roughness Condition Index (RCI)	N/A	N/A				
Distress Index Values						
Structural Crack Index	92	92				
Alligator Crack Index	100	100				
Longitudinal Crack Index	92	92				
Transverse Cracking Index	58	58				
Patching Index	100	100				
Rutting Index	92	92				
International Roughness Index (IRI)	N/A	N/A				
Lane & Width Information						
Number of Lanes	1	1				
Paved Width (ft)	12.1	12.1				
Lane Width (ft)	12.1	12.1

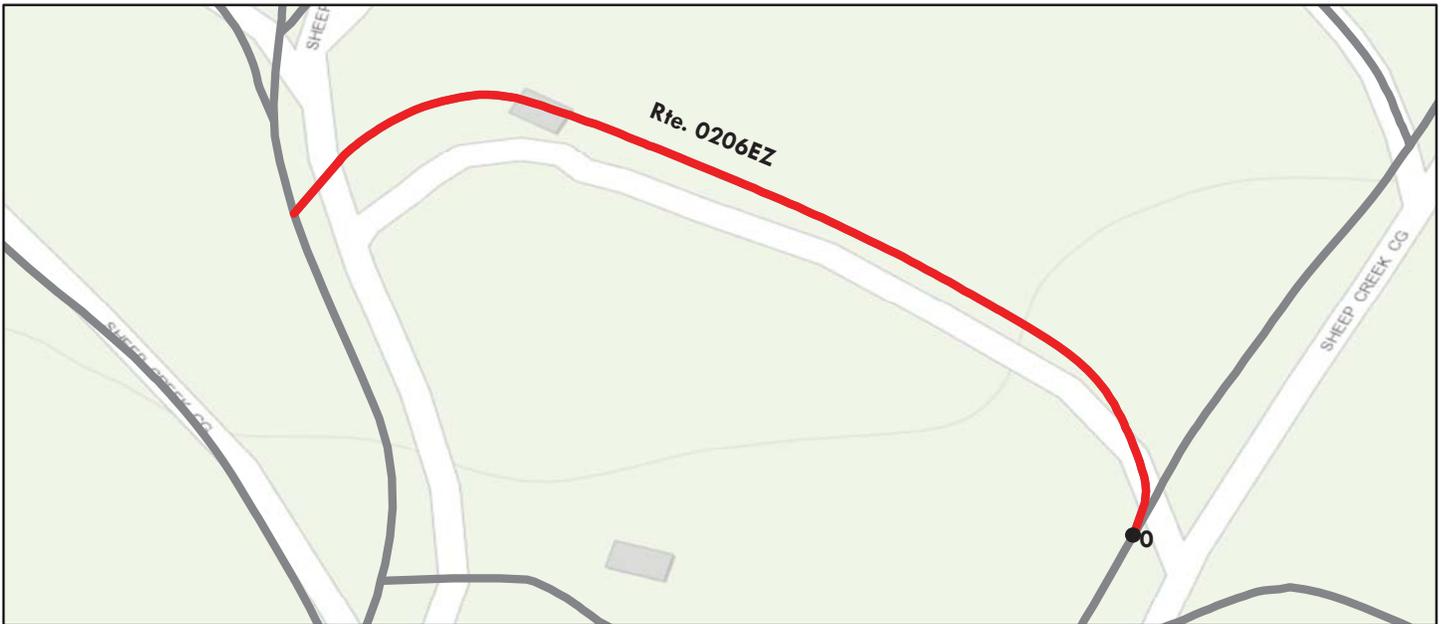
ROUTE 0206EZ: SHEEP CREEK CAMPGROUND ROAD E

Subcomponent of Route KICA-0206ZZ
Data Collection Vehicle (DCV) Rating

Route Condition Legend – Pavement Condition Rating (PCR)						
Poor (0 - 60)	Fair (61- 84)	Good (85 - 94)	Excellent (95 - 100)	Not Rated		
See Appendix for definitions and formulas						
Inspection Date: 5/28/2015	Beginning Section MP	0				
Paved Length (Miles): 0.11	Section Length (MI)	0.11				
Surface Type: ASPHALT	Route Summary					
Roadway Condition Information						
Pavement Condition Rating (PCR)	52	52				
Surface Condition Rating (SCR)	52	52				
Roughness Condition Index (RCI)	N/A	N/A				
Distress Index Values						
Structural Crack Index	94	94				
Alligator Crack Index	100	100				
Longitudinal Crack Index	94	94				
Transverse Cracking Index	52	52				
Patching Index	100	100				
Rutting Index	94	94				
International Roughness Index (IRI)	N/A	N/A				
Lane & Width Information						
Number of Lanes	1	1				
Paved Width (ft)	11.6	11.6				
Lane Width (ft)	11.6	11.6

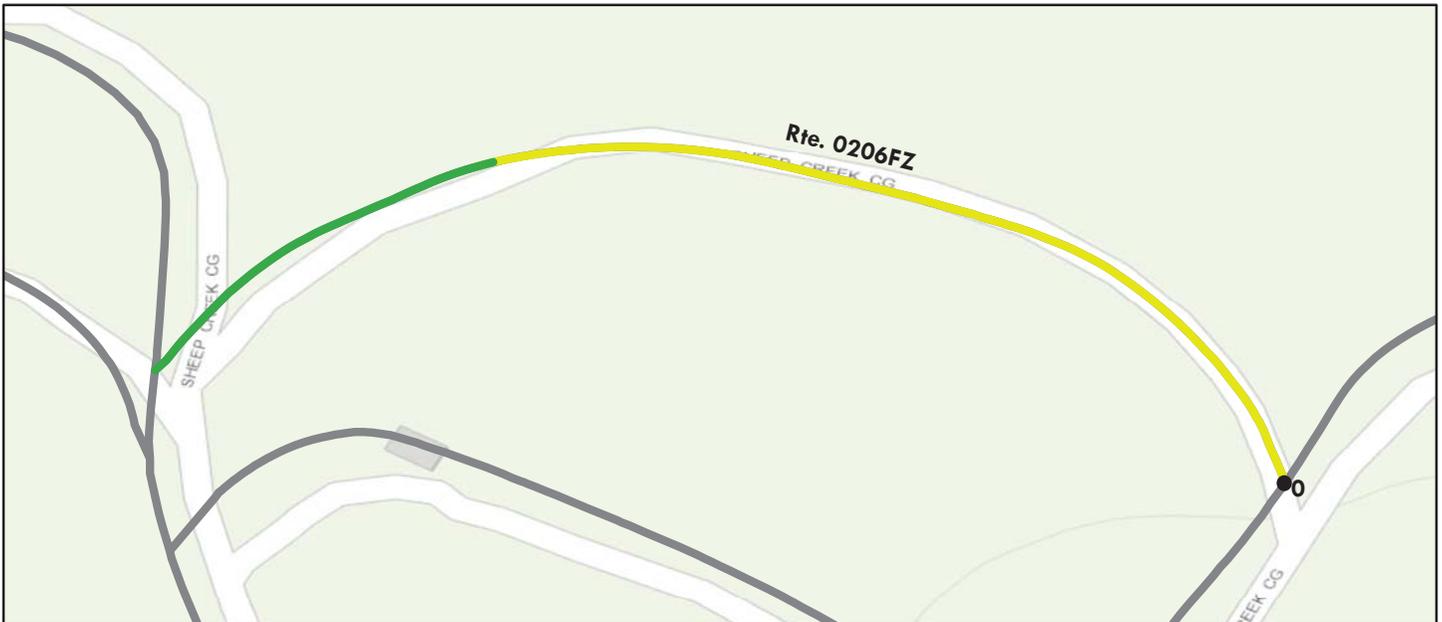
ROUTE 0206FZ: SHEEP CREEK CAMPGROUND ROAD F

Subcomponent of Route KICA-0206ZZ
Data Collection Vehicle (DCV) Rating

Route Condition Legend – Pavement Condition Rating (PCR)						
Poor (0 - 60)	Fair (61- 84)	Good (85 - 94)	Excellent (95 - 100)	Not Rated		
See Appendix for definitions and formulas						
Inspection Date: 5/28/2015	Beginning Section MP	0				
Paved Length (Miles): 0.14	Section Length (MI)	0.14				
Surface Type: ASPHALT	Route Summary					
Roadway Condition Information						
Pavement Condition Rating (PCR)	79	79				
Surface Condition Rating (SCR)	79	79				
Roughness Condition Index (RCI)	N/A	N/A				
Distress Index Values						
Structural Crack Index	97	97				
Alligator Crack Index	100	100				
Longitudinal Crack Index	97	97				
Transverse Cracking Index	79	79				
Patching Index	100	100				
Rutting Index	96	96				
International Roughness Index (IRI)	N/A	N/A				
Lane & Width Information						
Number of Lanes	1	1				
Paved Width (ft)	13.8	13.8				
Lane Width (ft)	13.8	13.8

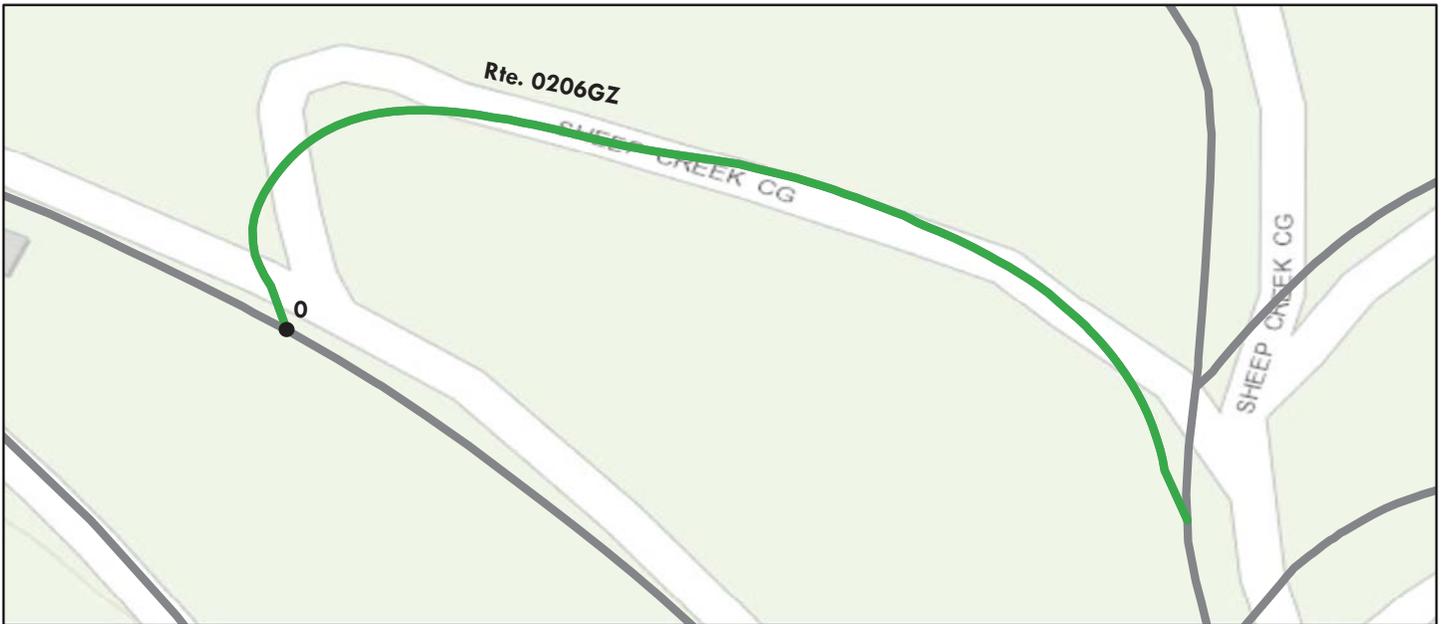
ROUTE 0206GZ: SHEEP CREEK CAMPGROUND ROAD G

Subcomponent of Route KICA-0206ZZ
Data Collection Vehicle (DCV) Rating

Route Condition Legend – Pavement Condition Rating (PCR)						
Poor (0 - 60)	Fair (61- 84)	Good (85 - 94)	Excellent (95 - 100)	Not Rated		
See Appendix for definitions and formulas						
Inspection Date: 5/28/2015	Beginning Section MP	0				
Paved Length (Miles): 0.09	Section Length (MI)	0.09				
Surface Type: ASPHALT	Route Summary					
Roadway Condition Information						
Pavement Condition Rating (PCR)	93	93				
Surface Condition Rating (SCR)	93	93				
Roughness Condition Index (RCI)	N/A	N/A				
Distress Index Values						
Structural Crack Index	96	96				
Alligator Crack Index	100	100				
Longitudinal Crack Index	96	96				
Transverse Cracking Index	93	93				
Patching Index	100	100				
Rutting Index	96	96				
International Roughness Index (IRI)	N/A	N/A				
Lane & Width Information						
Number of Lanes	1	1				
Paved Width (ft)	10.2	10.2				
Lane Width (ft)	10.2	10.2

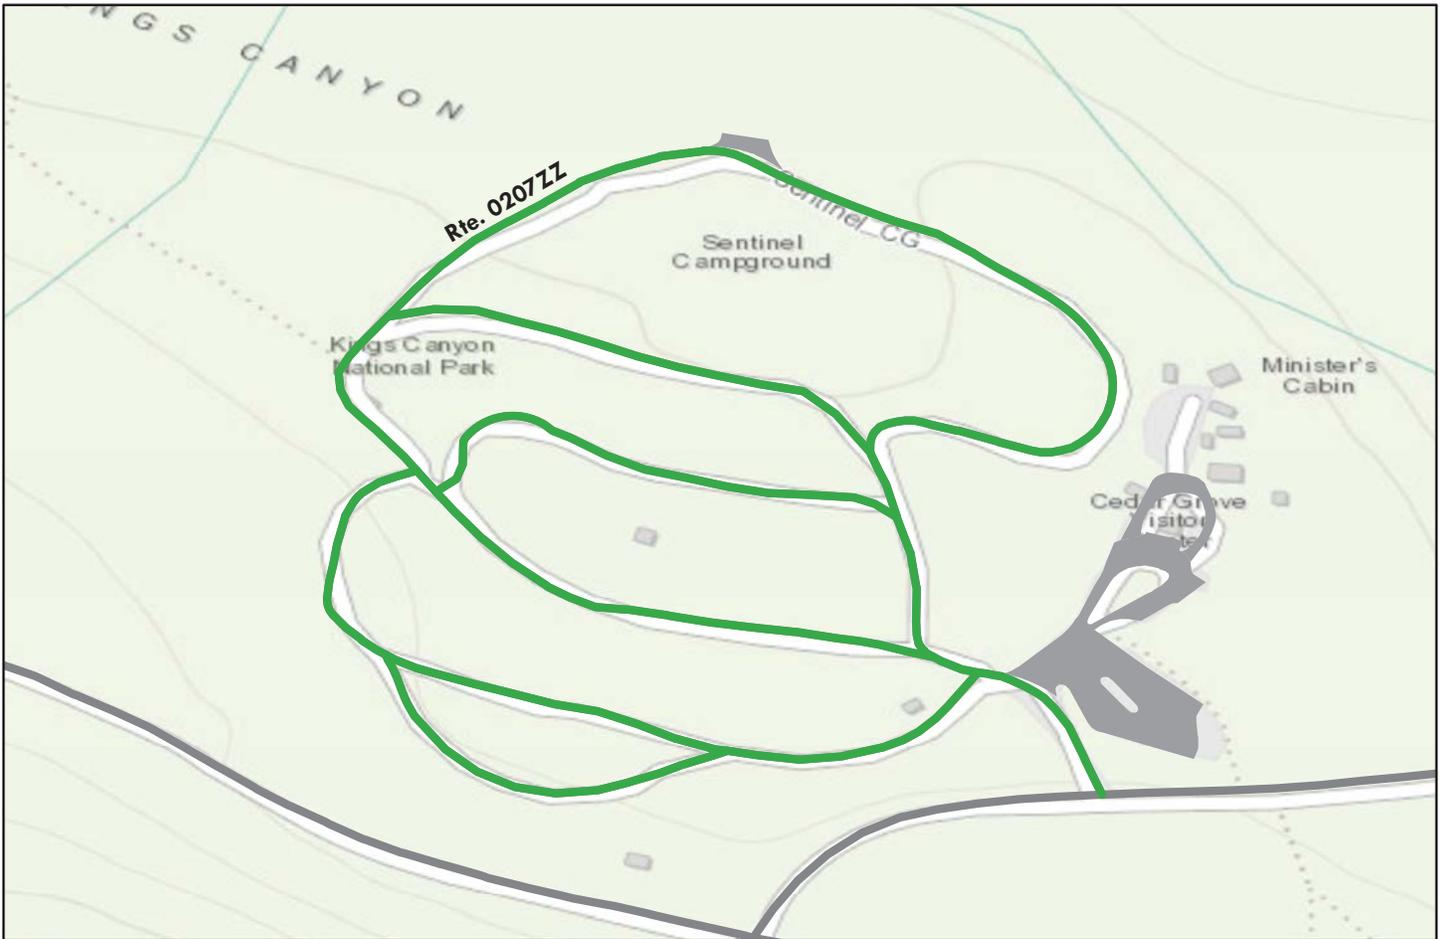
ROUTE 0207ZZ: SENTINEL CAMPGROUND ROADS

Summary Route

Note: The weighted average summary PCR value is calculated from only the sections of road where the PCR was collected. The overall PCR for the summary route may not reflect individual subcomponent ratings.

Route Condition Legend – Pavement Condition Rating (PCR)						
Poor (0 - 60)	Fair (61- 84)	Good (85 - 94)	Excellent (95 - 100)	Not Rated		
See Appendix for definitions and formulas						
Inspection Date: 5/28/2015						
Paved Length (Miles): 1.16						
Surface Type: ASPHALT	Route Summary					
Roadway Condition Information						
Pavement Condition Rating (PCR)	85					
Lane & Width Information						
Number of Lanes	1					
Paved Width (ft)	10.9					
Lane Width (ft)	10.9

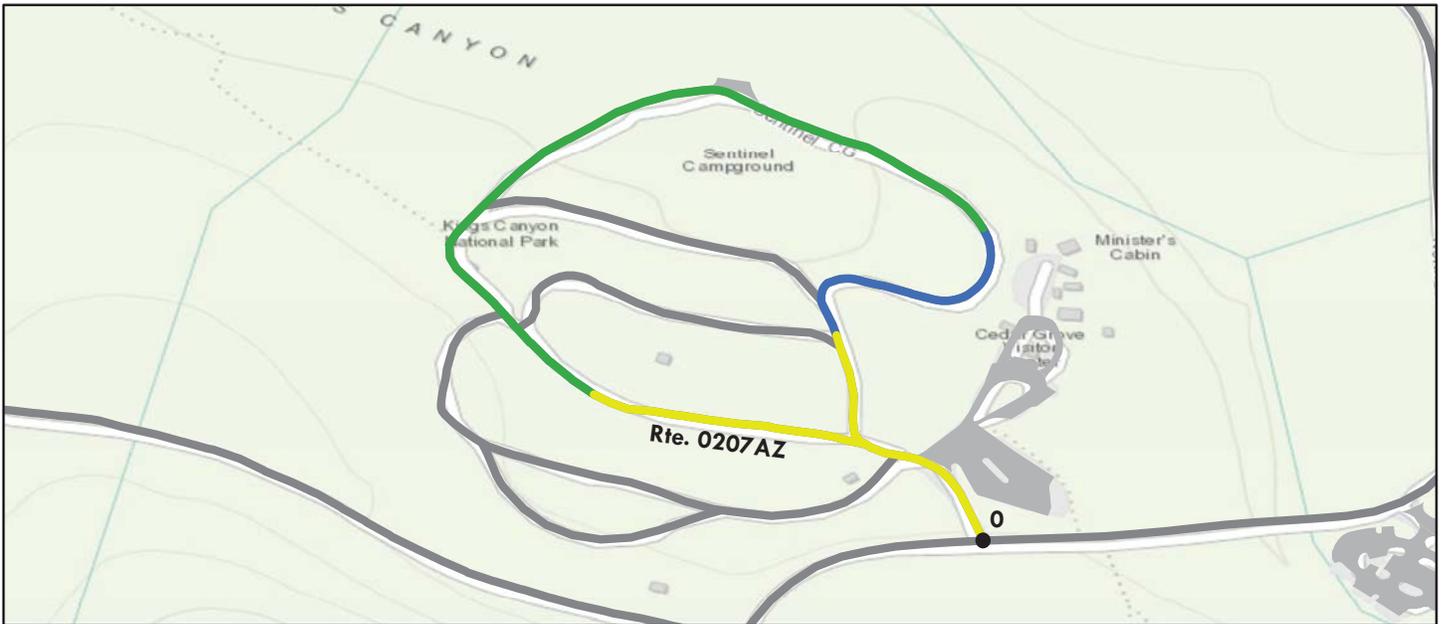
ROUTE 0207AZ: SENTINEL CAMPGROUND ROAD A

Subcomponent of Route KICA-0207ZZ
Data Collection Vehicle (DCV) Rating

Route Condition Legend – Pavement Condition Rating (PCR)						
Poor (0 - 60)	Fair (61- 84)	Good (85 - 94)	Excellent (95 - 100)	Not Rated		
See Appendix for definitions and formulas						
Inspection Date: 5/28/2015	Beginning Section MP	0				
Paved Length (Miles): 0.6	Section Length (MI)	0.6				
Surface Type: ASPHALT	Route Summary					
Roadway Condition Information						
Pavement Condition Rating (PCR)	88	88				
Surface Condition Rating (SCR)	88	88				
Roughness Condition Index (RCI)	N/A	N/A				
Distress Index Values						
Structural Crack Index	95	95				
Alligator Crack Index	100	100				
Longitudinal Crack Index	95	95				
Transverse Cracking Index	88	88				
Patching Index	100	100				
Rutting Index	93	93				
International Roughness Index (IRI)	N/A	N/A				
Lane & Width Information						
Number of Lanes	1	1				
Paved Width (ft)	11.8	11.8				
Lane Width (ft)	11.8	11.8

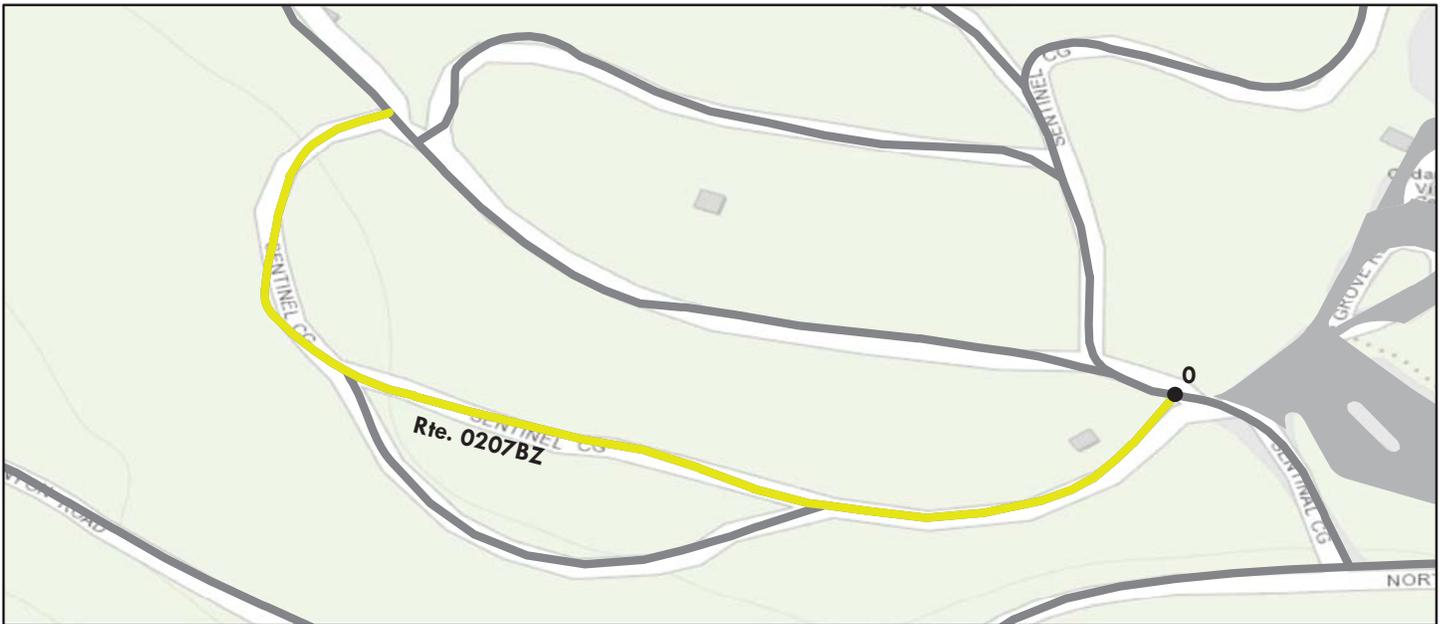
ROUTE 0207BZ: SENTINEL CAMPGROUND ROAD B

Subcomponent of Route KICA-0207ZZ
Data Collection Vehicle (DCV) Rating

Route Condition Legend – Pavement Condition Rating (PCR)						
Poor (0 - 60)	Fair (61- 84)	Good (85 - 94)	Excellent (95 - 100)	Not Rated		
See Appendix for definitions and formulas						
Inspection Date: 5/28/2015	Beginning Section MP	0				
Paved Length (Miles): 0.22	Section Length (MI)	0.22				
Surface Type: ASPHALT	Route Summary					
Roadway Condition Information						
Pavement Condition Rating (PCR)	74	74				
Surface Condition Rating (SCR)	74	74				
Roughness Condition Index (RCI)	N/A	N/A				
Distress Index Values						
Structural Crack Index	89	89				
Alligator Crack Index	100	100				
Longitudinal Crack Index	89	89				
Transverse Cracking Index	74	74				
Patching Index	100	100				
Rutting Index	92	92				
International Roughness Index (IRI)	N/A	N/A				
Lane & Width Information						
Number of Lanes	1	1				
Paved Width (ft)	11.6	11.6				
Lane Width (ft)	11.6	11.6

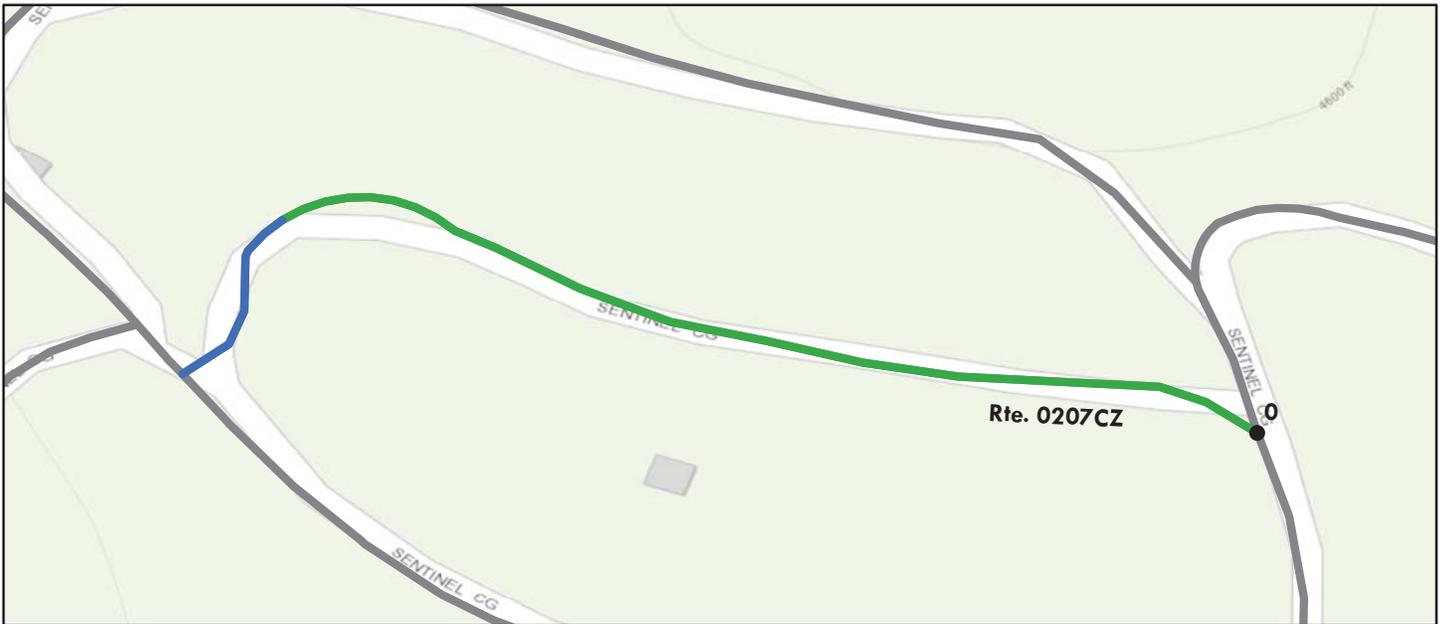
ROUTE 0207CZ: SENTINEL CAMPGROUND ROAD C

Subcomponent of Route KICA-0207ZZ
Data Collection Vehicle (DCV) Rating

Route Condition Legend – Pavement Condition Rating (PCR)						
Poor (0 - 60)	Fair (61- 84)	Good (85 - 94)	Excellent (95 - 100)	Not Rated		
See Appendix for definitions and formulas						
Inspection Date: 5/28/2015	Beginning Section MP	0				
Paved Length (Miles): 0.12	Section Length (MI)	0.12				
Surface Type: ASPHALT	Route Summary					
Roadway Condition Information						
Pavement Condition Rating (PCR)	92	92				
Surface Condition Rating (SCR)	92	92				
Roughness Condition Index (RCI)	N/A	N/A				
Distress Index Values						
Structural Crack Index	99	99				
Alligator Crack Index	100	100				
Longitudinal Crack Index	99	99				
Transverse Cracking Index	99	99				
Patching Index	100	100				
Rutting Index	92	92				
International Roughness Index (IRI)	N/A	N/A				
Lane & Width Information						
Number of Lanes	1	1				
Paved Width (ft)	9.5	9.5				
Lane Width (ft)	9.5	9.5

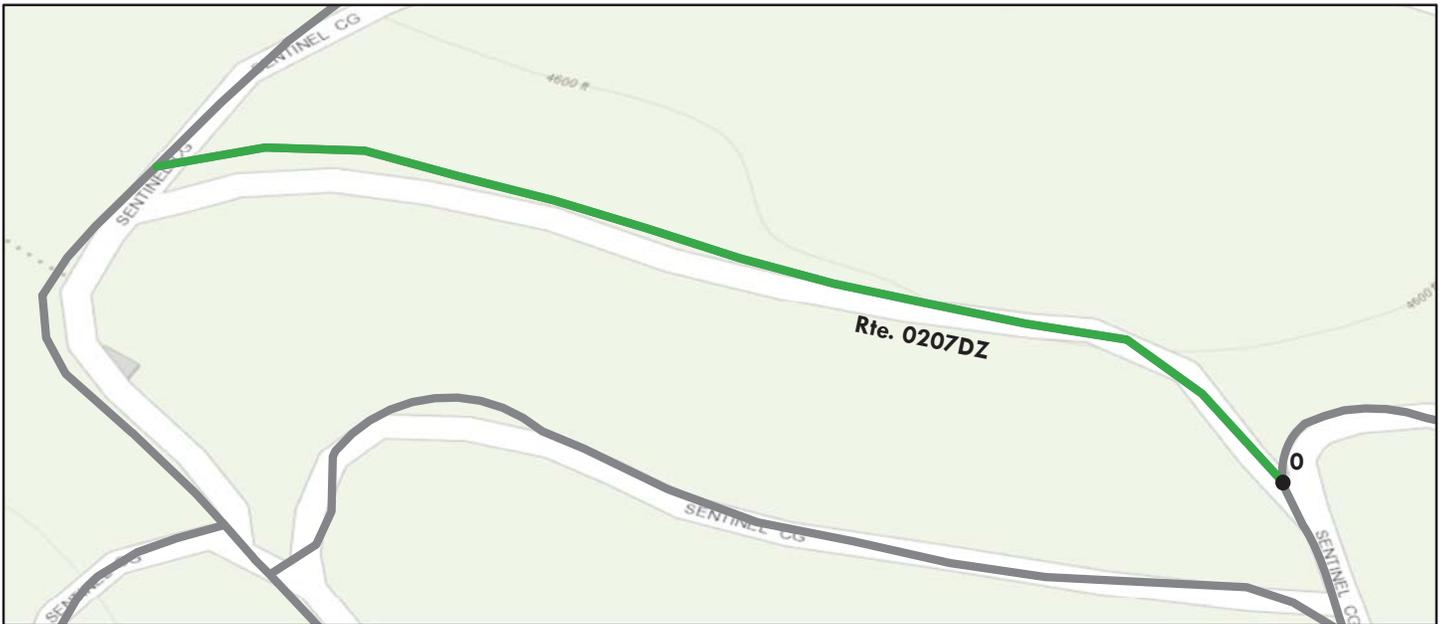
ROUTE 0207DZ: SENTINEL CAMPGROUND ROAD D

Subcomponent of Route KICA-0207ZZ
Data Collection Vehicle (DCV) Rating

Route Condition Legend – Pavement Condition Rating (PCR)						
Poor (0 - 60)	Fair (61- 84)	Good (85 - 94)	Excellent (95 - 100)	Not Rated		
See Appendix for definitions and formulas						
Inspection Date: 5/28/2015	Beginning Section MP	0				
Paved Length (Miles): 0.12	Section Length (MI)	0.12				
Surface Type: ASPHALT	Route Summary					
Roadway Condition Information						
Pavement Condition Rating (PCR)	93	93				
Surface Condition Rating (SCR)	93	93				
Roughness Condition Index (RCI)	N/A	N/A				
Distress Index Values						
Structural Crack Index	99	99				
Alligator Crack Index	100	100				
Longitudinal Crack Index	99	99				
Transverse Cracking Index	100	100				
Patching Index	100	100				
Rutting Index	93	93				
International Roughness Index (IRI)	N/A	N/A				
Lane & Width Information						
Number of Lanes	1	1				
Paved Width (ft)	8.8	8.8				
Lane Width (ft)	8.8	8.8

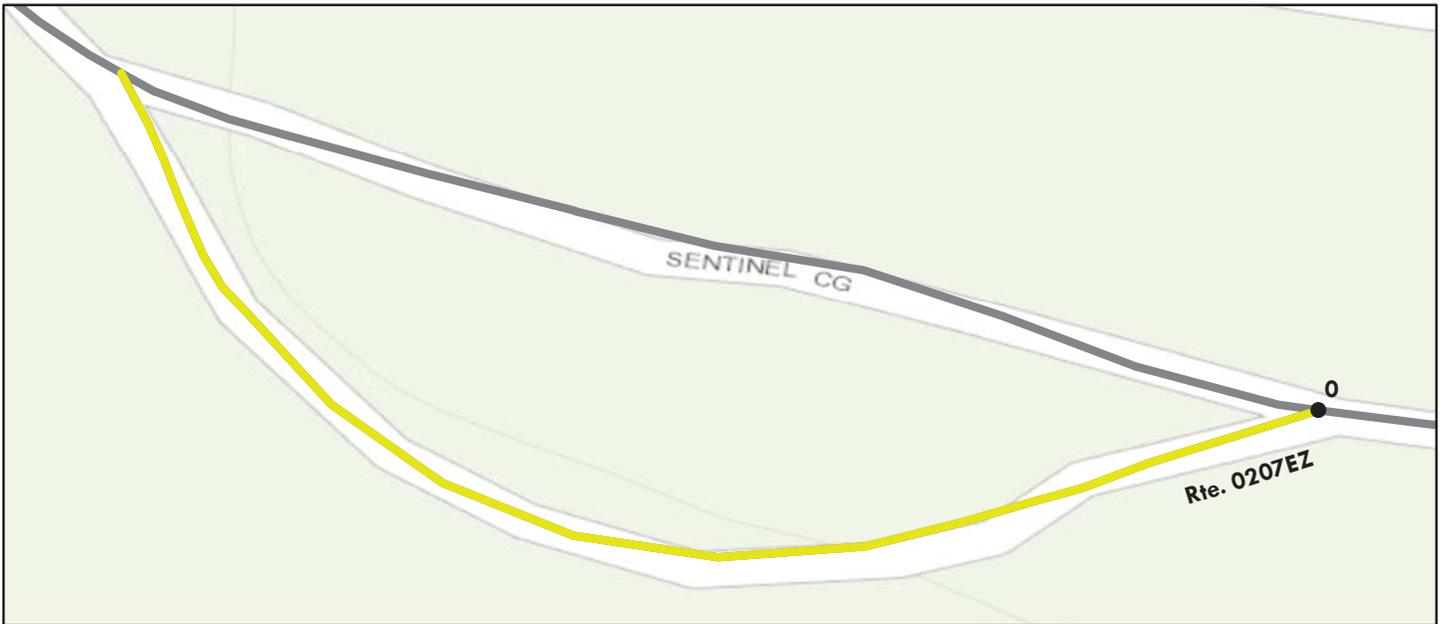
ROUTE 0207EZ: SENTINEL CAMPGROUND ROAD E

Subcomponent of Route KICA-0207ZZ
Data Collection Vehicle (DCV) Rating

Route Condition Legend – Pavement Condition Rating (PCR)						
Poor (0 - 60)	Fair (61- 84)	Good (85 - 94)	Excellent (95 - 100)	Not Rated		
See Appendix for definitions and formulas						
Inspection Date: 5/28/2015	Beginning Section MP	0				
Paved Length (Miles): 0.1	Section Length (MI)	0.1				
Surface Type: ASPHALT	Route Summary					
Roadway Condition Information						
Pavement Condition Rating (PCR)	66	66				
Surface Condition Rating (SCR)	66	66				
Roughness Condition Index (RCI)	N/A	N/A				
Distress Index Values						
Structural Crack Index	93	93				
Alligator Crack Index	100	100				
Longitudinal Crack Index	93	93				
Transverse Cracking Index	66	66				
Patching Index	100	100				
Rutting Index	92	92				
International Roughness Index (IRI)	N/A	N/A				
Lane & Width Information						
Number of Lanes	1	1				
Paved Width (ft)	8.4	8.4				
Lane Width (ft)	8.4	8.4

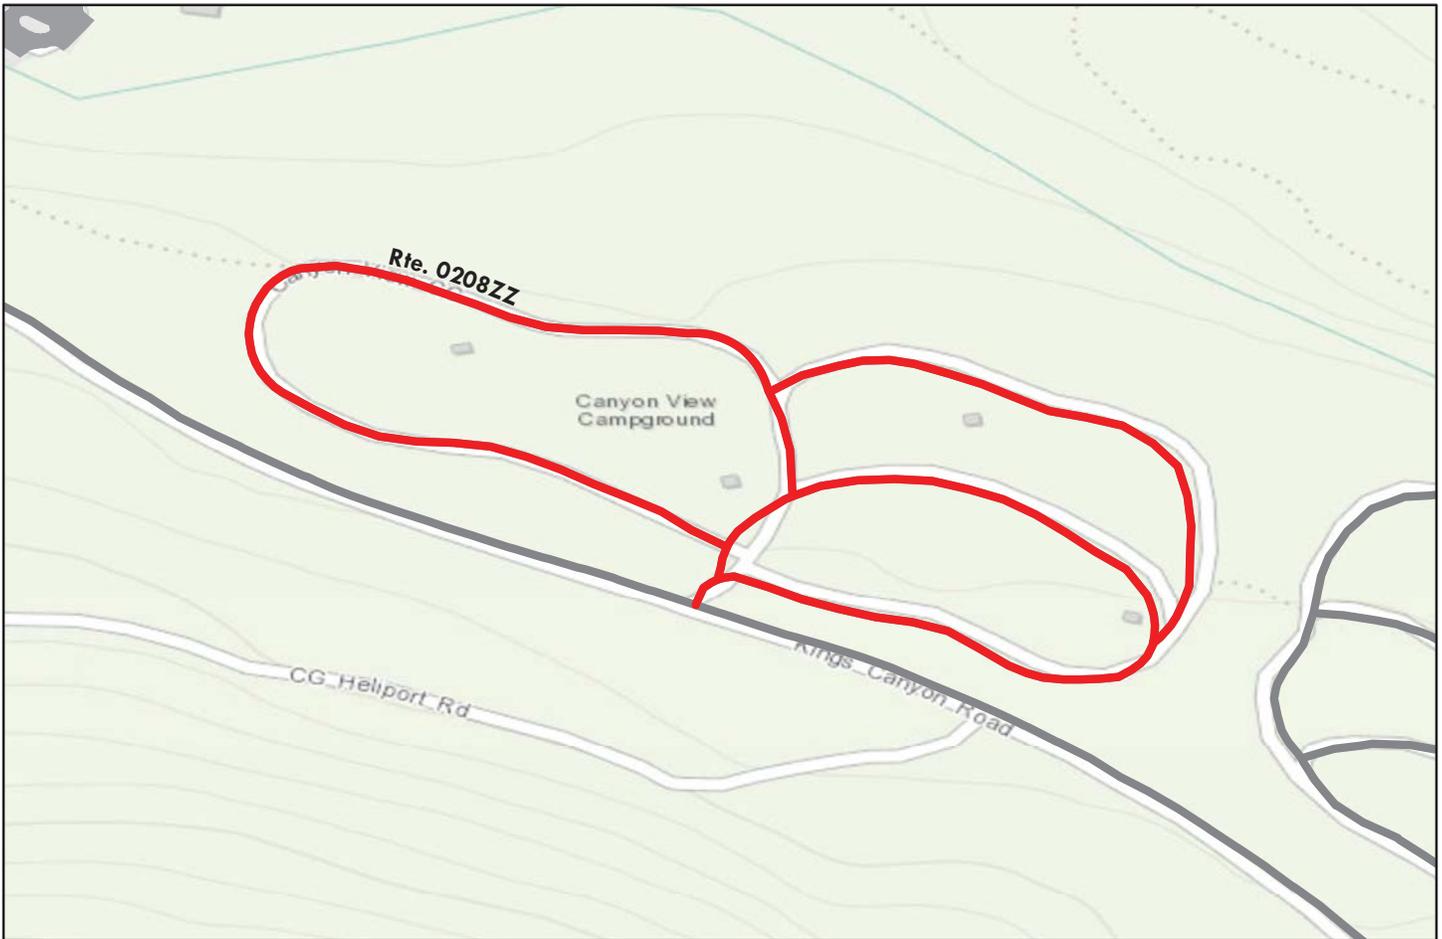
ROUTE 0208ZZ: CANYON VIEW CAMPGROUND ROADS

Summary Route

Note: The weighted average summary PCR value is calculated from only the sections of road where the PCR was collected. The overall PCR for the summary route may not reflect individual subcomponent ratings.

Route Condition Legend – Pavement Condition Rating (PCR)						
Poor (0 - 60)	Fair (61- 84)	Good (85 - 94)	Excellent (95 - 100)	Not Rated		
See Appendix for definitions and formulas						
Inspection Date: 5/28/2015						
Paved Length (Miles): 0.84						
Surface Type: ASPHALT	Route Summary					
Roadway Condition Information						
Pavement Condition Rating (PCR)	49					
Lane & Width Information						
Number of Lanes	1					
Paved Width (ft)	10.1					
Lane Width (ft)	10.1

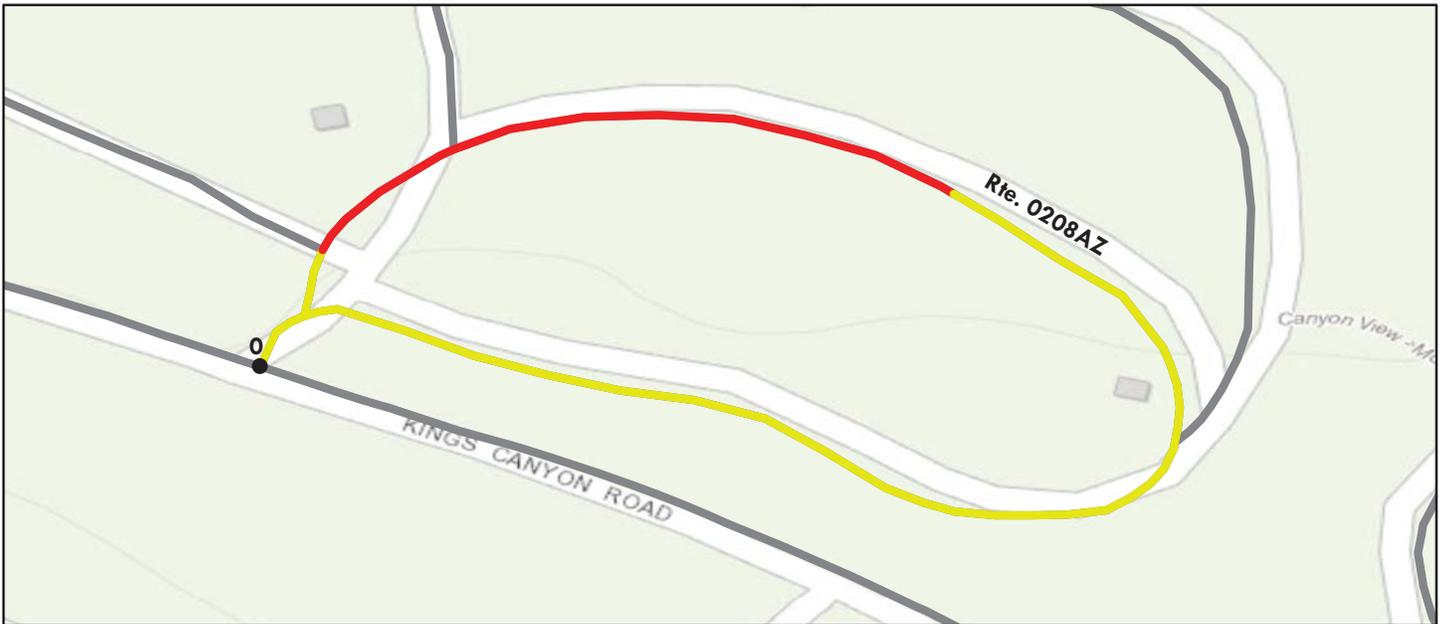
ROUTE 0208AZ: CANYON VIEW CAMPGROUND ROAD A

Subcomponent of Route KICA-0208ZZ
Data Collection Vehicle (DCV) Rating

Route Condition Legend – Pavement Condition Rating (PCR)						
Poor (0 - 60)	Fair (61- 84)	Good (85 - 94)	Excellent (95 - 100)	Not Rated		
See Appendix for definitions and formulas						
Inspection Date: 5/28/2015	Beginning Section MP	0				
Paved Length (Miles): 0.31	Section Length (MI)	0.31				
Surface Type: ASPHALT	Route Summary					
Roadway Condition Information						
Pavement Condition Rating (PCR)	63	63				
Surface Condition Rating (SCR)	63	63				
Roughness Condition Index (RCI)	N/A	N/A				
Distress Index Values						
Structural Crack Index	74	74				
Alligator Crack Index	100	100				
Longitudinal Crack Index	74	74				
Transverse Cracking Index	94	94				
Patching Index	98	98				
Rutting Index	63	63				
International Roughness Index (IRI)	N/A	N/A				
Lane & Width Information						
Number of Lanes	1	1				
Paved Width (ft)	9.9	9.9				
Lane Width (ft)	9.9	9.9

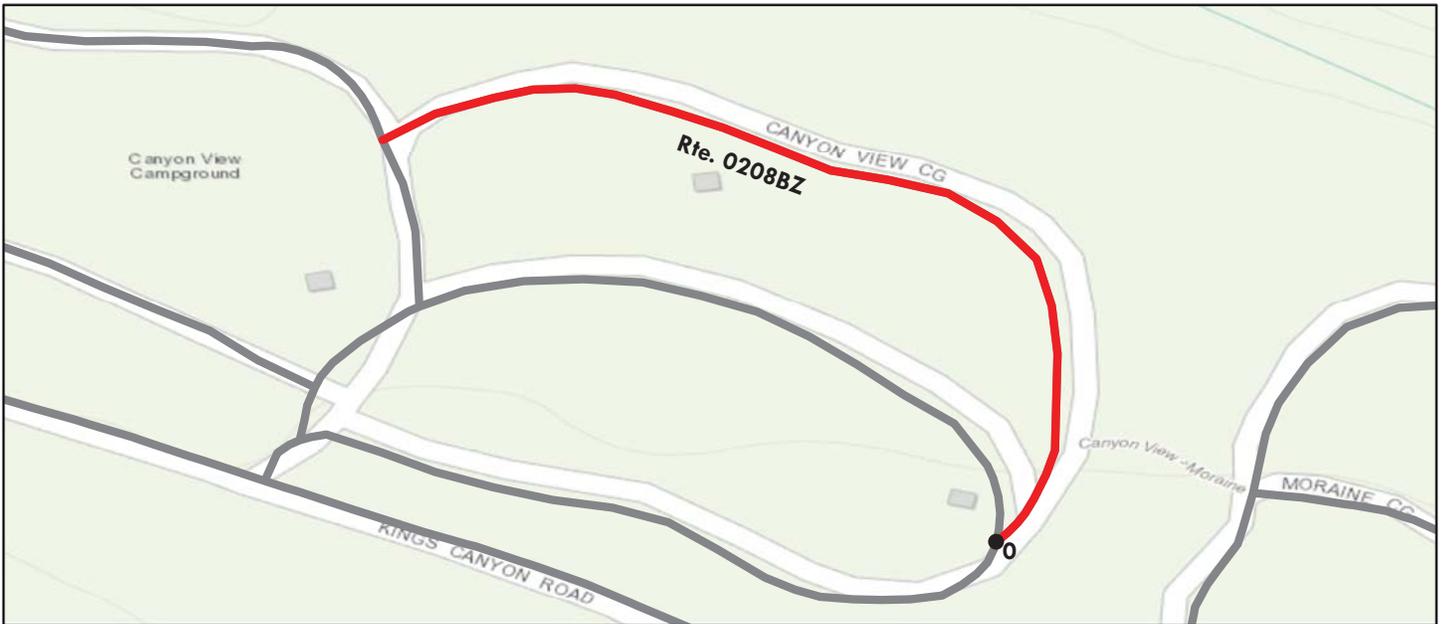
ROUTE 0208BZ: CANYON VIEW CAMPGROUND ROAD B

Subcomponent of Route KICA-0208ZZ
Data Collection Vehicle (DCV) Rating

Route Condition Legend – Pavement Condition Rating (PCR)						
Poor (0 - 60)	Fair (61- 84)	Good (85 - 94)	Excellent (95 - 100)	Not Rated		
See Appendix for definitions and formulas						
Inspection Date: 5/28/2015	Beginning Section MP	0				
Paved Length (Miles): 0.18	Section Length (MI)	0.18				
Surface Type: ASPHALT	Route Summary					
Roadway Condition Information						
Pavement Condition Rating (PCR)	54	54				
Surface Condition Rating (SCR)	54	54				
Roughness Condition Index (RCI)	N/A	N/A				
Distress Index Values						
Structural Crack Index	57	57				
Alligator Crack Index	98	98				
Longitudinal Crack Index	59	59				
Transverse Cracking Index	91	91				
Patching Index	93	93				
Rutting Index	54	54				
International Roughness Index (IRI)	N/A	N/A				
Lane & Width Information						
Number of Lanes	1	1				
Paved Width (ft)	10.5	10.5				
Lane Width (ft)	10.5	10.5

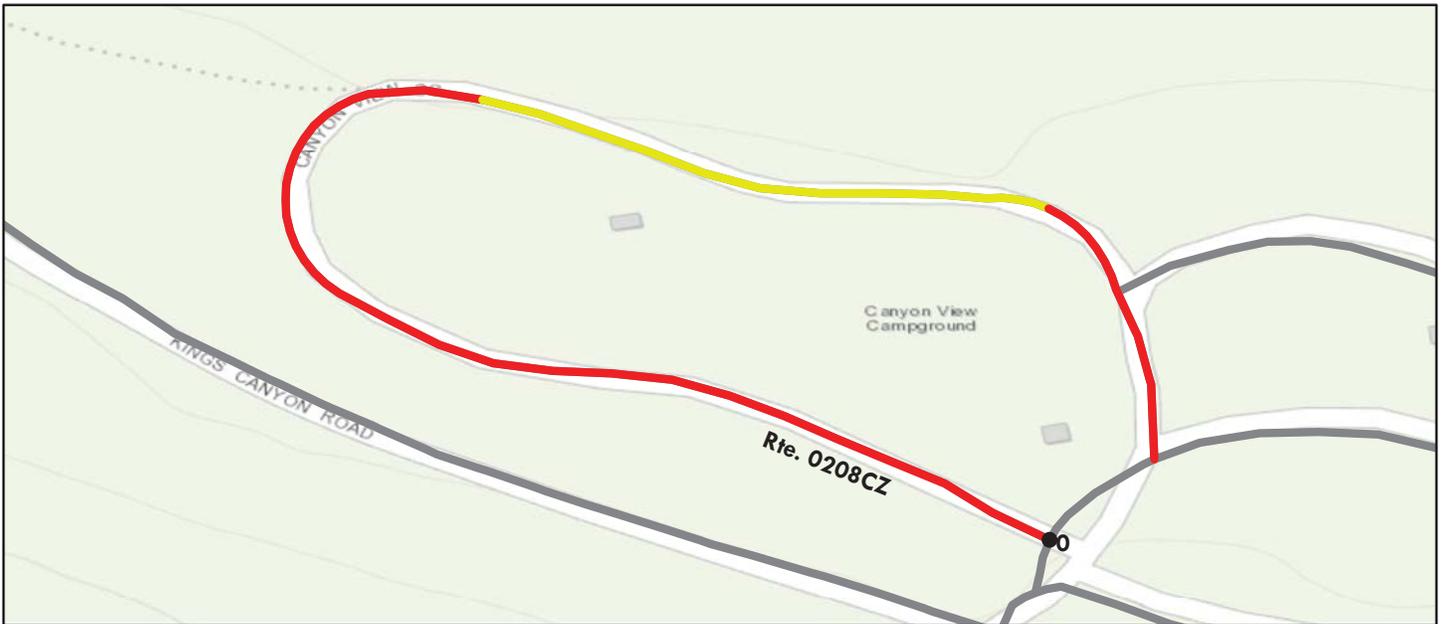
ROUTE 0208CZ: CANYON VIEW CAMPGROUND ROAD C

Subcomponent of Route KICA-0208ZZ
Data Collection Vehicle (DCV) Rating

Route Condition Legend – Pavement Condition Rating (PCR)						
Poor (0 - 60)	Fair (61- 84)	Good (85 - 94)	Excellent (95 - 100)	Not Rated		
See Appendix for definitions and formulas						
Inspection Date: 5/28/2015	Beginning Section MP	0				
Paved Length (Miles): 0.35	Section Length (MI)	0.35				
Surface Type: ASPHALT	Route Summary					
Roadway Condition Information						
Pavement Condition Rating (PCR)	35	35				
Surface Condition Rating (SCR)	66	66				
Roughness Condition Index (RCI)	N/A	N/A				
Distress Index Values						
Structural Crack Index	84	84				
Alligator Crack Index	100	100				
Longitudinal Crack Index	84	84				
Transverse Cracking Index	97	97				
Patching Index	99	99				
Rutting Index	66	66				
International Roughness Index (IRI)	N/A	N/A				
Lane & Width Information						
Number of Lanes	1	1				
Paved Width (ft)	10	10				
Lane Width (ft)	10	10

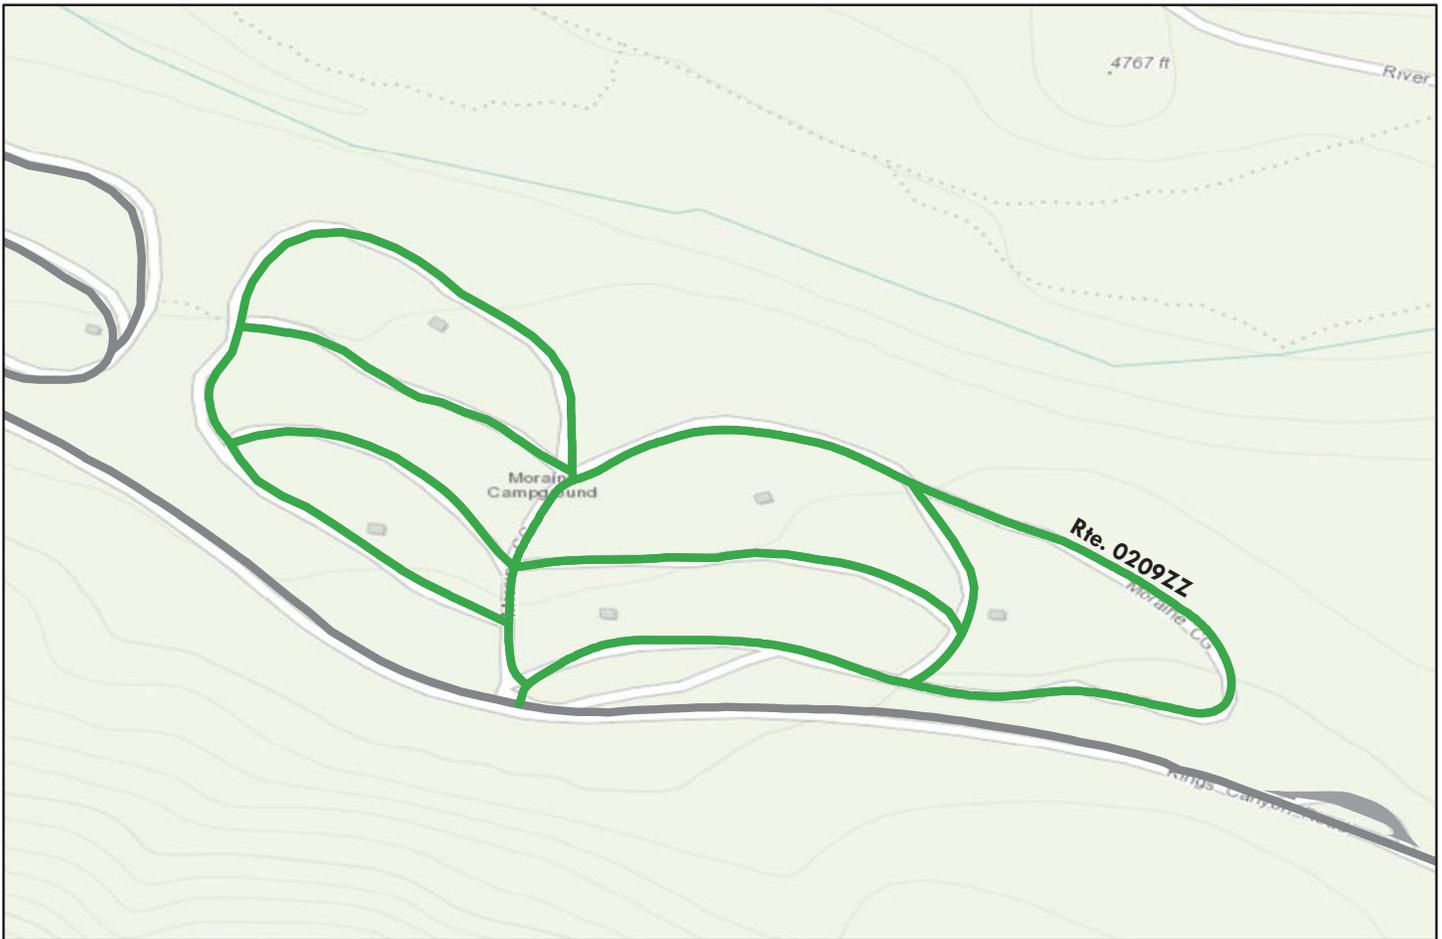
ROUTE 0209ZZ: MORAINES CAMPGROUND ROADS

Summary Route

Note: The weighted average summary PCR value is calculated from only the sections of road where the PCR was collected. The overall PCR for the summary route may not reflect individual subcomponent ratings.

Route Condition Legend – Pavement Condition Rating (PCR)						
Poor (0 - 60)	Fair (61- 84)	Good (85 - 94)	Excellent (95 - 100)	Not Rated		
See Appendix for definitions and formulas						
Inspection Date: 5/28/2015						
Paved Length (Miles): 1.49						
Surface Type: ASPHALT	Route Summary					
Roadway Condition Information						
Pavement Condition Rating (PCR)	91					
Lane & Width Information						
Number of Lanes	1					
Paved Width (ft)	12.5					
Lane Width (ft)	12.4
