KICA Cycle 6

Final Report

Road Inventory and Condition Assessment of Paved Routes Kings Canyon National Park

**Federal Highway Administration
Eastern Federal Lands Highway Division
Road Inventory Program (RIP)**

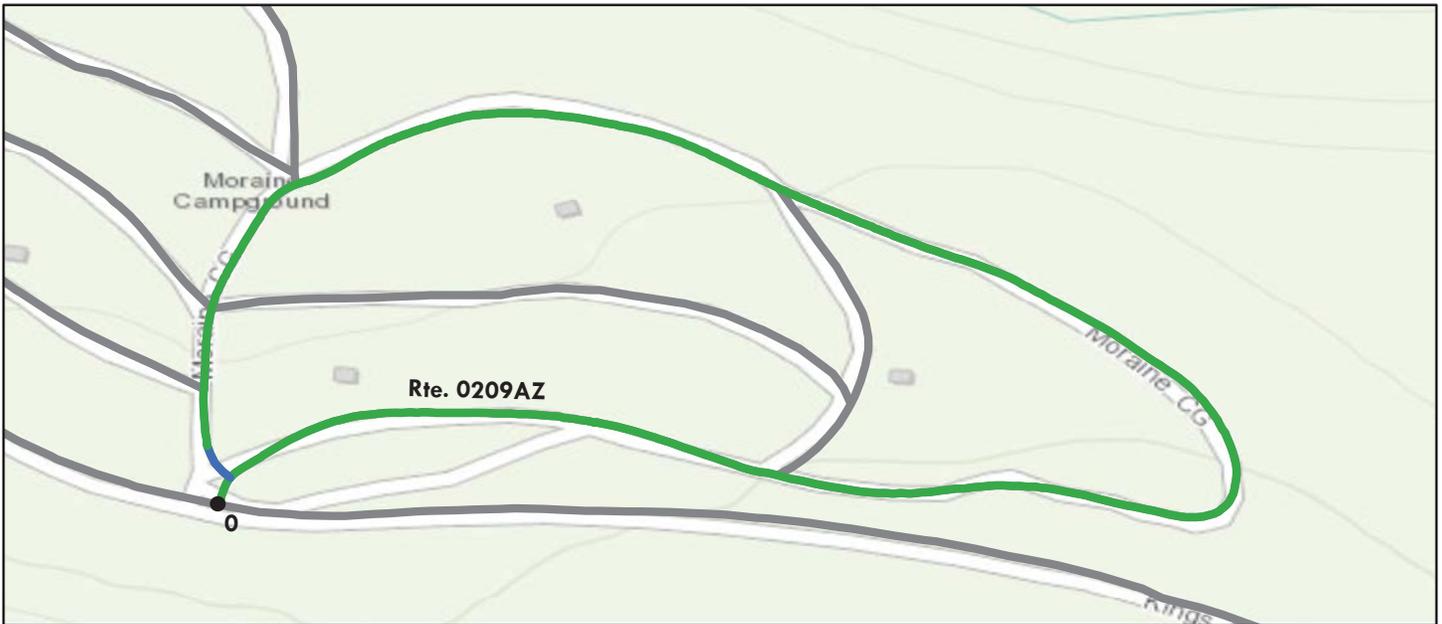
ROUTE 0209AZ: MORAINE CAMPGROUND ROAD A

Subcomponent of Route KICA-0209ZZ
Data Collection Vehicle (DCV) Rating

Route Condition Legend – Pavement Condition Rating (PCR)						
Poor (0 - 60)	Fair (61- 84)	Good (85 - 94)	Excellent (95 - 100)	Not Rated		
See Appendix for definitions and formulas						
Inspection Date: 5/28/2015	Beginning Section MP	0				
Paved Length (Miles): 0.61	Section Length (MI)	0.61				
Surface Type: ASPHALT	Route Summary					
Roadway Condition Information						
Pavement Condition Rating (PCR)	92	92				
Surface Condition Rating (SCR)	92	92				
Roughness Condition Index (RCI)	N/A	N/A				
Distress Index Values						
Structural Crack Index	99	99				
Alligator Crack Index	100	100				
Longitudinal Crack Index	99	99				
Transverse Cracking Index	92	92				
Patching Index	100	100				
Rutting Index	93	93				
International Roughness Index (IRI)	N/A	N/A				
Lane & Width Information						
Number of Lanes	1	1				
Paved Width (ft)	13.2	13.2				
Lane Width (ft)	13	13

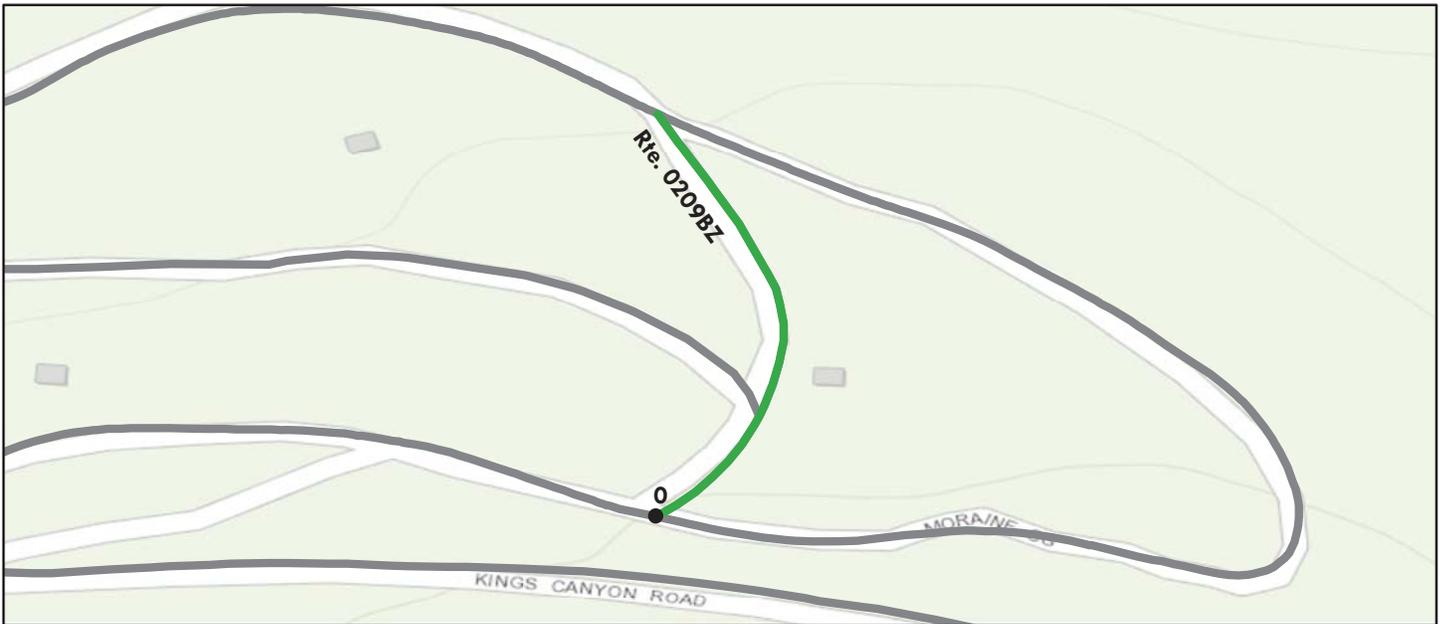
ROUTE 0209BZ: MORaine CAMPGROUND ROAD B

Subcomponent of Route KICA-0209ZZ
Data Collection Vehicle (DCV) Rating

Route Condition Legend – Pavement Condition Rating (PCR)						
Poor (0 - 60)	Fair (61- 84)	Good (85 - 94)	Excellent (95 - 100)	Not Rated		
See Appendix for definitions and formulas						
Inspection Date: 5/28/2015	Beginning Section MP	0				
Paved Length (Miles): 0.1	Section Length (MI)	0.1				
Surface Type: ASPHALT	Route Summary					
Roadway Condition Information						
Pavement Condition Rating (PCR)	92	92				
Surface Condition Rating (SCR)	92	92				
Roughness Condition Index (RCI)	N/A	N/A				
Distress Index Values						
Structural Crack Index	98	98				
Alligator Crack Index	100	100				
Longitudinal Crack Index	98	98				
Transverse Cracking Index	96	96				
Patching Index	100	100				
Rutting Index	92	92				
International Roughness Index (IRI)	N/A	N/A				
Lane & Width Information						
Number of Lanes	1	1				
Paved Width (ft)	11.7	11.7				
Lane Width (ft)	11.7	11.7

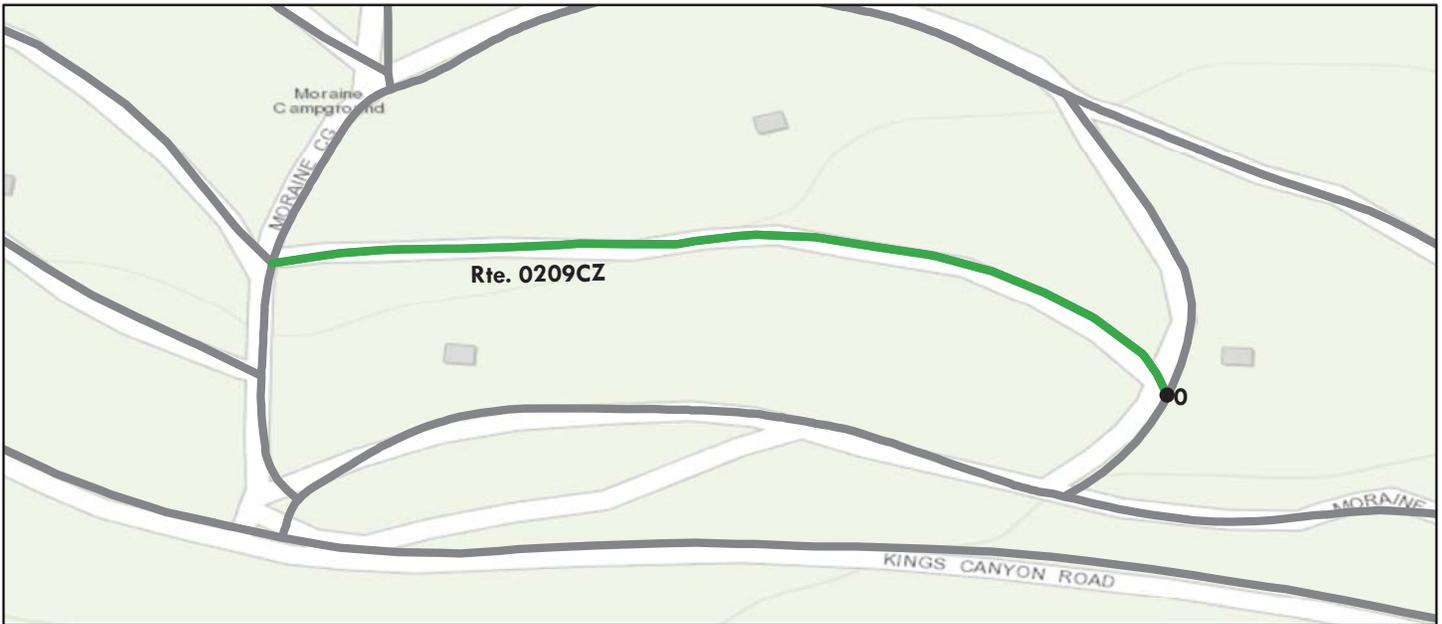
ROUTE 0209CZ: MORaine CAMPGROUND ROAD C

Subcomponent of Route KICA-0209ZZ
Data Collection Vehicle (DCV) Rating

Route Condition Legend – Pavement Condition Rating (PCR)						
Poor (0 - 60)	Fair (61- 84)	Good (85 - 94)	Excellent (95 - 100)	Not Rated		
See Appendix for definitions and formulas						
Inspection Date: 5/28/2015	Beginning Section MP	0				
Paved Length (Miles): 0.16	Section Length (MI)	0.16				
Surface Type: ASPHALT	Route Summary					
Roadway Condition Information						
Pavement Condition Rating (PCR)	93	93				
Surface Condition Rating (SCR)	93	93				
Roughness Condition Index (RCI)	N/A	N/A				
Distress Index Values						
Structural Crack Index	99	99				
Alligator Crack Index	100	100				
Longitudinal Crack Index	99	99				
Transverse Cracking Index	97	97				
Patching Index	100	100				
Rutting Index	93	93				
International Roughness Index (IRI)	N/A	N/A				
Lane & Width Information						
Number of Lanes	1	1				
Paved Width (ft)	12.1	12.1				
Lane Width (ft)	12.1	12.1

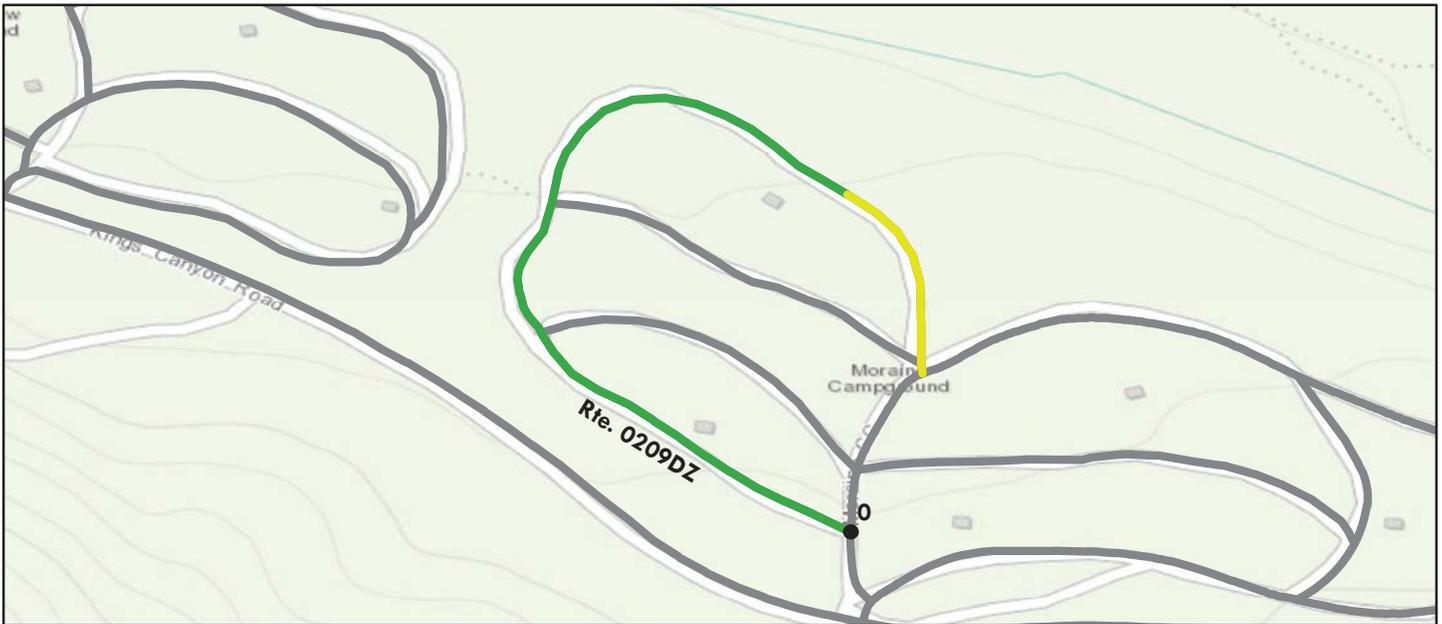
ROUTE 0209DZ: MORaine CAMPGROUND ROAD D

Subcomponent of Route KICA-0209ZZ
Data Collection Vehicle (DCV) Rating

Route Condition Legend – Pavement Condition Rating (PCR)						
Poor (0 - 60)	Fair (61- 84)	Good (85 - 94)	Excellent (95 - 100)	Not Rated		
See Appendix for definitions and formulas						
Inspection Date: 5/28/2015	Beginning Section MP	0				
Paved Length (Miles): 0.37	Section Length (MI)	0.37				
Surface Type: ASPHALT	Route Summary					
Roadway Condition Information						
Pavement Condition Rating (PCR)	88	88				
Surface Condition Rating (SCR)	88	88				
Roughness Condition Index (RCI)	N/A	N/A				
Distress Index Values						
Structural Crack Index	98	98				
Alligator Crack Index	100	100				
Longitudinal Crack Index	98	98				
Transverse Cracking Index	88	88				
Patching Index	100	100				
Rutting Index	94	94				
International Roughness Index (IRI)	N/A	N/A				
Lane & Width Information						
Number of Lanes	1	1				
Paved Width (ft)	12.6	12.6				
Lane Width (ft)	12.6	12.6

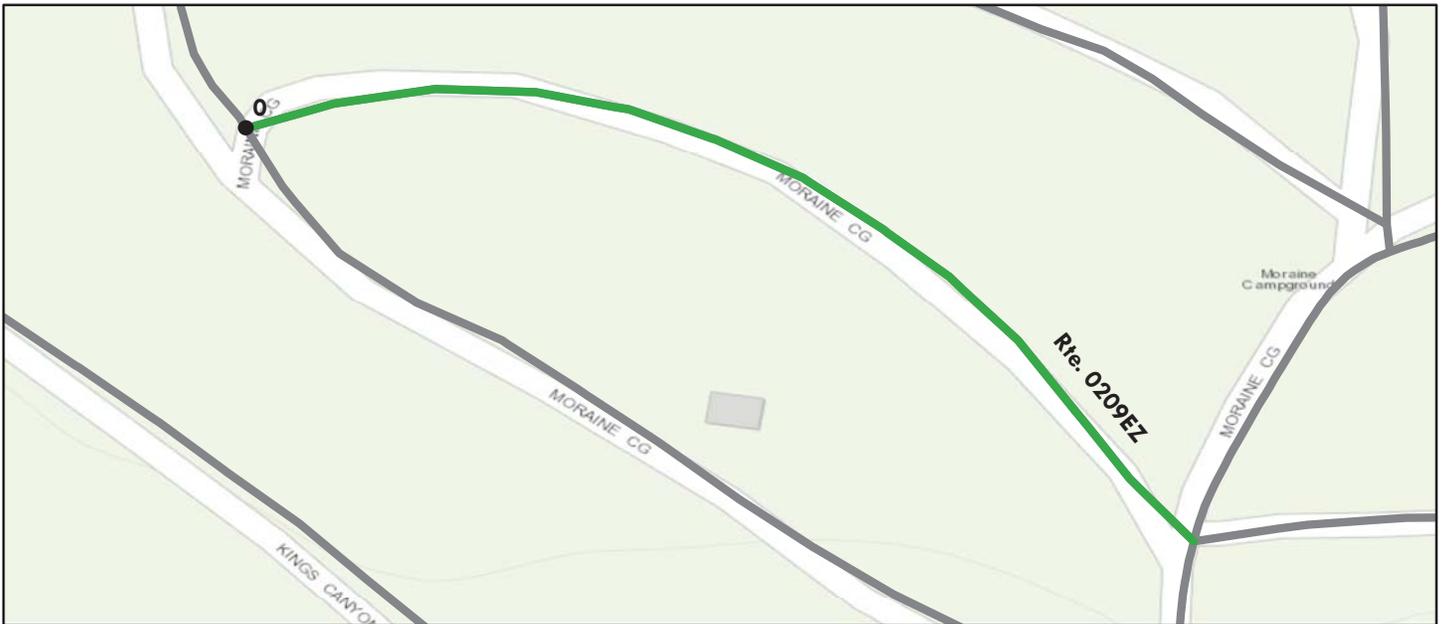
ROUTE 0209EZ: MORaine CAMPGROUND ROAD E

Subcomponent of Route KICA-0209ZZ
Data Collection Vehicle (DCV) Rating

Route Condition Legend – Pavement Condition Rating (PCR)						
Poor (0 - 60)	Fair (61- 84)	Good (85 - 94)	Excellent (95 - 100)	Not Rated		
See Appendix for definitions and formulas						
Inspection Date: 5/28/2015	Beginning Section MP	0				
Paved Length (Miles): 0.12	Section Length (MI)	0.12				
Surface Type: ASPHALT	Route Summary					
Roadway Condition Information						
Pavement Condition Rating (PCR)	94	94				
Surface Condition Rating (SCR)	94	94				
Roughness Condition Index (RCI)	N/A	N/A				
Distress Index Values						
Structural Crack Index	98	98				
Alligator Crack Index	100	100				
Longitudinal Crack Index	98	98				
Transverse Cracking Index	94	94				
Patching Index	100	100				
Rutting Index	95	95				
International Roughness Index (IRI)	N/A	N/A				
Lane & Width Information						
Number of Lanes	1	1				
Paved Width (ft)	10.8	10.8				
Lane Width (ft)	10.8	10.8

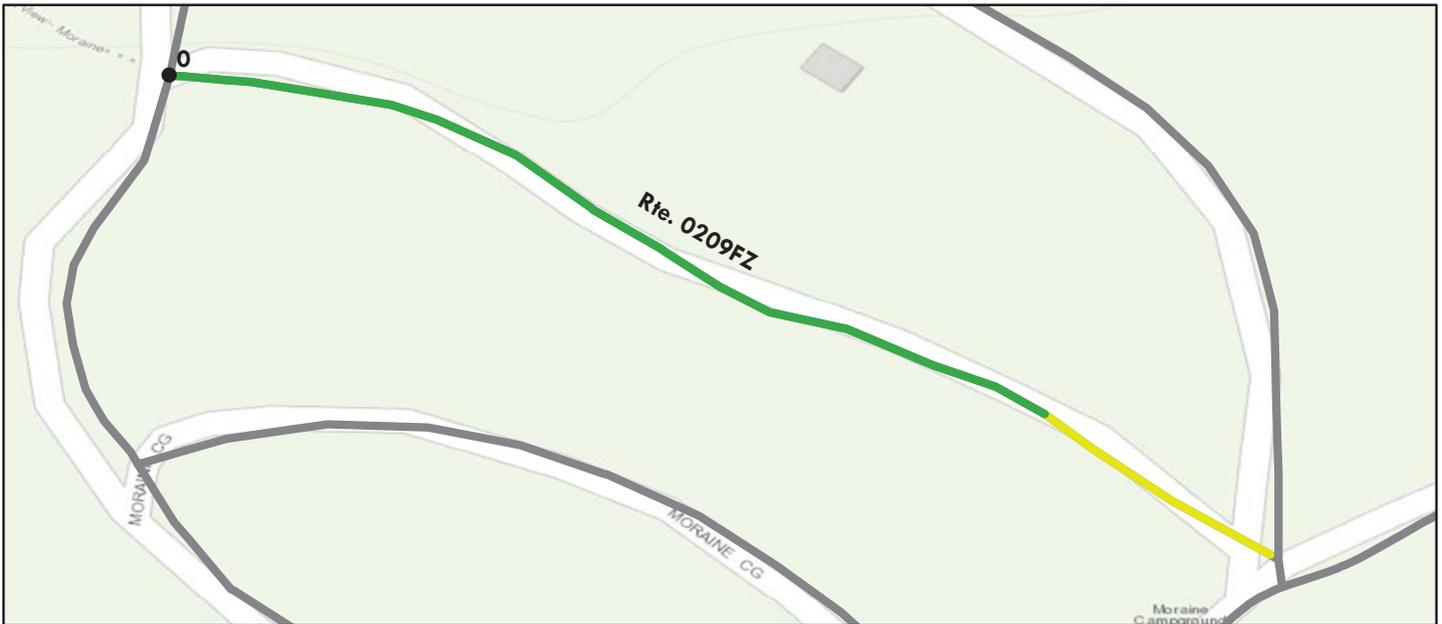
ROUTE 0209FZ: MORAINE CAMPGROUND ROAD F

Subcomponent of Route KICA-0209ZZ
Data Collection Vehicle (DCV) Rating

Route Condition Legend – Pavement Condition Rating (PCR)						
Poor (0 - 60)	Fair (61- 84)	Good (85 - 94)	Excellent (95 - 100)	Not Rated		
See Appendix for definitions and formulas						
Inspection Date: 5/28/2015	Beginning Section MP	0				
Paved Length (Miles): 0.13	Section Length (MI)	0.13				
Surface Type: ASPHALT	Route Summary					
Roadway Condition Information						
Pavement Condition Rating (PCR)	88	88				
Surface Condition Rating (SCR)	88	88				
Roughness Condition Index (RCI)	N/A	N/A				
Distress Index Values						
Structural Crack Index	98	98				
Alligator Crack Index	100	100				
Longitudinal Crack Index	98	98				
Transverse Cracking Index	88	88				
Patching Index	100	100				
Rutting Index	94	94				
International Roughness Index (IRI)	N/A	N/A				
Lane & Width Information						
Number of Lanes	1	1				
Paved Width (ft)	11.7	11.7				
Lane Width (ft)	11.7	11.7

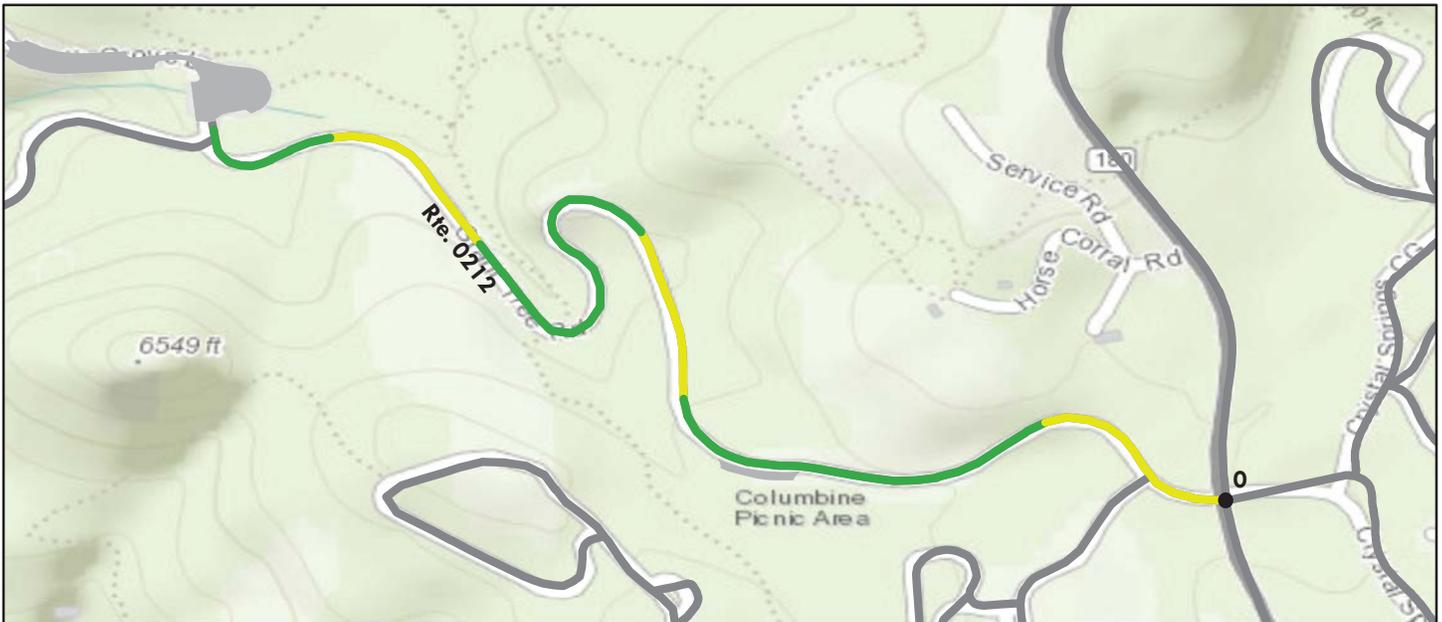
ROUTE 0212: GRANT TREE ROAD

Data Collection Vehicle (DCV) Rating

Route Condition Legend – Pavement Condition Rating (PCR)									
Poor (0 - 60)		Fair (61- 84)		Good (85 - 94)		Excellent (95 - 100)		Not Rated	
See Appendix for definitions and formulas									
Inspection Date:	5/30/2015	Beginning Section MP	0						
Paved Length (Miles):	0.77	Section Length (MI)	0.77						
Surface Type:	ASPHALT	Route Summary							
Roadway Condition Information									
Pavement Condition Rating (PCR)		82	82						
Surface Condition Rating (SCR)		95	95						
Roughness Condition Index (RCI)		62	62						
Distress Index Values									
Structural Crack Index		97	97						
Alligator Crack Index		100	100						
Longitudinal Crack Index		97	97						
Transverse Cracking Index		99	99						
Patching Index		100	100						
Rutting Index		95	95						
International Roughness Index (IRI)		230	230						
Lane & Width Information									
Number of Lanes		2	2						
Paved Width (ft)		26.6	26.6						
Lane Width (ft)		12.7	12.7

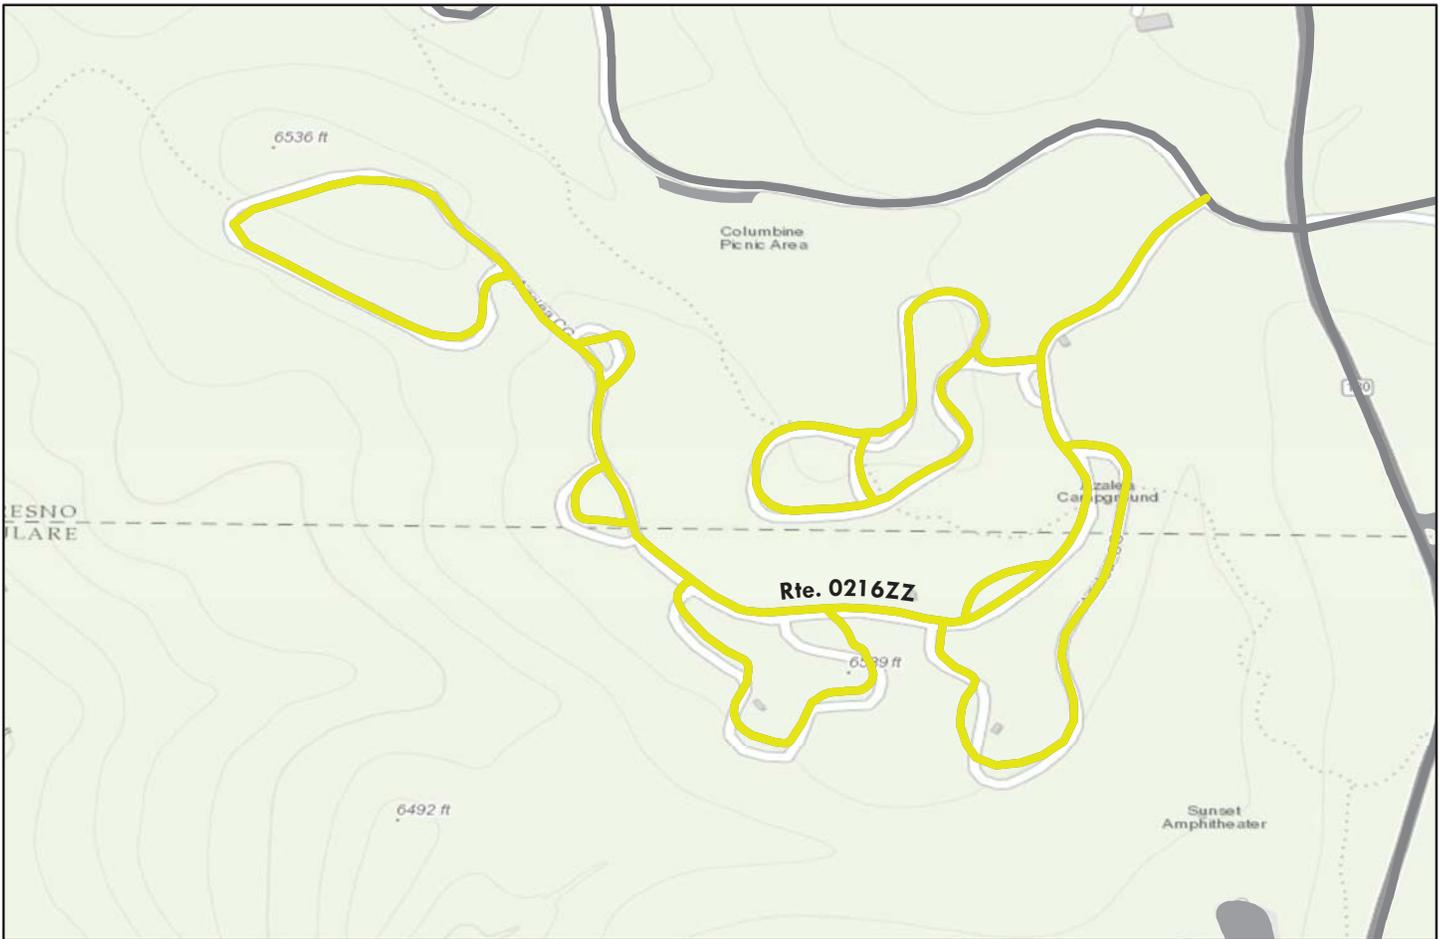
ROUTE 0216ZZ: AZALEA CAMPGROUND ROADS

Summary Route

Note: The weighted average summary PCR value is calculated from only the sections of road where the PCR was collected. The overall PCR for the summary route may not reflect individual subcomponent ratings.

Route Condition Legend – Pavement Condition Rating (PCR)						
Poor (0 - 60)	Fair (61- 84)	Good (85 - 94)	Excellent (95 - 100)	Not Rated		
See Appendix for definitions and formulas						
Inspection Date: 5/30/2015						
Paved Length (Miles): 1.74						
Surface Type: ASPHALT	Route Summary					
Roadway Condition Information						
Pavement Condition Rating (PCR)	75					
Lane & Width Information						
Number of Lanes	1					
Paved Width (ft)	13.4					
Lane Width (ft)	10.6

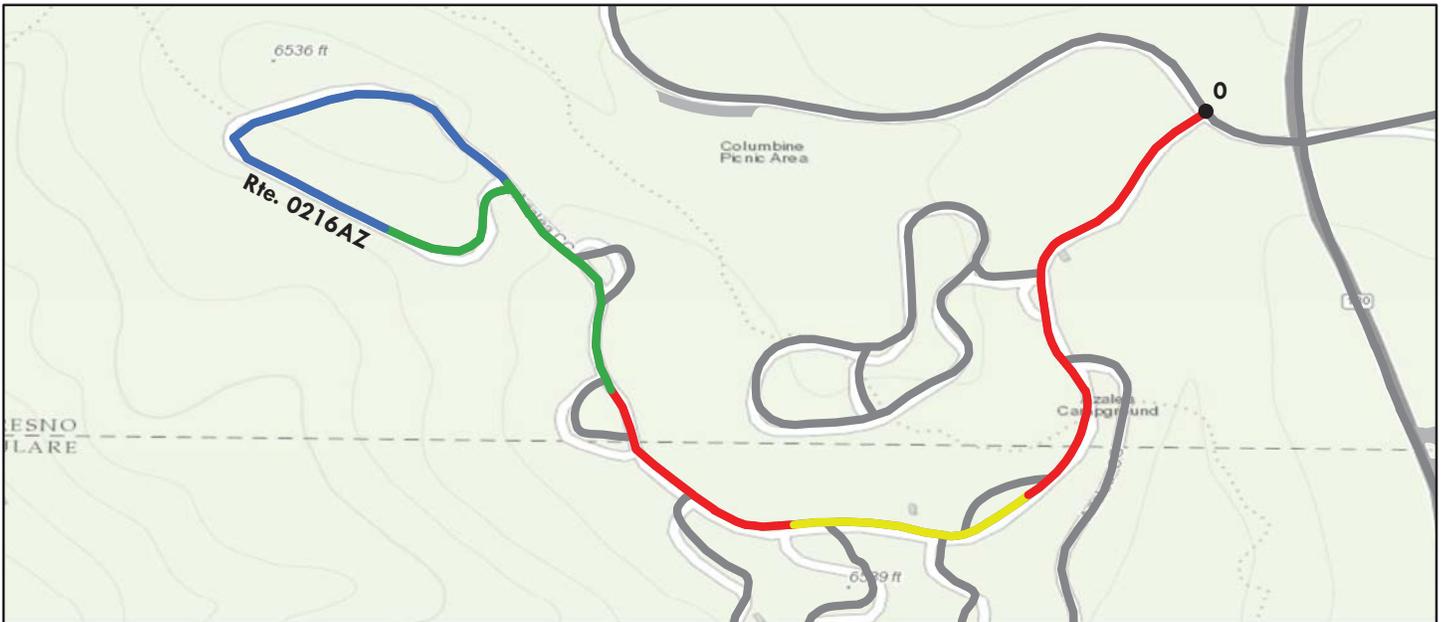
ROUTE 0216AZ: AZALEA CAMPGROUND ROAD A

Subcomponent of Route KICA-0216ZZ
Data Collection Vehicle (DCV) Rating

Route Condition Legend – Pavement Condition Rating (PCR)						
Poor (0 - 60)	Fair (61- 84)	Good (85 - 94)	Excellent (95 - 100)	Not Rated		
See Appendix for definitions and formulas						
Inspection Date: 5/30/2015	Beginning Section MP	0				
Paved Length (Miles): 0.77	Section Length (MI)	0.77				
Surface Type: ASPHALT	Route Summary					
Roadway Condition Information						
Pavement Condition Rating (PCR)	62	62				
Surface Condition Rating (SCR)	62	62				
Roughness Condition Index (RCI)	N/A	N/A				
Distress Index Values						
Structural Crack Index	62	62				
Alligator Crack Index	80	80				
Longitudinal Crack Index	82	82				
Transverse Cracking Index	85	85				
Patching Index	100	100				
Rutting Index	95	95				
International Roughness Index (IRI)	N/A	N/A				
Lane & Width Information						
Number of Lanes	2	2				
Paved Width (ft)	16.9	16.9				
Lane Width (ft)	10.7	10.7

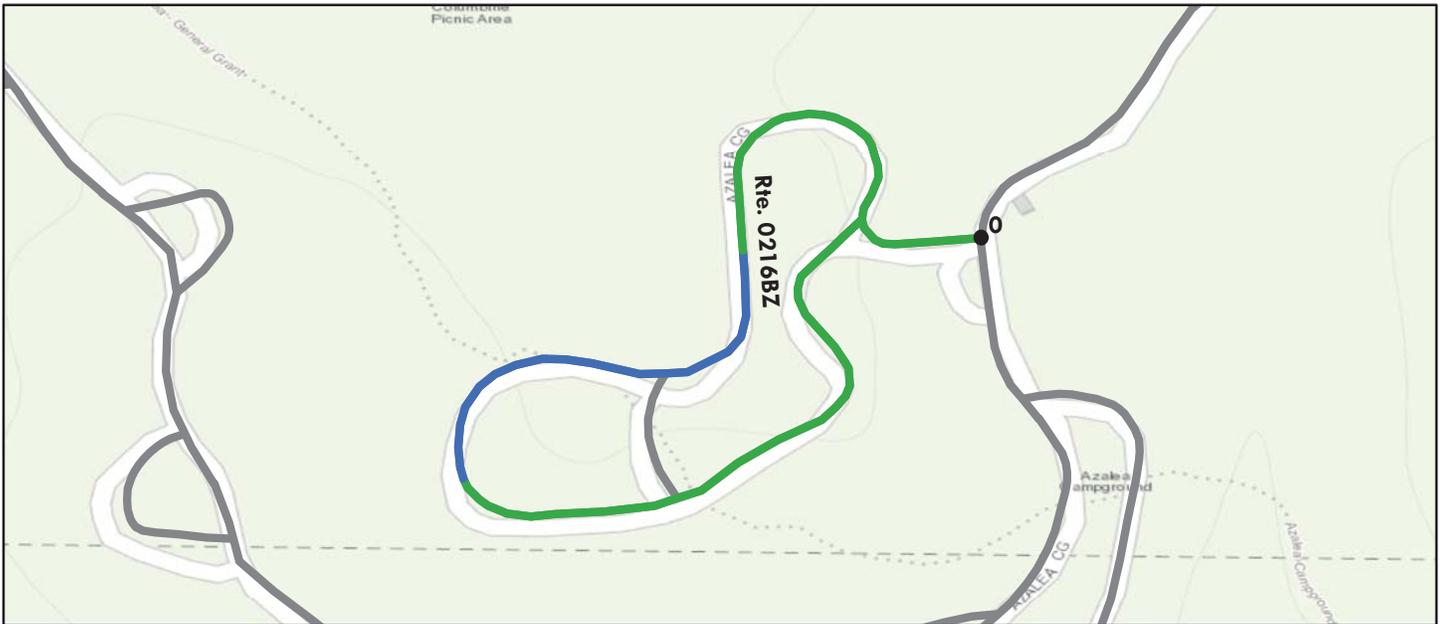
ROUTE 0216BZ: AZALEA CAMPGROUND ROAD B

Subcomponent of Route KICA-0216ZZ
Data Collection Vehicle (DCV) Rating

Route Condition Legend – Pavement Condition Rating (PCR)						
Poor (0 - 60)	Fair (61- 84)	Good (85 - 94)	Excellent (95 - 100)	Not Rated		
See Appendix for definitions and formulas						
Inspection Date: 5/30/2015	Beginning Section MP	0				
Paved Length (Miles): 0.34	Section Length (MI)	0.34				
Surface Type: ASPHALT	Route Summary					
Roadway Condition Information						
Pavement Condition Rating (PCR)	95	95				
Surface Condition Rating (SCR)	95	95				
Roughness Condition Index (RCI)	N/A	N/A				
Distress Index Values						
Structural Crack Index	99	99				
Alligator Crack Index	100	100				
Longitudinal Crack Index	99	99				
Transverse Cracking Index	99	99				
Patching Index	100	100				
Rutting Index	95	95				
International Roughness Index (IRI)	N/A	N/A				
Lane & Width Information						
Number of Lanes	1	1				
Paved Width (ft)	11.8	11.8				
Lane Width (ft)	11.3	11.3

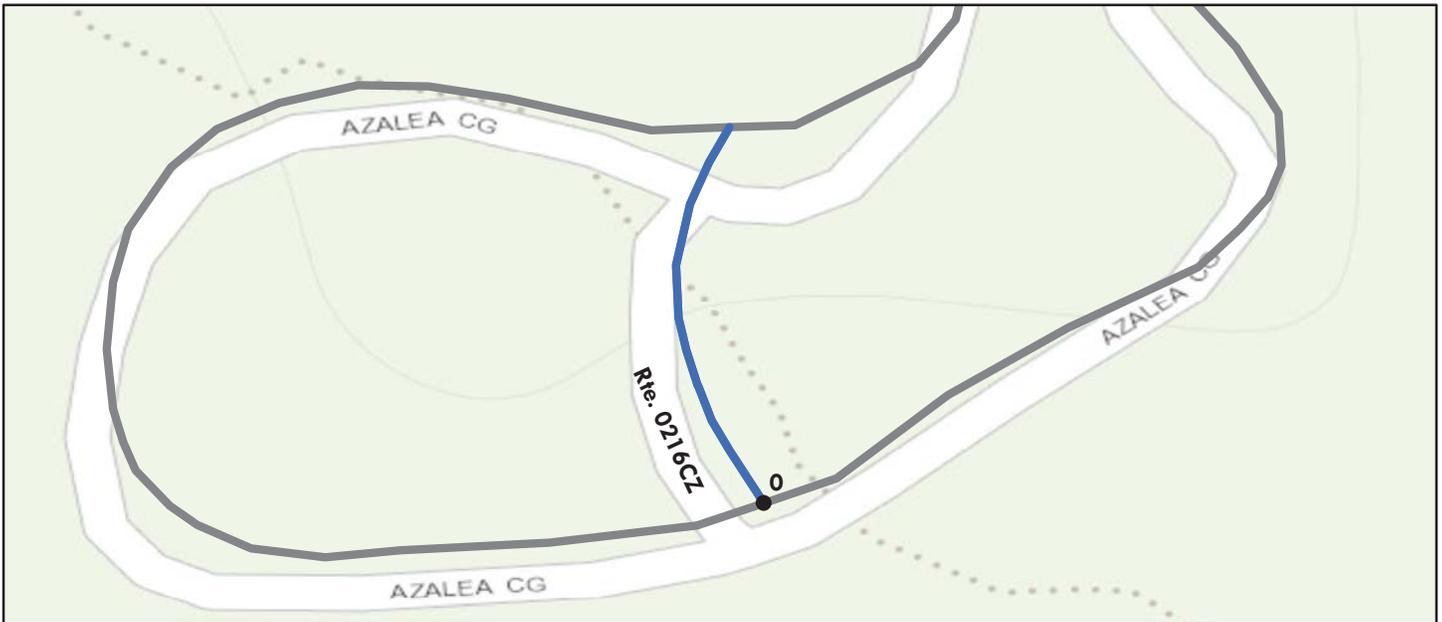
ROUTE 0216CZ: AZALEA CAMPGROUND ROAD C

Subcomponent of Route KICA-0216ZZ
Data Collection Vehicle (DCV) Rating

Route Condition Legend – Pavement Condition Rating (PCR)						
Poor (0 - 60)	Fair (61- 84)	Good (85 - 94)	Excellent (95 - 100)	Not Rated		
See Appendix for definitions and formulas						
Inspection Date: 5/30/2015	Beginning Section MP	0				
Paved Length (Miles): 0.03	Section Length (MI)	0.03				
Surface Type: ASPHALT	Route Summary					
Roadway Condition Information						
Pavement Condition Rating (PCR)	96	96				
Surface Condition Rating (SCR)	96	96				
Roughness Condition Index (RCI)	N/A	N/A				
Distress Index Values						
Structural Crack Index	100	100				
Alligator Crack Index	100	100				
Longitudinal Crack Index	100	100				
Transverse Cracking Index	100	100				
Patching Index	100	100				
Rutting Index	96	96				
International Roughness Index (IRI)	N/A	N/A				
Lane & Width Information						
Number of Lanes	1	1				
Paved Width (ft)	10.7	10.7				
Lane Width (ft)	10.7	10.7

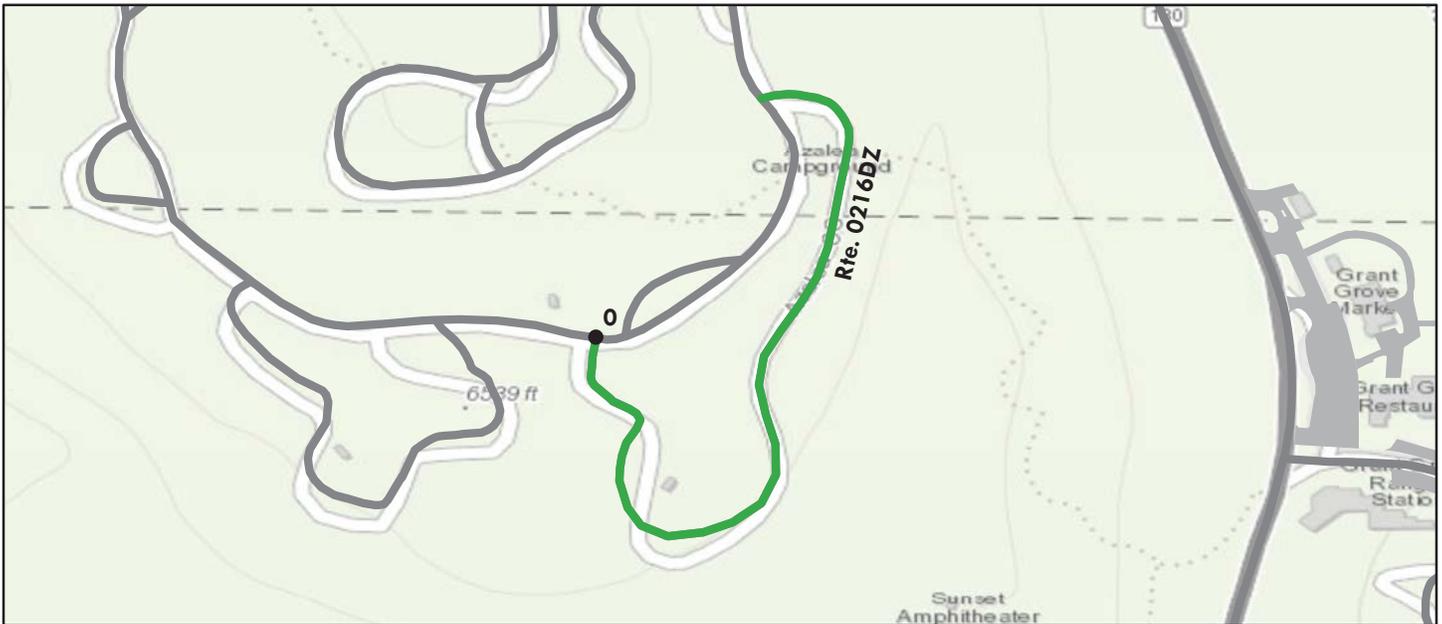
ROUTE 0216DZ: AZALEA CAMPGROUND ROAD D

Subcomponent of Route KICA-0216ZZ
Data Collection Vehicle (DCV) Rating

Route Condition Legend – Pavement Condition Rating (PCR)						
Poor (0 - 60)	Fair (61- 84)	Good (85 - 94)	Excellent (95 - 100)	Not Rated		
See Appendix for definitions and formulas						
Inspection Date: 5/30/2015	Beginning Section MP	0				
Paved Length (Miles): 0.26	Section Length (MI)	0.26				
Surface Type: ASPHALT	Route Summary					
Roadway Condition Information						
Pavement Condition Rating (PCR)	92	92				
Surface Condition Rating (SCR)	92	92				
Roughness Condition Index (RCI)	N/A	N/A				
Distress Index Values						
Structural Crack Index	98	98				
Alligator Crack Index	100	100				
Longitudinal Crack Index	98	98				
Transverse Cracking Index	97	97				
Patching Index	99	99				
Rutting Index	92	92				
International Roughness Index (IRI)	N/A	N/A				
Lane & Width Information						
Number of Lanes	1	1				
Paved Width (ft)	10.4	10.4				
Lane Width (ft)	10.4	10.4

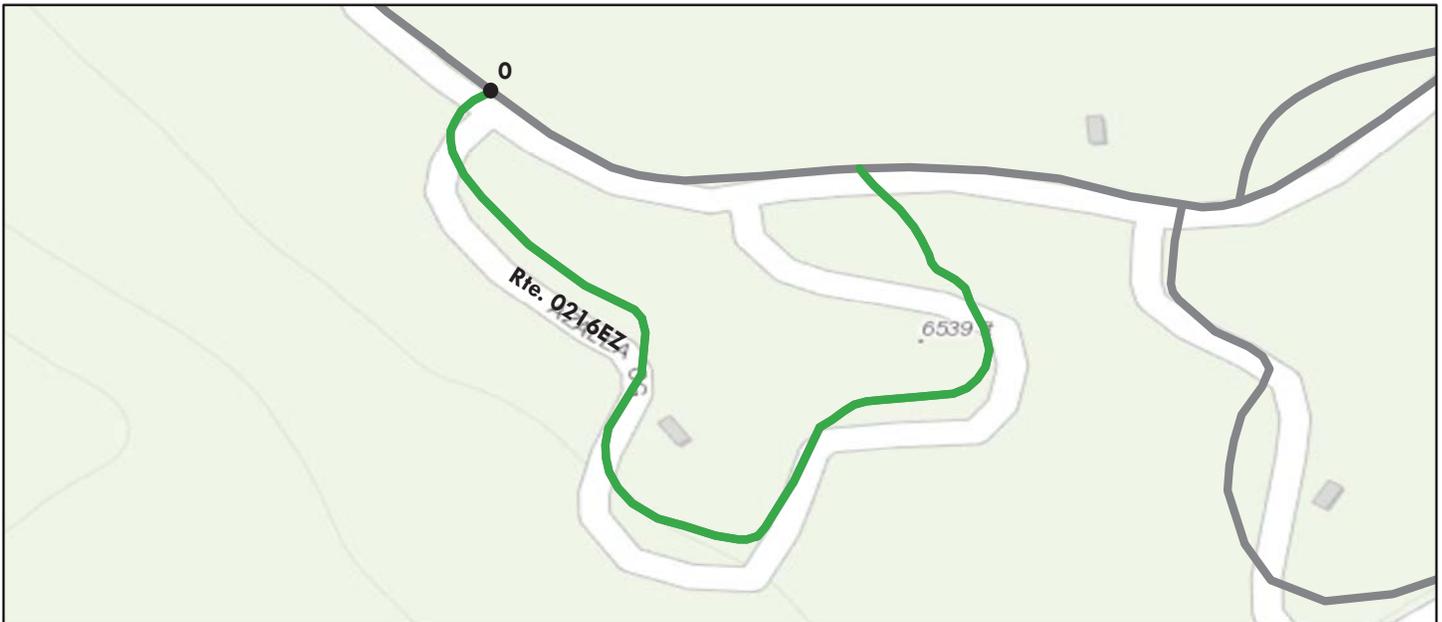
ROUTE 0216EZ: AZALEA CAMPGROUND ROAD E

Subcomponent of Route KICA-0216ZZ
Data Collection Vehicle (DCV) Rating

Route Condition Legend – Pavement Condition Rating (PCR)						
Poor (0 - 60)	Fair (61- 84)	Good (85 - 94)	Excellent (95 - 100)	Not Rated		
See Appendix for definitions and formulas						
Inspection Date: 5/30/2015	Beginning Section MP	0				
Paved Length (Miles): 0.2	Section Length (MI)	0.2				
Surface Type: ASPHALT	Route Summary					
Roadway Condition Information						
Pavement Condition Rating (PCR)	91	91				
Surface Condition Rating (SCR)	91	91				
Roughness Condition Index (RCI)	N/A	N/A				
Distress Index Values						
Structural Crack Index	98	98				
Alligator Crack Index	100	100				
Longitudinal Crack Index	98	98				
Transverse Cracking Index	92	92				
Patching Index	99	99				
Rutting Index	91	91				
International Roughness Index (IRI)	N/A	N/A				
Lane & Width Information						
Number of Lanes	1	1				
Paved Width (ft)	9.6	9.6				
Lane Width (ft)	9.6	9.6

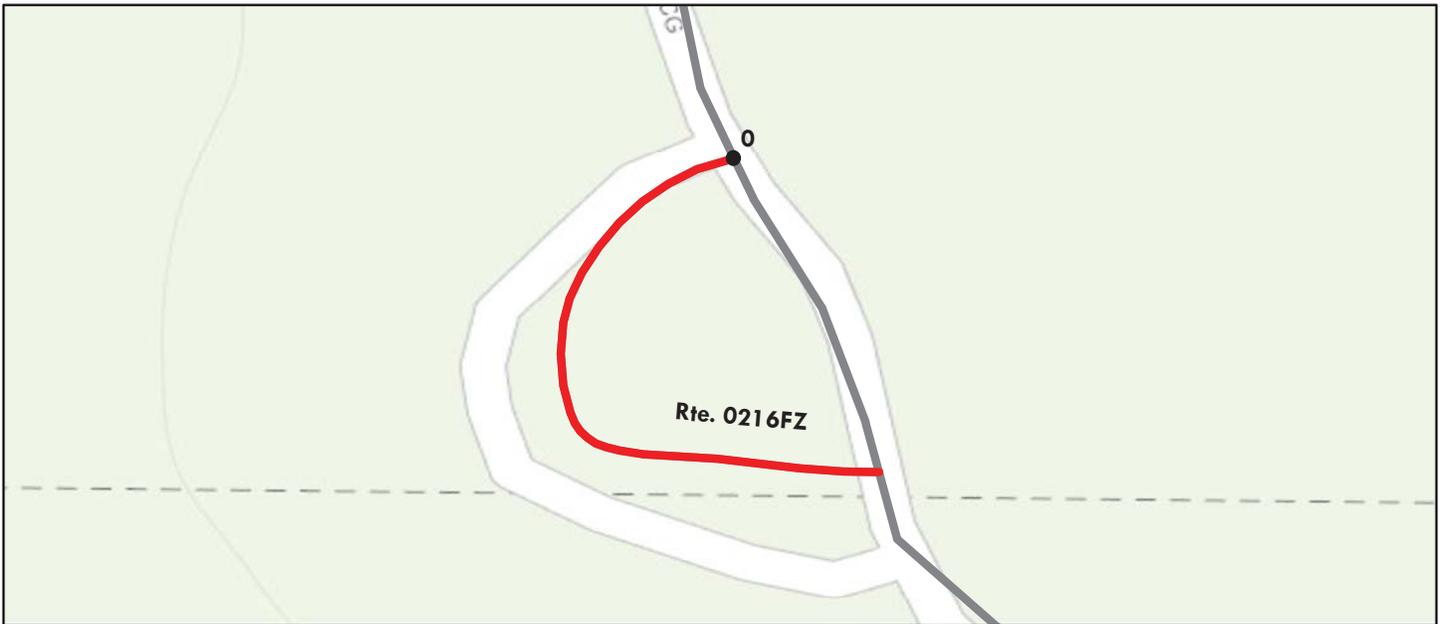
ROUTE 0216FZ: AZALEA CAMPGROUND ROAD F

Subcomponent of Route KICA-0216ZZ
Data Collection Vehicle (DCV) Rating

Route Condition Legend – Pavement Condition Rating (PCR)						
Poor (0 - 60)	Fair (61- 84)	Good (85 - 94)	Excellent (95 - 100)	Not Rated		
See Appendix for definitions and formulas						
Inspection Date: 5/30/2015	Beginning Section MP	0				
Paved Length (Miles): 0.05	Section Length (MI)	0.05				
Surface Type: ASPHALT	Route Summary					
Roadway Condition Information						
Pavement Condition Rating (PCR)	31	31				
Surface Condition Rating (SCR)	31	31				
Roughness Condition Index (RCI)	N/A	N/A				
Distress Index Values						
Structural Crack Index	31	31				
Alligator Crack Index	75	75				
Longitudinal Crack Index	56	56				
Transverse Cracking Index	60	60				
Patching Index	100	100				
Rutting Index	82	82				
International Roughness Index (IRI)	N/A	N/A				
Lane & Width Information						
Number of Lanes	1	1				
Paved Width (ft)	9.1	9.1				
Lane Width (ft)	9.1	9.1

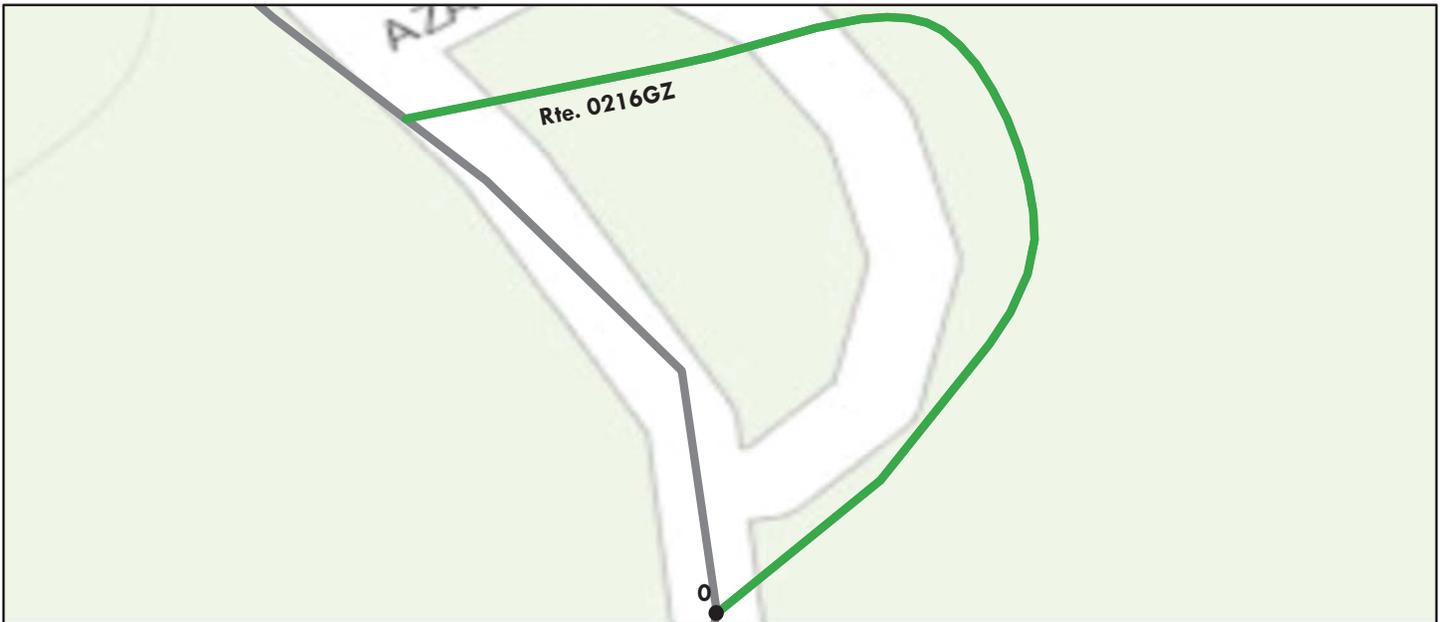
ROUTE 0216GZ: AZALEA CAMPGROUND ROAD G

Subcomponent of Route KICA-0216ZZ
Data Collection Vehicle (DCV) Rating

Route Condition Legend – Pavement Condition Rating (PCR)						
Poor (0 - 60)	Fair (61- 84)	Good (85 - 94)	Excellent (95 - 100)	Not Rated		
See Appendix for definitions and formulas						
Inspection Date: 5/30/2015	Beginning Section MP	0				
Paved Length (Miles): 0.05	Section Length (MI)	0.05				
Surface Type: ASPHALT	Route Summary					
Roadway Condition Information						
Pavement Condition Rating (PCR)	90	90				
Surface Condition Rating (SCR)	N/A	N/A				
Roughness Condition Index (RCI)	N/A	N/A				
Distress Index Values						
Structural Crack Index	N/A	N/A				
Alligator Crack Index	N/A	N/A				
Longitudinal Crack Index	N/A	N/A				
Transverse Cracking Index	N/A	N/A				
Patching Index	N/A	N/A				
Rutting Index	N/A	N/A				
International Roughness Index (IRI)	N/A	N/A				
Lane & Width Information						
Number of Lanes	1	1				
Paved Width (ft)	10.8	10.8				
Lane Width (ft)	10.8	10.8

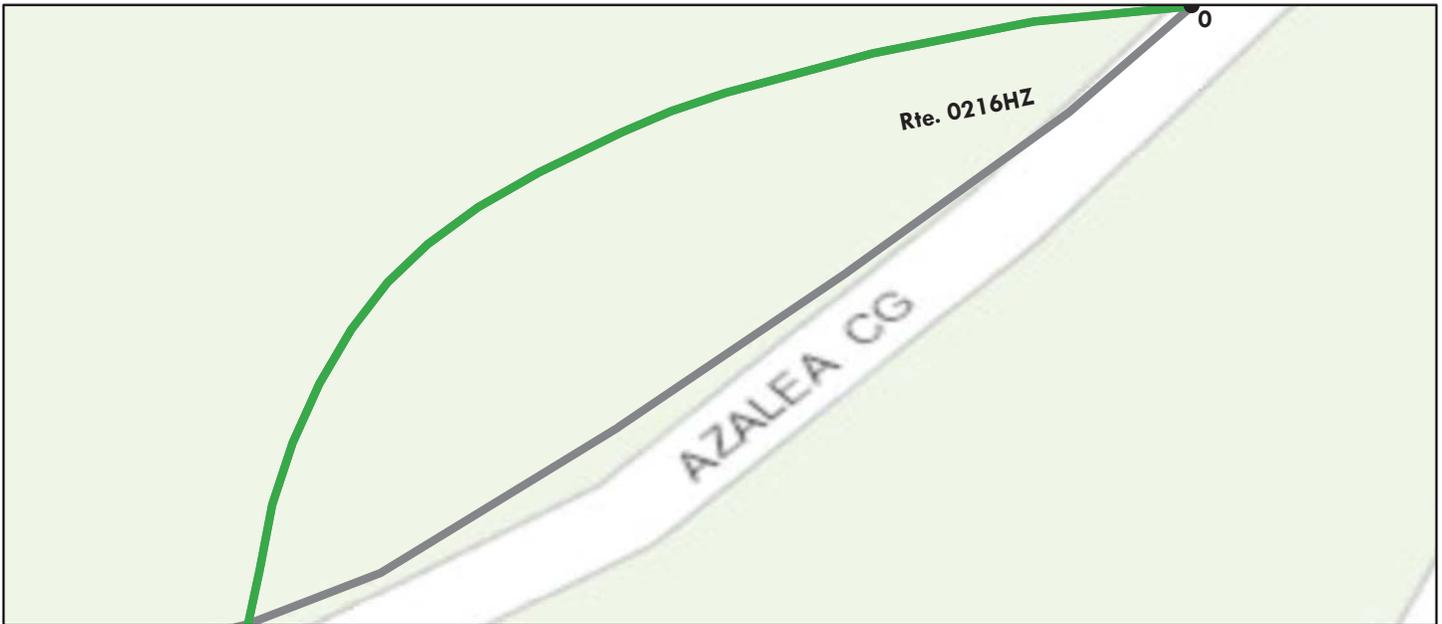
ROUTE 0216HZ: AZALEA CAMPGROUND ROAD H

Subcomponent of Route KICA-0216ZZ
Data Collection Vehicle (DCV) Rating

Route Condition Legend – Pavement Condition Rating (PCR)						
Poor (0 - 60)	Fair (61- 84)	Good (85 - 94)	Excellent (95 - 100)	Not Rated		
See Appendix for definitions and formulas						
Inspection Date: 5/30/2015	Beginning Section MP	0				
Paved Length (Miles): 0.05	Section Length (MI)	0.04				
Surface Type: ASPHALT	Route Summary					
Roadway Condition Information						
Pavement Condition Rating (PCR)	91	91				
Surface Condition Rating (SCR)	91	91				
Roughness Condition Index (RCI)	N/A	N/A				
Distress Index Values						
Structural Crack Index	91	91				
Alligator Crack Index	98	98				
Longitudinal Crack Index	93	93				
Transverse Cracking Index	92	92				
Patching Index	100	100				
Rutting Index	92	92				
International Roughness Index (IRI)	N/A	N/A				
Lane & Width Information						
Number of Lanes	1	1				
Paved Width (ft)	11	11				
Lane Width (ft)	11	11

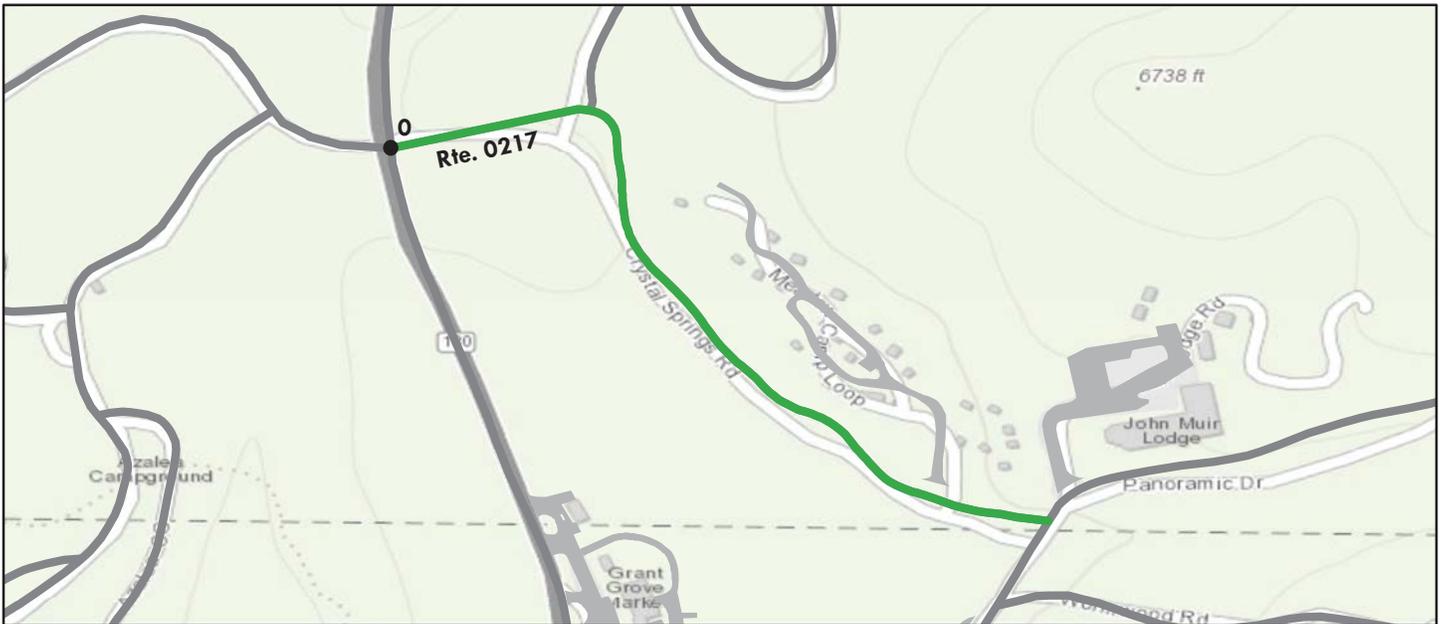
ROUTE 0217: CRYSTAL SPRINGS ROAD

Data Collection Vehicle (DCV) Rating

Route Condition Legend – Pavement Condition Rating (PCR)						
Poor (0 - 60)	Fair (61- 84)	Good (85 - 94)	Excellent (95 - 100)	Not Rated		
See Appendix for definitions and formulas						
Inspection Date: 5/30/2015	Beginning Section MP	0				
Paved Length (Miles): 0.28	Section Length (MI)	0.28				
Surface Type: ASPHALT	Route Summary					
Roadway Condition Information						
Pavement Condition Rating (PCR)	91	91				
Surface Condition Rating (SCR)	91	91				
Roughness Condition Index (RCI)	N/A	N/A				
Distress Index Values						
Structural Crack Index	99	99				
Alligator Crack Index	100	100				
Longitudinal Crack Index	99	99				
Transverse Cracking Index	98	98				
Patching Index	99	99				
Rutting Index	91	91				
International Roughness Index (IRI)	N/A	N/A				
Lane & Width Information						
Number of Lanes	2	2				
Paved Width (ft)	21.4	21.4				
Lane Width (ft)	10.7	10.7

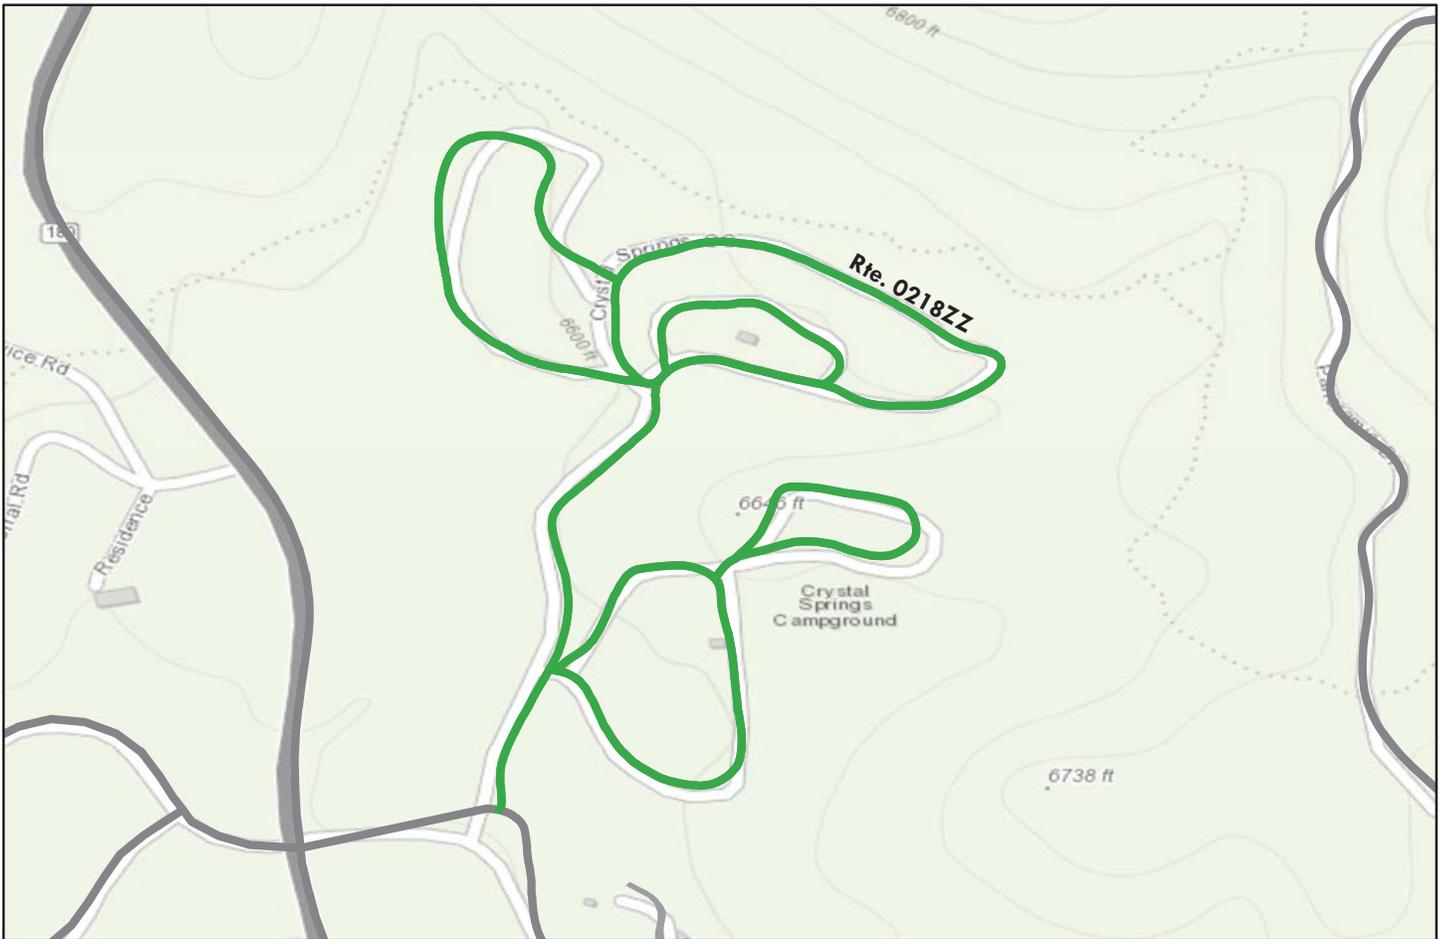
ROUTE 0218ZZ: CRYSTAL SPRINGS CAMPGROUND ROADS

Summary Route

Note: The weighted average summary PCR value is calculated from only the sections of road where the PCR was collected. The overall PCR for the summary route may not reflect individual subcomponent ratings.

Route Condition Legend – Pavement Condition Rating (PCR)						
Poor (0 - 60)	Fair (61- 84)	Good (85 - 94)	Excellent (95 - 100)	Not Rated		
See Appendix for definitions and formulas						
Inspection Date: 5/30/2015						
Paved Length (Miles): 1.14						
Surface Type: ASPHALT	Route Summary					
Roadway Condition Information						
Pavement Condition Rating (PCR)	88					
Lane & Width Information						
Number of Lanes	1					
Paved Width (ft)	14.3					
Lane Width (ft)	11.2
