KICA Cycle 6

Final Report

Road Inventory and Condition Assessment of Paved Routes Kings Canyon National Park

**Federal Highway Administration
Eastern Federal Lands Highway Division
Road Inventory Program (RIP)**

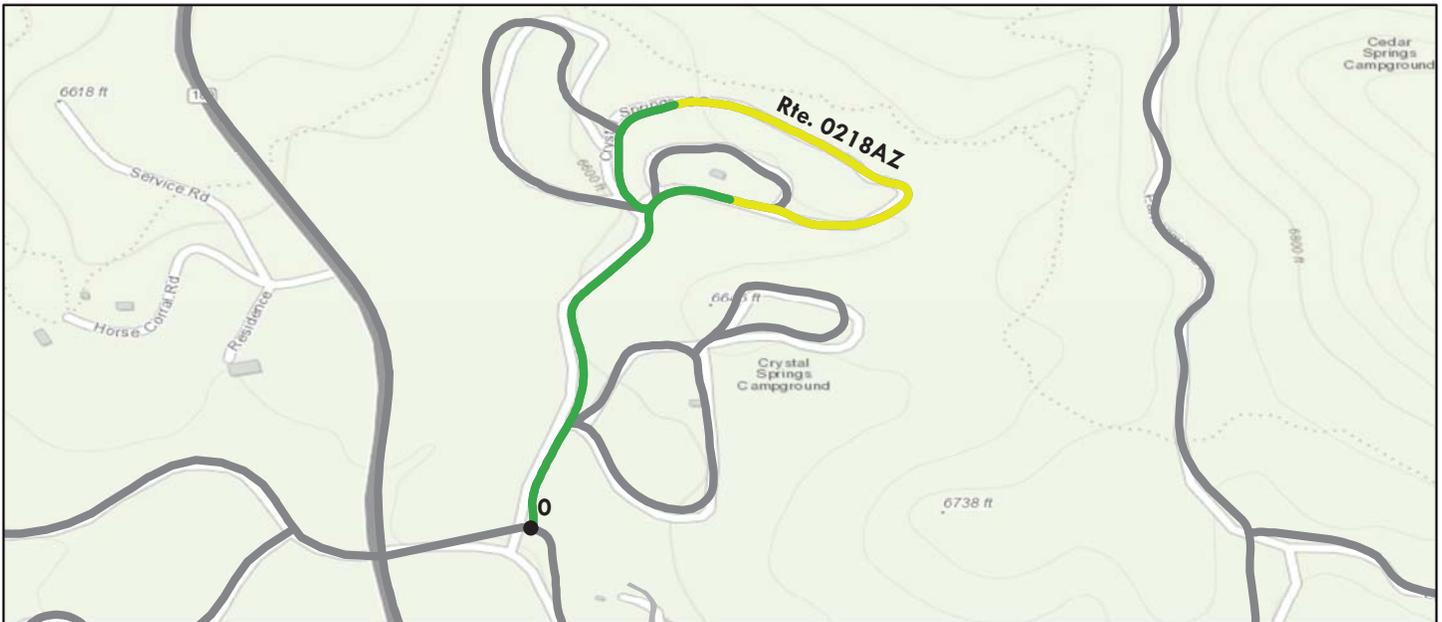
ROUTE 0218AZ: CRYSTAL SPRINGS CAMPGROUND ROAD A

Subcomponent of Route KICA-0218ZZ
 Data Collection Vehicle (DCV) Rating

Route Condition Legend – Pavement Condition Rating (PCR)						
Poor (0 - 60)	Fair (61- 84)	Good (85 - 94)	Excellent (95 - 100)	Not Rated		
See Appendix for definitions and formulas						
Inspection Date: 5/30/2015	Beginning Section MP	0				
Paved Length (Miles): 0.47	Section Length (MI)	0.47				
Surface Type: ASPHALT	Route Summary					
Roadway Condition Information						
Pavement Condition Rating (PCR)	86	86				
Surface Condition Rating (SCR)	86	86				
Roughness Condition Index (RCI)	N/A	N/A				
Distress Index Values						
Structural Crack Index	97	97				
Alligator Crack Index	100	100				
Longitudinal Crack Index	97	97				
Transverse Cracking Index	98	98				
Patching Index	100	100				
Rutting Index	86	86				
International Roughness Index (IRI)	N/A	N/A				
Lane & Width Information						
Number of Lanes	2	2				
Paved Width (ft)	19.4	19.4				
Lane Width (ft)	11.8	11.8

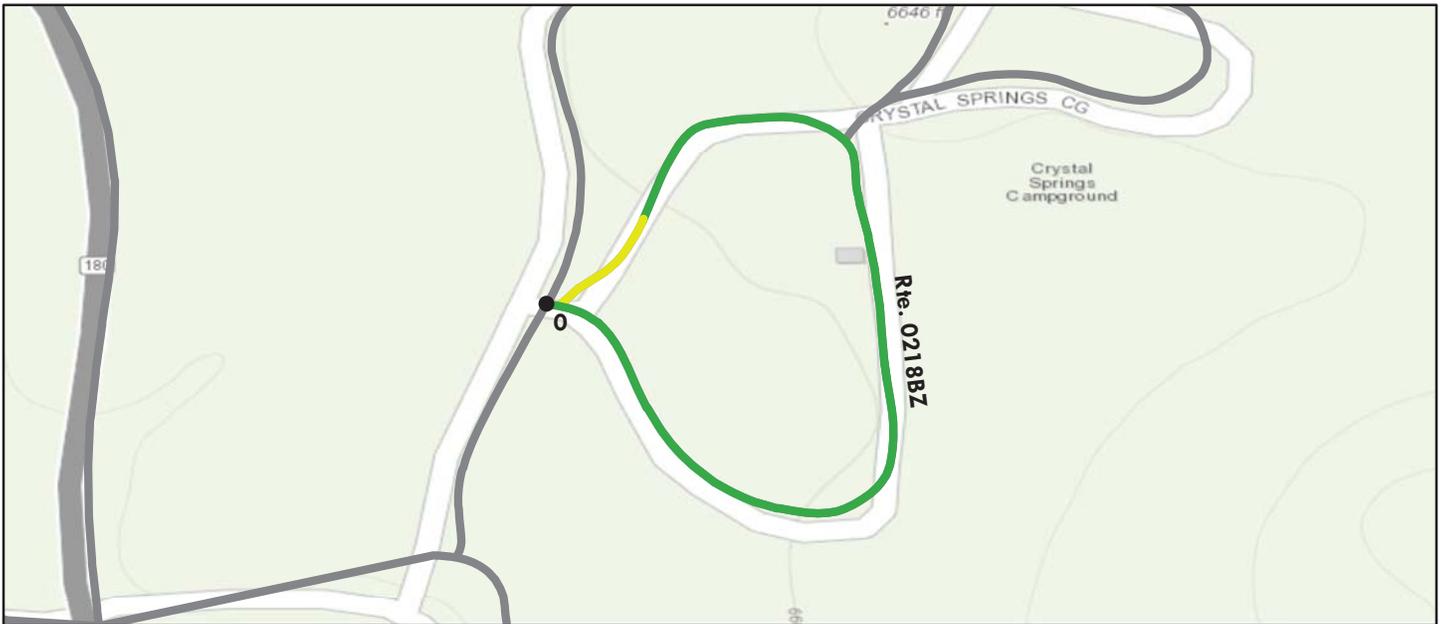
ROUTE 0218BZ: CRYSTAL SPRINGS CAMPGROUND ROAD B

Subcomponent of Route KICA-0218ZZ
 Data Collection Vehicle (DCV) Rating

Route Condition Legend – Pavement Condition Rating (PCR)						
Poor (0 - 60)	Fair (61- 84)	Good (85 - 94)	Excellent (95 - 100)	Not Rated		
See Appendix for definitions and formulas						
Inspection Date: 5/30/2015	Beginning Section MP	0				
Paved Length (Miles): 0.22	Section Length (MI)	0.22				
Surface Type: ASPHALT	Route Summary					
Roadway Condition Information						
Pavement Condition Rating (PCR)	91	91				
Surface Condition Rating (SCR)	91	91				
Roughness Condition Index (RCI)	N/A	N/A				
Distress Index Values						
Structural Crack Index	95	95				
Alligator Crack Index	100	100				
Longitudinal Crack Index	95	95				
Transverse Cracking Index	99	99				
Patching Index	100	100				
Rutting Index	91	91				
International Roughness Index (IRI)	N/A	N/A				
Lane & Width Information						
Number of Lanes	1	1				
Paved Width (ft)	11.8	11.8				
Lane Width (ft)	11.8	11.8

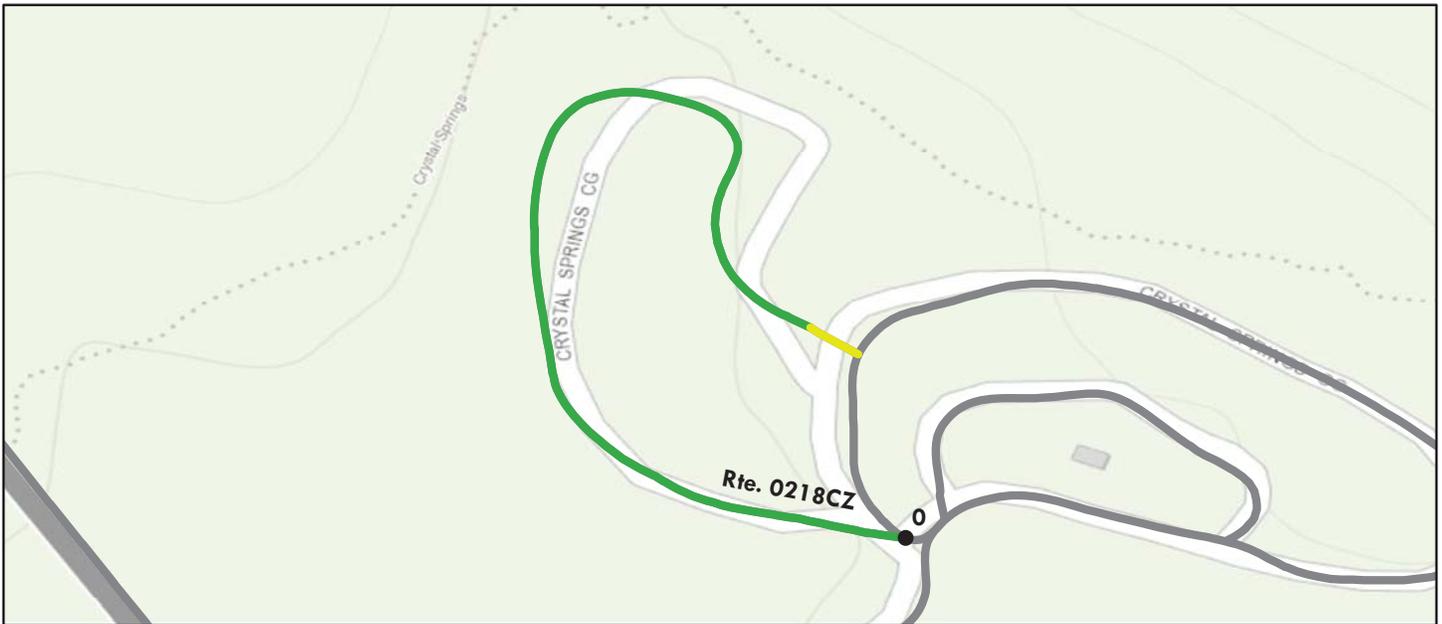
ROUTE 0218CZ: CRYSTAL SPRINGS CAMPGROUND ROAD C

Subcomponent of Route KICA-0218ZZ
Data Collection Vehicle (DCV) Rating

Route Condition Legend – Pavement Condition Rating (PCR)						
Poor (0 - 60)	Fair (61- 84)	Good (85 - 94)	Excellent (95 - 100)	Not Rated		
See Appendix for definitions and formulas						
Inspection Date: 5/30/2015	Beginning Section MP	0				
Paved Length (Miles): 0.21	Section Length (MI)	0.21				
Surface Type: ASPHALT	Route Summary					
Roadway Condition Information						
Pavement Condition Rating (PCR)	89	89				
Surface Condition Rating (SCR)	89	89				
Roughness Condition Index (RCI)	N/A	N/A				
Distress Index Values						
Structural Crack Index	98	98				
Alligator Crack Index	100	100				
Longitudinal Crack Index	98	98				
Transverse Cracking Index	98	98				
Patching Index	100	100				
Rutting Index	89	89				
International Roughness Index (IRI)	N/A	N/A				
Lane & Width Information						
Number of Lanes	1	1				
Paved Width (ft)	9.3	9.3				
Lane Width (ft)	9.3	9.3

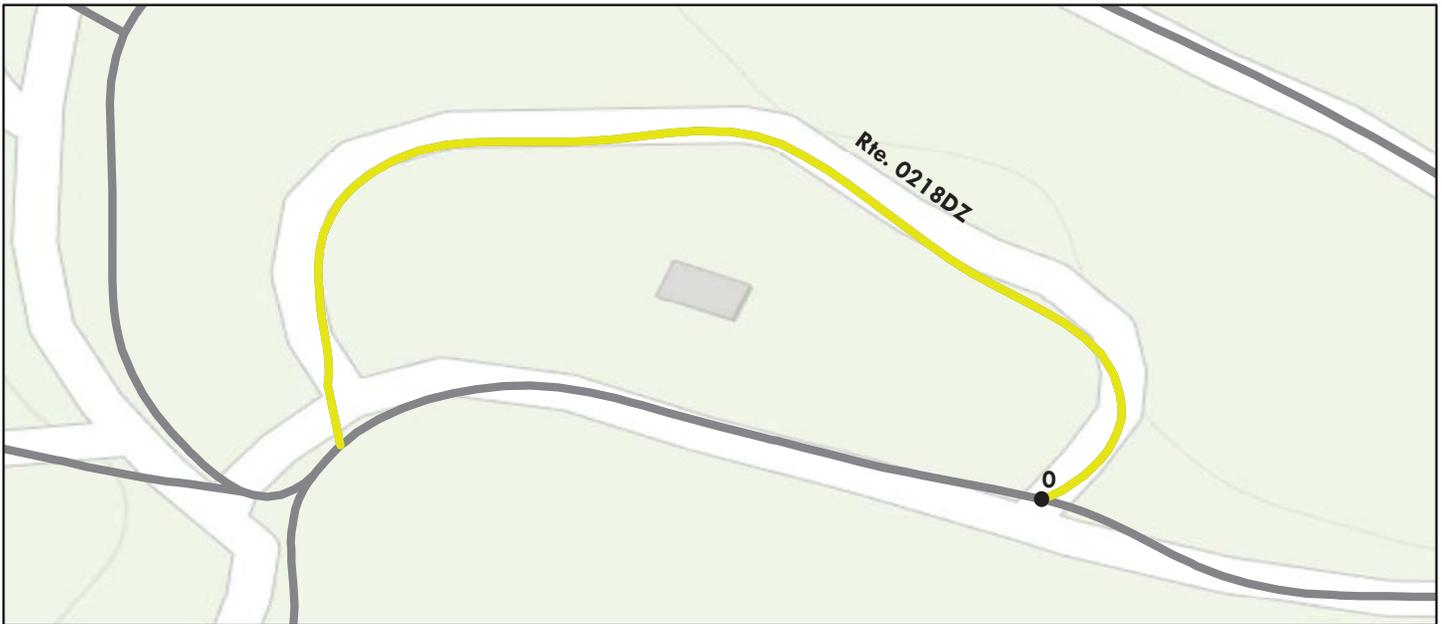
ROUTE 0218DZ: CRYSTAL SPRINGS CAMPGROUND ROAD D

Subcomponent of Route KICA-0218ZZ
Data Collection Vehicle (DCV) Rating

Route Condition Legend – Pavement Condition Rating (PCR)						
Poor (0 - 60)	Fair (61- 84)	Good (85 - 94)	Excellent (95 - 100)	Not Rated		
See Appendix for definitions and formulas						
Inspection Date: 5/30/2015	Beginning Section MP	0				
Paved Length (Miles): 0.1	Section Length (MI)	0.1				
Surface Type: ASPHALT	Route Summary					
Roadway Condition Information						
Pavement Condition Rating (PCR)	84	84				
Surface Condition Rating (SCR)	84	84				
Roughness Condition Index (RCI)	N/A	N/A				
Distress Index Values						
Structural Crack Index	94	94				
Alligator Crack Index	100	100				
Longitudinal Crack Index	94	94				
Transverse Cracking Index	98	98				
Patching Index	100	100				
Rutting Index	84	84				
International Roughness Index (IRI)	N/A	N/A				
Lane & Width Information						
Number of Lanes	1	1				
Paved Width (ft)	11.6	11.6				
Lane Width (ft)	11.6	11.6

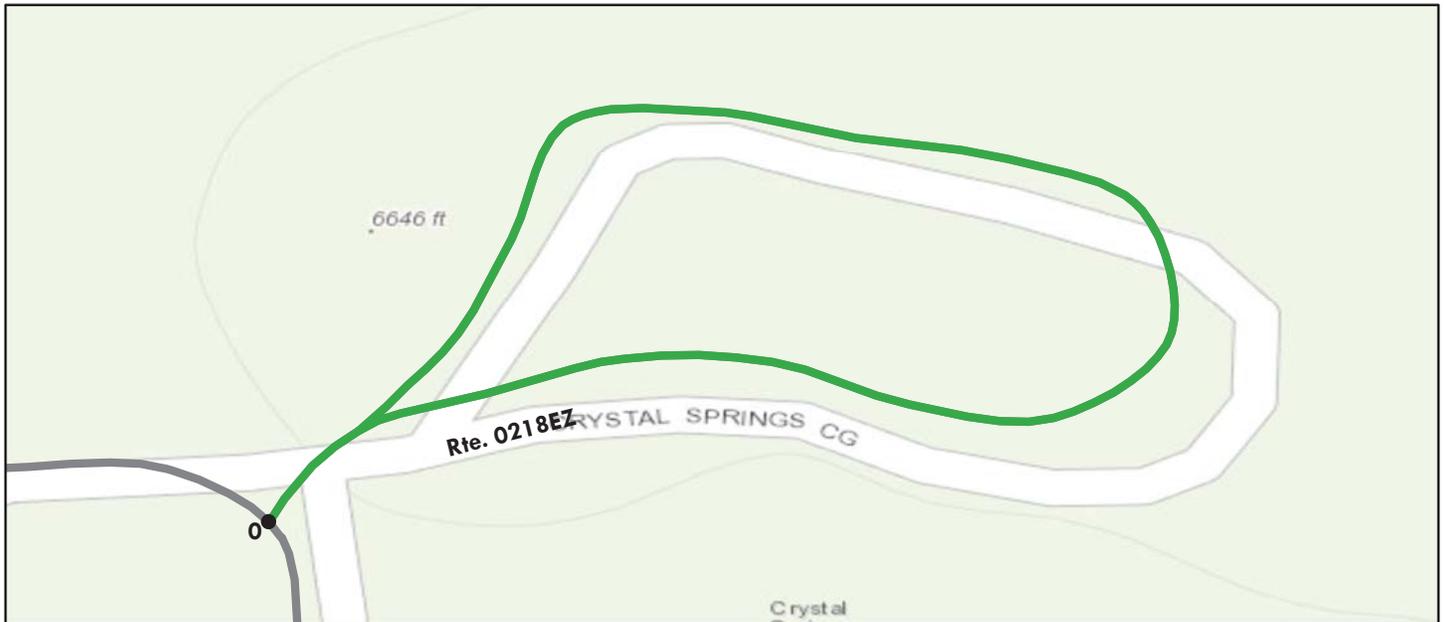
ROUTE 0218EZ: CRYSTAL SPRINGS CAMPGROUND ROAD E

Subcomponent of Route KICA-0218ZZ
Data Collection Vehicle (DCV) Rating

Route Condition Legend – Pavement Condition Rating (PCR)						
Poor (0 - 60)	Fair (61- 84)	Good (85 - 94)	Excellent (95 - 100)	Not Rated		
See Appendix for definitions and formulas						
Inspection Date: 5/30/2015	Beginning Section MP	0				
Paved Length (Miles): 0.15	Section Length (MI)	0.15				
Surface Type: ASPHALT	Route Summary					
Roadway Condition Information						
Pavement Condition Rating (PCR)	91	91				
Surface Condition Rating (SCR)	91	91				
Roughness Condition Index (RCI)	N/A	N/A				
Distress Index Values						
Structural Crack Index	95	95				
Alligator Crack Index	100	100				
Longitudinal Crack Index	95	95				
Transverse Cracking Index	99	99				
Patching Index	100	100				
Rutting Index	91	91				
International Roughness Index (IRI)	N/A	N/A				
Lane & Width Information						
Number of Lanes	1	1				
Paved Width (ft)	10.8	10.8				
Lane Width (ft)	10.8	10.8

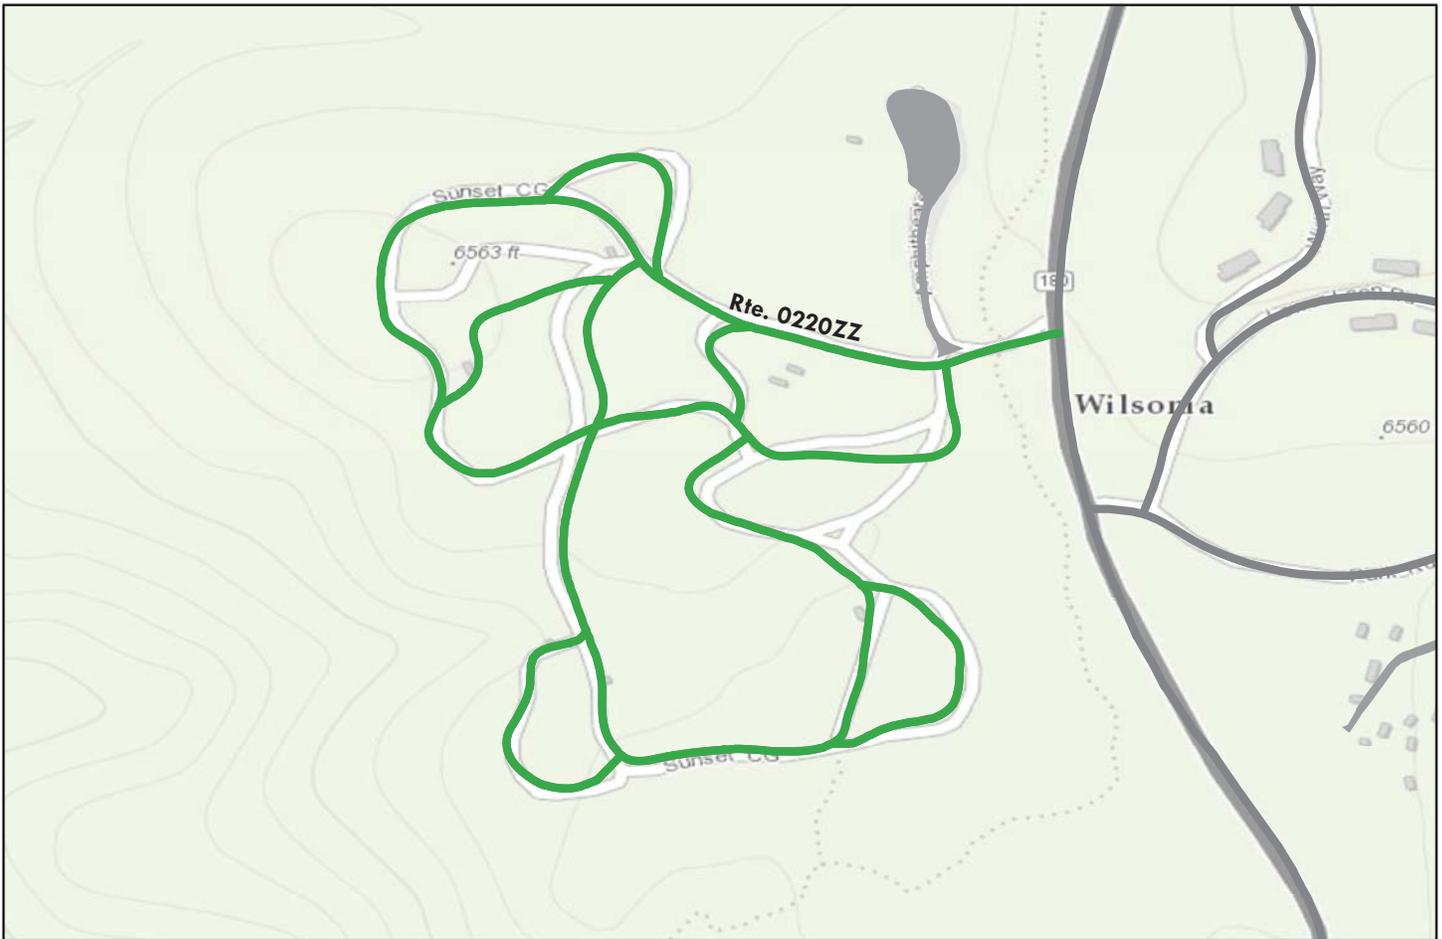
ROUTE 0220ZZ: SUNSET CAMPGROUND ROADS

Summary Route

Note: The weighted average summary PCR value is calculated from only the sections of road where the PCR was collected. The overall PCR for the summary route may not reflect individual subcomponent ratings.

Route Condition Legend – Pavement Condition Rating (PCR)						
Poor (0 - 60)	Fair (61- 84)	Good (85 - 94)	Excellent (95 - 100)	Not Rated		
See Appendix for definitions and formulas						
Inspection Date: 5/30/2015						
Paved Length (Miles): 1.31						
Surface Type: ASPHALT	Route Summary					
Roadway Condition Information						
Pavement Condition Rating (PCR)	94					
Lane & Width Information						
Number of Lanes	1					
Paved Width (ft)	14.5					
Lane Width (ft)	14.5

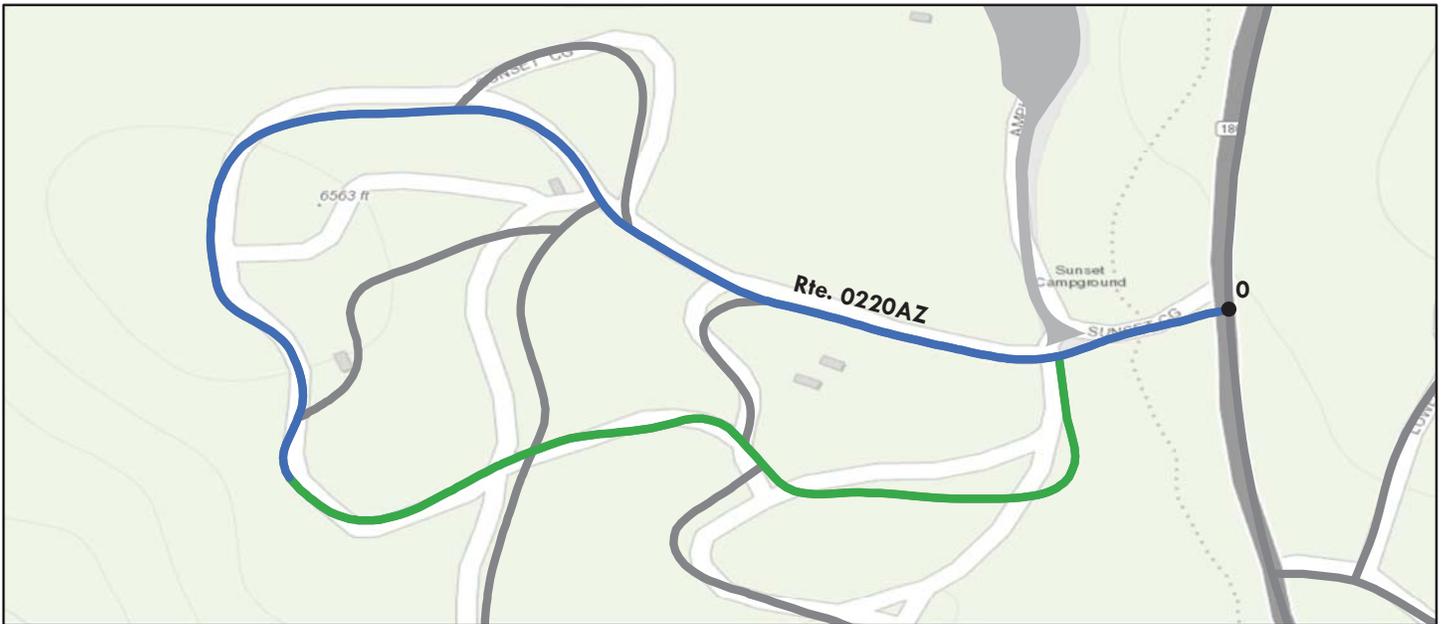
ROUTE 0220AZ: SUNSET CAMPGROUND ROAD A

Subcomponent of Route KICA-0220ZZ
Data Collection Vehicle (DCV) Rating

Route Condition Legend – Pavement Condition Rating (PCR)						
Poor (0 - 60)	Fair (61- 84)	Good (85 - 94)	Excellent (95 - 100)	Not Rated		
See Appendix for definitions and formulas						
Inspection Date: 5/30/2015	Beginning Section MP	0				
Paved Length (Miles): 0.5	Section Length (MI)	0.5				
Surface Type: ASPHALT	Route Summary					
Roadway Condition Information						
Pavement Condition Rating (PCR)	94	94				
Surface Condition Rating (SCR)	94	94				
Roughness Condition Index (RCI)	N/A	N/A				
Distress Index Values						
Structural Crack Index	99	99				
Alligator Crack Index	100	100				
Longitudinal Crack Index	99	99				
Transverse Cracking Index	98	98				
Patching Index	100	100				
Rutting Index	94	94				
International Roughness Index (IRI)	N/A	N/A				
Lane & Width Information						
Number of Lanes	1	1				
Paved Width (ft)	15.5	15.5				
Lane Width (ft)	15.5	15.5

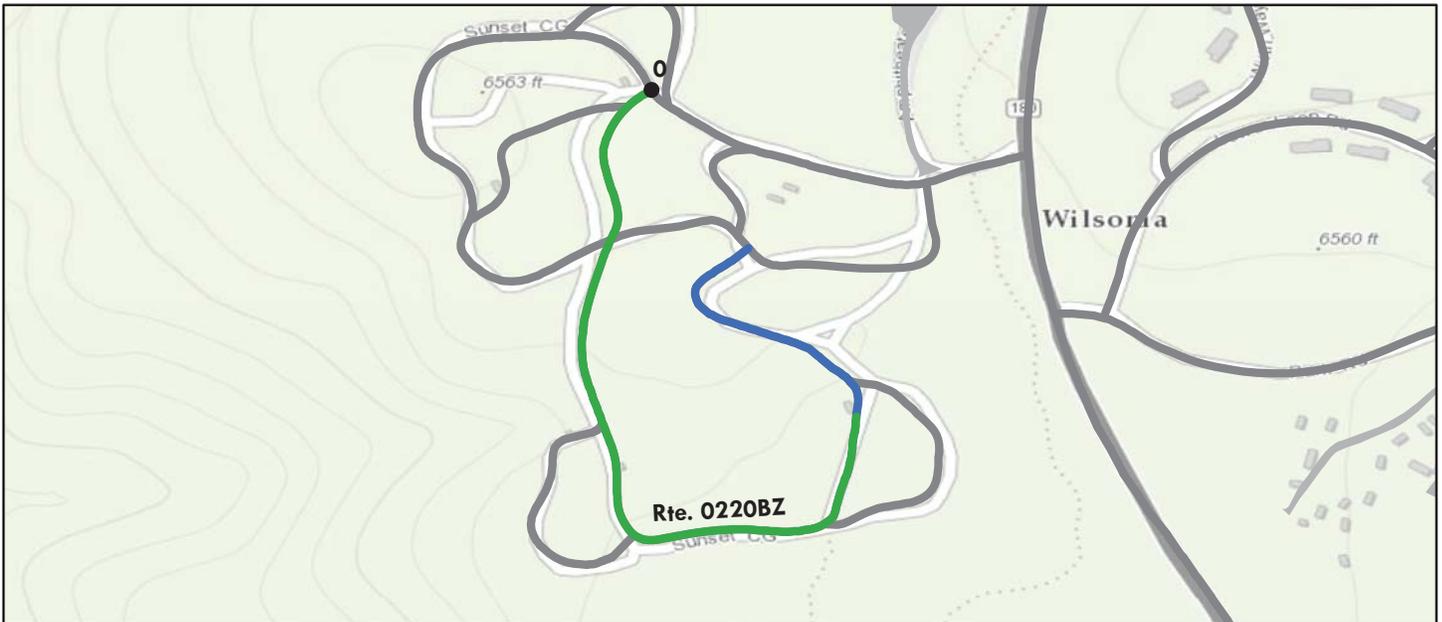
ROUTE 0220BZ: SUNSET CAMPGROUND ROAD B

Subcomponent of Route KICA-0220ZZ
Data Collection Vehicle (DCV) Rating

Route Condition Legend – Pavement Condition Rating (PCR)						
Poor (0 - 60)	Fair (61- 84)	Good (85 - 94)	Excellent (95 - 100)	Not Rated		
See Appendix for definitions and formulas						
Inspection Date: 5/30/2015	Beginning Section MP	0				
Paved Length (Miles): 0.41	Section Length (MI)	0.41				
Surface Type: ASPHALT	Route Summary					
Roadway Condition Information						
Pavement Condition Rating (PCR)	94	94				
Surface Condition Rating (SCR)	94	94				
Roughness Condition Index (RCI)	N/A	N/A				
Distress Index Values						
Structural Crack Index	98	98				
Alligator Crack Index	100	100				
Longitudinal Crack Index	98	98				
Transverse Cracking Index	99	99				
Patching Index	100	100				
Rutting Index	94	94				
International Roughness Index (IRI)	N/A	N/A				
Lane & Width Information						
Number of Lanes	1	1				
Paved Width (ft)	14.2	14.2				
Lane Width (ft)	14.2	14.2

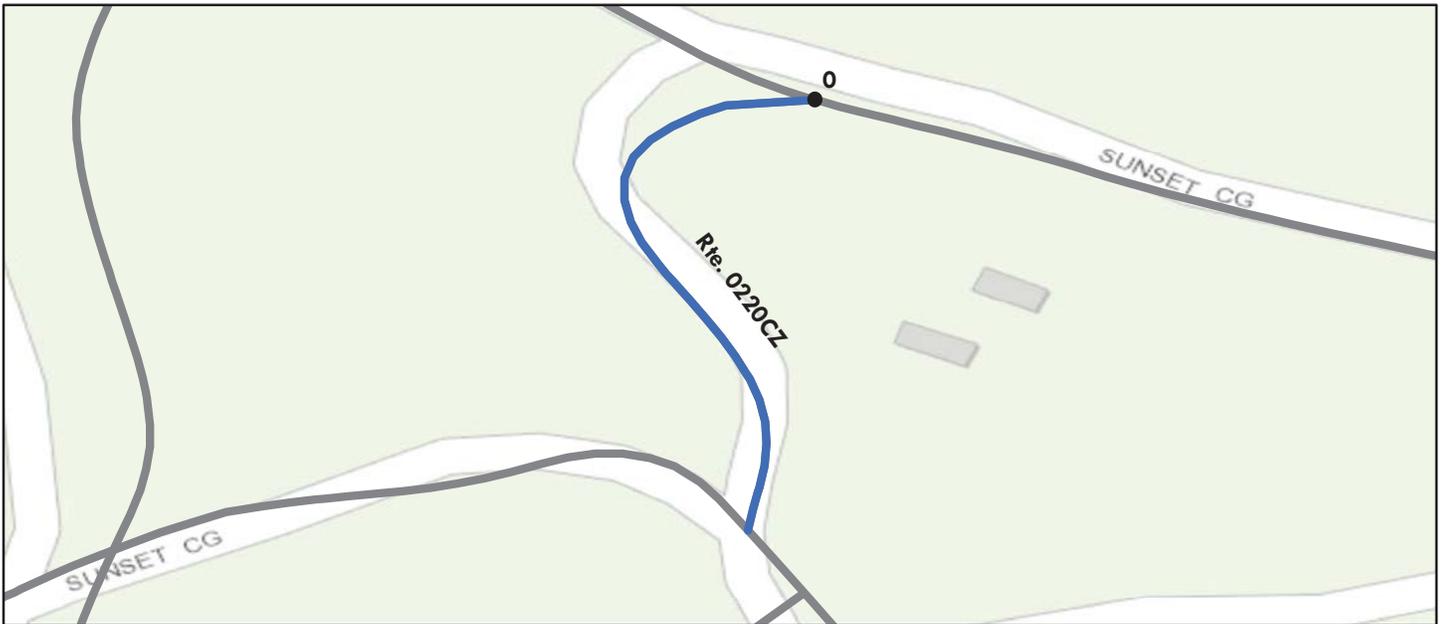
ROUTE 0220CZ: SUNSET CAMPGROUND ROAD C

Subcomponent of Route KICA-0220ZZ
Data Collection Vehicle (DCV) Rating

Route Condition Legend – Pavement Condition Rating (PCR)						
Poor (0 - 60)	Fair (61- 84)	Good (85 - 94)	Excellent (95 - 100)	Not Rated		
See Appendix for definitions and formulas						
Inspection Date: 5/30/2015	Beginning Section MP	0				
Paved Length (Miles): 0.05	Section Length (MI)	0.05				
Surface Type: ASPHALT	Route Summary					
Roadway Condition Information						
Pavement Condition Rating (PCR)	95	95				
Surface Condition Rating (SCR)	95	95				
Roughness Condition Index (RCI)	N/A	N/A				
Distress Index Values						
Structural Crack Index	95	95				
Alligator Crack Index	100	100				
Longitudinal Crack Index	95	95				
Transverse Cracking Index	97	97				
Patching Index	100	100				
Rutting Index	95	95				
International Roughness Index (IRI)	N/A	N/A				
Lane & Width Information						
Number of Lanes	1	1				
Paved Width (ft)	14.8	14.8				
Lane Width (ft)	14.8	14.8

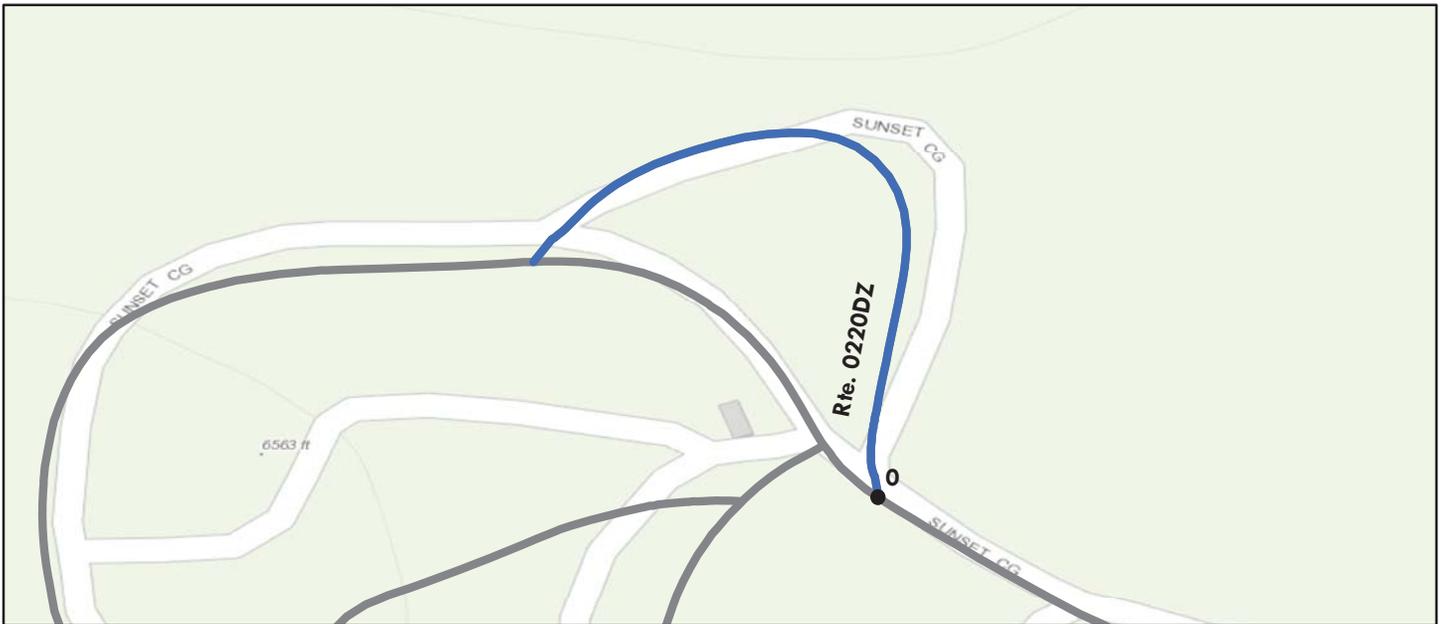
ROUTE 0220DZ: SUNSET CAMPGROUND ROAD D

Subcomponent of Route KICA-0220ZZ
Data Collection Vehicle (DCV) Rating

Route Condition Legend – Pavement Condition Rating (PCR)						
Poor (0 - 60)	Fair (61- 84)	Good (85 - 94)	Excellent (95 - 100)	Not Rated		
See Appendix for definitions and formulas						
Inspection Date: 5/30/2015	Beginning Section MP	0				
Paved Length (Miles): 0.08	Section Length (MI)	0.08				
Surface Type: ASPHALT	Route Summary					
Roadway Condition Information						
Pavement Condition Rating (PCR)	96	96				
Surface Condition Rating (SCR)	96	96				
Roughness Condition Index (RCI)	N/A	N/A				
Distress Index Values						
Structural Crack Index	99	99				
Alligator Crack Index	100	100				
Longitudinal Crack Index	99	99				
Transverse Cracking Index	97	97				
Patching Index	100	100				
Rutting Index	96	96				
International Roughness Index (IRI)	N/A	N/A				
Lane & Width Information						
Number of Lanes	1	1				
Paved Width (ft)	15.8	15.8				
Lane Width (ft)	15.8	15.8

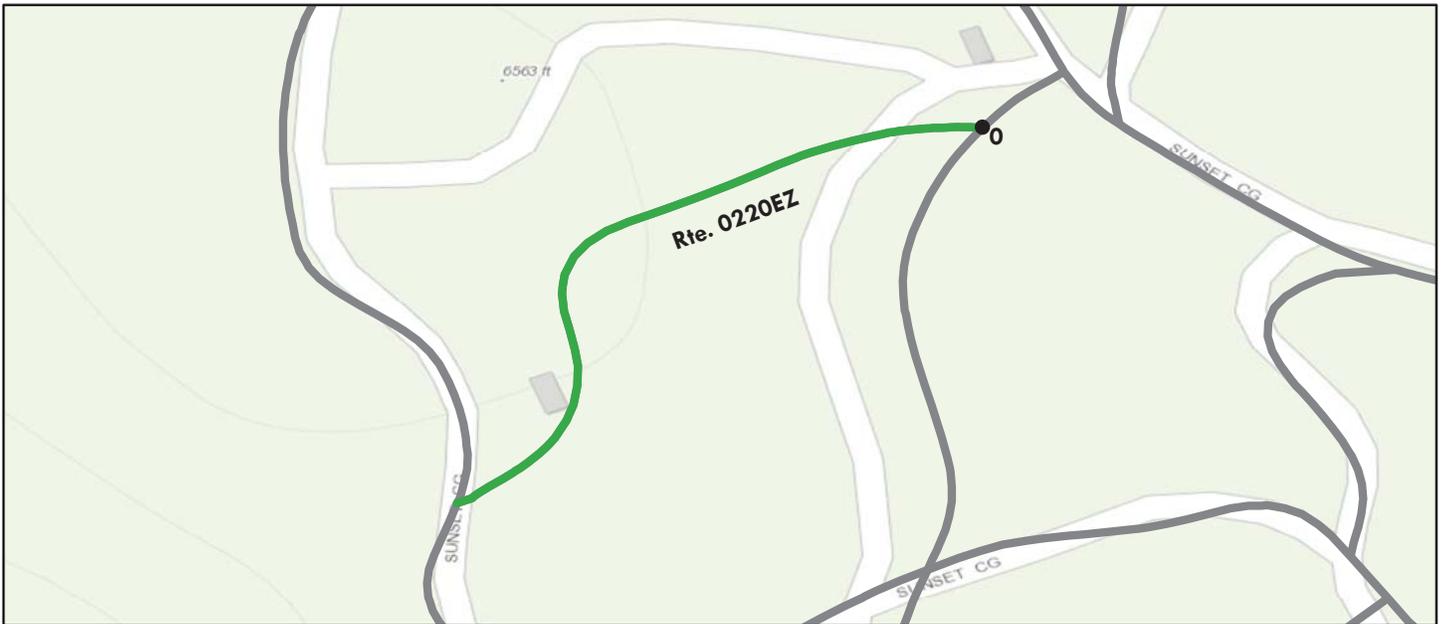
ROUTE 0220EZ: SUNSET CAMPGROUND ROAD E

Subcomponent of Route KICA-0220ZZ
Data Collection Vehicle (DCV) Rating

Route Condition Legend – Pavement Condition Rating (PCR)						
Poor (0 - 60)	Fair (61- 84)	Good (85 - 94)	Excellent (95 - 100)	Not Rated		
See Appendix for definitions and formulas						
Inspection Date: 5/30/2015	Beginning Section MP	0				
Paved Length (Miles): 0.08	Section Length (MI)	0.08				
Surface Type: ASPHALT	Route Summary					
Roadway Condition Information						
Pavement Condition Rating (PCR)	91	91				
Surface Condition Rating (SCR)	91	91				
Roughness Condition Index (RCI)	N/A	N/A				
Distress Index Values						
Structural Crack Index	99	99				
Alligator Crack Index	100	100				
Longitudinal Crack Index	99	99				
Transverse Cracking Index	99	99				
Patching Index	100	100				
Rutting Index	91	91				
International Roughness Index (IRI)	N/A	N/A				
Lane & Width Information						
Number of Lanes	1	1				
Paved Width (ft)	14.6	14.6				
Lane Width (ft)	14.6	14.6

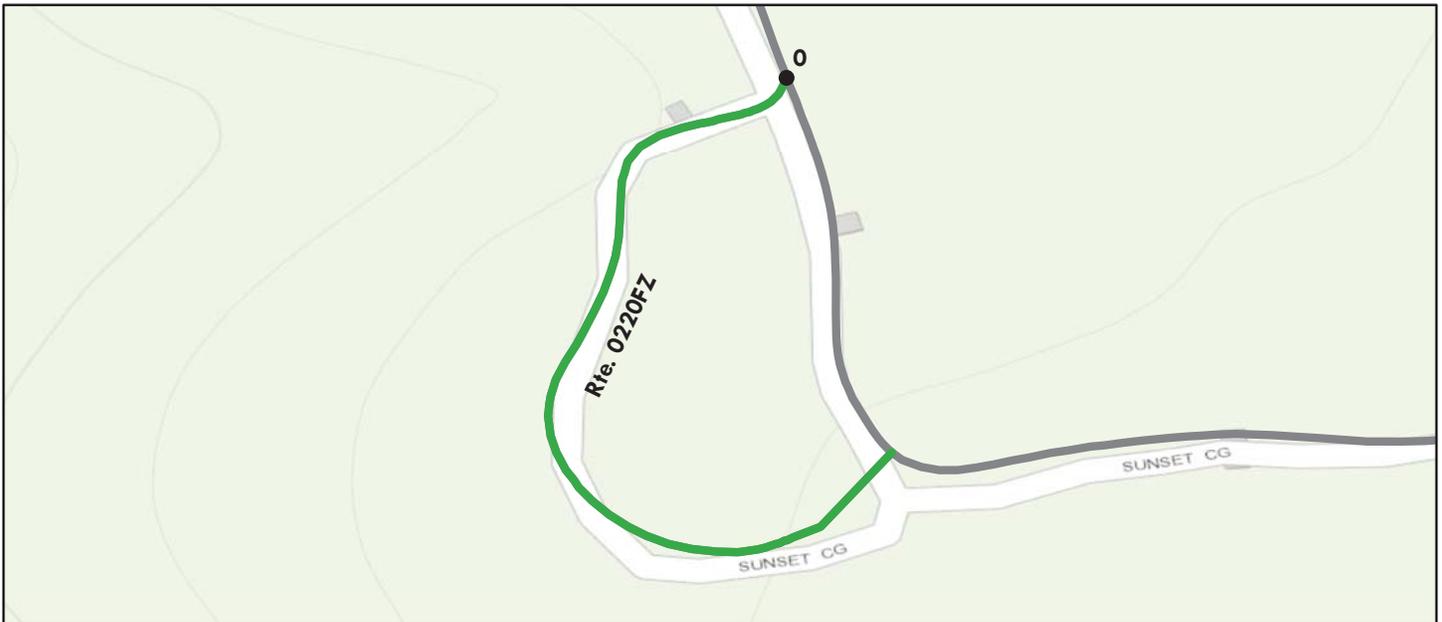
ROUTE 0220FZ: SUNSET CAMPGROUND ROAD F

Subcomponent of Route KICA-0220ZZ
Data Collection Vehicle (DCV) Rating

Route Condition Legend – Pavement Condition Rating (PCR)						
Poor (0 - 60)	Fair (61- 84)	Good (85 - 94)	Excellent (95 - 100)	Not Rated		
See Appendix for definitions and formulas						
Inspection Date: 5/30/2015	Beginning Section MP	0				
Paved Length (Miles): 0.09	Section Length (MI)	0.09				
Surface Type: ASPHALT	Route Summary					
Roadway Condition Information						
Pavement Condition Rating (PCR)	90	90				
Surface Condition Rating (SCR)	90	90				
Roughness Condition Index (RCI)	N/A	N/A				
Distress Index Values						
Structural Crack Index	100	100				
Alligator Crack Index	100	100				
Longitudinal Crack Index	100	100				
Transverse Cracking Index	99	99				
Patching Index	100	100				
Rutting Index	90	90				
International Roughness Index (IRI)	N/A	N/A				
Lane & Width Information						
Number of Lanes	1	1				
Paved Width (ft)	10.7	10.7				
Lane Width (ft)	10.7	10.7

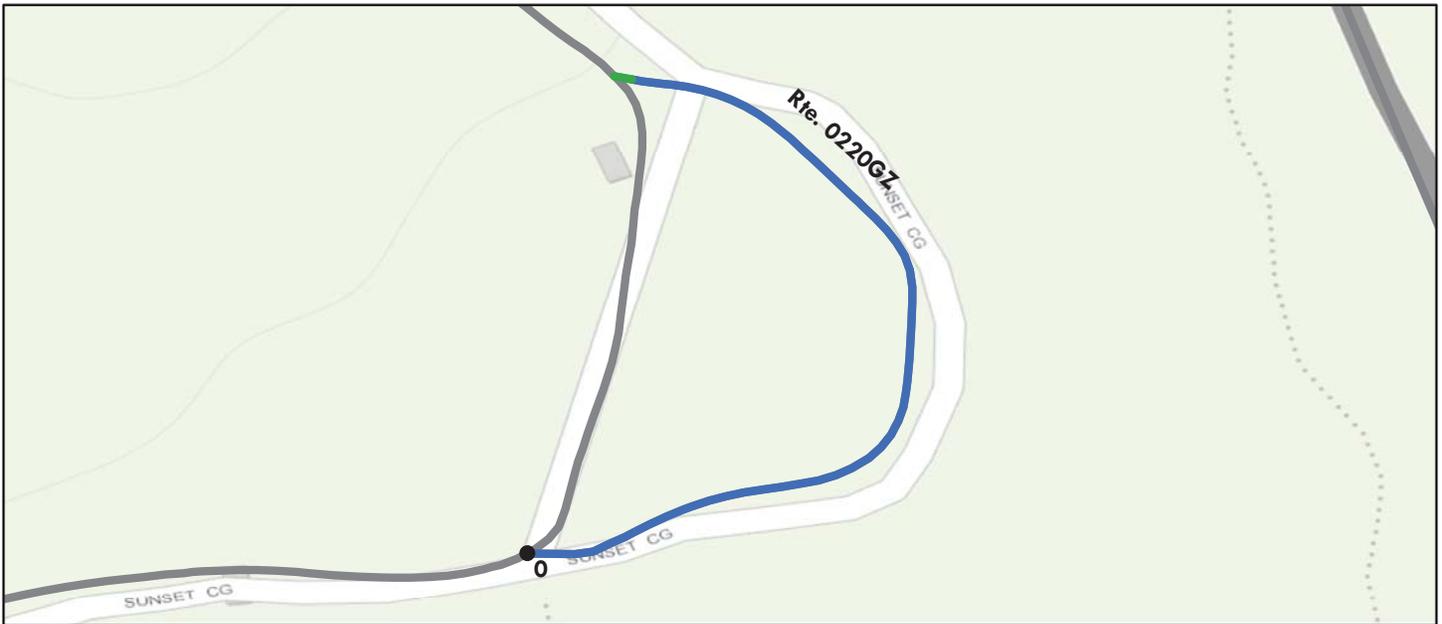
ROUTE 0220GZ: SUNSET CAMPGROUND ROAD G

Subcomponent of Route KICA-0220ZZ
Data Collection Vehicle (DCV) Rating

Route Condition Legend – Pavement Condition Rating (PCR)						
Poor (0 - 60)	Fair (61- 84)	Good (85 - 94)	Excellent (95 - 100)	Not Rated		
See Appendix for definitions and formulas						
Inspection Date: 5/30/2015	Beginning Section MP	0				
Paved Length (Miles): 0.1	Section Length (MI)	0.1				
Surface Type: ASPHALT	Route Summary					
Roadway Condition Information						
Pavement Condition Rating (PCR)	94	94				
Surface Condition Rating (SCR)	94	94				
Roughness Condition Index (RCI)	N/A	N/A				
Distress Index Values						
Structural Crack Index	100	100				
Alligator Crack Index	100	100				
Longitudinal Crack Index	100	100				
Transverse Cracking Index	99	99				
Patching Index	100	100				
Rutting Index	94	94				
International Roughness Index (IRI)	N/A	N/A				
Lane & Width Information						
Number of Lanes	1	1				
Paved Width (ft)	13.4	13.4				
Lane Width (ft)	13.4	13.4

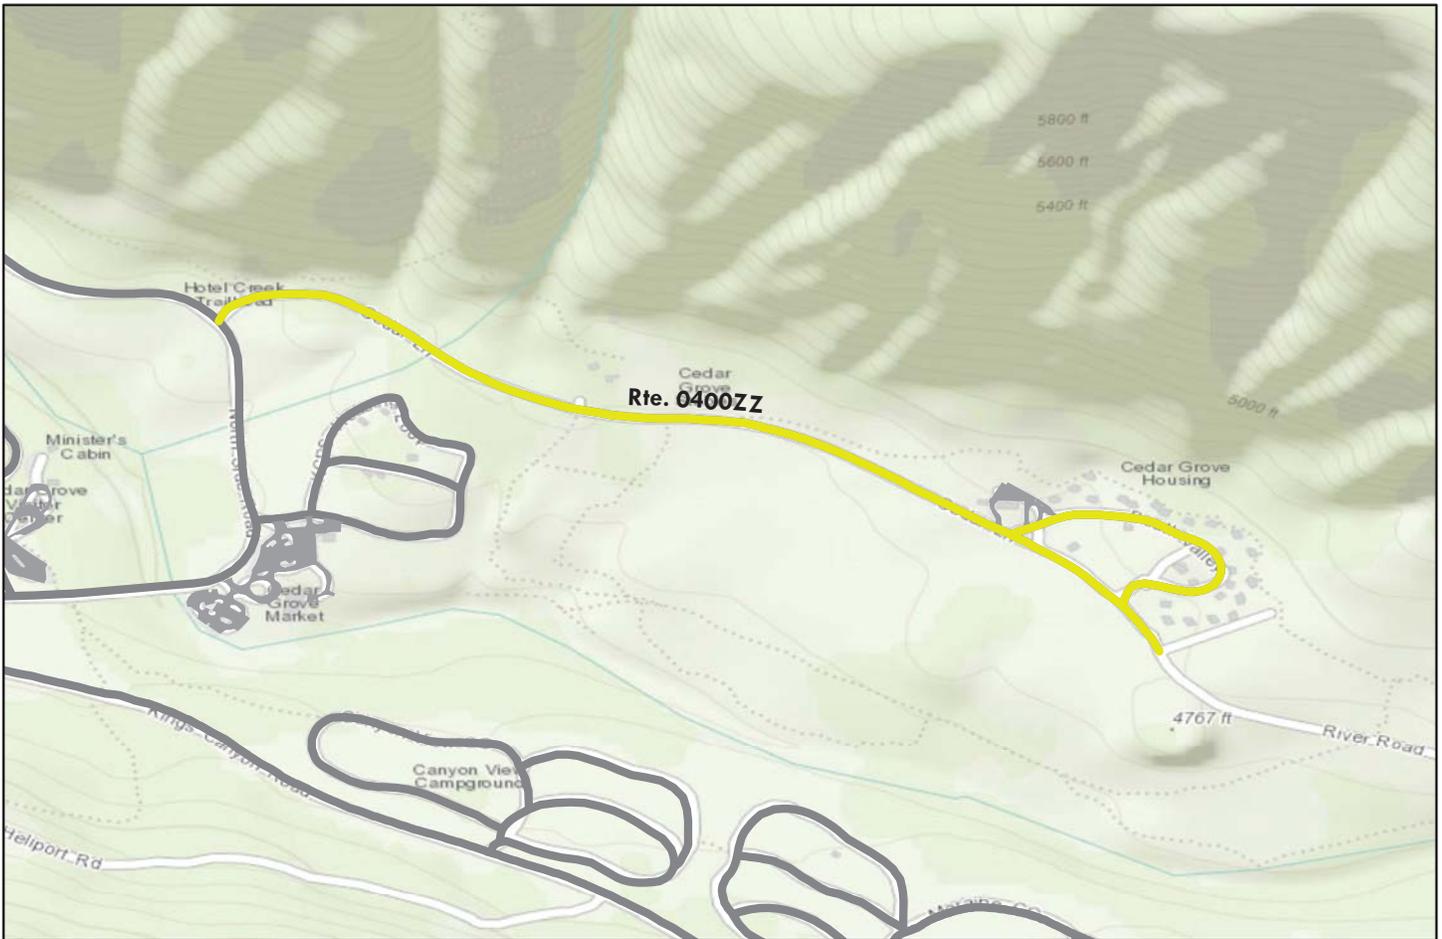
ROUTE 0400ZZ: CEDAR GROVE RESIDENCE ROADS

Summary Route

Note: The weighted average summary PCR value is calculated from only the sections of road where the PCR was collected. The overall PCR for the summary route may not reflect individual subcomponent ratings.

Route Condition Legend – Pavement Condition Rating (PCR)						
Poor (0 - 60)	Fair (61- 84)	Good (85 - 94)	Excellent (95 - 100)	Not Rated		
See Appendix for definitions and formulas						
Inspection Date:	5/28/2015					
Paved Length (Miles):	0.97					
Surface Type:	ASPHALT	Route Summary				
Roadway Condition Information						
Pavement Condition Rating (PCR)	76					
Lane & Width Information						
Number of Lanes	1					
Paved Width (ft)	18.7					
Lane Width (ft)	9.4

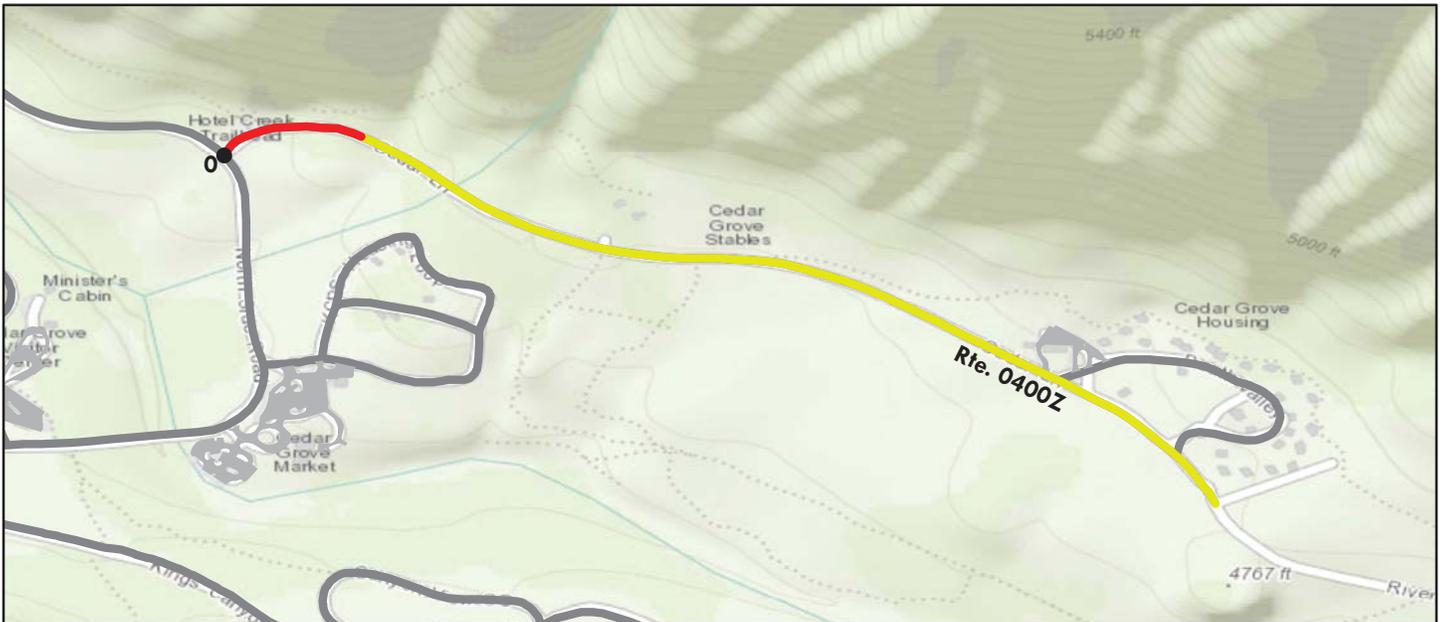
Subcomponent of Route KICA-0400ZZ

Data Collection Vehicle (DCV) Rating

Inspection Date: 5/28/2015	Beginning Section MP	0				
Paved Length (Miles): 0.73	Section Length (MI)	0.73				
Surface Type: ASPHALT	Route Summary					
Roadway Condition Information						
Pavement Condition Rating (PCR)	71	71				
Surface Condition Rating (SCR)	84	84				
Roughness Condition Index (RCI)	51	51				
Distress Index Values						
Structural Crack Index	96	96				
Alligator Crack Index	100	100				
Longitudinal Crack Index	96	96				
Transverse Cracking Index	84	84				
Patching Index	100	100				
Rutting Index	97	97				
International Roughness Index (IRI)	280	280				
Lane & Width Information						
Number of Lanes	2	2				
Paved Width (ft)	18.1	18.1				
Lane Width (ft)	9.1	9.1

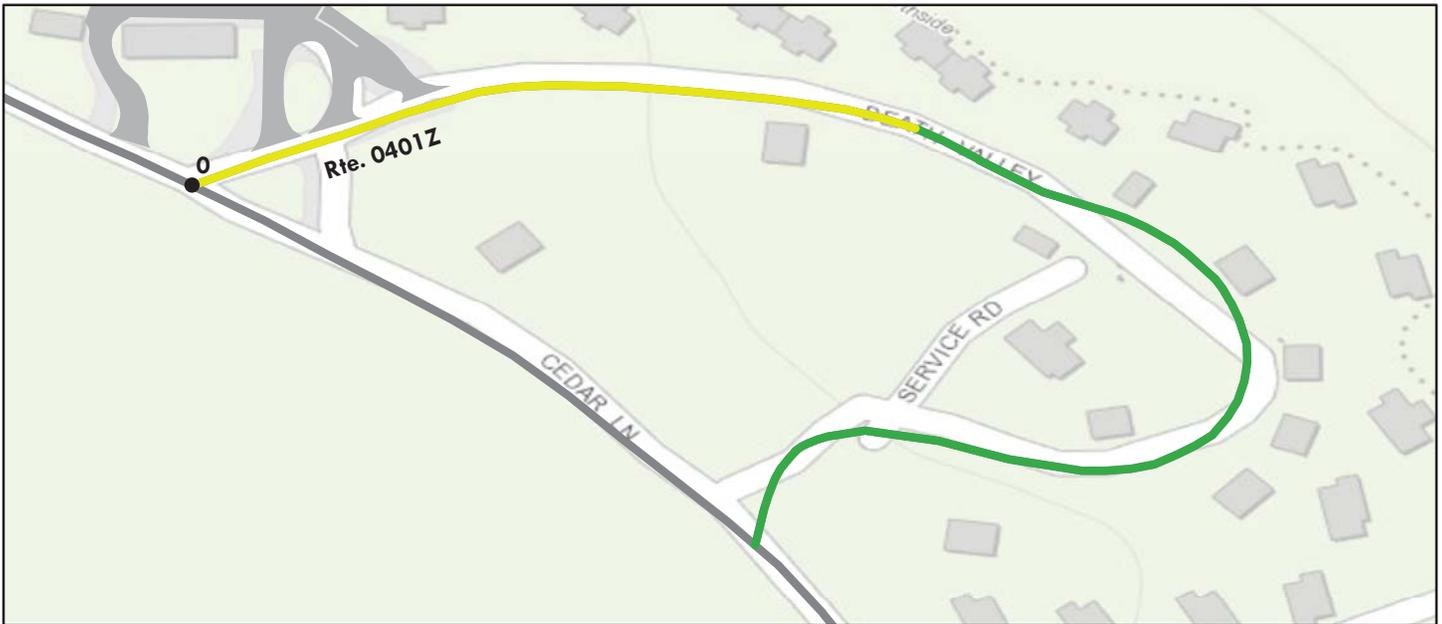
Subcomponent of Route KICA-0400ZZ

Data Collection Vehicle (DCV) Rating

Inspection Date: 5/28/2015	Beginning Section MP	0				
Paved Length (Miles): 0.24	Section Length (MI)	0.24				
Surface Type: ASPHALT	Route Summary					
Roadway Condition Information						
Pavement Condition Rating (PCR)	89	89				
Surface Condition Rating (SCR)	89	89				
Roughness Condition Index (RCI)	N/A	N/A				
Distress Index Values						
Structural Crack Index	94	94				
Alligator Crack Index	100	100				
Longitudinal Crack Index	94	94				
Transverse Cracking Index	89	89				
Patching Index	100	100				
Rutting Index	92	92				
International Roughness Index (IRI)	N/A	N/A				
Lane & Width Information						
Number of Lanes	2	2				
Paved Width (ft)	20.5	20.5				
Lane Width (ft)	10.2	10.2

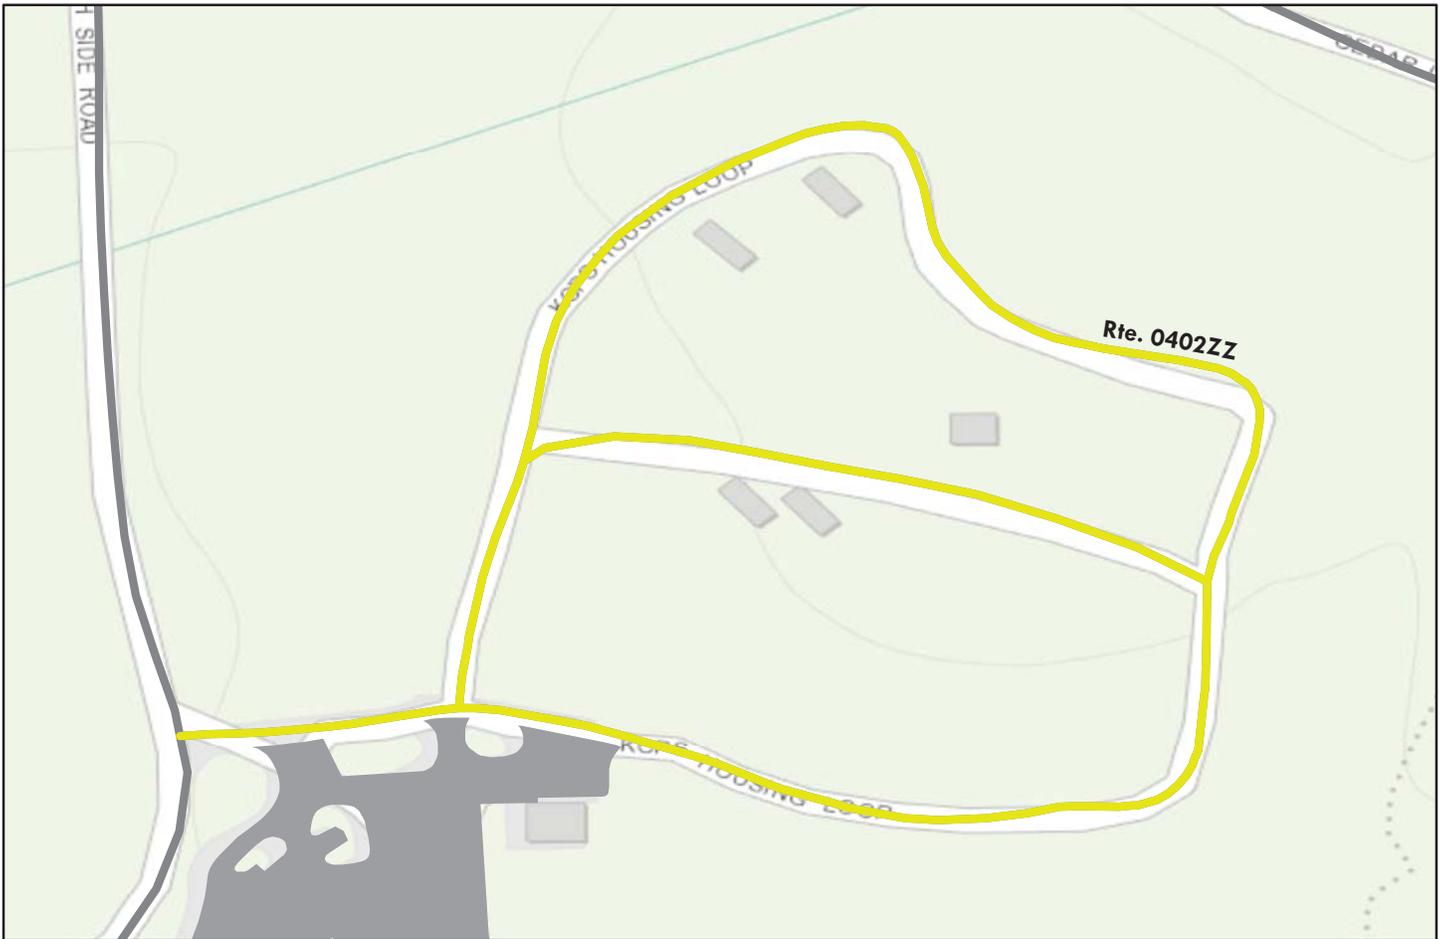
ROUTE 0402ZZ: PICNIC ESTATES HOUSING ROADS

Summary Route

Note: The weighted average summary PCR value is calculated from only the sections of road where the PCR was collected. The overall PCR for the summary route may not reflect individual subcomponent ratings.

Route Condition Legend – Pavement Condition Rating (PCR)						
Poor (0 - 60)	Fair (61- 84)	Good (85 - 94)	Excellent (95 - 100)	Not Rated		
See Appendix for definitions and formulas						
Inspection Date: 5/28/2015						
Paved Length (Miles): 0.48						
Surface Type: ASPHALT	Route Summary					
Roadway Condition Information						
Pavement Condition Rating (PCR)	69					
Lane & Width Information						
Number of Lanes	1					
Paved Width (ft)	14.9					
Lane Width (ft)	9.7

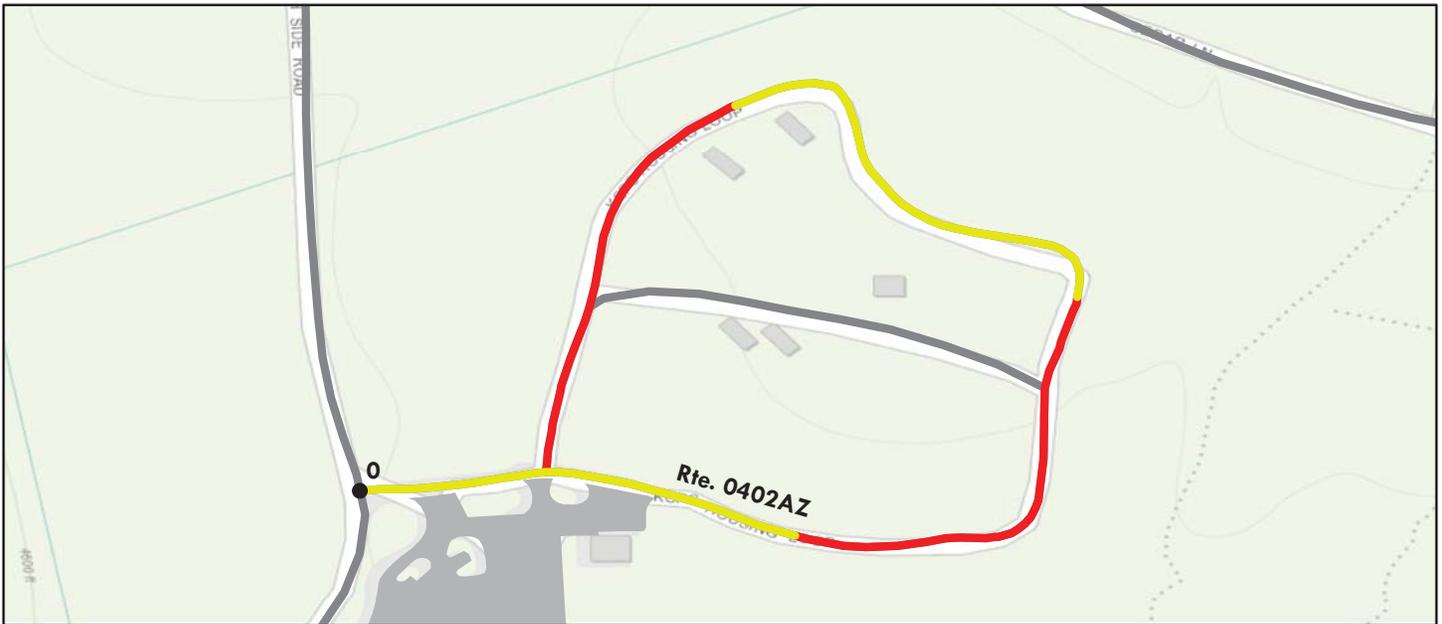
ROUTE 0402AZ: PICNIC ESTATES HOUSING ROAD A

Subcomponent of Route KICA-0402ZZ
Data Collection Vehicle (DCV) Rating

Route Condition Legend – Pavement Condition Rating (PCR)						
Poor (0 - 60)	Fair (61- 84)	Good (85 - 94)	Excellent (95 - 100)	Not Rated		
See Appendix for definitions and formulas						
Inspection Date: 5/28/2015	Beginning Section MP	0				
Paved Length (Miles): 0.39	Section Length (MI)	0.39				
Surface Type: ASPHALT	Route Summary					
Roadway Condition Information						
Pavement Condition Rating (PCR)	64	64				
Surface Condition Rating (SCR)	64	64				
Roughness Condition Index (RCI)	N/A	N/A				
Distress Index Values						
Structural Crack Index	79	79				
Alligator Crack Index	100	100				
Longitudinal Crack Index	79	79				
Transverse Cracking Index	64	64				
Patching Index	98	98				
Rutting Index	94	94				
International Roughness Index (IRI)	N/A	N/A				
Lane & Width Information						
Number of Lanes	2	2				
Paved Width (ft)	15.9	15.9				
Lane Width (ft)	9.5	9.5
