KICA Cycle 6

Final Report

Road Inventory and Condition Assessment of Paved Routes Kings Canyon National Park

**Federal Highway Administration
Eastern Federal Lands Highway Division
Road Inventory Program (RIP)**

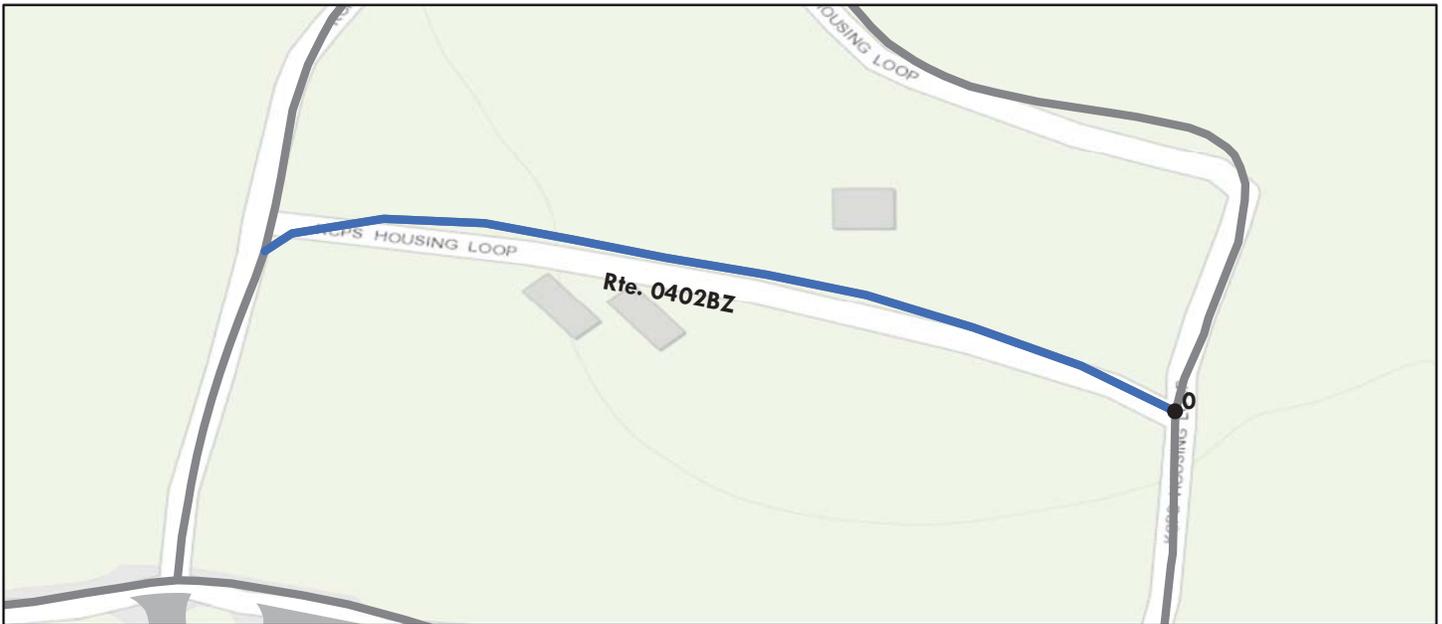
ROUTE 0402BZ: PICNIC ESTATES HOUSING ROAD B

Subcomponent of Route KICA-0402ZZ
Data Collection Vehicle (DCV) Rating

Route Condition Legend – Pavement Condition Rating (PCR)						
Poor (0 - 60)	Fair (61- 84)	Good (85 - 94)	Excellent (95 - 100)	Not Rated		
See Appendix for definitions and formulas						
Inspection Date: 5/28/2015	Beginning Section MP	0				
Paved Length (Miles): 0.09	Section Length (MI)	0.09				
Surface Type: ASPHALT	Route Summary					
Roadway Condition Information						
Pavement Condition Rating (PCR)	98	98				
Surface Condition Rating (SCR)	98	98				
Roughness Condition Index (RCI)	N/A	N/A				
Distress Index Values						
Structural Crack Index	100	100				
Alligator Crack Index	100	100				
Longitudinal Crack Index	100	100				
Transverse Cracking Index	100	100				
Patching Index	100	100				
Rutting Index	98	98				
International Roughness Index (IRI)	N/A	N/A				
Lane & Width Information						
Number of Lanes	1	1				
Paved Width (ft)	10.7	10.7				
Lane Width (ft)	10.7	10.7

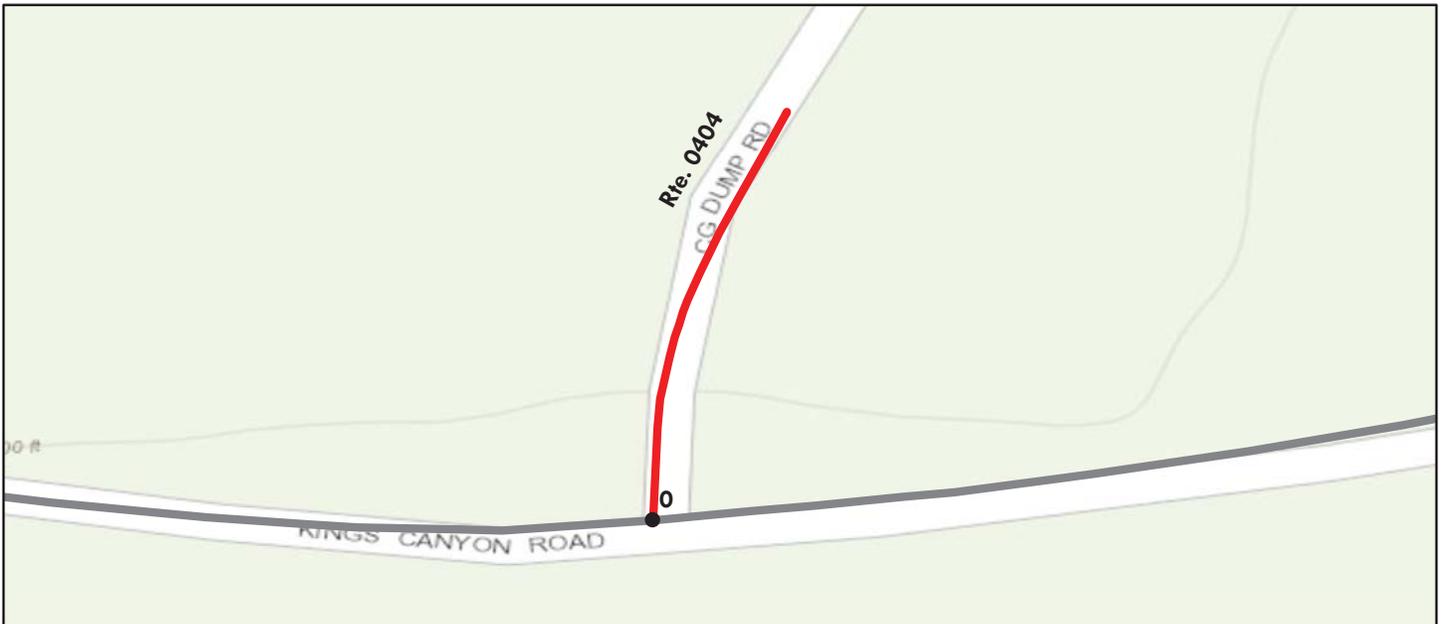
ROUTE 0404: CANYON VIEW SERVICE ROAD

Manual Rating

Route Condition Legend – Pavement Condition Rating (PCR)						
Poor (0 - 60)	Fair (61- 84)	Good (85 - 94)	Excellent (95 - 100)	Not Rated		
See Appendix for definitions and formulas						
Inspection Date:	9/24/2014	Beginning Section MP	0.00			
Paved Length (Miles):	0.04	Section Length (MI)	0.04			
Surface Type:	ASPHALT	Route Summary				
Roadway Condition Information						
Pavement Condition Rating (PCR)	53	53				
Surface Condition Rating (SCR)	53	53				
Roughness Condition Index (RCI)	N/A	N/A				
Distress Index Values						
Structural Crack Index	N/A	N/A				
Alligator Crack Index	90	90				
Longitudinal Crack Index	53	53				
Transverse Cracking Index	53	53				
Patching Index	90	90				
Rutting Index	53	53				
International Roughness Index (IRI)	N/A	N/A				
Lane & Width Information						
Number of Lanes	1	1				
Paved Width (ft)	12.5	12.5				
Lane Width (ft)	12.5	12.5

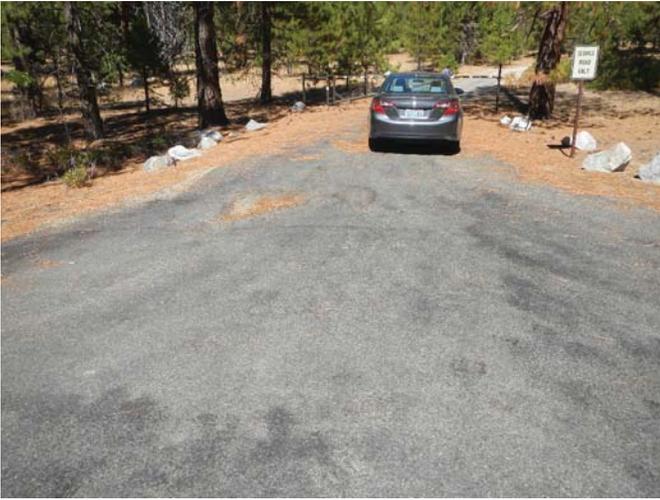
KICA_0404_8718.JPG

Condition photos are shown only for manually rated roads. Use the PathView program to see images of DCV rated roads.

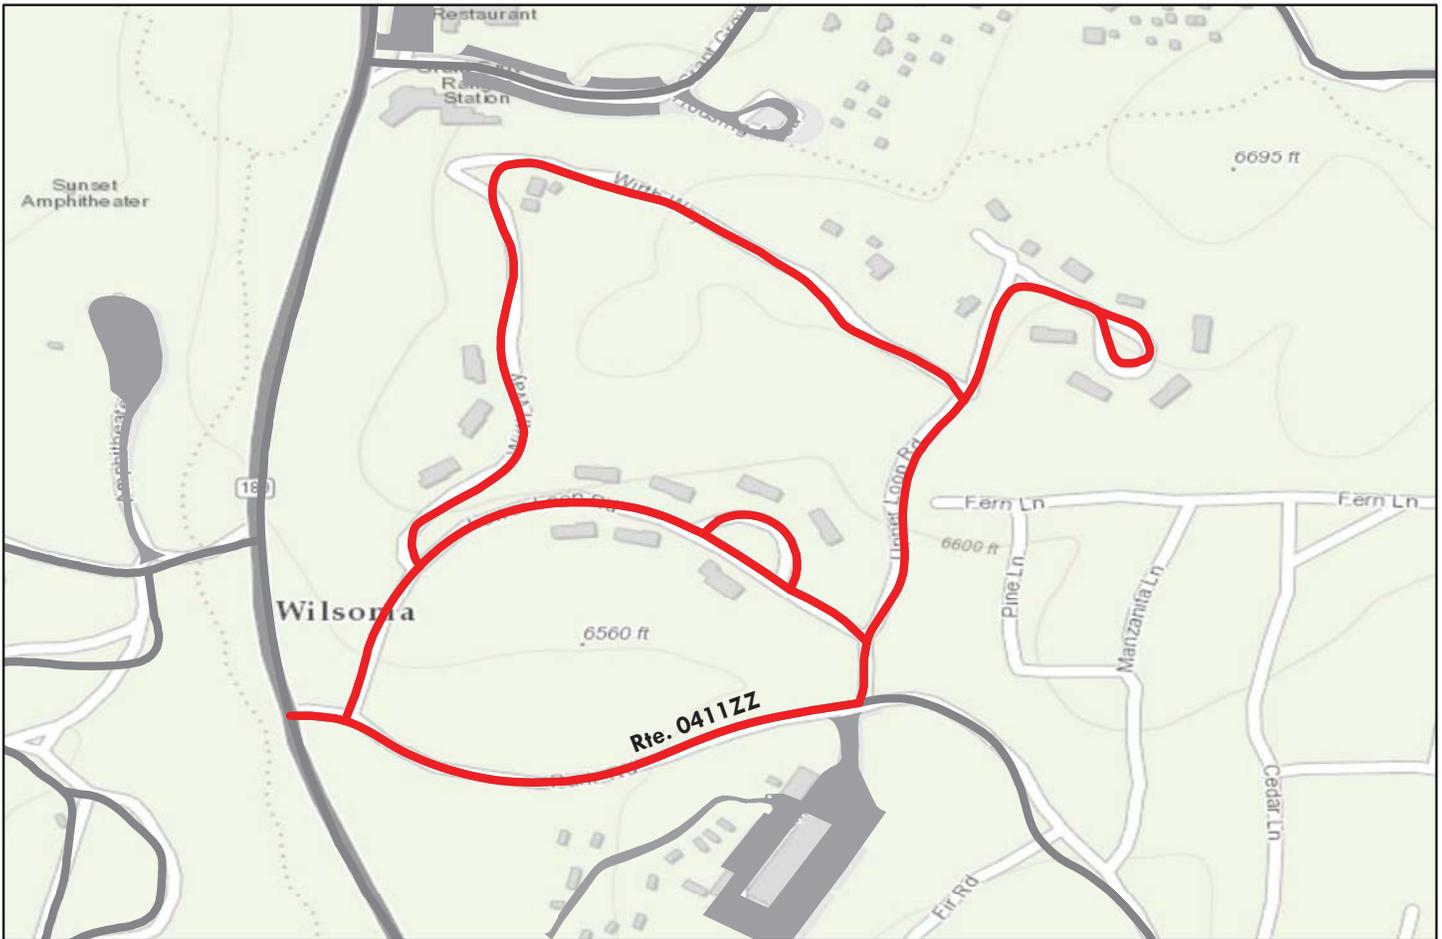
ROUTE 0411ZZ: GRANT GROVE RESIDENCE LOOPS

Note: The weighted average summary PCR value is calculated from only the sections of road where the PCR was collected. The overall PCR for the summary route may not reflect individual subcomponent ratings.

Route Condition Legend – Pavement Condition Rating (PCR)						
Poor (0 - 60)	Fair (61- 84)	Good (85 - 94)	Excellent (95 - 100)	Not Rated		
See Appendix for definitions and formulas						
Inspection Date:	5/30/2015					
Paved Length (Miles):	1.03					
Surface Type:	ASPHALT	Route Summary				
Roadway Condition Information						
Pavement Condition Rating (PCR)	37					
Lane & Width Information						
Number of Lanes	1					
Paved Width (ft)	17.1					
Lane Width (ft)	10.9

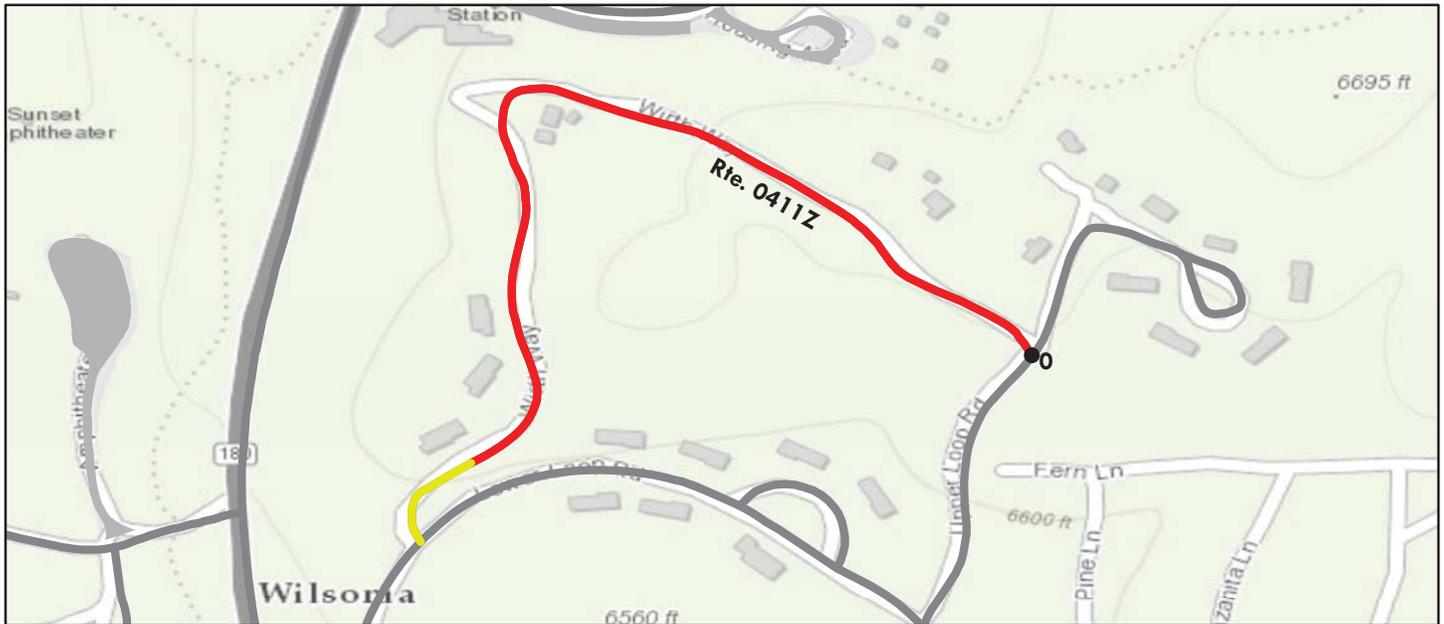
Subcomponent of Route KICA-0411ZZ

Inspection Date: 5/30/2015	Beginning Section MP	0				
Paved Length (Miles): 0.34	Section Length (MI)	0.34				
Surface Type: ASPHALT	Route Summary					
Roadway Condition Information						
Pavement Condition Rating (PCR)	40	40				
Surface Condition Rating (SCR)	40	40				
Roughness Condition Index (RCI)	N/A	N/A				
Distress Index Values						
Structural Crack Index	40	40				
Alligator Crack Index	79	79				
Longitudinal Crack Index	61	61				
Transverse Cracking Index	78	78				
Patching Index	100	100				
Rutting Index	90	90				
International Roughness Index (IRI)	N/A	N/A				
Lane & Width Information						
Number of Lanes	1	1				
Paved Width (ft)	14.2	14.2				
Lane Width (ft)	14.2	14.2

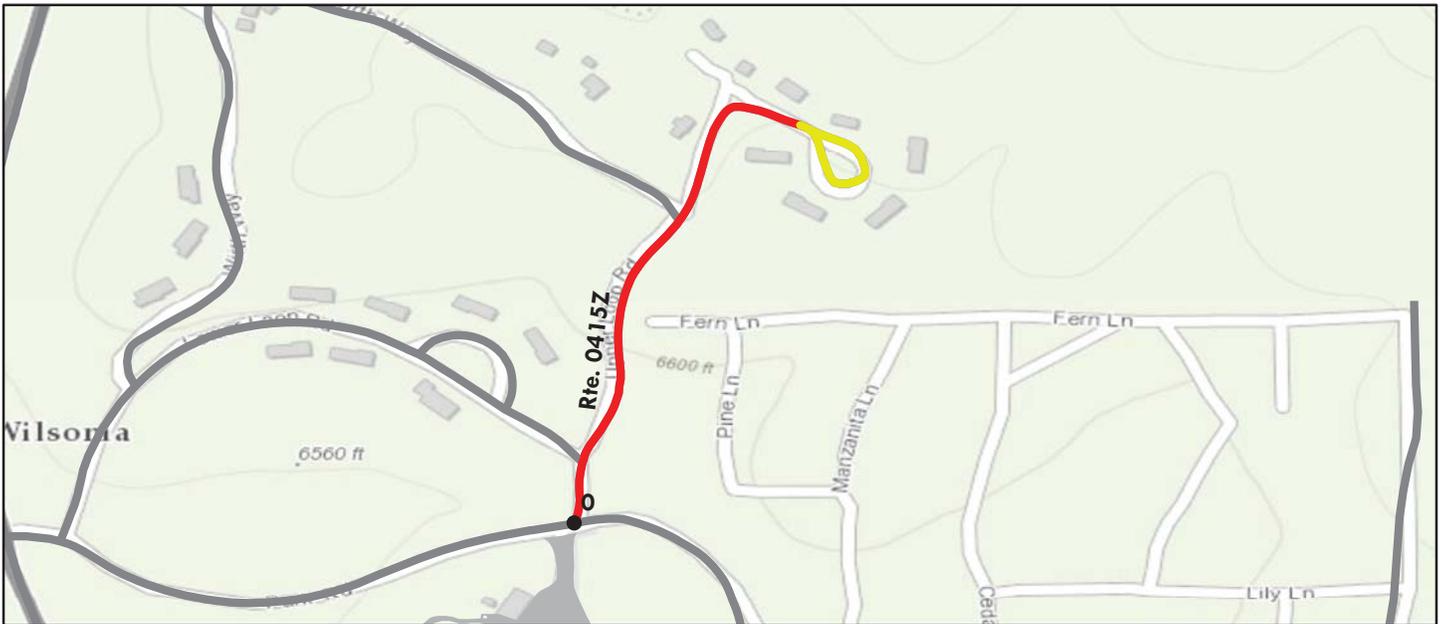
Subcomponent of Route KICA-0411ZZ

Inspection Date: 5/30/2015	Beginning Section MP	0				
Paved Length (Miles): 0.26	Section Length (MI)	0.26				
Surface Type: ASPHALT	Route Summary					
Roadway Condition Information						
Pavement Condition Rating (PCR)	22	22				
Surface Condition Rating (SCR)	22	22				
Roughness Condition Index (RCI)	N/A	N/A				
Distress Index Values						
Structural Crack Index	22	22				
Alligator Crack Index	56	56				
Longitudinal Crack Index	66	66				
Transverse Cracking Index	67	67				
Patching Index	100	100				
Rutting Index	89	89				
International Roughness Index (IRI)	N/A	N/A				
Lane & Width Information						
Number of Lanes	2	2				
Paved Width (ft)	16.8	16.8				
Lane Width (ft)	8.4	8.4

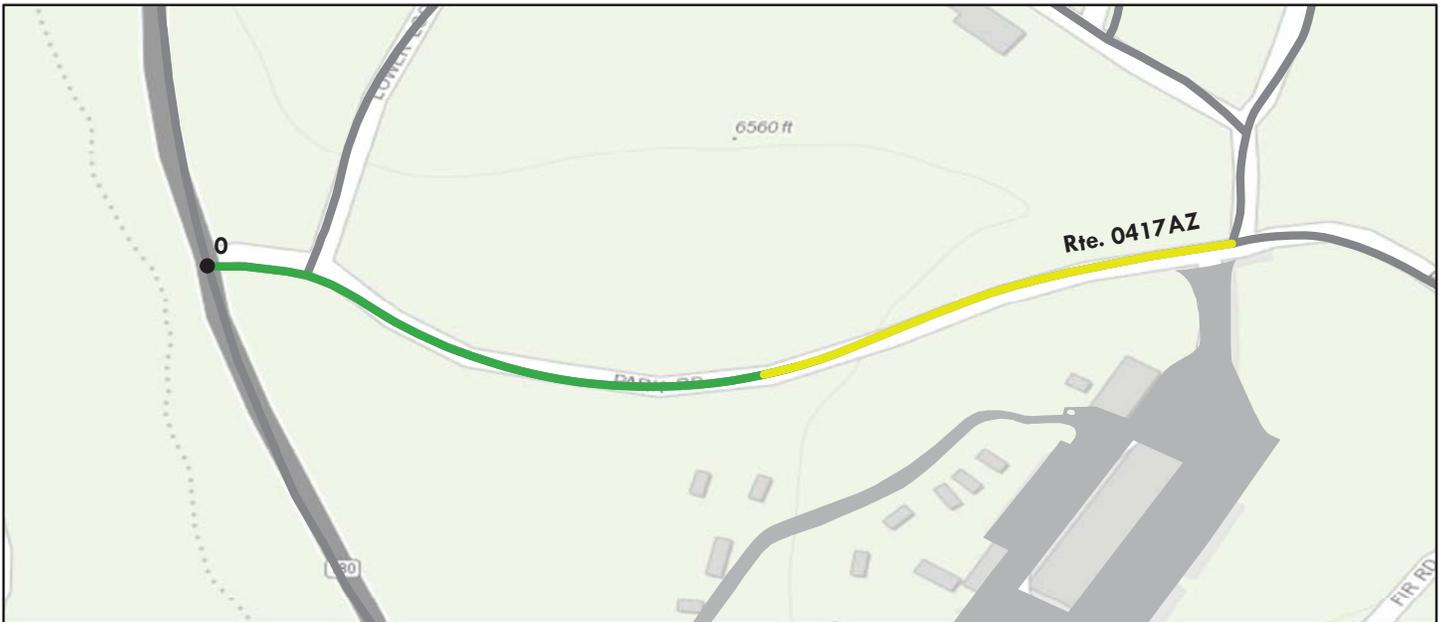
Subcomponent of Route KICA-0411ZZ

Inspection Date: 5/30/2015	Beginning Section MP	0				
Paved Length (Miles): 0.18	Section Length (MI)	0.18				
Surface Type: ASPHALT	Route Summary					
Roadway Condition Information						
Pavement Condition Rating (PCR)	86	86				
Surface Condition Rating (SCR)	86	86				
Roughness Condition Index (RCI)	N/A	N/A				
Distress Index Values						
Structural Crack Index	86	86				
Alligator Crack Index	100	100				
Longitudinal Crack Index	86	86				
Transverse Cracking Index	100	100				
Patching Index	100	100				
Rutting Index	98	98				
International Roughness Index (IRI)	N/A	N/A				
Lane & Width Information						
Number of Lanes	2	2				
Paved Width (ft)	20	20				
Lane Width (ft)	10.4	10.4

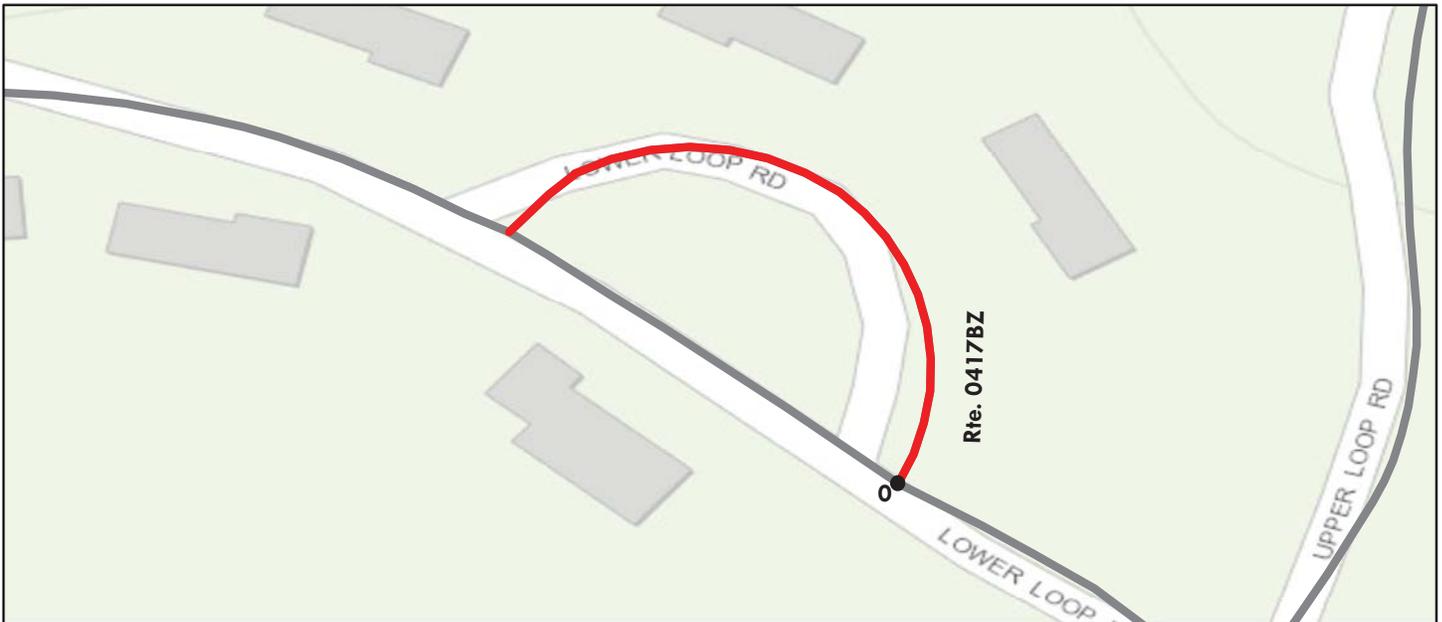
Subcomponent of Route KICA-0411ZZ

Route Condition Legend – Pavement Condition Rating (PCR)						
Poor (0 - 60)	Fair (61- 84)	Good (85 - 94)	Excellent (95 - 100)	Not Rated		
See Appendix for definitions and formulas						
Inspection Date: 5/30/2015	Beginning Section MP	0				
Paved Length (Miles): 0.05	Section Length (MI)	0.05				
Surface Type: ASPHALT	Route Summary					
Roadway Condition Information						
Pavement Condition Rating (PCR)	0	0				
Surface Condition Rating (SCR)	0	0				
Roughness Condition Index (RCI)	N/A	N/A				
Distress Index Values						
Structural Crack Index	0	0				
Alligator Crack Index	0	0				
Longitudinal Crack Index	80	80				
Transverse Cracking Index	74	74				
Patching Index	100	100				
Rutting Index	95	95				
International Roughness Index (IRI)	N/A	N/A				
Lane & Width Information						
Number of Lanes	2	2				
Paved Width (ft)	21.9	21.9				
Lane Width (ft)	11	11

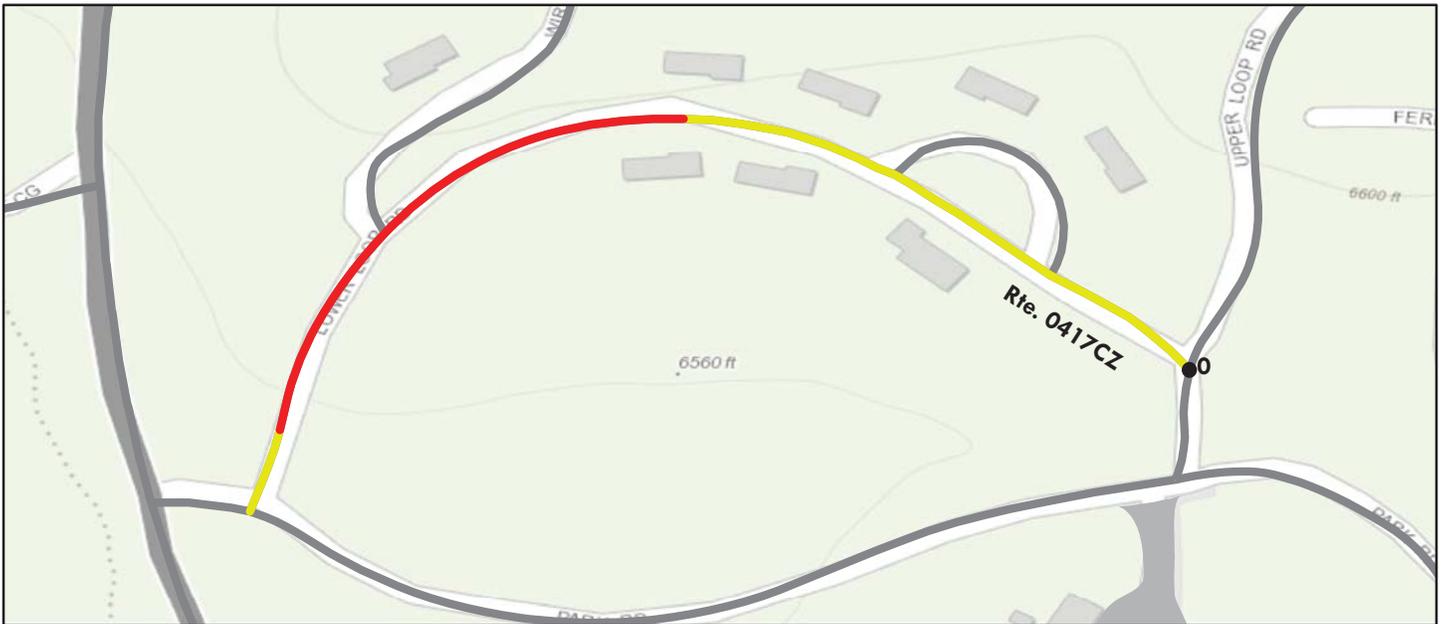
Subcomponent of Route KICA-0411ZZ

Route Condition Legend – Pavement Condition Rating (PCR)						
Poor (0 - 60)	Fair (61- 84)	Good (85 - 94)	Excellent (95 - 100)	Not Rated		
See Appendix for definitions and formulas						
Inspection Date: 5/30/2015	Beginning Section MP	0				
Paved Length (Miles): 0.22	Section Length (MI)	0.22				
Surface Type: ASPHALT	Route Summary					
Roadway Condition Information						
Pavement Condition Rating (PCR)	16	16				
Surface Condition Rating (SCR)	16	16				
Roughness Condition Index (RCI)	N/A	N/A				
Distress Index Values						
Structural Crack Index	16	16				
Alligator Crack Index	47	47				
Longitudinal Crack Index	69	69				
Transverse Cracking Index	74	74				
Patching Index	100	100				
Rutting Index	97	97				
International Roughness Index (IRI)	N/A	N/A				
Lane & Width Information						
Number of Lanes	2	2				
Paved Width (ft)	18.7	18.7				
Lane Width (ft)	9.2	9.2

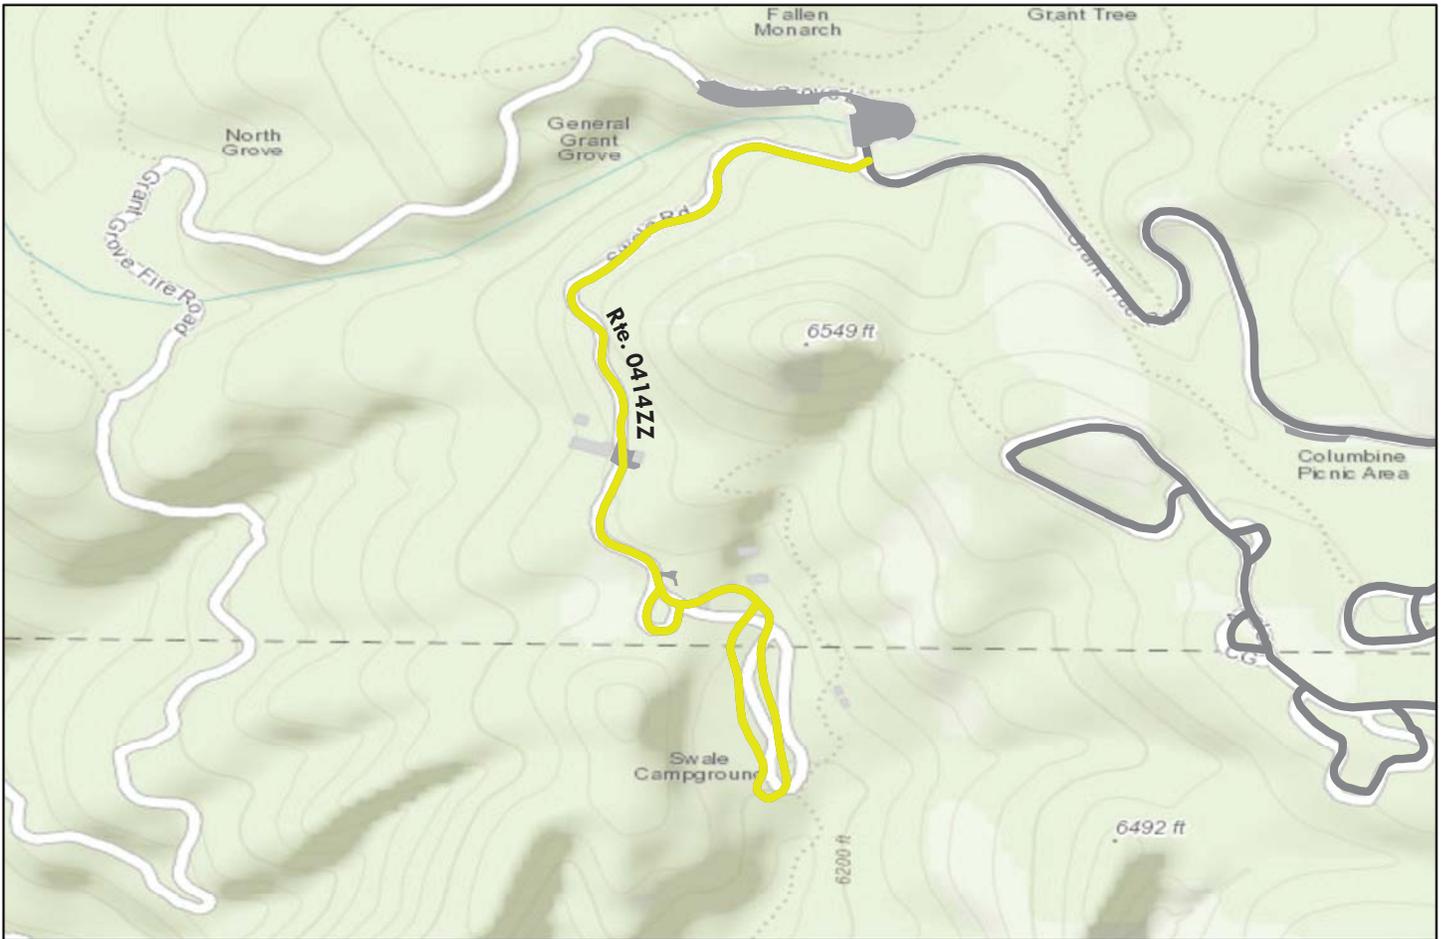
ROUTE 0414ZZ: SWALE WORK CENTER ROADS

Note: The weighted average summary PCR value is calculated from only the sections of road where the PCR was collected. The overall PCR for the summary route may not reflect individual subcomponent ratings.

Route Condition Legend – Pavement Condition Rating (PCR)						
Poor (0 - 60)	Fair (61- 84)	Good (85 - 94)	Excellent (95 - 100)	Not Rated		
See Appendix for definitions and formulas						
Inspection Date: 5/30/2015						
Paved Length (Miles): 0.88						
Surface Type: ASPHALT	Route Summary					
Roadway Condition Information						
Pavement Condition Rating (PCR)	61					
Lane & Width Information						
Number of Lanes	1					
Paved Width (ft)	14.9					
Lane Width (ft)	10.3

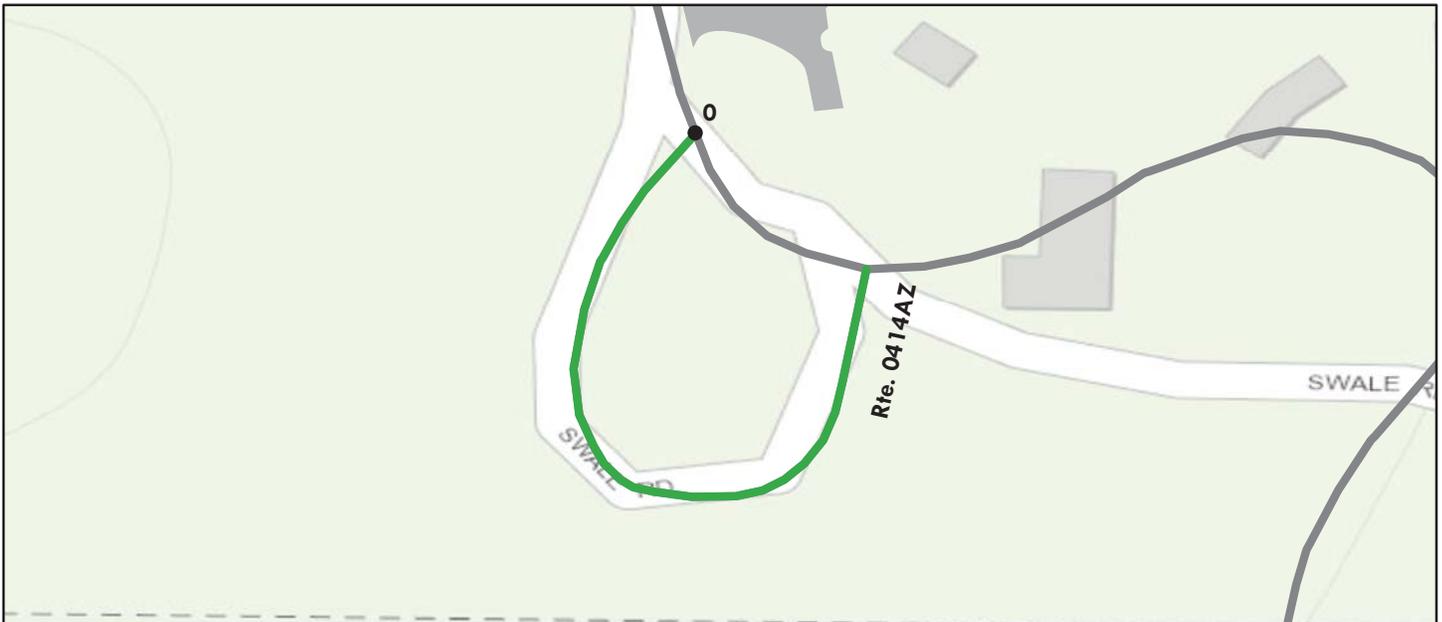
ROUTE 0414AZ: SWALE WORK CENTER LOOP A

Route Condition Legend – Pavement Condition Rating (PCR)						
Poor (0 - 60)	Fair (61- 84)	Good (85 - 94)	Excellent (95 - 100)	Not Rated		
See Appendix for definitions and formulas						
Inspection Date: 5/30/2015	Beginning Section MP	0				
Paved Length (Miles): 0.06	Section Length (MI)	0.06				
Surface Type: ASPHALT	Route Summary					
Roadway Condition Information						
Pavement Condition Rating (PCR)	85	85				
Surface Condition Rating (SCR)	85	85				
Roughness Condition Index (RCI)	N/A	N/A				
Distress Index Values						
Structural Crack Index	93	93				
Alligator Crack Index	100	100				
Longitudinal Crack Index	93	93				
Transverse Cracking Index	92	92				
Patching Index	100	100				
Rutting Index	85	85				
International Roughness Index (IRI)	N/A	N/A				
Lane & Width Information						
Number of Lanes	1	1				
Paved Width (ft)	10.4	10.4				
Lane Width (ft)	10.4	10.4

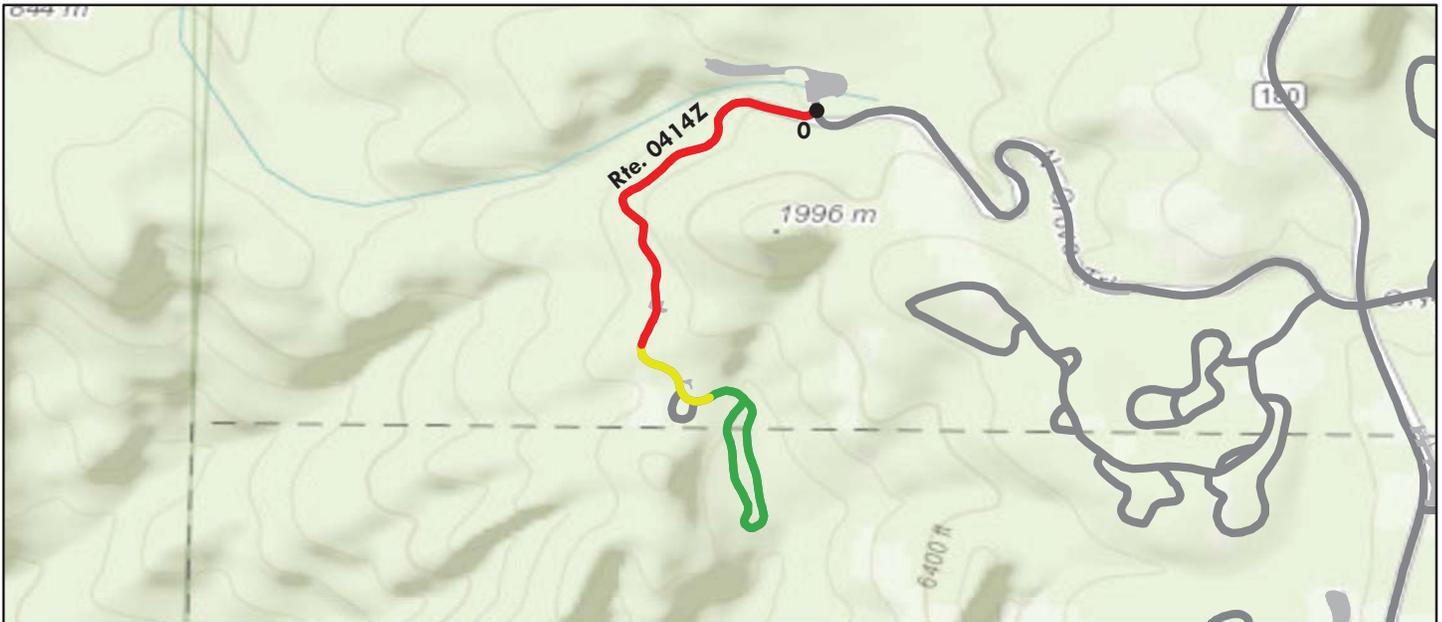
ROUTE 0414Z: SWALE ROAD

Inspection Date: 5/30/2015	Beginning Section MP	0				
Paved Length (Miles): 0.82	Section Length (MI)	0.82				
Surface Type: ASPHALT	Route Summary					
Roadway Condition Information						
Pavement Condition Rating (PCR)	60	60				
Surface Condition Rating (SCR)	60	60				
Roughness Condition Index (RCI)	N/A	N/A				
Distress Index Values						
Structural Crack Index	60	60				
Alligator Crack Index	82	82				
Longitudinal Crack Index	78	78				
Transverse Cracking Index	95	95				
Patching Index	100	100				
Rutting Index	93	93				
International Roughness Index (IRI)	N/A	N/A				
Lane & Width Information						
Number of Lanes	2	2				
Paved Width (ft)	15.2	15.2				
Lane Width (ft)	10.3	10.3

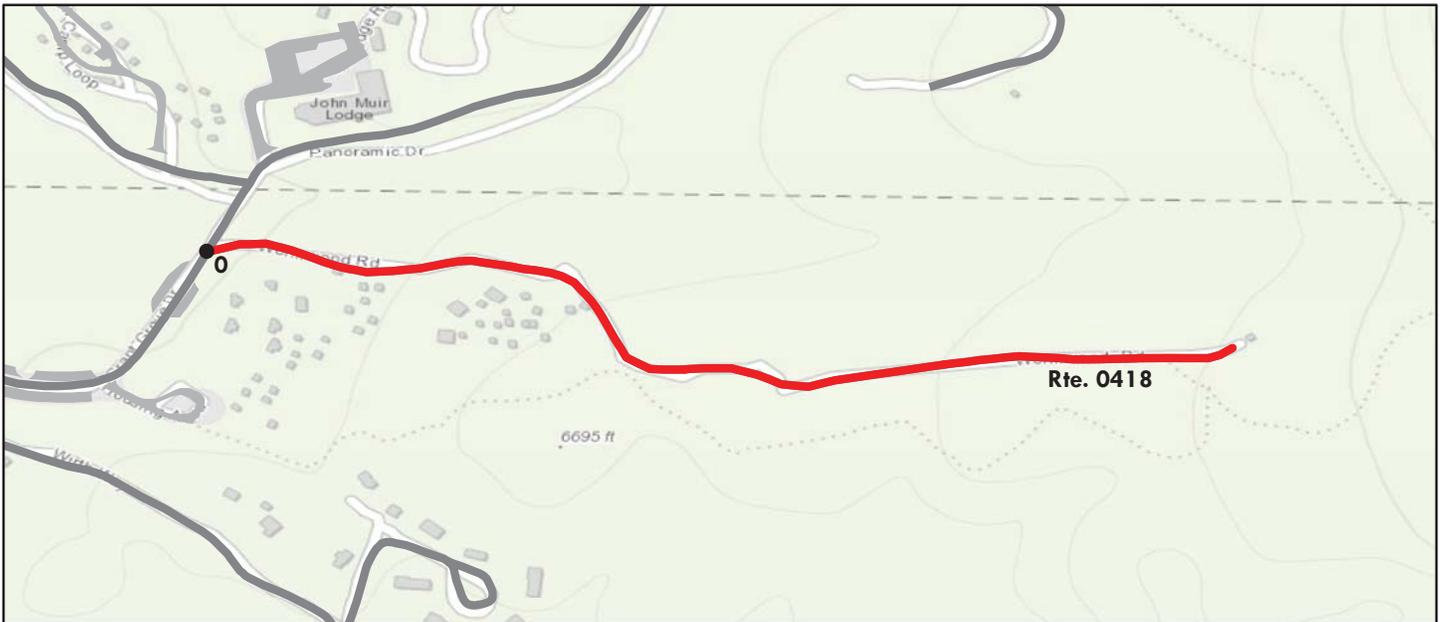
ROUTE 0418: WATER TANK ROAD

Route Condition Legend – Pavement Condition Rating (PCR)						
Poor (0 - 60)	Fair (61- 84)	Good (85 - 94)	Excellent (95 - 100)	Not Rated		
See Appendix for definitions and formulas						
Inspection Date: 5/30/2015	Beginning Section MP	0				
Paved Length (Miles): 0.41	Section Length (MI)	0.41				
Surface Type: ASPHALT	Route Summary					
Roadway Condition Information						
Pavement Condition Rating (PCR)	16	16				
Surface Condition Rating (SCR)	16	16				
Roughness Condition Index (RCI)	N/A	N/A				
Distress Index Values						
Structural Crack Index	16	16				
Alligator Crack Index	79	79				
Longitudinal Crack Index	37	37				
Transverse Cracking Index	83	83				
Patching Index	96	96				
Rutting Index	93	93				
International Roughness Index (IRI)	N/A	N/A				
Lane & Width Information						
Number of Lanes	1	1				
Paved Width (ft)	10.7	10.7				
Lane Width (ft)	10.7	10.7

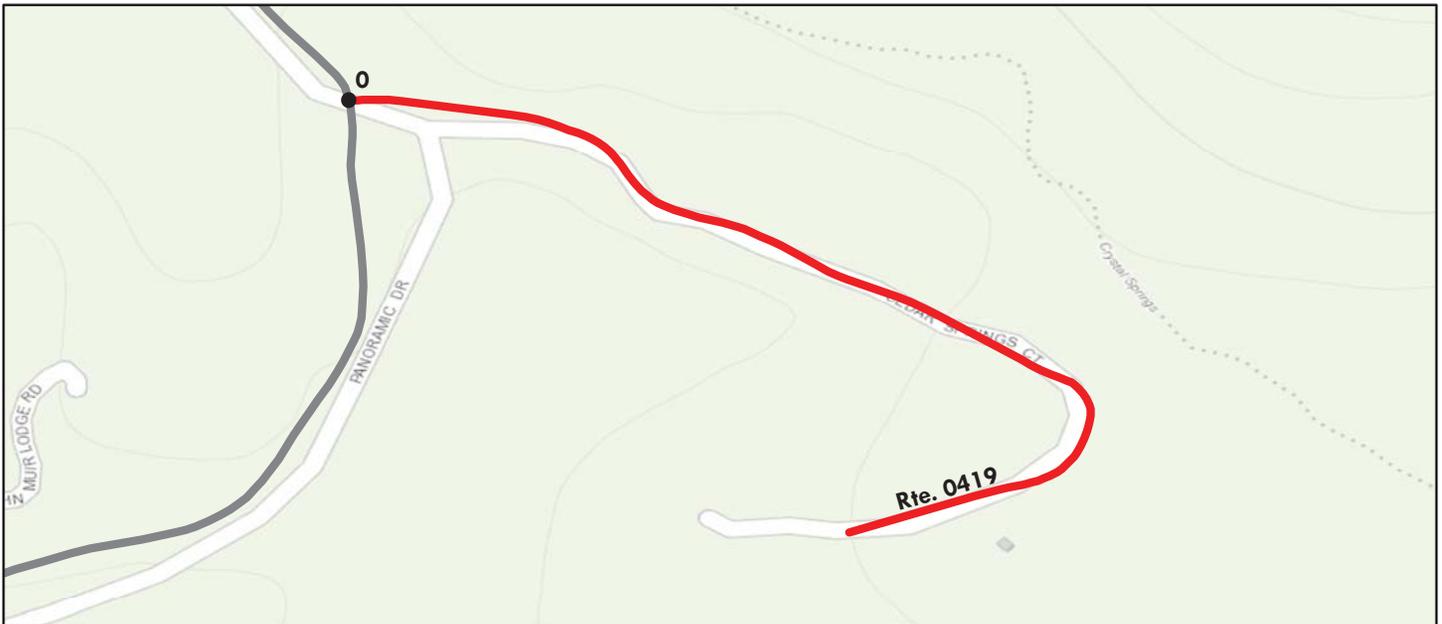
ROUTE 0419: TRAILER RESIDENCE ROAD

Inspection Date:	9/25/2014	Beginning Section MP	0.00				
Paved Length (Miles):	0.23	Section Length (MI)	0.23				
Surface Type:	ASPHALT	Route Summary					
Roadway Condition Information							
Pavement Condition Rating (PCR)	30	30					
Surface Condition Rating (SCR)	30	30					
Roughness Condition Index (RCI)	N/A	N/A					
Distress Index Values							
Structural Crack Index	N/A	N/A					
Alligator Crack Index	30	30					
Longitudinal Crack Index	30	30					
Transverse Cracking Index	53	53					
Patching Index	30	30					
Rutting Index	53	53					
International Roughness Index (IRI)	N/A	N/A					
Lane & Width Information							
Number of Lanes	1	1					
Paved Width (ft)	12	12					
Lane Width (ft)	12	12

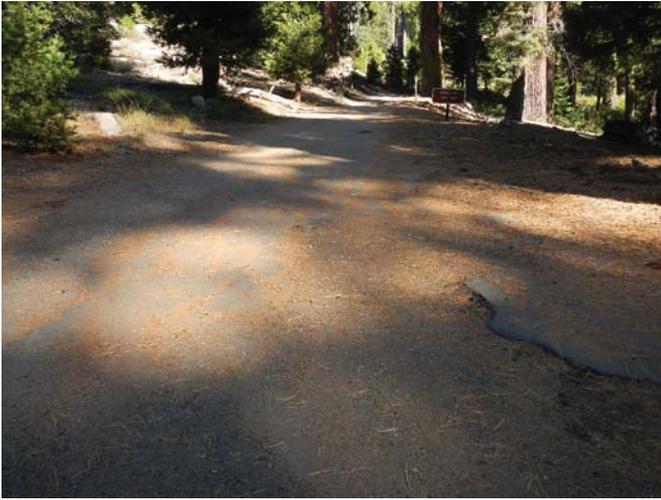
KICA_0419_8879.JPG

Condition photos are shown only for manually rated roads. Use the PathView program to see images of DCV rated roads.

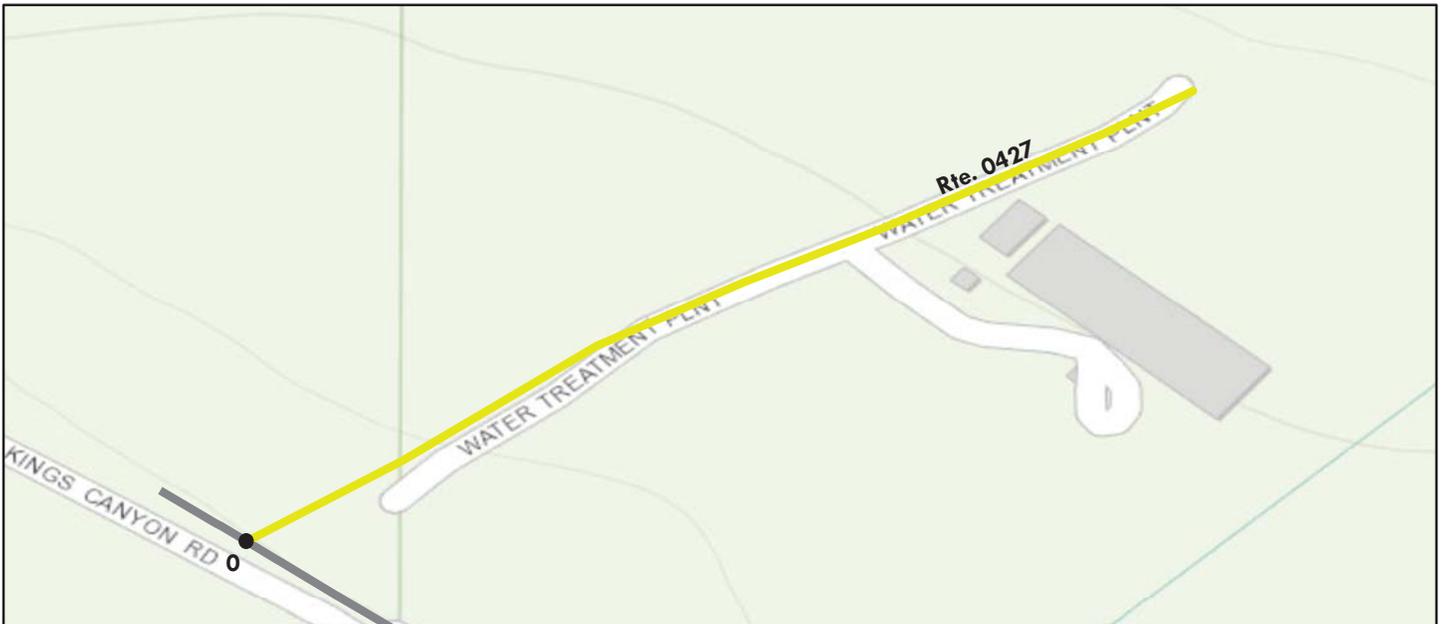
ROUTE 0427: CEDAR GROVE WATER TANK ROAD

Route Condition Legend – Pavement Condition Rating (PCR)						
Poor (0 - 60)	Fair (61- 84)	Good (85 - 94)	Excellent (95 - 100)	Not Rated		
See Appendix for definitions and formulas						
Inspection Date:	9/24/2014	Beginning Section MP	0.00			
Paved Length (Miles):	0.15	Section Length (MI)	0.15			
Surface Type:	ASPHALT	Route Summary				
Roadway Condition Information						
Pavement Condition Rating (PCR)	73	73				
Surface Condition Rating (SCR)	73	73				
Roughness Condition Index (RCI)	N/A	N/A				
Distress Index Values						
Structural Crack Index	N/A	N/A				
Alligator Crack Index	90	90				
Longitudinal Crack Index	90	90				
Transverse Cracking Index	73	73				
Patching Index	97	97				
Rutting Index	90	90				
International Roughness Index (IRI)	N/A	N/A				
Lane & Width Information						
Number of Lanes	1	1				
Paved Width (ft)	13	13				
Lane Width (ft)	13	13

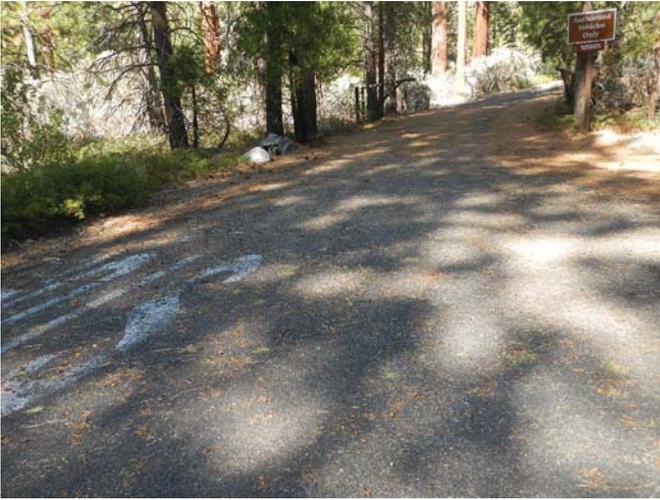
KICA_0427_8750.JPG

Condition photos are shown only for manually rated roads. Use the PathView program to see images of DCV rated roads.

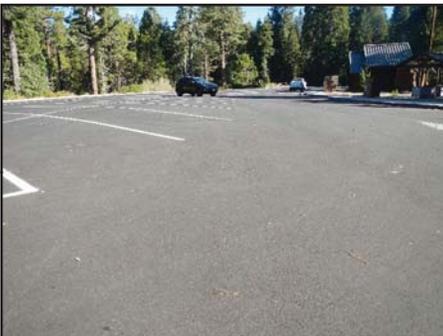
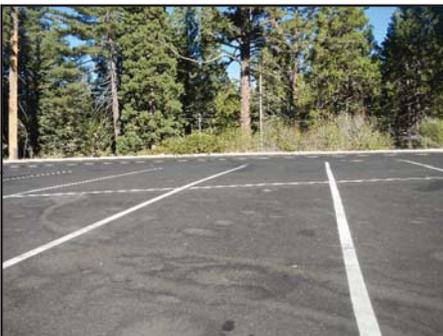
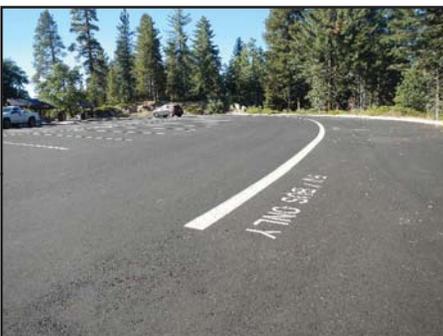
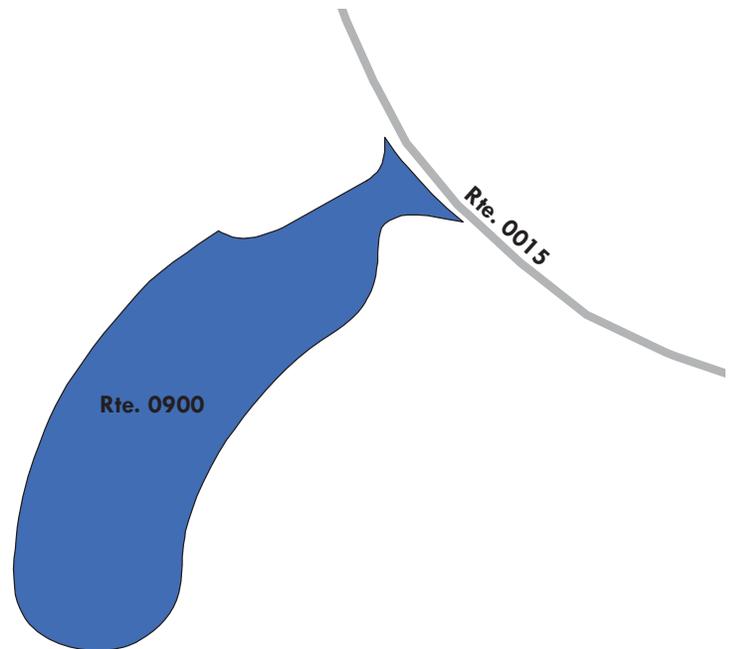
Inspection Date	FMSS Number	User Access	Surface Type
9/25/2014	73099	PUBLIC	ASPHALT
Area (Sq. Ft.)	Lane Miles (11' Widths)	Curb Reveal (Inches)	Curb Recommendation
36,569	0.63	NOT APPLICABLE	DO NOTHING
Curb Type		Curb & Gutter Type	
NO CURB		CONCRETE	
Pavement Recommendation		Condition Rating / PCR	
DO NOTHING		EXCELLENT / 97

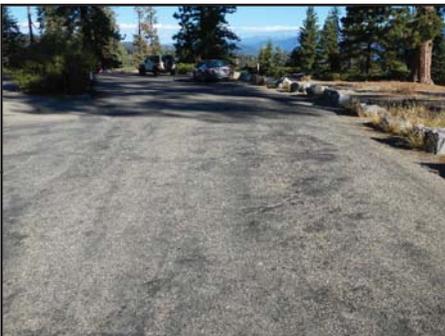
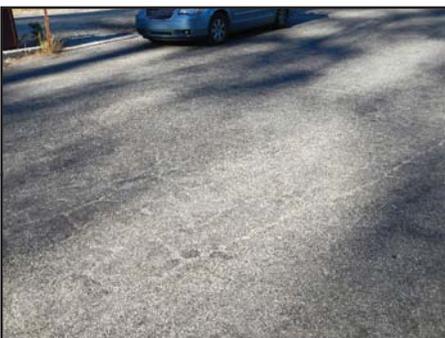
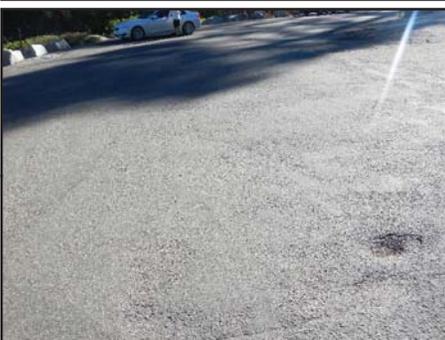
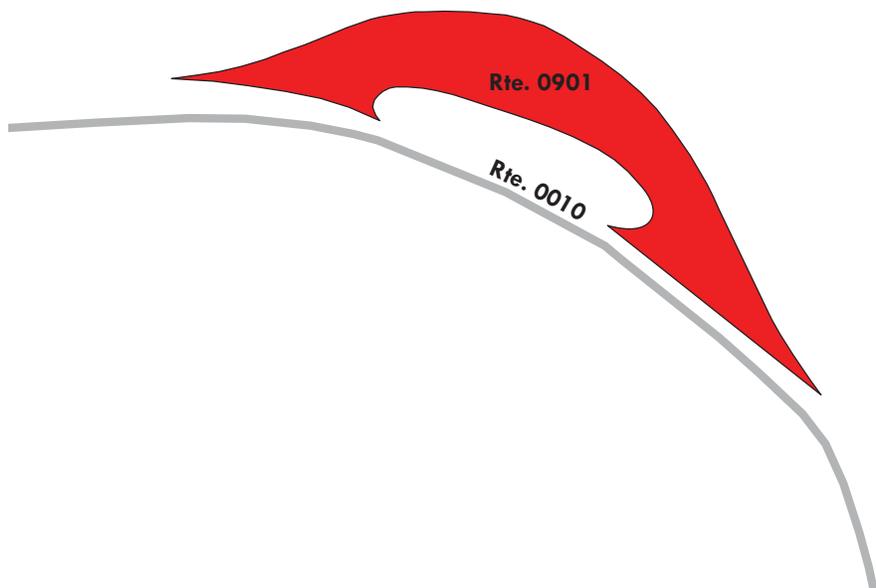
ROUTE 0901: KINGS CANYON OVERLOOK PARKING

Inspection Date	FMSS Number	User Access	Surface Type
9/25/2014	73101	PUBLIC	ASPHALT
Area (Sq. Ft.)	Lane Miles (11' Widths)	Curb Reveal (Inches)	Curb Recommendation
7,973	0.137	NOT APPLICABLE	NOT APPLICABLE
Curb Type		Curb & Gutter Type	
NO CURB		NO CURB AND GUTTER	
Pavement Recommendation		Condition Rating / PCR	
HEAVY 3R TREATMENTS		POOR / 53

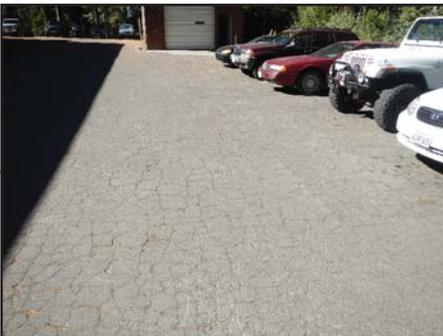
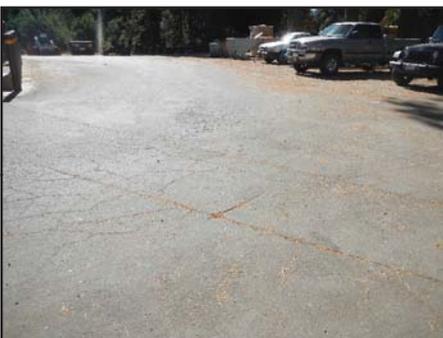
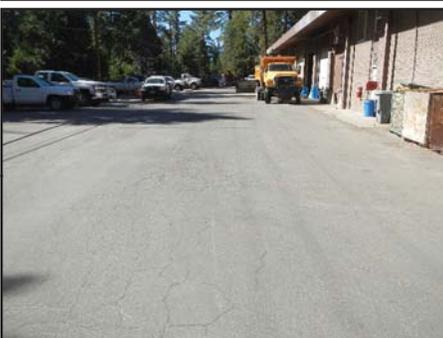
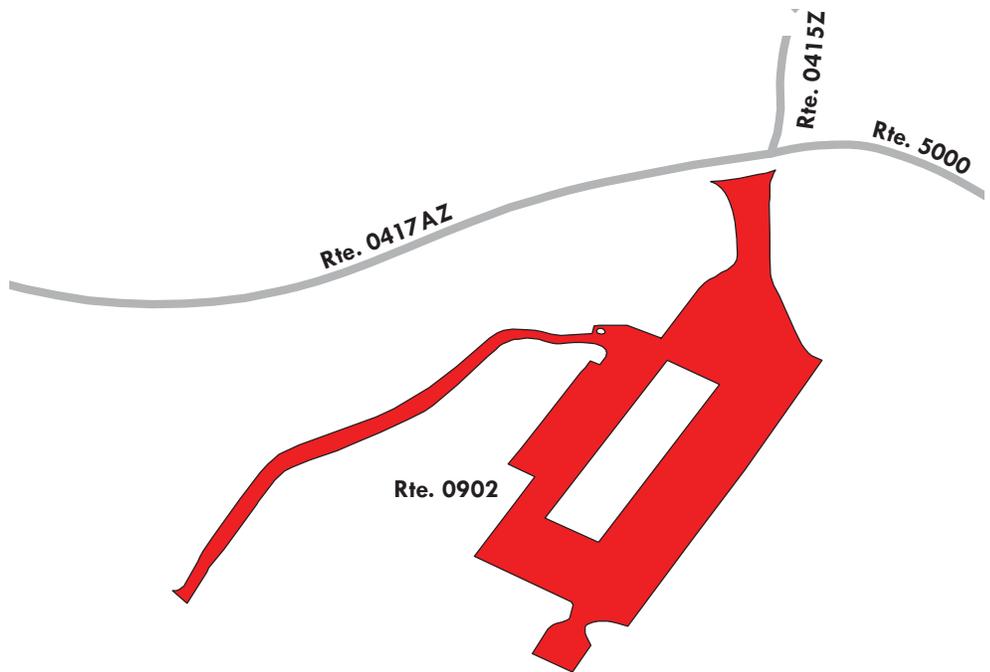
Inspection Date	FMSS Number	User Access	Surface Type
9/25/2014	73103	NONPUBLIC	ASPHALT
Area (Sq. Ft.)	Lane Miles (11' Widths)	Curb Reveal (Inches)	Curb Recommendation
55,475	0.955	NOT APPLICABLE	NOT APPLICABLE
Curb Type		Curb & Gutter Type	
NO CURB		NO CURB AND GUTTER	
Pavement Recommendation		Condition Rating / PCR	
RECONSTRUCTION		POOR / 30

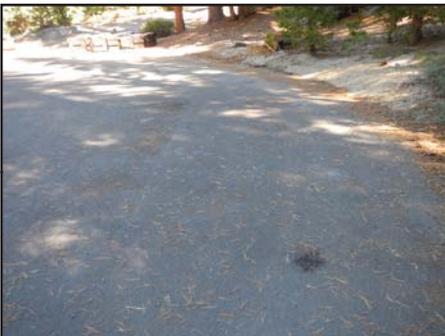
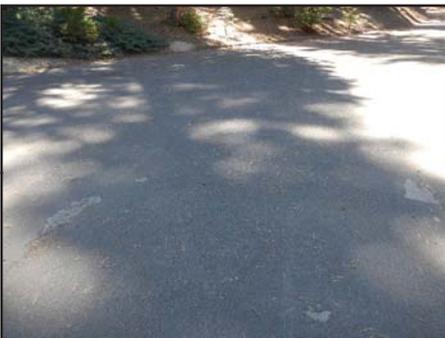
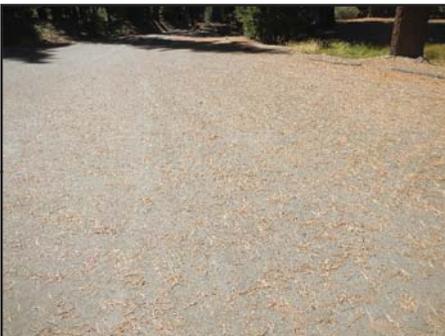
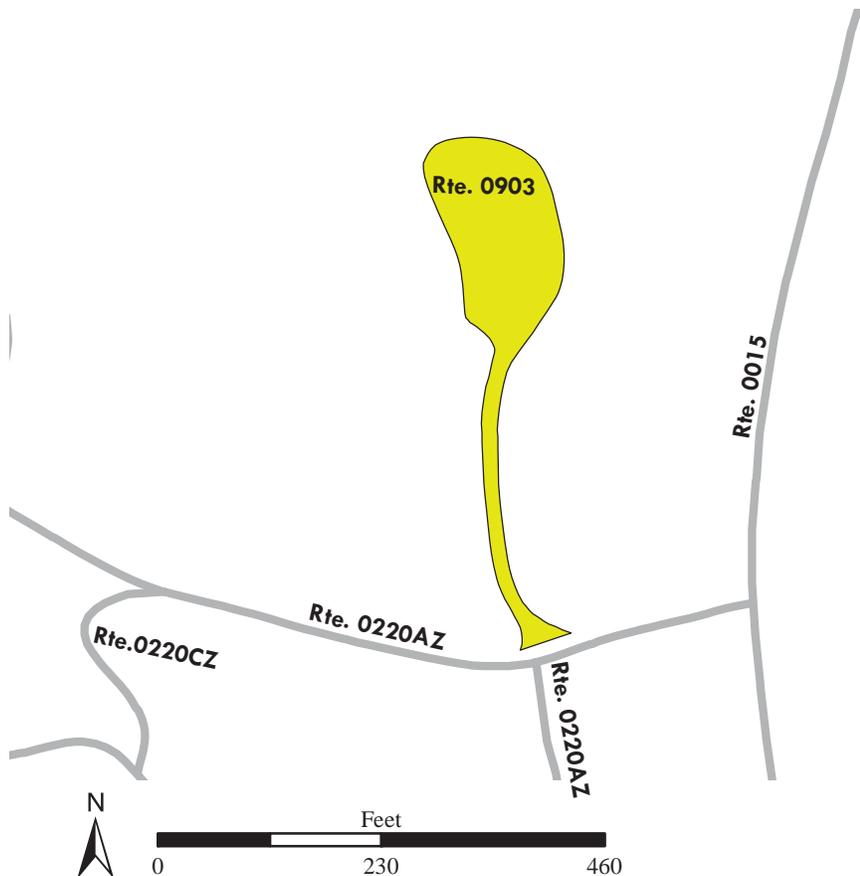
ROUTE 0903: SUNSET AMPHITHEATER PARKING

Inspection Date	FMSS Number	User Access	Surface Type
9/25/2014	73104	PUBLIC	ASPHALT
Area (Sq. Ft.)	Lane Miles (11' Widths)	Curb Reveal (Inches)	Curb Recommendation
21,891	0.377	4	MODERATE REPAIR
Curb Type		Curb & Gutter Type	
ASPHALT		NO CURB AND GUTTER	
Pavement Recommendation		Condition Rating / PCR	
LIGHT 3R TREATMENTS		FAIR / 73
