KICA Cycle 6

Final Report

Road Inventory and Condition Assessment of Paved Routes Kings Canyon National Park

**Federal Highway Administration
Eastern Federal Lands Highway Division
Road Inventory Program (RIP)**

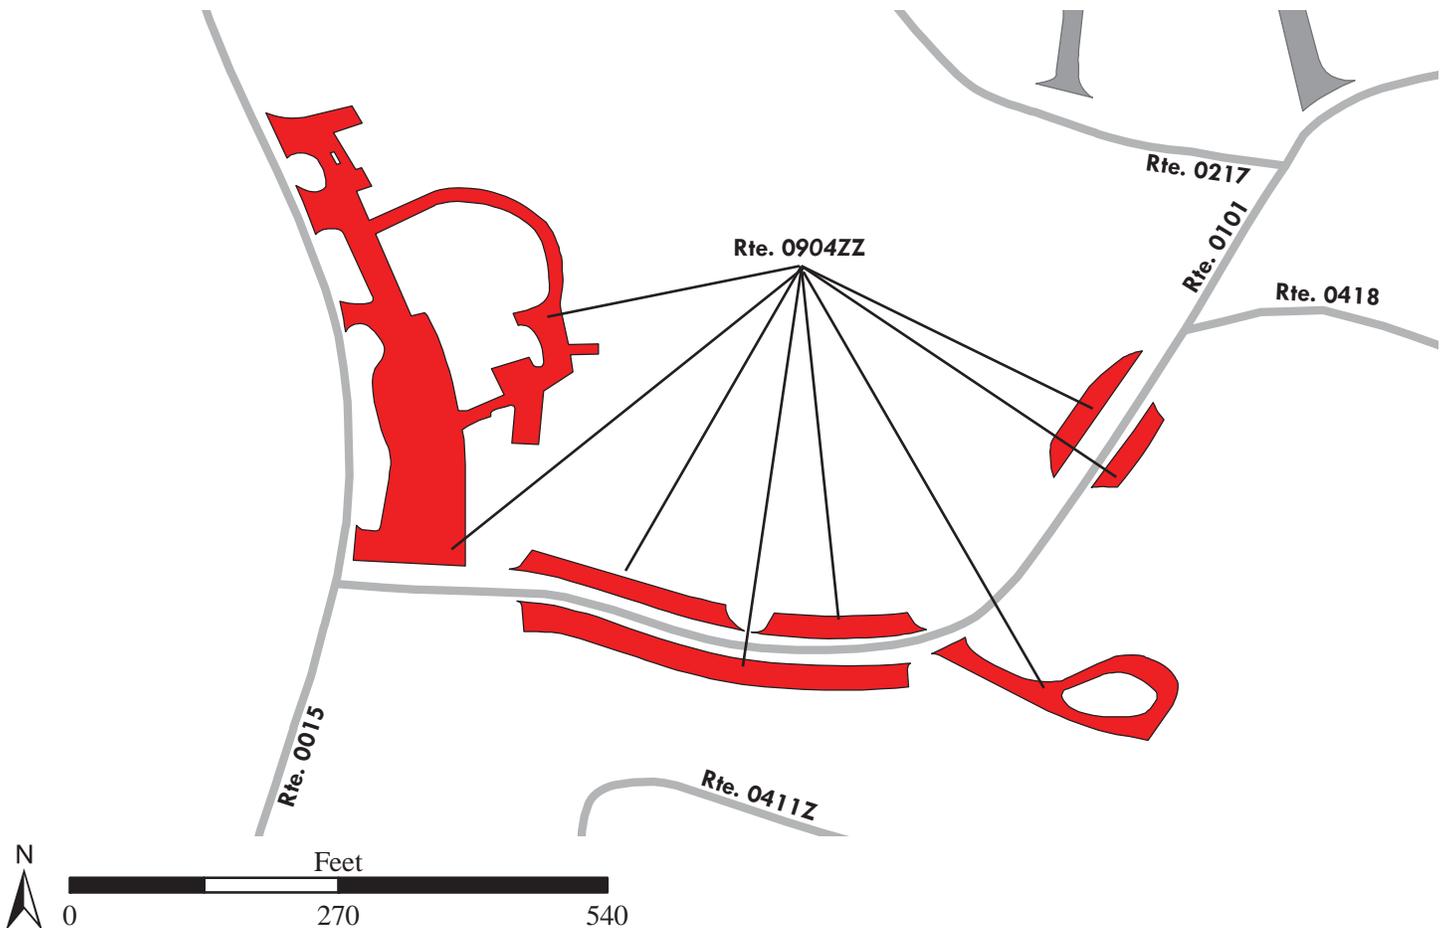
ROUTE 0904ZZ: CONCESSION PARKING - THE PLAZA

Inspection Date	FMSS Number	User Access	Surface Type
9/25/2014	73105	PUBLIC	ASPHALT
Area (Sq. Ft.)	Lane Miles (11' Widths)	Condition Rating / PCR	
55,629	0.957	SUMMARY / 48	
Route Condition Legend – Pavement Condition Rating (PCR)			
Poor (0 - 60)	Fair (61- 84)	Good (85 - 94)	Excellent (95 - 100) Not Rated
See Appendix for definitions and formulas

The condition shown on this page reflects the overall route condition and may not reflect individual subcomponent ratings.

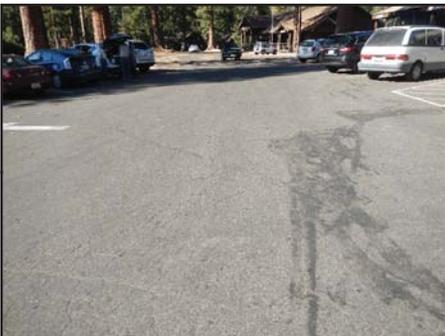
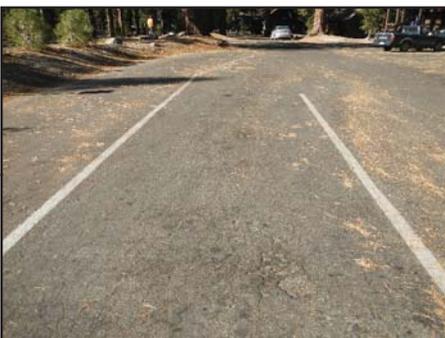
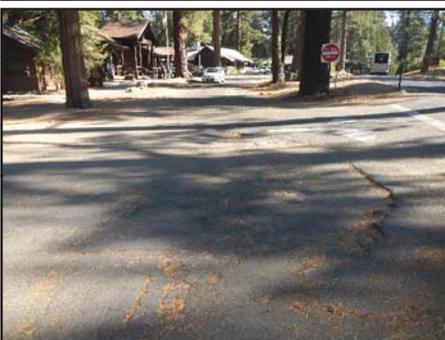
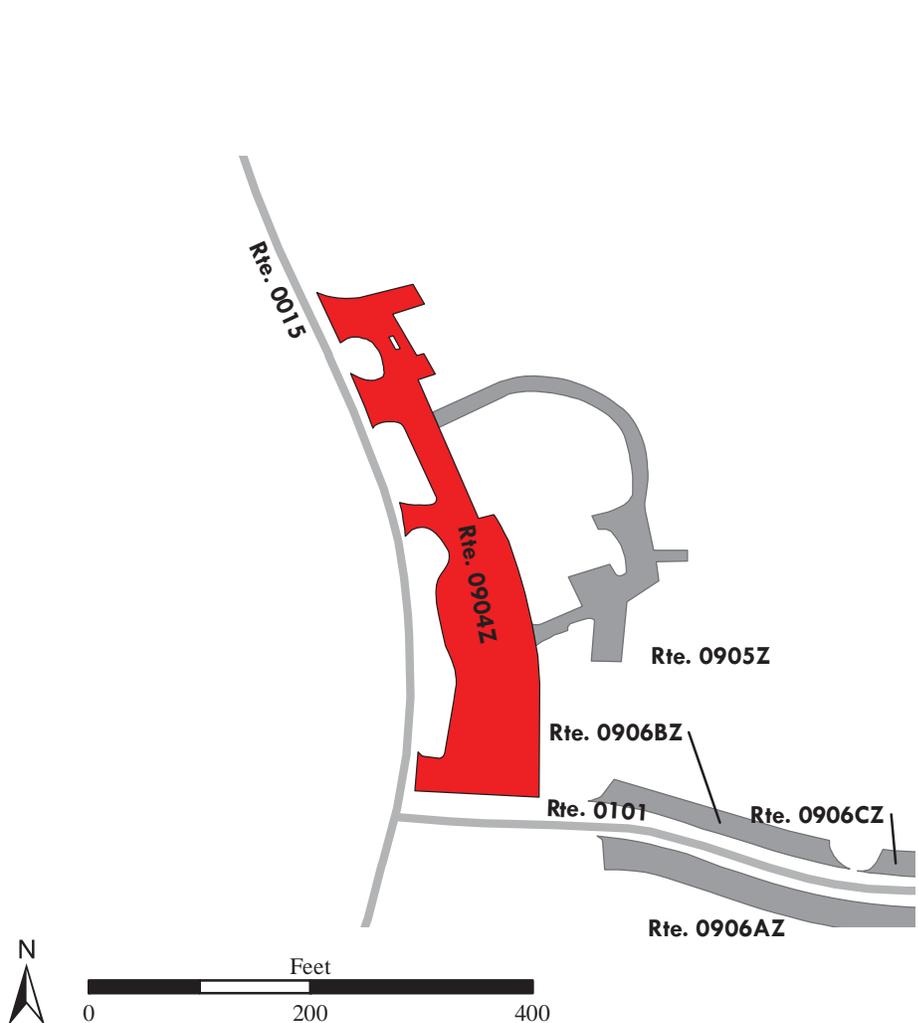
ROUTE 0904Z: GRANT GROVE PLAZA PARKING

Inspection Date	FMSS Number	User Access	Surface Type
9/25/2014	73105	PUBLIC	ASPHALT
Area (Sq. Ft.)	Lane Miles (11' Widths)	Curb Reveal (Inches)	Curb Recommendation
24,015	0.413	NOT APPLICABLE	MODERATE REPAIR
Curb Type		Curb & Gutter Type	
NO CURB		CONCRETE	
Pavement Recommendation		Condition Rating / PCR	
RECONSTRUCTION		POOR / 30

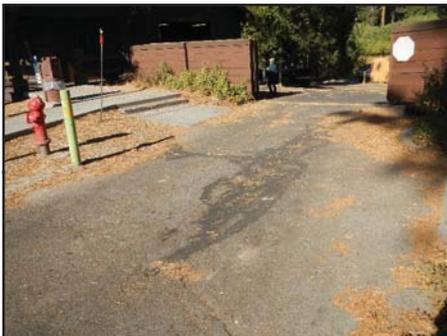
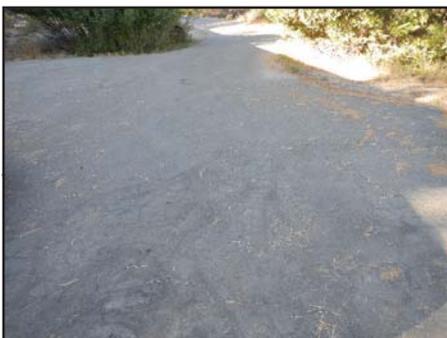
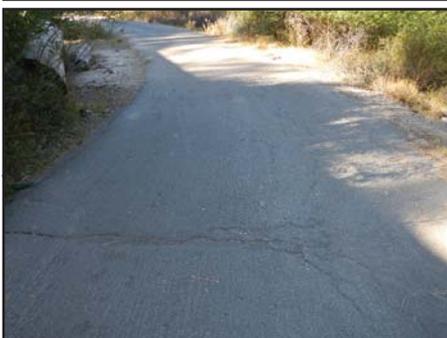
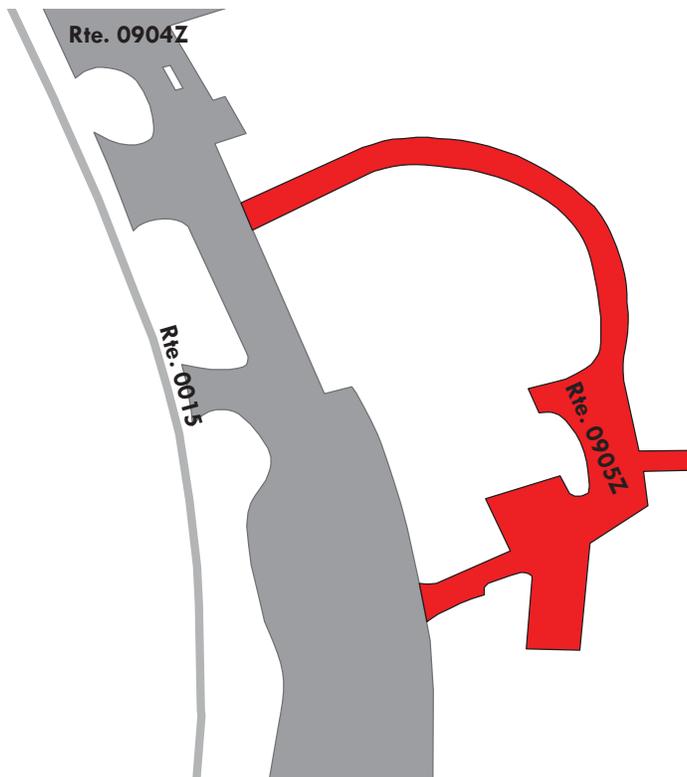
ROUTE 0905Z: GRANT GROVE CONCESSION SERVICE ACCESS PARKING

Inspection Date	FMSS Number	User Access	Surface Type
9/25/2014	73105	NONPUBLIC	ASPHALT
Area (Sq. Ft.)	Lane Miles (11' Widths)	Curb Reveal (Inches)	Curb Recommendation
8,079	0.139	NOT APPLICABLE	NOT APPLICABLE
Curb Type		Curb & Gutter Type	
NO CURB		NO CURB AND GUTTER	
Pavement Recommendation		Condition Rating / PCR	
HEAVY 3R TREATMENTS		POOR / 53

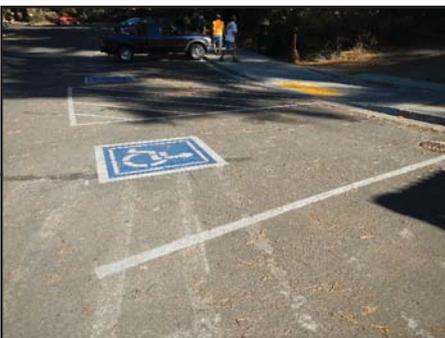
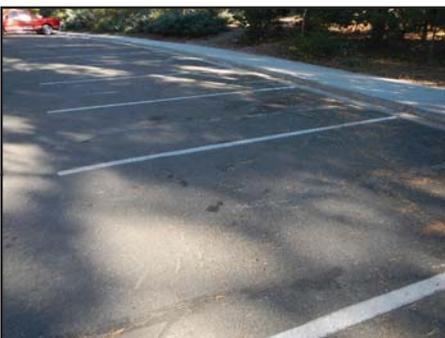
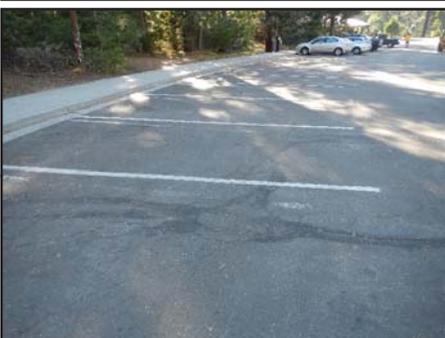
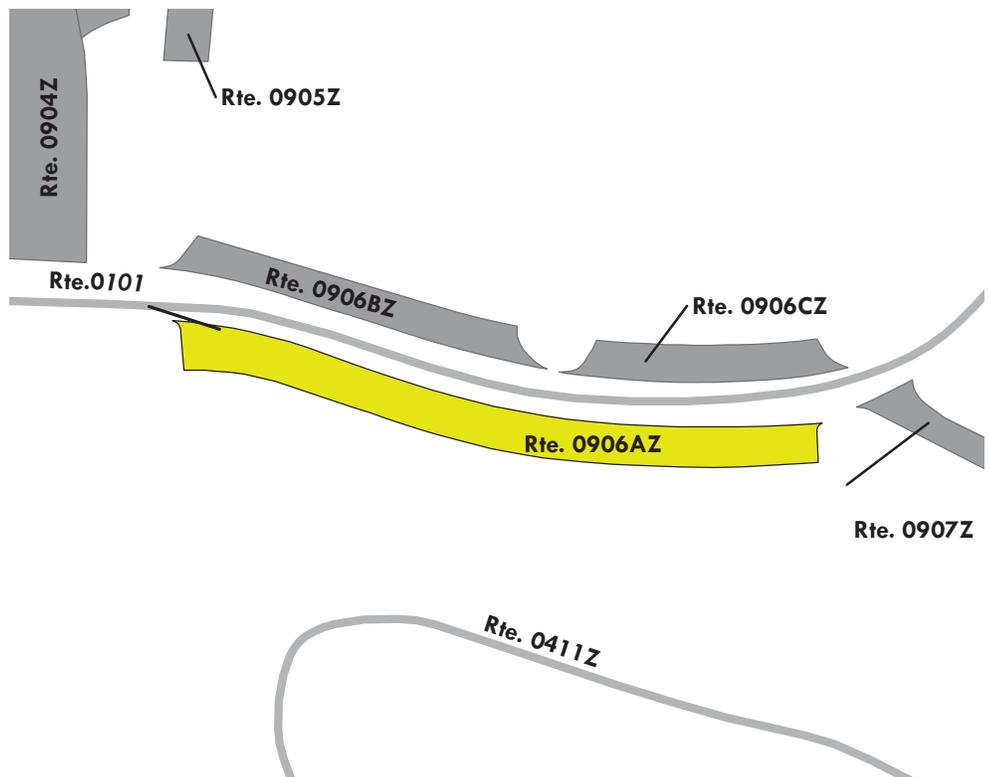
ROUTE 0906AZ: GRANT GROVE VISITOR CENTER PARKING AREA A

Inspection Date	FMSS Number	User Access	Surface Type
9/25/2014	73105	PUBLIC	ASPHALT
Area (Sq. Ft.)	Lane Miles (11' Widths)	Curb Reveal (Inches)	Curb Recommendation
7,982	0.137	NOT APPLICABLE	MODERATE REPAIR
Curb Type		Curb & Gutter Type	
NO CURB		CONCRETE	
Pavement Recommendation		Condition Rating / PCR	
LIGHT 3R TREATMENTS		FAIR / 73

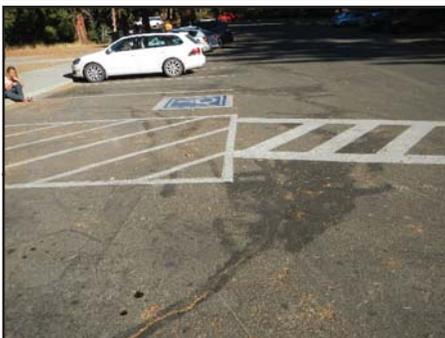
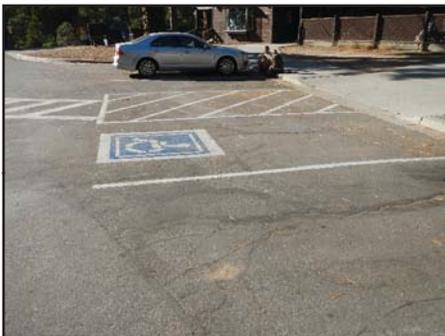
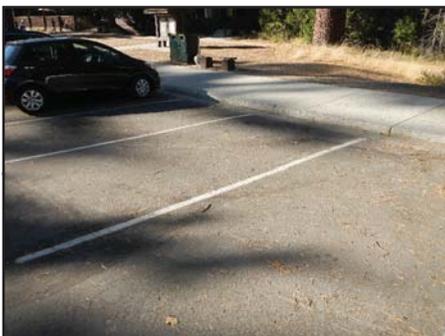
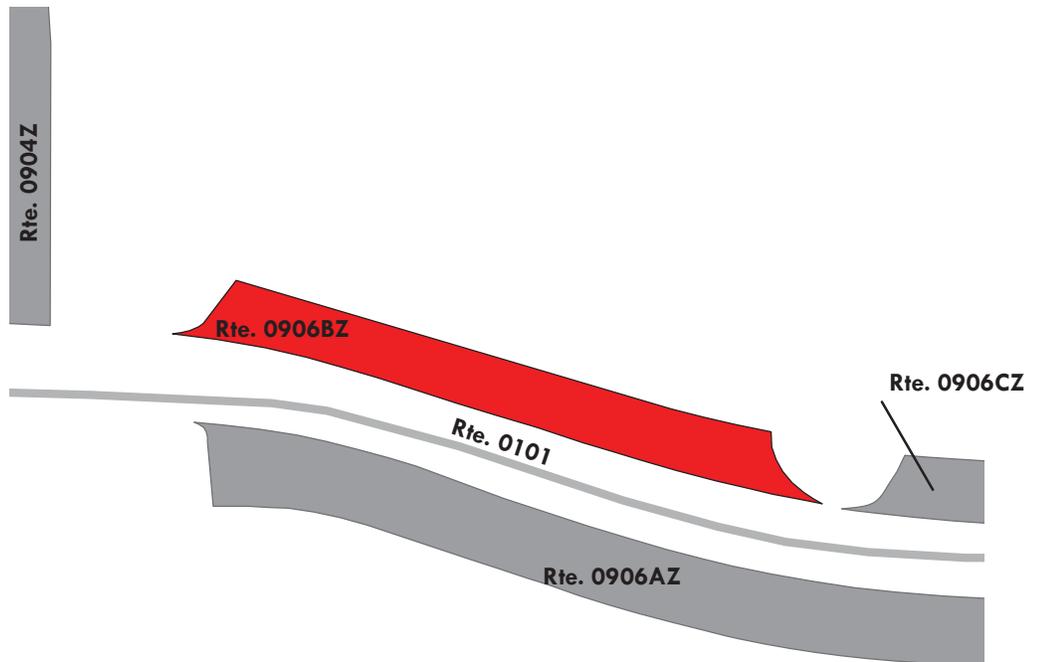
ROUTE 0906BZ: GRANT GROVE VISITOR CENTER PARKING AREA B

Inspection Date	FMSS Number	User Access	Surface Type
9/25/2014	73105	PUBLIC	ASPHALT
Area (Sq. Ft.)	Lane Miles (11' Widths)	Curb Reveal (Inches)	Curb Recommendation
3,553	0.061	NOT APPLICABLE	MODERATE REPAIR
Curb Type		Curb & Gutter Type	
NO CURB		CONCRETE	
Pavement Recommendation		Condition Rating / PCR	
HEAVY 3R TREATMENTS		POOR / 53

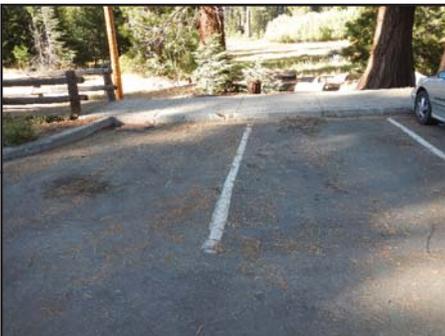
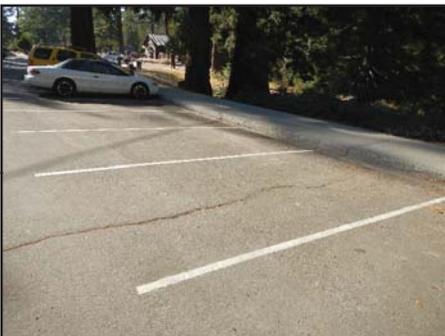
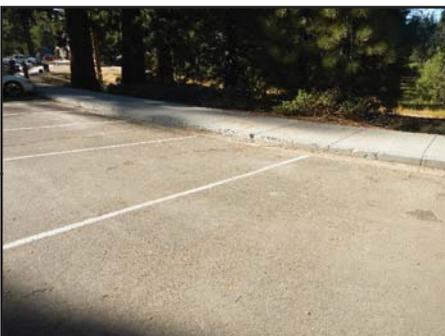
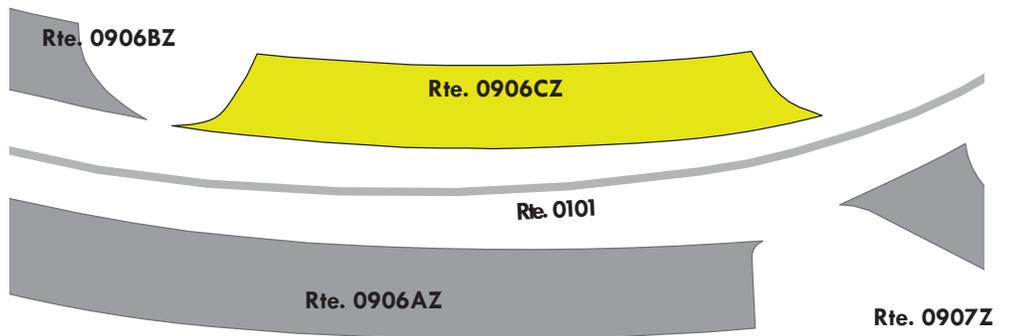
ROUTE 0906CZ: GRANT GROVE VISITOR CENTER PARKING AREA C

Inspection Date	FMSS Number	User Access	Surface Type
9/25/2014	73105	PUBLIC	ASPHALT
Area (Sq. Ft.)	Lane Miles (11' Widths)	Curb Reveal (Inches)	Curb Recommendation
2,639	0.045	NOT APPLICABLE	MODERATE REPAIR
Curb Type		Curb & Gutter Type	
NO CURB		CONCRETE	
Pavement Recommendation		Condition Rating / PCR	
LIGHT 3R TREATMENTS		FAIR / 73

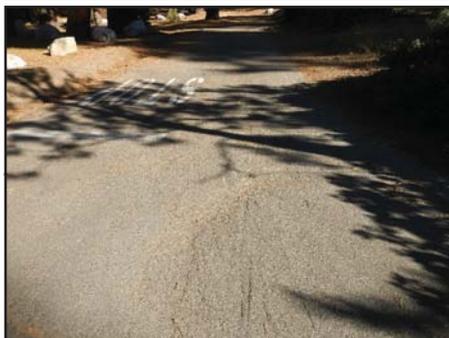
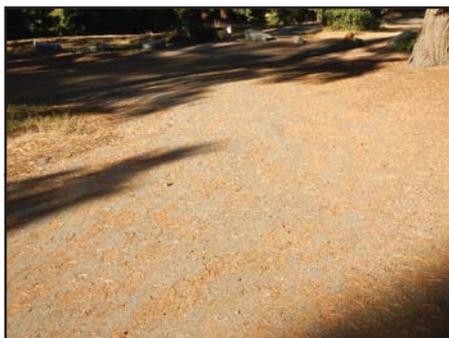
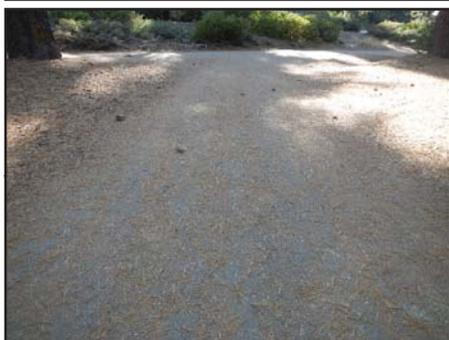
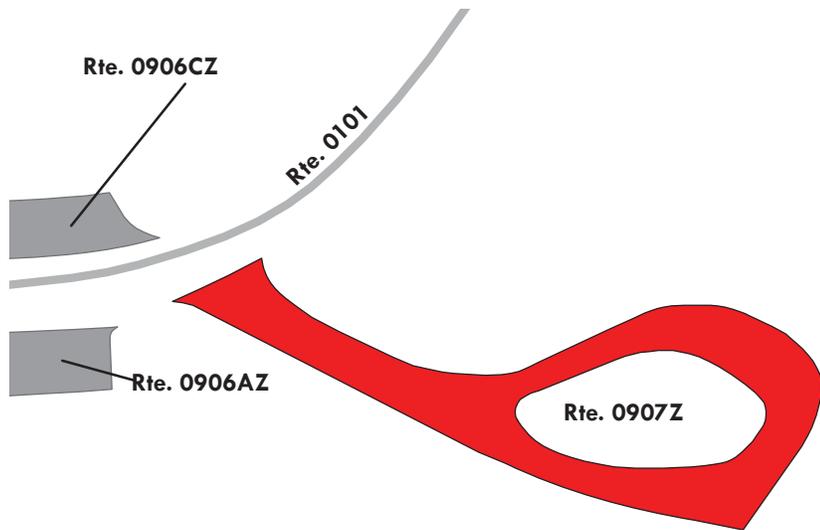
ROUTE 0907Z: MANZANITA TRAIL PARKING

Inspection Date	FMSS Number	User Access	Surface Type
9/25/2014	73105	PUBLIC	ASPHALT
Area (Sq. Ft.)	Lane Miles (11' Widths)	Curb Reveal (Inches)	Curb Recommendation
5,565	0.096	NOT APPLICABLE	NOT APPLICABLE
Curb Type		Curb & Gutter Type	
NO CURB		NO CURB AND GUTTER	
Pavement Recommendation		Condition Rating / PCR	
HEAVY 3R TREATMENTS		POOR / 53

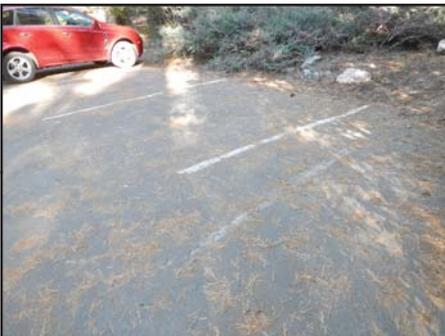
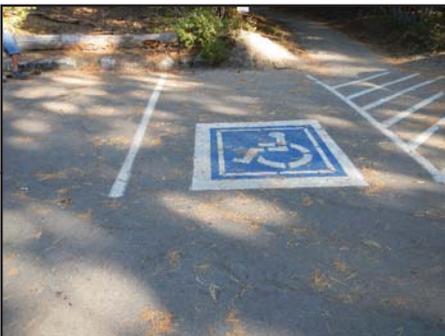
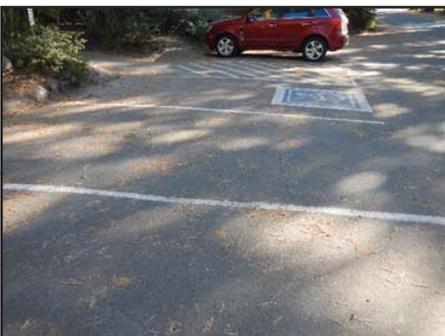
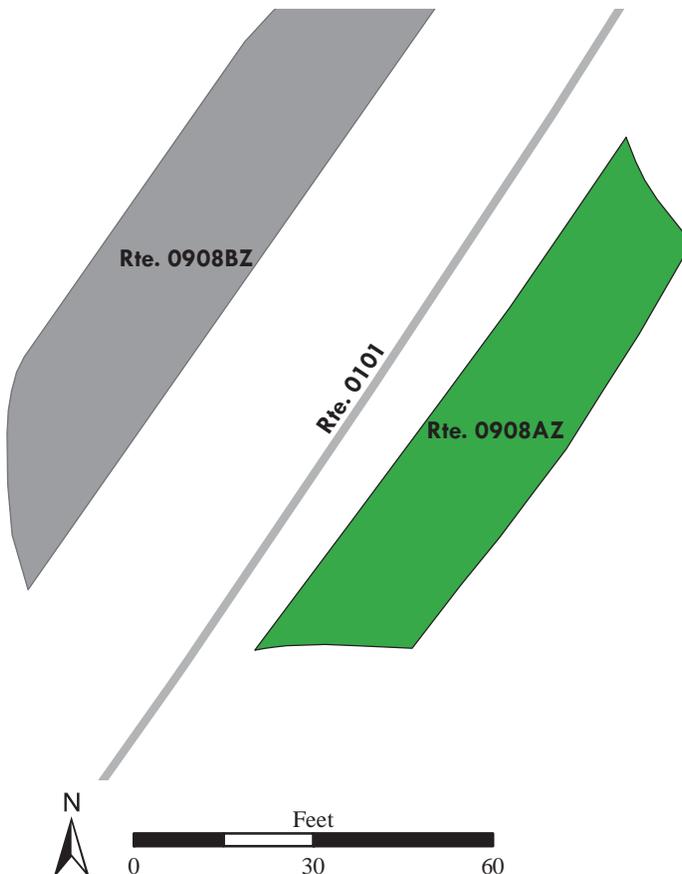
ROUTE 0908AZ: GRANT GROVE VILLAGE PARKING AREA A

Inspection Date	FMSS Number	User Access	Surface Type
9/25/2014	73105	PUBLIC	ASPHALT
Area (Sq. Ft.)	Lane Miles (11' Widths)	Curb Reveal (Inches)	Curb Recommendation
1,542	0.027	NOT APPLICABLE	NOT APPLICABLE
Curb Type		Curb & Gutter Type	
NO CURB		NO CURB AND GUTTER	
Pavement Recommendation		Condition Rating / PCR	
PREVENTIVE MAINTENANCE		GOOD / 90

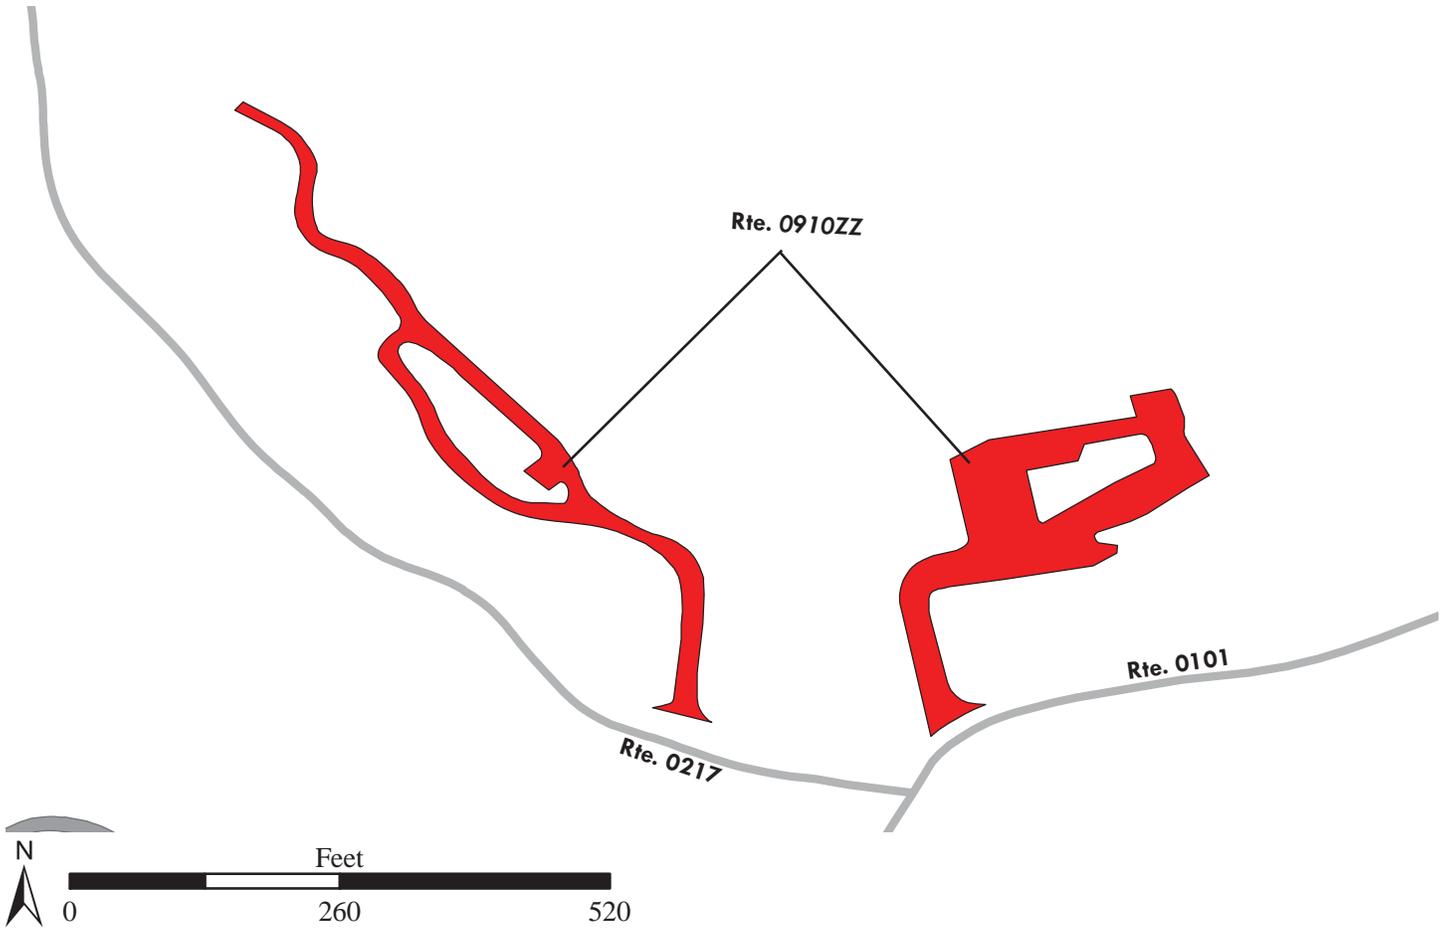
ROUTE 0910ZZ: JOHN MUIR LODGE/ MEADOW CAMP PARKING

Inspection Date	FMSS Number	User Access	Surface Type
9/25/2014	73111	PUBLIC	ASPHALT
Area (Sq. Ft.)	Lane Miles (11' Widths)	Condition Rating / PCR	
37,708	0.65	SUMMARY / 44

The condition shown on this page reflects the overall route condition and may not reflect individual subcomponent ratings.

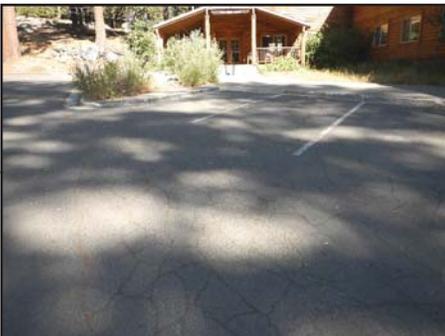
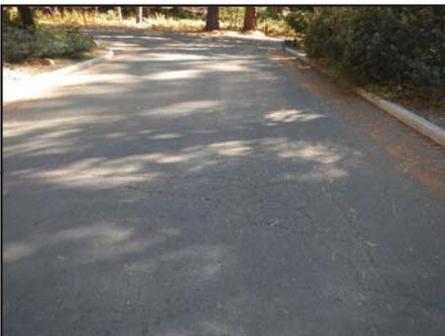
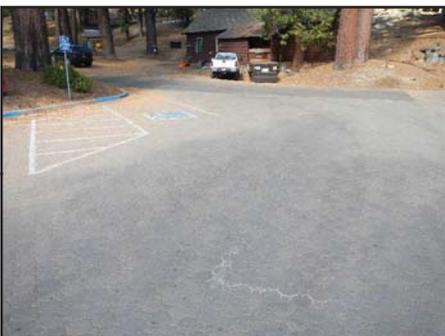
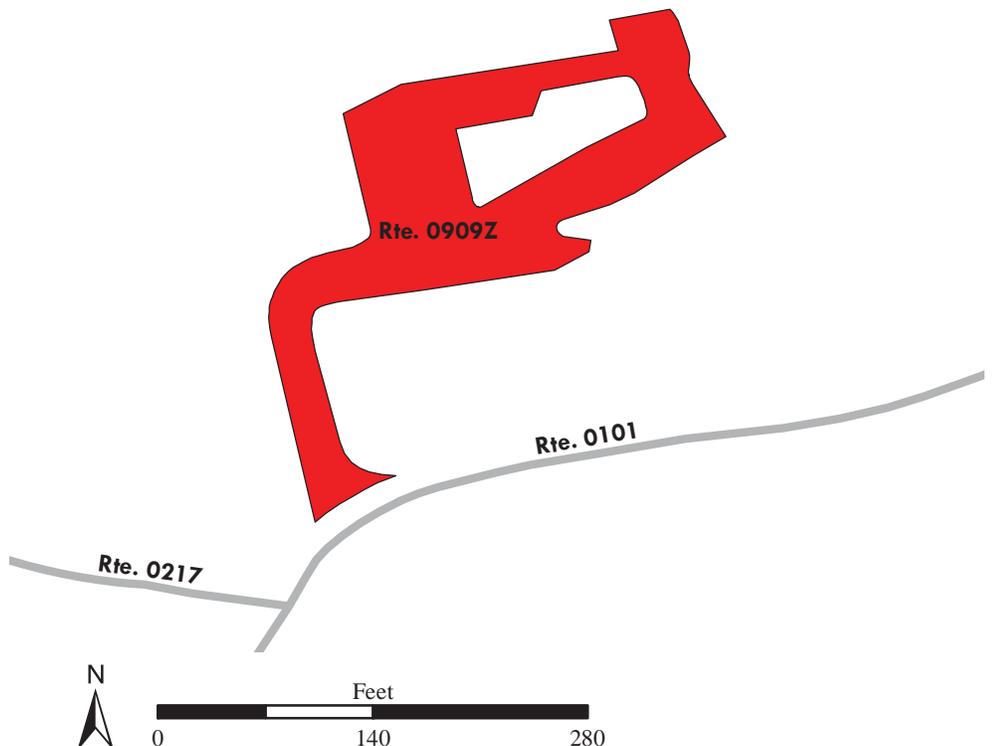
ROUTE 0909Z: JOHN MUIR LODGE PARKING

Inspection Date	FMSS Number	User Access	Surface Type
9/25/2014	73111	PUBLIC	ASPHALT
Area (Sq. Ft.)	Lane Miles (11' Widths)	Curb Reveal (Inches)	Curb Recommendation
22,507	0.388	5	REPLACE
Curb Type		Curb & Gutter Type	
CONCRETE		CONCRETE	
Pavement Recommendation		Condition Rating / PCR	
HEAVY 3R TREATMENTS		POOR / 53

Parking area consists of multiple surface types: 1 part Asphalt at 19,414 square feet; 4 parts of Brick at 3093 square feet.

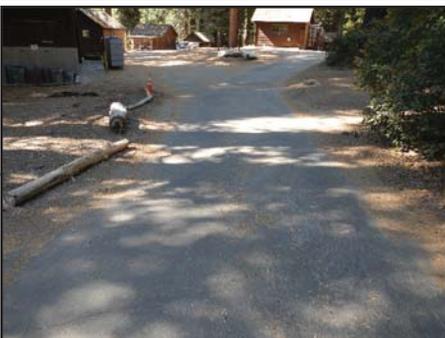
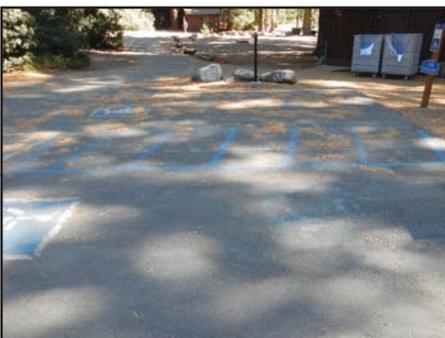
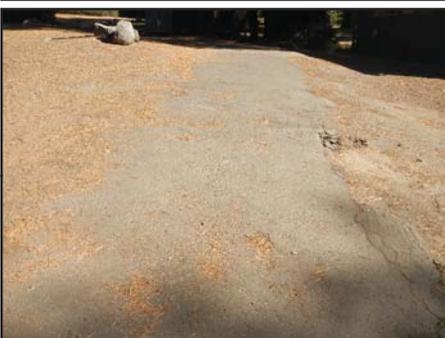
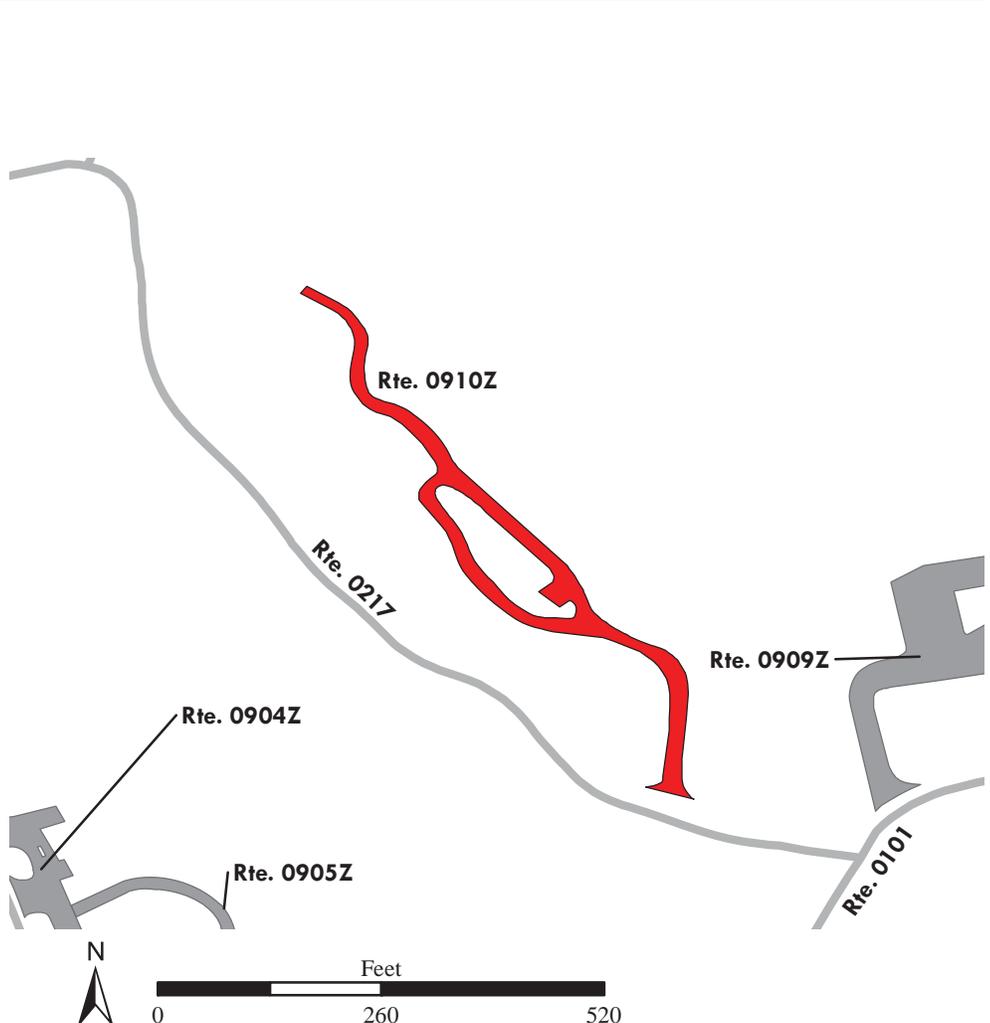
ROUTE 0910Z: MEADOW CAMP CABINS ROAD

Inspection Date	FMSS Number	User Access	Surface Type
9/25/2014	73111	PUBLIC	ASPHALT
Area (Sq. Ft.)	Lane Miles (11' Widths)	Curb Reveal (Inches)	Curb Recommendation
15,201	0.262	NOT APPLICABLE	NOT APPLICABLE
Curb Type		Curb & Gutter Type	
NO CURB		NO CURB AND GUTTER	
Pavement Recommendation		Condition Rating / PCR	
RECONSTRUCTION		POOR / 30

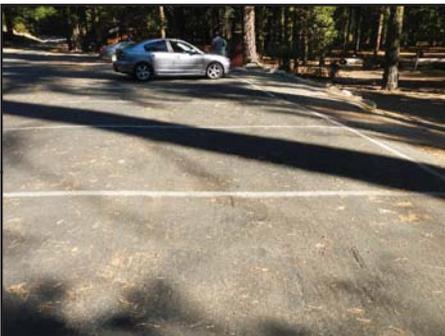
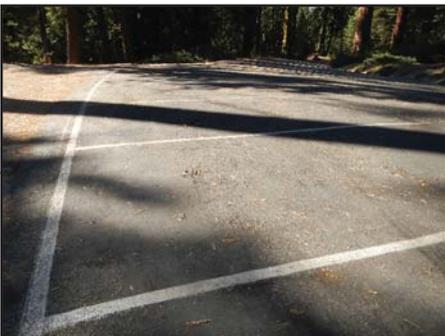
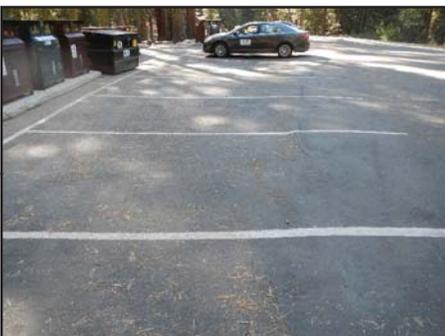
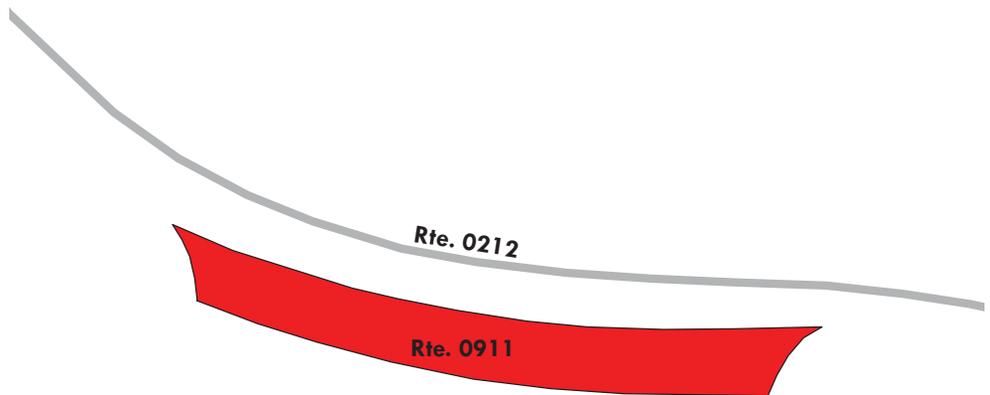
ROUTE 0911: COLUMBINE PICNIC PARKING AREA

Inspection Date	FMSS Number	User Access	Surface Type
9/25/2014	73135	PUBLIC	ASPHALT
Area (Sq. Ft.)	Lane Miles (11' Widths)	Curb Reveal (Inches)	Curb Recommendation
4,728	0.081	NOT APPLICABLE	NOT APPLICABLE
Curb Type		Curb & Gutter Type	
NO CURB		NO CURB AND GUTTER	
Pavement Recommendation		Condition Rating / PCR	
HEAVY 3R TREATMENTS		POOR / 53

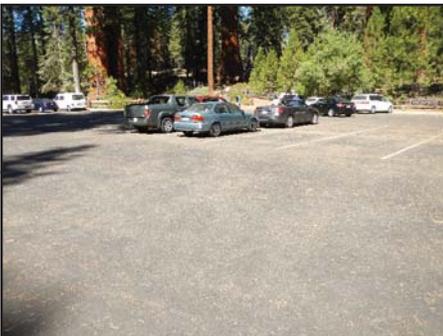
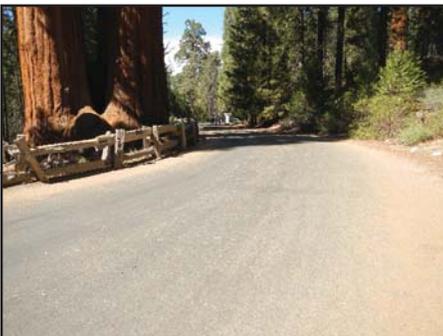
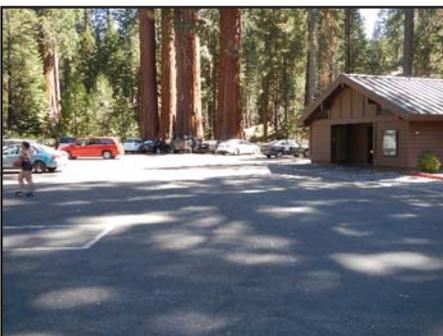
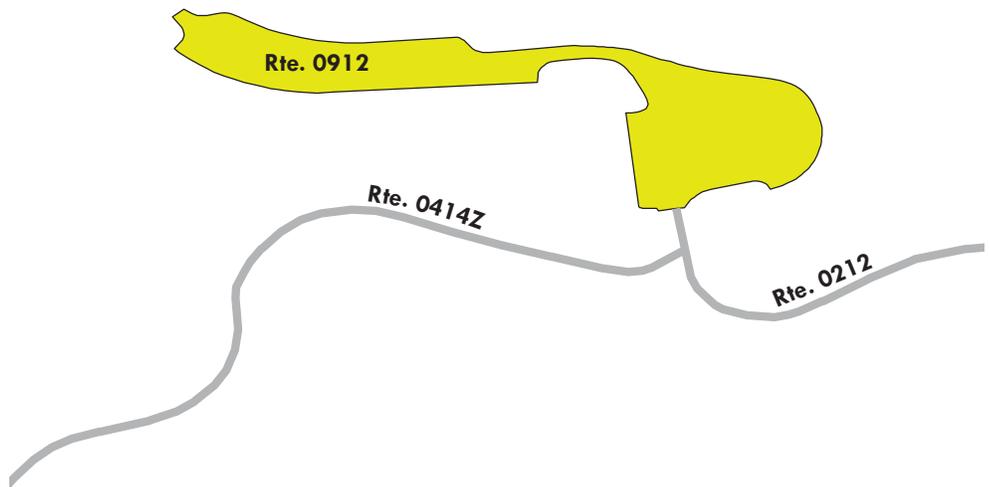
ROUTE 0912: GRANT TREE PARKING

Inspection Date	FMSS Number	User Access	Surface Type
9/25/2014	73136	PUBLIC	ASPHALT
Area (Sq. Ft.)	Lane Miles (11' Widths)	Curb Reveal (Inches)	Curb Recommendation
50,958	0.877	NOT APPLICABLE	LIGHT REPAIR
Curb Type		Curb & Gutter Type	
NO CURB		CONCRETE	
Pavement Recommendation		Condition Rating / PCR	
LIGHT 3R TREATMENTS		FAIR / 73

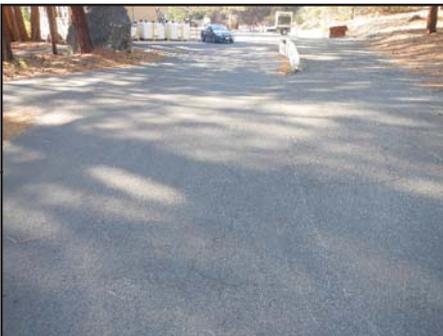
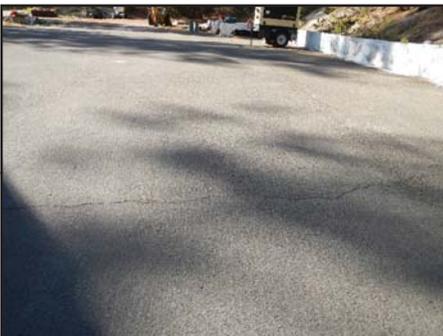
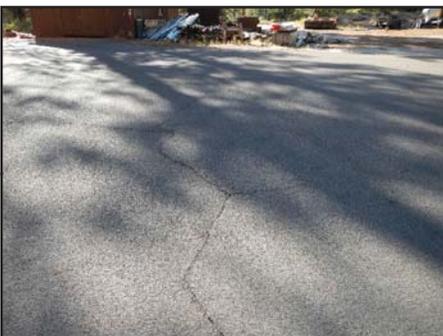
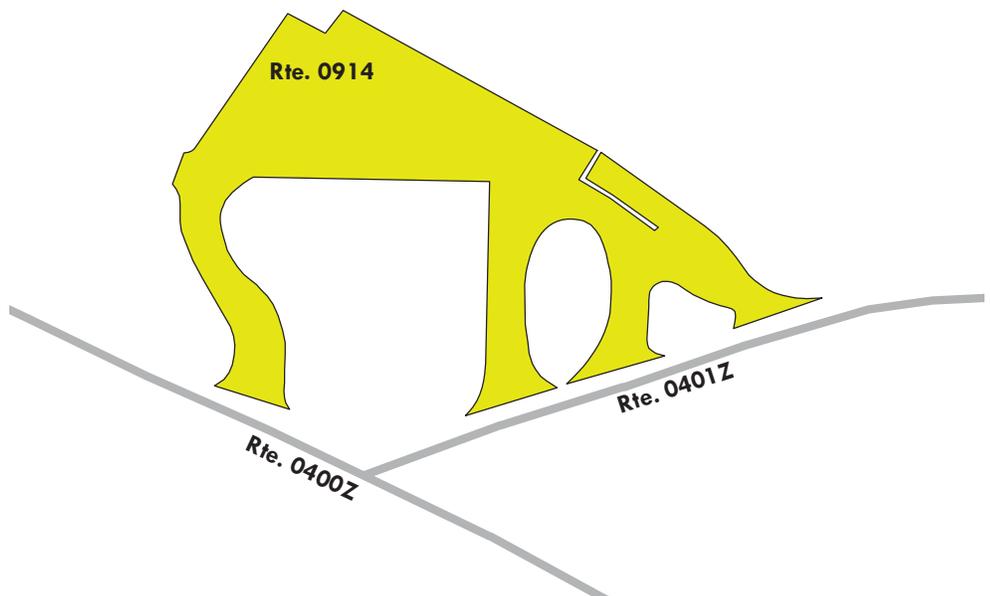
ROUTE 0914: CEDAR GROVE MAINTENANCE AREA

Inspection Date	FMSS Number	User Access	Surface Type
9/24/2014	73139	NONPUBLIC	ASPHALT
Area (Sq. Ft.)	Lane Miles (11' Widths)	Curb Reveal (Inches)	Curb Recommendation
16,522	0.284	NOT APPLICABLE	NOT APPLICABLE
Curb Type		Curb & Gutter Type	
NO CURB		NO CURB AND GUTTER	
Pavement Recommendation		Condition Rating / PCR	
LIGHT 3R TREATMENTS		FAIR / 73

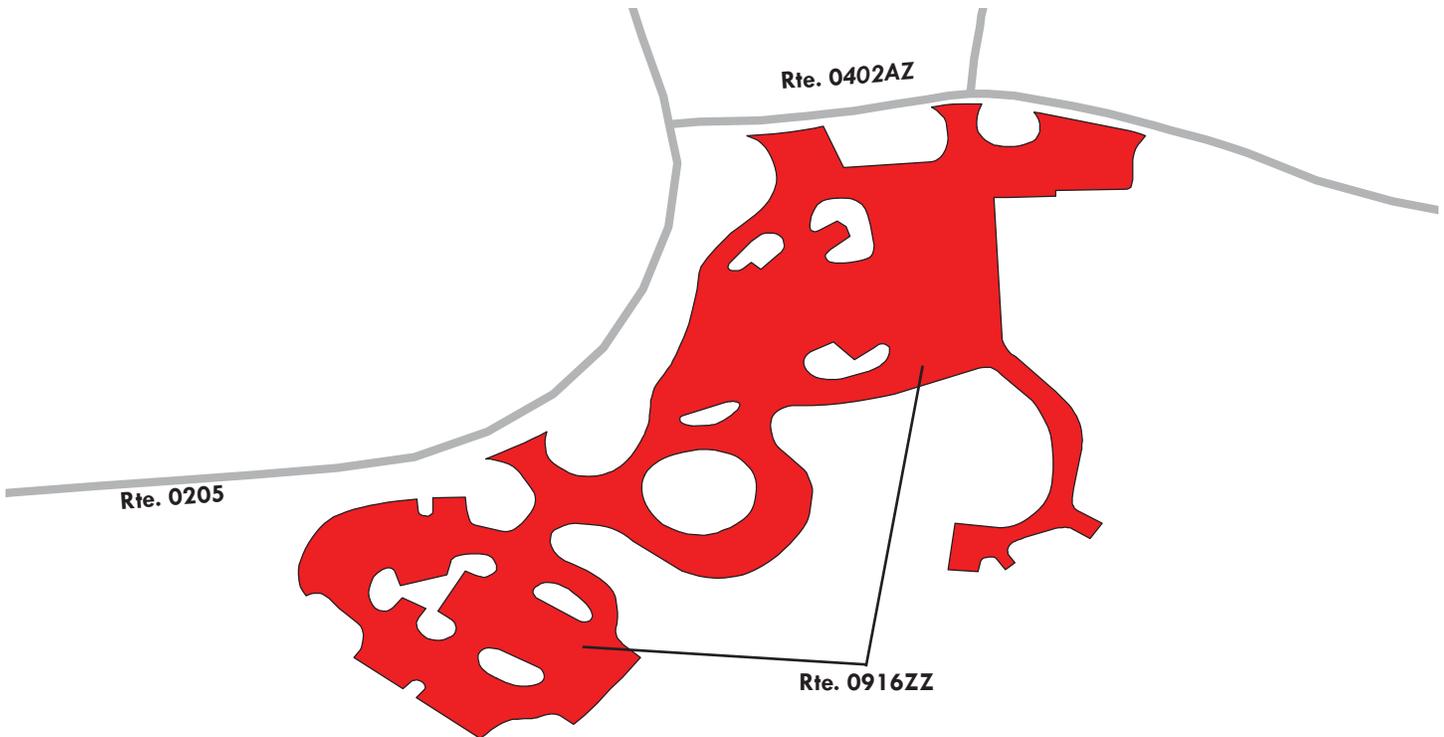
ROUTE 0916ZZ: CEDAR GROVE VILLAGE / PICNIC PARKING

Inspection Date	FMSS Number	User Access	Surface Type
9/24/2014	73140	PUBLIC	ASPHALT
Area (Sq. Ft.)	Lane Miles (11' Widths)	Condition Rating / PCR	
78,942	1.359	SUMMARY / 46	
Route Condition Legend – Pavement Condition Rating (PCR)			
Poor (0 - 60)	Fair (61- 84)	Good (85 - 94)	Excellent (95 - 100) Not Rated
See Appendix for definitions and formulas

The condition shown on this page reflects the overall route condition and may not reflect individual subcomponent ratings.

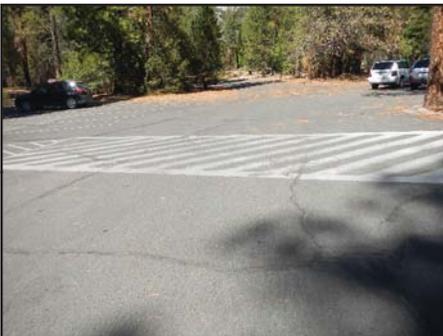
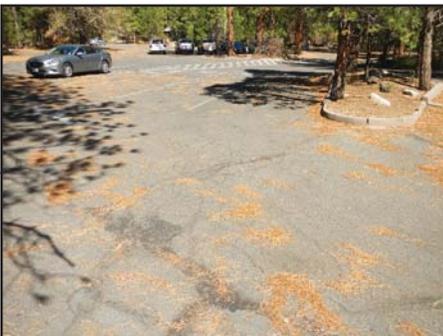
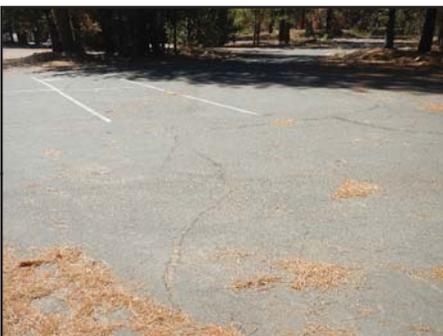
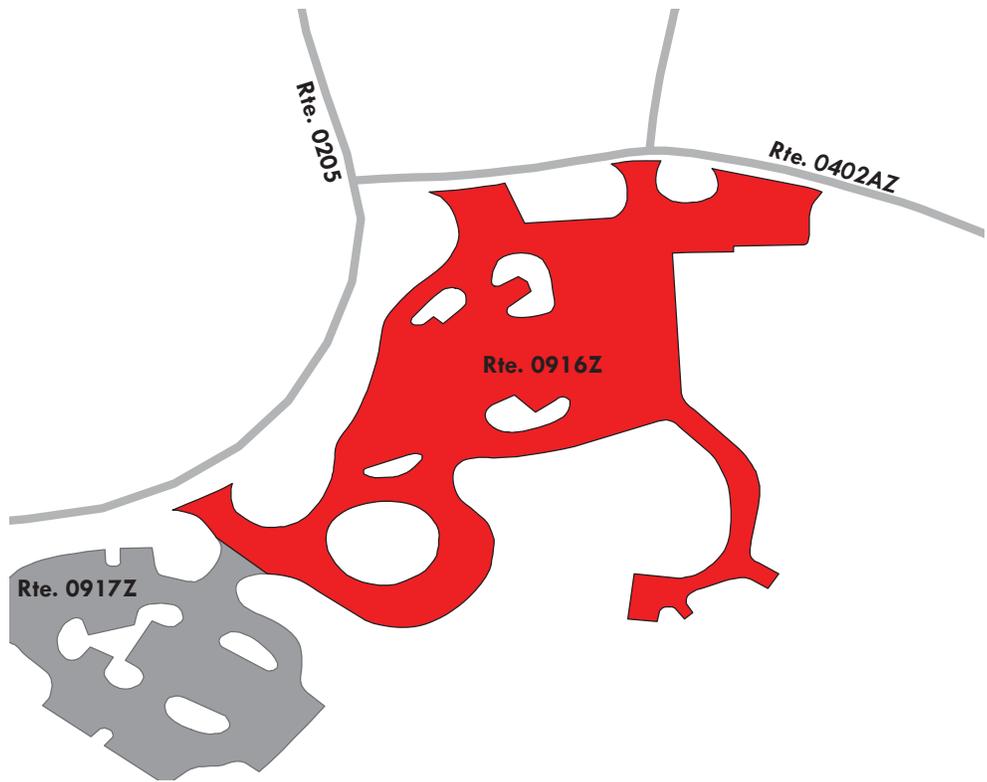
ROUTE 0916Z: CEDAR GROVE VILLAGE PARKING

Inspection Date	FMSS Number	User Access	Surface Type
9/24/2014	73140	PUBLIC	ASPHALT
Area (Sq. Ft.)	Lane Miles (11' Widths)	Curb Reveal (Inches)	Curb Recommendation
55,246	0.951	NOT APPLICABLE	REPLACE
Curb Type		Curb & Gutter Type	
NO CURB		CONCRETE	
Pavement Recommendation		Condition Rating / PCR	
HEAVY 3R TREATMENTS		POOR / 53

Parking area consists of multiple surface types: 1 part Asphalt at 53,117 square feet; 1 part of Concrete at 2129 square feet.

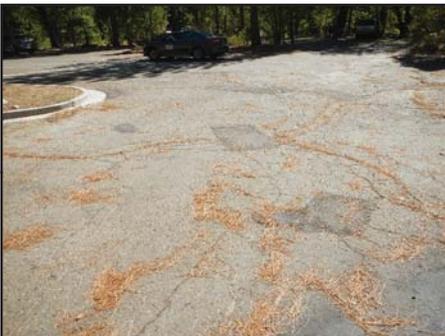
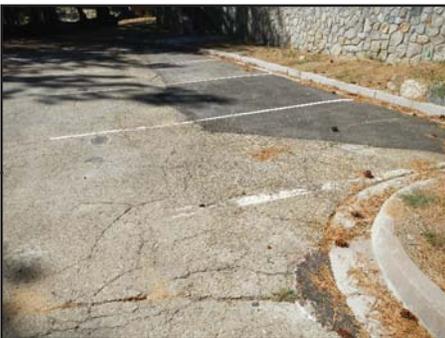
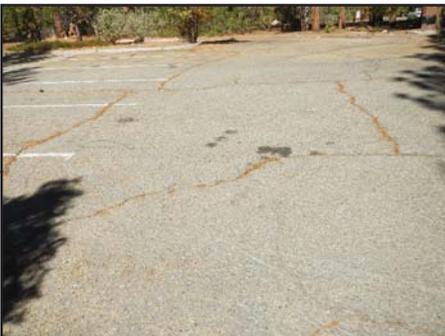
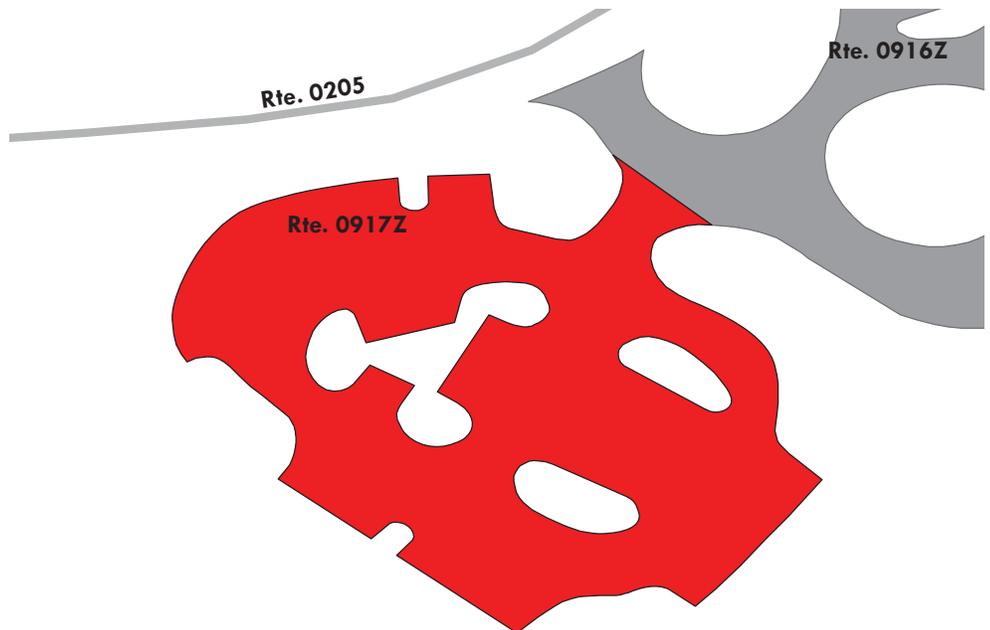
ROUTE 0917Z: CEDAR GROVE VILLAGE PICNIC PARKING

Inspection Date	FMSS Number	User Access	Surface Type
9/24/2014	73140	PUBLIC	ASPHALT
Area (Sq. Ft.)	Lane Miles (11' Widths)	Curb Reveal (Inches)	Curb Recommendation
23,696	0.408	NOT APPLICABLE	REPLACE
Curb Type		Curb & Gutter Type	
NO CURB		CONCRETE	
Pavement Recommendation		Condition Rating / PCR	
RECONSTRUCTION		POOR / 30

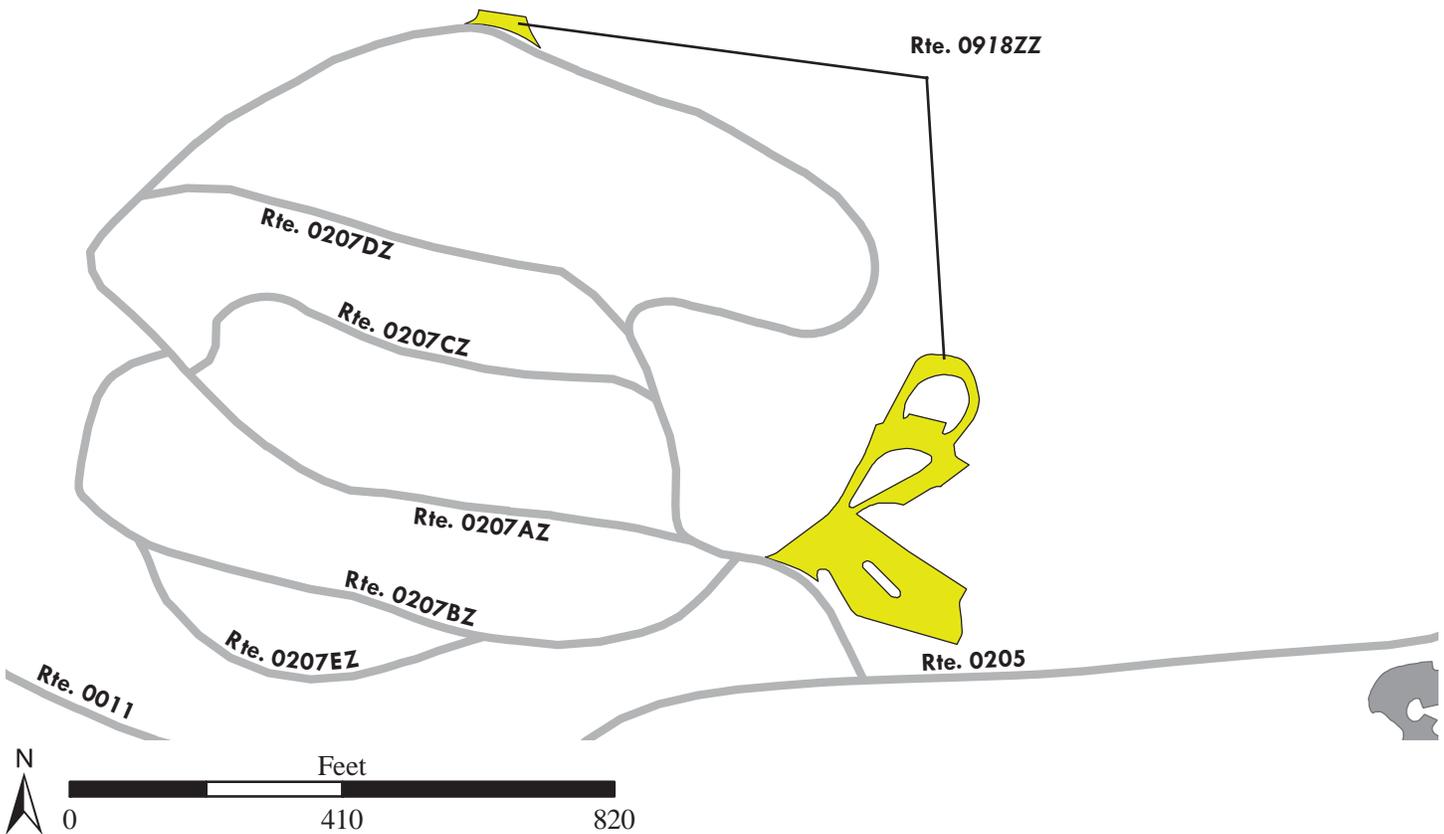
ROUTE 0918ZZ: CEDAR GROVE VISITOR CENTER PARKING AREAS

Inspection Date	FMSS Number	User Access	Surface Type
9/24/2014	73142	PUBLIC	ASPHALT
Area (Sq. Ft.)	Lane Miles (11' Widths)	Condition Rating / PCR	
38,038	0.655	SUMMARY / 71	
Route Condition Legend – Pavement Condition Rating (PCR)			
Poor (0 - 60)	Fair (61- 84)	Good (85 - 94)	Excellent (95 - 100)
Not Rated			
See Appendix for definitions and formulas

The condition shown on this page reflects the overall route condition and may not reflect individual subcomponent ratings.
