KICA Cycle 6

Final Report

Road Inventory and Condition Assessment of Paved Routes Kings Canyon National Park

**Federal Highway Administration
Eastern Federal Lands Highway Division
Road Inventory Program (RIP)**

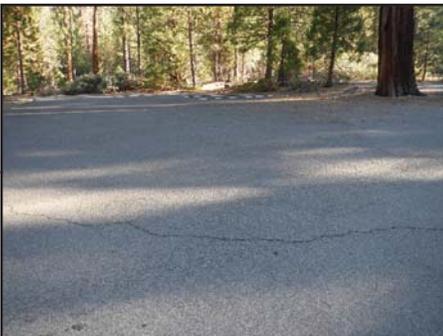
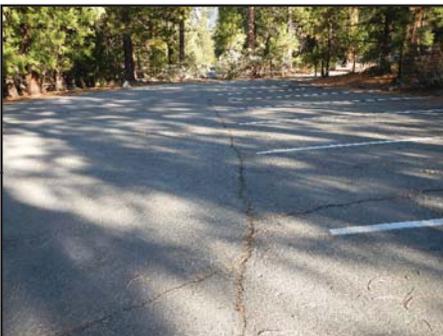
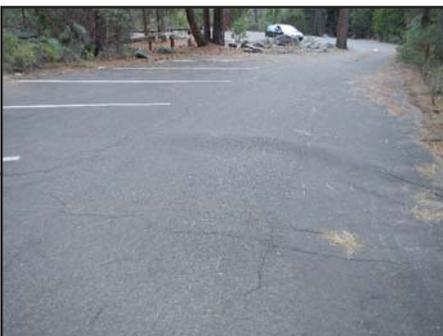
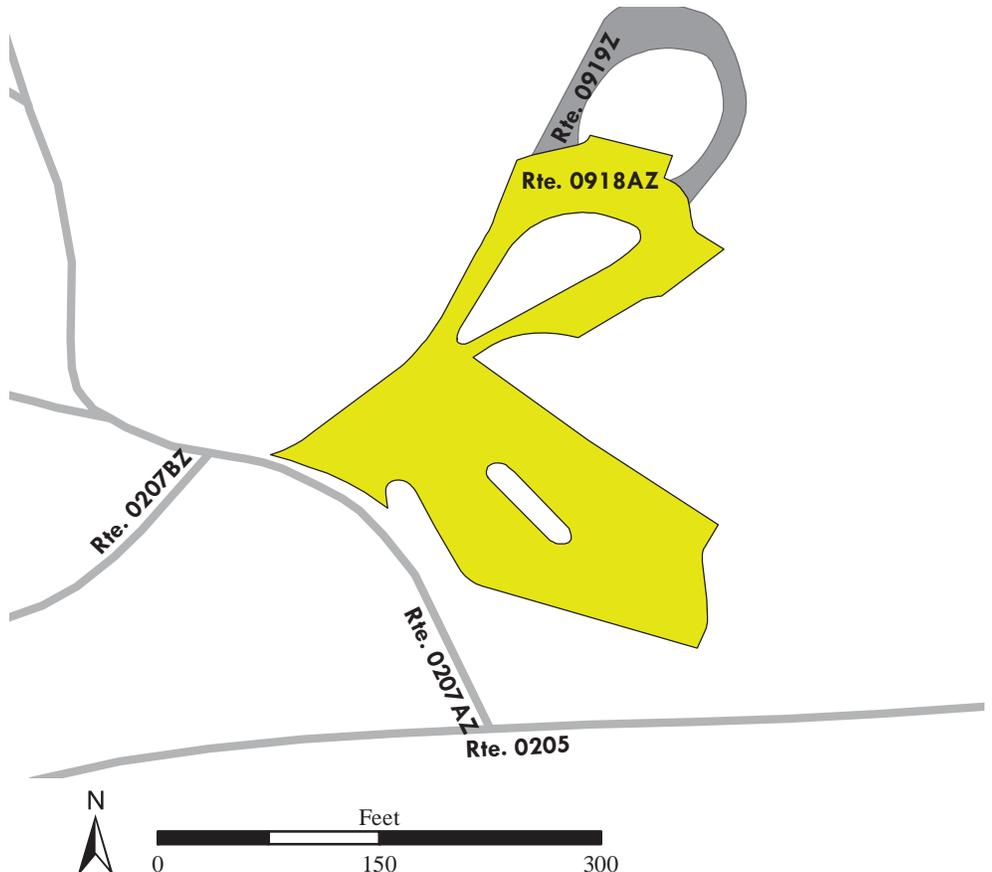
ROUTE 0918AZ: CEDAR GROVE VISITOR CENTER PARKING AREA A

Inspection Date	FMSS Number	User Access	Surface Type
9/24/2014	73142	PUBLIC	ASPHALT
Area (Sq. Ft.)	Lane Miles (11' Widths)	Curb Reveal (Inches)	Curb Recommendation
31,902	0.549	3	MODERATE REPAIR
Curb Type		Curb & Gutter Type	
ASPHALT		NO CURB AND GUTTER	
Pavement Recommendation		Condition Rating / PCR	
LIGHT 3R TREATMENTS		FAIR / 73

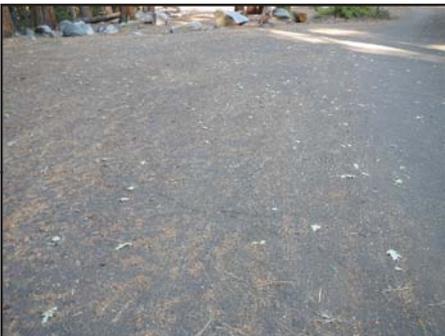
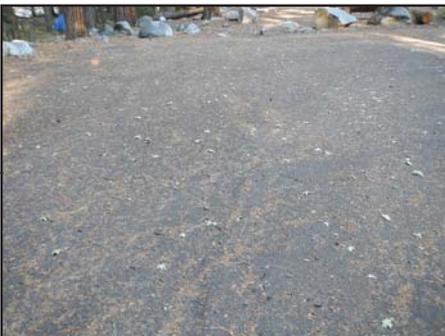
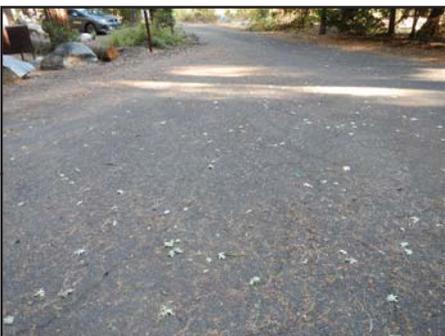
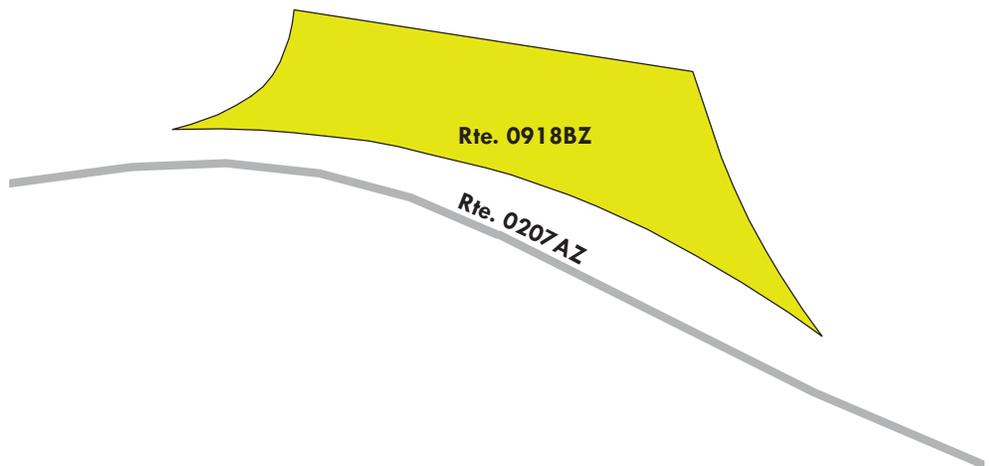
Inspection Date	FMSS Number	User Access	Surface Type
9/24/2014	73142	PUBLIC	ASPHALT
Area (Sq. Ft.)	Lane Miles (11' Widths)	Curb Reveal (Inches)	Curb Recommendation
1,682	0.029	NOT APPLICABLE	NOT APPLICABLE
Curb Type		Curb & Gutter Type	
NO CURB		NO CURB AND GUTTER	
Pavement Recommendation		Condition Rating / PCR	
LIGHT 3R TREATMENTS		FAIR / 73

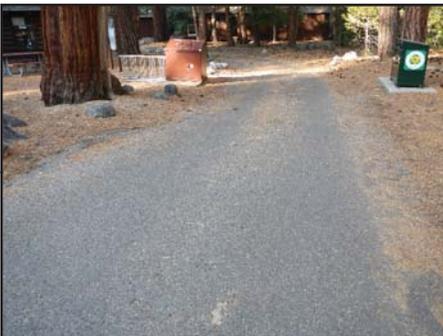
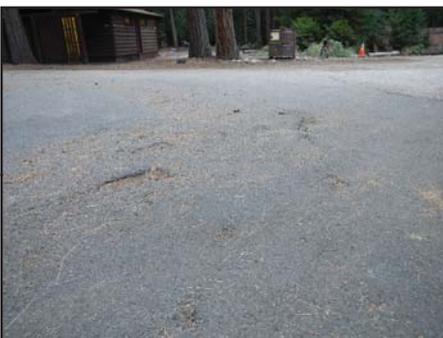
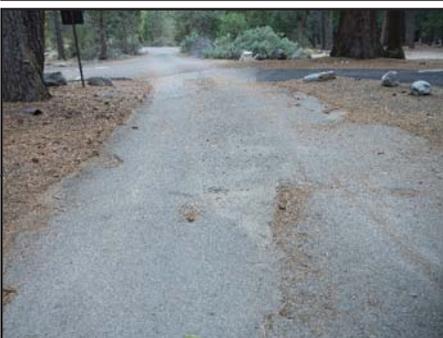
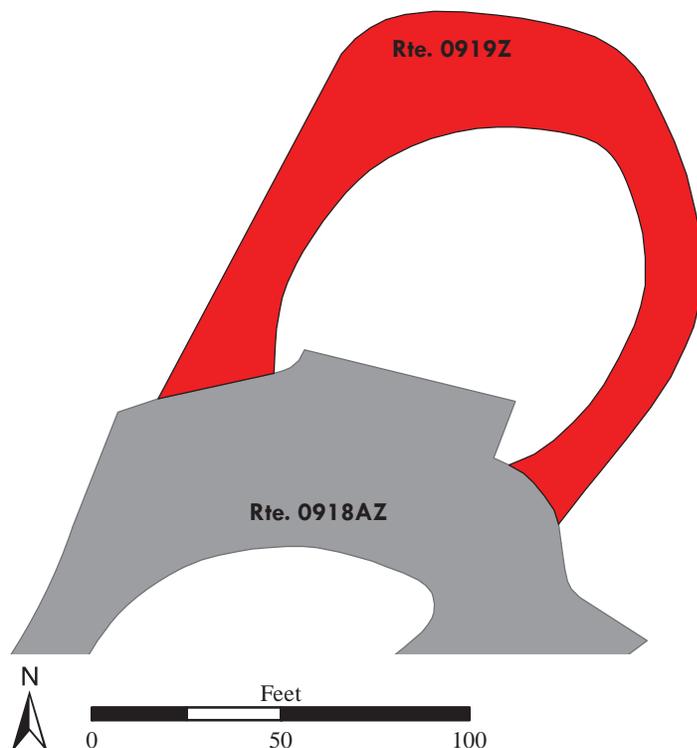
ROUTE 0919Z: WOLVERTON CORRAL FACILITY

Inspection Date	FMSS Number	User Access	Surface Type
9/24/2014	73142	NONPUBLIC	ASPHALT
Area (Sq. Ft.)	Lane Miles (11' Widths)	Curb Reveal (Inches)	Curb Recommendation
4,454	0.077	NOT APPLICABLE	NOT APPLICABLE
Curb Type		Curb & Gutter Type	
NO CURB		NO CURB AND GUTTER	
Pavement Recommendation		Condition Rating / PCR	
HEAVY 3R TREATMENTS		POOR / 53

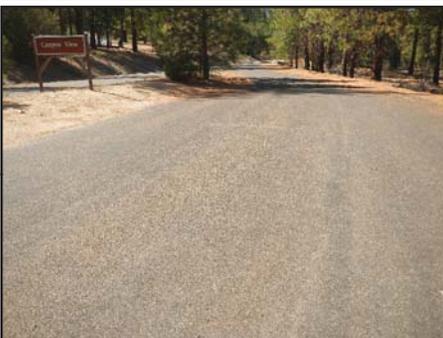
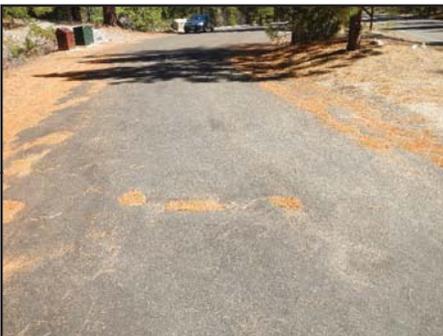
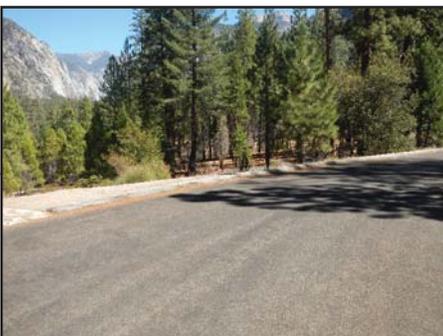
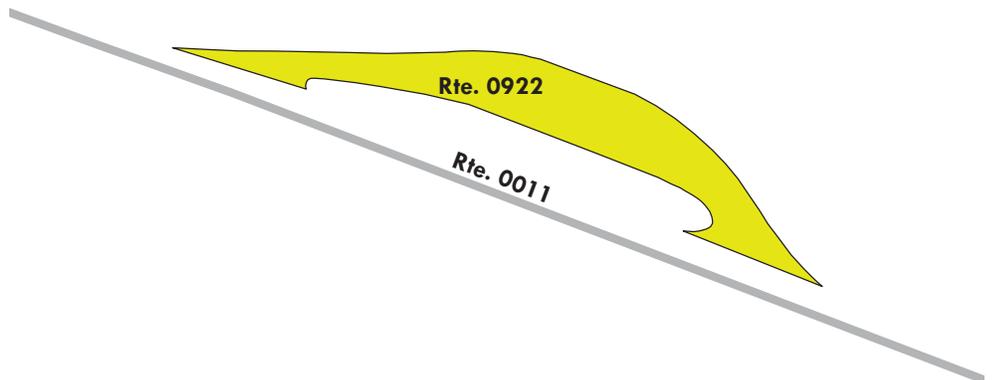
ROUTE 0922: CANYON VIEW PARKING

Inspection Date	FMSS Number	User Access	Surface Type
9/24/2014	73147	PUBLIC	ASPHALT
Area (Sq. Ft.)	Lane Miles (11' Widths)	Curb Reveal (Inches)	Curb Recommendation
6,768	0.117	4	REPLACE
Curb Type		Curb & Gutter Type	
ASPHALT		NO CURB AND GUTTER	
Pavement Recommendation		Condition Rating / PCR	
LIGHT 3R TREATMENTS		FAIR / 73

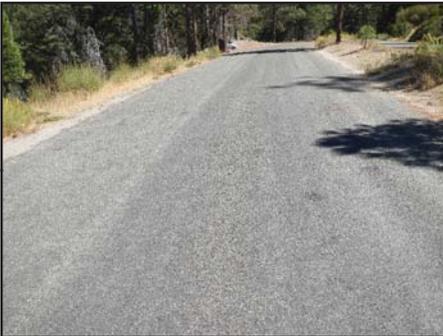
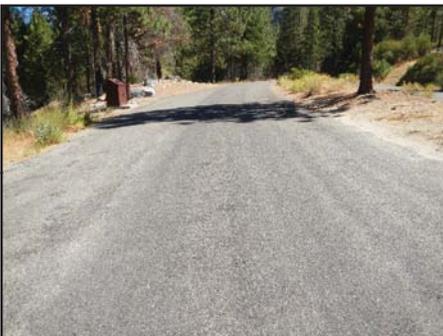
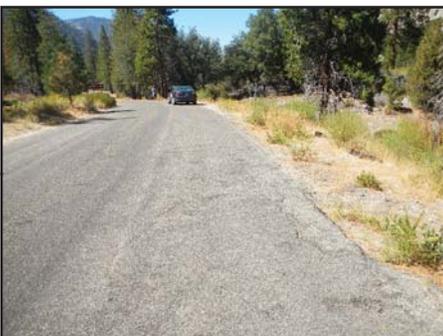
ROUTE 0923: KNAPP'S CABIN PARKING

Inspection Date	FMSS Number	User Access	Surface Type
9/24/2014	73148	PUBLIC	ASPHALT
Area (Sq. Ft.)	Lane Miles (11' Widths)	Curb Reveal (Inches)	Curb Recommendation
9,268	0.16	NOT APPLICABLE	NOT APPLICABLE
Curb Type		Curb & Gutter Type	
NO CURB		NO CURB AND GUTTER	
Pavement Recommendation		Condition Rating / PCR	
LIGHT 3R TREATMENTS		FAIR / 73

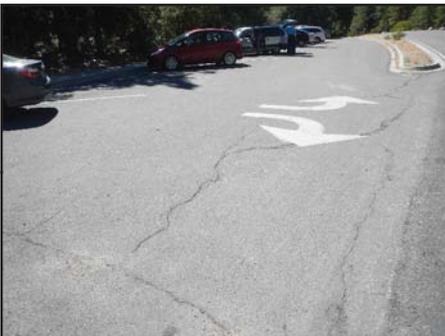
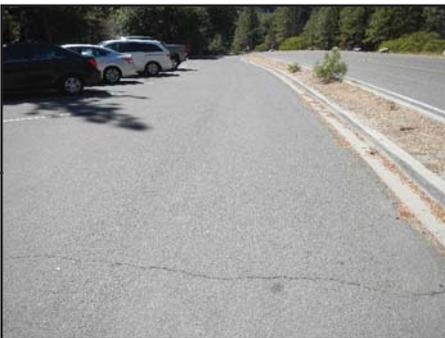
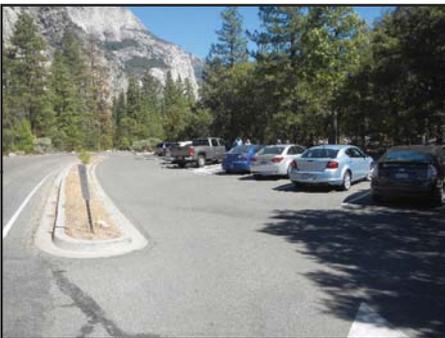
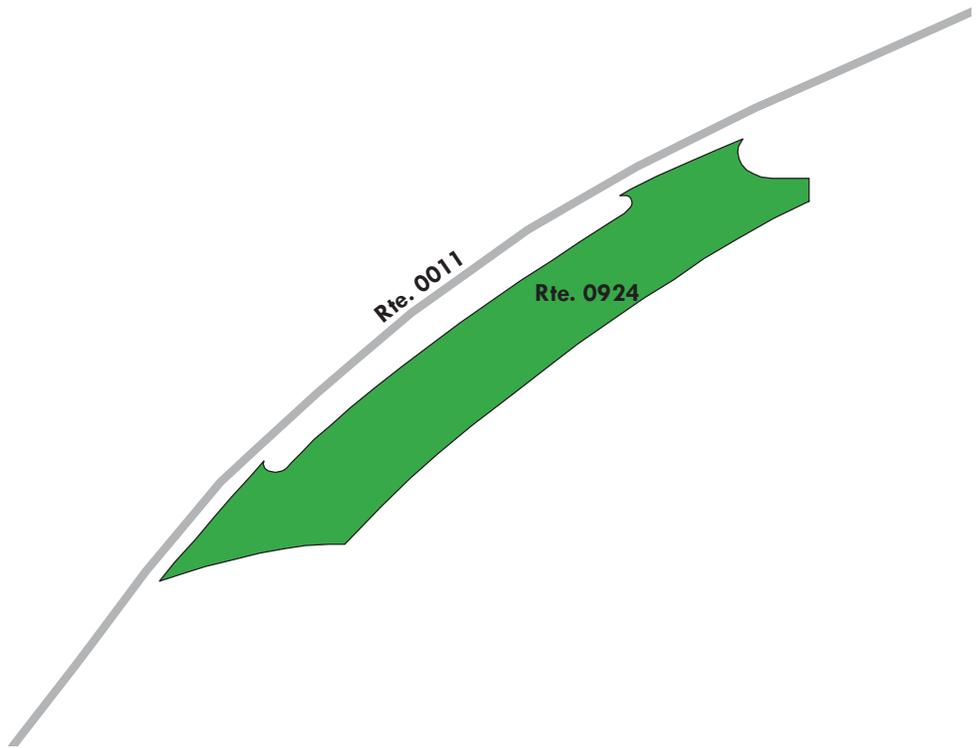
ROUTE 0924: ROARING RIVER FALLS PARKING

Inspection Date	FMSS Number	User Access	Surface Type
9/24/2014	73150	PUBLIC	ASPHALT
Area (Sq. Ft.)	Lane Miles (11' Widths)	Curb Reveal (Inches)	Curb Recommendation
9,437	0.162	NOT APPLICABLE	DO NOTHING
Curb Type		Curb & Gutter Type	
NO CURB		CONCRETE	
Pavement Recommendation		Condition Rating / PCR	
PREVENTIVE MAINTENANCE		GOOD / 90

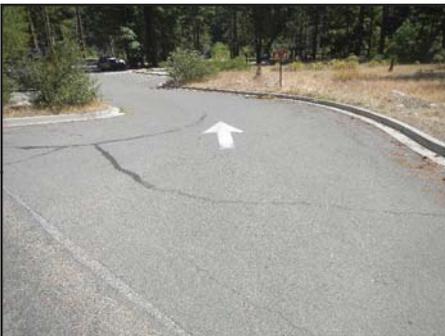
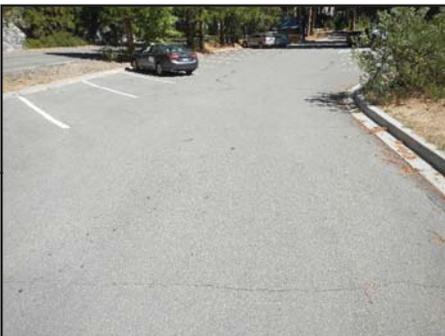
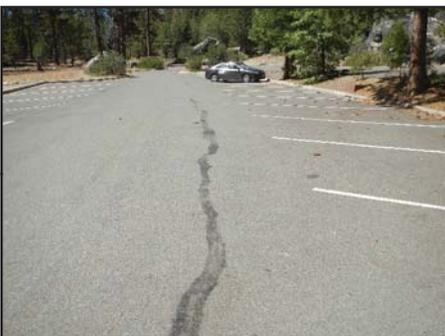
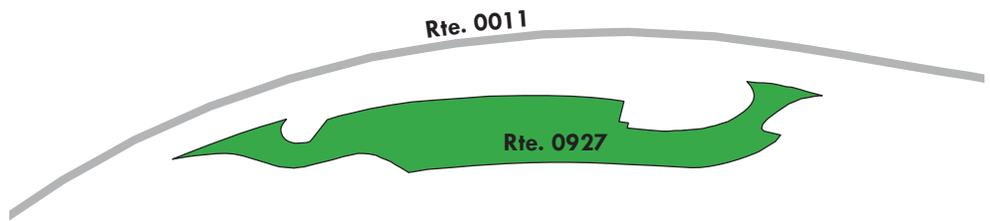
ROUTE 0927: ZUMWALT MEADOW PARKING

Inspection Date	FMSS Number	User Access	Surface Type
9/24/2014	73604	PUBLIC	ASPHALT
Area (Sq. Ft.)	Lane Miles (11' Widths)	Curb Reveal (Inches)	Curb Recommendation
13,033	0.224	NOT APPLICABLE	DO NOTHING
Curb Type		Curb & Gutter Type	
NO CURB		CONCRETE	
Pavement Recommendation		Condition Rating / PCR	
PREVENTIVE MAINTENANCE		GOOD / 90

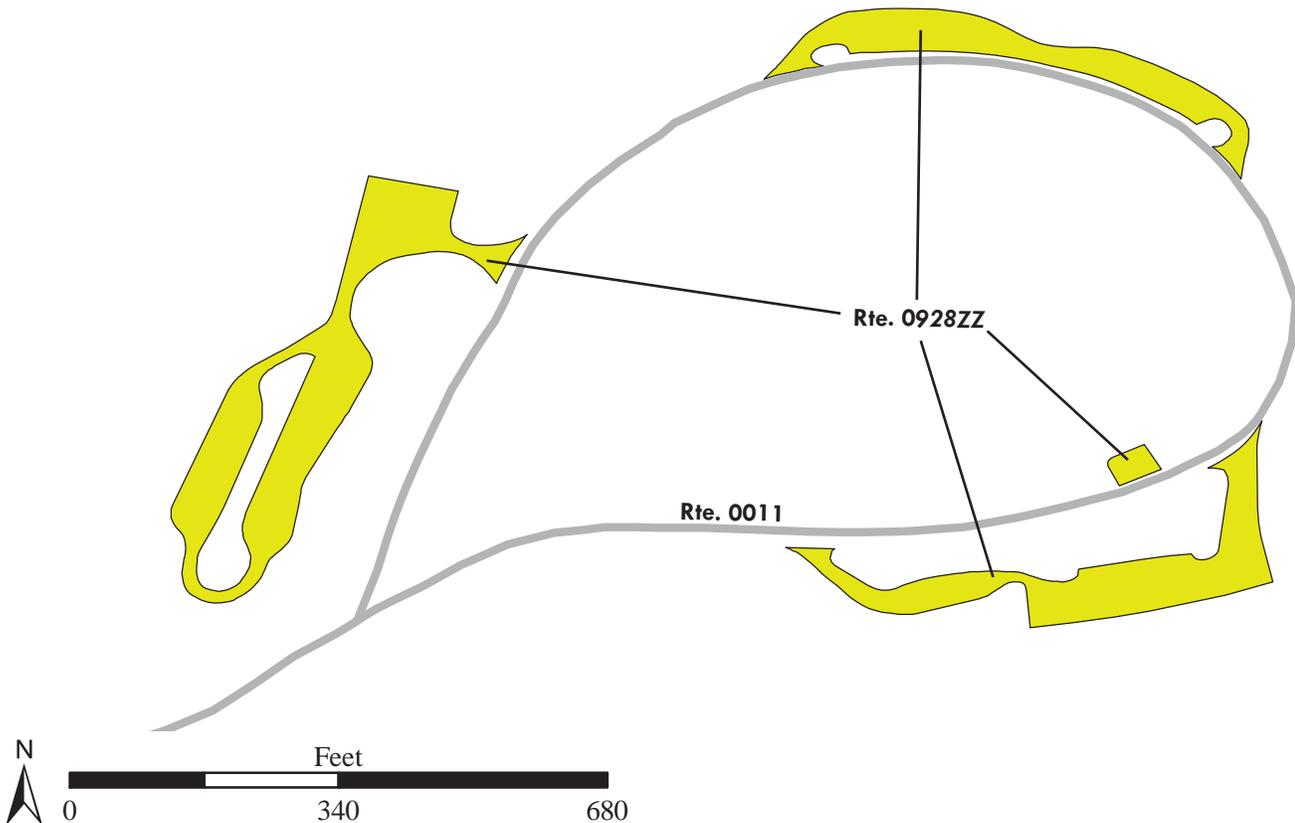
ROUTE 0928ZZ: ROAD'S END PARKING LOTS

Inspection Date	FMSS Number	User Access	Surface Type
9/24/2014	73606	PUBLIC	ASPHALT
Area (Sq. Ft.)	Lane Miles (11' Widths)	Condition Rating / PCR	
89,073	1.533	SUMMARY / 67

The condition shown on this page reflects the overall route condition and may not reflect individual subcomponent ratings.

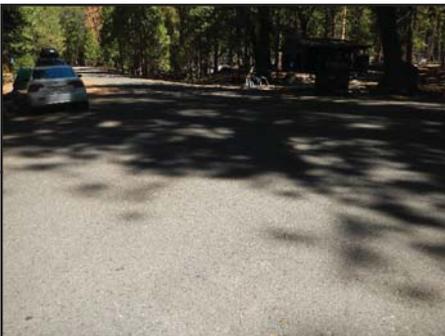
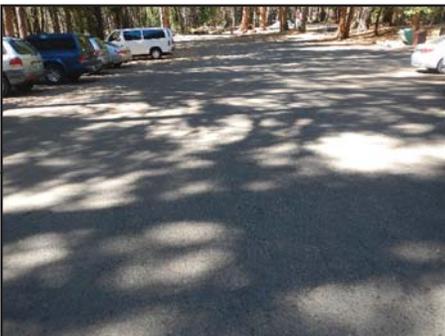
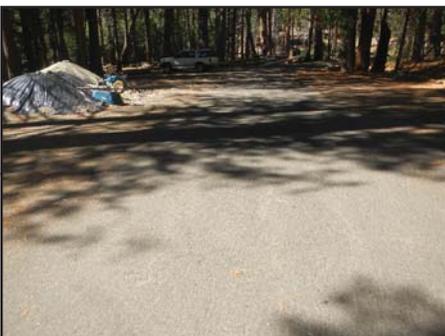
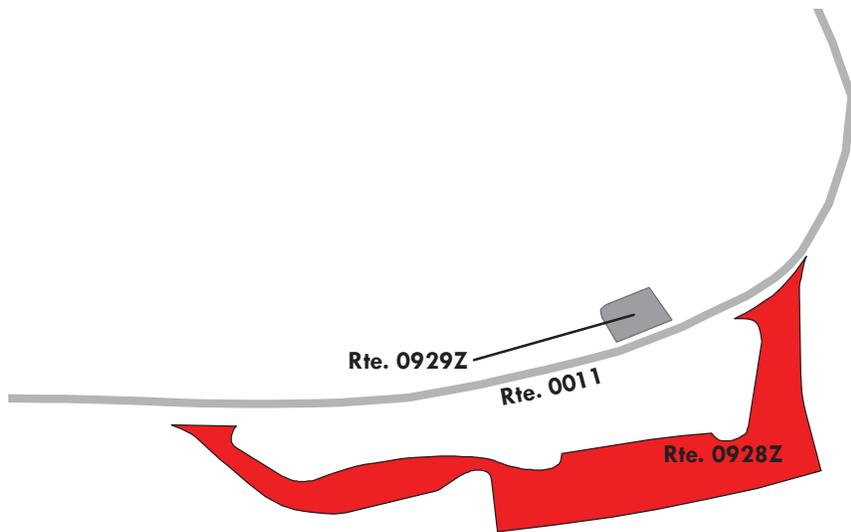
ROUTE 0928Z: ROAD'S END INFORMATION PARKING

Inspection Date	FMSS Number	User Access	Surface Type
9/24/2014	73606	PUBLIC	ASPHALT
Area (Sq. Ft.)	Lane Miles (11' Widths)	Curb Reveal (Inches)	Curb Recommendation
26,318	0.453	NOT APPLICABLE	NOT APPLICABLE
Curb Type		Curb & Gutter Type	
NO CURB		NO CURB AND GUTTER	
Pavement Recommendation		Condition Rating / PCR	
HEAVY 3R TREATMENTS		POOR / 53

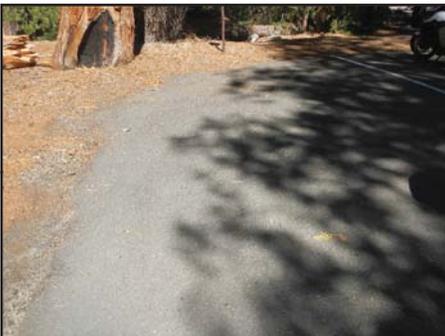
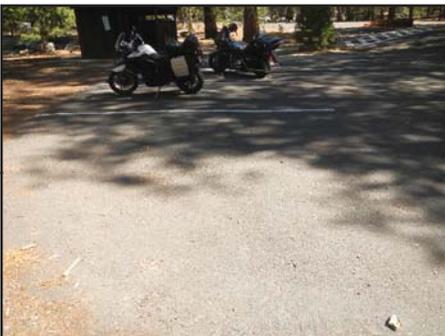
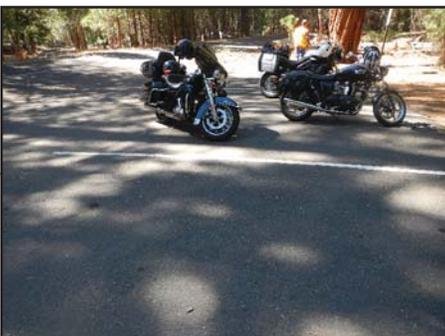
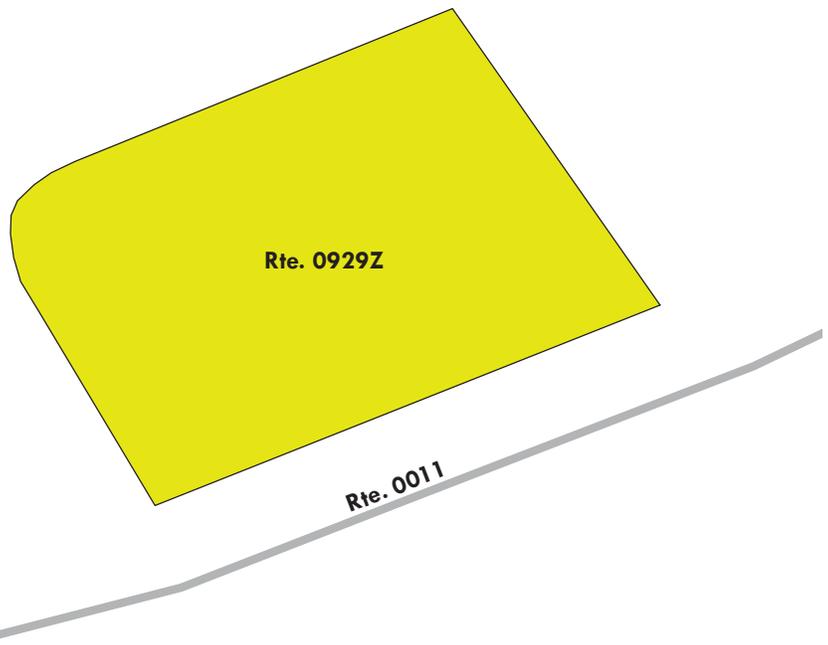
ROUTE 0929Z: ROAD'S END RESTROOM PARKING

Inspection Date	FMSS Number	User Access	Surface Type
9/24/2014	73606	PUBLIC	ASPHALT
Area (Sq. Ft.)	Lane Miles (11' Widths)	Curb Reveal (Inches)	Curb Recommendation
1,591	0.027	NOT APPLICABLE	NOT APPLICABLE
Curb Type		Curb & Gutter Type	
NO CURB		NO CURB AND GUTTER	
Pavement Recommendation		Condition Rating / PCR	
LIGHT 3R TREATMENTS		FAIR / 73

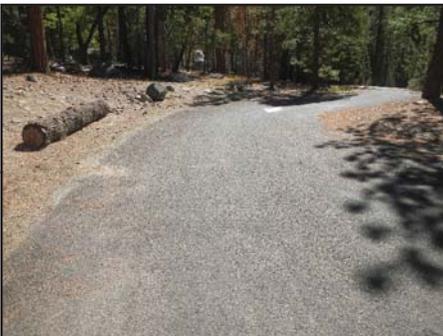
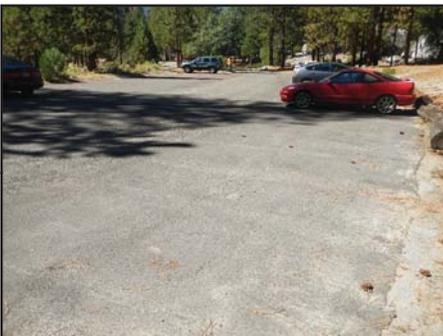
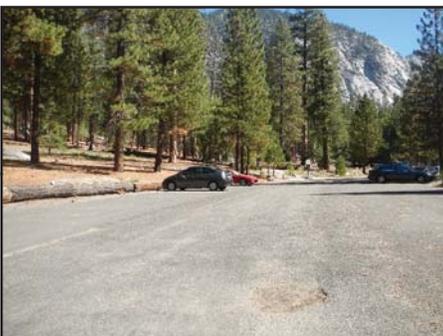
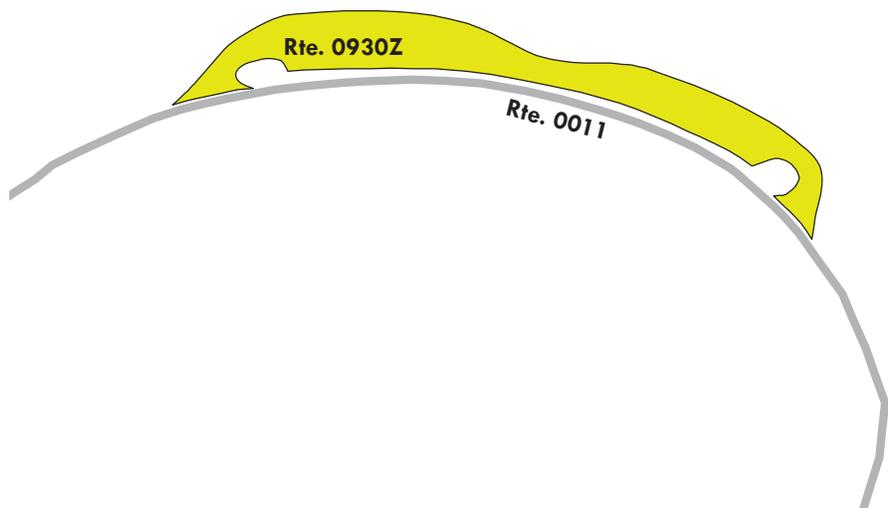
ROUTE 0930Z: COPPER CREEK TRAIL PARKING

Inspection Date	FMSS Number	User Access	Surface Type
9/24/2014	73606	PUBLIC	ASPHALT
Area (Sq. Ft.)	Lane Miles (11' Widths)	Curb Reveal (Inches)	Curb Recommendation
20,521	0.353	NOT APPLICABLE	NOT APPLICABLE
Curb Type		Curb & Gutter Type	
NO CURB		NO CURB AND GUTTER	
Pavement Recommendation		Condition Rating / PCR	
LIGHT 3R TREATMENTS		FAIR / 73

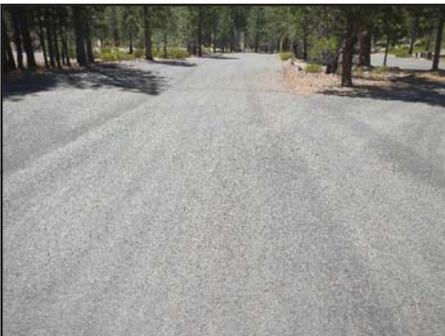
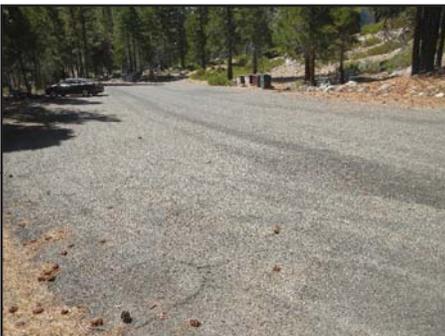
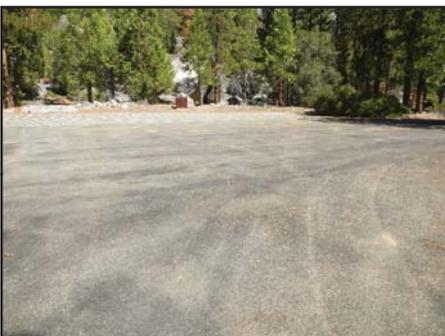
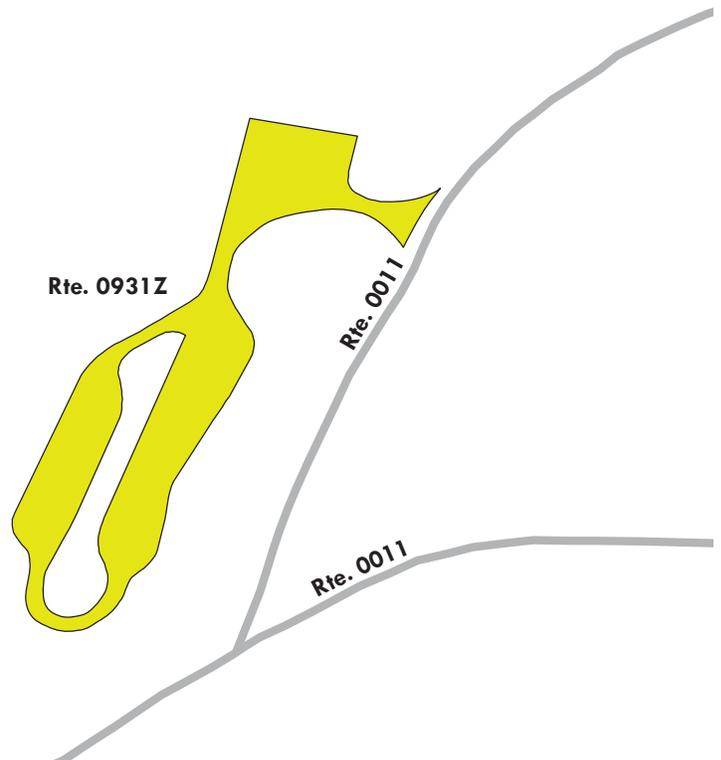
ROUTE 0931Z: ROAD'S END LONG TERM PARKING

Inspection Date	FMSS Number	User Access	Surface Type
9/24/2014	73606	PUBLIC	ASPHALT
Area (Sq. Ft.)	Lane Miles (11' Widths)	Curb Reveal (Inches)	Curb Recommendation
40,643	0.7	NOT APPLICABLE	NOT APPLICABLE
Curb Type		Curb & Gutter Type	
NO CURB		NO CURB AND GUTTER	
Pavement Recommendation		Condition Rating / PCR	
LIGHT 3R TREATMENTS		FAIR / 73

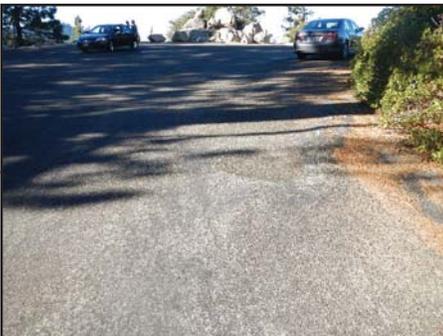
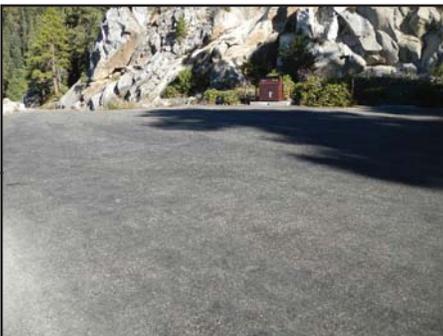
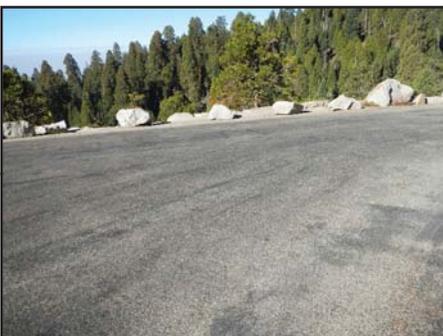
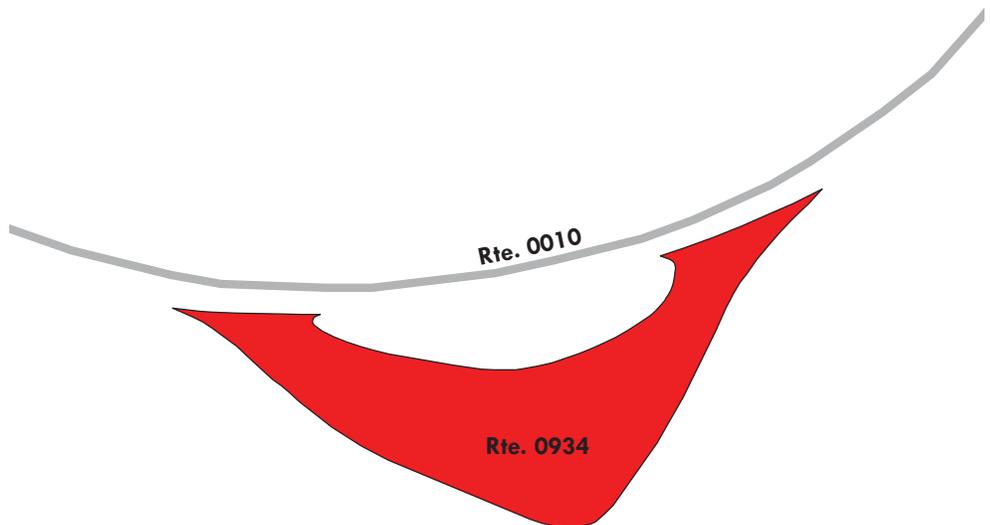
ROUTE 0934: REDWOOD CANYON OVERLOOK PARKING

Inspection Date	FMSS Number	User Access	Surface Type
9/25/2014	73614	PUBLIC	ASPHALT
Area (Sq. Ft.)	Lane Miles (11' Widths)	Curb Reveal (Inches)	Curb Recommendation
9,895	0.17	NOT APPLICABLE	NOT APPLICABLE
Curb Type		Curb & Gutter Type	
NO CURB		NO CURB AND GUTTER	
Pavement Recommendation		Condition Rating / PCR	
HEAVY 3R TREATMENTS		POOR / 53

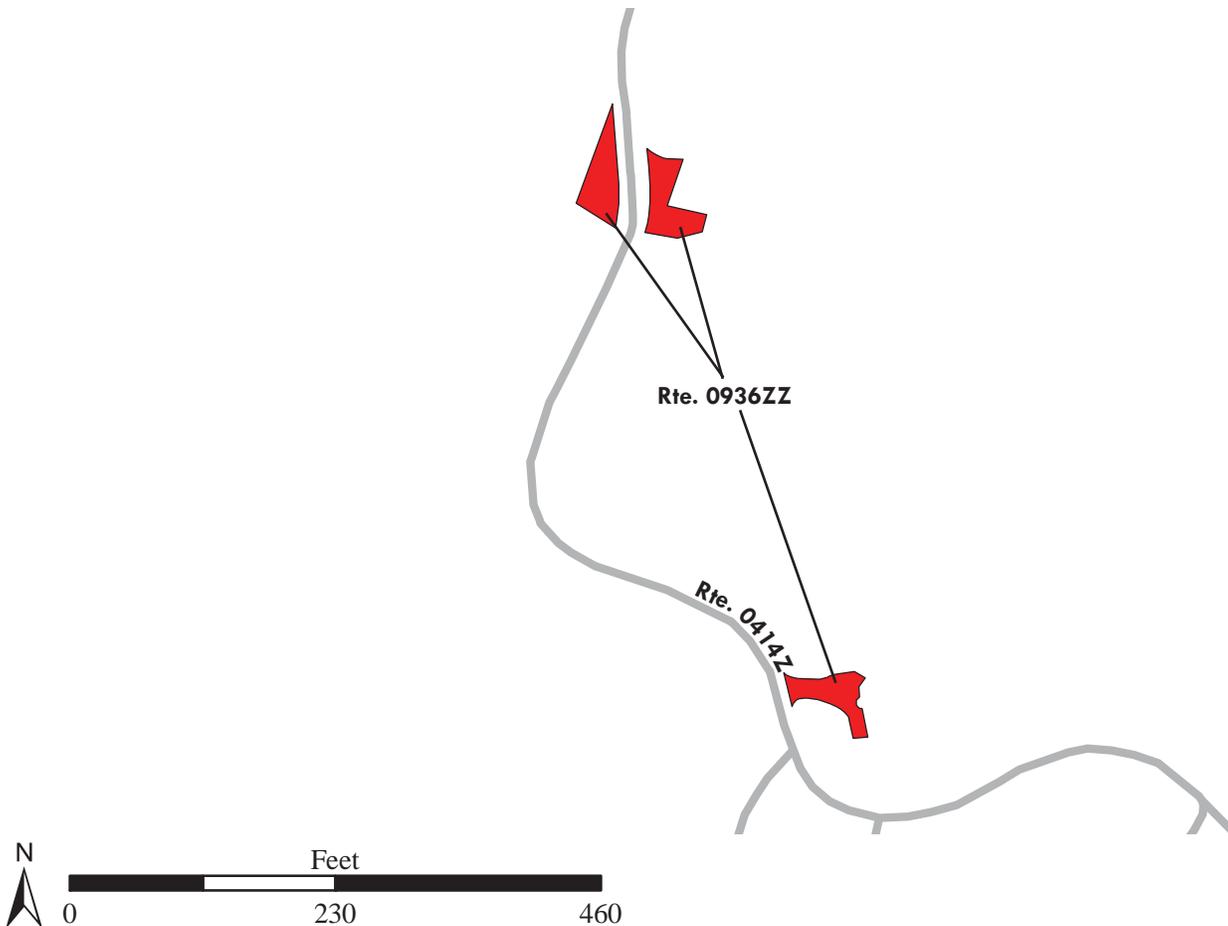
ROUTE 0936ZZ: SWALE WORK CENTER PARKING AREAS

Inspection Date	FMSS Number	User Access	Surface Type
9/25/2014	N/A	NONPUBLIC	ASPHALT
Area (Sq. Ft.)	Lane Miles (11' Widths)	Condition Rating / PCR	
4,784	0.082	SUMMARY / 43	
Route Condition Legend – Pavement Condition Rating (PCR)			
Poor (0 - 60)	Fair (61- 84)	Good (85 - 94)	Excellent (95 - 100)
See Appendix for definitions and formulas

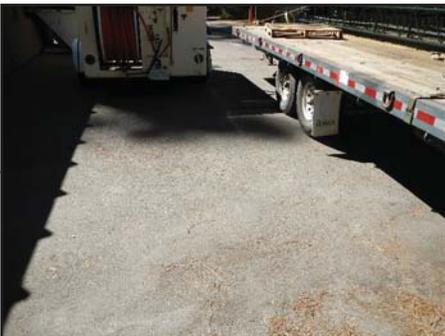
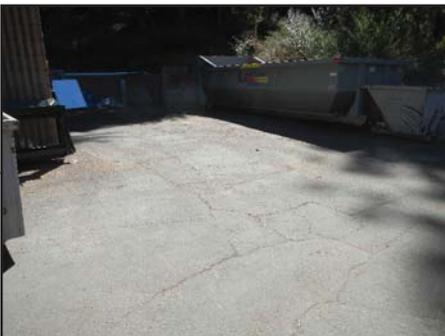
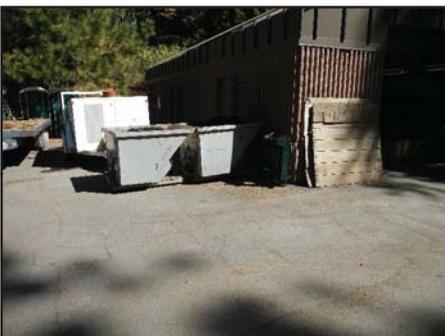
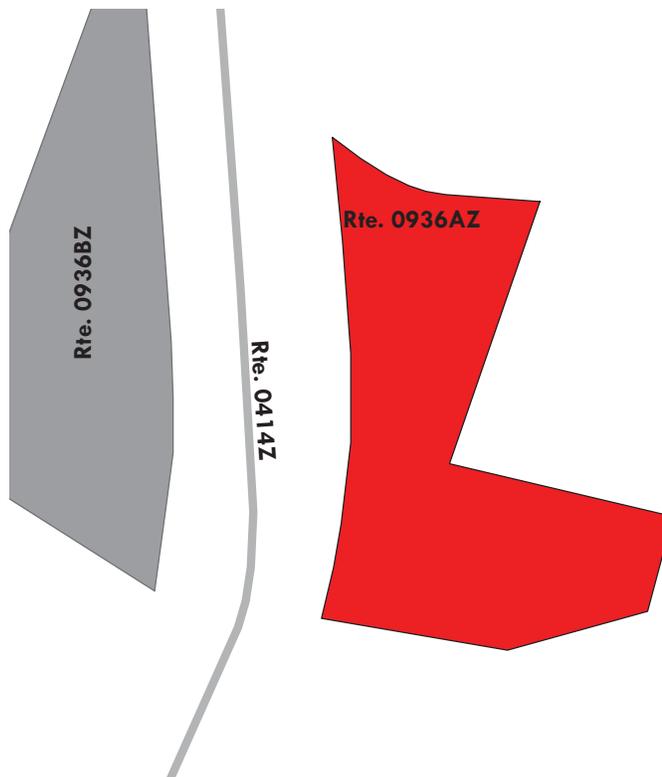
ROUTE 0936AZ: SWALE WORK CENTER PARKING A

Inspection Date	FMSS Number	User Access	Surface Type
9/25/2014	N/A	NONPUBLIC	ASPHALT
Area (Sq. Ft.)	Lane Miles (11' Widths)	Curb Reveal (Inches)	Curb Recommendation
1,695	0.029	NOT APPLICABLE	NOT APPLICABLE
Curb Type		Curb & Gutter Type	
NO CURB		NO CURB AND GUTTER	
Pavement Recommendation		Condition Rating / PCR	
RECONSTRUCTION		POOR / 30

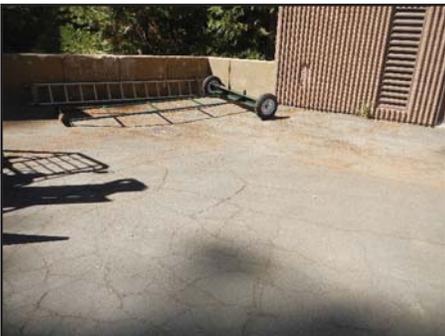
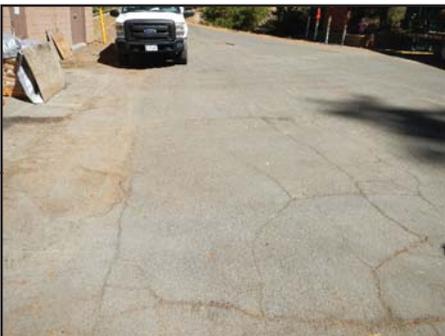
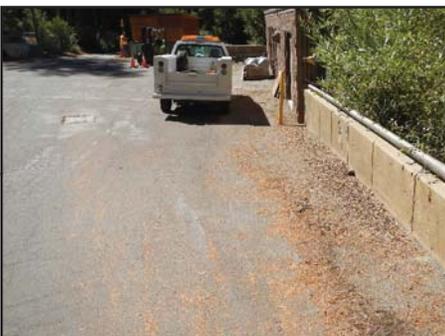
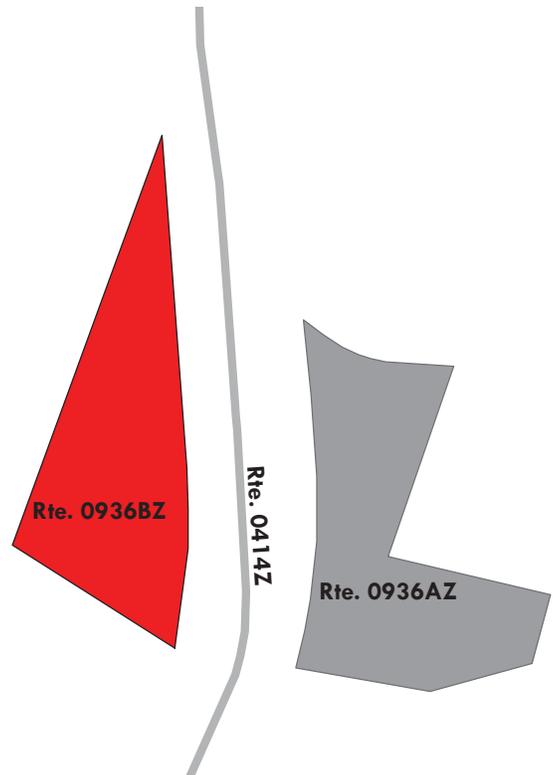
ROUTE 0936BZ: SWALE WORK CENTER PARKING B

Inspection Date	FMSS Number	User Access	Surface Type
9/25/2014	N/A	NONPUBLIC	ASPHALT
Area (Sq. Ft.)	Lane Miles (11' Widths)	Curb Reveal (Inches)	Curb Recommendation
1,623	0.028	NOT APPLICABLE	NOT APPLICABLE
Curb Type		Curb & Gutter Type	
NO CURB		NO CURB AND GUTTER	
Pavement Recommendation		Condition Rating / PCR	
RECONSTRUCTION		POOR / 30

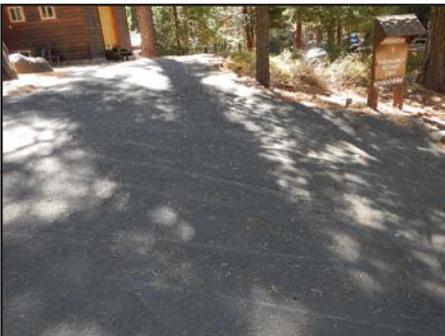
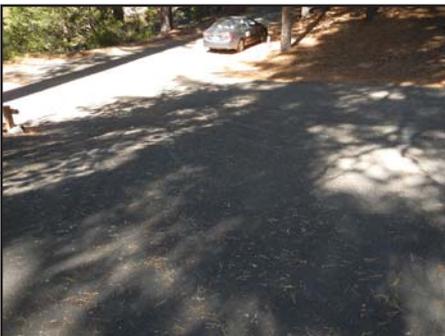
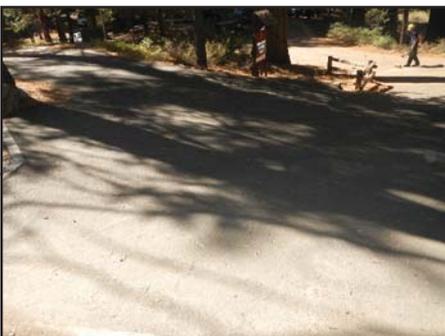
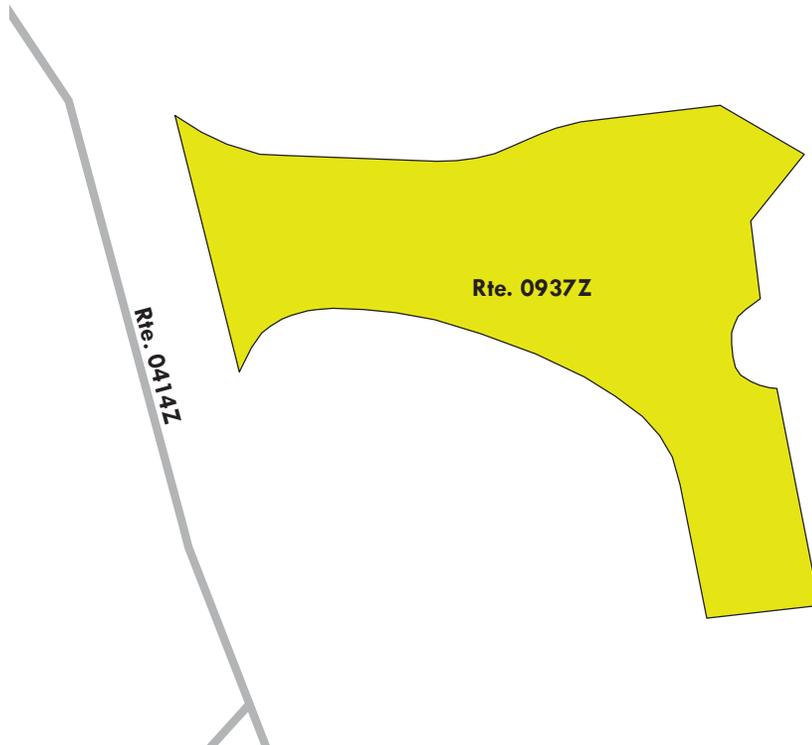
ROUTE 0937Z: ARROWHEAD INTERAGENCY HOTSHOT CREW PARKING

Inspection Date	FMSS Number	User Access	Surface Type
9/25/2014	N/A	NONPUBLIC	ASPHALT
Area (Sq. Ft.)	Lane Miles (11' Widths)	Curb Reveal (Inches)	Curb Recommendation
1,466	0.025	NOT APPLICABLE	NOT APPLICABLE
Curb Type		Curb & Gutter Type	
NO CURB		NO CURB AND GUTTER	
Pavement Recommendation		Condition Rating / PCR	
LIGHT 3R TREATMENTS		FAIR / 73

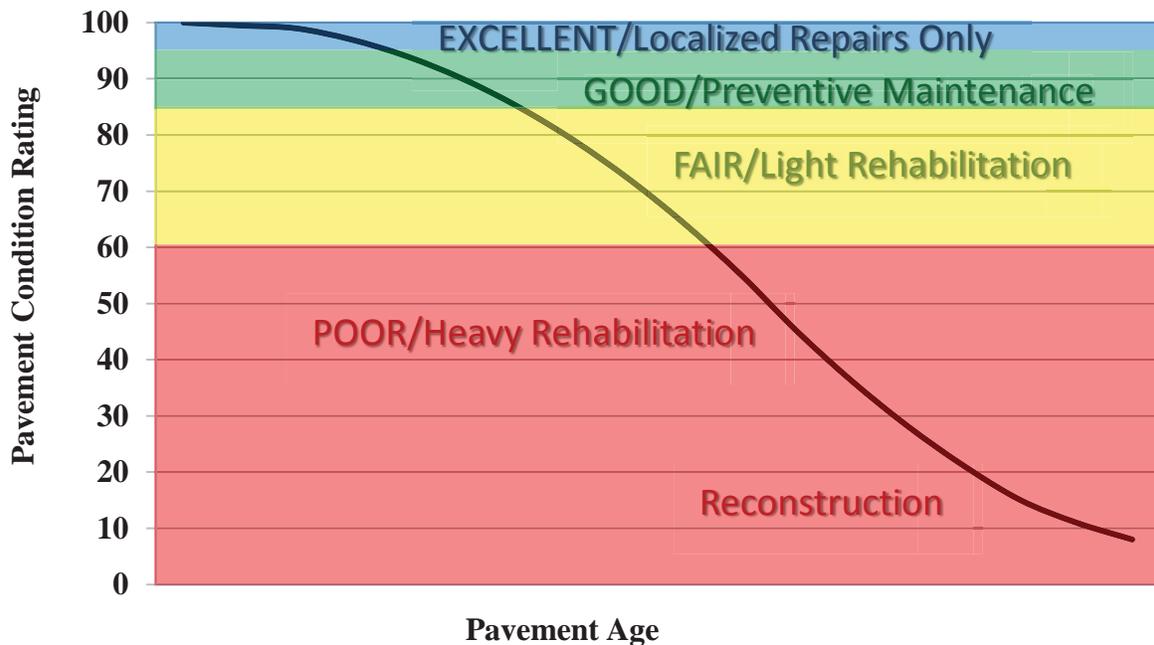
Condition Categories and Treatments

Description of Pavement Treatment Types

1. **Preventive Maintenance** is a planned strategy of cost-effective treatments to an existing roadway system and its appurtenances that preserves the system, retards future deterioration, and maintains or improves the functional condition of the system (without significantly increasing the structural capacity). Preventive maintenance is typically applied to pavements in good condition having significant remaining service life. As a major component of pavement preservation, preventive maintenance is a strategy of extending the service life by applying cost-effective treatments to the surface or near-surface of structurally sound pavements. Examples of preventive treatments include asphalt crack sealing, chip sealing, slurry or micro-surfacing, thin and ultra-thin hot-mix asphalt overlay, concrete joint sealing, diamond grinding, dowel-bar retrofit, and isolated, partial and/or full-depth concrete repairs to restore functionality of individual slabs.
