LARO Cycle 6

Final Report

Road Inventory and Condition Assessment of Paved Routes Lake Roosevelt National Recreation Area

**Federal Highway Administration
Eastern Federal Lands Highway Division
Road Inventory Program (RIP)**

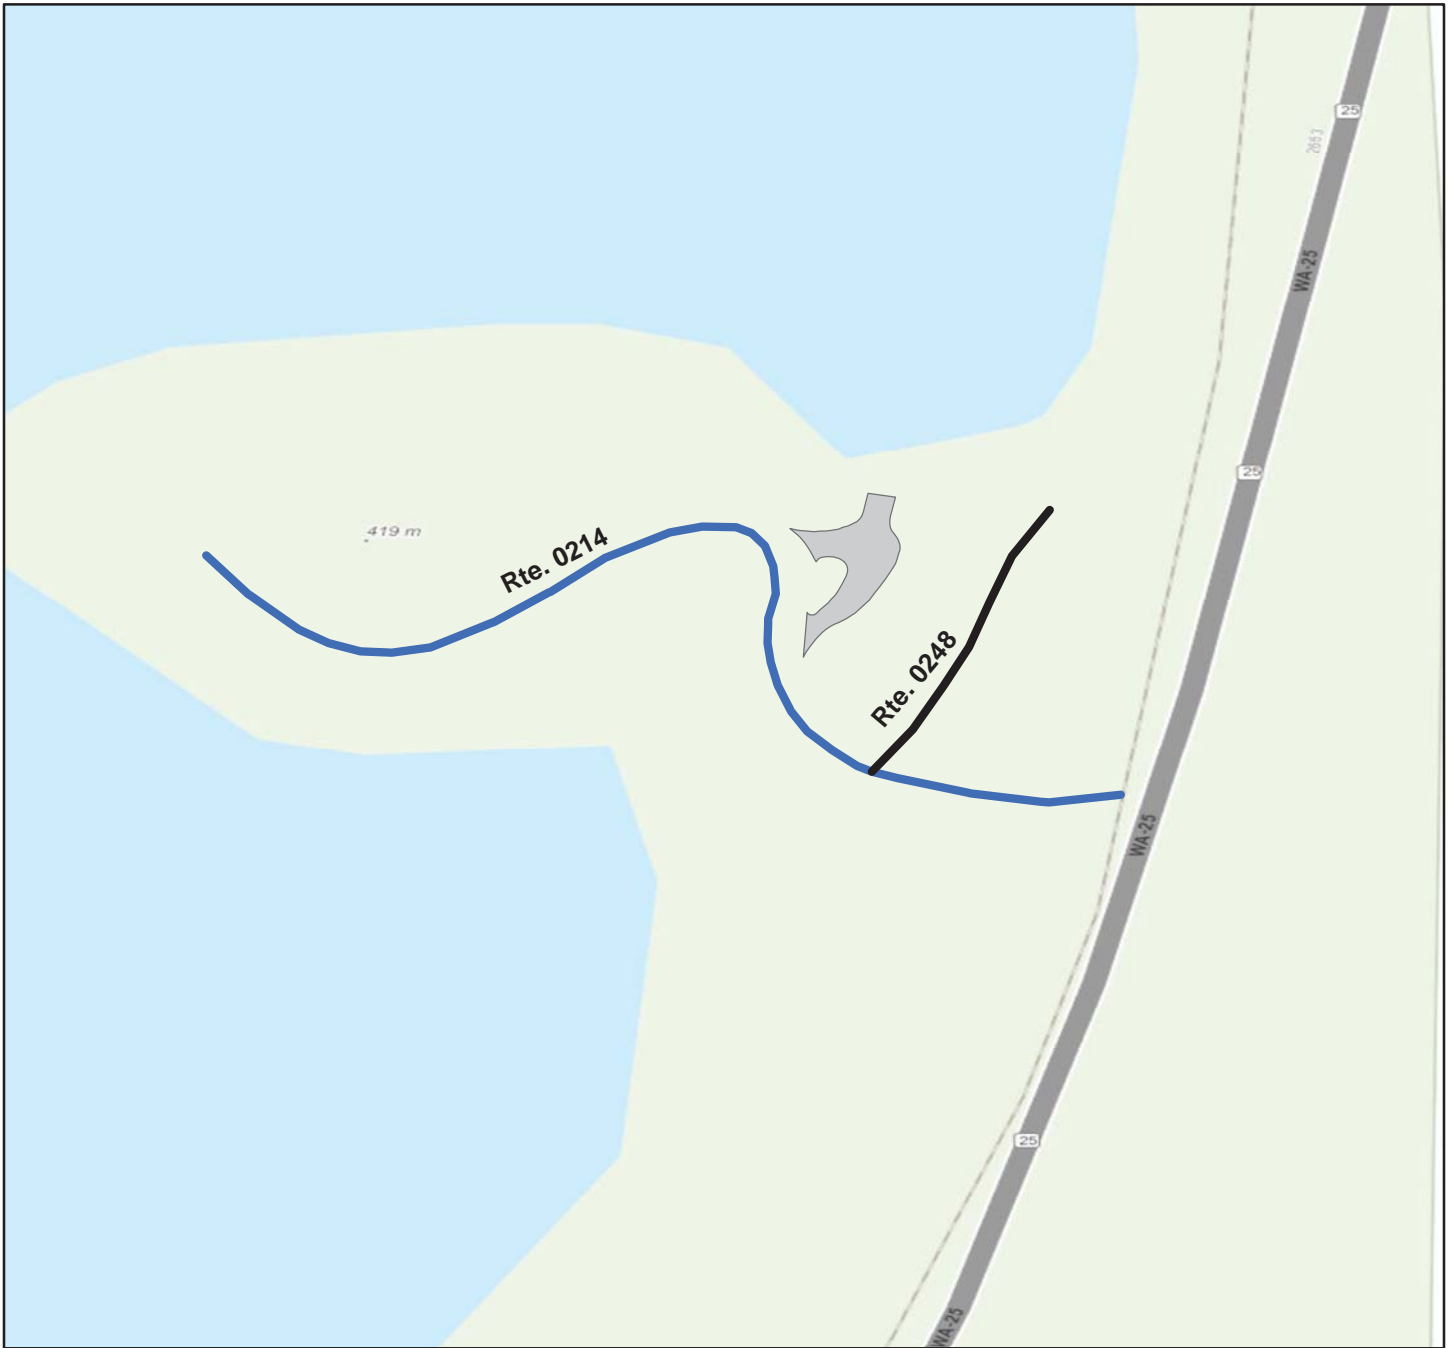
Map 1A

ROUTE CONDITION MAP

PCR - MILE BY MILE

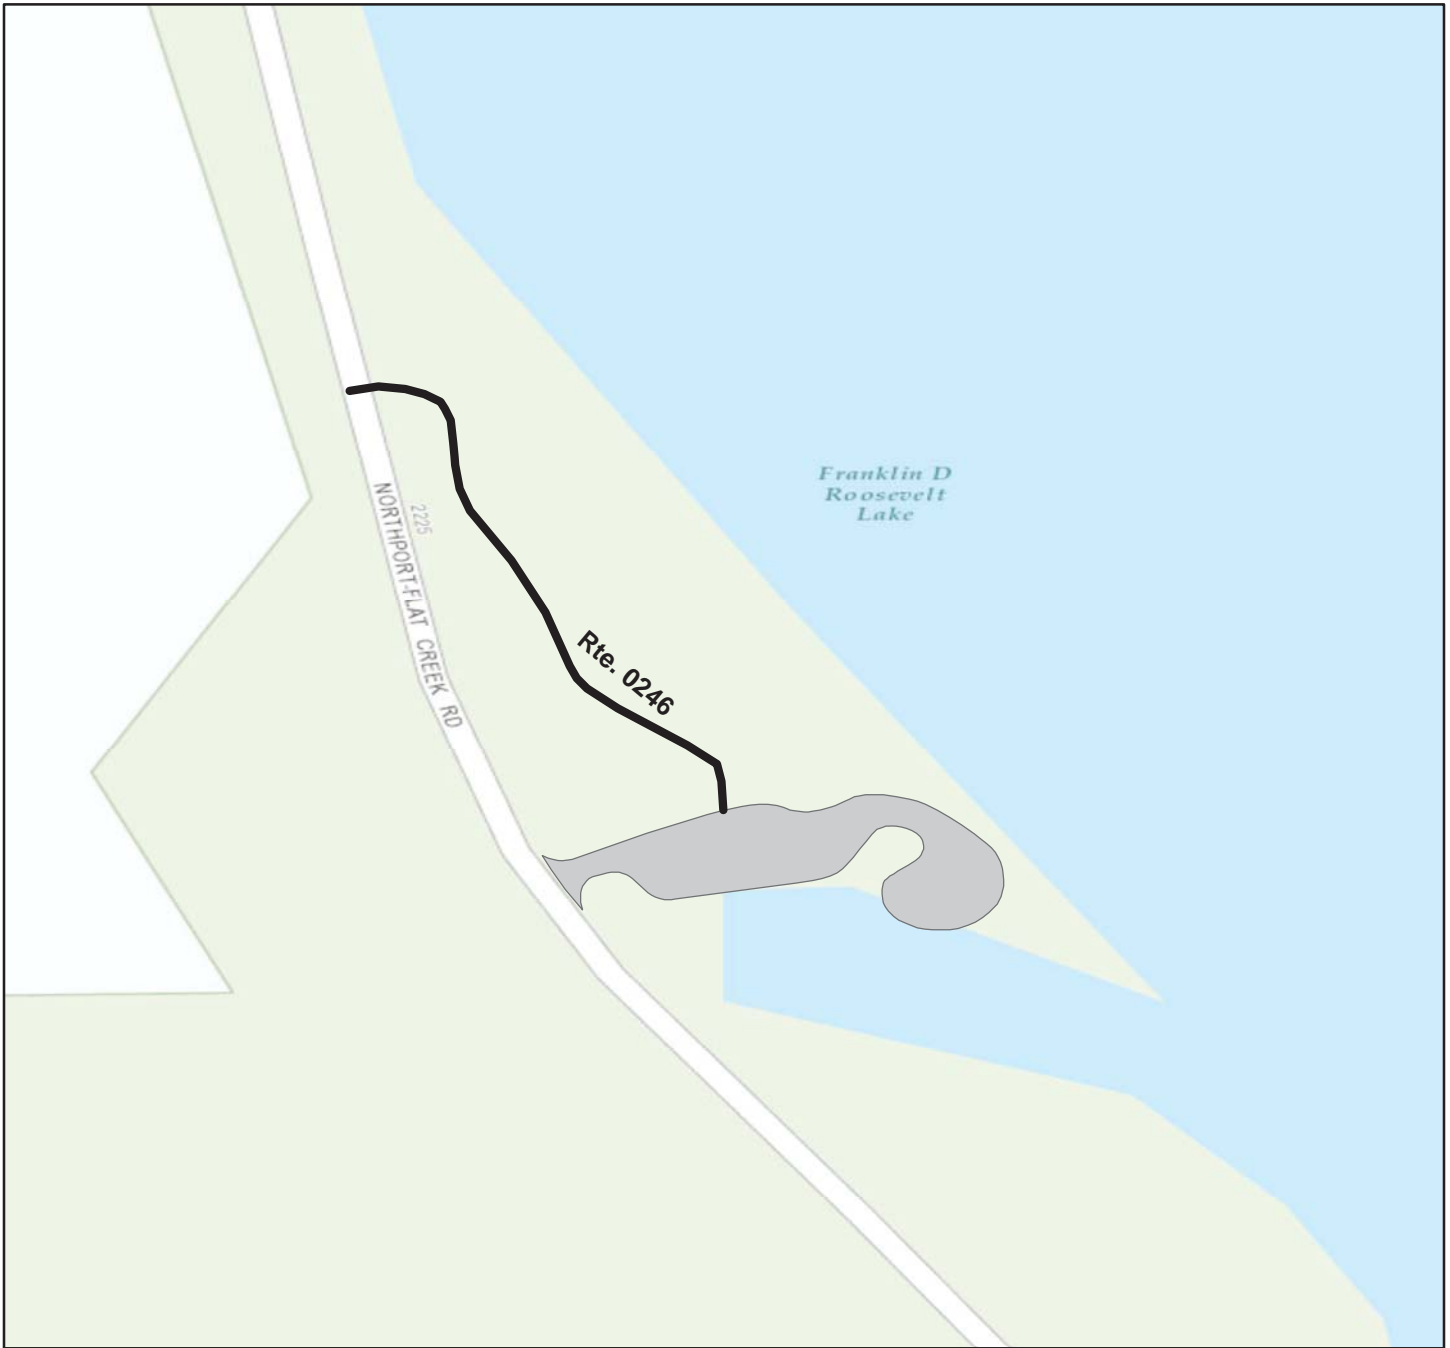
Map 1B

ROUTE CONDITION MAP

PCR - MILE BY MILE

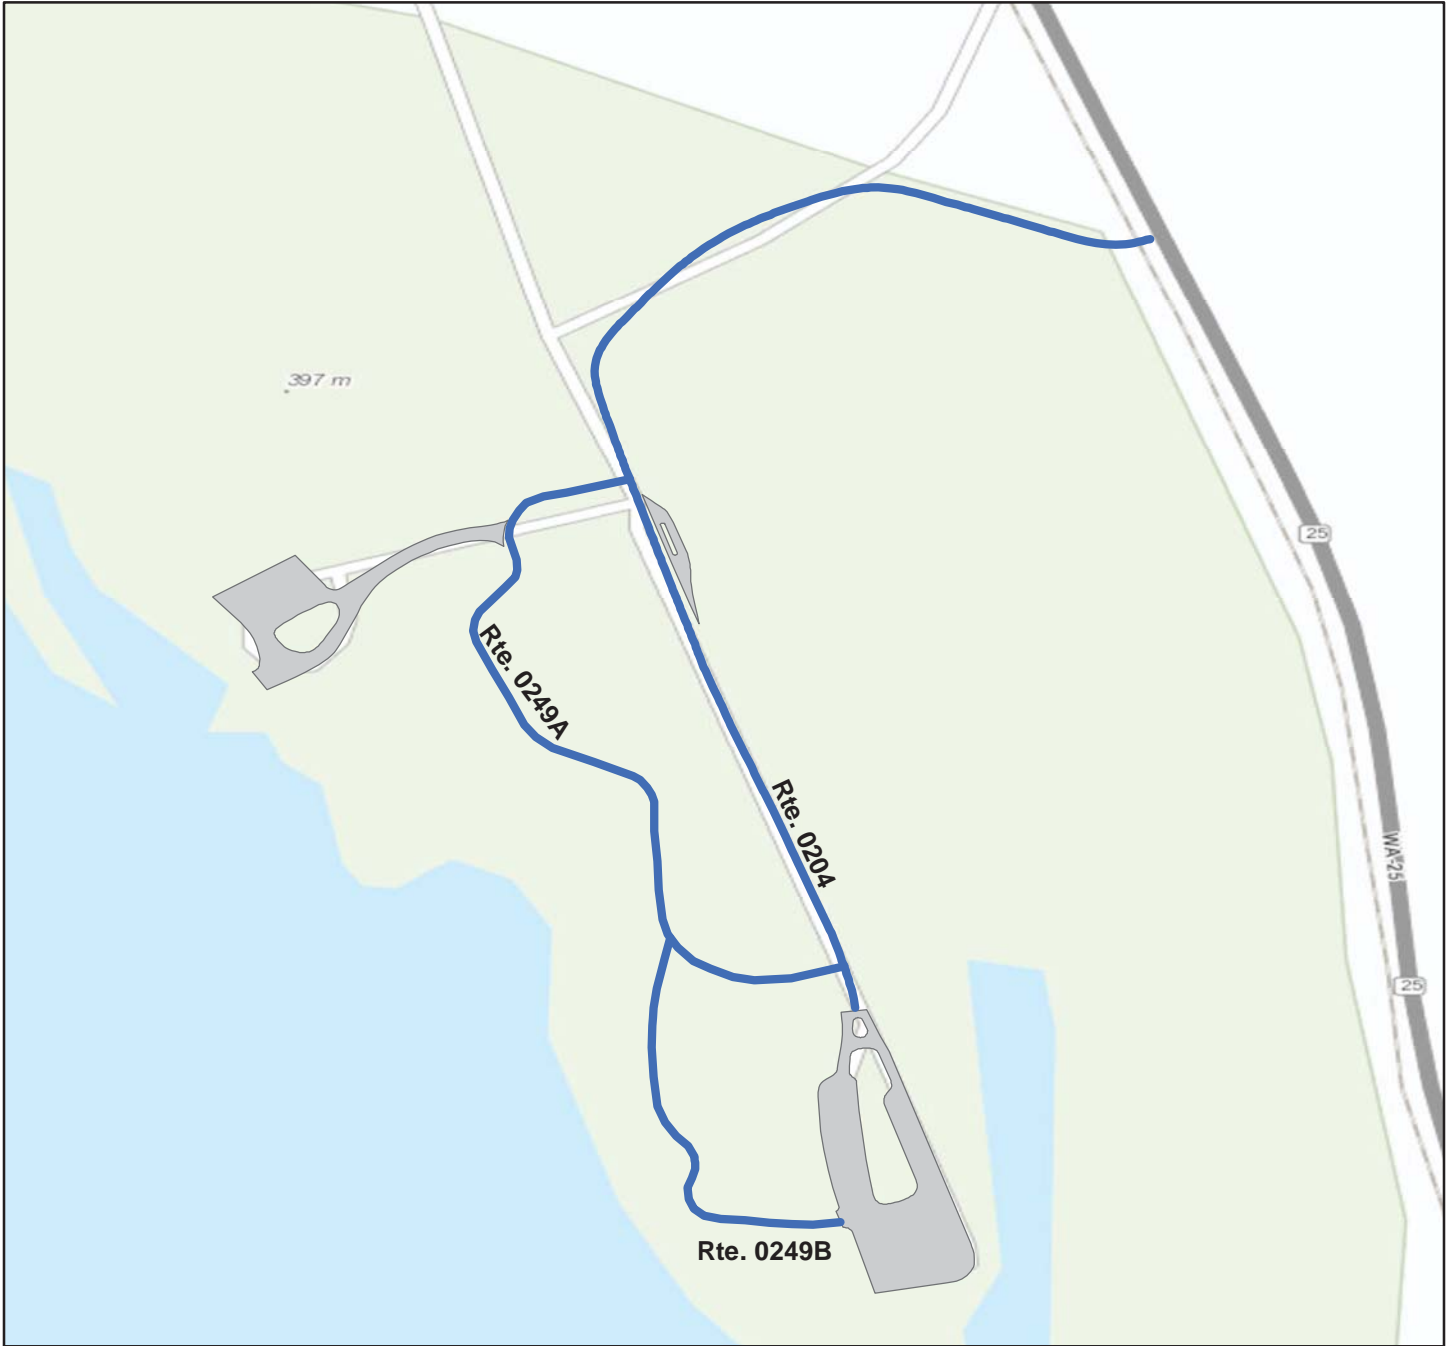
Map 1C

ROUTE CONDITION MAP

PCR - MILE BY MILE

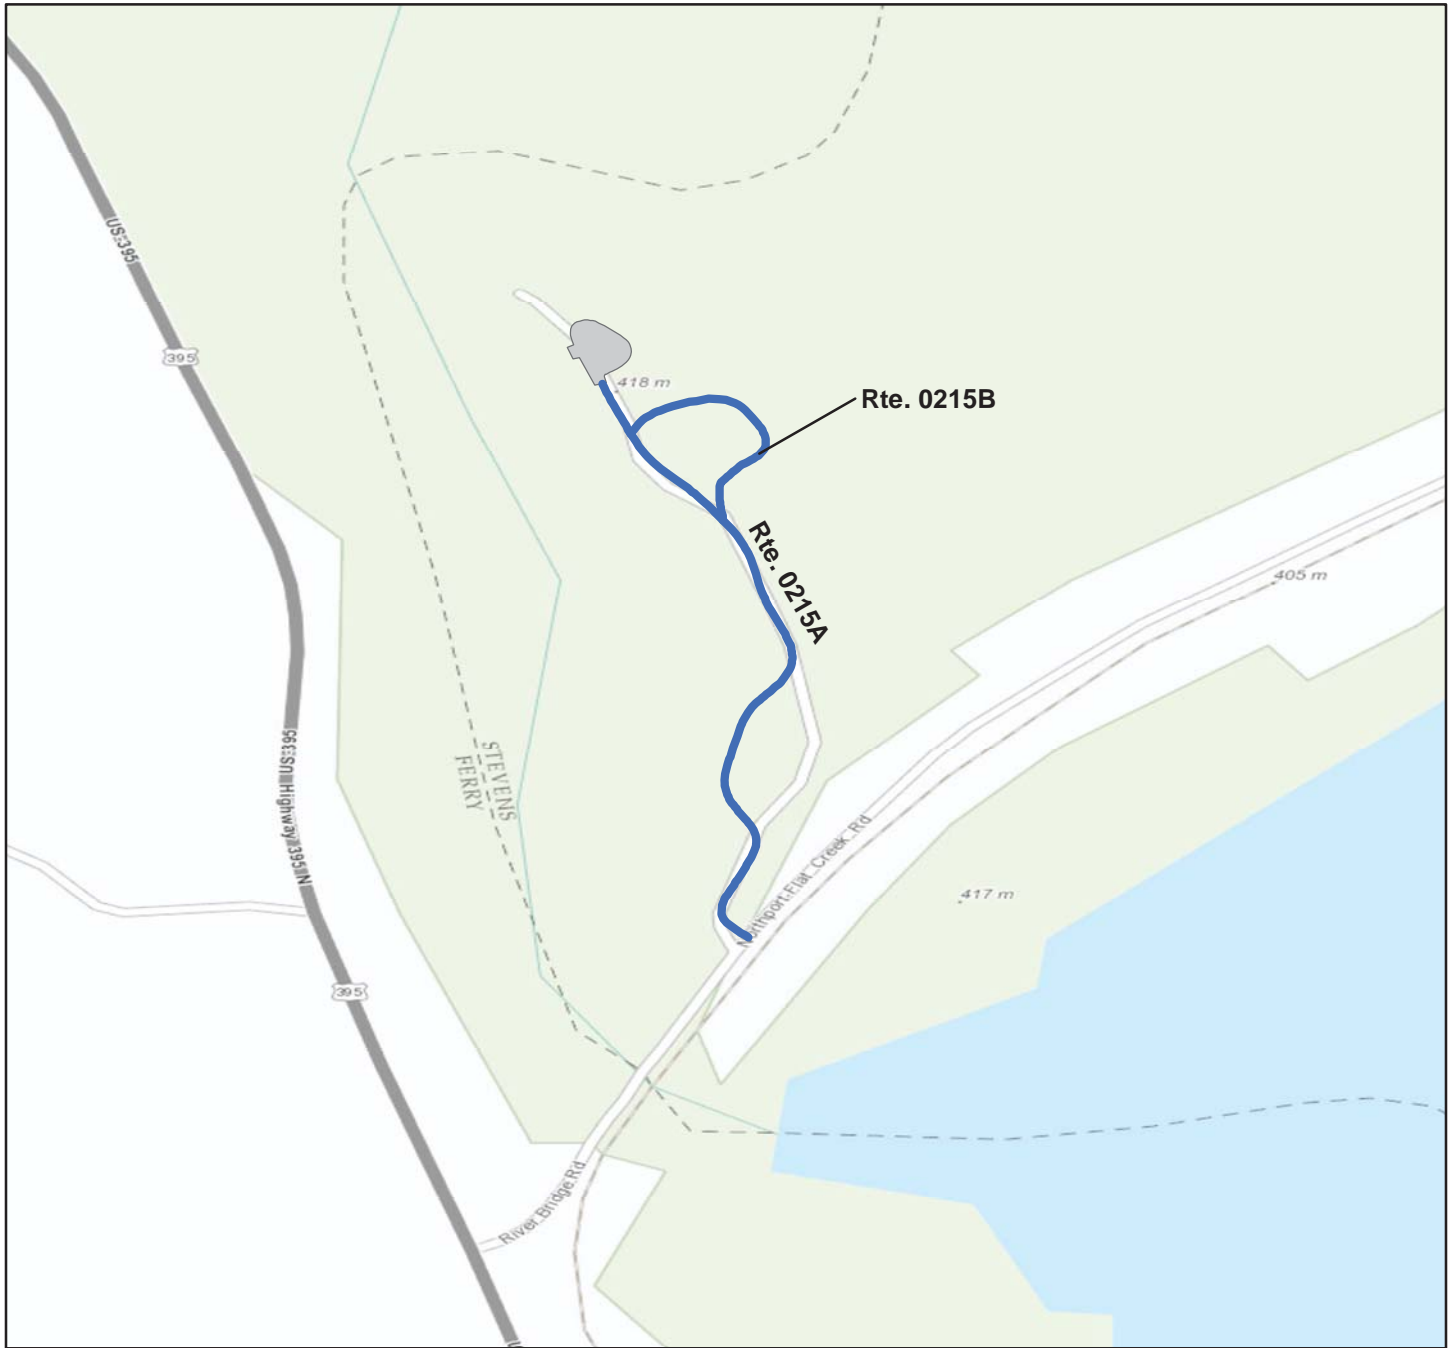
Map 1D

ROUTE CONDITION MAP

PCR - MILE BY MILE

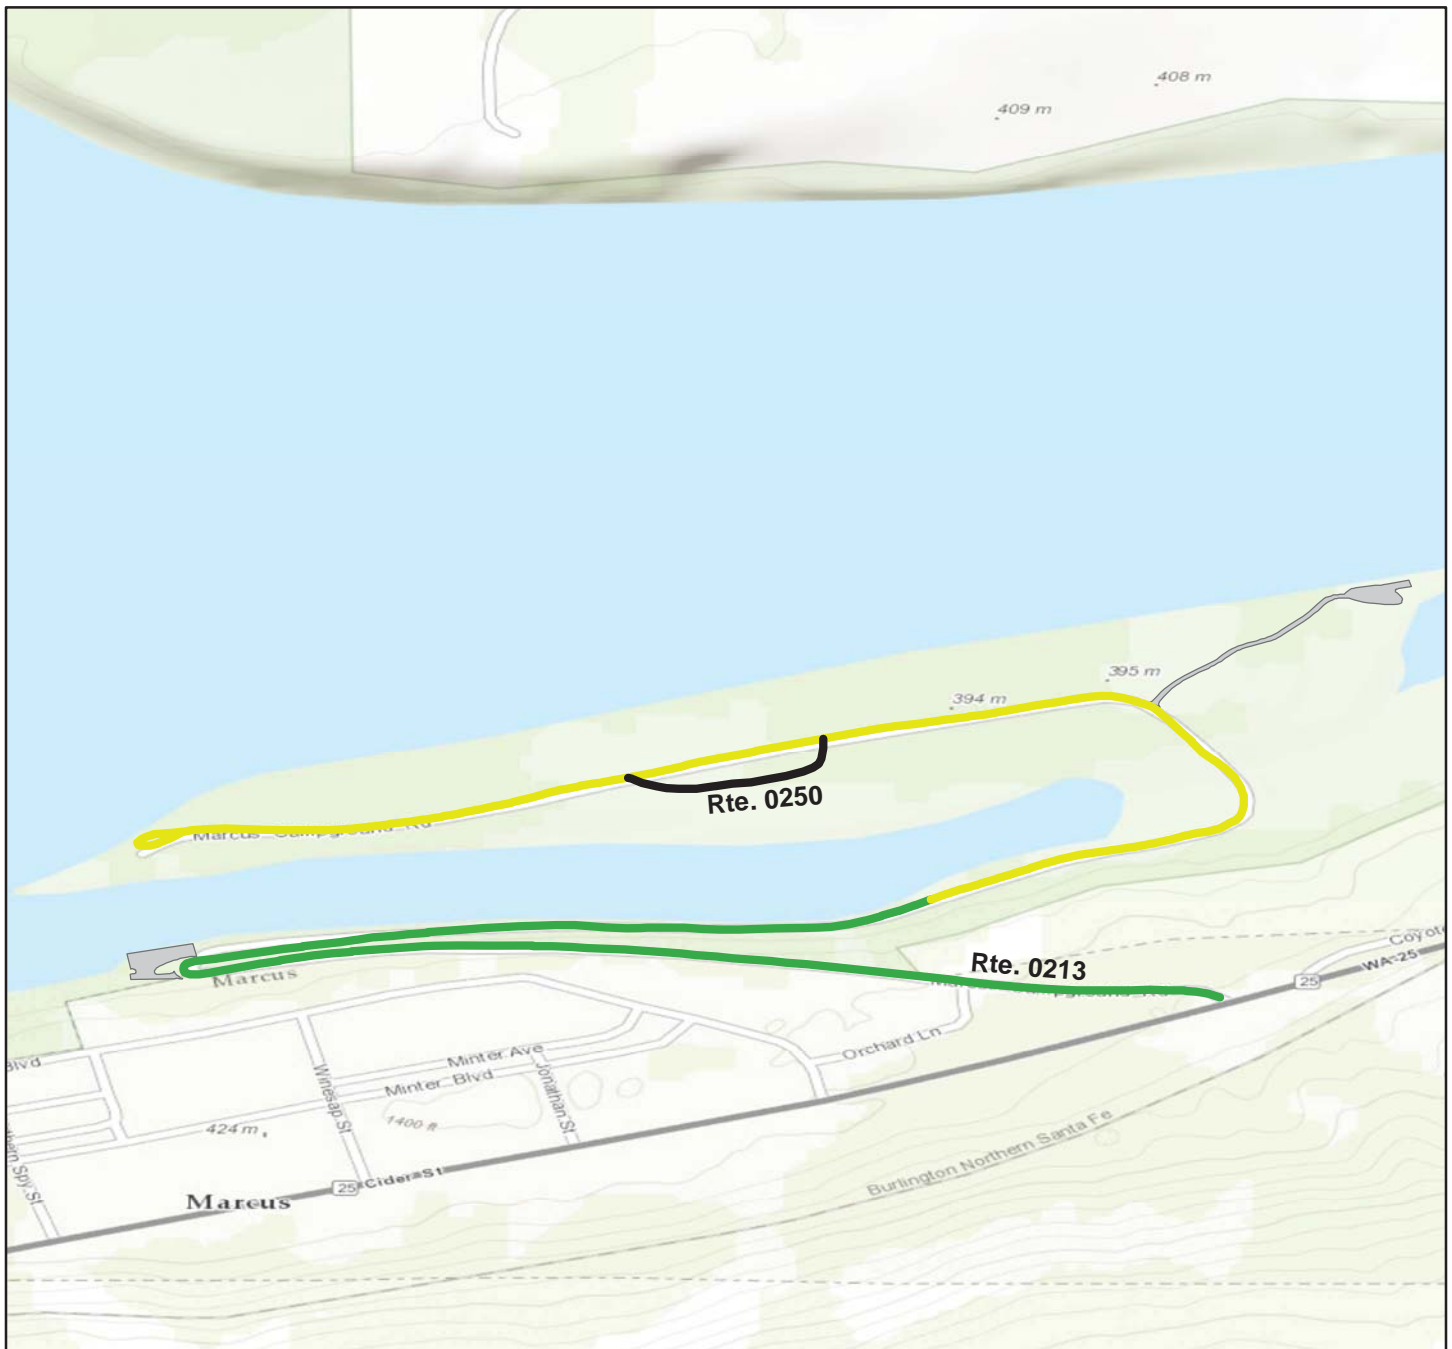
Map 1E

ROUTE CONDITION MAP

PCR - MILE BY MILE

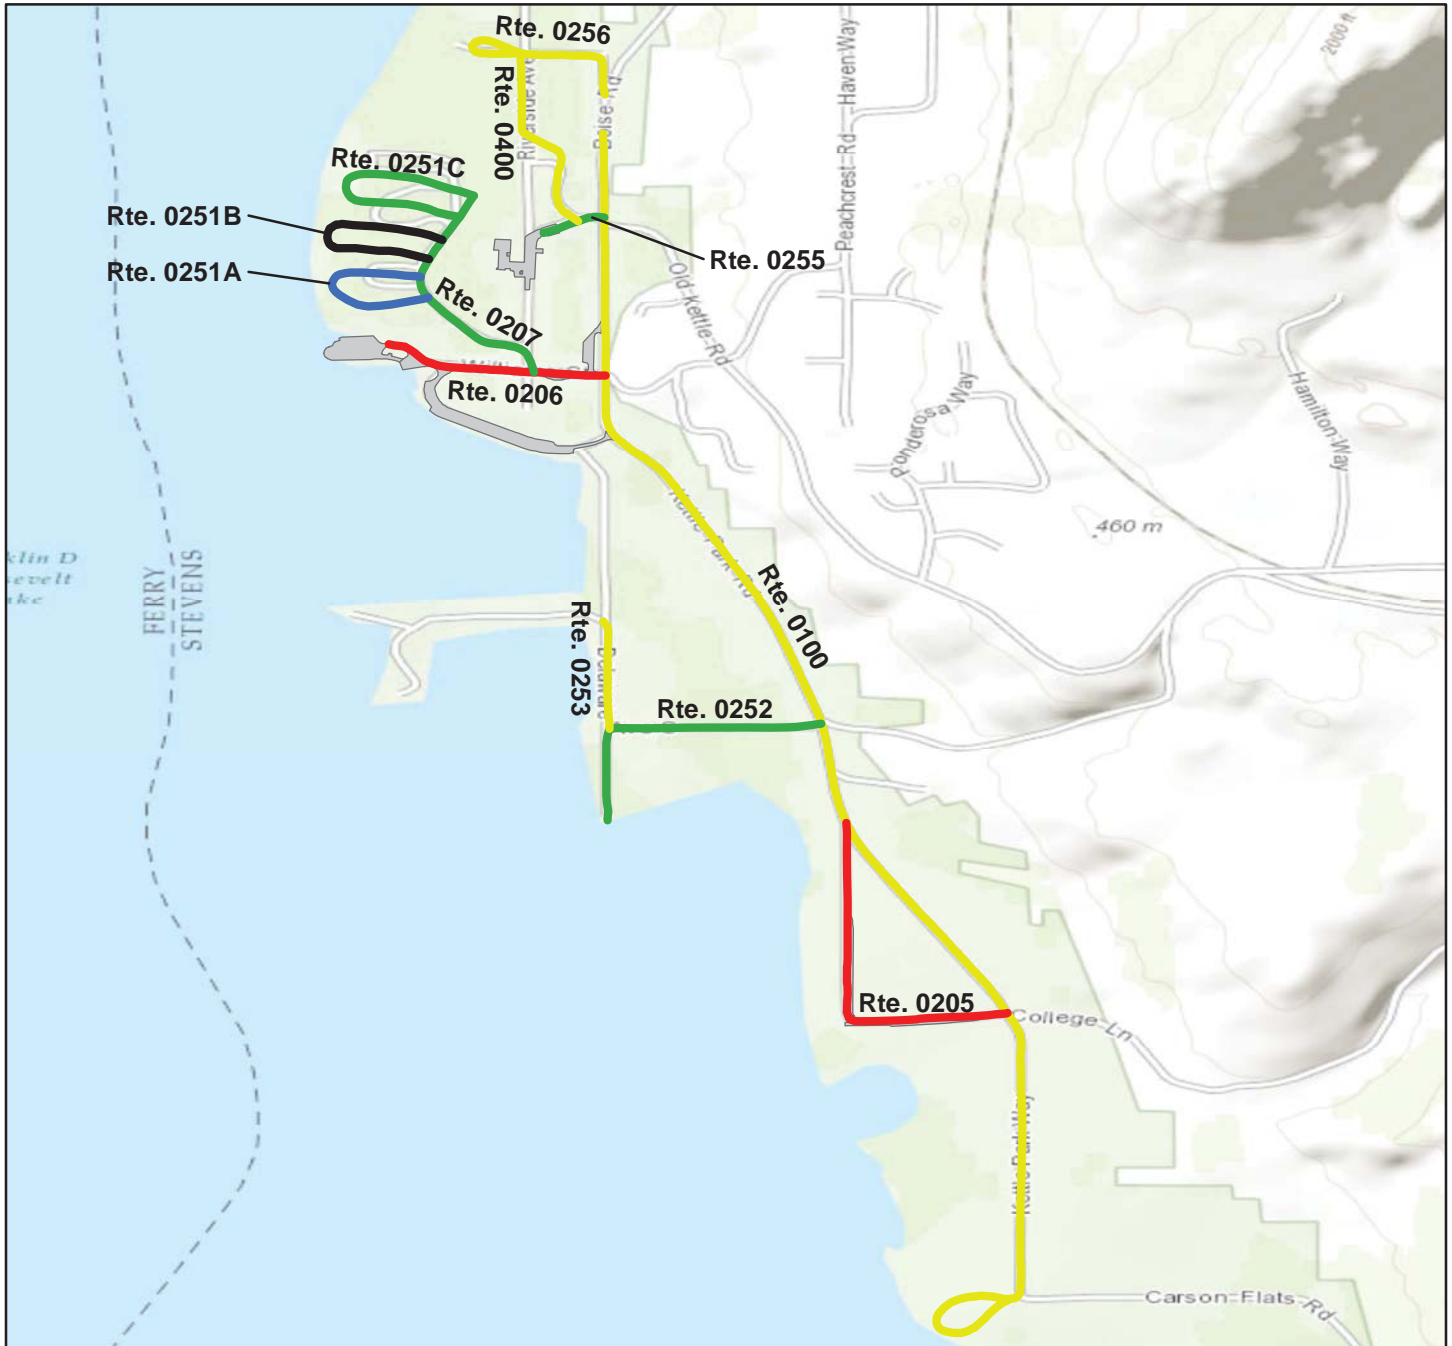
Map 1F

ROUTE CONDITION MAP

PCR - MILE BY MILE

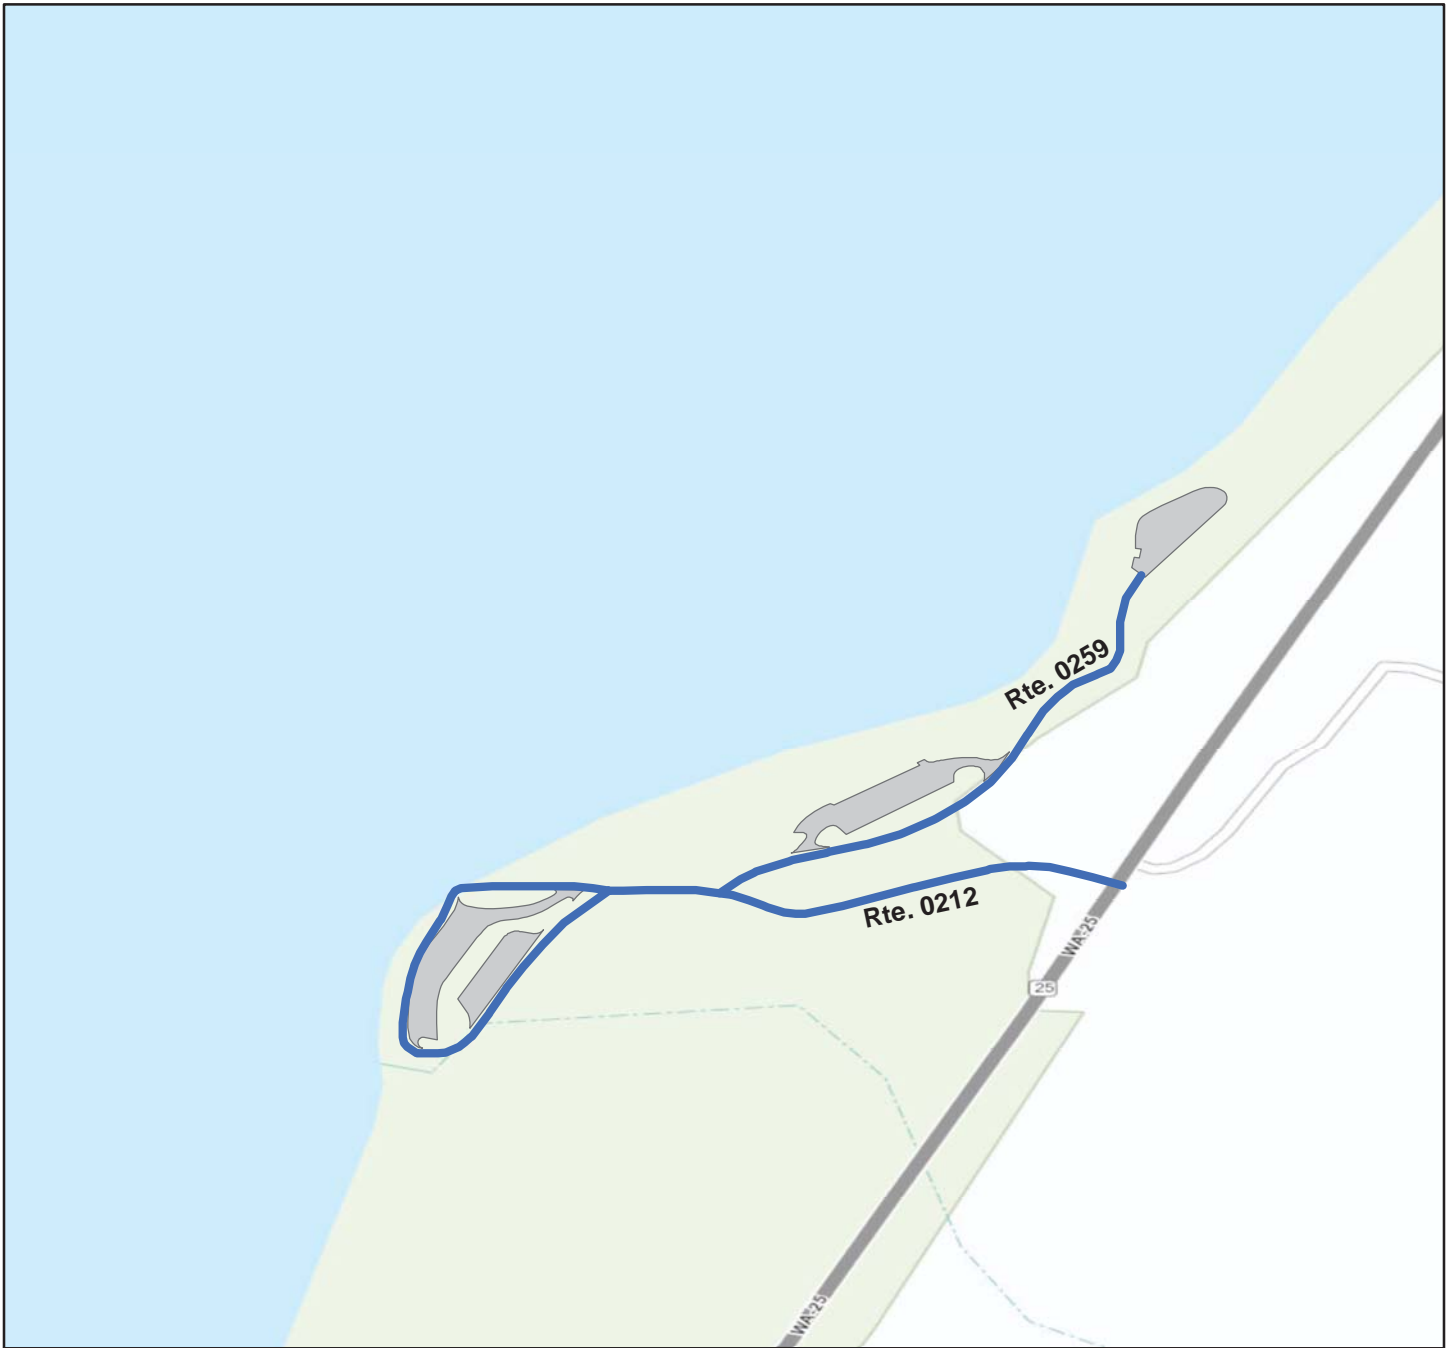
Map 1G

ROUTE CONDITION MAP

PCR - MILE BY MILE

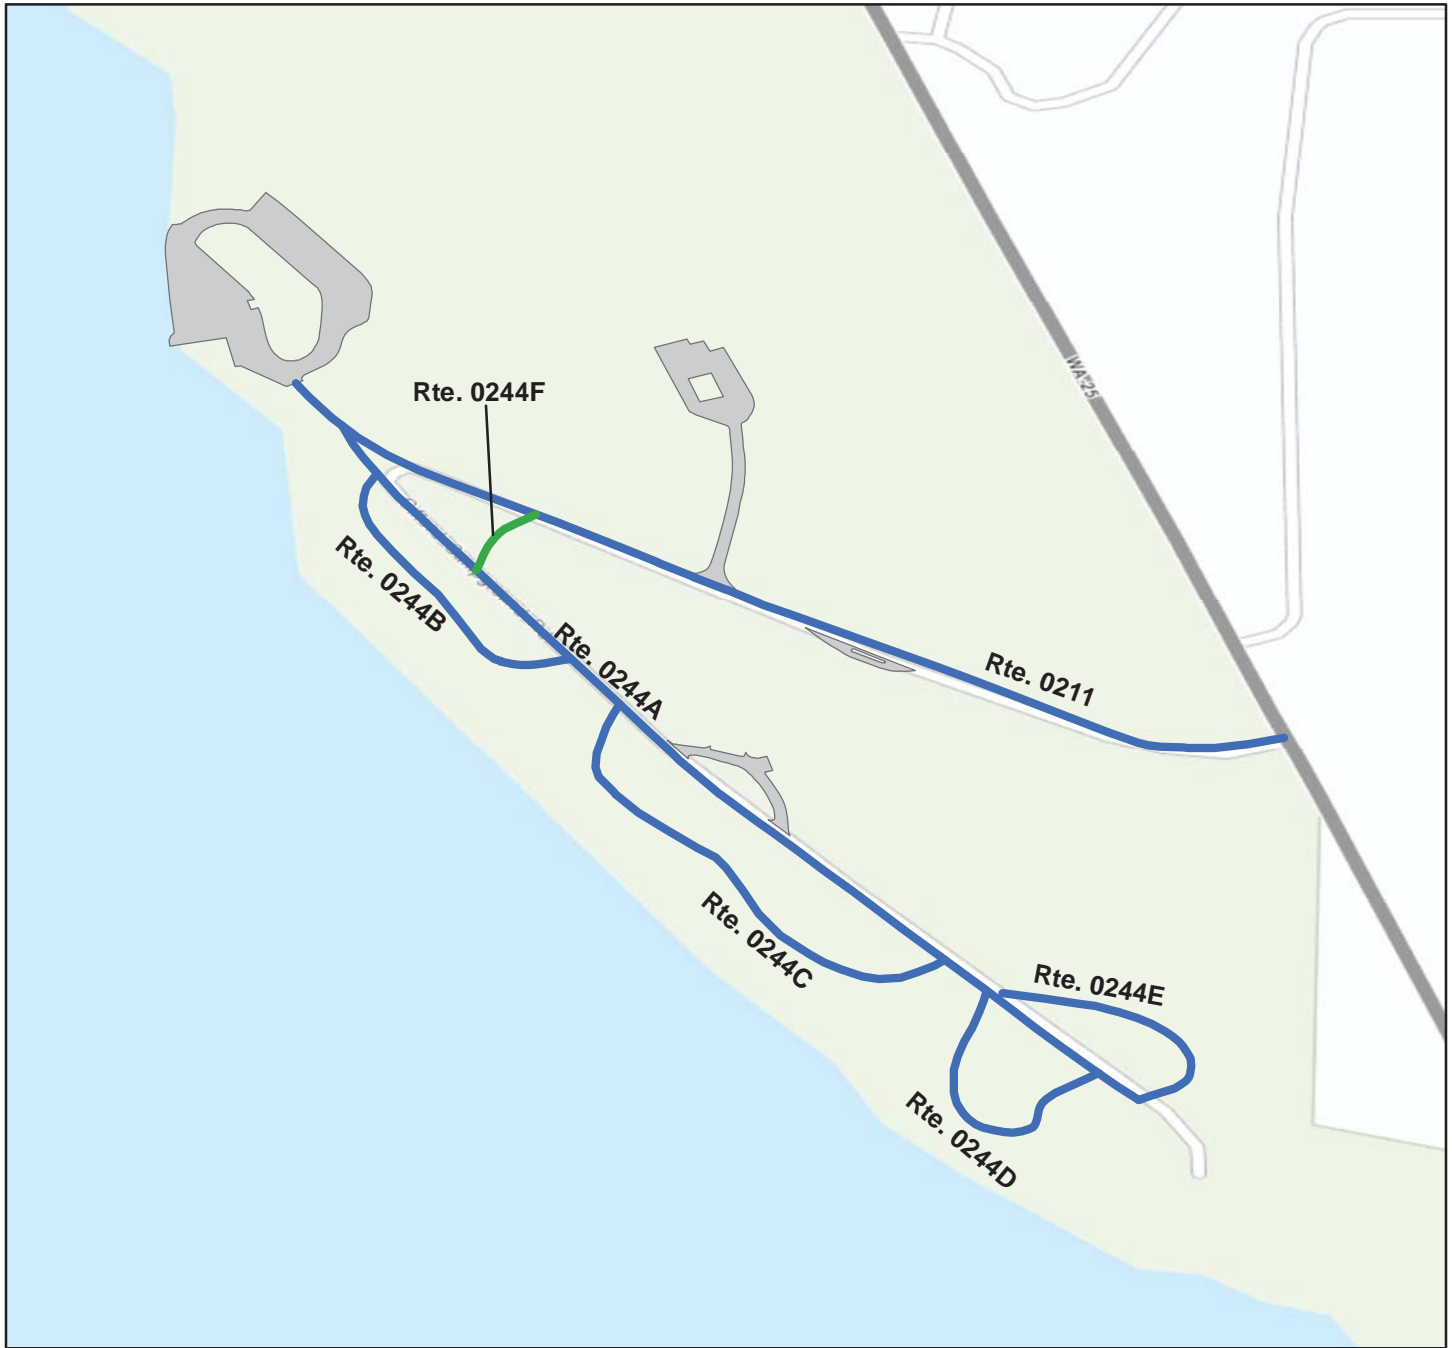
Map 2B

ROUTE CONDITION MAP

PCR - MILE BY MILE

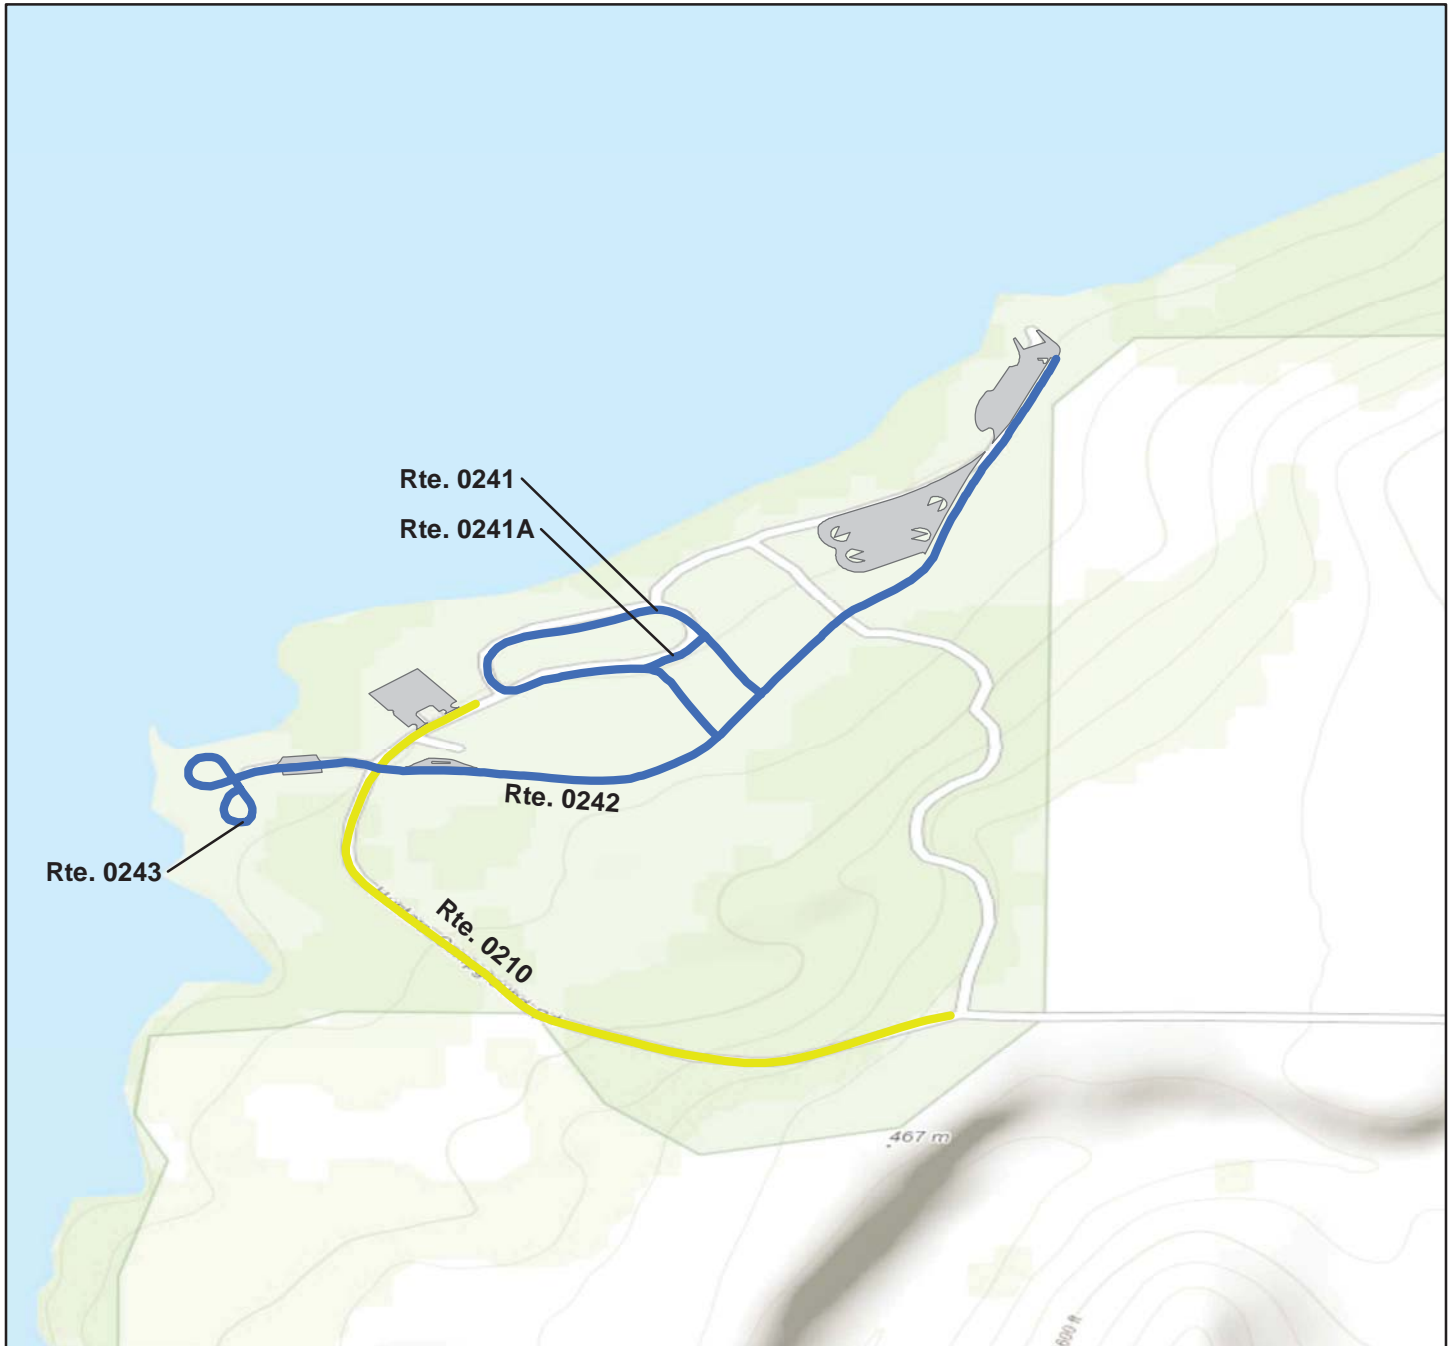
Map 3

ROUTE CONDITION MAP

PCR - MILE BY MILE

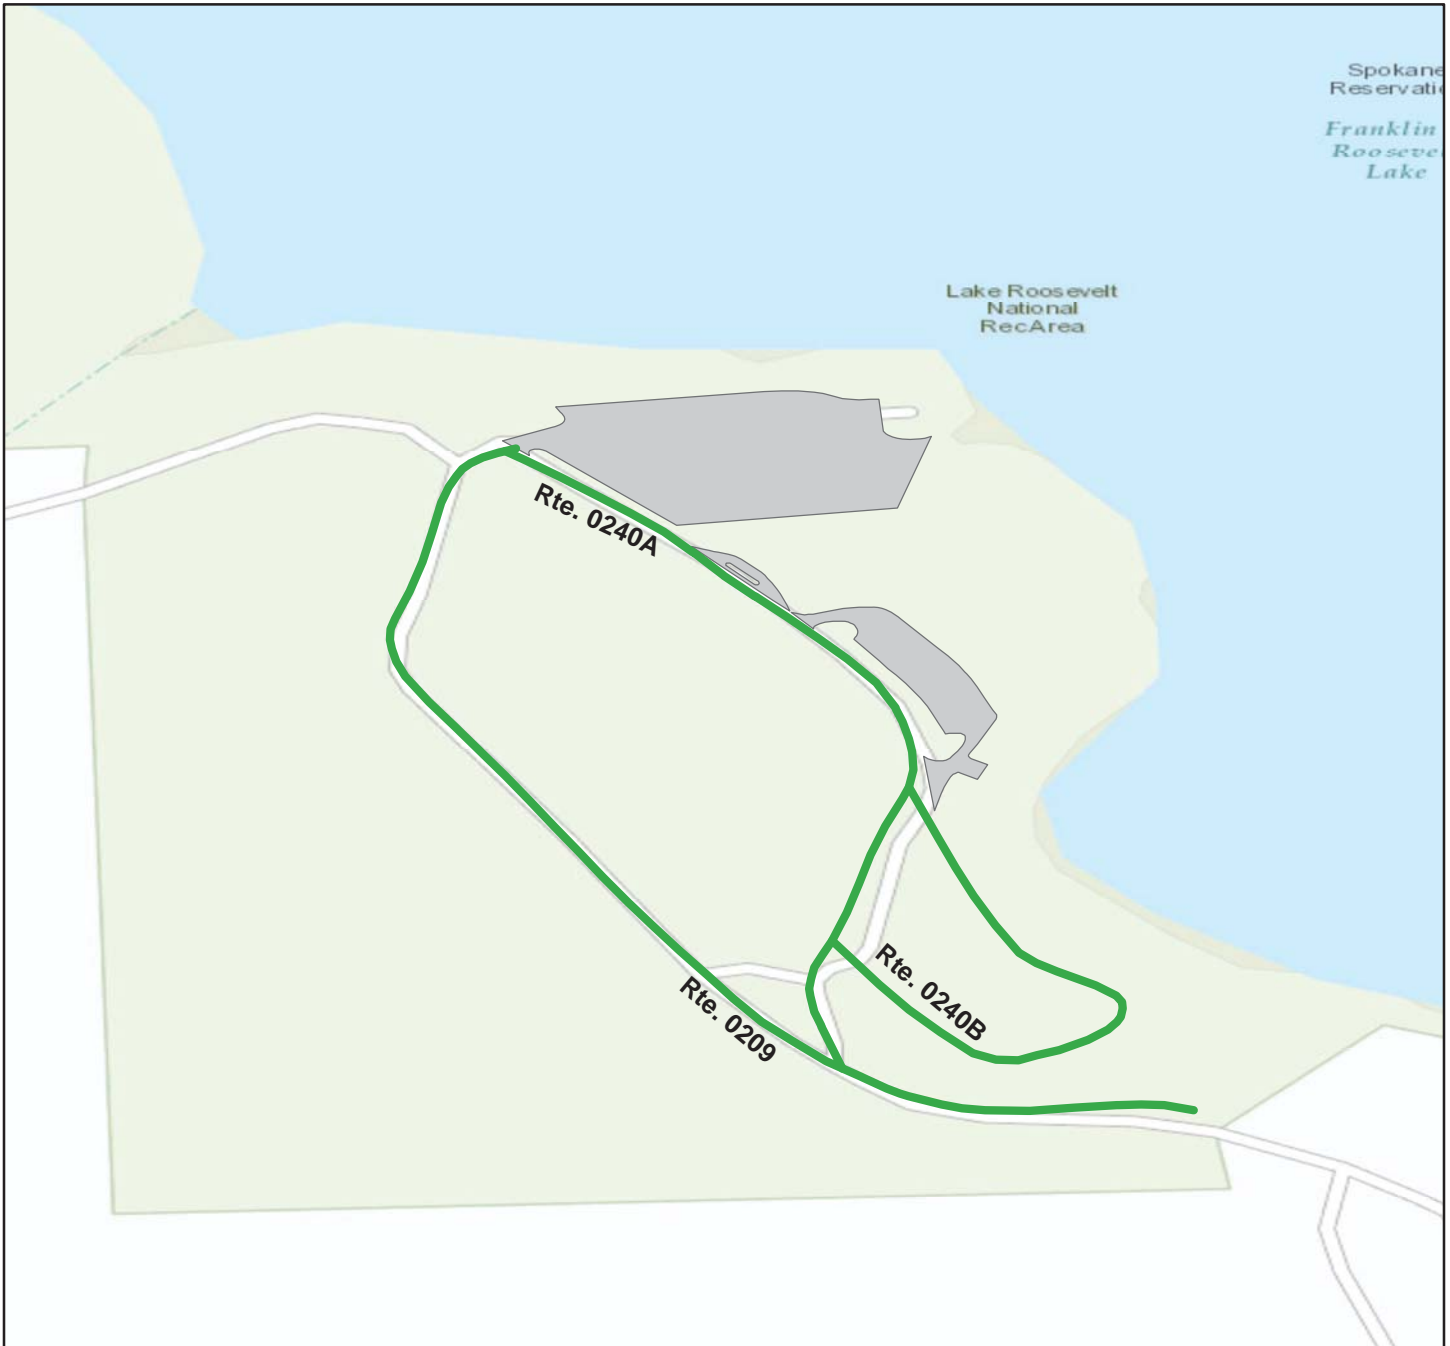
Map 4A

ROUTE CONDITION MAP

PCR - MILE BY MILE

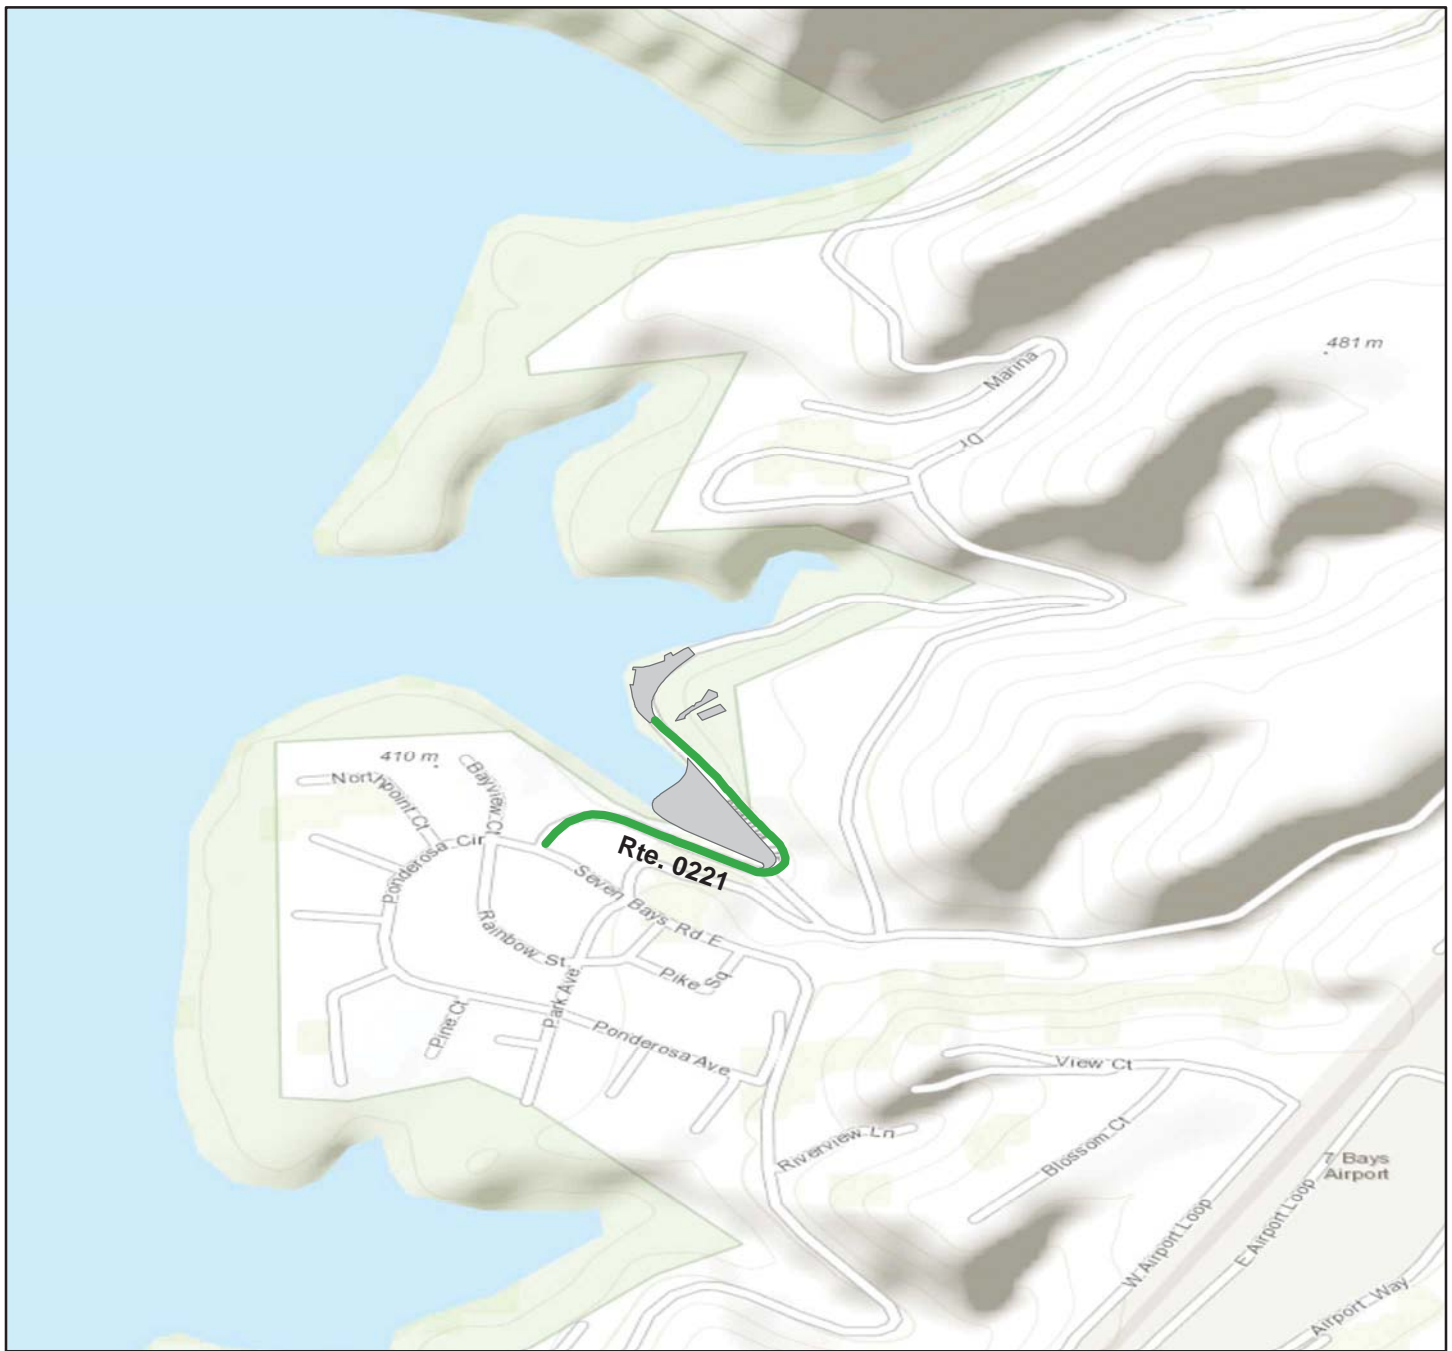
Map 4C

ROUTE CONDITION MAP

PCR - MILE BY MILE
