LARO Cycle 6

Final Report

Road Inventory and Condition Assessment of Paved Routes Lake Roosevelt National Recreation Area

**Federal Highway Administration
Eastern Federal Lands Highway Division
Road Inventory Program (RIP)**

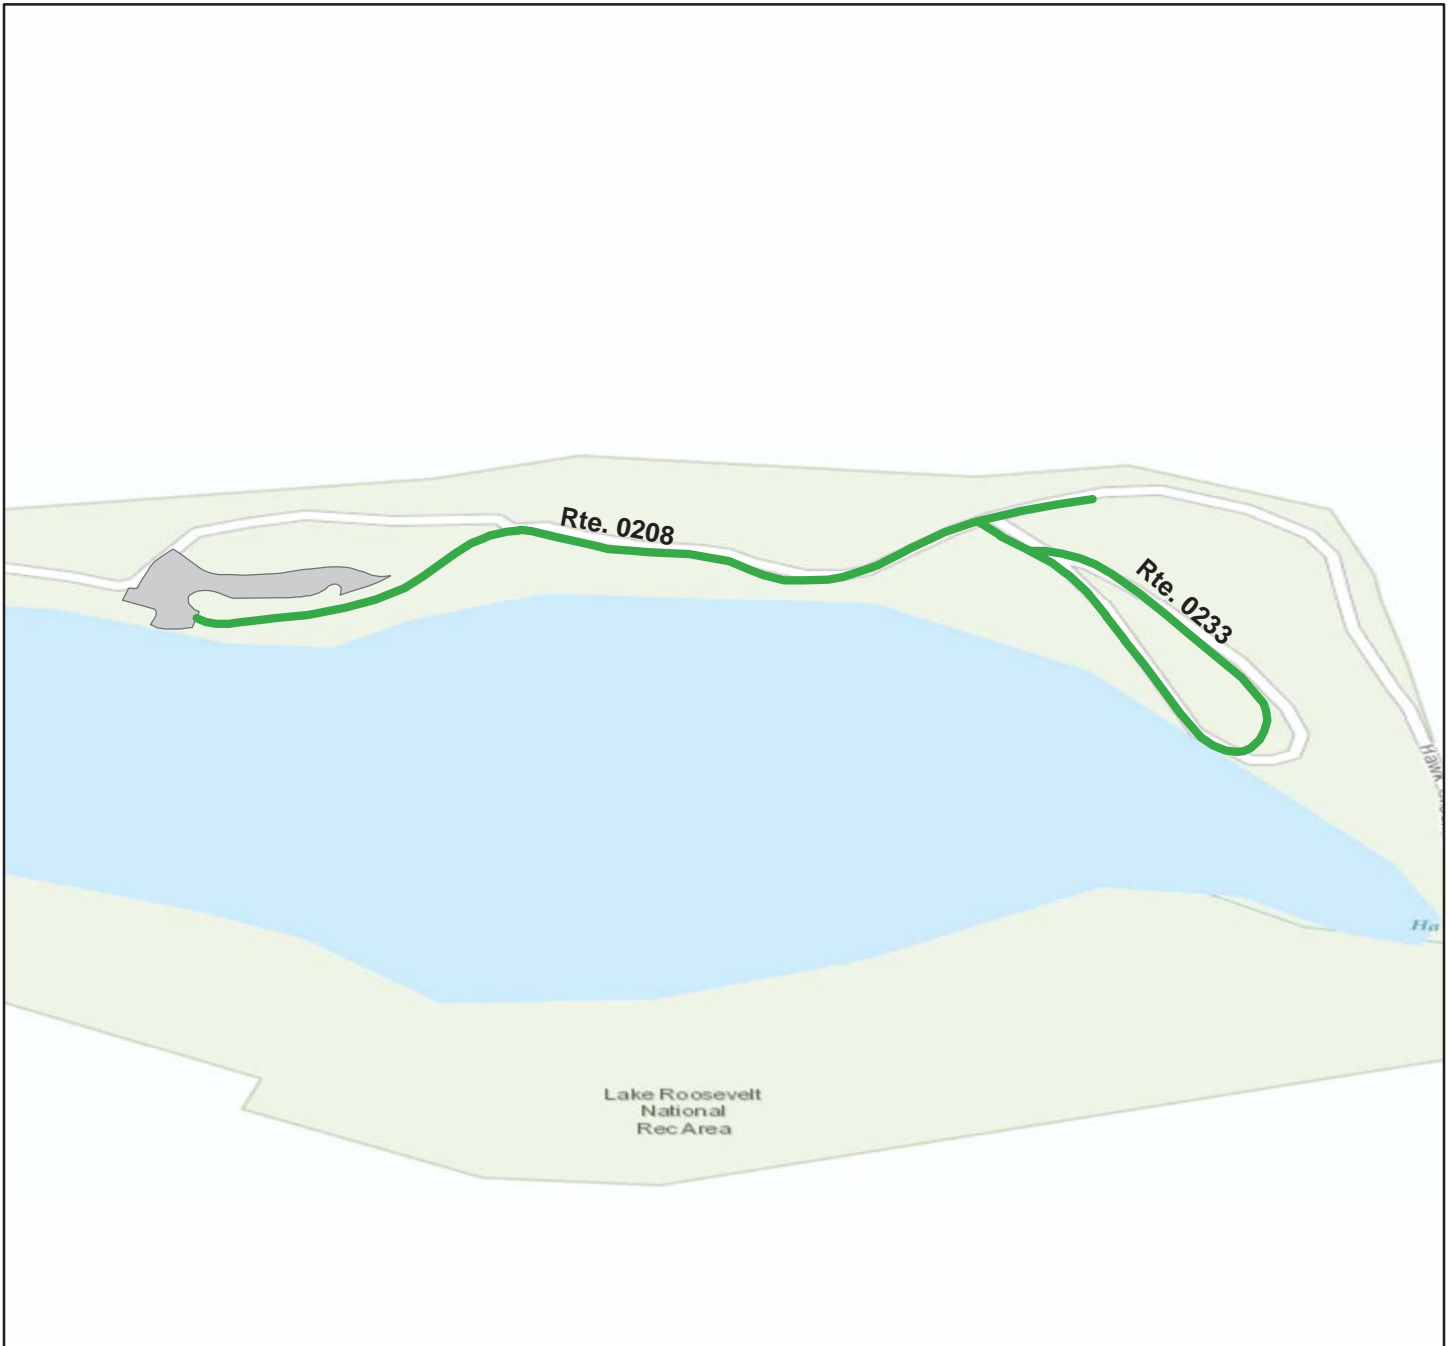
Map 4D

ROUTE CONDITION MAP

PCR - MILE BY MILE

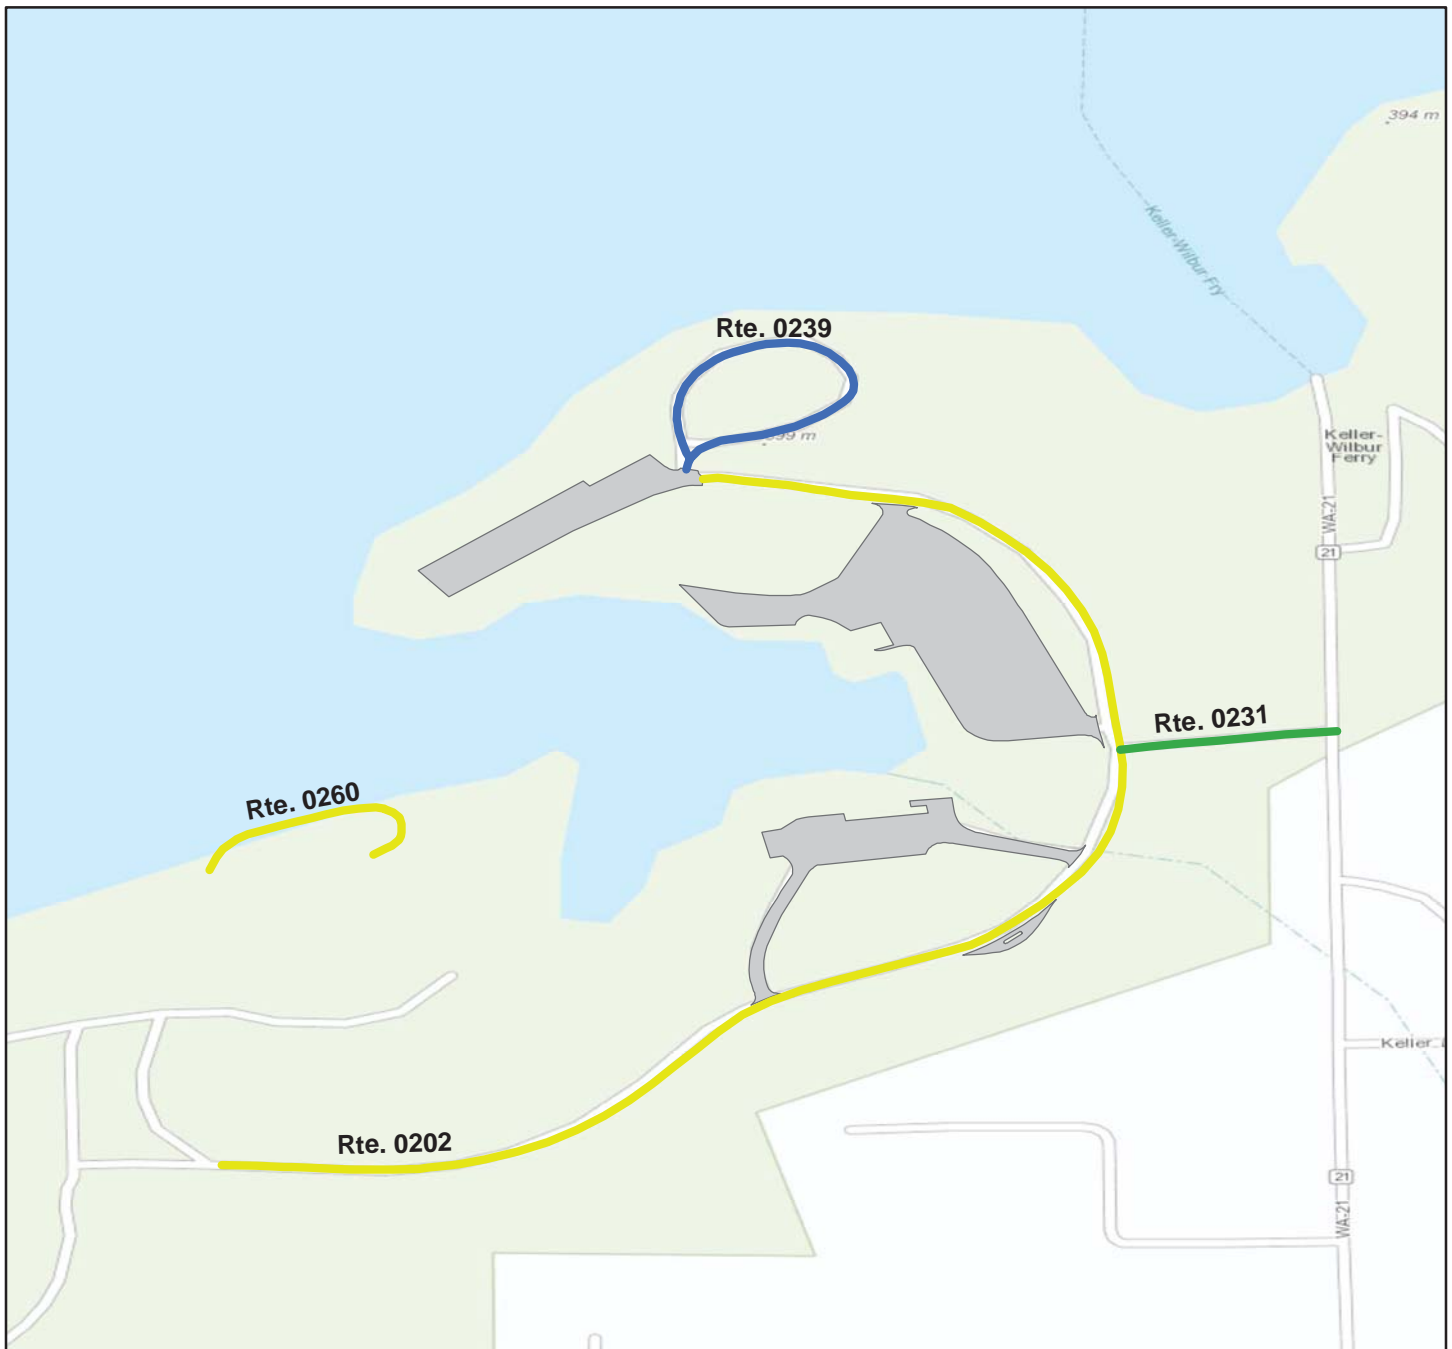
Map 5A

ROUTE CONDITION MAP

PCR - MILE BY MILE

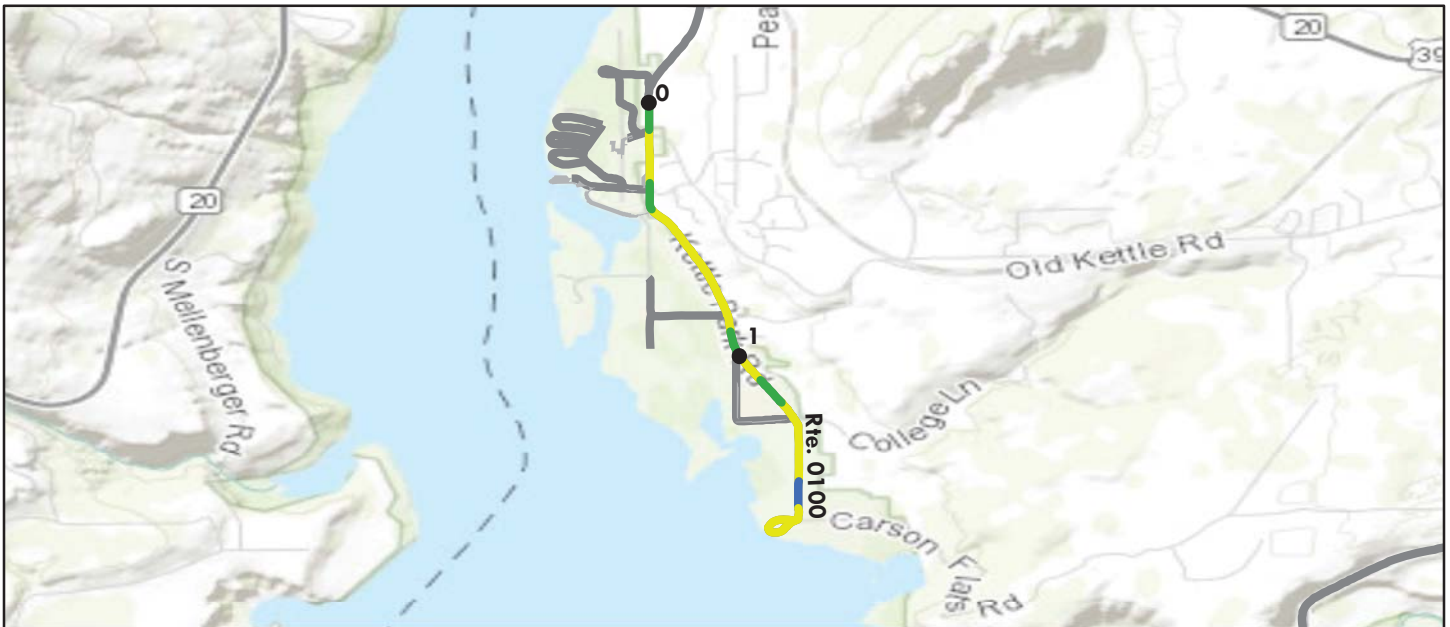
ROUTE 0100: KETTLE FALLS ENTRANCE ROAD

Data Collection Vehicle (DCV) Rating

Route Condition Legend – Pavement Condition Rating (PCR)						
Poor (0 - 60)	Fair (61- 84)	Good (85 - 94)	Excellent (95 - 100)	Not Rated		
See Appendix for definitions and formulas						
Inspection Date: 10/2/2015	Beginning Section MP	0	1			
Paved Length (Miles): 1.81	Section Length (MI)	1	0.81			
Surface Type: ASPHALT	Route Summary					
Roadway Condition Information						
Pavement Condition Rating (PCR)	82	81	80			
Surface Condition Rating (SCR)	92	92	89			
Roughness Condition Index (RCI)	66	65	67			
Distress Index Values						
Structural Crack Index	95	100	89			
Alligator Crack Index	99	100	98			
Longitudinal Crack Index	96	100	91			
Transverse Cracking Index	98	99	98			
Patching Index	100	100	99			
Rutting Index	92	92	91			
International Roughness Index (IRI)	217	220	214			
Lane & Width Information						
Number of Lanes	2	2	2			
Paved Width (ft)	19.6	20.9	18.4			
Lane Width (ft)	10.2	10.3	10

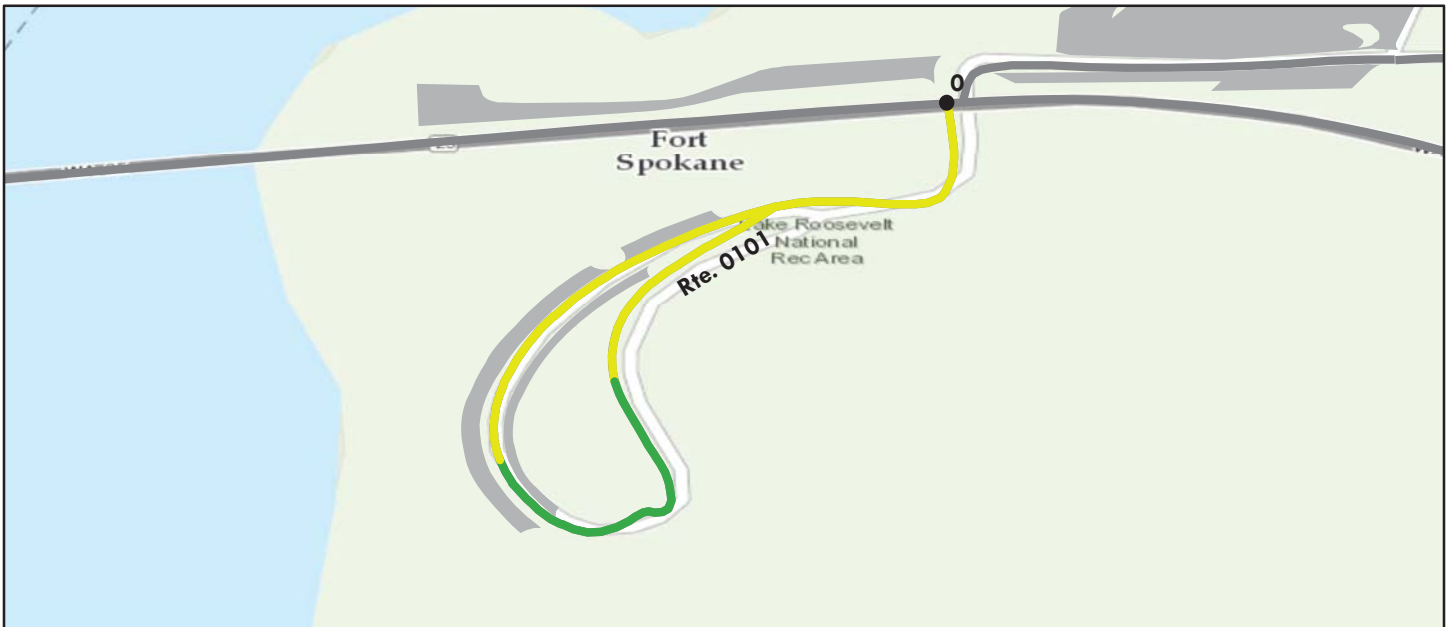
ROUTE 0101: FORT SPOKANE PICNIC AREA LOOP ROAD

Data Collection Vehicle (DCV) Rating

Route Condition Legend – Pavement Condition Rating (PCR)						
Poor (0 - 60)	Fair (61- 84)	Good (85 - 94)	Excellent (95 - 100)	Not Rated		
See Appendix for definitions and formulas						
Inspection Date:	10/1/2015	Beginning Section MP	0			
Paved Length (Miles):	0.38	Section Length (MI)	0.38			
Surface Type:	ASPHALT	Route Summary				
Roadway Condition Information						
Pavement Condition Rating (PCR)	77	77				
Surface Condition Rating (SCR)	77	77				
Roughness Condition Index (RCI)	N/A	N/A				
Distress Index Values						
Structural Crack Index	91	91				
Alligator Crack Index	100	100				
Longitudinal Crack Index	91	91				
Transverse Cracking Index	77	77				
Patching Index	100	100				
Rutting Index	95	95				
International Roughness Index (IRI)	N/A	N/A				
Lane & Width Information						
Number of Lanes	1	1				
Paved Width (ft)	20	20				
Lane Width (ft)	17.3	17.3

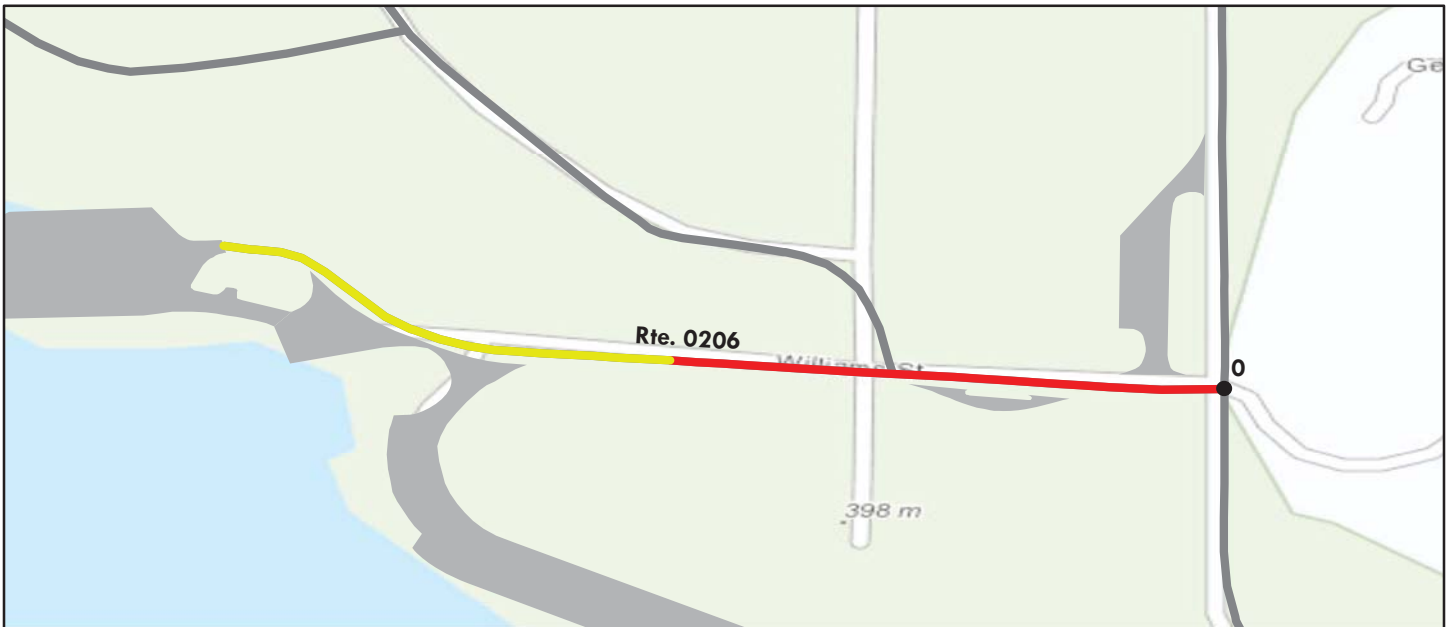
ROUTE 0206: KETTLE FALLS MARINA ACCESS ROAD

Data Collection Vehicle (DCV) Rating

Route Condition Legend – Pavement Condition Rating (PCR)						
Poor (0 - 60)	Fair (61- 84)	Good (85 - 94)	Excellent (95 - 100)	Not Rated		
See Appendix for definitions and formulas						
Inspection Date: 10/2/2015	Beginning Section MP	0				
Paved Length (Miles): 0.2	Section Length (MI)	0.2				
Surface Type: ASPHALT	Route Summary					
Roadway Condition Information						
Pavement Condition Rating (PCR)	52	52				
Surface Condition Rating (SCR)	52	52				
Roughness Condition Index (RCI)	N/A	N/A				
Distress Index Values						
Structural Crack Index	92	92				
Alligator Crack Index	100	100				
Longitudinal Crack Index	92	92				
Transverse Cracking Index	52	52				
Patching Index	100	100				
Rutting Index	95	95				
International Roughness Index (IRI)	N/A	N/A				
Lane & Width Information						
Number of Lanes	2	2				
Paved Width (ft)	38.3	38.3				
Lane Width (ft)	19	19

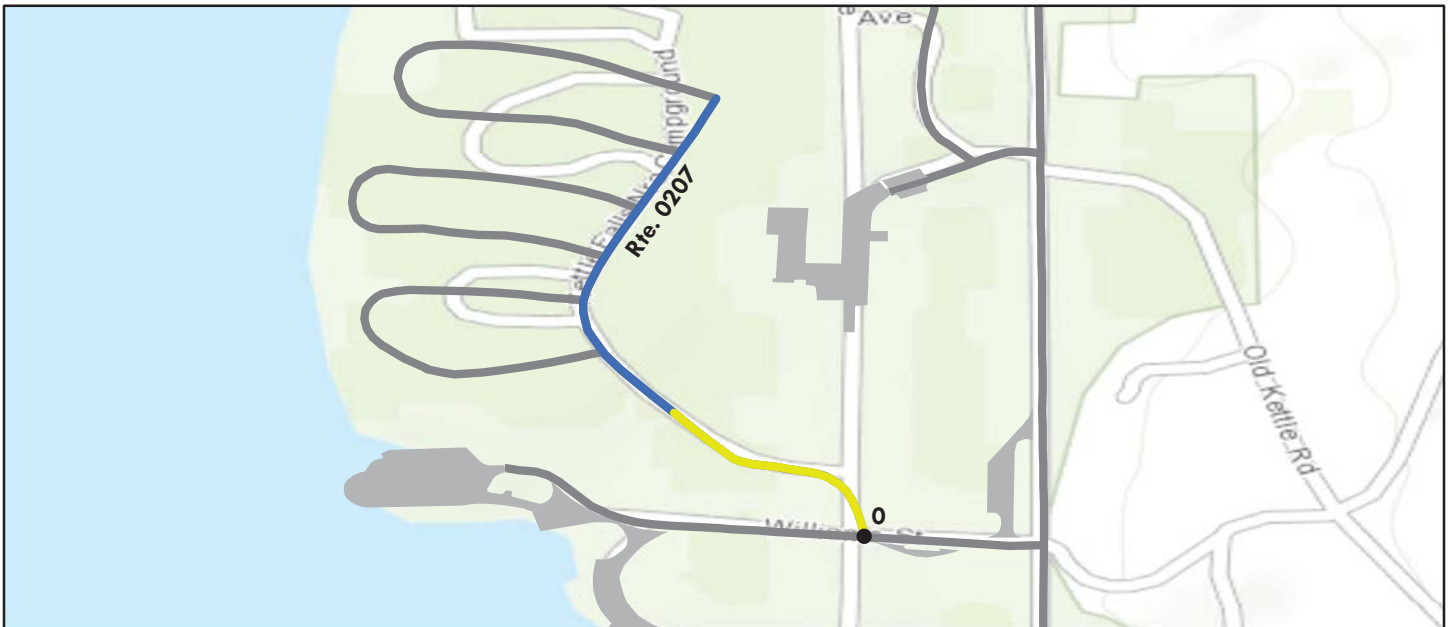
ROUTE 0207: KETTLE FALLS CAMPGROUND ROAD

Data Collection Vehicle (DCV) Rating

Route Condition Legend – Pavement Condition Rating (PCR)						
Poor (0 - 60)	Fair (61- 84)	Good (85 - 94)	Excellent (95 - 100)	Not Rated		
See Appendix for definitions and formulas						
Inspection Date:	10/2/2015	Beginning Section MP	0			
Paved Length (Miles):	0.29	Section Length (MI)	0.29			
Surface Type:	ASPHALT	Route Summary				
Roadway Condition Information						
Pavement Condition Rating (PCR)	90	90				
Surface Condition Rating (SCR)	90	90				
Roughness Condition Index (RCI)	N/A	N/A				
Distress Index Values						
Structural Crack Index	99	99				
Alligator Crack Index	100	100				
Longitudinal Crack Index	99	99				
Transverse Cracking Index	90	90				
Patching Index	100	100				
Rutting Index	99	99				
International Roughness Index (IRI)	N/A	N/A				
Lane & Width Information						
Number of Lanes	2	2				
Paved Width (ft)	19	19				
Lane Width (ft)	9.8	9.8

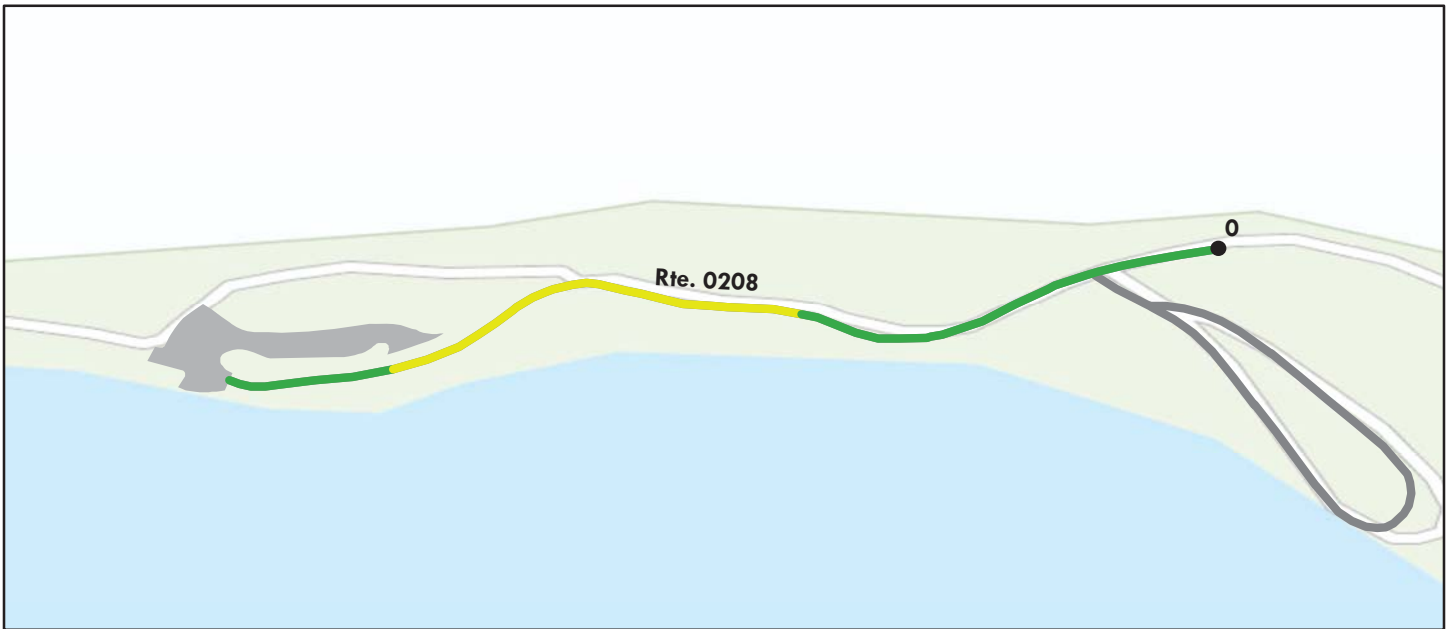
ROUTE 0208: HAWK CREEK CAMPGROUND ROAD

Data Collection Vehicle (DCV) Rating

Route Condition Legend – Pavement Condition Rating (PCR)						
Poor (0 - 60)	Fair (61- 84)	Good (85 - 94)	Excellent (95 - 100)	Not Rated		
See Appendix for definitions and formulas						
Inspection Date: 10/1/2015	Beginning Section MP	0				
Paved Length (Miles): 0.24	Section Length (MI)	0.24				
Surface Type: ASPHALT	Route Summary					
Roadway Condition Information						
Pavement Condition Rating (PCR)	85	85				
Surface Condition Rating (SCR)	85	85				
Roughness Condition Index (RCI)	N/A	N/A				
Distress Index Values						
Structural Crack Index	85	85				
Alligator Crack Index	100	100				
Longitudinal Crack Index	85	85				
Transverse Cracking Index	94	94				
Patching Index	100	100				
Rutting Index	92	92				
International Roughness Index (IRI)	N/A	N/A				
Lane & Width Information						
Number of Lanes	2	2				
Paved Width (ft)	18.1	18.1				
Lane Width (ft)	9.1	9.1

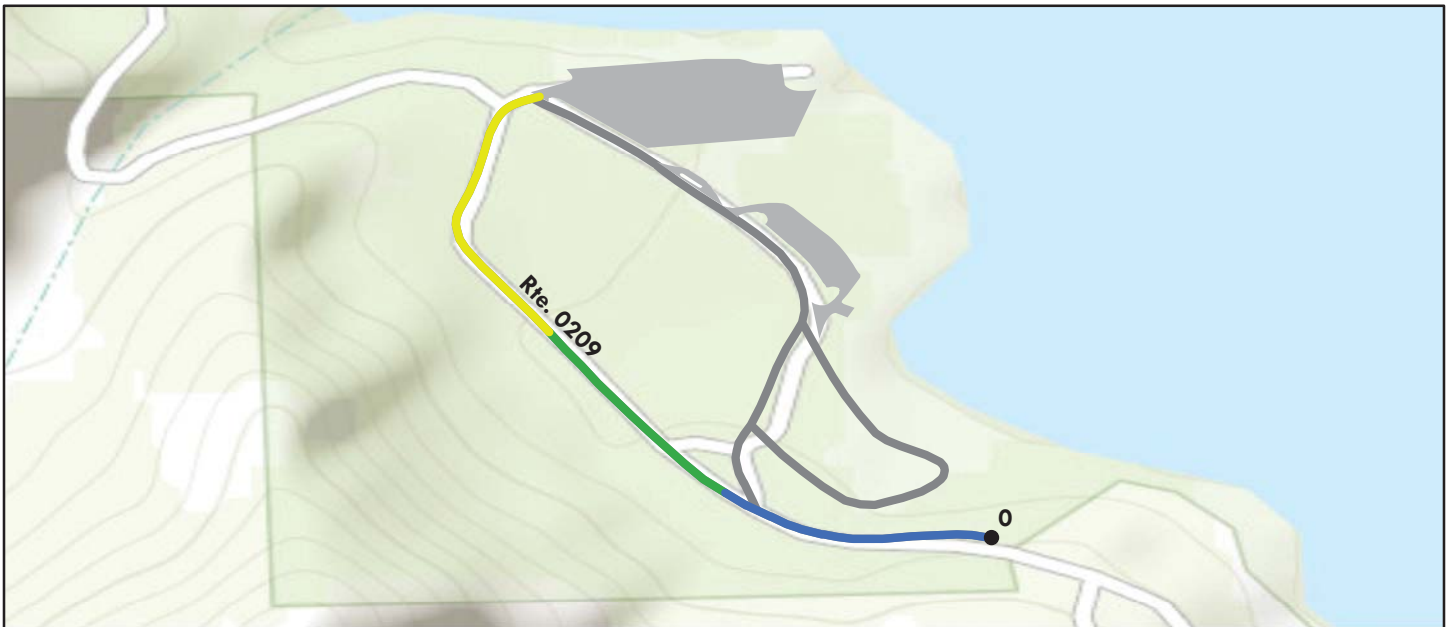
ROUTE 0209: PORCUPINE BAY CAMPGROUND ROAD

Data Collection Vehicle (DCV) Rating

Route Condition Legend – Pavement Condition Rating (PCR)						
Poor (0 - 60)	Fair (61- 84)	Good (85 - 94)	Excellent (95 - 100)	Not Rated		
See Appendix for definitions and formulas						
Inspection Date: 10/1/2015	Beginning Section MP	0				
Paved Length (Miles): 0.34	Section Length (MI)	0.34				
Surface Type: ASPHALT	Route Summary					
Roadway Condition Information						
Pavement Condition Rating (PCR)	90	90				
Surface Condition Rating (SCR)	90	90				
Roughness Condition Index (RCI)	N/A	N/A				
Distress Index Values						
Structural Crack Index	99	99				
Alligator Crack Index	100	100				
Longitudinal Crack Index	99	99				
Transverse Cracking Index	90	90				
Patching Index	100	100				
Rutting Index	97	97				
International Roughness Index (IRI)	N/A	N/A				
Lane & Width Information						
Number of Lanes	2	2				
Paved Width (ft)	20.6	20.6				
Lane Width (ft)	9.4	9.4

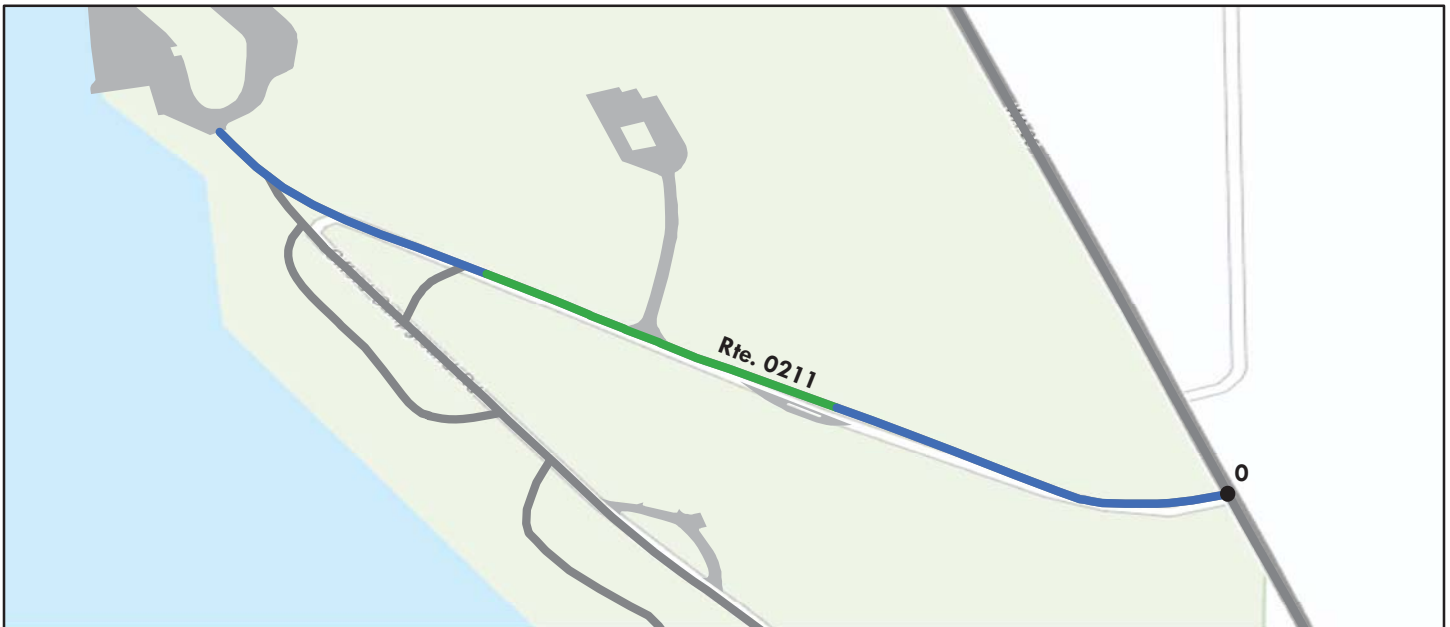
ROUTE 0211: GIFFORD CAMPGROUND ACCESS ROAD

Data Collection Vehicle (DCV) Rating

Route Condition Legend – Pavement Condition Rating (PCR)						
Poor (0 - 60)	Fair (61- 84)	Good (85 - 94)	Excellent (95 - 100)	Not Rated		
See Appendix for definitions and formulas						
Inspection Date: 10/2/2015	Beginning Section MP	0				
Paved Length (Miles): 0.29	Section Length (MI)	0.29				
Surface Type: ASPHALT	Route Summary					
Roadway Condition Information						
Pavement Condition Rating (PCR)	95	95				
Surface Condition Rating (SCR)	95	95				
Roughness Condition Index (RCI)	N/A	N/A				
Distress Index Values						
Structural Crack Index	99	99				
Alligator Crack Index	100	100				
Longitudinal Crack Index	99	99				
Transverse Cracking Index	99	99				
Patching Index	100	100				
Rutting Index	95	95				
International Roughness Index (IRI)	N/A	N/A				
Lane & Width Information						
Number of Lanes	2	2				
Paved Width (ft)	20.8	20.8				
Lane Width (ft)	10.4	10.4

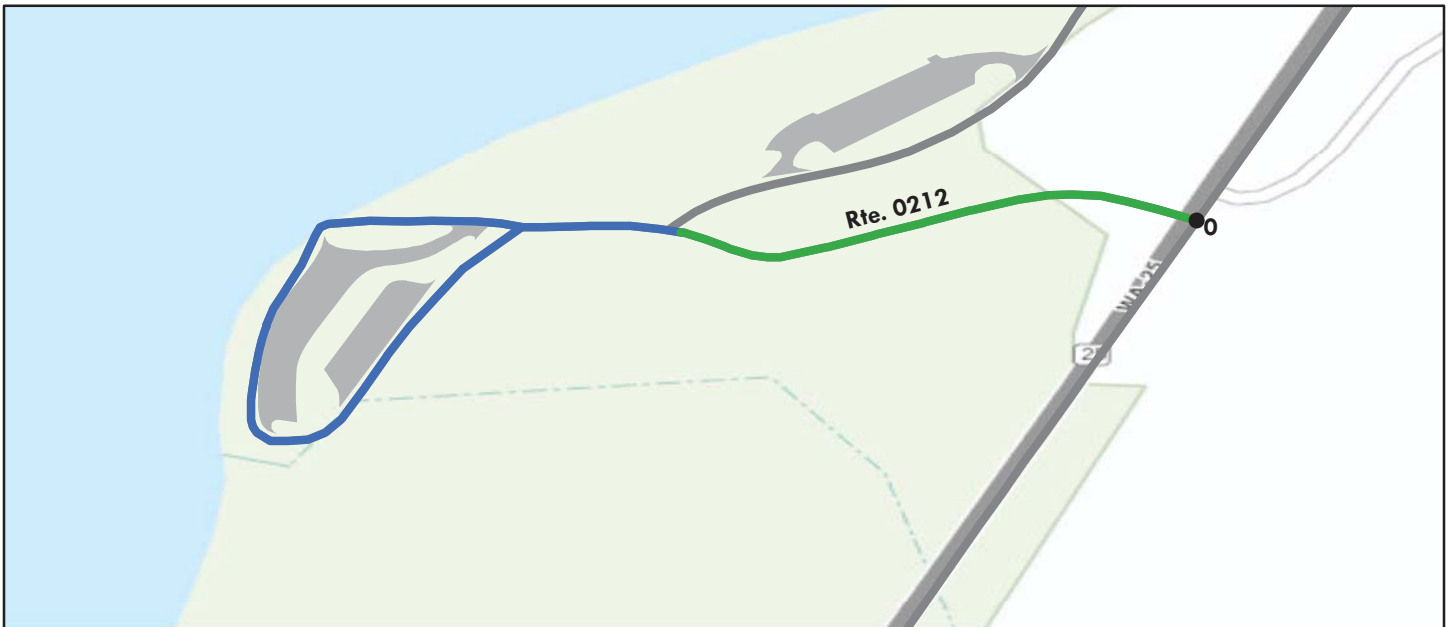
ROUTE 0212: BRADBURY DAY USE AREA ROAD

Data Collection Vehicle (DCV) Rating

Route Condition Legend – Pavement Condition Rating (PCR)						
Poor (0 - 60)	Fair (61- 84)	Good (85 - 94)	Excellent (95 - 100)	Not Rated		
See Appendix for definitions and formulas						
Inspection Date: 10/2/2015	Beginning Section MP	0				
Paved Length (Miles): 0.31	Section Length (MI)	0.31				
Surface Type: ASPHALT	Route Summary					
Roadway Condition Information						
Pavement Condition Rating (PCR)	97	97				
Surface Condition Rating (SCR)	97	97				
Roughness Condition Index (RCI)	N/A	N/A				
Distress Index Values						
Structural Crack Index	97	97				
Alligator Crack Index	100	100				
Longitudinal Crack Index	97	97				
Transverse Cracking Index	100	100				
Patching Index	100	100				
Rutting Index	97	97				
International Roughness Index (IRI)	N/A	N/A				
Lane & Width Information						
Number of Lanes	1	1				
Paved Width (ft)	20.7	20.7				
Lane Width (ft)	15.1	15.1

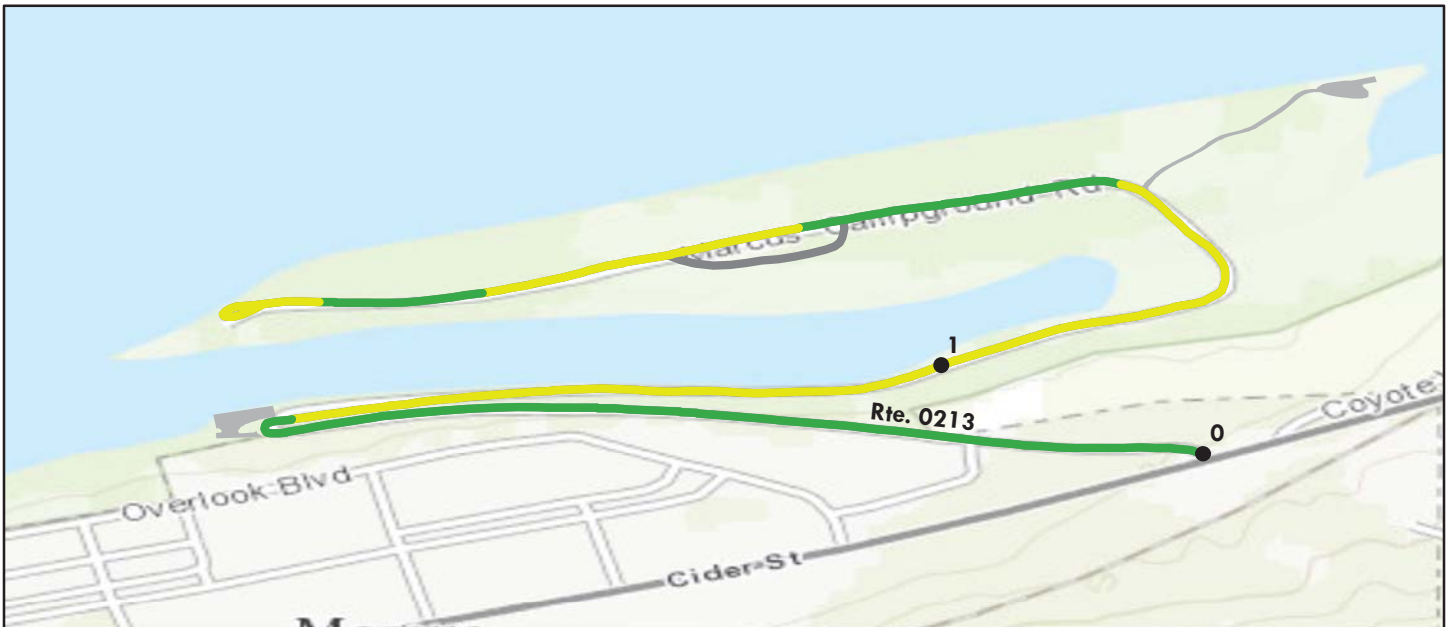
ROUTE 0213: MARCUS ISLAND CAMPGROUND ENTRANCE ROAD

Data Collection Vehicle (DCV) Rating

Route Condition Legend – Pavement Condition Rating (PCR)						
Poor (0 - 60)	Fair (61- 84)	Good (85 - 94)	Excellent (95 - 100)	Not Rated		
See Appendix for definitions and formulas						
Inspection Date: 10/2/2015	Beginning Section MP	0	1			
Paved Length (Miles): 1.88	Section Length (MI)	1	0.88			
Surface Type: ASPHALT	Route Summary					
Roadway Condition Information						
Pavement Condition Rating (PCR)	83	85	81			
Surface Condition Rating (SCR)	98	98	99			
Roughness Condition Index (RCI)	60	66	53			
Distress Index Values						
Structural Crack Index	100	99	100			
Alligator Crack Index	100	100	100			
Longitudinal Crack Index	100	99	100			
Transverse Cracking Index	100	99	100			
Patching Index	100	100	100			
Rutting Index	98	98	99			
International Roughness Index (IRI)	240	215	268			
Lane & Width Information						
Number of Lanes	2	2	2			
Paved Width (ft)	17.6	17.1	18.2			
Lane Width (ft)	9.1	8.6	9.8

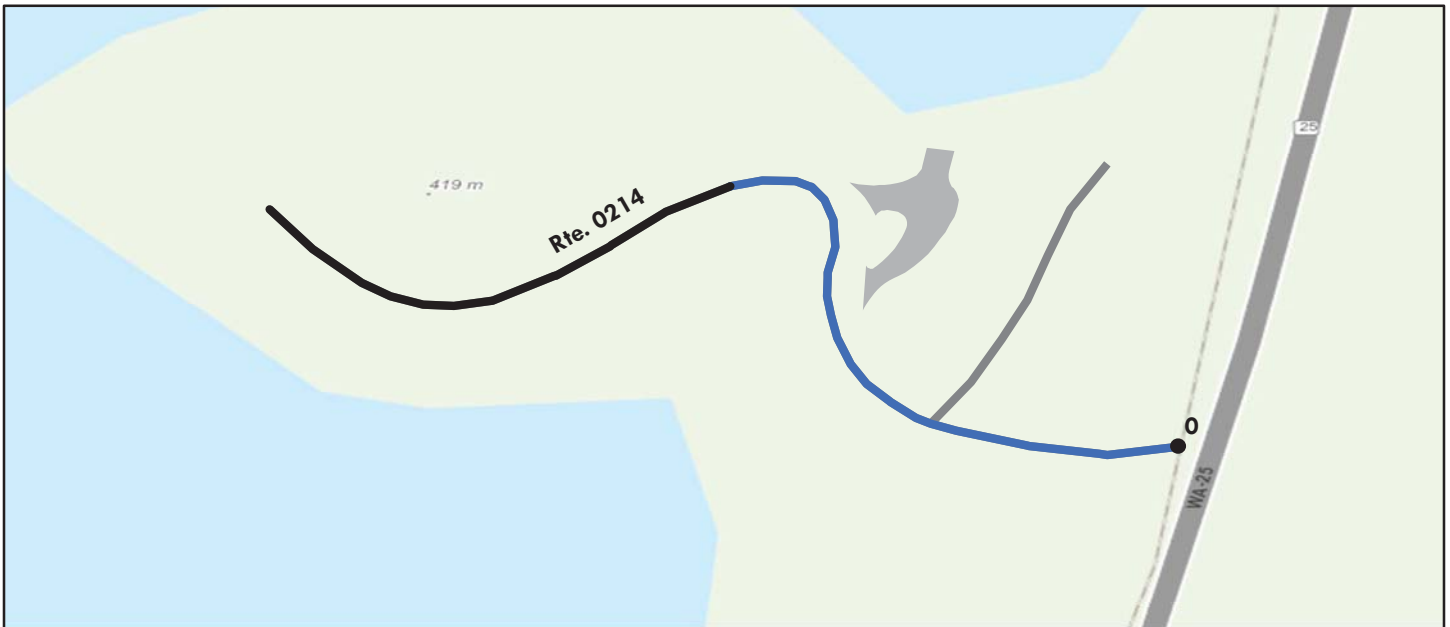
ROUTE 0214: NORTH GORGE CAMPGROUND ROAD

Data Collection Vehicle (DCV) Rating

Route Condition Legend – Pavement Condition Rating (PCR)						
Poor (0 - 60)	Fair (61- 84)	Good (85 - 94)	Excellent (95 - 100)	Not Rated		
See Appendix for definitions and formulas						
Inspection Date: 10/2/2015	Beginning Section MP	0				
Paved Length (Miles): 0.18	Section Length (MI)	0.18				
Surface Type: ASPHALT	Route Summary					
Roadway Condition Information						
Pavement Condition Rating (PCR)	N/A	N/A				
Surface Condition Rating (SCR)	N/A	N/A				
Roughness Condition Index (RCI)	N/A	N/A				
Distress Index Values						
Structural Crack Index	N/A	N/A				
Alligator Crack Index	N/A	N/A				
Longitudinal Crack Index	N/A	N/A				
Transverse Cracking Index	N/A	N/A				
Patching Index	N/A	N/A				
Rutting Index	N/A	N/A				
International Roughness Index (IRI)	N/A	N/A				
Lane & Width Information						
Number of Lanes	1	1				
Paved Width (ft)	17.2	17.2				
Lane Width (ft)	12.4	12.4

Note: This road did not receive a condition rating due to debris on road (leaves / pine needles).

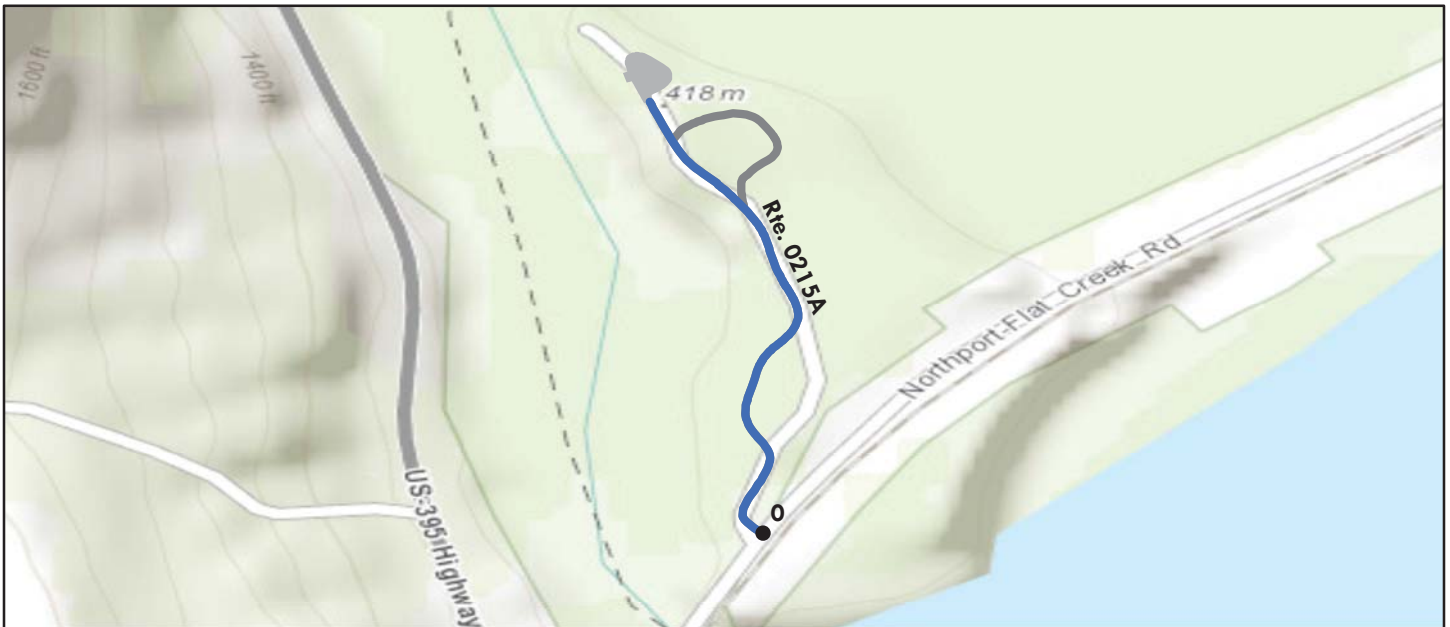
ROUTE 0215A: KAMLOOPS ISLAND CAMPGROUND ROAD

Data Collection Vehicle (DCV) Rating

Route Condition Legend – Pavement Condition Rating (PCR)						
Poor (0 - 60)	Fair (61- 84)	Good (85 - 94)	Excellent (95 - 100)	Not Rated		
See Appendix for definitions and formulas						
Inspection Date: 10/2/2015	Beginning Section MP	0				
Paved Length (Miles): 0.26	Section Length (MI)	0.26				
Surface Type: ASPHALT	Route Summary					
Roadway Condition Information						
Pavement Condition Rating (PCR)	98	98				
Surface Condition Rating (SCR)	98	98				
Roughness Condition Index (RCI)	N/A	N/A				
Distress Index Values						
Structural Crack Index	100	100				
Alligator Crack Index	100	100				
Longitudinal Crack Index	100	100				
Transverse Cracking Index	100	100				
Patching Index	100	100				
Rutting Index	98	98				
International Roughness Index (IRI)	N/A	N/A				
Lane & Width Information						
Number of Lanes	2	2				
Paved Width (ft)	17.3	17.3				
Lane Width (ft)	8.6	8.6

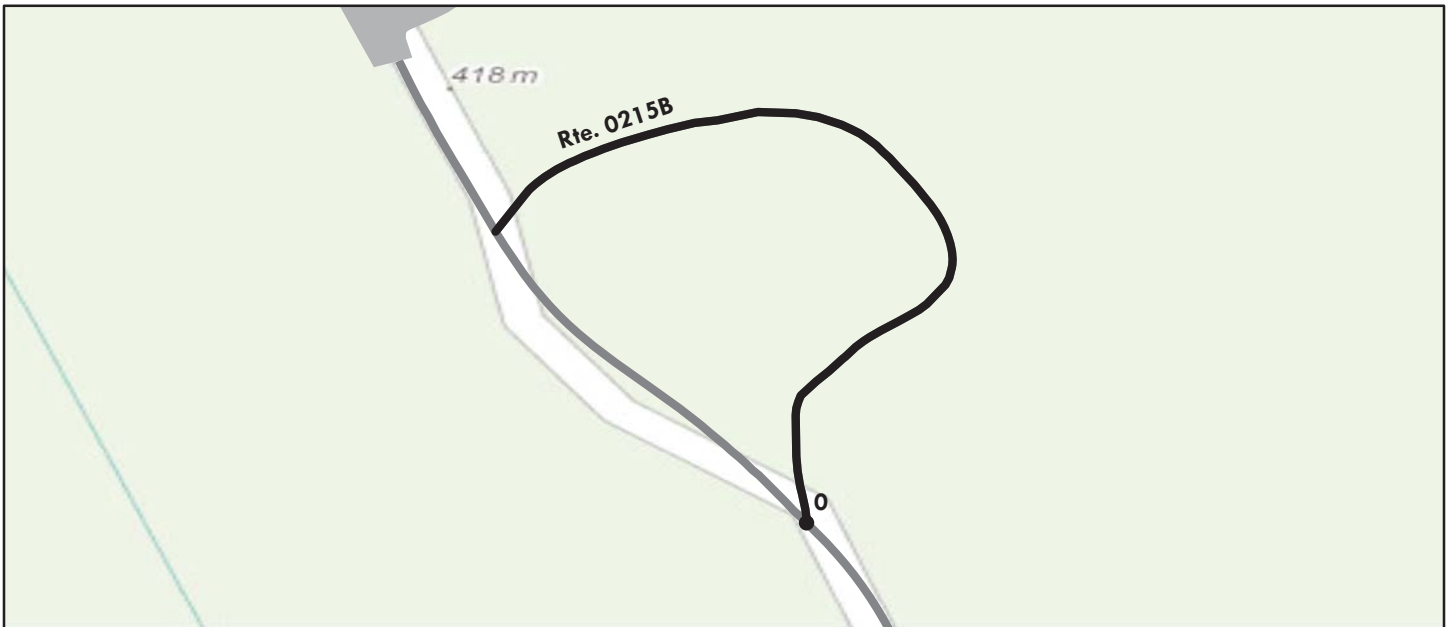
ROUTE 0215B: KAMLOOPS ISLAND CAMPGROUND LOOP

Data Collection Vehicle (DCV) Rating

Route Condition Legend – Pavement Condition Rating (PCR)						
Poor (0 - 60)	Fair (61- 84)	Good (85 - 94)	Excellent (95 - 100)	Not Rated		
See Appendix for definitions and formulas						
Inspection Date: 10/2/2015	Beginning Section MP	0				
Paved Length (Miles): 0.09	Section Length (MI)	0.09				
Surface Type: ASPHALT	Route Summary					
Roadway Condition Information						
Pavement Condition Rating (PCR)	N/A	N/A				
Surface Condition Rating (SCR)	N/A	N/A				
Roughness Condition Index (RCI)	N/A	N/A				
Distress Index Values						
Structural Crack Index	N/A	N/A				
Alligator Crack Index	N/A	N/A				
Longitudinal Crack Index	N/A	N/A				
Transverse Cracking Index	N/A	N/A				
Patching Index	N/A	N/A				
Rutting Index	N/A	N/A				
International Roughness Index (IRI)	N/A	N/A				
Lane & Width Information						
Number of Lanes	1	1				
Paved Width (ft)	14.1	14.1				
Lane Width (ft)	14.1	14.1

Note: This road did not receive a condition rating due to debris on road (leaves / pine needles).

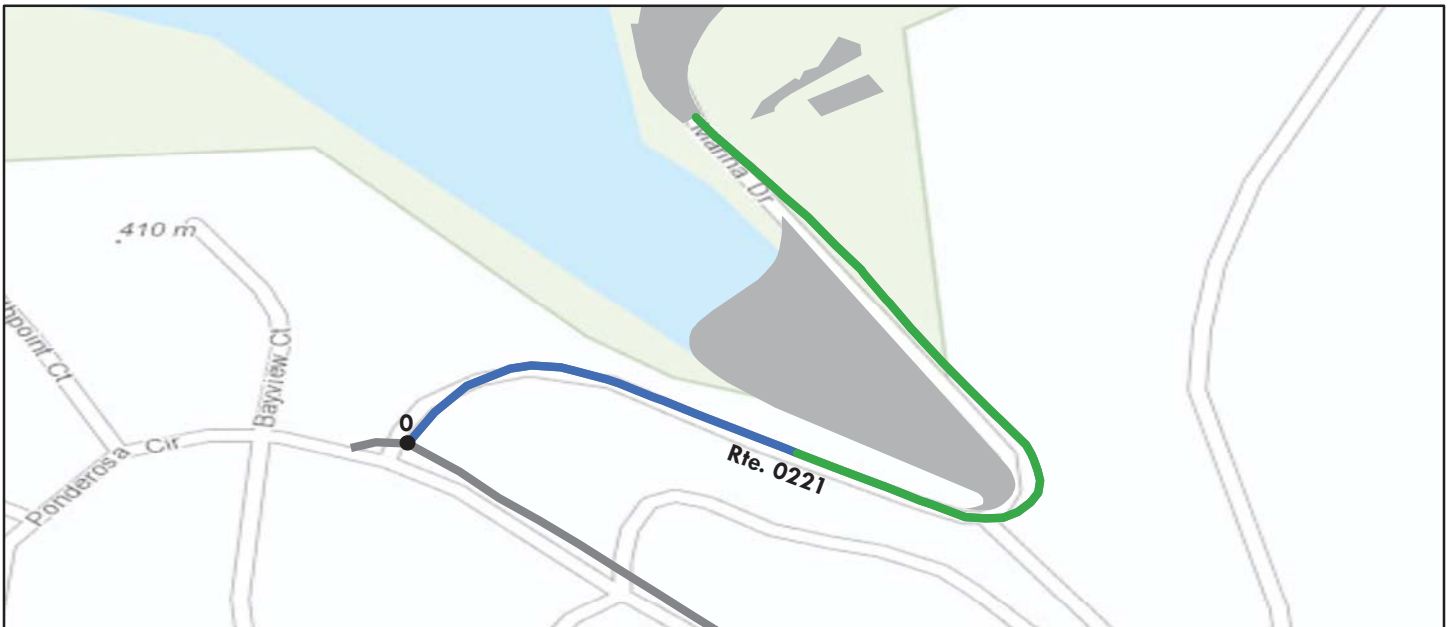
ROUTE 0221: SEVEN BAYS MARINA ACCESS ROAD

Data Collection Vehicle (DCV) Rating

Route Condition Legend – Pavement Condition Rating (PCR)						
Poor (0 - 60)	Fair (61- 84)	Good (85 - 94)	Excellent (95 - 100)	Not Rated		
See Appendix for definitions and formulas						
Inspection Date:	10/1/2015	Beginning Section MP	0			
Paved Length (Miles):	0.28	Section Length (MI)	0.28			
Surface Type:	ASPHALT	Route Summary				
Roadway Condition Information						
Pavement Condition Rating (PCR)	94	94				
Surface Condition Rating (SCR)	94	94				
Roughness Condition Index (RCI)	N/A	N/A				
Distress Index Values						
Structural Crack Index	94	94				
Alligator Crack Index	99	99				
Longitudinal Crack Index	95	95				
Transverse Cracking Index	98	98				
Patching Index	100	100				
Rutting Index	95	95				
International Roughness Index (IRI)	N/A	N/A				
Lane & Width Information						
Number of Lanes	2	2				
Paved Width (ft)	25.9	25.9				
Lane Width (ft)	12.4	12.4

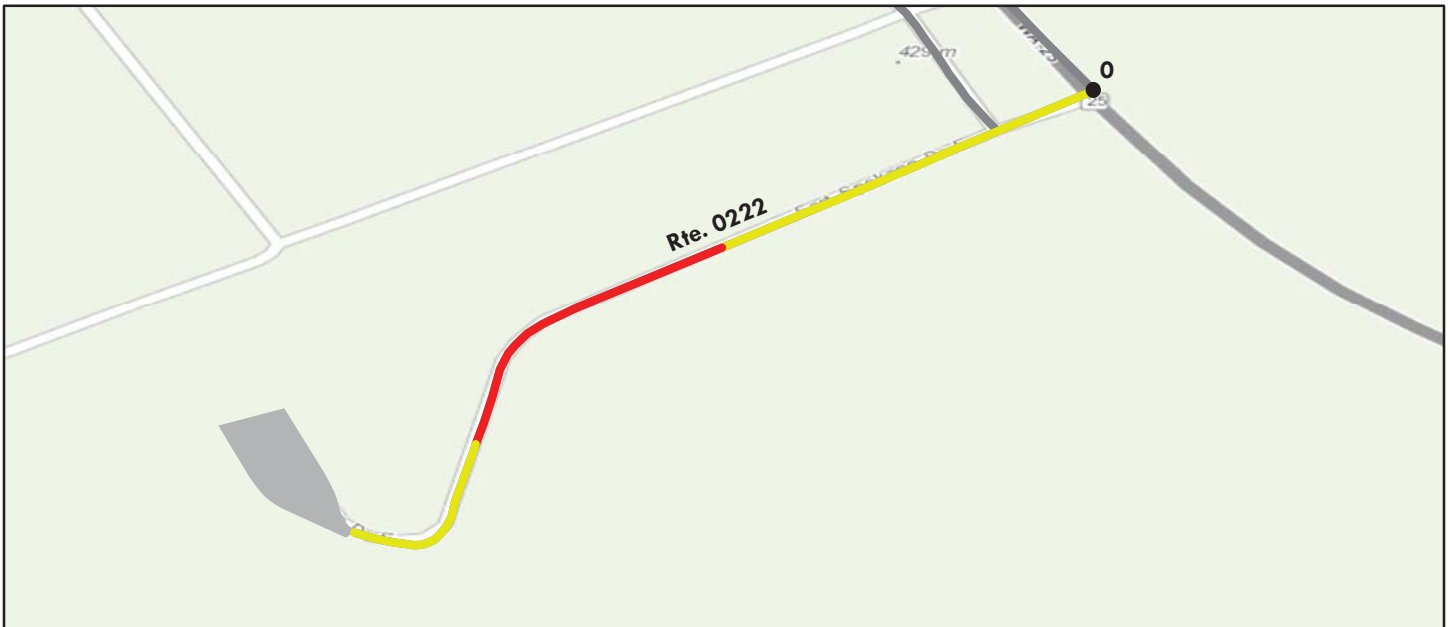
ROUTE 0222: FORT SPOKANE VISITOR CENTER ACCESS ROAD

Data Collection Vehicle (DCV) Rating

Route Condition Legend – Pavement Condition Rating (PCR)						
Poor (0 - 60)	Fair (61- 84)	Good (85 - 94)	Excellent (95 - 100)	Not Rated		
See Appendix for definitions and formulas						
Inspection Date:	10/1/2015	Beginning Section MP	0			
Paved Length (Miles):	0.26	Section Length (MI)	0.26			
Surface Type:	ASPHALT	Route Summary				
Roadway Condition Information						
Pavement Condition Rating (PCR)	71	71				
Surface Condition Rating (SCR)	71	71				
Roughness Condition Index (RCI)	N/A	N/A				
Distress Index Values						
Structural Crack Index	77	77				
Alligator Crack Index	94	94				
Longitudinal Crack Index	83	83				
Transverse Cracking Index	71	71				
Patching Index	100	100				
Rutting Index	96	96				
International Roughness Index (IRI)	N/A	N/A				
Lane & Width Information						
Number of Lanes	2	2				
Paved Width (ft)	18.7	18.7				
Lane Width (ft)	9.2	9.2

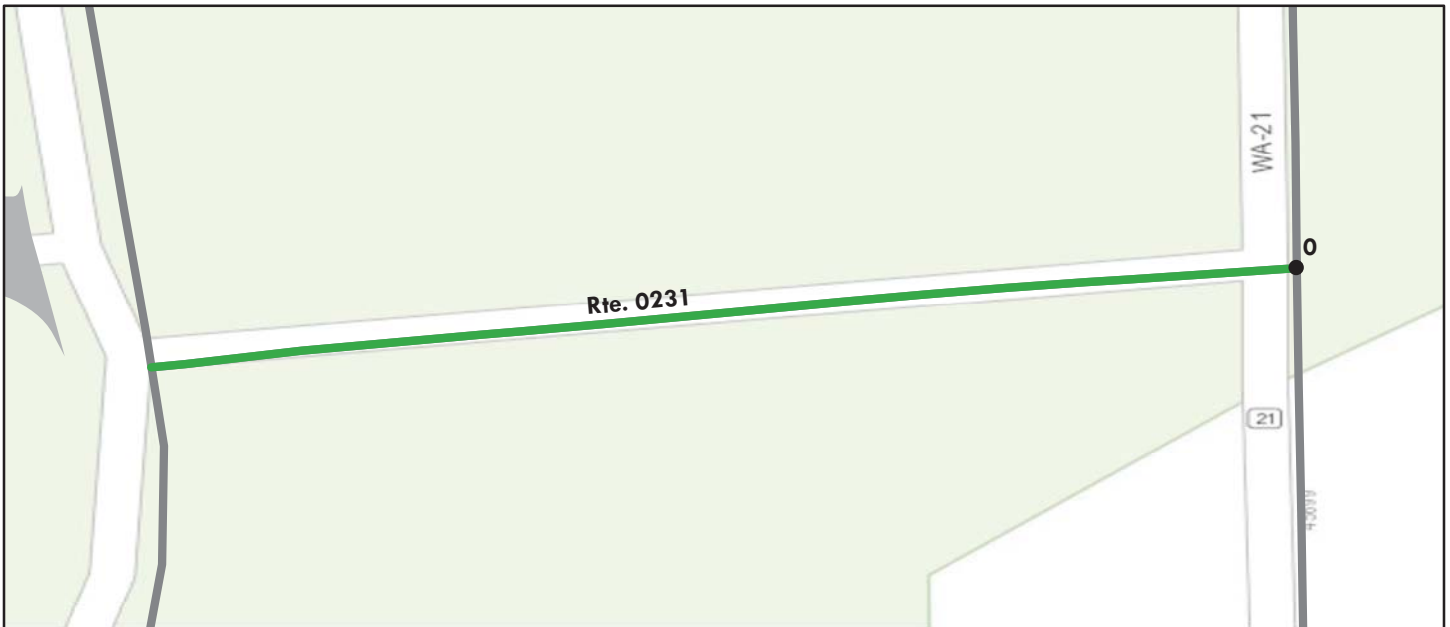
ROUTE 0231: KELLER FERRY CAMPGROUND ENTRANCE ROAD

Data Collection Vehicle (DCV) Rating

Route Condition Legend – Pavement Condition Rating (PCR)						
Poor (0 - 60)	Fair (61- 84)	Good (85 - 94)	Excellent (95 - 100)	Not Rated		
See Appendix for definitions and formulas						
Inspection Date:	10/1/2015	Beginning Section MP	0			
Paved Length (Miles):	0.06	Section Length (MI)	0.06			
Surface Type:	ASPHALT	Route Summary				
Roadway Condition Information						
Pavement Condition Rating (PCR)	88	88				
Surface Condition Rating (SCR)	88	88				
Roughness Condition Index (RCI)	N/A	N/A				
Distress Index Values						
Structural Crack Index	97	97				
Alligator Crack Index	100	100				
Longitudinal Crack Index	97	97				
Transverse Cracking Index	88	88				
Patching Index	100	100				
Rutting Index	100	100				
International Roughness Index (IRI)	N/A	N/A				
Lane & Width Information						
Number of Lanes	2	2				
Paved Width (ft)	26.4	26.4				
Lane Width (ft)	13.3	13.3

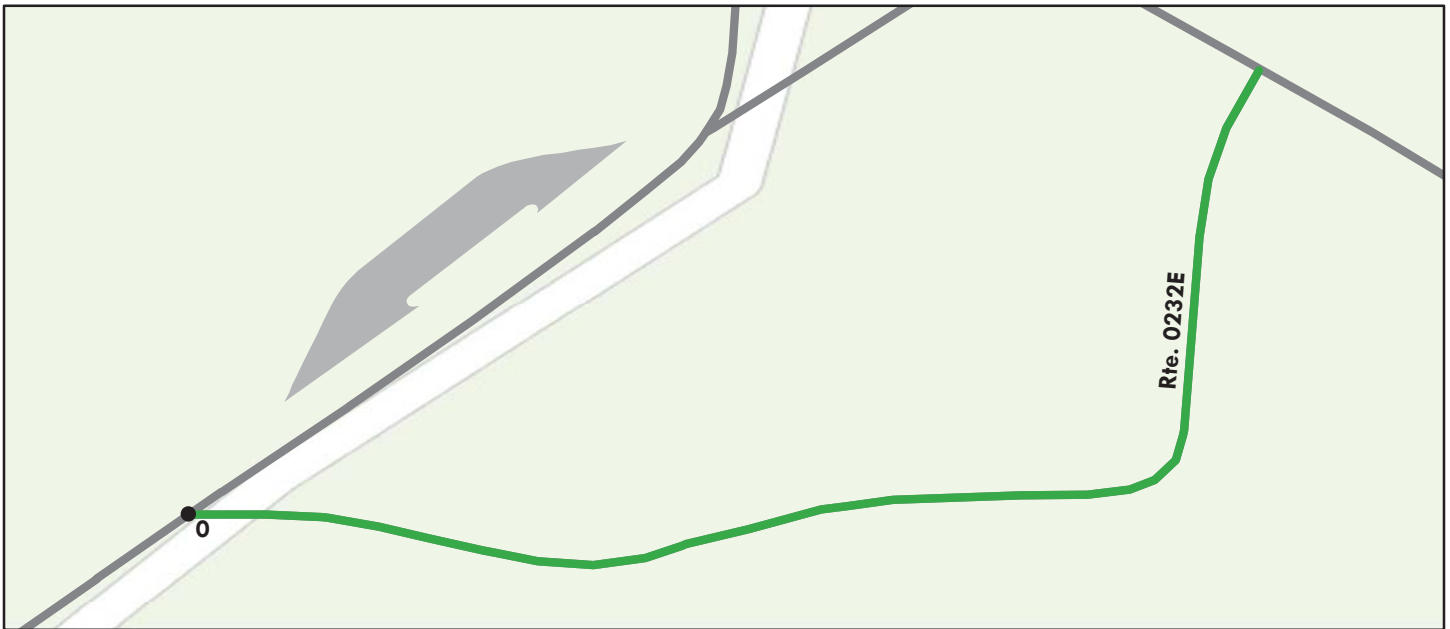
ROUTE 0232E: FORT SPOKANE CAMPGROUND LOOPE

Route Condition Legend – Pavement Condition Rating (PCR)						
Poor (0 - 60)	Fair (61- 84)	Good (85 - 94)	Excellent (95 - 100)	Not Rated		
See Appendix for definitions and formulas						
Inspection Date: 10/1/2015	Beginning Section MP	0				
Paved Length (Miles): 0.09	Section Length (MI)	0.09				
Surface Type: ASPHALT	Route Summary					
Roadway Condition Information						
Pavement Condition Rating (PCR)	91	91				
Surface Condition Rating (SCR)	91	91				
Roughness Condition Index (RCI)	N/A	N/A				
Distress Index Values						
Structural Crack Index	93	93				
Alligator Crack Index	100	100				
Longitudinal Crack Index	93	93				
Transverse Cracking Index	91	91				
Patching Index	100	100				
Rutting Index	92	92				
International Roughness Index (IRI)	N/A	N/A				
Lane & Width Information						
Number of Lanes	1	1				
Paved Width (ft)	12	12				
Lane Width (ft)	12	12
