LARO Cycle 6

Final Report

Road Inventory and Condition Assessment of Paved Routes Lake Roosevelt National Recreation Area

**Federal Highway Administration
Eastern Federal Lands Highway Division
Road Inventory Program (RIP)**

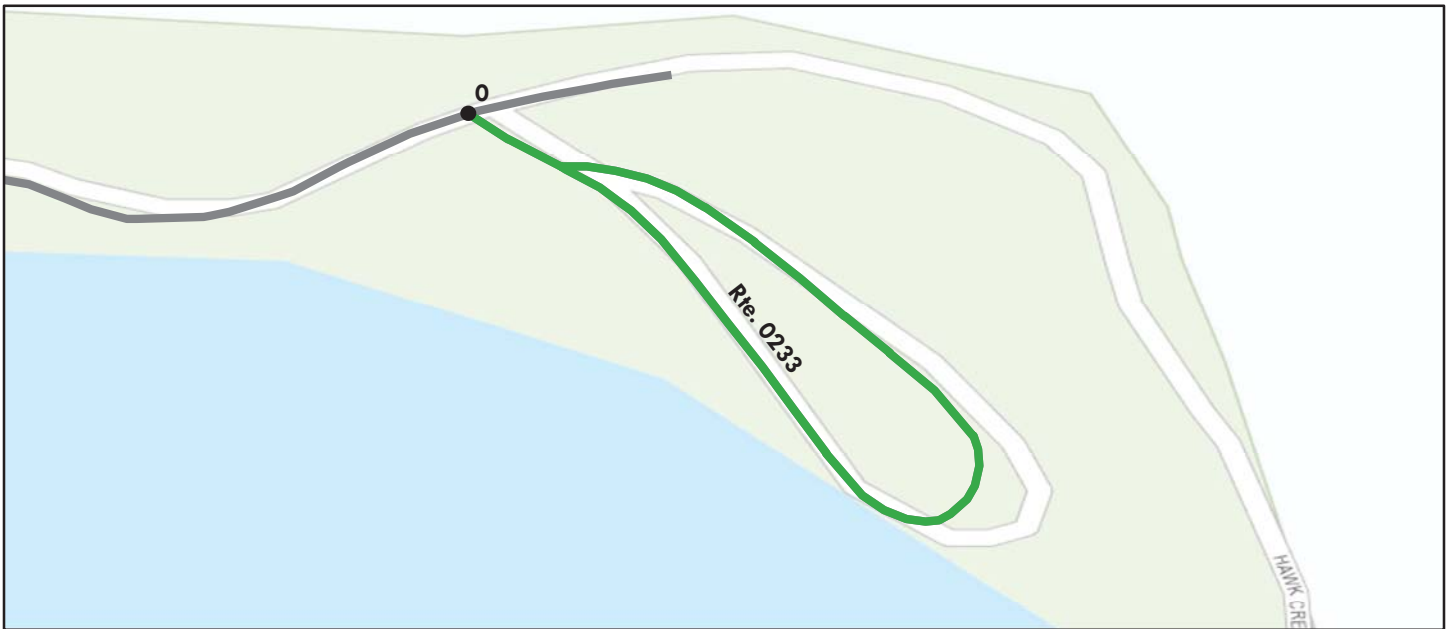
ROUTE 0233: HAWK CREEK CAMPGROUND LOOP

Route Condition Legend – Pavement Condition Rating (PCR)						
Poor (0 - 60)	Fair (61- 84)	Good (85 - 94)	Excellent (95 - 100)	Not Rated		
See Appendix for definitions and formulas						
Inspection Date:	10/1/2015	Beginning Section MP	0			
Paved Length (Miles):	0.21	Section Length (MI)	0.21			
Surface Type:	ASPHALT	Route Summary				
Roadway Condition Information						
Pavement Condition Rating (PCR)	89	89				
Surface Condition Rating (SCR)	89	89				
Roughness Condition Index (RCI)	N/A	N/A				
Distress Index Values						
Structural Crack Index	99	99				
Alligator Crack Index	100	100				
Longitudinal Crack Index	99	99				
Transverse Cracking Index	99	99				
Patching Index	100	100				
Rutting Index	89	89				
International Roughness Index (IRI)	N/A	N/A				
Lane & Width Information						
Number of Lanes	1	1				
Paved Width (ft)	15.6	15.6				
Lane Width (ft)	14.8	14.8

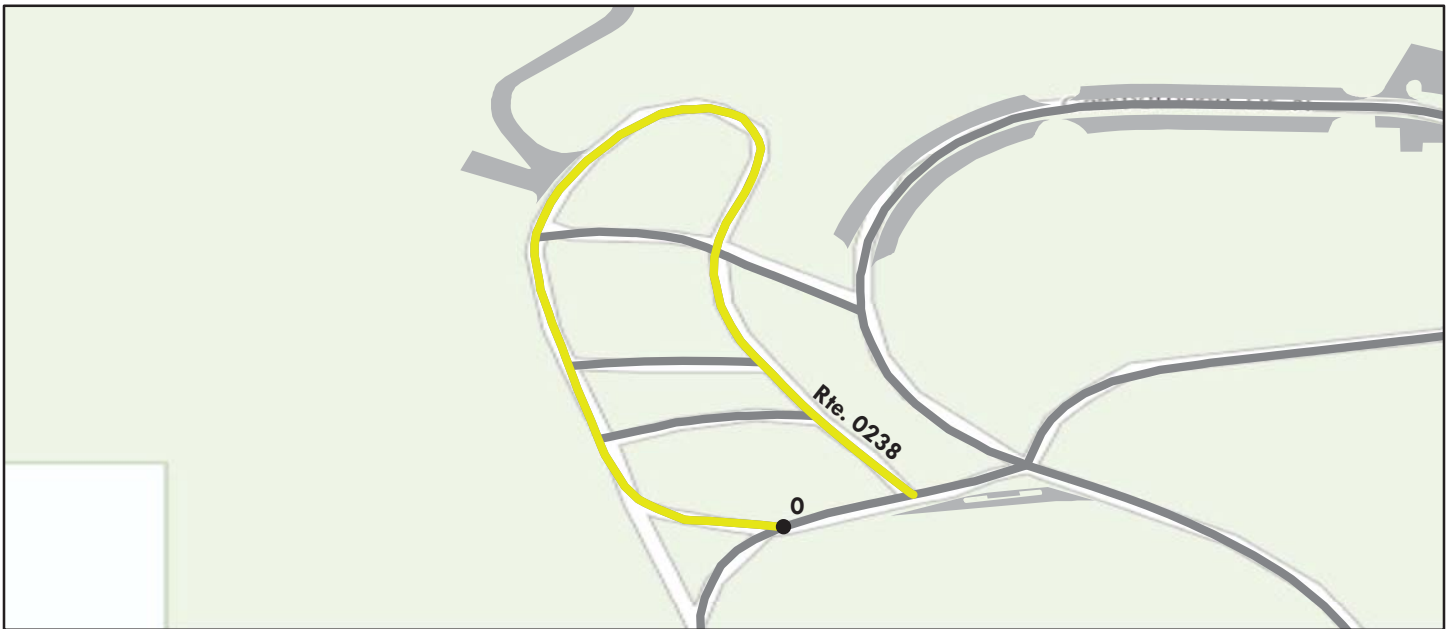
ROUTE 0238: SPRING CANYON CAMPGROUND ROAD

Route Condition Legend – Pavement Condition Rating (PCR)									
Poor (0 - 60)		Fair (61- 84)		Good (85 - 94)		Excellent (95 - 100)		Not Rated	
See Appendix for definitions and formulas									
Inspection Date:	10/1/2015	Beginning Section MP	0						
Paved Length (Miles):	0.29	Section Length (MI)	0.29						
Surface Type:	ASPHALT	Route Summary							
Roadway Condition Information									
Pavement Condition Rating (PCR)		76	76						
Surface Condition Rating (SCR)		76	76						
Roughness Condition Index (RCI)		N/A	N/A						
Distress Index Values									
Structural Crack Index		96	96						
Alligator Crack Index		100	100						
Longitudinal Crack Index		96	96						
Transverse Cracking Index		76	76						
Patching Index		100	100						
Rutting Index		97	97						
International Roughness Index (IRI)		N/A	N/A						
Lane & Width Information									
Number of Lanes		1	1						
Paved Width (ft)		14.8	14.8						
Lane Width (ft)		14.8	14.8

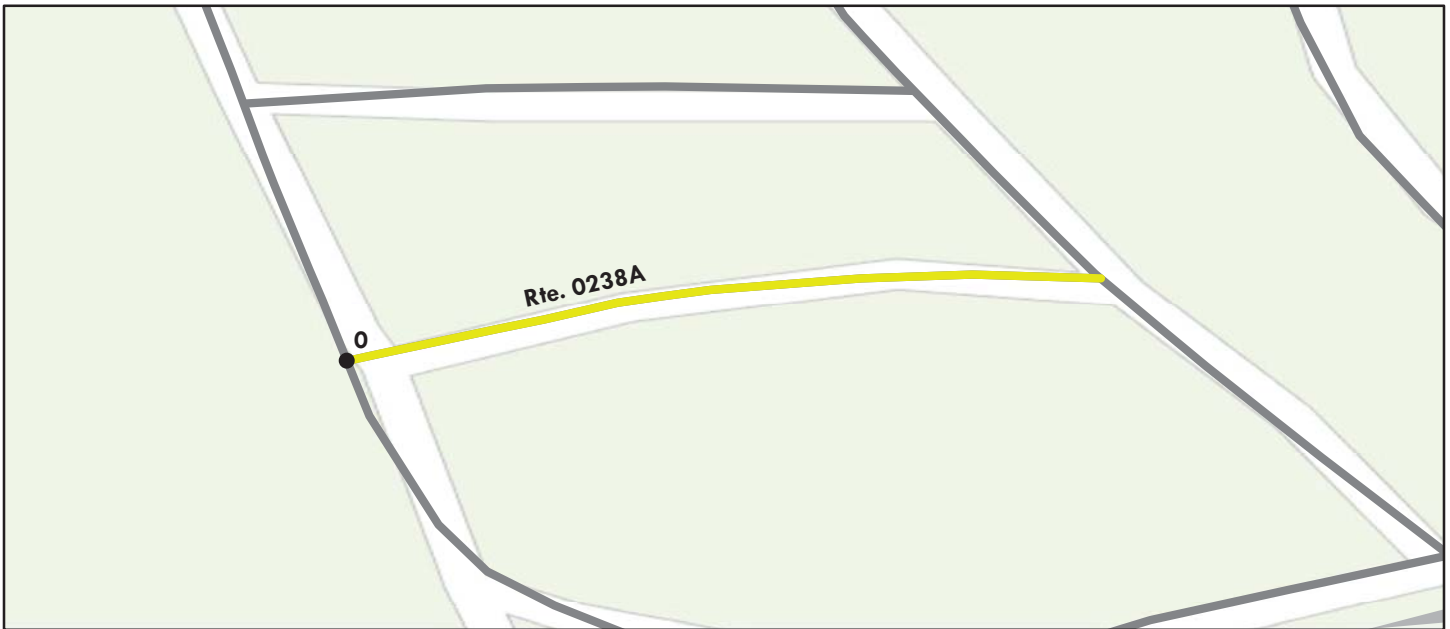
ROUTE 0238A: SPRING CANYON CAMPGROUND CONNECTOR A

Route Condition Legend – Pavement Condition Rating (PCR)						
Poor (0 - 60)	Fair (61- 84)	Good (85 - 94)	Excellent (95 - 100)	Not Rated		
See Appendix for definitions and formulas						
Inspection Date:	10/1/2015	Beginning Section MP	0			
Paved Length (Miles):	0.04	Section Length (MI)	0.04			
Surface Type:	ASPHALT	Route Summary				
Roadway Condition Information						
Pavement Condition Rating (PCR)	68	68				
Surface Condition Rating (SCR)	68	68				
Roughness Condition Index (RCI)	N/A	N/A				
Distress Index Values						
Structural Crack Index	99	99				
Alligator Crack Index	100	100				
Longitudinal Crack Index	99	99				
Transverse Cracking Index	68	68				
Patching Index	100	100				
Rutting Index	94	94				
International Roughness Index (IRI)	N/A	N/A				
Lane & Width Information						
Number of Lanes	1	1				
Paved Width (ft)	11.8	11.8				
Lane Width (ft)	11.8	11.8

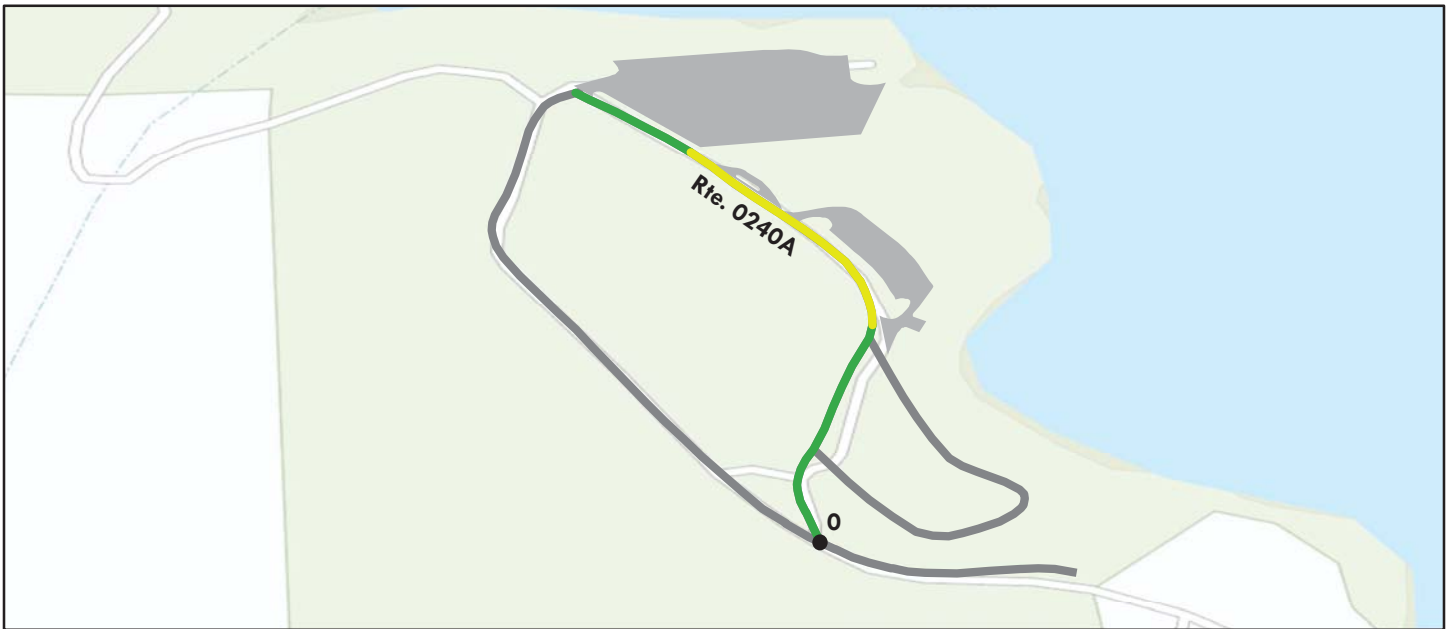
ROUTE 0240A: PORCUPINE BAY CAMPGROUND MAIN ROAD

Route Condition Legend – Pavement Condition Rating (PCR)						
Poor (0 - 60)	Fair (61- 84)	Good (85 - 94)	Excellent (95 - 100)	Not Rated		
See Appendix for definitions and formulas						
Inspection Date:	10/1/2015	Beginning Section MP	0			
Paved Length (Miles):	0.25	Section Length (MI)	0.25			
Surface Type:	ASPHALT	Route Summary				
Roadway Condition Information						
Pavement Condition Rating (PCR)	85	85				
Surface Condition Rating (SCR)	85	85				
Roughness Condition Index (RCI)	N/A	N/A				
Distress Index Values						
Structural Crack Index	98	98				
Alligator Crack Index	100	100				
Longitudinal Crack Index	98	98				
Transverse Cracking Index	85	85				
Patching Index	100	100				
Rutting Index	95	95				
International Roughness Index (IRI)	N/A	N/A				
Lane & Width Information						
Number of Lanes	1	1				
Paved Width (ft)	17.9	17.9				
Lane Width (ft)	17.9	17.9

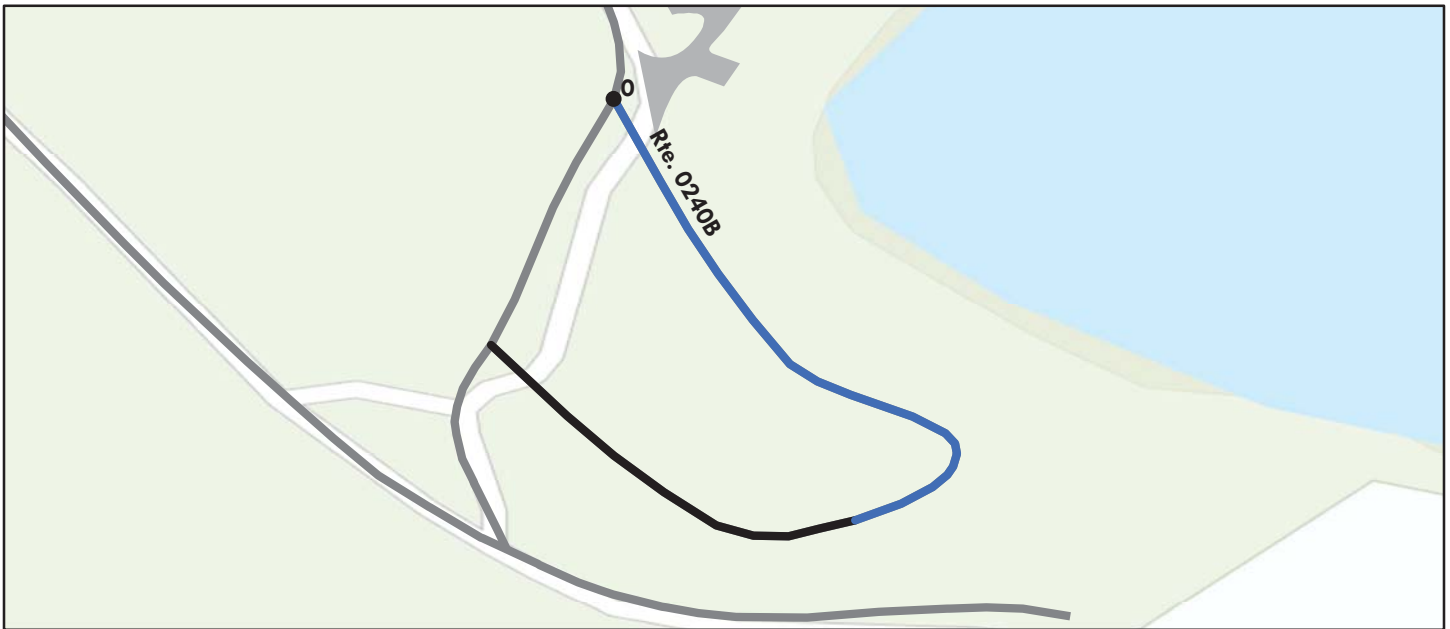
ROUTE 0240B: PORCUPINE BAY CAMPGROUND LOOP ROAD

Route Condition Legend – Pavement Condition Rating (PCR)						
Poor (0 - 60)	Fair (61- 84)	Good (85 - 94)	Excellent (95 - 100)	Not Rated		
See Appendix for definitions and formulas						
Inspection Date:	10/1/2015	Beginning Section MP	0			
Paved Length (Miles):	0.16	Section Length (MI)	0.16			
Surface Type:	ASPHALT	Route Summary				
Roadway Condition Information						
Pavement Condition Rating (PCR)	94	94				
Surface Condition Rating (SCR)	94	94				
Roughness Condition Index (RCI)	N/A	N/A				
Distress Index Values						
Structural Crack Index	99	99				
Alligator Crack Index	100	100				
Longitudinal Crack Index	99	99				
Transverse Cracking Index	99	99				
Patching Index	100	100				
Rutting Index	94	94				
International Roughness Index (IRI)	N/A	N/A				
Lane & Width Information						
Number of Lanes	1	1				
Paved Width (ft)	12.8	12.8				
Lane Width (ft)	12.8	12.8

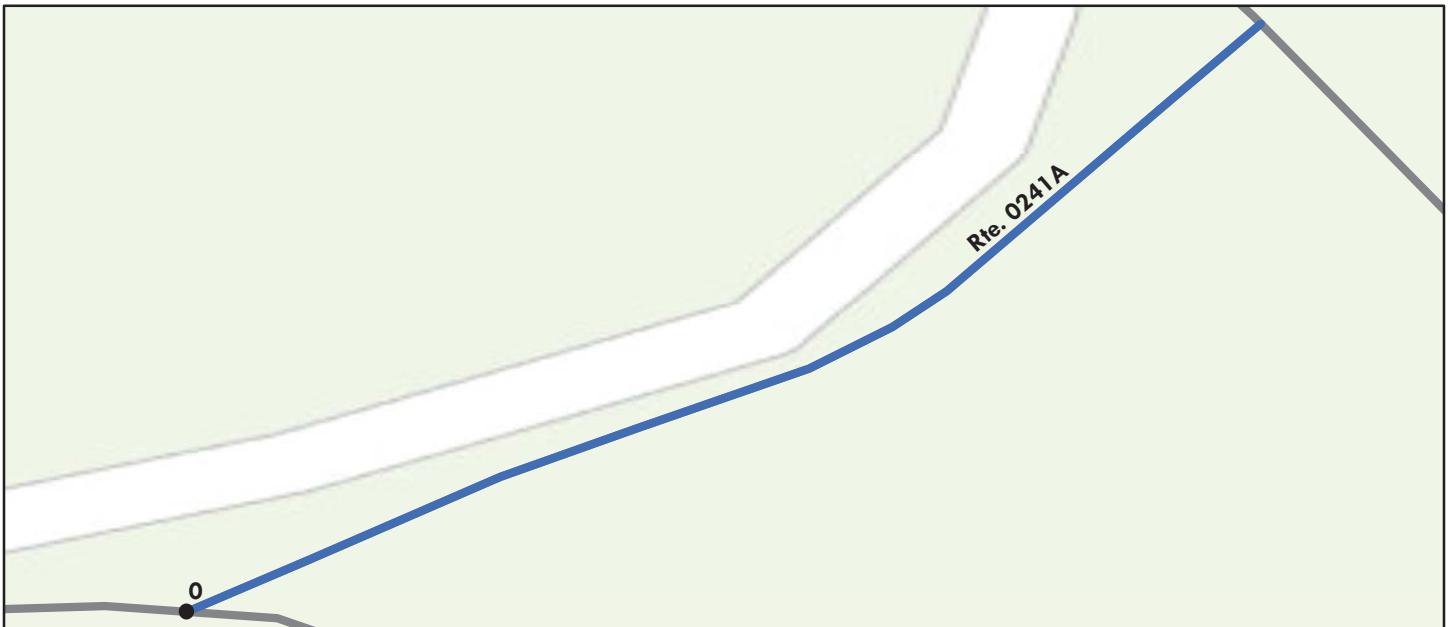
ROUTE 0241A: HUNTERS CAMPGROUND CONNECTOR ROAD

Route Condition Legend – Pavement Condition Rating (PCR)						
Poor (0 - 60)	Fair (61- 84)	Good (85 - 94)	Excellent (95 - 100)	Not Rated		
See Appendix for definitions and formulas						
Inspection Date:	10/2/2015	Beginning Section MP	0			
Paved Length (Miles):	0.03	Section Length (MI)	0.03			
Surface Type:	ASPHALT	Route Summary				
Roadway Condition Information						
Pavement Condition Rating (PCR)	99	99				
Surface Condition Rating (SCR)	99	99				
Roughness Condition Index (RCI)	N/A	N/A				
Distress Index Values						
Structural Crack Index	99	99				
Alligator Crack Index	100	100				
Longitudinal Crack Index	99	99				
Transverse Cracking Index	99	99				
Patching Index	100	100				
Rutting Index	99	99				
International Roughness Index (IRI)	N/A	N/A				
Lane & Width Information						
Number of Lanes	1	1				
Paved Width (ft)	16.4	16.4				
Lane Width (ft)	16.4	16.4

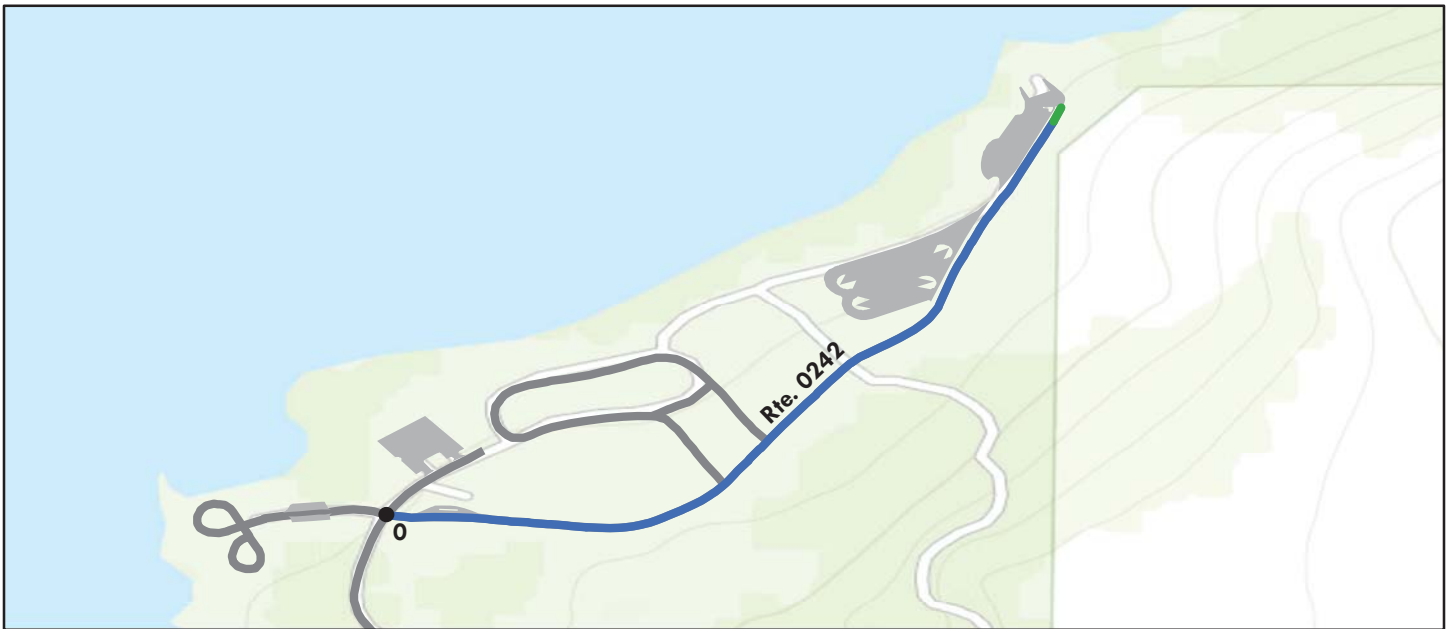
ROUTE 0242: HUNTERS BOAT LAUNCH ACCESS ROAD

Route Condition Legend – Pavement Condition Rating (PCR)									
Poor (0 - 60)		Fair (61- 84)		Good (85 - 94)		Excellent (95 - 100)		Not Rated	
See Appendix for definitions and formulas									
Inspection Date:	10/2/2015	Beginning Section MP	0						
Paved Length (Miles):	0.51	Section Length (MI)	0.51						
Surface Type:	ASPHALT	Route Summary							
Roadway Condition Information									
Pavement Condition Rating (PCR)		97	97						
Surface Condition Rating (SCR)		97	97						
Roughness Condition Index (RCI)		N/A	N/A						
Distress Index Values									
Structural Crack Index		99	99						
Alligator Crack Index		100	100						
Longitudinal Crack Index		99	99						
Transverse Cracking Index		100	100						
Patching Index		100	100						
Rutting Index		97	97						
International Roughness Index (IRI)		N/A	N/A						
Lane & Width Information									
Number of Lanes		2	2						
Paved Width (ft)		23.9	23.9						
Lane Width (ft)		11.9	11.9

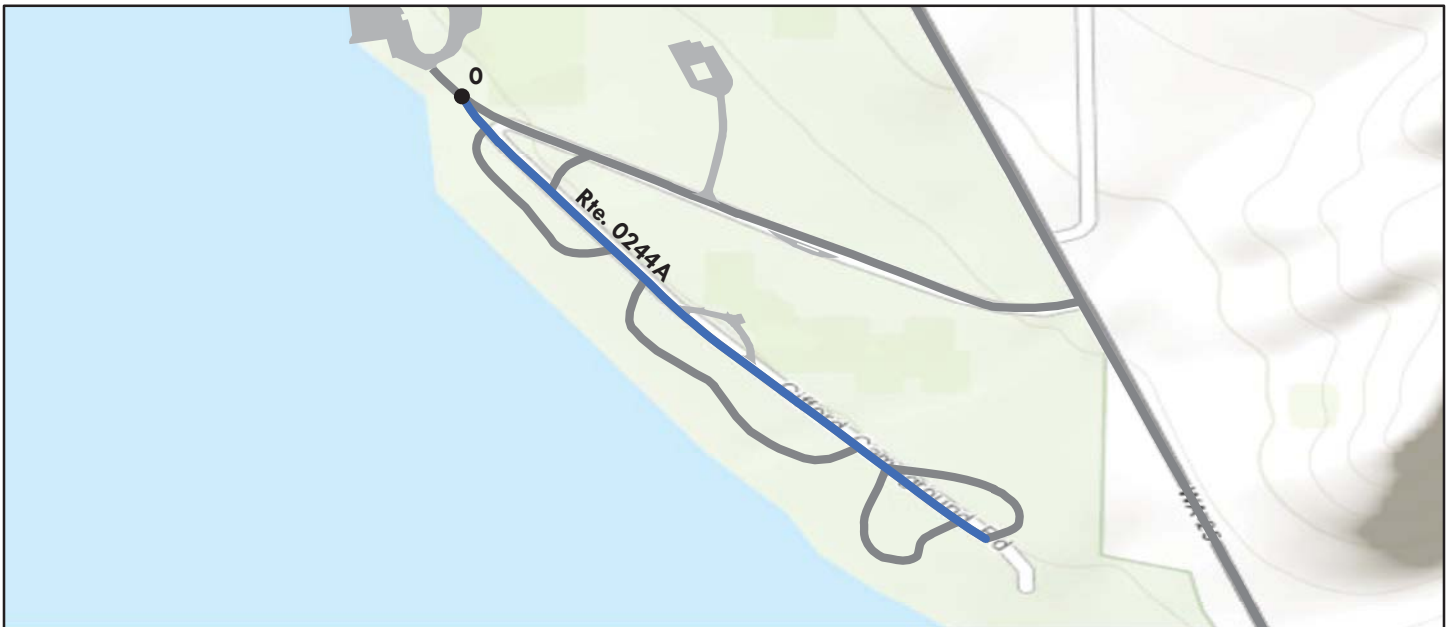
ROUTE 0244A: GIFFORD CAMPGROUND ROAD

Route Condition Legend – Pavement Condition Rating (PCR)						
Poor (0 - 60)	Fair (61- 84)	Good (85 - 94)	Excellent (95 - 100)	Not Rated		
See Appendix for definitions and formulas						
Inspection Date: 10/2/2015	Beginning Section MP	0				
Paved Length (Miles): 0.33	Section Length (MI)	0.33				
Surface Type: ASPHALT	Route Summary					
Roadway Condition Information						
Pavement Condition Rating (PCR)	97	97				
Surface Condition Rating (SCR)	97	97				
Roughness Condition Index (RCI)	N/A	N/A				
Distress Index Values						
Structural Crack Index	100	100				
Alligator Crack Index	100	100				
Longitudinal Crack Index	100	100				
Transverse Cracking Index	100	100				
Patching Index	100	100				
Rutting Index	97	97				
International Roughness Index (IRI)	N/A	N/A				
Lane & Width Information						
Number of Lanes	2	2				
Paved Width (ft)	21.7	21.7				
Lane Width (ft)	10.9	10.9

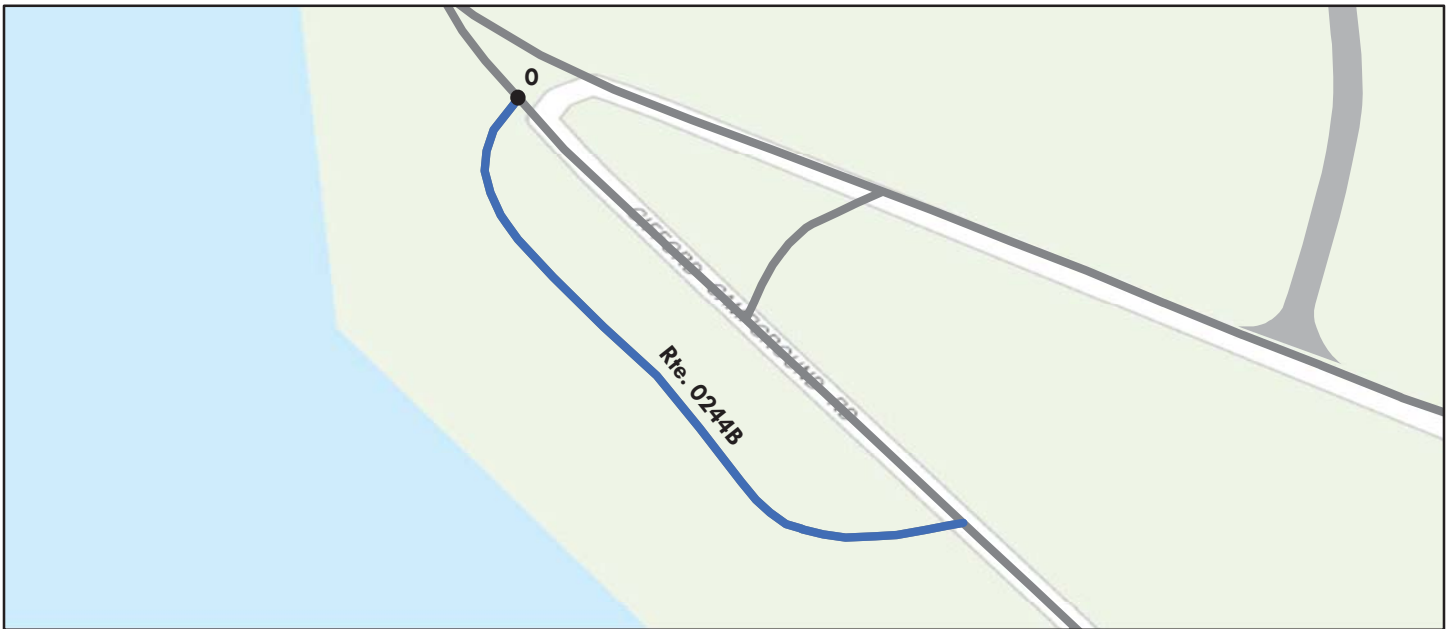
ROUTE 0244B: GIFFORD CAMPGROUND LOOP B

Route Condition Legend – Pavement Condition Rating (PCR)						
Poor (0 - 60)	Fair (61- 84)	Good (85 - 94)	Excellent (95 - 100)	Not Rated		
See Appendix for definitions and formulas						
Inspection Date: 10/2/2015	Beginning Section MP	0				
Paved Length (Miles): 0.09	Section Length (MI)	0.09				
Surface Type: ASPHALT	Route Summary					
Roadway Condition Information						
Pavement Condition Rating (PCR)	96	96				
Surface Condition Rating (SCR)	96	96				
Roughness Condition Index (RCI)	N/A	N/A				
Distress Index Values						
Structural Crack Index	100	100				
Alligator Crack Index	100	100				
Longitudinal Crack Index	100	100				
Transverse Cracking Index	100	100				
Patching Index	100	100				
Rutting Index	96	96				
International Roughness Index (IRI)	N/A	N/A				
Lane & Width Information						
Number of Lanes	1	1				
Paved Width (ft)	13.9	13.9				
Lane Width (ft)	13.9	13.9

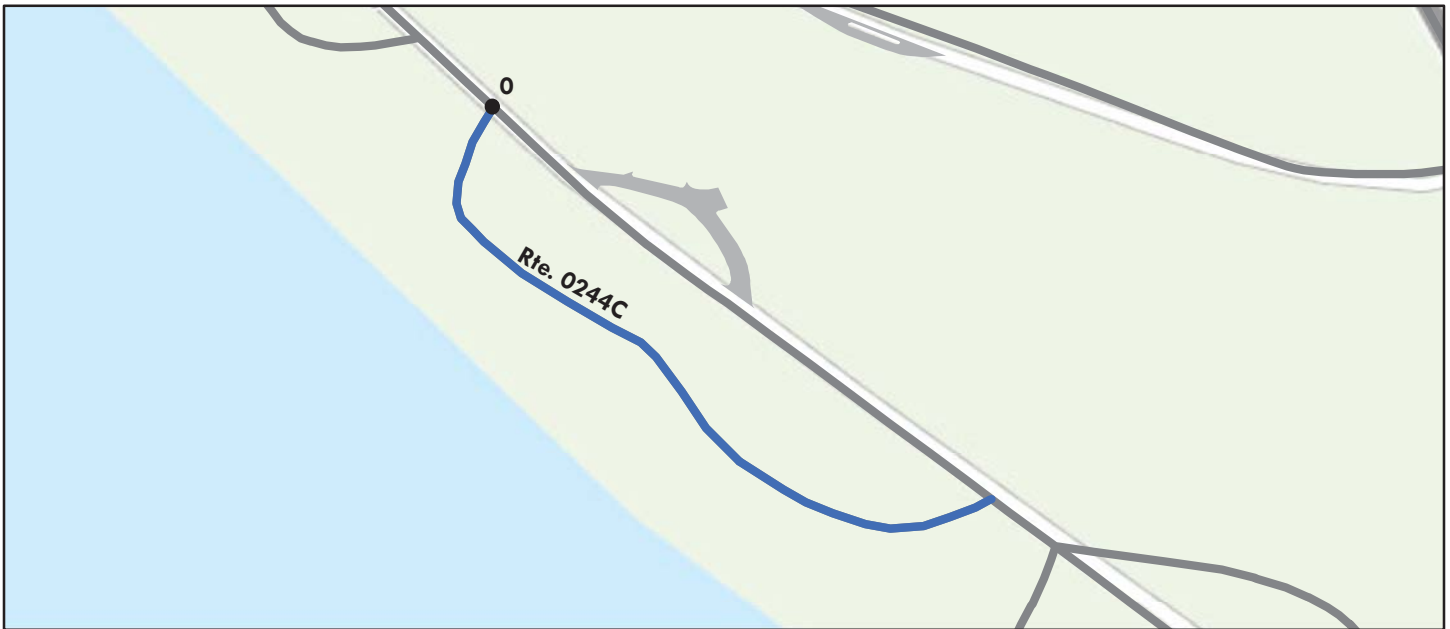
ROUTE 0244C: GIFFORD CAMPGROUND LOOP C

Route Condition Legend – Pavement Condition Rating (PCR)						
Poor (0 - 60)	Fair (61- 84)	Good (85 - 94)	Excellent (95 - 100)	Not Rated		
See Appendix for definitions and formulas						
Inspection Date: 10/2/2015	Beginning Section MP	0				
Paved Length (Miles): 0.15	Section Length (MI)	0.15				
Surface Type: ASPHALT	Route Summary					
Roadway Condition Information						
Pavement Condition Rating (PCR)	98	98				
Surface Condition Rating (SCR)	98	98				
Roughness Condition Index (RCI)	N/A	N/A				
Distress Index Values						
Structural Crack Index	100	100				
Alligator Crack Index	100	100				
Longitudinal Crack Index	100	100				
Transverse Cracking Index	100	100				
Patching Index	100	100				
Rutting Index	98	98				
International Roughness Index (IRI)	N/A	N/A				
Lane & Width Information						
Number of Lanes	1	1				
Paved Width (ft)	15.2	15.2				
Lane Width (ft)	15.2	15.2

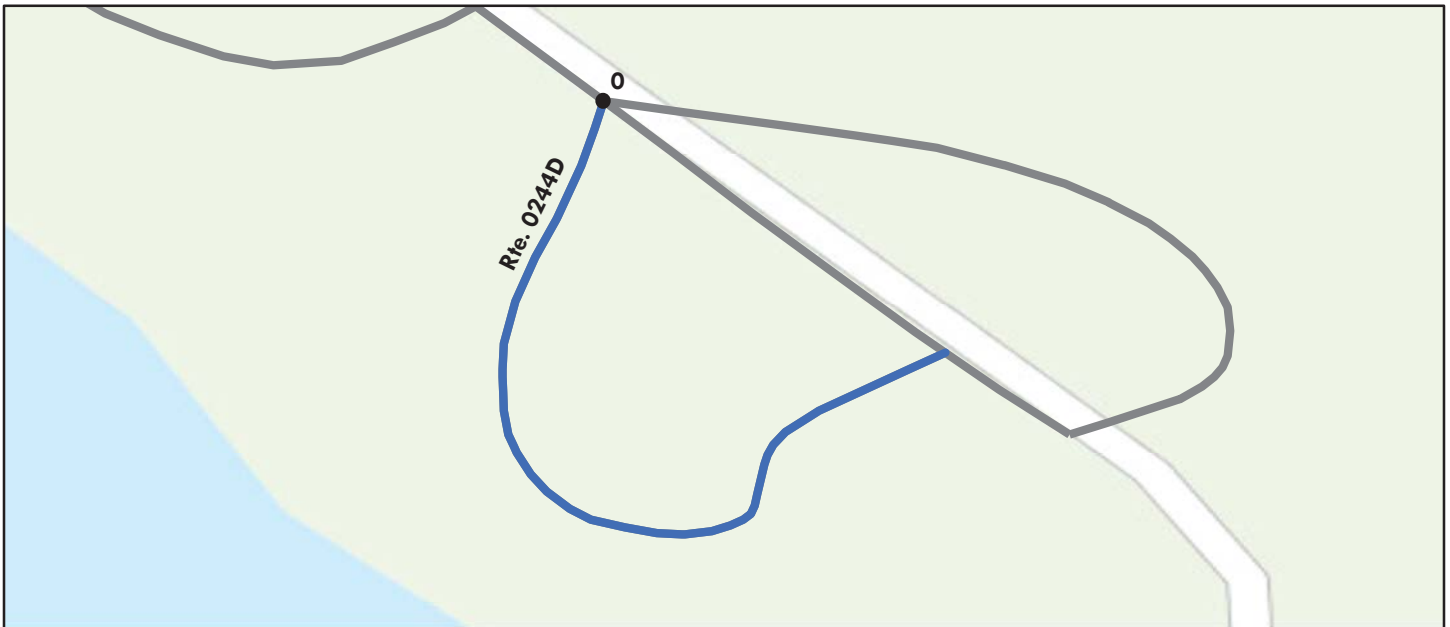
ROUTE 0244D: GIFFORD CAMPGROUND LOOP D

Route Condition Legend – Pavement Condition Rating (PCR)						
Poor (0 - 60)	Fair (61- 84)	Good (85 - 94)	Excellent (95 - 100)	Not Rated		
See Appendix for definitions and formulas						
Inspection Date:	10/2/2015	Beginning Section MP	0			
Paved Length (Miles):	0.09	Section Length (MI)	0.09			
Surface Type:	ASPHALT	Route Summary				
Roadway Condition Information						
Pavement Condition Rating (PCR)	97	97				
Surface Condition Rating (SCR)	97	97				
Roughness Condition Index (RCI)	N/A	N/A				
Distress Index Values						
Structural Crack Index	100	100				
Alligator Crack Index	100	100				
Longitudinal Crack Index	100	100				
Transverse Cracking Index	99	99				
Patching Index	100	100				
Rutting Index	97	97				
International Roughness Index (IRI)	N/A	N/A				
Lane & Width Information						
Number of Lanes	1	1				
Paved Width (ft)	13	13				
Lane Width (ft)	13	13

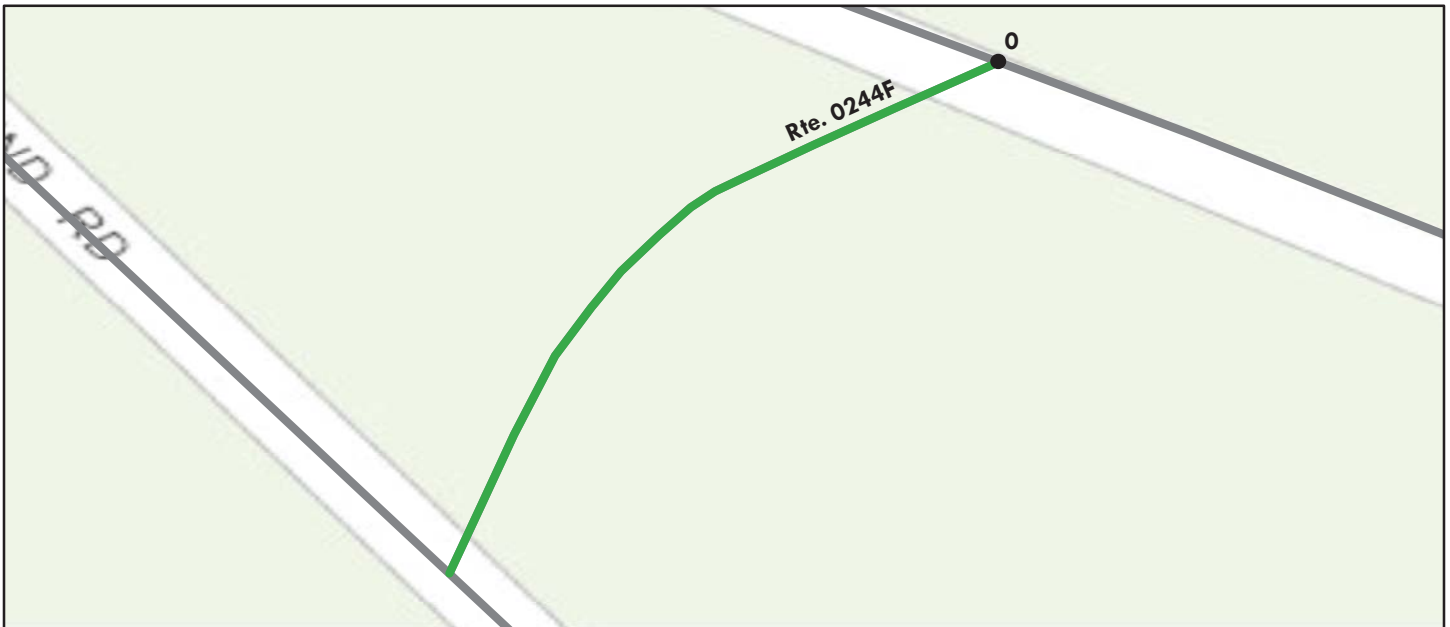
ROUTE 0244F: GIFFORD CAMPGROUND EXIT SPUR

Route Condition Legend – Pavement Condition Rating (PCR)						
Poor (0 - 60)	Fair (61- 84)	Good (85 - 94)	Excellent (95 - 100)	Not Rated		
See Appendix for definitions and formulas						
Inspection Date: 10/2/2015	Beginning Section MP	0				
Paved Length (Miles): 0.02	Section Length (MI)	0.02				
Surface Type: ASPHALT	Route Summary					
Roadway Condition Information						
Pavement Condition Rating (PCR)	91	91				
Surface Condition Rating (SCR)	91	91				
Roughness Condition Index (RCI)	N/A	N/A				
Distress Index Values						
Structural Crack Index	100	100				
Alligator Crack Index	100	100				
Longitudinal Crack Index	100	100				
Transverse Cracking Index	100	100				
Patching Index	100	100				
Rutting Index	91	91				
International Roughness Index (IRI)	N/A	N/A				
Lane & Width Information						
Number of Lanes	2	2				
Paved Width (ft)	19.9	19.9				
Lane Width (ft)	9.9	9.9

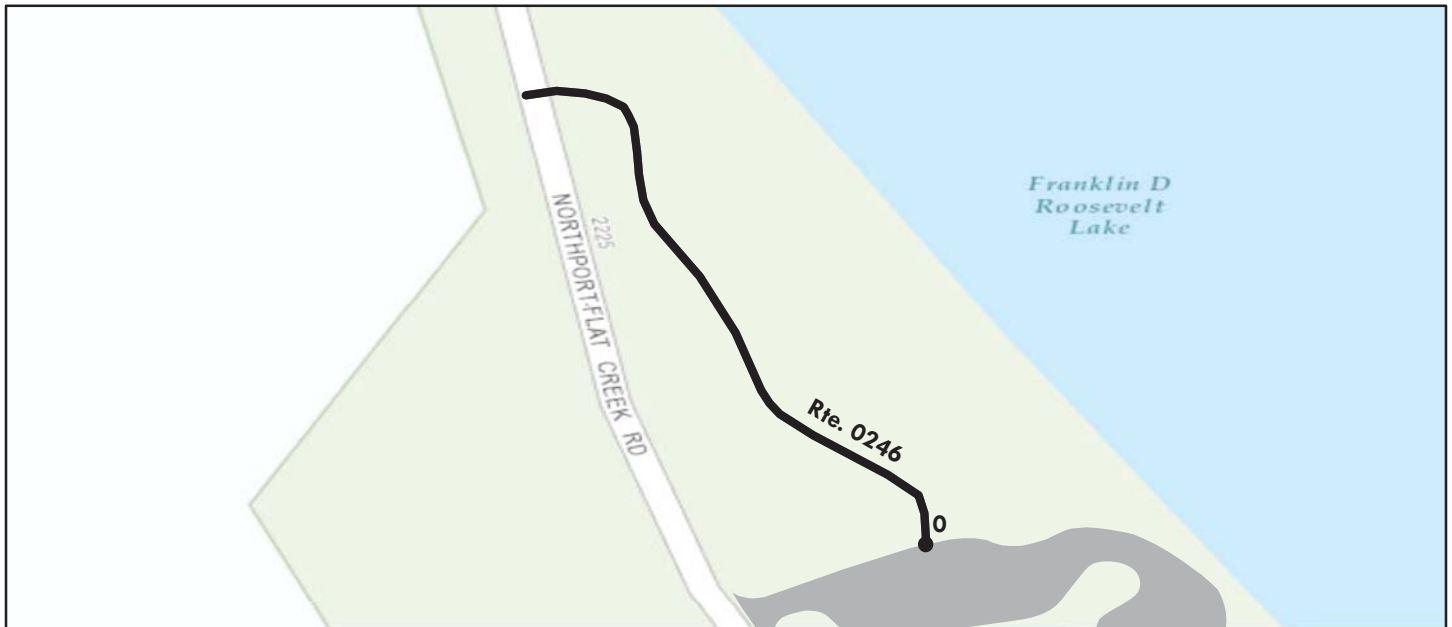
ROUTE 0246: SNAG COVE CAMPGROUND LOOP

Route Condition Legend – Pavement Condition Rating (PCR)						
Poor (0 - 60)	Fair (61- 84)	Good (85 - 94)	Excellent (95 - 100)	Not Rated		
See Appendix for definitions and formulas						
Inspection Date: 10/2/2015	Beginning Section MP	0				
Paved Length (Miles): 0.09	Section Length (MI)	0.09				
Surface Type: ASPHALT	Route Summary					
Roadway Condition Information						
Pavement Condition Rating (PCR)	N/A	N/A				
Surface Condition Rating (SCR)	N/A	N/A				
Roughness Condition Index (RCI)	N/A	N/A				
Distress Index Values						
Structural Crack Index	N/A	N/A				
Alligator Crack Index	N/A	N/A				
Longitudinal Crack Index	N/A	N/A				
Transverse Cracking Index	N/A	N/A				
Patching Index	N/A	N/A				
Rutting Index	N/A	N/A				
International Roughness Index (IRI)	N/A	N/A				
Lane & Width Information						
Number of Lanes	1	1				
Paved Width (ft)	11.4	11.4				
Lane Width (ft)	11.4	11.4

Note: This road did not receive a condition rating due to debris on road (leaves / pine needles).

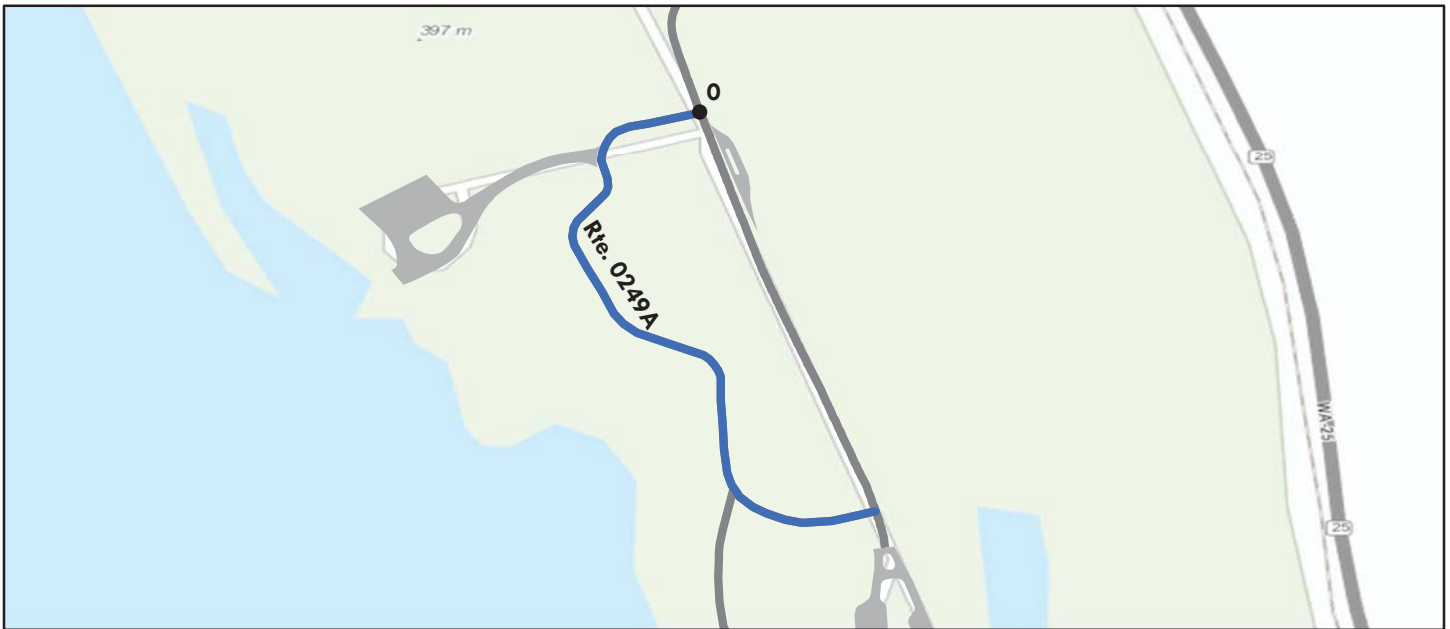
ROUTE 0249A: EVANS CAMPGROUND LOOP A

Route Condition Legend – Pavement Condition Rating (PCR)						
Poor (0 - 60)	Fair (61- 84)	Good (85 - 94)	Excellent (95 - 100)	Not Rated		
See Appendix for definitions and formulas						
Inspection Date: 10/2/2015	Beginning Section MP	0				
Paved Length (Miles): 0.22	Section Length (MI)	0.22				
Surface Type: ASPHALT	Route Summary					
Roadway Condition Information						
Pavement Condition Rating (PCR)	97	97				
Surface Condition Rating (SCR)	97	97				
Roughness Condition Index (RCI)	N/A	N/A				
Distress Index Values						
Structural Crack Index	100	100				
Alligator Crack Index	100	100				
Longitudinal Crack Index	100	100				
Transverse Cracking Index	99	99				
Patching Index	100	100				
Rutting Index	97	97				
International Roughness Index (IRI)	N/A	N/A				
Lane & Width Information						
Number of Lanes	2	2				
Paved Width (ft)	19.1	19.1				
Lane Width (ft)	9.6	9.6

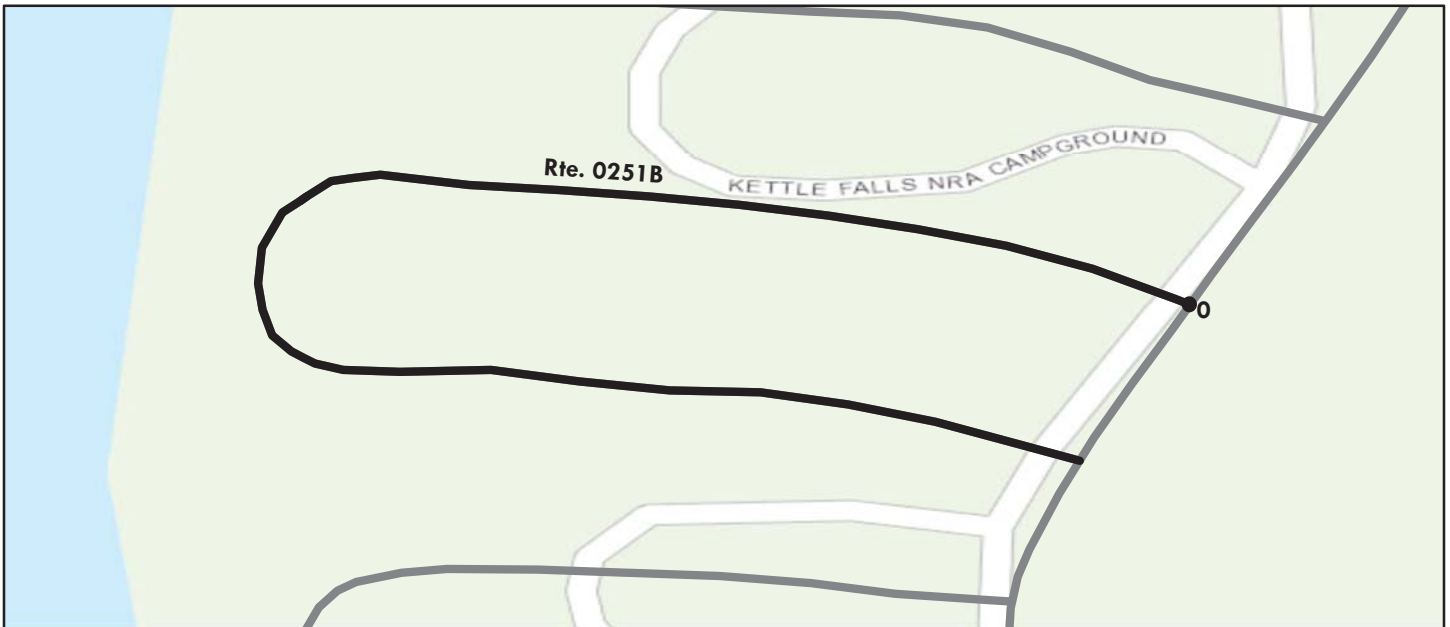
ROUTE 0251B: KETTLE FALLS CAMPGROUND LOOP 2

Route Condition Legend – Pavement Condition Rating (PCR)						
Poor (0 - 60)	Fair (61- 84)	Good (85 - 94)	Excellent (95 - 100)	Not Rated		
See Appendix for definitions and formulas						
Inspection Date: 10/2/2015	Beginning Section MP	0				
Paved Length (Miles): 0.21	Section Length (MI)	0.21				
Surface Type: ASPHALT	Route Summary					
Roadway Condition Information						
Pavement Condition Rating (PCR)	N/A	N/A				
Surface Condition Rating (SCR)	N/A	N/A				
Roughness Condition Index (RCI)	N/A	N/A				
Distress Index Values						
Structural Crack Index	N/A	N/A				
Alligator Crack Index	N/A	N/A				
Longitudinal Crack Index	N/A	N/A				
Transverse Cracking Index	N/A	N/A				
Patching Index	N/A	N/A				
Rutting Index	N/A	N/A				
International Roughness Index (IRI)	N/A	N/A				
Lane & Width Information						
Number of Lanes	1	1				
Paved Width (ft)	12	12				
Lane Width (ft)	12	12

Note: This road did not receive a condition rating due to debris on road (leaves / pine needles).

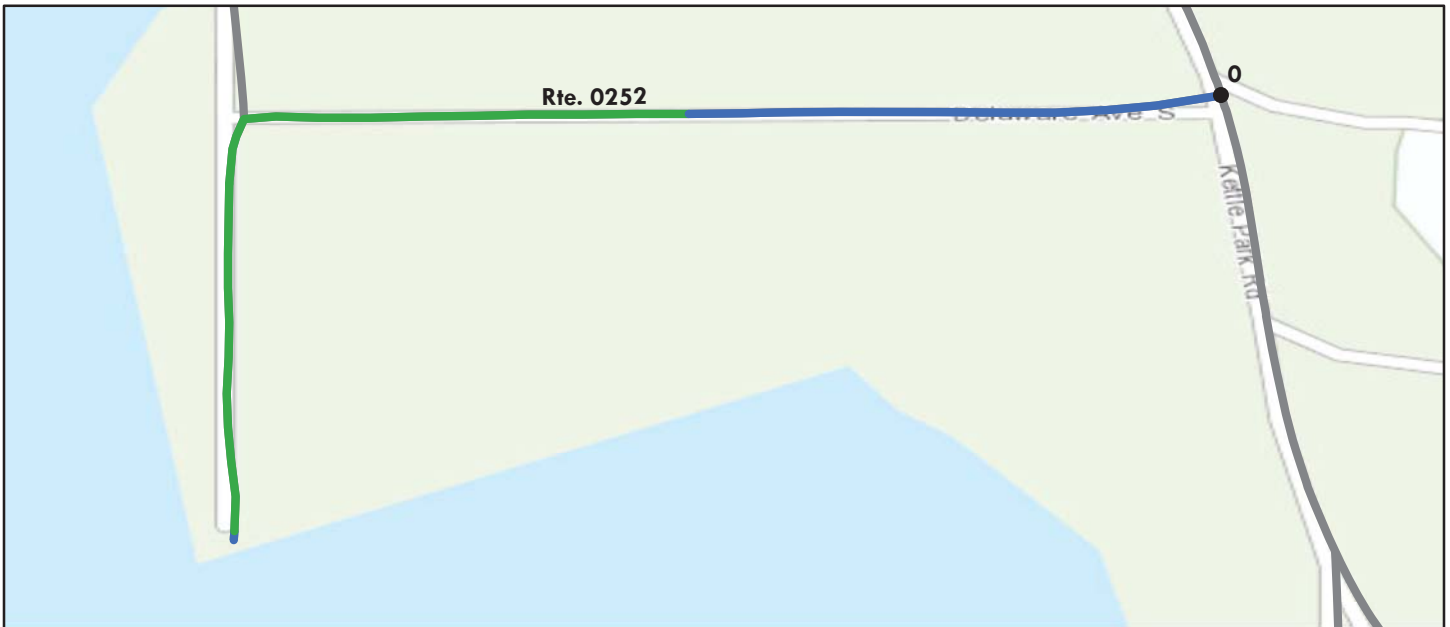
ROUTE 0252: KETTLE FALLS LOCUST GROVE GROUP CAMPGROUND ROAD

Route Condition Legend – Pavement Condition Rating (PCR)						
Poor (0 - 60)	Fair (61- 84)	Good (85 - 94)	Excellent (95 - 100)	Not Rated		
See Appendix for definitions and formulas						
Inspection Date: 10/2/2015	Beginning Section MP	0				
Paved Length (Miles): 0.3	Section Length (MI)	0.3				
Surface Type: ASPHALT	Route Summary					
Roadway Condition Information						
Pavement Condition Rating (PCR)	94	94				
Surface Condition Rating (SCR)	94	94				
Roughness Condition Index (RCI)	N/A	N/A				
Distress Index Values						
Structural Crack Index	94	94				
Alligator Crack Index	100	100				
Longitudinal Crack Index	94	94				
Transverse Cracking Index	94	94				
Patching Index	100	100				
Rutting Index	95	95				
International Roughness Index (IRI)	N/A	N/A				
Lane & Width Information						
Number of Lanes	1	1				
Paved Width (ft)	13.3	13.3				
Lane Width (ft)	13.3	13.3

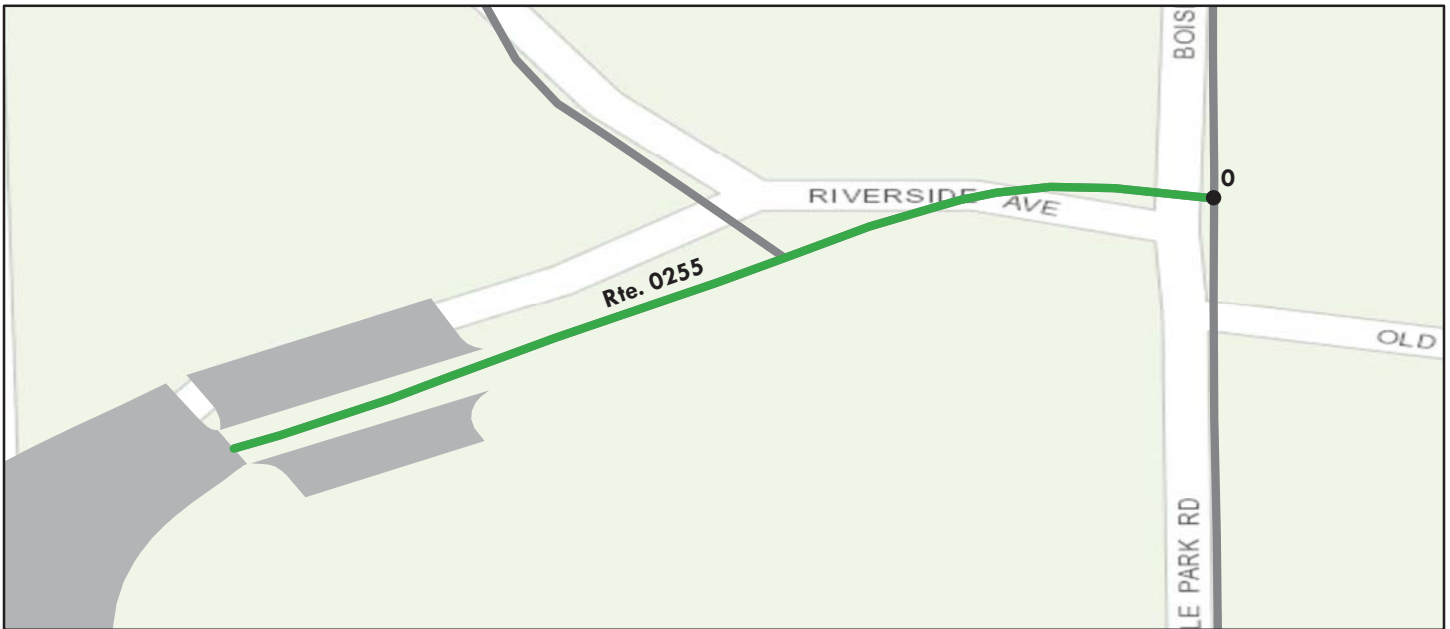
ROUTE 0255: KETTLE FALLS FACILITIES ROAD

Route Condition Legend – Pavement Condition Rating (PCR)						
Poor (0 - 60)	Fair (61- 84)	Good (85 - 94)	Excellent (95 - 100)	Not Rated		
See Appendix for definitions and formulas						
Inspection Date:	10/2/2015	Beginning Section MP	0			
Paved Length (Miles):	0.06	Section Length (MI)	0.06			
Surface Type:	ASPHALT	Route Summary				
Roadway Condition Information						
Pavement Condition Rating (PCR)	89	89				
Surface Condition Rating (SCR)	89	89				
Roughness Condition Index (RCI)	N/A	N/A				
Distress Index Values						
Structural Crack Index	97	97				
Alligator Crack Index	100	100				
Longitudinal Crack Index	97	97				
Transverse Cracking Index	89	89				
Patching Index	100	100				
Rutting Index	96	96				
International Roughness Index (IRI)	N/A	N/A				
Lane & Width Information						
Number of Lanes	2	2				
Paved Width (ft)	15.2	15.2				
Lane Width (ft)	7.6	7.6

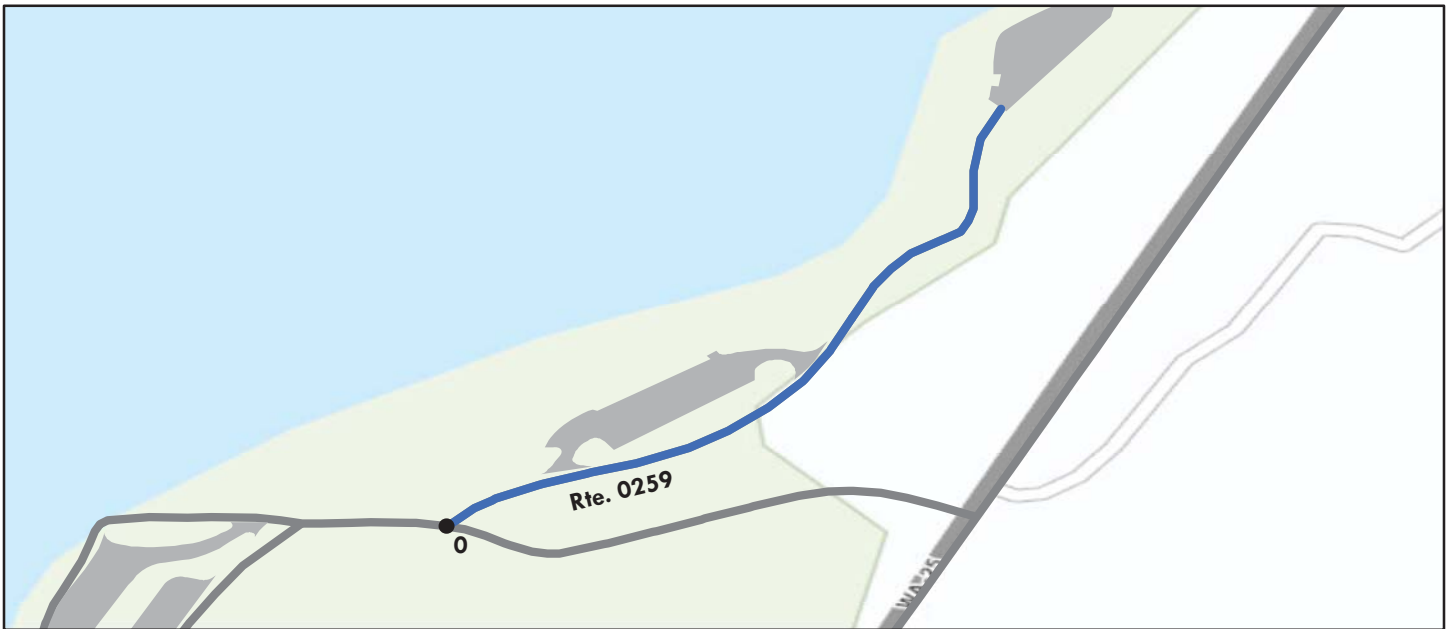
ROUTE 0259: BRADBURY DAY USE ACCESS ROAD

Data Collection Vehicle (DCV) Rating

Route Condition Legend – Pavement Condition Rating (PCR)						
Poor (0 - 60)	Fair (61- 84)	Good (85 - 94)	Excellent (95 - 100)	Not Rated		
See Appendix for definitions and formulas						
Inspection Date:	10/2/2015	Beginning Section MP	0			
Paved Length (Miles):	0.17	Section Length (MI)	0.17			
Surface Type:	ASPHALT	Route Summary				
Roadway Condition Information						
Pavement Condition Rating (PCR)	99	99				
Surface Condition Rating (SCR)	99	99				
Roughness Condition Index (RCI)	N/A	N/A				
Distress Index Values						
Structural Crack Index	100	100				
Alligator Crack Index	100	100				
Longitudinal Crack Index	100	100				
Transverse Cracking Index	99	99				
Patching Index	100	100				
Rutting Index	99	99				
International Roughness Index (IRI)	N/A	N/A				
Lane & Width Information						
Number of Lanes	1	1				
Paved Width (ft)	13.6	13.6				
Lane Width (ft)	12.6	12.6

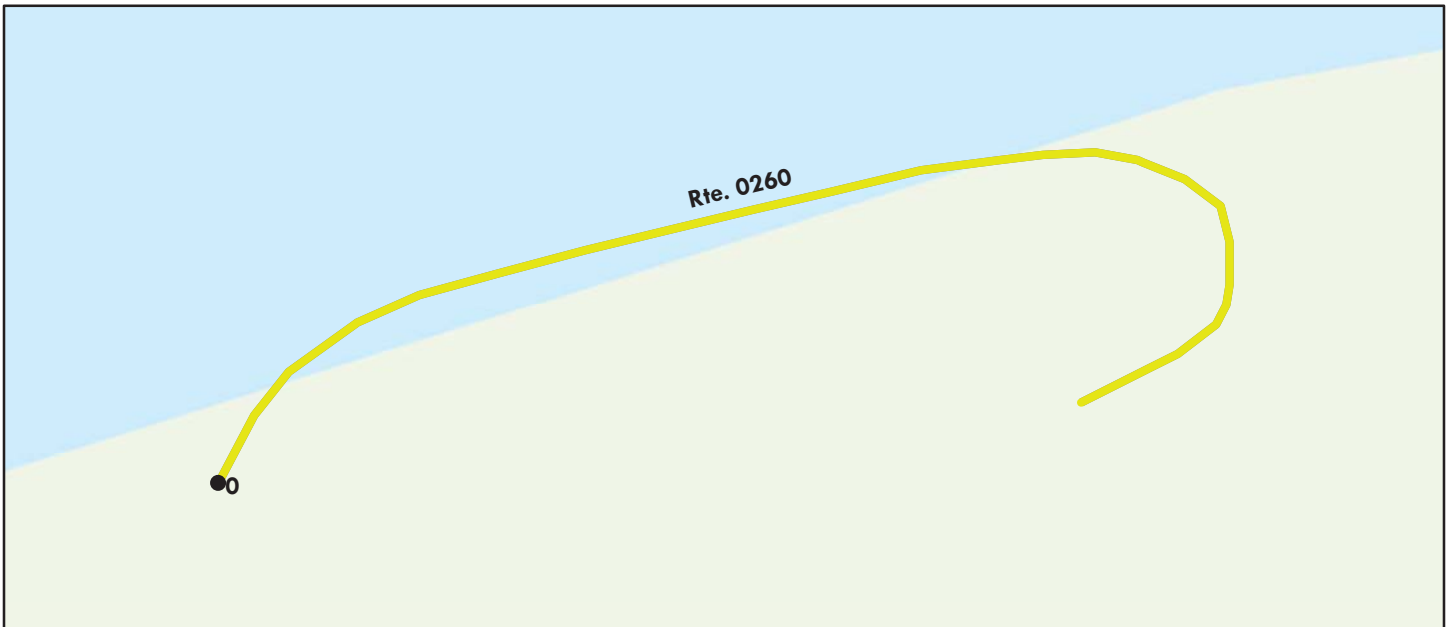
ROUTE 0260: KELLER FERRY FLOATING DOCK HOUSE ROAD

Data Collection Vehicle (DCV) Rating

Route Condition Legend – Pavement Condition Rating (PCR)						
Poor (0 - 60)	Fair (61- 84)	Good (85 - 94)	Excellent (95 - 100)	Not Rated		
See Appendix for definitions and formulas						
Inspection Date:	10/1/2015	Beginning Section MP	0			
Paved Length (Miles):	0.09	Section Length (MI)	0.09			
Surface Type:	ASPHALT	Route Summary				
Roadway Condition Information						
Pavement Condition Rating (PCR)	84	84				
Surface Condition Rating (SCR)	84	84				
Roughness Condition Index (RCI)	N/A	N/A				
Distress Index Values						
Structural Crack Index	99	99				
Alligator Crack Index	100	100				
Longitudinal Crack Index	99	99				
Transverse Cracking Index	84	84				
Patching Index	100	100				
Rutting Index	89	89				
International Roughness Index (IRI)	N/A	N/A				
Lane & Width Information						
Number of Lanes	1	1				
Paved Width (ft)	12.2	12.2				
Lane Width (ft)	12.2	12.2

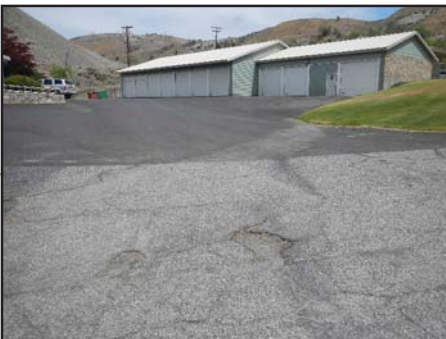
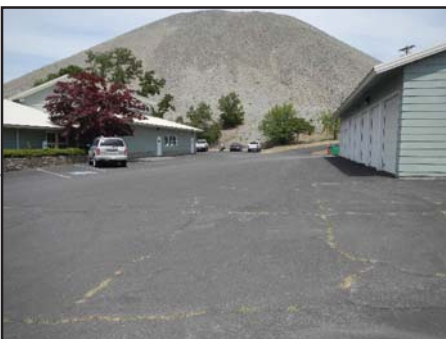
ROUTE 0901: SPRING CANYON HOUSING PARKING

Inspection Date	FMSS Number	User Access	Surface Type
6/22/2015	39277	NONPUBLIC	ASPHALT
Area (Sq. Ft.)	Lane Miles (11' Widths)	Curb Reveal (Inches)	Curb Recommendation
8,785	0.151	NOT APPLICABLE	NOT APPLICABLE
Curb Type		Curb & Gutter Type	
NO CURB		NO CURB AND GUTTER	
Pavement Recommendation		Condition Rating / PCR	
HEAVY 3R TREATMENTS		POOR / 53
