LARO Cycle 6

Final Report

Road Inventory and Condition Assessment of Paved Routes Lake Roosevelt National Recreation Area

**Federal Highway Administration
Eastern Federal Lands Highway Division
Road Inventory Program (RIP)**

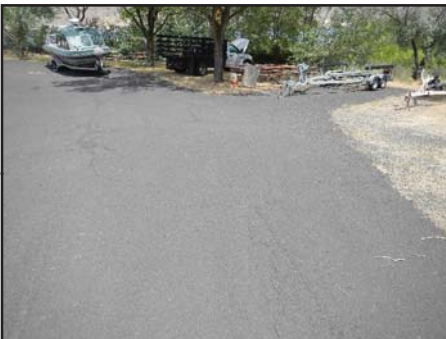
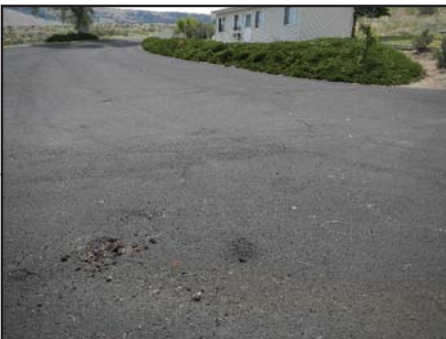
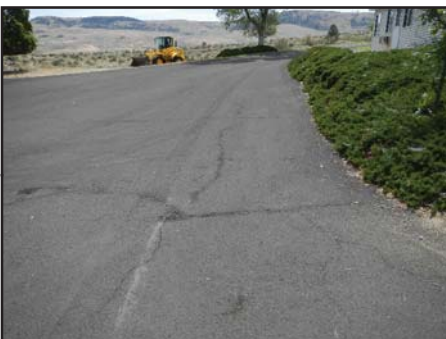
ROUTE 0902G: SPRING CANYON BOAT LAUNCH PARKING G

Inspection Date	FMSS Number	User Access	Surface Type
6/22/2015	105463	PUBLIC	ASPHALT
Area (Sq. Ft.)	Lane Miles (11' Widths)	Curb Reveal (Inches)	Curb Recommendation
41,488	0.714	NOT APPLICABLE	DO NOTHING
Curb Type		Curb & Gutter Type	
NO CURB		CONCRETE	
Pavement Recommendation		Condition Rating / PCR	
PREVENTIVE MAINTENANCE		GOOD / 90

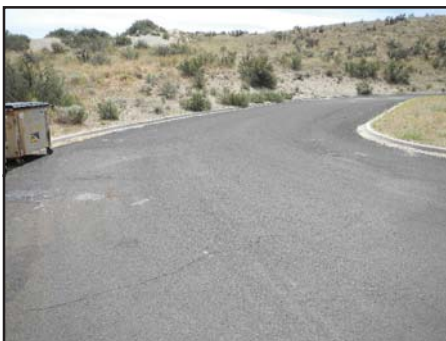
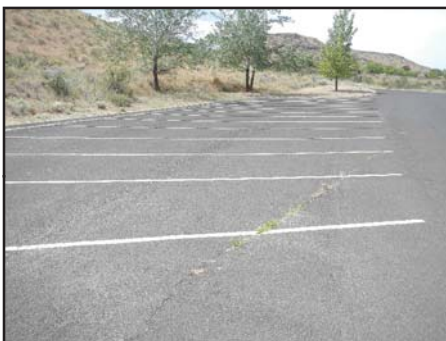
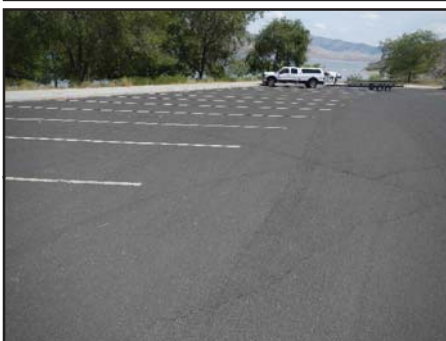
ROUTE 0902H: SPRING CANYON BOAT LAUNCH PARKING H

Inspection Date	FMSS Number	User Access	Surface Type
6/22/2015	108149	PUBLIC	ASPHALT
Area (Sq. Ft.)	Lane Miles (11' Widths)	Curb Reveal (Inches)	Curb Recommendation
27,648	0.476	NOT APPLICABLE	NOT APPLICABLE
Curb Type		Curb & Gutter Type	
NO CURB		NO CURB AND GUTTER	
Pavement Recommendation		Condition Rating / PCR	
HEAVY 3R TREATMENTS		POOR / 53

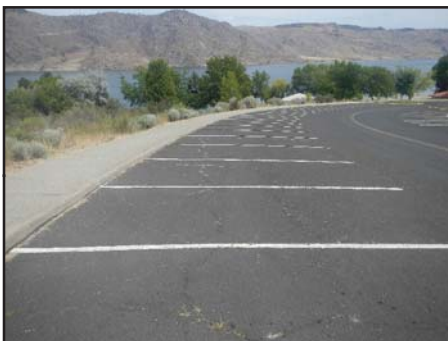
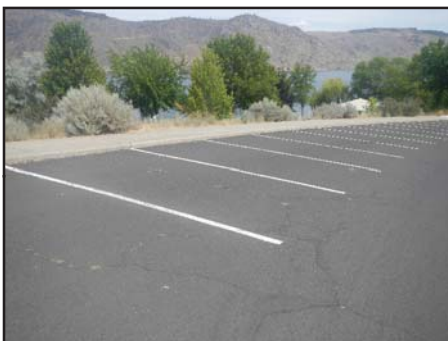
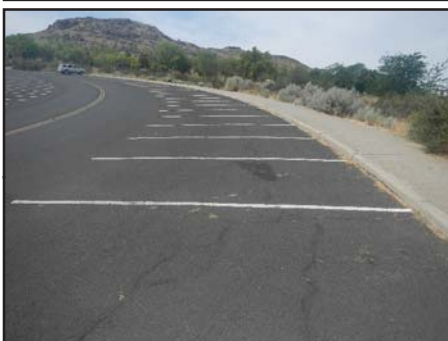
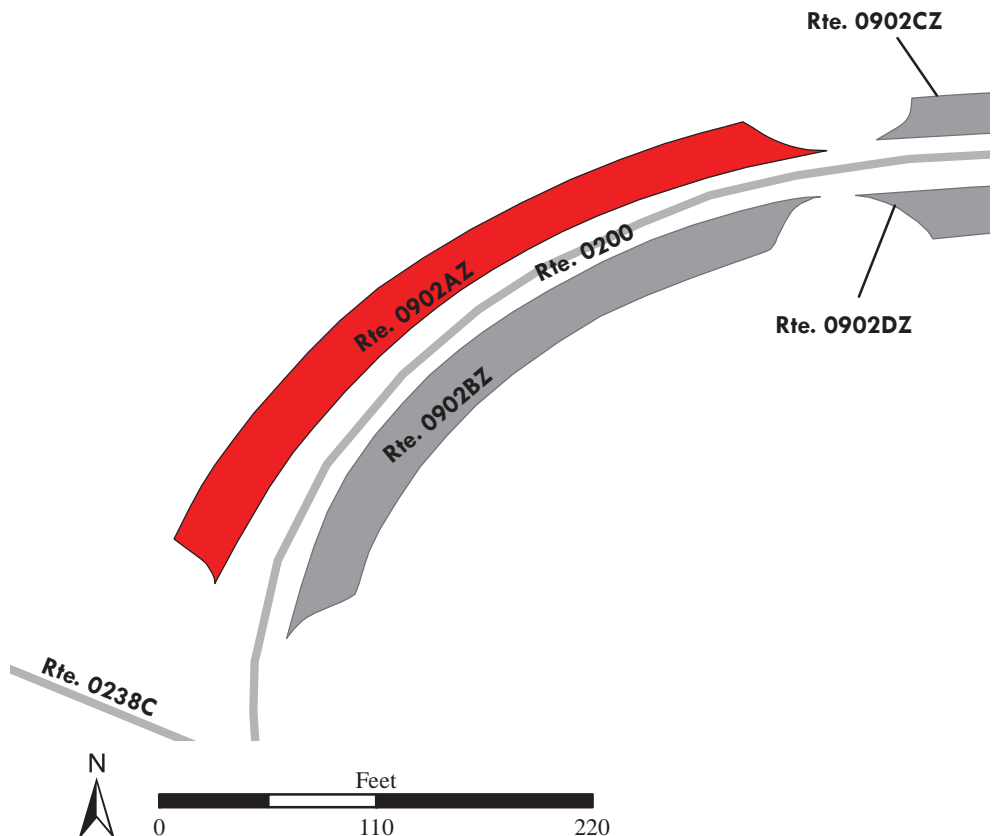
ROUTE 0902AZ: SPRING CANYON DAY USE PARKING A

Inspection Date	FMSS Number	User Access	Surface Type
6/22/2015	39278	PUBLIC	ASPHALT
Area (Sq. Ft.)	Lane Miles (11' Widths)	Curb Reveal (Inches)	Curb Recommendation
6,406	0.11	5	DO NOTHING
Curb Type		Curb & Gutter Type	
CONCRETE		NO CURB AND GUTTER	
Pavement Recommendation		Condition Rating / PCR	
HEAVY 3R TREATMENTS		POOR / 53

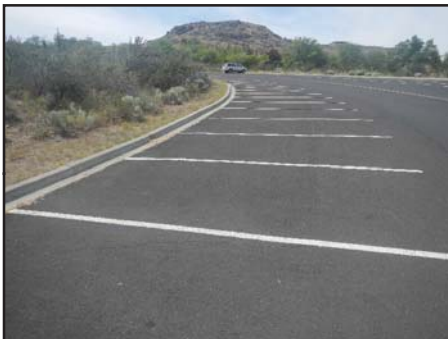
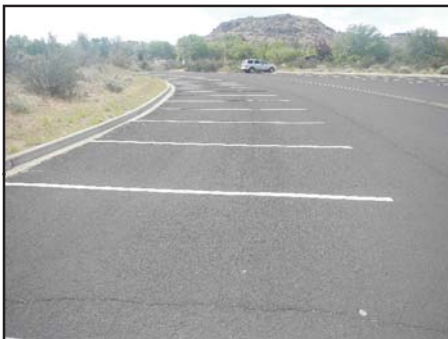
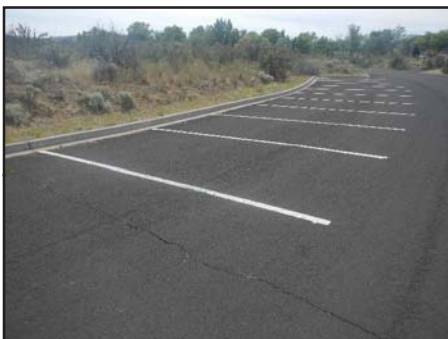
ROUTE 0902BZ: SPRING CANYON DAY USE PARKING B

Inspection Date	FMSS Number	User Access	Surface Type
6/22/2015	39278	PUBLIC	ASPHALT
Area (Sq. Ft.)	Lane Miles (11' Widths)	Curb Reveal (Inches)	Curb Recommendation
5,695	0.098	NOT APPLICABLE	DO NOTHING
Curb Type		Curb & Gutter Type	
NO CURB		CONCRETE	
Pavement Recommendation		Condition Rating / PCR	
PREVENTIVE MAINTENANCE		GOOD / 90

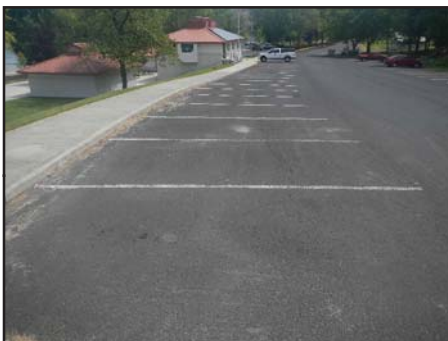
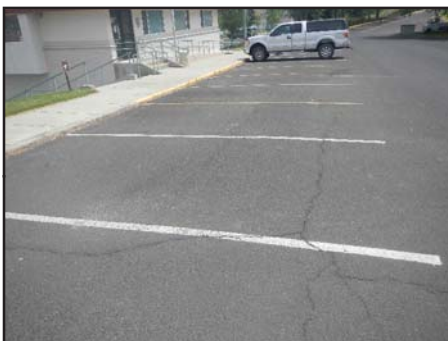
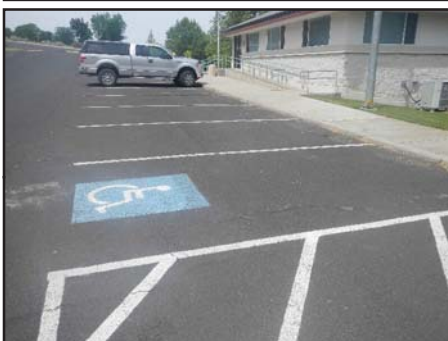
ROUTE 0902CZ: SPRING CANYON DAY USE PARKING C

Inspection Date	FMSS Number	User Access	Surface Type
6/22/2015	39278	PUBLIC	ASPHALT
Area (Sq. Ft.)	Lane Miles (11' Widths)	Curb Reveal (Inches)	Curb Recommendation
5,638	0.097	3	DO NOTHING
Curb Type		Curb & Gutter Type	
CONCRETE		NO CURB AND GUTTER	
Pavement Recommendation		Condition Rating / PCR	
HEAVY 3R TREATMENTS		POOR / 53

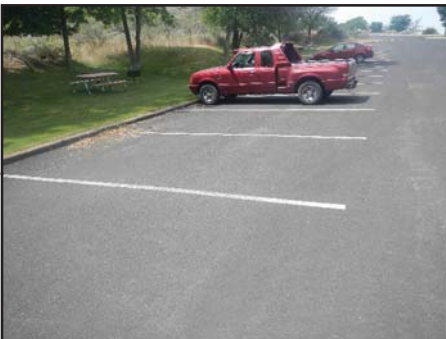
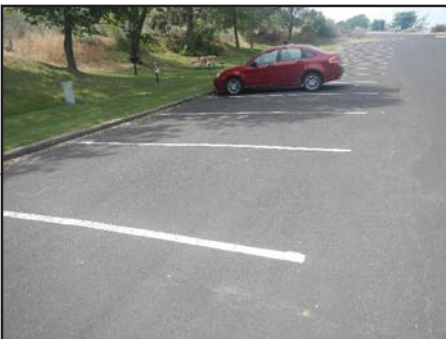
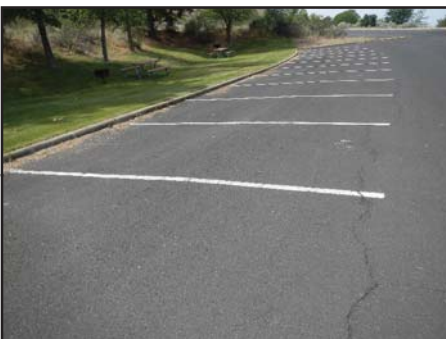
ROUTE 0902DZ: SPRING CANYON DAY USE PARKING D

Inspection Date	FMSS Number	User Access	Surface Type
6/22/2015	39278	PUBLIC	ASPHALT
Area (Sq. Ft.)	Lane Miles (11' Widths)	Curb Reveal (Inches)	Curb Recommendation
5,986	0.103	4	LIGHT REPAIR
Curb Type		Curb & Gutter Type	
CONCRETE		NO CURB AND GUTTER	
Pavement Recommendation		Condition Rating / PCR	
PREVENTIVE MAINTENANCE		GOOD / 90

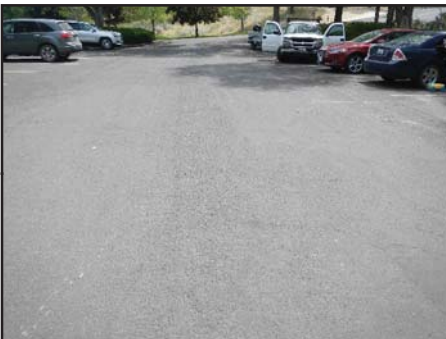
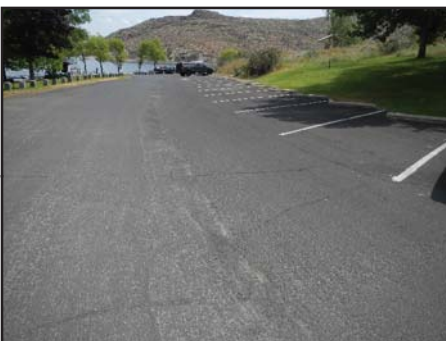
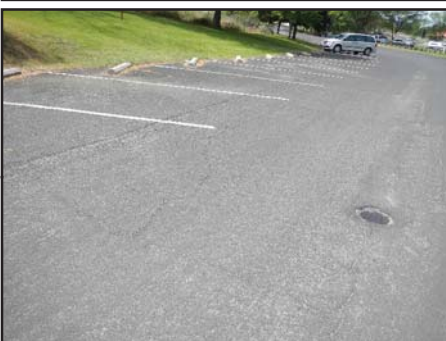
ROUTE 0902FZ: SPRING CANYON DAY USE PARKING F

Inspection Date	FMSS Number	User Access	Surface Type
6/22/2015	39278	PUBLIC	ASPHALT
Area (Sq. Ft.)	Lane Miles (11' Widths)	Curb Reveal (Inches)	Curb Recommendation
3,290	0.057	NOT APPLICABLE	NOT APPLICABLE
Curb Type		Curb & Gutter Type	
NO CURB		NO CURB AND GUTTER	
Pavement Recommendation		Condition Rating / PCR	
HEAVY 3R TREATMENTS		POOR / 53

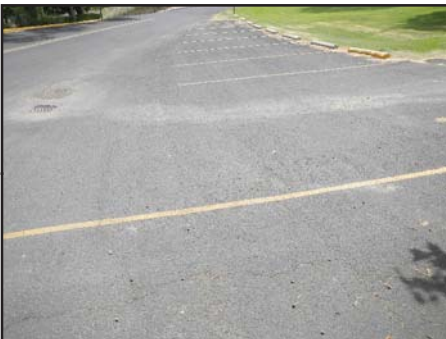
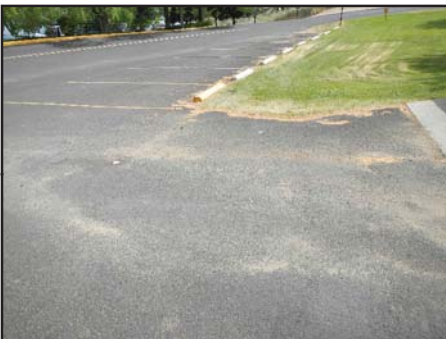
ROUTE 0904: SPRING CANYON RV CAMPGROUND PARKING

Inspection Date	FMSS Number	User Access	Surface Type
6/22/2015	39280	PUBLIC	ASPHALT
Area (Sq. Ft.)	Lane Miles (11' Widths)	Curb Reveal (Inches)	Curb Recommendation
53,107	0.914	NOT APPLICABLE	LIGHT REPAIR
Curb Type		Curb & Gutter Type	
NO CURB		CONCRETE	
Pavement Recommendation		Condition Rating / PCR	
HEAVY 3R TREATMENTS		POOR / 53

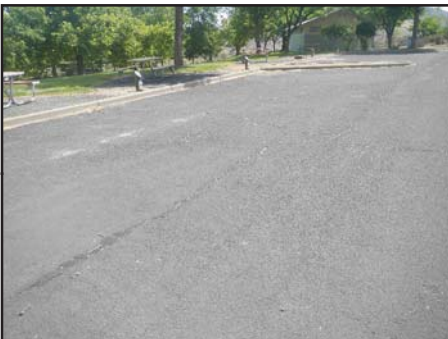
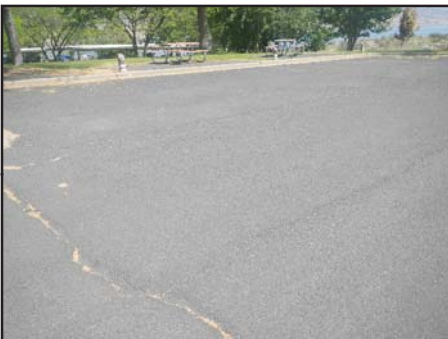
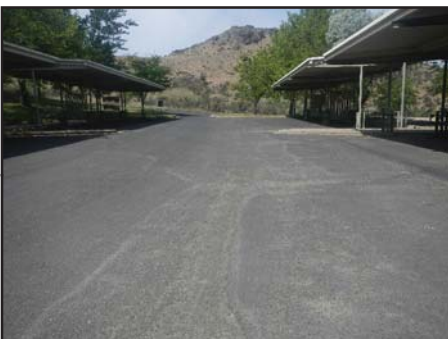
ROUTE 0905: FORT SPOKANE FACILITIES PARKING

Inspection Date	FMSS Number	User Access	Surface Type
6/21/2015	39281	PUBLIC	ASPHALT
Area (Sq. Ft.)	Lane Miles (11' Widths)	Curb Reveal (Inches)	Curb Recommendation
36,269	0.624	NOT APPLICABLE	NOT APPLICABLE
Curb Type		Curb & Gutter Type	
NO CURB		NO CURB AND GUTTER	
Pavement Recommendation		Condition Rating / PCR	
HEAVY 3R TREATMENTS		POOR / 53

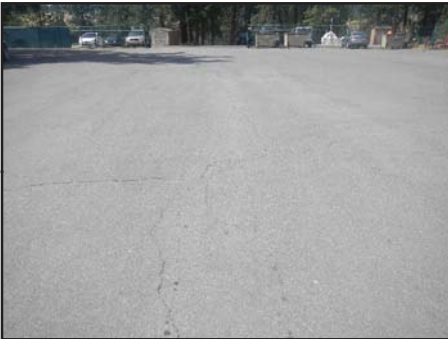
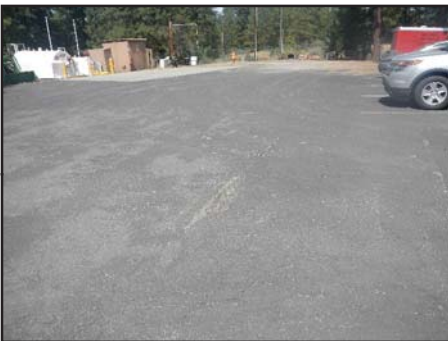
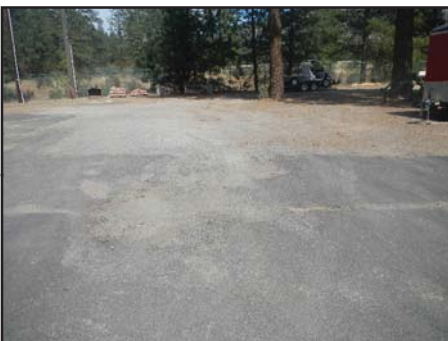
ROUTE 0906: FORT SPOKANE VISITOR CENTER PARKING

Parking area consists of multiple surface types: 1 part Asphalt at 35,193 square feet; 1 part Concrete at 1,076 square feet.

Inspection Date	FMSS Number	User Access	Surface Type
6/21/2015	39283	PUBLIC	ASPHALT
Area (Sq. Ft.)	Lane Miles (11' Widths)	Curb Reveal (Inches)	Curb Recommendation
20,030	0.345	NOT APPLICABLE	NOT APPLICABLE
Curb Type		Curb & Gutter Type	
NO CURB		NO CURB AND GUTTER	
Pavement Recommendation		Condition Rating / PCR	
HEAVY 3R TREATMENTS		POOR / 53

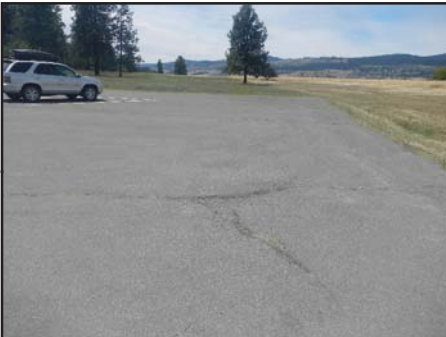
ROUTE 0907ZZ: FORT SPOKANE BOAT LAUNCH PARKING

Inspection Date	FMSS Number	User Access	Surface Type
6/21/2015	39284	PUBLIC	ASPHALT
Area (Sq. Ft.)	Lane Miles (11' Widths)	Condition Rating / PCR	
112,173	1.932	SUMMARY / 57

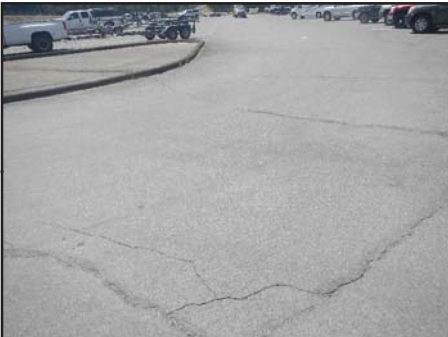
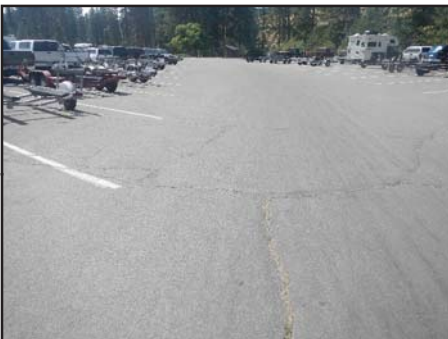
ROUTE 0907BZ: FORT SPOKANE BOAT LAUNCH PARKING B

Inspection Date	FMSS Number	User Access	Surface Type
6/21/2015	39284	PUBLIC	ASPHALT
Area (Sq. Ft.)	Lane Miles (11' Widths)	Curb Reveal (Inches)	Curb Recommendation
13,505	0.233	NOT APPLICABLE	NOT APPLICABLE
Curb Type		Curb & Gutter Type	
NO CURB		NO CURB AND GUTTER	
Pavement Recommendation		Condition Rating / PCR	
PREVENTIVE MAINTENANCE		GOOD / 90

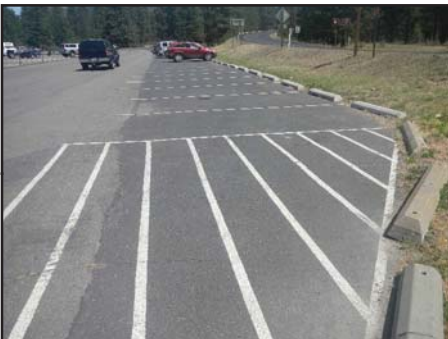
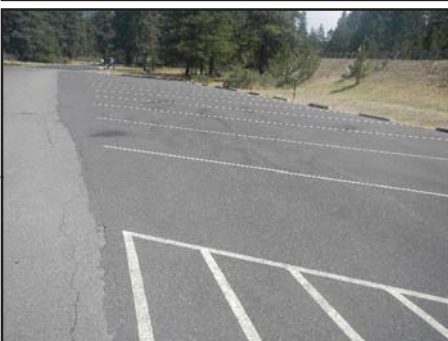
ROUTE 0908: FORT SPOKANE GROUP CAMP PARKING

Inspection Date	FMSS Number	User Access	Surface Type
6/21/2015	39286	PUBLIC	ASPHALT
Area (Sq. Ft.)	Lane Miles (11' Widths)	Curb Reveal (Inches)	Curb Recommendation
26,325	0.453	5	DO NOTHING
Curb Type		Curb & Gutter Type	
CONCRETE		NO CURB AND GUTTER	
Pavement Recommendation		Condition Rating / PCR	
PREVENTIVE MAINTENANCE		GOOD / 90

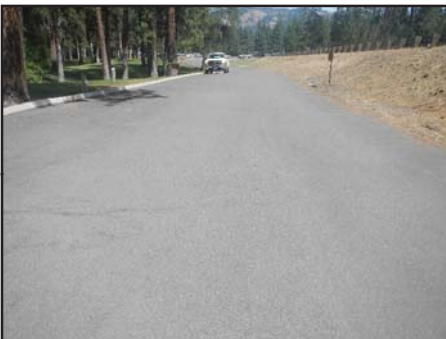
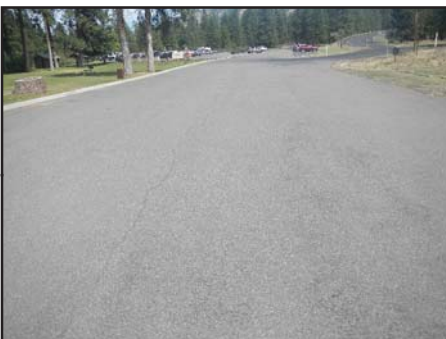
ROUTE 0909ZZ: FORT SPOKANE PICNIC LOOP PARKING AREA COMPLEX

Inspection Date	FMSS Number	User Access	Surface Type
6/21/2015	39287	PUBLIC	ASPHALT
Area (Sq. Ft.)	Lane Miles (11' Widths)	Condition Rating / PCR	
24,888	0.429	SUMMARY / 90

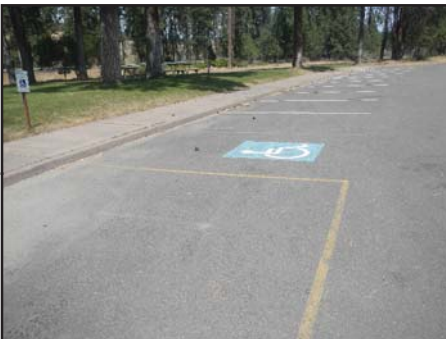
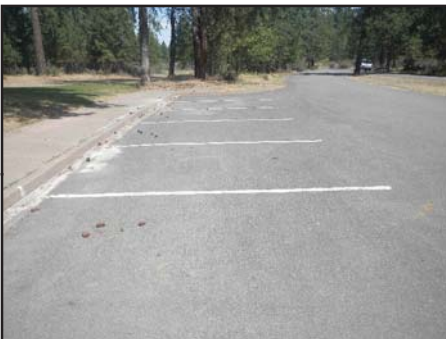
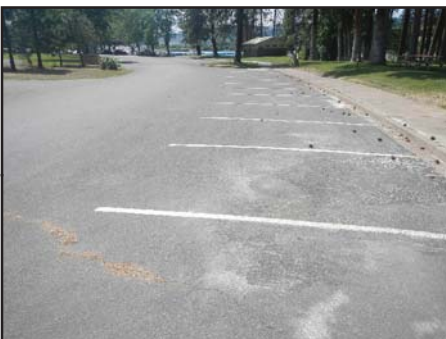
ROUTE 0909BZ: FORT SPOKANE PICNIC LOOP PARKING B

Inspection Date	FMSS Number	User Access	Surface Type
6/21/2015	39287	PUBLIC	ASPHALT
Area (Sq. Ft.)	Lane Miles (11' Widths)	Curb Reveal (Inches)	Curb Recommendation
14,205	0.245	NOT APPLICABLE	DO NOTHING
Curb Type		Curb & Gutter Type	
NO CURB		CONCRETE	
Pavement Recommendation		Condition Rating / PCR	
PREVENTIVE MAINTENANCE		GOOD / 90

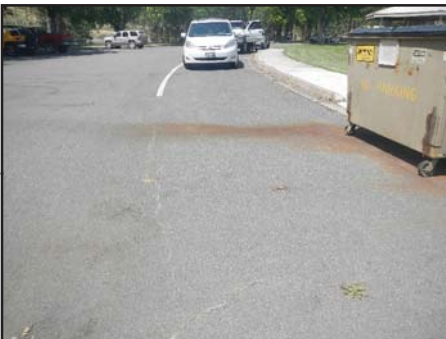
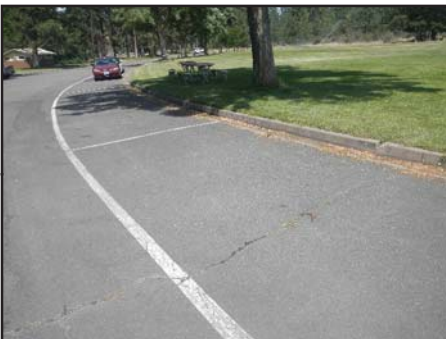
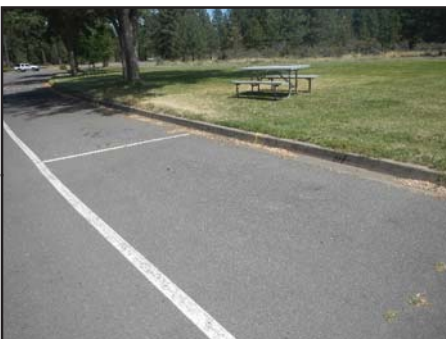
ROUTE 0909CZ: FORT SPOKANE PICNIC LOOP PARKING C

Inspection Date	FMSS Number	User Access	Surface Type
6/21/2015	39287	PUBLIC	ASPHALT
Area (Sq. Ft.)	Lane Miles (11' Widths)	Curb Reveal (Inches)	Curb Recommendation
7,280	0.125	NOT APPLICABLE	DO NOTHING
Curb Type		Curb & Gutter Type	
NO CURB		CONCRETE	
Pavement Recommendation		Condition Rating / PCR	
PREVENTIVE MAINTENANCE		GOOD / 90

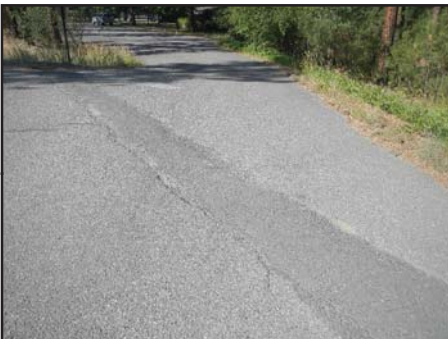
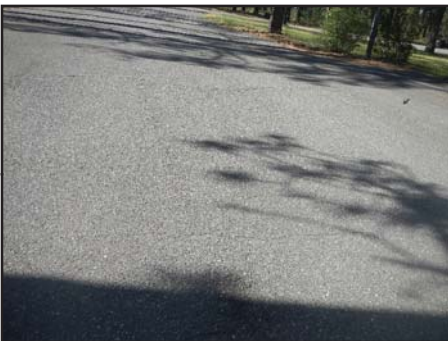
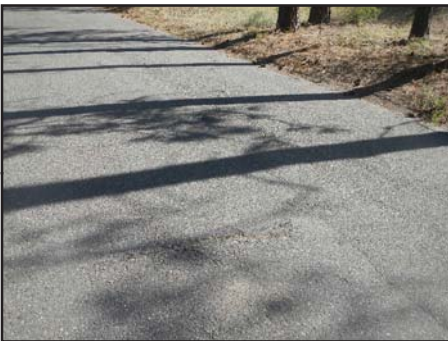
ROUTE 0910: KETTLE FALLS INFORMATION CENTER PARKING

Inspection Date	FMSS Number	User Access	Surface Type
6/21/2015	39097	PUBLIC	ASPHALT
Area (Sq. Ft.)	Lane Miles (11' Widths)	Curb Reveal (Inches)	Curb Recommendation
12,924	0.223	NOT APPLICABLE	NOT APPLICABLE
Curb Type		Curb & Gutter Type	
NO CURB		NO CURB AND GUTTER	
Pavement Recommendation		Condition Rating / PCR	
PREVENTIVE MAINTENANCE		GOOD / 90

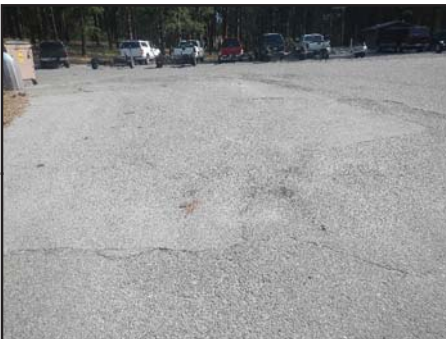
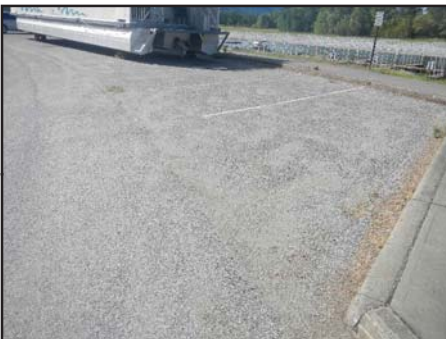
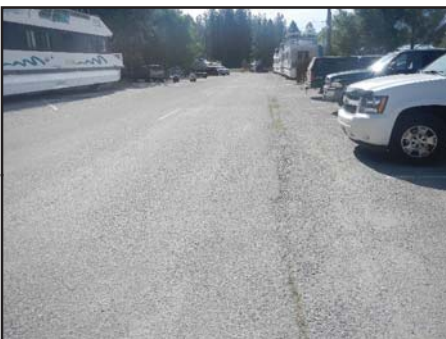
ROUTE 0911A: KETTLE FALLS BOAT LAUNCH PARKING A

Inspection Date	FMSS Number	User Access	Surface Type
6/21/2015	39090	PUBLIC	ASPHALT
Area (Sq. Ft.)	Lane Miles (11' Widths)	Curb Reveal (Inches)	Curb Recommendation
81,482	1.403	6	LIGHT REPAIR
Curb Type		Curb & Gutter Type	
CONCRETE		NO CURB AND GUTTER	
Pavement Recommendation		Condition Rating / PCR	
HEAVY 3R TREATMENTS		POOR / 53

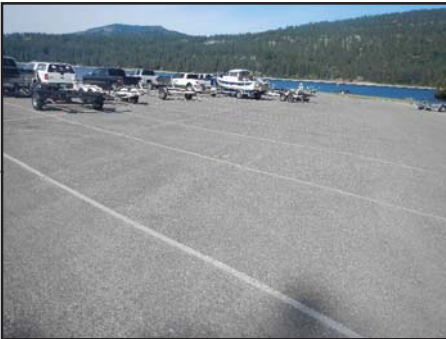
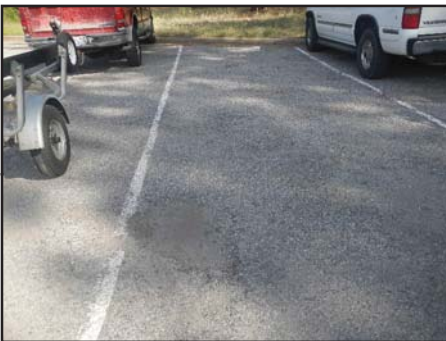
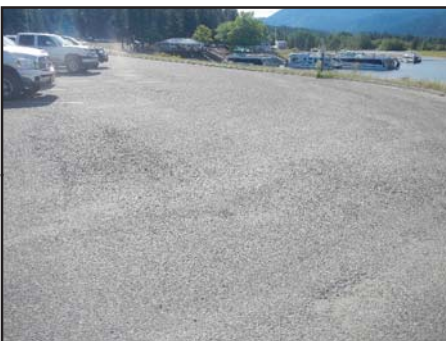
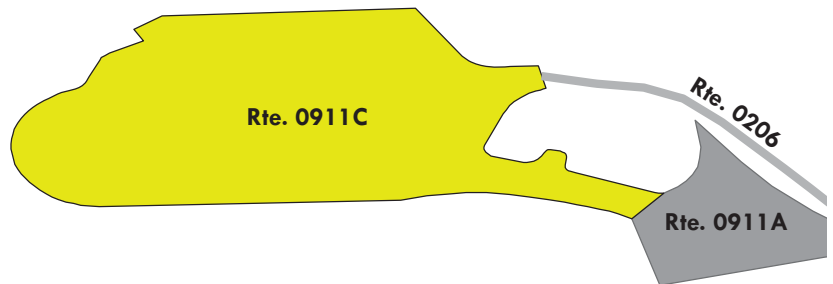
ROUTE 0911C: KETTLE FALLS BOAT LAUNCH PARKING C

Inspection Date	FMSS Number	User Access	Surface Type
6/21/2015	105447	PUBLIC	ASPHALT
Area (Sq. Ft.)	Lane Miles (11' Widths)	Curb Reveal (Inches)	Curb Recommendation
41,739	0.719	5	DO NOTHING
Curb Type		Curb & Gutter Type	
CONCRETE		NO CURB AND GUTTER	
Pavement Recommendation		Condition Rating / PCR	
LIGHT 3R TREATMENTS		FAIR / 73

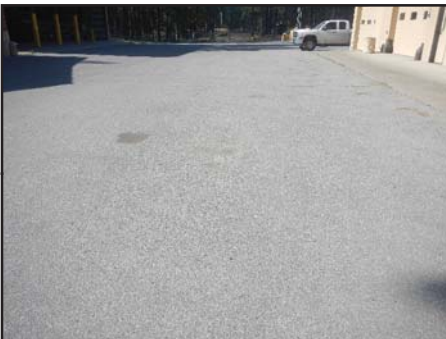
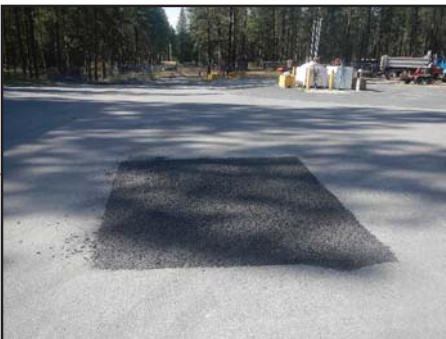
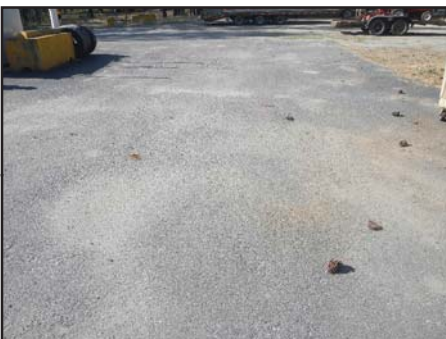
ROUTE 0913AZ: KETTLE FALLS FACILITIES PARKING A

Inspection Date	FMSS Number	User Access	Surface Type
6/21/2015	39095	NONPUBLIC	ASPHALT
Area (Sq. Ft.)	Lane Miles (11' Widths)	Curb Reveal (Inches)	Curb Recommendation
39,676	0.683	6	LIGHT REPAIR
Curb Type		Curb & Gutter Type	
CONCRETE		NO CURB AND GUTTER	
Pavement Recommendation		Condition Rating / PCR	
PREVENTIVE MAINTENANCE		GOOD / 90

Parking area consists of multiple surface types: 1 part Asphalt at 39,148 square feet; 2 parts Concrete at 528 square feet.

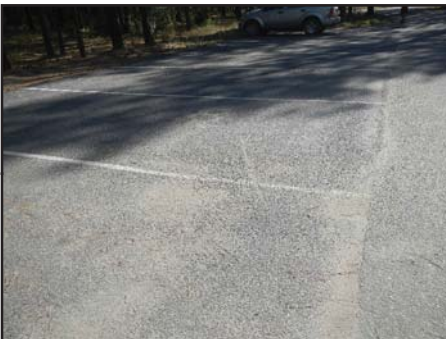
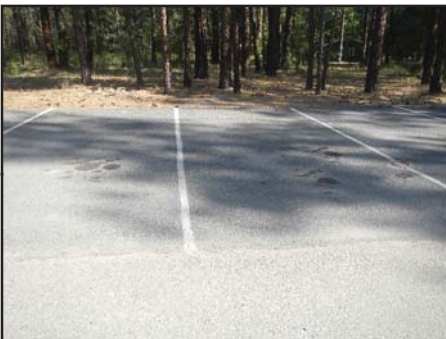
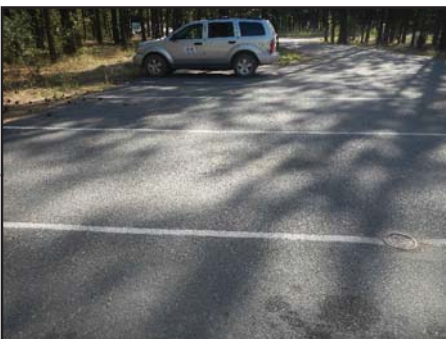
ROUTE 0913BZ: KETTLE FALLS FACILITIES PARKING B

Inspection Date	FMSS Number	User Access	Surface Type
6/21/2015	39095	NONPUBLIC	ASPHALT
Area (Sq. Ft.)	Lane Miles (11' Widths)	Curb Reveal (Inches)	Curb Recommendation
2,016	0.035	NOT APPLICABLE	NOT APPLICABLE
Curb Type		Curb & Gutter Type	
NO CURB		NO CURB AND GUTTER	
Pavement Recommendation		Condition Rating / PCR	
PREVENTIVE MAINTENANCE		GOOD / 90

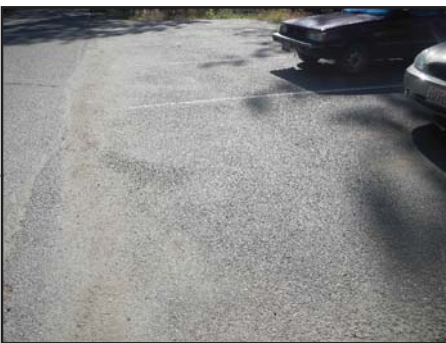
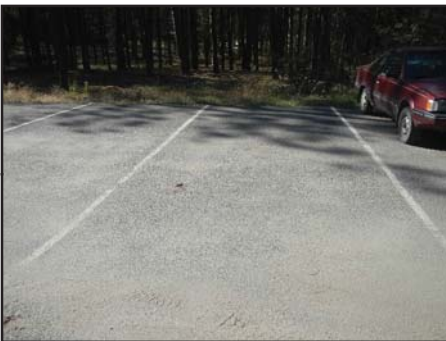
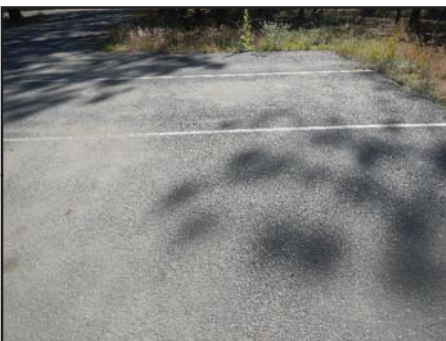
ROUTE 0913CZ: KETTLE FALLS FACILITIES PARKING C

Inspection Date	FMSS Number	User Access	Surface Type
6/21/2015	39095	NONPUBLIC	ASPHALT
Area (Sq. Ft.)	Lane Miles (11' Widths)	Curb Reveal (Inches)	Curb Recommendation
1,183	0.02	NOT APPLICABLE	NOT APPLICABLE
Curb Type		Curb & Gutter Type	
NO CURB		NO CURB AND GUTTER	
Pavement Recommendation		Condition Rating / PCR	
PREVENTIVE MAINTENANCE		GOOD / 90

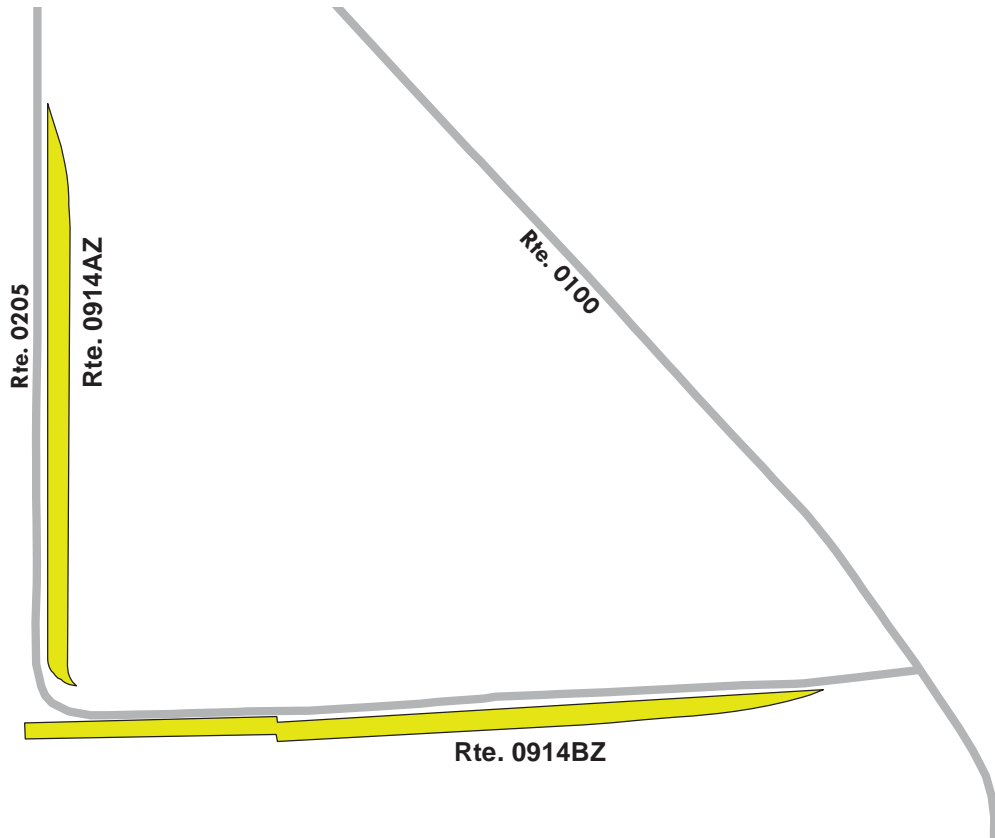
ROUTE 0914ZZ: KETTLE FALLS DAY USE PARKING AREA COMPLEX

Inspection Date	FMSS Number	User Access	Surface Type
6/21/2015	39093	PUBLIC	ASPHALT
Area (Sq. Ft.)	Lane Miles (11' Widths)	Condition Rating / PCR	
27,210	0.469	SUMMARY / 64	
Route Condition Legend – Pavement Condition Rating (PCR)			
Poor (0 - 60)	Fair (61- 84)	Good (85 - 94)	Excellent (95 - 100) Not Rated
See Appendix for definitions and formulas

The condition shown on this page reflects the overall route condition and may not reflect individual subcomponent ratings.

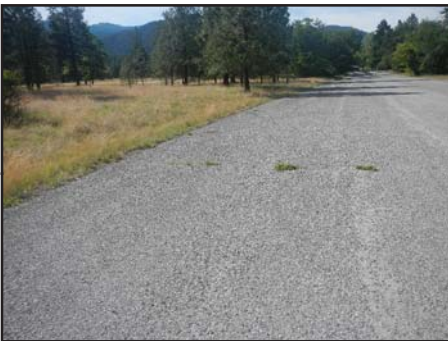
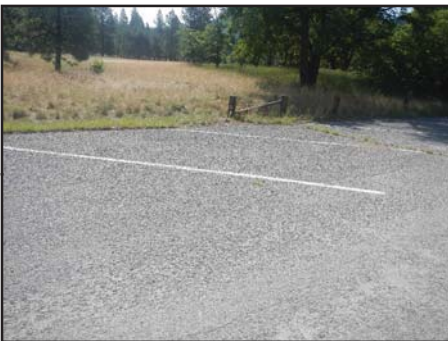
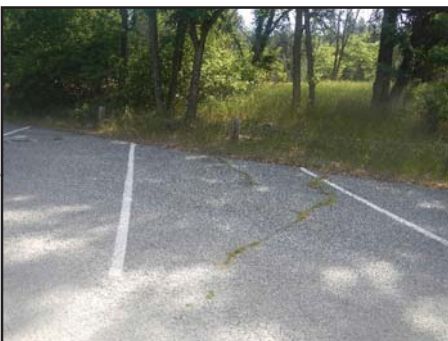
ROUTE 0914AZ: KETTLE FALLS DAY USE AREA PARKING A

Inspection Date	FMSS Number	User Access	Surface Type
6/21/2015	39093	PUBLIC	ASPHALT
Area (Sq. Ft.)	Lane Miles (11' Widths)	Curb Reveal (Inches)	Curb Recommendation
12,128	0.209	NOT APPLICABLE	NOT APPLICABLE
Curb Type		Curb & Gutter Type	
NO CURB		NO CURB AND GUTTER	
Pavement Recommendation		Condition Rating / PCR	
HEAVY 3R TREATMENTS		POOR / 53

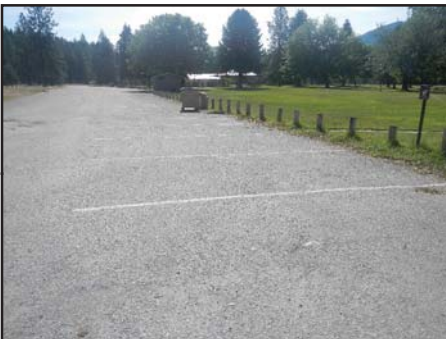
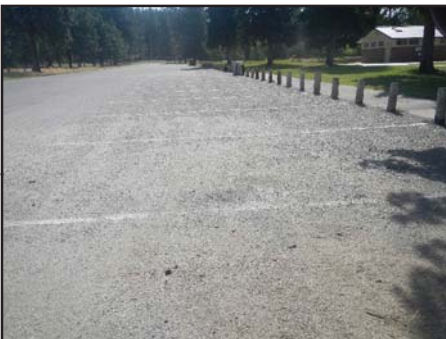
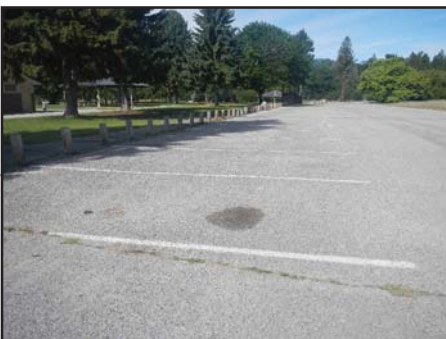
ROUTE 0915: KELLER FERRY BOAT LAUNCH PARKING

Inspection Date	FMSS Number	User Access	Surface Type
6/22/2015	39461	PUBLIC	ASPHALT
Area (Sq. Ft.)	Lane Miles (11' Widths)	Curb Reveal (Inches)	Curb Recommendation
122,483	2.109	3	DO NOTHING
Curb Type		Curb & Gutter Type	
CONCRETE		NO CURB AND GUTTER	
Pavement Recommendation		Condition Rating / PCR	
HEAVY 3R TREATMENTS		POOR / 53

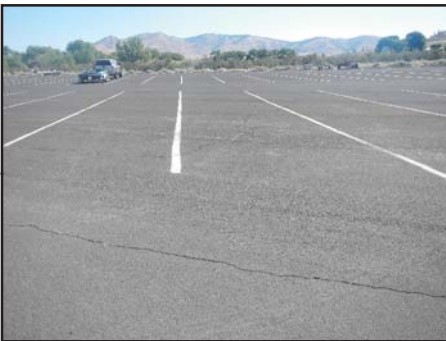
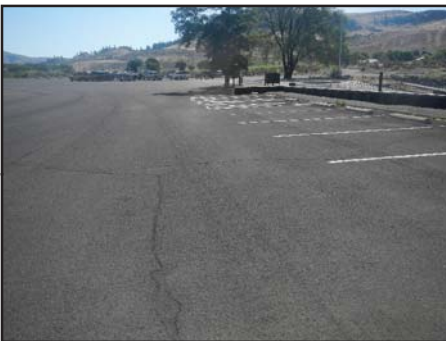
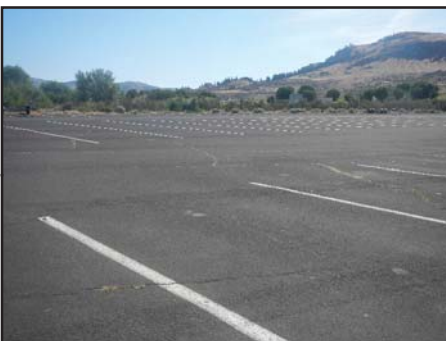
ROUTE 0917: GIFFORD BOAT LAUNCH PARKING

Inspection Date	FMSS Number	User Access	Surface Type
6/21/2015	39254	PUBLIC	ASPHALT
Area (Sq. Ft.)	Lane Miles (11' Widths)	Curb Reveal (Inches)	Curb Recommendation
48,623	0.837	6	DO NOTHING
Curb Type		Curb & Gutter Type	
CONCRETE		NO CURB AND GUTTER	
Pavement Recommendation		Condition Rating / PCR	
PREVENTIVE MAINTENANCE		GOOD / 90

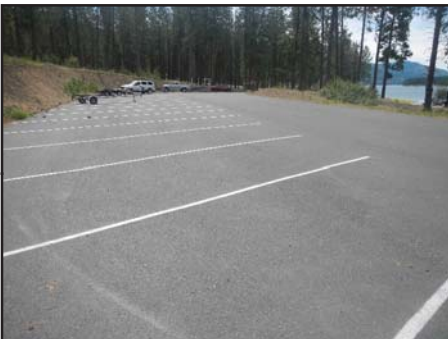
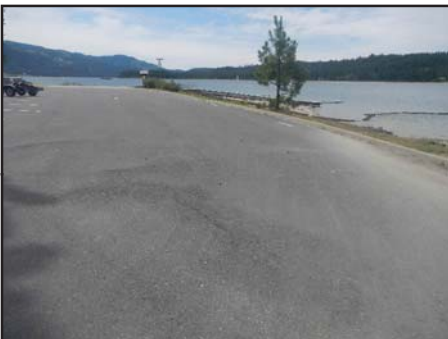
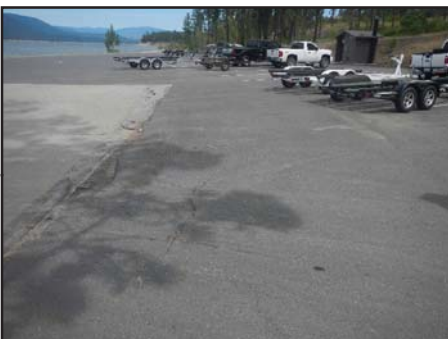
ROUTE 0918A: HUNTERS BOAT LAUNCH AREA A PARKING

Inspection Date	FMSS Number	User Access	Surface Type
6/21/2015	39285	PUBLIC	ASPHALT
Area (Sq. Ft.)	Lane Miles (11' Widths)	Curb Reveal (Inches)	Curb Recommendation
33,929	0.584	5	DO NOTHING
Curb Type		Curb & Gutter Type	
CONCRETE		NO CURB AND GUTTER	
Pavement Recommendation		Condition Rating / PCR	
DO NOTHING		EXCELLENT / 97

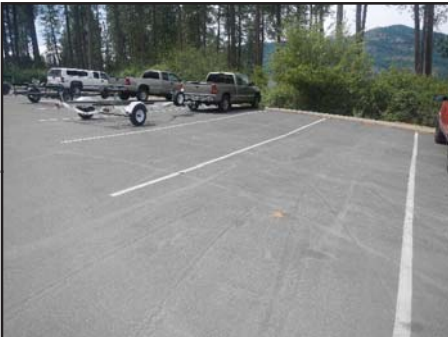
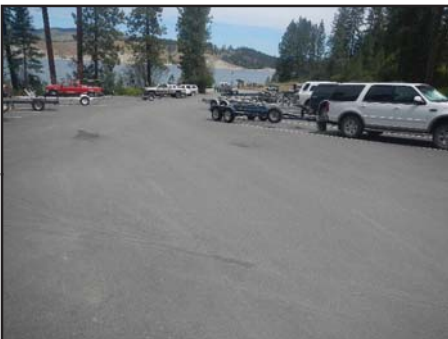
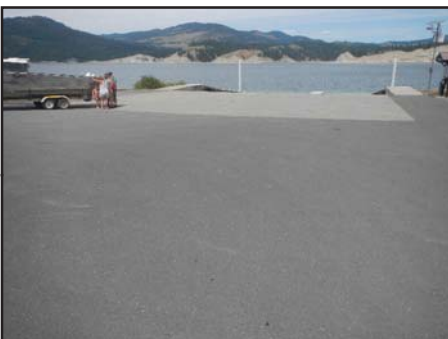
ROUTE 0918B: HUNTERS BOAT LAUNCH AREA B PARKING

Inspection Date	FMSS Number	User Access	Surface Type
6/21/2015	39288	PUBLIC	ASPHALT
Area (Sq. Ft.)	Lane Miles (11' Widths)	Curb Reveal (Inches)	Curb Recommendation
72,377	1.246	5	DO NOTHING
Curb Type		Curb & Gutter Type	
CONCRETE		NO CURB AND GUTTER	
Pavement Recommendation		Condition Rating / PCR	
PREVENTIVE MAINTENANCE		GOOD / 90

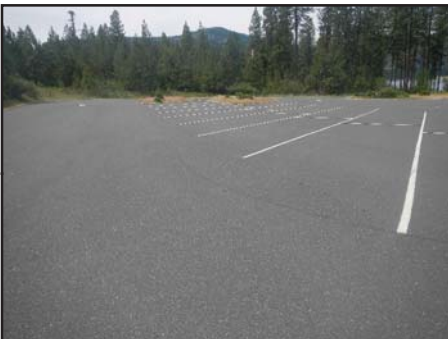
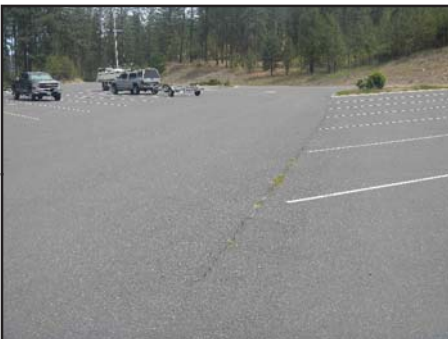
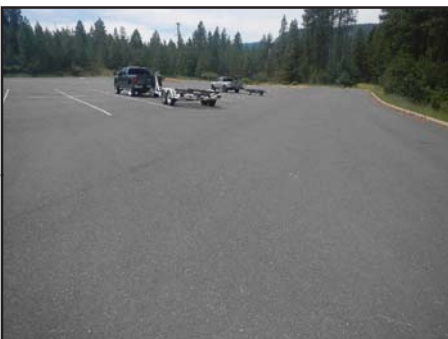
ROUTE 0919: SEVEN BAYS MARINA PARKING

Inspection Date	FMSS Number	User Access	Surface Type
6/21/2015	9964	PUBLIC	ASPHALT
Area (Sq. Ft.)	Lane Miles (11' Widths)	Curb Reveal (Inches)	Curb Recommendation
18,142	0.312	7	LIGHT REPAIR
Curb Type		Curb & Gutter Type	
CONCRETE		NO CURB AND GUTTER	
Pavement Recommendation		Condition Rating / PCR	
PREVENTIVE MAINTENANCE		GOOD / 90

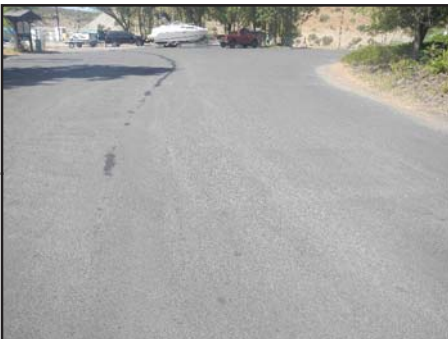
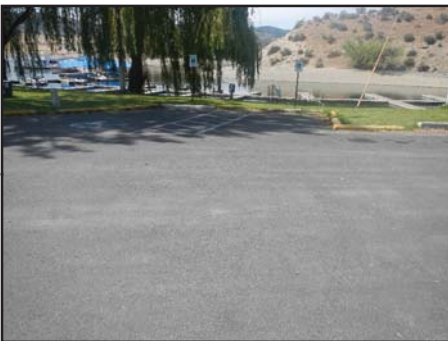
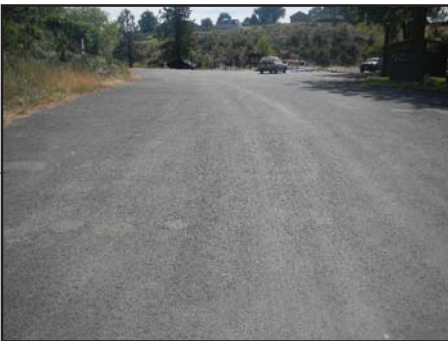
ROUTE 0920: HAWK CREEK BOAT LAUNCH PARKING

Inspection Date	FMSS Number	User Access	Surface Type
6/21/2015	39466	PUBLIC	ASPHALT
Area (Sq. Ft.)	Lane Miles (11' Widths)	Curb Reveal (Inches)	Curb Recommendation
18,901	0.325	NOT APPLICABLE	NOT APPLICABLE
Curb Type		Curb & Gutter Type	
NO CURB		NO CURB AND GUTTER	
Pavement Recommendation		Condition Rating / PCR	
PREVENTIVE MAINTENANCE		GOOD / 90

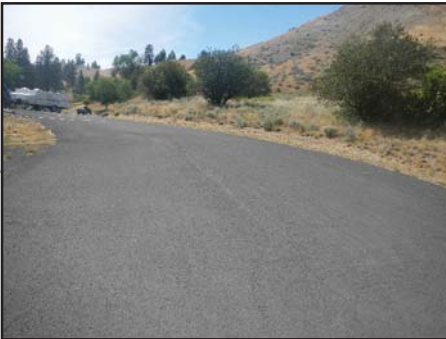
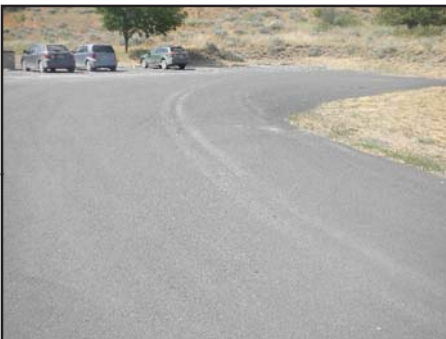
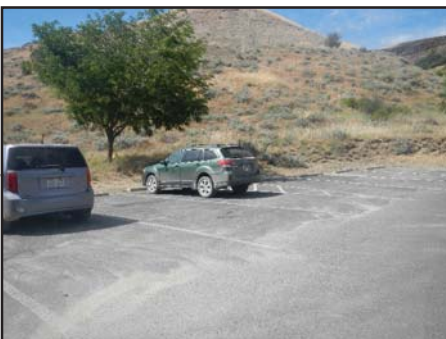
ROUTE 0921: LINCOLN MILL BOAT LAUNCH PARKING

Inspection Date	FMSS Number	User Access	Surface Type
6/22/2015	9952	PUBLIC	ASPHALT
Area (Sq. Ft.)	Lane Miles (11' Widths)	Curb Reveal (Inches)	Curb Recommendation
48,153	0.829	6	DO NOTHING
Curb Type		Curb & Gutter Type	
CONCRETE		NO CURB AND GUTTER	
Pavement Recommendation		Condition Rating / PCR	
LIGHT 3R TREATMENTS		FAIR / 73

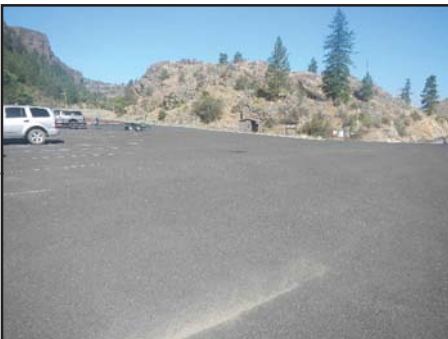
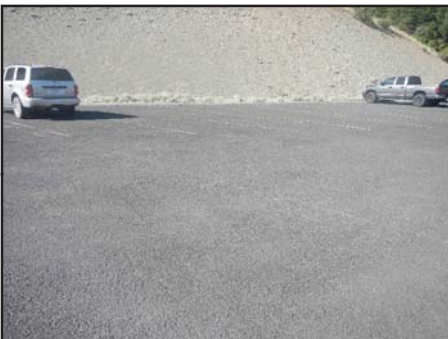
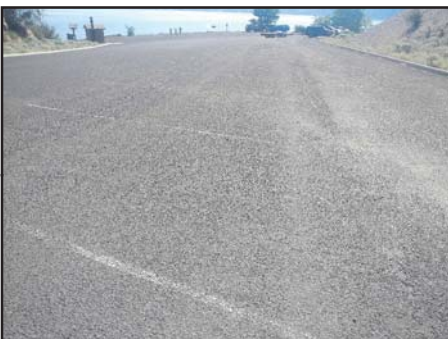
ROUTE 0922: HANSON HARBOR BOAT LAUNCH PARKING

Inspection Date	FMSS Number	User Access	Surface Type
6/22/2015	39468	PUBLIC	ASPHALT
Area (Sq. Ft.)	Lane Miles (11' Widths)	Curb Reveal (Inches)	Curb Recommendation
51,206	0.882	NOT APPLICABLE	NOT APPLICABLE
Curb Type		Curb & Gutter Type	
NO CURB		NO CURB AND GUTTER	
Pavement Recommendation		Condition Rating / PCR	
HEAVY 3R TREATMENTS		POOR / 53

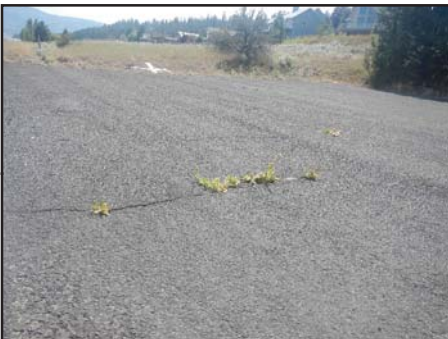
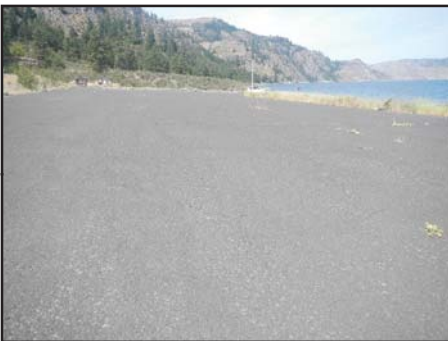
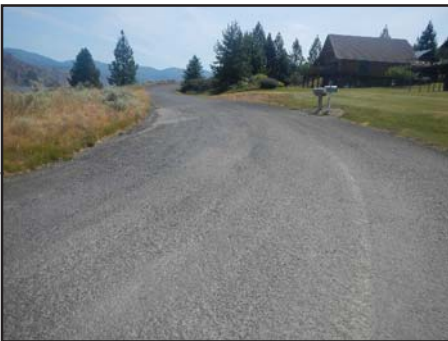
ROUTE 0923: PORCUPINE BAY BOAT LAUNCH PARKING

Inspection Date	FMSS Number	User Access	Surface Type
6/21/2015	39469	PUBLIC	ASPHALT
Area (Sq. Ft.)	Lane Miles (11' Widths)	Curb Reveal (Inches)	Curb Recommendation
78,712	1.355	NOT APPLICABLE	LIGHT REPAIR
Curb Type		Curb & Gutter Type	
NO CURB		CONCRETE	
Pavement Recommendation		Condition Rating / PCR	
HEAVY 3R TREATMENTS		POOR / 53

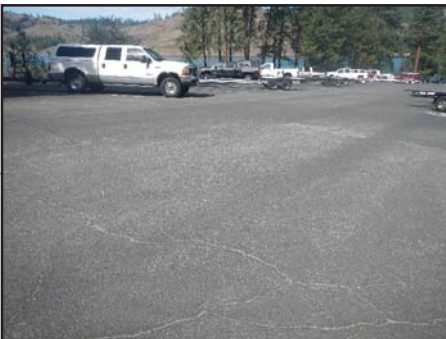
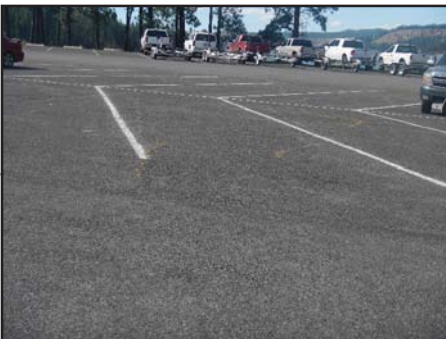
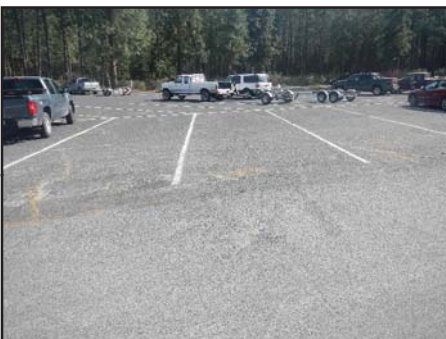
ROUTE 0926: DAISY BOAT LAUNCH PARKING

Inspection Date	FMSS Number	User Access	Surface Type
6/21/2015	39245	PUBLIC	ASPHALT
Area (Sq. Ft.)	Lane Miles (11' Widths)	Curb Reveal (Inches)	Curb Recommendation
26,873	0.463	5	DO NOTHING
Curb Type		Curb & Gutter Type	
CONCRETE		NO CURB AND GUTTER	
Pavement Recommendation		Condition Rating / PCR	
PREVENTIVE MAINTENANCE		GOOD / 90

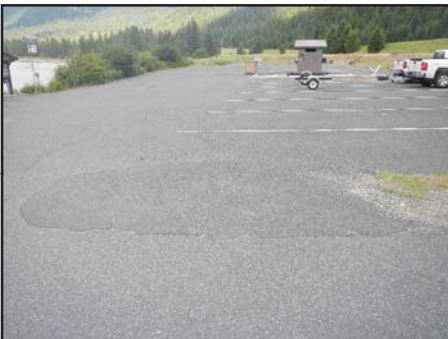
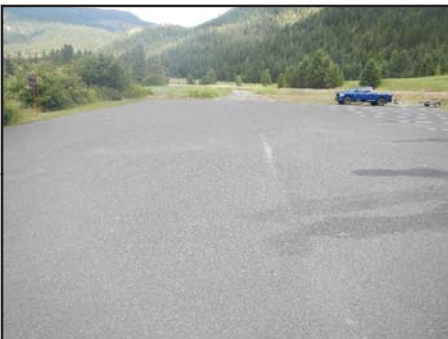
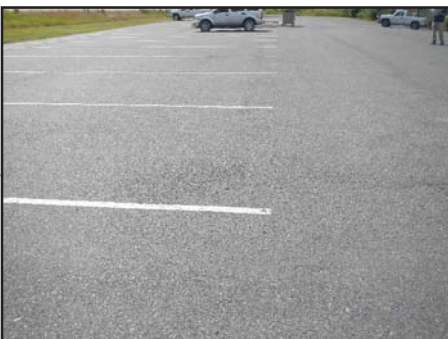
ROUTE 0927: CHINA BEND BOAT LAUNCH PARKING

Inspection Date	FMSS Number	User Access	Surface Type
6/20/2015	3856	PUBLIC	ASPHALT
Area (Sq. Ft.)	Lane Miles (11' Widths)	Curb Reveal (Inches)	Curb Recommendation
23,874	0.411	6	DO NOTHING
Curb Type		Curb & Gutter Type	
CONCRETE		NO CURB AND GUTTER	
Pavement Recommendation		Condition Rating / PCR	
PREVENTIVE MAINTENANCE		GOOD / 90

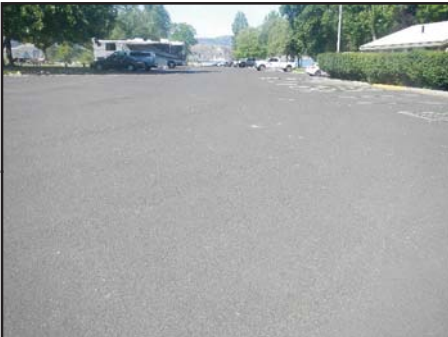
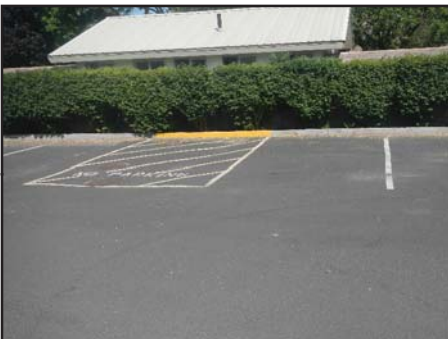
ROUTE 0928: KELLER FERRY PICNIC / CAMP AREA PARKING

Inspection Date	FMSS Number	User Access	Surface Type
6/22/2015	39475	PUBLIC	ASPHALT
Area (Sq. Ft.)	Lane Miles (11' Widths)	Curb Reveal (Inches)	Curb Recommendation
36,432	0.627	NOT APPLICABLE	DO NOTHING
Curb Type		Curb & Gutter Type	
NO CURB		CONCRETE	
Pavement Recommendation		Condition Rating / PCR	
HEAVY 3R TREATMENTS		POOR / 53

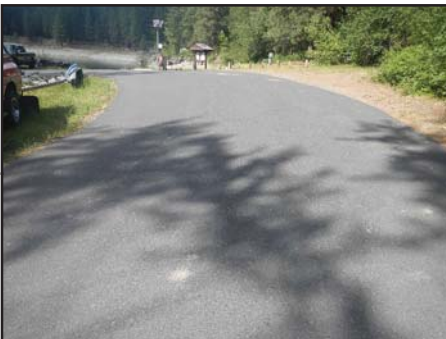
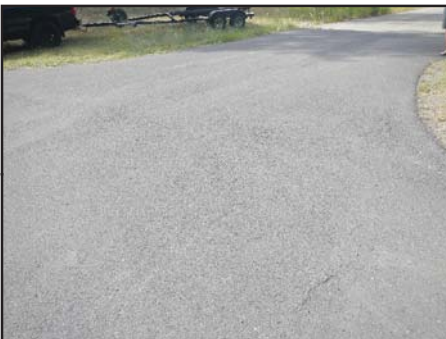
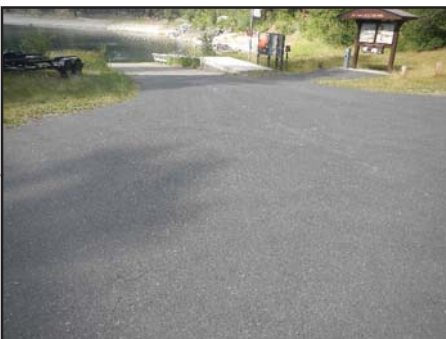
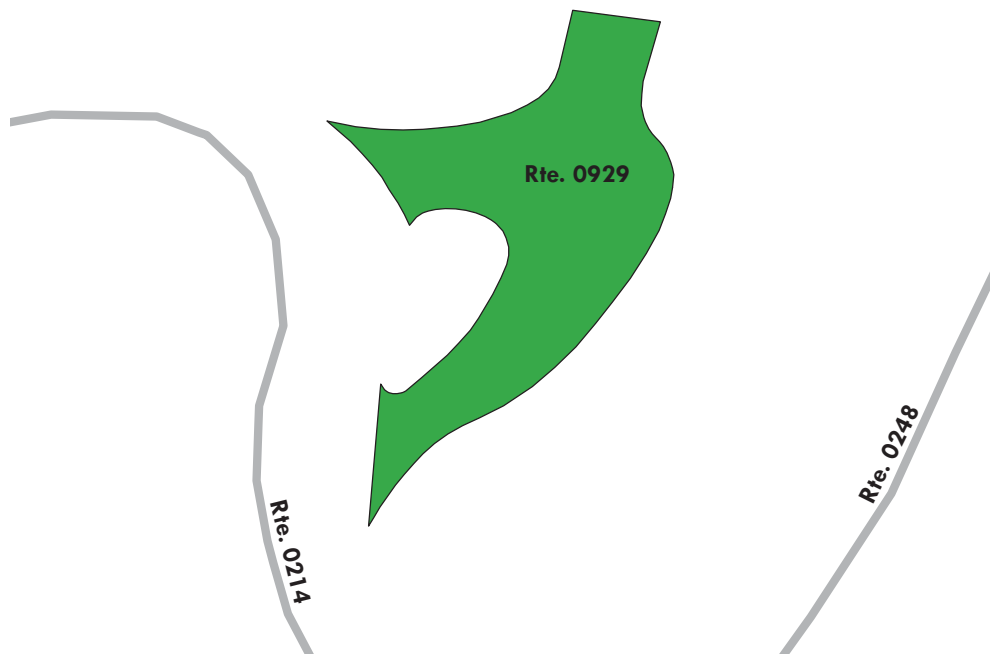
ROUTE 0929: NORTH GORGE BOAT LAUNCH PARKING

Inspection Date	FMSS Number	User Access	Surface Type
6/20/2015	39353	PUBLIC	ASPHALT
Area (Sq. Ft.)	Lane Miles (11' Widths)	Curb Reveal (Inches)	Curb Recommendation
5,214	0.09	NOT APPLICABLE	NOT APPLICABLE
Curb Type		Curb & Gutter Type	
NO CURB		NO CURB AND GUTTER	
Pavement Recommendation		Condition Rating / PCR	
PREVENTIVE MAINTENANCE		GOOD / 90

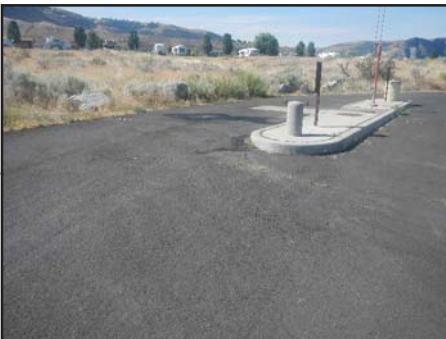
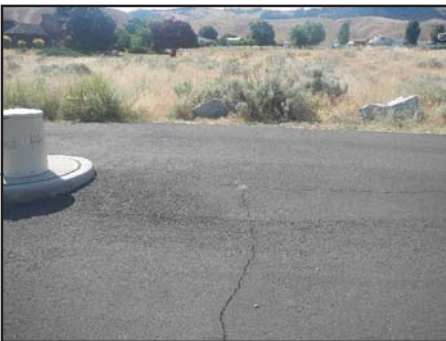
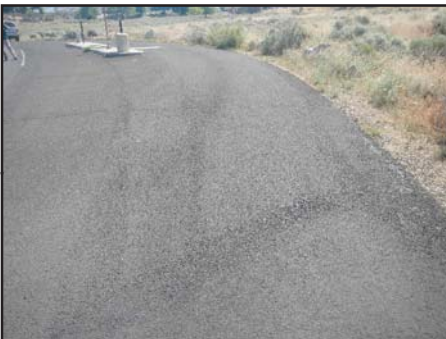
ROUTE 0931: KELLER FERRY RV DUMP STATION PARKING

Inspection Date	FMSS Number	User Access	Surface Type
6/22/2015	39478	PUBLIC	ASPHALT
Area (Sq. Ft.)	Lane Miles (11' Widths)	Curb Reveal (Inches)	Curb Recommendation
2,960	0.051	4	DO NOTHING
Curb Type		Curb & Gutter Type	
CONCRETE		NO CURB AND GUTTER	
Pavement Recommendation		Condition Rating / PCR	
PREVENTIVE MAINTENANCE		GOOD / 90

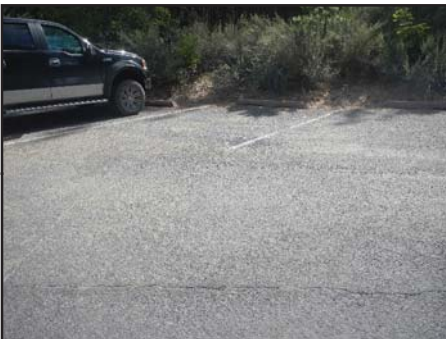
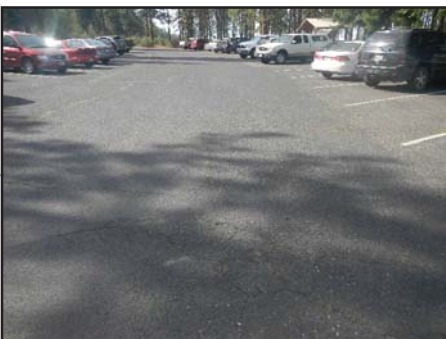
ROUTE 0932: PORCUPINE BAY DAY USE PARKING

Inspection Date	FMSS Number	User Access	Surface Type
6/21/2015	39483	PUBLIC	ASPHALT
Area (Sq. Ft.)	Lane Miles (11' Widths)	Curb Reveal (Inches)	Curb Recommendation
20,681	0.356	NOT APPLICABLE	NOT APPLICABLE
Curb Type		Curb & Gutter Type	
NO CURB		NO CURB AND GUTTER	
Pavement Recommendation		Condition Rating / PCR	
HEAVY 3R TREATMENTS		POOR / 53
