LARO Cycle 6

Final Report

Road Inventory and Condition Assessment of Paved Routes Lake Roosevelt National Recreation Area

**Federal Highway Administration
Eastern Federal Lands Highway Division
Road Inventory Program (RIP)**

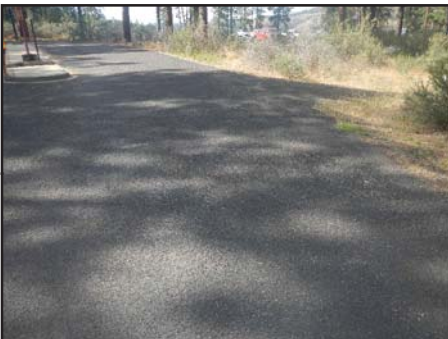
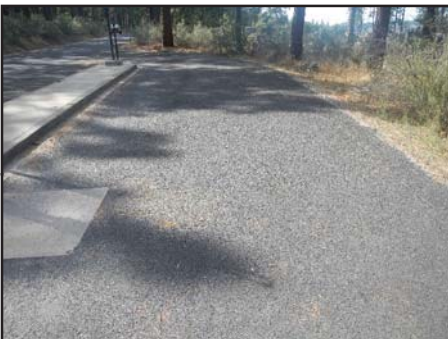
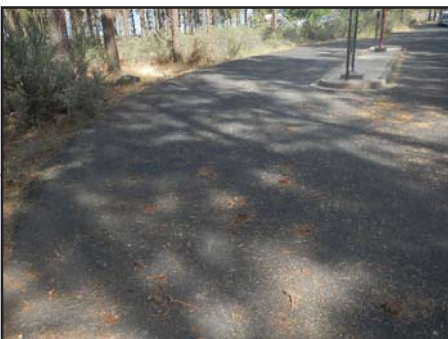
ROUTE 0933: PORCUPINE BAY RV DUMP STATION PARKING

Inspection Date	FMSS Number	User Access	Surface Type
6/21/2015	39485	PUBLIC	ASPHALT
Area (Sq. Ft.)	Lane Miles (11' Widths)	Curb Reveal (Inches)	Curb Recommendation
2,345	0.04	NOT APPLICABLE	LIGHT REPAIR
Curb Type		Curb & Gutter Type	
NO CURB		CONCRETE	
Pavement Recommendation		Condition Rating / PCR	
PREVENTIVE MAINTENANCE		GOOD / 90

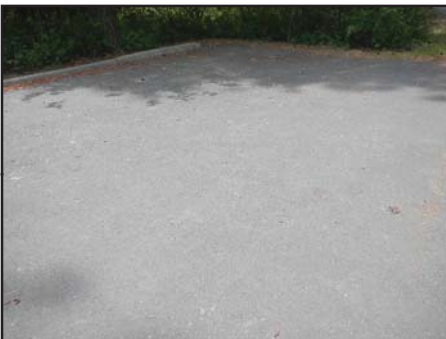
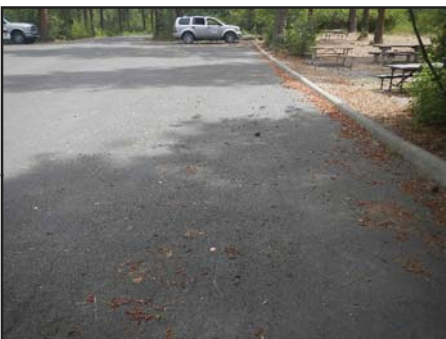
ROUTE 0934AZ: HUNTERS GROUP CAMPGROUND PARKING A

Inspection Date	FMSS Number	User Access	Surface Type
6/21/2015	39261	PUBLIC	ASPHALT
Area (Sq. Ft.)	Lane Miles (11' Widths)	Curb Reveal (Inches)	Curb Recommendation
2,277	0.039	5	DO NOTHING
Curb Type		Curb & Gutter Type	
CONCRETE		NO CURB AND GUTTER	
Pavement Recommendation		Condition Rating / PCR	
DO NOTHING		EXCELLENT / 97

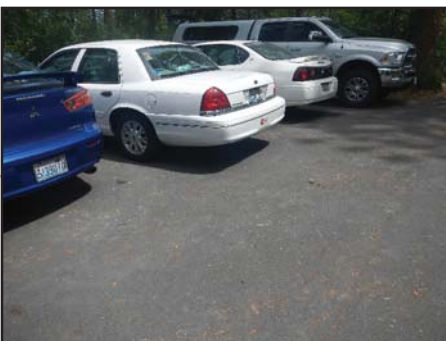
ROUTE 0934BZ: HUNTERS GROUP CAMPGROUND PARKING B

Inspection Date	FMSS Number	User Access	Surface Type
6/21/2015	39261	PUBLIC	ASPHALT
Area (Sq. Ft.)	Lane Miles (11' Widths)	Curb Reveal (Inches)	Curb Recommendation
3,066	0.053	5	DO NOTHING
Curb Type		Curb & Gutter Type	
CONCRETE		NO CURB AND GUTTER	
Pavement Recommendation		Condition Rating / PCR	
PREVENTIVE MAINTENANCE		GOOD / 90

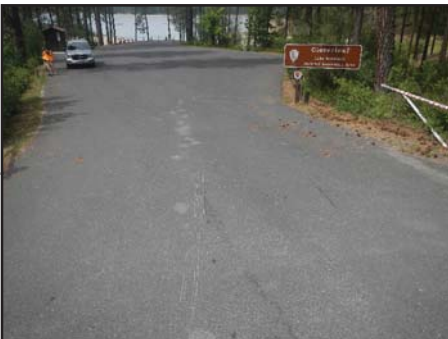
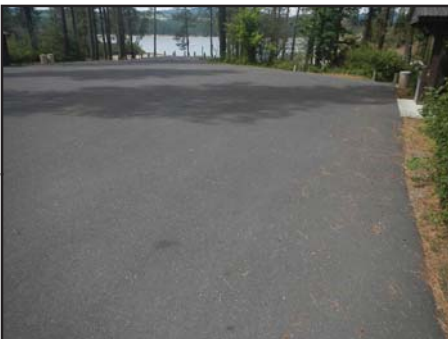
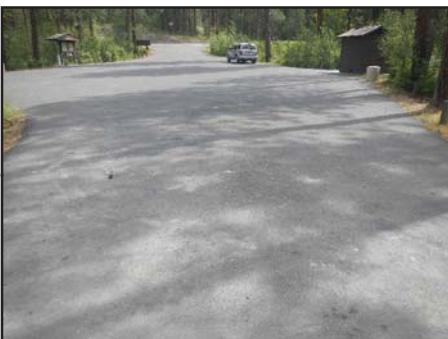
ROUTE 0936: CLOVERLEAF CAMPGROUND PARKING

Inspection Date	FMSS Number	User Access	Surface Type
6/21/2015	00002828	PUBLIC	ASPHALT
Area (Sq. Ft.)	Lane Miles (11' Widths)	Curb Reveal (Inches)	Curb Recommendation
11,623	0.2	NOT APPLICABLE	NOT APPLICABLE
Curb Type		Curb & Gutter Type	
NO CURB		NO CURB AND GUTTER	
Pavement Recommendation		Condition Rating / PCR	
PREVENTIVE MAINTENANCE		GOOD / 90

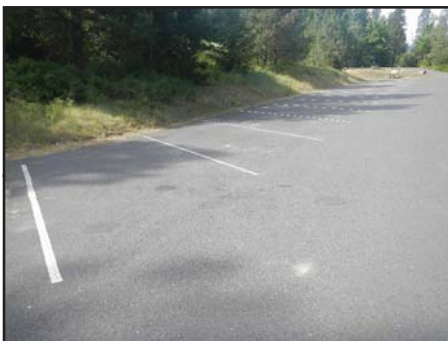
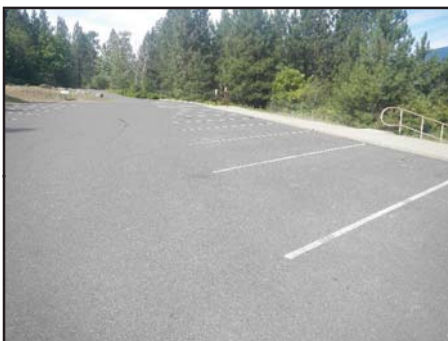
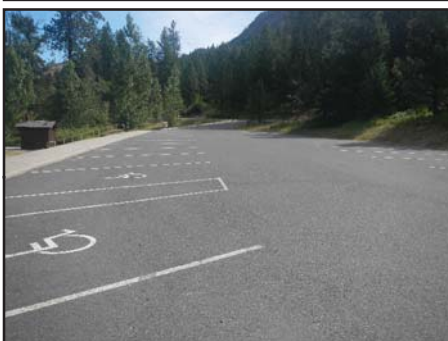
ROUTE 0937AZ: BRADBURY BEACH BOAT LAUNCH PARKING A

Inspection Date	FMSS Number	User Access	Surface Type
6/21/2015	108155	PUBLIC	ASPHALT
Area (Sq. Ft.)	Lane Miles (11' Widths)	Curb Reveal (Inches)	Curb Recommendation
14,214	0.245	6	DO NOTHING
Curb Type		Curb & Gutter Type	
CONCRETE		NO CURB AND GUTTER	
Pavement Recommendation		Condition Rating / PCR	
DO NOTHING		EXCELLENT / 97

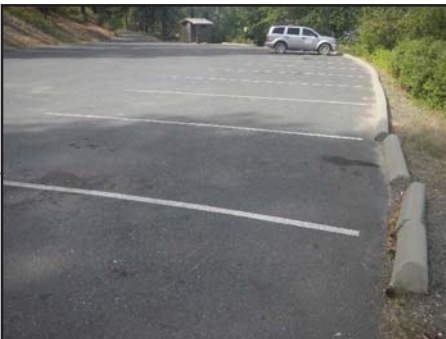
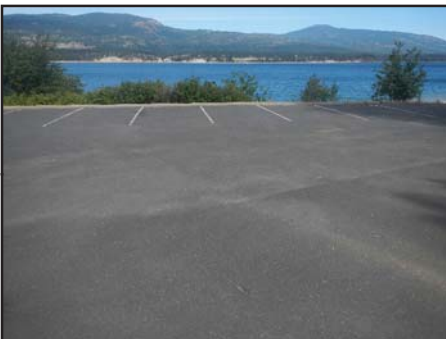
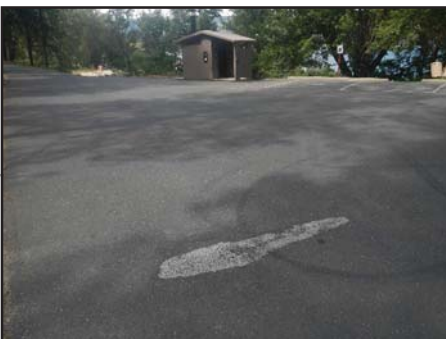
ROUTE 0937BZ: BRADBURY BEACH BOAT LAUNCH PARKING B

Inspection Date	FMSS Number	User Access	Surface Type
6/21/2015	108155	PUBLIC	ASPHALT
Area (Sq. Ft.)	Lane Miles (11' Widths)	Curb Reveal (Inches)	Curb Recommendation
10,631	0.183	6	LIGHT REPAIR
Curb Type		Curb & Gutter Type	
CONCRETE		NO CURB AND GUTTER	
Pavement Recommendation		Condition Rating / PCR	
PREVENTIVE MAINTENANCE		GOOD / 90

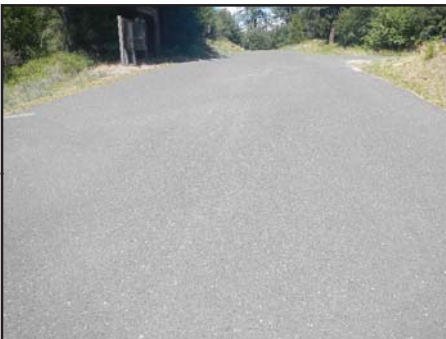
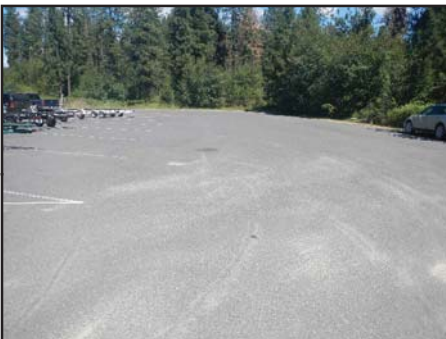
ROUTE 0938: FRENCH ROCKS BOAT LAUNCH PARKING

Inspection Date	FMSS Number	User Access	Surface Type
6/20/2015	3913	PUBLIC	ASPHALT
Area (Sq. Ft.)	Lane Miles (11' Widths)	Curb Reveal (Inches)	Curb Recommendation
54,841	0.944	NOT APPLICABLE	NOT APPLICABLE
Curb Type		Curb & Gutter Type	
NO CURB		NO CURB AND GUTTER	
Pavement Recommendation		Condition Rating / PCR	
PREVENTIVE MAINTENANCE		GOOD / 90

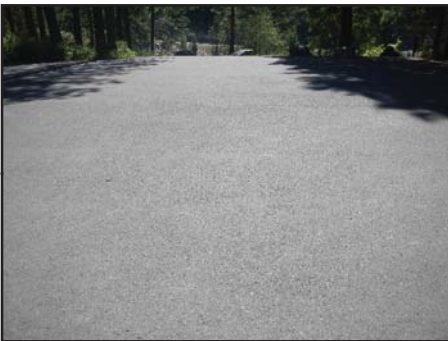
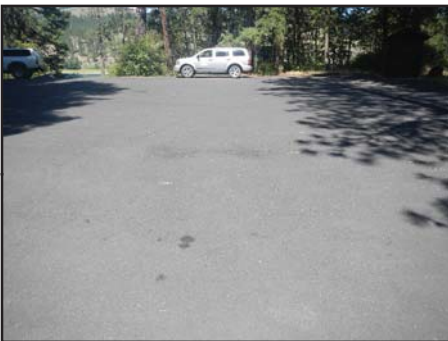
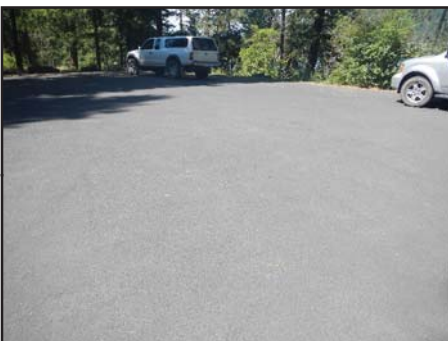
ROUTE 0939: KAMLOOPS ISLAND CAMPGROUND LOOP PARKING

Inspection Date	FMSS Number	User Access	Surface Type
6/20/2015	39296	PUBLIC	ASPHALT
Area (Sq. Ft.)	Lane Miles (11' Widths)	Curb Reveal (Inches)	Curb Recommendation
8,219	0.142	NOT APPLICABLE	NOT APPLICABLE
Curb Type		Curb & Gutter Type	
NO CURB		NO CURB AND GUTTER	
Pavement Recommendation		Condition Rating / PCR	
DO NOTHING		EXCELLENT / 97

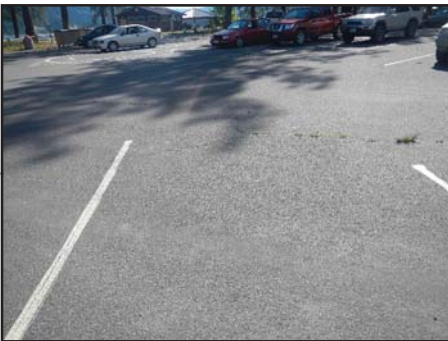
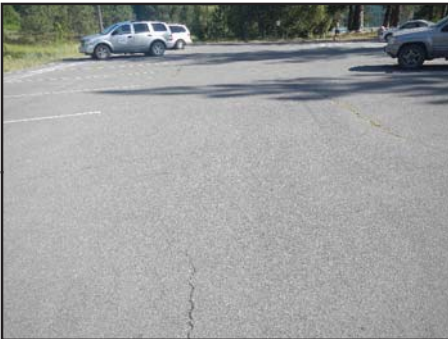
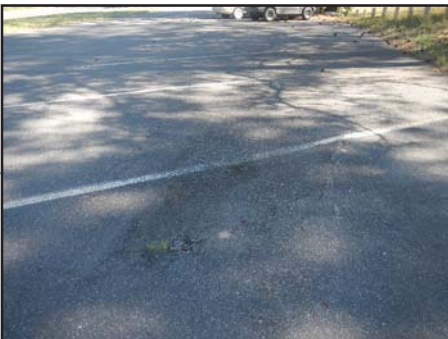
ROUTE 0940: EVANS DAY USE PARKING

Inspection Date	FMSS Number	User Access	Surface Type
6/20/2015	39250	PUBLIC	ASPHALT
Area (Sq. Ft.)	Lane Miles (11' Widths)	Curb Reveal (Inches)	Curb Recommendation
40,736	0.701	NOT APPLICABLE	NOT APPLICABLE
Curb Type		Curb & Gutter Type	
NO CURB		NO CURB AND GUTTER	
Pavement Recommendation		Condition Rating / PCR	
LIGHT 3R TREATMENTS		FAIR / 73

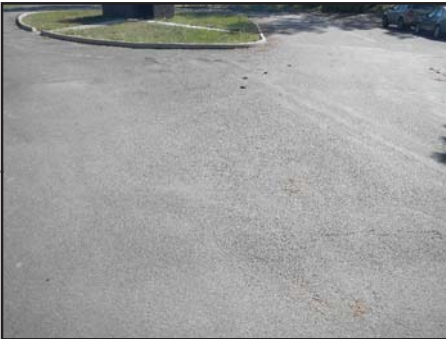
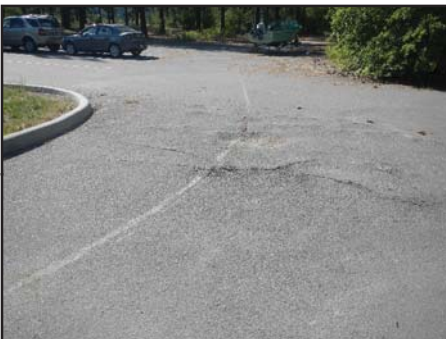
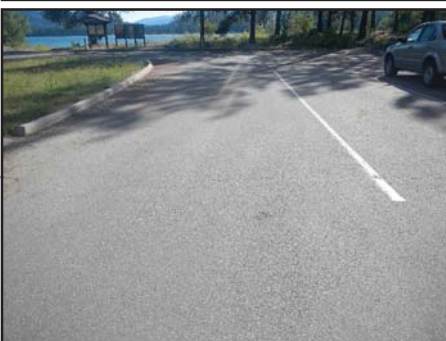
ROUTE 0941: EVANS BOAT LAUNCH PARKING

Inspection Date	FMSS Number	User Access	Surface Type
6/20/2015	39247	PUBLIC	ASPHALT
Area (Sq. Ft.)	Lane Miles (11' Widths)	Curb Reveal (Inches)	Curb Recommendation
23,260	0.4	6	DO NOTHING
Curb Type		Curb & Gutter Type	
ASPHALT AND CONCRETE		NO CURB AND GUTTER	
Pavement Recommendation		Condition Rating / PCR	
HEAVY 3R TREATMENTS		POOR / 53

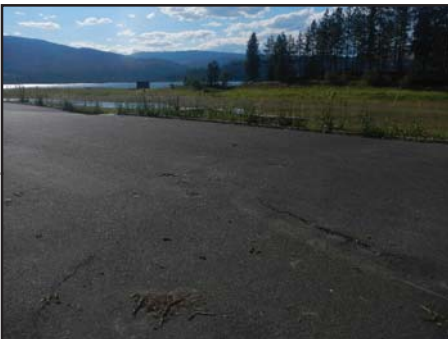
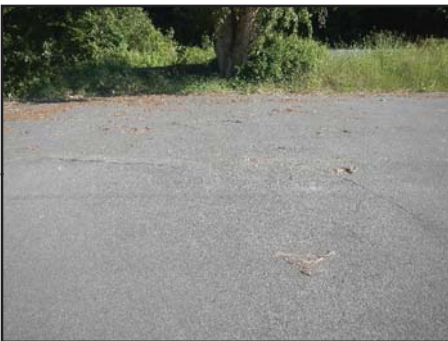
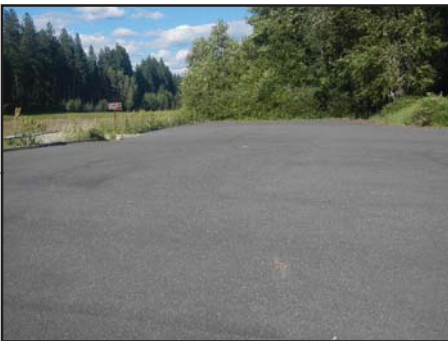
ROUTE 0942: MARCUS ISLAND BOAT LAUNCH PARKING

Inspection Date	FMSS Number	User Access	Surface Type
6/20/2015	39307	PUBLIC	ASPHALT
Area (Sq. Ft.)	Lane Miles (11' Widths)	Curb Reveal (Inches)	Curb Recommendation
17,066	0.294	3	DO NOTHING
Curb Type		Curb & Gutter Type	
CONCRETE		NO CURB AND GUTTER	
Pavement Recommendation		Condition Rating / PCR	
PREVENTIVE MAINTENANCE		GOOD / 90

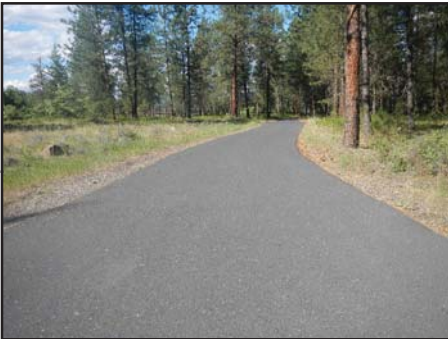
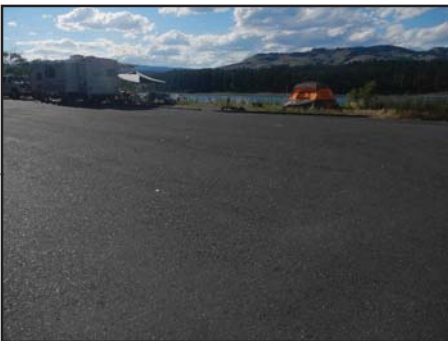
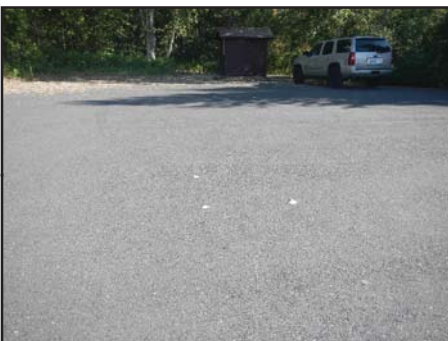
ROUTE 0944: SNAG COVE CAMPGROUND AND BOAT LAUNCH PARKING

Inspection Date	FMSS Number	User Access	Surface Type
6/20/2015	39362	PUBLIC	ASPHALT
Area (Sq. Ft.)	Lane Miles (11' Widths)	Curb Reveal (Inches)	Curb Recommendation
17,651	0.304	4	DO NOTHING
Curb Type		Curb & Gutter Type	
CONCRETE		NO CURB AND GUTTER	
Pavement Recommendation		Condition Rating / PCR	
PREVENTIVE MAINTENANCE		GOOD / 90

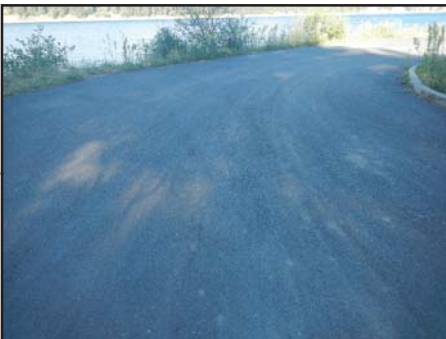
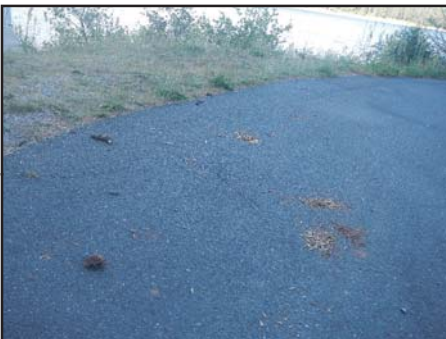
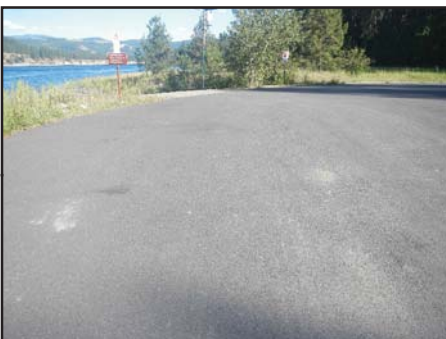
ROUTE 0947: SEVEN BAYS BOAT LAUNCH PARKING

Inspection Date	FMSS Number	User Access	Surface Type
6/21/2015	39489	PUBLIC	ASPHALT
Area (Sq. Ft.)	Lane Miles (11' Widths)	Curb Reveal (Inches)	Curb Recommendation
54,700	0.942	7	DO NOTHING
Curb Type		Curb & Gutter Type	
CONCRETE		NO CURB AND GUTTER	
Pavement Recommendation		Condition Rating / PCR	
PREVENTIVE MAINTENANCE		GOOD / 90

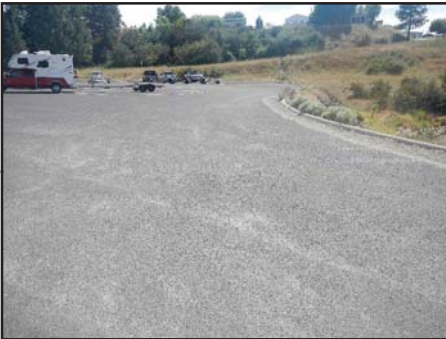
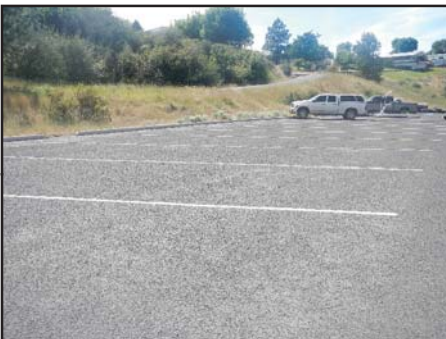
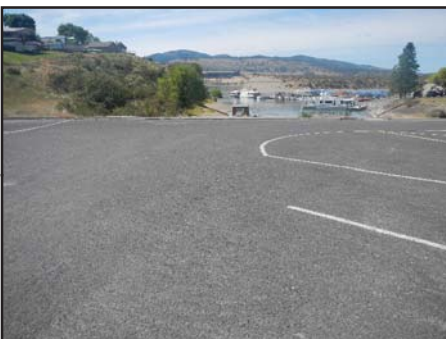
ROUTE 0949: GIFFORD CAMPGROUND DUMP STATION

Inspection Date	FMSS Number	User Access	Surface Type
6/21/2015	39255	PUBLIC	ASPHALT
Area (Sq. Ft.)	Lane Miles (11' Widths)	Curb Reveal (Inches)	Curb Recommendation
2,058	0.035	NOT APPLICABLE	NOT APPLICABLE
Curb Type		Curb & Gutter Type	
NO CURB		NO CURB AND GUTTER	
Pavement Recommendation		Condition Rating / PCR	
PREVENTIVE MAINTENANCE		GOOD / 90

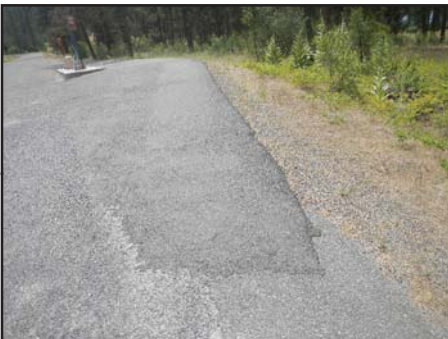
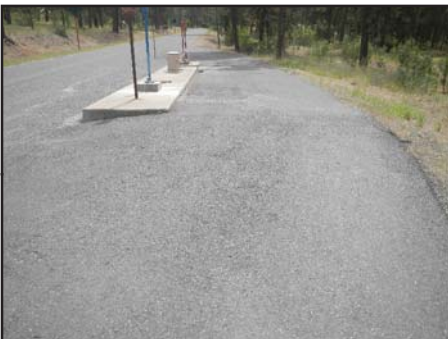
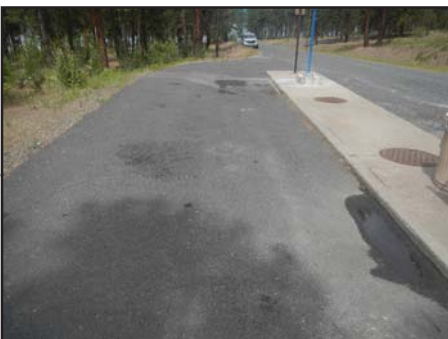
ROUTE 0950: KETTLE FALLS DUMP STATION

Inspection Date	FMSS Number	User Access	Surface Type
6/21/2015	39094	PUBLIC	ASPHALT
Area (Sq. Ft.)	Lane Miles (11' Widths)	Curb Reveal (Inches)	Curb Recommendation
2,147	0.037	3	DO NOTHING
Curb Type		Curb & Gutter Type	
CONCRETE		NO CURB AND GUTTER	
Pavement Recommendation		Condition Rating / PCR	
LIGHT 3R TREATMENTS		FAIR / 73

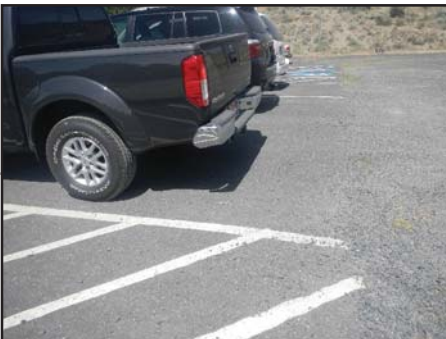
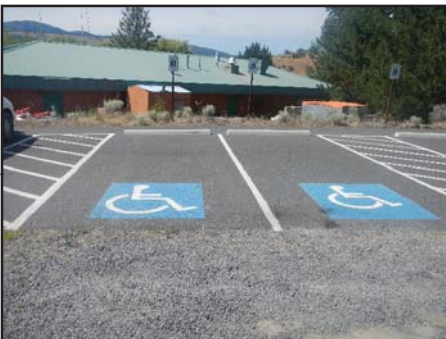
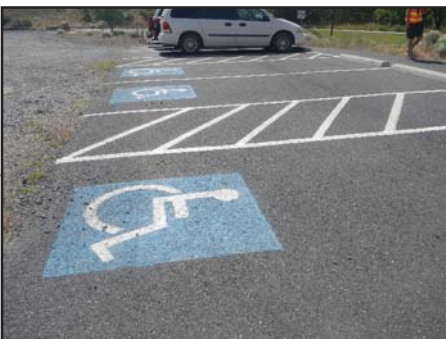
ROUTE 0951BZ: SEVEN BAYS UPPER STORE / RESTAURANT PARKING B

Inspection Date	FMSS Number	User Access	Surface Type
6/21/2015	39262	PUBLIC	ASPHALT
Area (Sq. Ft.)	Lane Miles (11' Widths)	Curb Reveal (Inches)	Curb Recommendation
2,780	0.048	0	DO NOTHING
Curb Type		Curb & Gutter Type	
CONCRETE		NO CURB AND GUTTER	
Pavement Recommendation		Condition Rating / PCR	
PREVENTIVE MAINTENANCE		GOOD / 90

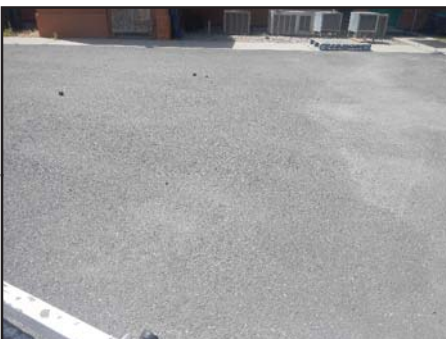
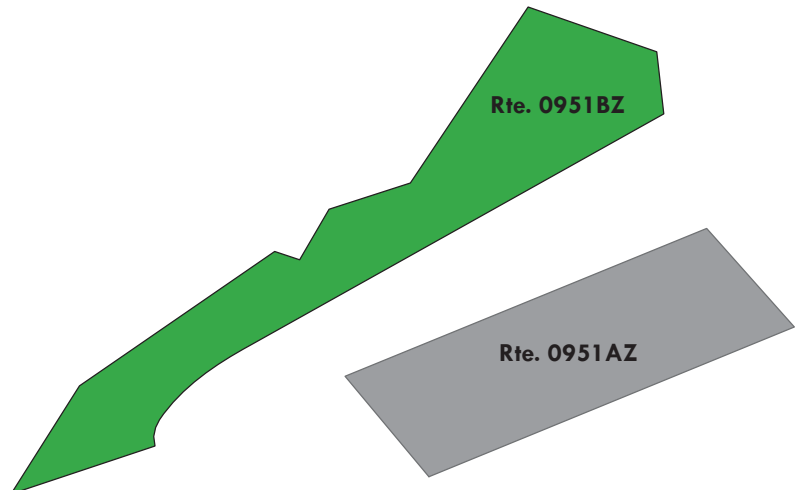
ROUTE 0954: FORT SPOKANE CAMPGROUND DUMP STATION

Inspection Date	FMSS Number	User Access	Surface Type
6/21/2015	39491	PUBLIC	ASPHALT
Area (Sq. Ft.)	Lane Miles (11' Widths)	Curb Reveal (Inches)	Curb Recommendation
2,280	0.039	NOT APPLICABLE	DO NOTHING
Curb Type		Curb & Gutter Type	
NO CURB		CONCRETE	
Pavement Recommendation		Condition Rating / PCR	
PREVENTIVE MAINTENANCE		GOOD / 90

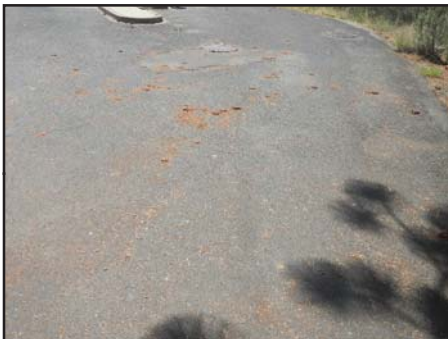
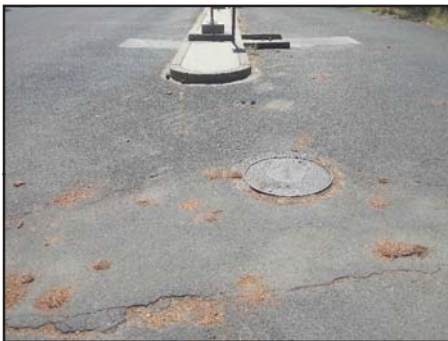
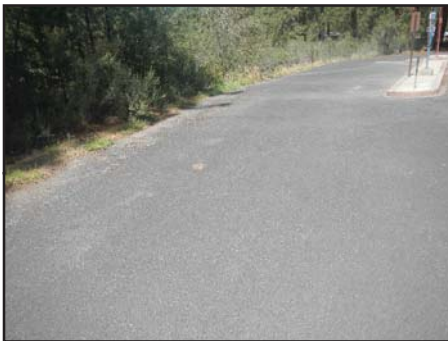
ROUTE 0955: HUNTERS RV DUMP STATION

Inspection Date	FMSS Number	User Access	Surface Type
6/21/2015	39291	PUBLIC	ASPHALT
Area (Sq. Ft.)	Lane Miles (11' Widths)	Curb Reveal (Inches)	Curb Recommendation
3,741	0.064	4	LIGHT REPAIR
Curb Type		Curb & Gutter Type	
CONCRETE		NO CURB AND GUTTER	
Pavement Recommendation		Condition Rating / PCR	
DO NOTHING		EXCELLENT / 97

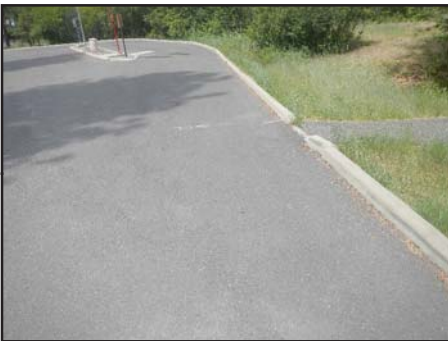
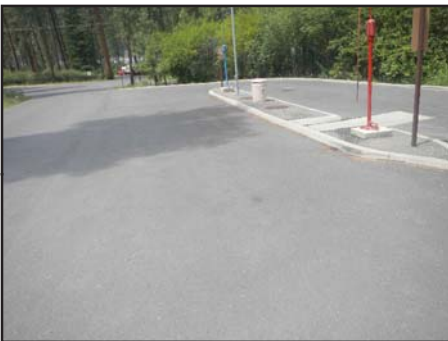
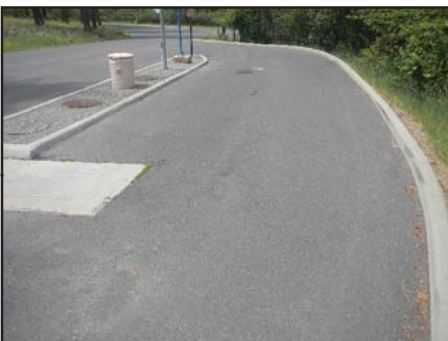
ROUTE 0956: SPRING CANYON RV DUMP STATION

Inspection Date	FMSS Number	User Access	Surface Type
6/22/2015	39493	PUBLIC	ASPHALT
Area (Sq. Ft.)	Lane Miles (11' Widths)	Curb Reveal (Inches)	Curb Recommendation
2,651	0.046	NOT APPLICABLE	DO NOTHING
Curb Type		Curb & Gutter Type	
NO CURB		CONCRETE	
Pavement Recommendation		Condition Rating / PCR	
PREVENTIVE MAINTENANCE		GOOD / 90
