MORA Cycle 6

Final Report

Road Inventory and Condition Assessment of Paved Routes Mount Rainier National Park

Report Date: May 2016

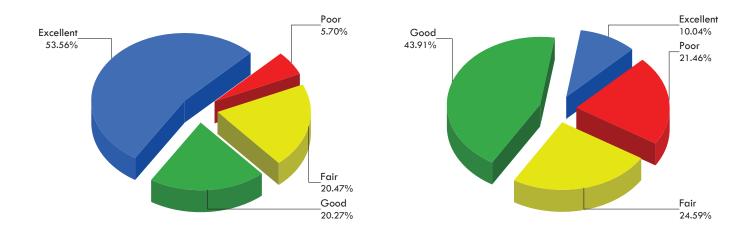
Figure 1: Pavement Condition Rating Breakdown for Paved Roads and Parking Areas

Road Condition Percentages

Parking Area Condition Percentages

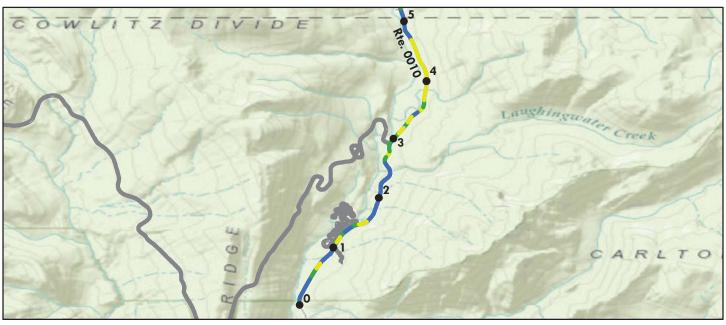
ROUTE 0010: STATE ROUTE 123 (EAST SIDE HIGHWAY)

Data Collection Vehicle (DCV) Rating

Route	Condition Legend – Pav	ement Condi	tion Rating (PCR)			
Poor (0 - 60) Fair (Good ((85 - 94)	Excellent (95 - 100)	Not Rated		
	See Appendix for def	initions and f	ormulas				
Inspection Date: 8/8/2015	Beginning Section MP	0	1	2	3	4	
Paved Length (Miles): 13.86	Section Length (MI)	1	1	1	1	1	
Surface Type: ASPHALT	Route Summary						
Roadway Condition Information							
Pavement Condition Rating (PCR)	96	94	93	94	81	80	
Surface Condition Rating (SCR)	99	99	99	99	94	96	
Roughness Condition Index (RCI)	92	86	85	87	62	55	
Distress Index Values							
Structural Crack Index	100	100	99	100	99	99	
Alligator Crack Index	100	100	100	100	100	100	
Longitudinal Crack Index	100	100	99	100	99	99	
Transverse Cracking Index	100	100	100	100	100	100	
Patching Index	100	100	100	100	99	100	
Rutting Index	99	99	99	99	94	96	
International Roughness Index (IRI)	135	152	155	150	230	260	
Lane & Width Information							
Number of Lanes	2	2	2	2	2	2

Paved Width (ft)	20	20.3	18.2	21.2	19.8	20.2	
Lane Width (ft)	8.8	9	9.1	9	8.9	8.7

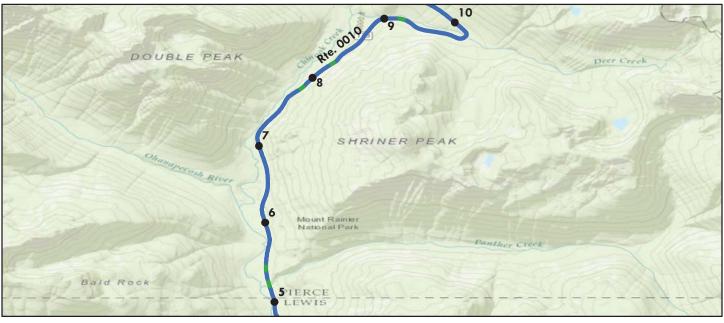
ROUTE 0010: STATE ROUTE 123 (EAST SIDE HIGHWAY)

Data Collection Vehicle (DCV) Rating

Route (Condition Legend – Pav	ement Condi	tion Rating (PCR)		
Poor (0 - 60			(85 - 94)	Excellent (Not Ra	ted
		See Appendix for def	initions and f	ormulas			
Inspection Date:	8/8/2015	Beginning Section MP	5	6	7	8	9
Paved Length (Mile	s): 13.86	Section Length (MI)	1	1	1	1	1
Surface Type:	ASPHALT	Route Summary					
Roadway Condition	Information						
Pavement Condition	n Rating (PCR)	96	100	100	100	100	99
Surface Condition R	ating (SCR)	99	100	100	100	100	99
Roughness Condition Index (RCI)		92	99	100	99	100	99
Distress Index Value	es						
Structural Crack Inc	dex	100	100	100	100	100	100
Alligator Crack Ind	ex	100	100	100	100	100	100
Longitudinal Crack	Index	100	100	100	100	100	100
Transverse Crackin	g Index	100	100	100	100	100	100
Patching Index		100	100	100	100	100	100
Rutting Index		99	100	100	100	100	99
International Rough	nness Index (IRI)	135	118	99	117	89	118
Lane & Width Info	rmation						
Number of Lanes		2	2	2	2	2	2

Paved Width (ft)		20	20	20.5	20.6	19.8	20
Lane Width (ft)		8.8	8.5	8.9	8.3	8.6	8.8

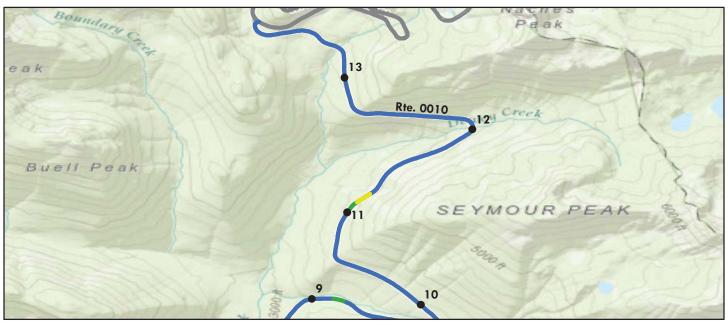
ROUTE 0010: STATE ROUTE 123 (EAST SIDE HIGHWAY)

Data Collection Vehicle (DCV) Rating

Route	Condition Legend – Pav	ement Condi	tion Rating (PCR)		
Poor (0 - 60) Fair (61- 84) Good	(85 - 94)	Excellent (95 - 100)	Not Ra	ted
	See Appendix for def	initions and f	ormulas			
Inspection Date: 8/8/2015	Beginning Section MP	10	11	12	13	
Paved Length (Miles): 13.86	Section Length (MI)	1	1	1	0.86	
Surface Type: ASPHALT	Route Summary					
Roadway Condition Information						
Pavement Condition Rating (PCR)	96	100	100	100	99	
Surface Condition Rating (SCR)	99	100	100	100	99	
Roughness Condition Index (RCI)	92	100	100	100	100	
Distress Index Values						
Structural Crack Index	100	100	100	100	100	
Alligator Crack Index	100	100	100	100	100	
Longitudinal Crack Index	100	100	100	100	100	
Transverse Cracking Index	100	100	100	100	100	
Patching Index	100	100	100	100	100	
Rutting Index	99	100	100	100	99	
International Roughness Index (IRI)	135	91	106	90	113	
Lane & Width Information						
Number of Lanes	2	2	2	2	2

Paved Width (ft)	20	19.6	19.4	20.4	20.5	
Lane Width (ft)	8.8	8.8	8.7	8.9	8.8

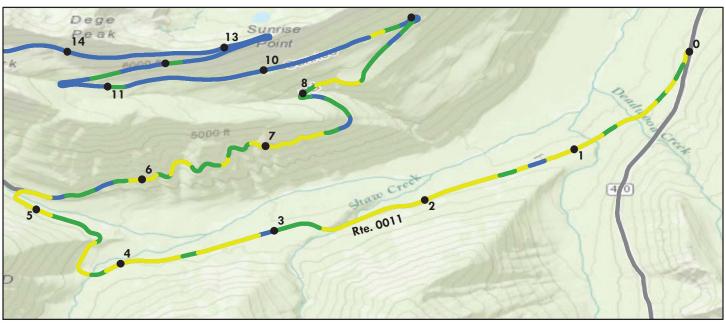
ROUTE 0011: SUNRISE ROAD

Data Collection Vehicle (DCV) Rating

Route Condition	ı Legend – Pav	ement Condi	tion Rating (PCR)		
Poor (0 - 60)	Fair (61- 84)		(85 - 94)	Excellent (Not Rated	
	See A	appendix for def	, , , , , , , , , , , , , , , , , , , ,	ormulas	<u> </u>		
Inspection Date: 8/8/2015	Beginni	ng Section MP	0	1	2	3	4
Paved Length (Miles): 15.38	Section	Length (MI)	1	1	1	1	1
Surface Type: ASPHAI	T Route S	ummary					
Roadway Condition Information	n						
Pavement Condition Rating (PC	CR)	90	79	81	81	80	83
Surface Condition Rating (SCR)		99	99	99	99	98	98
Roughness Condition Index (RCI)	76	48	55	55	54	61
Distress Index Values							
Structural Crack Index		100	100	100	100	100	100
Alligator Crack Index		100	100	100	100	100	100
Longitudinal Crack Index		100	100	100	100	100	100
Transverse Cracking Index		100	100	100	100	100	100
Patching Index		100	100	100	100	100	100
Rutting Index		99	99	99	99	98	98
International Roughness Index	(IRI)	181	292	263	261	266	234
Lane & Width Information

Number of Lanes		2	2	2	2	2	2
Paved Width (ft)		20.7	21.4	21.1	20.4	20.8	20.1
Lane Width (ft)		9.8	10.1	9.8	9.8	9.7	9.7

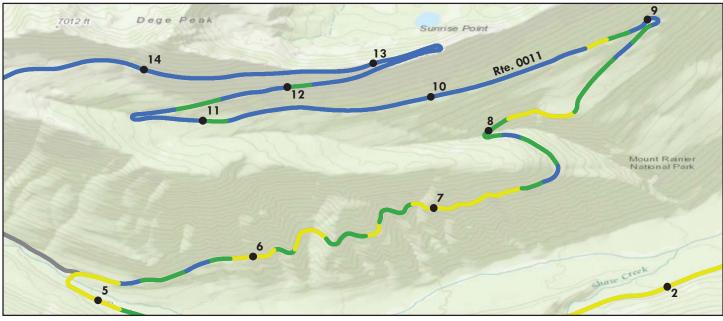
ROUTE 0011: SUNRISE ROAD

Data Collection Vehicle (DCV) Rating

Route	Condition Legend – Pav	ement Condi	tion Rating (PCR)		
Poor (0 - 60) Fair (6	Good ((85 - 94)	Excellent (95 - 100)	Not Ra	ted
	See Appendix for def	initions and f	ormulas			
Inspection Date: 8/8/2015	Beginning Section MP	5	6	7	8	9
Paved Length (Miles): 15.38	Section Length (MI)	1	1	1	1	1
Surface Type: ASPHALT	Route Summary					
Roadway Condition Information						
Pavement Condition Rating (PCR)	90	85	84	86	88	99
Surface Condition Rating (SCR)	99	99	97	97	98	98
Roughness Condition Index (RCI)	76	65	64	70	72	100
Distress Index Values						
Structural Crack Index	100	100	100	100	100	100
Alligator Crack Index	100	100	100	100	100	100
Longitudinal Crack Index	100	100	100	100	100	100
Transverse Cracking Index	100	100	100	100	100	100
Patching Index	100	100	100	100	100	100
Rutting Index	99	99	97	97	98	98
International Roughness Index (IRI)	181	220	225	200	196	102
Lane & Width Information						
Number of Lanes	2	2	2	2	2	2

Paved Width (ft)	20.7	19.7	21.3	21.8	20.8	20.1
Lane Width (ft)	9.8	9.7	9.9	9.8	9.8	10

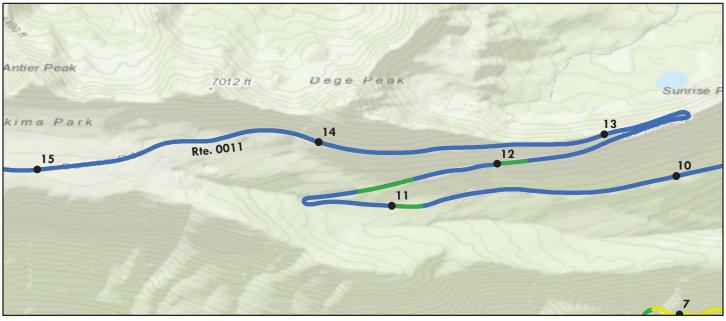
ROUTE 0011: SUNRISE ROAD

Route	Condition Legend – Pav	ement Condi	tion Rating (PCR)		
Poor (0 - 60) Fair (6	Good ((85 - 94)	Excellent (95 - 100)	Not Ra	ted
	See Appendix for def	initions and f	ormulas			
Inspection Date: 8/8/2015	Beginning Section MP	10	11	12	13	14
Paved Length (Miles): 15.38	Section Length (MI)	1	1	1	1	1
Surface Type: ASPHALT	Route Summary			•		
Roadway Condition Information						
Pavement Condition Rating (PCR)	90	99	98	99	100	100
Surface Condition Rating (SCR)	99	99	98	99	100	100
Roughness Condition Index (RCI)	76	100	99	100	100	100
Distress Index Values						
Structural Crack Index	100	100	100	100	100	100
Alligator Crack Index	100	100	100	100	100	100
Longitudinal Crack Index	100	100	100	100	100	100
Transverse Cracking Index	100	100	100	100	100	100
Patching Index	100	100	100	100	100	100
Rutting Index	99	99	98	99	100	100
International Roughness Index (IRI)	181	104	118	109	82	86
Lane & Width Information						
Number of Lanes	2	2	2	2	2	2

Paved Width (ft)	20.7	20.4	21.6	20.4	20.4	20.5
Lane Width (ft)	9.8	9.5	10	10.1	10	10

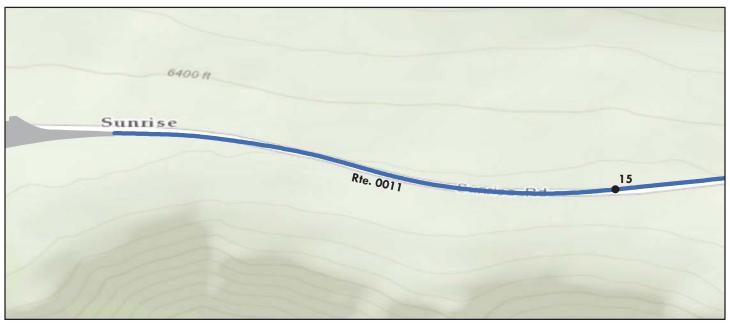
ROUTE 0011: SUNRISE ROAD

Route (Condition Legend – Pav	ement Condi	ition Rating (PCR)		
Poor (0 - 60	_		(85 - 94)	Excellent (9		Not Ra	ted
		See Appendix for def	,				
Inspection Date:	8/8/2015	Beginning Section MP	15				
Paved Length (Mile	s): 15.38	Section Length (MI)	0.38				
Surface Type:	ASPHALT	Route Summary					
Roadway Condition	Information						
Pavement Condition	n Rating (PCR)	90	100				
Surface Condition R	ating (SCR)	99	100				
Roughness Condition	n Index (RCI)	76	100				
Distress Index Value	es						
Structural Crack Inc	dex	100	100				
Alligator Crack Ind	ex	100	100				
Longitudinal Crack	Index	100	100				
Transverse Crackin	g Index	100	100				
Patching Index		100	100				
Rutting Index		99	100				
International Rough	nness Index (IRI)	181	86				
Lane & Width Infor	rmation						
Number of Lanes		2	2				
Paved Width (ft)		20.7	21.2				
Lane Width (ft)		9.8	9.8

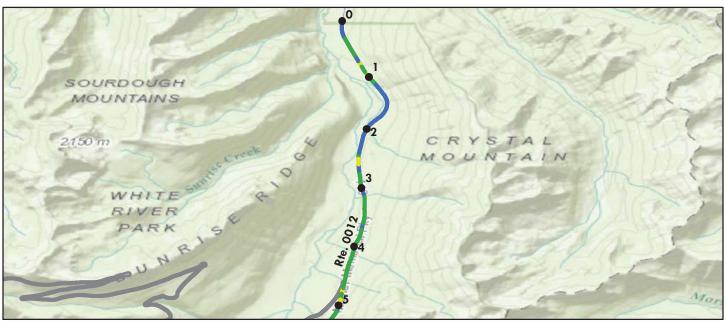
ROUTE 0012: STATE ROUTE 410 (MATHER MEMORIAL PARKWAY)

Route	Condition Legend – Pav	ement Condi	tion Rating (PCR)			
Poor (0 - 60) Fair (6	Good ((85 - 94)	Excellent (95 - 100)	Not Rated		
	See Appendix for def	initions and f	ormulas				
Inspection Date: 8/8/2015	Beginning Section MP	0	1	2	3	4	
Paved Length (Miles): 11.68	Section Length (MI)	1	1	1	1	1	
Surface Type: ASPHALT	Route Summary						
Roadway Condition Information							
Pavement Condition Rating (PCR)	94	93	99	95	91	88	
Surface Condition Rating (SCR)	99	100	100	100	100	100	
Roughness Condition Index (RCI)	87	83	98	87	77	69	
Distress Index Values							
Structural Crack Index	100	100	100	100	100	100	
Alligator Crack Index	100	100	100	100	100	100	
Longitudinal Crack Index	100	100	100	100	100	100	
Transverse Cracking Index	100	100	100	100	100	100	
Patching Index	100	100	100	100	100	100	
Rutting Index	99	100	100	100	100	100	
International Roughness Index (IRI)	148	161	121	149	178	206	
Lane & Width Information

Number of Lanes	2	2	2	2	2	2	
Paved Width (ft)	20.7	20.2	20.2	19.6	20.3	20.4	
Lane Width (ft)	8.3	9	8.1	7.9	7.8	8.4

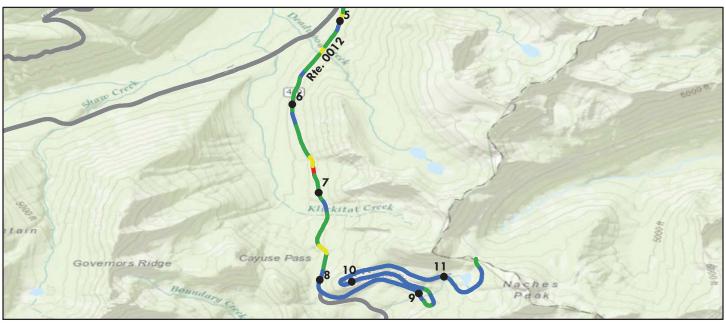
ROUTE 0012: STATE ROUTE 410 (MATHER MEMORIAL PARKWAY)

Route C	Condition Legend – Pav	ement Condi	tion Rating (PCR)		
Poor (0 - 60)	Fair (6		(85 - 94)	Excellent (95 - 100)		Not Rated	
		See Appendix for def	finitions and f	ormulas			
Inspection Date: 8/8	3/2015	Beginning Section MP	5	6	7	8	9
Paved Length (Miles): 11	.68	Section Length (MI)	1	1	1	1	1
Surface Type: AS	SPHALT	Route Summary				•	
Roadway Condition Info	rmation						
Pavement Condition Rati	ng (PCR)	94	91	84	90	100	97
Surface Condition Rating (Surface Condition Rating (SCR)		99	97	100	100	95
Roughness Condition Inde	x (RCI)	87	80	64	76	100	100
Distress Index Values							
Structural Crack Index		100	99	100	100	100	100
Alligator Crack Index		100	100	100	100	100	100
Longitudinal Crack Index	ζ	100	99	100	100	100	100
Transverse Cracking Inde	ex	100	100	100	100	100	100
Patching Index		100	100	97	100	100	100
Rutting Index		99	100	99	100	100	95
International Roughness	Index (IRI)	148	170	224	182	104	85
Lane & Width Information	on

Number of Lanes		2	2	2	2	2	2
Paved Width (ft)		20.7	21.6	20.2	19.9	21.3	20.4
Lane Width (ft)		8.3	8.3	8.2	7.8	8.4	8.1

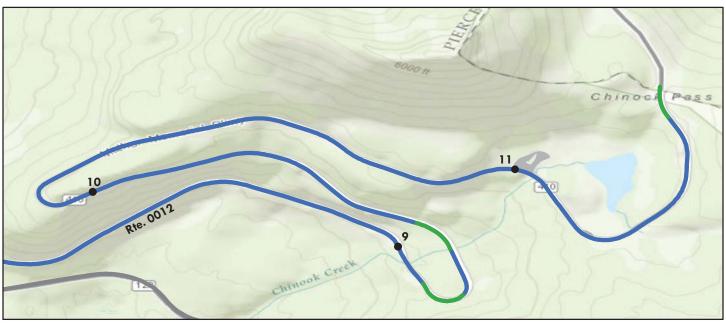
ROUTE 0012: STATE ROUTE 410 (MATHER MEMORIAL PARKWAY)

Route (Condition Legend – Pav	ement Condi	tion Rating (PCR)		
Poor (0 - 60			(85 - 94)	Excellent (Not Rated	
		See Appendix for def	initions and f	ormulas			
Inspection Date:	8/8/2015	Beginning Section MP	10	11			
Paved Length (Miles): 11.68		Section Length (MI)	1	0.68			
Surface Type:	ASPHALT	Route Summary					
Roadway Condition	Information						
Pavement Condition	n Rating (PCR)	94	99	99			
Surface Condition R	ating (SCR)	99	99	99			
Roughness Condition	n Index (RCI)	87	100	100			
Distress Index Value	es						
Structural Crack Inc	dex	100	100	99			
Alligator Crack Ind	ex	100	100	100			
Longitudinal Crack	Index	100	100	99			
Transverse Crackin	g Index	100	100	100			
Patching Index		100	100	100			
Rutting Index		99	99	100			
International Rough	nness Index (IRI)	148	80	94			
Lane & Width Info	rmation						
Number of Lanes		2	2	2			
Paved Width (ft)		20.7	22.6	21.8			
Lane Width (ft)		8.3	8.6	9.1

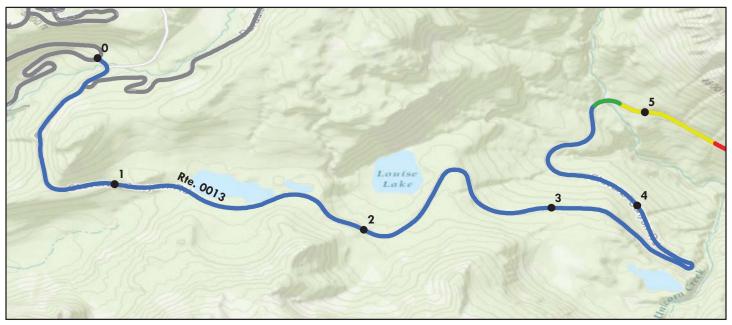
ROUTE 0013: STEVENS CANYON ROAD

R	oute Condition Legend – Pa	vement Condi	tion Rating (PCR)		
		(85 - 94)	Excellent (Not Ra	ted
` '	See Appendix for de		× 1	<u> </u>		
Inspection Date: 8/8/2015	Beginning Section MI	0	1	2	3	4
Paved Length (Miles): 19.04	Section Length (MI)	1	1	1	1	1
Surface Type: ASPHALT	Route Summary					
Roadway Condition Information						
Pavement Condition Rating (PCR)	85	100	100	100	100	98
Surface Condition Rating (SCR)	80	100	100	100	100	96
Roughness Condition Index (RCI)	93	100	100	100	100	100
Distress Index Values						
Structural Crack Index	89	100	100	100	100	96
Alligator Crack Index	100	100	100	100	100	100
Longitudinal Crack Index	89	100	100	100	100	96
Transverse Cracking Index	80	100	100	100	100	96
Patching Index	100	100	100	100	100	100
Rutting Index	100	100	100	100	100	100
International Roughness Index (IR	I) 133	105	92	83	83	88
Lane & Width Information						
Number of Lanes	2	2	2	2	2	2
Paved Width (ft)	25.6	24.8	24.8	25.2	26.5	25.6

Lane Width (ft)	11	10.4	10.7	11.4	11.8	11.6

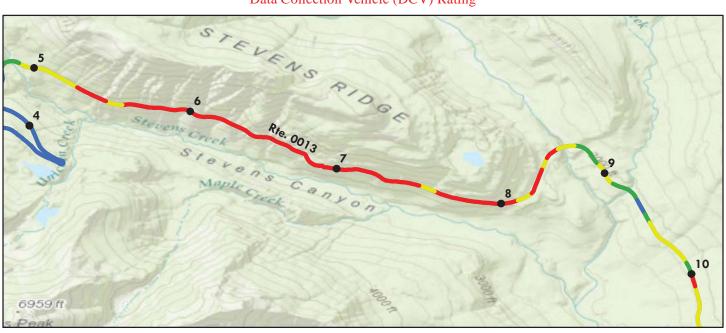
ROUTE 0013: STEVENS CANYON ROAD

Route	Condition Legend – Pav	ement Condi	tion Rating (PCR)		
Poor (0 - 60) Fair (Good ((85 - 94)	Excellent (95 - 100)	Not Ra	ted
	See Appendix for def	initions and f	ormulas			
Inspection Date: 8/8/2015	Beginning Section MP	5	6	7	8	9
Paved Length (Miles): 19.04	Section Length (MI)	1	1	1	1	1
Surface Type: ASPHALT	Route Summary					
Roadway Condition Information						
Pavement Condition Rating (PCR)	85	44	32	26	68	85
Surface Condition Rating (SCR)	80	30	0	0	54	83
Roughness Condition Index (RCI)	93	66	79	65	92	88
Distress Index Values						
Structural Crack Index	89	69	57	59	71	83
Alligator Crack Index	100	100	100	100	100	99
Longitudinal Crack Index	89	69	57	59	71	84
Transverse Cracking Index	80	30	0	0	54	93
Patching Index	100	100	100	100	100	100
Rutting Index	100	99	99	97	100	99
International Roughness Index (IRI)	133	216	173	220	136	146
Lane & Width Information						
Number of Lanes	2	2	2	2	2	2
Paved Width (ft)	25.6	25.2	25.9	28.1	25.5	24.5

Lane Width (ft)	11	10.9	11.1	10.9	11	10.7

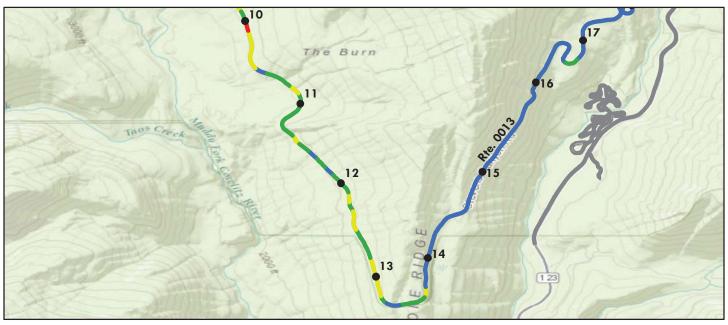
ROUTE 0013: STEVENS CANYON ROAD

Route	Condition Legend – Pav	ement Condi	tion Rating (PCR)		
Poor (0 - 60) Fair (6	Good ((85 - 94)	Excellent (95 - 100)	Not Rated	
	See Appendix for def	initions and f	ormulas			
Inspection Date: 8/8/2015	Beginning Section MP	10	11	12	13	14
Paved Length (Miles): 19.04	Section Length (MI)	1	1	1	1	1
Surface Type: ASPHALT	Route Summary					
Roadway Condition Information						
Pavement Condition Rating (PCR)	85	77	90	83	92	100
Surface Condition Rating (SCR)	80	75	91	85	92	100
Roughness Condition Index (RCI)	93	80	88	80	92	100
Distress Index Values						
Structural Crack Index	89	75	91	85	92	100
Alligator Crack Index	100	97	100	100	100	100
Longitudinal Crack Index	89	78	91	85	92	100
Transverse Cracking Index	80	89	97	95	95	100
Patching Index	100	99	99	100	100	100
Rutting Index	100	99	99	98	99	100
International Roughness Index (IRI)	133	170	146	168	134	101
Lane & Width Information						
Number of Lanes	2	2	2	2	2	2

Paved Width (ft)	25.6	24.4	24.4	24.8	30.2	24.4
Lane Width (ft)	11	10.3	10.6	10.3	10.7	10.9

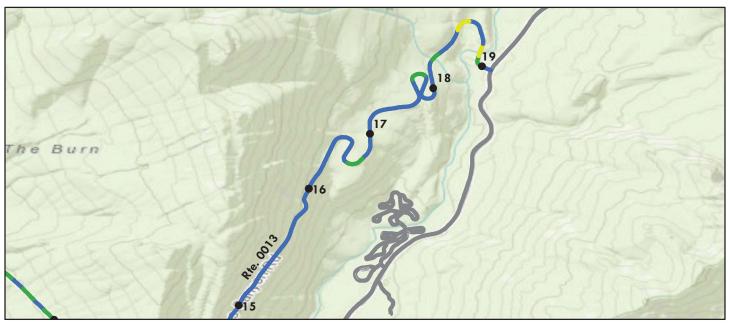
ROUTE 0013: STEVENS CANYON ROAD

Route Condition Legend –	- Pavement Cond	ition Rating (PCR)		
Poor (0 - 60)		ood (85 - 94)	Excellent (95 - 100)		Not Rated	
	See Appendix fo	or definitions and f	ormulas			
Inspection Date: 8/8/2015	Beginning Section	MP 15	16	17	18	19
Paved Length (Miles): 19.04	Section Length (M	II) 1	1	1	1	0.04
Surface Type: ASPHALT	Route Summary		•	•		
Roadway Condition Information						
Pavement Condition Rating (PCF	R) 85	100	100	100	93	99
Surface Condition Rating (SCR)	80	100	100	100	100	99
Roughness Condition Index (RCI)	93	100	100	99	82	N/A
Distress Index Values						
Structural Crack Index	89	100	100	100	100	100
Alligator Crack Index	100	100	100	100	100	100
Longitudinal Crack Index	89	100	100	100	100	100
Transverse Cracking Index	80	100	100	100	100	100
Patching Index	100	100	100	100	100	100
Rutting Index	100	100	100	100	100	99
International Roughness Index (I	RI) 133	88	98	117	163	N/A
Lane & Width Information

Number of Lanes	2	2	2	2	2	2
Paved Width (ft)	25.6	25.1	24.3	24.3	27.1	56
Lane Width (ft)	11	10.8	10.9	11	12.4	15.8

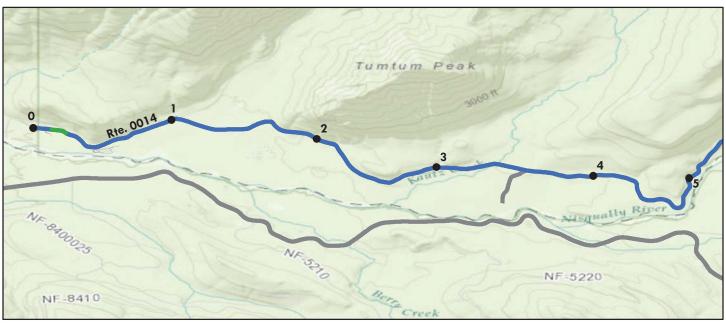
ROUTE 0014: STATE ROUTE 706 (NISQUALLY ROAD)

Roy	te Condition Legend – Pay	zement Condi	ition Rating (PCR)		
		(85 - 94)	Excellent (Not Ra	ted
2 332 (3 34)	See Appendix for de		`			
Inspection Date: 8/7/2015	Beginning Section MP		1	2	3	4
Paved Length (Miles): 17.65	Section Length (MI)	1	1	1	1	1
Surface Type: ASPHALT	Route Summary		!	!	!	
Roadway Condition Information						
Pavement Condition Rating (PCR)	86	99	100	100	100	100
Surface Condition Rating (SCR)	95	99	100	100	100	100
Roughness Condition Index (RCI)	73	100	100	100	100	100
Distress Index Values						
Structural Crack Index	96	100	100	100	100	100
Alligator Crack Index	100	100	100	100	100	100
Longitudinal Crack Index	96	100	100	100	100	100
Transverse Cracking Index	99	100	100	100	100	100
Patching Index	95	100	100	100	100	100
Rutting Index	95	99	100	100	100	100
International Roughness Index (IRI)	193	100	93	95	85	97
Lane & Width Information						
Number of Lanes	2	2	2	2	2	2
Paved Width (ft)	20.3	20.8	20.7	20	20.6	19.4

Lane Width (ft)	9.1	9.2	9	8.9	8.9	8.9

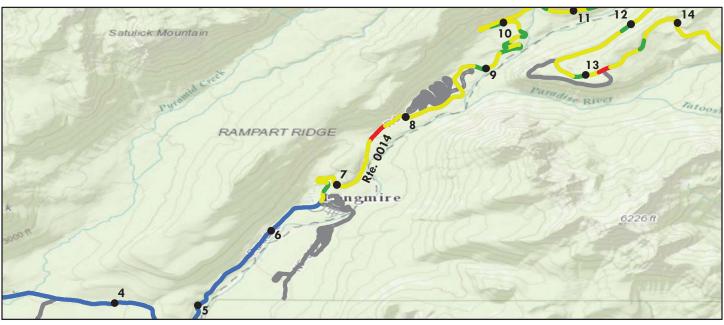
ROUTE 0014: STATE ROUTE 706 (NISQUALLY ROAD)

Route	Condition Legend – Pay	ement Condi	tion Rating (PCR)		
		(85 - 94)	Excellent (95 - 100)		Not Rated	
	See Appendix for det	finitions and f	ormulas			
Inspection Date: 8/7/2015	Beginning Section MP	5	6	7	8	9
Paved Length (Miles): 17.65	Section Length (MI)	1	1	1	1	1
Surface Type: ASPHALT	Route Summary			•		•
Roadway Condition Information						
Pavement Condition Rating (PCR)	86	100	90	71	76	84
Surface Condition Rating (SCR)	95	100	96	86	88	91
Roughness Condition Index (RCI)	73	100	82	48	59	73
Distress Index Values						
Structural Crack Index	96	100	100	92	97	100
Alligator Crack Index	100	100	100	100	100	100
Longitudinal Crack Index	96	100	100	92	97	100
Transverse Cracking Index	99	100	100	100	100	100
Patching Index	95	100	96	86	91	99
Rutting Index	95	100	96	88	88	91
International Roughness Index (IRI)	193	93	164	296	245	190
Lane & Width Information						
Number of Lanes	2	2	2	2	2	2
Paved Width (ft)	20.3	20.3	19.6	20.1	21.3	21.1

Lane Width (ft)	9.1	8.8	8.9	9.5	9.5	8.8

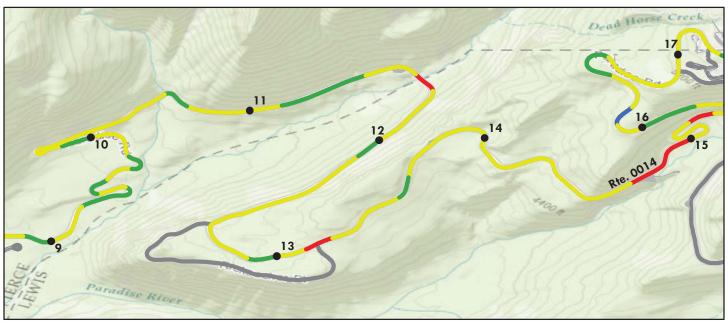
ROUTE 0014: STATE ROUTE 706 (NISQUALLY ROAD)

Route (Condition Legend – Pav	ement Condi	tion Rating (PCR)		
Poor (0 - 60) Fair (6	1- 84) Good ((85 - 94)	Excellent (95 - 100)		Not Ra	ted
	See Appendix for def	initions and fo	ormulas			
Inspection Date: 8/7/2015	Beginning Section MP	10	11	12	13	14
Paved Length (Miles): 17.65	Section Length (MI)	1	1	1	1	1
Surface Type: ASPHALT	Route Summary				•	
Roadway Condition Information						
Pavement Condition Rating (PCR)	86	78	80	80	69	68
Surface Condition Rating (SCR)	95	94	92	94	81	86
Roughness Condition Index (RCI)	73	53	61	59	52	42
Distress Index Values						
Structural Crack Index	96	94	97	95	81	86
Alligator Crack Index	100	100	100	100	94	100
Longitudinal Crack Index	96	94	97	95	87	86
Transverse Cracking Index	99	100	99	99	99	99
Patching Index	95	97	96	95	88	87
Rutting Index	95	95	92	94	93	95
International Roughness Index (IRI)	193	268	234	242	276	327
Lane & Width Information						
Number of Lanes	2	2	2	2	2	2

Paved Width (ft)	20.3	19	21.8	19.7	20.5	19.3
Lane Width (ft)	9.1	8.7	9.5	8	9.6	9.2

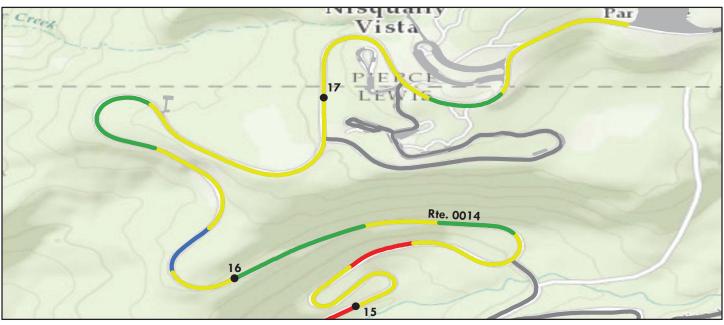
ROUTE 0014: STATE ROUTE 706 (NISQUALLY ROAD)

Route (Condition Legend – Pav	ement Condi	tion Rating (PCR)	
Poor (0 - 60			(85 - 94)	Excellent (Not Rated
		See Appendix for def	initions and f	ormulas		
Inspection Date:	8/7/2015	Beginning Section MP	15	16	17	
Paved Length (Mile	es): 17.65	Section Length (MI)	1	1	0.65	
Surface Type:	ASPHALT	Route Summary				
Roadway Condition	n Information					
Pavement Condition	on Rating (PCR)	86	77	83	81	
Surface Condition R	Rating (SCR)	95	93	92	87	
Roughness Condition	on Index (RCI)	73	54	70	71	
Distress Index Valu	es					
Structural Crack In	dex	96	94	92	96	
Alligator Crack Inc	dex	100	100	100	100	
Longitudinal Crack	Index	96	94	92	96	
Transverse Crackin	ng Index	99	99	97	97	
Patching Index		95	93	94	87	
Rutting Index		95	95	96	93	
International Roug	hness Index (IRI)	193	264	203	200	
Lane & Width Info	rmation					
Number of Lanes		2	2	2	2	
Paved Width (ft)		20.3	19.7	20.2	21.5	
Lane Width (ft)		9.1	9.5	8.9	9.2

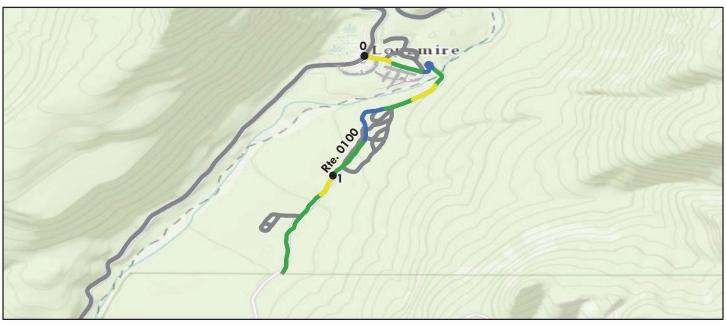
ROUTE 0100: LONGMIRE SOUTH BACK GATE ROAD

Route (Condition Legend – Pav	ement Condi	tion Rating (PCR)			
Poor (0 - 6			(85 - 94)	Excellent (Not Rated		
		See Appendix for def	initions and f	ormulas				
Inspection Date:	8/9/2015	Beginning Section MP	0	1				
Paved Length (Mile	es): 1.49	Section Length (MI)	1	0.49				
Surface Type:	ASPHALT	Route Summary				•		
Roadway Condition	n Information							
Pavement Condition	on Rating (PCR)	85	96	86				
Surface Condition R	Rating (SCR)	97	96	99				
Roughness Condition	on Index (RCI)	67	N/A	67				
Distress Index Valu	es							
Structural Crack In	ıdex	97	96	100				
Alligator Crack Inc	dex	99	99	100				
Longitudinal Crack	Index	98	97	100				
Transverse Crackin	ng Index	99	99	100				
Patching Index		99	98	100				
Rutting Index		98	98	99				
International Roug	hness Index (IRI)	214	N/A	214				
Lane & Width Info	rmation							
Number of Lanes		2	2	1				
Paved Width (ft)		14.7	16.1	12				
Lane Width (ft)		11.1	10.6	12

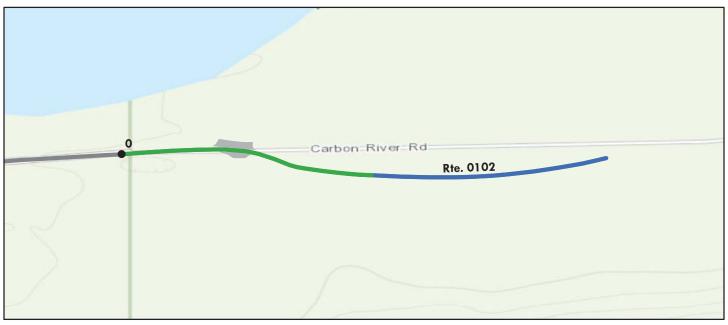
ROUTE 0102: CARBON RIVER ENTRANCE ROAD

Route (Condition Legend – Pay	zement Condi	ition Rating (PCR)		
Poor (0 - 60)	Fair (6		(85 - 94)	Excellent (-	Not Rat	ted
		See Appendix for de	finitions and f	ormulas			
Inspection Date: 8	/9/2015	Beginning Section MP	0				
Paved Length (Miles): 0.19		Section Length (MI)	0.19				
Surface Type: A	ASPHALT	Route Summary					
Roadway Condition Info	ormation						
Pavement Condition Ra	ting (PCR)	94	94				
Surface Condition Rating	(SCR)	94	94				
Roughness Condition Ind	lex (RCI)	N/A	N/A				
Distress Index Values							
Structural Crack Index		99	99				
Alligator Crack Index		100	100				
Longitudinal Crack Inde	ex	99	99				
Transverse Cracking Inc	dex	100	100				
Patching Index		100	100				
Rutting Index		94	94				
International Roughness	s Index (IRI)	N/A	N/A				
Lane & Width Informat	tion						
Number of Lanes		1	1				
Paved Width (ft)		12	12				
Lane Width (ft)		8.6	8.6

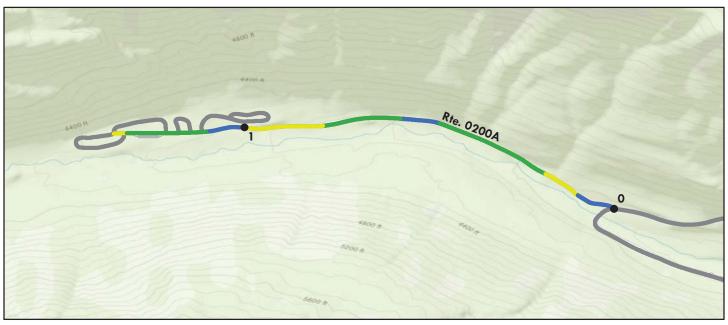
ROUTE 0200A: WHITE RIVER CAMPGROUND ENTRANCE ROAD

Route (Condition Legend – Pav	ement Condi	tion Rating (PCR)		
Poor (0 - 60			(85 - 94)	Excellent (Not Rated	
		See Appendix for def	initions and f	ormulas			_
Inspection Date:	8/8/2015	Beginning Section MP	0	1			
Paved Length (Mile	es): 1.33	Section Length (MI)	1	0.33			
Surface Type:	ASPHALT	Route Summary		•	•		
Roadway Condition	Information						
Pavement Condition	n Rating (PCR)	86	87	91			
Surface Condition R	ating (SCR)	98	99	91			
Roughness Condition	n Index (RCI)	69	69	N/A			
Distress Index Value	es						
Structural Crack Inc	dex	98	100	93			
Alligator Crack Ind	lex	100	100	100			
Longitudinal Crack	Index	98	100	93			
Transverse Crackin	g Index	98	100	91			
Patching Index		100	100	100			
Rutting Index		99	99	98			
International Rough	nness Index (IRI)	206	205	N/A			
Lane & Width Info	rmation						
Number of Lanes		2	2	2			
Paved Width (ft)		22.8	23.6	20.3			
Lane Width (ft)		11.2	11.7	9.7

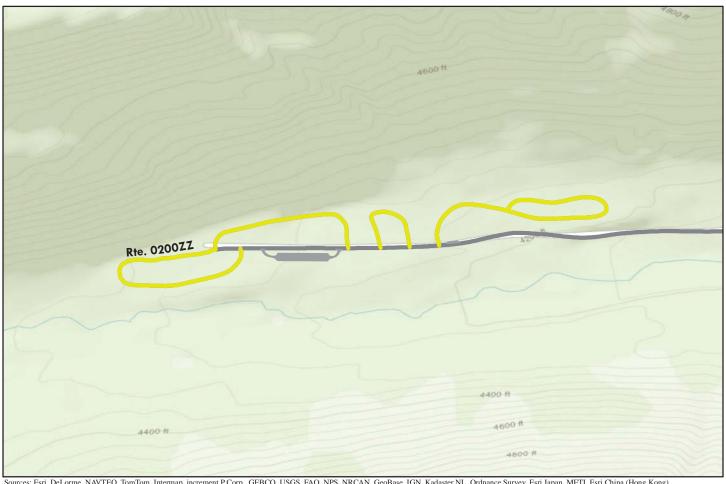
ROUTE 0200ZZ: WHITE RIVER CAMPGROUND LOOPS

Note: The weighted average summary PCR value is calculated from only the sections of road where the PCR was collected. The overall PCR for the summary

route may not reflect individua	i subcomponent rat	mgs.								
	Route Condition Legend – Pavement Condition Rating (PCR)									
Poor (0 - 60) Fair (6		1- 84) Good (8		(85 - 94)	Excellent (95 - 100)		Not Ra	ted		
See Appendix for definitions and formulas										
Inspection Date: 8/8	8/2015									
Paved Length (Miles): 0.8	89									
Surface Type: AS	SPHALT	Route Sumn	nary		•					
Roadway Condition Info	rmation									
Pavement Condition Rational	ing (PCR)	81								
Lane & Width Informati	on									
Number of Lanes		1								
Paved Width (ft)		13.2	2							
Lane Width (ft)		10.9	9

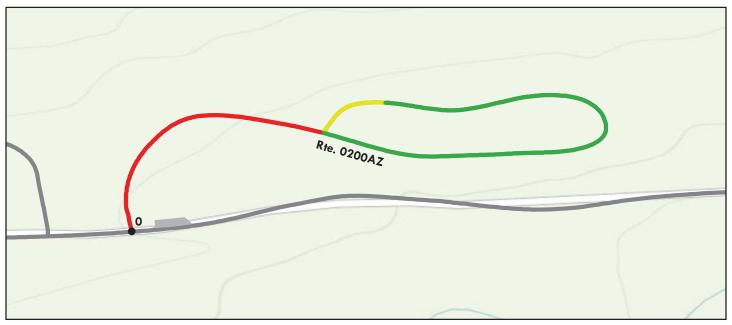
ROUTE 0200AZ: WHITE RIVER CAMPGROUND LOOP A

Route (Condition Legend – Pav	ement Condi	ition Rating (1	PCR)		
Poor (0 - 60			(85 - 94)	Excellent (9		Not Ra	ted
		See Appendix for def	, , , , , , , , , , , , , , , , , , , ,				
Inspection Date:	8/8/2015	Beginning Section MP	0				
Paved Length (Mile	es): 0.33	Section Length (MI)	0.33				
Surface Type:	ASPHALT	Route Summary					
Roadway Condition	n Information						
Pavement Conditio	n Rating (PCR)	74	74				
Surface Condition R	ating (SCR)	74	74				
Roughness Condition	n Index (RCI)	N/A	N/A				
Distress Index Value	es						
Structural Crack In-	dex	74	74				
Alligator Crack Ind	lex	99	99				
Longitudinal Crack	Index	75	75				
Transverse Crackin	ig Index	92	92				
Patching Index		98	98				
Rutting Index		92	92				
International Rough	hness Index (IRI)	N/A	N/A				
Lane & Width Info	rmation						
Number of Lanes		1	1				
Paved Width (ft)		14.2	14.2				
Lane Width (ft)		10.6	10.6

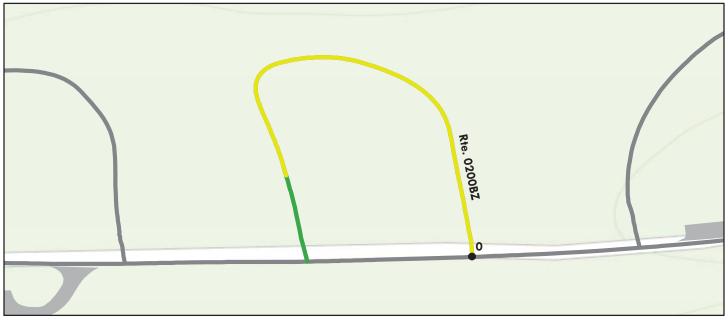
ROUTE 0200BZ: WHITE RIVER CAMPGROUND LOOP B

Route (Condition Legend – Pav	ement Condi	tion Rating ()	PCR)		
Poor (0 - 60			(85 - 94)	Excellent (9		Not Ra	ted
		See Appendix for def	1				
Inspection Date:	8/8/2015	Beginning Section MP	0				
Paved Length (Mile	es): 0.12	Section Length (MI)	0.12				
Surface Type:	ASPHALT	Route Summary					
Roadway Condition	Information						
Pavement Conditio	n Rating (PCR)	82	82				
Surface Condition R	ating (SCR)	82	82				
Roughness Condition	n Index (RCI)	N/A	N/A				
Distress Index Value	es						
Structural Crack Inc	dex	83	83				
Alligator Crack Ind	lex	100	100				
Longitudinal Crack	Index	83	83				
Transverse Crackin	g Index	94	94				
Patching Index		100	100				
Rutting Index		82	82				
International Rough	nness Index (IRI)	N/A	N/A				
Lane & Width Info	rmation						
Number of Lanes		2	2				
Paved Width (ft)		14	14				
Lane Width (ft)		7	7

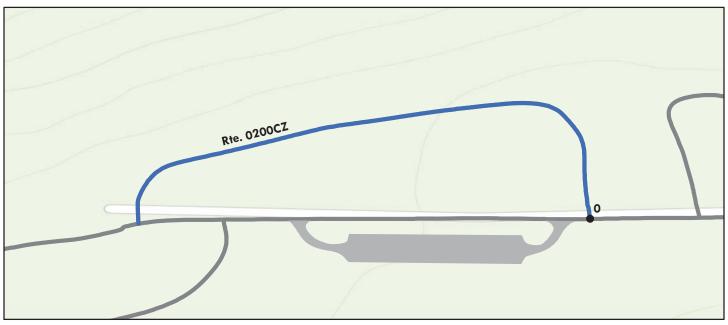
ROUTE 0200CZ: WHITE RIVER CAMPGROUND LOOP C

Route (Condition Legend – Pav	ement Condi	tion Rating (Po	CR)		
Poor (0 - 60	_		(85 - 94)	Excellent (95		Not Rat	ed
		See Appendix for def	initions and f	ormulas			
Inspection Date:	8/8/2015	Beginning Section MP	0				
Paved Length (Mile	es): 0.18	Section Length (MI)	0.18				
Surface Type:	ASPHALT	Route Summary					
Roadway Condition	n Information						
Pavement Conditio	n Rating (PCR)	95	95				
Surface Condition R	ating (SCR)	95	95				
Roughness Condition	n Index (RCI)	N/A	N/A				
Distress Index Value	es						
Structural Crack In-	dex	95	95				
Alligator Crack Ind	lex	100	100				
Longitudinal Crack	Index	95	95				
Transverse Crackin	g Index	99	99				
Patching Index		100	100				
Rutting Index		97	97				
International Rough	hness Index (IRI)	N/A	N/A				
Lane & Width Info	rmation						
Number of Lanes		1	1				
Paved Width (ft)		12.5	12.5				
Lane Width (ft)		12.5	12.5

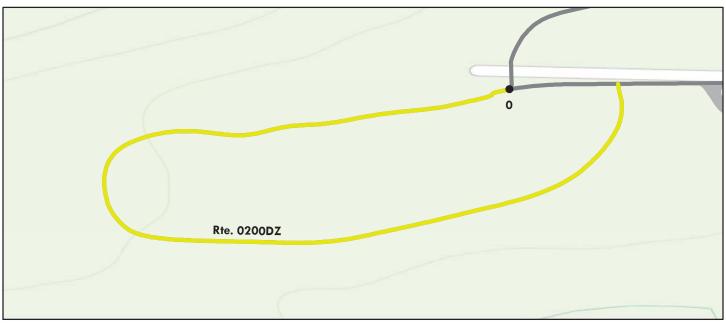
ROUTE 0200DZ: WHITE RIVER CAMPGROUND LOOP D

Route (Condition Legend – Pav	ement Condi	ition Rating (PCR)		
Poor (0 - 60			(85 - 94)	Excellent (9		Not Ra	ted
		See Appendix for def	1				
Inspection Date:	8/8/2015	Beginning Section MP	0				
Paved Length (Mile	es): 0.26	Section Length (MI)	0.26				
Surface Type:	ASPHALT	Route Summary					
Roadway Condition	n Information						
Pavement Conditio	on Rating (PCR)	80	80				
Surface Condition R	tating (SCR)	80	80				
Roughness Conditio	n Index (RCI)	N/A	N/A				
Distress Index Valu	es						
Structural Crack In	dex	96	96				
Alligator Crack Inc	lex	100	100				
Longitudinal Crack	Index	96	96				
Transverse Crackin	ig Index	80	80				
Patching Index		100	100				
Rutting Index		93	93				
International Rough	hness Index (IRI)	N/A	N/A				
Lane & Width Info	rmation						
Number of Lanes		1	1				
Paved Width (ft)		12	12				
Lane Width (ft)		12	12

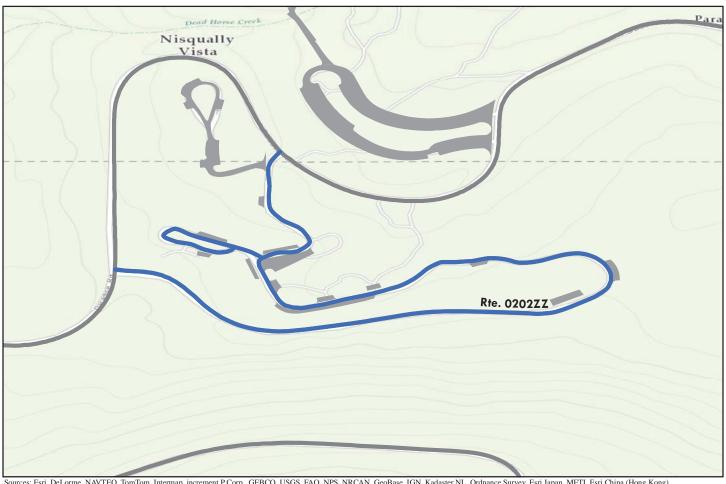
ROUTE 0202ZZ: PARADISE PICNIC AREA ROADS

Note: The weighted average summary PCR value is calculated from only the sections of road where the PCR was collected. The overall PCR for the summary

route may not reflect indiv	iduai subcomponent rat	mgs.								
	Route Condition Legend – Pavement Condition Rating (PCR)									
Poor (0 - 60)	Fair (6)	1-84)	Good	(85 - 94)	Excellent (Excellent (95 - 100)		ted		
		See Appen	dix for def	initions and f	ormulas					
Inspection Date:	8/9/2015									
Paved Length (Miles)): 0.86									
Surface Type:	ASPHALT	Route Sumn	nary		•					
Roadway Condition I	Information									
Pavement Condition	Rating (PCR)	97								
Lane & Width Inform	nation									
Number of Lanes		1								
Paved Width (ft)		18.1	1							
Lane Width (ft)		16.4	4

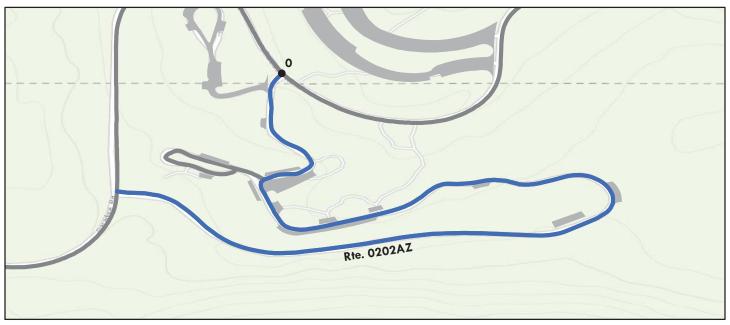
ROUTE 0202AZ: PARADISE PICNIC AREA ROAD

Route (Condition Legend – Pav	ement Condi	ition Rating (PCR)		
Poor (0 - 60			(85 - 94)	Excellent (9		Not Ra	ted
		See Appendix for def	,				
Inspection Date:	8/9/2015	Beginning Section MP	0				
Paved Length (Mile	es): 0.75	Section Length (MI)	0.75				
Surface Type:	ASPHALT	Route Summary					
Roadway Condition	Information						
Pavement Condition	n Rating (PCR)	97	97				
Surface Condition R	ating (SCR)	97	97				
Roughness Condition	n Index (RCI)	N/A	N/A				
Distress Index Value	es						
Structural Crack Inc	dex	100	100				
Alligator Crack Ind	lex	100	100				
Longitudinal Crack	Index	100	100				
Transverse Crackin	g Index	100	100				
Patching Index		100	100				
Rutting Index		97	97				
International Rough	nness Index (IRI)	N/A	N/A				
Lane & Width Info	rmation						
Number of Lanes		1	1				
Paved Width (ft)		18.8	18.8				
Lane Width (ft)		17.1	17.1

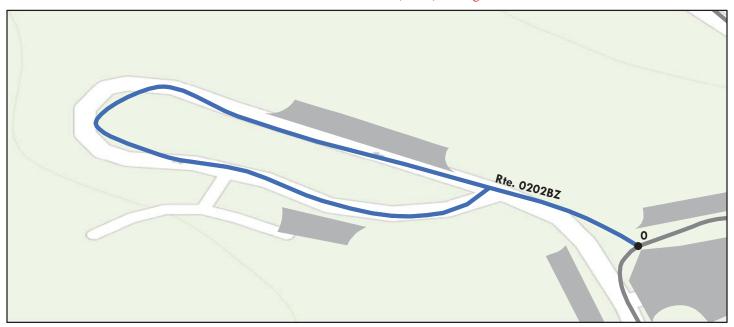
ROUTE 0202BZ: PARADISE PICNIC AREA LOOP

Route (Condition Legend – Pav	ement Condi	ition Rating (PCR)		
Poor (0 - 6			(85 - 94)	Excellent (•	Not Rat	ted
		See Appendix for def	initions and f	ormulas			
Inspection Date:	8/8/2015	Beginning Section MP	0				
Paved Length (Mile	es): 0.12	Section Length (MI)	0.12				
Surface Type:	ASPHALT	Route Summary					
Roadway Condition	n Information						
Pavement Condition	on Rating (PCR)	98	98				
Surface Condition R	Rating (SCR)	98	98				
Roughness Condition	on Index (RCI)	N/A	N/A				
Distress Index Valu	es						
Structural Crack In	ıdex	100	100				
Alligator Crack Inc	dex	100	100				
Longitudinal Crack	Index	100	100				
Transverse Crackin	ng Index	100	100				
Patching Index		100	100				
Rutting Index		98	98				
International Roug	hness Index (IRI)	N/A	N/A				
Lane & Width Info	rmation						
Number of Lanes		1	1				
Paved Width (ft)		13.8	13.8				
Lane Width (ft)		11.9	11.9

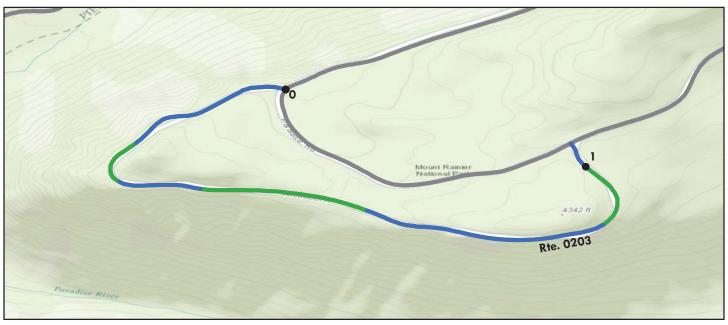
ROUTE 0203: MILLER CUT OFF / RICKSECKER POINT LOOP ROAD

Data Collection Vehicle (DCV) Rating

Route (Condition Legen	d – Pavement Cond	ition Rating (PCR)		
Poor (0 - 60)	Fair (6		Good (85 - 94)	Excellent (Not Rated	
		See Appendix	for definitions and f	ormulas			
Inspection Date: 8/8//	2015	Beginning Secti	on MP 0	1			
Paved Length (Miles): 1.05		Section Length	(MI) 1	0.05			
Surface Type: ASF	HALT	Route Summar	y			•	
Roadway Condition Inform	nation						
Pavement Condition Rating	g (PCR)	93	93	96			
Surface Condition Rating (S	CR)	97	97	96			
Roughness Condition Index	(RCI)	86	86	N/A			
Distress Index Values							
Structural Crack Index		100	100	100			
Alligator Crack Index		100	100	100			
Longitudinal Crack Index		100	100	100			
Transverse Cracking Index		100	100	100			
Patching Index		99	99	100			
Rutting Index		97	97	96			
International Roughness In	dex (IRI)	151	150	N/A			
Lane & Width Information	1						
Number of Lanes		1	1	1			
Paved Width (ft)		19.6	19.7	18.4			
Lane Width (ft)		14.4	14.5	13.1

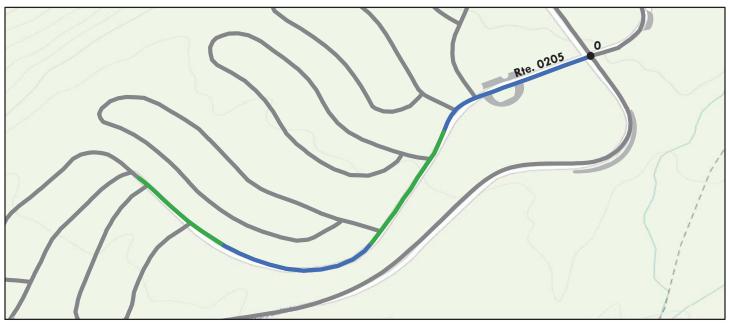
ROUTE 0205: COUGAR ROCK CAMPGROUND ENTRANCE ROAD

Data Collection Vehicle (DCV) Rating

Route (Condition Legend – Pav	ement Condi	ition Rating (PCR)		
Poor (0 - 60			(85 - 94)	Excellent (Not Ra	ted
		See Appendix for def	initions and f	ormulas			
Inspection Date:	8/9/2015	Beginning Section MP	0				
Paved Length (Mile	es): 0.38	Section Length (MI)	0.38				
Surface Type:	ASPHALT	Route Summary					
Roadway Condition	n Information						
Pavement Condition	on Rating (PCR)	96	96				
Surface Condition R	Rating (SCR)	96	96				
Roughness Condition	on Index (RCI)	N/A	N/A				
Distress Index Valu	es						
Structural Crack In	ıdex	100	100				
Alligator Crack Inc	dex	100	100				
Longitudinal Crack	c Index	100	100				
Transverse Crackir	ng Index	100	100				
Patching Index		96	96				
Rutting Index		97	97				
International Roug	hness Index (IRI)	N/A	N/A				
Lane & Width Info	rmation						
Number of Lanes		2	2				
Paved Width (ft)		21	21				
Lane Width (ft)		10.9	10.9

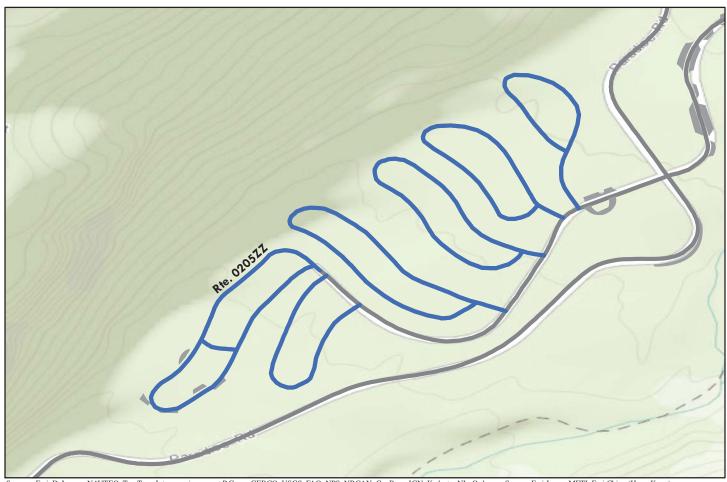
ROUTE 0205ZZ: COUGAR ROCK CAMPGROUND LOOPS

Summary Route

Note: The weighted average summary PCR value is calculated from only the sections of road where the PCR was collected. The overall PCR for the summary route may not reflect individual subcomponent ratings.

oute may not renect individual subcomponent ratings.									
	Route Condition Legend – Pavement Condition Rating (PCR)								
Poor (0 - 60)	Fair (61	Good Good		(85 - 94)	Excellent (95 - 100)		Not Ra	ted	
		See Appen	dix for def	initions and f	ormulas	_			
Inspection Date:	8/9/2015								
Paved Length (Miles)	: 1.97								
Surface Type:	ASPHALT	Route Summ	ary						
Roadway Condition I	Information								
Pavement Condition	Rating (PCR)	96							
Lane & Width Inform	nation								
Number of Lanes		1							
Paved Width (ft)		13.1							
Lane Width (ft)		12.7	1

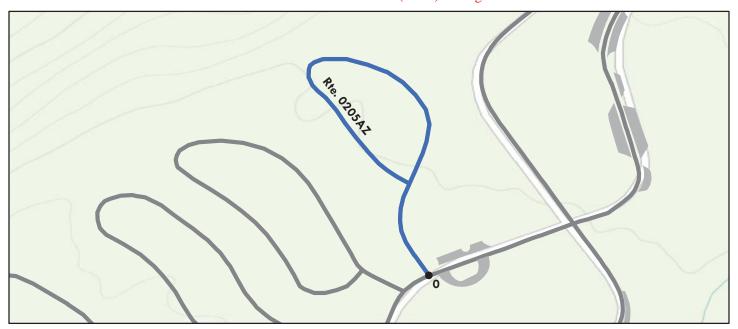
ROUTE 0205AZ: COUGAR ROCK CAMPGROUND LOOPA

Subcomponent of Route MORA-0205ZZ Data Collection Vehicle (DCV) Rating

Route (Condition Legend – Pav	ement Condi	ition Rating (PCR)		
Poor (0 - 60			(85 - 94)	Excellent (9		Not Ra	ted
		See Appendix for def	,				
Inspection Date:	8/9/2015	Beginning Section MP	0				
Paved Length (Mile	es): 0.26	Section Length (MI)	0.26				
Surface Type:	ASPHALT	Route Summary					
Roadway Condition	Information						
Pavement Conditio	n Rating (PCR)	96	96				
Surface Condition R	ating (SCR)	96	96				
Roughness Condition	n Index (RCI)	N/A	N/A				
Distress Index Value	es						
Structural Crack In-	dex	100	100				
Alligator Crack Ind	lex	100	100				
Longitudinal Crack	Index	100	100				
Transverse Crackin	g Index	100	100				
Patching Index		99	99				
Rutting Index		96	96				
International Rough	nness Index (IRI)	N/A	N/A				
Lane & Width Info	rmation						
Number of Lanes		1	1				
Paved Width (ft)		14.1	14.1				
Lane Width (ft)		11.7	11.7

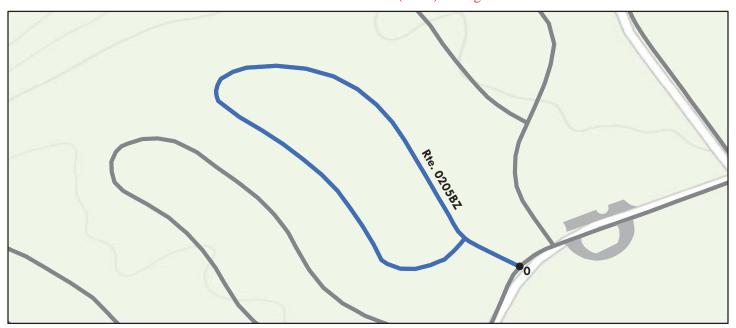
ROUTE 0205BZ: COUGAR ROCK CAMPGROUND LOOP B

Subcomponent of Route MORA-0205ZZ Data Collection Vehicle (DCV) Rating

Route (Condition Legend – Pav	ement Condi	ition Rating (PCR)		
Poor (0 - 60			(85 - 94)	Excellent (9		Not Ra	ted
		See Appendix for def	1				
Inspection Date:	8/9/2015	Beginning Section MP	0				
Paved Length (Mile	es): 0.29	Section Length (MI)	0.29				
Surface Type:	ASPHALT	Route Summary					
Roadway Condition	Information						
Pavement Conditio	n Rating (PCR)	96	96				
Surface Condition R	ating (SCR)	96	96				
Roughness Condition	n Index (RCI)	N/A	N/A				
Distress Index Value	es						
Structural Crack In-	dex	100	100				
Alligator Crack Ind	lex	100	100				
Longitudinal Crack	Index	100	100				
Transverse Crackin	g Index	100	100				
Patching Index		100	100				
Rutting Index		96	96				
International Rough	nness Index (IRI)	N/A	N/A				
Lane & Width Info	rmation						
Number of Lanes		1	1				
Paved Width (ft)		13.1	13.1				
Lane Width (ft)		12.3	12.3

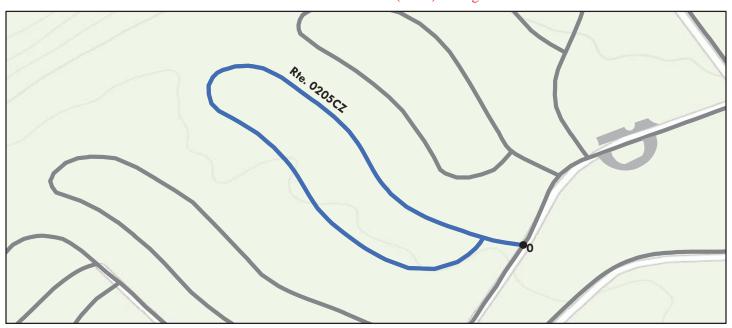
ROUTE 0205CZ: COUGAR ROCK CAMPGROUND LOOP C

Data Collection Vehicle (DCV) Rating

Route (Condition Legend – Pav	ement Condi	ition Rating (PCR)		
Poor (0 - 60	_		(85 - 94)	Excellent (9		Not Ra	ted
		See Appendix for def	,				
Inspection Date:	8/9/2015	Beginning Section MP	0				
Paved Length (Mile	es): 0.34	Section Length (MI)	0.34				
Surface Type:	ASPHALT	Route Summary					
Roadway Condition	Information						
Pavement Conditio	n Rating (PCR)	96	96				
Surface Condition R	ating (SCR)	96	96				
Roughness Condition	n Index (RCI)	N/A	N/A				
Distress Index Value	es						
Structural Crack Inc	dex	100	100				
Alligator Crack Ind	lex	100	100				
Longitudinal Crack	Index	100	100				
Transverse Crackin	g Index	99	99				
Patching Index		98	98				
Rutting Index		96	96				
International Rough	nness Index (IRI)	N/A	N/A				
Lane & Width Info	rmation						
Number of Lanes		1	1				
Paved Width (ft)		13.1	13.1				
Lane Width (ft)		13.1	13.1

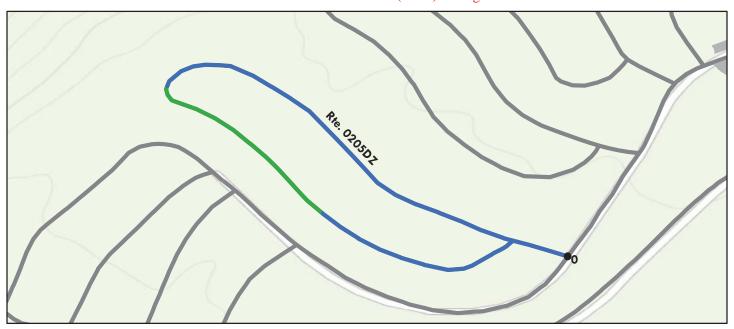
ROUTE 0205DZ: COUGAR ROCK CAMPGROUND LOOP D

Subcomponent of Route MORA-0205ZZ Data Collection Vehicle (DCV) Rating

Route (Condition Legend – Pav	ement Condi	ition Rating (PCR)		
Poor (0 - 60			(85 - 94)	Excellent (Not Ra	ted
		See Appendix for def	initions and f	ormulas			
Inspection Date:	8/9/2015	Beginning Section MP	0				
Paved Length (Mile	es): 0.4	Section Length (MI)	0.4				
Surface Type:	ASPHALT	Route Summary					
Roadway Condition	n Information						
Pavement Condition	on Rating (PCR)	97	97				
Surface Condition R	Rating (SCR)	97	97				
Roughness Condition	on Index (RCI)	N/A	N/A				
Distress Index Valu	es						
Structural Crack In	ıdex	100	100				
Alligator Crack Inc	dex	100	100				
Longitudinal Crack	Index	100	100				
Transverse Crackin	ng Index	100	100				
Patching Index		100	100				
Rutting Index		97	97				
International Roug	hness Index (IRI)	N/A	N/A				
Lane & Width Info	rmation						
Number of Lanes		1	1				
Paved Width (ft)		14	14				
Lane Width (ft)		14	14

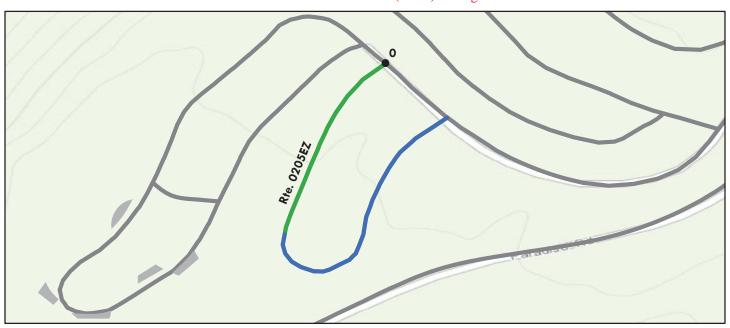
ROUTE 0205EZ: COUGAR ROCK CAMPGROUND LOOP E

Data Collection Vehicle (DCV) Rating

Route (Condition Legend – Pav	ement Condi	ition Rating (PCR)		
Poor (0 - 60	_		(85 - 94)	Excellent (9		Not Ra	ted
		See Appendix for def	,				
Inspection Date:	8/9/2015	Beginning Section MP	0				
Paved Length (Miles	s): 0.23	Section Length (MI)	0.23				
Surface Type:	ASPHALT	Route Summary					
Roadway Condition	Information						
Pavement Condition	n Rating (PCR)	95	95				
Surface Condition Ra	ating (SCR)	95	95				
Roughness Condition	n Index (RCI)	N/A	N/A				
Distress Index Value	es						
Structural Crack Inc	dex	100	100				
Alligator Crack Ind	ex	100	100				
Longitudinal Crack	Index	100	100				
Transverse Cracking	g Index	100	100				
Patching Index		100	100				
Rutting Index		95	95				
International Rough	nness Index (IRI)	N/A	N/A				
Lane & Width Infor	mation						
Number of Lanes		1	1				
Paved Width (ft)		12.2	12.2				
Lane Width (ft)		12.2	12.2

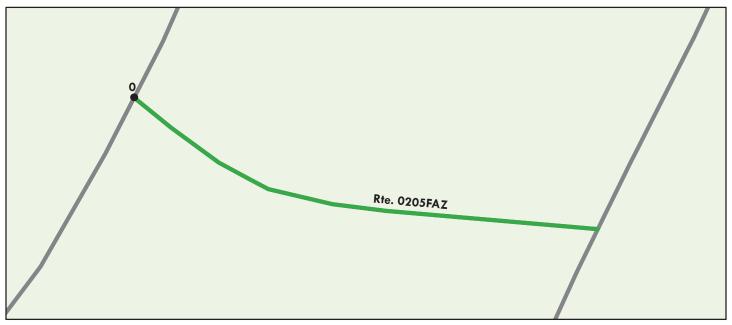
ROUTE 0205FAZ: COUGAR ROCK CAMPGROUND LOOP F BISECTOR

Subcomponent of Route MORA-0205ZZ Data Collection Vehicle (DCV) Rating

Route (Condition Legend – Pav	ement Condi	tion Rating (P	CR)		
Poor (0 - 60			(85 - 94)	Excellent (95		Not Rat	ted
		See Appendix for def	1				
Inspection Date:	8/9/2015	Beginning Section MP	0				
Paved Length (Mile	es): 0.02	Section Length (MI)	0.02				
Surface Type:	ASPHALT	Route Summary					
Roadway Condition	n Information						
Pavement Conditio	n Rating (PCR)	93	93				
Surface Condition R	tating (SCR)	93	93				
Roughness Conditio	n Index (RCI)	N/A	N/A				
Distress Index Valu	es						
Structural Crack In	dex	100	100				
Alligator Crack Ind	lex	100	100				
Longitudinal Crack	Index	100	100				
Transverse Crackin	ig Index	100	100				
Patching Index		100	100				
Rutting Index		93	93				
International Rough	hness Index (IRI)	N/A	N/A				
Lane & Width Info	rmation						
Number of Lanes		1	1				
Paved Width (ft)		12.6	12.6				
Lane Width (ft)		12.6	12.6

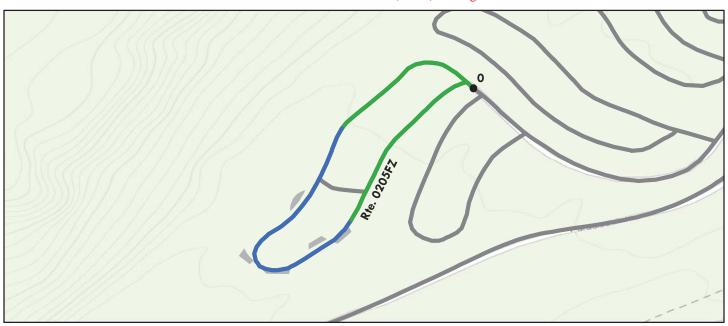
ROUTE 0205FZ: COUGAR ROCK CAMPGROUND LOOP F

Subcomponent of Route MORA-0205ZZ Data Collection Vehicle (DCV) Rating

Route (Condition Legend – Pav	ement Condi	ition Rating (PC	CR)		
Poor (0 - 60			(85 - 94)	Excellent (95		Not Rated	
		See Appendix for def	,				
Inspection Date:	8/9/2015	Beginning Section MP	0				
Paved Length (Mile	es): 0.43	Section Length (MI)	0.43				
Surface Type:	ASPHALT	Route Summary					
Roadway Condition	n Information						
Pavement Conditio	on Rating (PCR)	95	95				
Surface Condition R	Rating (SCR)	95	95				
Roughness Conditio	on Index (RCI)	N/A	N/A				
Distress Index Valu	es						
Structural Crack In	dex	100	100				
Alligator Crack Inc	lex	100	100				
Longitudinal Crack	Index	100	100				
Transverse Crackin	ng Index	100	100				
Patching Index		95	95				
Rutting Index		95	95				
International Rough	hness Index (IRI)	N/A	N/A				
Lane & Width Info	rmation						
Number of Lanes		1	1				
Paved Width (ft)		12.2	12.2				
Lane Width (ft)		12.2	12.2

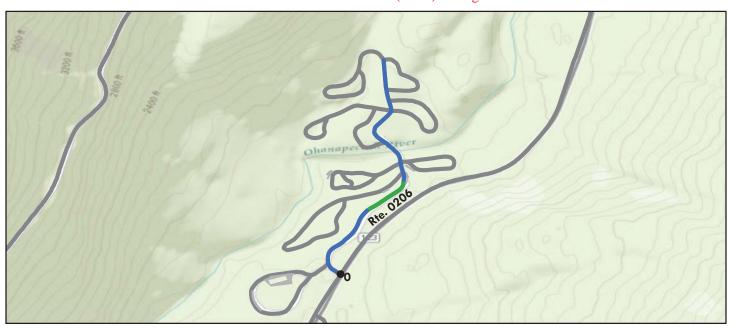
ROUTE 0206: OHANA CAMPGROUND ENTRANCE ROAD

Data Collection Vehicle (DCV) Rating

Route (Condition Legend – Pav	ement Condi	ition Rating (F	PCR)		
Poor (0 - 60	_		(85 - 94)	Excellent (9		Not Ra	ted
,		See Appendix for def	1				
Inspection Date:	8/8/2015	Beginning Section MP	0				
Paved Length (Mile	es): 0.64	Section Length (MI)	0.64				
Surface Type:	ASPHALT	Route Summary					
Roadway Condition	Information						
Pavement Condition	n Rating (PCR)	96	96				
Surface Condition R	ating (SCR)	96	96				
Roughness Condition	n Index (RCI)	N/A	N/A				
Distress Index Value	es						
Structural Crack Inc	dex	100	100				
Alligator Crack Ind	lex	100	100				
Longitudinal Crack	Index	100	100				
Transverse Crackin	g Index	100	100				
Patching Index		99	99				
Rutting Index		96	96				
International Rough	nness Index (IRI)	N/A	N/A				
Lane & Width Info	rmation						
Number of Lanes		2	2				
Paved Width (ft)		21.8	21.8				
Lane Width (ft)		11.3	11.3

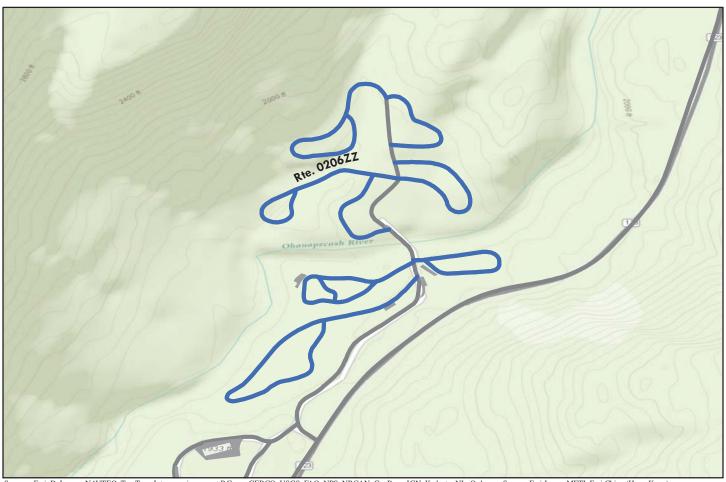
ROUTE 0206ZZ: OHANA CAMPGROUND LOOPS

Summary Route

Note: The weighted average summary PCR value is calculated from only the sections of road where the PCR was collected. The overall PCR for the summary route may not reflect individual subcomponent ratings.

route may not reflect indivi	iduai subcomponent rai	mgs.								
	Route C	Condition Leg	gend – Pav	ement Condi	ition Rating (PCR)				
Poor (0 - 60)	Fair (6)	1- 84)	Good	(85 - 94)	Excellent (95 - 100)	Not Ra	ted		
	See Appendix for definitions and formulas									
Inspection Date:	8/8/2015									
Paved Length (Miles): 2.08										
Surface Type:										
Roadway Condition I	nformation									
Pavement Condition	Rating (PCR)	96								
Lane & Width Inform	nation									
Number of Lanes		1								
Paved Width (ft)		13.	7							
Lane Width (ft)		11.	8
